ProSpec Home Inspection of Long Island Property Inspection Report

2 Barry Dr, E. Northport, NY 11731
Inspection prepared for:
Date of Inspection: 6/12/2020 Time: 9:00 AM
Age of Home: unknown Size: 2,800 sq.ft.
Weather: Sunny, 79 F
Home completely renovated in 2007.

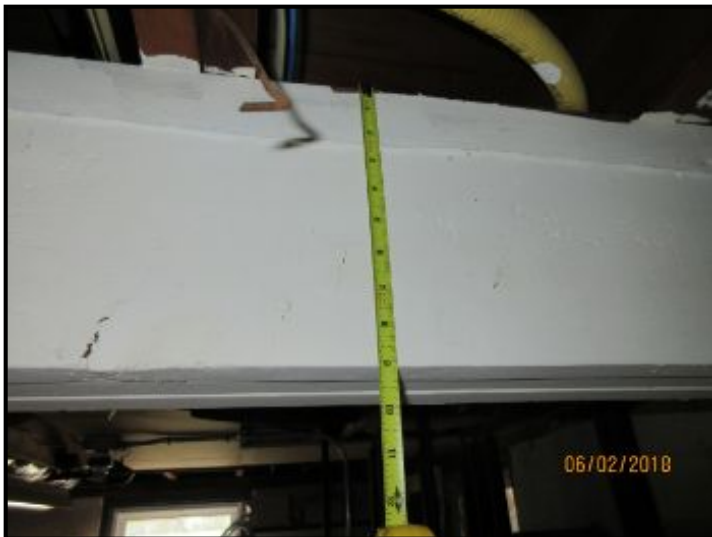
Floor Structure: 9x5 Wood main beam supported by steel lally columns, 2x8 Joists 16" O.C. (w/cross braces), T&G floor boards.

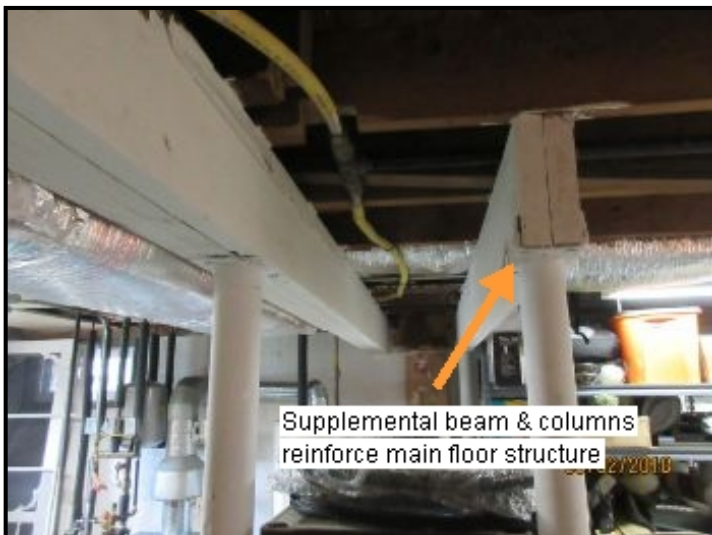
Floor Structure: 9x5 Wood main beam supported by steel lally columns, Supplemental beam and columns noted.

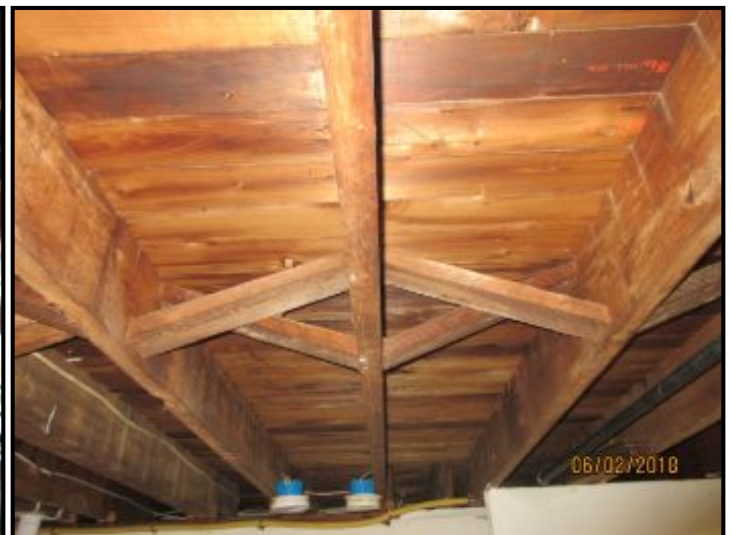
Floor Structure: 2x8 Joists 16" O.C. (w/cross braces), T&G floor boards.

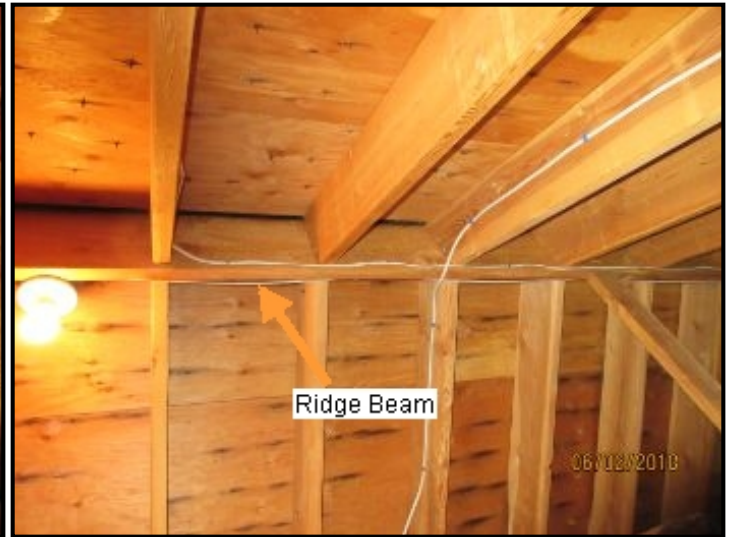
Roof Structure: 2x8 Rafters 16" O.C. w/collar-ties, 2x10 ridge beam, Plywood roof boards.

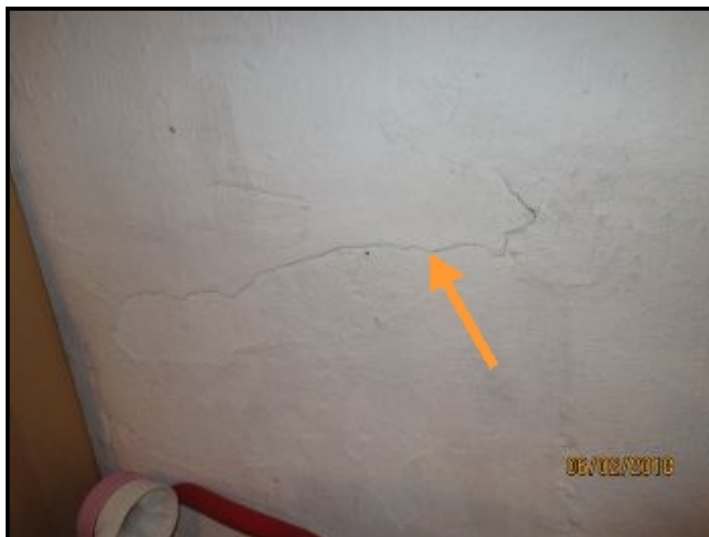
Flakes of concrete detached from the interior surface of the concrete foundation walls appeared to be caused by the effect of moisture diffusing through the foundation wall upon pockets of minerals in the concrete. This condition was limited in scope and will not affect the structural integrity of the foundation wall. It does indicate that some amount of moisture from the soil is finding its way through the wall, indicating some level of failure of the system(s) typically installed to prevent this condition. Interior foundation wall surfaces have been painted with masonry waterproofing paint.

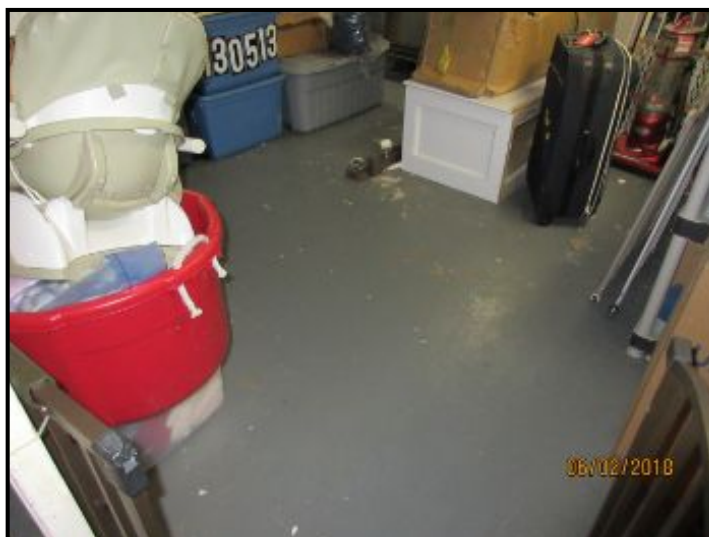
At the time of the inspection, the Inspector observed no deficiencies in the condition of the visible portions of the concrete floor slab -- In normal condition for its age.

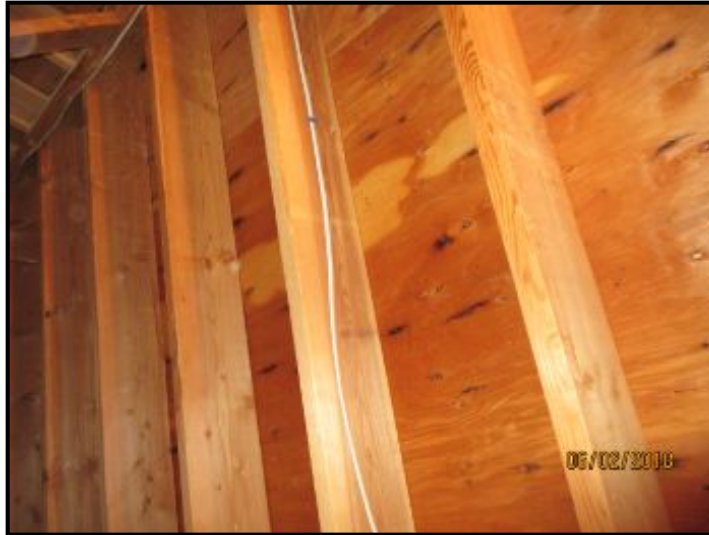
No evidence of moisture penetration at visible portions of the roof structure were observed at time of inspection.

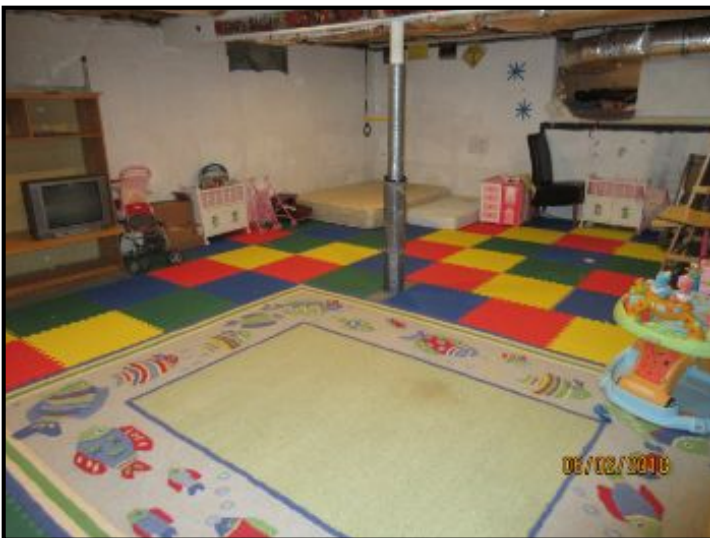
- At the time of the inspection, the Inspector observed no deficiencies in the condition of the unfinished basement area. Inspection of unfinished basements typically includes evaluation of:
 - Basement floor
 - Foundation walls
 - Structure (floor, walls & ceiling)
 - Plumbing (water, sewer, gas and any sump pumps)
 - Electrical
 - Provisions for egress
 - **HVAC** (ducts and any equipment)
- Some areas of the basement were not visible due to the occupant's belongings. The Inspector recommends inspection of these portions of the basement for notable defects once access has been provided prior to close.

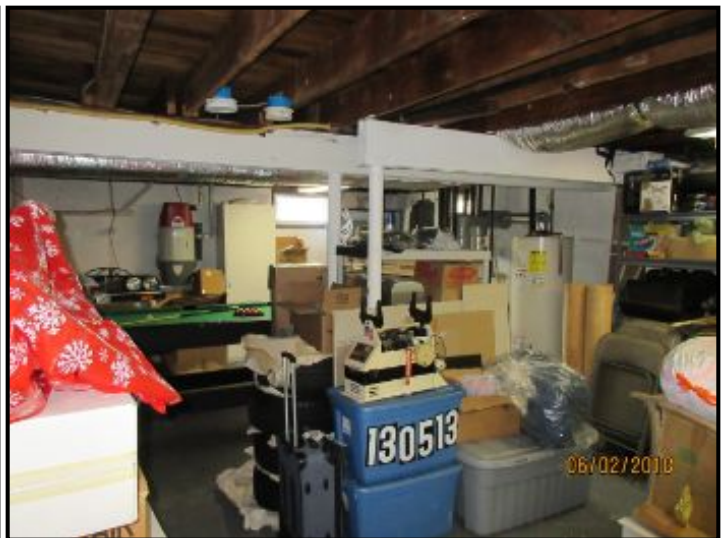
Some areas of the basement were not visible due to the occupant's belongings. The Inspector recommends inspection of these portions of the basement for notable defects once access has been provided prior to close.

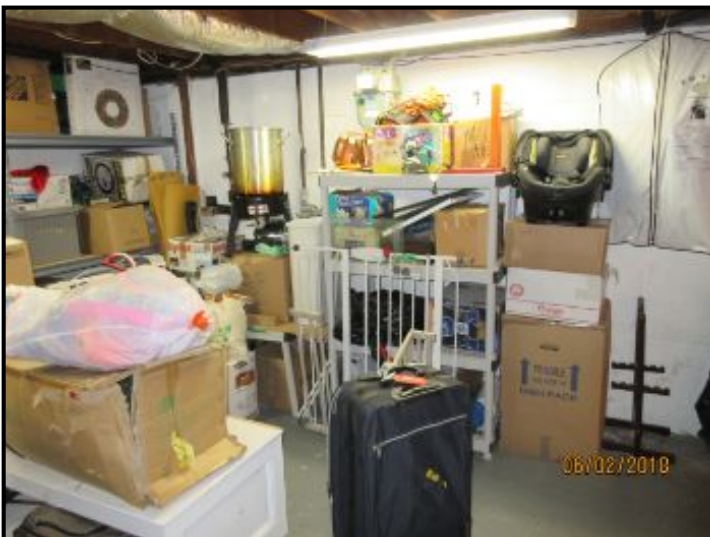
Some areas of the basement were not visible due to the occupant's belongings. The Inspector recommends inspection of these portions of the basement for notable defects once access has been provided prior to close.

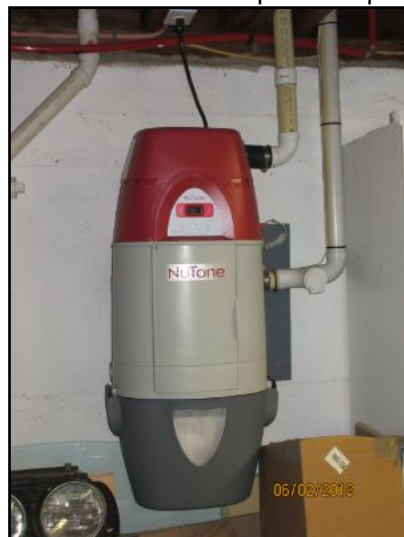
Central vacuum system was operated during inspection.

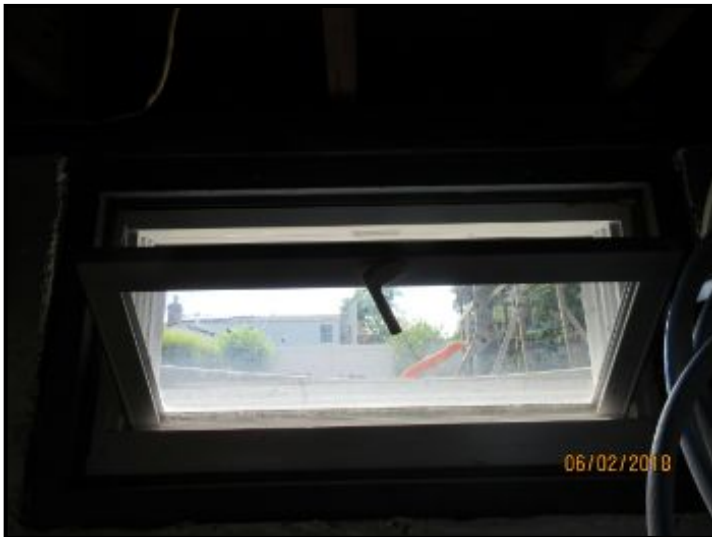
Vinyl framed Hopper windows noted. Operated windows appeared functional.

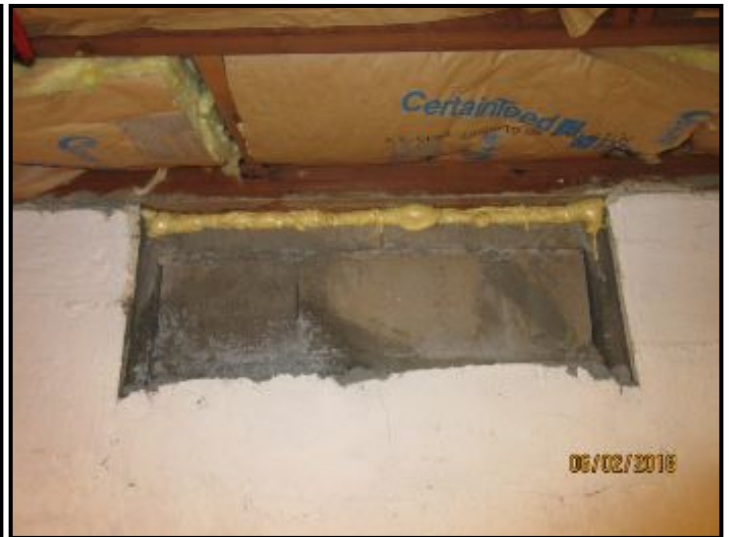
Basement window opening infilled during 2007 renovation/expansion.

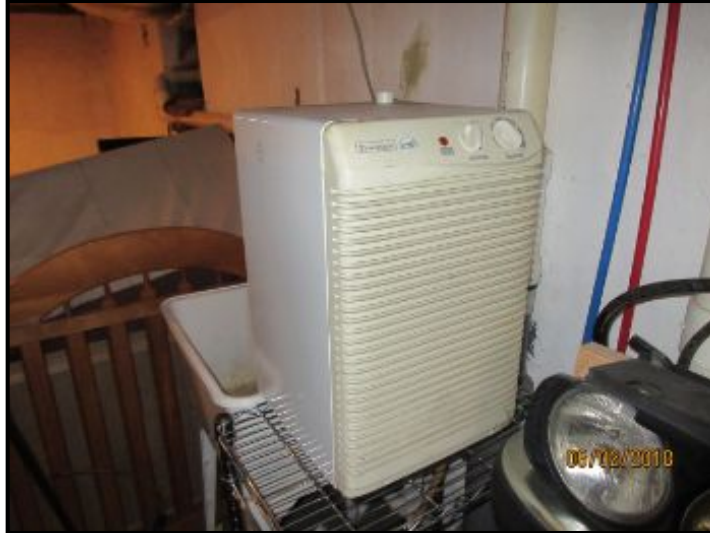
Humidity Control: It is advised to use a Dehumidifier to maintain lower humidity levels and to prevent bio-growth in the basement. Acceptable levels are 45-55% during the cooling season and 35-45% during the heating season. Modern dehumidifiers are equipped with a humidity gauge to monitor humidity levels.

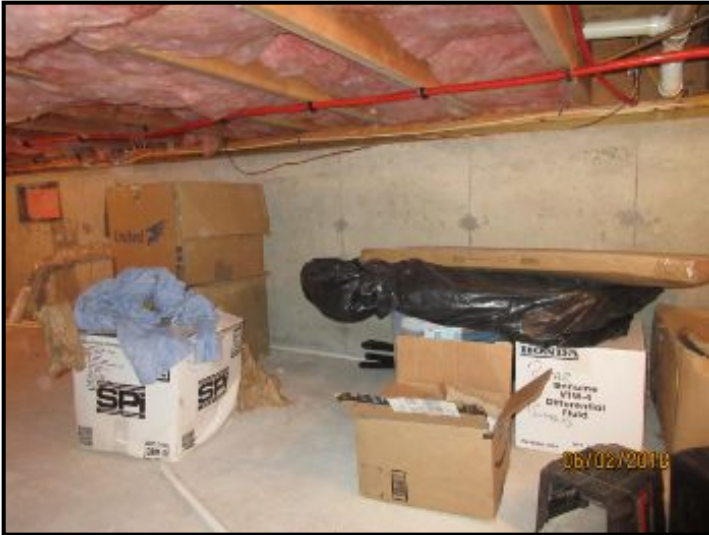
- Partial Crawlspace (rear addition structure only)
- Readily accessible
- Crawlspace access via wall opening in basement.
- Conditions inspected: crawled in space
- Crawlspace floor is concrete.
- Dampness: None observed

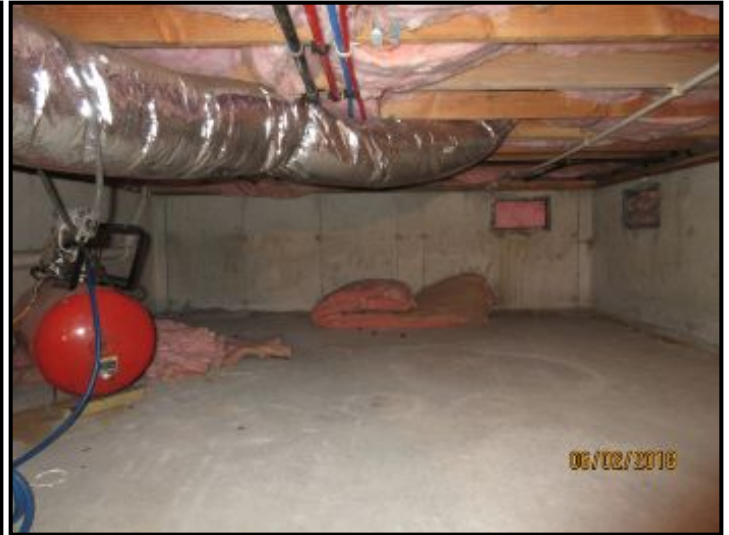
Crawlspace floor is concrete. Dampness: None observed

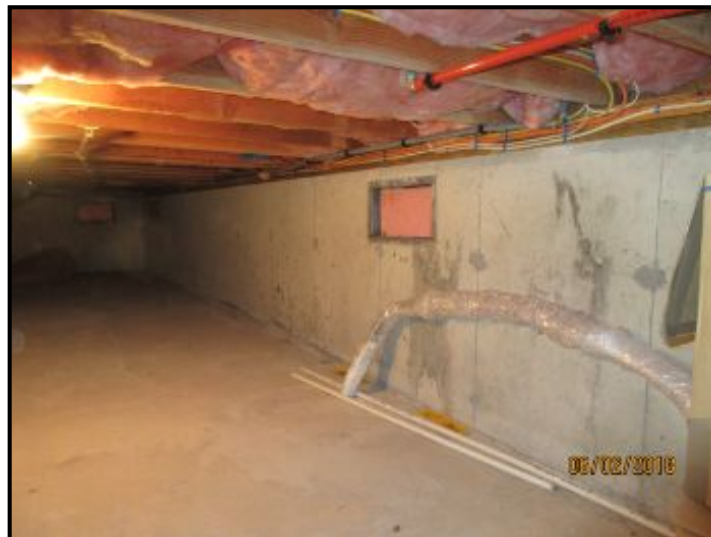
No evidence of moisture penetration observed at the visible portions of the foundation wall at the time of inspection.

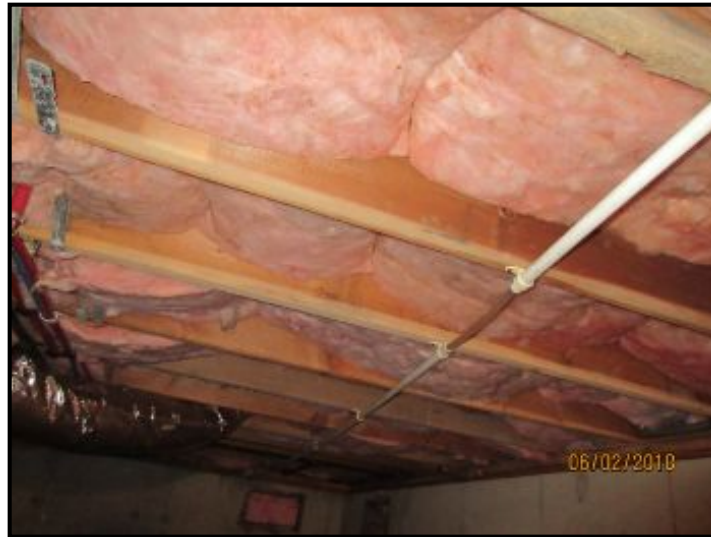
Unfinished fiberglass batts noted in joist cavities and perimeter joist bays.

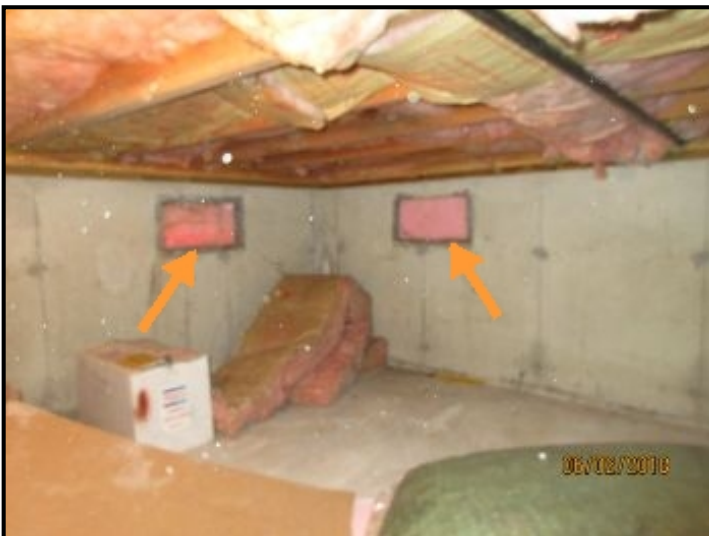
Screened vents noted at foundation walls.

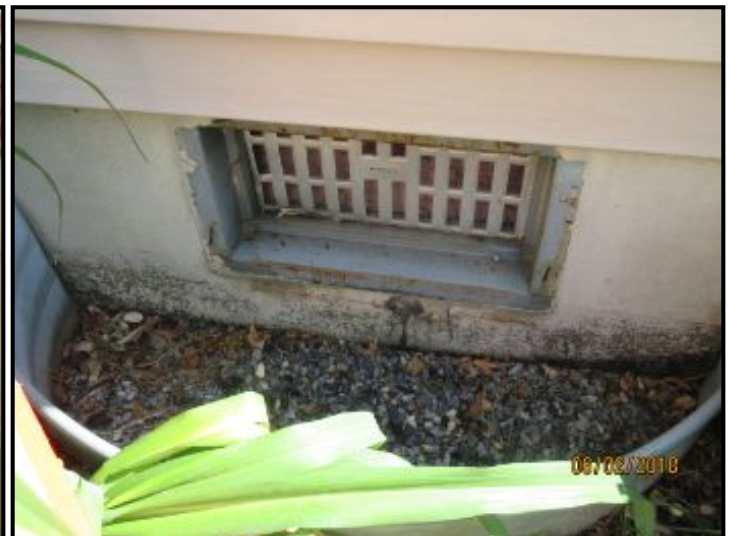
Screened vents noted at foundation walls.

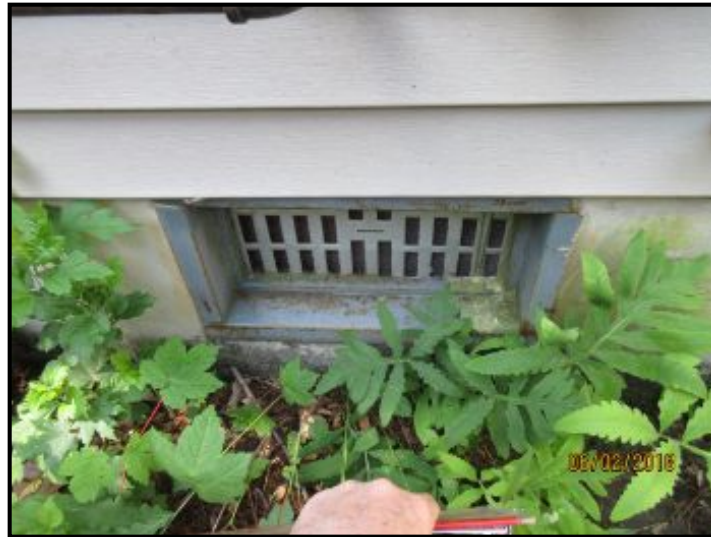
Screened vents noted at foundation walls.

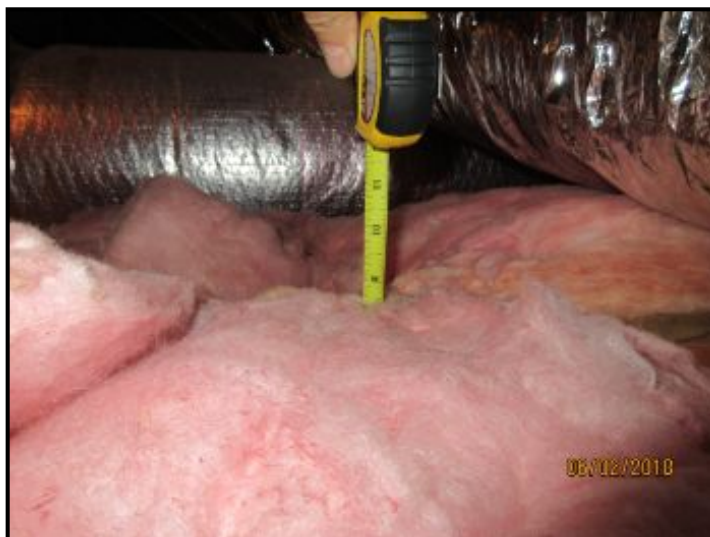
Insulation depth varies 9+ inches (R-31 overall); Good Insulation.

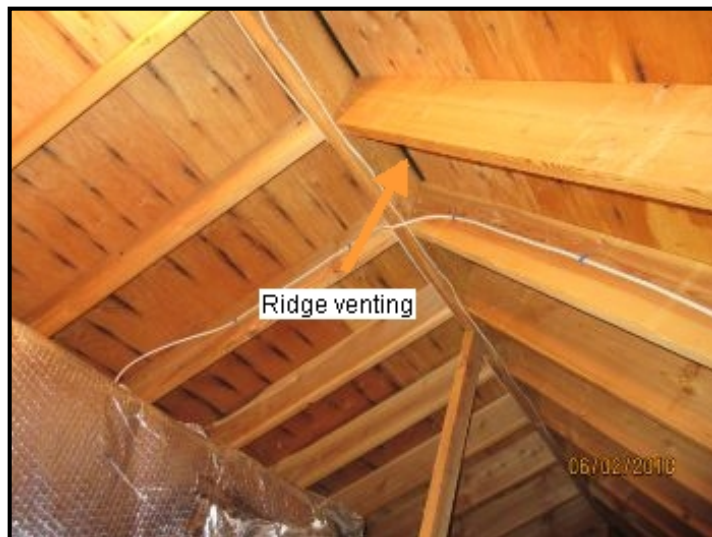
Ridge exhaust venting noted

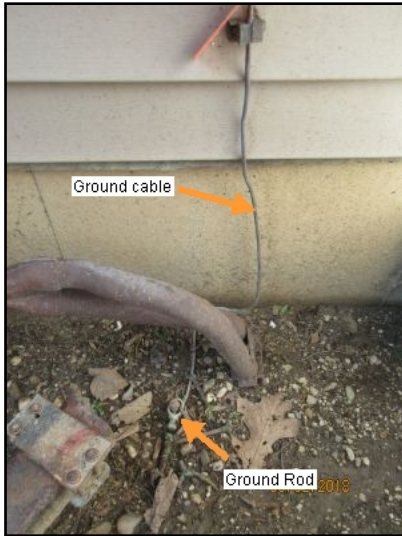
Grounding rod and cable bonding noted at service entrance.

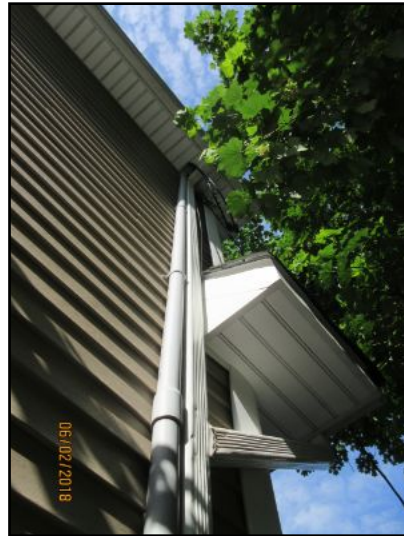
Tree branches in close proximity to electrical service drop cable, recommend trimming back tree branches.

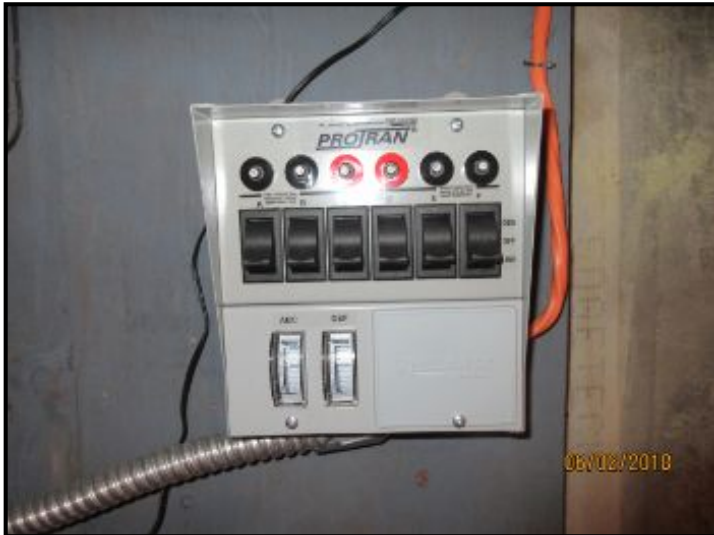
The home had provisions to connect a portable backup generator to provide the home with electricity when power is not available from public utilities. Inspection of backup generators and their electrical components lies beyond the scope of the General Home Inspection. The Inspector recommends that before the expiration of your Inspection Objection Deadline you have this backup system inspected by a qualified electrical contractor.

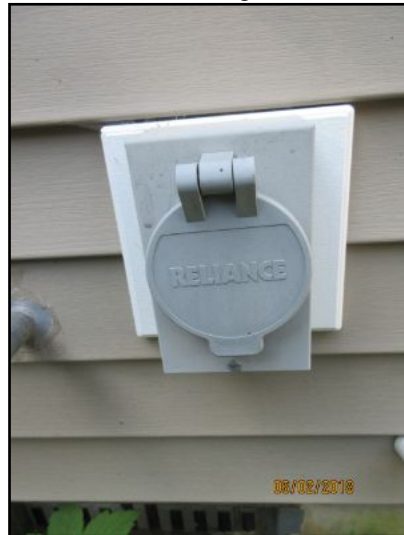
The home had provisions to connect a portable backup generator to provide the home with electricity when power is not available from public utilities. Inspection of backup generators and their electrical components lies beyond the scope of the General Home Inspection. The Inspector recommends that before the expiration of your Inspection Objection Deadline you have this backup system inspected by a qualified electrical contractor.

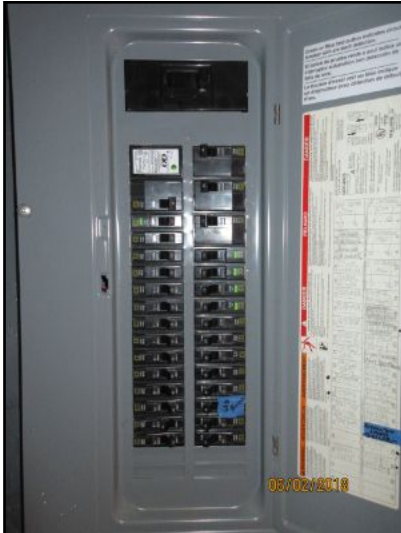
Main Panel (40 spaces): 4 - Spare circuit breaker space(s) noted.

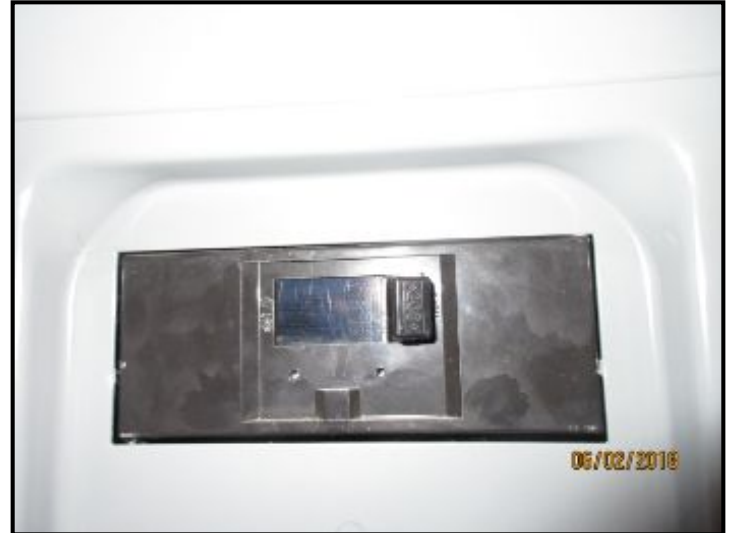
Main Disconnect: 200 amp main breaker serves the property.

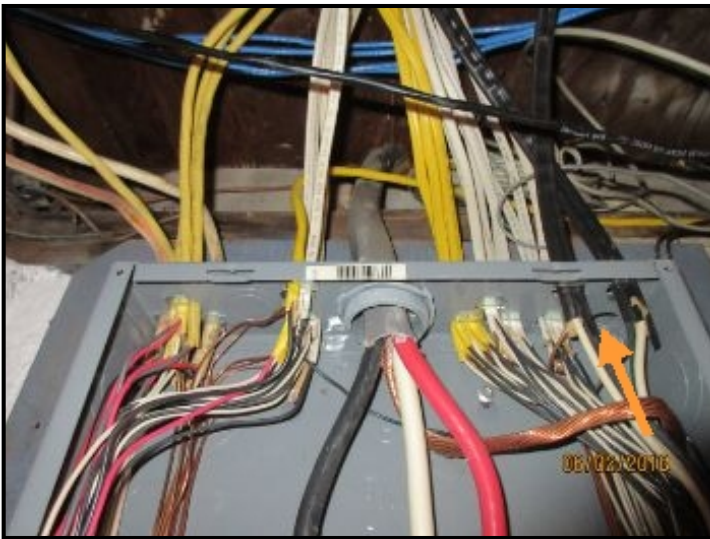
Unused knockouts should be blanked off to prevent vermin from entering the panel box.

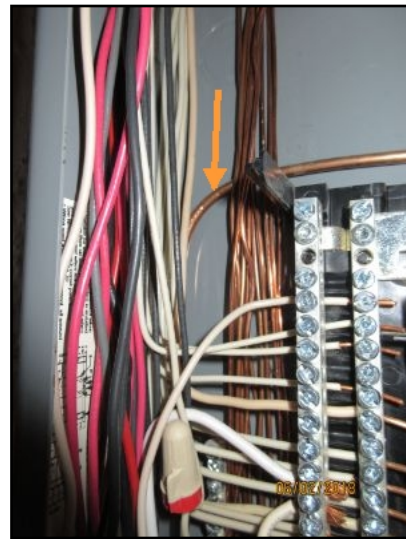
Ground wire connection at neutral bus noted. Have electrician ensure that ground is continuous.

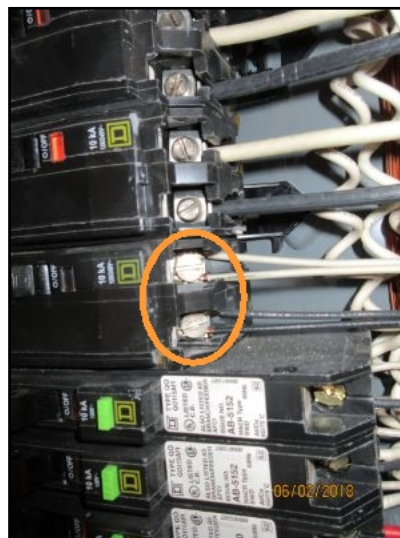
Double Tapped Breaker observed inside panel box (more than one electrical conductor attached).

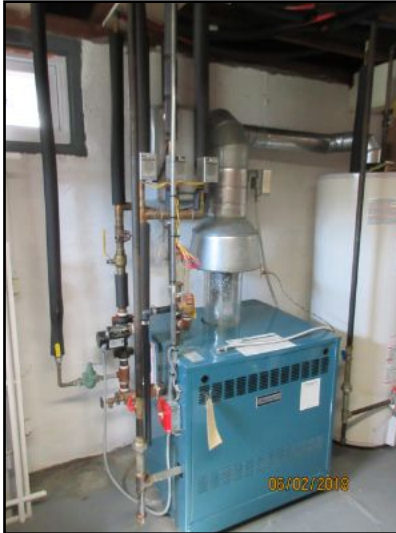
Burnham Gas-fired Forced Hot Water Boiler.

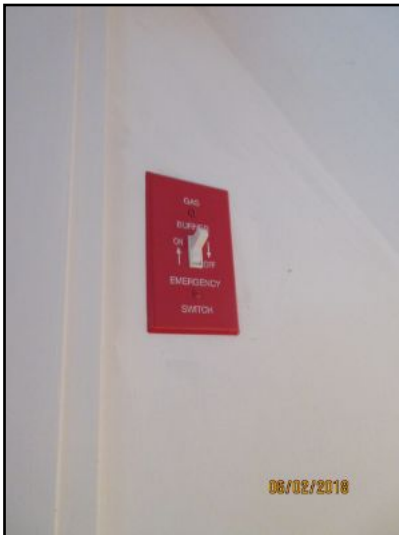
Remote Emergency Shut-off switch noted.

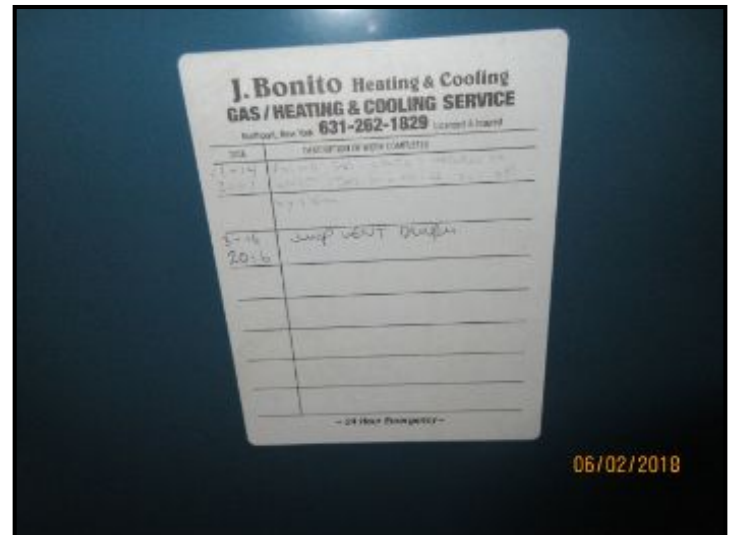
Boiler Service Tag indicates the boiler was last serviced on 3/16/2016. Recommend annual inspection/maintenance be performed by a licensed HVAC contractor to ensure safe and efficient operation.

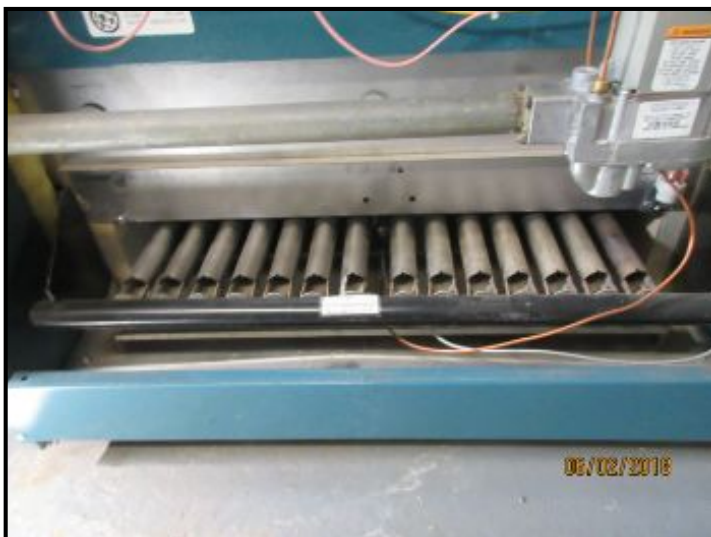
Burner fired by thermostat.

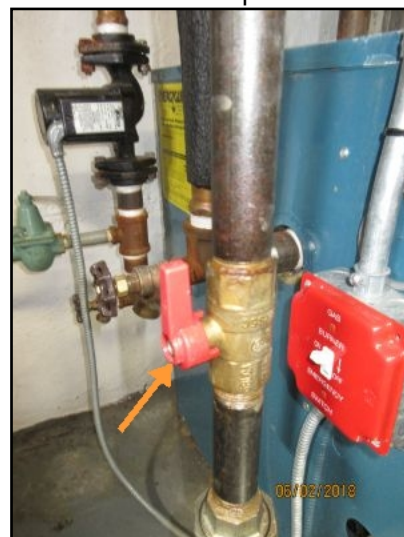
Gas supply shut-off valve located at furnace/ boiler.

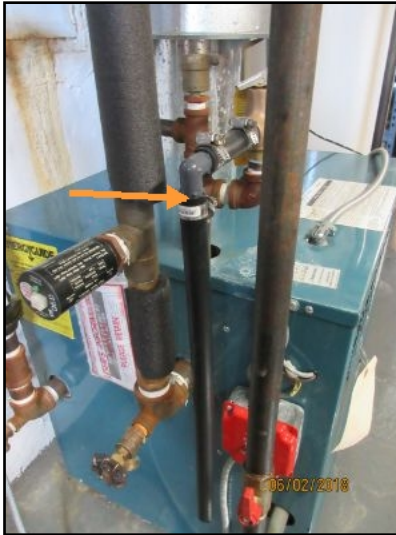
TPR (Temperature Pressure Relief) valve extension pipe elbow appears to be made of non-approved materials. The TPR valve is designed to release water (and thus relieves pressure) if either the temp or pressure in the boiler gets too high. The extension piping should be constructed of an approved material, such as copper, CPVC, polyethylene, galvanized steel, polypropylene, or stainless steel. PVC and other non-approved plastics should not be used since they can easily melt. We recommend an HVAC contractor install a proper extension tube terminating no more than 6 inches above the floor or waste receptor. This tube should have no more than one elbow and no fittings or a threaded end.

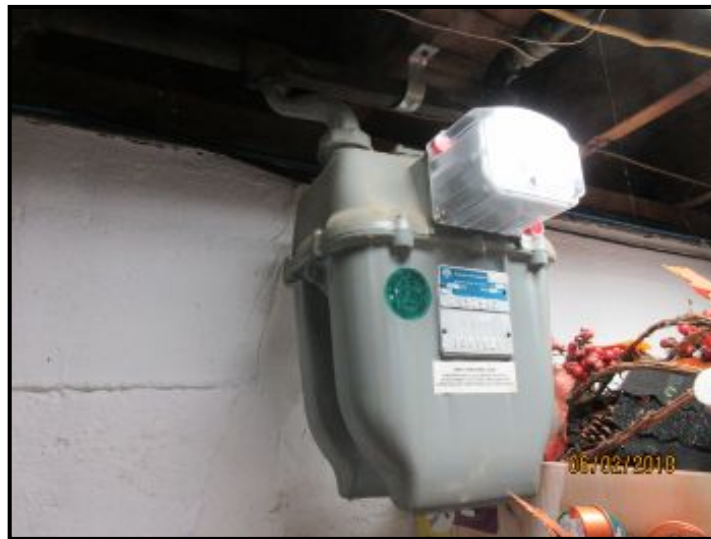
Public Gas Service: Meter, shutoff valve and vented regulator noted in basement.

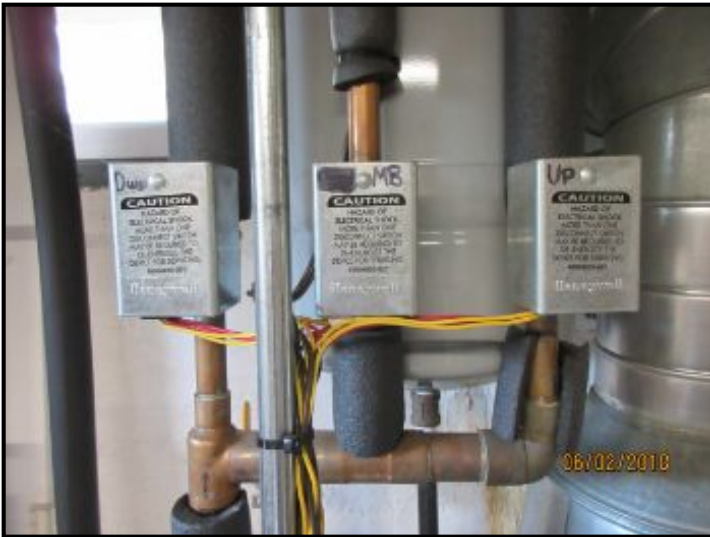
3-zone heating system noted.

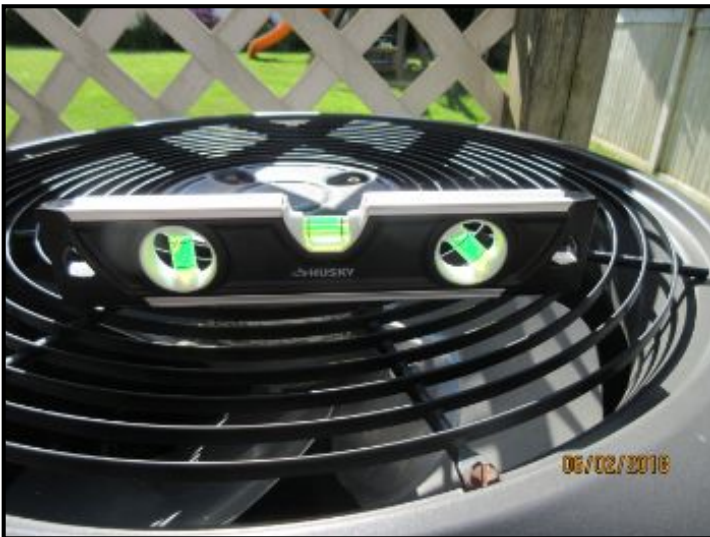
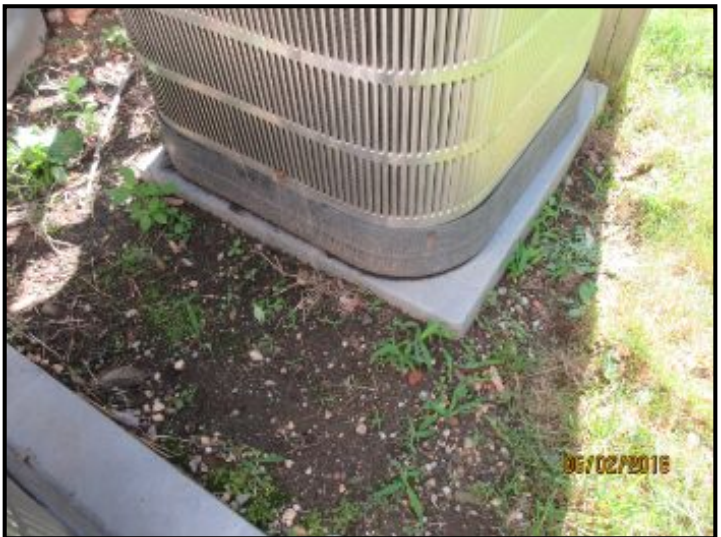
AC#1: Outdoor condenser is not level due to settling; this may shorten motor life. Suggest leveling mounting pad or unit itself.

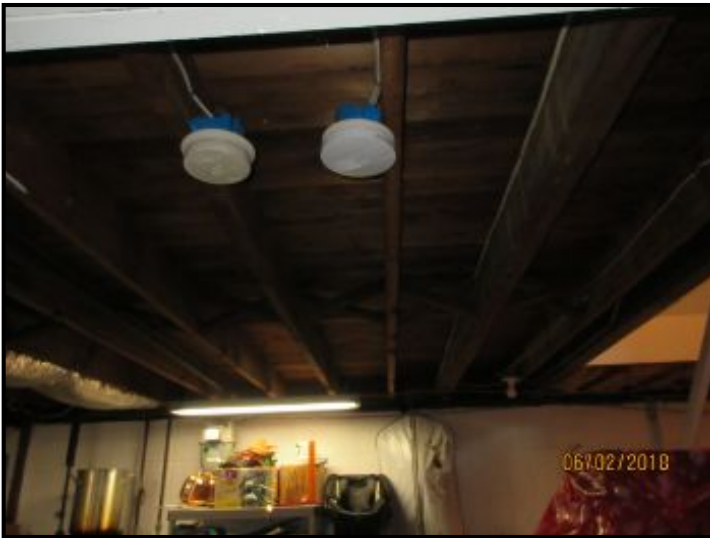
Smoke and CO detectors noted in basement.

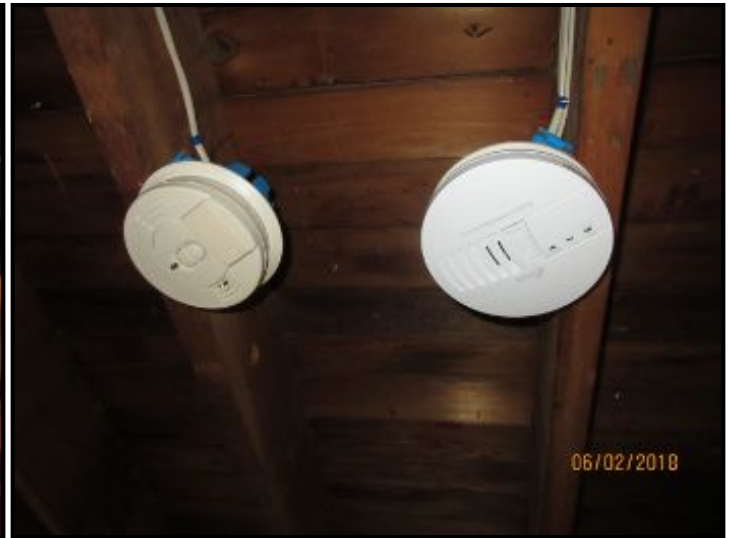
LIFE SAFETY: Maintain functioning Smoke and Carbon Monoxide detectors at each level of the home for Life Safety. Detectors are generally reliable for up to 5 yrs.

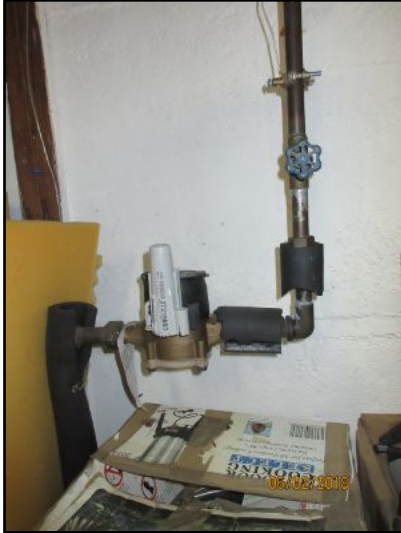
Water Service Entrance: 3/4" Copper line, meter and shut-off valves. Ground connection observed; suggest having electrician ensure that ground is continuous.

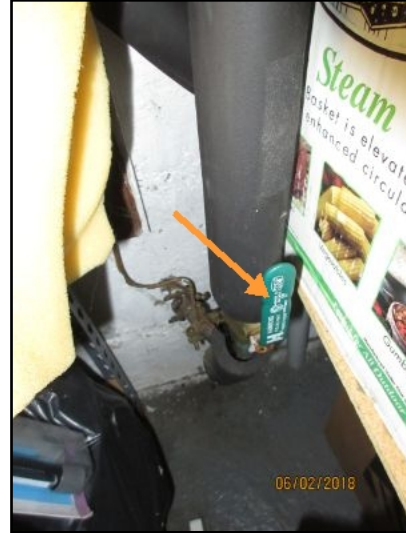
Main shutoff: Ball valve

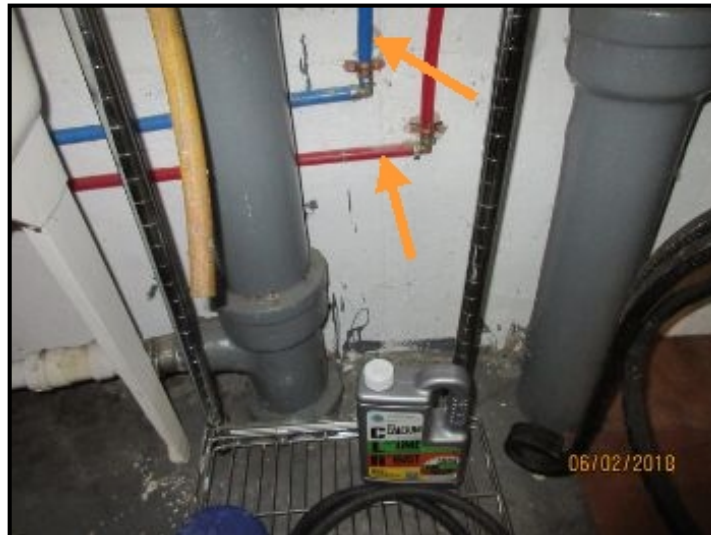
Supply Pipe Materials observed included PEX (cross-linked polyethylene) plastic tubing.

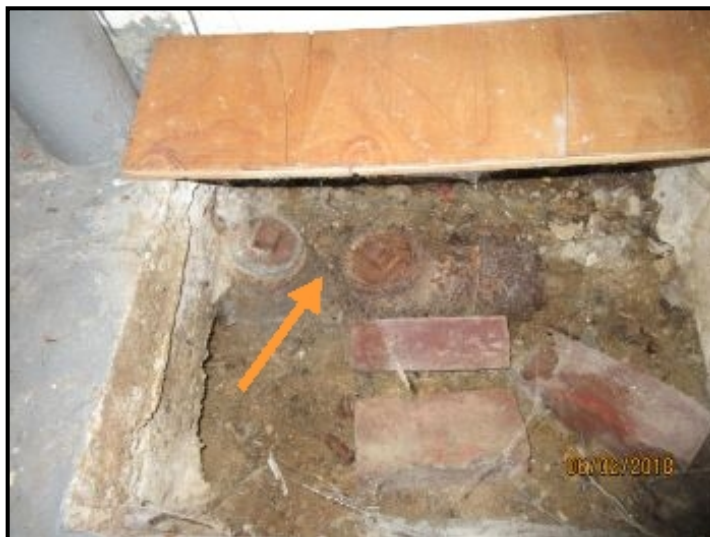
Waste Pipe Exit located at the rear of the house/basement with whole-house trap/ vent/ clean-out. Whole-house trap is below floor/ grade and covered.

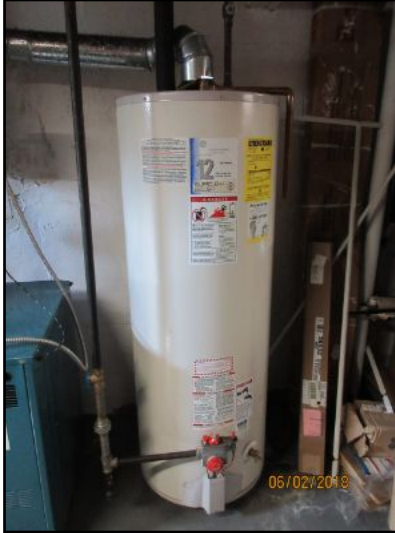
Water heater located in the basement. Gas, direct-fired water heater.

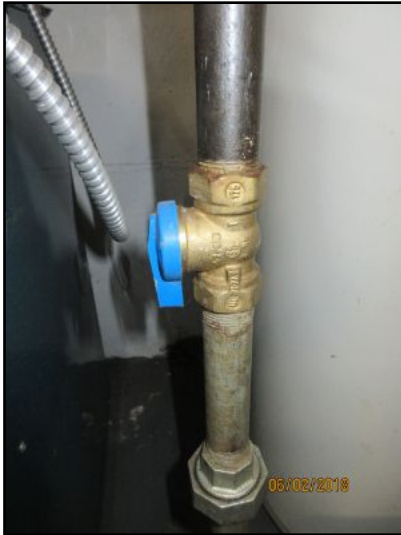
Gas supply shut-off valve noted at water heater

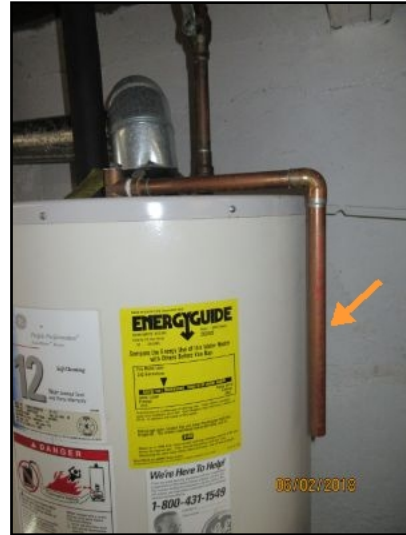
Temperature Pressure Relief (TPR) valve extension pipe is too short. This is a potential scalding concern as the TPR valve is designed to release water (and thus relieves pressure) if either the temp or pressure in the tank gets too high. We recommend an HVAC contractor install a proper extension tube terminating no more than 6 inches above the floor or waste receptor. This tube should have no more than one elbow and no fittings or a threaded end.

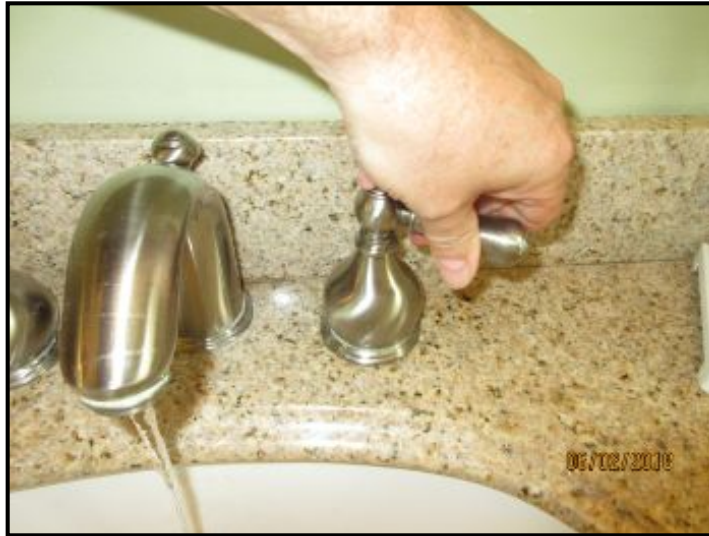
Sink faucet cold water handle was difficult to operate; suggest faucet repair.

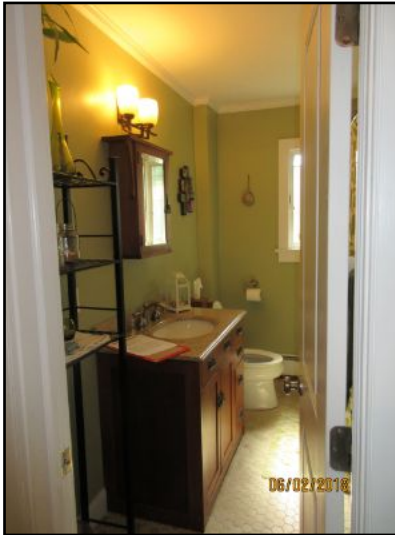
1st Floor Bathroom, Toilet, Vanity, Built-in Tub, Window, HVAC: Baseboard heat noted, Bathroom Floor: Ceramic tile, Shower Wall: Fiberglass surround

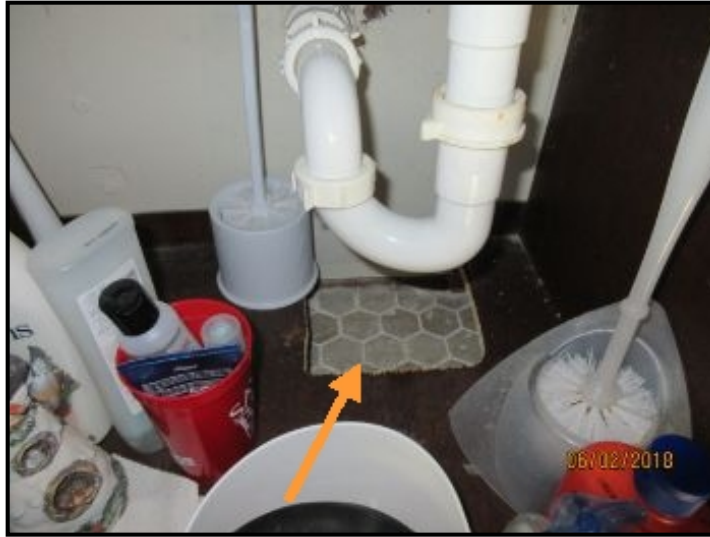
Vanity cabinet floor was cut out.

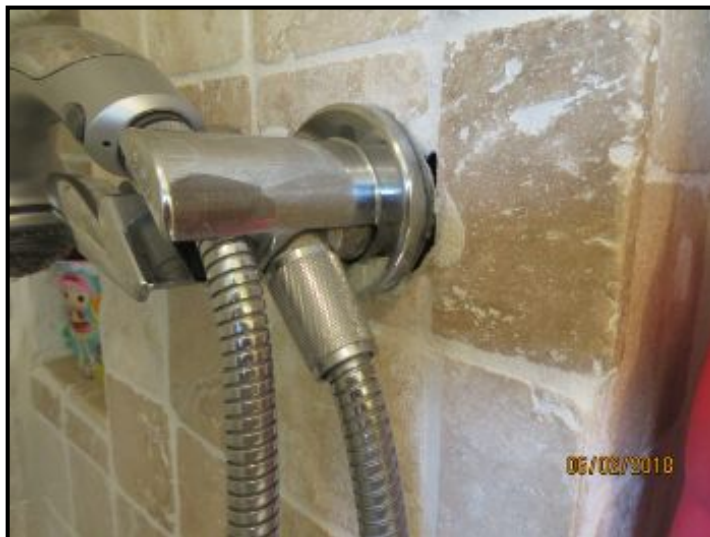
Shower wall tile grout missing at shower handle mount; suggest repairing grout here.

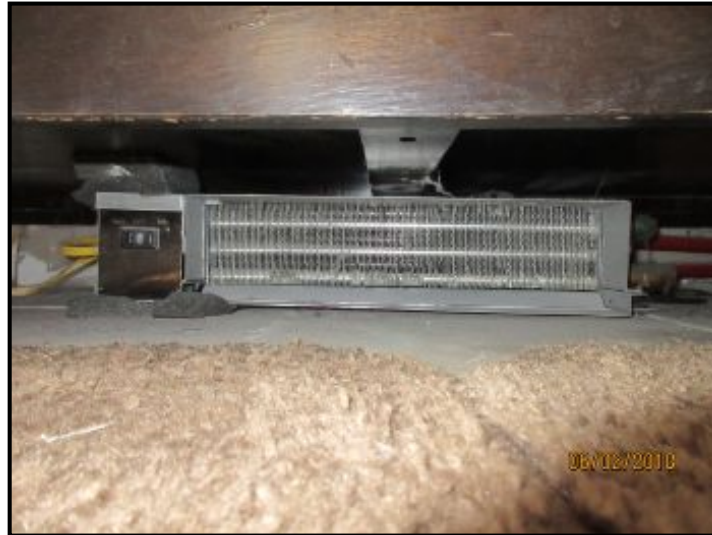
HVAC: Kick space heater noted

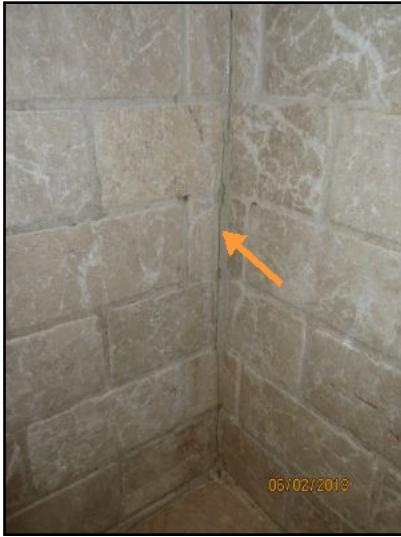
Shower wall corner grout (movement joint) is cracked. This is common; suggest replacing grout with matching silicone based sealant at corner movement joints.

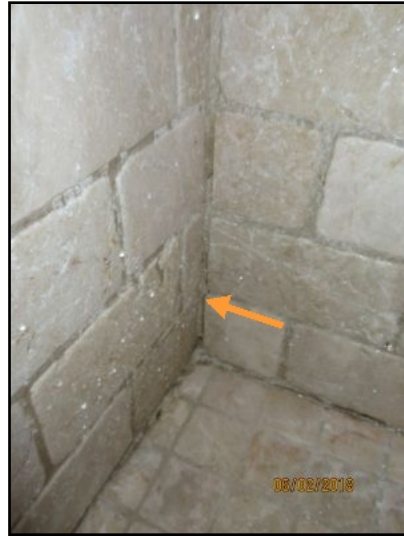
Shower wall corner grout (movement joint) is cracked. This is common; suggest replacing grout with matching silicone based sealant at corner movement joints.

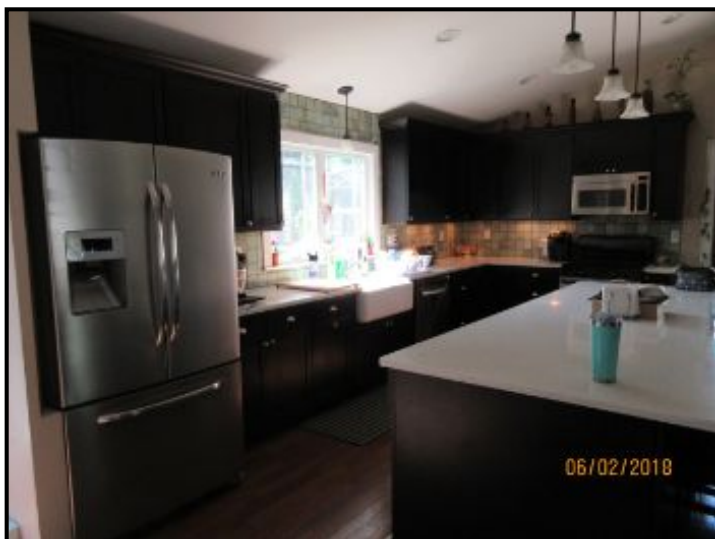
KITCHEN - 1st Floor Kitchen (First Floor)

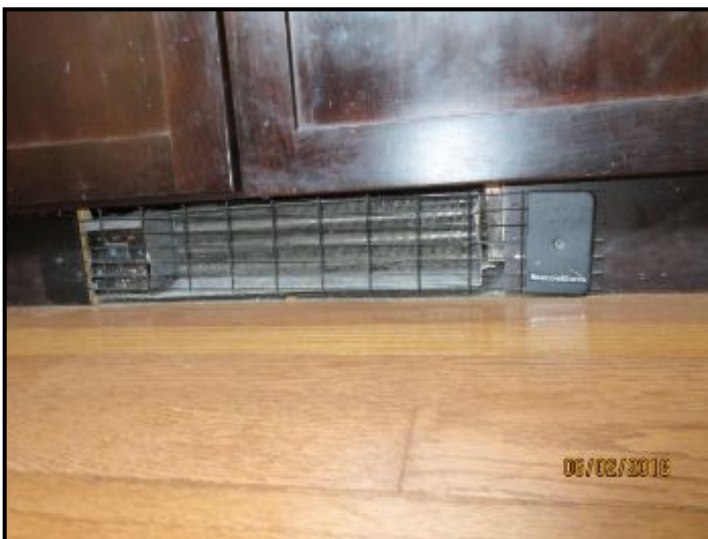
Kick space heater noted.

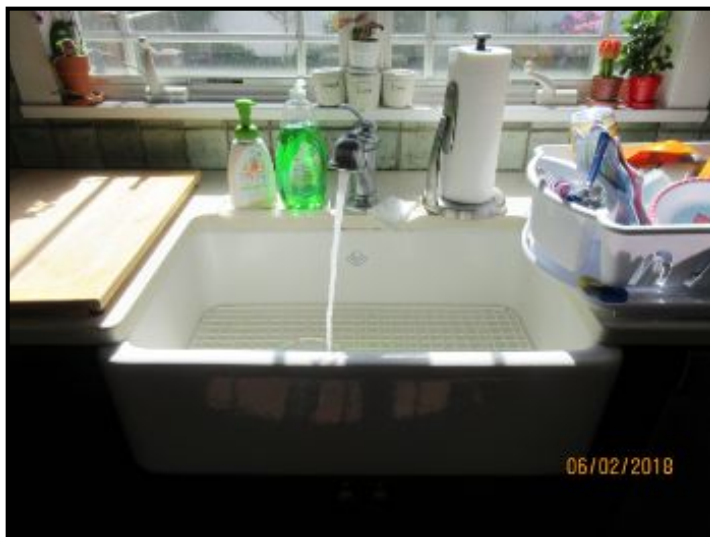
KITCHEN - 1st Floor Continued

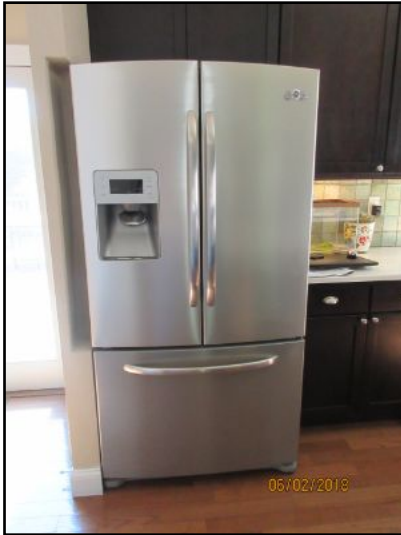
Refrigerator appears to be 11 yrs old.
