ProSpec Home Inspection of Long Island Property Inspection Report

2 Barry Dr, E. Northport, NY 11731
Inspection prepared for:
Date of Inspection: 6/12/2020 Time: 9:00 AM
Age of Home: unknown Size: 2,800 sq.ft.
Weather: Sunny, 79 F
Home completely renovated in 2007.

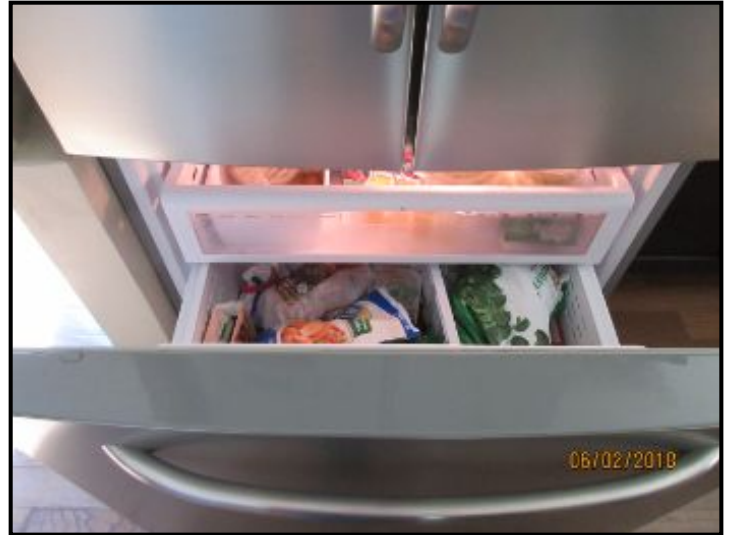
Refrigerator/freezer operating and frost free.

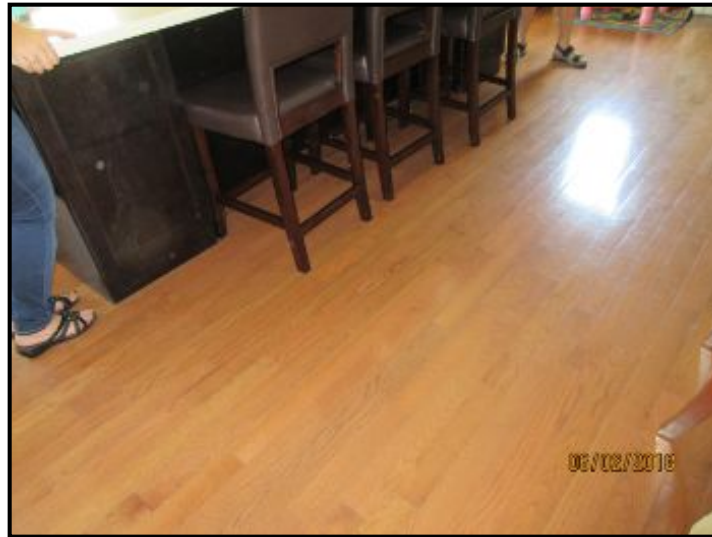
Engineered hardwood flooring noted

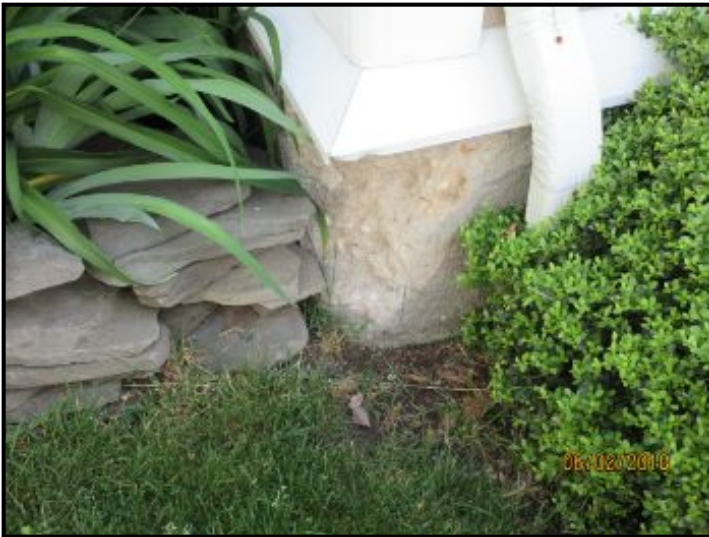
Cracked off piece of foundation front corner is cosmetic only.

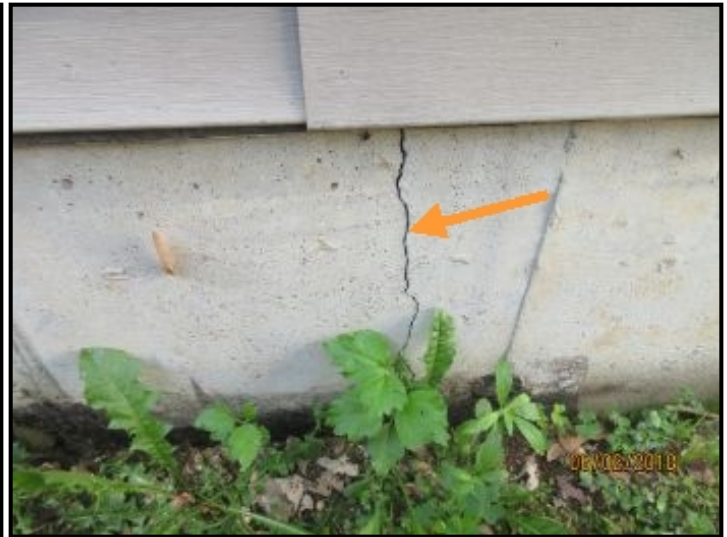
CRACKS: (1/4" or less) Cracks/Holes present in foundation wall / floor. Cracks that are less than 1/4" are not commonly regarded as being structurally significant. Recommend sealing the cracks with epoxy filler to prevent water infiltration, and monitor for further movement.

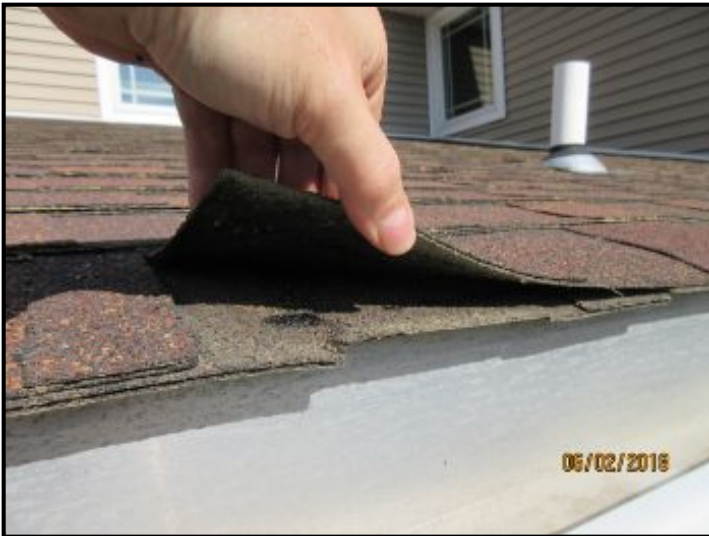
Two layers of asphalt shingles noted at lower roof.

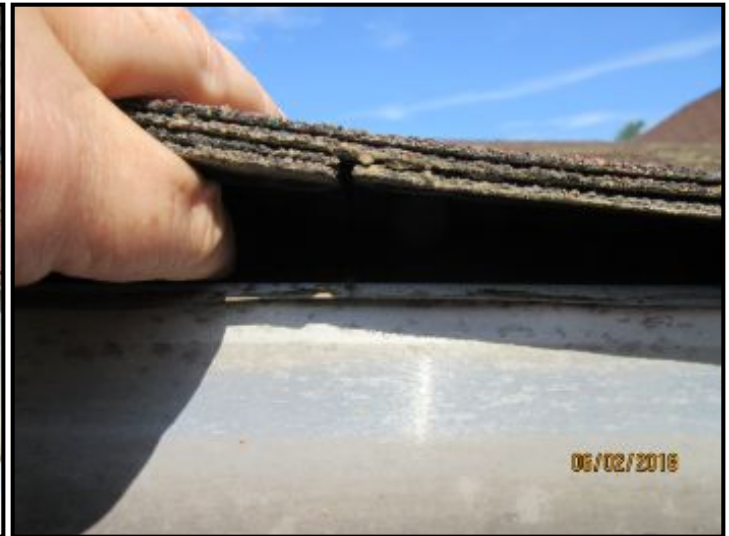
Ice shield observed.

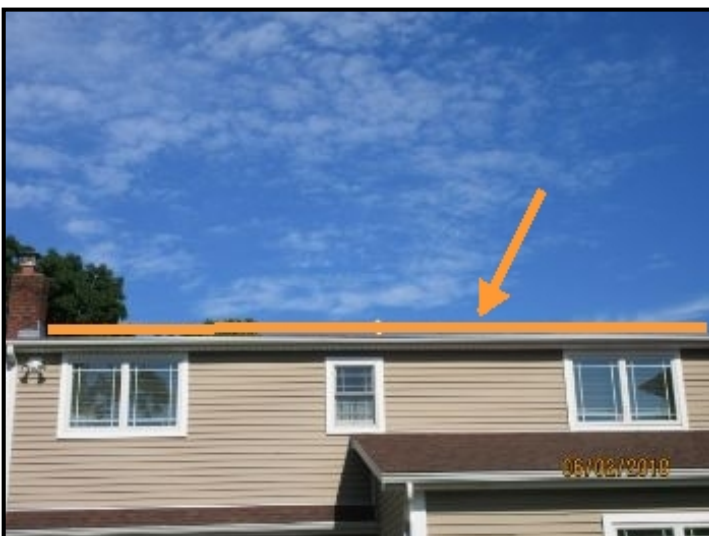
Roof ridge beams appeared straight and even.

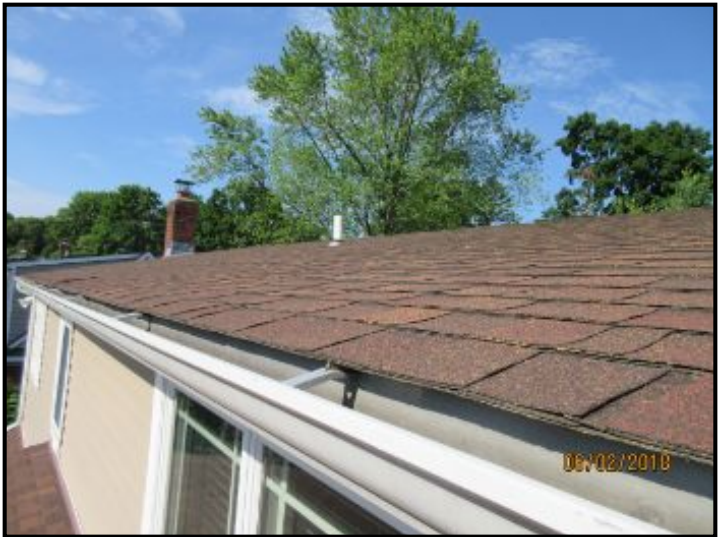
No major system safety or function concerns noted for the visible portions of the roof.

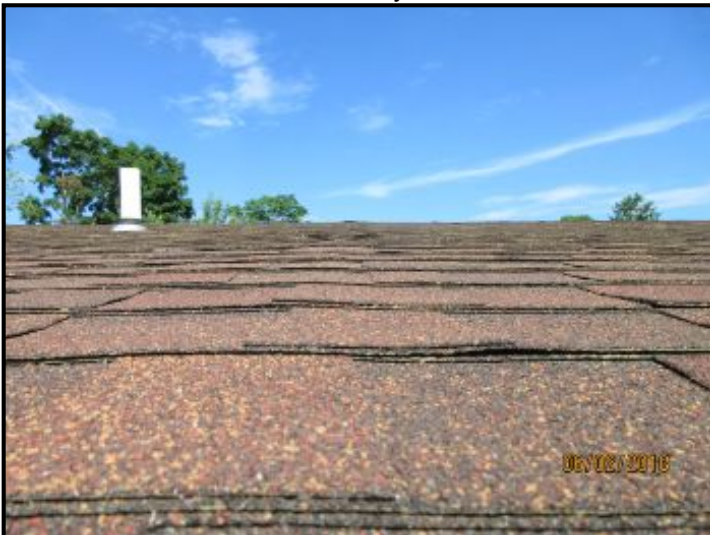
House top asphalt roof covering appeared to be approximately 11 yrs old.

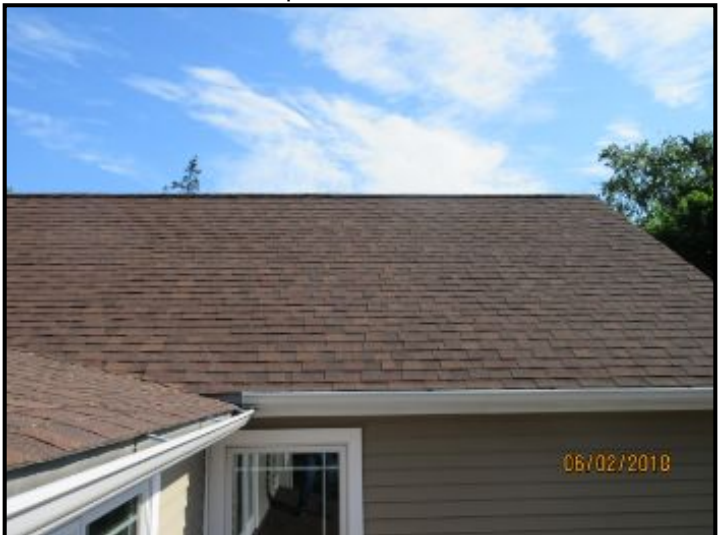
Upper roof in good condition.

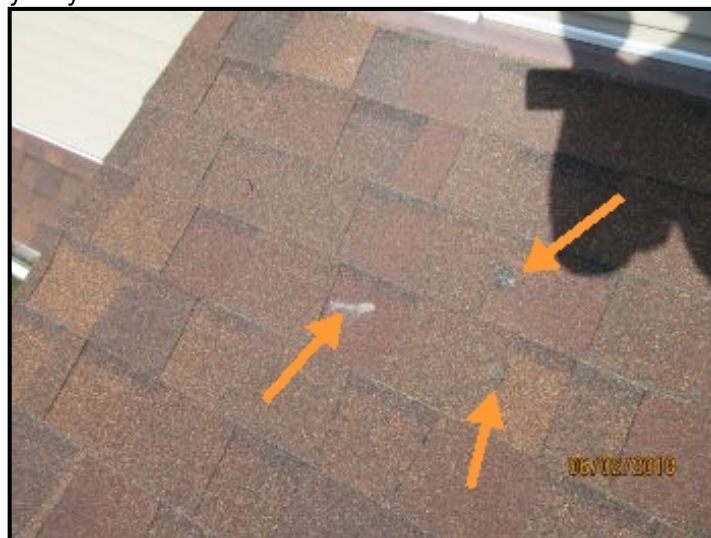
Beginning signs of minor wear and tear likely caused by walking on roof.

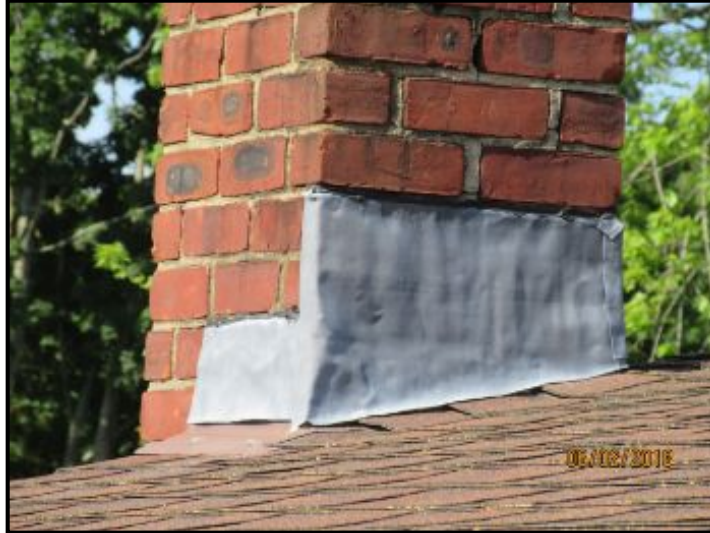
Recommend re-sealing gaps in chimney flashing as a part of routine maintenance to prevent water entry.

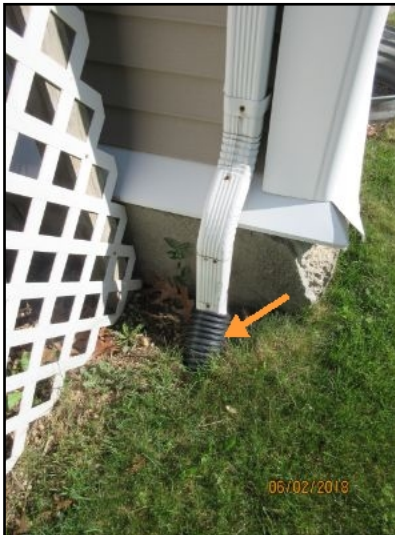
Downspouts drain to underground dry well(s)

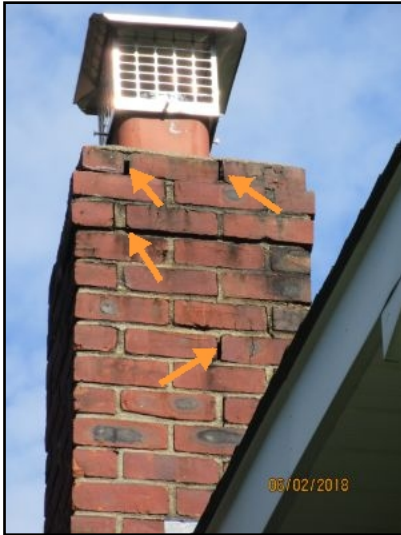
Chimney mortar joints show signs of deterioration. Recommend a mason to renew mortar joints; repointing as required to prevent further degradation.

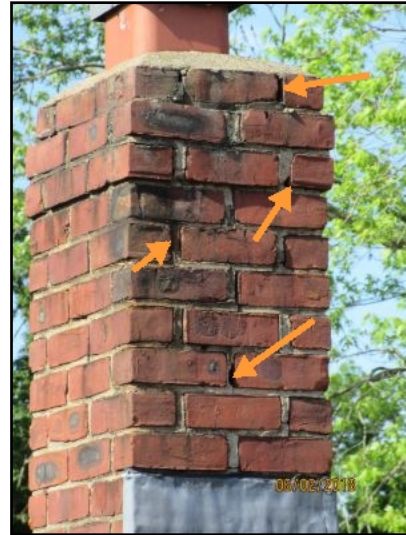
Chimney mortar joints show signs of deterioration. Recommend a mason to renew mortar joints; repointing as required to prevent further degradation.

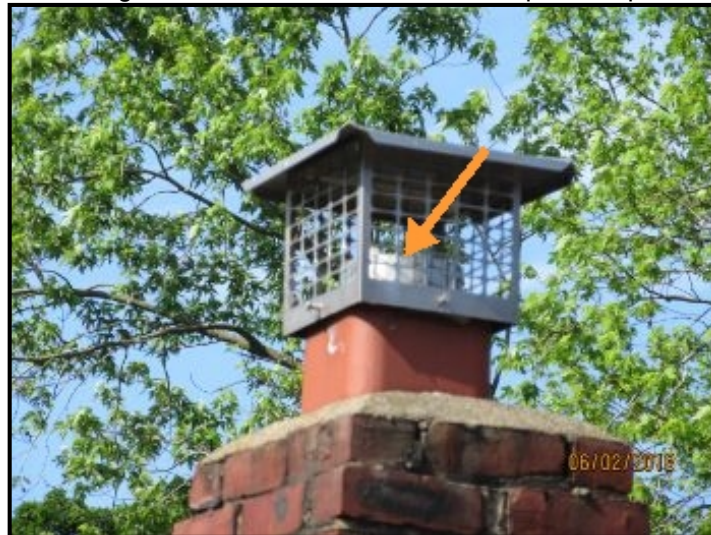
Metal chimney liner observed.

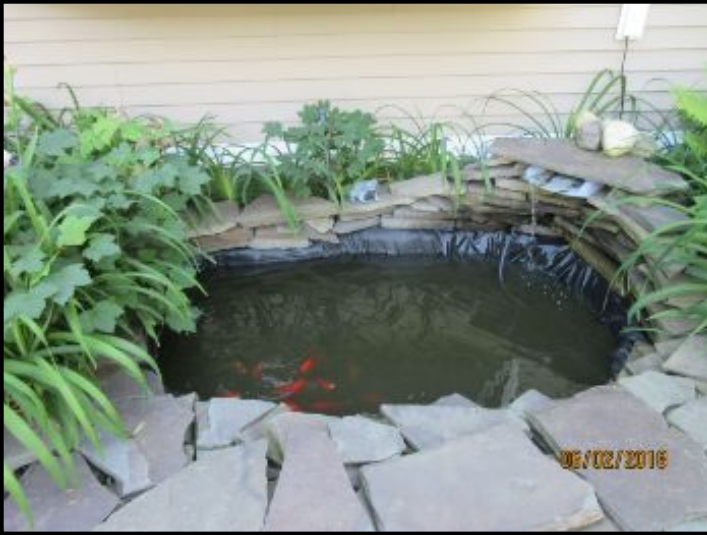
Koi pond at front noted (not inspected).

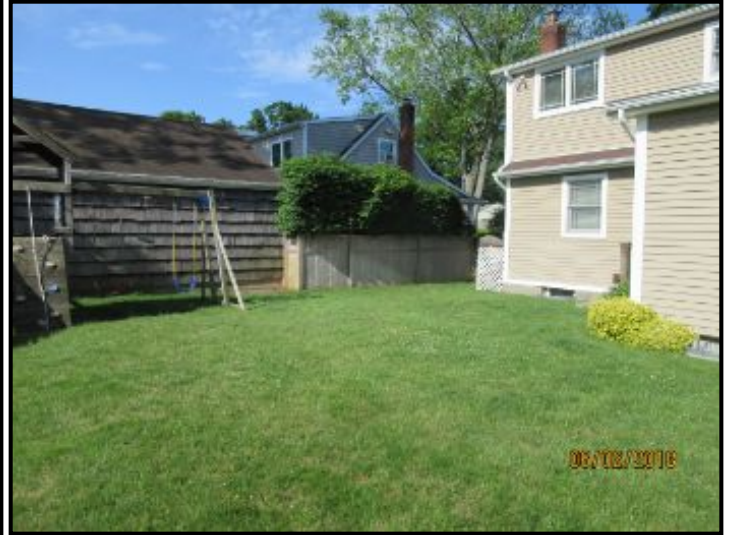
GROUNDS Grounds General

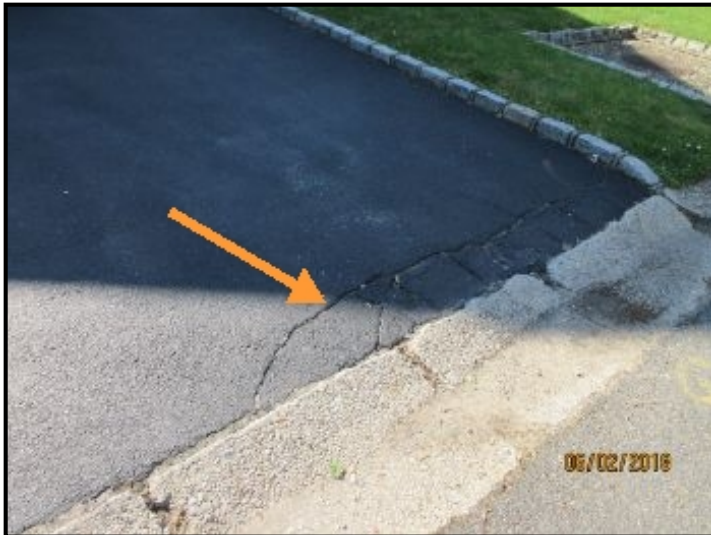
Moderate cracks in driveway near sidewalk noted. Seal cracks to prevent subsequent water entry and freeze-thaw damage.

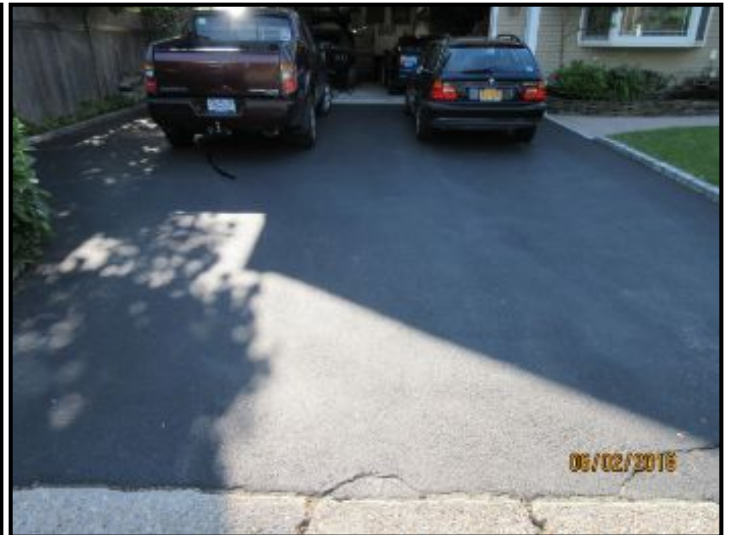
Asphalt driveways require sealing every 3-5 yrs to prevent freeze/thaw damage.

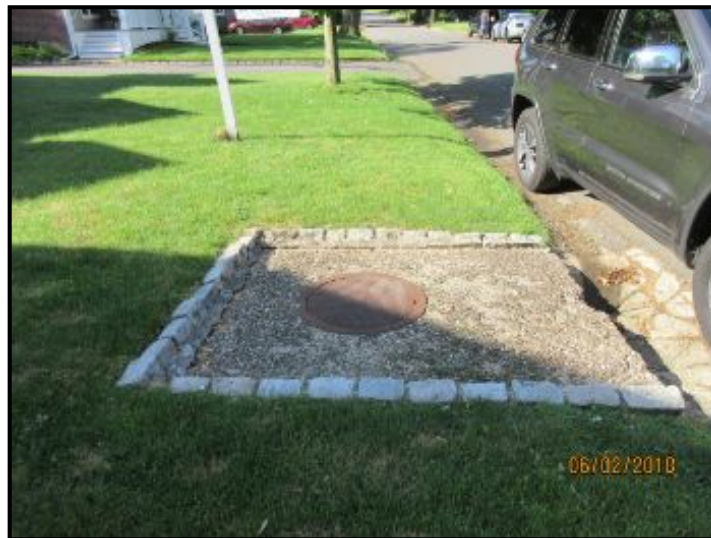
3. Sidewalk & Walkway

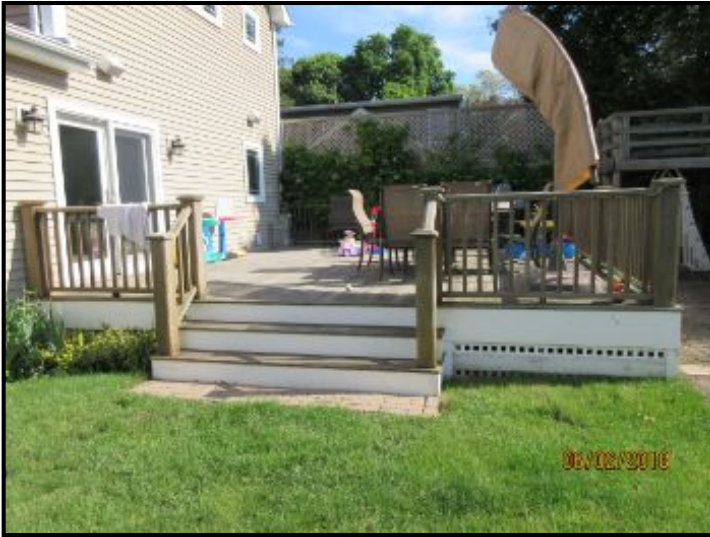
Recommend seller provide C.O. for the deck addition.

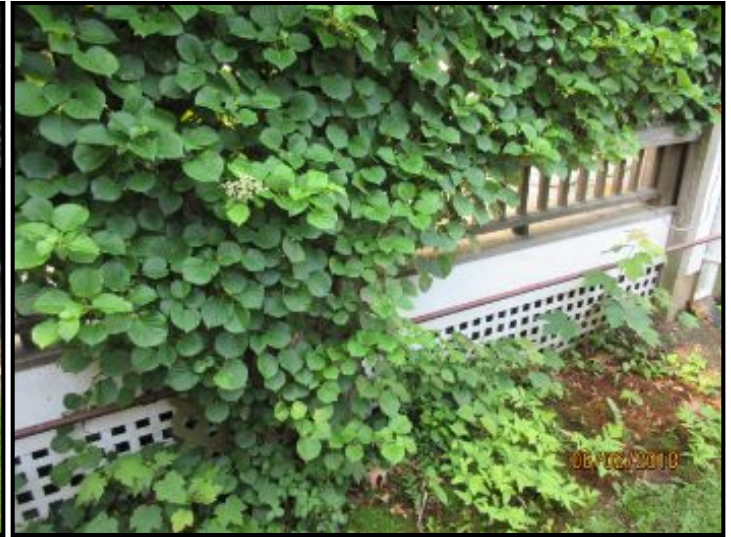
LIMITATION: Limited review due to a lack of access to deck structure beneath.

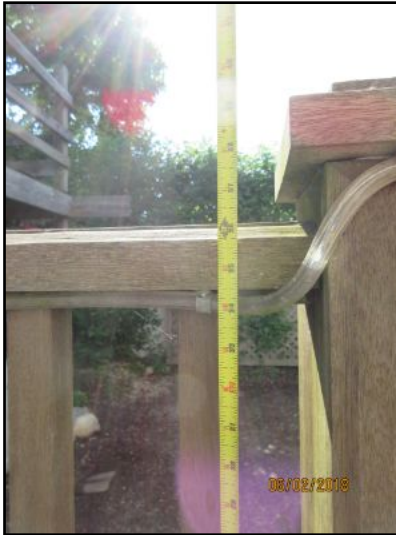
Guardrails meet the 36" min. height requirement.

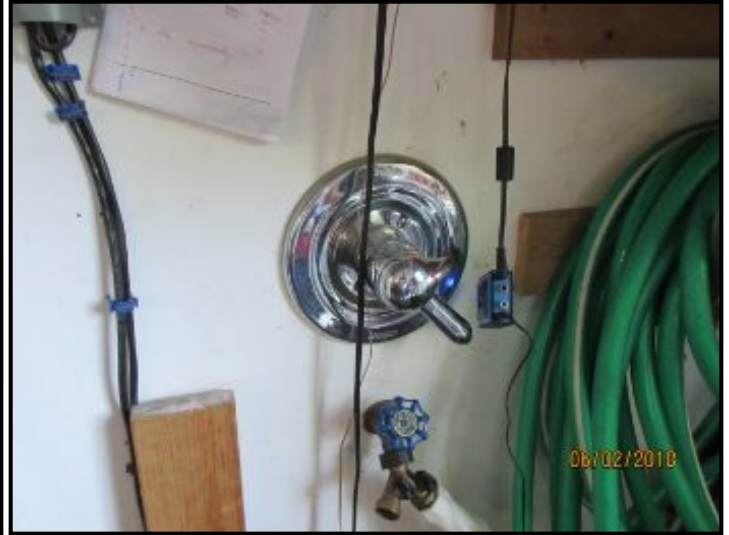
Hot/Cold mixing valve at garage hose bibb noted for washing cars.

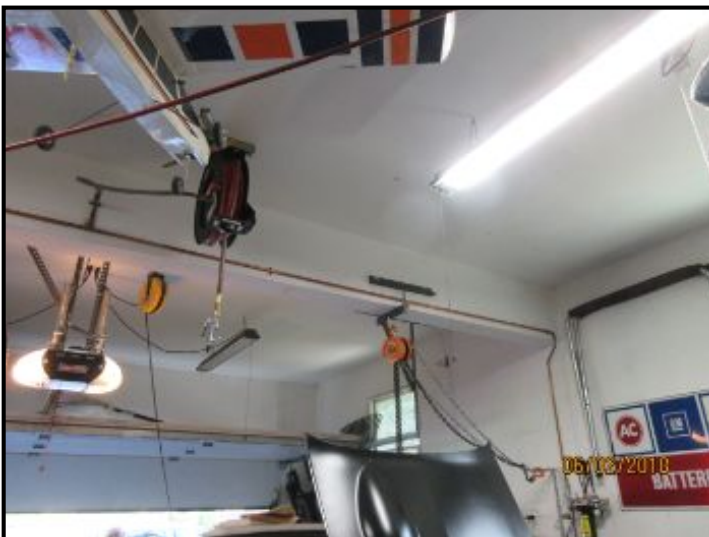
Limited review due to finished ceilings and walls.

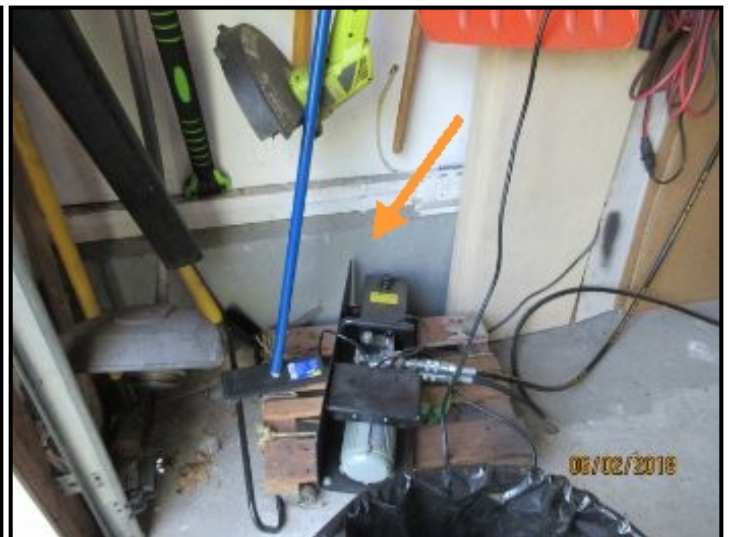
Garage raised foundation walls noted.

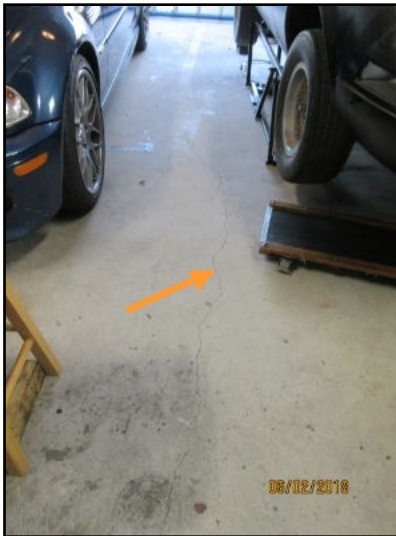
Bare concrete floor noted. Common settlement crack noted in garage concrete floor slab. Recommend sealing the cracks with epoxy filler to prevent water infiltration, and monitor for further movement.

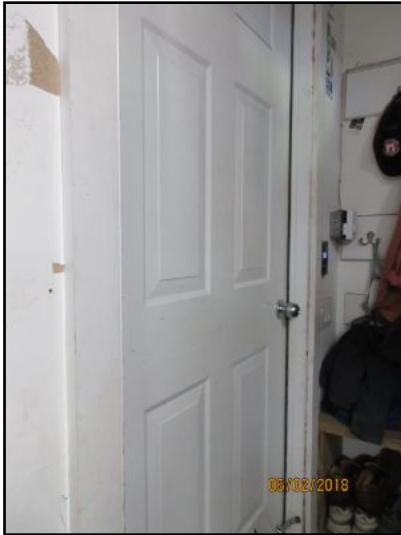
Metal fire door with automatic closer noted.

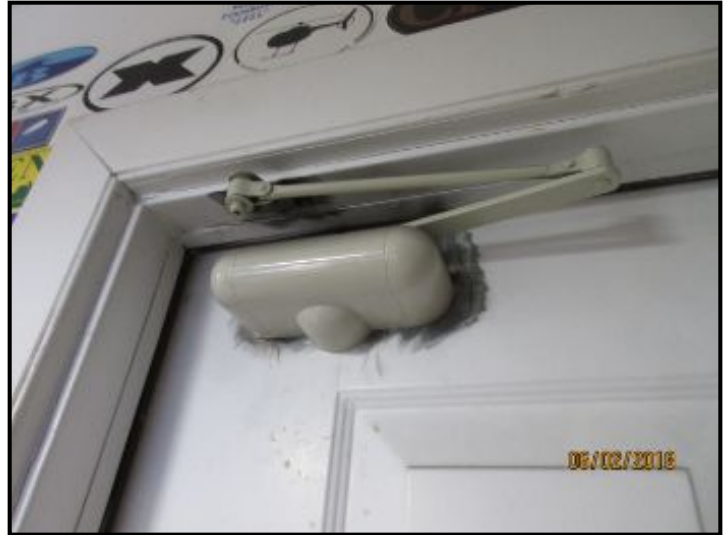
Appeared satisfactory and functional, at time of inspection.

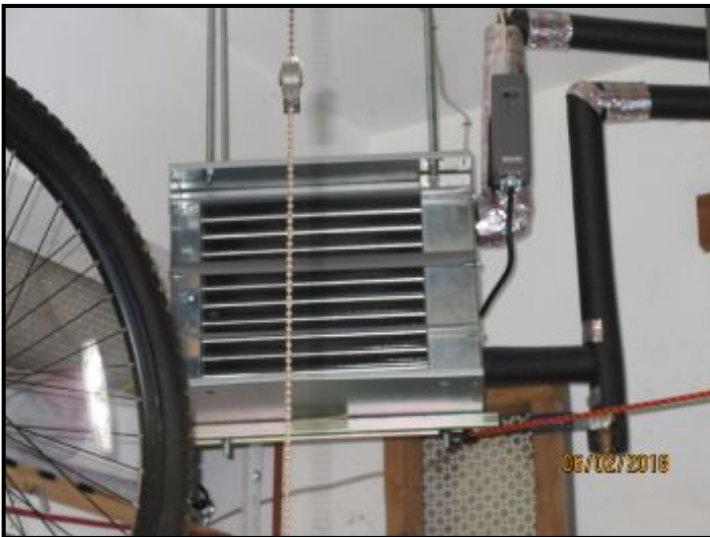
Unit Heater with thermostat noted in garage.

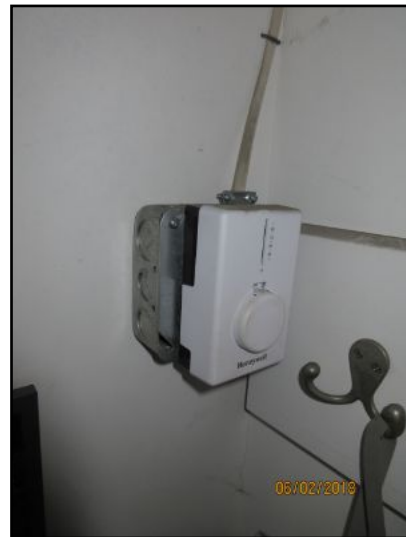
Unit Heater with thermostat noted in garage.

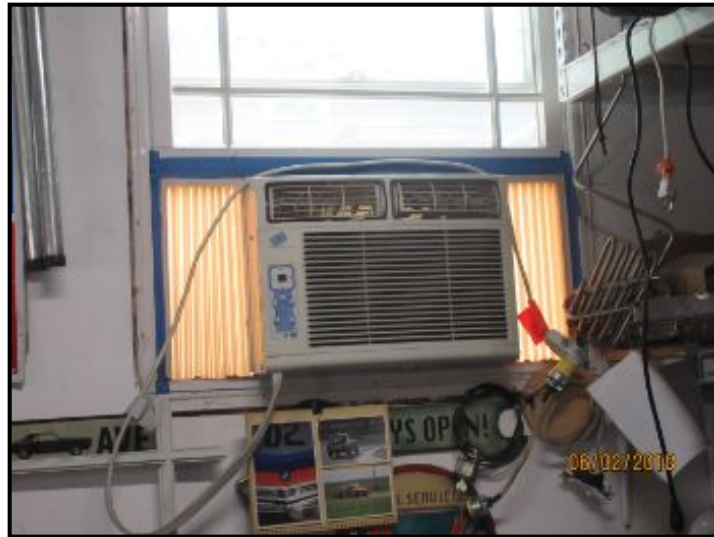
Window A/C unit not tested (exclusion).
