# ProSpec Home Inspection of Long Island Property Inspection Report

Massapequa, NY 11758

Inspection prepared for: Name Deleted  
Date of Inspection: 1/25/2019 Time: 10:00 AM  
Age of Home: 68 yrs old Size: 2,006 sq. ft.  
Approx. Year Built: 1950

Inspector: Russell Classi, P.E.  
License #16000077480  
Phone: (516) 580-1848  
Email: ProSpecofLI@gmail.com  
[www.NassauProfessionalHomeInspector.com](http://www.NassauProfessionalHomeInspector.com)

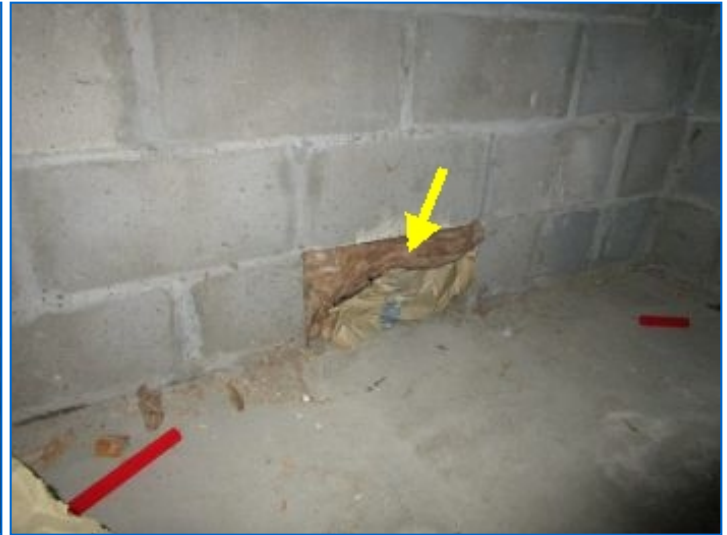
All flood opening vents must be FEMA compliant. Recommend unblocking flood vents upon completion of work.

Recommend contractor unblock flood vents upon completion of work.

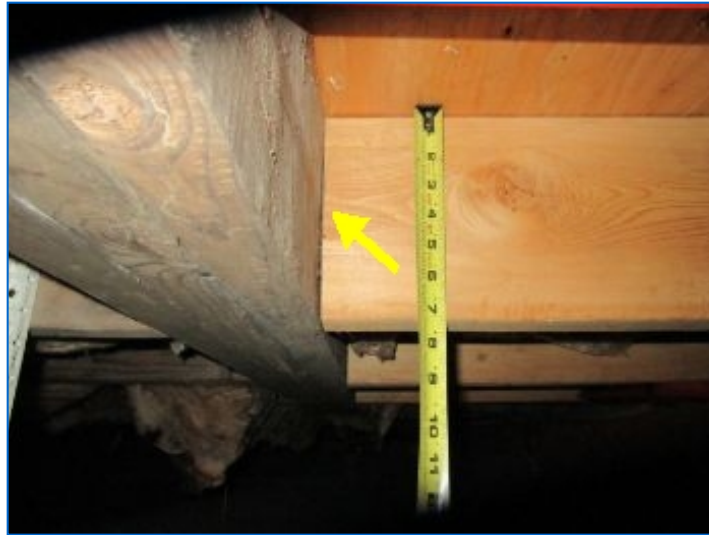
Floor joists were toe-nailed to main beams. This is not compliant with current building standards. Recommend installing proper joist fasteners such as Simpson Strong-Ties.

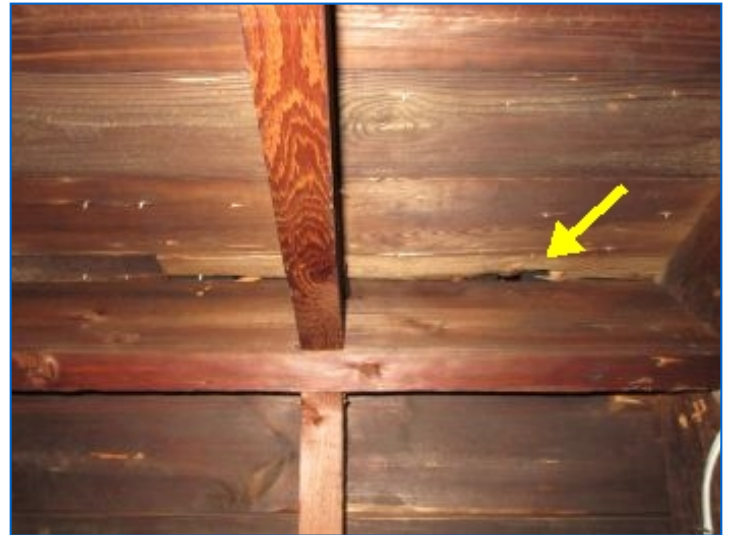
Damage noted at roof boards along roof ridge; persons stepping near the ridge can easily damage the ridge cap shingles in this area/s.

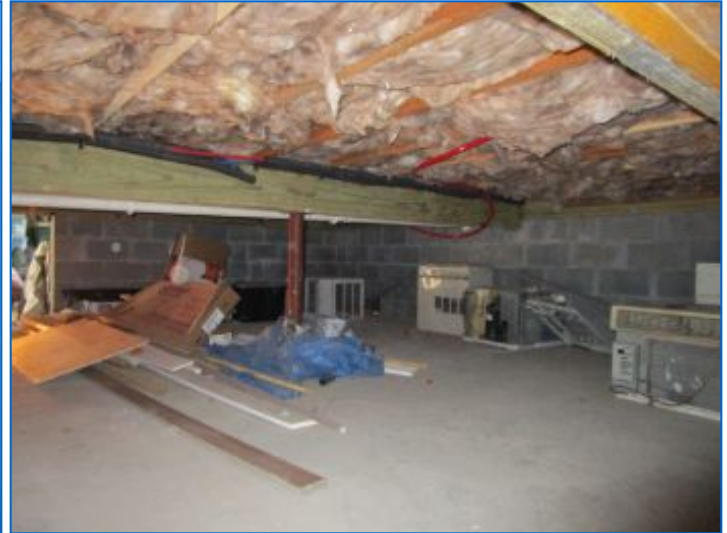
Main crawlspace

Crawlspace access door was missing. Recommend a proper door be installed.

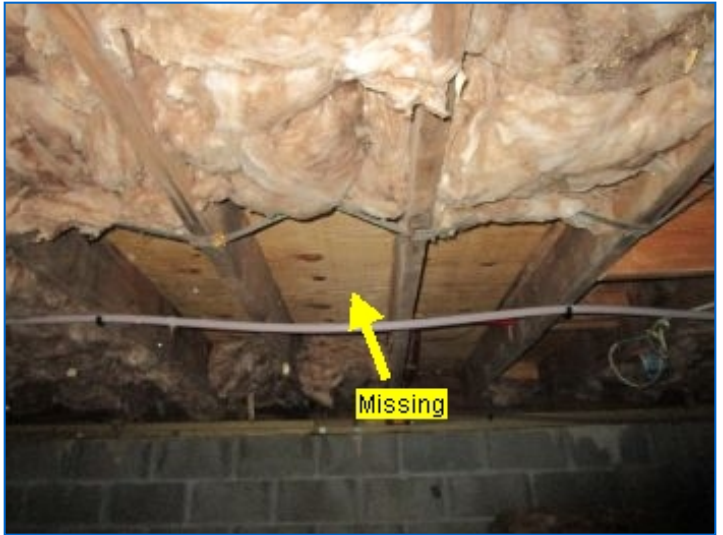
Batt insulation was observed to be hanging/missing at a few joist cavity locations. Recommend restoring missing/hanging insulation and securing in place using insulation support wires.

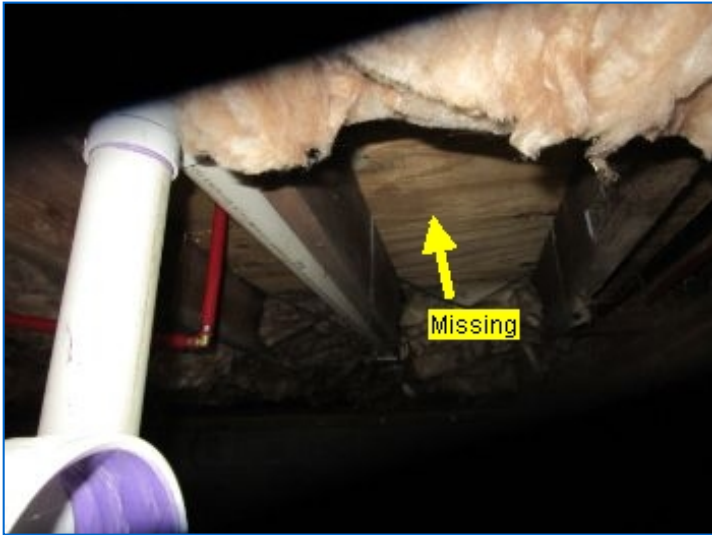
Batt insulation was observed to be hanging/missing at a few joist cavity locations. Recommend restoring missing/hanging insulation and securing in place using insulation support wires.

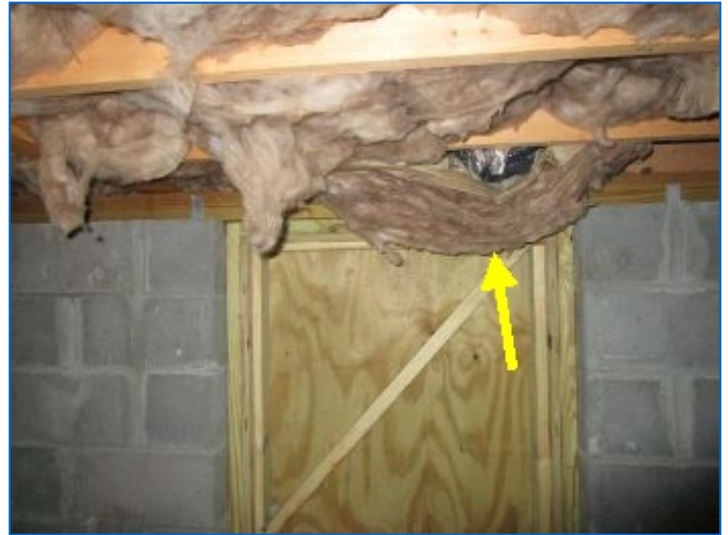
Batt insulation was observed to be hanging/missing at a few joist cavity locations. Recommend restoring missing/hanging insulation and securing in place using insulation support wires.

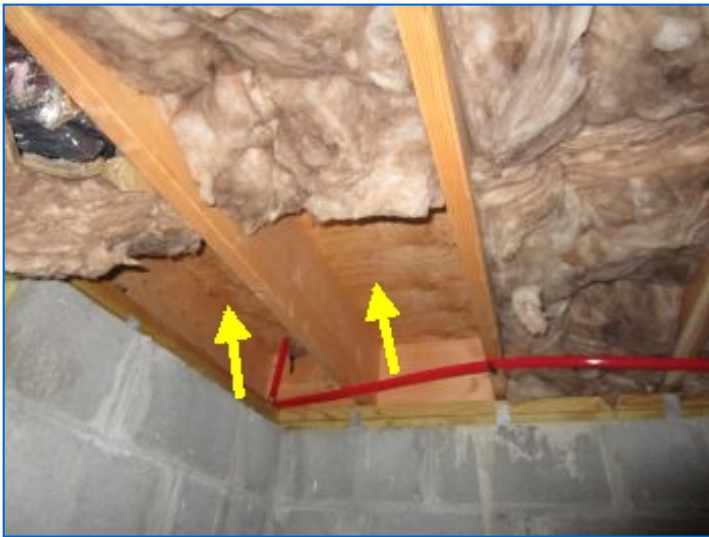
Batt insulation was observed to be hanging/missing at a few joist cavity locations. Recommend restoring missing/hanging insulation and securing in place using insulation support wires.

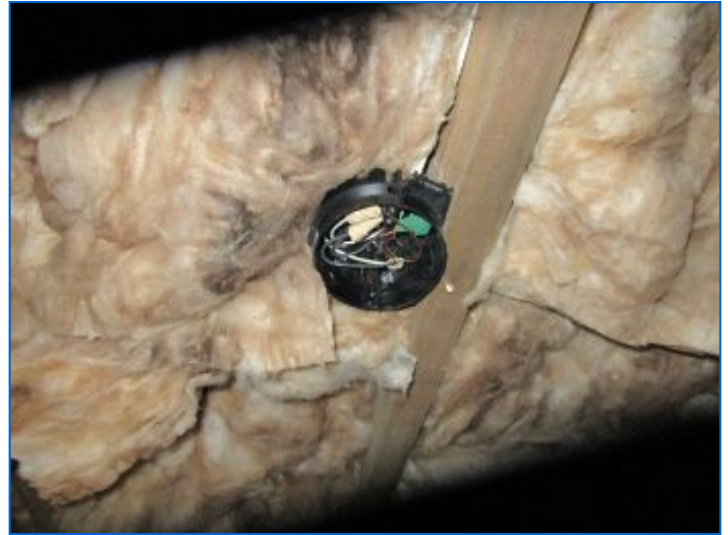
Open junction boxes were observed, which is a safety concern. Recommend installing proper covers, as needed for safety.

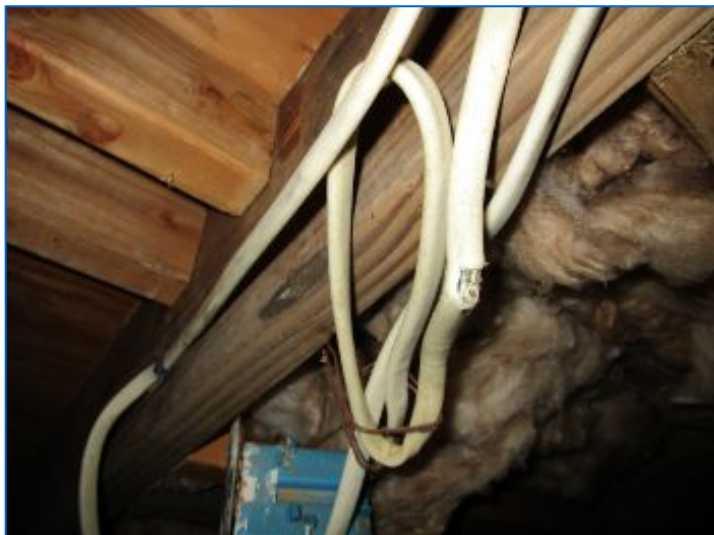
Damaged cable with potentially live electrical wires exposed to touch in the crawlspace; electric shock and short circuit hazard. Defective wires should be removed and replaced by a licensed electrician.

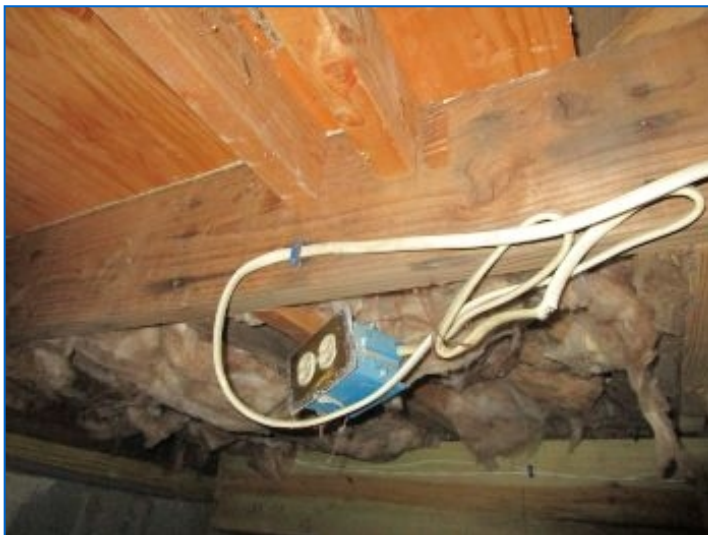
Proper GFCI type receptacles were not installed in the crawlspace. Recommend licensed electrician provide GFCI receptacle provisions.

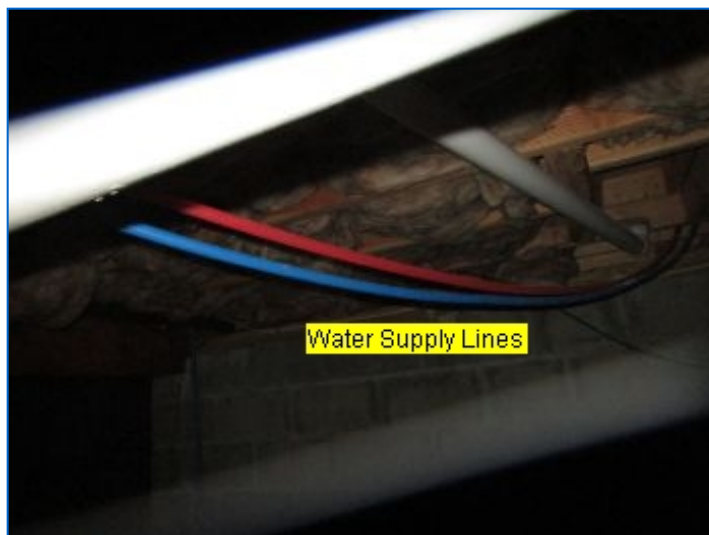
Water supply lines in unheated spaces should be insulated as a minimum, (crawlspaces, exterior walls, etc.).

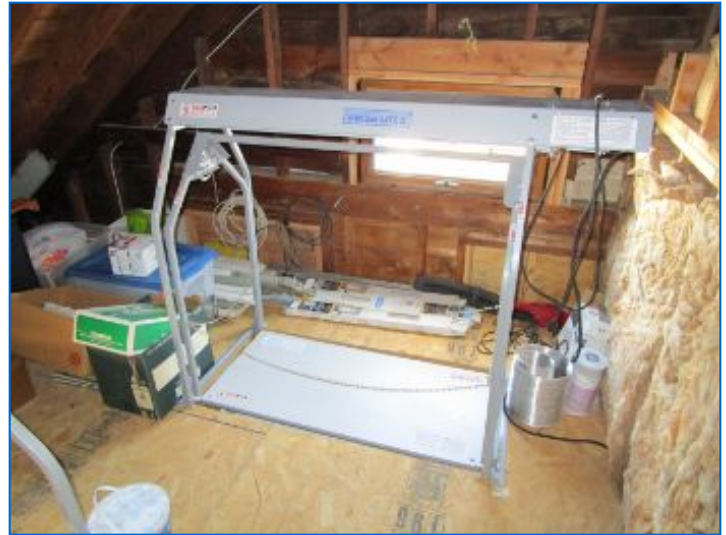
Attic storage lift did not have a dedicated outlet installed.

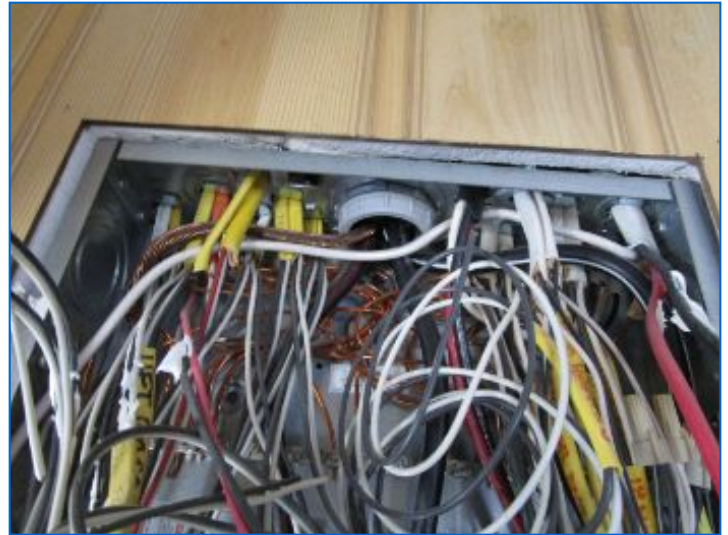
Excessive wire lengths in panel box; overcrowded condition. Recommend qualified electrician reduce crowding by shorten wire lengths. Provide proper circuit breaker index.

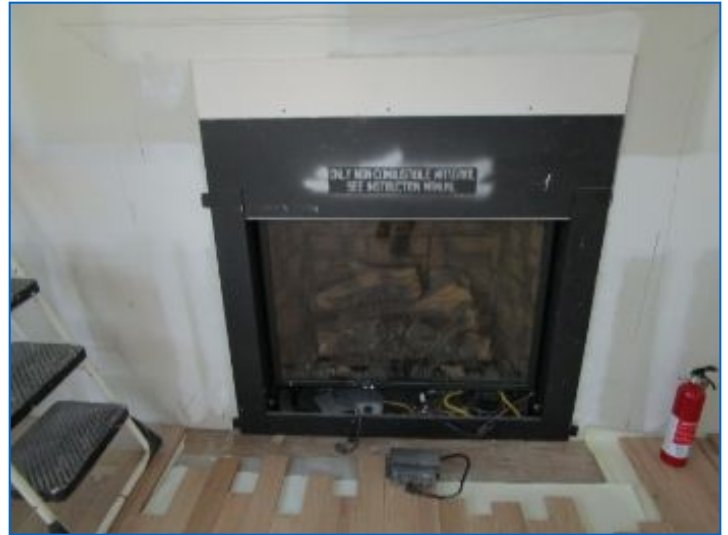
Gas fireplace surround/mantle, stone hearth and manufacturer approved startup of fireplace was yet to be completed.

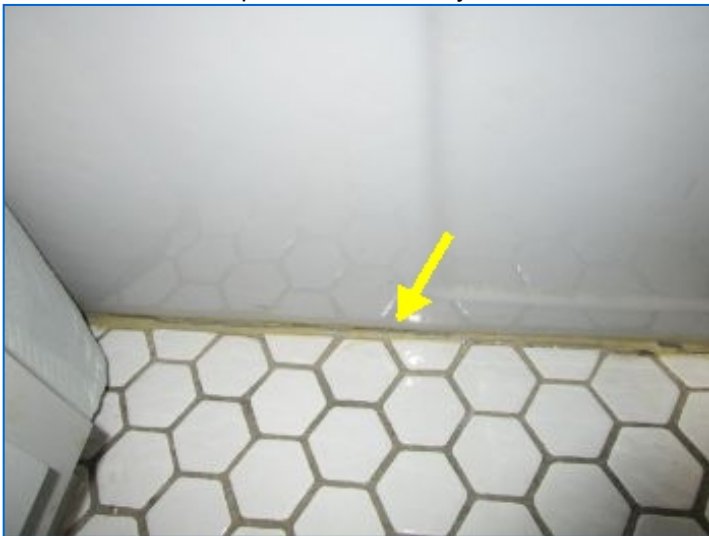
Cracked grout at floor-tub joint noted to have been caused by the structure elevation. Grout repairs recommended to prevent water entry.

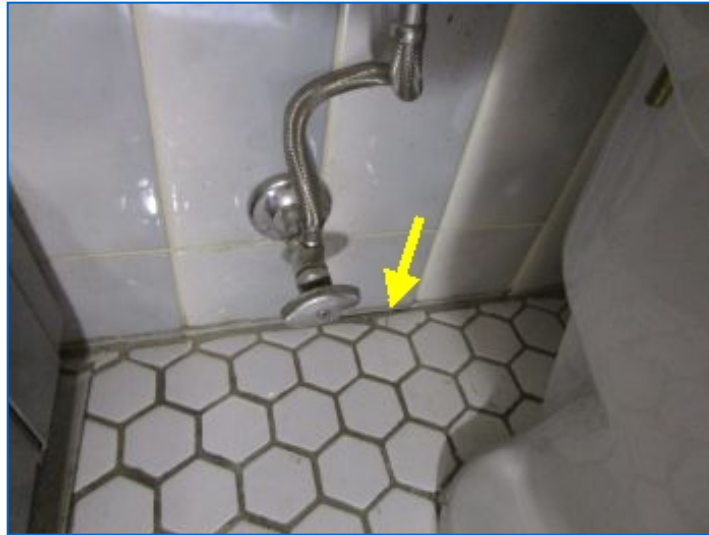
Cracked grout at floor-wall joint noted to have been caused by the structure elevation. Grout repairs recommended to prevent water entry.

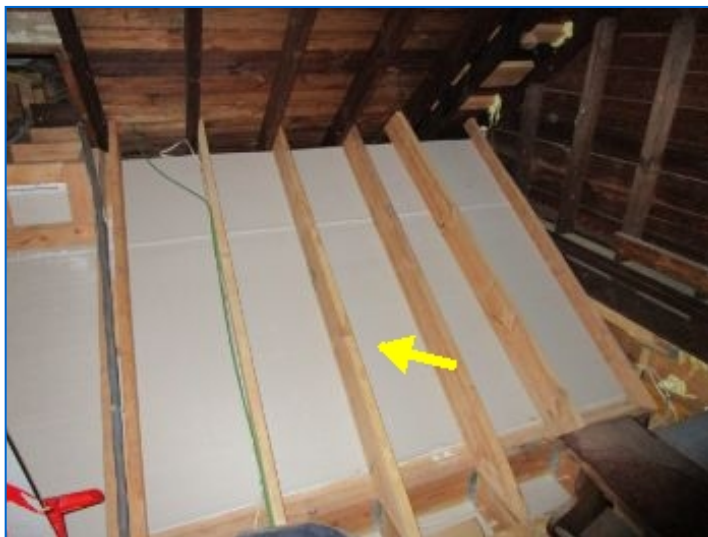
Ceiling above stair area in garage where homeowner requested/desired the installation of a handicap lift. The concern is that this ceiling may prohibit installation of the desired lift system. It appears possible that this ceiling could be modified to create the required clearance. Recommend a qualified contractor evaluate options/cost for the ceiling modification.

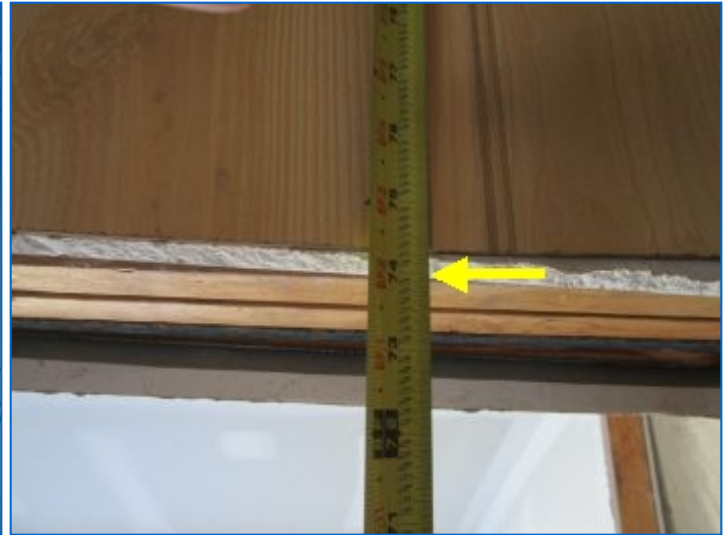
Utility Room: The height of a standard doors is 6 feet 8 inches. The height of the rough opening for a door is the door height plus 2-5/8 inches, therefore 82-5/8 inches. The height of the existing rough opening for the utility room door is only 74 inches which is 8-5/8 inches too short.

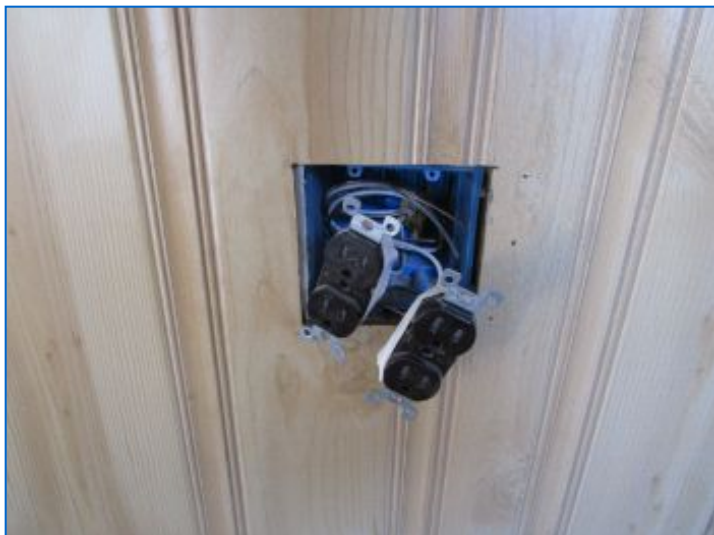
One or more electrical receptacles in the utility room was missing a cover plate at the time of the inspection. This condition is a shock/electrocution. Approved cover plates should be installed by a qualified electrical contractor to prevent direct contact with energized electrical components.

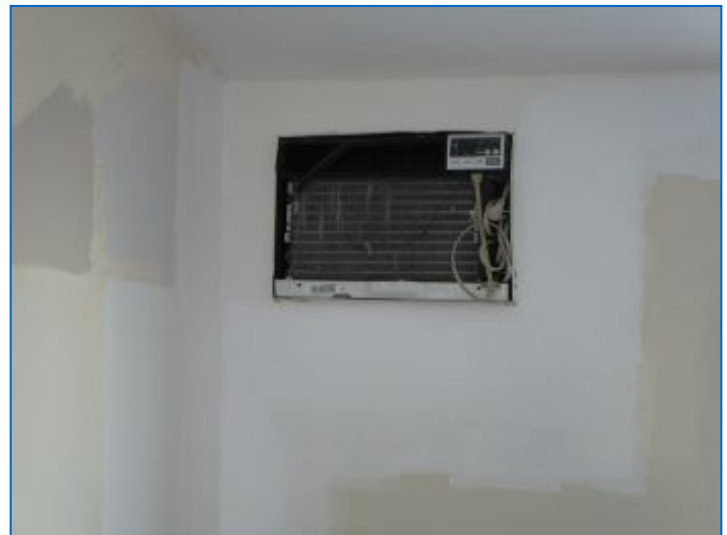
A/C front cover was missing/broken and needs replacement for proper operation.

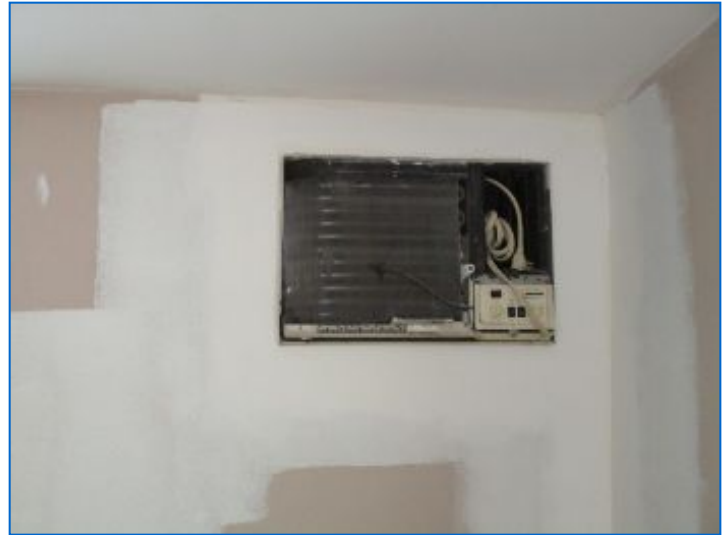
A/C front cover was missing/broken and needs replacement for proper operation.

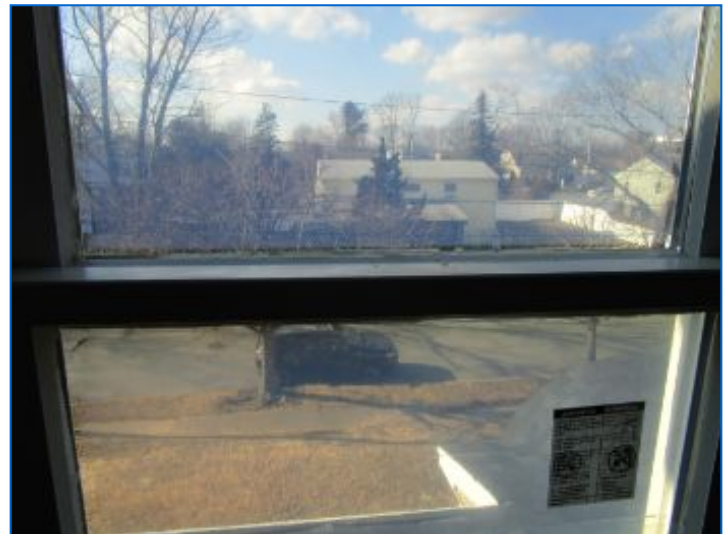
Front window hardware noted missing.

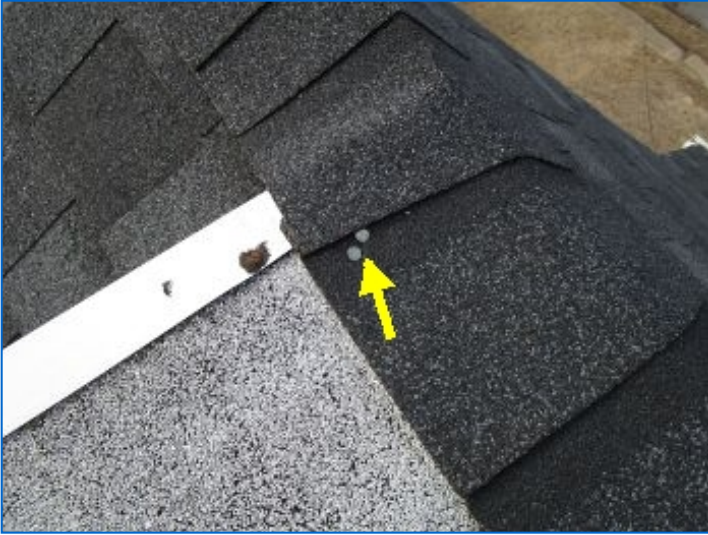
Exposed and countersunk nail heads at roofing material. Recommend sealing all fastener heads.

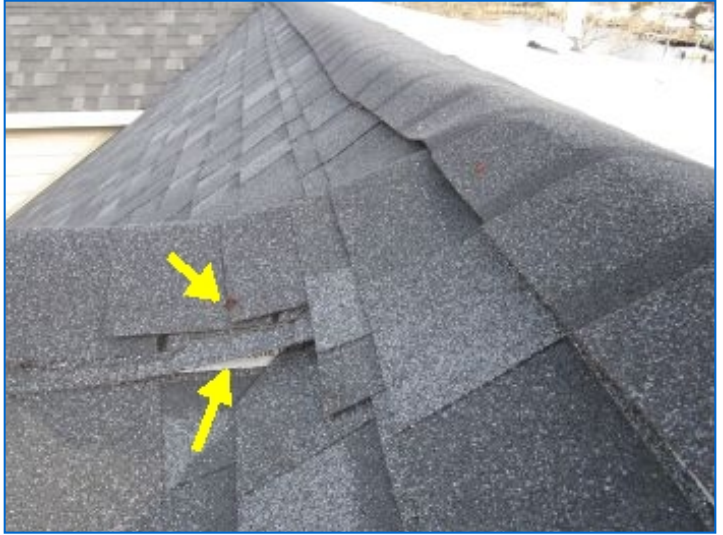
Some shingles damaged; improper nails used; undercut shingles; shoddy repairs noted Recommend proper repairs by a licensed qualified roofing contractor.

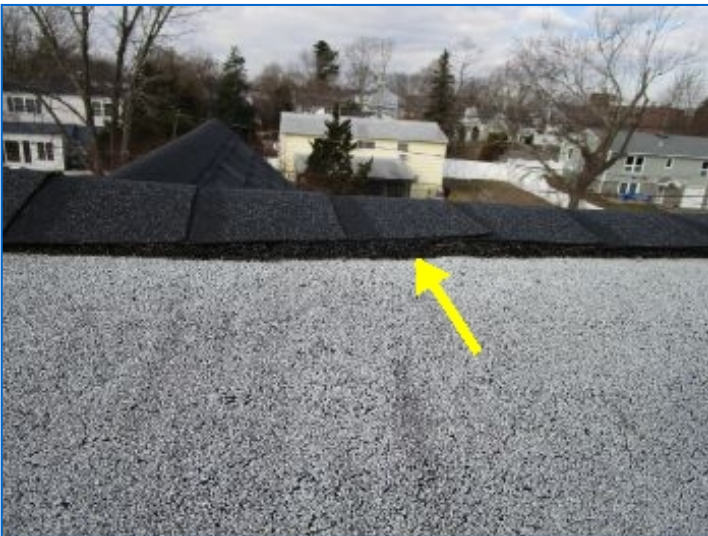
Ridge cap shingle overlap appeared too little at ridge vent and low-slope roof interface (potential water intrusion).

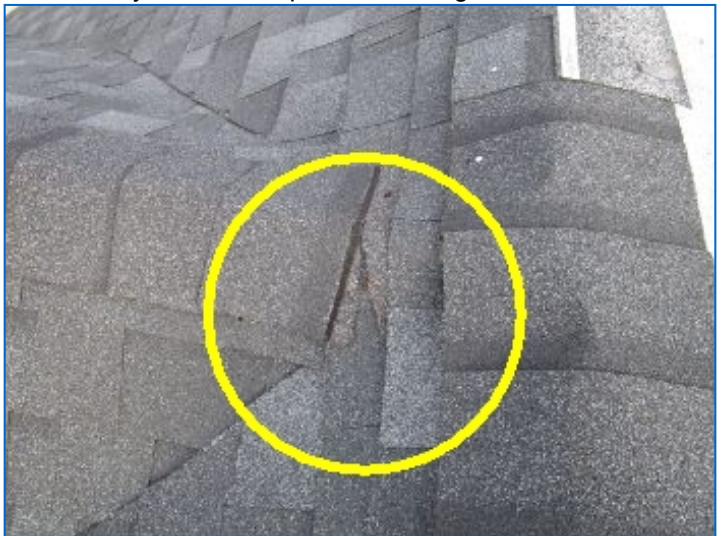
Some shingles damaged; improper nails used; undercut shingles; shoddy repairs noted Recommend proper repairs by a licensed qualified roofing contractor.

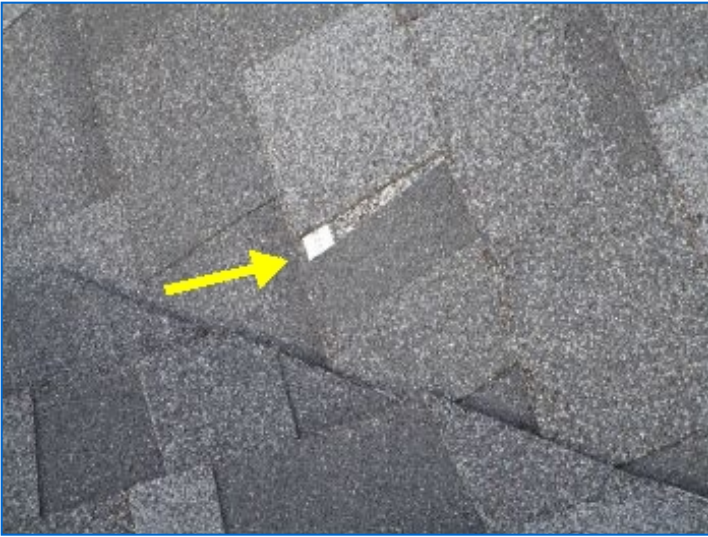
Signs of inferior workmanship by roofers.

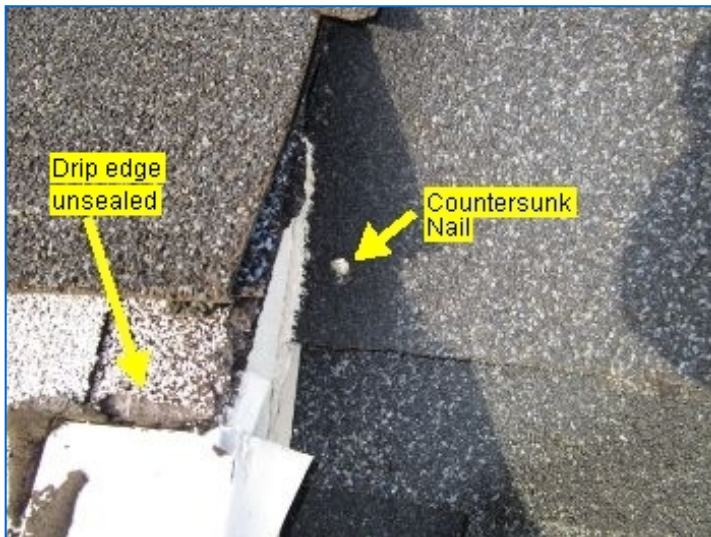
Signs of inferior workmanship by roofers. Conditions that can lead to water intrusion noted. The Inspector recommends review by a qualified roofing contractor to provide remedial improvements and warranty workmanship for the roof. Exposed and countersunk nail heads at roofing material. Recommend sealing all fastener heads.

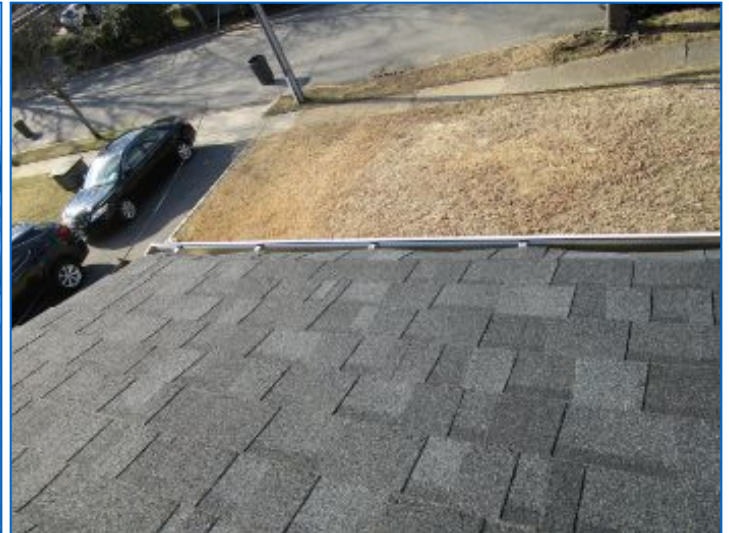
Shingles extended to far over gutter which may affect proper gutter drainage; recommend corrective action.

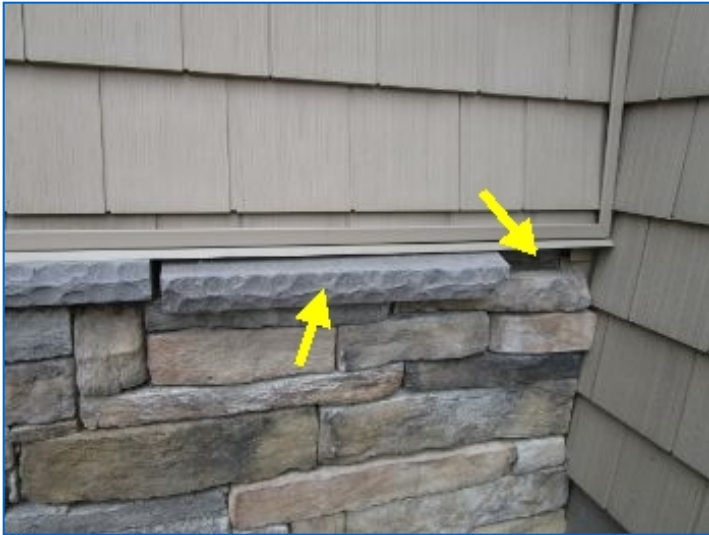
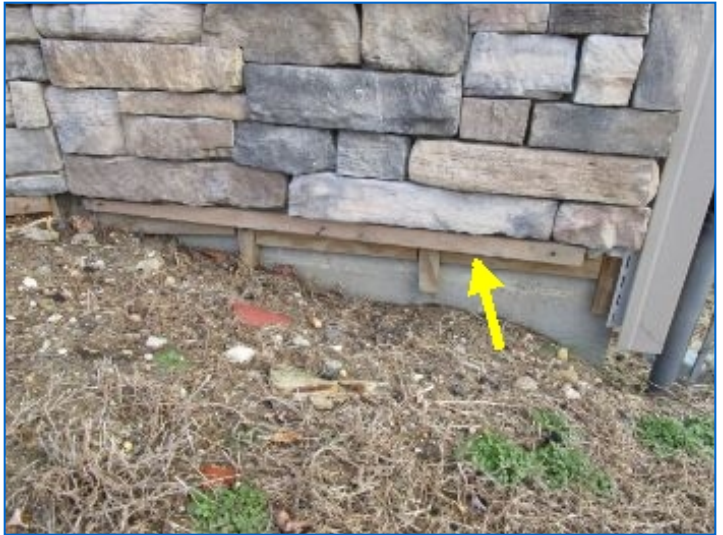
Missing and loose cap stones at front wall; incomplete work.

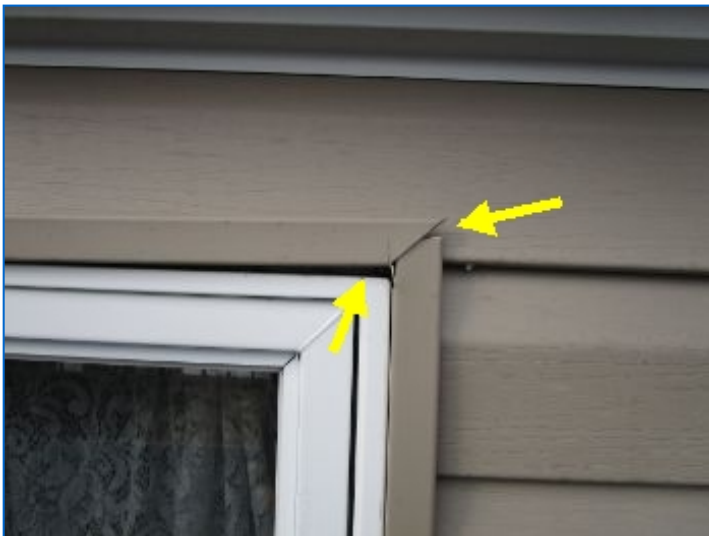
Some signs of sloppy trim work noted at rear dormer.

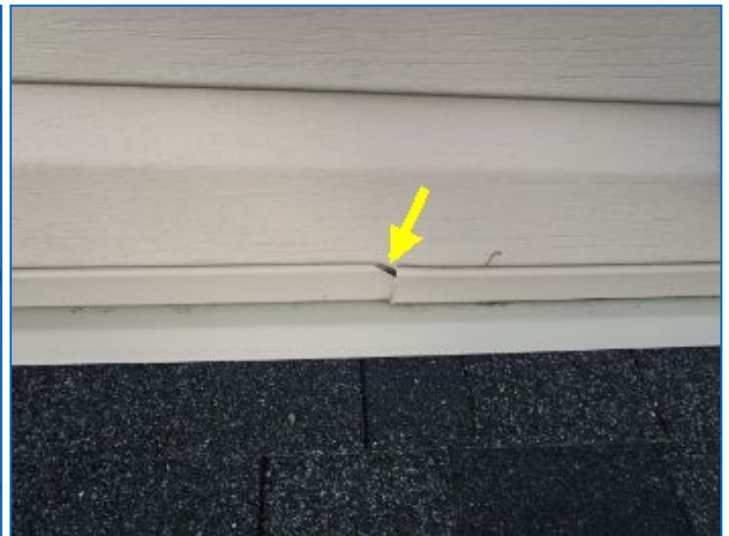
Some signs of sloppy trim work noted at rear dormer.

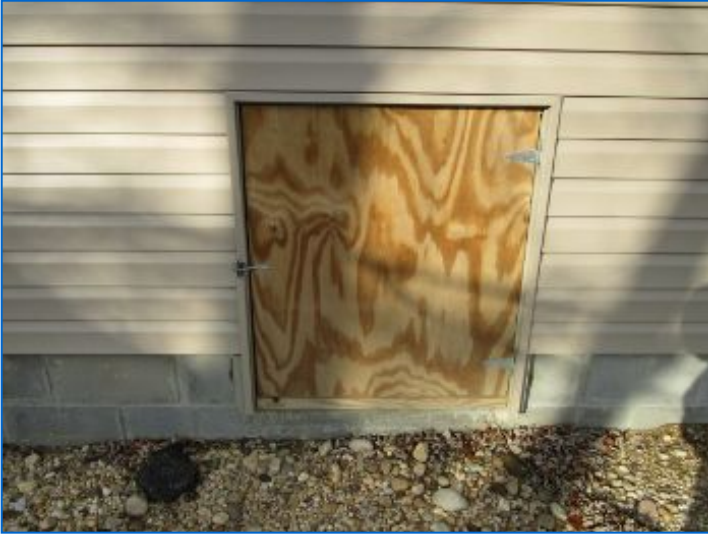
Exterior door for crawlspace not finished or secured. Recommend contractor provide a properly finished and lockable access door.

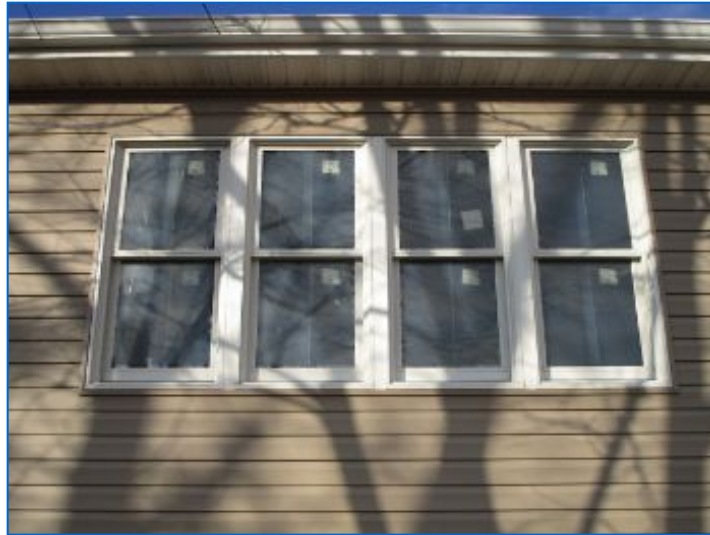
All window screens were missing. Contractor to provide.

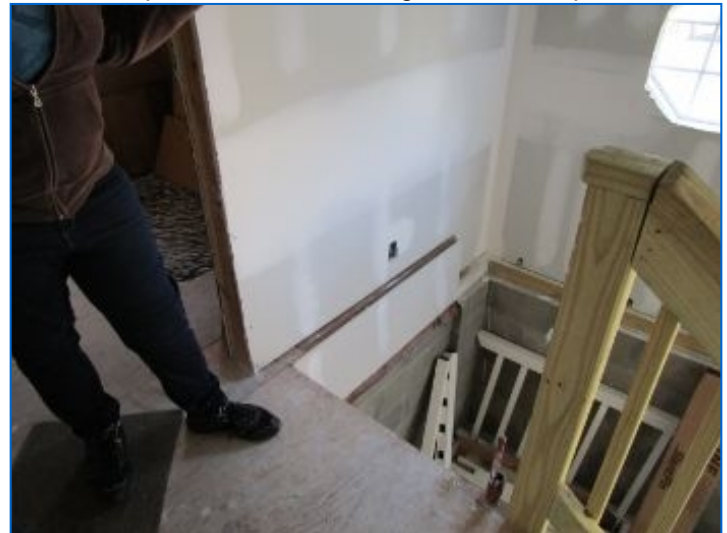
Guardrail (temporary) for fall protection was missing at time of inspection.

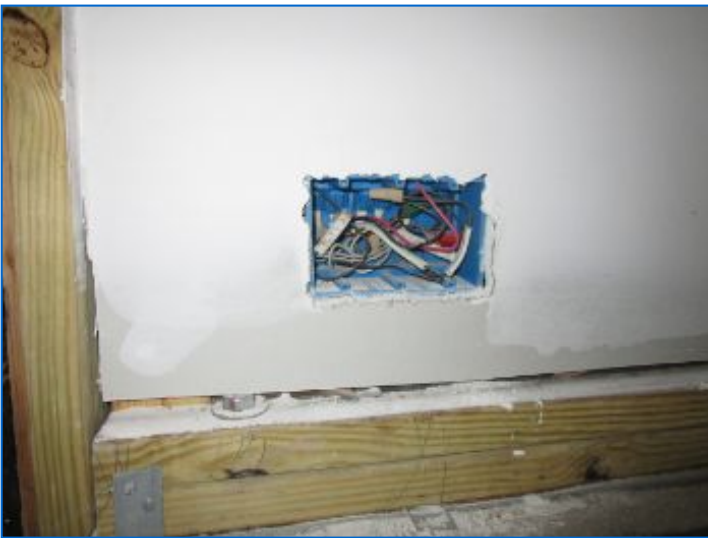
Open junction boxes observed; incomplete work. Exposed wires are a safety concern. Recommend completing work or install proper covers, as needed for safety.

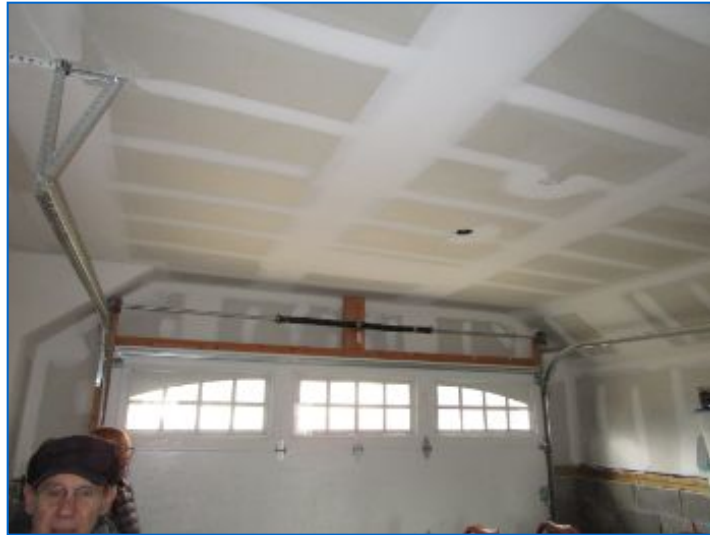
Vehicle door opener was missing. Recommend having a qualified contractor perform installation.

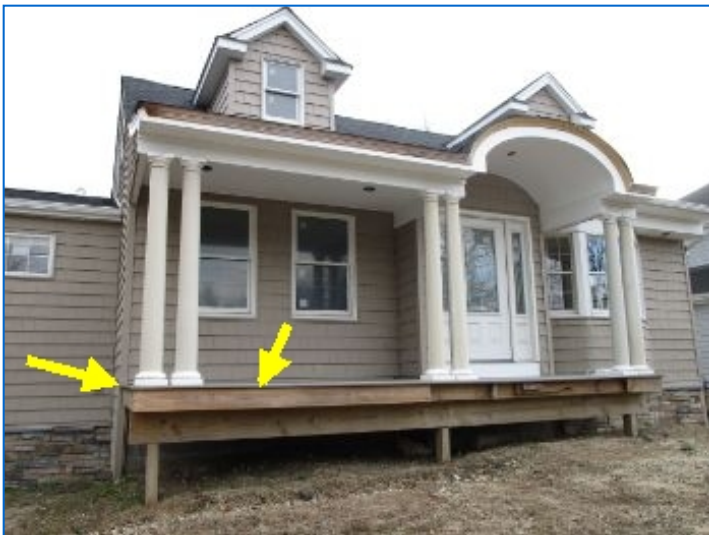
After final regrading the front landscape the finished porch may have walking surface greater than 30 inches above grade which would be required to be protected by a guardrail. Safe building practices dictate that any walking surface 30 inches or more above grade should have a guardrail.

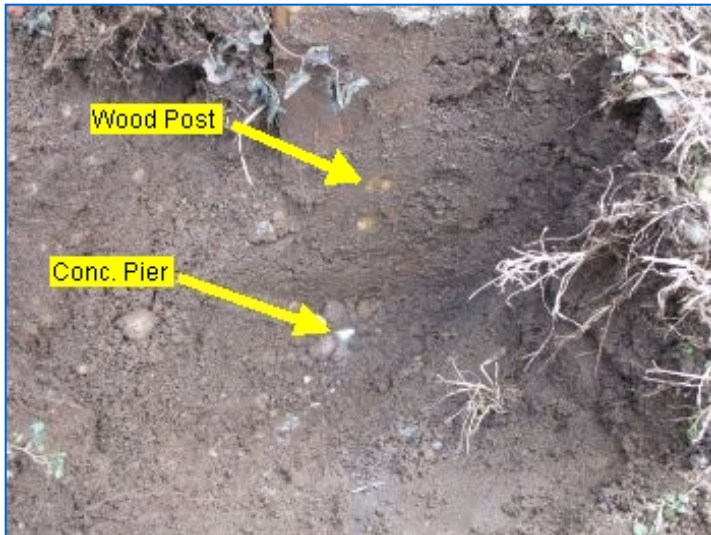
Foundation piers for porch support posts did not extend high enough above grade to prevent wood post contact with soil. This condition will cause eventual decay of post bases. The Inspector recommends correction by a qualified contractor to prevent soil contact with wood posts, framework and lattice.

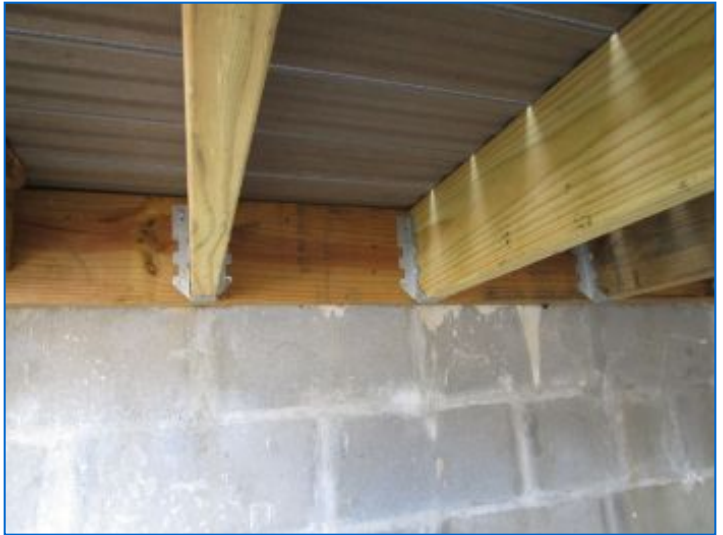
The porch was attached to the home by a ledger fastened to the exterior walls with nails only. The inspector recommends fastening the ledger to the home with adequate hardware such as corrosion resistant lag screws of proper size. All work should be performed by a qualified contractor.

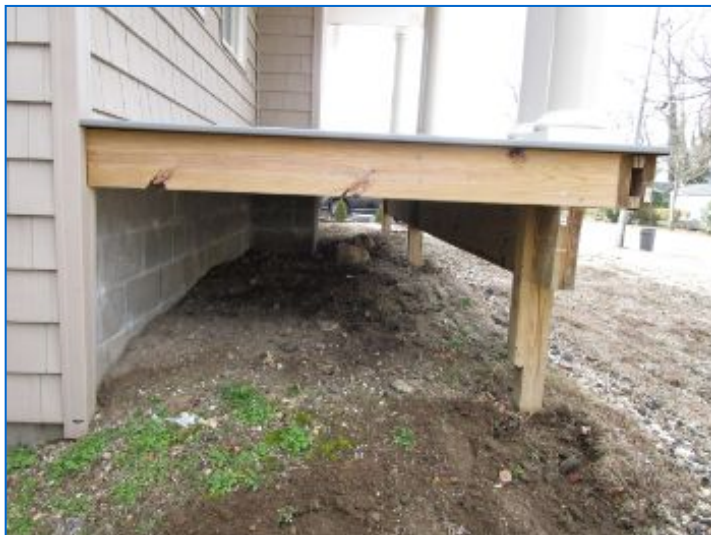
Porch structure finishes missing including fascia boards, frames and lattice.

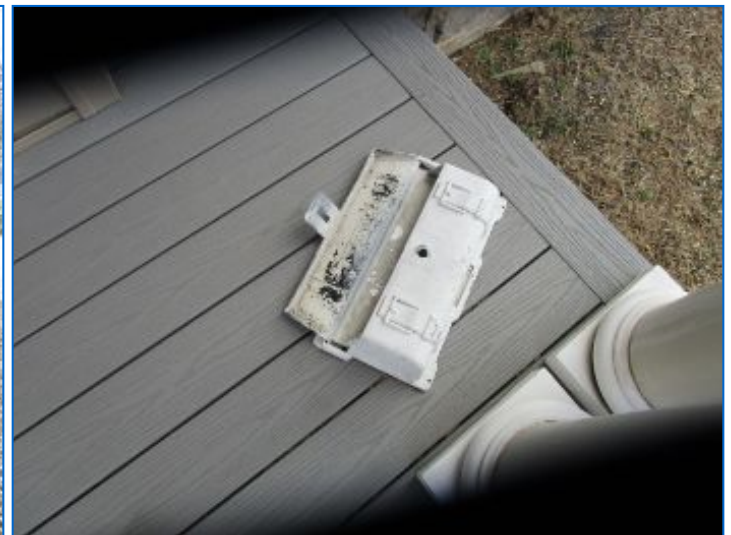
Mailbox not installed.

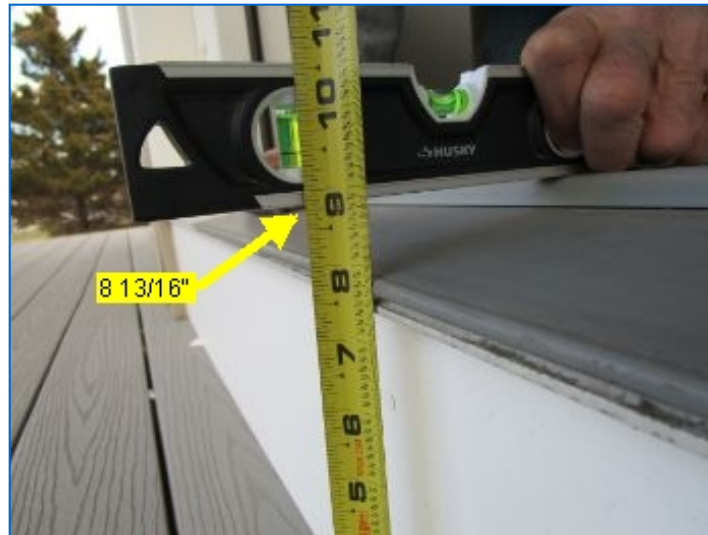
From the porch surface to the door threshold, the step riser exceeded the  $7\frac{3}{4}$ -inch maximum recommended by generally-accepted standards. This condition is a potential trip hazard. All corrections should be made by a licensed qualified contractor. Per the drawings, Front Elevation shows the porch surface even with the door threshold height.

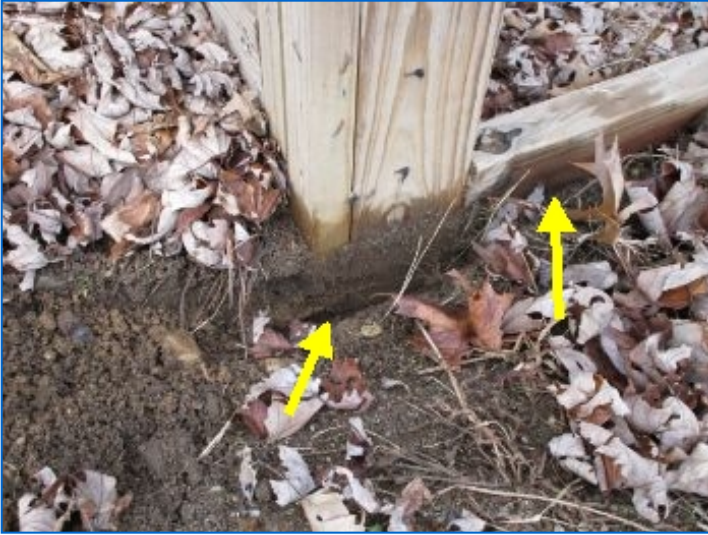
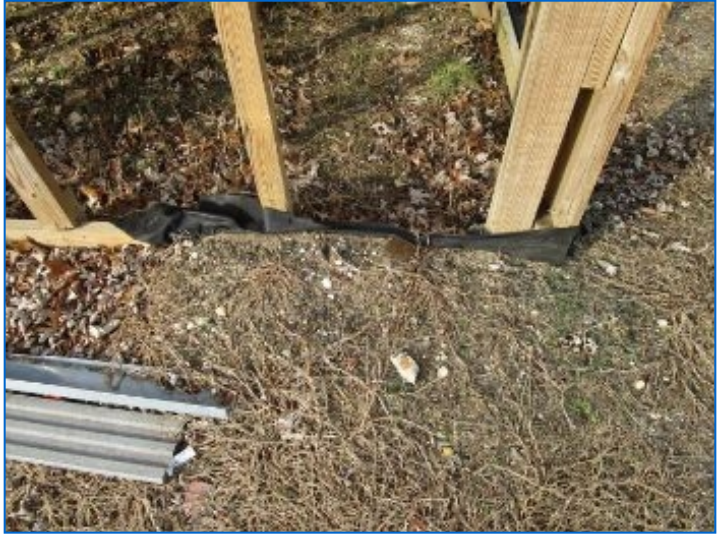
Foundation piers for deck support posts did not extend high enough above grade to prevent wood post contact with soil. This condition will cause eventual decay of post bases.

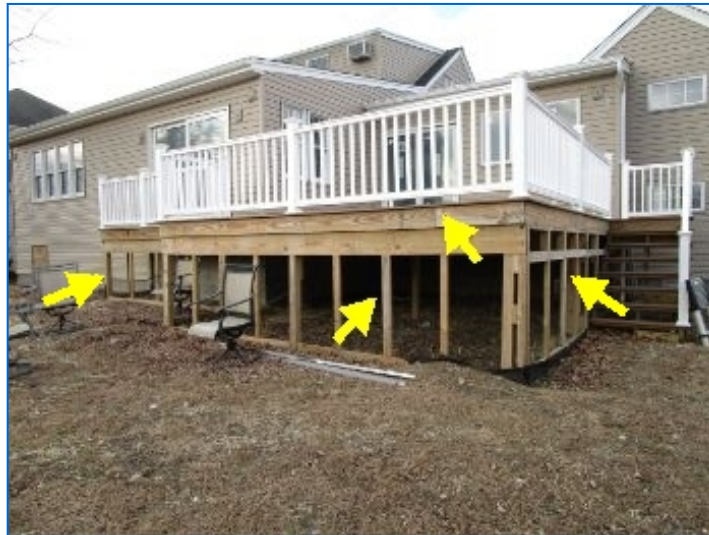
Deck structure finishes missing including fascia boards, frames and lattice.

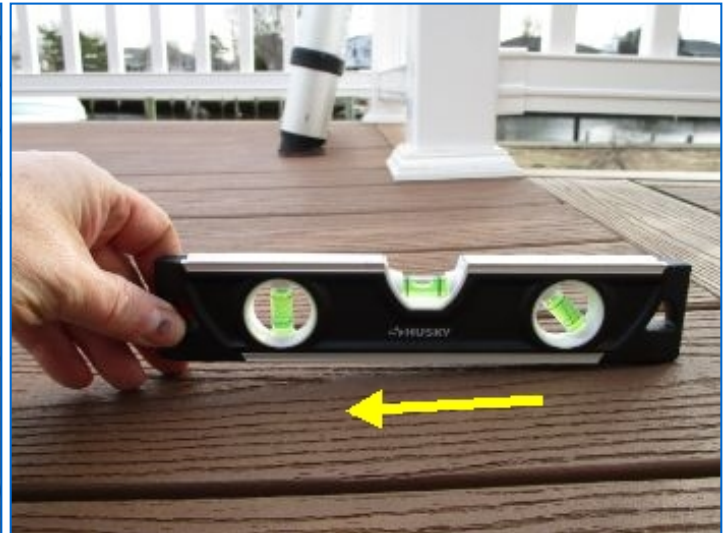
The planking was uneven where connected to adjoining deck area. Potential trip hazard. Suggest shimming planks to reduce severity.

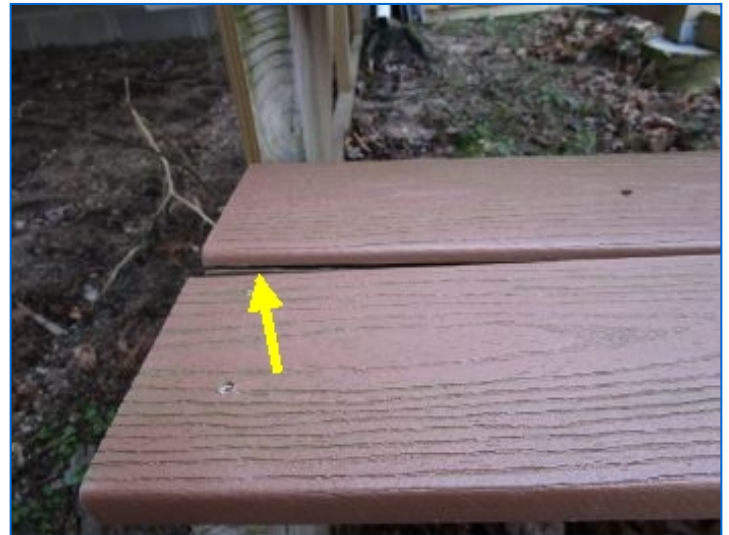
Composite planks at steps were not adequately fastened and were lifting at stringers. These planks were not fastened using the manufacturer clips. Recommend securing all plank ends to stringers.

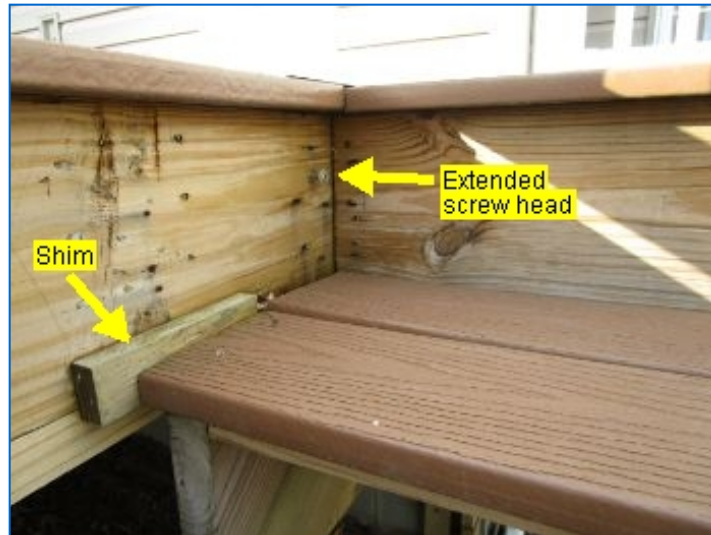
Unfinished or inferior workmanship noted at stairs.
