BUILDING ANALYSIS REPORT

Client: *Heting Chu*
(Clock Tower)

Property Location: *1 Ellent Ct*
Glen Cove, NY 11542

Date of Inspection: *7/11/2016*

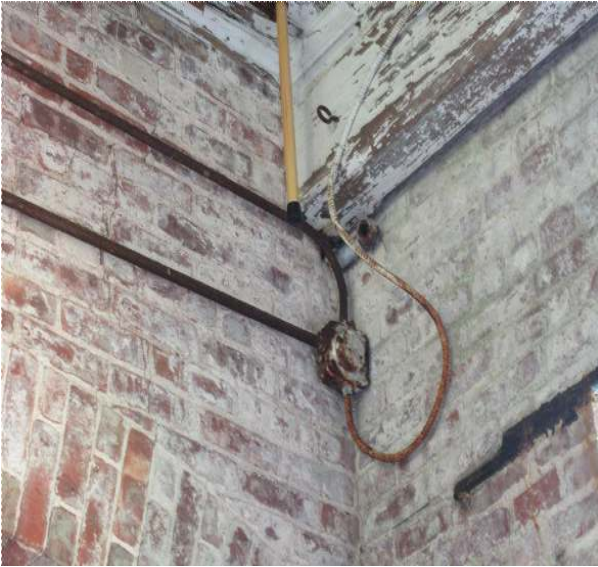
IMG_a1176.JPG

Abandoned rusted electrical conduit, box and BX cable. Suggest removing these materials that are in plain sight for aesthetic purposes. and patch repair walls.

Abandoned rusted electrical conduit, box and BX cable. Suggest removing these materials that are in plain sight for aesthetic purposes and patch repair

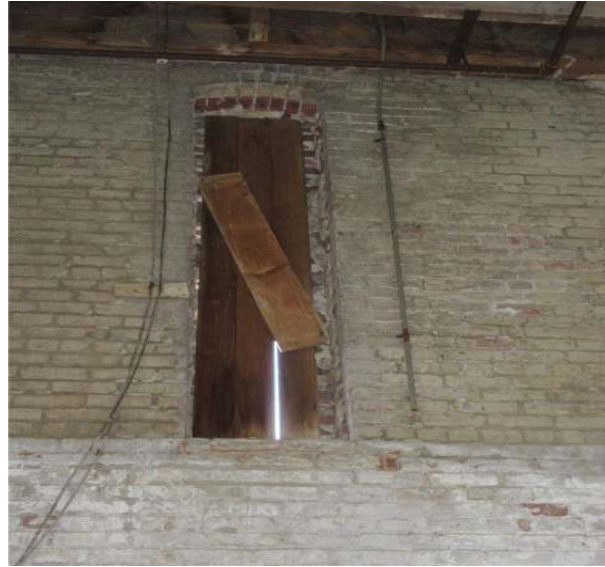
IMG_1185.JPG

Window boarding to be removed upon implementing window repairs.

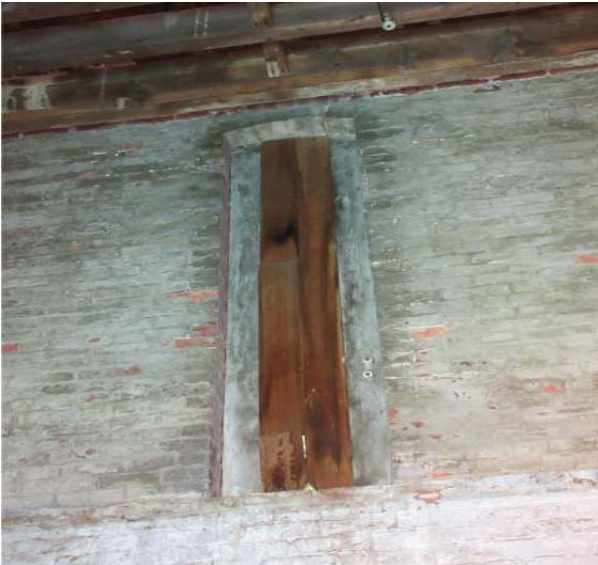
IMG_1186.JPG

Window boarding to be removed upon implementing window repairs.

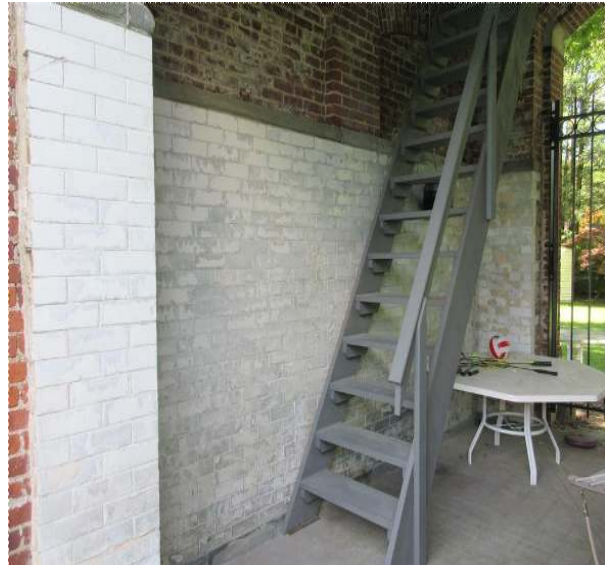
IMG_1177.JPG

Glazed brick with glazed surface damaged and missing.

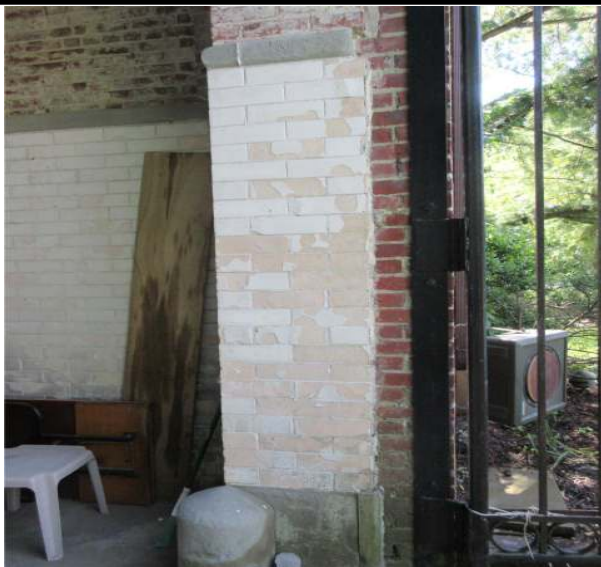
IMG_1178.JPG
Glazed brick with glazed surface damaged and missing.

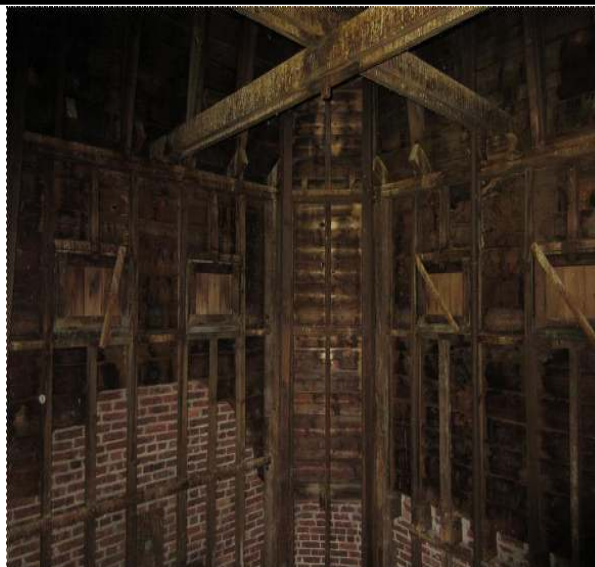
IMG_1202.JPG

View looking inside from 4th level door to observation deck level from ladder. Poop stains on wood beams from when pigeons occupied the tower.

Higher beams and ledges (above 3rd floor) with poop stains from when pigeons occupied the tower. Suggest cleaning with mild detergent all exposed surfaces that occupants might come in contact with. Noted old abandoned sprinkler piping.

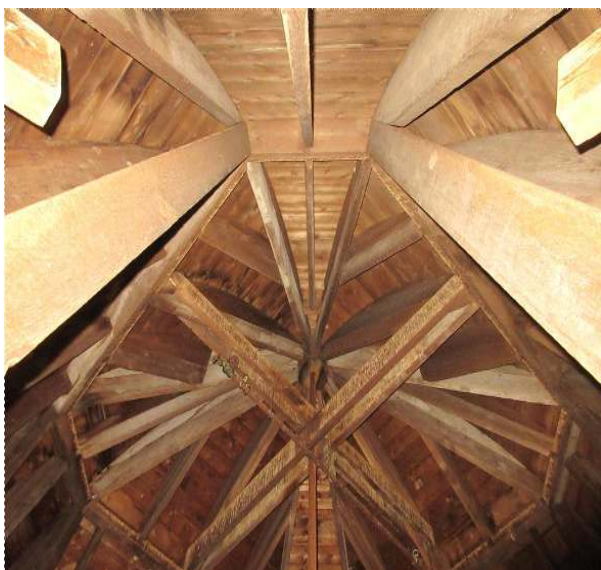
IMG_1203.JPG

View looking up from 4th level. Poop stains on wood beams and ledges from when pigeons occupied the tower. Notice old abandoned sprinkler piping.

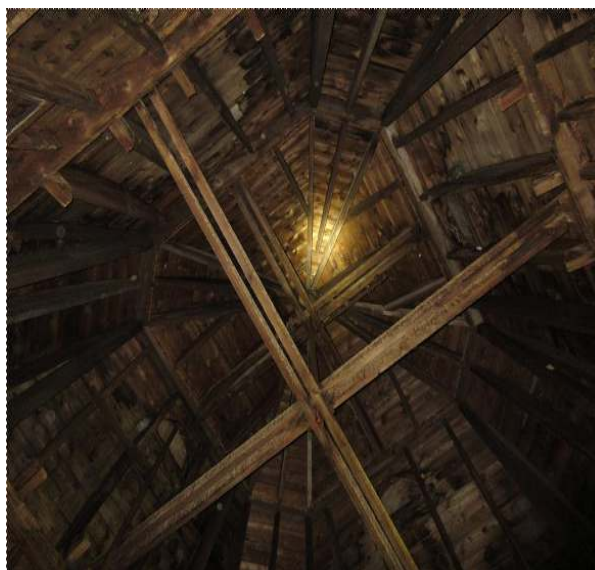
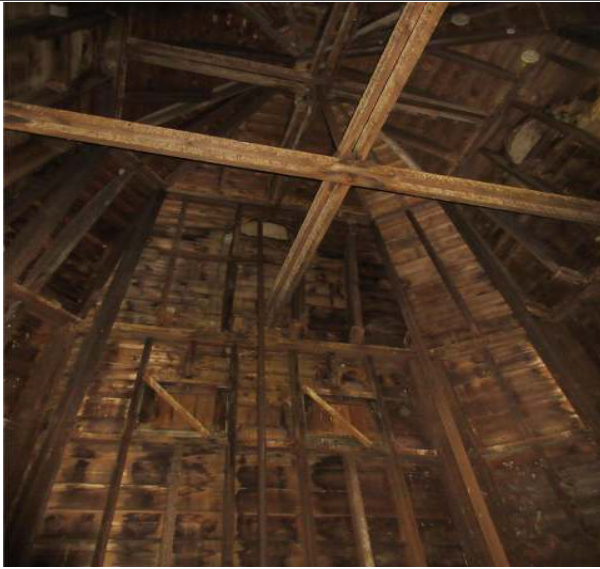
View looking up from 3rd floor. Water stains on wall boards indicate water has entered the structure. Note that cupolas vents were boarded closed.

View looking up from 3rd floor. Water stains on wall boards indicates that water has entered the structure. Note that cupolas vents were boarded closed.

The four Cupolas in the domed roof were boarded closed. This eliminates the ventilation needed for the upper part of the tower where heat and vapor pressure will build. Recommend replacing these boards with copper bird/insect screens to provide ventilation of this space needed to protect the wood from effects of sustained moisture and heat. Currently, this space is enclosed (except for the unwanted leakage points).

Punctures in copper sheeting at observation deck wall is a typical place where water can enter the structure. Looking up from 3rd floor observed water stains on wall boards indicating that water has entered the structure. Suggest a copper roof specialist conduct a detailed inspection/test to identify all leaks/breaks in the copper envelope, and apply the appropriate repairs/sealant where needed to prevent water entry.

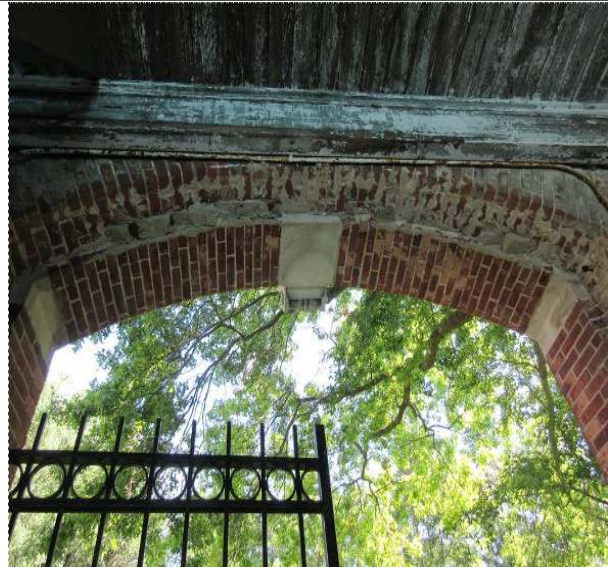
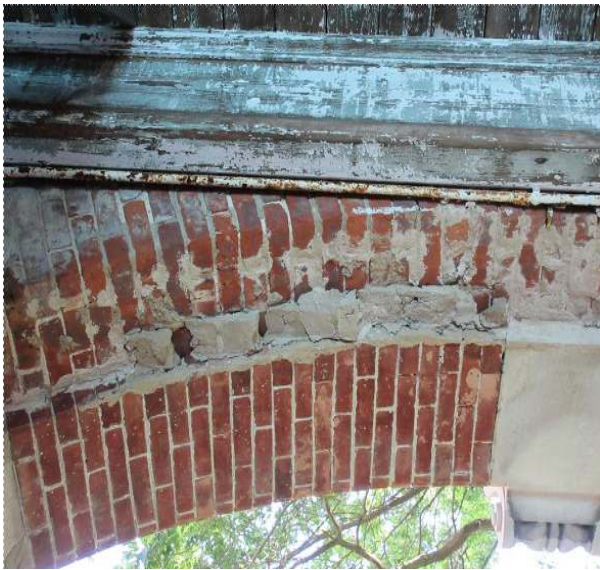
Cement patch repairs at underside of rear arch appear to be sloppy and may become loose. Suggest corrective measures here.

Cement patch repairs at underside of rear arch appear to sloppy and may become loose. Suggest corrective measures here.

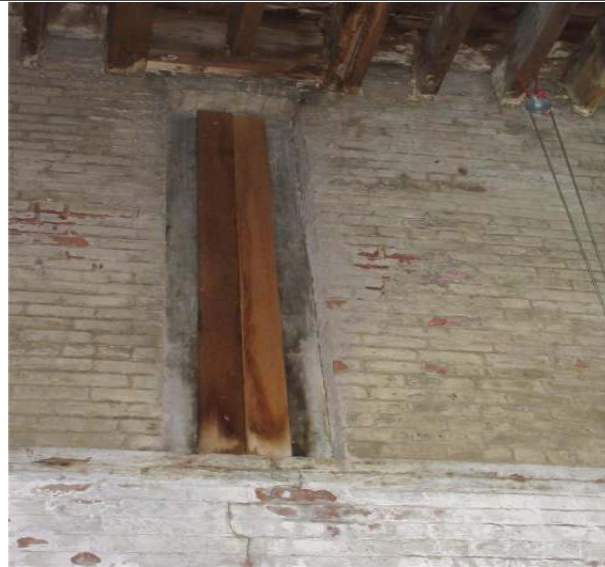
IMG_f1187.JPG

Left-side window boarded closed from inside. Window boarding to be removed upon implementing window repairs.

Left-side vertical window frame appears essentially intact (boarded from inside). Suggest repairing damaged portion and fit with new glass panes.

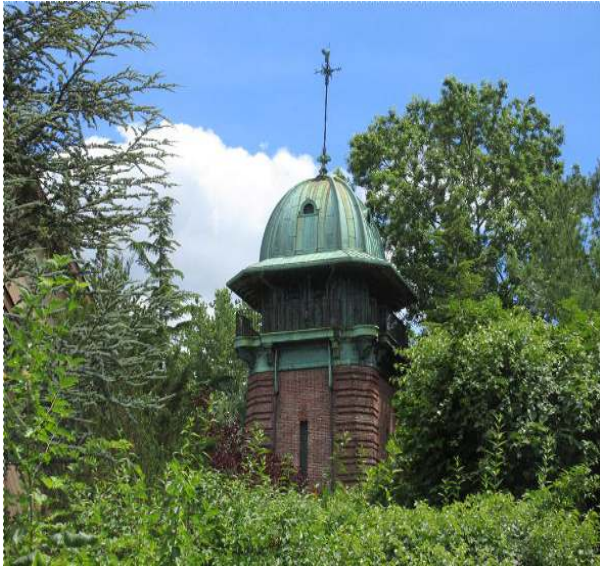
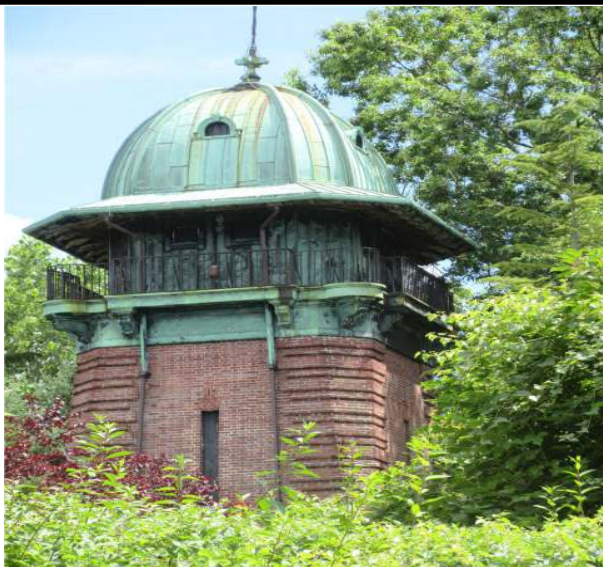
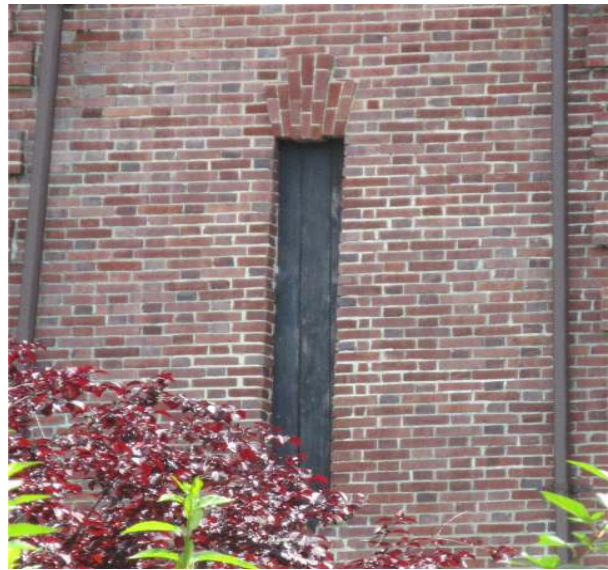
Front-side (pool) window frame missing (boarded from inside). Suggest installing custom wood window frame with glass panes to match existing windows.

Front-side (pool-side) vertical window frame completely missing (boarded from inside). Suggest installing custom wood window frame with glass panes to match existing windows.

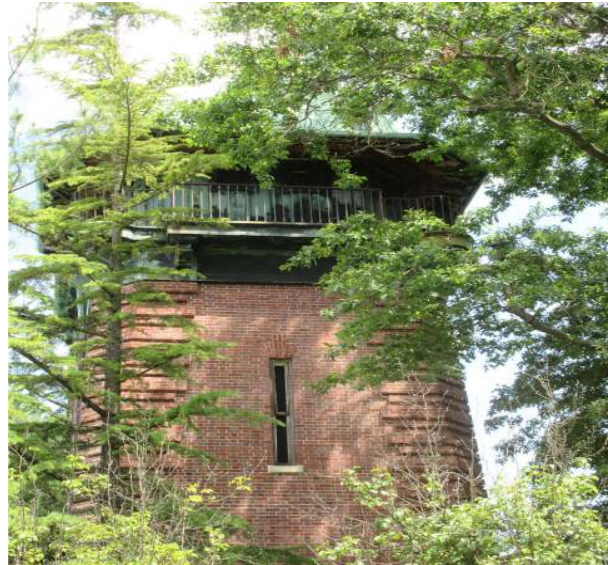
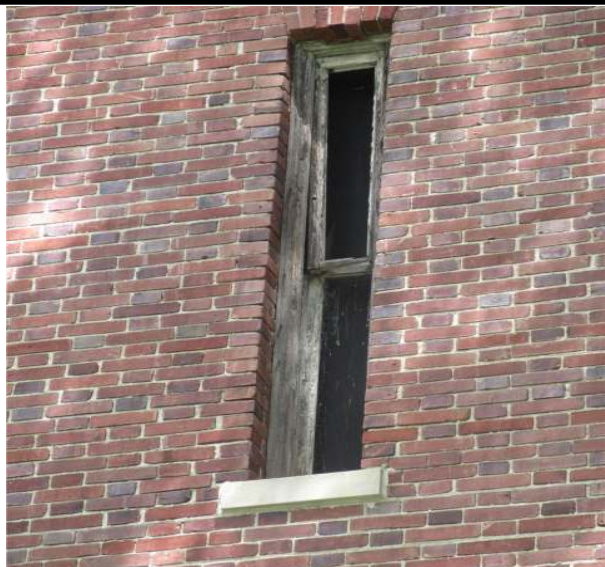
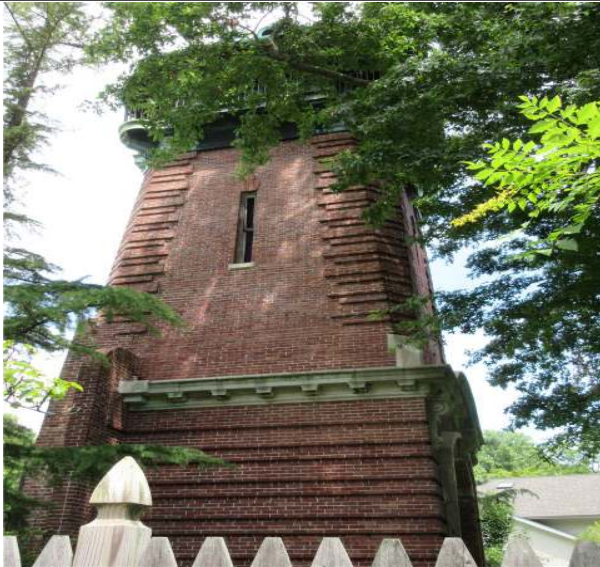
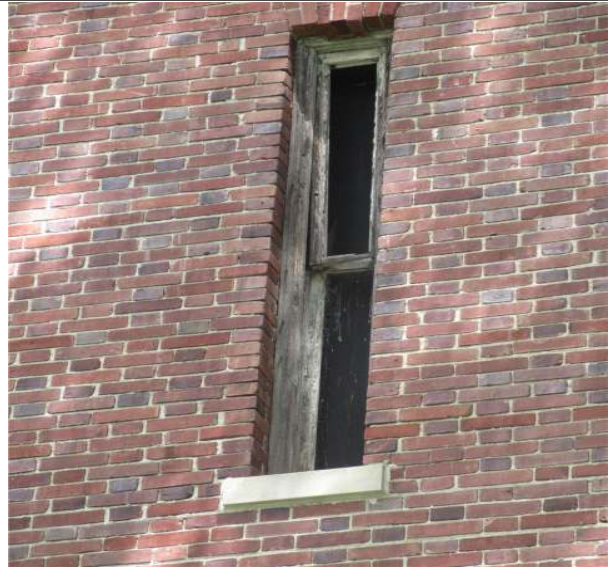
Right-side vertical window frame appears somewhat intact (boarded from inside). Suggest repairing damaged portion and fit with new glass panes.

Right-side vertical window frame appears somewhat intact. Suggest repairing damaged portion and fit with new glass panes.

Right-side vertical window frame appears somewhat intact (boarded from inside). Suggest repairing damaged portion and fit with new glass panes.

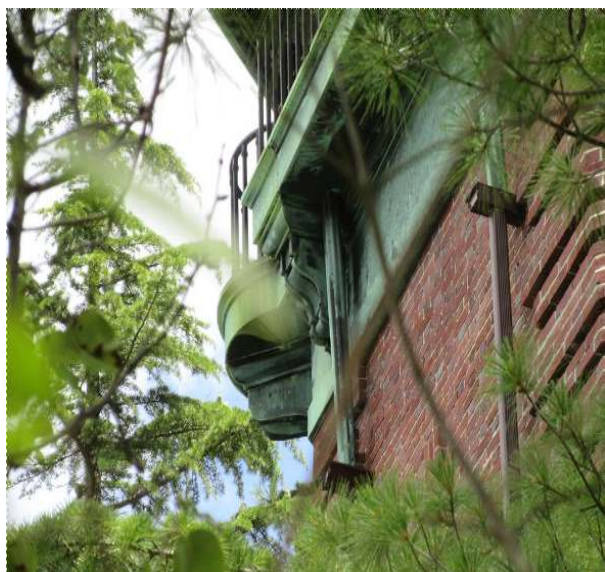
IMG_1145.JPG

Original copper downspouts (green patina) compared to the modern aluminum downspouts/gutter segments (brown).

Original copper downspouts at front have been replaced with modern aluminum type downspouts. Suggest repairing dented copper gutters at front. Suggest replacing rectangular aluminum downspouts with circular shaped antique copper downspouts to match existing original sections of downspouts seen below observation deck.

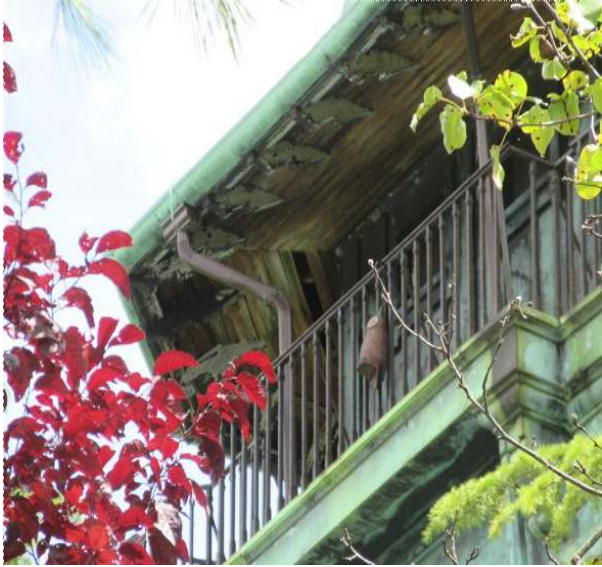
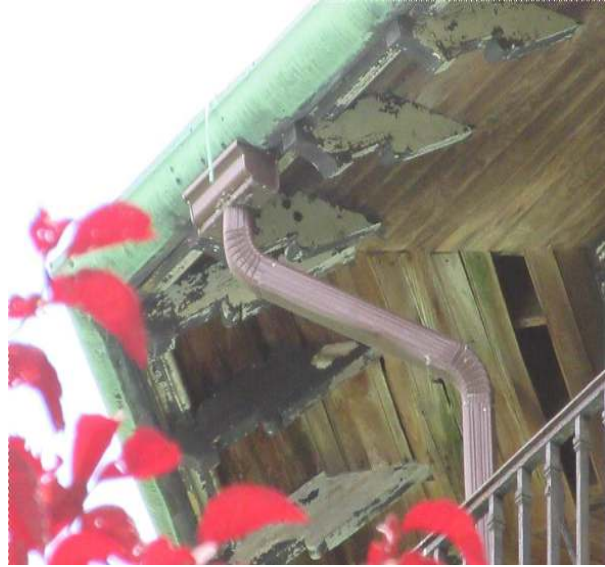
Photo shows missing planks at ceiling of overhang as well as deteriorated white painted finish on rafters supporting the overhang.

Missing planks at ceiling of overhang as well as deteriorated painted finish on rafters supporting the overhang. Suggest repairs and paint to maintain the structure and appearance.

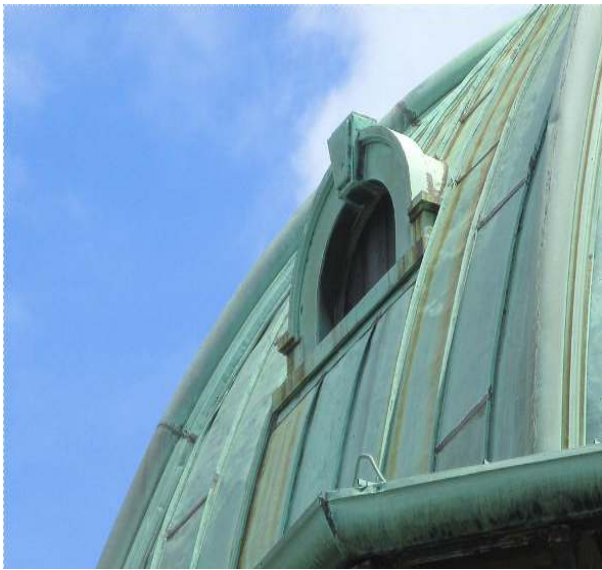
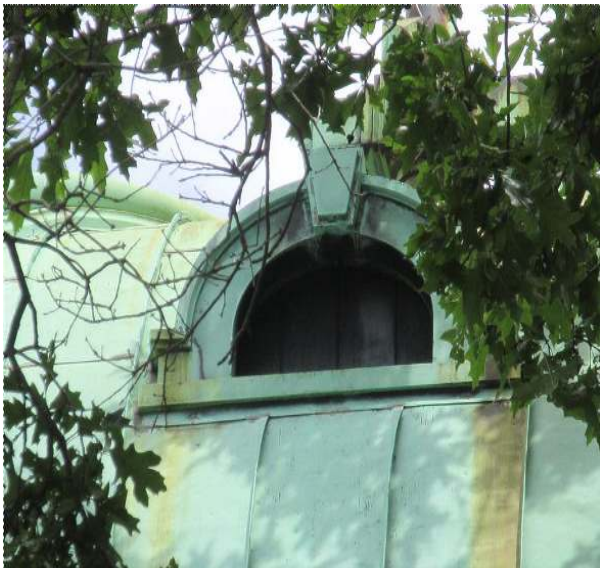
Cupolas in dome were boarded closed (four places). Refer to comments in Attic section.

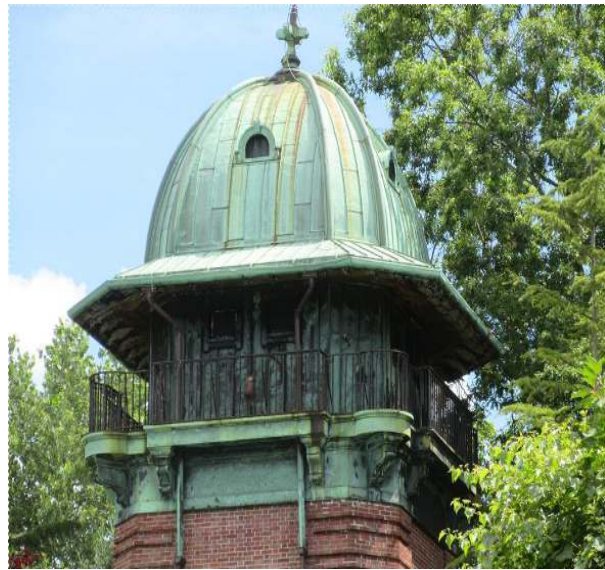
IMG_1151.JPG

Exterior close-up view of front-side shows varying shades of patina on the copper as well as rust stains, likely originating from the weather vane iron assembly.

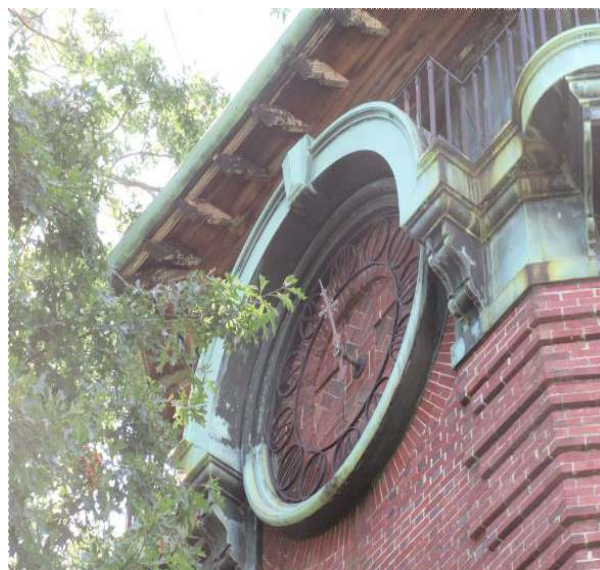
IMG_1164.JPG

Clock face dial with (second) hand missing.

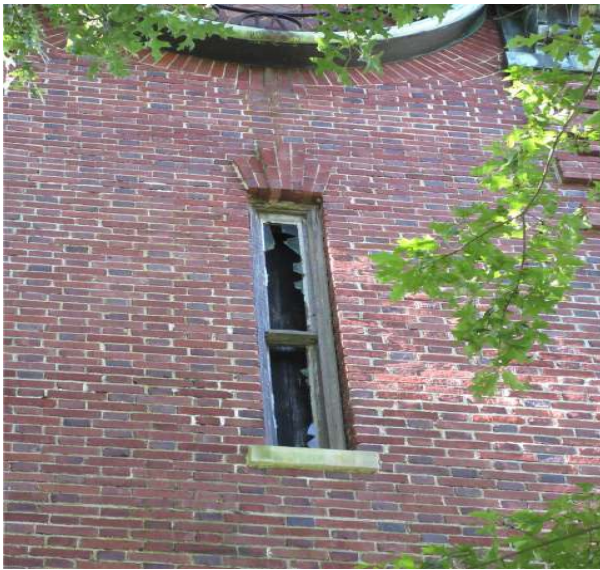
IMG_1209.JPG

Rear-side (clock-side) window frame appears essentially intact with glass broken (boarded from inside). Suggest replacing broken glass with new glass panes.

Rear-side (clock-side) vertical window frame appears essentially intact with glass broken (boarded from inside). Suggest replacing broken glass with new glass panes.

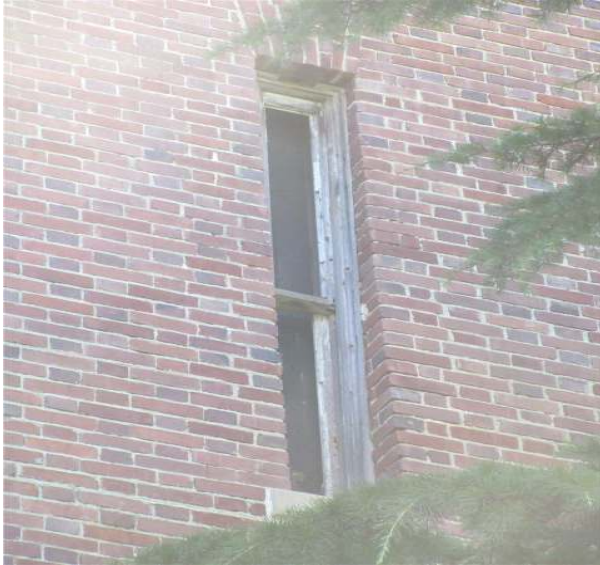
IMG_1210.JPG

Left-side vertical window frame appears essentially intact (boarded from inside). Suggest repairing as needed and fit with new glass panes.

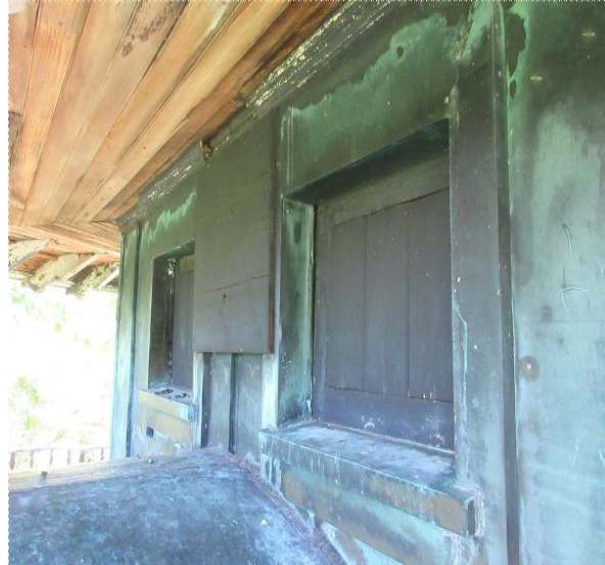
IMG_1196.JPG

Existing windows over around observation deck are boarded closed. Suggest painting bords to match greenish copper patina color.

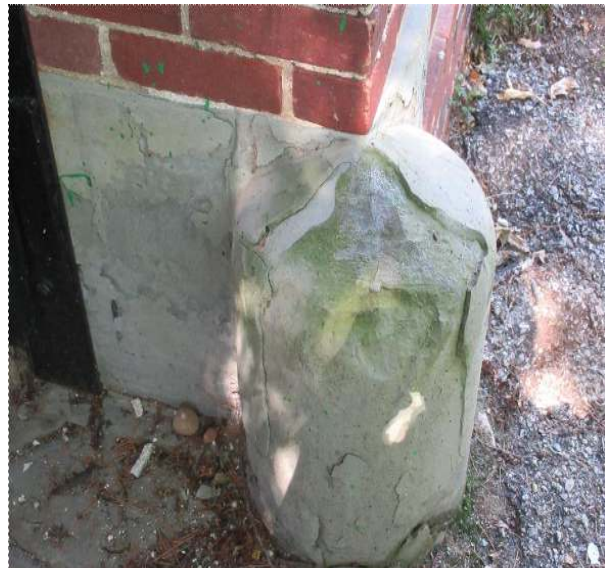
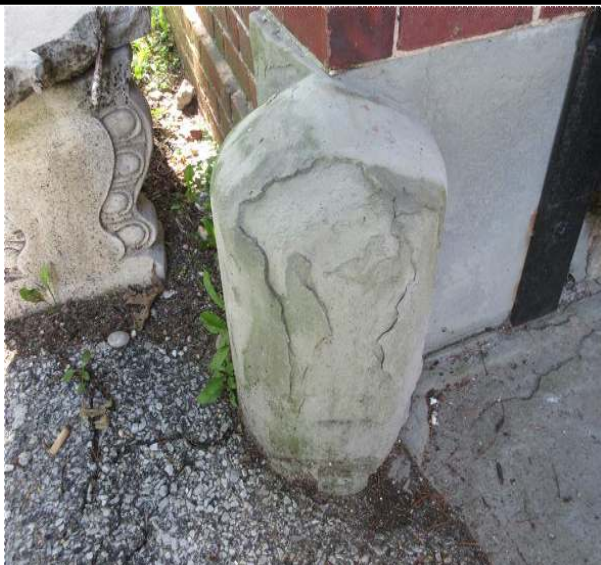
Cornerstone cement topping has delaminated (cosmetic repair - 3 places).

Fractured cement cornerstone (cosmetic repair); Cornerstone cement topping has delaminated (cosmetic repair - 3 places).

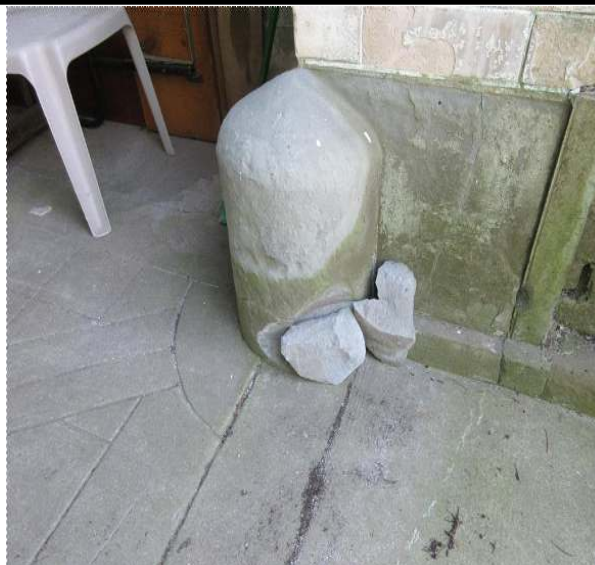
IMG_1179.JPG

Fractured cement cornerstone needs repair (cosmetic).

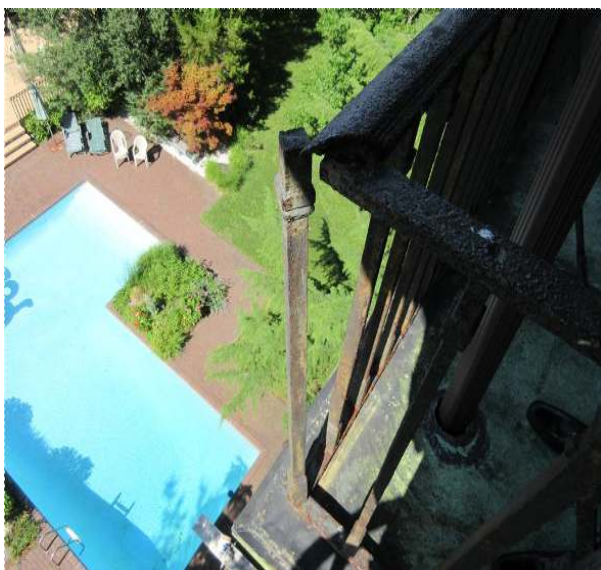
IMG_1190.JPG

Wrought iron railing spindle has detached from top rail corner and needs to be secured/re-attached.

Although observation deck railing appears to be secure, we recommend not leaning over it; Noted trip hazard created by railing braces. Remove abandoned 1/2" dia. pipe along floor. Wrought iron railing spindle has detached from top rail corner and needs to be secured/re-attached. Recommend exercising extreme caution when navigating the about the observation deck. Suggest Caution signage!

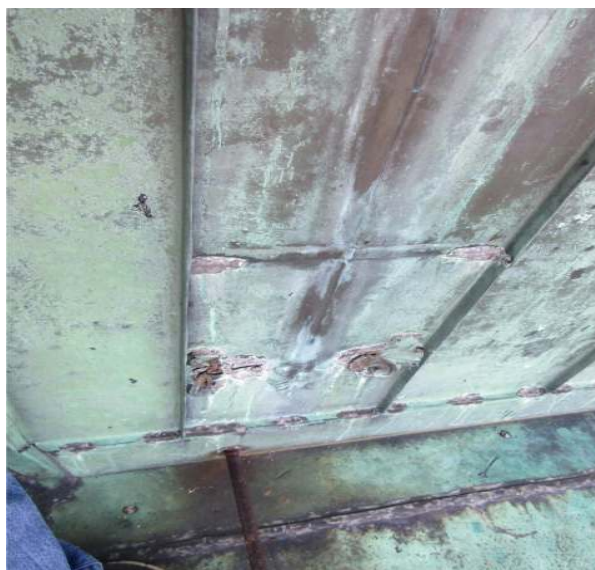
IMG_1198.JPG

Defects in copper sheeting allow water entry into the structure and should be sealed.

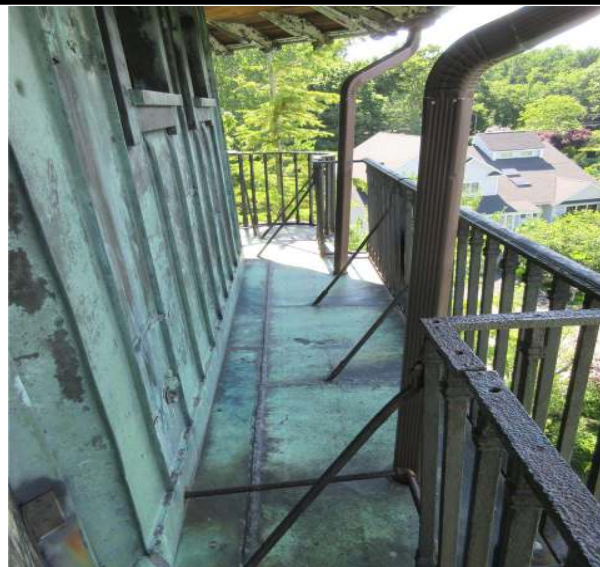
IMG_1201.JPG

Copper plated observation deck walkway with wrought iron railing. Railing braces can be a tripping hazard. Remove abandoned 1/2" dia. pipe at floor.

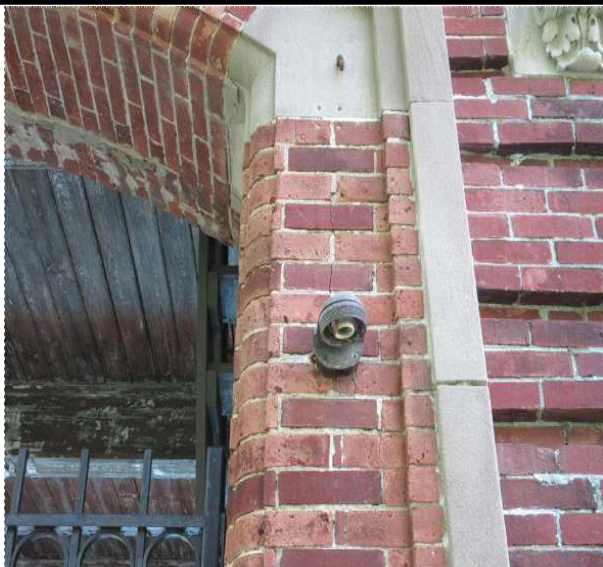
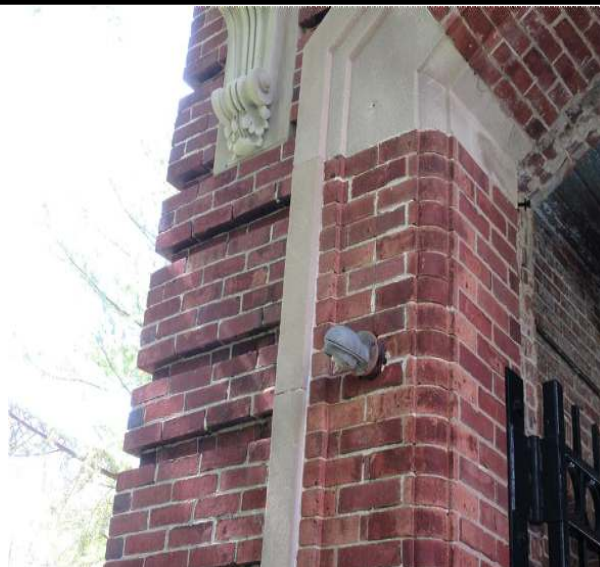
Old abandoned light fixtures at rear-side. Suggest removal for aesthetic purposes and patch repair related wall penetrations to match existing brickwork.

Old abandoned light fixtures at rear-side. Suggest removal for aesthetic purposes and patch repair related wall penetrations to match existing brickwork.

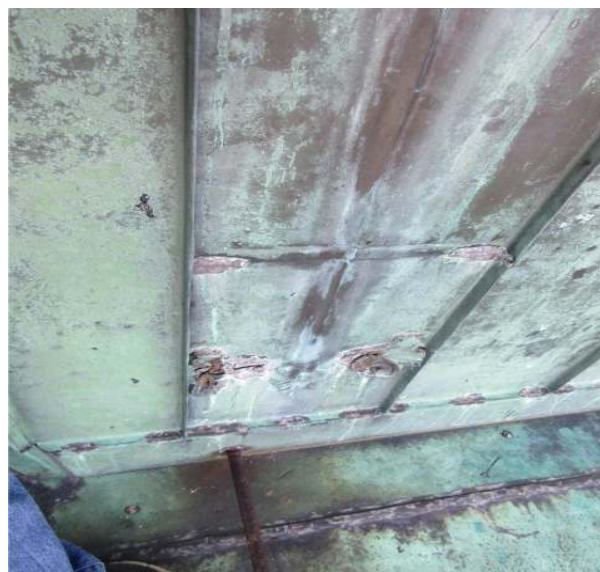
IMG_m1198.JPG

Punctures in copper sheeting at observation deck wall is a typical place where water can enter the structure.

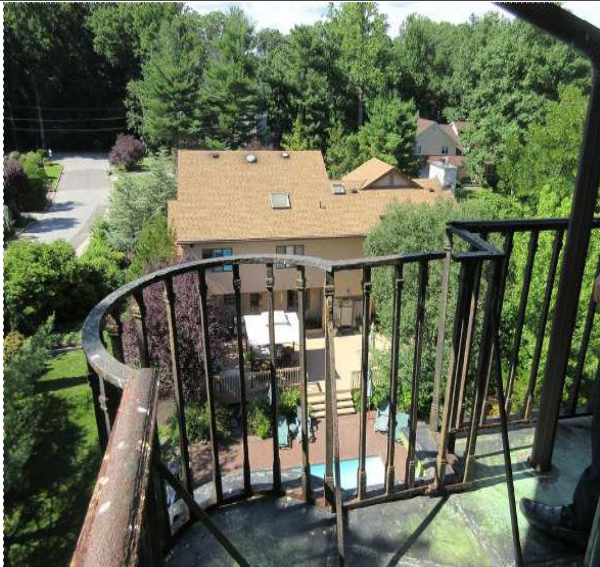
IMG_n1192.JPG

Wrought iron railing at observation deck overlooking the backyard. Although railing appears to be secure, we recommend not leaning over it.

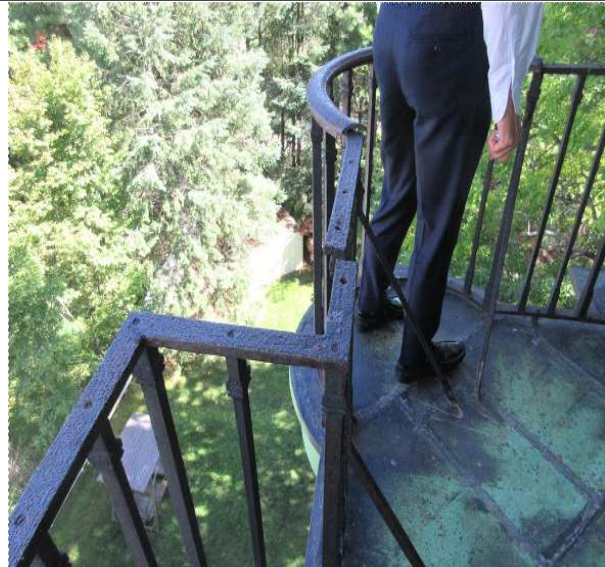
IMG_o1194.JPG

Railing missing significant sections of iron moulding on top rail. Exercise caution when navigating observation deck. Note trip hazard created by railing braces.

Railing missing significant sections of iron molding on top rail. Misaligned top rail noted. Suggest re-aligning observation deck rails. Suggest painting railings with corrosion inhibiting paint. Exercise caution when navigating observation deck.

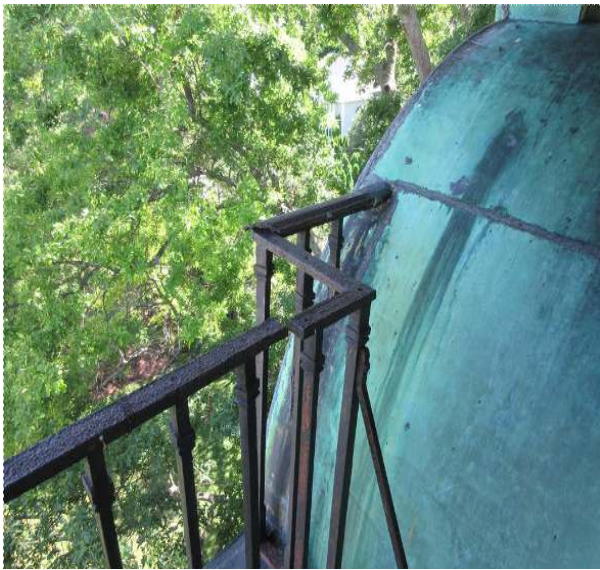
IMG_p1195.JPG

Railing missing significant sections of iron moulding on top rail; misaligned top rail noted. Suggest re-aligning observation deck rails. Suggest painting railings.

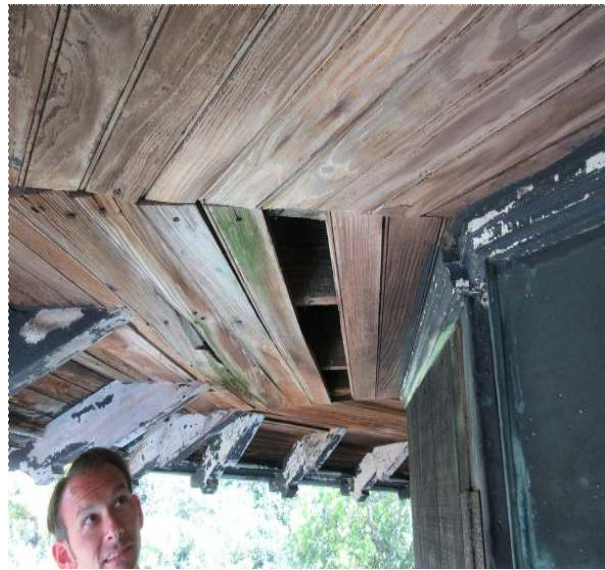
IMG_q1199.JPG

Missing planks at observation deck overhang. Suggest replacing missing wood planks with cedar or equal (keep birds out).

Missing and damaged planks at observation deck overhang. Suggest replacing missing/damaged wood planks with cedar or equal (keep birds out).

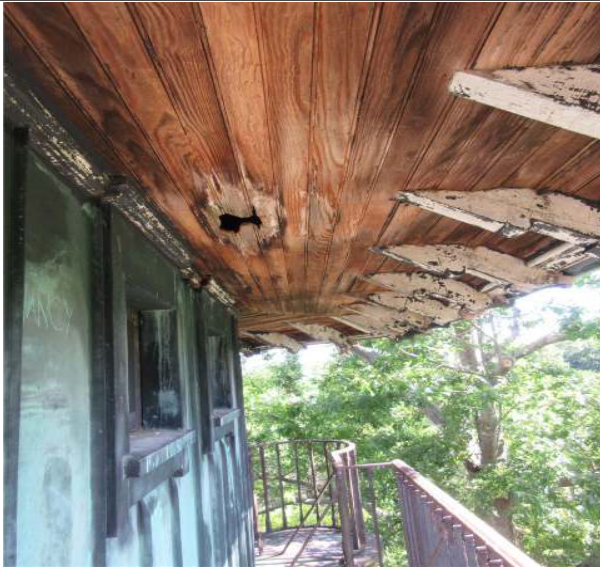
IMG_r1191.JPG

Damaged planks at observation deck overhang. Suggest removing and replacing damaged planks with cedar or equal.

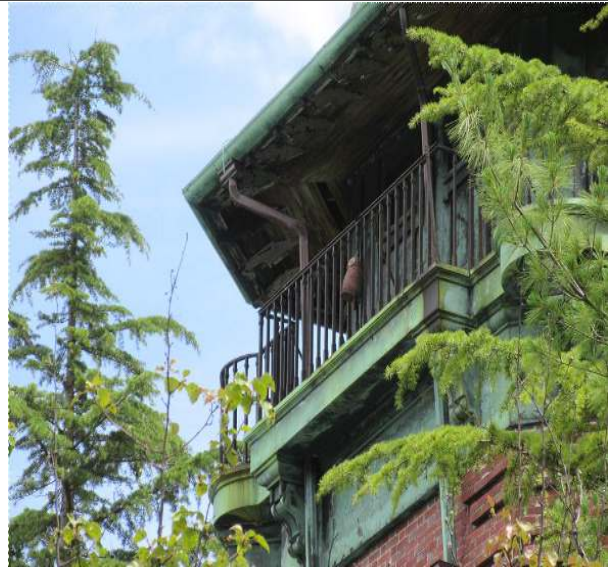
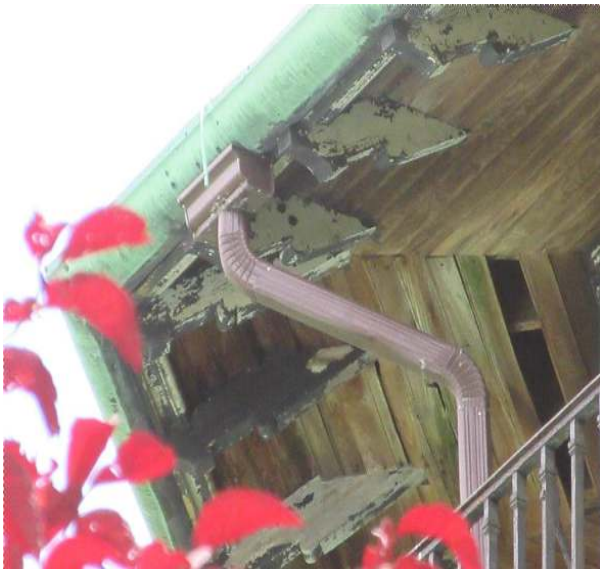
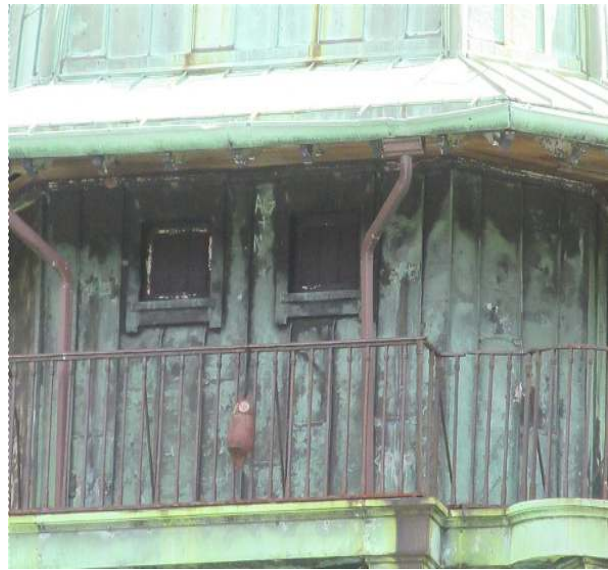
Original copper downspouts at front have been replaced with modern aluminum type downspouts. Suggest repairing dented copper gutters at front.
