ProSpec Home Inspection of Long Island Property Inspection Report

2 Clearmeadow Ln, Woodbury, NY 11797
Inspection prepared for: Name Deleted Date
of Inspection: 11/16/2018 Time: 1:00 PM
Age of Home: 30 yrs old Size: 4,024 sq. ft.
Approx. Year Built: 1988

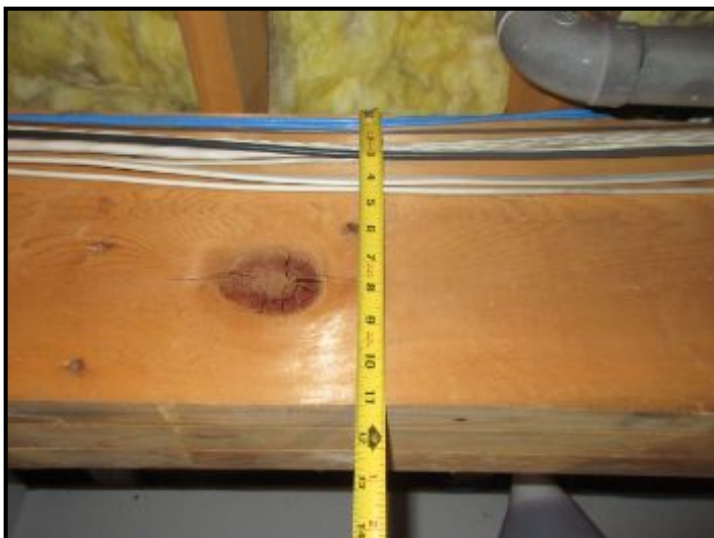
Main Floor Structure: 5x12 wood main beam supported by steel lally columns, 2x10 Joists 16" O.C. (w/cross braces), plywood floor boards.

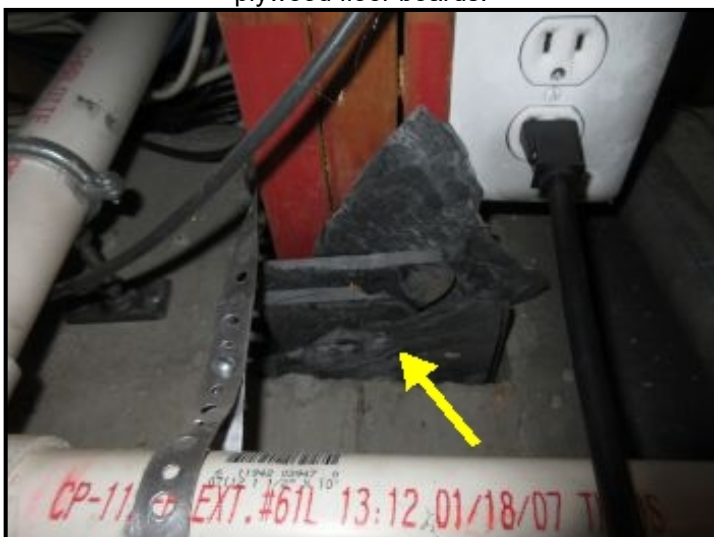
Main Floor Structure: 5x12 wood main beam shimmed at foundation wall; slate shims.

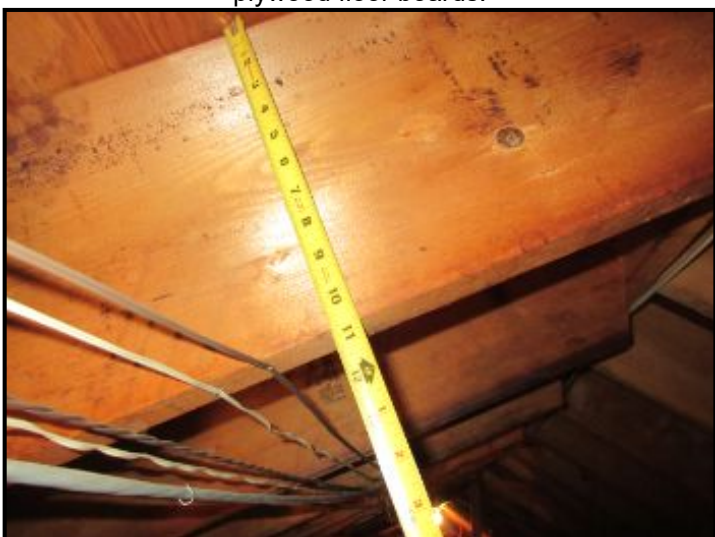
Roof Structure: 2x8 and 2x10 Rafters 16" O.C. w/collar-ties, 2x8 ridge beam, Plywood roof boards.

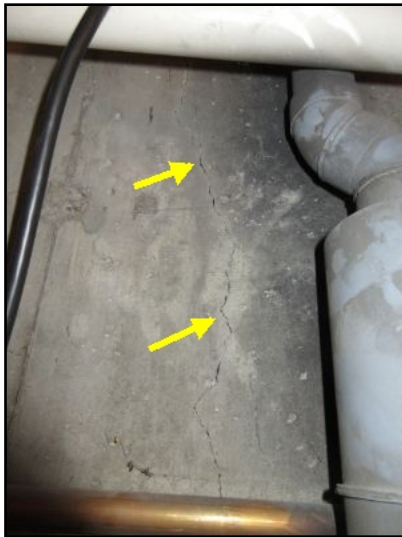
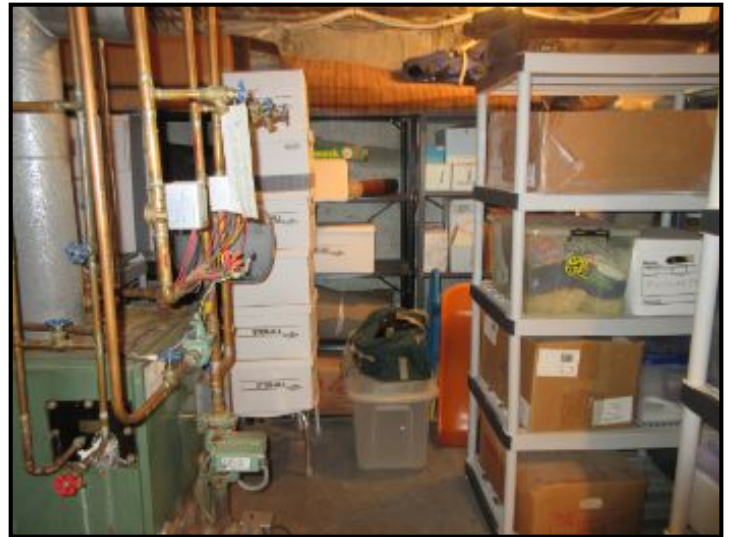
Cracking visible at the foundation wall appeared typical of differential settlement. Differential settlement happens when one portion of the foundation settles at a rate different from adjacent portions of the foundation. Stresses are created at the point of changing support that are relieved by cracking. The Inspector suggests that before the expiration of your Inspection Objection Deadline you consult with a structural engineer to more accurately determine the cause, and to discuss the need for repair and/or possible corrective measures. All work should be performed by a qualified contractor.

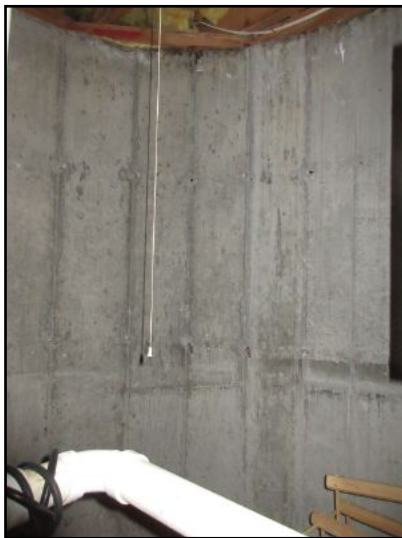
Visible areas of the foundation walls appeared dry at time of inspection.

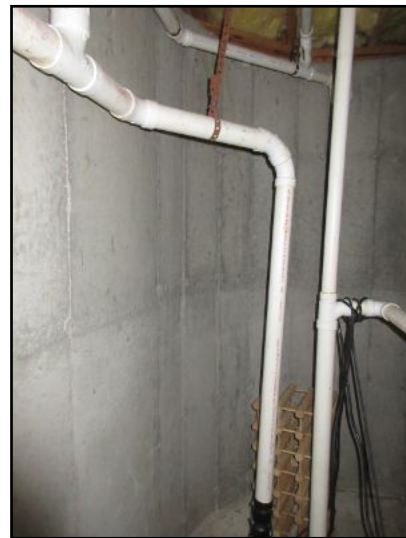
Visible areas of the foundation walls appeared dry at time of inspection.

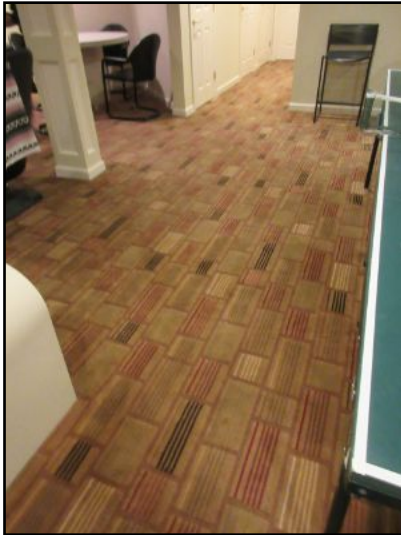
Limitation: Concrete floor slab was Mostly concealed by Floor Covering; unable to fully inspect floor slab.

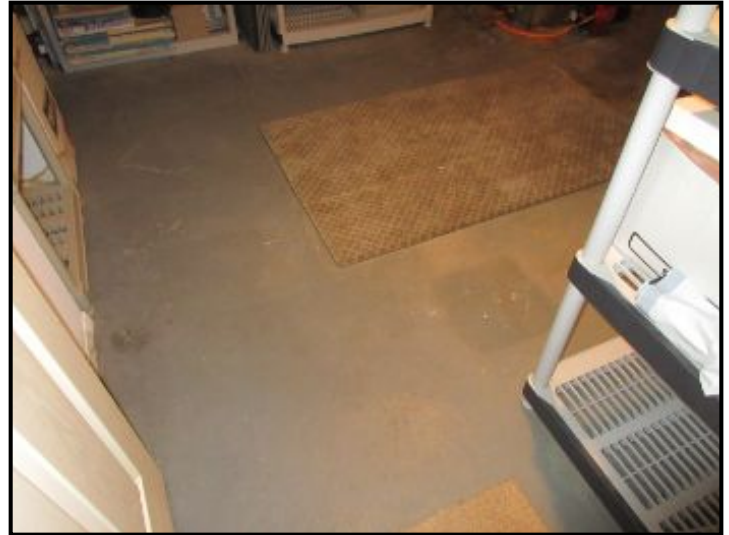
No evidence of moisture penetration was observed at the visible portions of the concrete floor slab at the time of inspection.

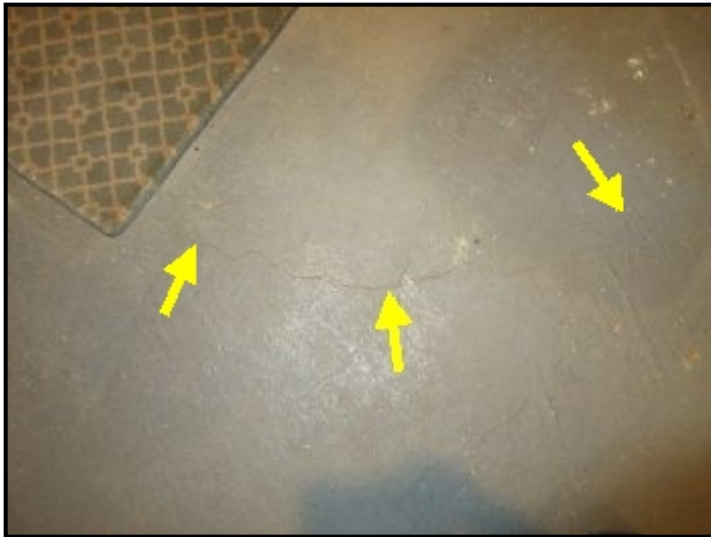
Common shrinkage/settlement cracks observed in concrete floor slab; these may leak at some point.

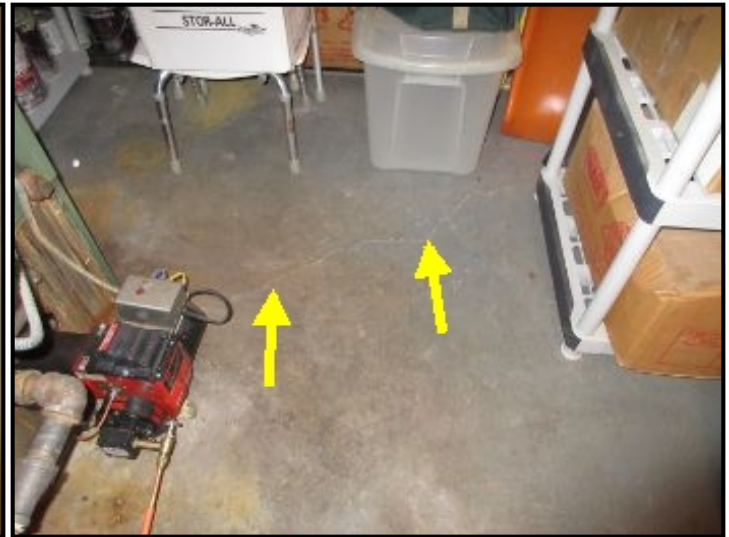
Common shrinkage/settlement cracks observed in concrete floor slab; these may leak at some point.

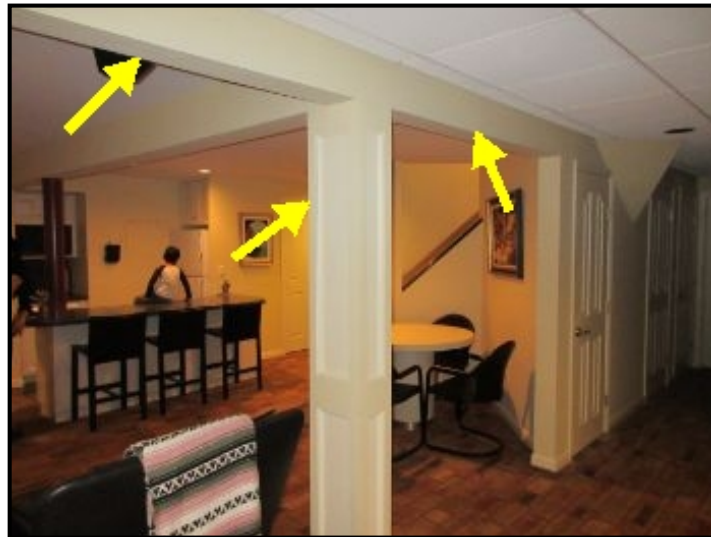
Main beam(s) and columns were Mostly finished/concealed; unable to fully inspect.

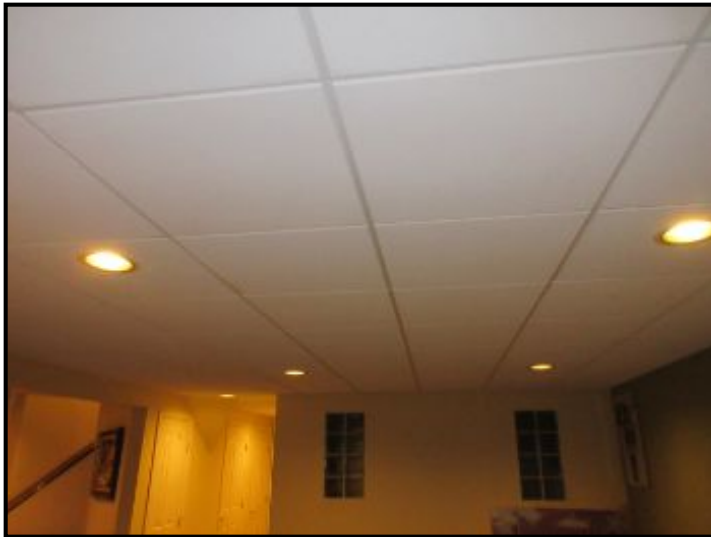
Limitation: Ceilings were Mostly Closed; unable to fully inspect main floor structure.

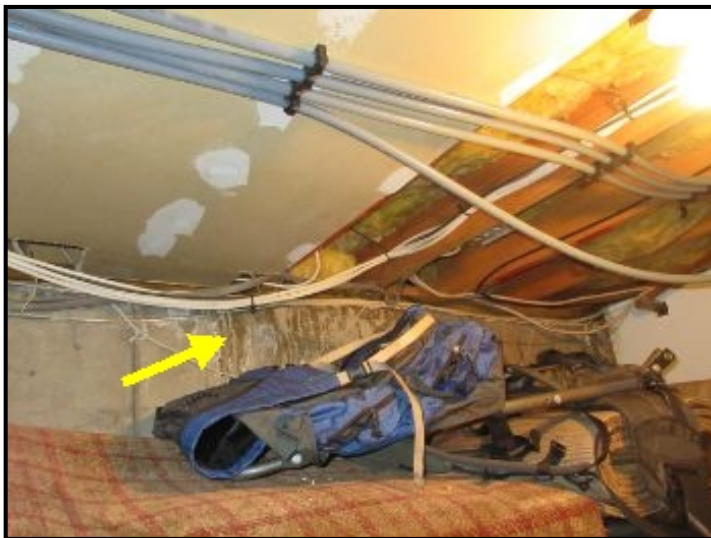
Signs of Past moisture intrusion was observed in the form of stains at the east-side, bare section of the foundation wall.

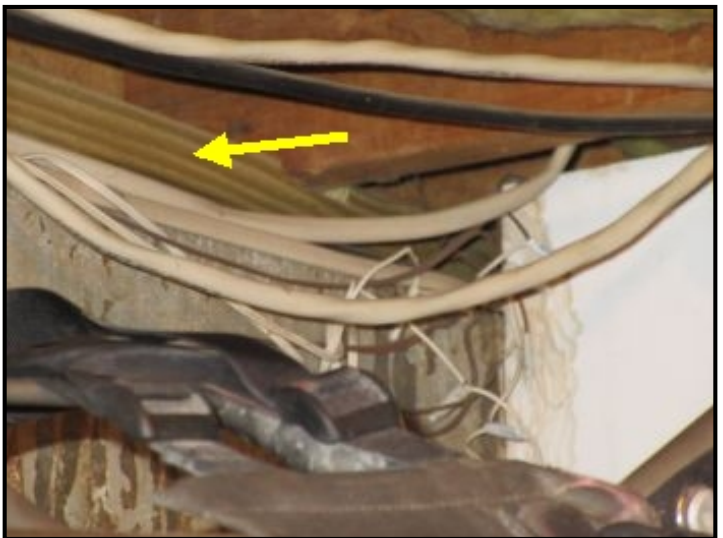
REPAIRS: Section of the Sill Plate at east side was replaced with pressure treated wood. Past termite water damage is suspected.

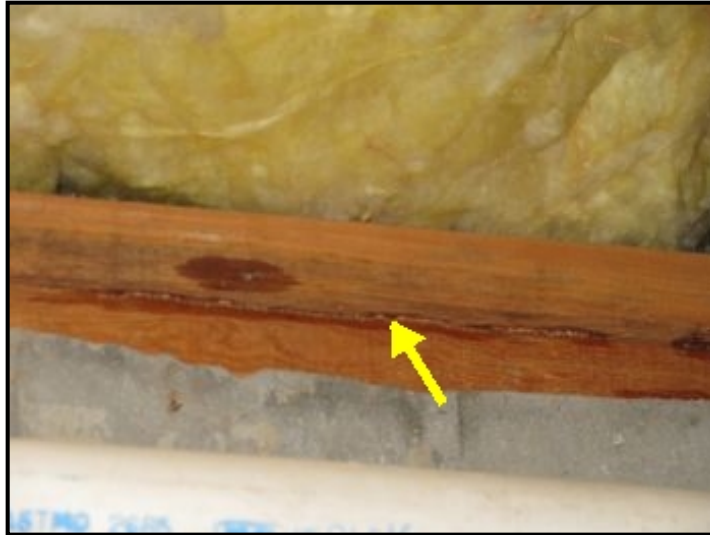
Past termite activity noted at Sill plate at West wall of Basement. Refer to NPMA-33 report.

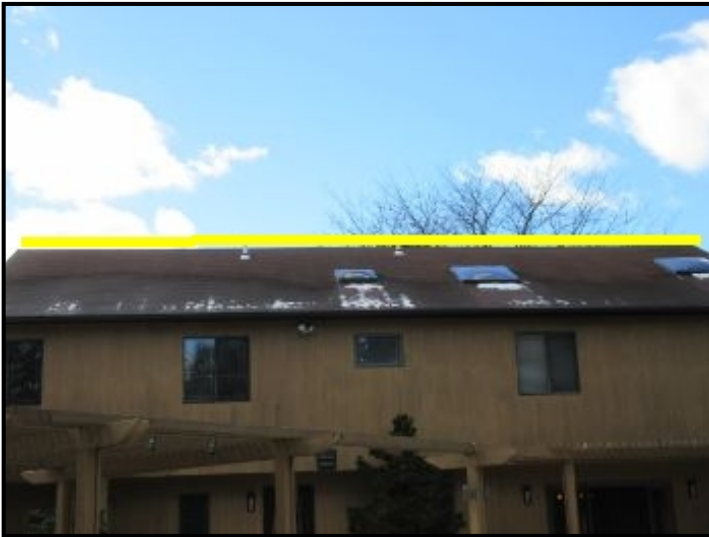
Roof ridge beam appeared fairly straight and even overall based on the age of the structure.

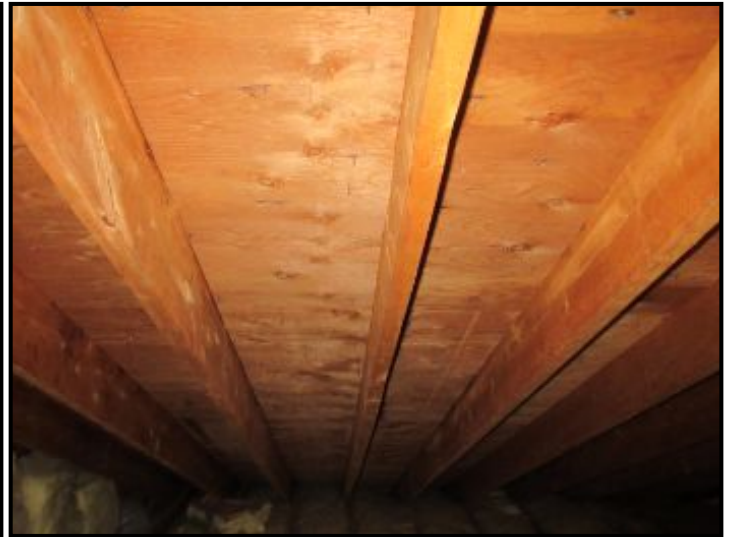
Roof structure in generally sound condition.

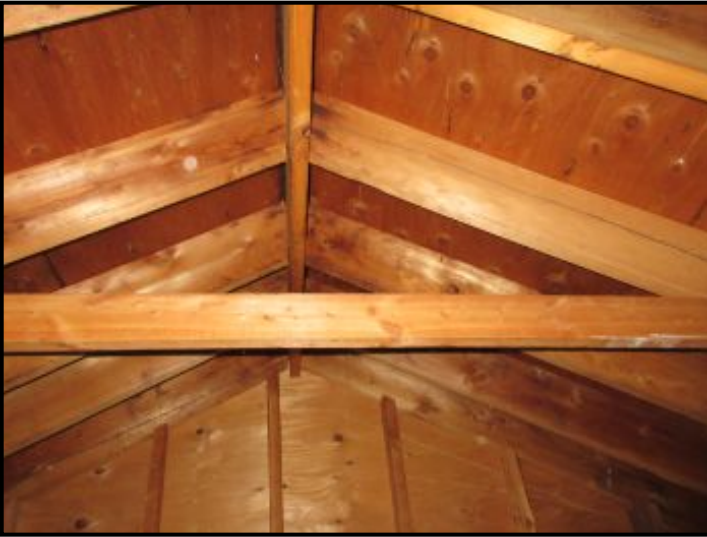
Structure at northern end.

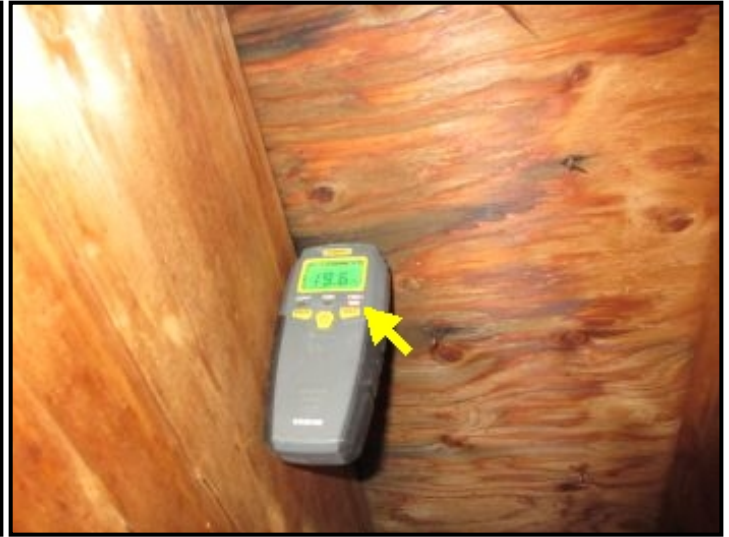
Moisture penetration noted at south end roof boards. Roof cover replacement is recommended.

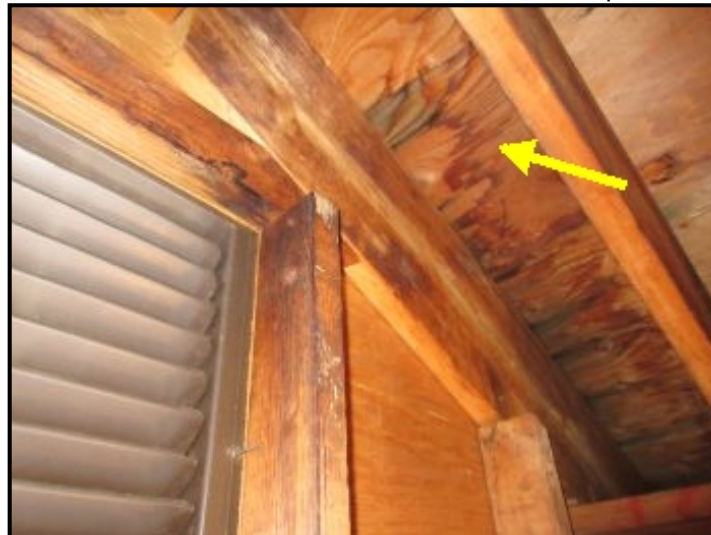
Moisture penetration noted at south end roof boards. Roof cover replacement is recommended.

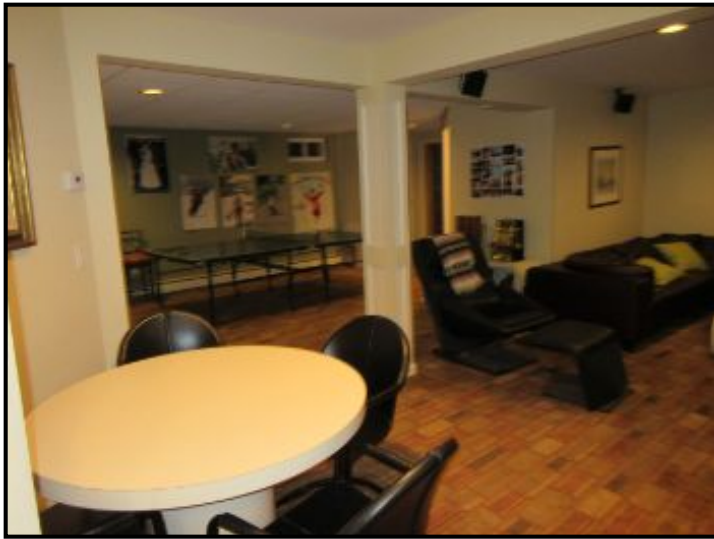
BASEMENT Basement General

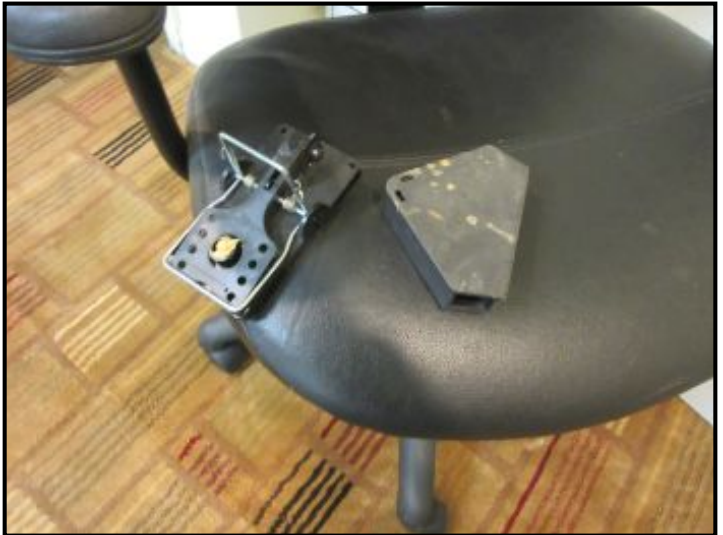
Mouse trap and bait station noted above hung ceiling.

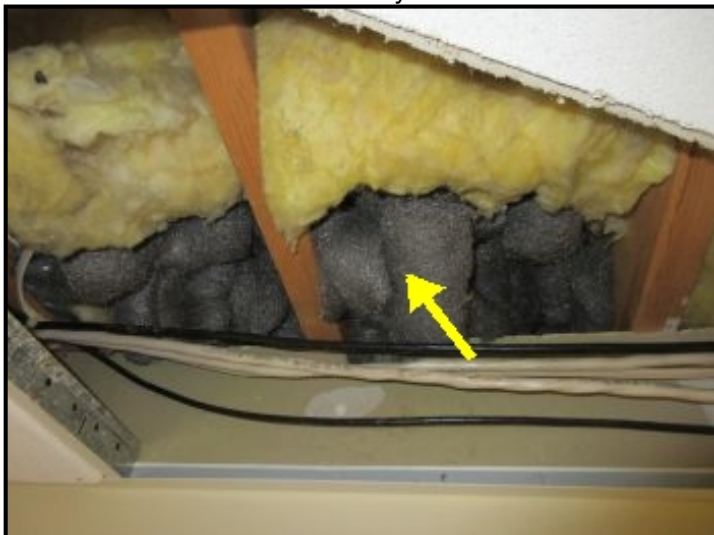
Steel wool used to prevent mice from entering above basement ceiling.

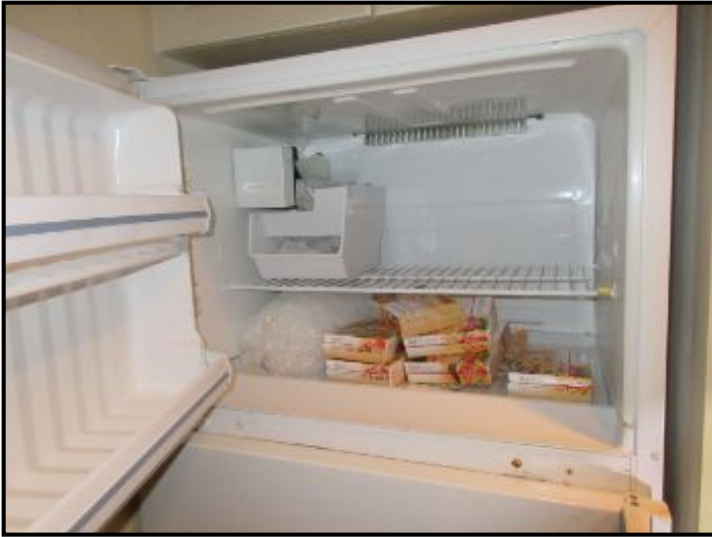
Refrigerator located in Basement was operating and frost free.

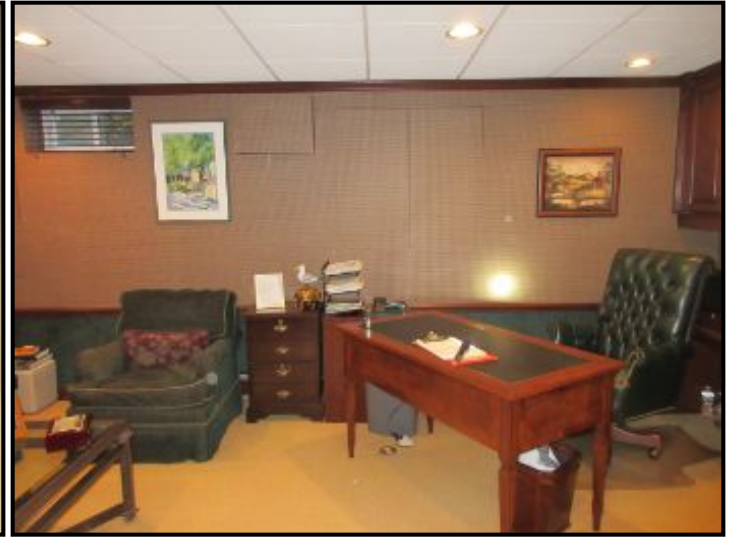
Office, location where utilities enter the home.

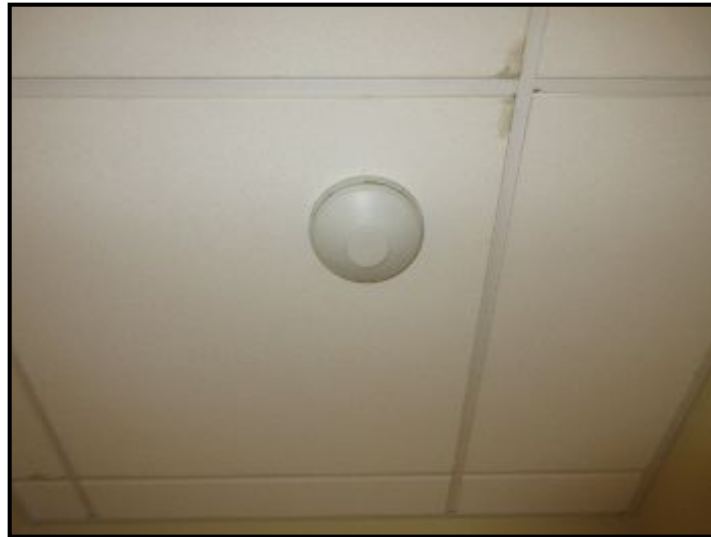
LIFE SAFETY: Maintain functioning Smoke and Carbon Monoxide detectors near bedrooms and at each level of the home for Life Safety. Detectors are generally reliable for up to 5 yrs.

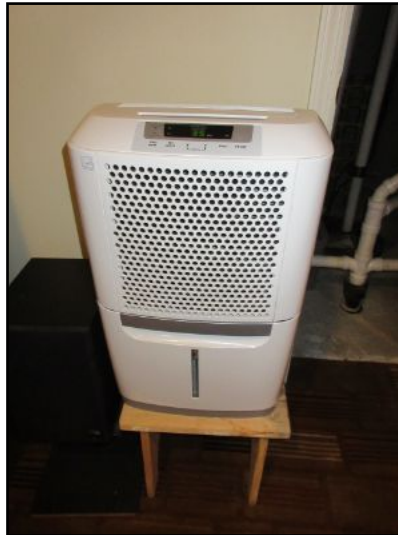
Humidity Control: It is advised to use a Dehumidifier to maintain lower humidity levels and to prevent bio-growth in the basement. Acceptable levels are 45-55% during the cooling season and 35-45% during the heating season. Modern dehumidifiers are equipped with a humidity gauge to monitor humidity levels.

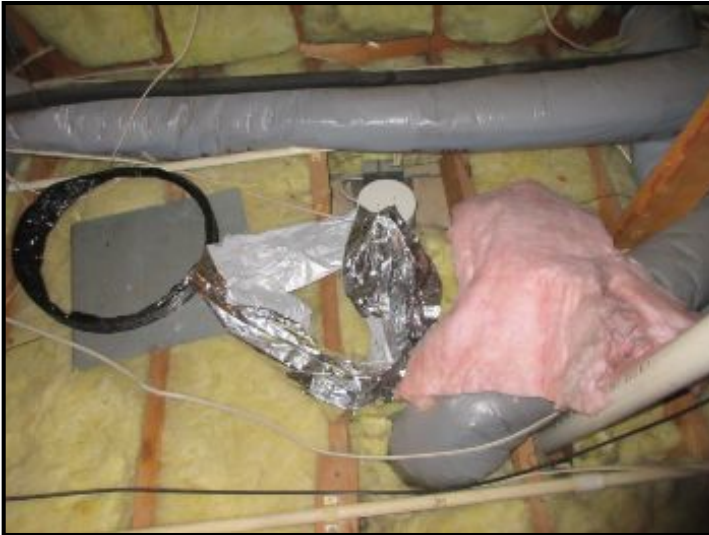
Debris observed in attic left behind from past construction activities. Suggest removing debris. in order to move more safely through attic space.

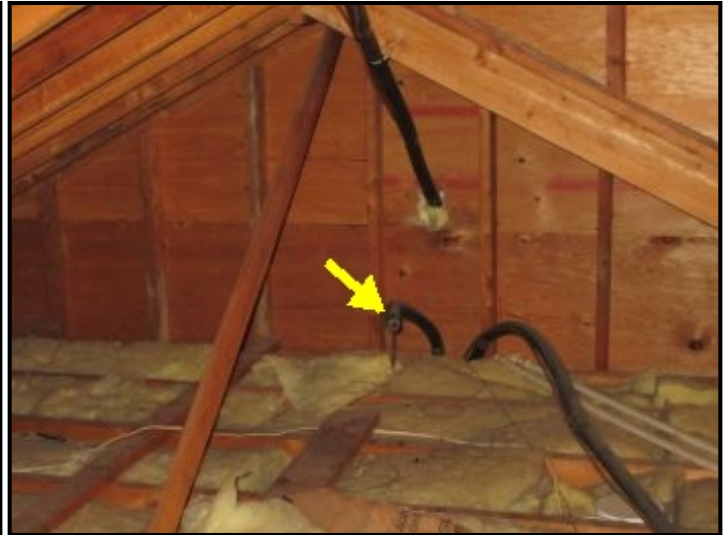
Unused set of A/C refrigerant piping noted.

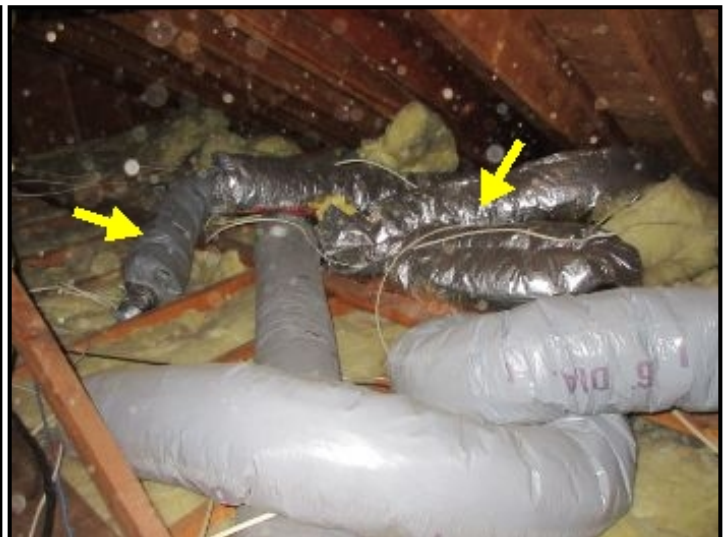
Debris/unused ducts observed in attic left behind from past construction activities. Suggest removing debris. in order to move more safely through attic space.

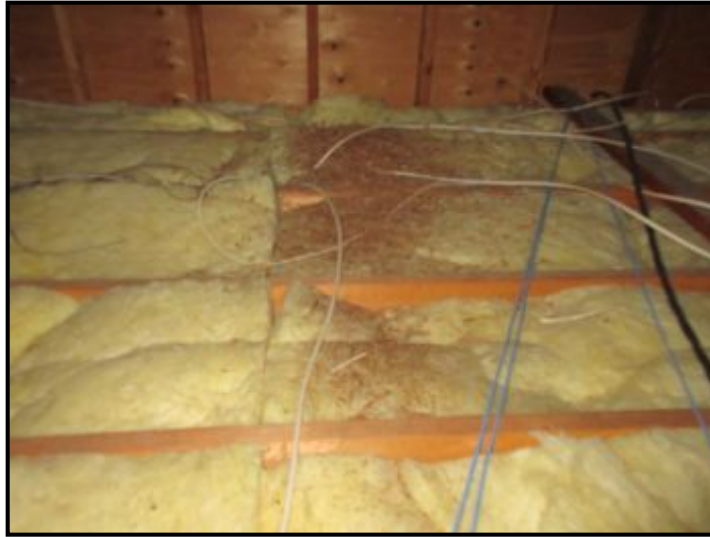
Signs of past nest droppings at north end of attic, perhaps from birds nesting in the ridge vent above. No signs of present activity here.

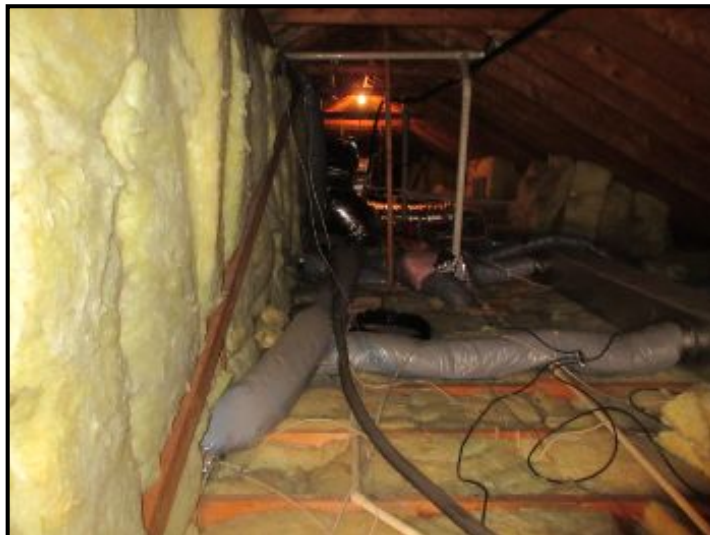
No floor boards in attic, with insulation cover at attic floor joist cavities. Inspector could not safely access all areas of the attic without risking damage to insulation and drywall ceilings below. This limited accessibility into attic for more thorough inspection of attic and roof structure. Recommend providing additional planks or floor boards for the needed access.

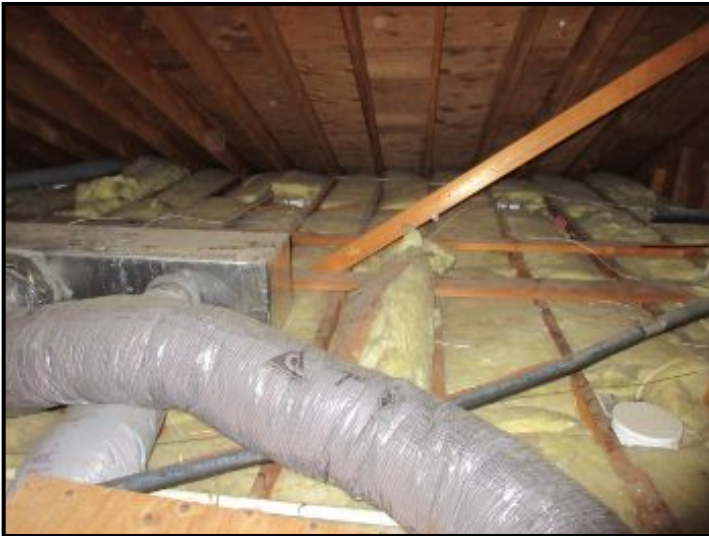
Installed in joist cavities.

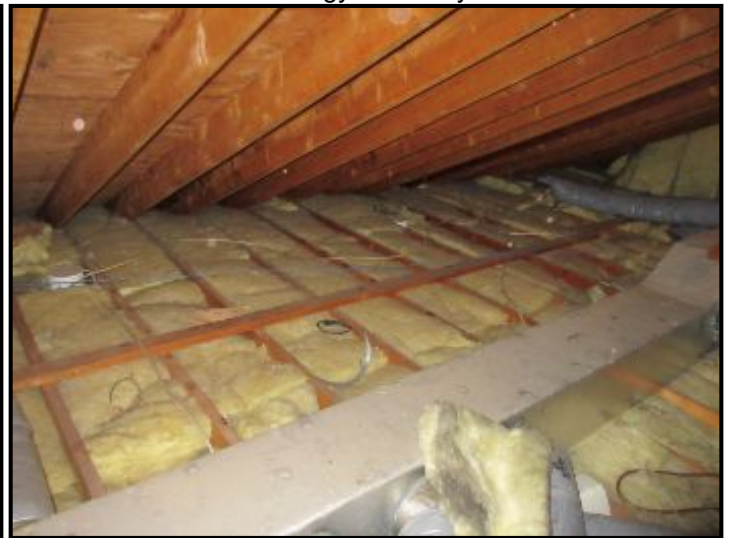
Installed in joist cavities.

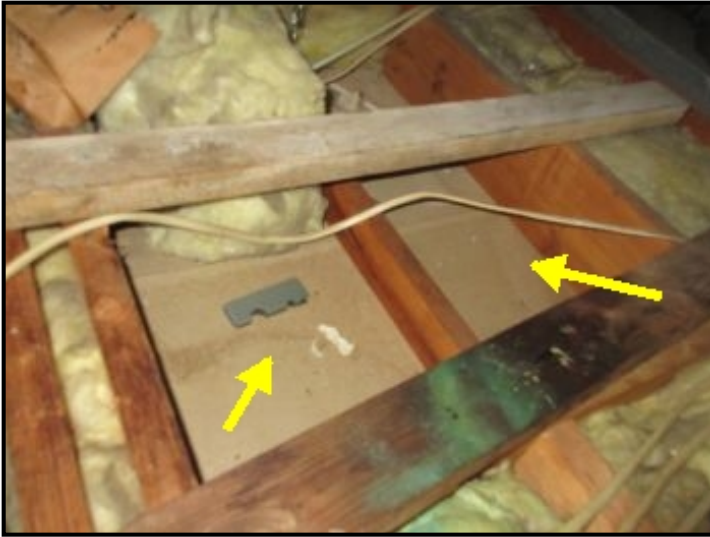
Insulation is missing in some sections of the attic floor.

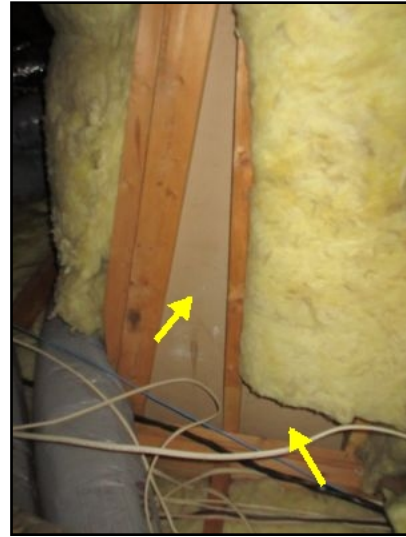
Insulation is missing at section of vaulted ceiling. Recommend restoring missing insulation.

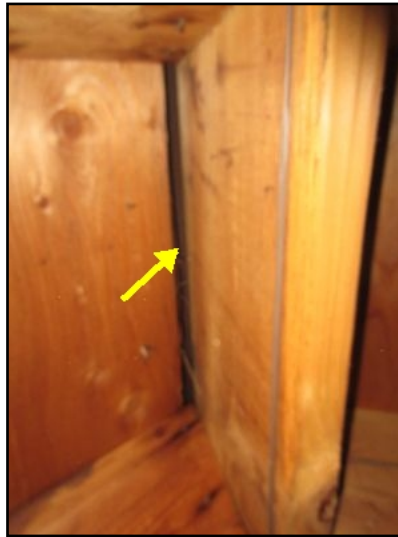
Ridge exhaust venting noted at north end of attic.

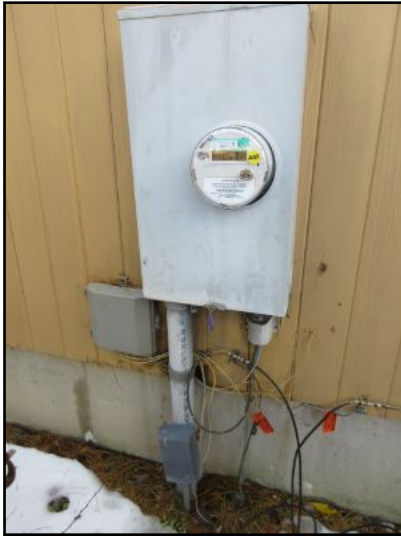
Underground service lateral; 120/240 volts. No major system safety or function concerns noted at time of inspection.

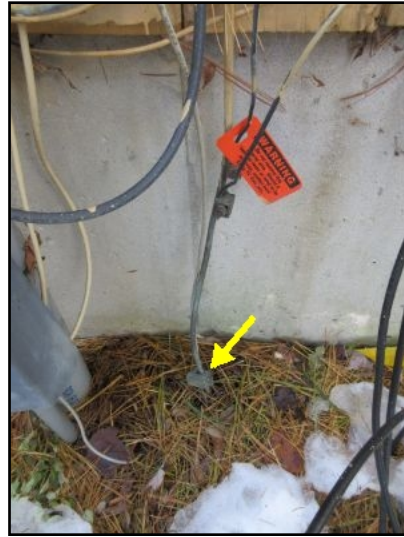
Grounding Rod and cable connection noted at service entrance.

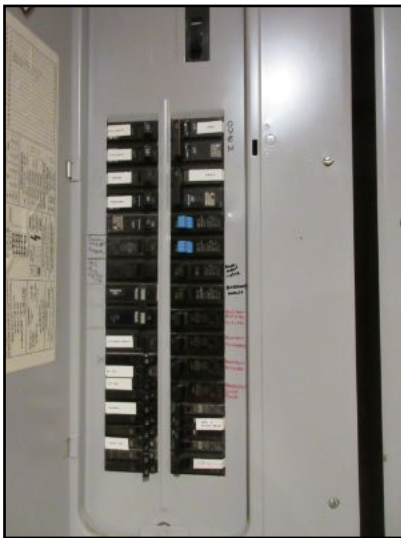
Main Panel #1: 30 circuit breaker spaces; 0 spare breaker space(s) noted.

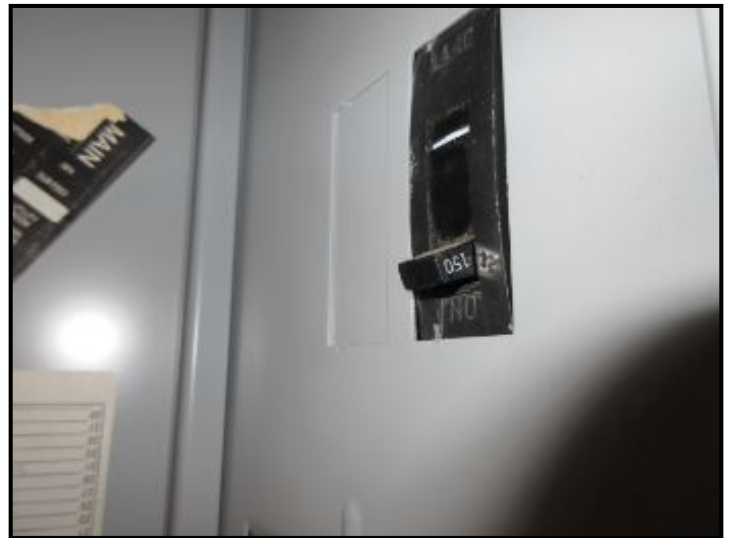
Main Panel #1 Main Disconnect: 150 amp main breaker serves Part of the property.

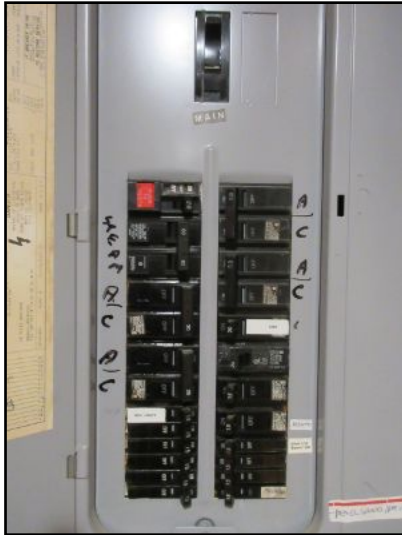
Main Panel #2: 20 circuit breaker spaces; 0 spare breaker space(s) noted.

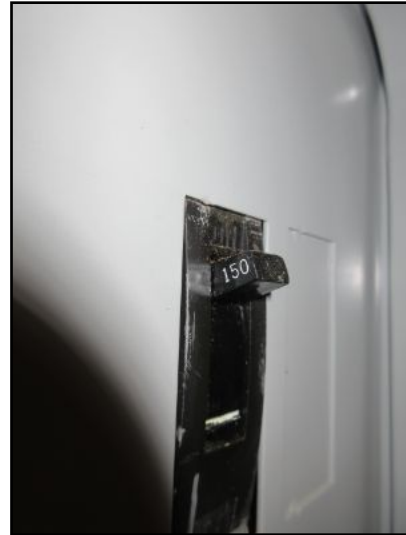
Main Panel #2 Main Disconnect: 150 amp main breaker serves Part of the property.

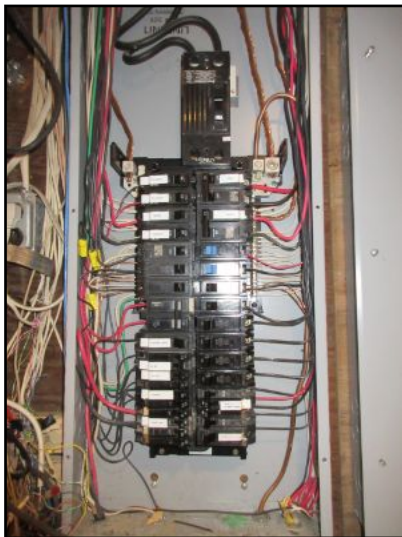
Main panel interior checked.

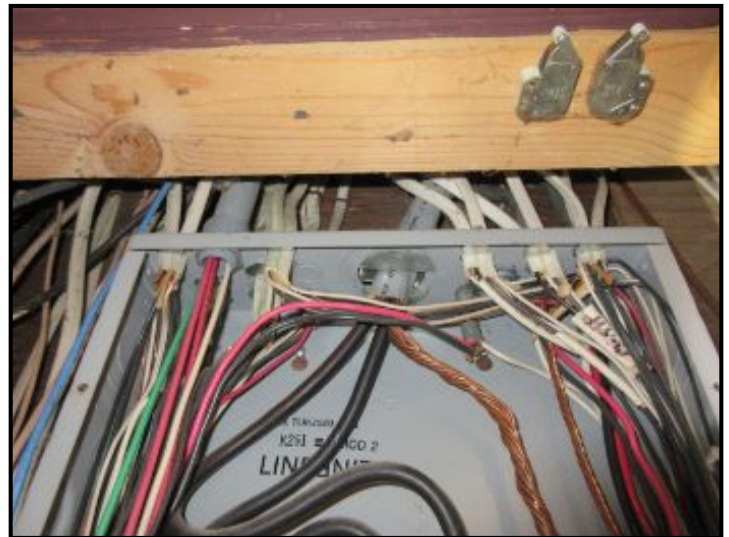
Distribution wiring observed consisted of copper, non-metallic sheathed cable.

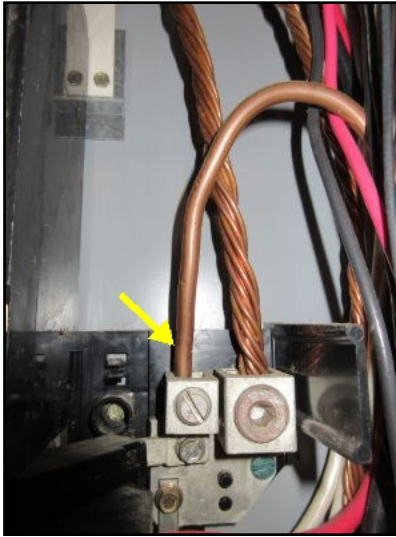
Neutral bus grounding observed. Suggest having electrician ensure that ground is continuous.

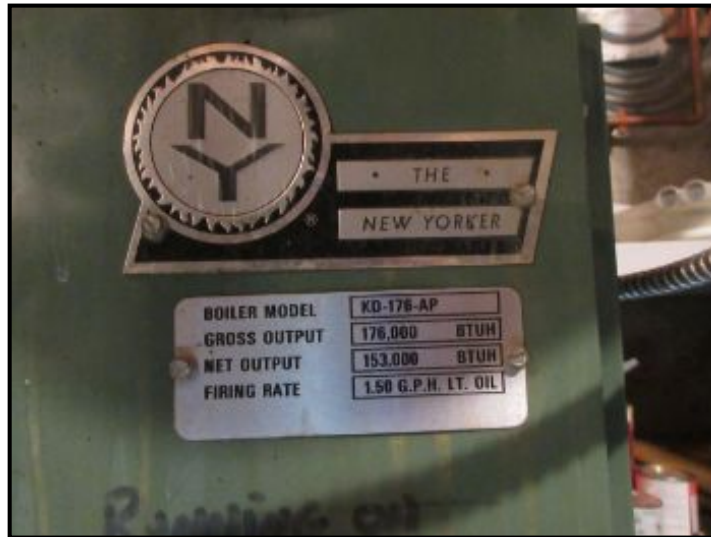
Unit data plate/serial no. did not reveal the manufacture date of the unit. Based on the conditions, we estimate that this is the originally installed unit; approximately 30 yrs old. Normal design service life expectancy of a Cast Iron Boiler is 40 yrs with proper maintenance.

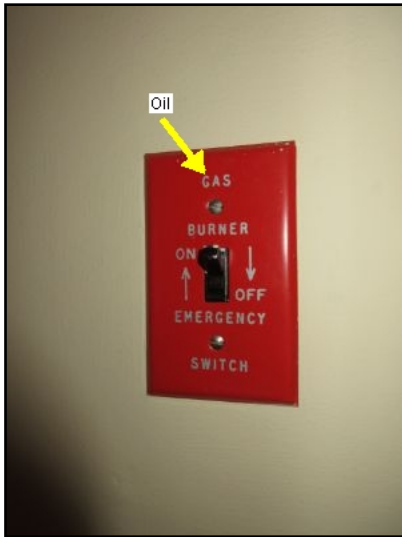
Oil Burner: Remote Emergency Shut-off switch noted.

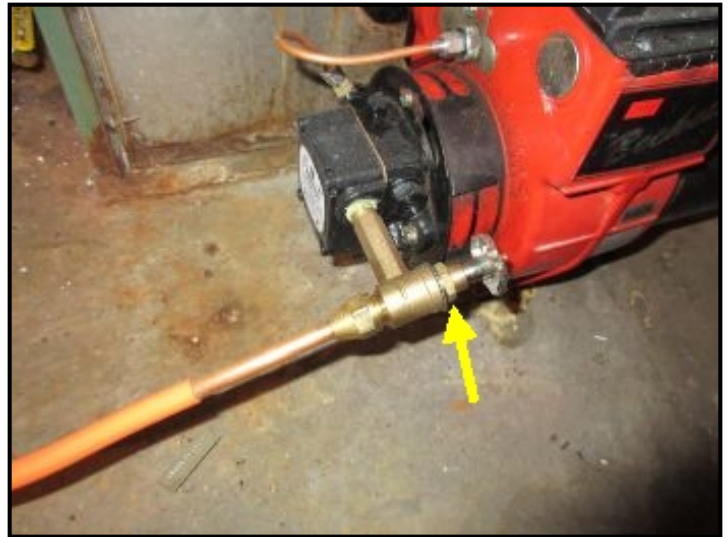
Oil shut-off valve only. No oil filter used for boiler; suggest adding an oil filter to improve the operation and longevity of the boiler.

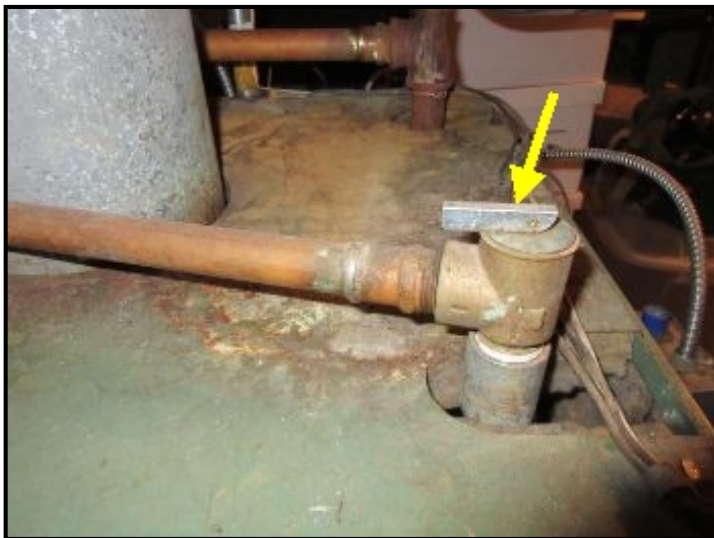
TPR (Temperature Pressure Relief) valve and discharge pipe show no deficiencies.

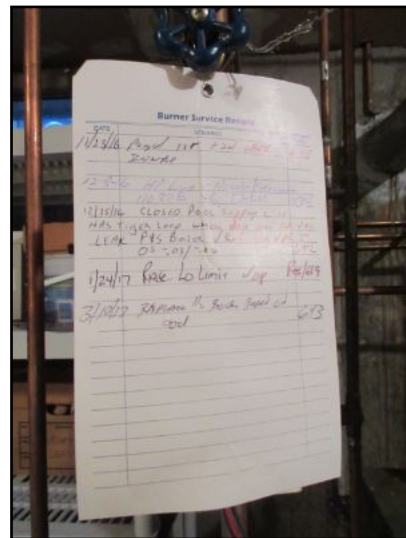
Service Tag indicates the boiler was last serviced on 3/10/2017, over 1 year ago. Recommend annual inspection/maintenance be performed by a licensed HVAC contractor to ensure safe and efficient operation.

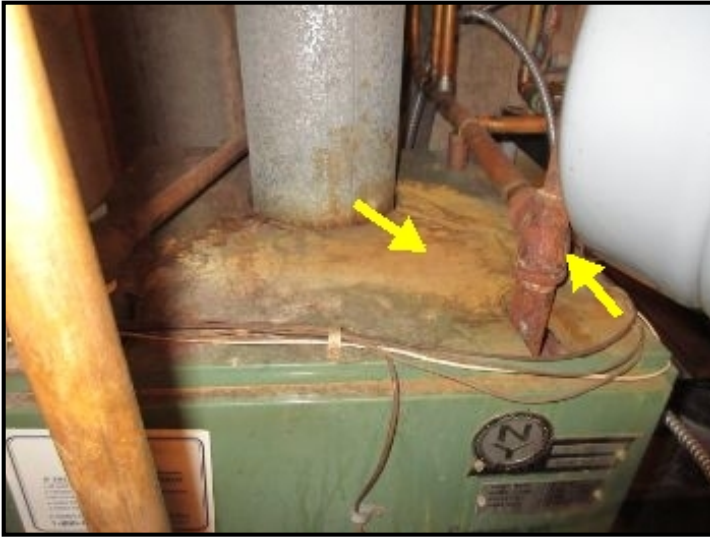
Rust stains and surface rust on boiler casing and piping from past piping leak/s. Recommend monitoring and repair/improve connection if necessary when unit is serviced by HVAC contractor

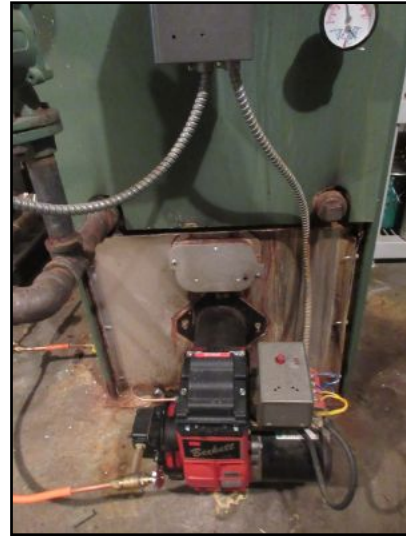
Cast Iron Forced Hot Water Boiler; Manufactured by New Yorker. Burner fired by thermostat.

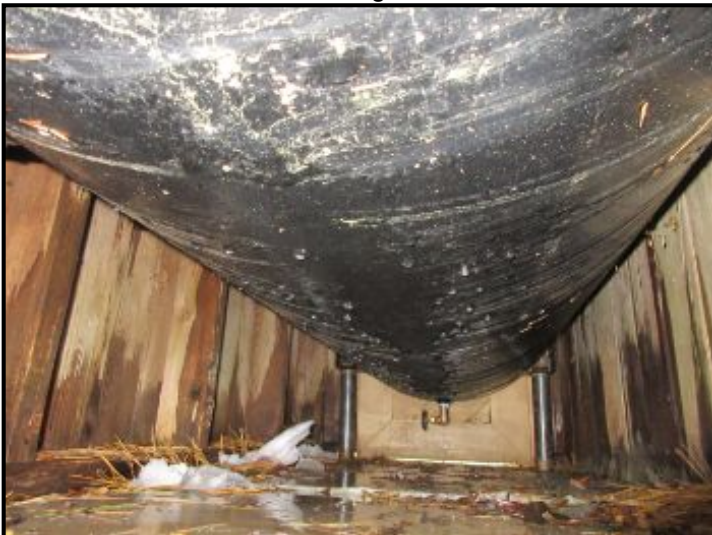
Newer above ground oil tank showed no signs of leakage.

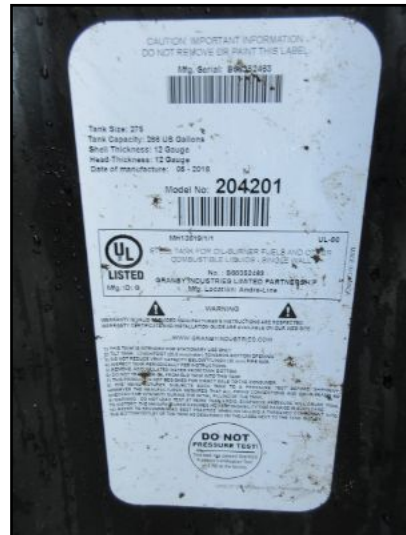
Tank data tag indicates a nominal capacity of 275 gals. and a manufacture date of 6/2018 (0.25 yr old).

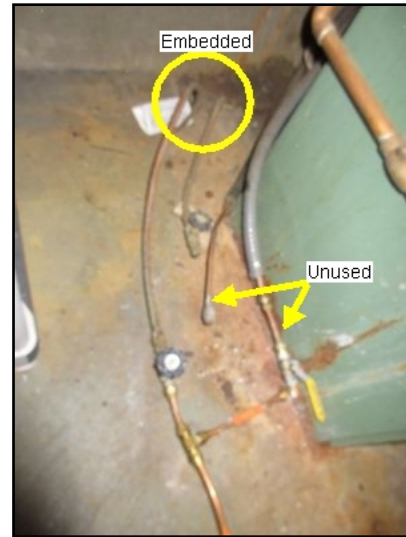
Oil lines (from underground oil tank) embedded in concrete slab is not in compliance with current standards. Installation of above slab line/s recommended in order to reduce possibility of corrosion. Unused oil lines (for pool heater) noted in basement due to new above ground tank installation.

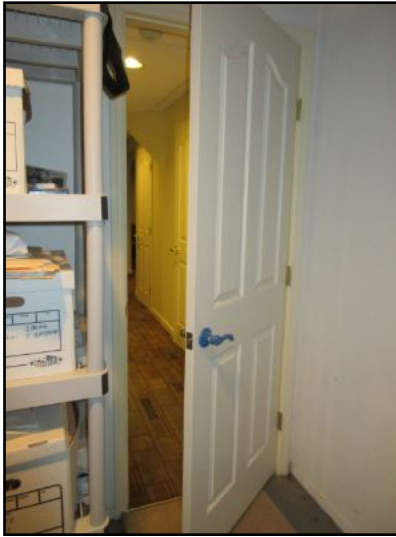
There is no visible permanent venting into furnace room, other than the door staying open. Recommend HVAC contractor or trade professional install appropriate vents into the basement furnace room. Refer to Combustion Air Requirement.

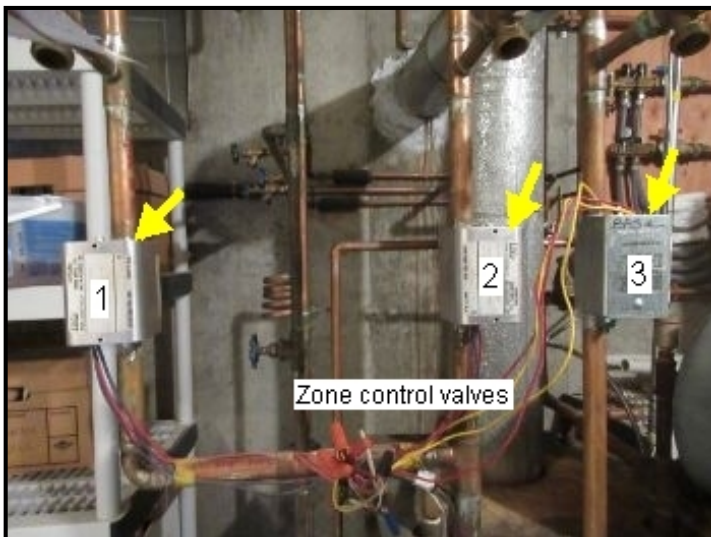
4-zone heating system noted, including kitchen radiant floor zone.

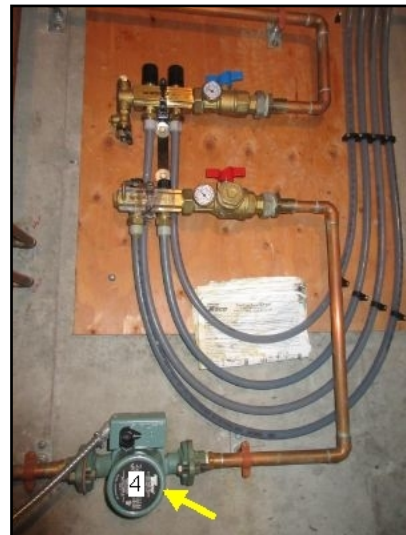
Radiant subfloor heat in kitchen; not tested at time of inspection. Suggest testing prior to close, during walk-thru perhaps by turning up thermostat and checking for floor warm-up temperature not to exceed 85 degF.

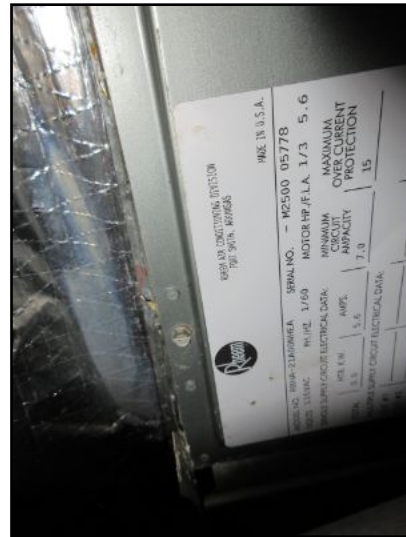
AC#1 Rheem Air Handling Unit data plate/serial no. indicates a cooling capacity of 3 tons, and a manufacture date of 6/2000, (18.5 yrs old).

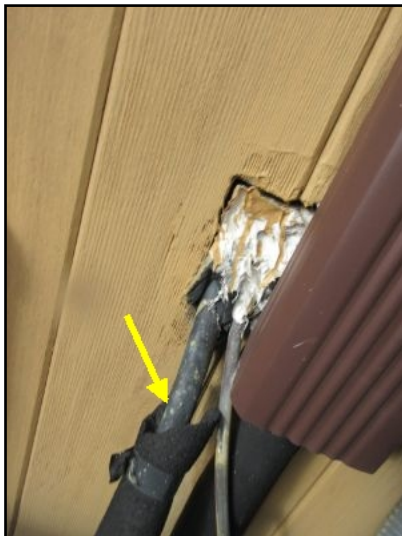
AC#1 Outdoor refrigerant pipe insulation is deteriorated/missing at outdoor condenser. Recommend replacing outdoor deteriorated/missing insulation for the larger suction line.

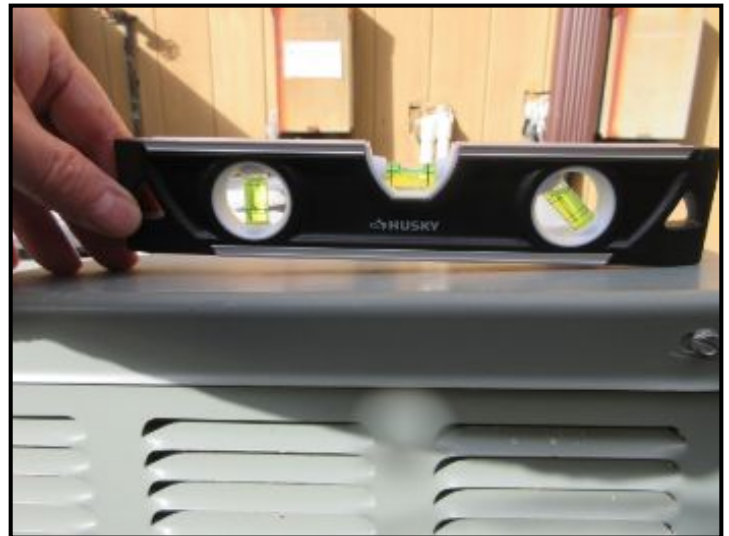
AC#1 condenser is not level; this may shorten motor life. Suggest leveling mounting pad or unit itself.

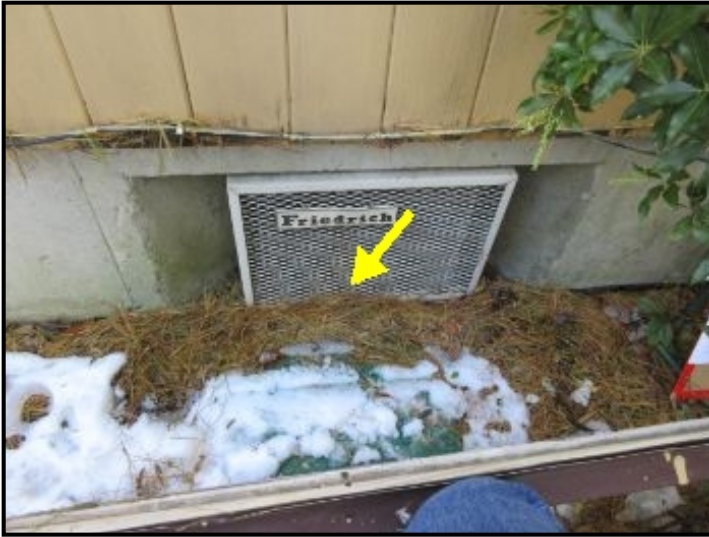
Basement through-wall A/C noted. Recommend lowering soil level to prevent contact with A/C metal casing to prolong the life of the unit.
