ProSpec Home Inspection of Long Island Property Inspection Report

2 Clearmeadow Ln, Woodbury, NY 11797
Inspection prepared for: Name Deleted Date
of Inspection: 11/16/2018 Time: 1:00 PM
Age of Home: 30 yrs old Size: 4,024 sq. ft.
Approx. Year Built: 1988

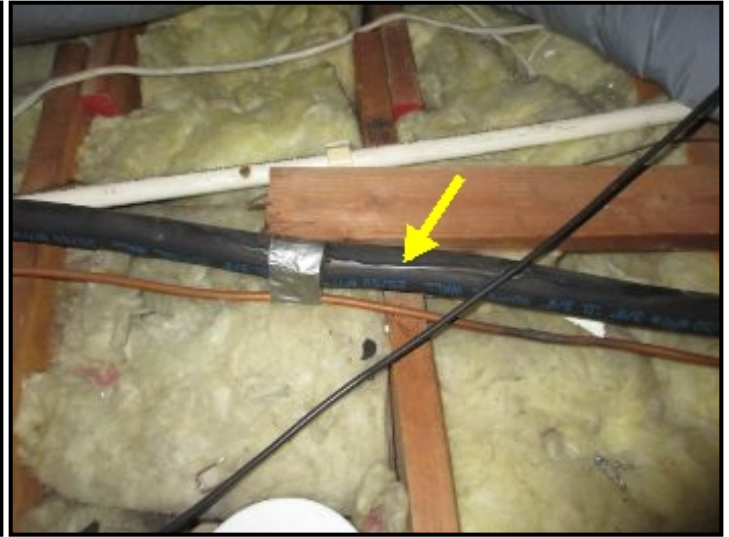
Refrigerant pipe insulation not covering entire pipe in attic space where condensation can form and drip onto insulation. Recommend HVAC technician review conditions and make any corrective repairs.

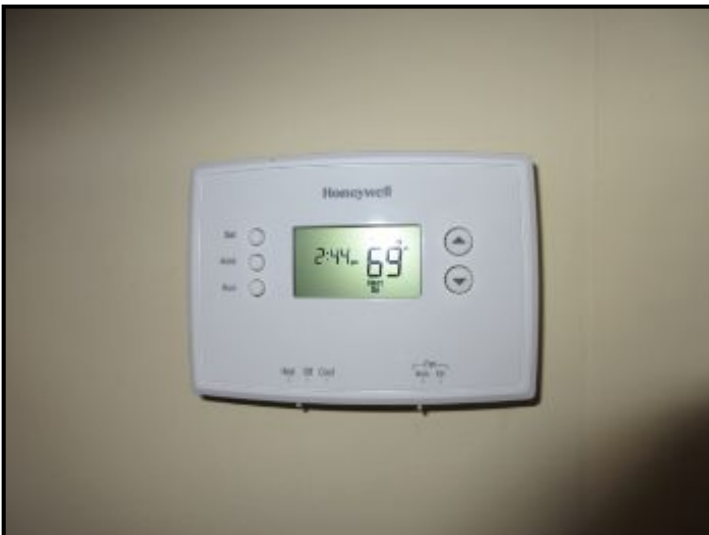
Digital Programmable type thermostat noted in Basement.

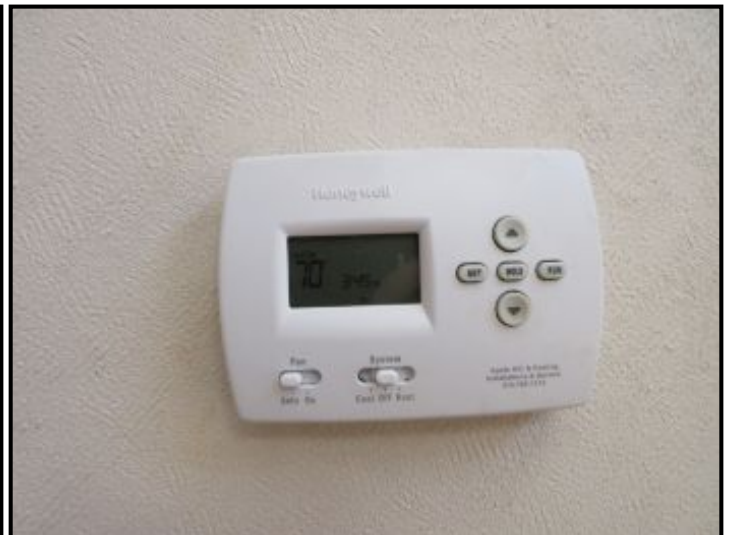
Digital Programmable type thermostat noted in Kitchen/general area.

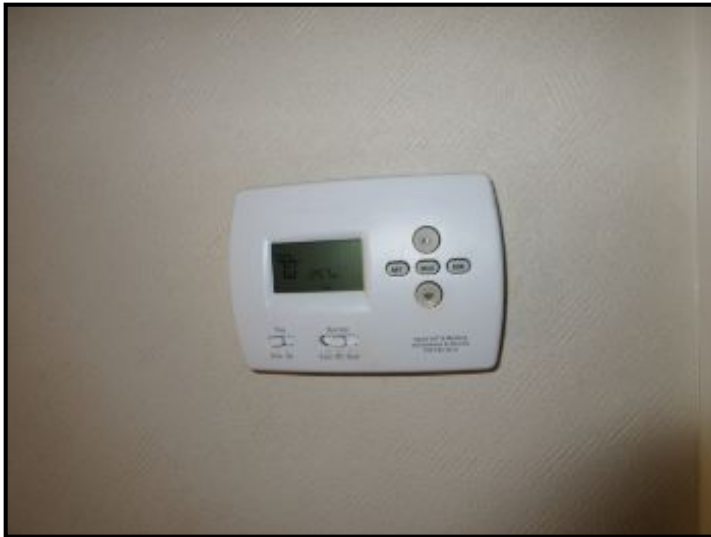
Digital Programmable type thermostat noted in Hallway (2nd floor).

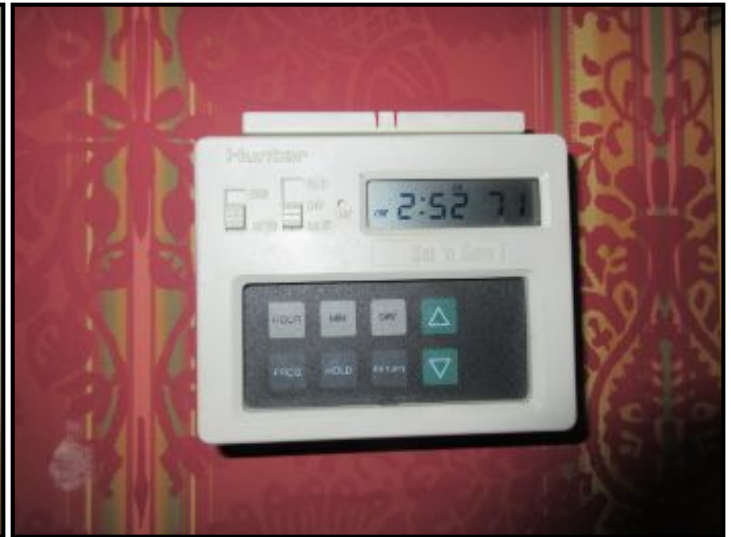
Digital Programmable type thermostat noted in Master bedroom.

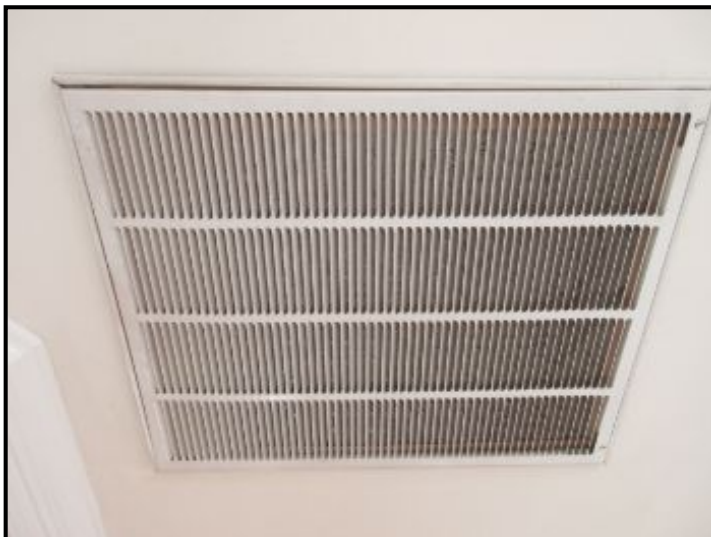
AC#1: Disposable filter located in filter-grille at Hallway (2nd floor) ceiling.

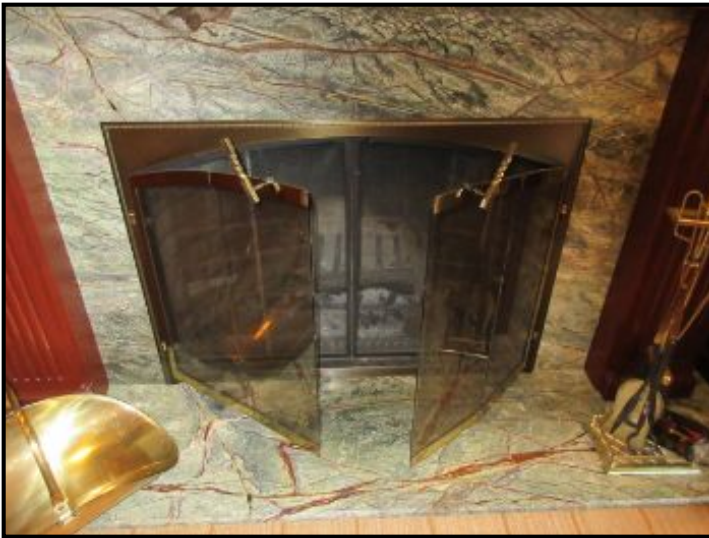
Wood burning fireplace in Den on Main level.

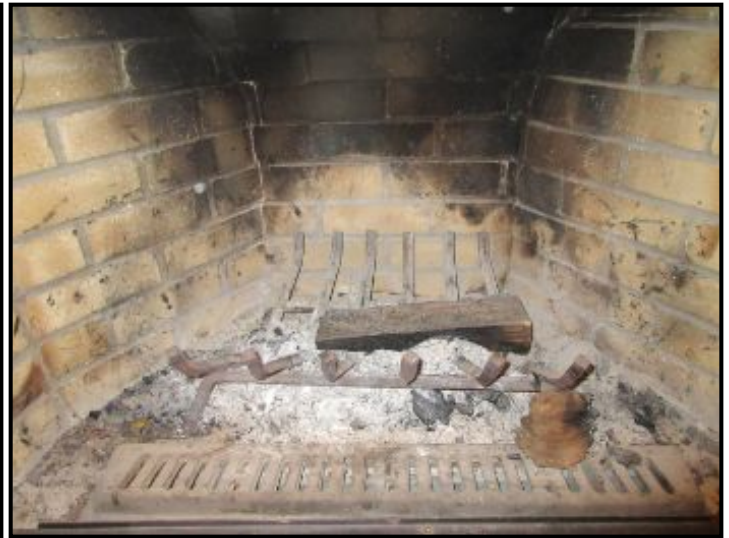
Masonry fireplace noted. Appeared in serviceable condition.

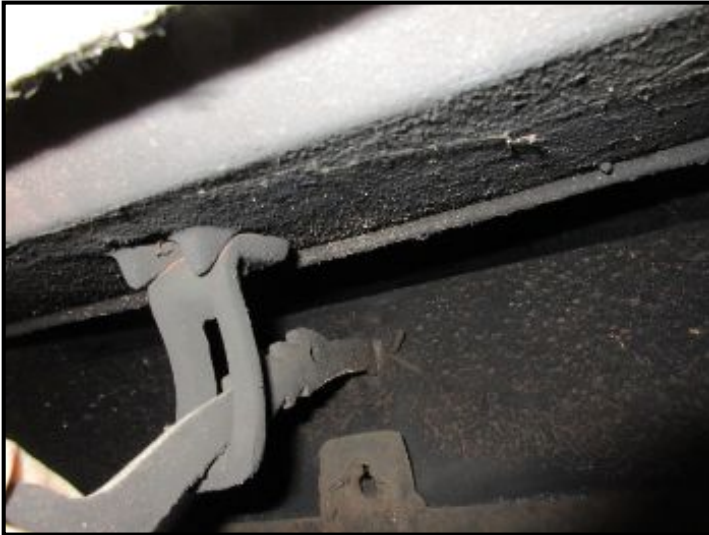
Damper was operable; opened and closed several times.

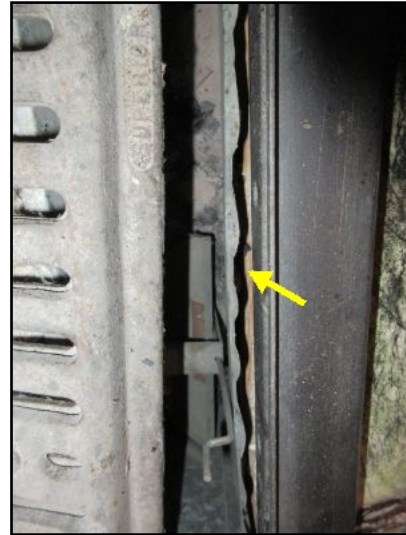
Gap noted between sheet metal for combustion air inlet and hearth, exposing the wood subfloor to the fireplace where embers can enter; potential fire hazard. Recommend fireplace specialist review and provide the appropriate repair.

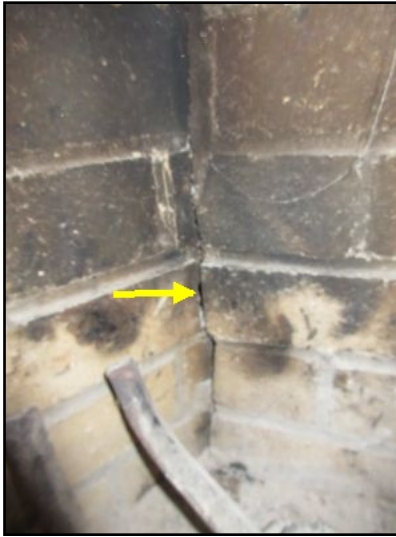
Gap noted in rear corner mortar joint. Recommend fireplace specialist review and provide the appropriate repair.

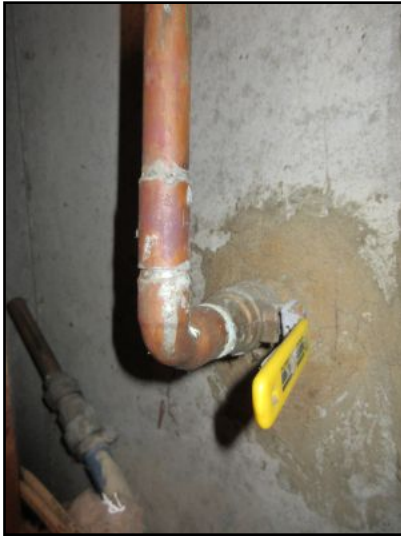
Public water service entrance located in basement.

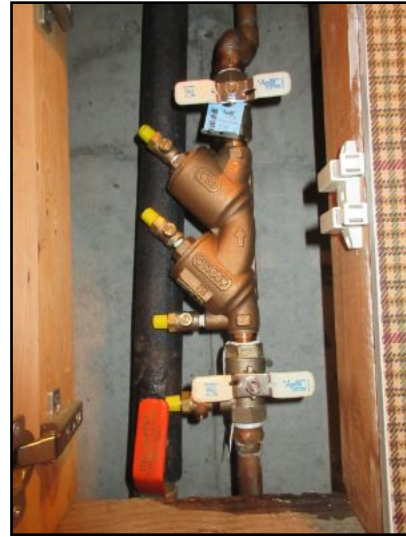
Backflow preventer for sprinkler system noted.

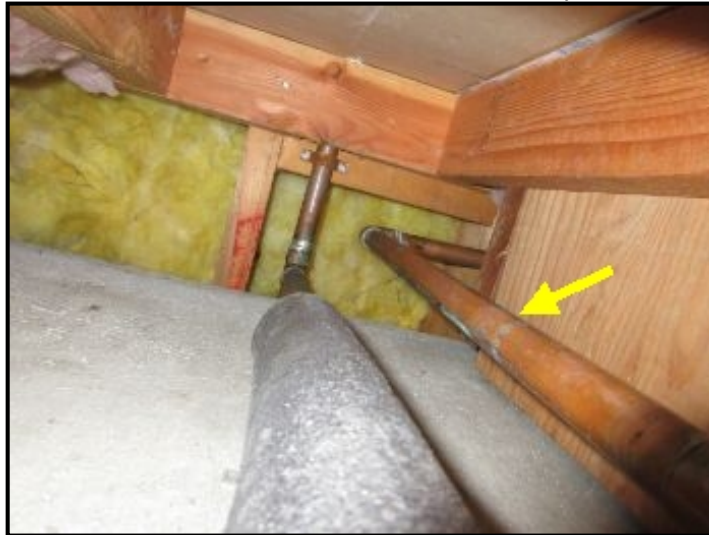
Grounding at service entrance is missing. Recommend licensed electrician provide the proper grounding connections.

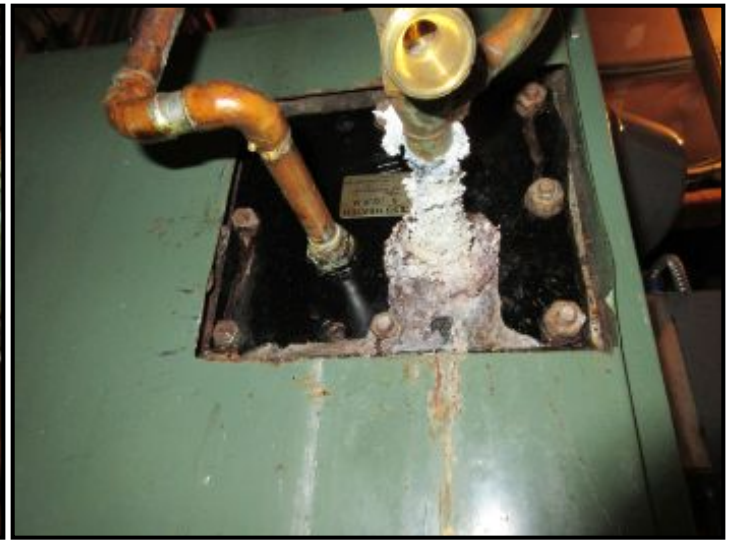
Unit's general condition indicates that it has reached its designed life expectancy. Consider replacement. We make no warranty, guarantee or estimation as to the remaining useful life of this unit.

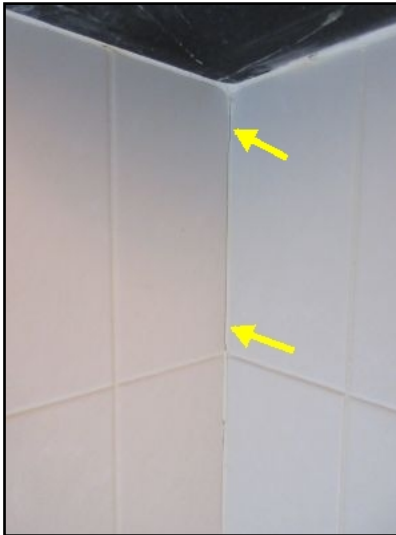
Shower wall corner grout (movement joint) is cracked. This is common; suggest replacing grout with matching silicone based sealant at corner movement joints.

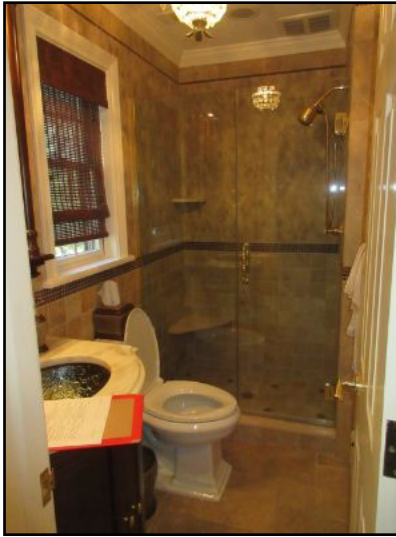
1st Floor Hall Bathroom

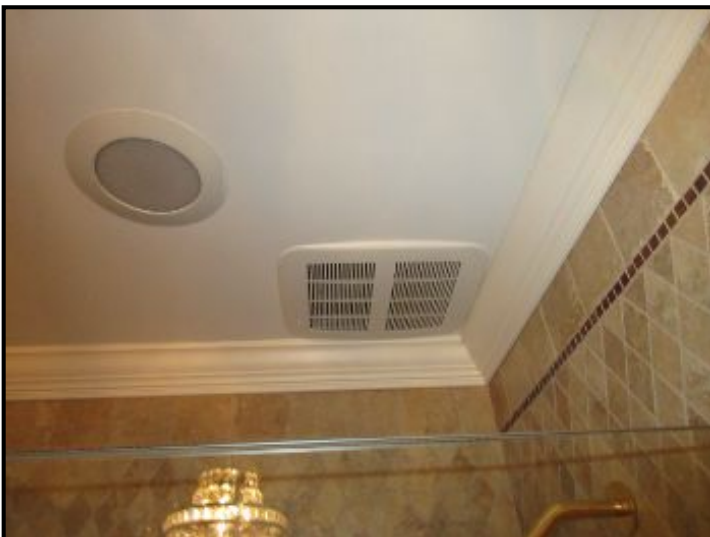
Bathroom exhaust fan was not operable at time of inspection. Power source is likely same as the wall outlet.

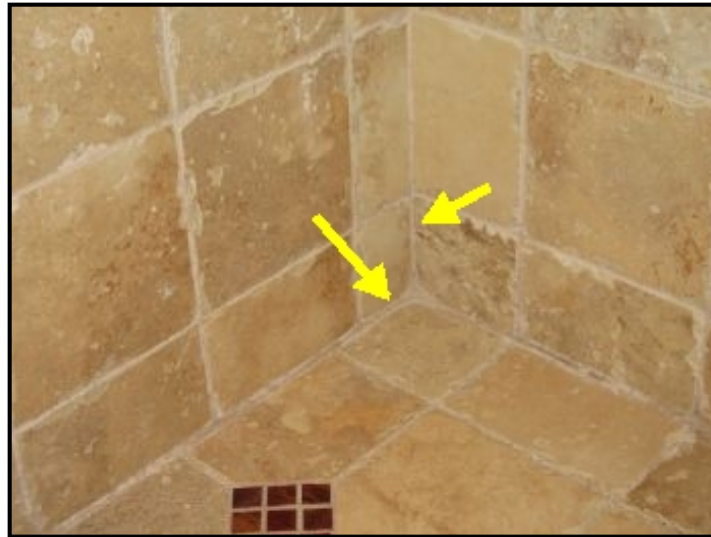
Shower wall/floor corner grout (movement joint) has slight cracks. This is common; suggest replacing grout with matching silicone based sealant at corner movement joints.

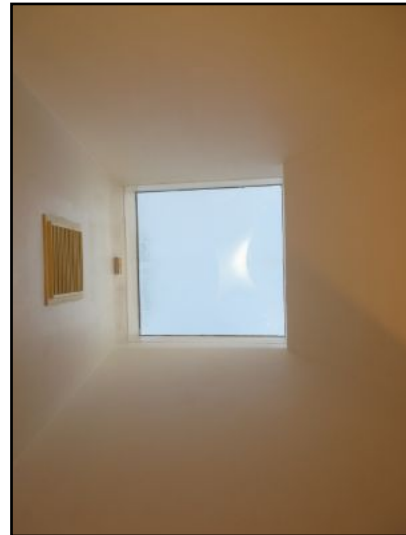
2nd Floor Hall Bathroom

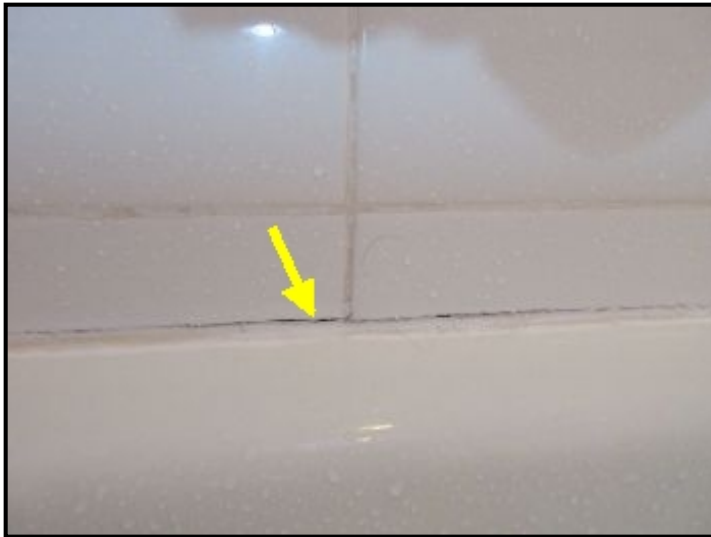
Tub perimeter grout (movement joint) is cracked/missing. Suggest replacing grout with matching silicone based sealant at movement joints.

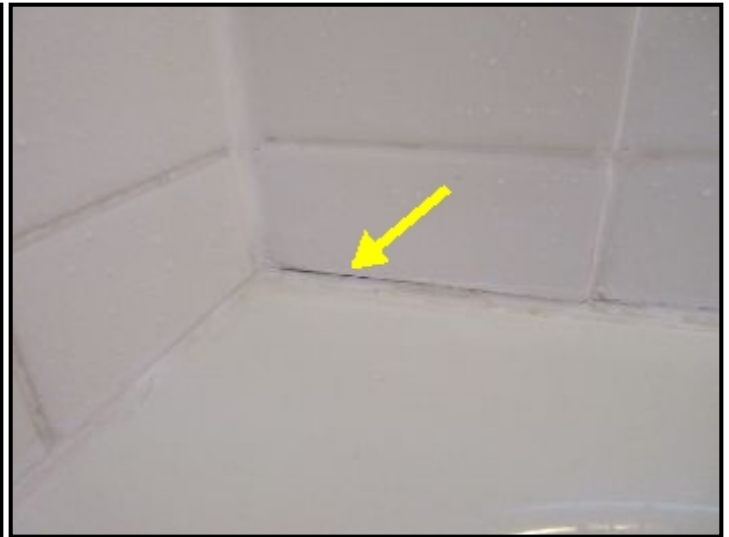
Tub perimeter grout (movement joint) is cracked/missing. Suggest replacing grout with matching silicone based sealant at movement joints.

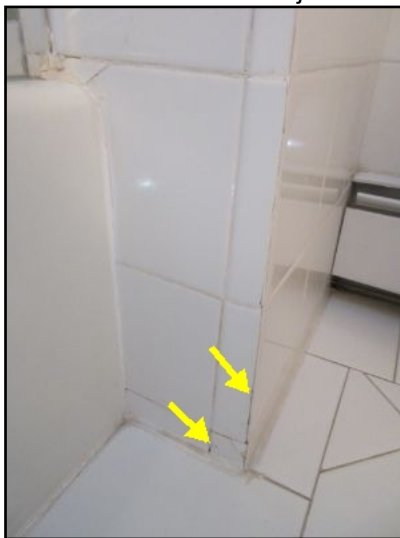
Wall tile damaged, grout cracked/missing; suggest tile and grout repair/s.

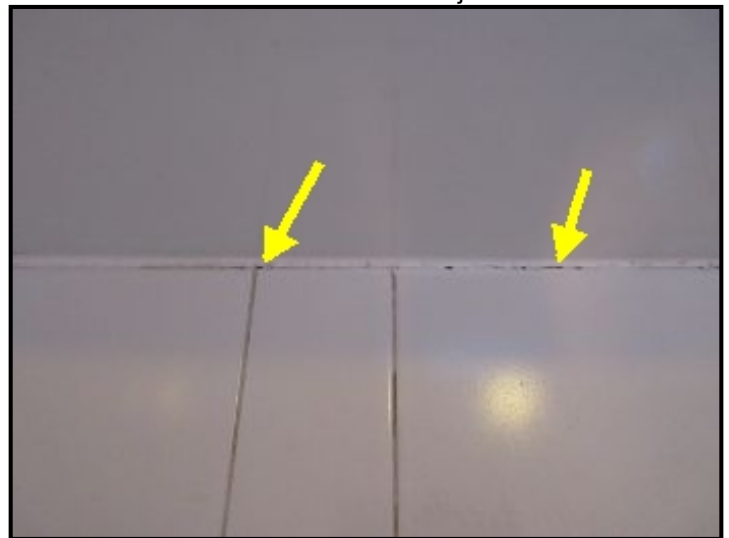
Tub base grout is cracked/missing at floor joint. Suggest grout repair to prevent water entry beneath floor tiles.

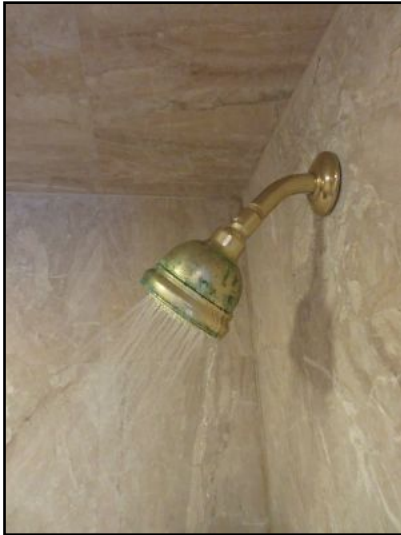
Shower head had water deposits/stains.

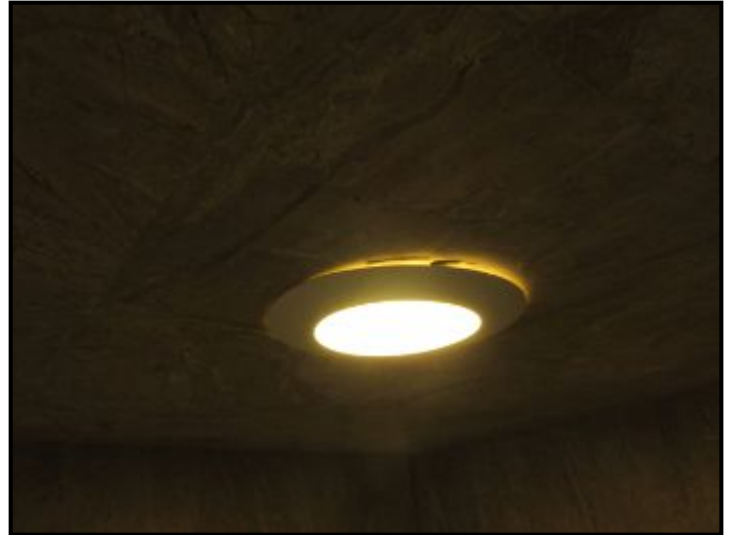
Shower recessed light not adequately seated/sealed; suggest repair by a licensed electrician.

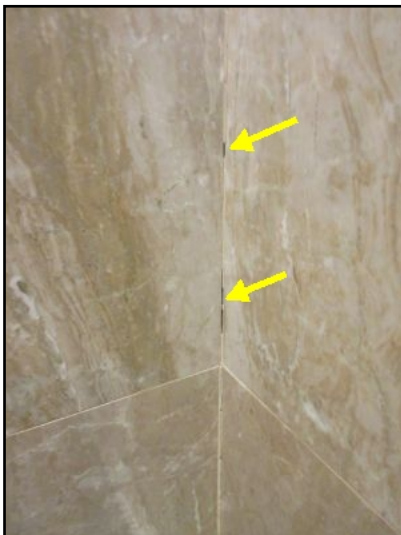
Shower wall corner grout (movement joint) is cracked. This is common; suggest replacing grout with matching silicone based sealant at corner movement joints.

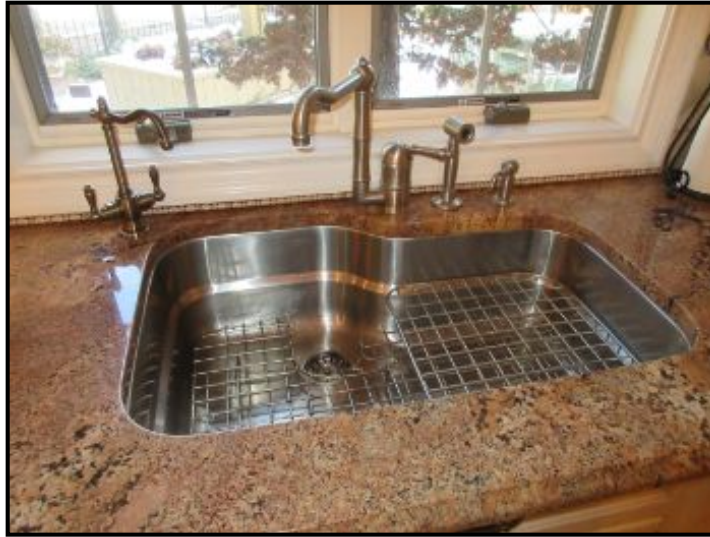
Faucets operated normally at time of inspection.

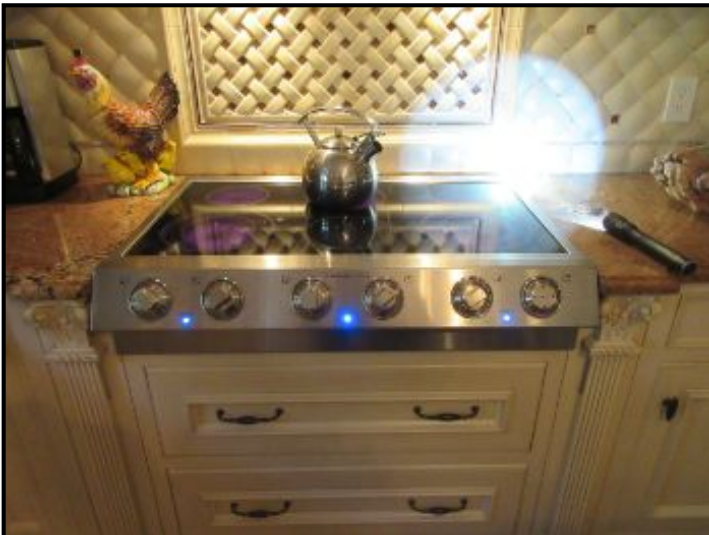
- Electric Cooktop
- Cook top had broken right-side temperature control knob. Exact knob replacements may be available for purchase, or generic ones may be purchased.
- Cook top elements were tested at the time of inspection and appeared to function properly. These can fail at anytime without warning. No warranty, guarantee, or certification is given as to future failure.

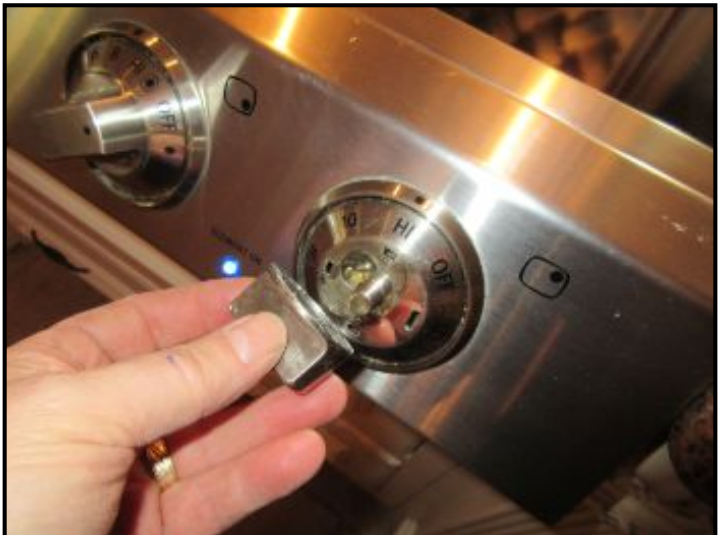
Cook top had broken right-side temperature control knob. Exact knob replacements may be available for purchase, or generic ones may be purchased.

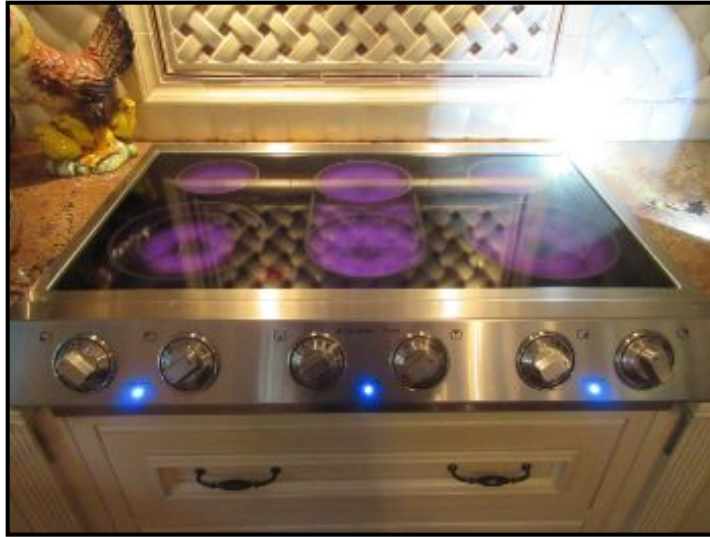
Cook top elements were tested at the time of inspection and appeared to function properly. These can fail at anytime without warning. No warranty, guarantee, or certification is given as to future failure.

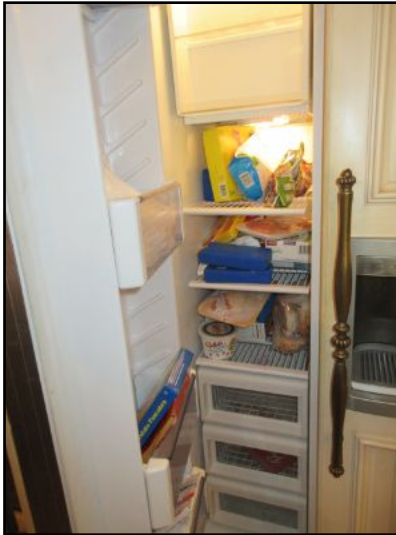
Refrigerator/freezer operating and frost free.

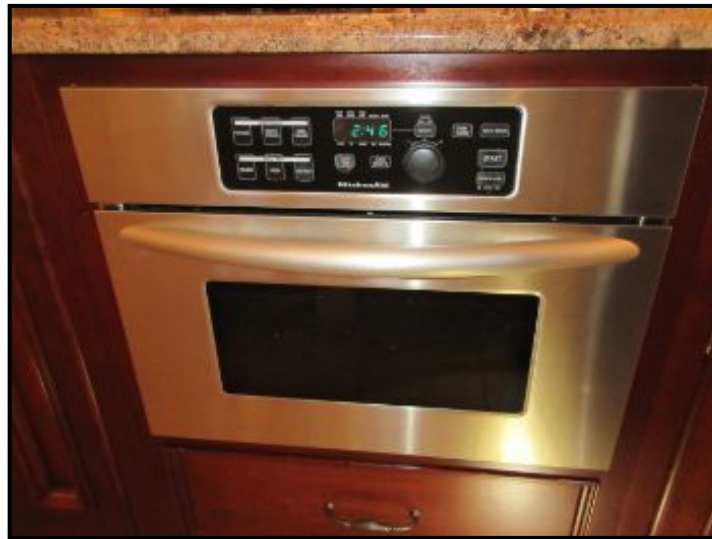
Microwave appeared operable at time of inspection.

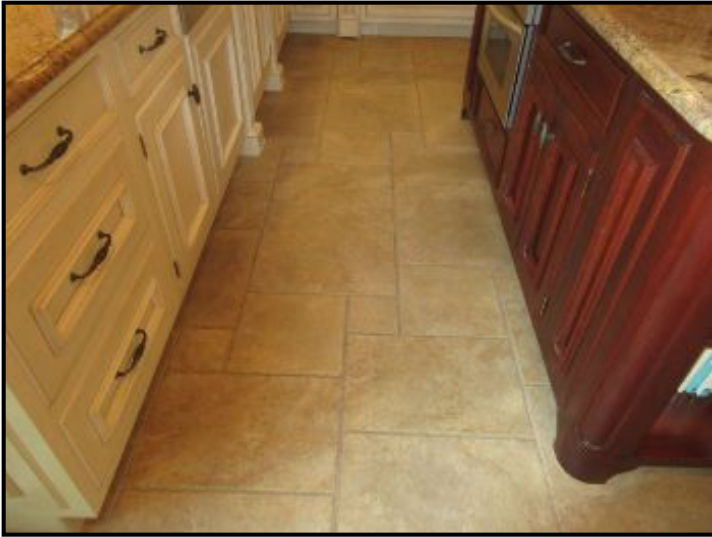
Porcelain tile noted.

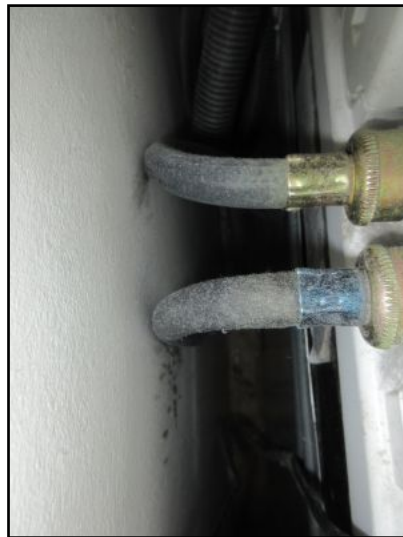
Leaks: No signs observed at time of inspection.

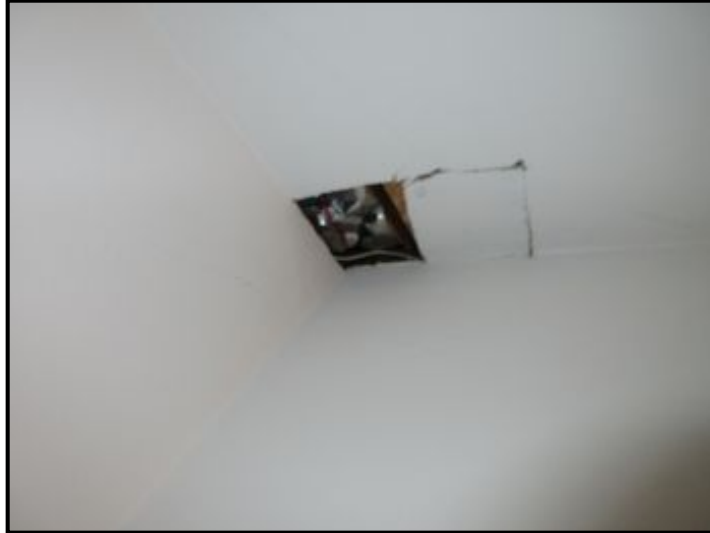
2nd floor, front eave storage space: Unrepaired opening in ceiling.

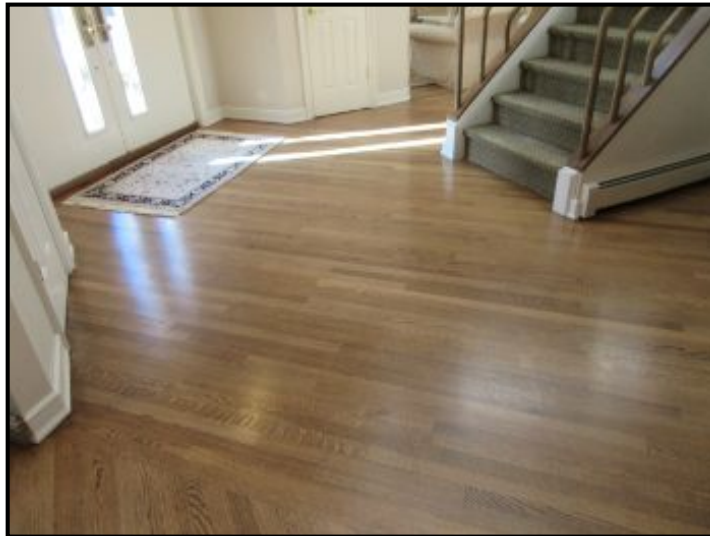
Hardwood flooring noted throughout 1st floor in good condition.

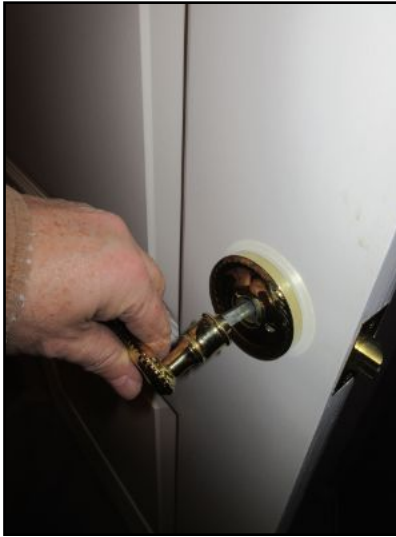
Door lever minor repair needed for Bedroom (2nd floor, rear).

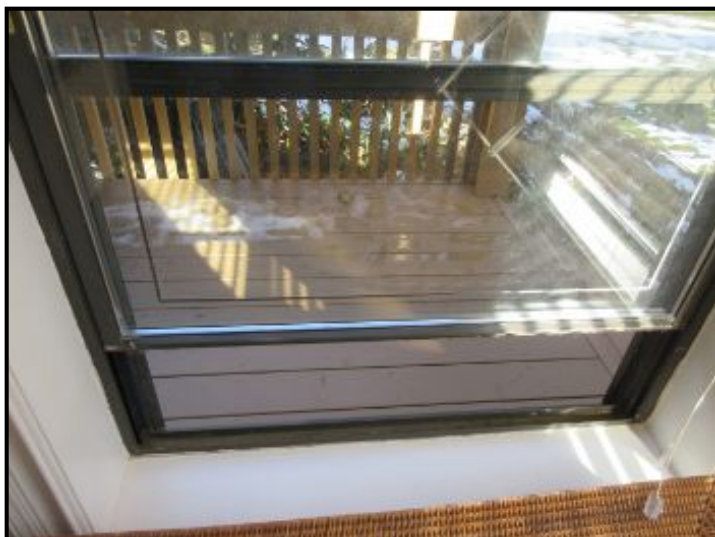
Aluminum framed Double Hung windows noted; original windows (30 yrs old).

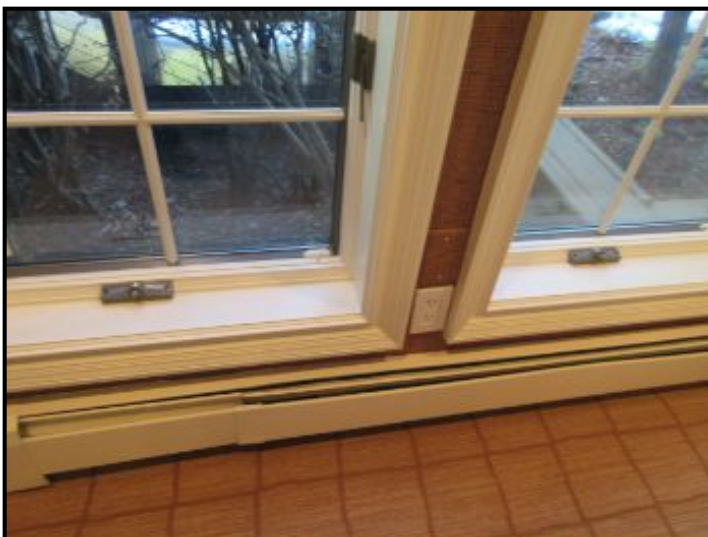
Wood framed Casement windows noted.

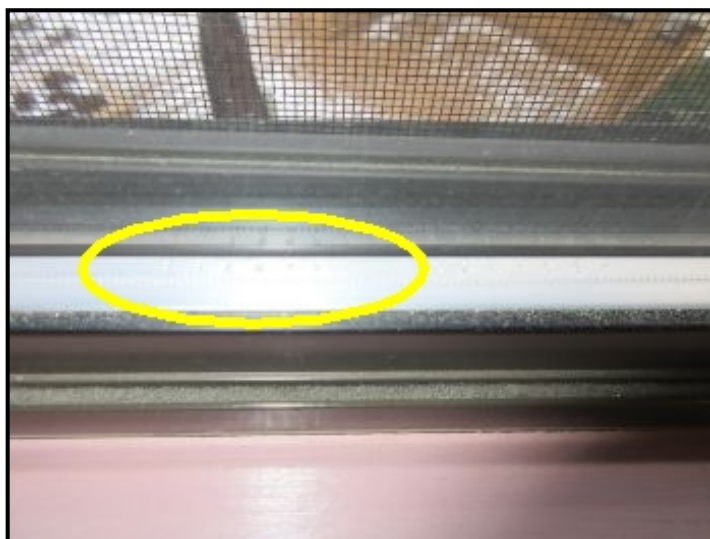
All remaining Aluminum framed windows at 1st & 2nd floors had a manufacture year stamp of 1987 (approx. 30 yrs old).

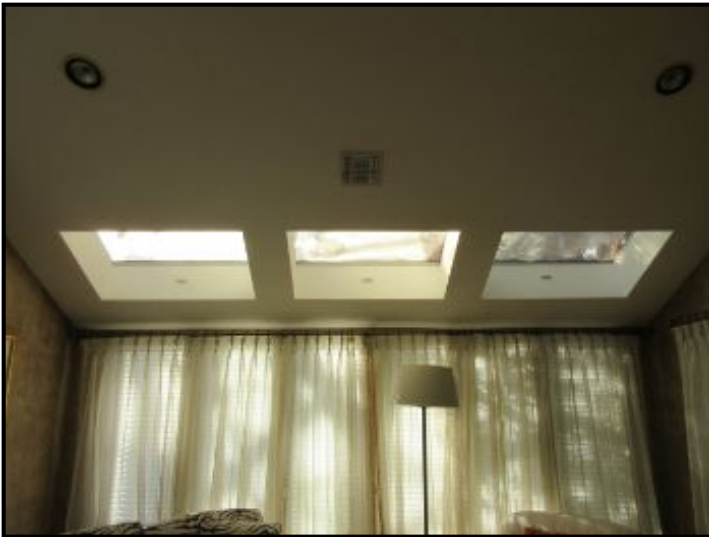
Living room skylights

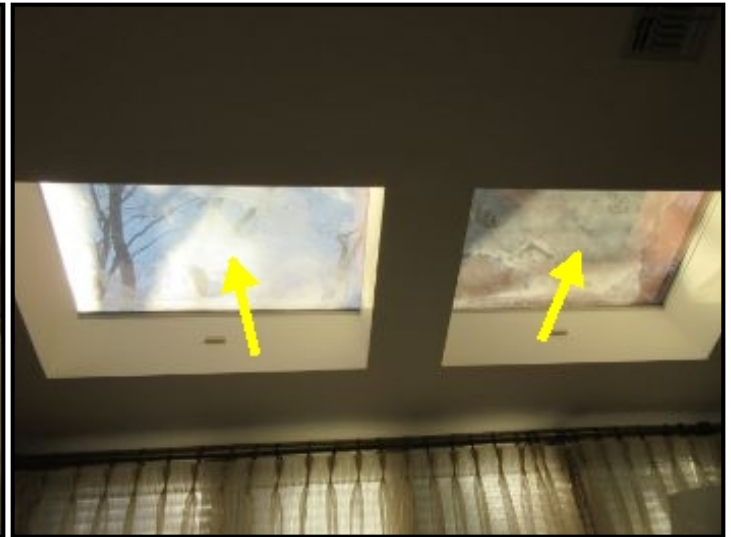
Although no condensation was visible at the time of the inspection, staining and etching of the glass at skylights in the Living room indicates a loss of thermal integrity. Etching of the glass from long-term exposure to condensation constitutes permanent damage. The Inspector recommends that before the expiration of your Inspection Objection Deadline you consult with a qualified contractor to discuss options and costs for replacement.

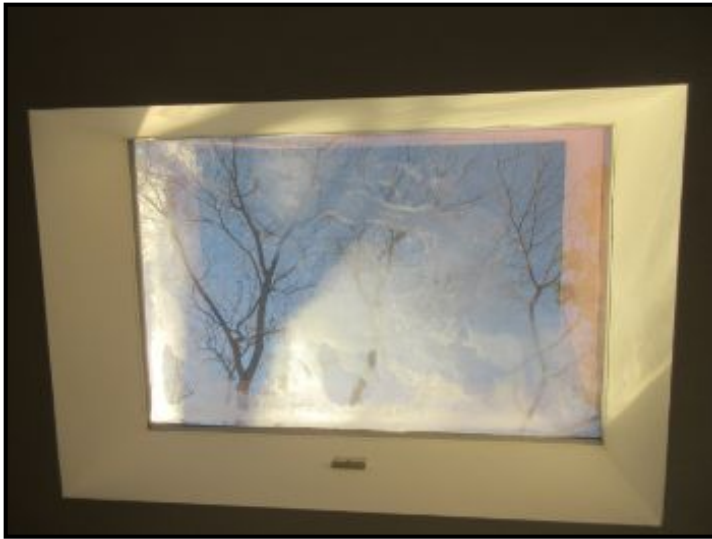
Although no condensation was visible at the time of the inspection, staining and etching of the glass at skylights in the Living room indicates a loss of thermal integrity. Etching of the glass from long-term exposure to condensation constitutes permanent damage. The Inspector recommends that before the expiration of your Inspection Objection Deadline you consult with a qualified contractor to discuss options and costs for replacement.

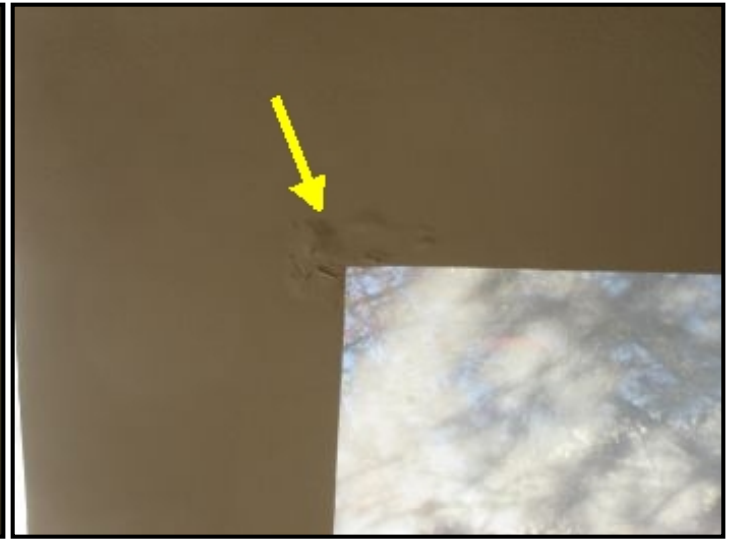
Interior signs of a leak at living room skylight; suggest qualified roofing contractor investigate source of leak and ensure proper seal until roof cover is replaced.

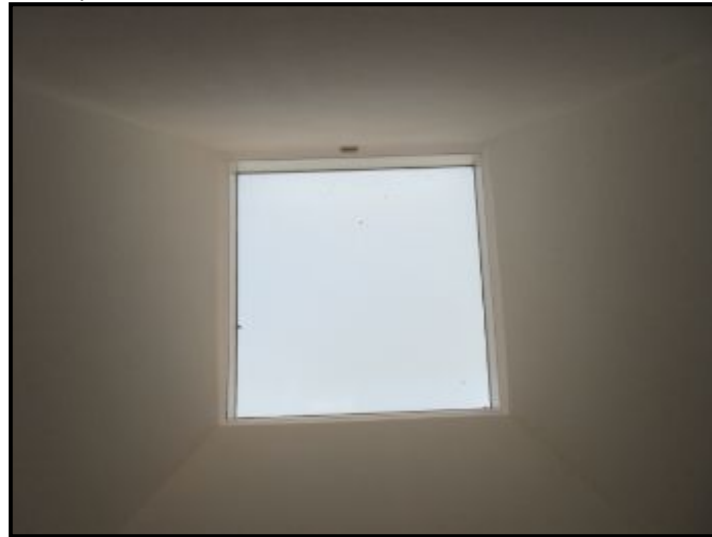
Master bedroom suite

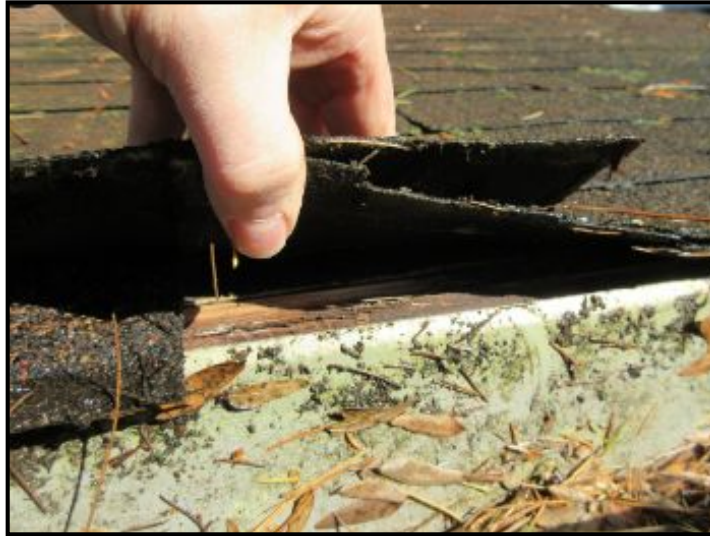
1 layer/s of asphalt shingles noted. Ice shield was noted.

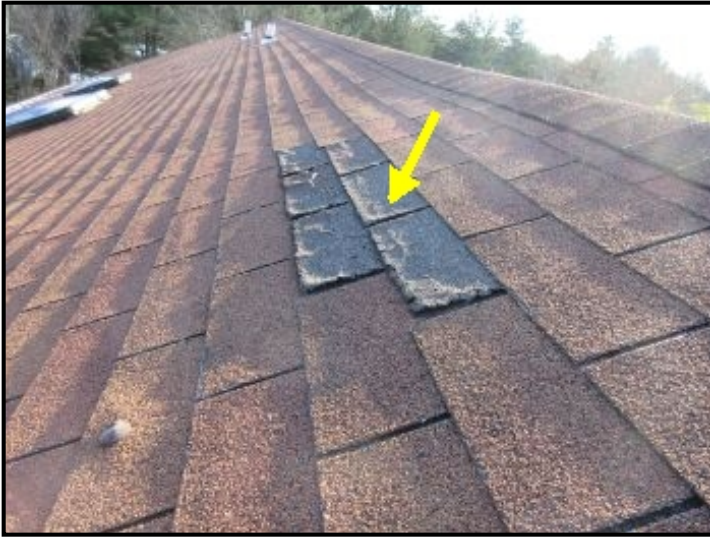
Past roof repair noted.

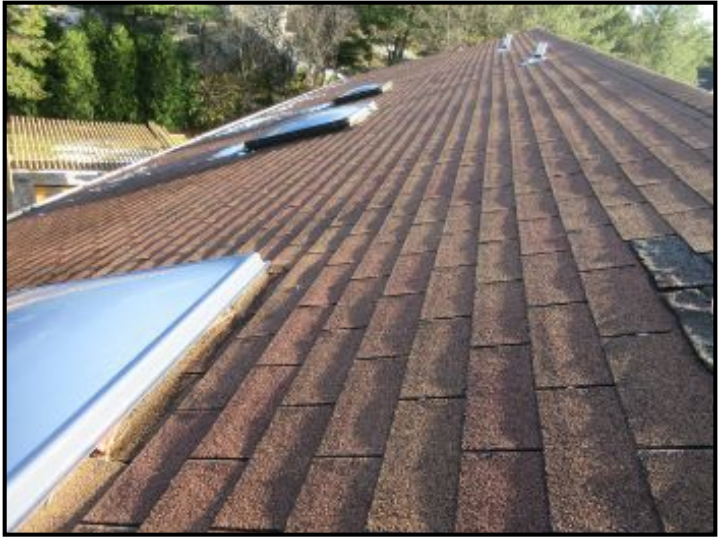
At the time of the inspection, asphalt composition shingles covering the roof of this home appeared to be at or near the end of their useful lives.

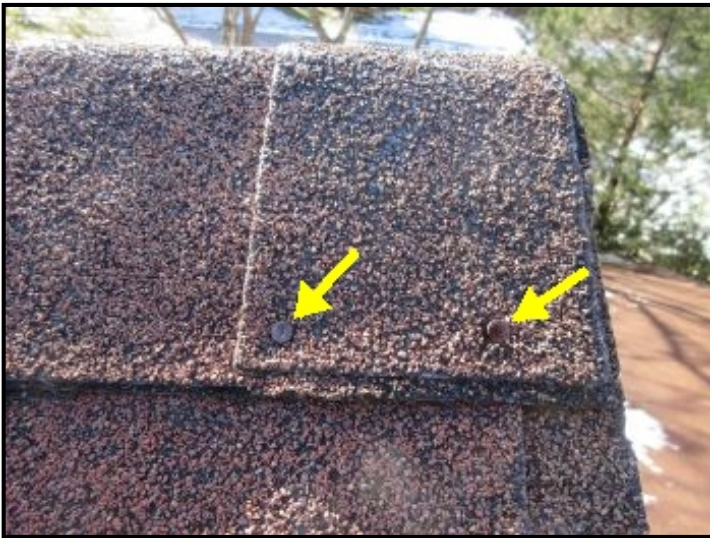
Exposed nail heads on roofing material. Recommend sealing all fastener heads.

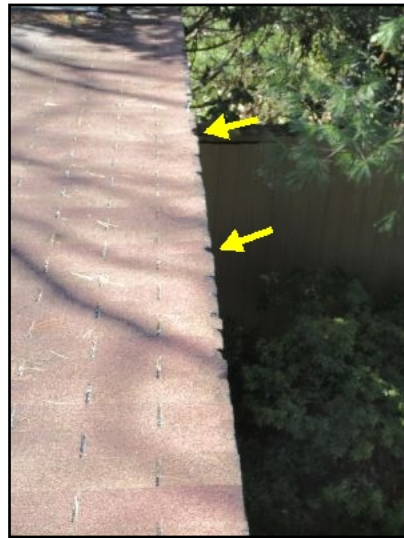
Signs of past shingle damage caused by tree branches abrading shingle edges.

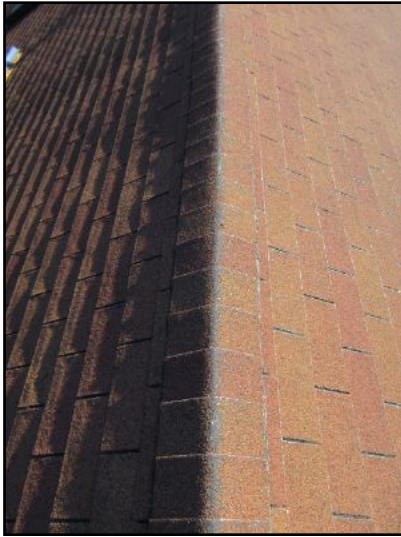
Asphalt composition shingles covering the roof of this home exhibited general deterioration commensurate with the age of the roof (30 yrs).

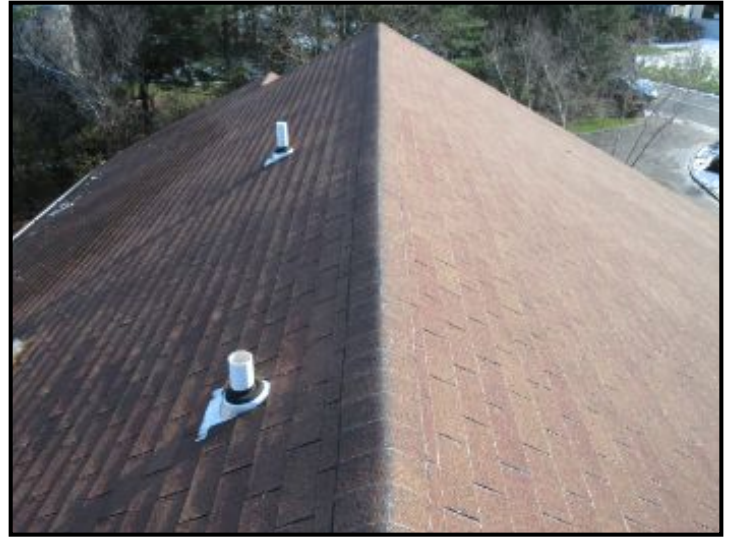
At the time of the inspection, asphalt composition shingles covering the roof of this home appeared to be at or near the end of their useful lives.

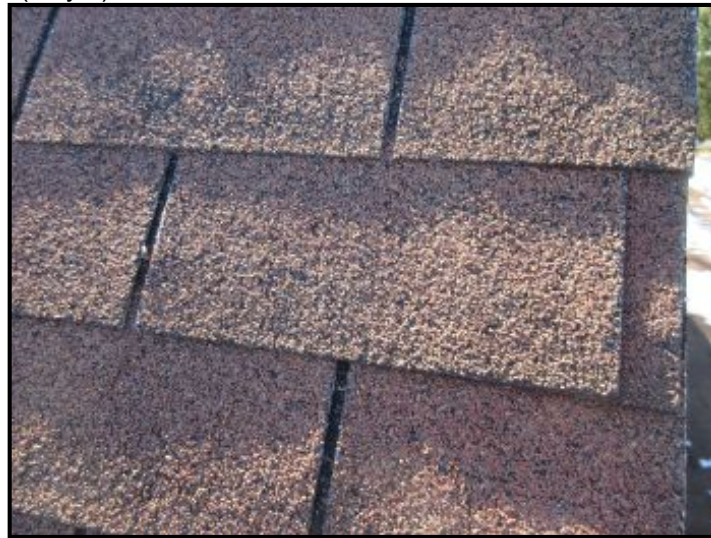
The top asphalt roof covering showed conditions consistent with 30 yr old shingles.

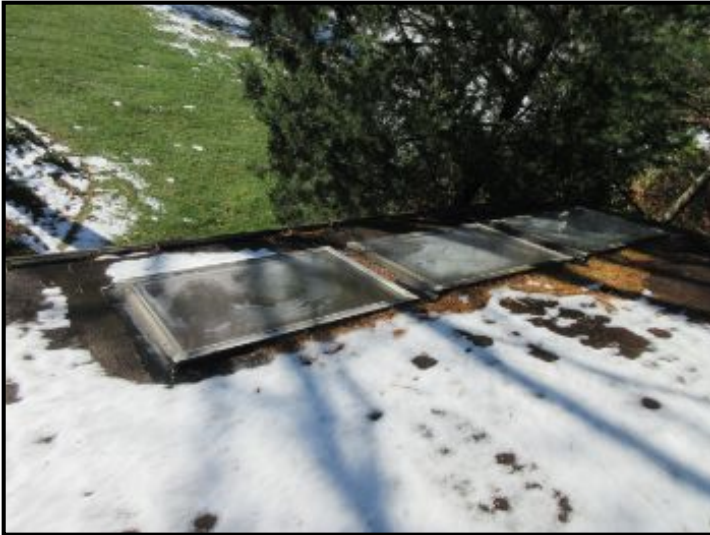
Skylights over living room; flashings covered with organic debris; slippery conditions. Signs of a leak noted at interior; suggest qualified roofing contractor seal around skylight/s temporarily until roof cover is replaced.

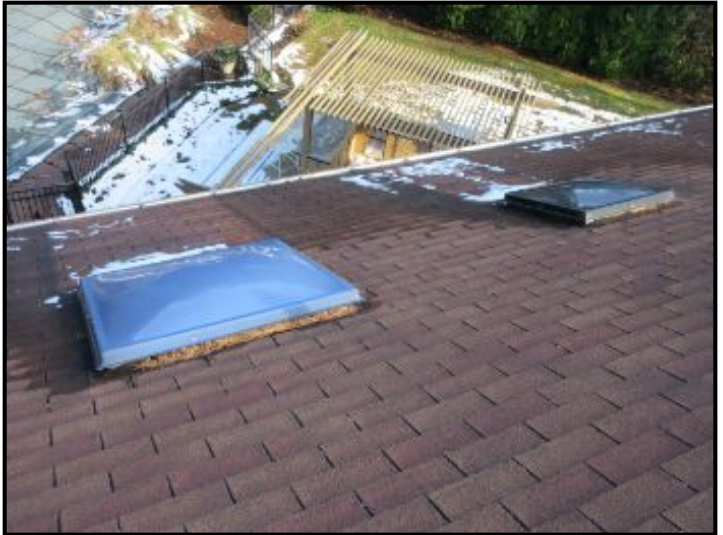
Skylight flashings covered with organic debris; suggest qualified roofing contractor ensure proper seal around skylight/s until roof cover is replaced.

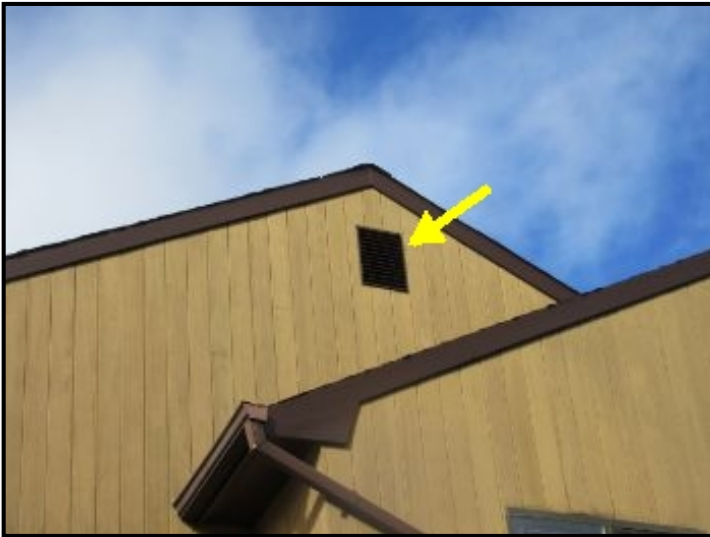
Gable-end louver vent(s) noted for attic ventilation.

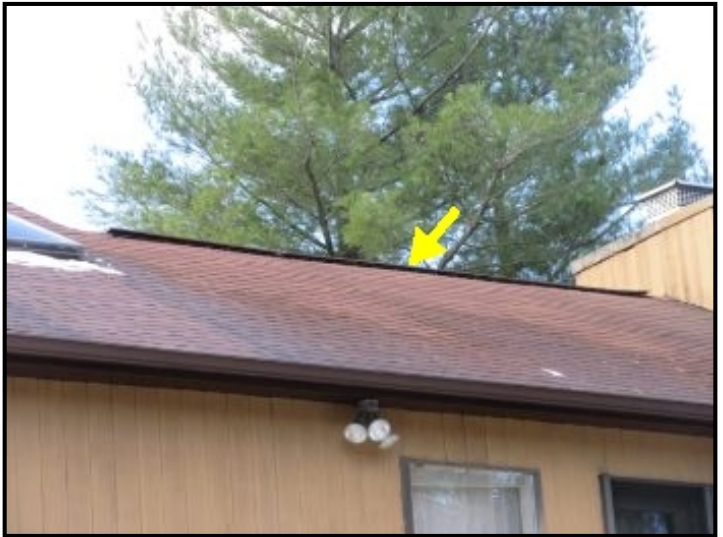
Ridge exhaust venting noted for north attic ventilation.

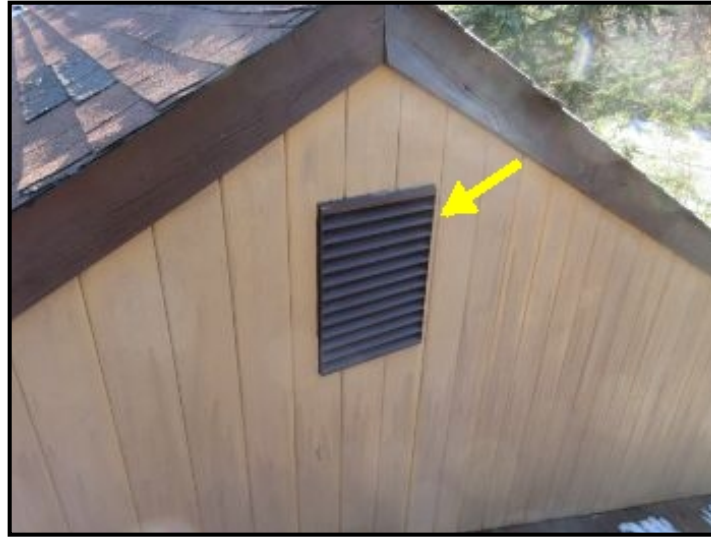
Gable-end louver vent(s) noted for attic ventilation.

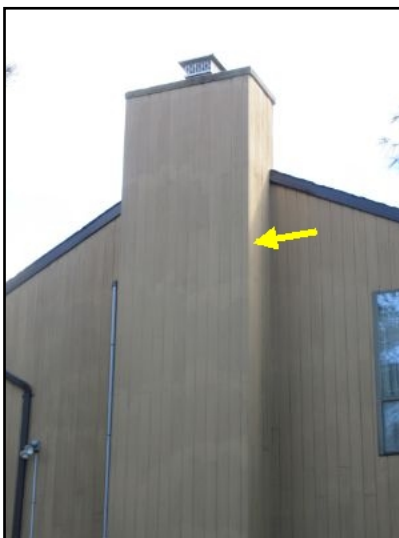
Architectural chase noted

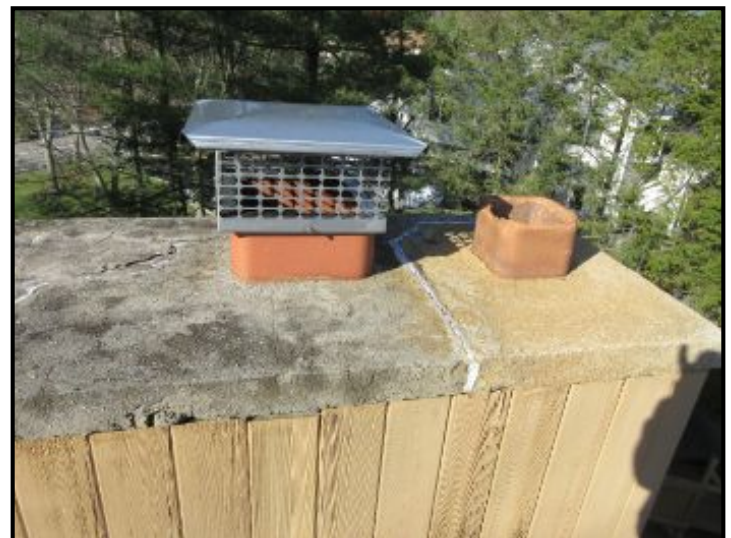
Combined fireplace and furnace chimney brick enclosure noted.

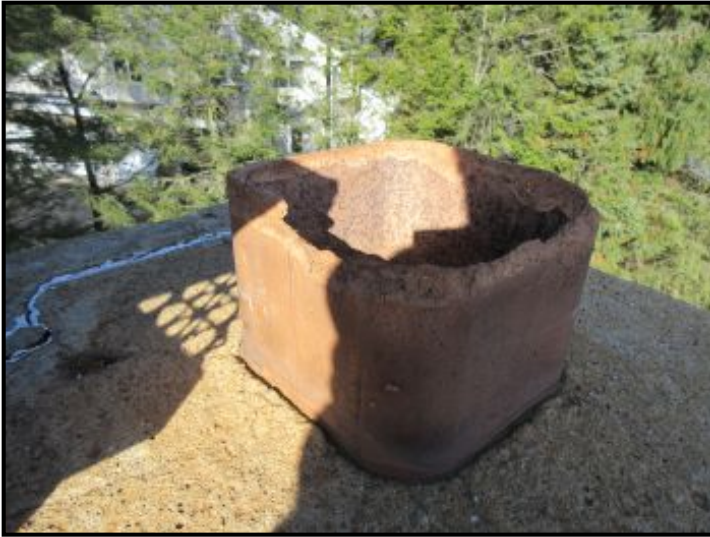
Chimney cap w/spark arrestor missing. Suggest installing a chimney rain cap to prevent the entrance of precipitation and local wildlife to preserve the life of the chimney and minimize chimney maintenance. Rain caps come with a spark arrestor which prevents emission of flammable debris from fireplace combustion sources.
