ProSpec Home Inspection of Long Island Property Inspection Report

2 Clearmeadow Ln, Woodbury, NY 11797
Inspection prepared for: Name Deleted Date
of Inspection: 11/16/2018 Time: 1:00 PM
Age of Home: 30 yrs old Size: 4,024 sq. ft.
Approx. Year Built: 1988

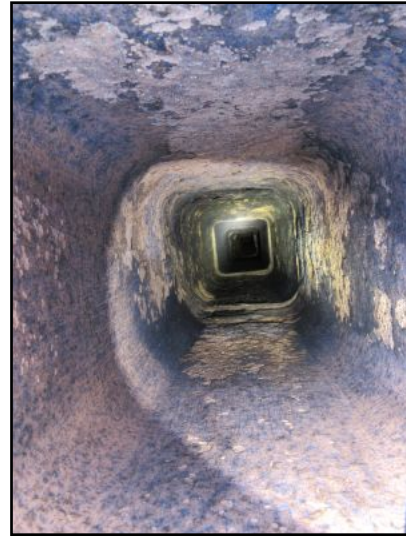
The boiler chimney stack has an unlined flue. While this may have been acceptable at the time of construction, flue liners are a fire safety feature which the client should consider installing to enhance safety. Regular cleaning of the chimney is recommended to ensure safe and efficient operation.

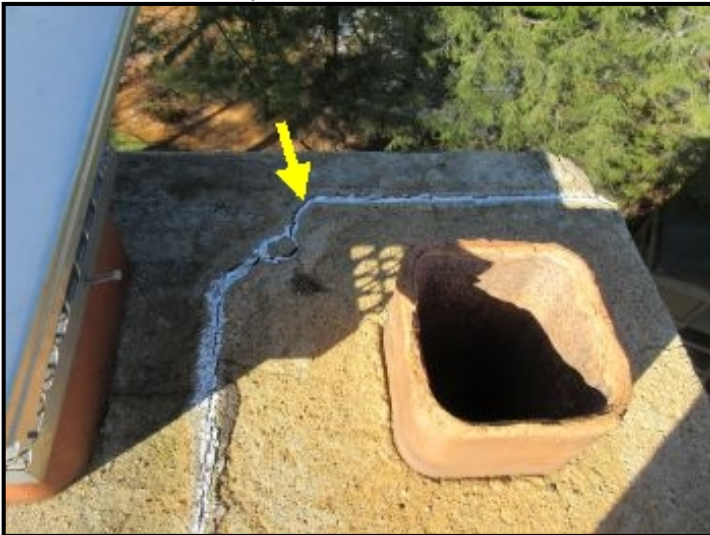
Crown cement cracks were sealed but are no longer leak tight. Recommend chimney specialist repair/seal crown cement to prevent water entry that can deteriorate brick mortar joints.

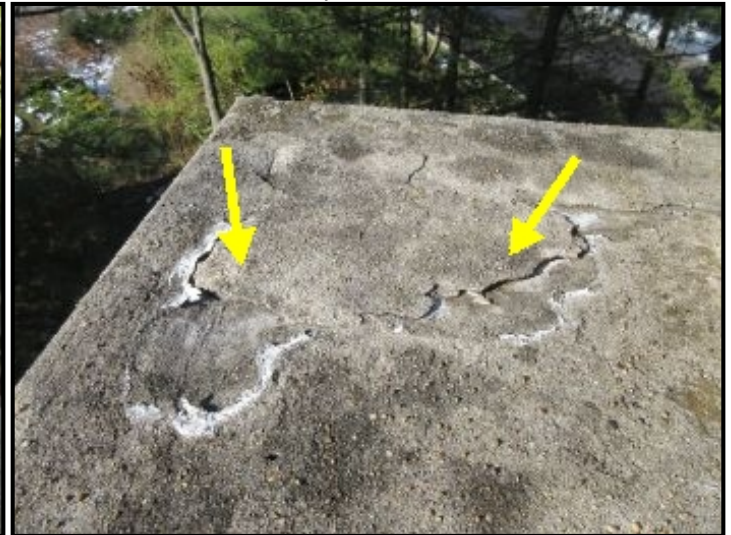
Spalling noted at chimney crown. Suggest a qualified chimney contractor review and provide the needed repair to prevent further weathering.

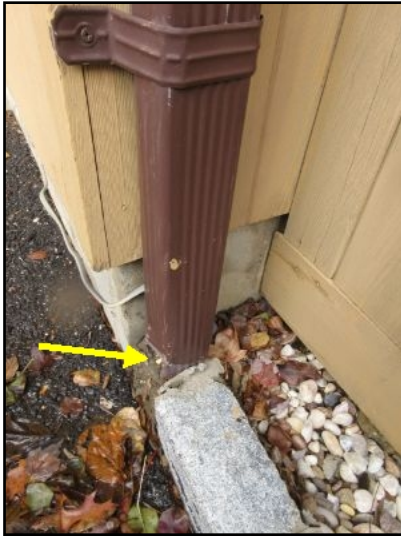
Downspout extension missing at South side. Recommend extending downspout/s 4 ft minimum where possible to divert run-off away from the structure to prevent water seepage through foundation walls.

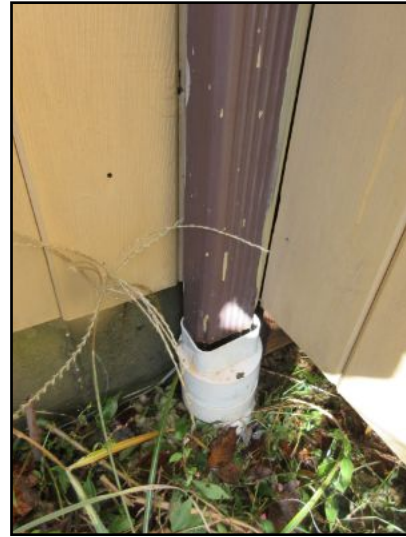
Most downspouts appear to drain to underground drywell.

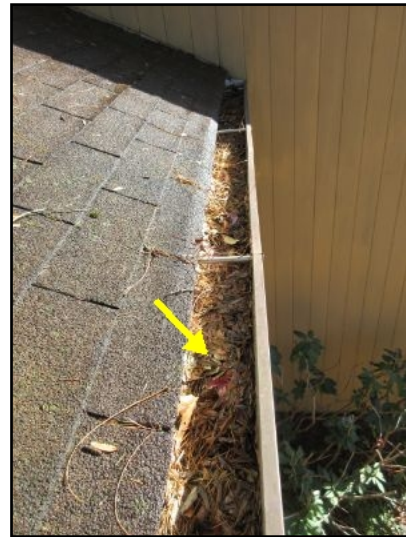
MAINTENANCE: Keep gutters cleared of organic debris to prevent downspouts from being clogged, causing overflow and ice damming at gutters; ensure that all downspouts have extensions to carry water away from the foundation.

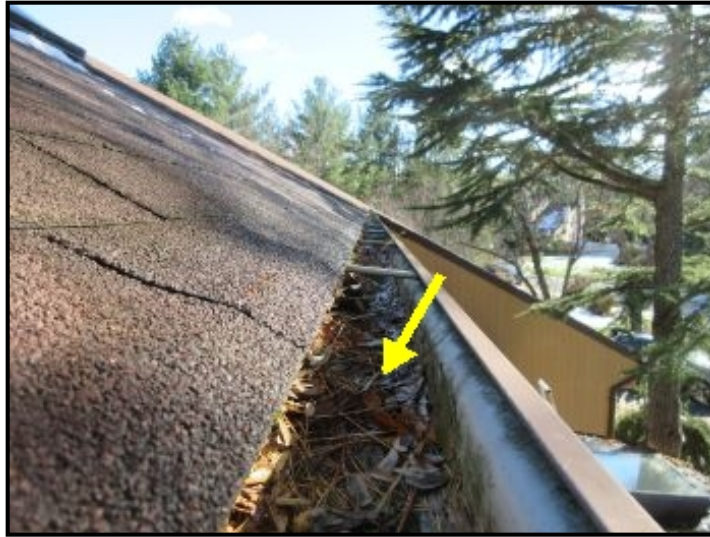
MAINTENANCE: Keep gutters cleared of organic debris to prevent downspouts from being clogged, causing overflow and ice damming at gutters; ensure that all downspouts have extensions to carry water away from the foundation.

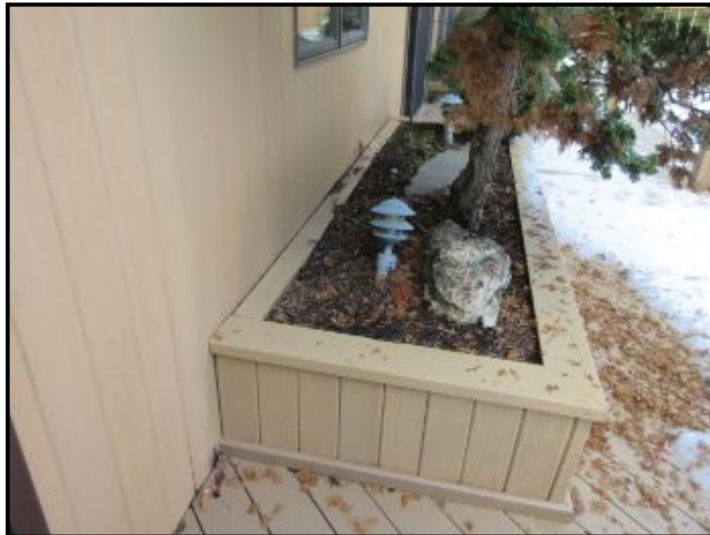
Planters against the house siding should include moisture barrier to prevent soil in contact with wood siding.

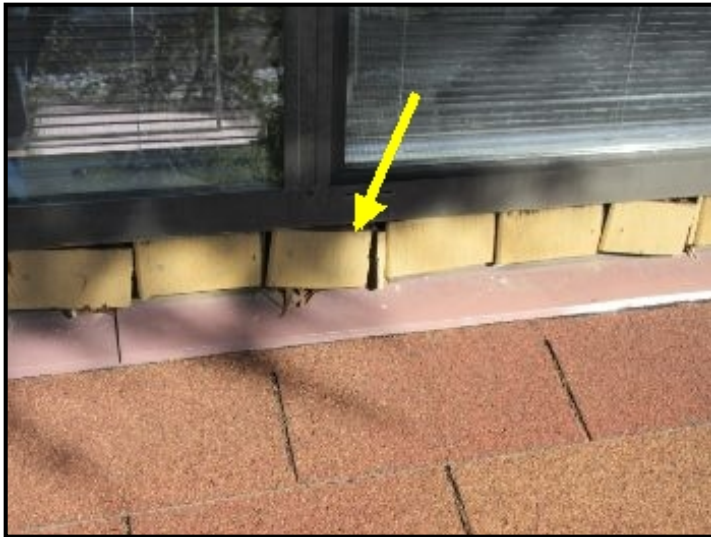
Small pieces of siding not properly secured to wall sheathing at flashing; recommend qualified contractor provide corrective repair.

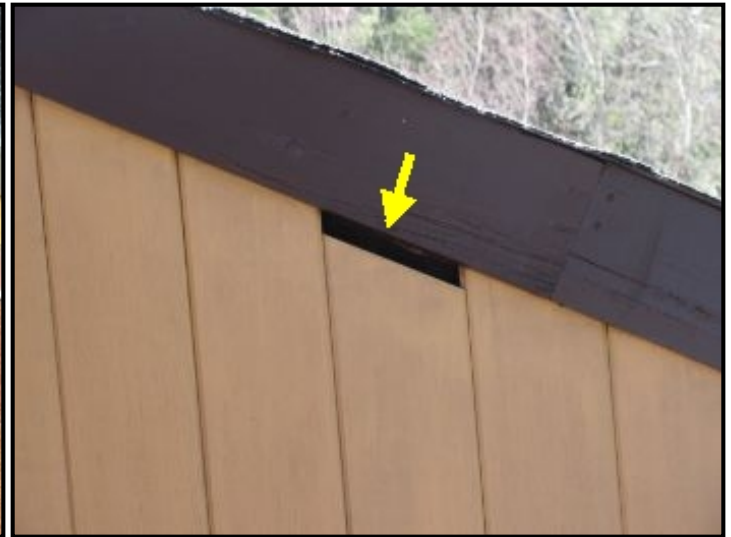
Gap noted at siding in front, facing north; recommend qualified contractor provide corrective repair to prevent water entry.

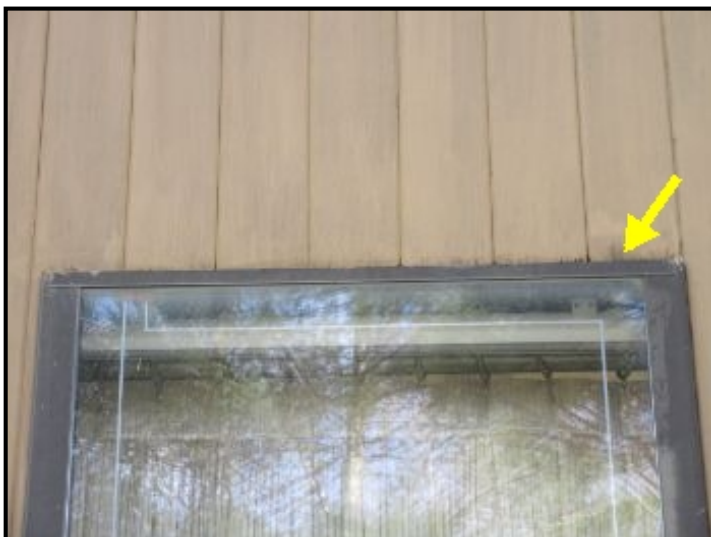
Signs of some siding deterioration along drip edge above original aluminum frame windows due to a lack of sealant here.

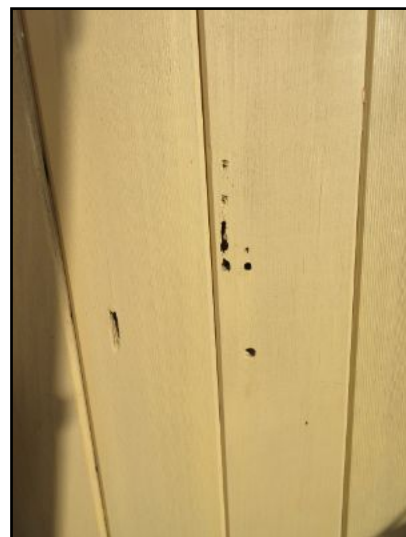
Small holes in front siding below dining room window; appears to be past damage that was since painted over. Not from termites. Cedar siding holes like these are usually the result of woodpeckers foraging for insects.

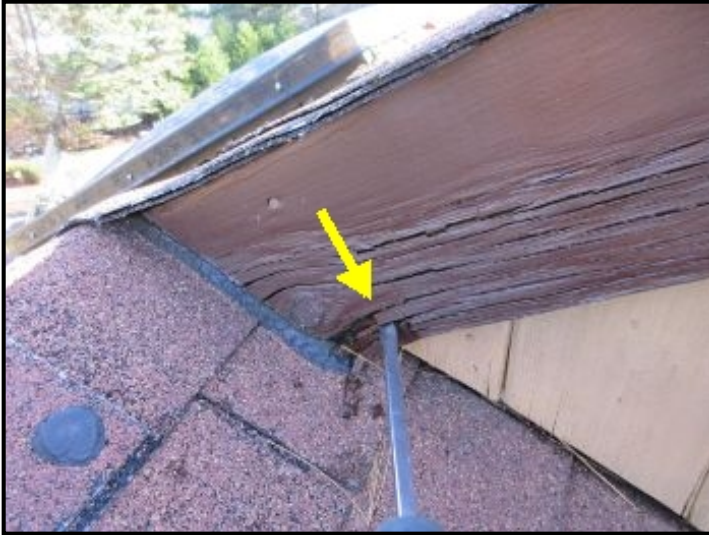
Wood deterioration noted at barge boards (north). Recommend replacement of deteriorated barge boards at time of roofing replacement.

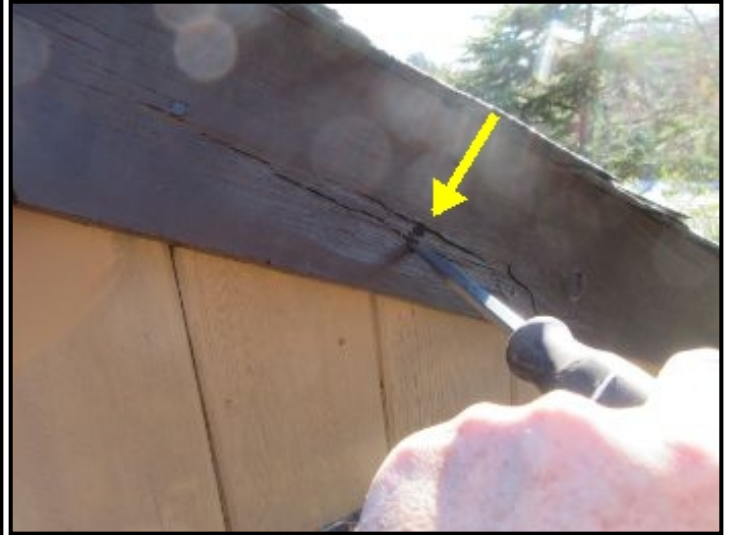
Wood deterioration noted at barge boards (north). Recommend replacement of deteriorated barge boards at time of roofing replacement.

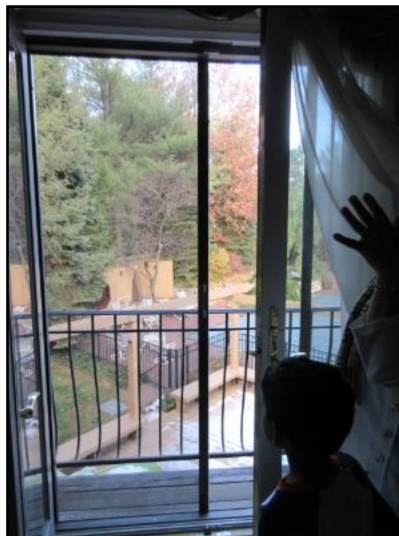
Sliding screen has damage at bottom at master bedroom balcony. Suggest screen repair.

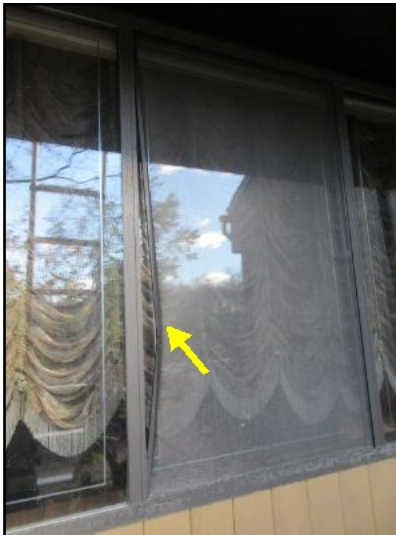
Damaged screen observed at the Front of the home.

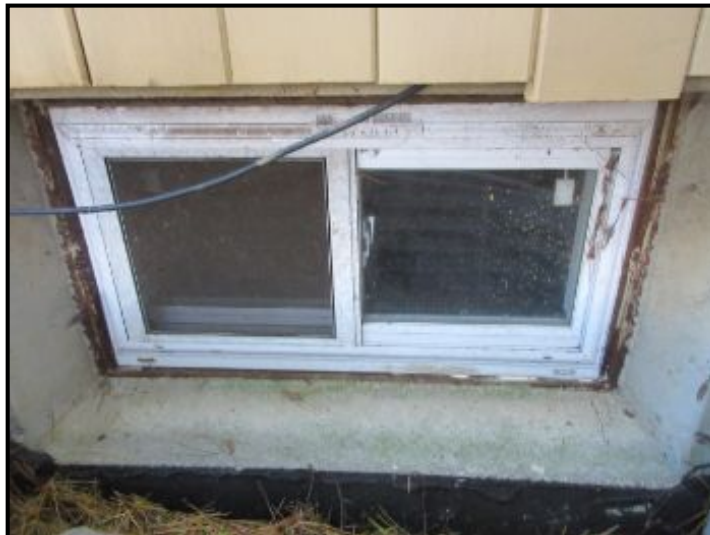
Insulated vinyl framed sliding windows noted.

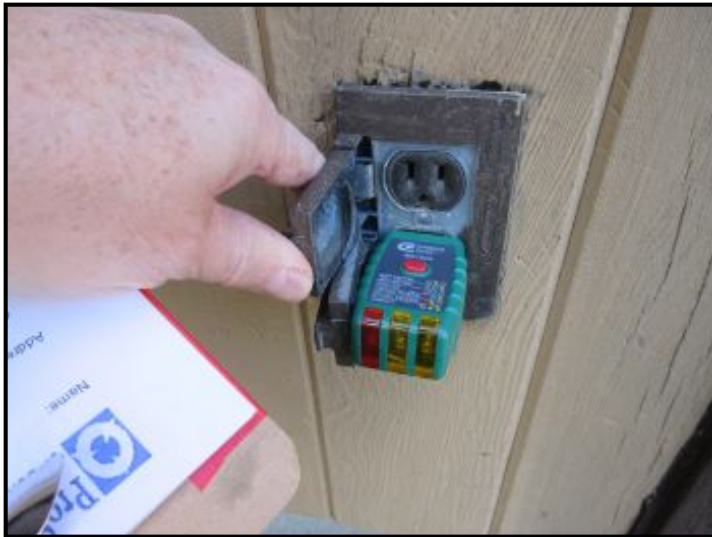
No Power at Non-GFCI type receptacle/s at time of inspection. Recommend having seller locate source / restore power prior to close.

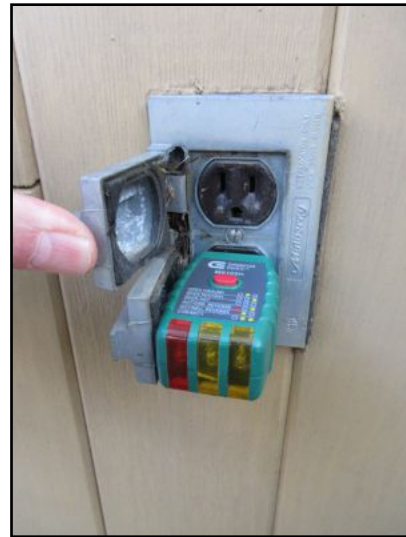
No power at GFCI type receptacle/s at time of inspection. Recommend having seller locate source / restore power prior to close.

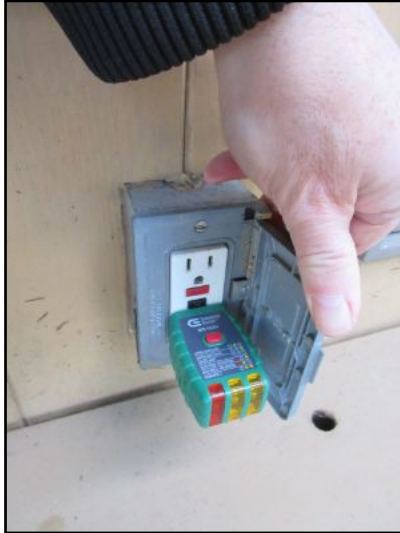
No power at GFCI type receptacle/s at time of inspection. Recommend having seller locate source / restore power prior to close.

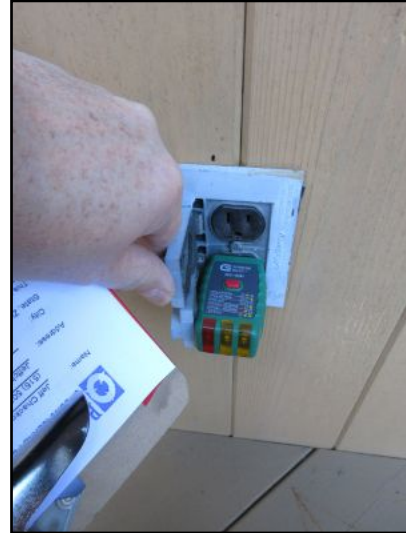
No Power at Non-GFCI type receptacle/s at time of inspection. Recommend having seller locate source / restore power prior to close.

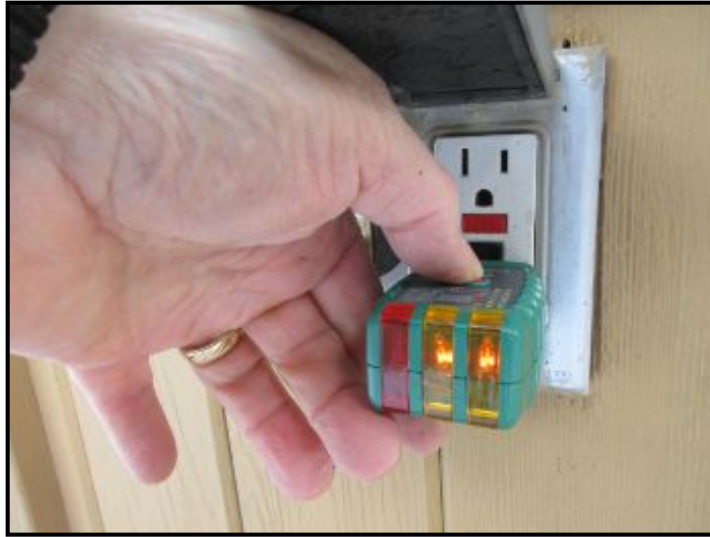
GFCI type receptacle at did not trip when tested. Recommend rewiring or replacing GFCI receptacle.

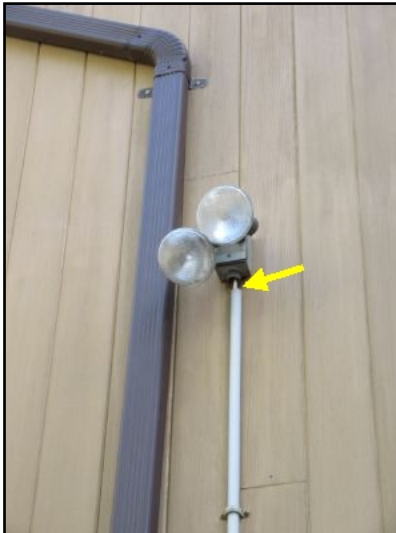
Exposed power wires to outdoor lighting fixture at north side. Suggest electrician repair.

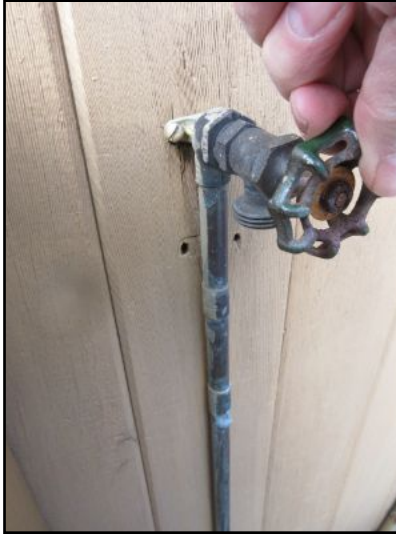
Hose bibb not active at South side; possibly turned off from inside. Suggest further review; possible repair needed.

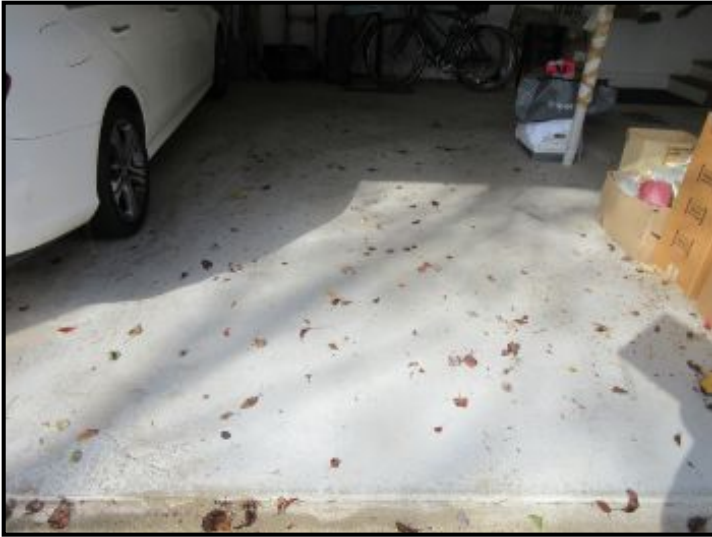
At the time of the inspection, the Inspector observed no deficiencies in the condition of the visible portions of the concrete floor slab -- In normal condition for its age.

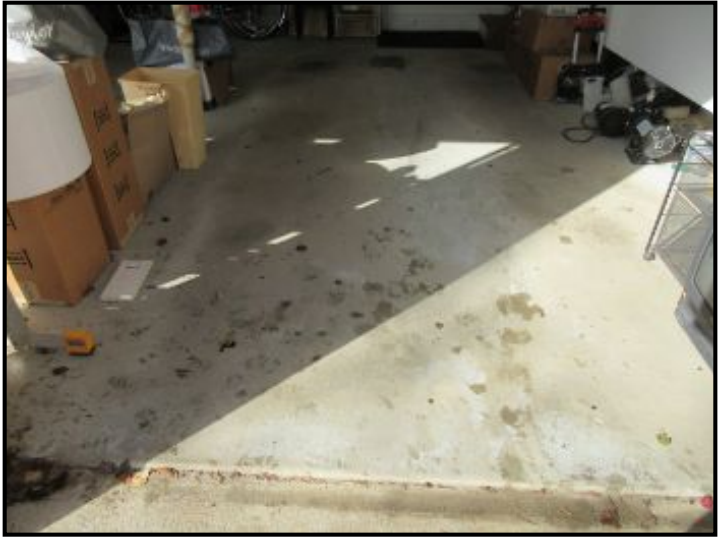
Minor oil staining noted.

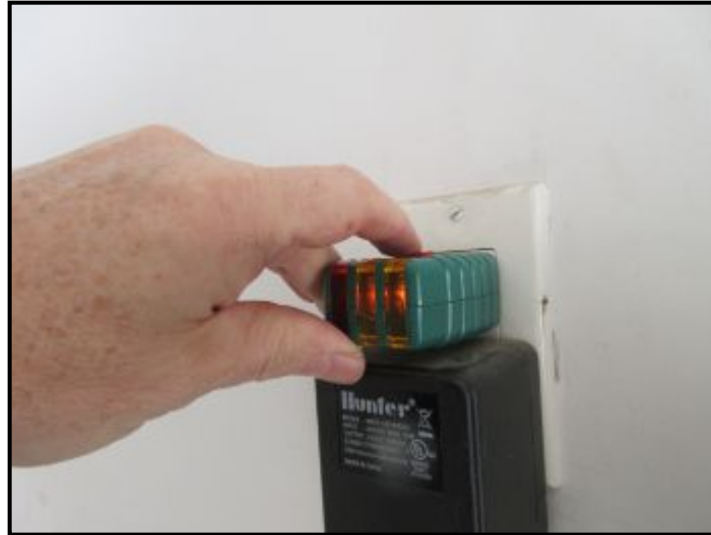
Receptacle not GFCI protected. Recommend updating to GFCI protected receptacles. Refer to Electrical section.

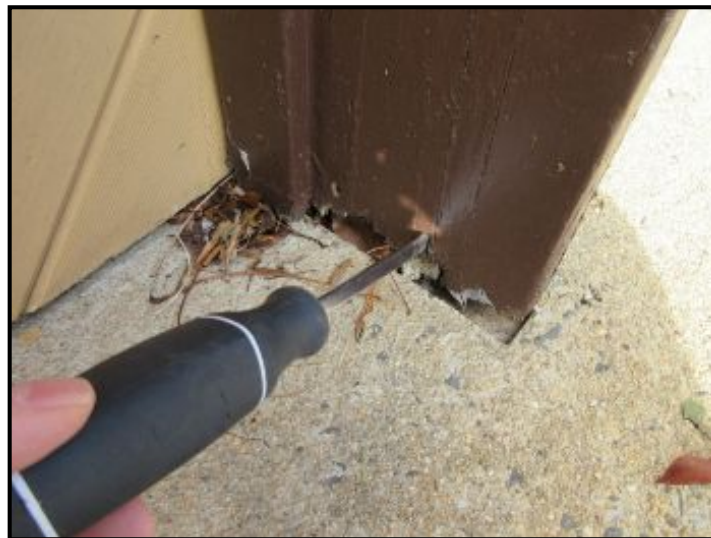
Vehicle door Jamb/s showed signs of water damage.

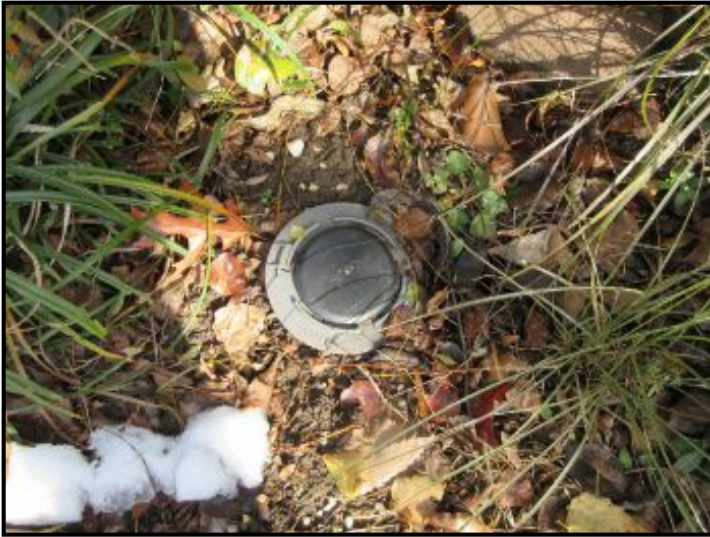
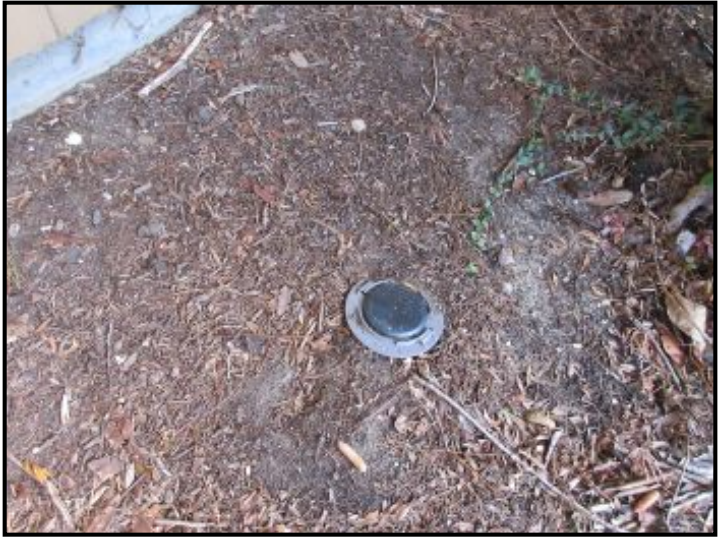
Previous Termite Treatment noted; Bait stations observed at perimeter of the structure.

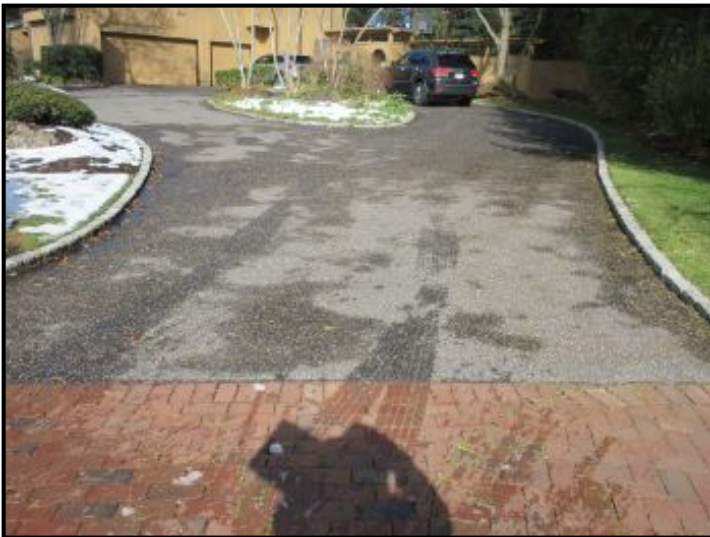
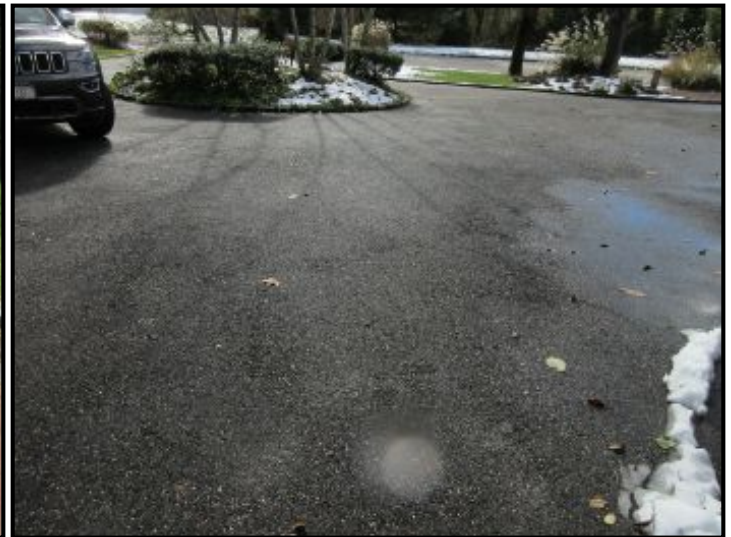
Driveway was in satisfactory and functional condition with normal wear for its age.

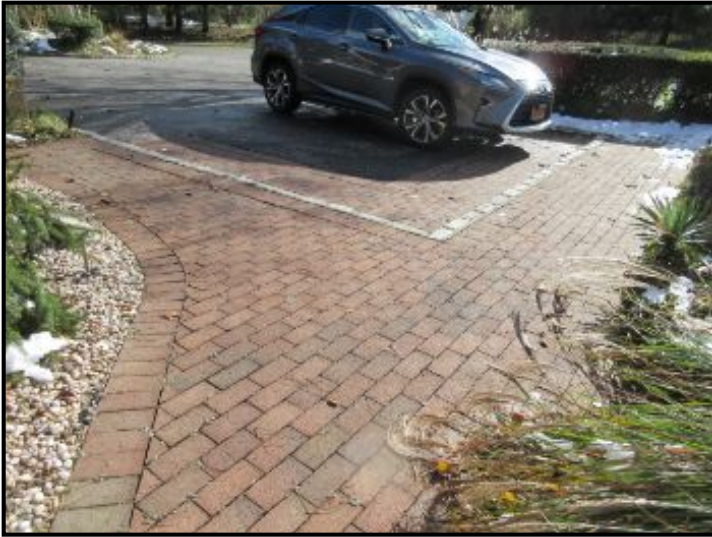
Brick walkways noted.

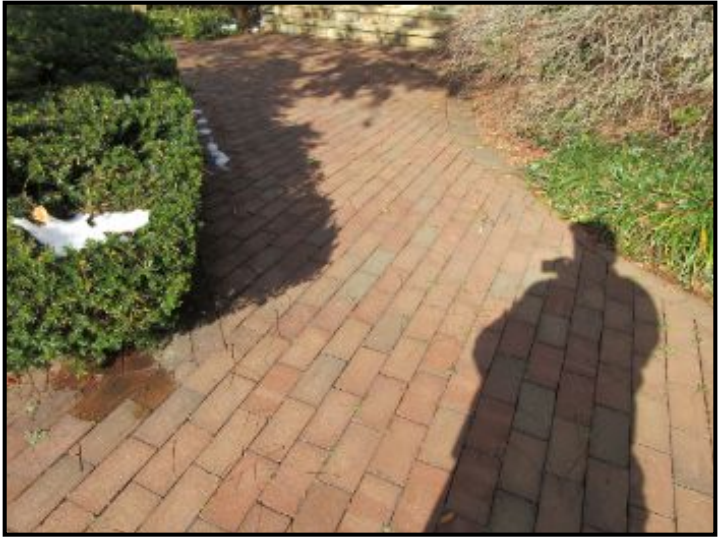
Brick walkways noted.

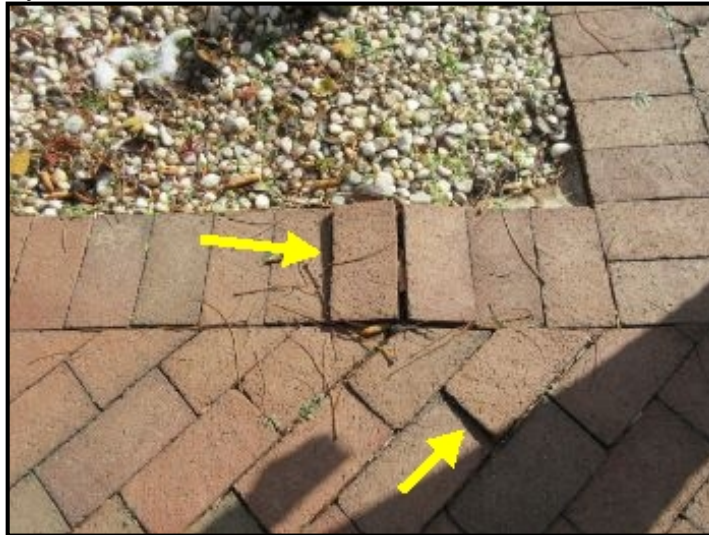
Uneven settlement of brick walkway noted. Monitor and/or repair to prevent potential trip hazard from developing.

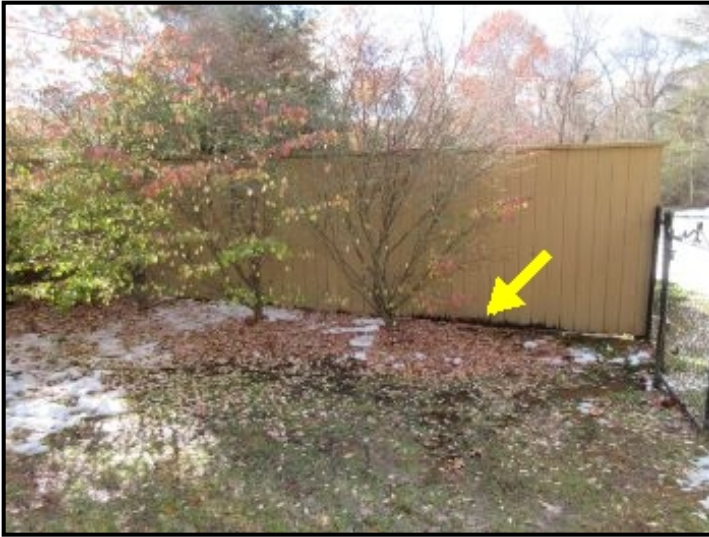
Wooden fence at north yard

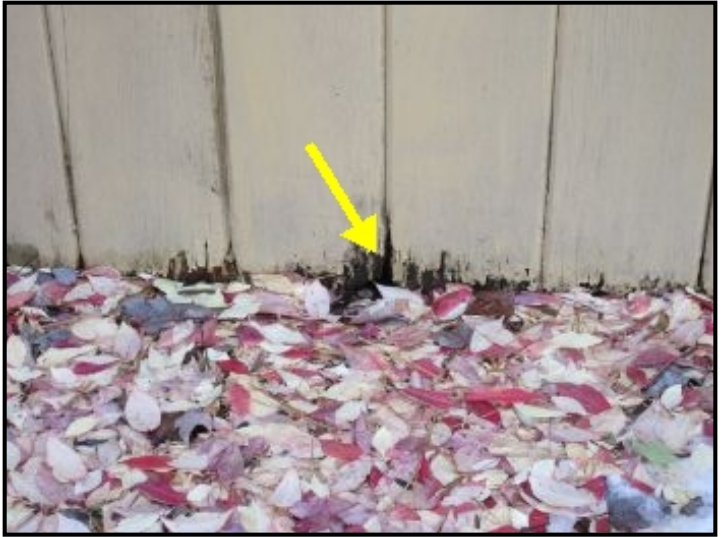
Wood fence shows signs of deterioration; wood in contact with earth. Recommend lowering soil level to prevent wood contact with earth.

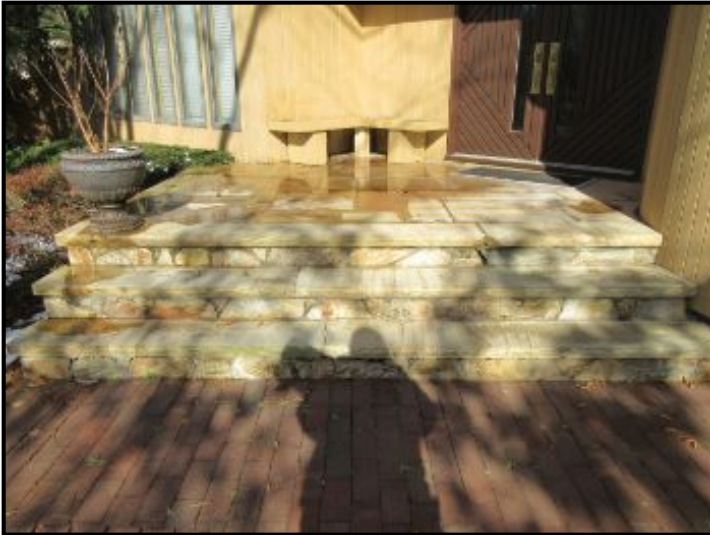
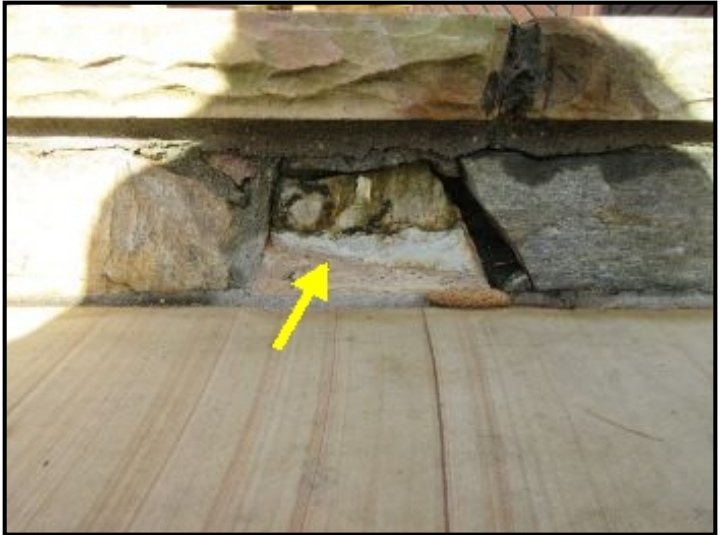
Masonry Steps and Landings noted. No major system safety or function concerns noted at time of inspection.

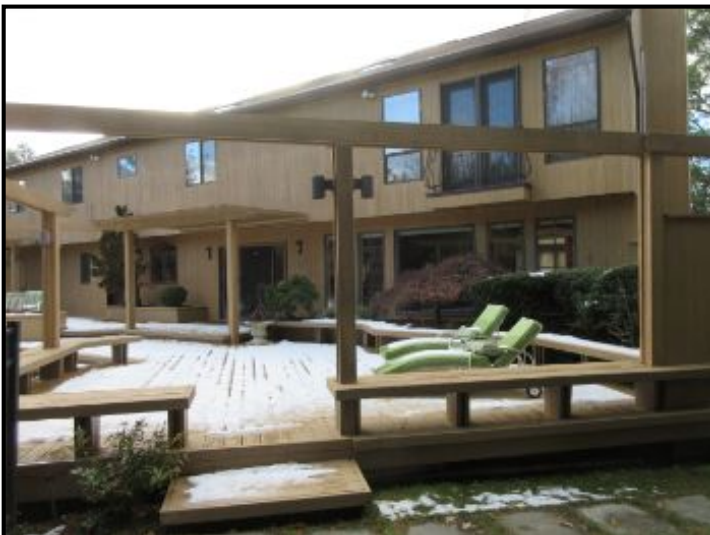
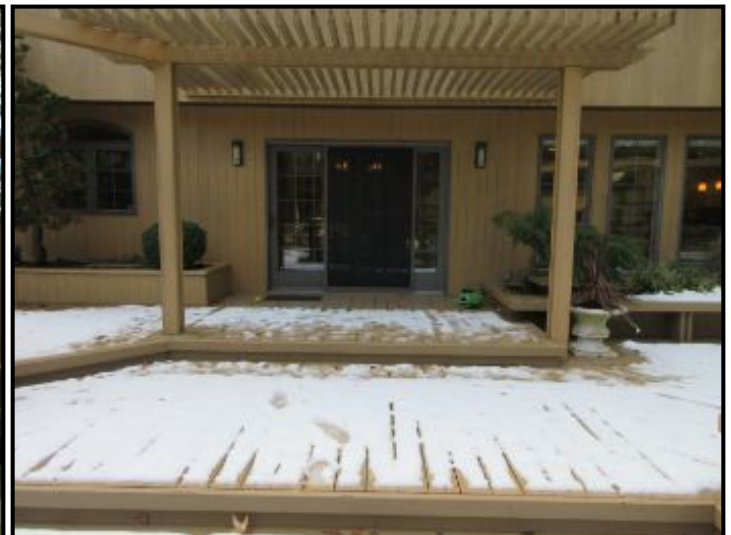
DECK AREA Deck General

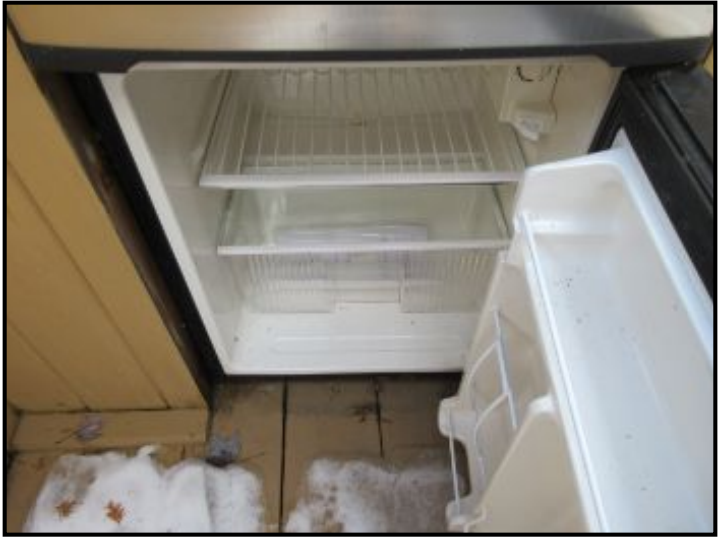
Mini-fridge at barbecue station was not powered/operating; appeared fairly new and unused. Recommend requesting seller to confirm the completion of mini-fridge installation.

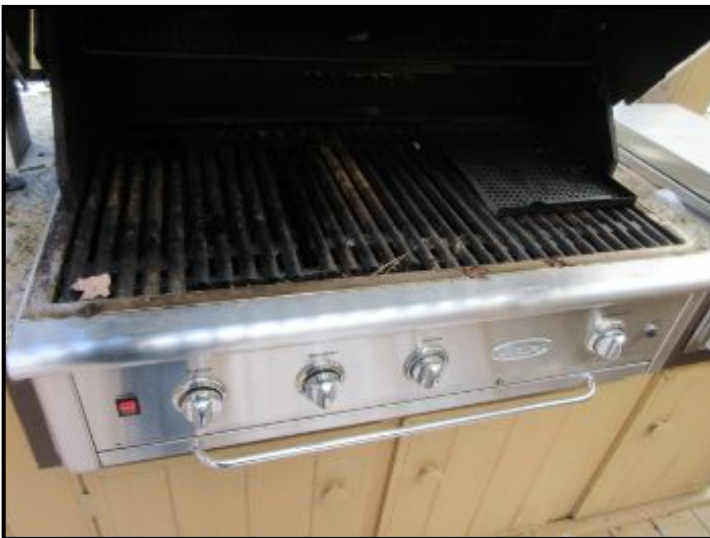
Barbecue left burner did not light via igniter; suggest maintenance be performed to verify all burner operation.

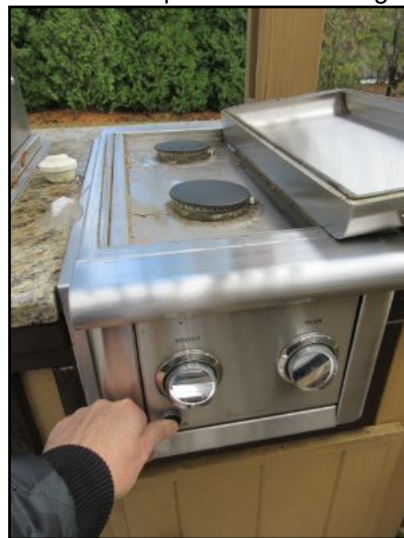
Barbecue hot plate burners were inoperable; igniter didn't appear to work. Suggest repair.

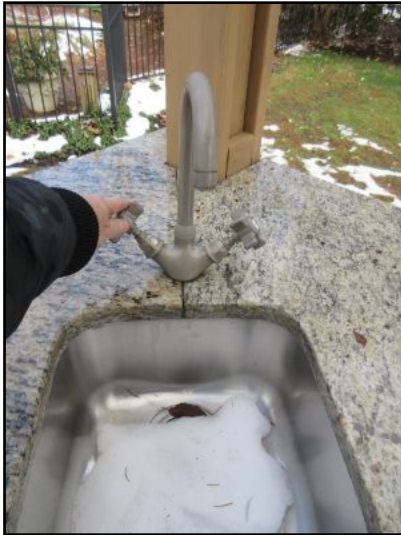
Bar sink turned off; winterized; unable to test.

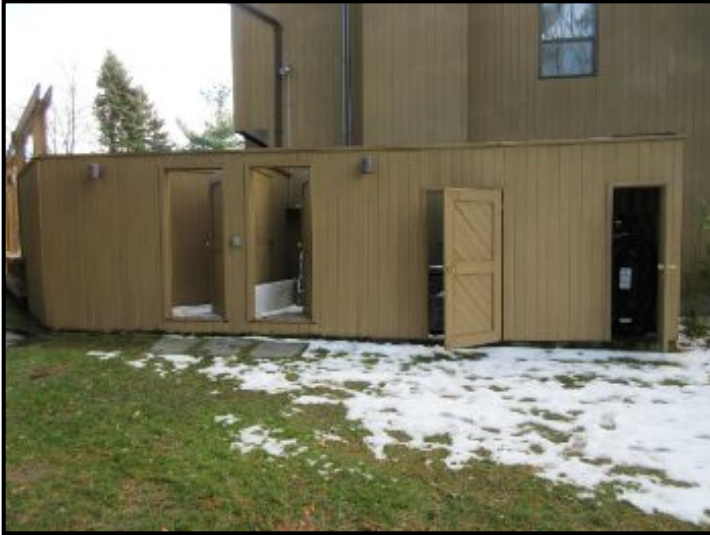
- Outdoor shower was turned off at time of inspection (winterized perhaps); unable to test. • Pool filter winterized, piping disconnected and pump removed. System/operation unknown. We recommend contacting a qualified pool service technician for evaluation upon seasonal start-up.
- In this situation, the Inspector recommends that the seller warrant the operational status of the filtration system on an one-time start-up basis when warmer weather allows.
- Pool not inspected. Recommend seller allowing for a qualified pool contractor inspect the pool liner for possible defects caused by ground settlement.
- Door at outdoor shower did not latch; suggest hardware repair.

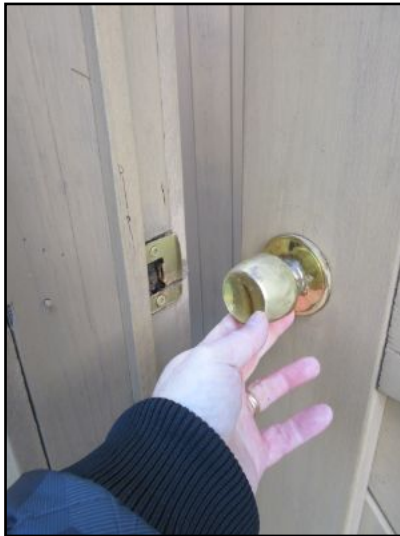
Door at outdoor shower did not latch; suggest hardware repair.

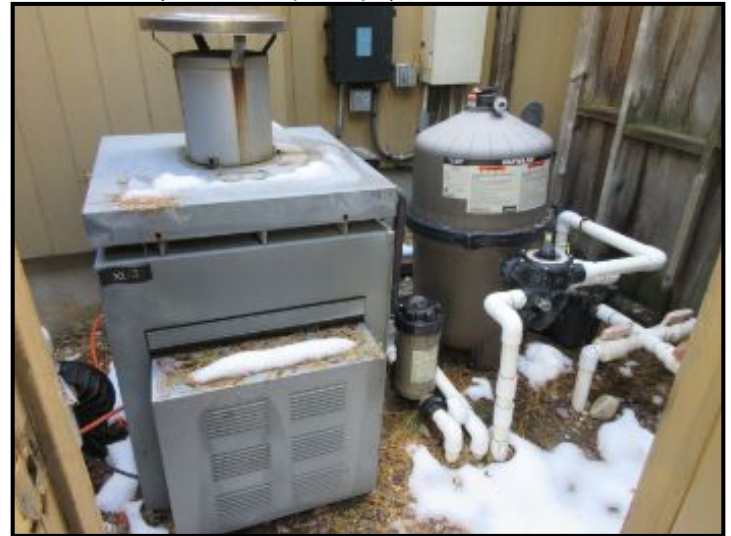
Pool heater, filter, pump/s and piping were winterized; unable to test.

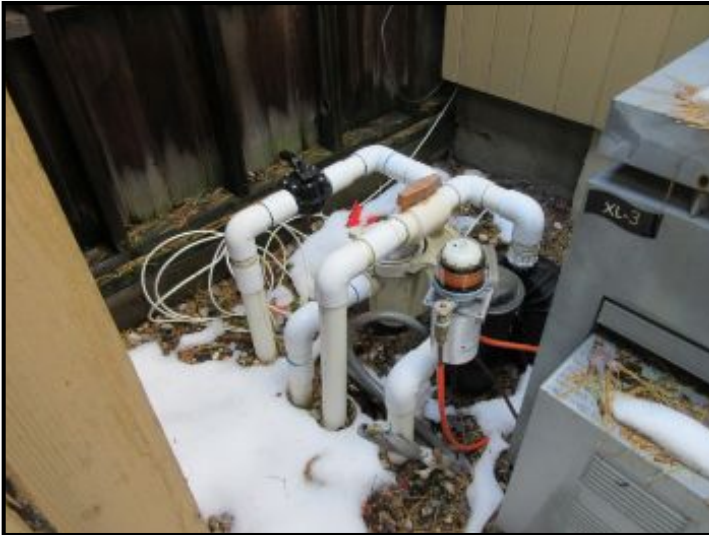
No apparent cracks that would cause leakage in the PVC piping, however piping was drained at time of inspection.

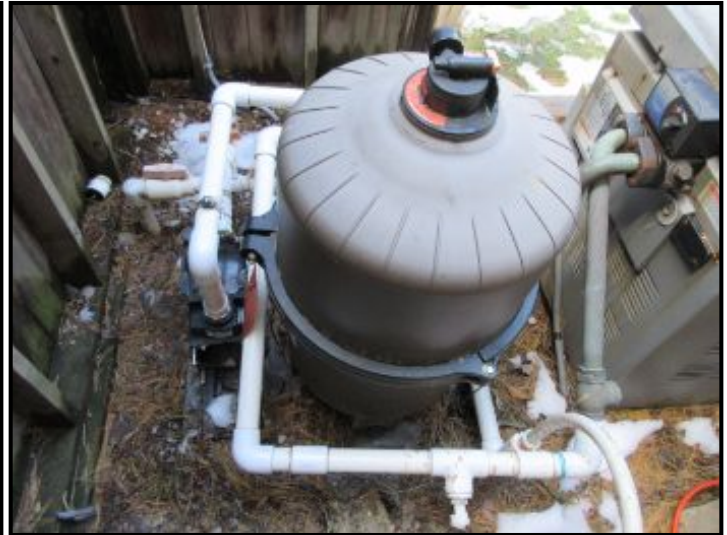
Pool filter appeared generally to be in serviceable condition at the time of the inspection, however was shut-down, winterized and could not be tested at time of inspection.

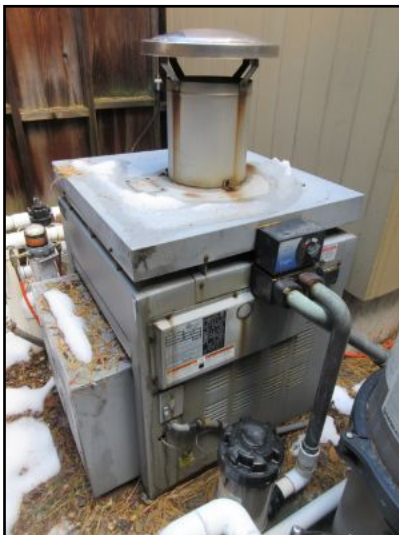
Oil-fired Pool heater generally appeared to be in serviceable condition at the time of the inspection, however was shut-down, winterized and could not be tested at time of inspection.

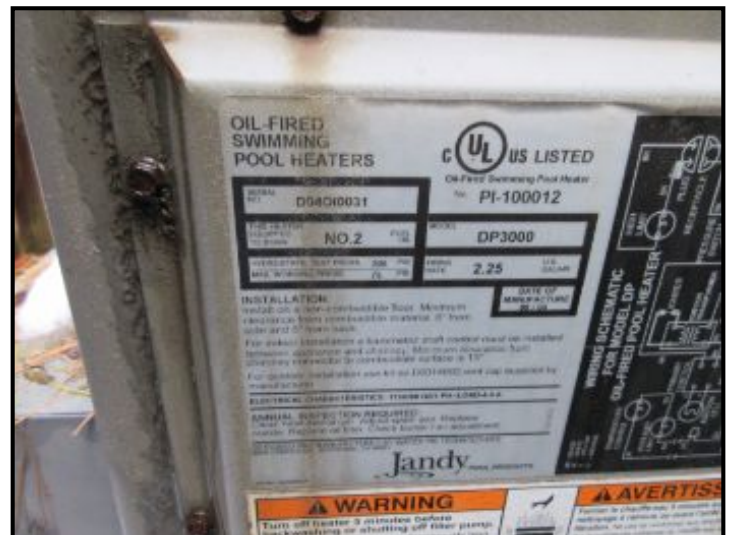
Jandy Pool Heater data plate/serial no. indicates a manufacture date of 9/2004, (9 yrs old).

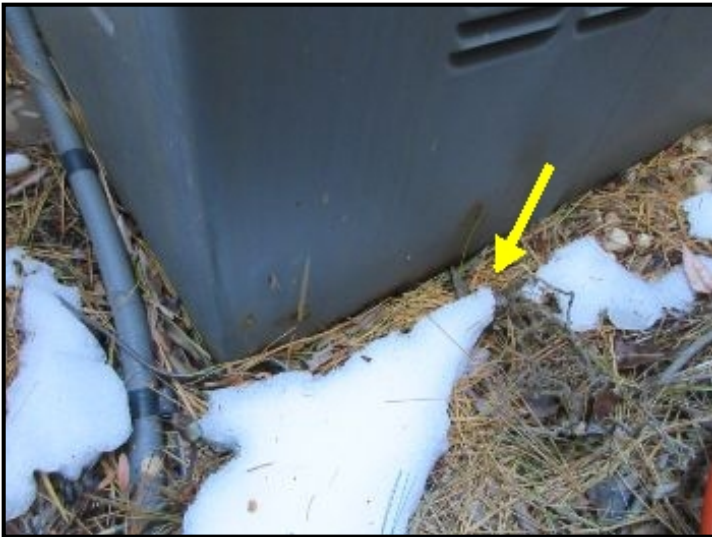
Recommend lowering soil level to prevent contact with pool heater metal casing to prolong the life of the unit.

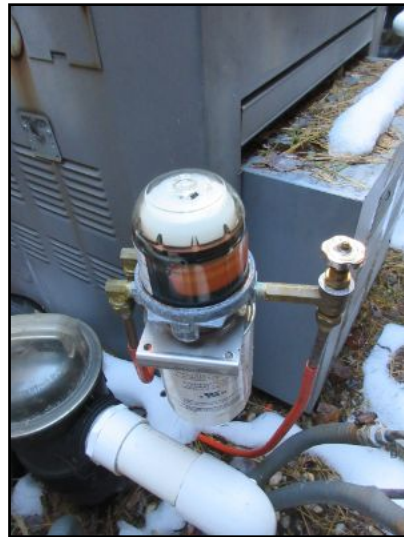
Oil shut-off valve and filter located at burner.

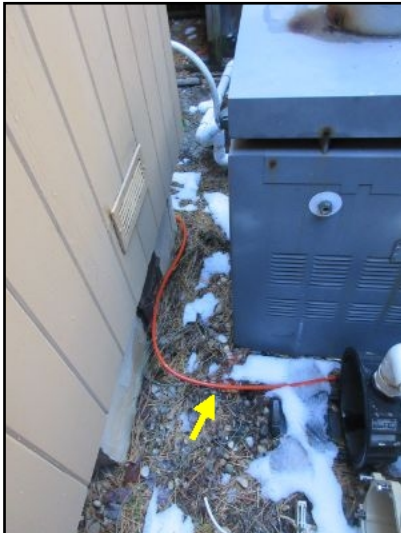
New fuel line from new above ground oil tank.
