ProSpec Home Inspection of Long Island Property Inspection Report

Inspector: Russell Classi, P.E.
License #16000077480
Phone: (516) 580-1848
Email: ProSpecofLI@gmail.com
www.NassauProfessionalHomeInspector.com

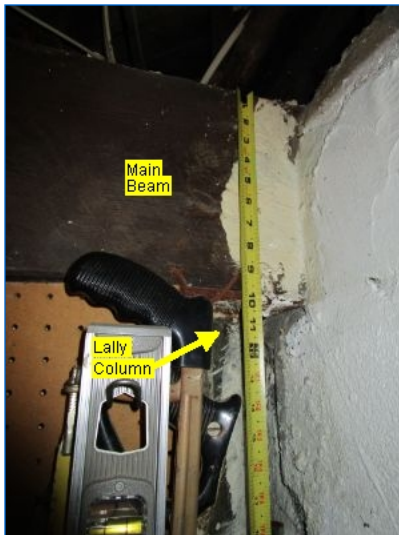
Main Floor Structure: Wood main beam supported by steel lally columns, 2x10 Joists 16" O.C., T&G floor boards.

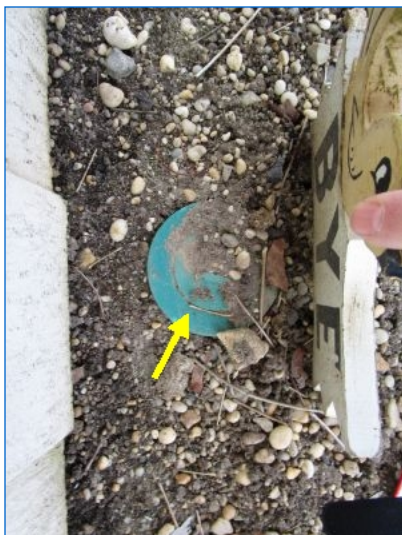
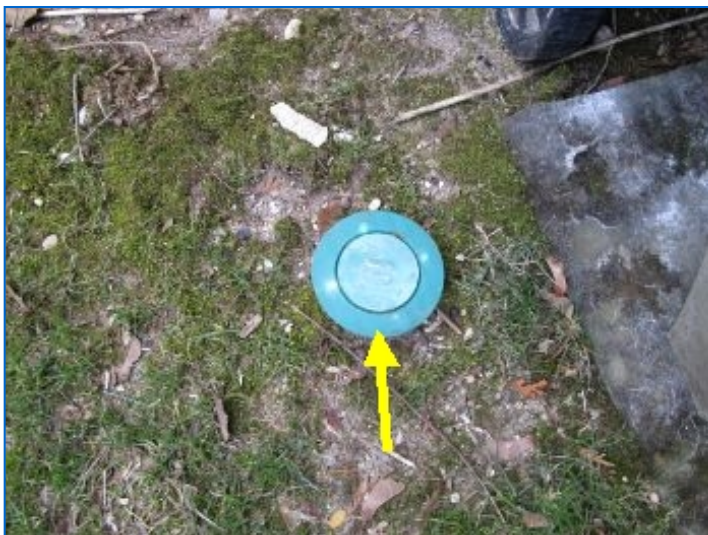
Previous Termite Treatment noted; Bait Stations observed at the perimeter of the structure. Refer to attached NPMA-33 report form.

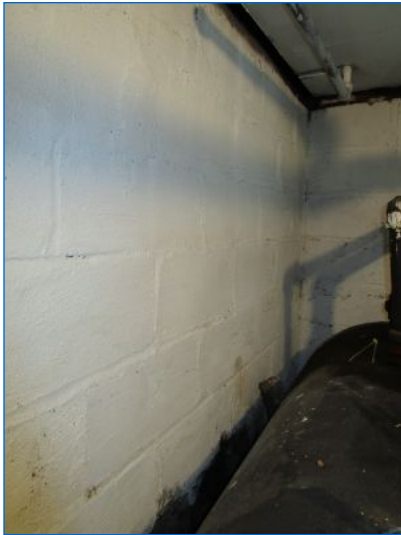
No evidence of moisture intrusion was observed at the visible portions of the foundation walls at the time of inspection.

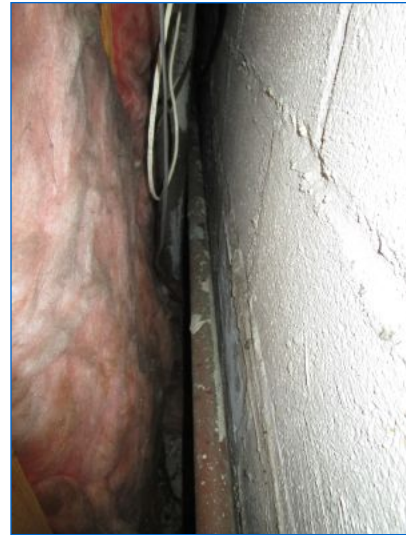
No evidence of moisture intrusion was observed at the visible portions of the foundation walls at the time of inspection.

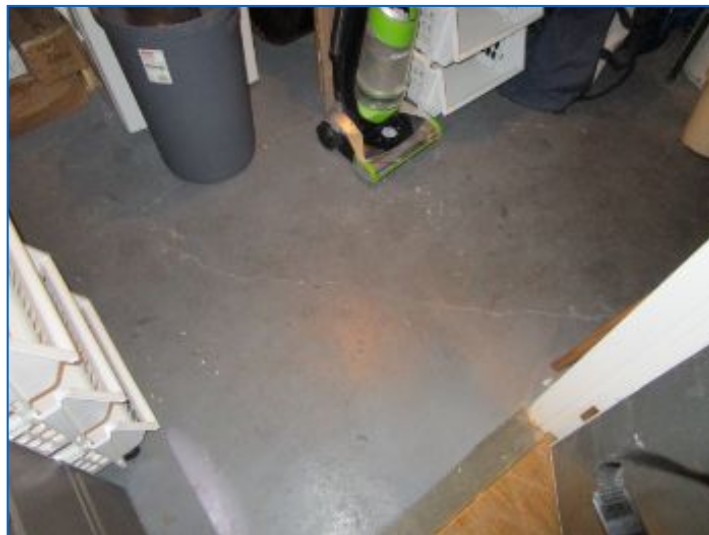
No significant deficiencies observed in the condition of the visible portions of the concrete floor slab at time of inspection -
- In normal condition for its age.

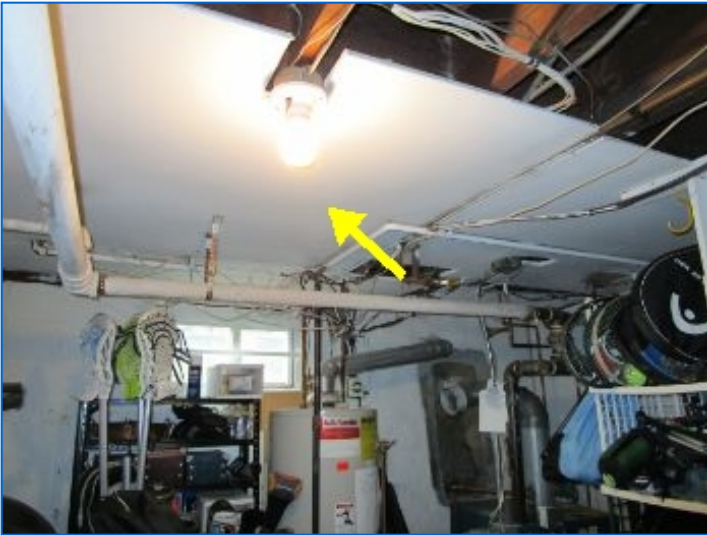
Boiler room ceiling was largely covered.

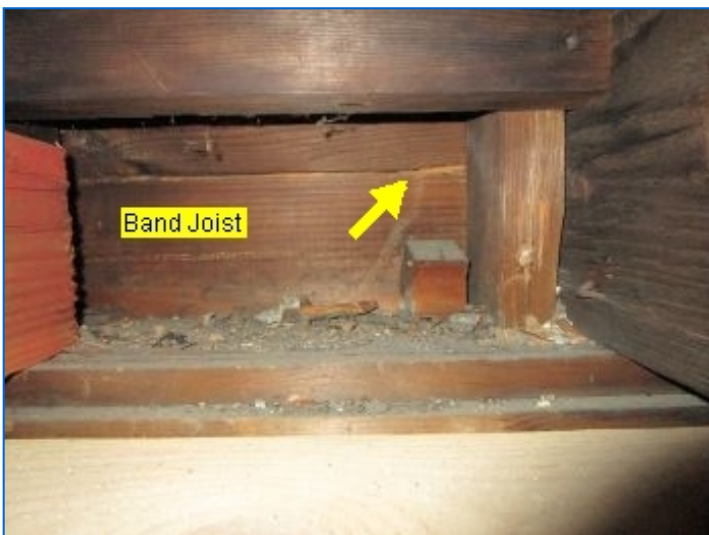
Signs of past termite damage was observed at floor joists, band joist and blocking above basement office at south wall above office in basement. Floor joist repairs were noted. Refer to NPMA-33 Report.

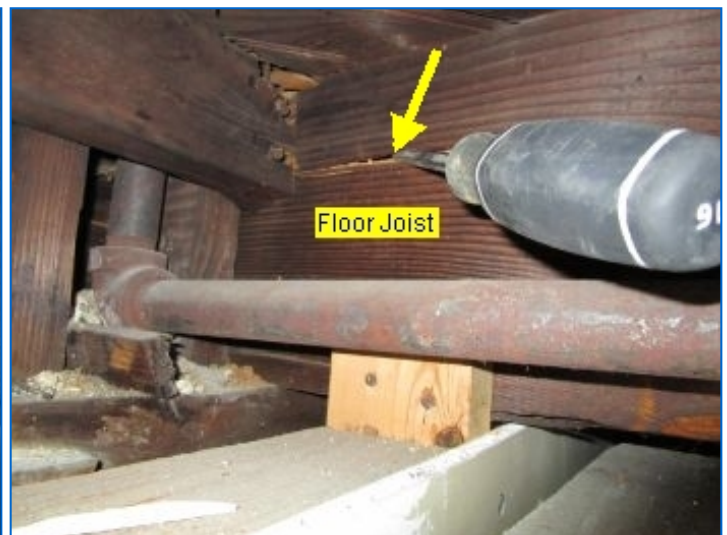
Signs of past termite damage was observed at floor joists, band joist and blocking above basement office at south wall above office in basement. Floor joist repairs were noted. Refer to NPMA-33 Report.

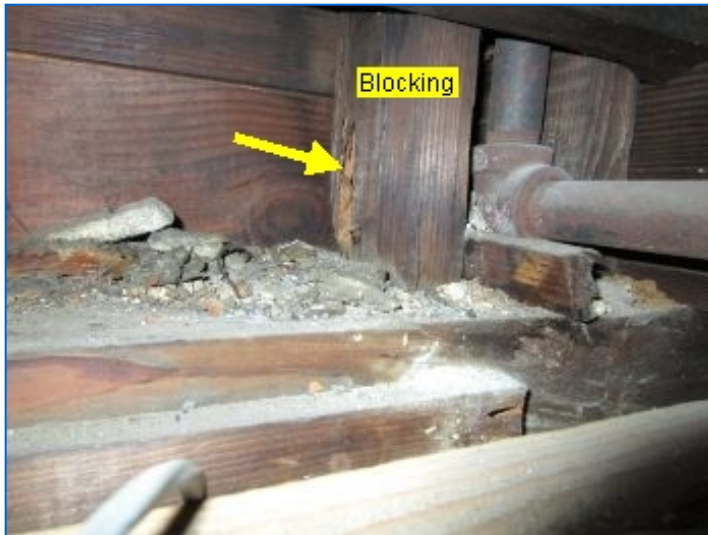
Signs of past termite damage was observed at floor joists, band joist and blocking above basement office at south wall above office in basement. Floor joist repairs were noted. Refer to NPMA-33 Report.

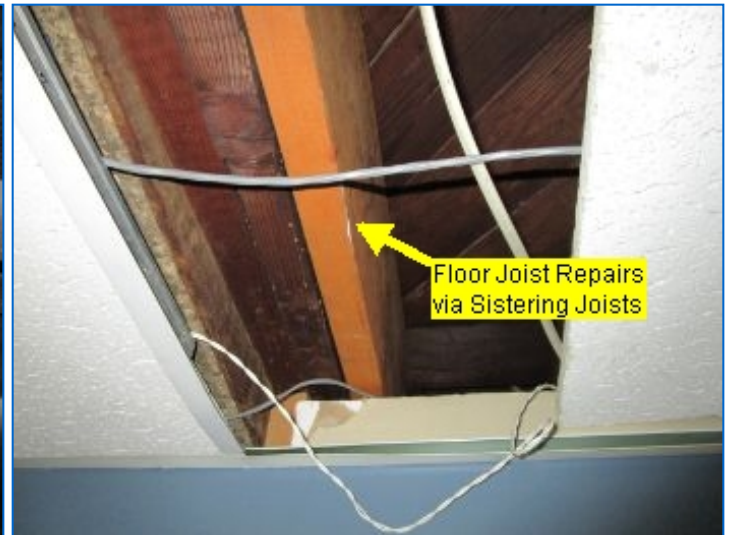
Signs of past termite damage was observed at floor joists, band joist and blocking above basement office at south wall above office in basement. Floor joist repairs were noted (2 places). Refer to NPMA-33 Report.

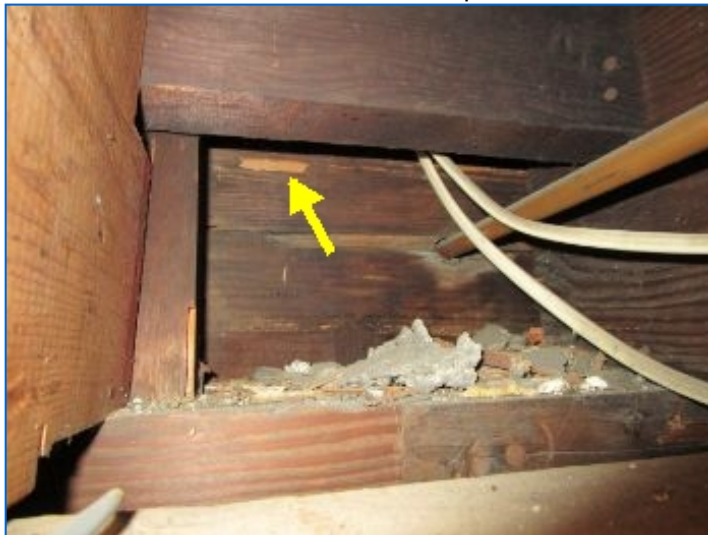
Signs of past termite damage was observed at floor joists, band joist and blocking above basement office at south wall above office in basement. Floor joist repairs were noted (2 places). Refer to NPMA-33 Report.

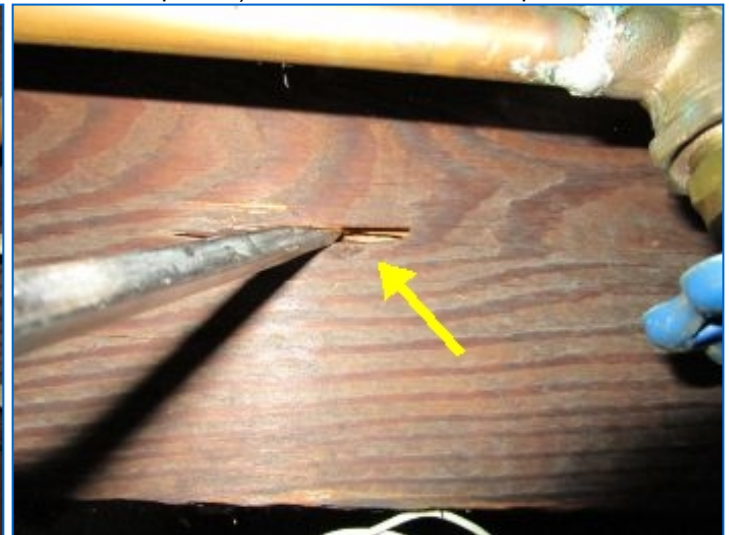
Signs of past termite damage was observed at floor joists, band joist and blocking above basement office at south wall above office in basement. Floor joist repairs were noted (2 places). Refer to NPMA-33 Report.

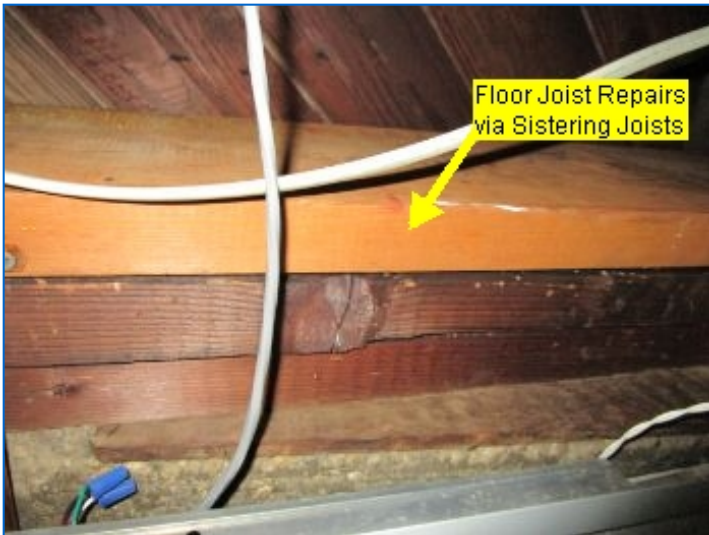
Signs of past termite damage was observed at floor joists, band joist and blocking above basement office at south wall above office in basement. Floor joist repairs were noted (2 places). Refer to NPMA-33 Report.

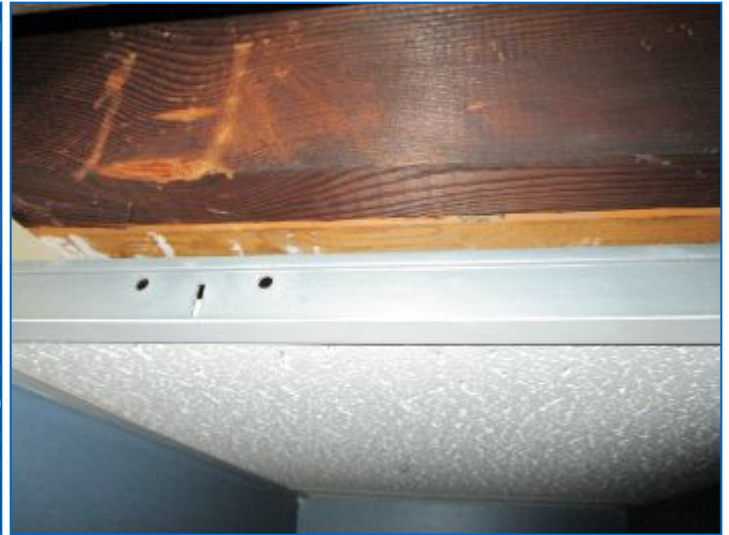
Signs of past termite damage was observed at floor joists, band joist and blocking above basement office at south wall above office in basement. Floor joist repairs were noted (2 places). Refer to NPMA-33 Report.

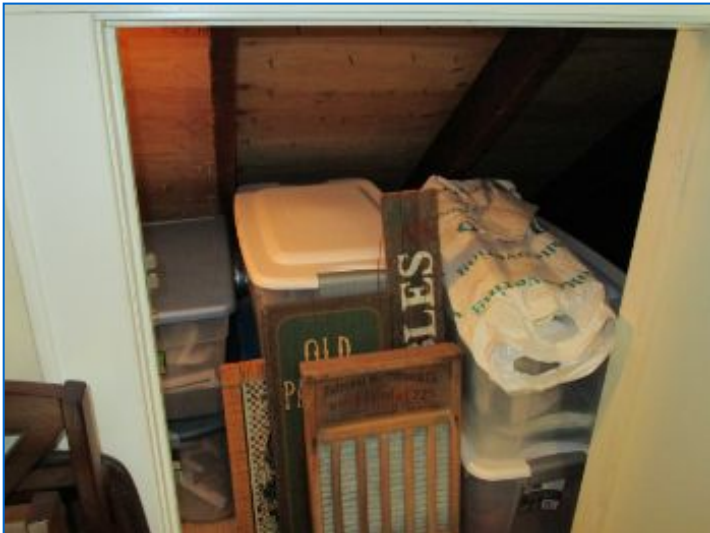
Moderate storage was noted in the attic eave spaces at time of inspection.

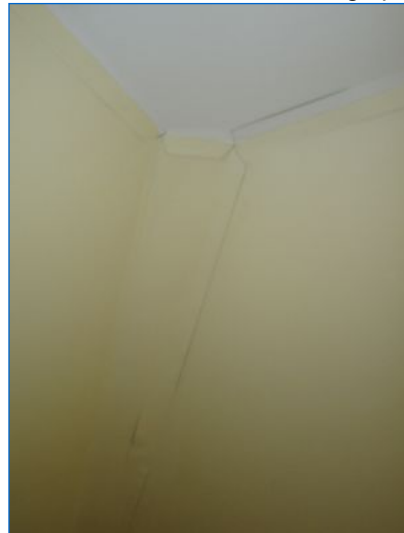
Cosmetic deficiencies noted at ceiling taped joints caused by temperature variances occurring over time.

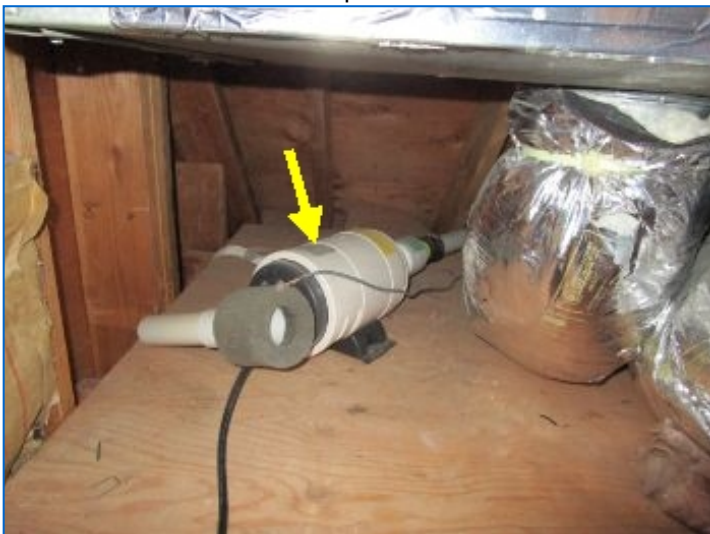
Air pump located in attic eave space; for master bath whirlpool.

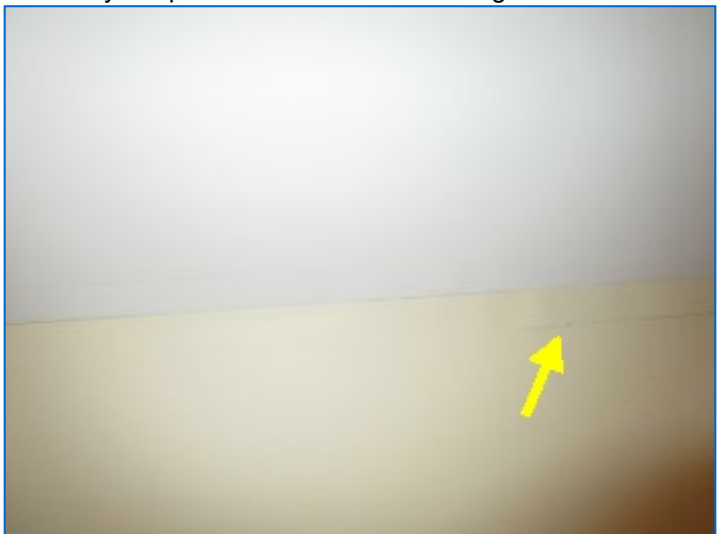
Cosmetic deficiencies noted at ceiling taped joints caused by temperature variances occurring over time.

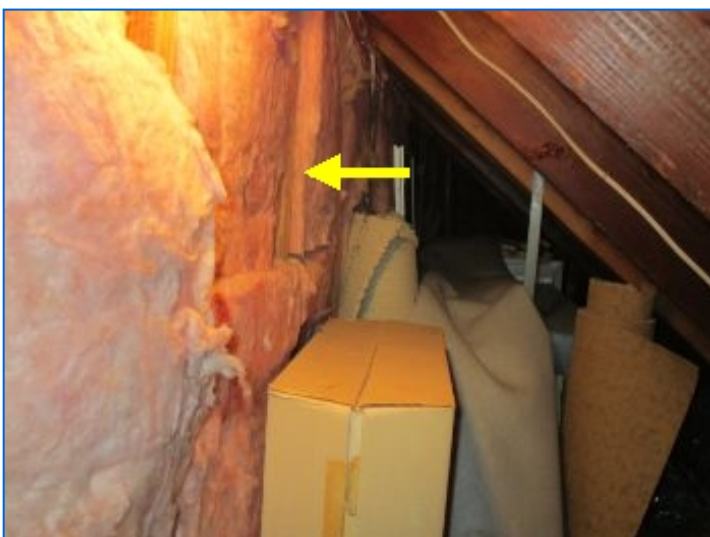
Insulation installed in knee wall cavities.

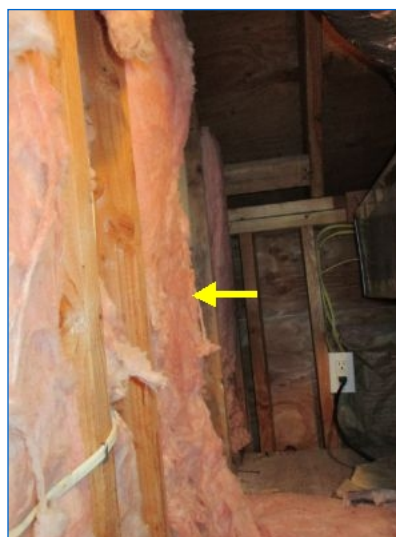
Insulation installed in knee wall cavities.

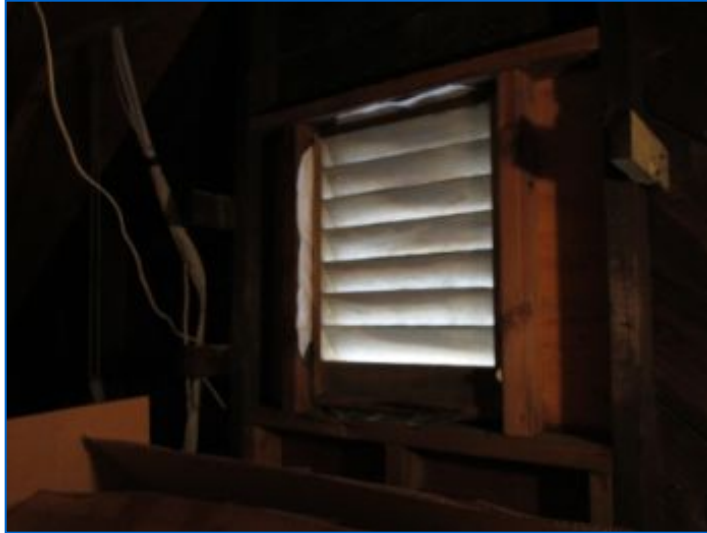
Attic (unfinished spaces) appeared to be adequately ventilated.

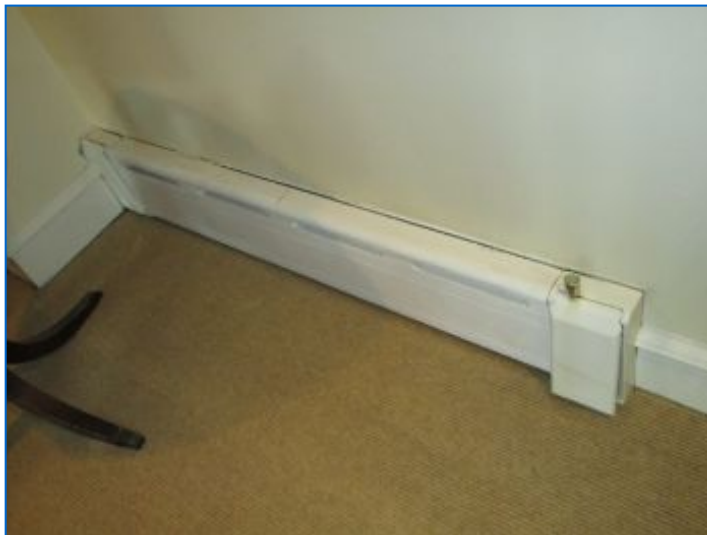
Baseboard cast iron radiators noted

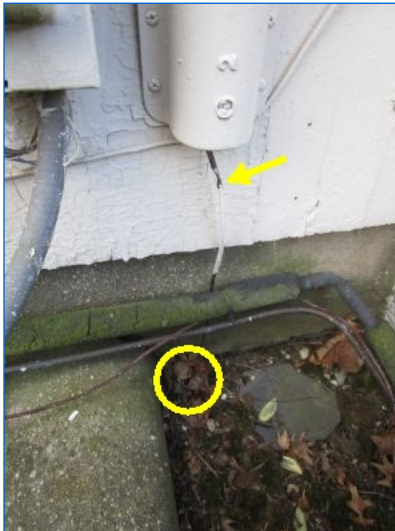
Grounding Rod and cable connection noted at service entrance.

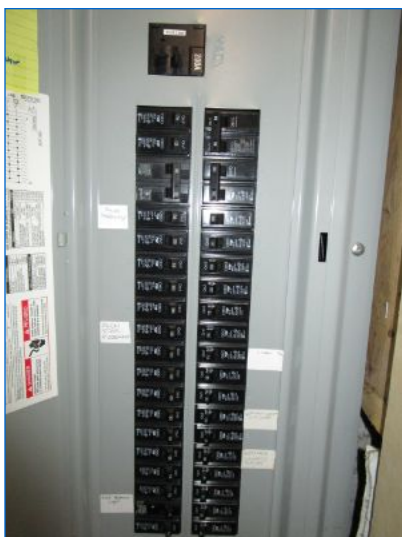
Main Panel: 40 circuit breaker spaces; 0 spare breaker space(s) noted.

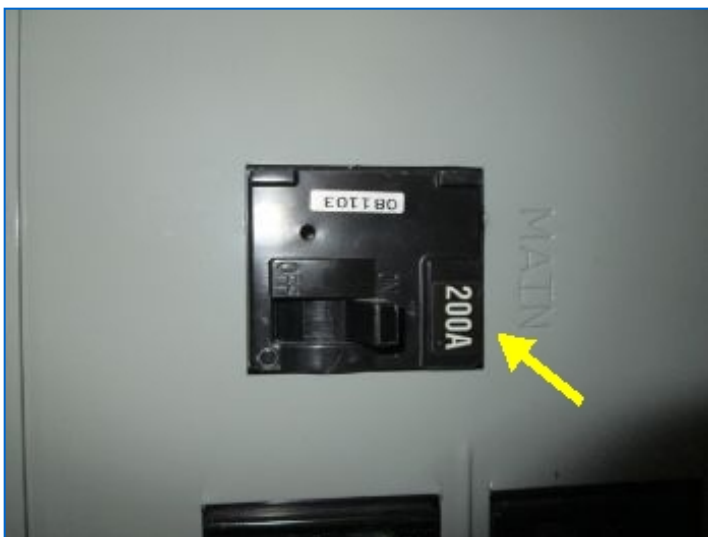
Main Disconnect: 200 amp main breaker serves the property.

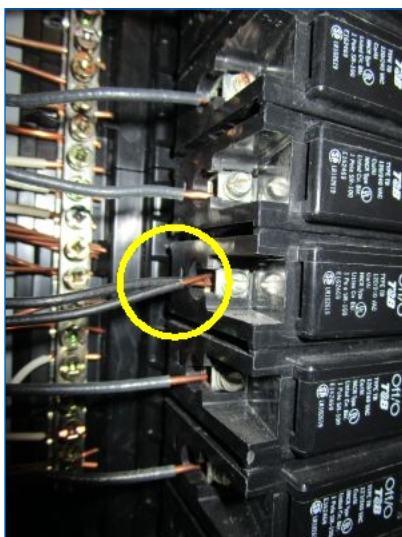
Double Tapped Breaker/s observed inside panel box (more than one electrical conductor attached). This is not standard practice, and may cause overheating or even an electrical fire. Recommend evaluation by a licensed electrician.

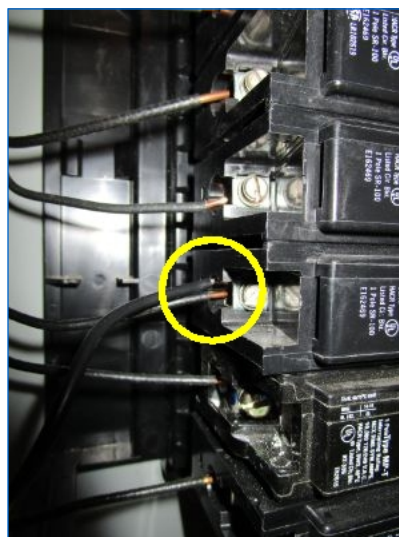
Double Tapped Breaker/s observed inside panel box (more than one electrical conductor attached). This is not standard practice, and may cause overheating or even an electrical fire. Recommend evaluation by a licensed electrician.

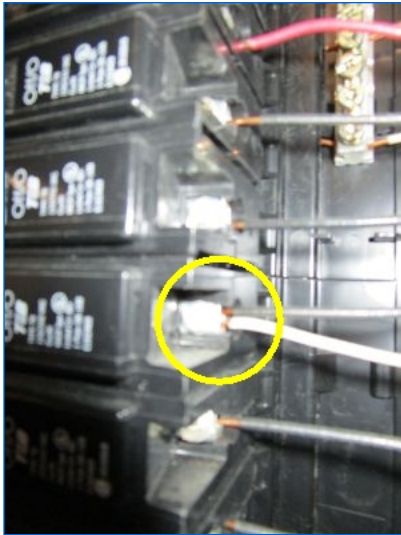
Double Tapped Breaker/s observed inside panel box (more than one electrical conductor attached). This is not standard practice, and may cause overheating or even an electrical fire. Recommend evaluation by a licensed electrician.

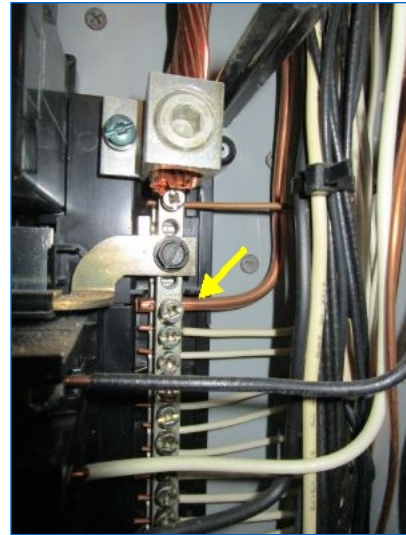
Neutral bus grounding observed. Suggest having electrician ensure that ground is continuous.

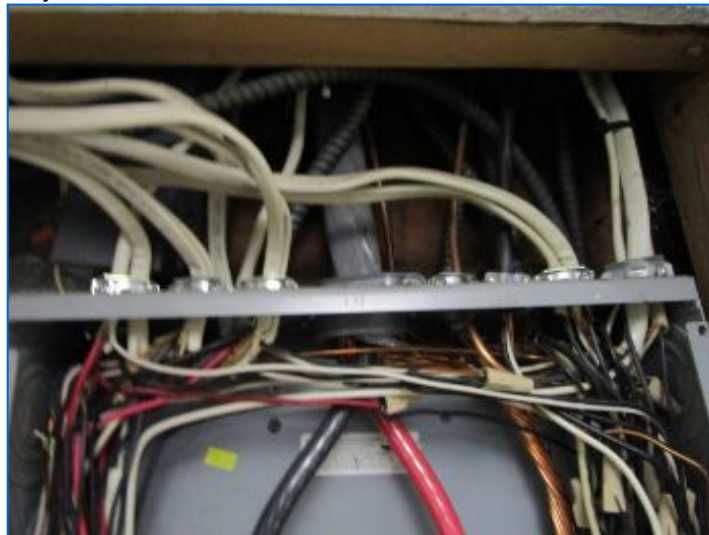
Distribution wiring observed consisted of copper, non-metallic and metallic armored cable.

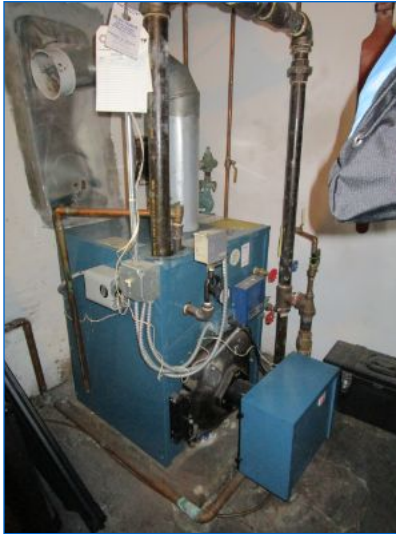
Heating Equipment located in Basement was operable.

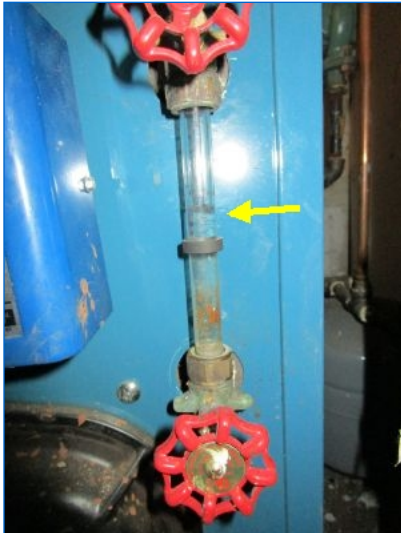
Check steam boiler water level periodically to ensure safe operation.

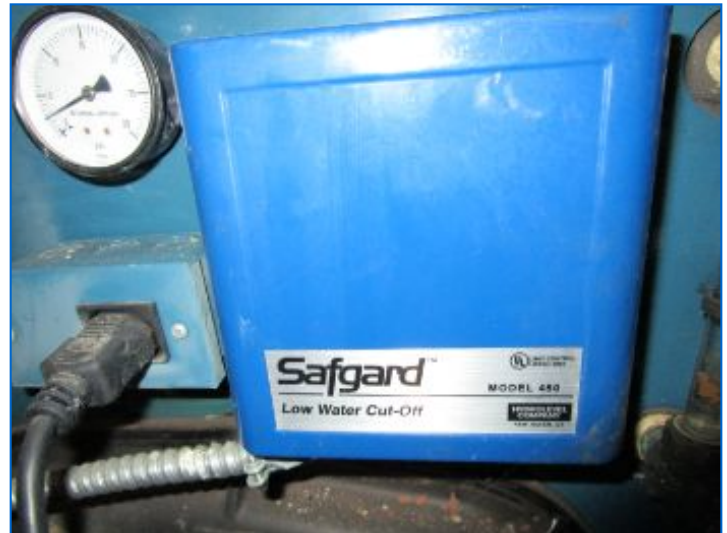
Low water cut-off noted.

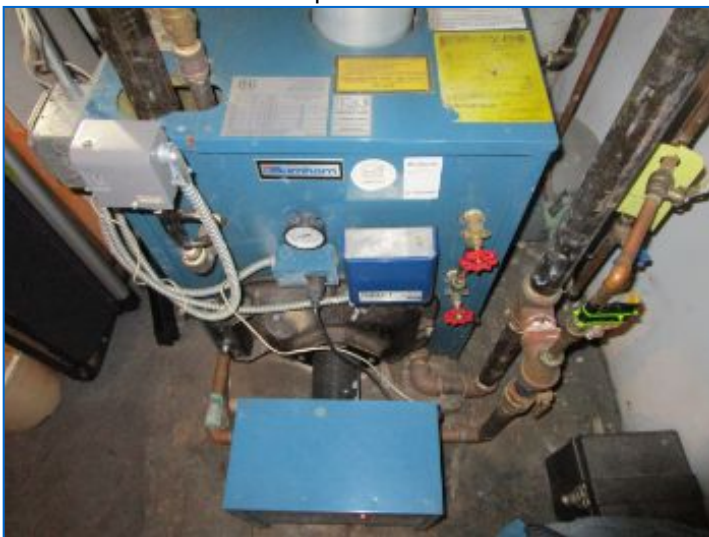
Service Tag Missing. Recommend annual inspection/maintenance be performed by a licensed HVAC contractor to ensure safe and efficient operation.

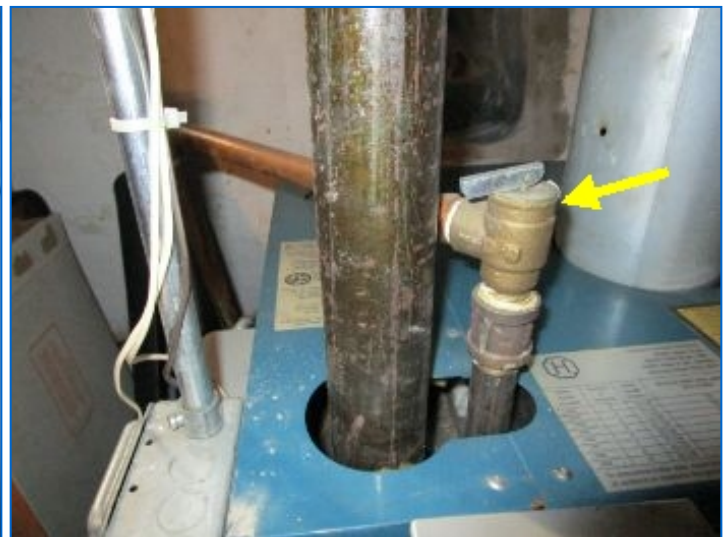
TPR (Temperature Pressure Relief) valve and discharge pipe show no deficiencies.

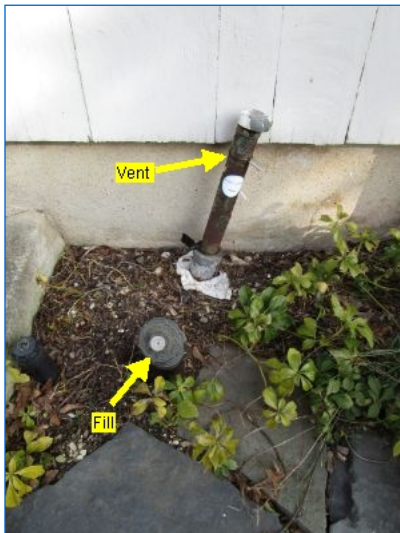
Oil tank fill cap and vent pipes located at the South exterior of the home.

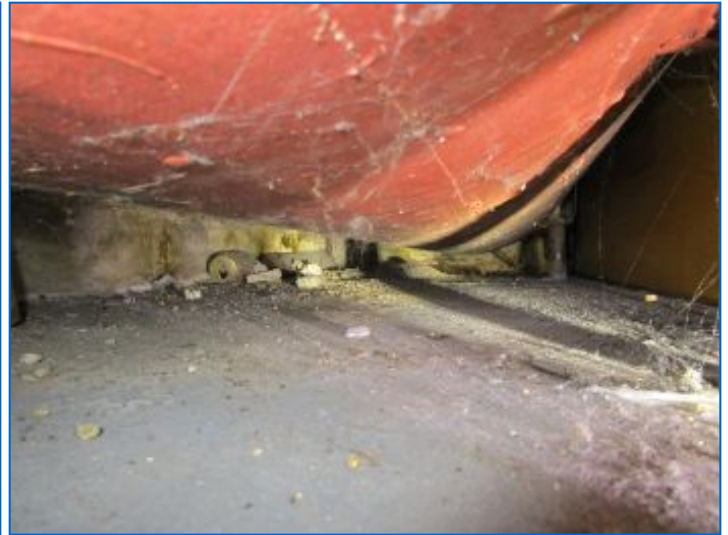
Oil tank showed no apparent signs of leakage at the visible portions of tank at time of inspection.

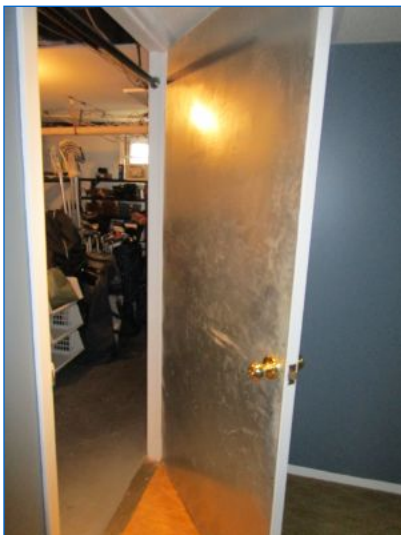
Boiler room door with sheet metal cover on interior noted.

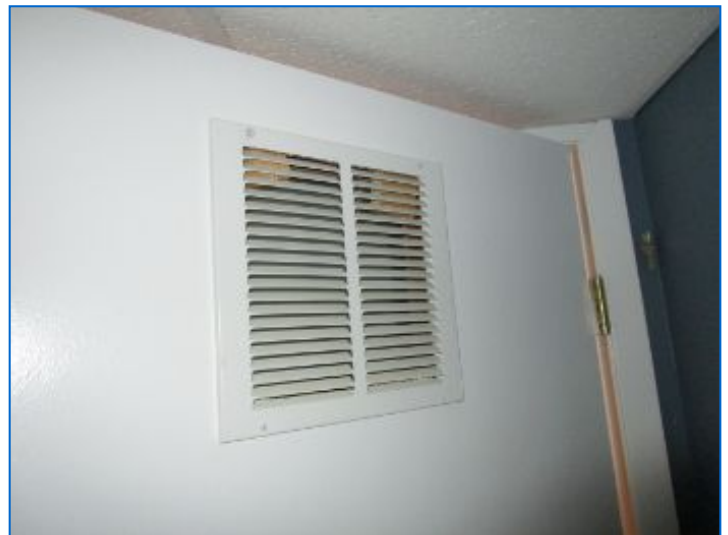
Boiler room door exterior grille was blanked off by sheet metal cover. See Combustion Air Venting notation.

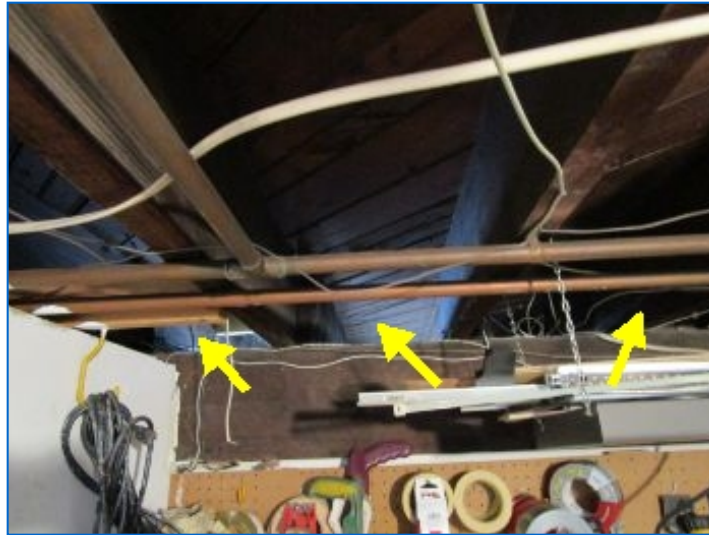
Combustion Air Venting: In this home, the fuel burning appliances are using indoor air for ventilation and combustion via ceiling space openings to boiler room and basement transfer grilles.

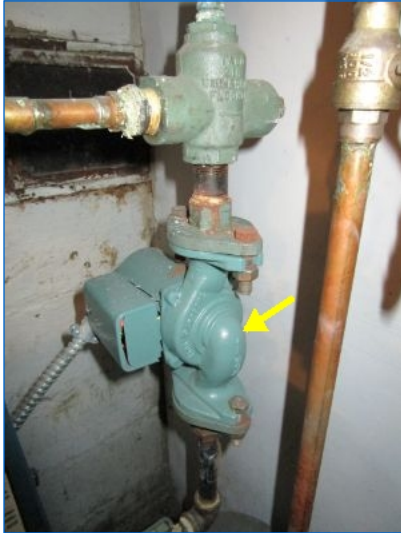
Integral tankless water heater being used for hydronic baseboard heating; utilizes a pump, separate zone for the Den.

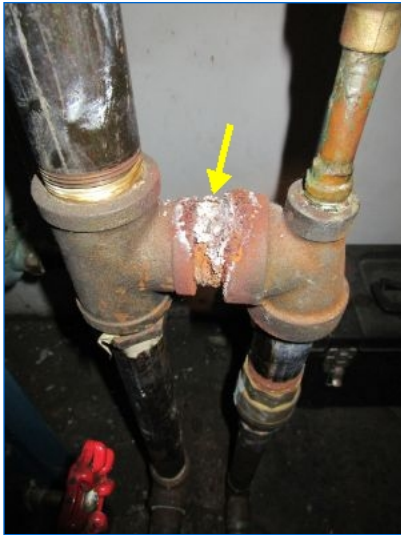
Deposits observed at heating pipe fittings; a sign of past leakage.

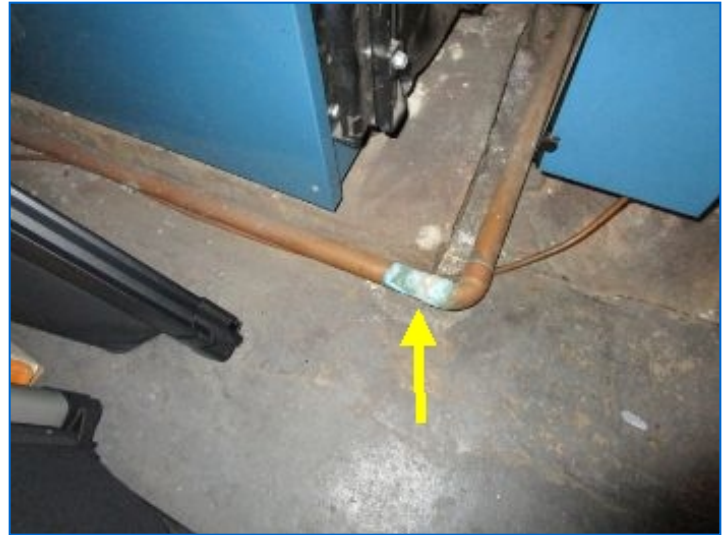
Deposits observed at heating pipe fittings; a sign of past leakage.

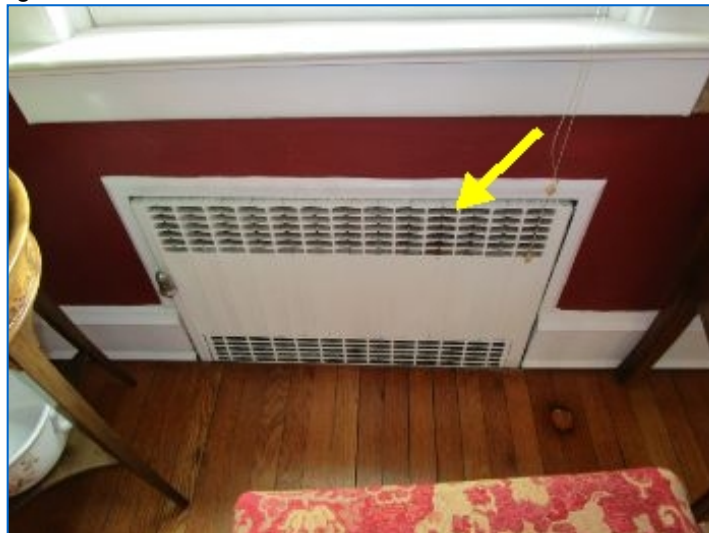
Heat distribution type/s included Radiators (cast iron).

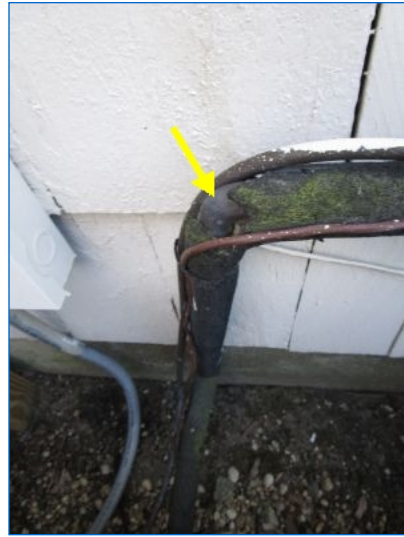
AC#1 outdoor refrigerant pipe insulation was deteriorated/missing at outdoor condenser. Recommend replacing outdoor deteriorated/missing insulation for the larger suction line.

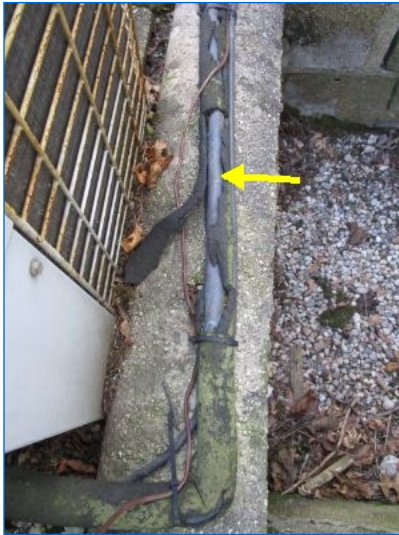
AC#2 outdoor refrigerant pipe insulation was deteriorated/missing at outdoor condenser. Recommend replacing outdoor deteriorated/missing insulation for the larger suction line.

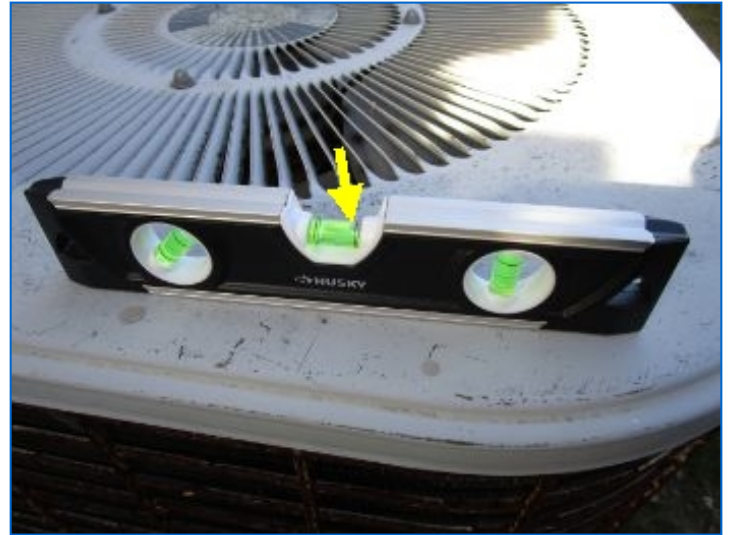
AC#2 Condenser was not level; this can shorten motor life. Suggest leveling mounting pad or unit itself.

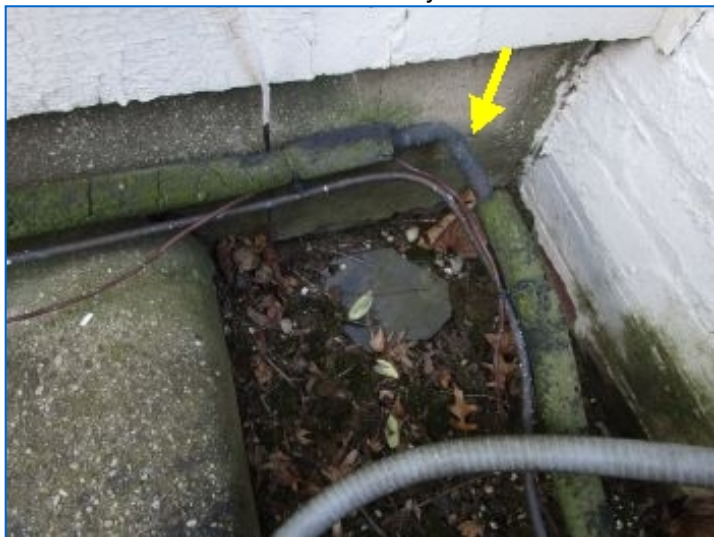
AC#3 outdoor refrigerant pipe insulation was deteriorated/missing at outdoor condenser. Recommend replacing outdoor deteriorated/missing insulation for the larger suction line.

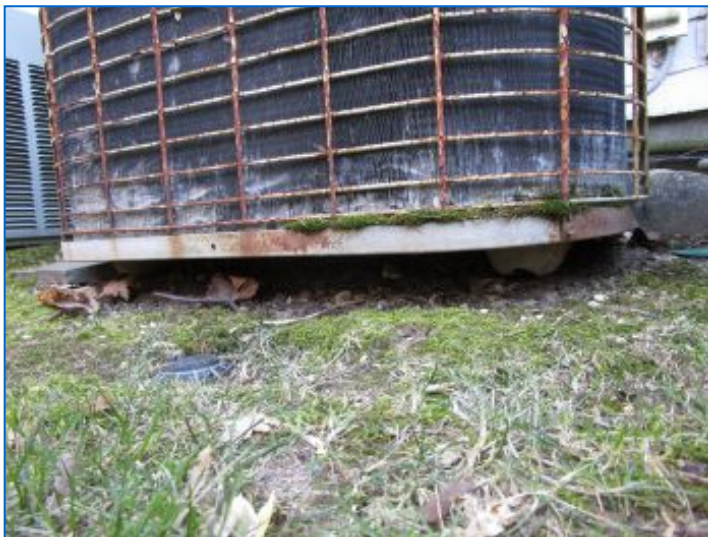
AC#2 Outdoor condenser coil aluminum fins were bent and dirty; this will reduce performance and efficiency of the system. A qualified HVAC professional can comb fins straight and clean coil to improve A/C system performance and efficiency.

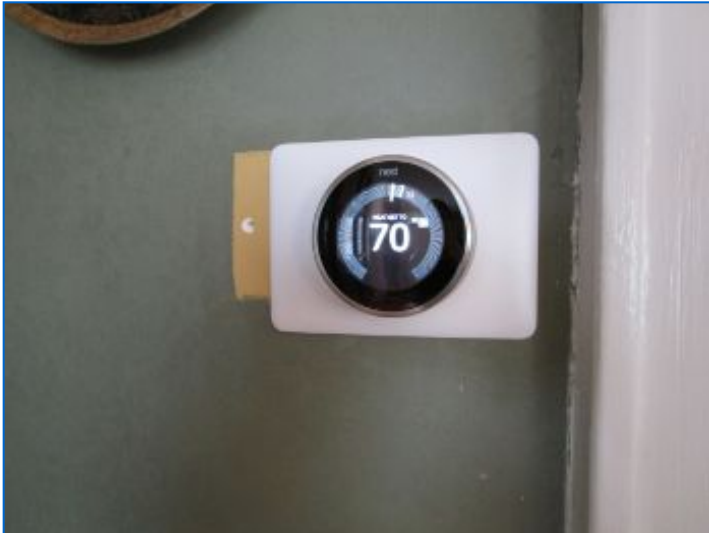
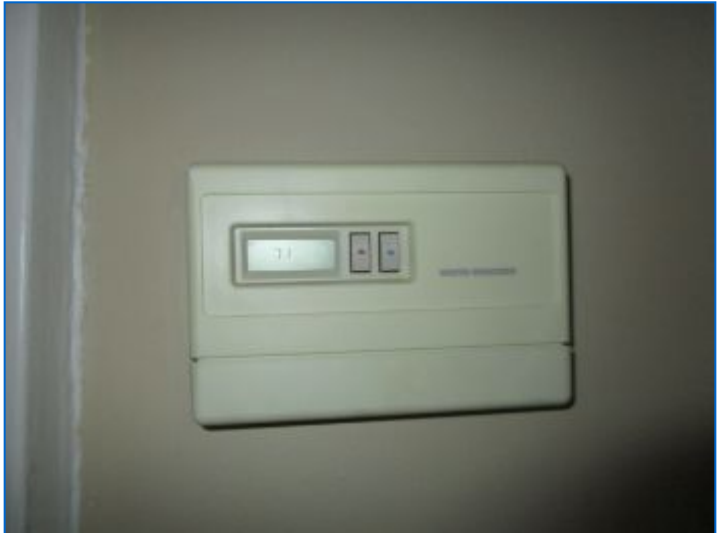
Digital Programmable type thermostat (Nest) noted in Dining room; Heating only, serves the 1st floor accept the Den.

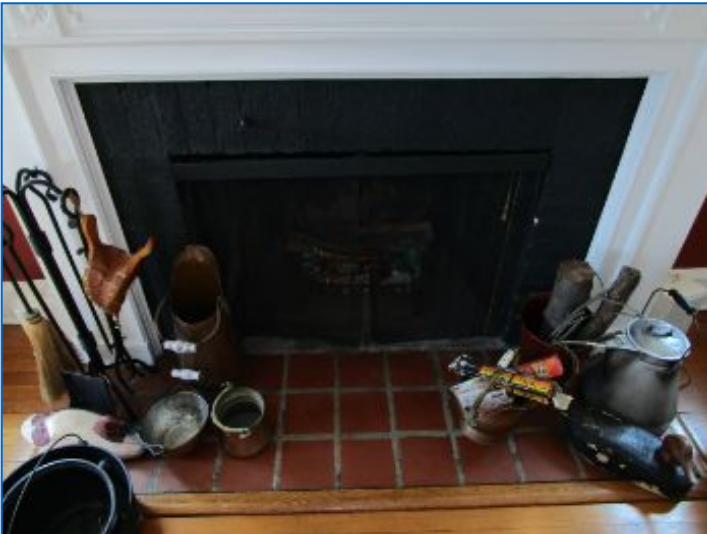
Wood burning fireplace in Living room on 1st floor. Fireplace enclosure was functional.

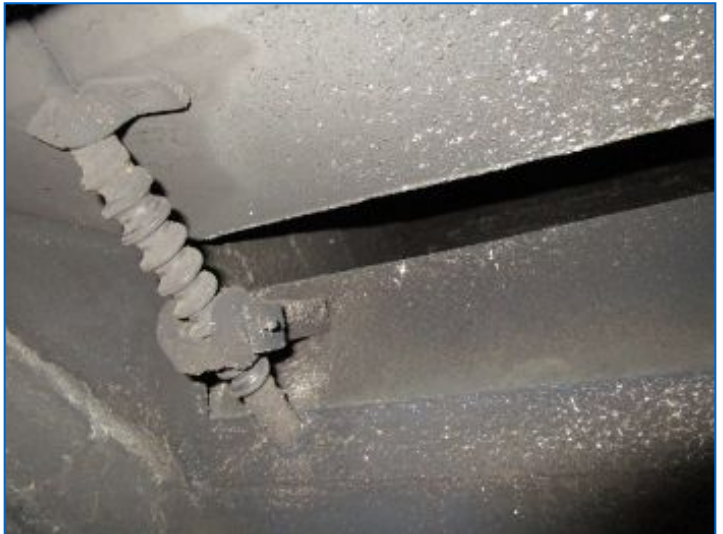
Damper was operable; opened and closed several times.

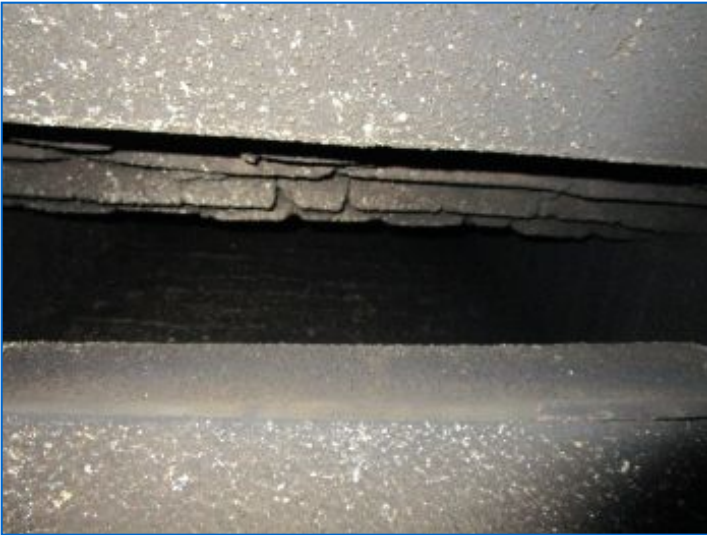
Signs of high usage noted based on the amount of soot at time of inspection. Recommend fireplace professional clean and further inspect the fireplace.

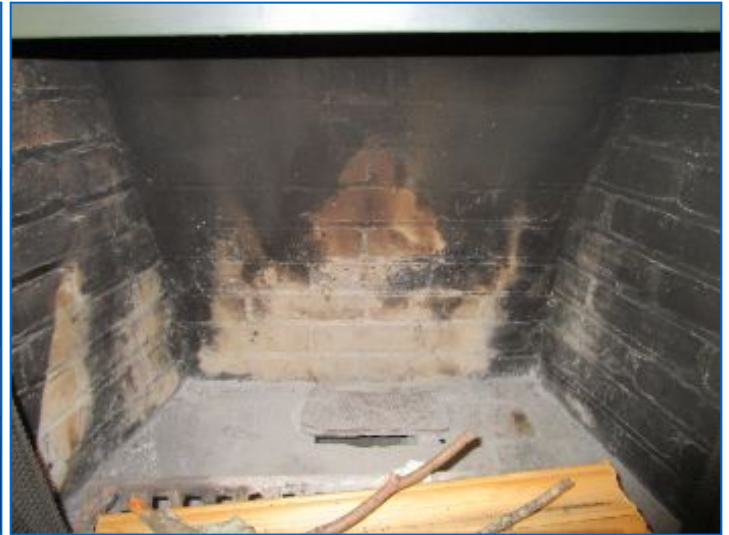
Signs of high usage noted based on the amount of soot at time of inspection. Recommend fireplace professional clean and further inspect the fireplace.

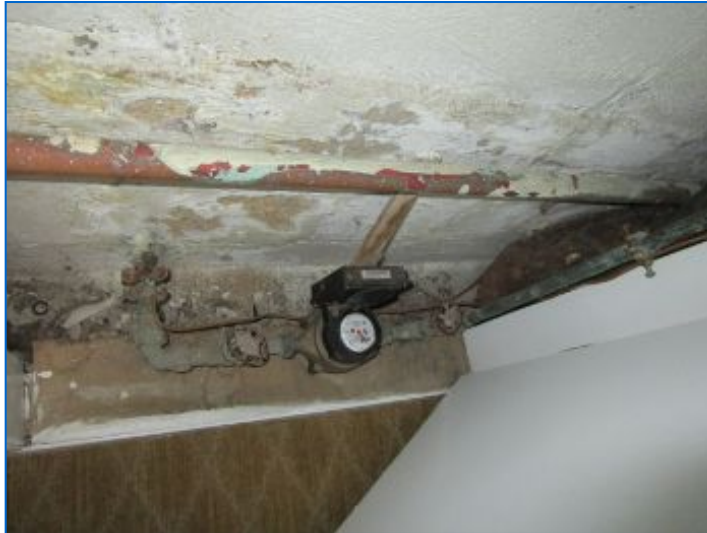
Water Service Entrance: 3/4" Copper line with Meter and shutoff valve/s. System Grounding: Ground wire connection/s noted at water main.

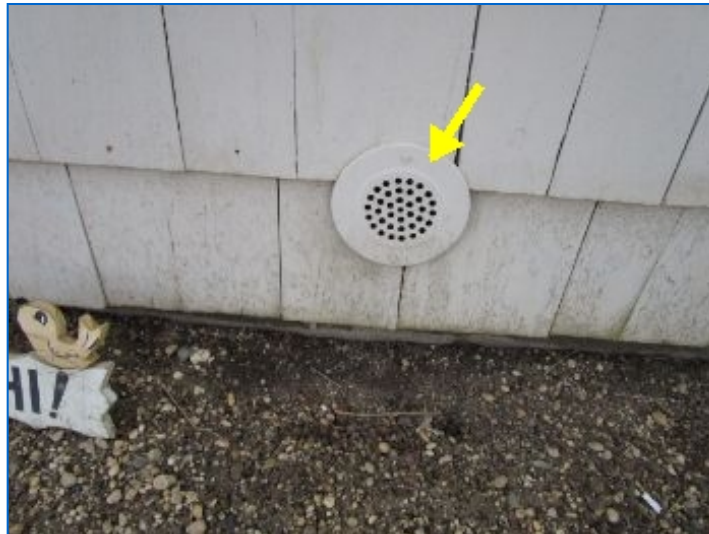
Vent for waste pipe exit noted at the rear of the home. Whole house trap was not visually accessible at time of the inspection. Request seller to identify exact location for visual access.

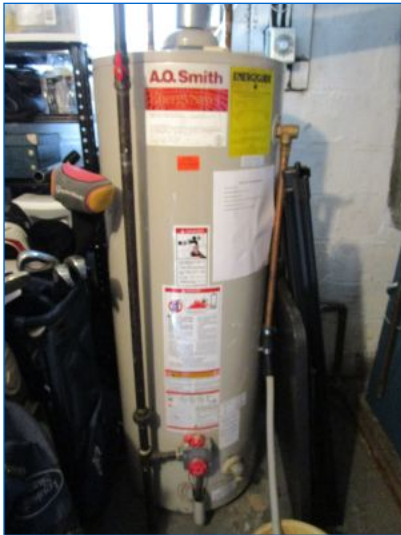
Gas, direct-fired water heater was operable.

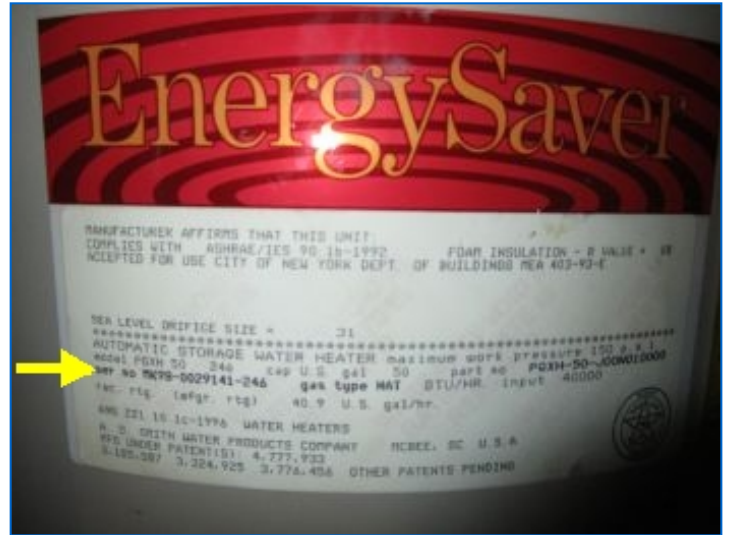
A.O. Smith 50 gallon capacity. Water Heater data plate/serial no. indicates a manufacture date of 10/1998 (20.8 yrs old).

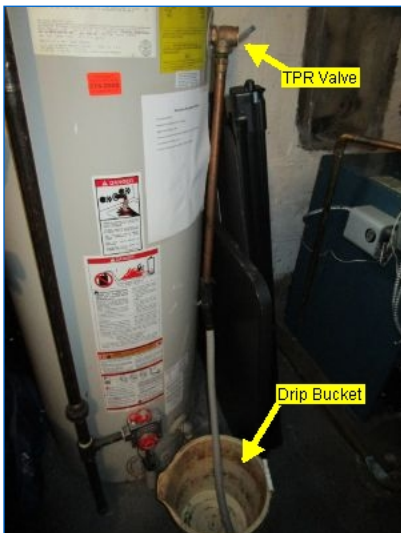
Temperature Pressure Relief (TPR) valve with extension pipe was noted to be dripping water into a bucket; suspect a defective TPR valve.

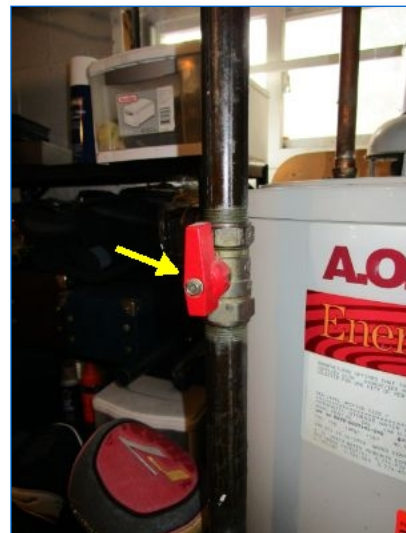
Gas supply shut-off valve and drip leg noted at water heater

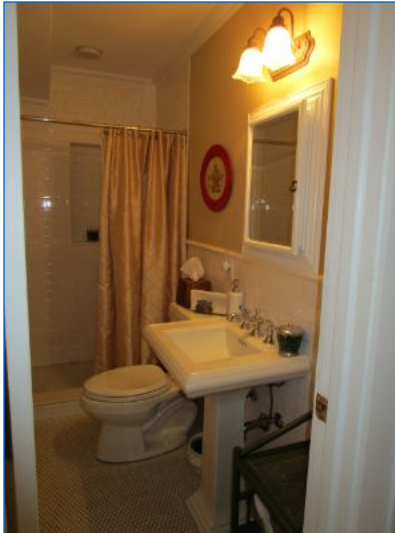
1st Floor Hall Bathroom

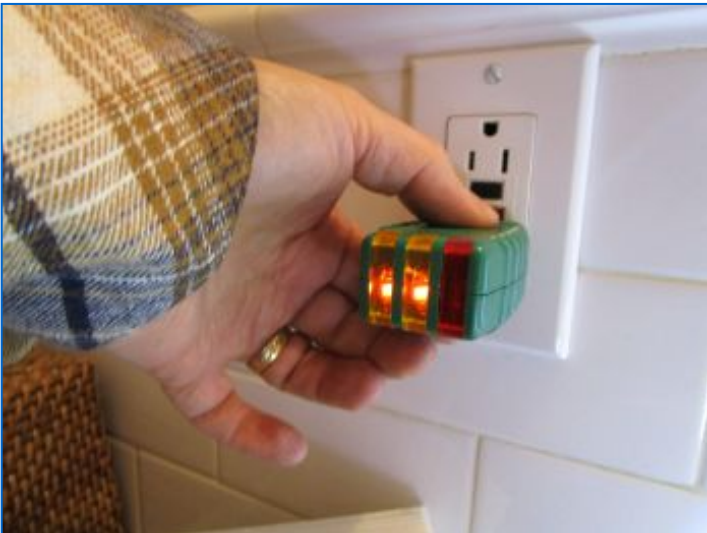
GFCI type receptacle did not trip when tested. Recommend rewiring/replacing GFCI receptacle.

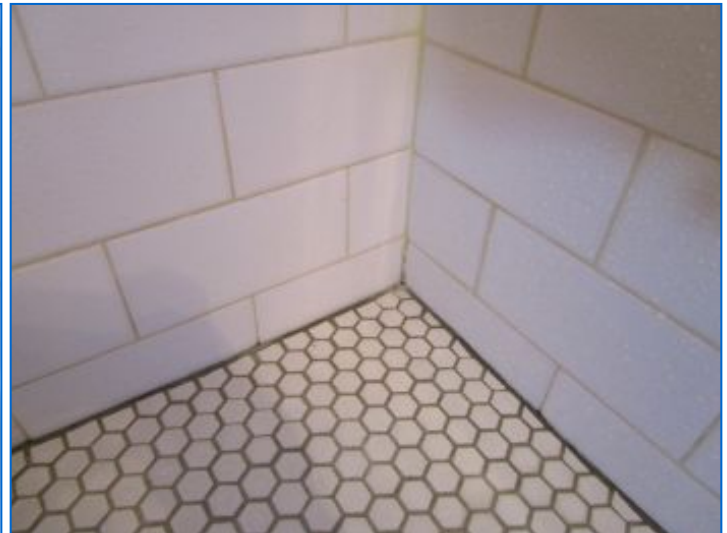
Shower wall corner grout (movement joint) is cracked. This is common; suggest replacing grout with matching silicone based sealant at corner movement joints.
