ProSpec Home Inspection of Long Island Property Inspection Report

Inspector: Russell Classi, P.E.
License #16000077480
Phone: (516) 580-1848
Email: ProSpecofLI@gmail.com
www.NassauProfessionalHomeInspector.com

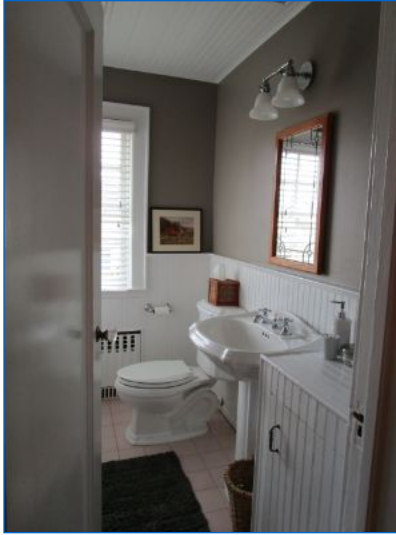
2nd Floor Hall Bathroom

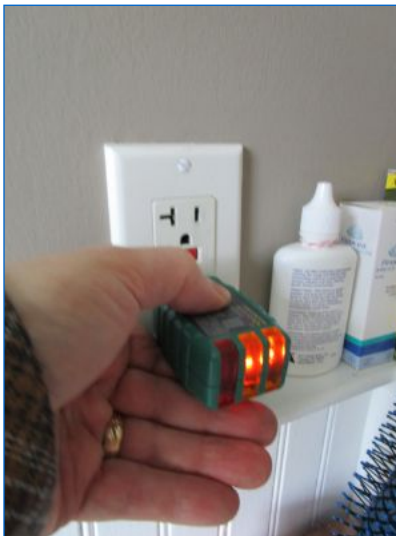
GFCI type receptacle did not trip when tested. Recommend rewiring/replacing GFCI receptacle.

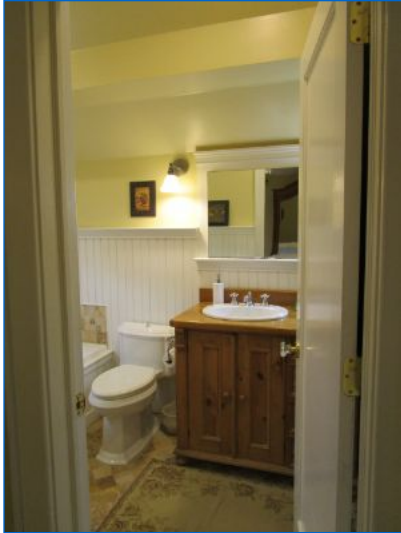
Master Bathroom - No defects noted.

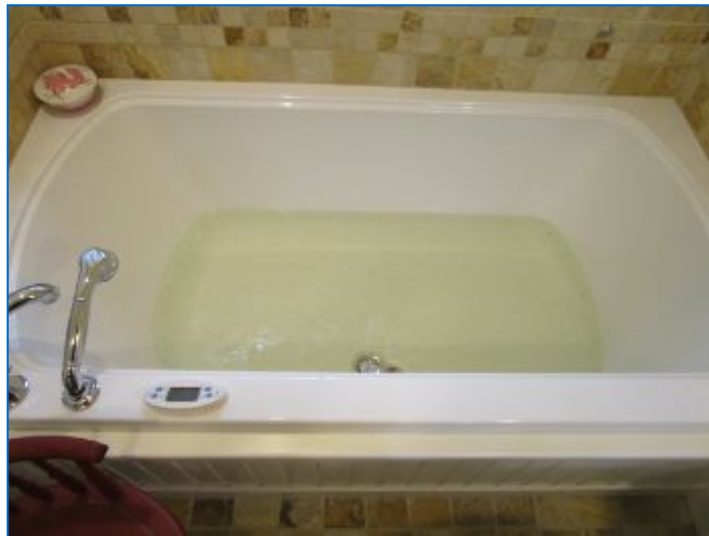
Whirlpool pump was operable at time of inspection.

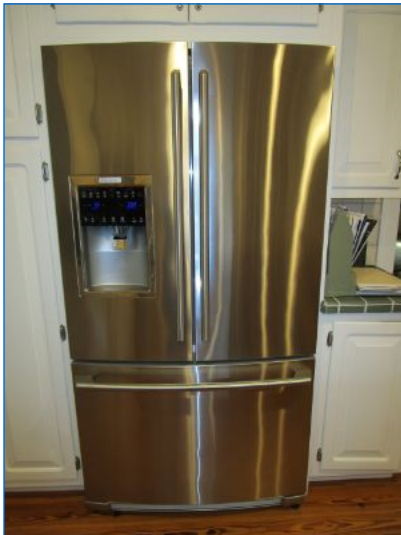
Refrigerator appeared to be approximately 1 yrs old.

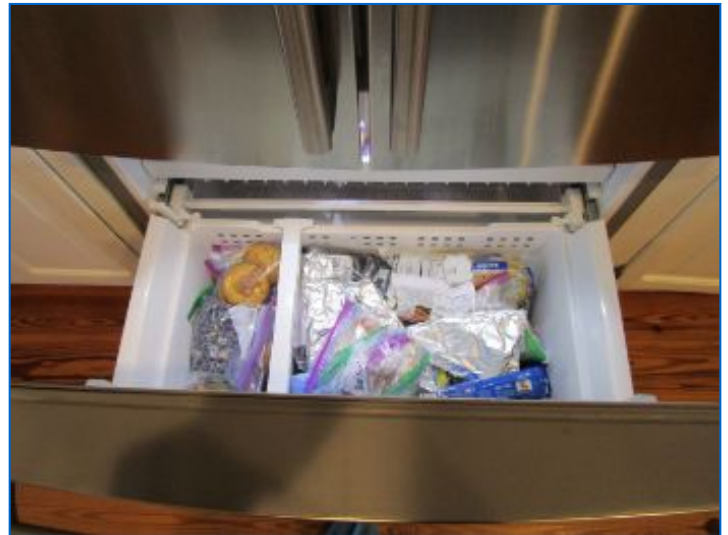
Refrigerator/freezer operating and frost free.

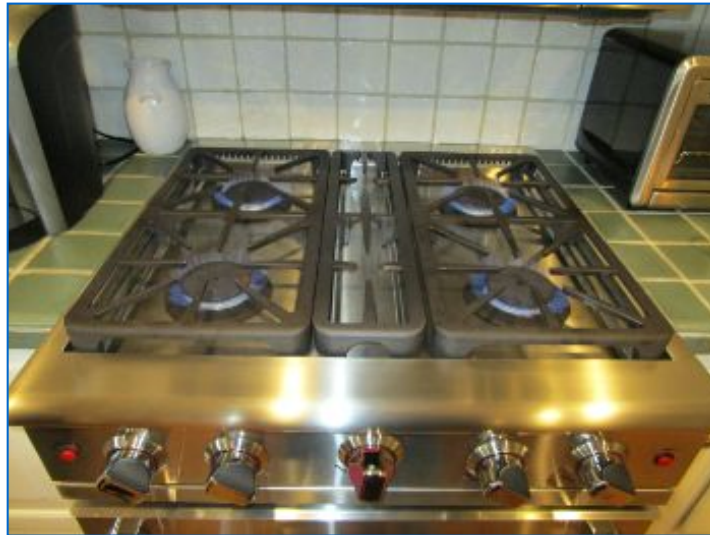
Gas-fired range; operable. Range appeared to be approximately 1 yrs old.

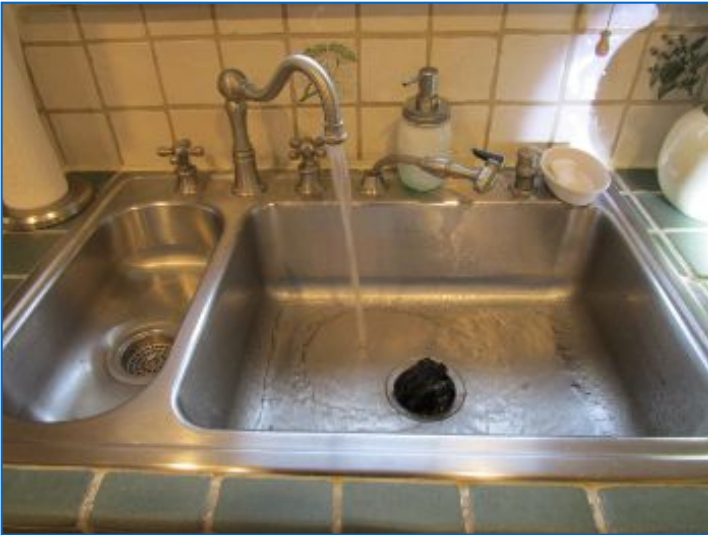
The kitchen sink had functional flow and functional drainage at the time of the inspection.

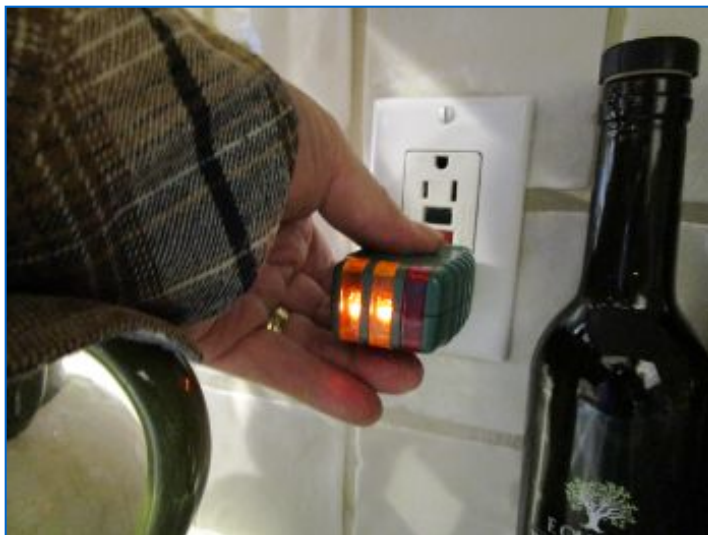
GFCI type receptacle did not trip when tested. Recommend rewiring or replacing GFCI receptacle.

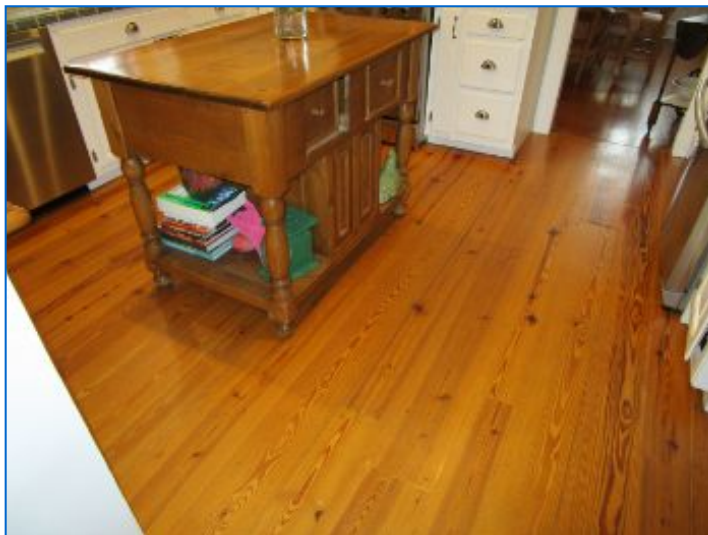
Solid hardwood flooring noted.

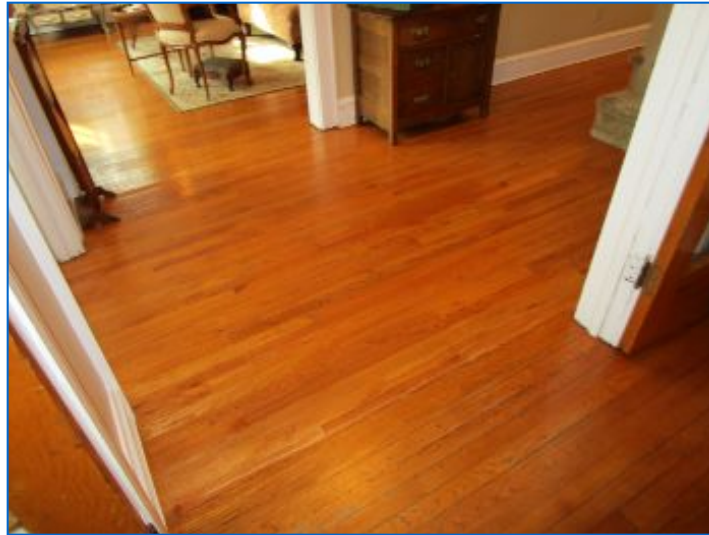
Hardwood flooring noted throughout 1st floor.

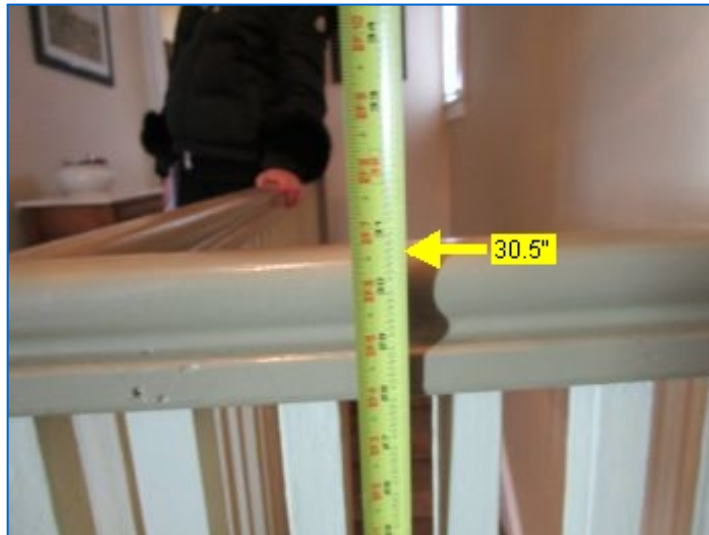
The horizontal guardrails protecting this stairwell were less than 36 inches in height. Although this condition is now considered a potential fall hazard, it is not uncommon in older homes such as this one, built during a time period during which safety standards were different from generally-accepted current safety standards. Homes are not required to be updated to comply with newly enacted safety standards. Because this is a life-safety issue, the Inspector recommends having the guardrails altered or replaced with guardrails at least 36 inches in height to comply with modern safety standards.

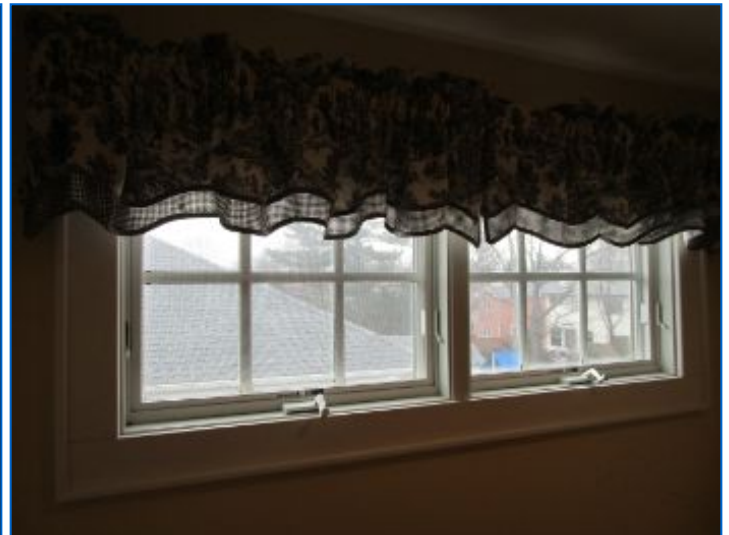
Casement windows noted in attic.

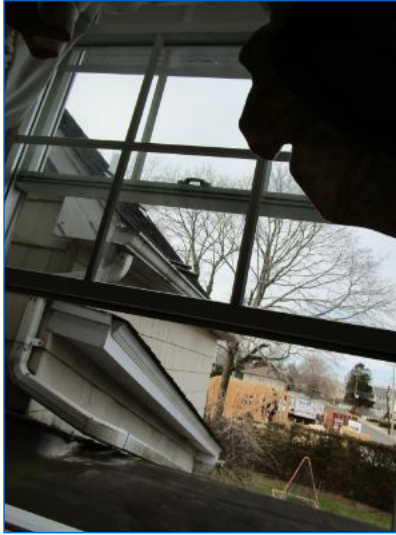
Many screens were missing or not installed at the time of inspection.

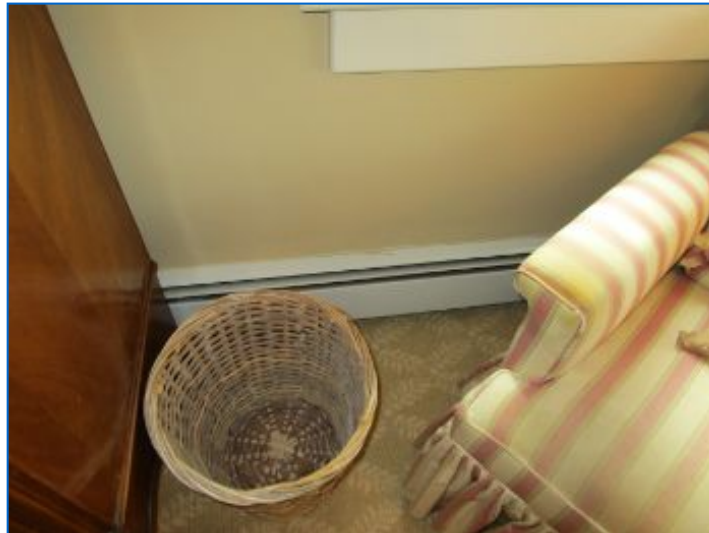
Baseboard convectors noted (hydronic heating zone).

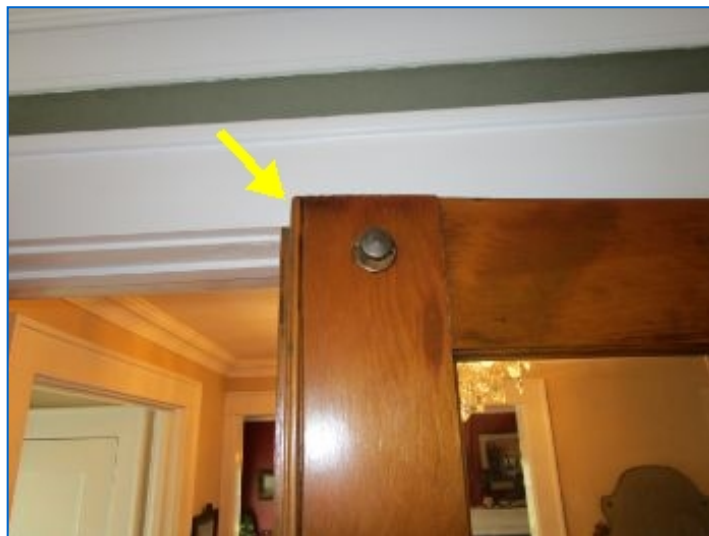
Right door hits against top frame; does not close. Suggest door/hinge adjustment.

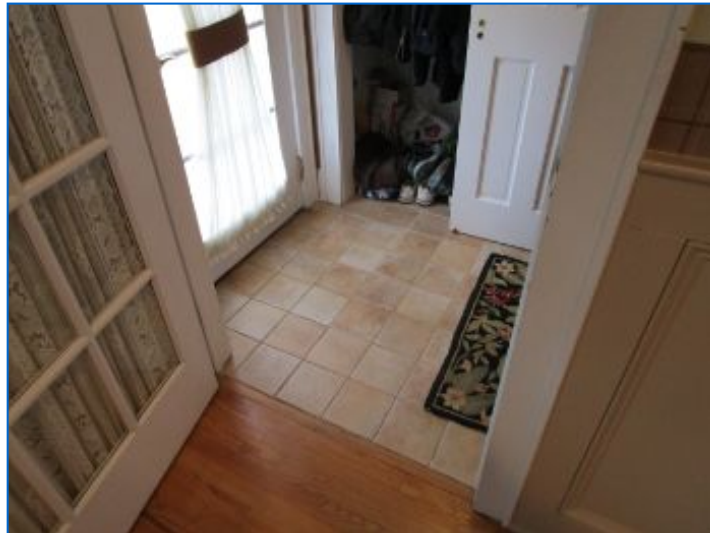
Hardwood floor noted, Ceramic tile at rear entry.

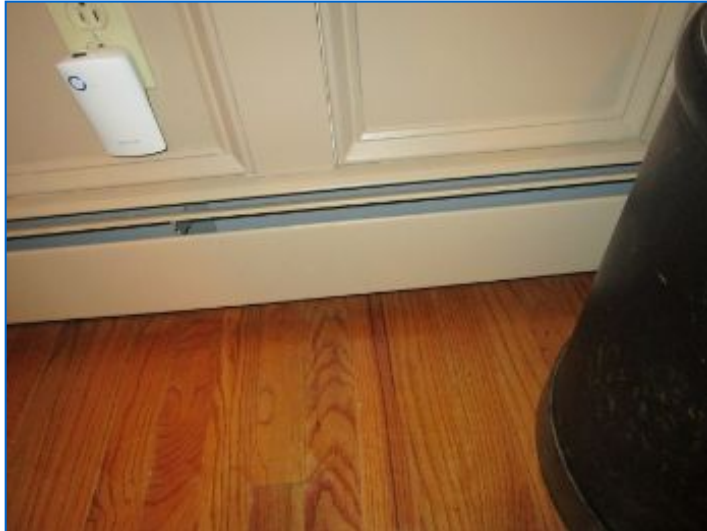
Baseboard convectors noted (hydronic heating zone).

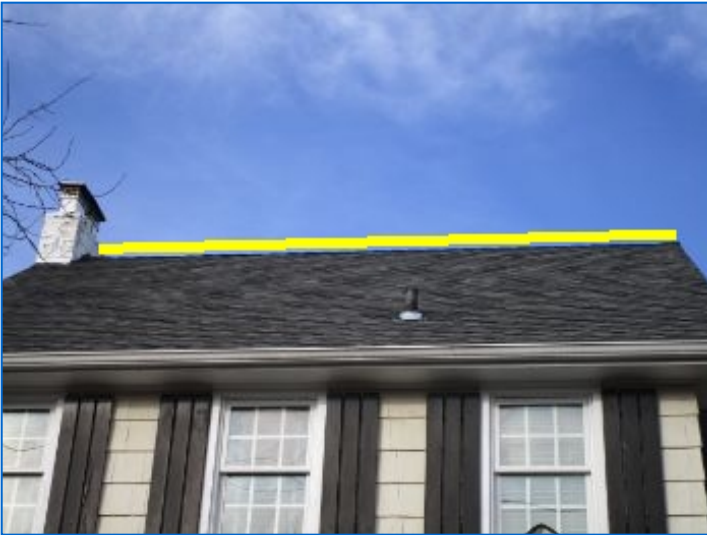
Roof ridge beam appeared straight and even.

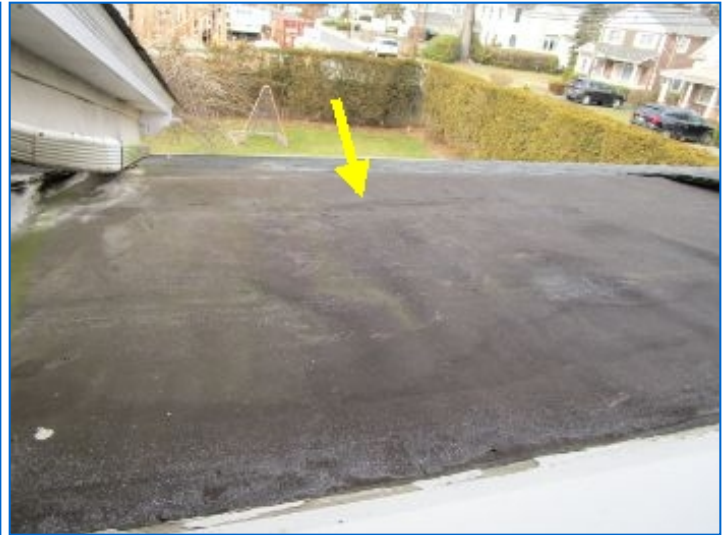
Semi-flat roof, rubber membrane noted here.

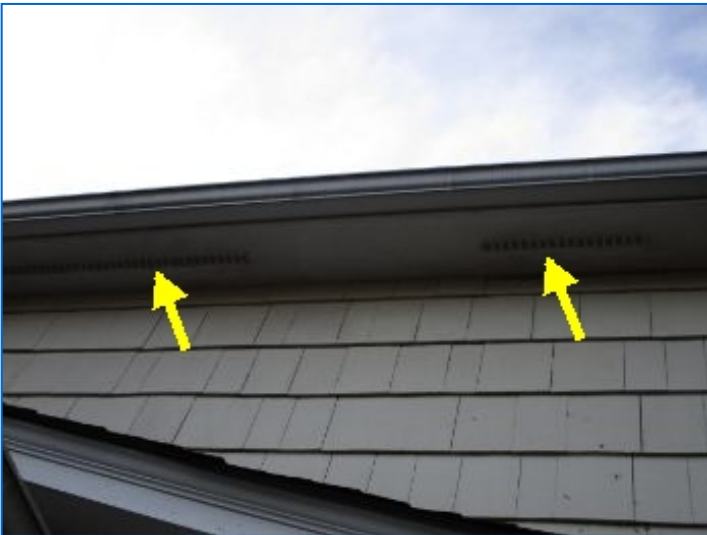
Under eave soffit inlet vents noted for attic ventilation.

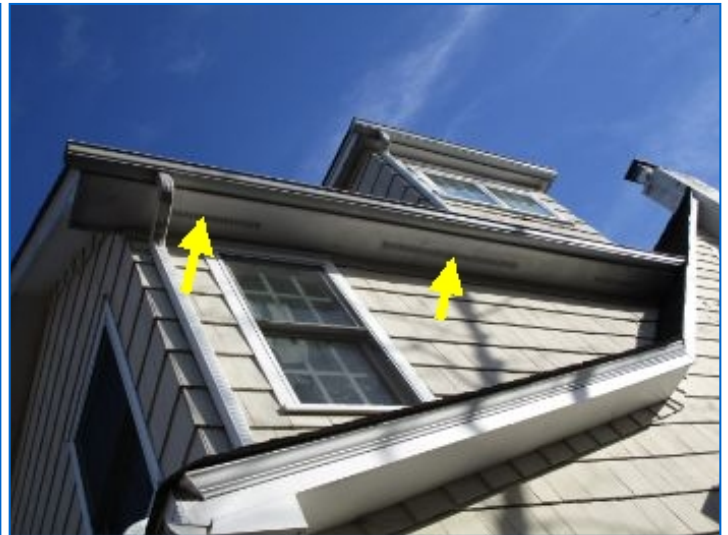
Under eave soffit inlet vents noted for attic ventilation.

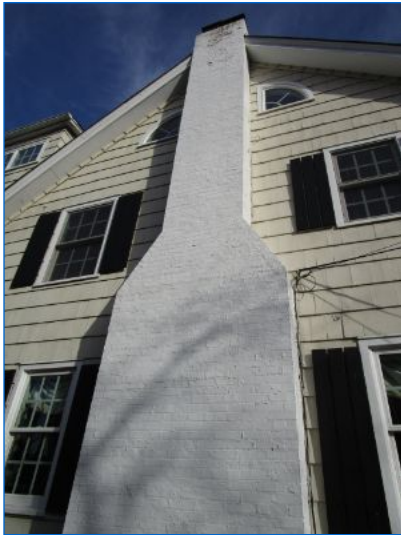
At the time of the inspection, the Inspector observed no deficiencies in the condition of the portions of the chimney visible from the ground.

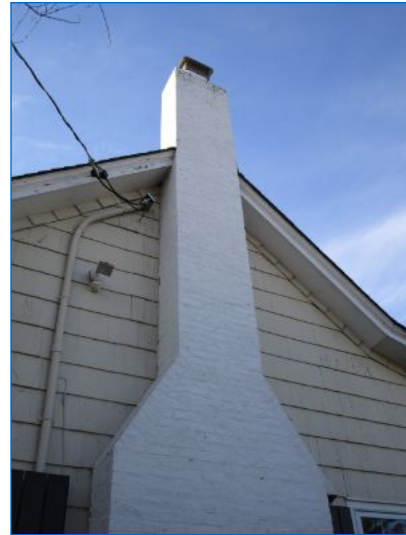
At the time of the inspection, the Inspector observed no deficiencies in the condition of the portions of the chimney visible from the ground.

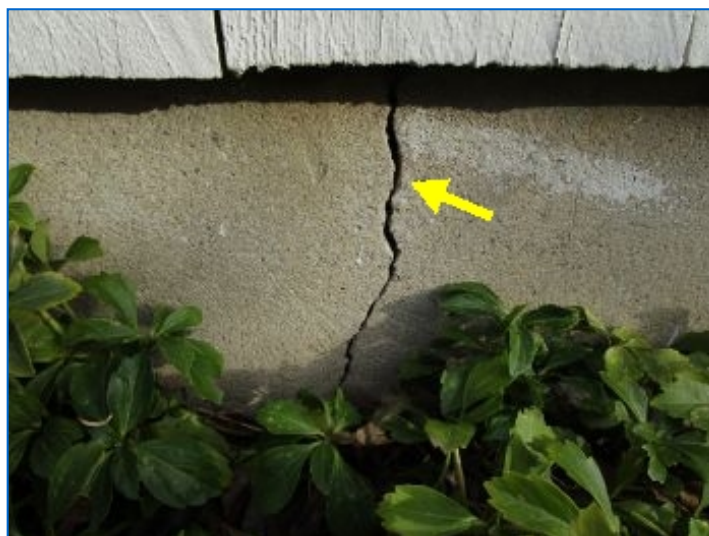
Differential Settlement Crack observed at south foundation wall. These can be a pathway for water entry. Recommend a qualified professional to fill/seal foundation crack/s with epoxy filler to prevent water intrusion, and monitor for further movement.

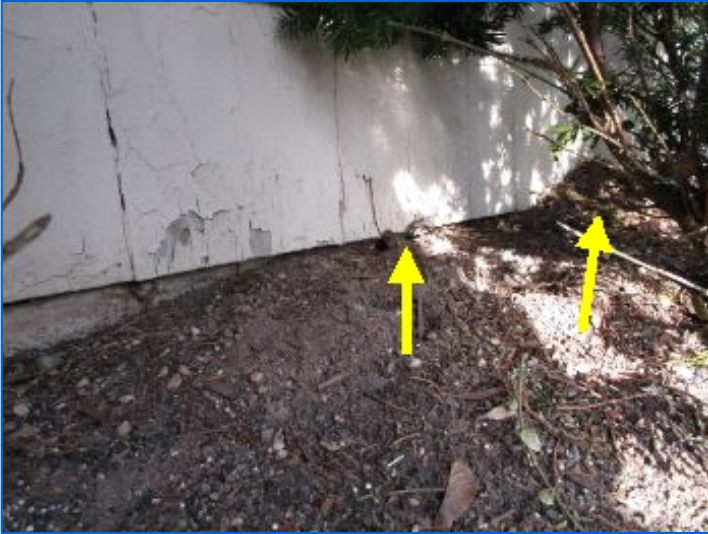
Wood siding covering exterior walls of the home was in contact with soil at front planting bed. This condition will result in deterioration of these areas from wood decay unless these areas are re-graded to provide clearance between wood and soil.

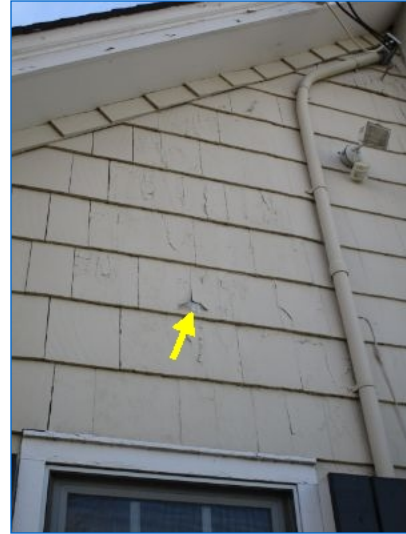
Wood siding covering the exterior walls of the home had areas of peeling paint revealing the white paint layer beneath. Paint should be maintained in good condition to help prevent damage to wood siding from sun and moisture.

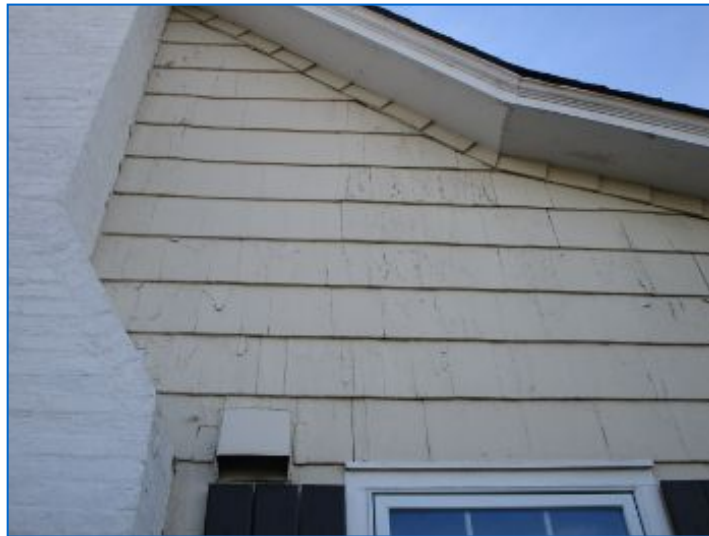
Wood siding covering the exterior walls of the home had areas of peeling paint revealing the white paint layer beneath. Paint should be maintained in good condition to help prevent damage to wood siding from sun and moisture. The Inspector suggests that before the expiration of your Inspection Objection Deadline you consult with a qualified contractor to gain an idea of options and costs for repainting.

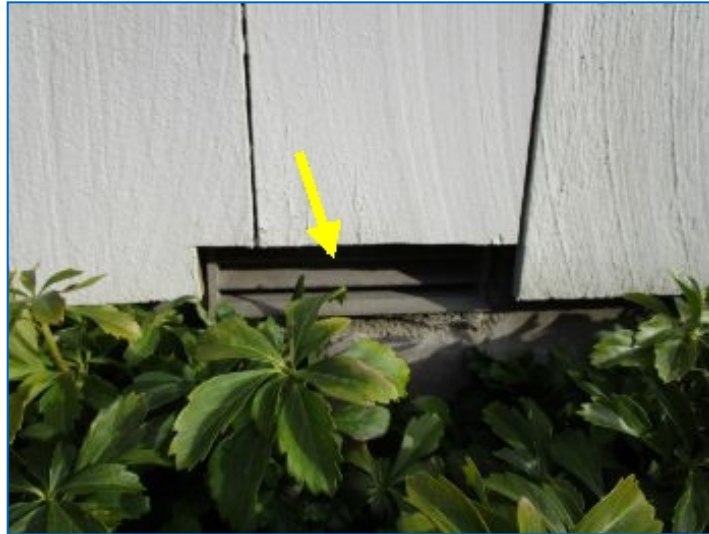
Vents noted for crawlspace beneath the rear addition only. There was no access provided to this space for visual inspection.

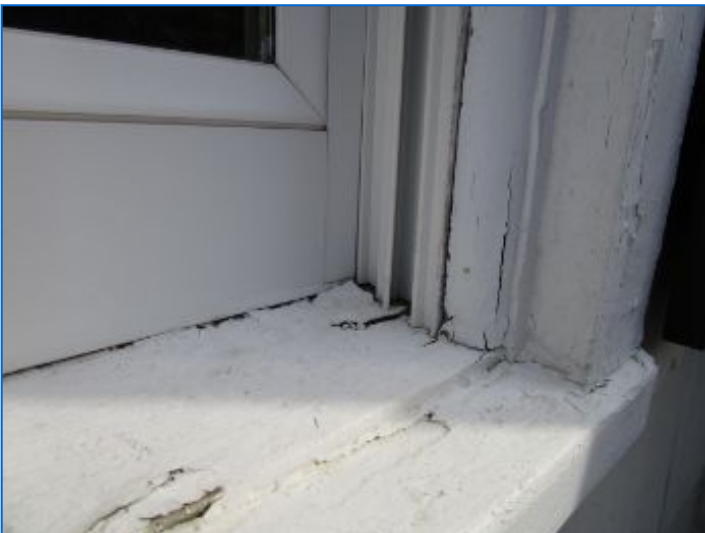
Some window frames/sills had peeling paint and needed maintenance at the time of the inspection. The Inspector recommends maintenance be performed by a qualified contractor.

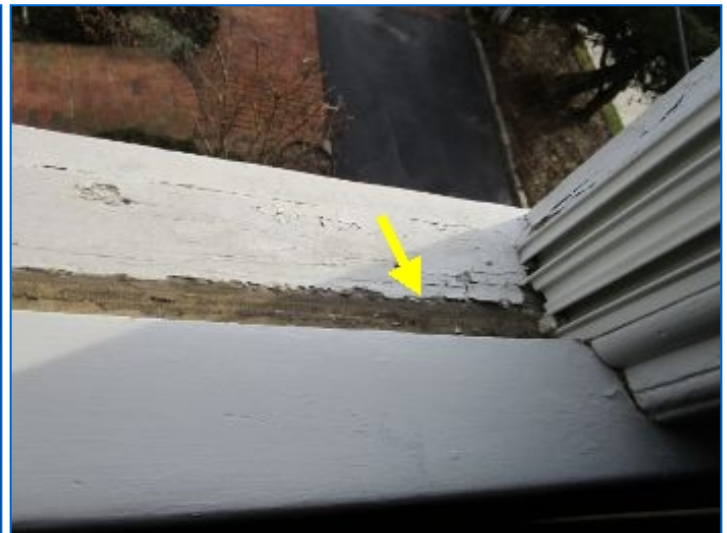
Some window frames/sills had peeling paint and needed maintenance at the time of the inspection. The Inspector recommends maintenance be performed by a qualified contractor.

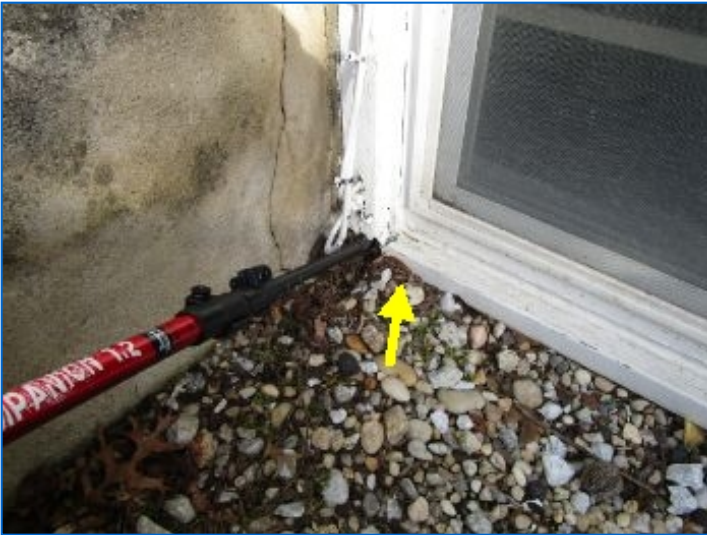
Basement window wood frames in contact with soil showed signs of moisture damage at South side. Recommend lowering soil level 6 inches below wood frames and provide top layer of gravel.

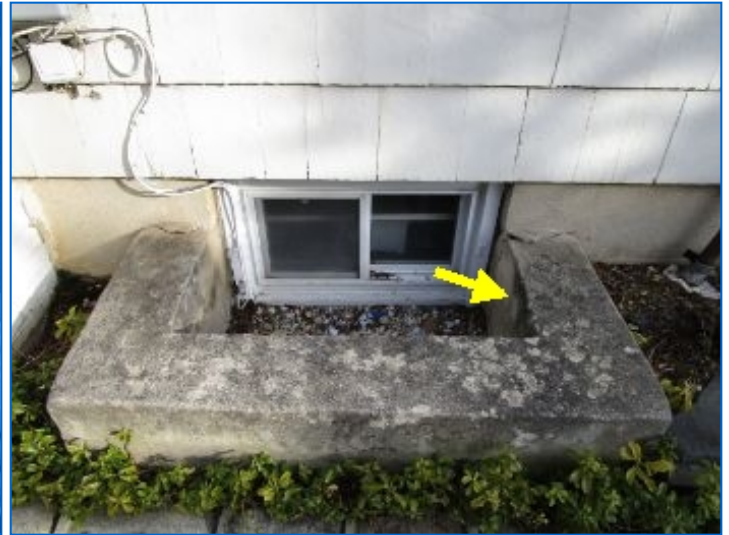
Poured concrete window wells noted at south side. Suggest covers or steel grates for small child fall protection.

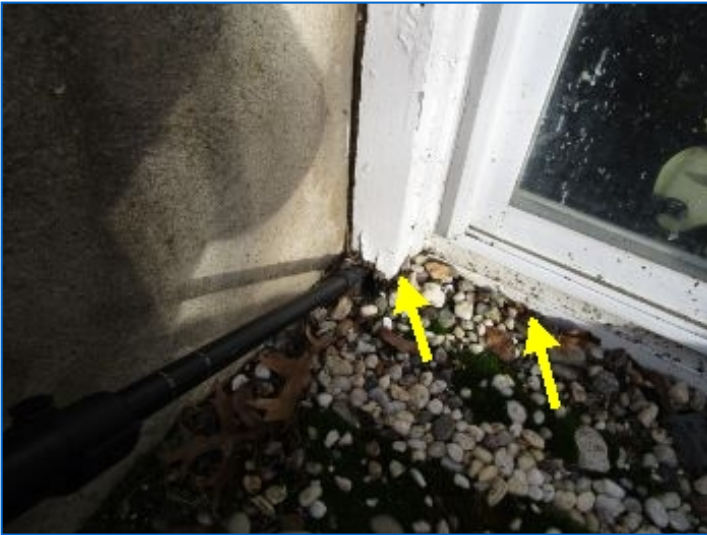
Basement window wood frames in contact with soil showed signs of moisture damage at South side (2 locations). Recommend lowering soil level 6 inches below wood frames and provide top layer of gravel. Repair moisture damaged sections of frames.

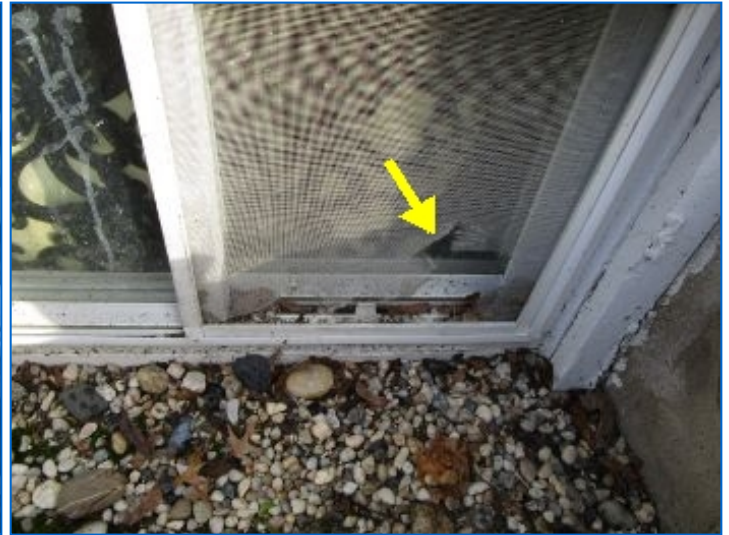
Torn screen noted at south basement window.

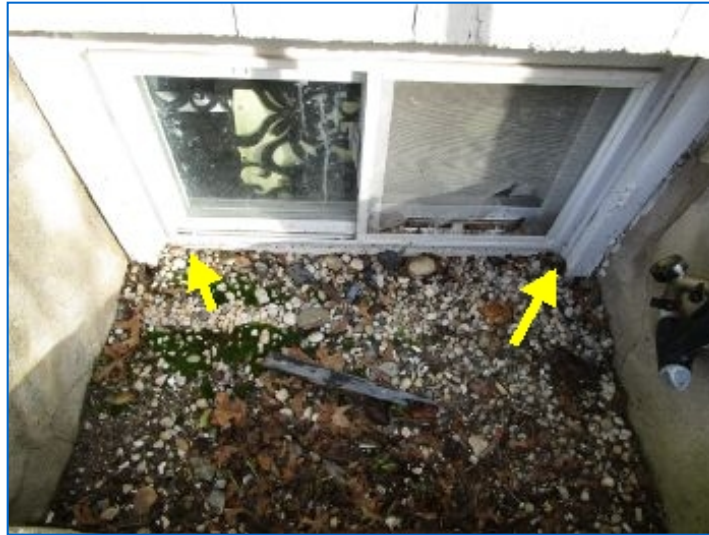
Basement window wood frames in contact with soil showed signs of moisture damage at South side (2 locations). Recommend lowering soil level 6 inches below wood frames and provide top layer of gravel. Repair moisture damaged sections of frames.

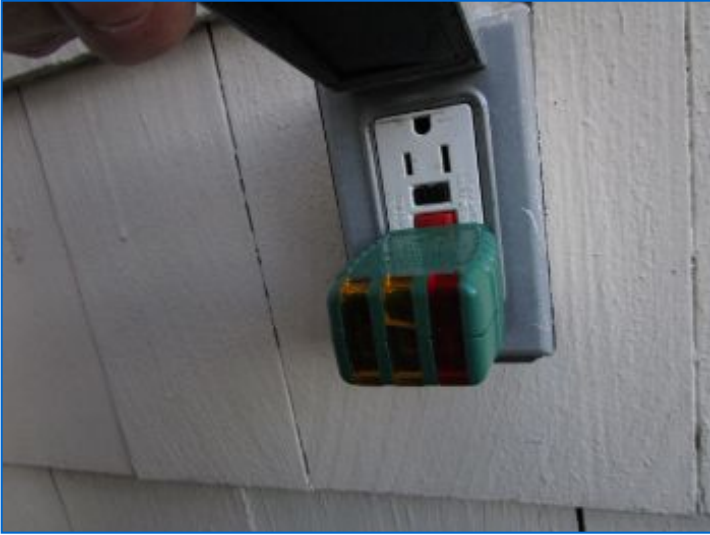
No power at GFCI type receptacle at rear at time of inspection. Recommend having seller locate source - restore power prior to close.

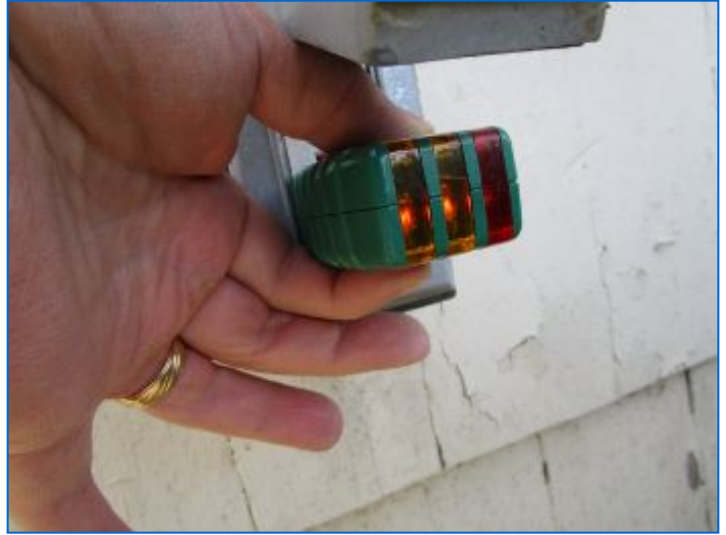
GFCI type receptacle at garage exterior did not trip when tested. Recommend rewiring or replacing GFCI receptacle. Refer to Electrical section.

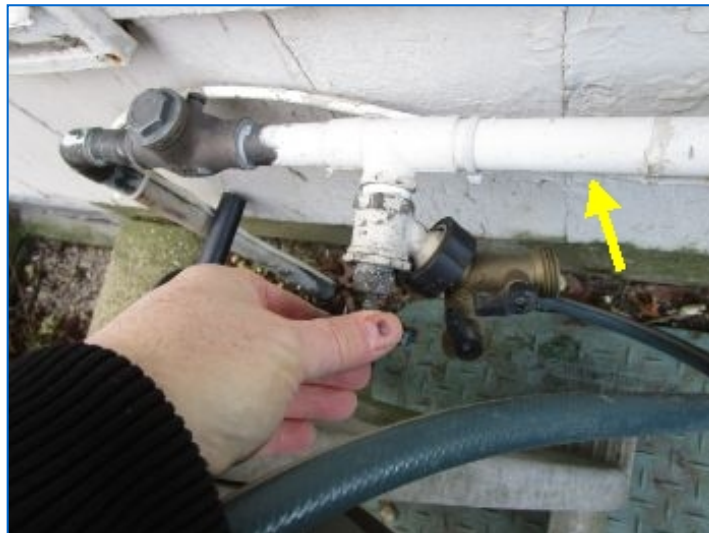
Exterior pipe extension to hose bibb must be drained to winterize to avoid freeze damage to exterior pipe.

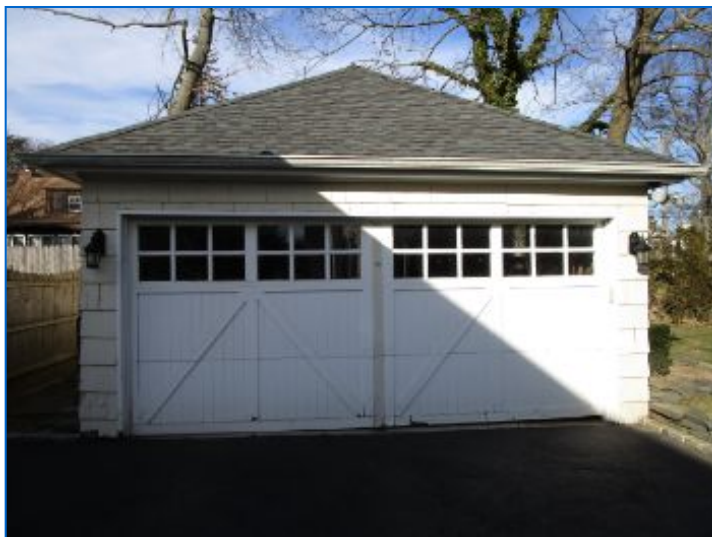
GARAGE General Conditions

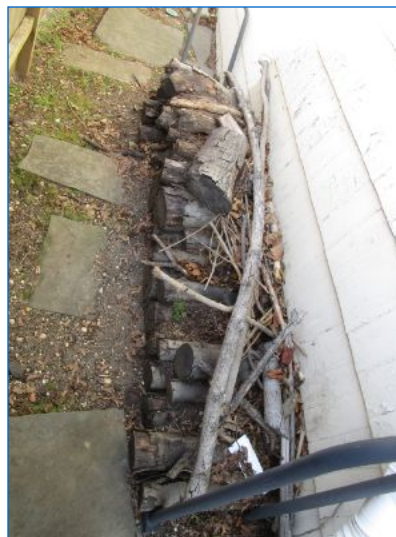
Recommend relocating log pile a minimum of 15 ft. from the structure as this can attract wood destroying insects.

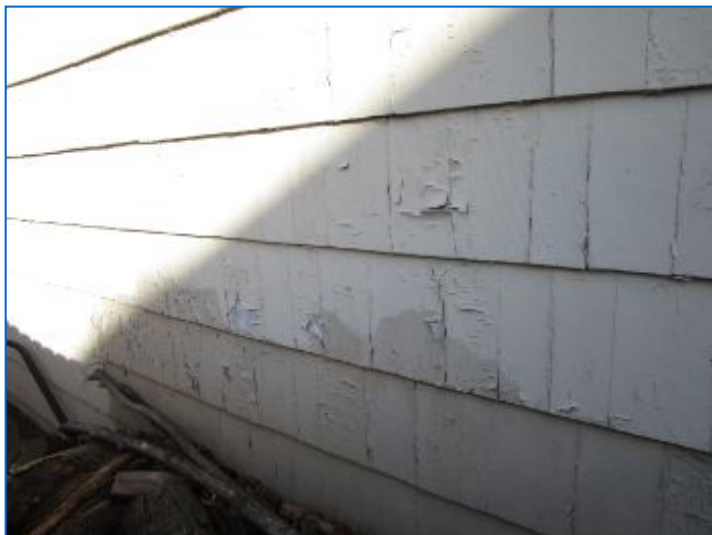
Wood siding covering the exterior walls of the garage had areas of peeling paint exposing the wood siding beneath. Paint should be maintained in good condition to help prevent damage to wood siding from sun and moisture. The Inspector suggests that before the expiration of your Inspection Objection Deadline you consult with a qualified contractor to gain an idea of options and costs for repainting.

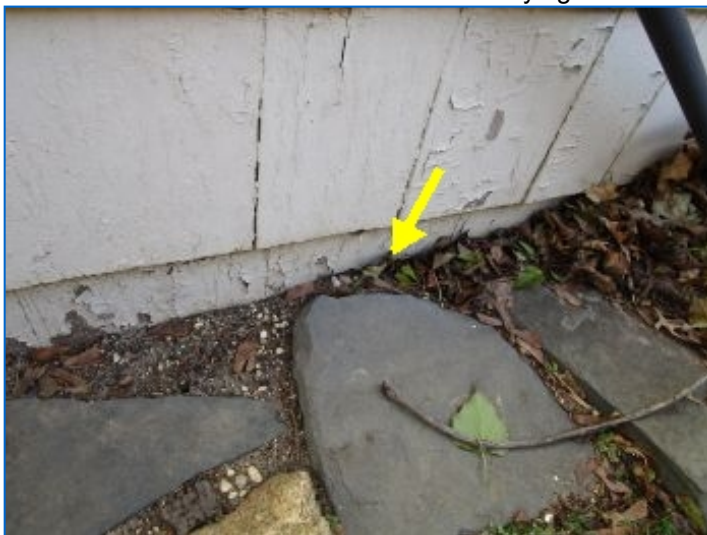
Wood siding covering exterior walls of the garage was in contact with soil. This condition will result in deterioration of these areas from wood decay; re-grade these areas to provide clearance between wood and soil.

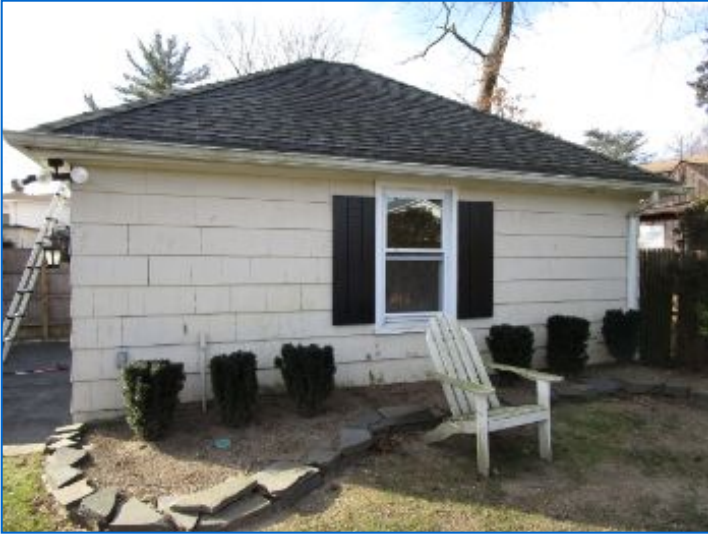
GARAGE General Conditions

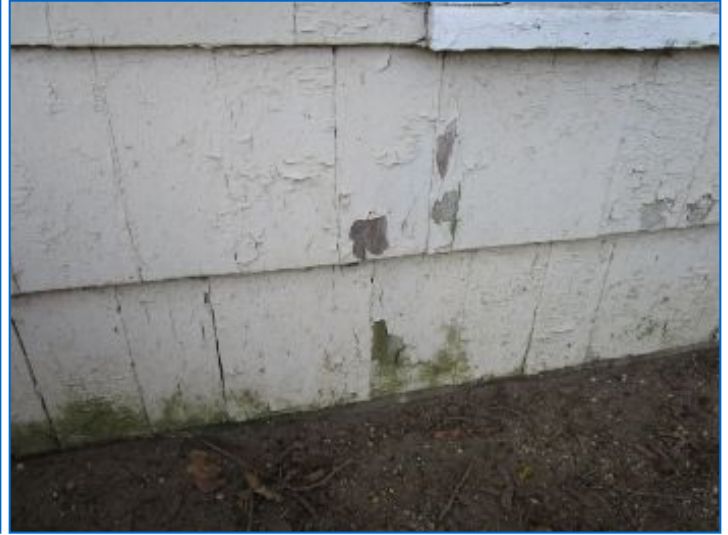
Wood siding covering the exterior walls of the garage had areas of peeling paint exposing the wood siding beneath. Paint should be maintained in good condition to help prevent damage to wood siding from sun and moisture.

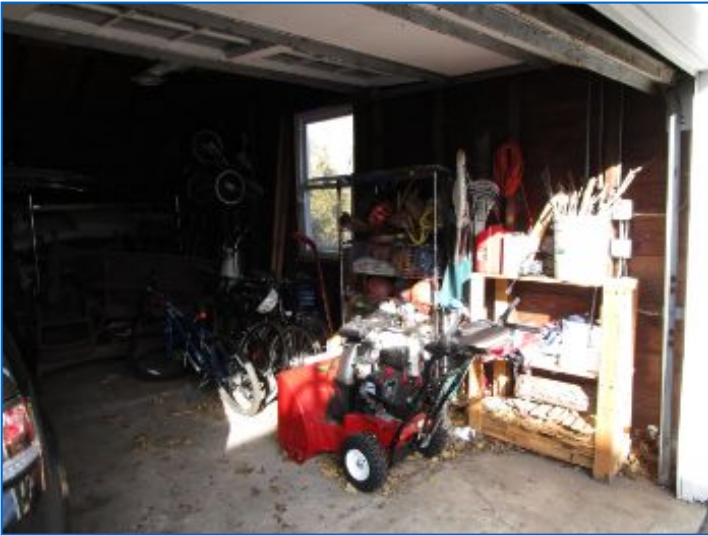
Limitation: Shelving & stored items limited visual access of garage walls/structure; unable to fully inspect.

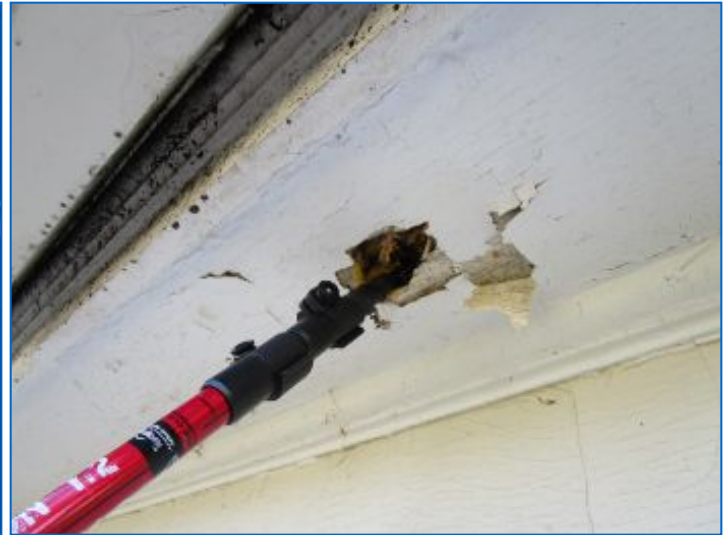
Moisture damage at underside of eave facing north.

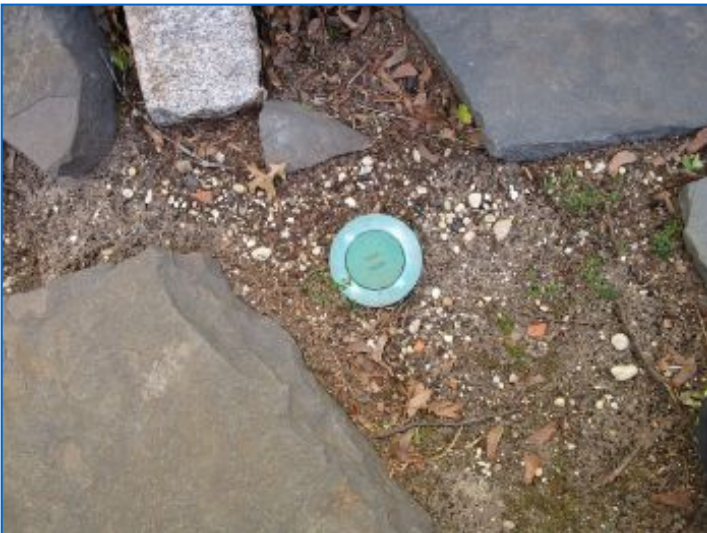
Previous Termite Treatment noted; Bait Stations observed at the perimeter of the structure. Refer to attached NPMA-33 report form.

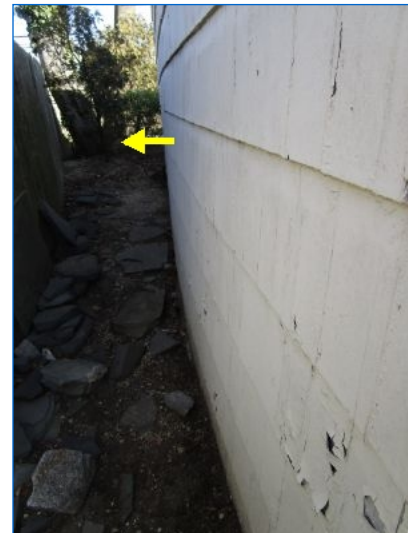
Wall bulging outward at lower rear of garage. This is a structural defect and safety concern.

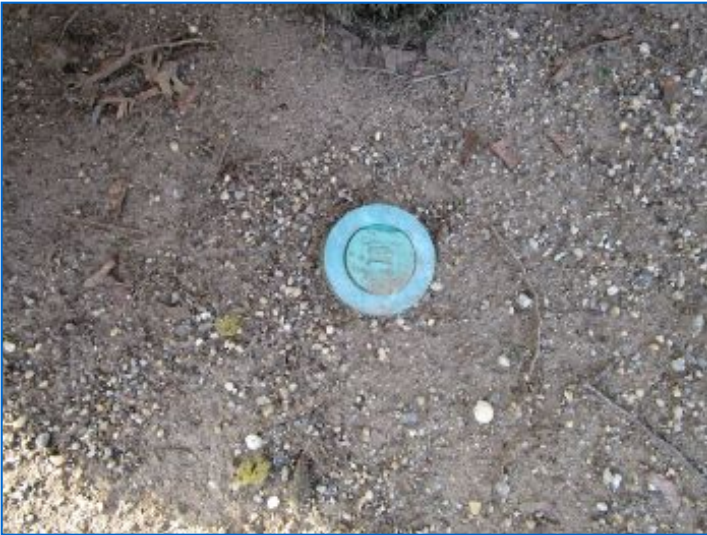
Previous Termite Treatment noted; Bait Stations observed at the perimeter of the structure. Refer to attached NPMA-33 report form.

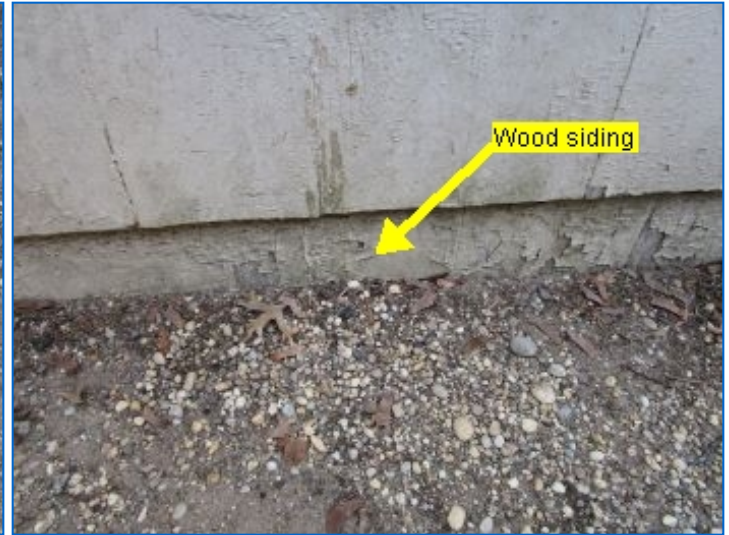
Soil level at perimeter of the structure is too high relative to the wood siding and sill plates in garage. This enables water penetration/damage to occur and provides termites and other wood destroying insects easy access to the wood structure. Recommend lowering soil level to 4-6" below siding. Suggest gravel at perimeter if necessary instead of soil.

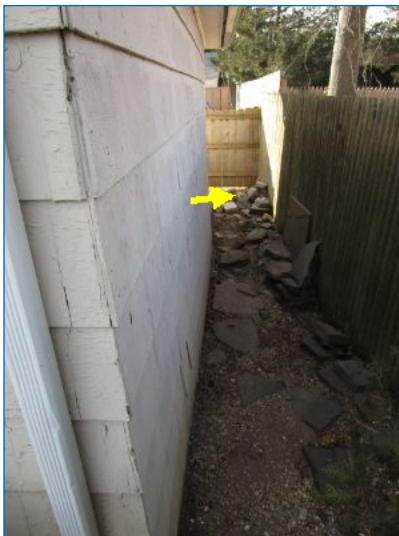
Wall bulging outward at lower rear of garage. This is a structural defect and safety concern.

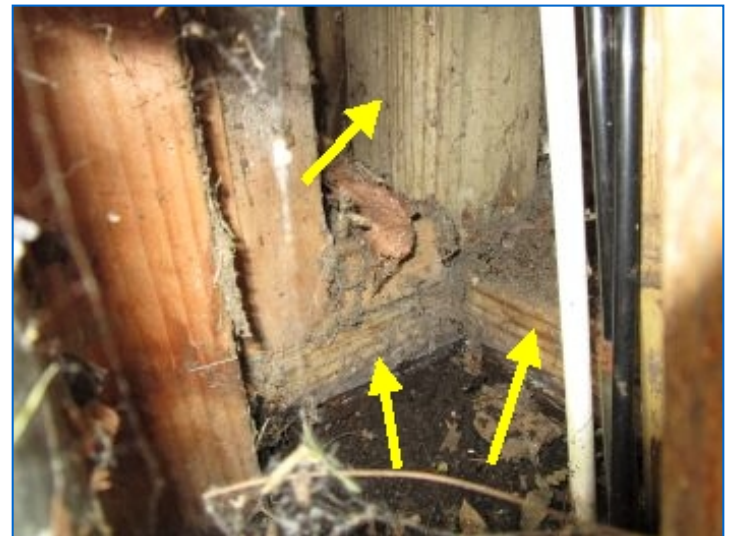
REPAIRS: Sections of the sill plate and wall studs were replaced with pressure treated wood but only at the front of the garage. Based on noted conditions this was due to moisture and past termite damage.

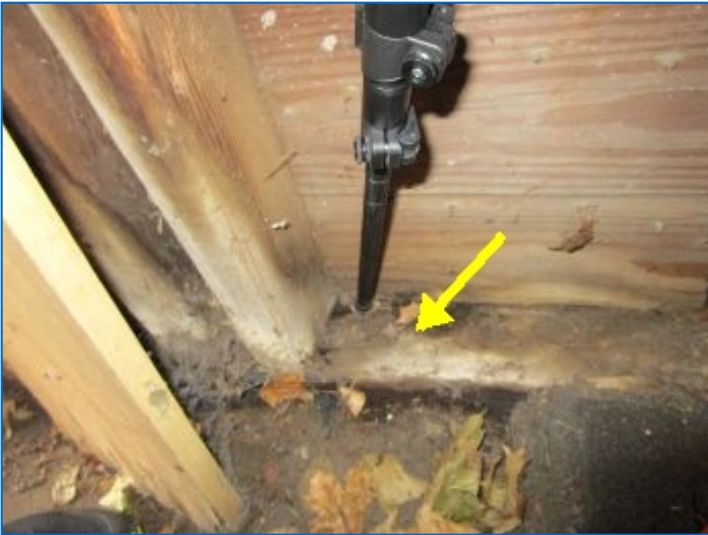
Moderate to severe moisture damage noted at sill plates at all walls of the garage.

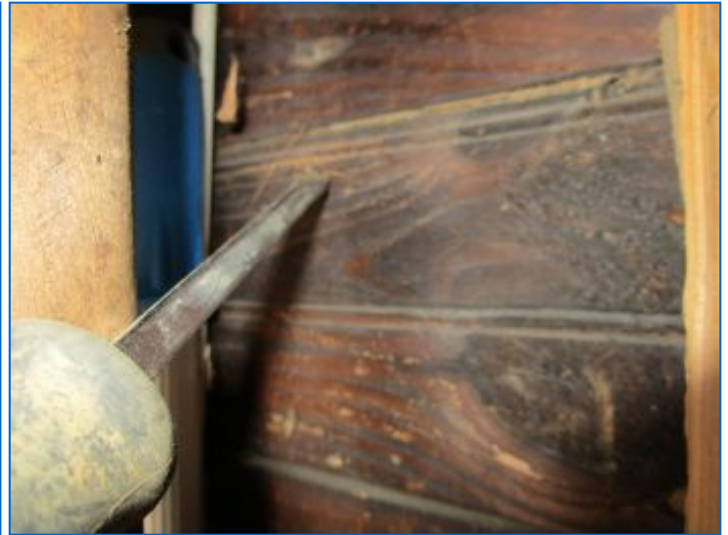
Past Termite damage observed at wall boards at North and South front areas of garage.

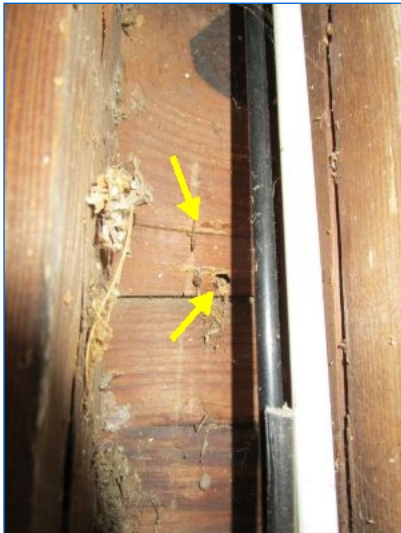
Past Termite damage observed at wall boards at North and South front areas of garage.

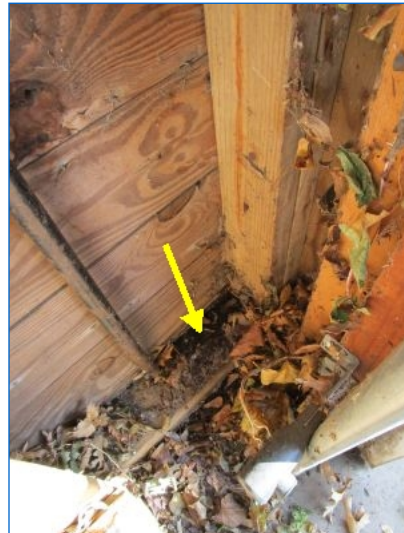
Moderate to severe moisture damage noted at sill plates at all walls of the garage.

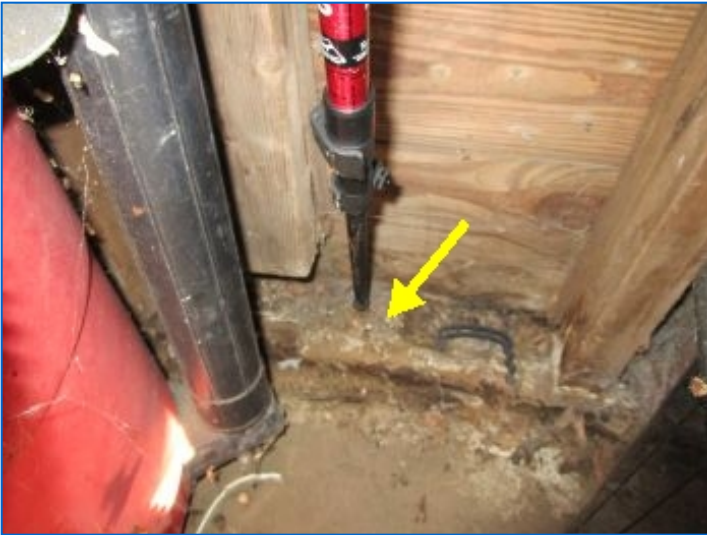
Moderate to severe moisture damage noted at sill plates at all walls of the garage.

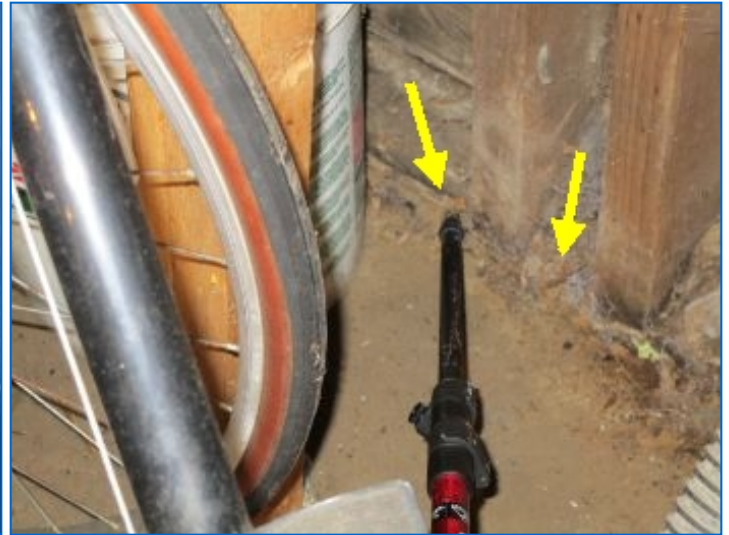
Moderate to severe moisture damage noted at sill plates at all walls of the garage.

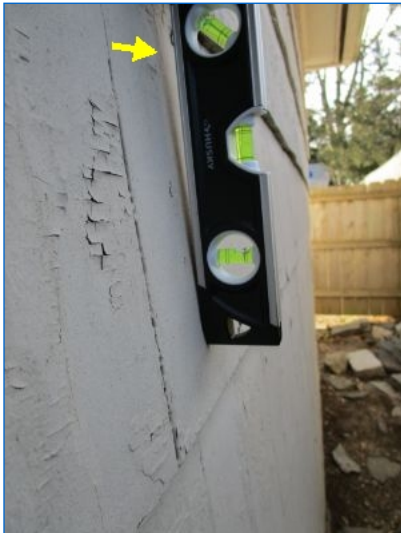
RECOMMENDATION: Wall bulging outward at lower rear of garage. The Inspector recommends that before the expiration of your Inspection Objection Deadline you consult with a qualified contractor to discuss options and costs for corrective repairs or replacement to address this structural defect/safety concern.
