ProSpec Home Inspection of Long Island Property Inspection Report

Inspector: Russell Classi, P.E.
License #16000077480
Phone: (516) 580-1848
Email: ProSpecofLI@gmail.com
www.NassauProfessionalHomeInspector.com

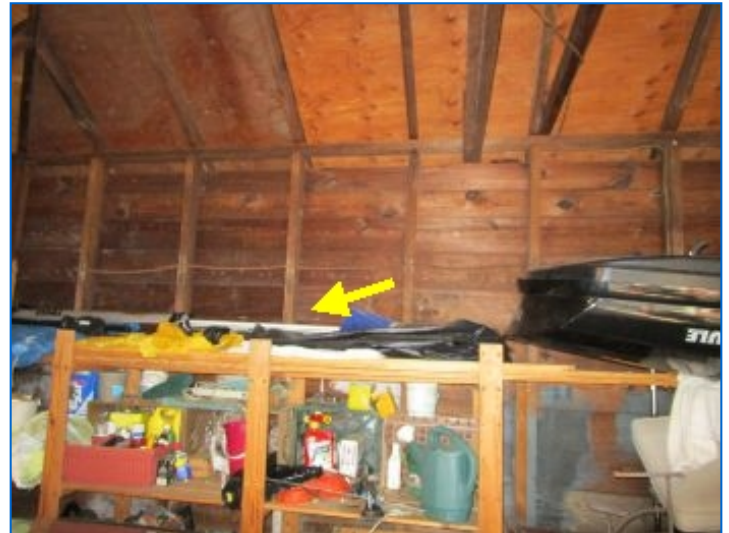
RECOMMENDATION: Wall bulging outward at lower rear of garage. The Inspector recommends that before the expiration of your Inspection Objection Deadline you consult with a qualified contractor to discuss options and costs for corrective repairs or replacement to address this structural defect/safety concern.

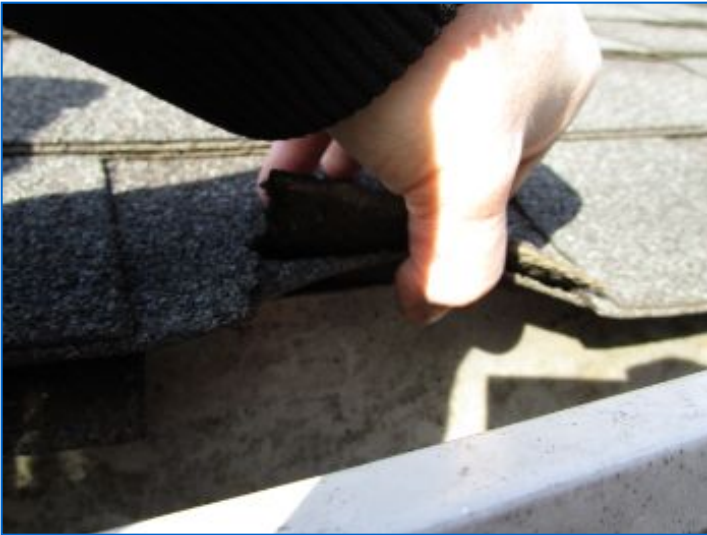
The roof had one layer of asphalt shingles installed at the time of the inspection.

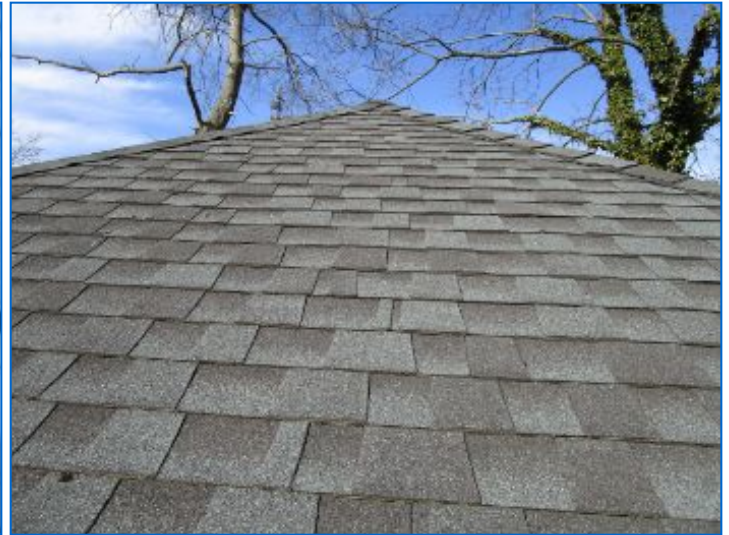
Top asphalt roof covering showed conditions consistent with 5 yr old shingles.

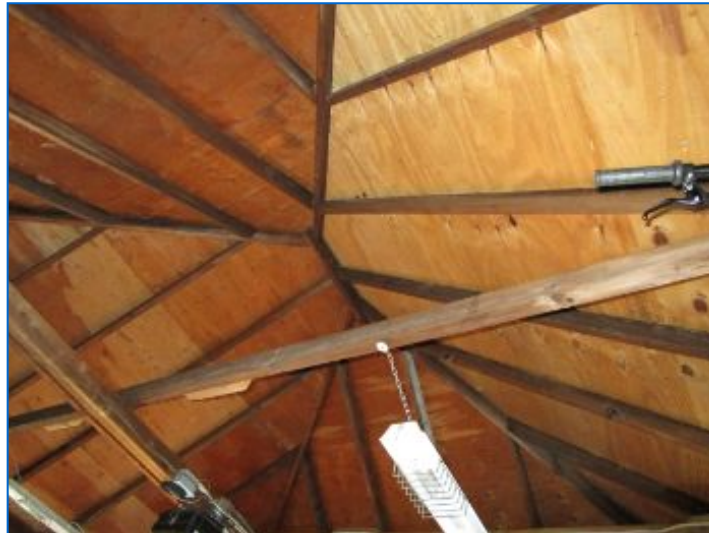
Garage roof boards were apparently replaced when the roof shingles were replaced.

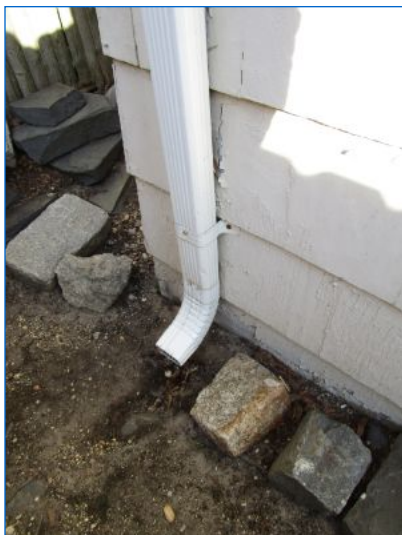
Downspout extensions missing. Recommend extending downspouts 4 ft minimum where possible to divert run-off away from the structure and to prevent soil erosion at the slab foundation perimeter.

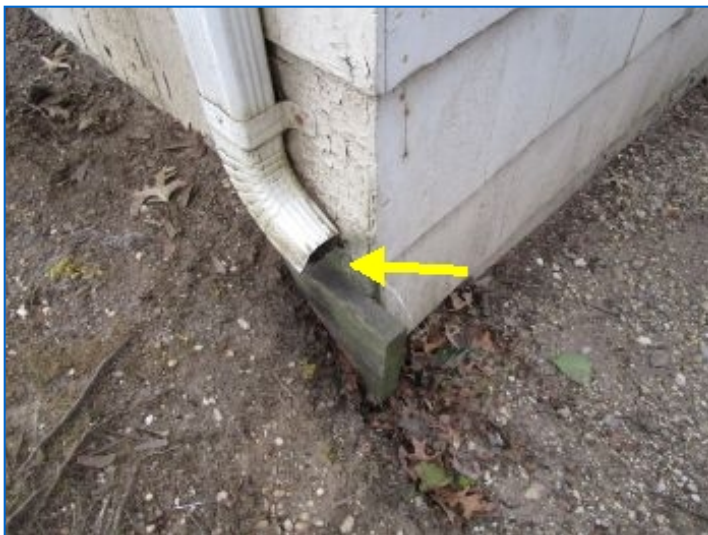
Downspout extensions missing. Recommend extending downspouts 4 ft minimum where possible to divert run-off away from the structure and to prevent soil erosion at the slab foundation perimeter.

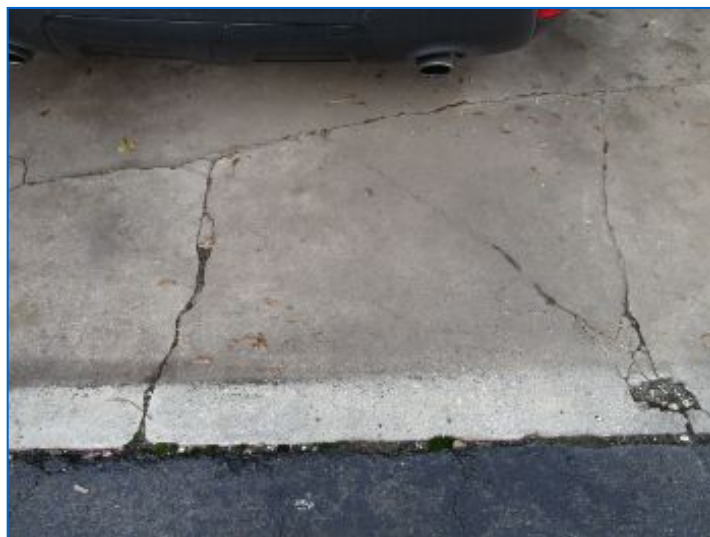
Settlement Cracks: Settled areas of the garage floor appeared to be related to settling of the soil beneath the concrete floor slab. This condition is typical of inadequate compaction of soil beneath the slab at the time of original construction. Settling due to inadequate compaction takes place in the first few years after original construction, and then stops. If this is the cause, the condition would now be stable.

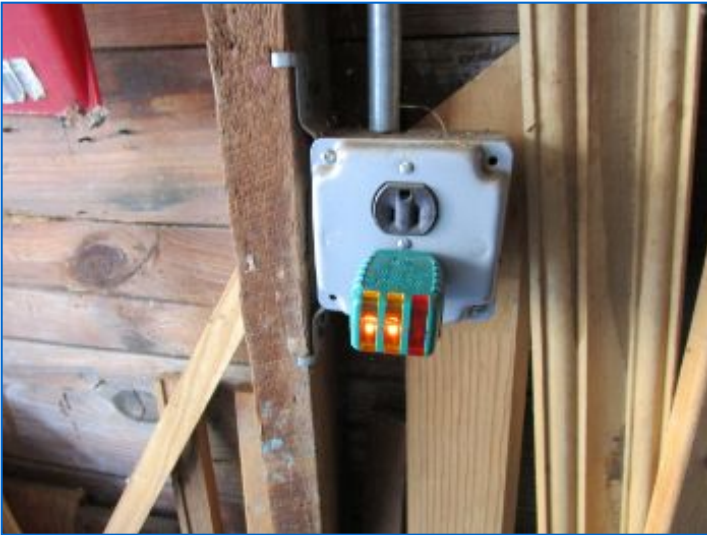
Inside receptacle/s were not GFCI protected. Recommend updating to GFCI protected receptacles. Refer to Electrical section.

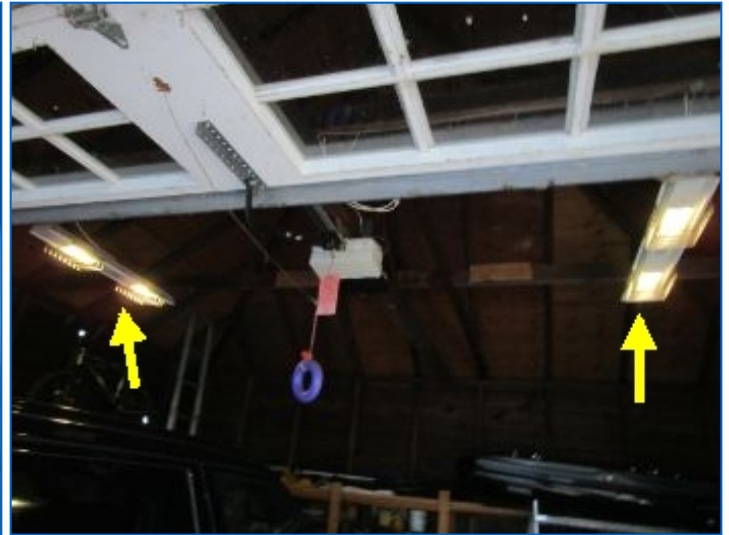
Light fixtures were operable.

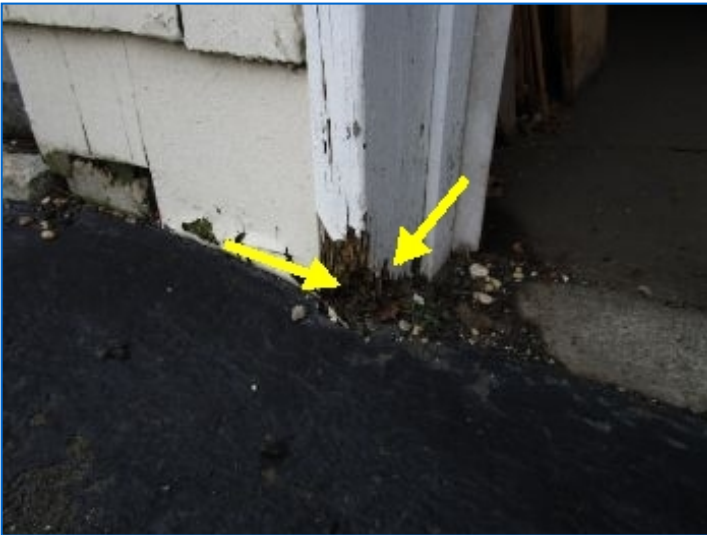
Vehicle door Jamb/s deteriorated (water damage).

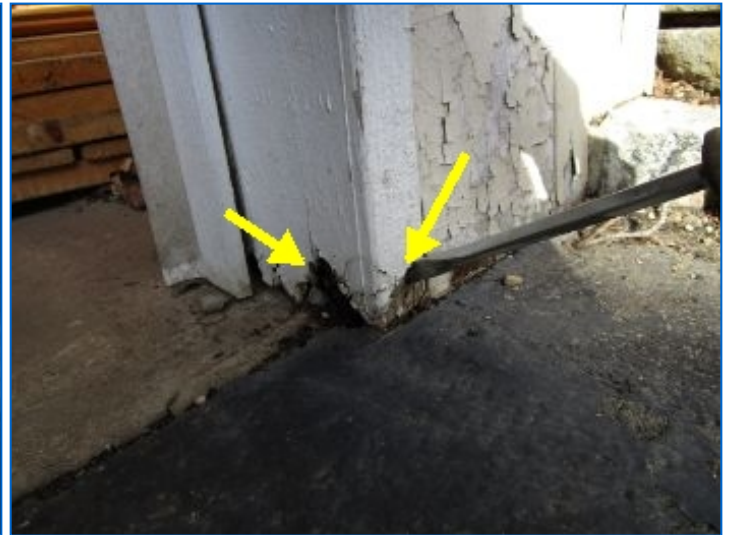
Vehicle door Jamb/s deteriorated (water damage).

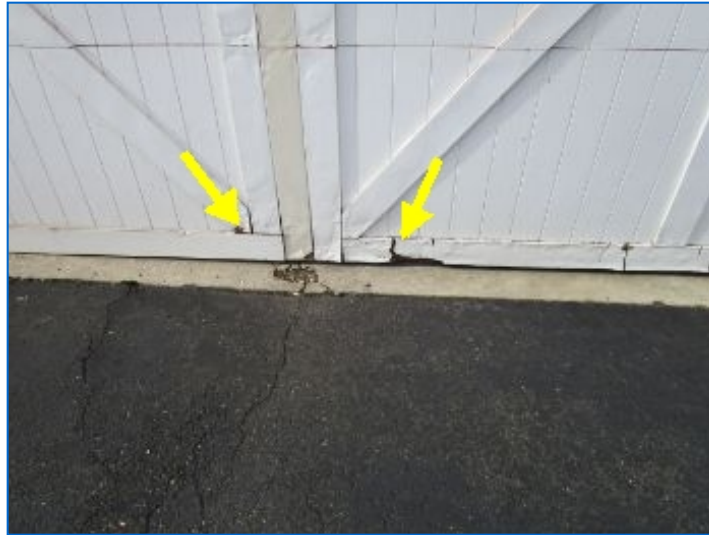
Rotted wood at bottom of sectional roll-up door. Recommend repairing damaged areas.

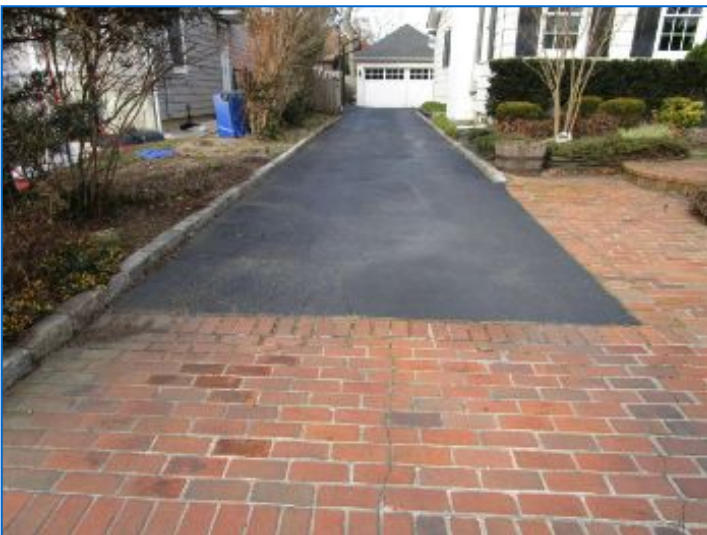
Maintenance: Asphalt driveways require sealing every 3-5 yrs to prevent water penetration and freeze-thaw damage.

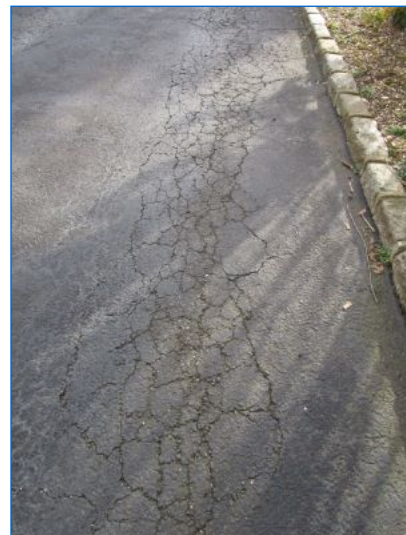
The asphalt driveway had moderate surface deterioration and displacement. The Inspector recommends that before the expiration of your Inspection Objection Deadline you consult with a qualified contractor to discuss options and costs for repair or replacement.

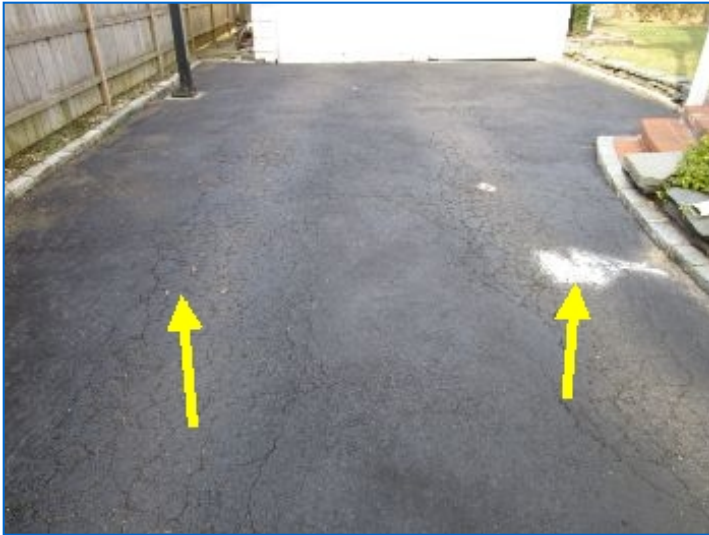
The asphalt driveway had moderate surface deterioration and displacement. The Inspector recommends that before the expiration of your Inspection Objection Deadline you consult with a qualified contractor to discuss options and costs for repair or replacement.

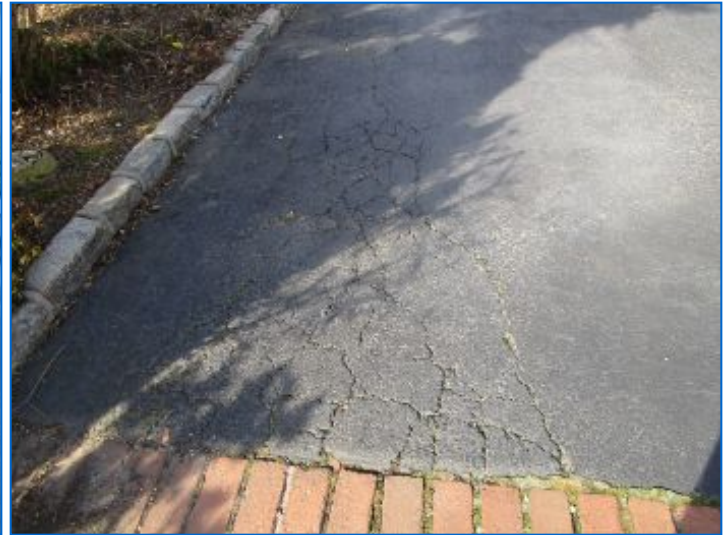
The asphalt driveway had moderate surface deterioration and displacement. The Inspector recommends that before the expiration of your Inspection Objection Deadline you consult with a qualified contractor to discuss options and costs for repair or replacement.

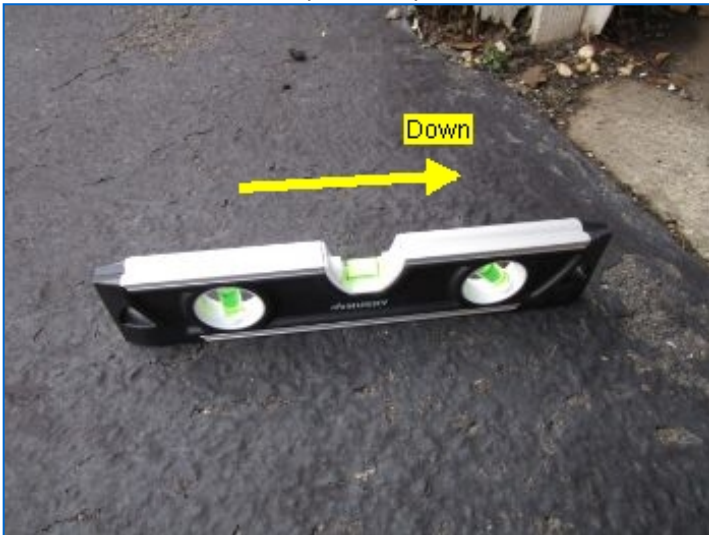
Driveway improperly sloped towards the garage. Recommend regrading the driveway as needed to allow run-off to flow away from garage/structure.

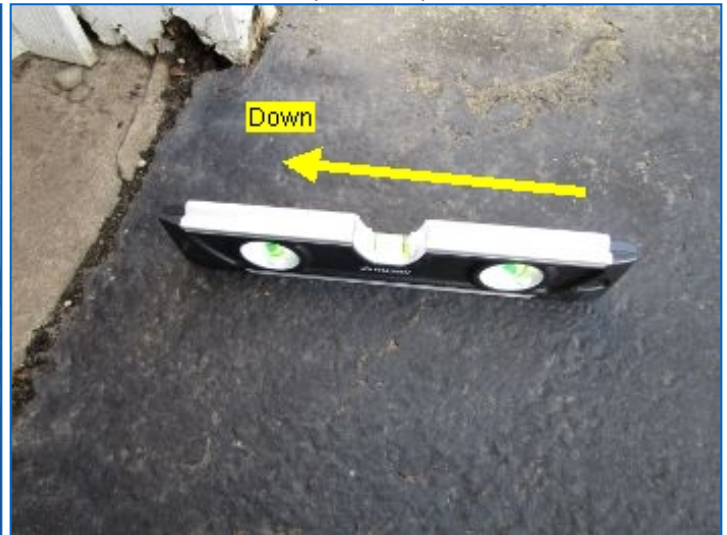
Driveway improperly sloped towards the garage. Recommend regrading the driveway as needed to allow run-off to flow away from garage/structure.

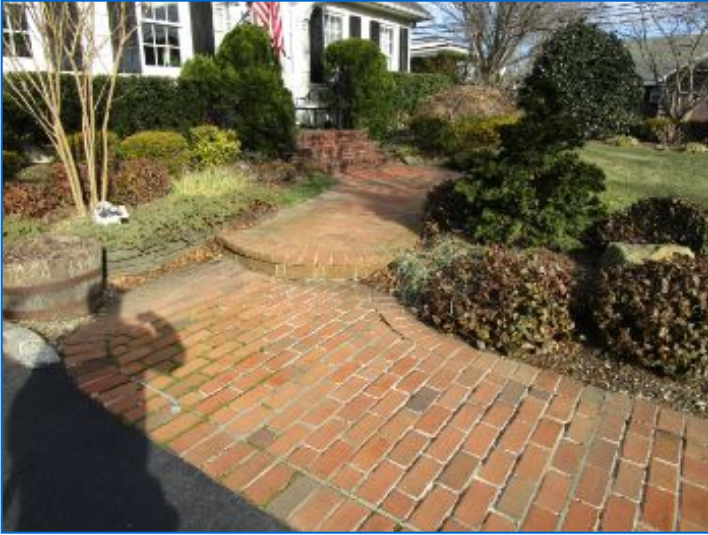
Walkways: No major system safety or function concerns noted at time of inspection.

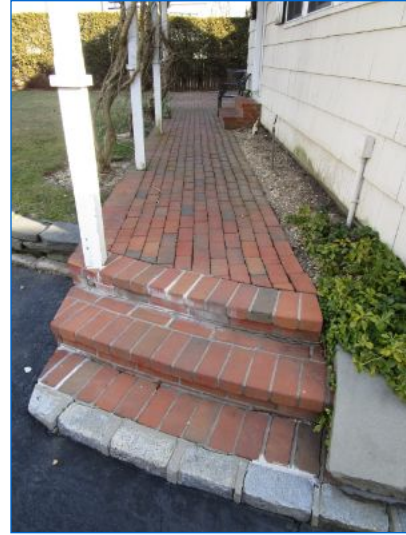
Walkways: No major system safety or function concerns noted at time of inspection.

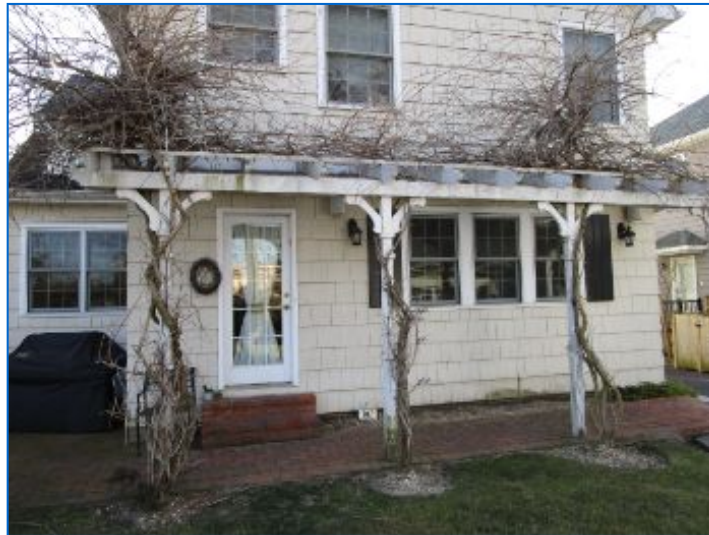
Vines can grow aggressively and can damage siding/finishes and provide a pathway for insects. We recommend cutting back from the structure.

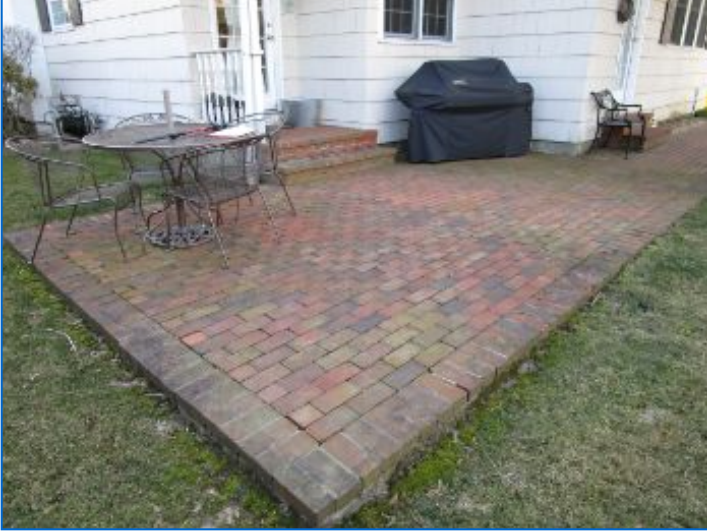
Patio/s: Brick noted.

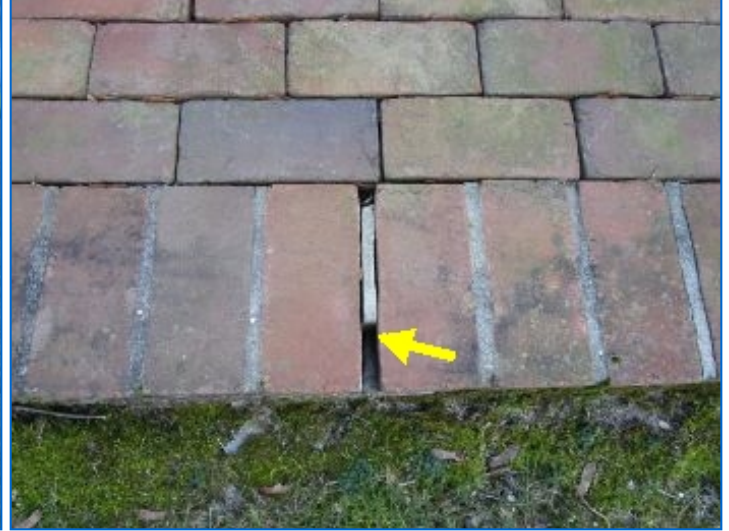
Patio was in functional condition. Minor mortar repairs suggested at border brick.
