BUILDING ANALYSIS REPORT

Property Location: *118 Lott Street*
Brooklyn, NY 11226

Date of Inspection: *1/3/2016*

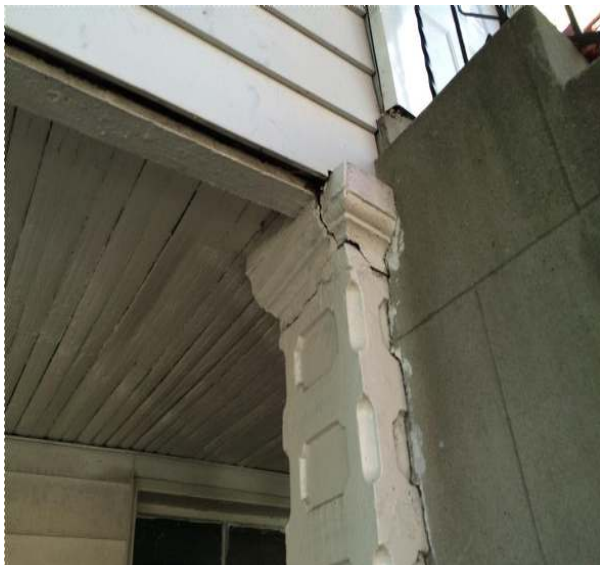
IMG_0851.JPG

originally supported by undersized header over window at left side of house had since failed to adequately support this beam (screw jacks added). Connection point of column below 2nd floor front enclosed porch is cracked due to differential settlement of the building which is also evident by the uneven floor inside this porch. Front stairs not original may have been replaced to mask structural inadequacies with the enclosed front porch and entrance as evidenced by the other observations.

Connection point of column supporting enclosed front porch is cracked due to differential settlement of the building which is also evident by the uneven floor inside this porch.

Renovate front enclosed porch; remediate slanted and open floor sections. Est'd Cost: \$10,000

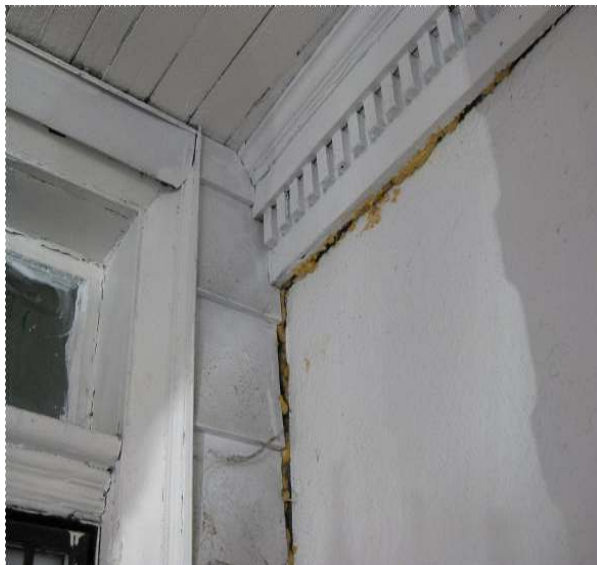
IMG_2456.JPG

Further evidence of differential settlement beneath the enclosed front porch. Also observed by the uneven floor inside this porch.

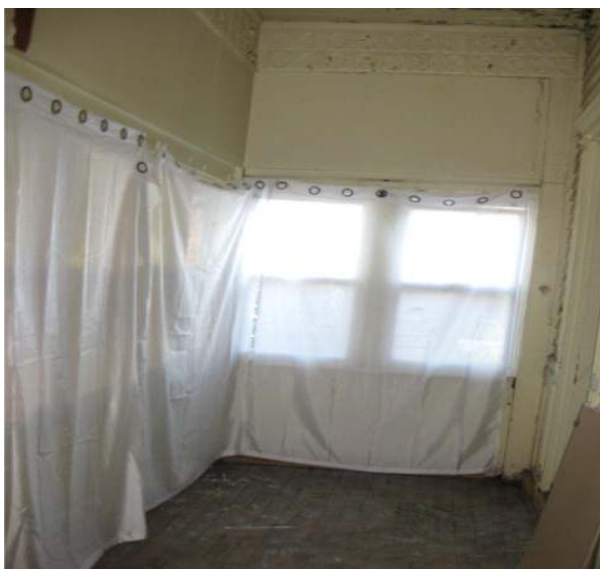
IMG_2545.JPG

Enclosed front porch has a very uneven floor caused by differential settlement evidenced by cracked column connection and gap in outside wall below at front of house.

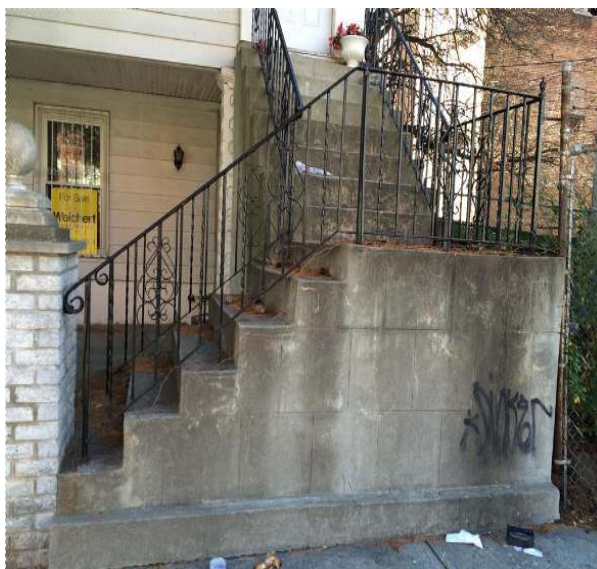
IMG_0835.JPG

Front stairs not original may have been replaced to mask structural inadequacies with the enclosed front porch and entrance as evidenced by the other observations.

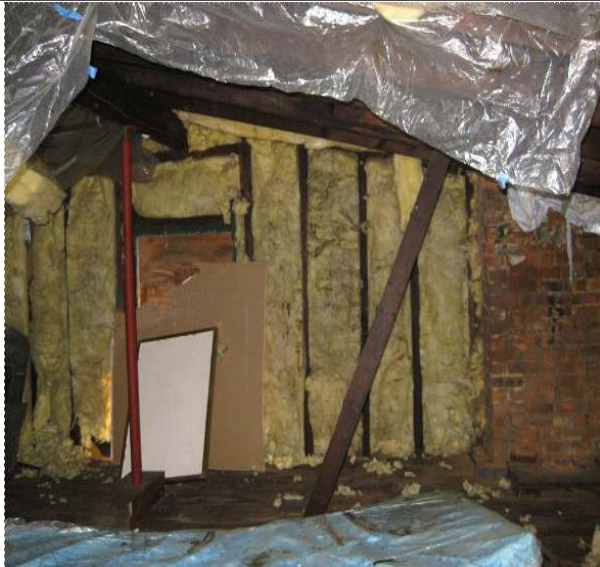
IMG_2556.JPG

Roof ridge beam originally supported by undersized header over window at left side of house had since failed to adequately support this beam. Screw jack was added.

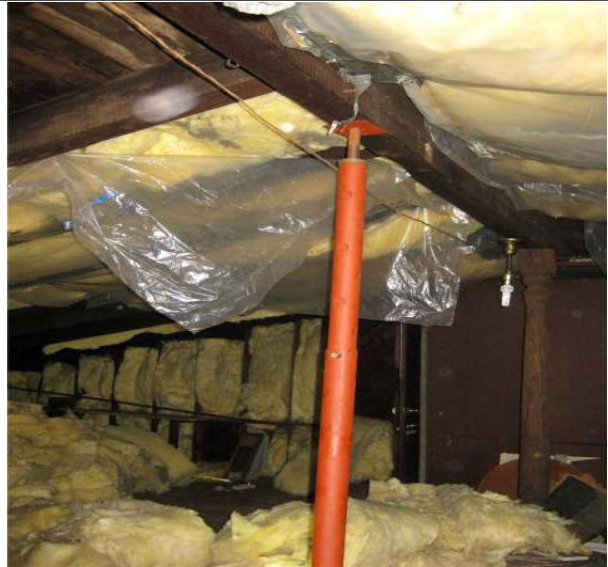
IMG_2560.JPG

Screw jack columns at two locations in attic added to support roof ridge beam.

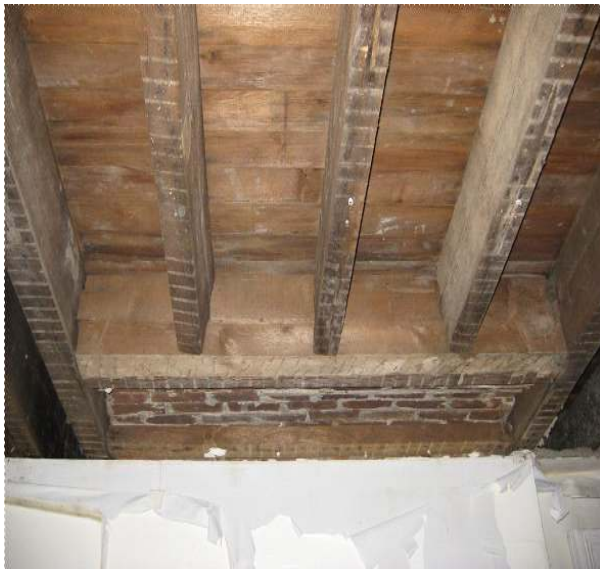
IMG_2509.JPG

Exposed floor joist for 2nd floor are of solid heavy construction and appear in good condition.

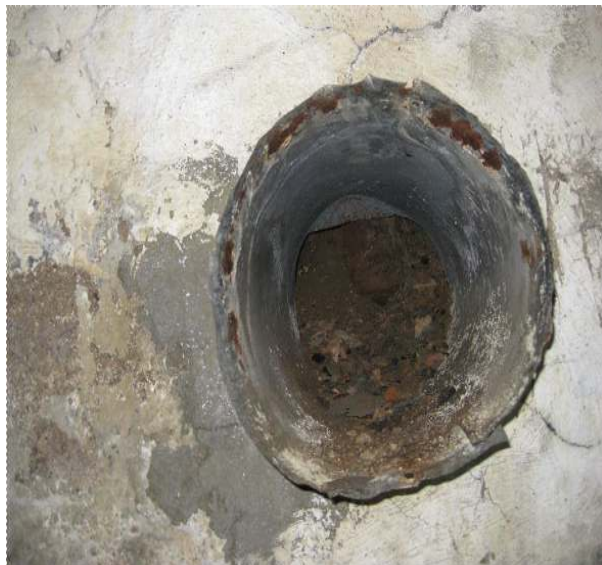
IMG_2490.JPG

Flue connection blocked. Recommend chimney sweep contractor to clear and inspect chimney liner.

Chimney sweep contractor to clean chimney, and make necessary repairs including re-pointing, crown cement, liner and rain cap. Est'd Cost: \$2,500

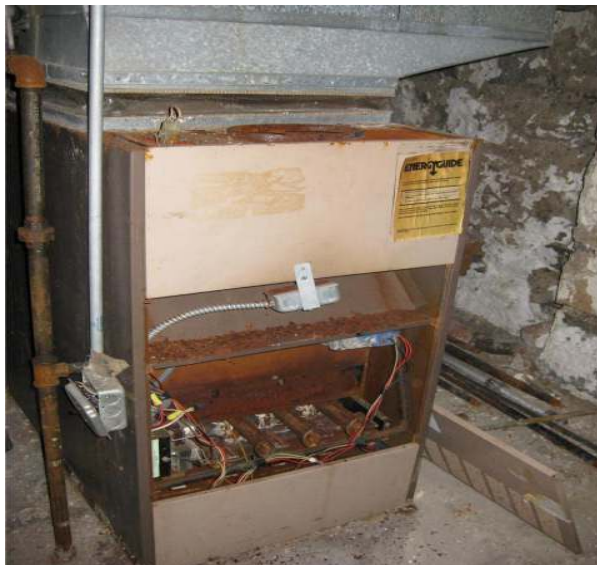
IMG_2491.JPG

Abandoned gas-fired hot air furnace is inoperable with flue connection removed. Suggest qualifier contractor to replace and certify a new hot air furnace.

Replace existing furnace with a new 200,000 btuh gas-fired forced hot air furnace and humidifier; Ductwork contractor to clean ductwork interior, make misc. repairs to registers, dampers and insulation. Est'd Cost: \$7,500

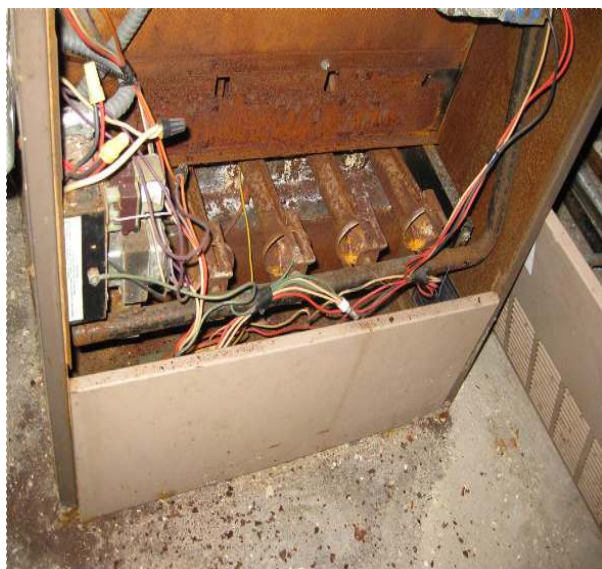
IMG_2493.JPG

Rusted burner section of hot air furnace.

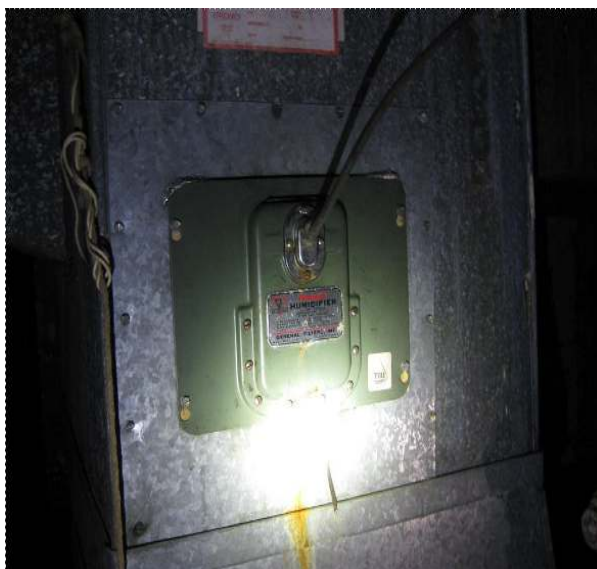
IMG_2496.JPG

Hot air furnace humidifier to be updated. Suggest ductwork contractor to clean and inspect ductwork interior.

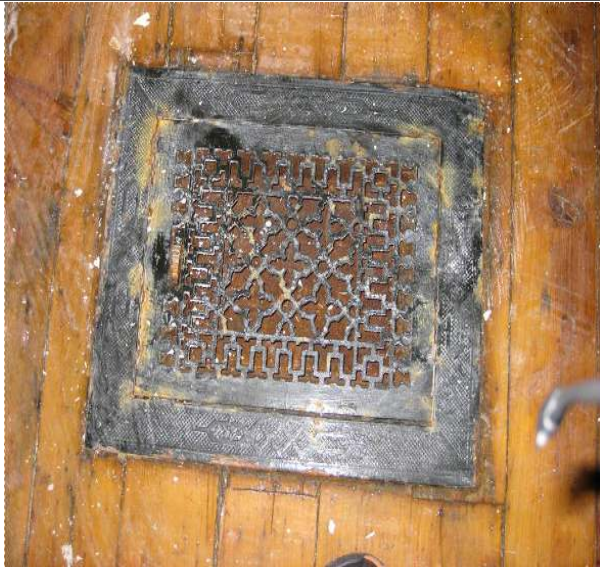
IMG_2520.JPG

Some of the older floor supply grille dampers are rusted and inoperable.

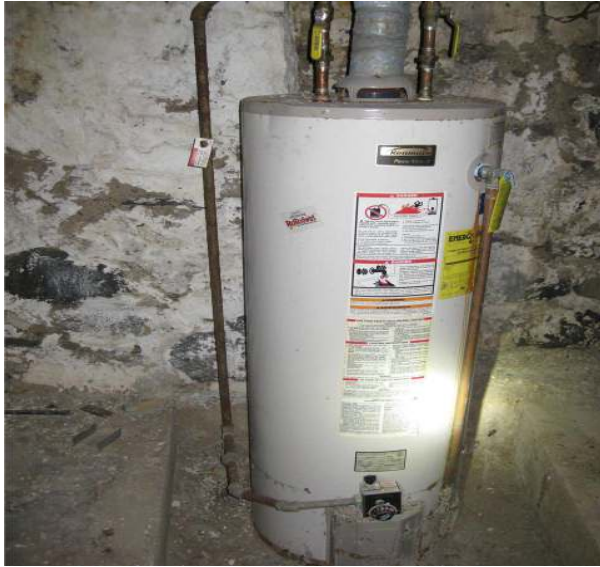
IMG_2488.JPG

Abandoned 18 yr old 50 gal. hot water heater not operated in about 3 yrs - suggest replacing.

Replace 50 gal. gas-fired hot water heater with new 80 gal hot water heater; Provide misc. plumbing repairs in homes. Est'd Cost: \$4,000

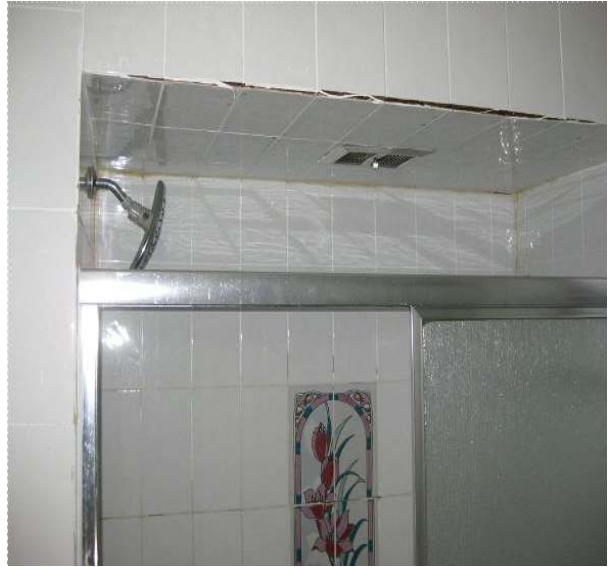
IMG_2498.JPG

Bathroom #1: shower ceiling is damaged with signs of water entry from roof leakage.

Updates and repairs suggested for both bathrooms. Option-1: provide misc. repairs and exhaust fans for each bathroom; Option-2: completely renovate each bathroom. Est'd Cost: \$5,000 - \$30,000

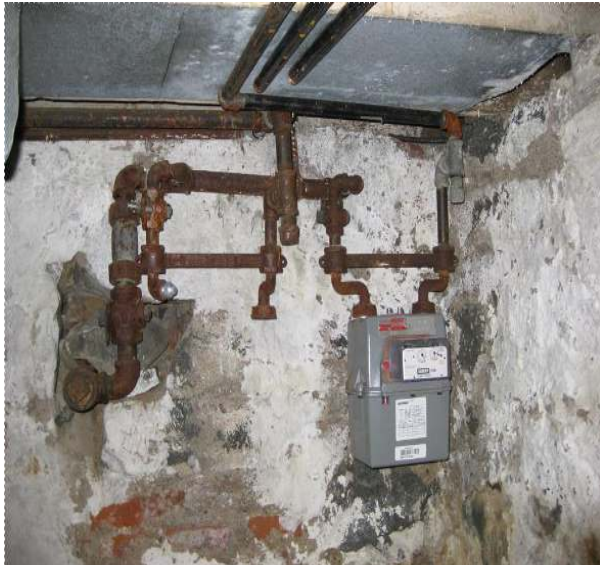
IMG_2478.JPG

Piping hook-up can be used for two separat gas services. One gas meter currently.

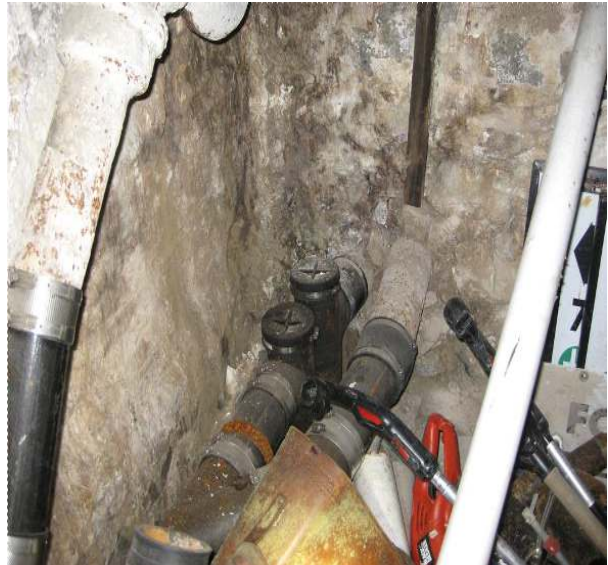
IMG_2480.JPG

House sanitary waste line and vent exit through foundation with house trap. Drain connection at left believed to be from abandoned roof downspout connection outside.

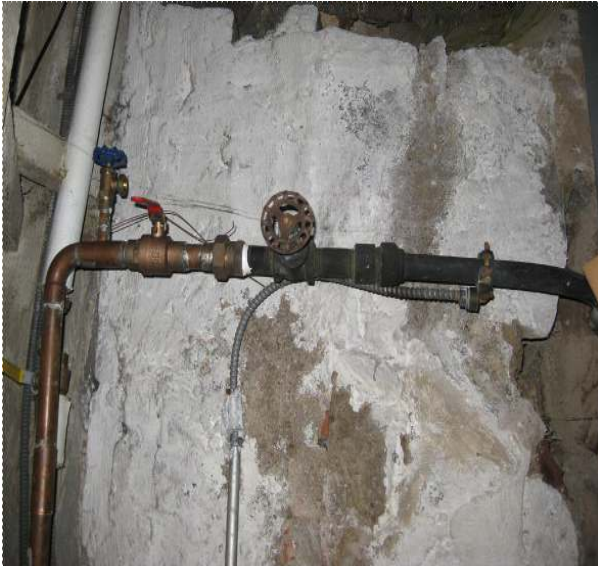
IMG_2486.JPG

Water service turned off, no meter in basement. Electrical ground connection noted.

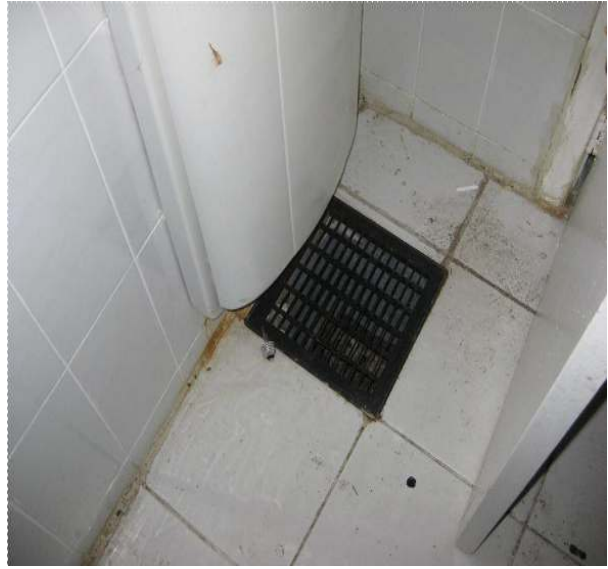
IMG_2500.JPG

Signs of water entry from roof leakage as indicated by rust drip stain on floor tile grout.

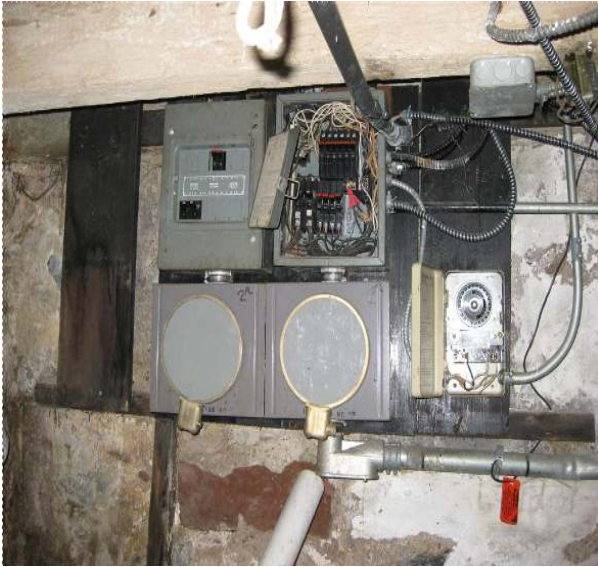
IMG_2479.JPG

Electrical service is split into two service accounts with meters removed from their meter pans.

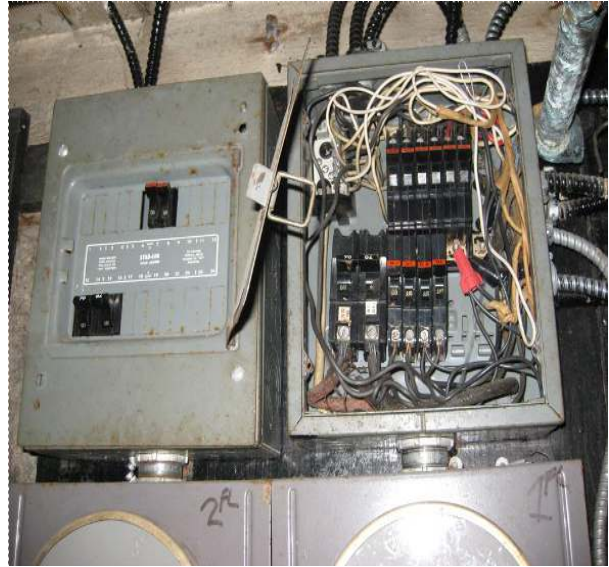
IMG_2481.JPG

Two 70 amp each panels serving the two apartments. Limited number of circuits based on the size of the home. Cover broken.

Upgrade the two main electrical service panels to 100 amps each and add four more circuits per apartment; Update and repair outlets and wiring as necessary based on water damage; Provide GFCI outlets in all potential wet areas; Provide CO and smoke detectors in basement and on each floor. Est'd Cost: \$8,000

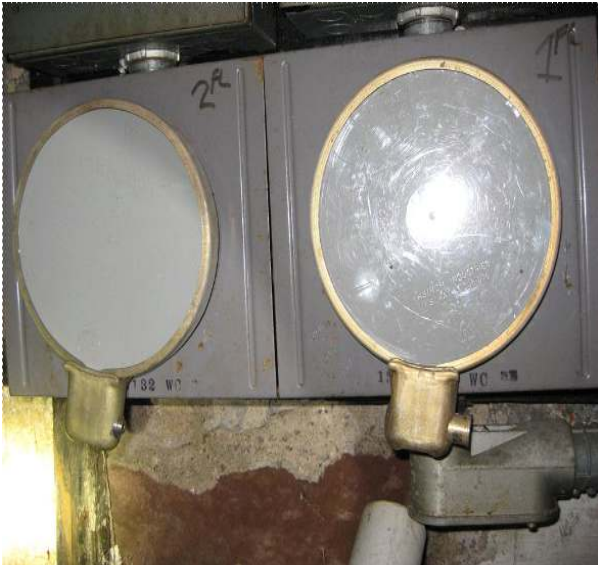
IMG_2482.JPG

Two service accounts with meters removed from their meter pans.

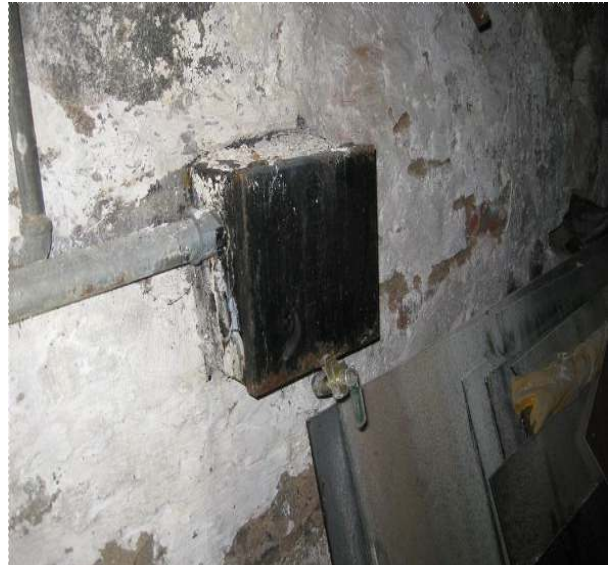
IMG_2483.JPG

Primary electrical service entry through foundation wall.

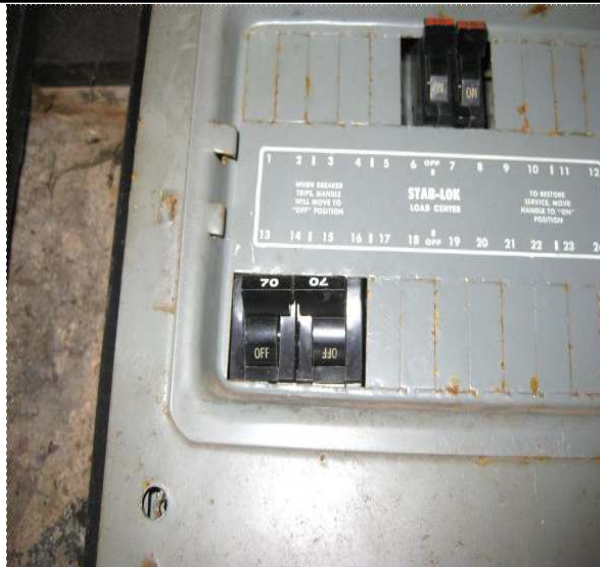
IMG_2484.JPG

70 amp main breaker for service to one apartment, or section of the house.

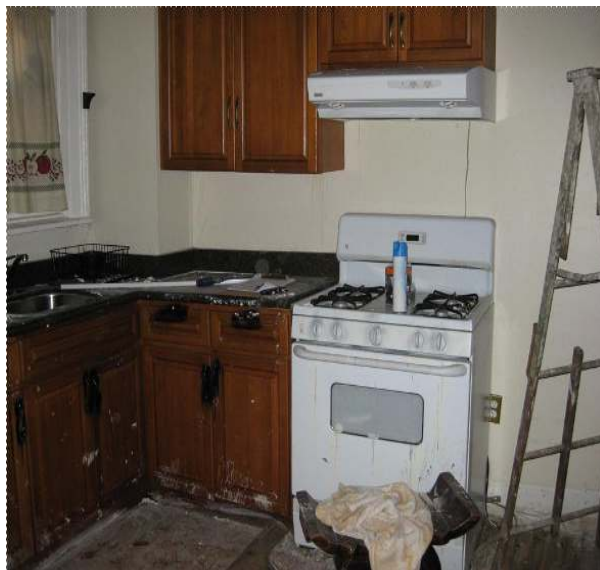
IMG_2507.JPG

Kitchen appears to be in salvageable condition with cleaning and repairs depending on the extent of the general renovation work intended.

Refurbishment of kitchens will depend on the extent of the general renovation work intended; Provide new kitchen appliances. Est'd Cost: \$8,000 - \$24,000

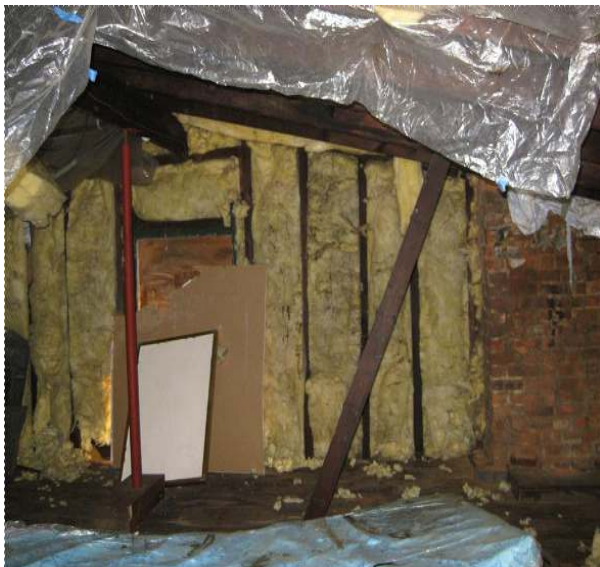
IMG_2556.JPG

Feudal repair attempts (plastic above) to mitigate ongoing water damage caused by roof leaks.

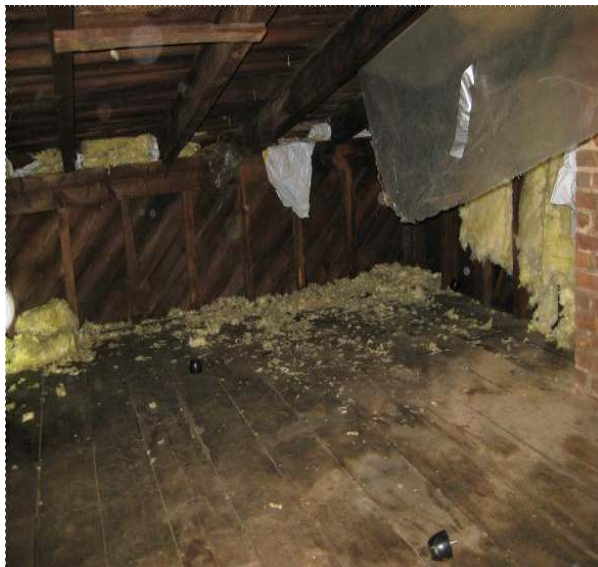
IMG_2558.JPG

Upper roof structure has 16% + moisture content due to roof leaks, however majority of this wood appears in generally good condition as seen from attic space. See Structural

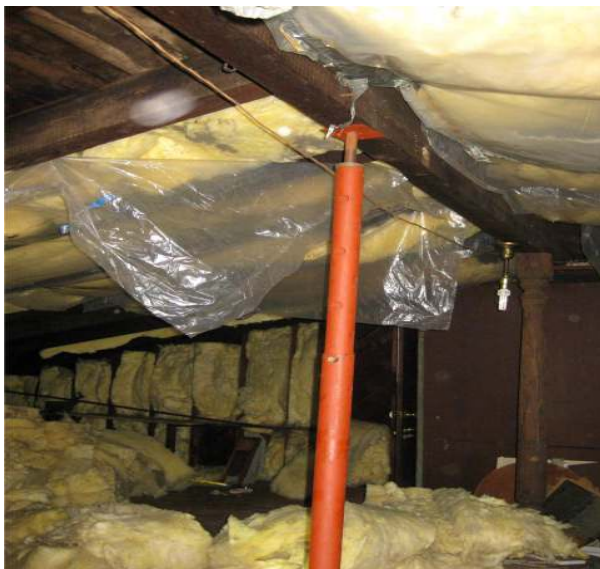
IMG_2560.JPG

Screw jack column in attic added to support ridge beam.

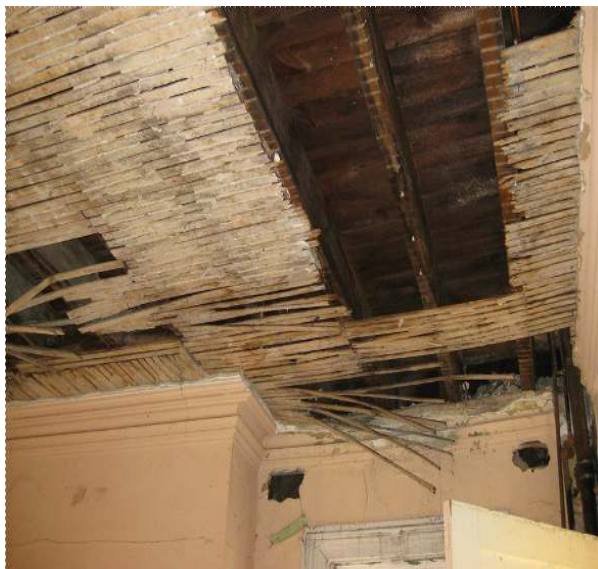
IMG_2536.JPG

Roof leaks have caused extensive water damage to the old plaster and lath construction on ceilings and walls.

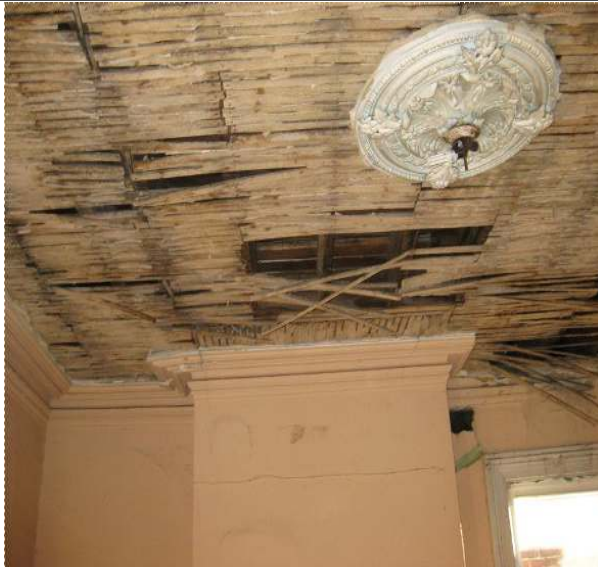
IMG_2537.JPG

It's estimated that approximately 70% of the ceilings are affected and need replacing.

Replace approximately 70% of the plaster ceilings and approximately 30% of the plaster walls 1/2" with sheetrock; Provide 3'5" min thick batt insulation in walls (and ceilings for sound proofing); Restore other plaster and painted wood surfaces by resurfacing/refinishing or applying 1/4" sheetrock overlay and finishing as applicable. Repair damaged structural studs and floor boards; Replace approximately 65% of the hardwood flooring; Resurface and refinish salvageable hardwood flooring. Rooms with extensive damage particularly on the first/second floors will require complete gut renovation. Est'd Cost: \$220,000

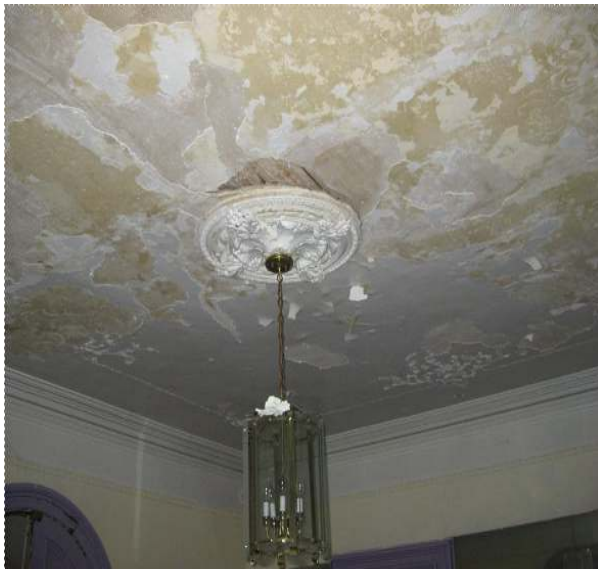
IMG_2542.JPG

Extensive water damage to the old plaster/lath ceiling. It's estimated that approximately 70% of the ceilings are affected and need replacing.

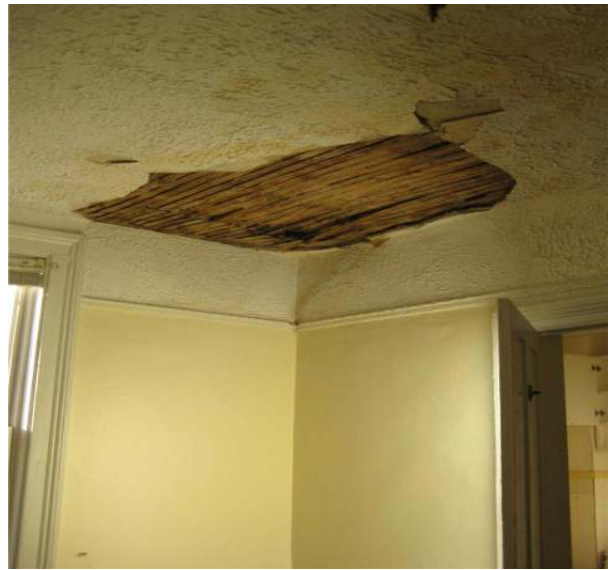
IMG_2550.JPG

Stucco ceiling with extensive water damage to be replaced.

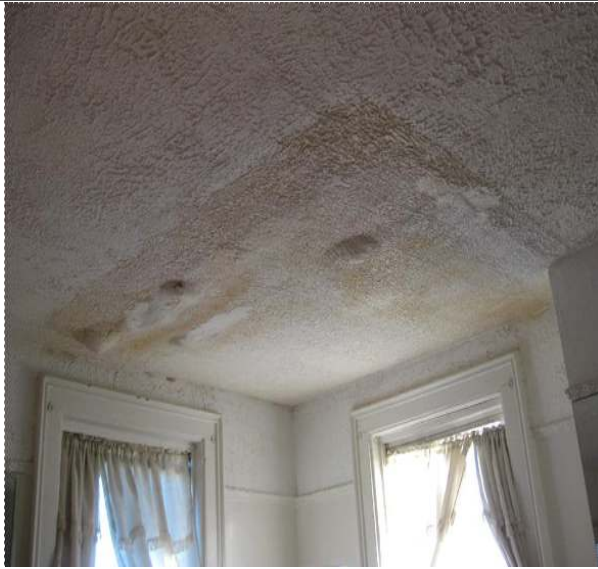
IMG_2551.JPG

Stucco ceiling with extensive water damage to be replaced.

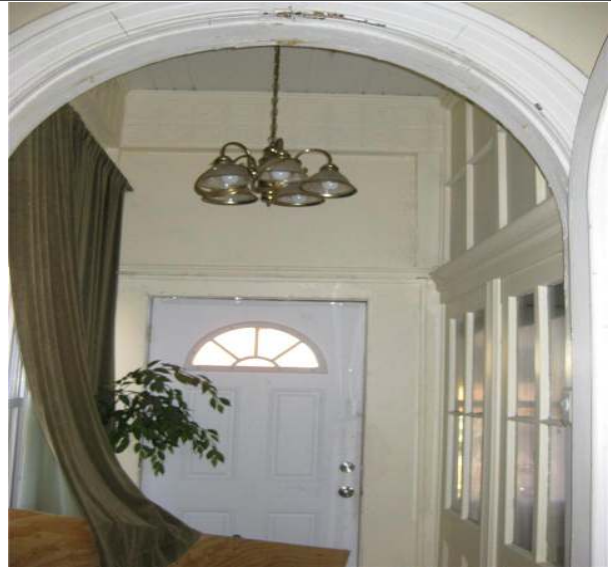
IMG_2546.JPG

Restoration of historic mouldings is achievable depending on surrounding water damages.

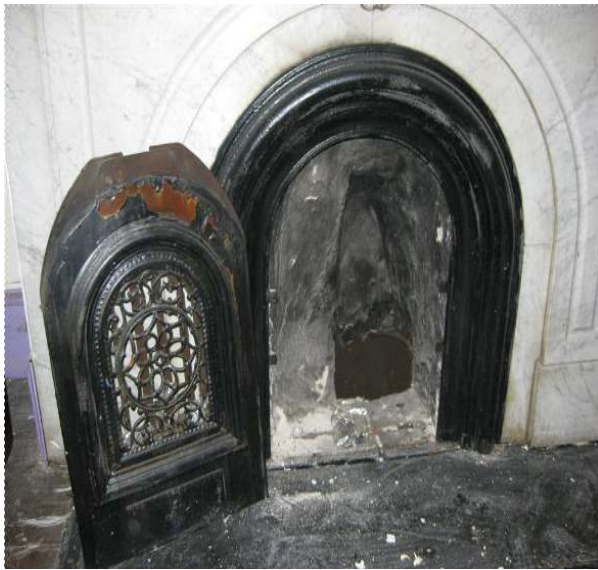
IMG_2543.JPG

2nd floor fireplace converted to a hot air outlet connected to furnace in basement, with damper and grate cover.

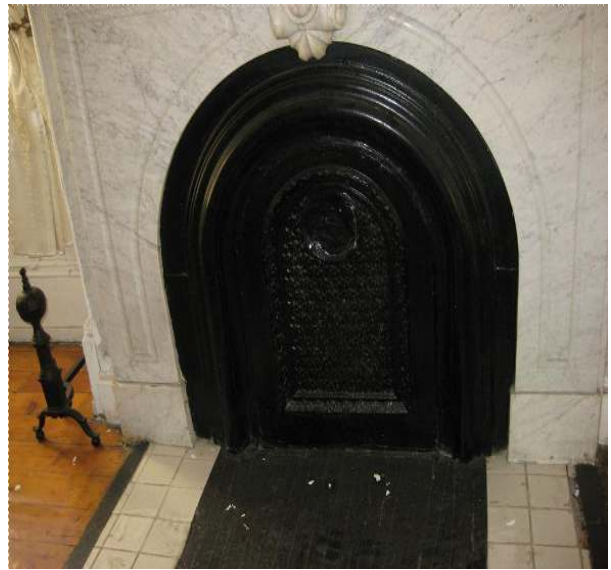
IMG_2552.JPG

3rd floor fireplace blanked off and made inoperable.

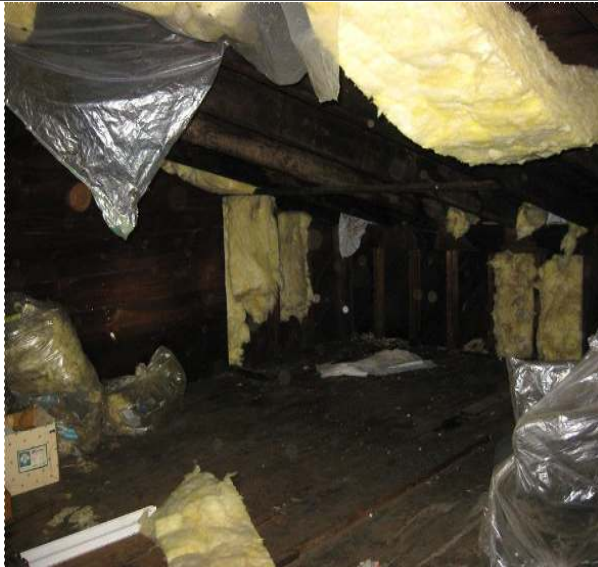
IMG_2559.JPG

Failed attempt was made to insulate the attic walls and rafter spaces.

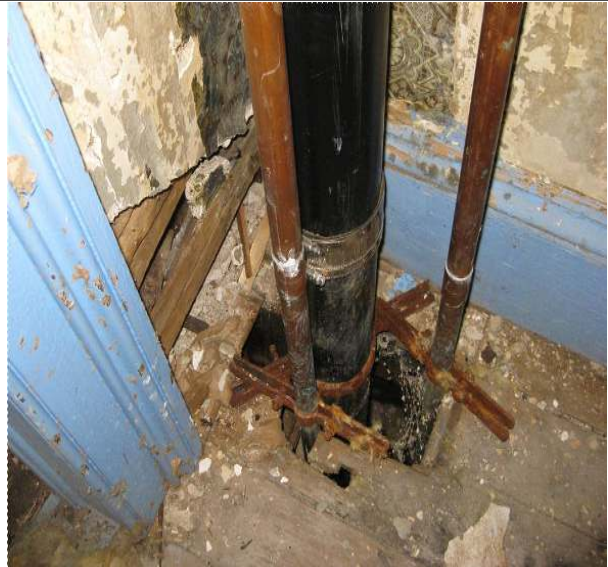
IMG_2539.JPG

Damage to underlying studs and floor boards can be repaired.

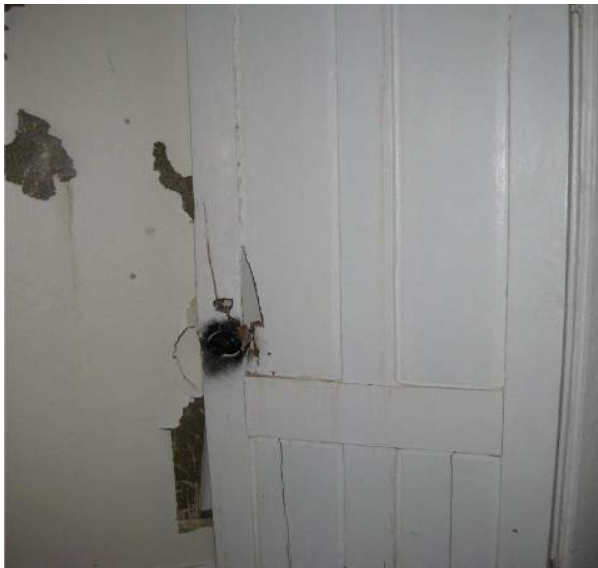
IMG_2517.JPG

Interior door damaged. Some do not close completely, others are stuck closed due to water penetration. Door replacements suggested.

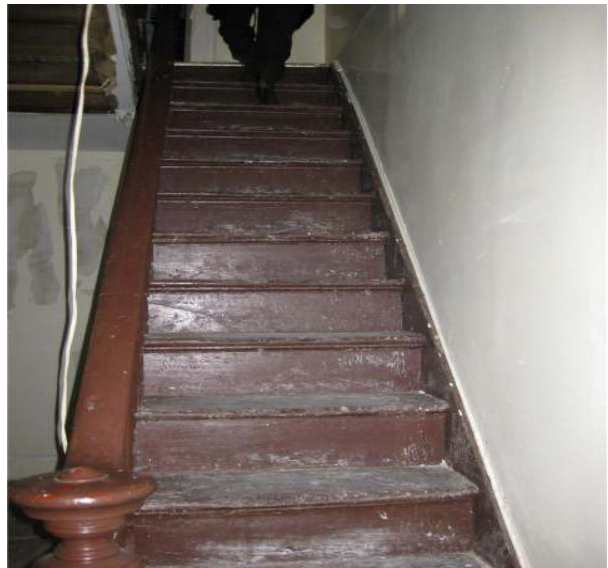
IMG_2531.JPG

Stairs to 2nd floor are slightly crooked due to structural settlement.

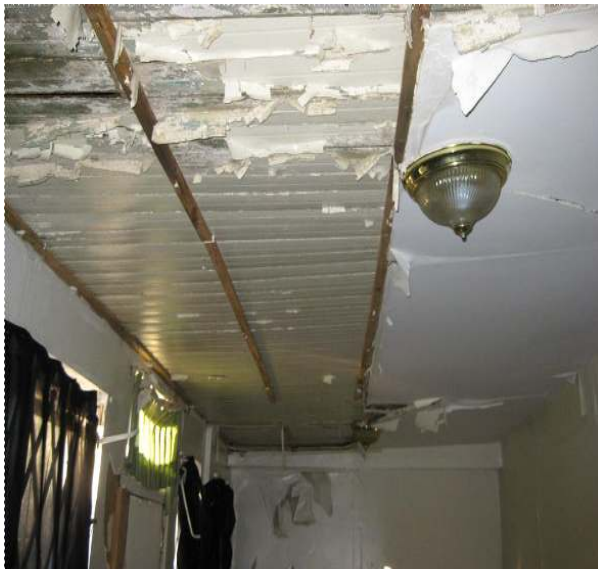
IMG_2524.JPG

1st floor rear enclosed porch has extensive water damage to ceiling walls and floor and requires gut-renovation. Windows and doors need replacing.

Gut renovate rear enclosed porch. Est'd Cost: \$20,000

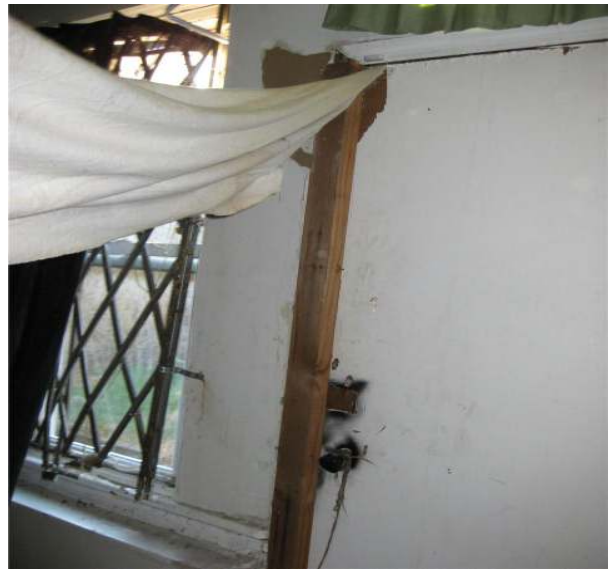
IMG_2526.JPG

1st floor rear enclosed porch door is unuseable.

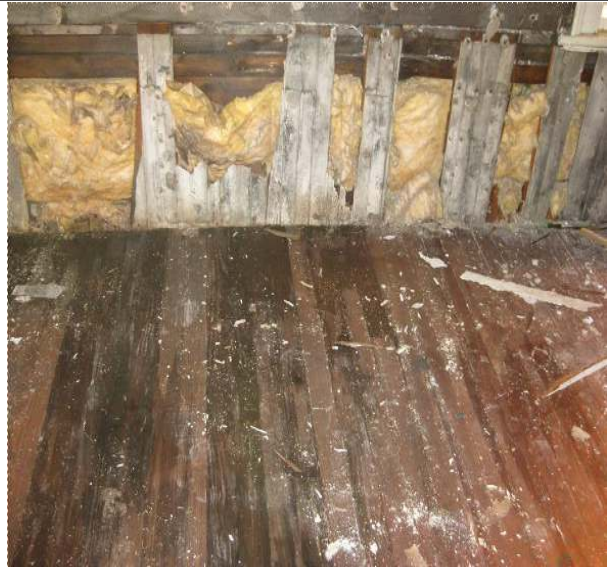
IMG_2535.JPG

Approximately 65% of the hardwood flooring has been impacted and will require replacement. Approx. 30% of the walls are affected and will need replacing.

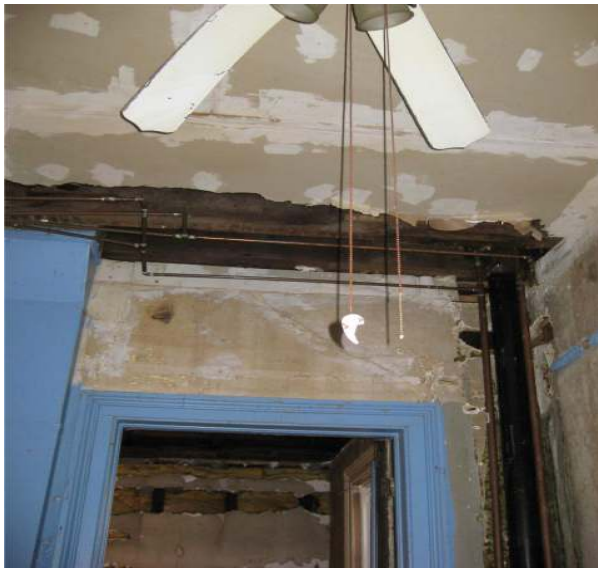
IMG_2538.JPG

Plumbing pipes exposed due to destruction to enclosure caused by the water damage.

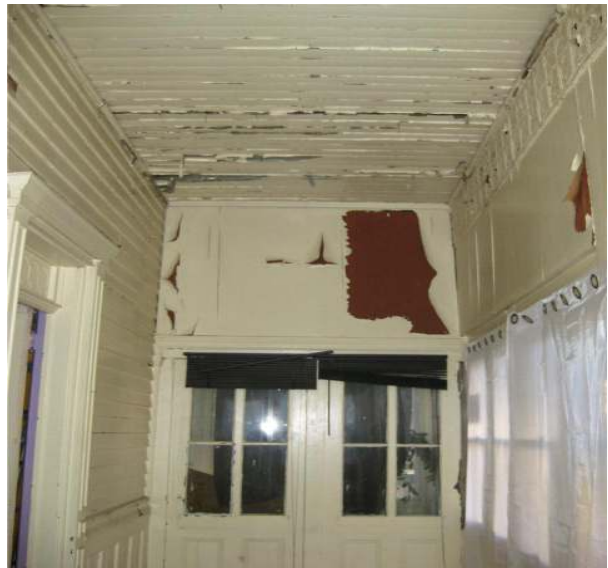
IMG_2544.JPG

2nd floor foyer paint delaminated due to neglect and moisture.

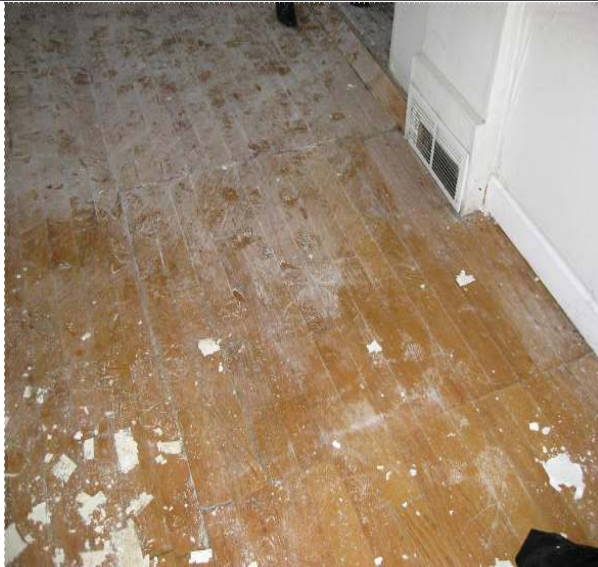
IMG_2523.JPG

Some hardwood floors can be resurfaced and refinished.

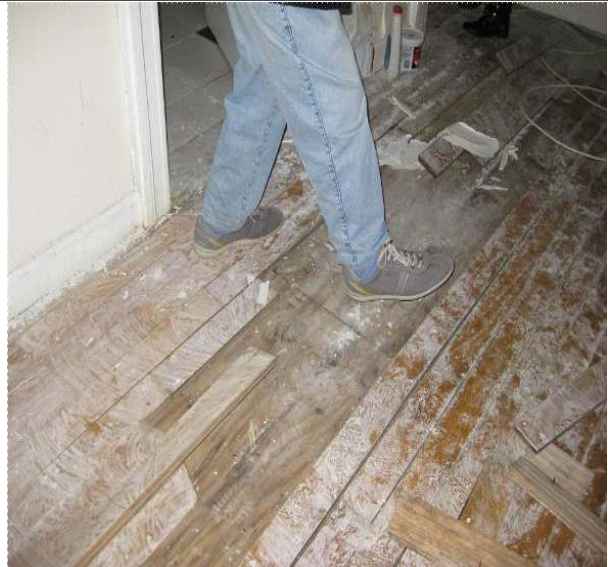
IMG_2527.JPG

Approximately 65% of the hardwood flooring has been impacted and will require replacement.

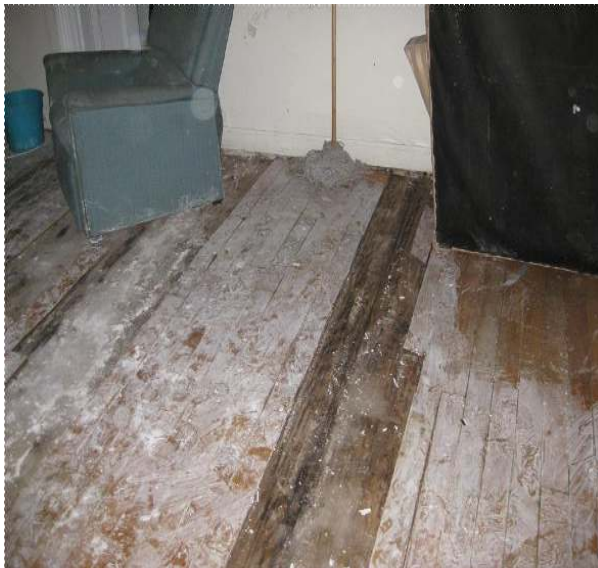
IMG_2511.JPG

Approximately 65% of the hardwood flooring has been impacted and will require replacement.

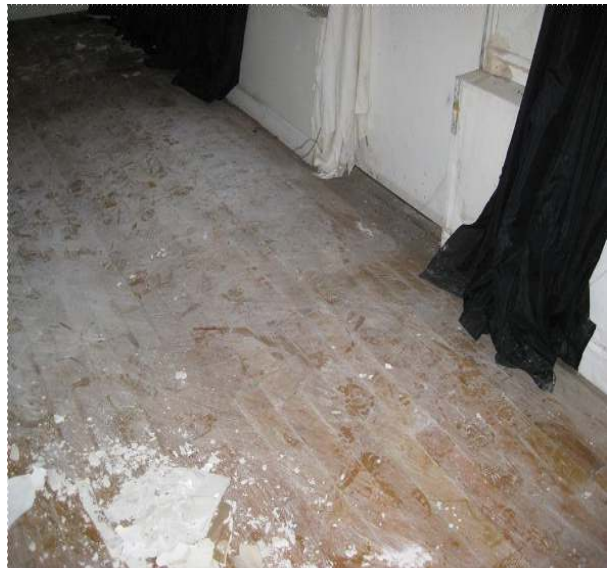
IMG_2525.JPG

1st floor rear enclosed porch hardwood flooring has expanded and buckled upward 5-6 inches above the subfloor from water penetration.

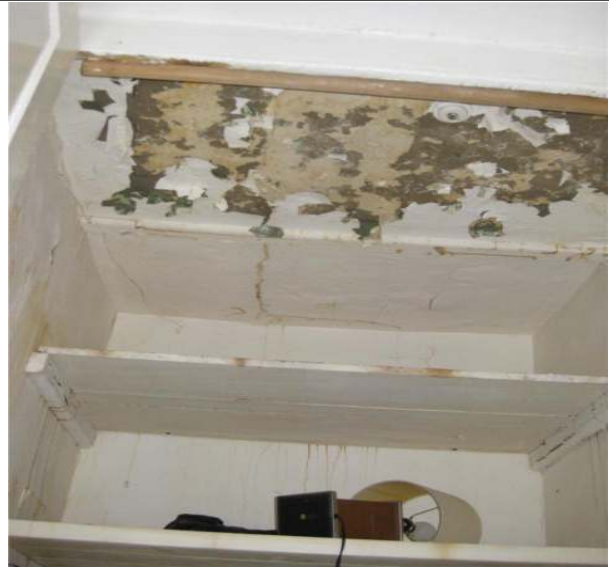
IMG_2521.JPG

Photo shows typical condition in closets.

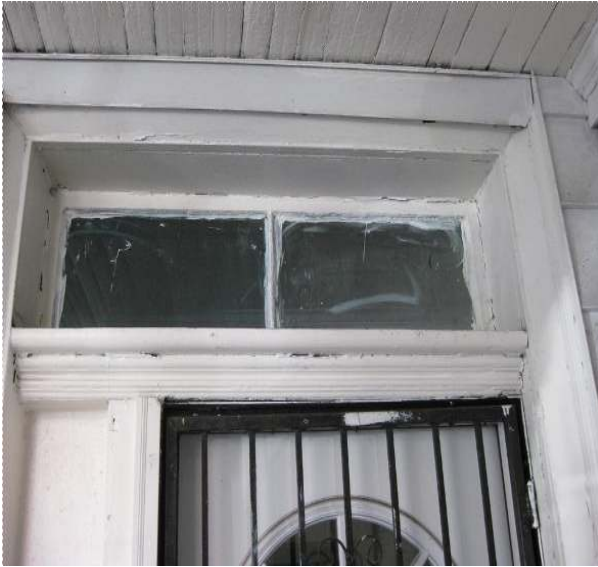
IMG_2457.JPG

Old style single pane exterior transom windows are inefficient.

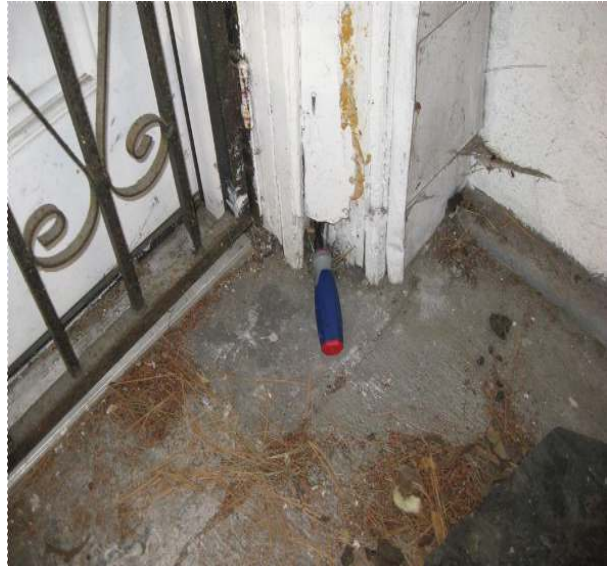
IMG_2459.JPG

Front door jamb and trim is badly deteriorated (dry rot).

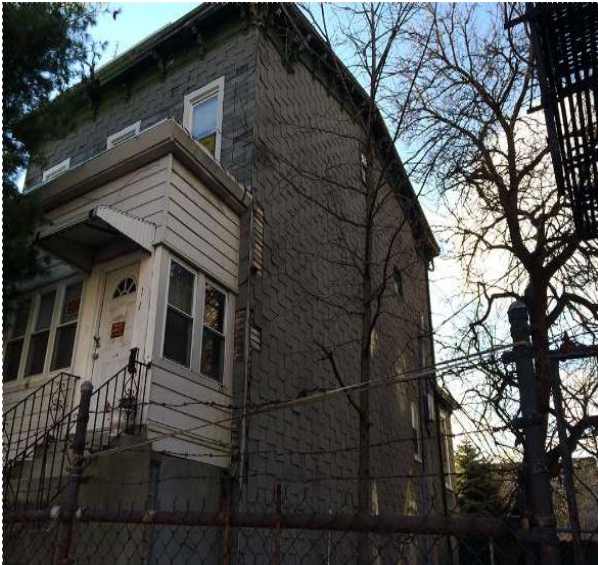
IMG_0837.JPG

Right Side: Old asphalt wall covering is extremely degraded with pieces falling off, exposing the unprotected clapboarding beneath.

Replace old asphalt exterior wall covering with vapor barrier, (rigid insulation) and new siding (vinyl); Repair damaged clapboarding beneath; Repair damaged stucco cement at foundation wall and paint. Est'd Cost: \$45,000

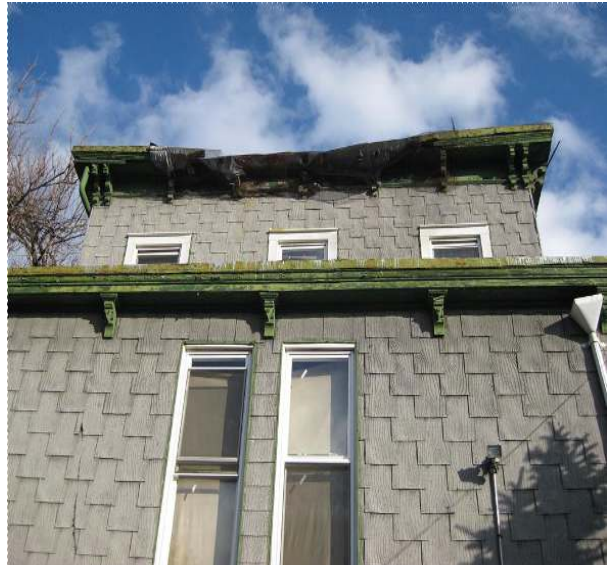
IMG_2464.JPG

Collapsed roof edge at back of house caused by ice damming and subsequent roof leakage.

Replace roof: Reusing the rafters Repair damaged roof boards provide new roof membrane, ice shield, flashing and attic venting; Repair collapsed roof edge at back of house; Replace fascias and capping, repair soffits, cornices and paint; Provide new roof drainage system and downspouts. Est'd Cost: \$37,000

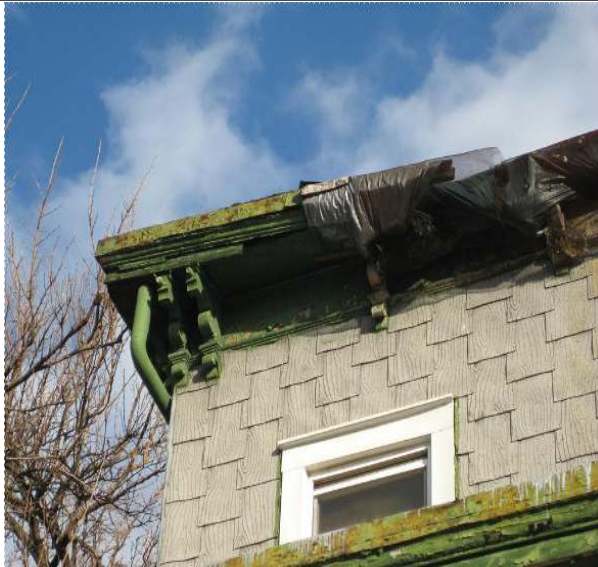
IMG_2467.JPG

Extensive roof leakage appears to have temporary "band-aid" repairs, attempting to mitigate the continuing damage inside the structure.

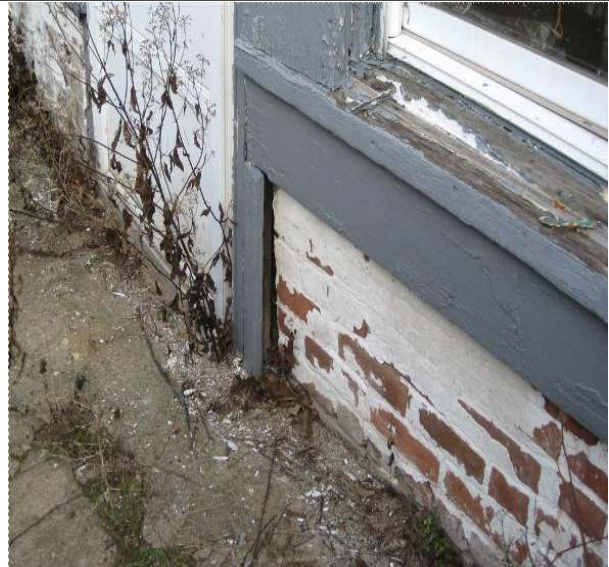
IMG_2469.JPG

Gap between trim and foundation provides access for vermine.

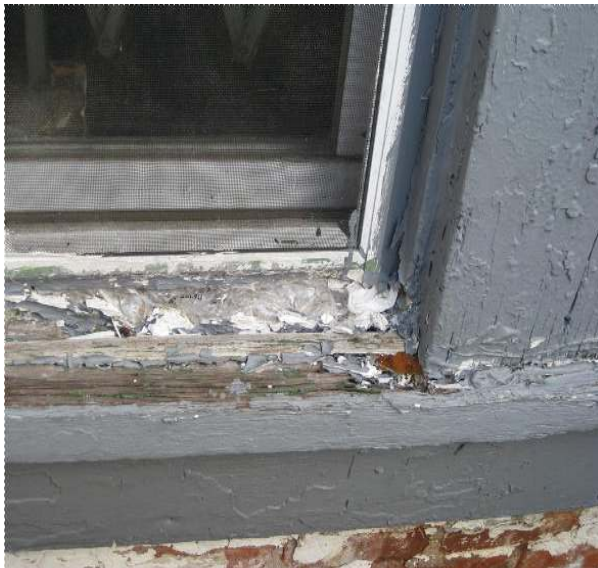
IMG_2471.JPG

Wood trim at rear windows is badly deteriorated.

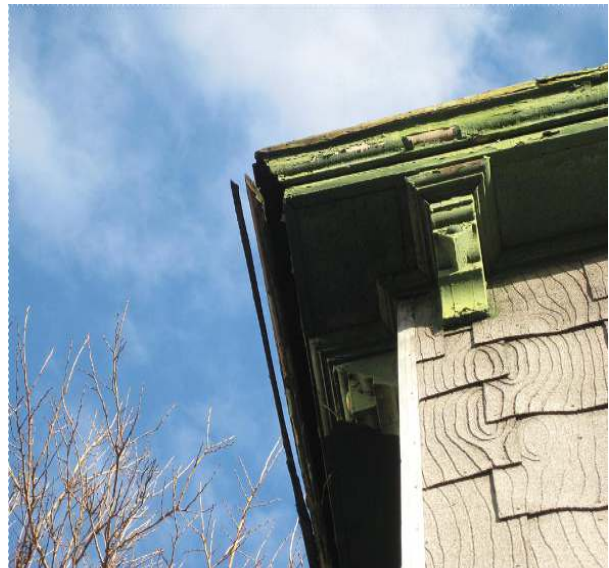
IMG_2472.JPG

Exterior trim, fascias and soffits at roof levels show deterioration.

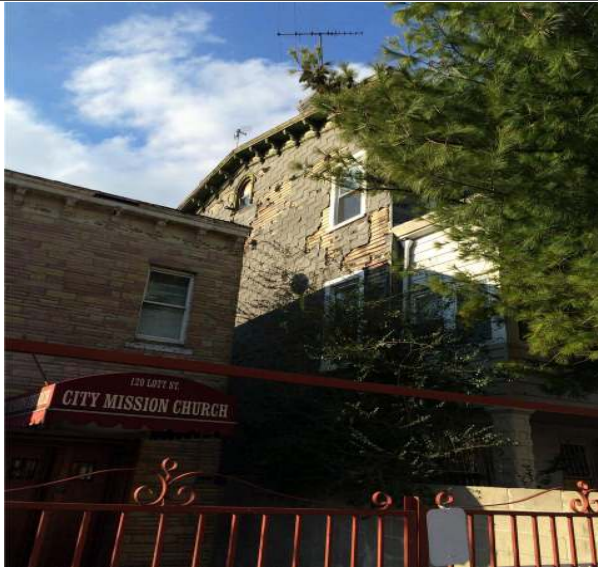
IMG_0842.JPG

Left Side: Old asphalt wall covering is extremely degraded with pieces falling off, exposing the unprotected clapboarding beneath.

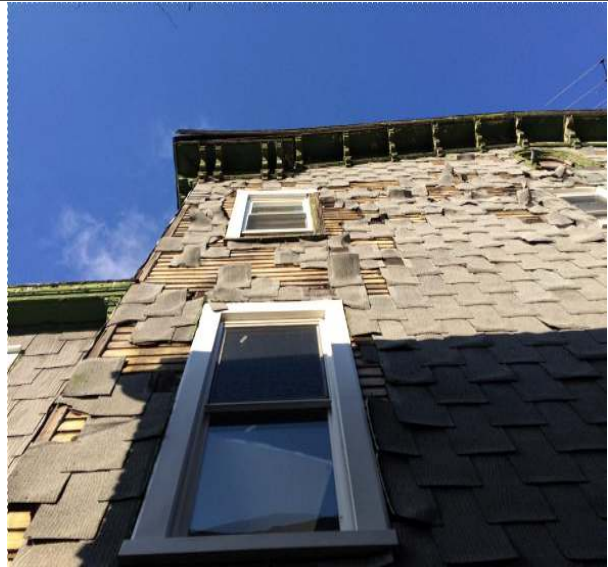
IMG_0864.JPG

Left Rear Side: Old asphalt wall covering is extremely degraded with pieces falling off, exposing the unprotected clapboarding beneath. Exterior vapor barrier is not present.
