BUILDING ANALYSIS REPORT

Property Location: *118 Lott Street*
Brooklyn, NY 11226

Date of Inspection: *1/3/2016*

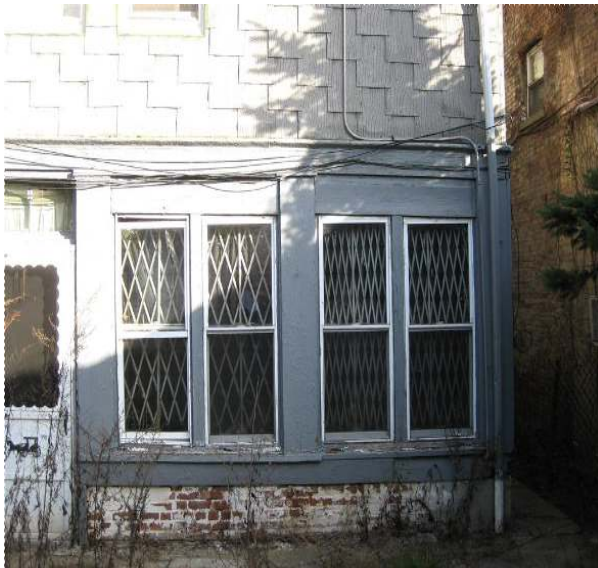
IMG_2462.JPG

Stucco at foundation wall is missing at back of house.

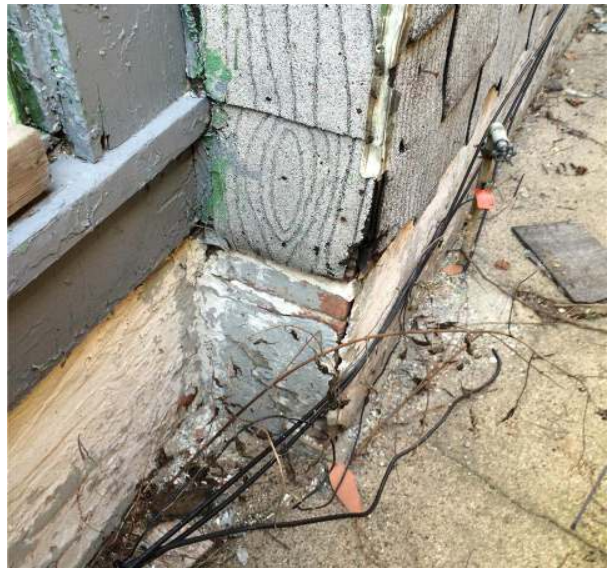
IMG_0872.JPG

Stucco at foundation wall is damaged at several locations.

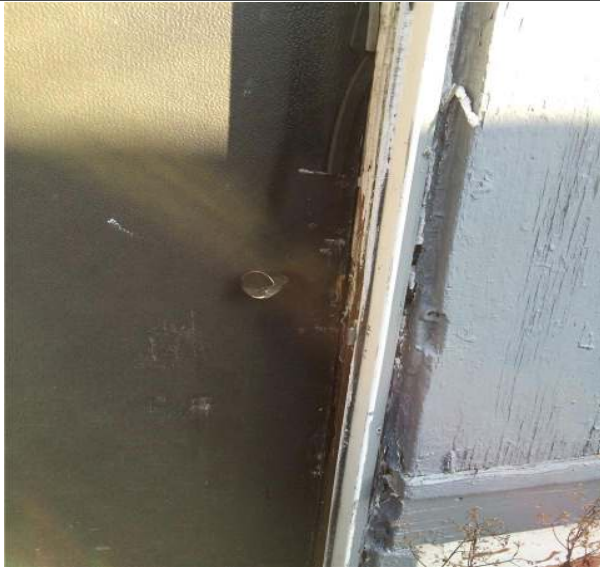
IMG_0868.JPG
Rear door is not useable.

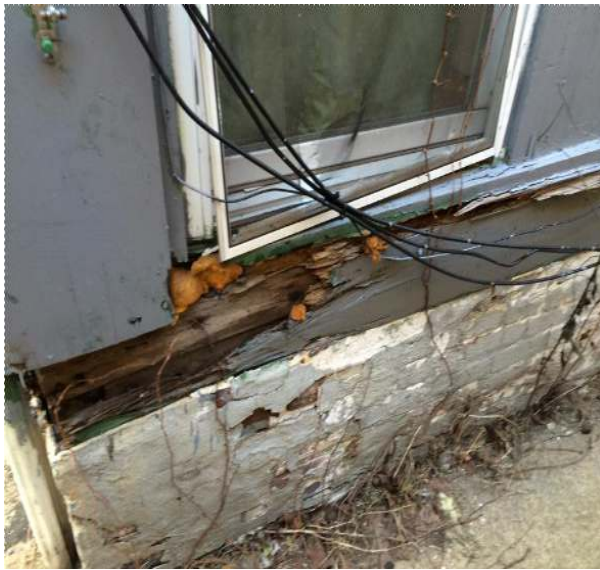
IMG_0866.JPG
Wood trim at rear windows is badly deteriorated.

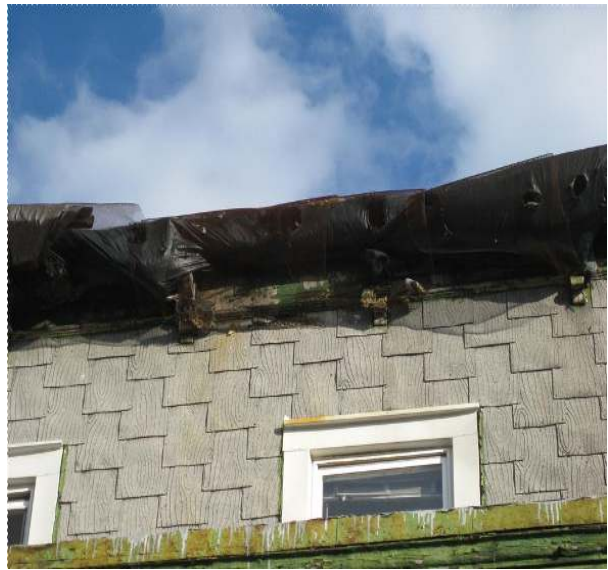
IMG_2466.JPG
Rear facias and soffits at roof levels are deteriorated with some of the old-style architectural cornices missing and damaged.

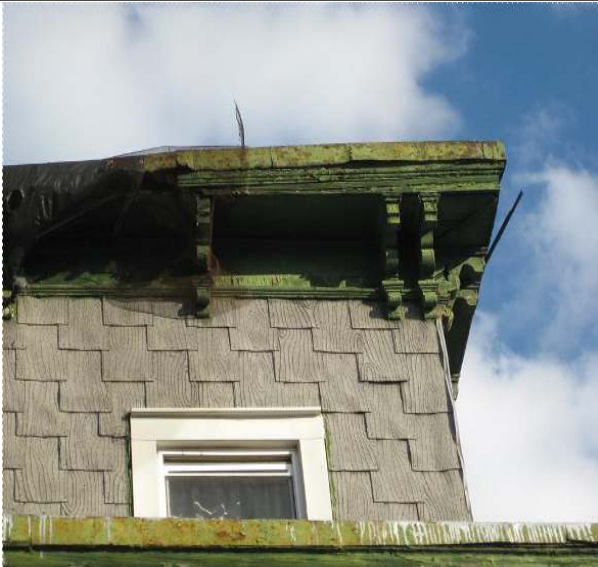
IMG_2465.JPG

Facias, capping and soffits along roof edges are deteriorated with some of the old-style architectural cornices missing and damaged.

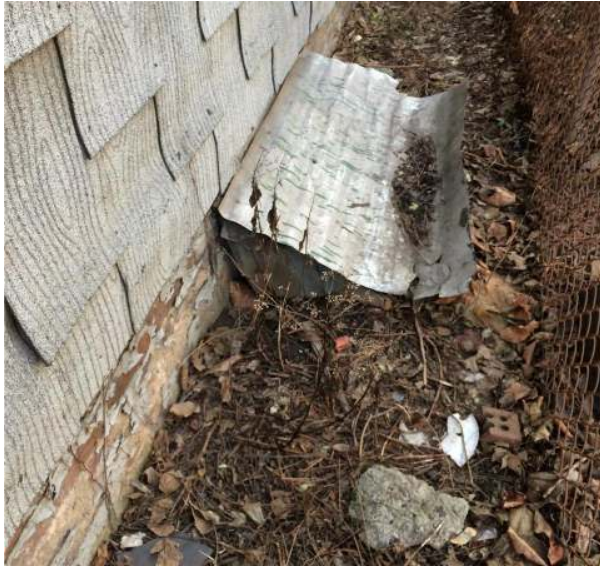
IMG_0891.JPG
Sheet metal access cover at side of house (unknown).

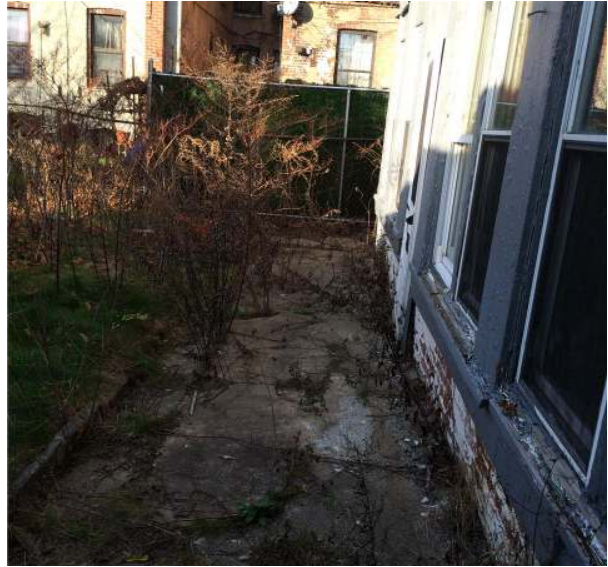
IMG_0896.JPG
Backyard concrete area is cracked.

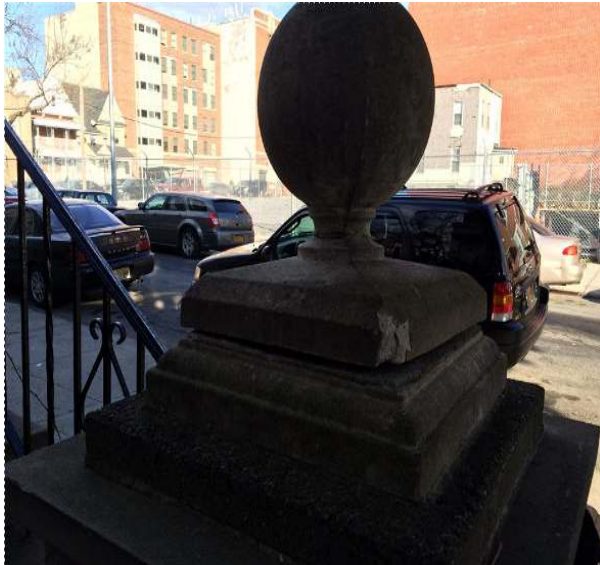
IMG_0849.JPG
Concrete ball ornament on masonry column in front yard is loose and can fall.

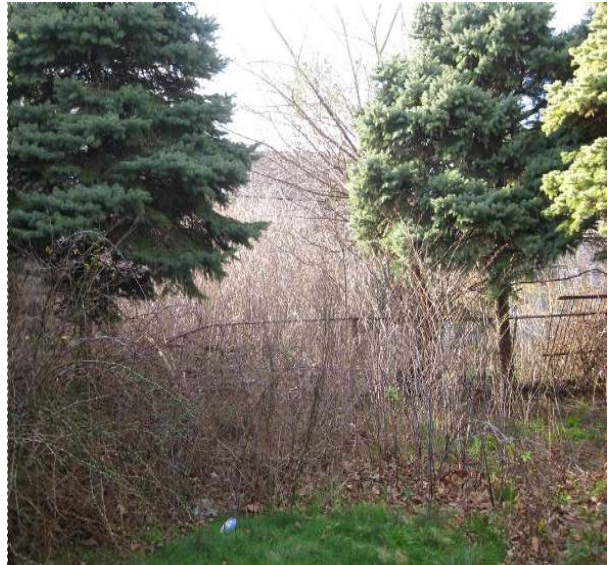
IMG_2475.JPG
Backyard is overgrown.
Fencing is old, rusty and dilapidated.

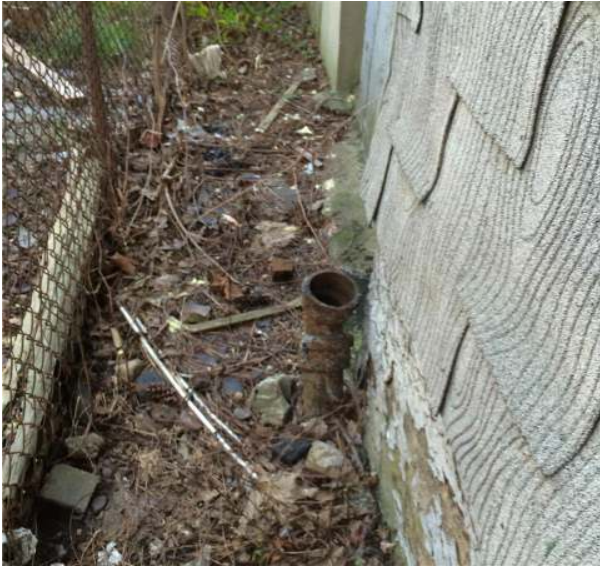
IMG_0892.JPG

Abandoned roof downspout drainage connection.
