# ProSpec Home Inspection of Long Island Property Inspection Report

213 Glenmore St, E. Williston NY, 11596  
Inspection prepared for: Name Deleted  
Date of Inspection: 3/24/2019 Time: 12:00 PM  
Age of Home: 88 yrs old  
Approx Year Built: 1930

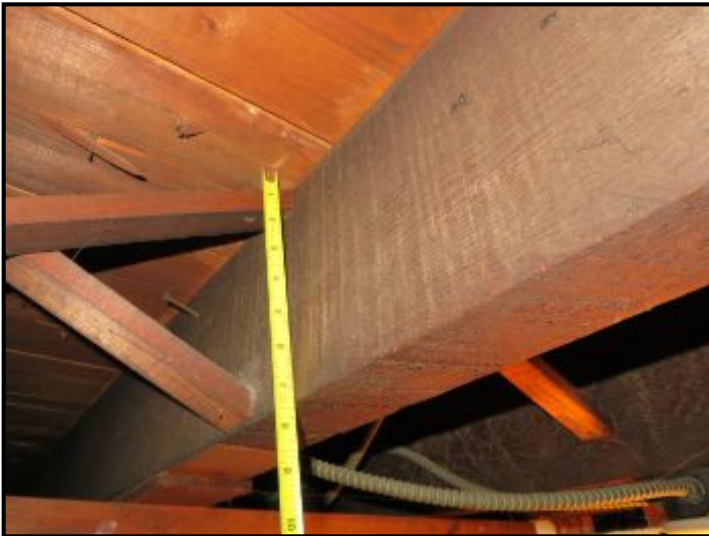
3x8 Joists 16" O.C. (w/cross braces), T&G floor boards

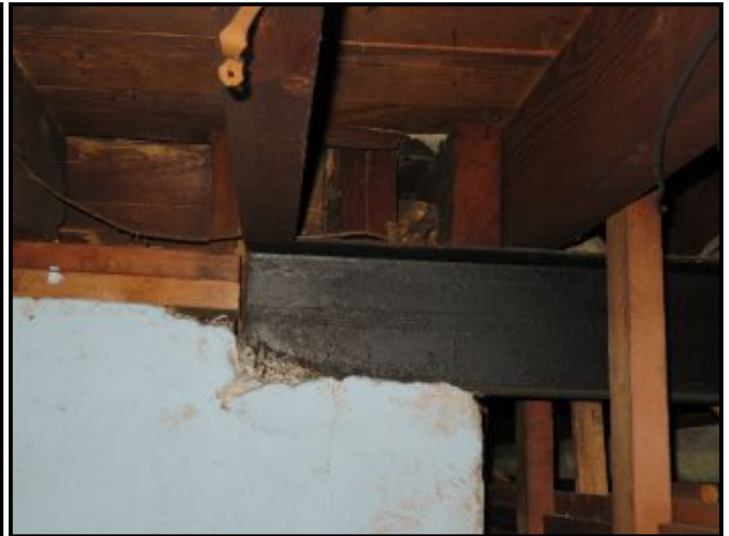
Floor Structure: Steel girder supported by foundation wall and steel lally columns, 3x8 Joists 16" O.C. (w/cross braces), T&G floor boards

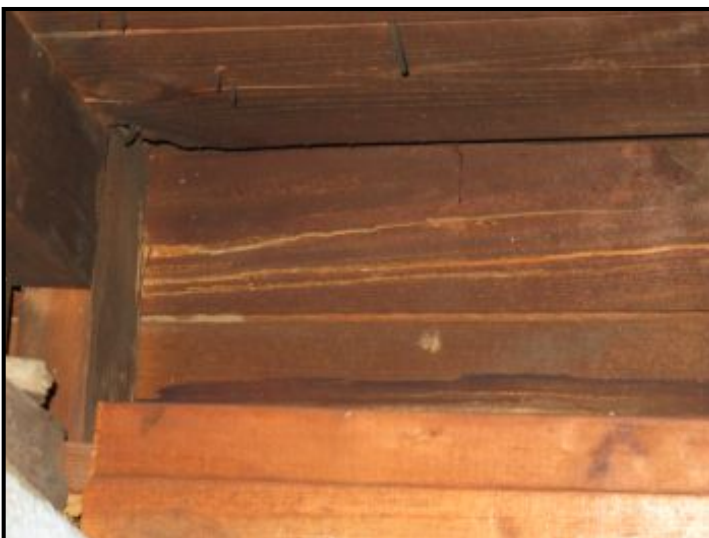
Termite damage noted at band joist, sill plate and vertical studs located in boiler room at north foundation wall. Refer to NPMA-33 report.

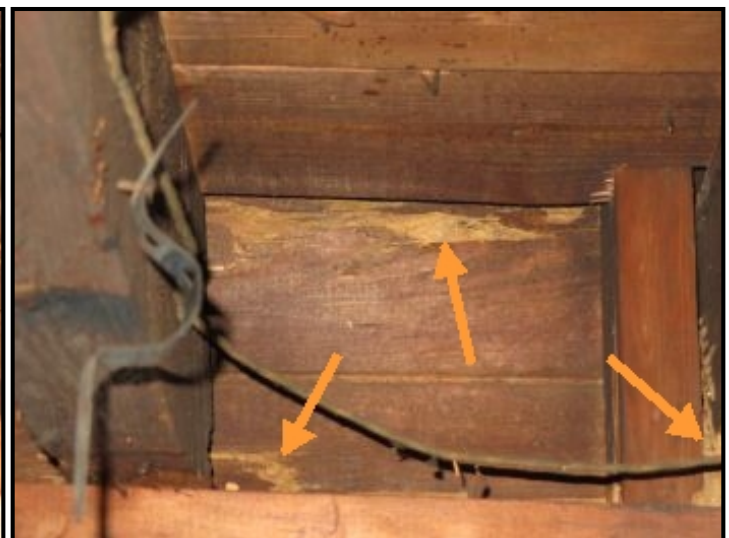
Termite damage noted at band joist, sill plate and vertical studs located in boiler room at north foundation wall. Refer to NPMA-33 report.

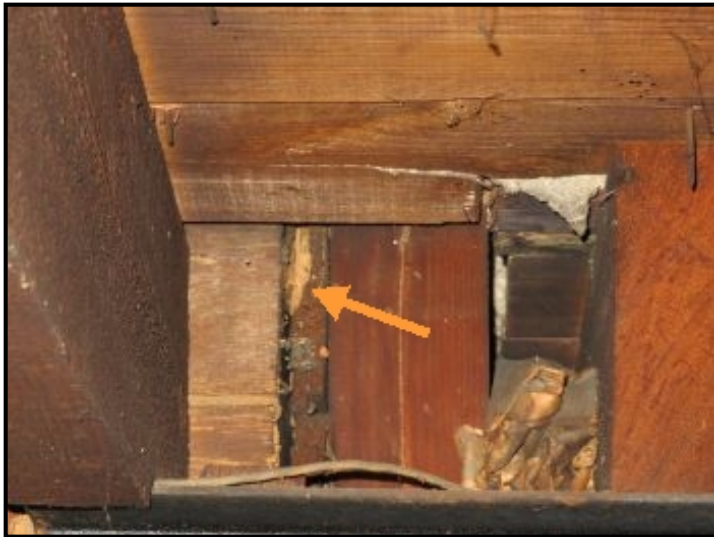
Termite damage noted at vertical studs located in boiler room at north foundation walls. Refer to NPMA-33 report.

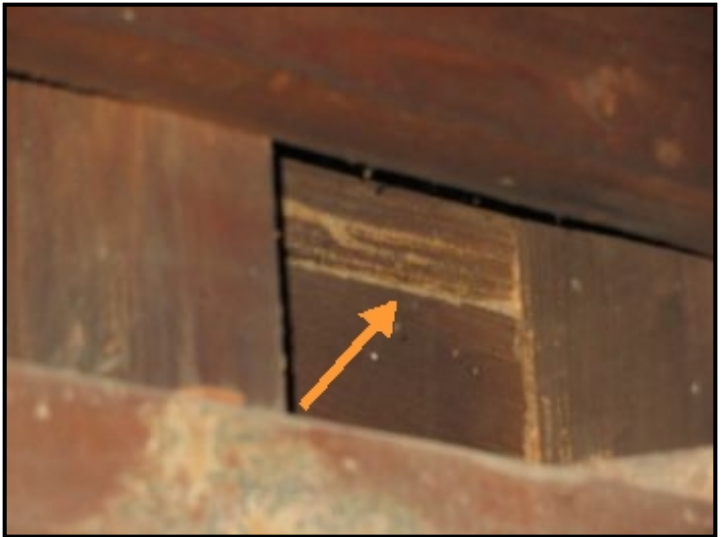
Termite damage and activity noted at west wall in boiler. Refer to NPMA-33 report form.

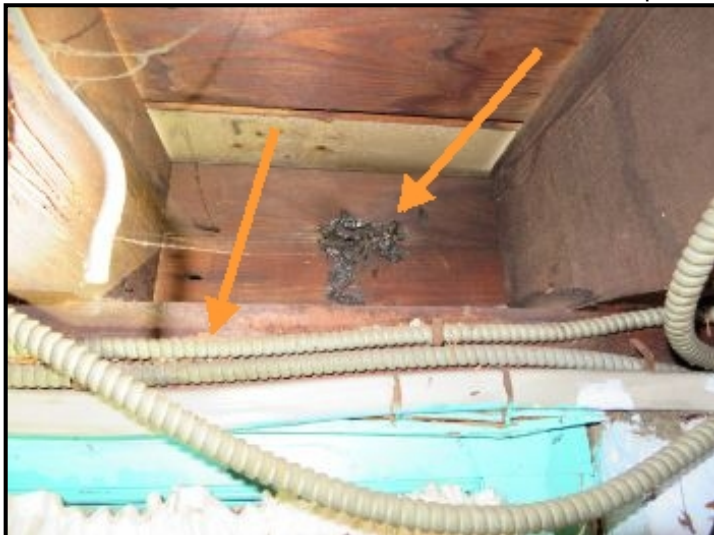
Termite damage noted at band joist and sill plate located in boiler room at south foundation wall.

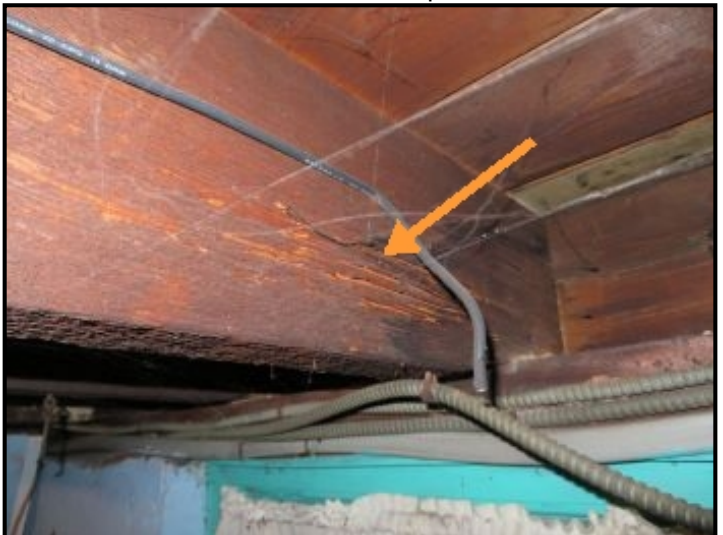
Termite damage noted at joist and sill plate located in boiler room at south foundation wall. Refer to NPMA-33 report.

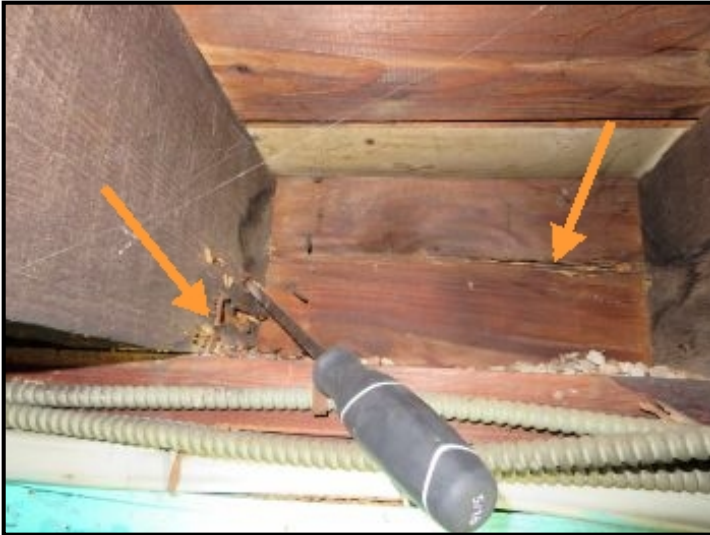
Termite damage noted at joist and sill plate located in boiler room at south foundation wall. Refer to NPMA-33 report.

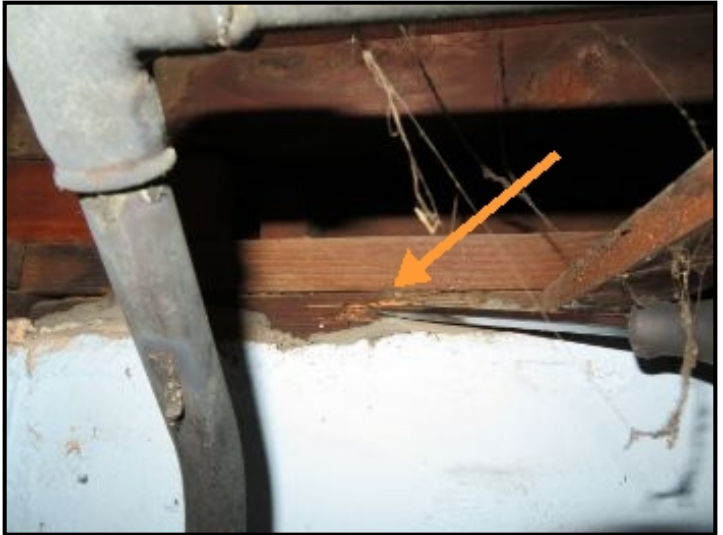
Extensive termite damage noted at sill plate in laundry along east foundation wall.

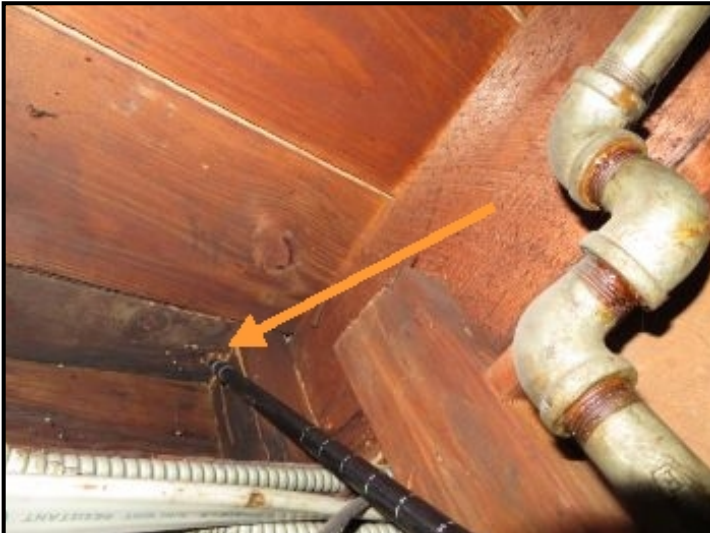
Termite damage noted at floor board and vertical stud located in gas meter closet at south foundation wall.

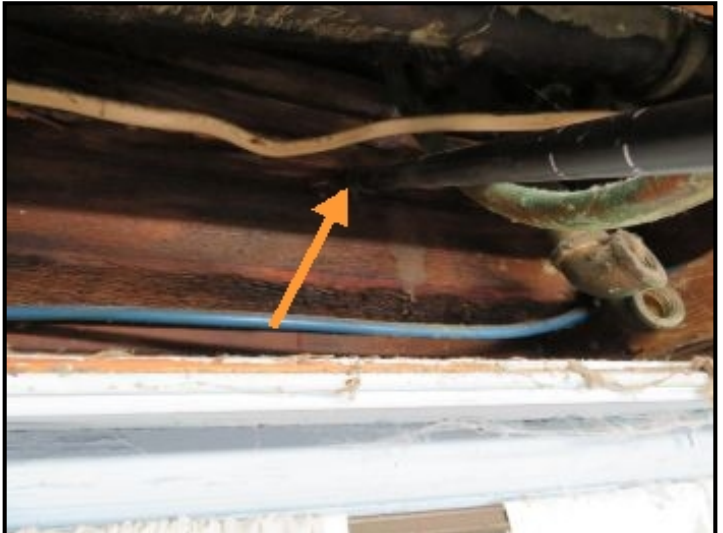
Extensive termite damage noted at joists and sill plate in laundry and crawlspace along east foundation wall.

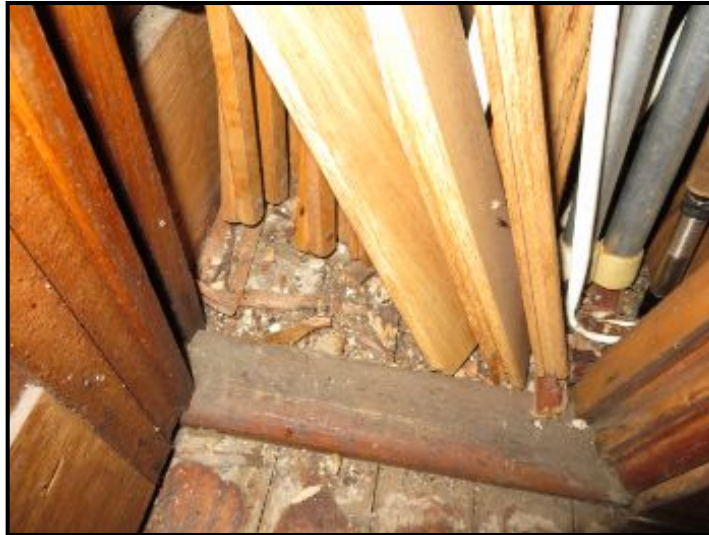
Evidence of past water penetration observed.

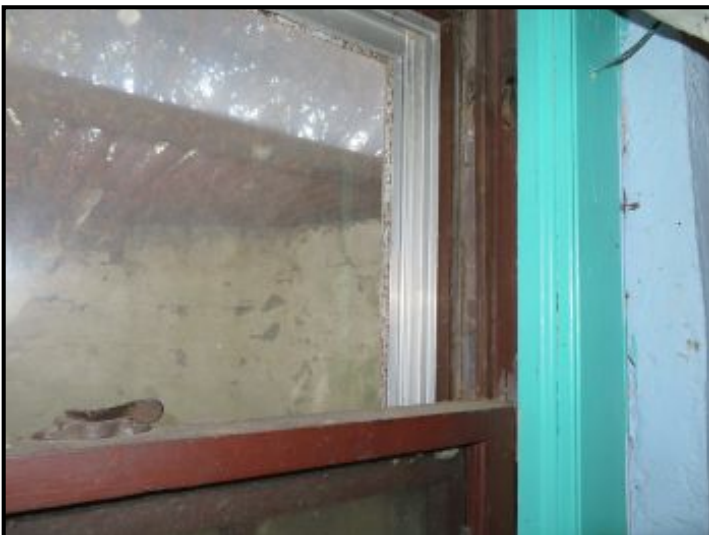
Broken sash wire/cord observed on window frame. This is a "Safety Concern". Sash wire/cord holds window in open position. Suggest repairs/replacement as needed to ensure safety.

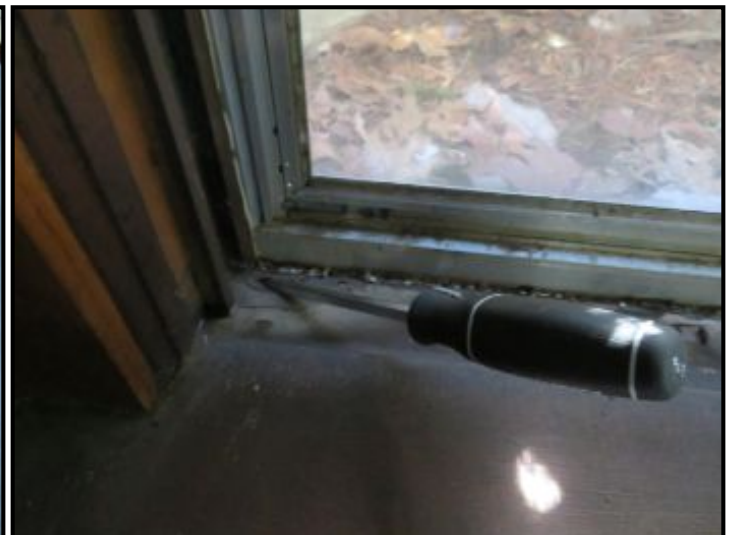
Deterioration of wooden sills and frames noted. Replacement may be necessary at some point.

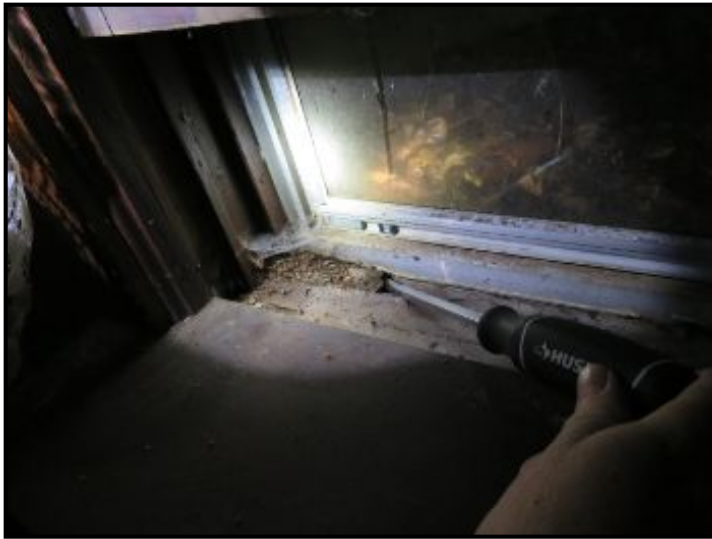
Deterioration of wooden sills and frames noted. Replacement may be necessary at some point.

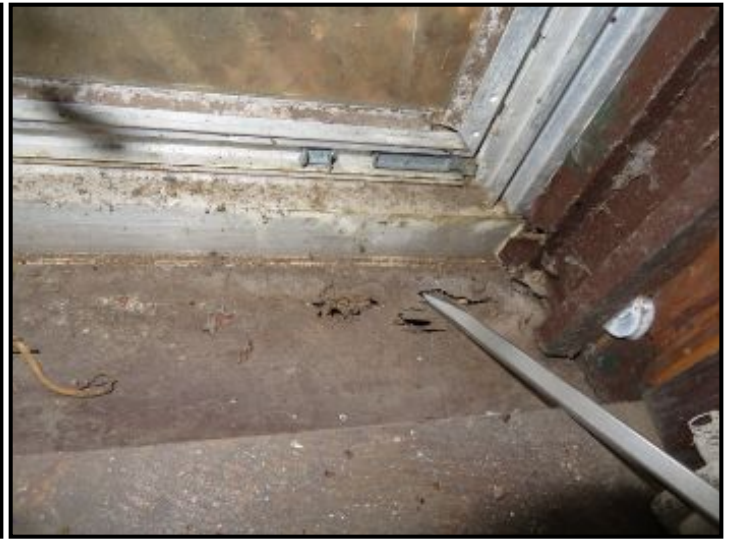
Deterioration of wooden sills and frames noted. Replacement may be necessary at some point.

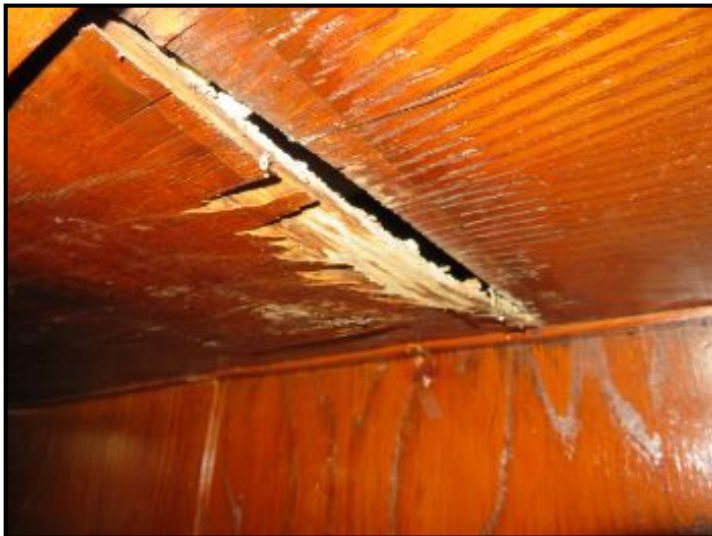
Water damage observed at basement ceiling caused by either past plumbing leaks. Suggest monitoring for recurrence and repair as necessary.

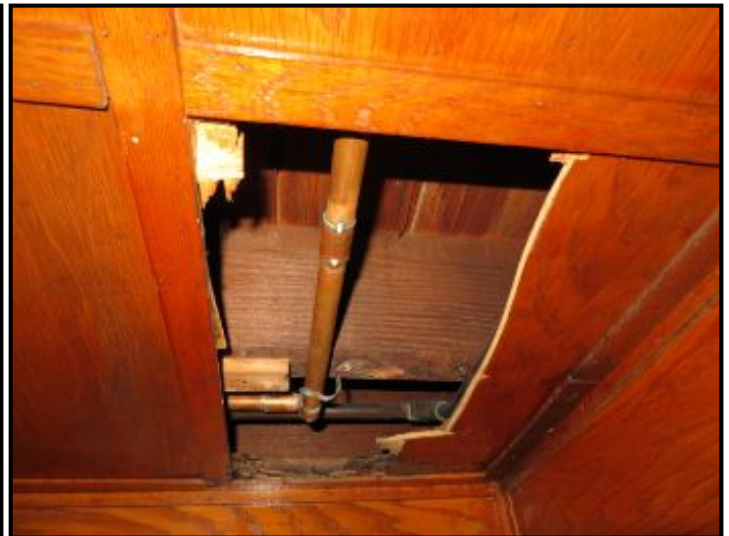
Access to utilities above basement ceiling is limited.

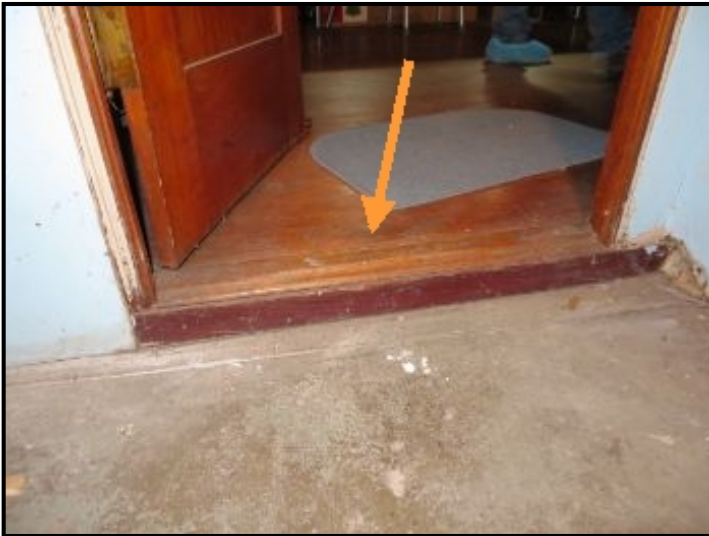
The basement floor was framed and included an under-floor space.

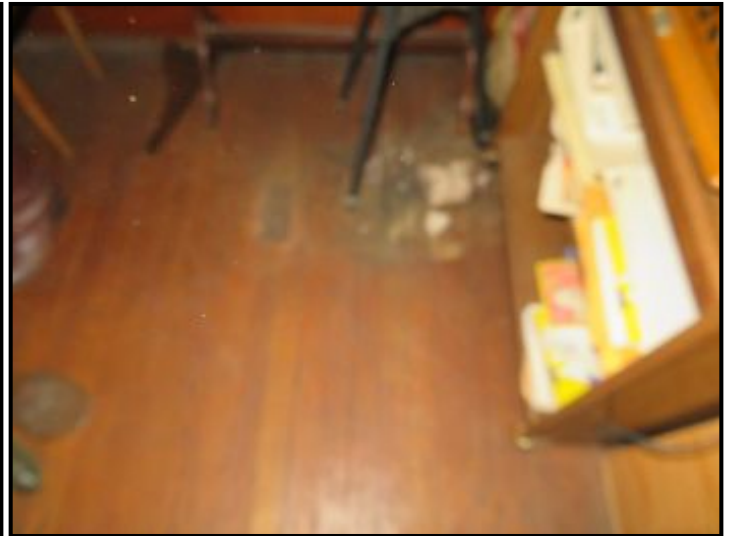
Basement hardwood floor showed signs of past water damage.

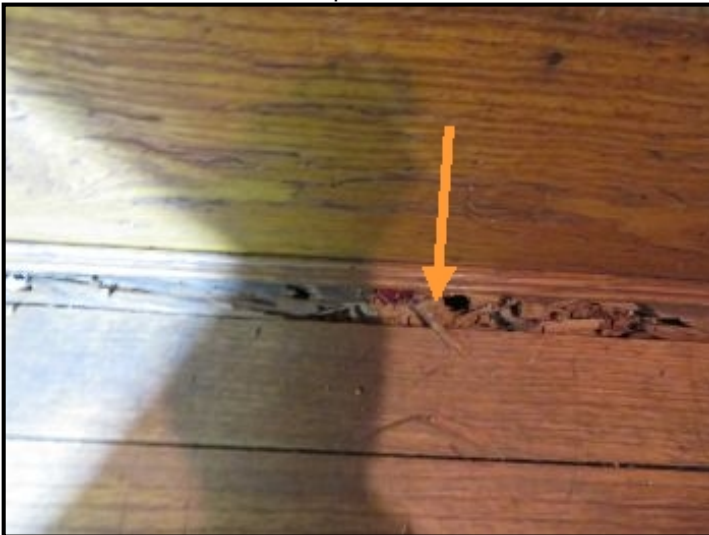
Termite damage noted at hardwood floor covering in closet at north exterior wall.

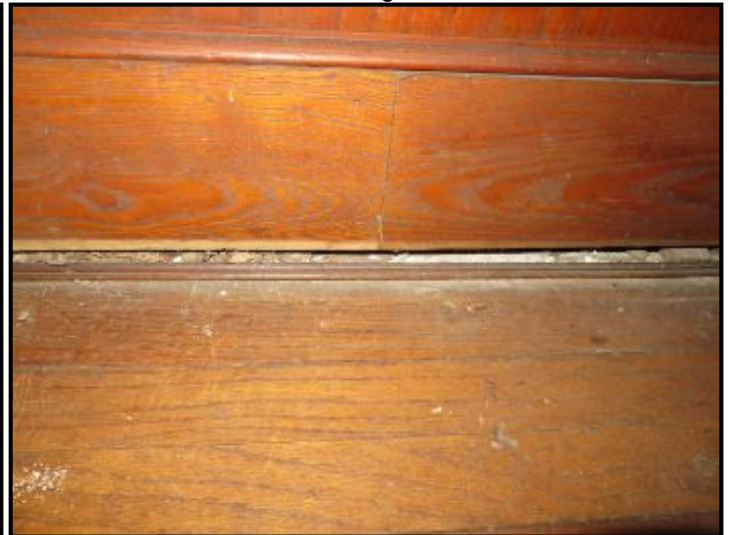
Basement hardwood floor depression; signs of deterioration at south exterior wall.

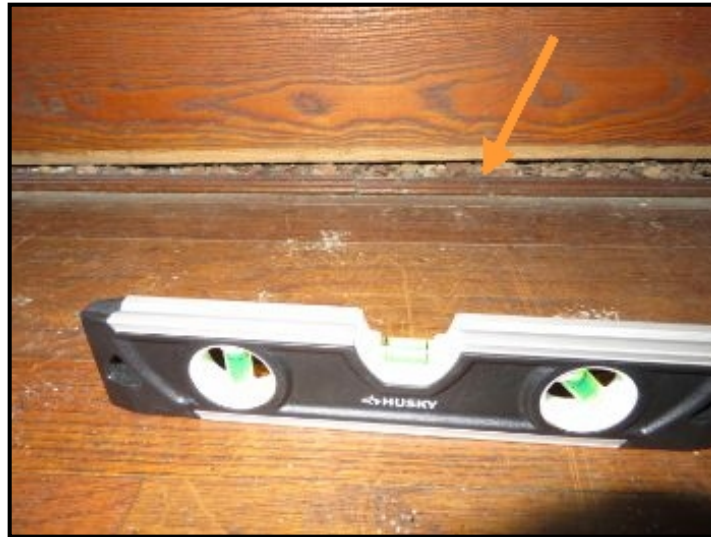
Basement hardwood floor depression; signs of deterioration at south exterior wall.

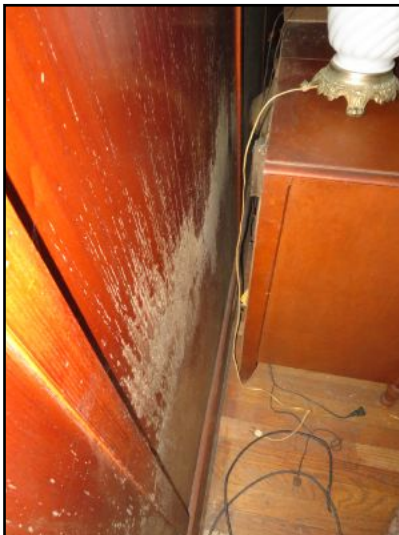
Mold-like bio growth observed. Professional testing & evaluation advised.

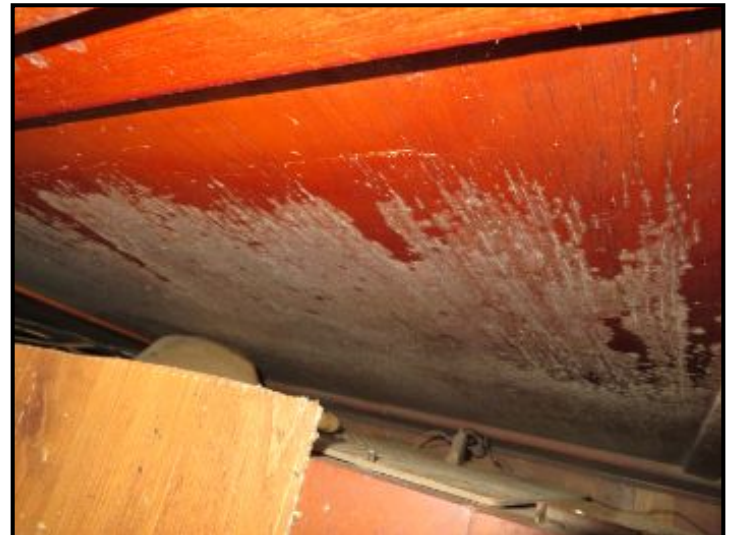
Possible organic substance noted. The United States Environmental Protection Association (EPA) states, "If you believe that you may have a hidden mold problem, consider hiring a professional." . If any area of the residence is suspected of having organic growth, or any member of your family or household is sensitive to mold we recommend Sampling & Lab Testing to identify the types of mold (or other airborne allergens) that could be present.

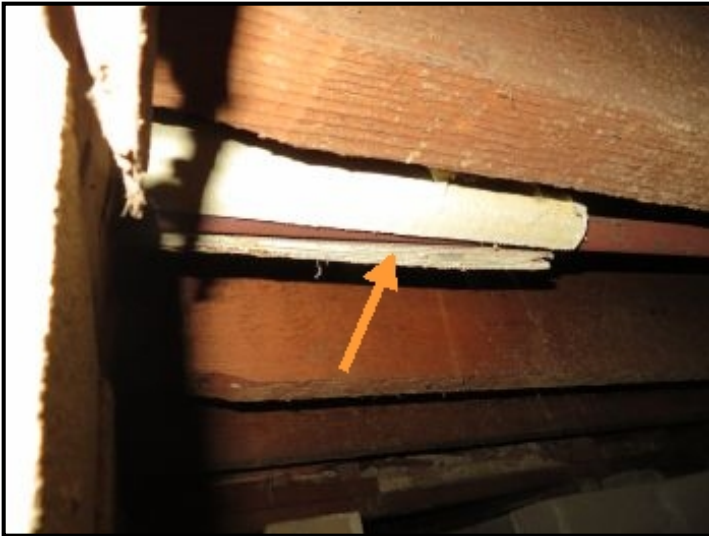
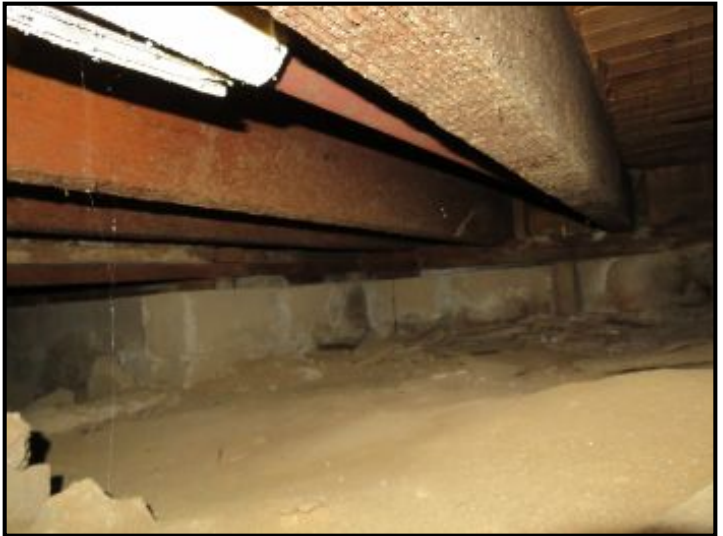
Boiler steam supply pipe insulation likely contains asbestos. Do not disturb this material. Options include encapsulation to prevent material from becoming friable and/or removal following EPA guidelines. Replacement insulation types such as fiberglass and foam are recommended.

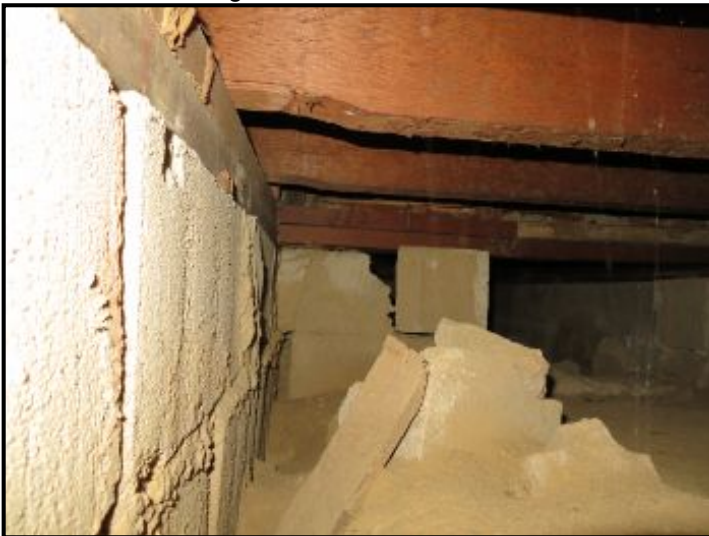
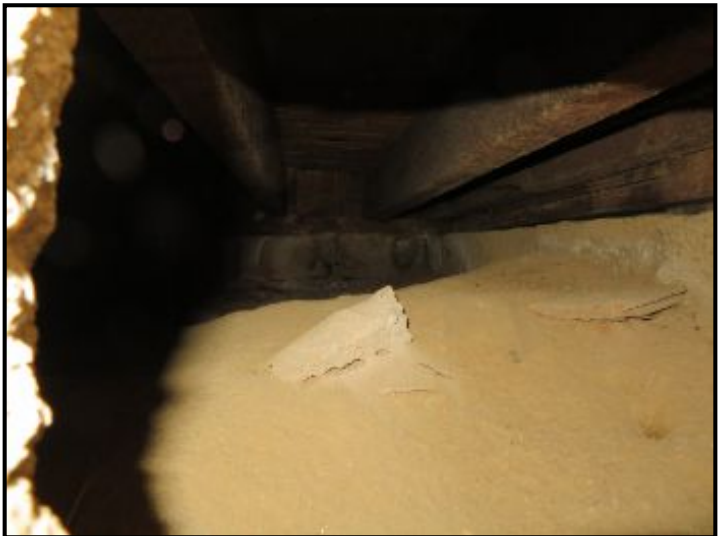
CRAWLSPACE CRAWLSPACE

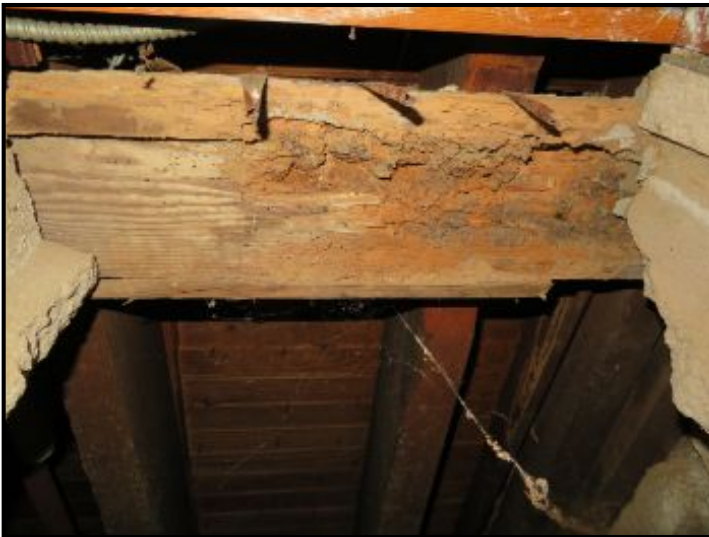
Termite damage and activity noted at crawlspace accessway.

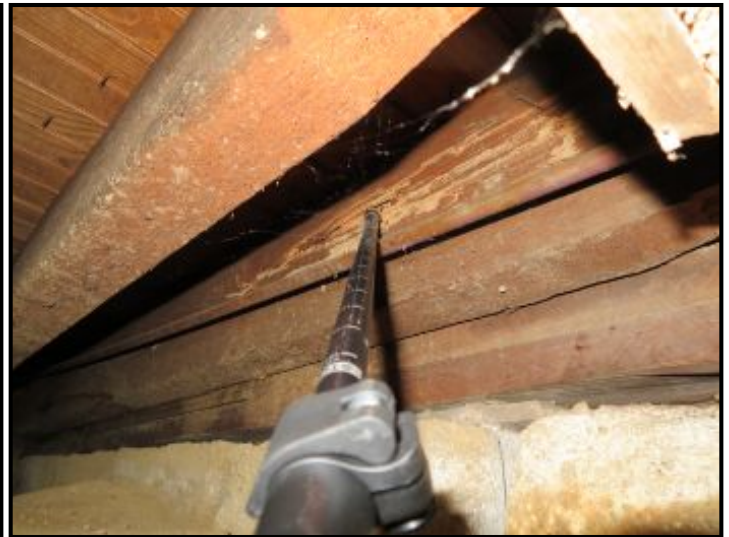
Extensive termite damage and activity noted at joists in crawlspace along east foundation wall.

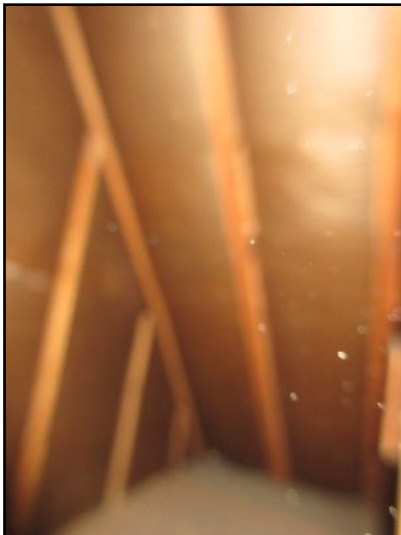
Fiberglass batts with kraft paper facing noted.

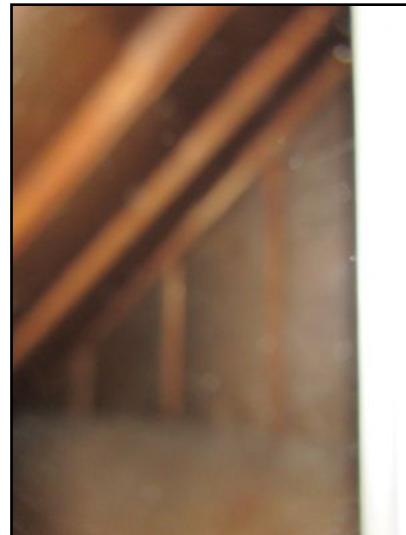
Installed in rafter cavities. Loose fill insulation noted.

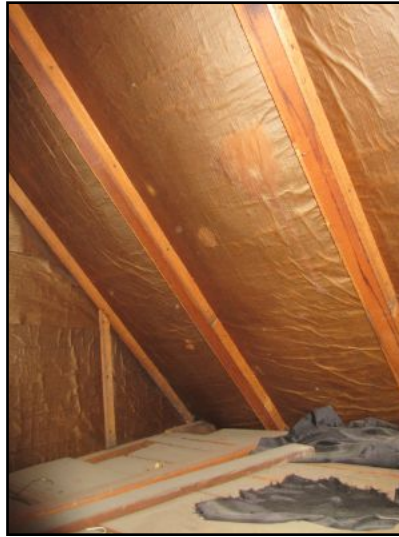
Fiberglass batts with kraft paper facing noted.

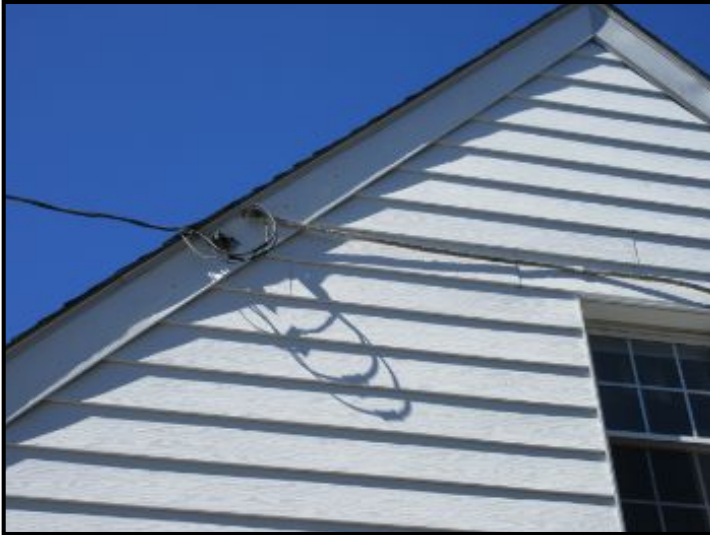
Overhead service drop; 120/240 volts.

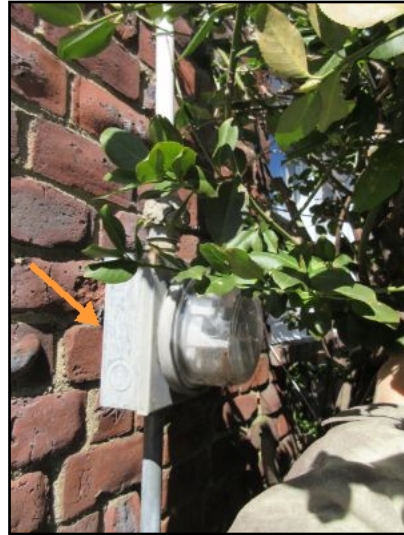
Meter box and riser not properly attached to the house. Recommend licensed electrician to repair.

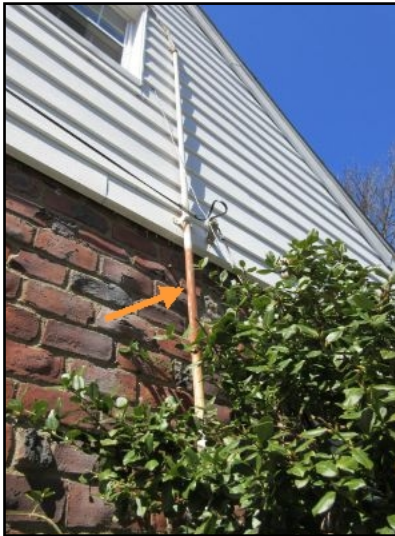
Vegetation contacting electric service meter. Recommend trimming back vegetation.

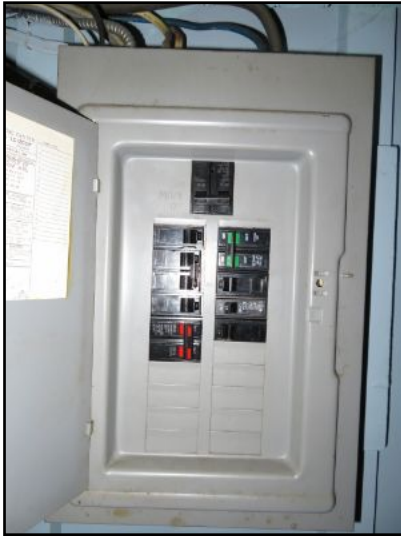
Main Panel in Basement laundry room.

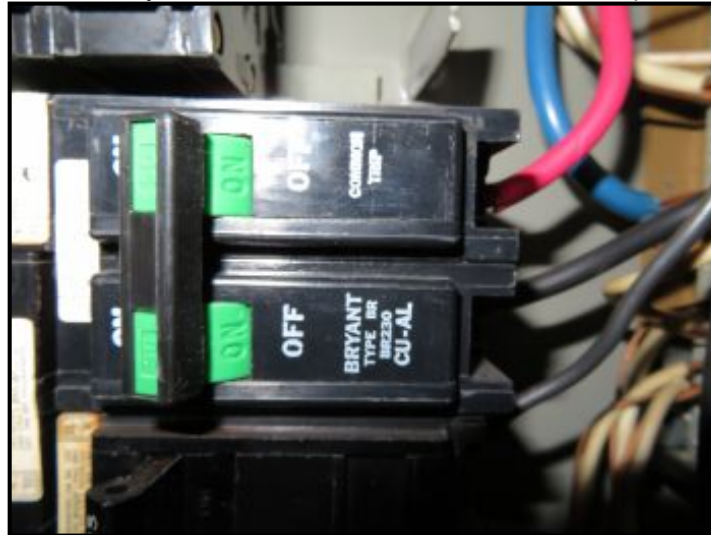
Sub Panel Supply: 30 amp breaker supplies sub panel located in boiler room.

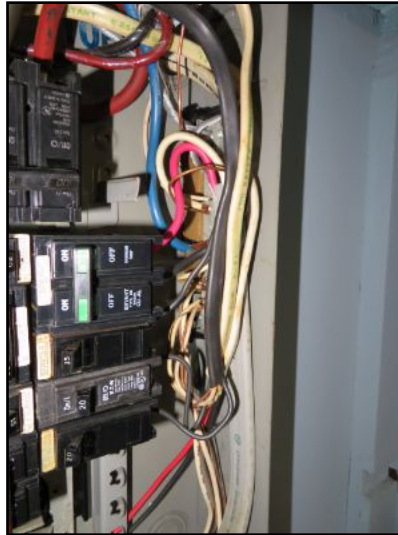
Ground wire connection at neutral bus noted. Have electrician ensure that ground is continuous.

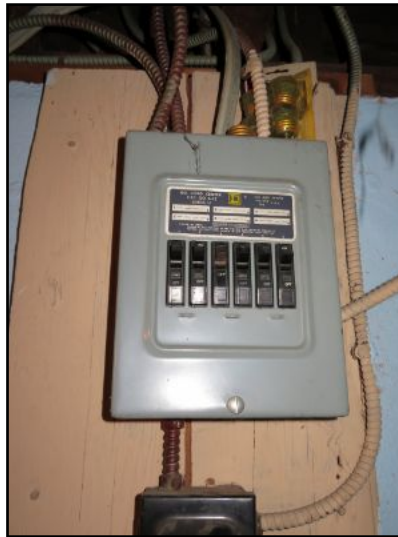
Sub Panel in Boiler Room.

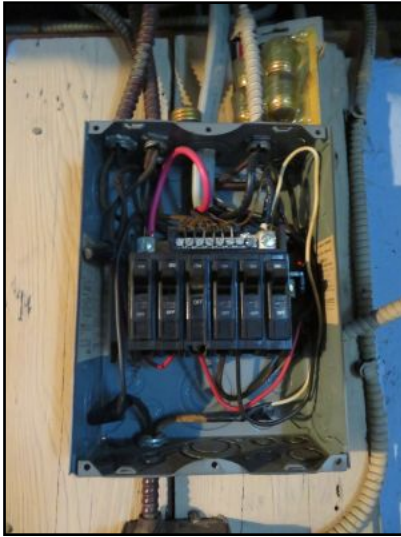
No major system safety or function concerns noted at time of inspection at sub panel box.

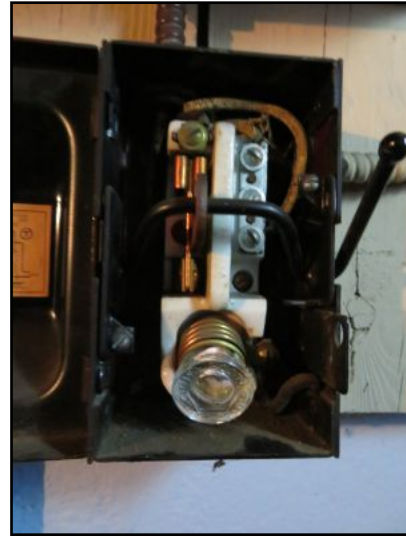
Old type fused disconnect switch noted.

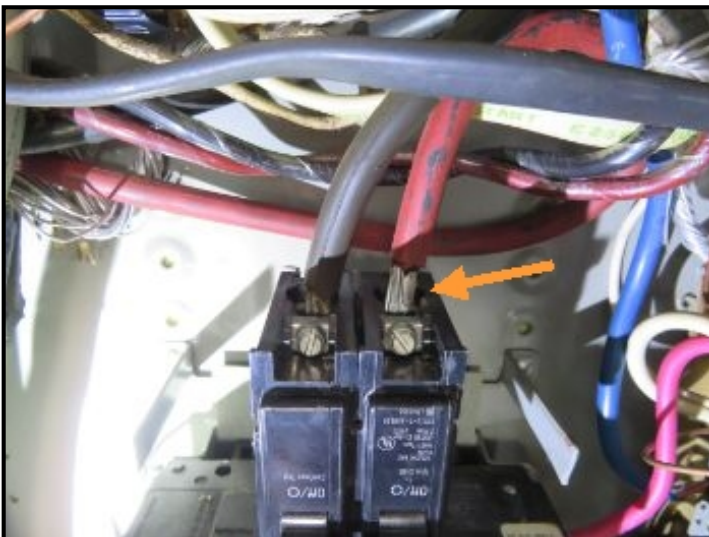
Aluminum non-metallic sheathed cable noted.

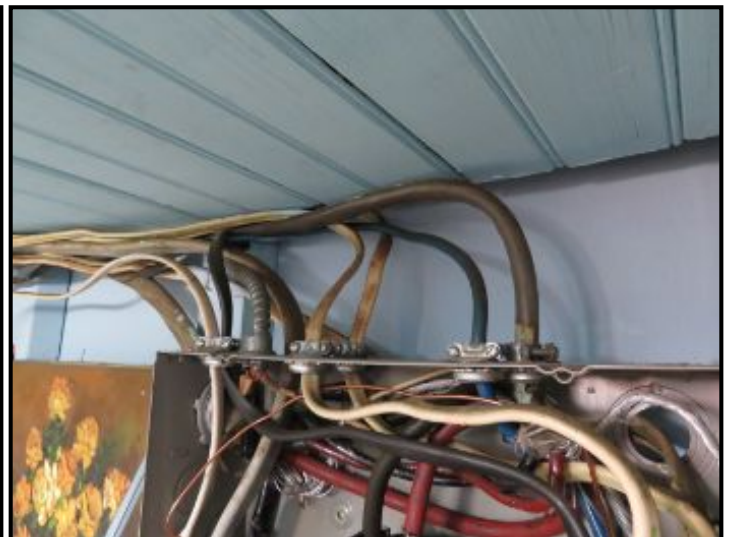
Various wire types noted

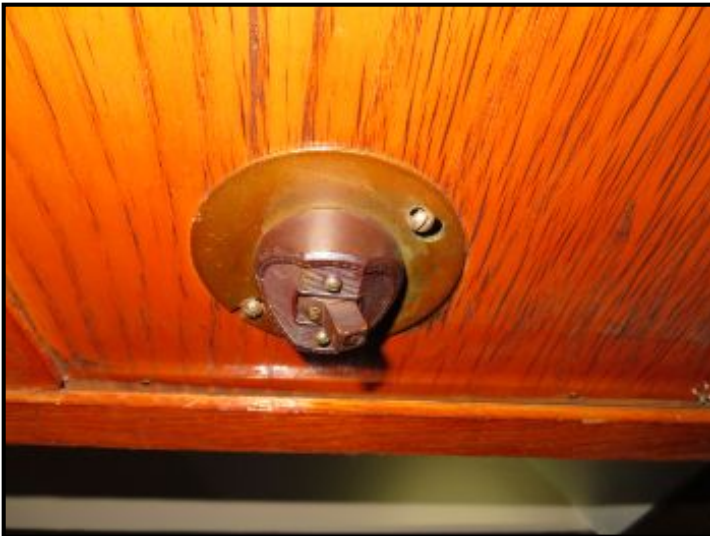
Oil Burner: Remote Emergency Shut-off switch was functional.

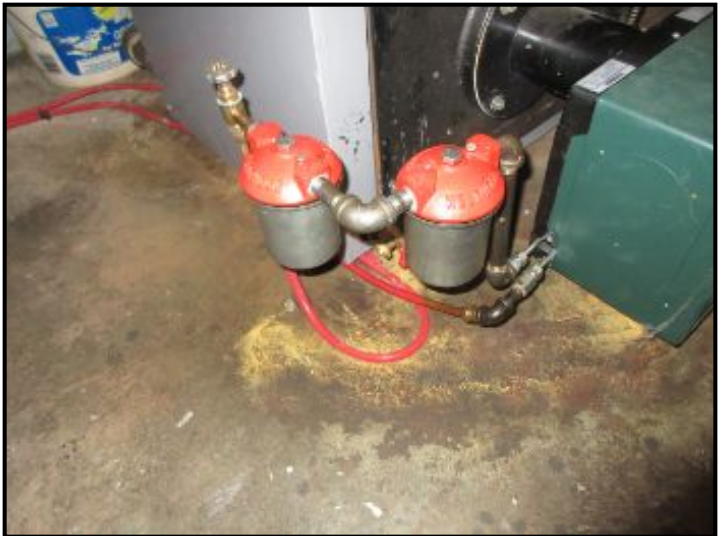
Oil shut-off valve and filters noted at burner.

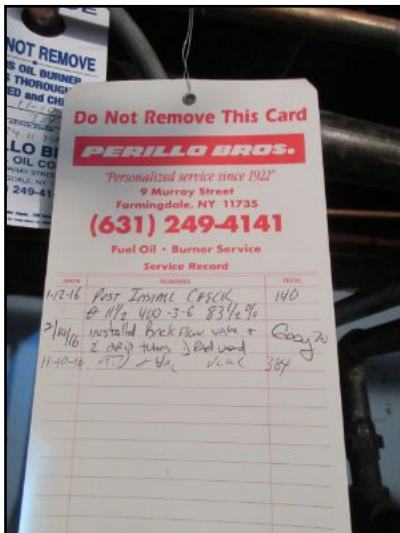
Furnace Service Tag indicates the boiler was last serviced on 11 2016. Recommend annual inspection/maintenance be performed by a licensed HVAC contractor to ensure safe and efficient operation.

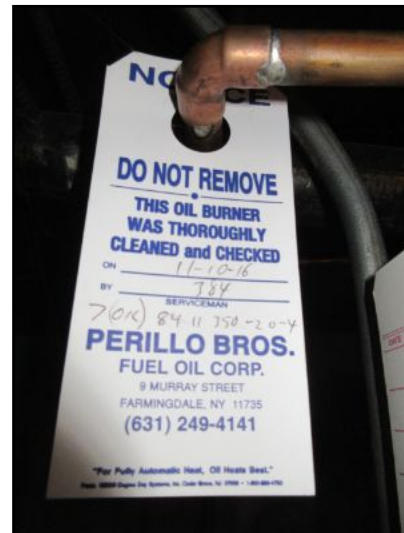
Furnace Service Tag indicates the boiler was last serviced on 11 2016. Recommend annual inspection/maintenance be performed by a licensed HVAC contractor to ensure safe and efficient operation.

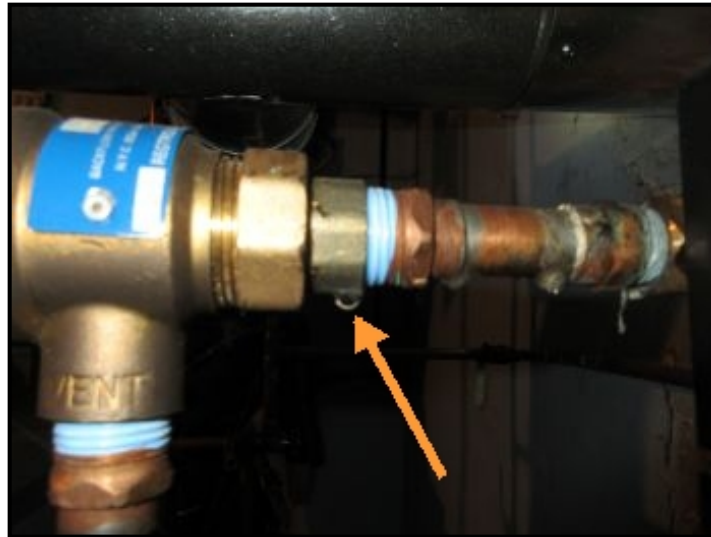
Drip leak observed at boiler check valve connection. Repair needed.

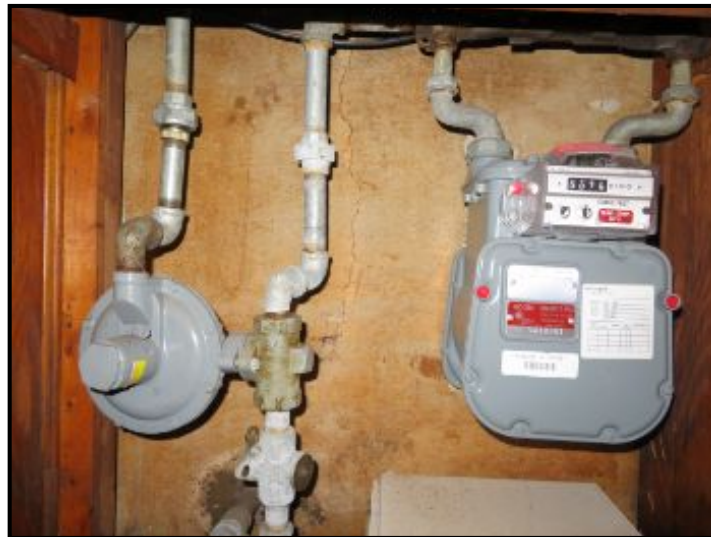
Public Gas Service: Meter, shutoff valve and vented regulator noted in basement. Gas supply presently used for cooking only.

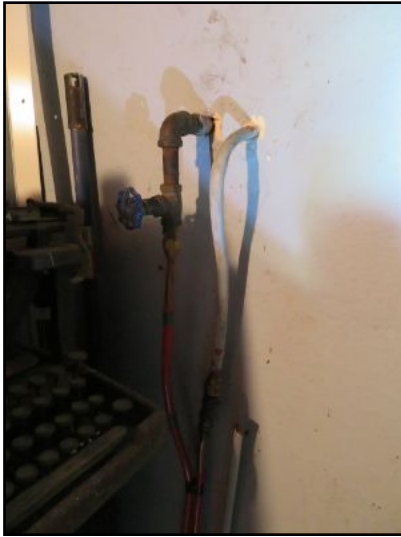
Oil lines to underground fuel storage tank.

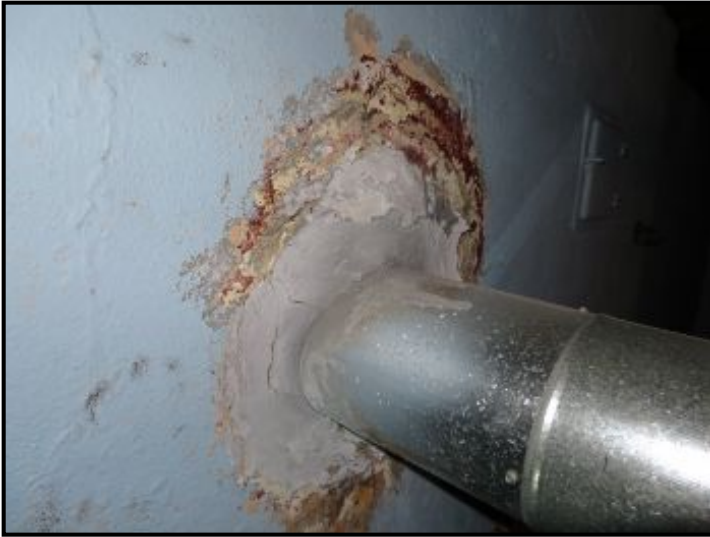
Maintain sealed connection between equipment vent pipe and chimney wall.

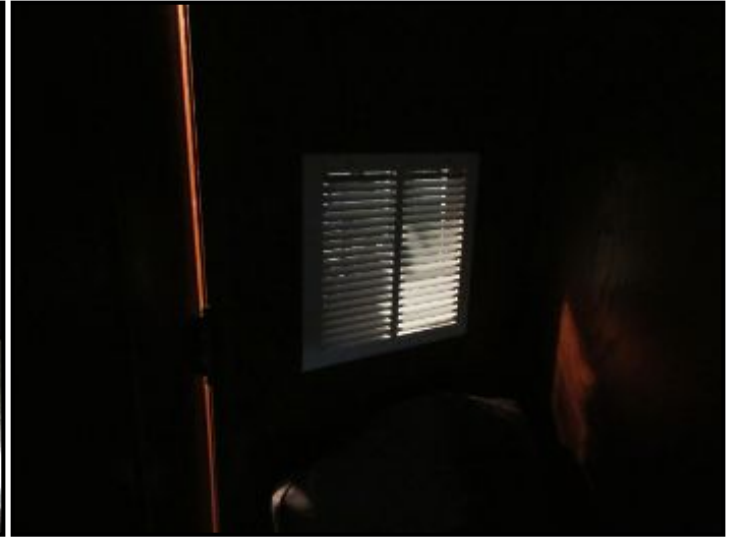
**COMBUSTION AIR REQUIRED:** The room containing fuel-burning appliances and all communicating spaces must have a combined volume of not less than 50 cubic feet per 1,000 Btu/h of the combined input rating of all appliances installed in that space. Two permanent louvered openings connecting adjacent spaces shall be provided: one within 12 inches from the ceiling and one within 12 inches from the floor of the adjoining spaces. The net free area of each opening shall be a minimum of 1 square inch per 1,000 Btu/h of the aggregate input rating of the installed appliances and shall not be less than 100 square inches. The openings are not required if a fully louvered door to the furnace room is provided.

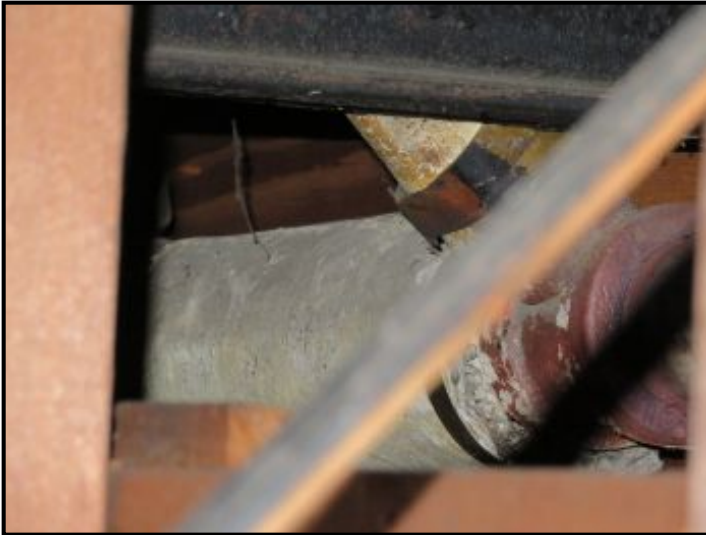
Some sections of heating pipe insulation appears to contain asbestos. This material appeared to be in serviceable condition at the time of inspection. Asbestos materials are considered safe by the EPA if they are not disturbed, torn, ripped, or damaged. No torn, ripped, or damaged materials were observed. If client has any concerns regarding asbestos materials, an asbestos testing lab should be consulted for further review to ensure safety. Other options include encapsulation to prevent material from becoming friable or removal following EPA guidelines. Replace with new pipe insulation such as foam or fiberglass type.

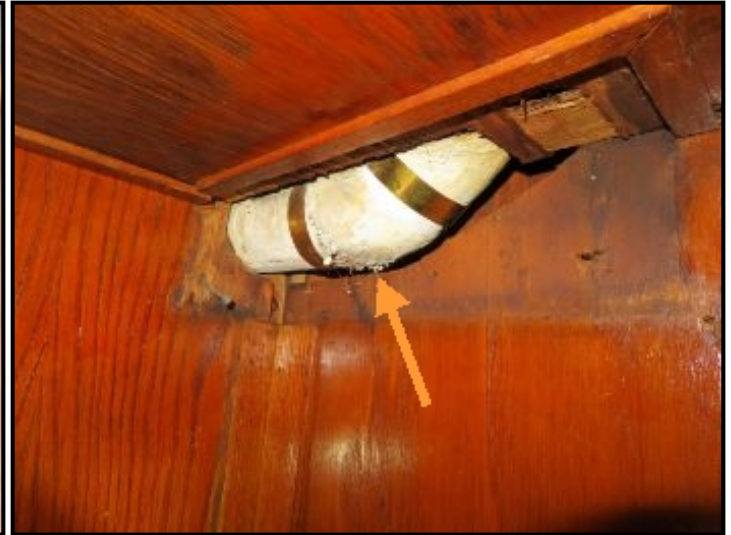
Friable asbestos insulation noted. Heating pipe insulation appears to contain asbestos. This material appeared to be in serviceable condition at the time of inspection. Asbestos materials are considered safe by the EPA if they are not disturbed, torn, ripped, or damaged. No torn, ripped, or damaged materials were observed. If client has any concerns regarding asbestos materials, an asbestos testing lab should be consulted for further review to ensure safety. Other options include encapsulation to prevent material from becoming friable or removal following EPA guidelines. Replace with new pipe insulation such as foam or fiberglass type.

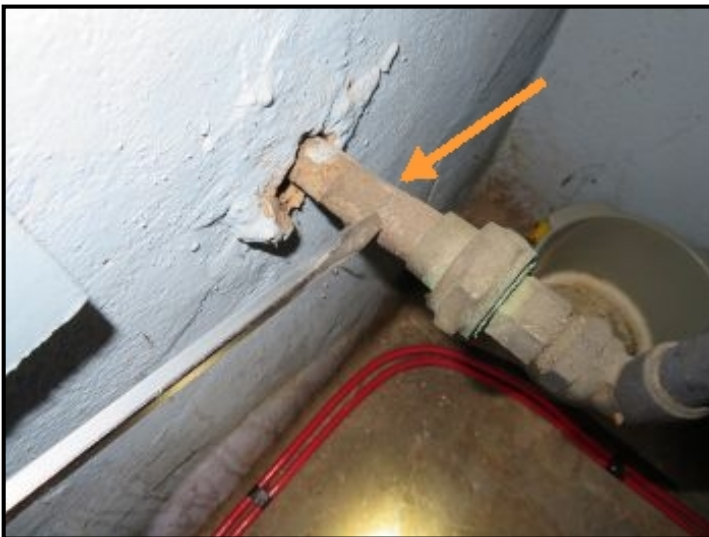
Water Service Entrance: 3/4" Lead pipe noted.

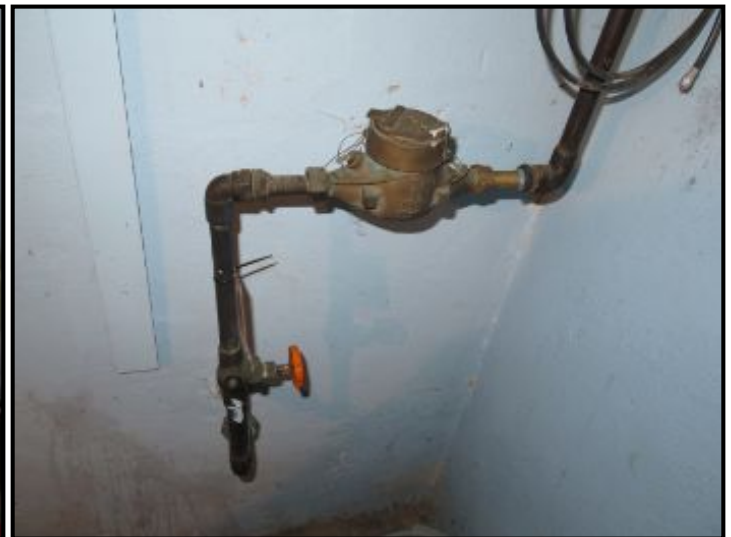
Water Service Entrance: 3/4" Lead pipe, meter and shut-off valves. Recommend having licensed electrician ensure that proper ground is installed.

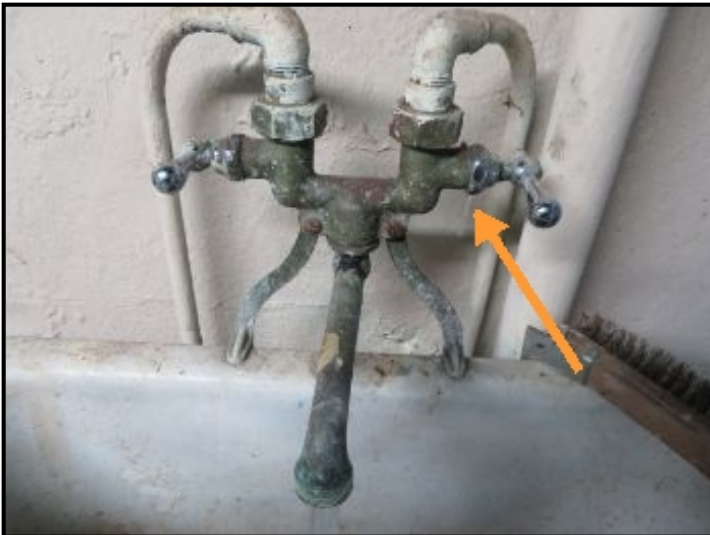
Slop Sink faucet leaks at handle; recommend faucet repair or replacement.

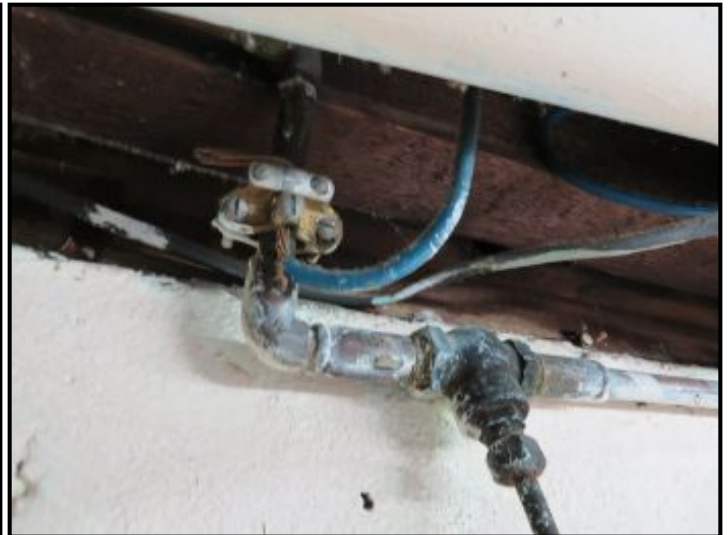
Water piping in laundry room grounding observed. Recommend having licensed electrician ensure that proper plumbing grounding is installed.
