# ProSpec Home Inspection of Long Island Property Inspection Report

213 Glenmore St, E. Williston NY, 11596  
Inspection prepared for: Name Deleted  
Date of Inspection: 3/24/2019 Time: 12:00 PM  
Age of Home: 88 yrs old  
Approx Year Built: 1930

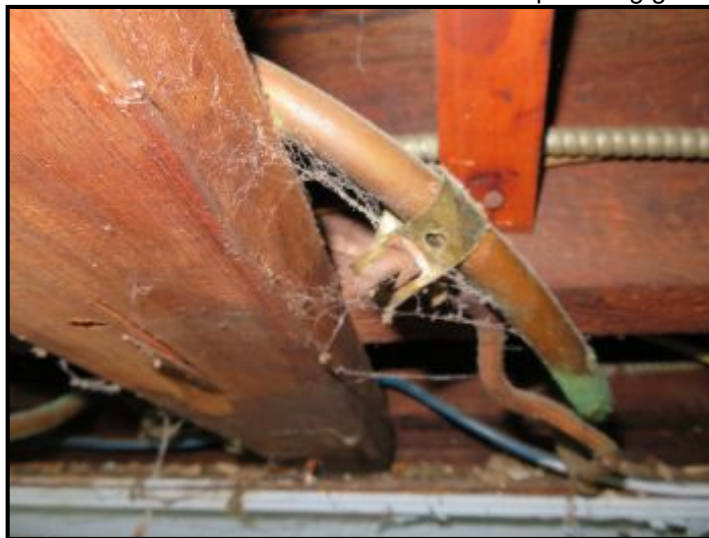
Water piping in laundry room grounding observed. Recommend having licensed electrician ensure that proper plumbing grounding is installed.

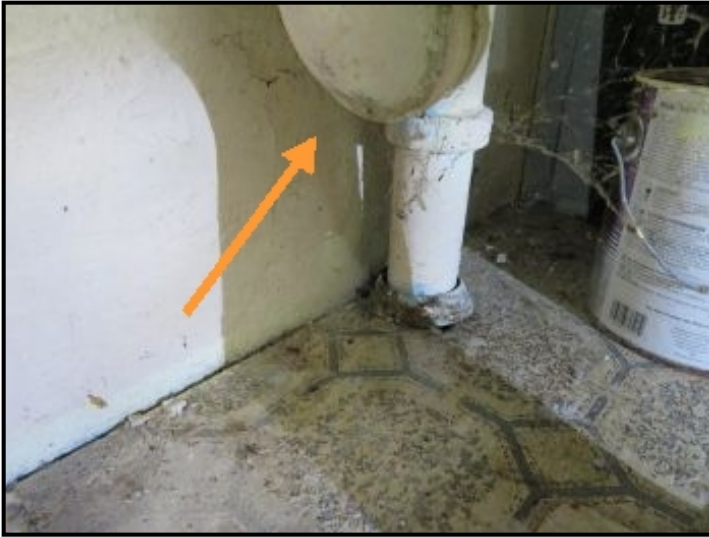
Visible leaking under the slop sink. Source of existing leak(s) could not be determined; suggest Plumber to evaluate and repair.

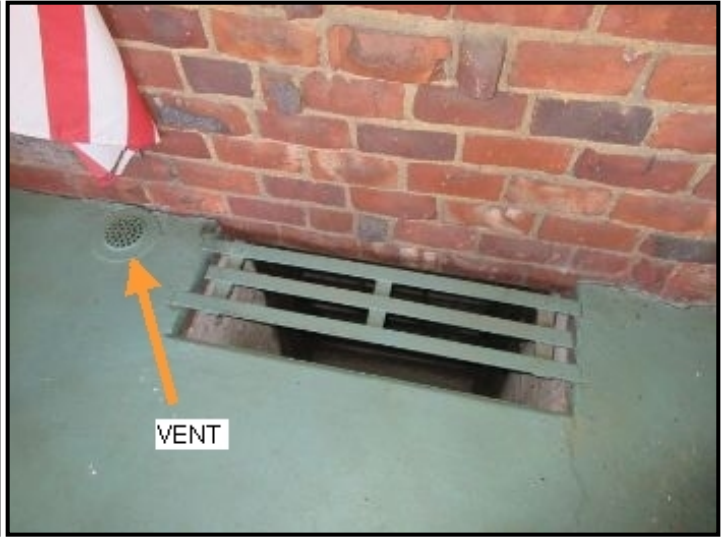
Waste Pipe Exit located at the rear of the house. Whole-house trap with vent connection at basement north wall.

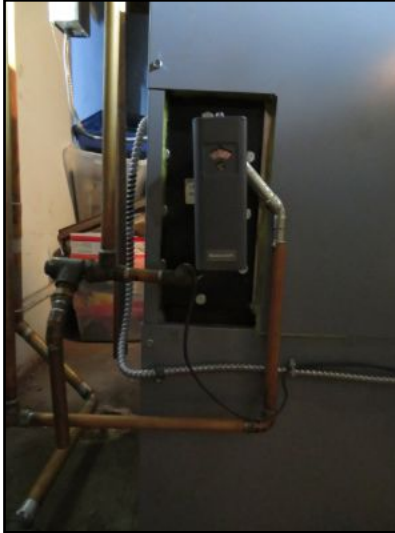
Tankless coil, integral with heating system.

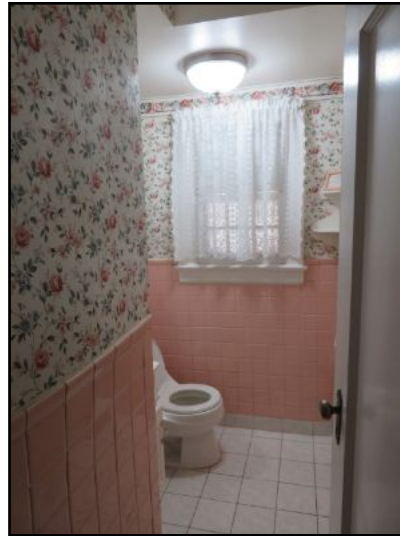
First Floor Hall, Toilet, Vanity, Exhaust Fan, Window, Radiator heat noted, Ceramic tile Floor

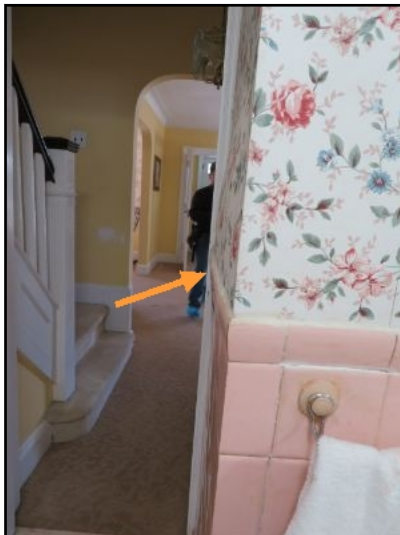
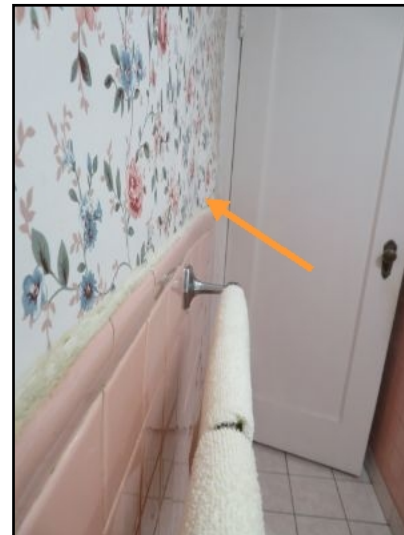
Bathroom walls bulged at few locations with tiles loosening. It's the inspectors opinion that these defects were caused by past water/plumbing leaks. Wall repairs required.

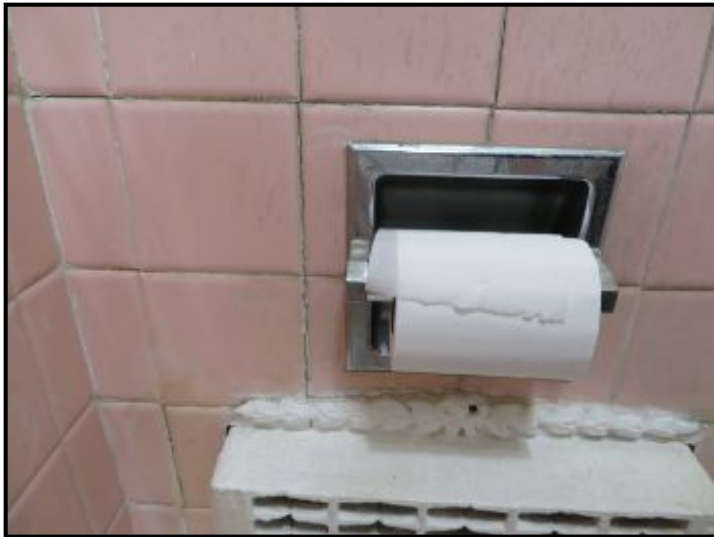
Wall tile grout missing.

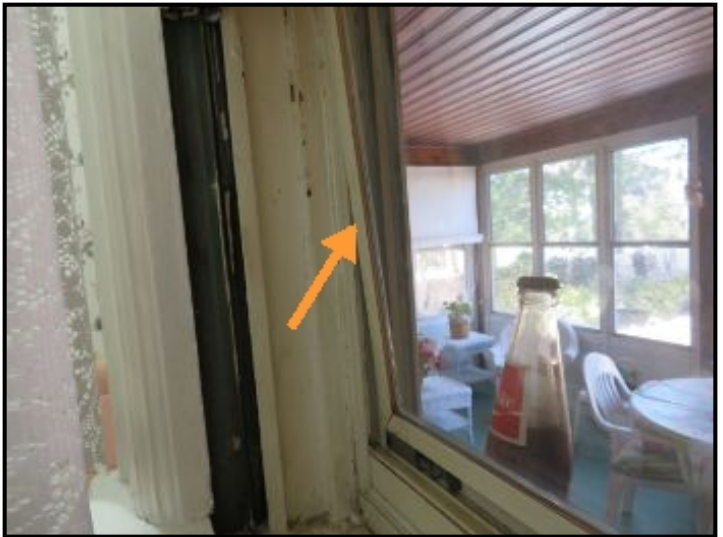
Outer window sash off track.

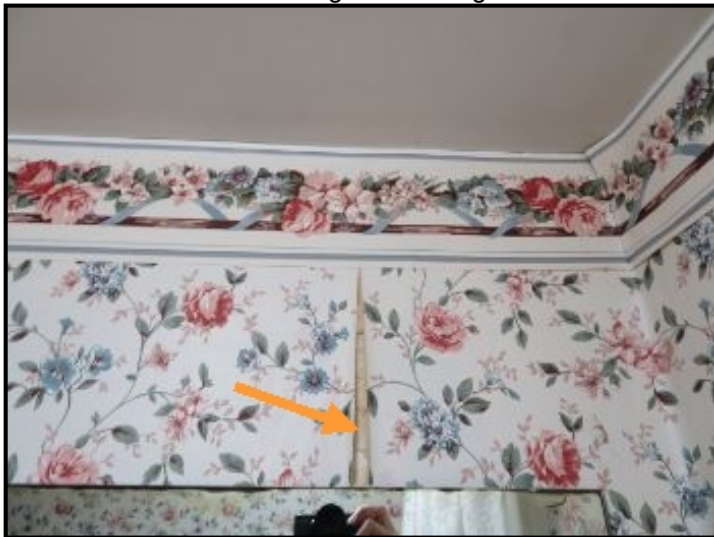
Defects noted at ceiling/walls suspected to be caused by past water/plumbing leaks.

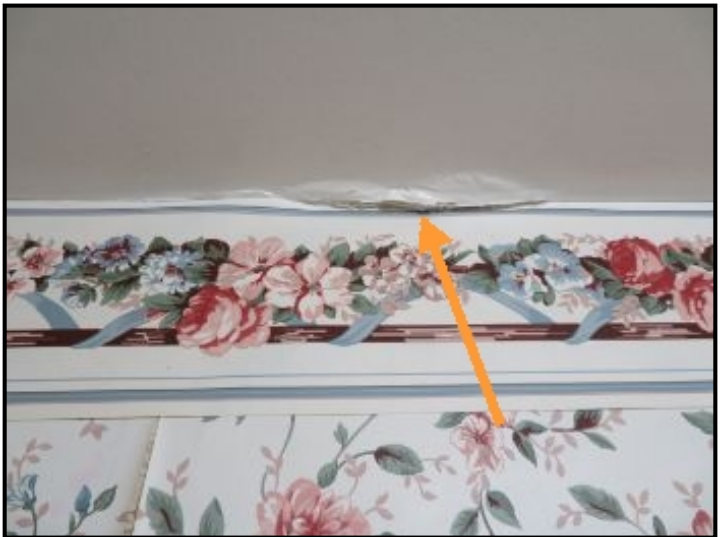
Defects noted at ceiling/walls suspected to be caused by past water/plumbing leaks.

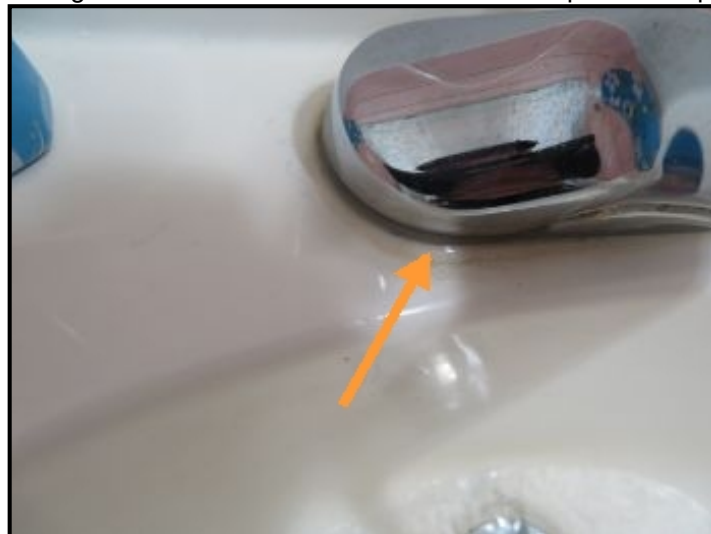
Sink faucet leaks at base; recommend faucet repair or replacement.

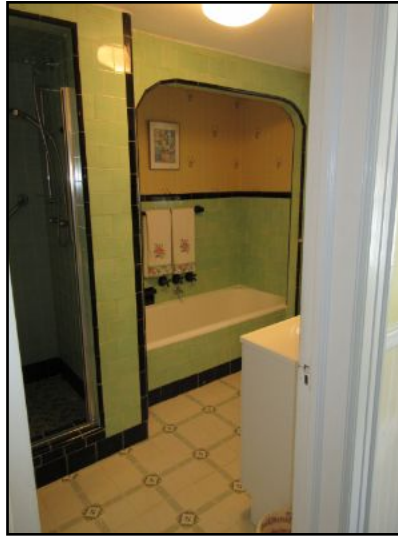
Second Floor Hall, Toilet, Vanity, Stall Shower , Built-in Tub, Window, Radiator heat noted, Resilient tile Floor, Ceramic tile Shower Wall

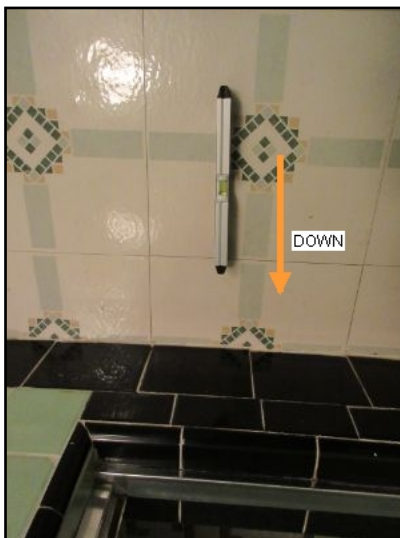
Bathroom floor pitched downward to shower base.

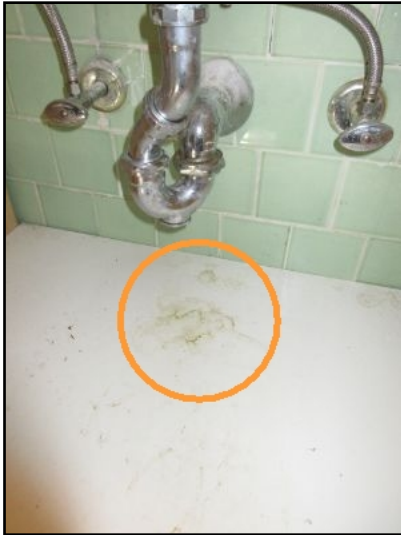
Visible leaking under the sink at drain pipe connection. Plumber to evaluate and repair.

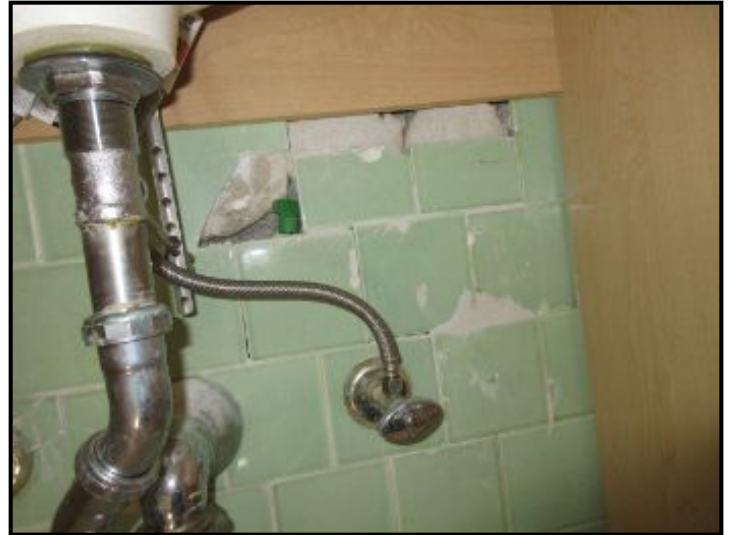
Wall tile damaged/missing below sink; suggest repair(s).

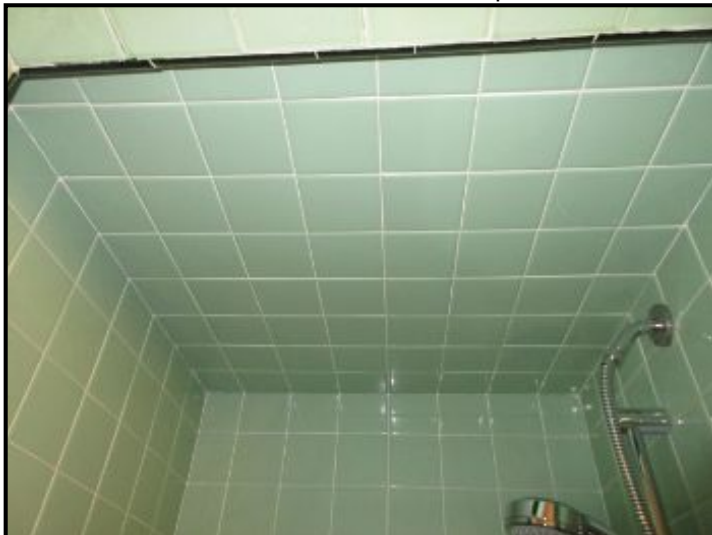
Light needed in stall shower.

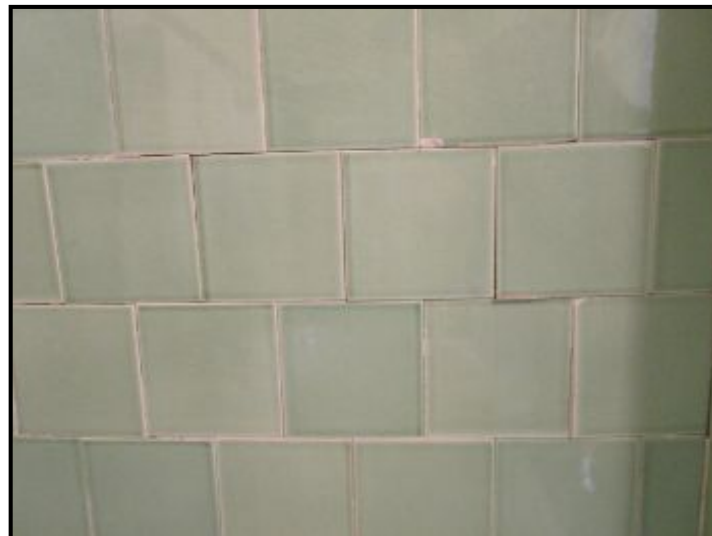
Wall tile grout missing.

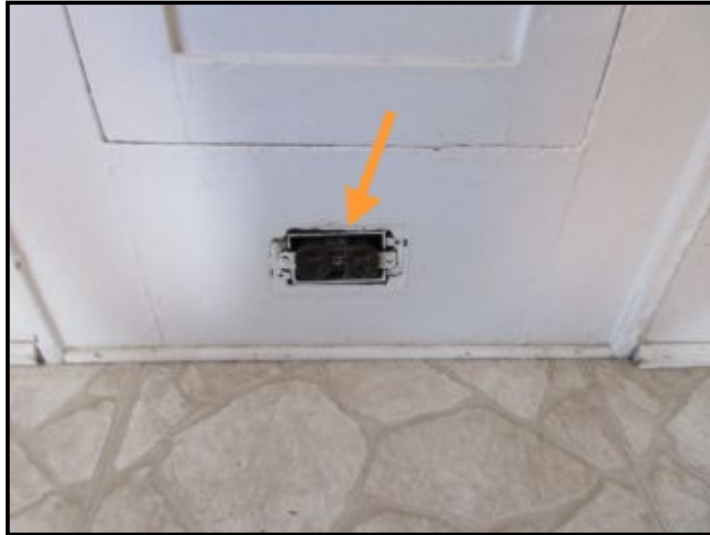
Cover plate missing. Provide missing receptacle and switch cover plates.

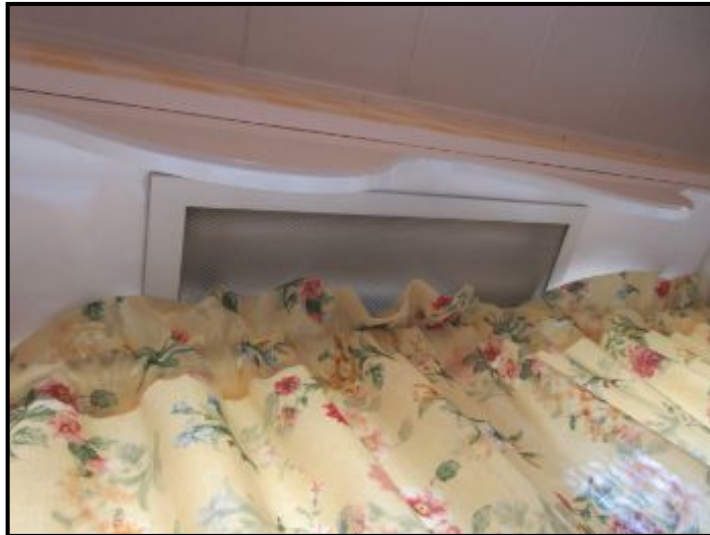
Light switch not found

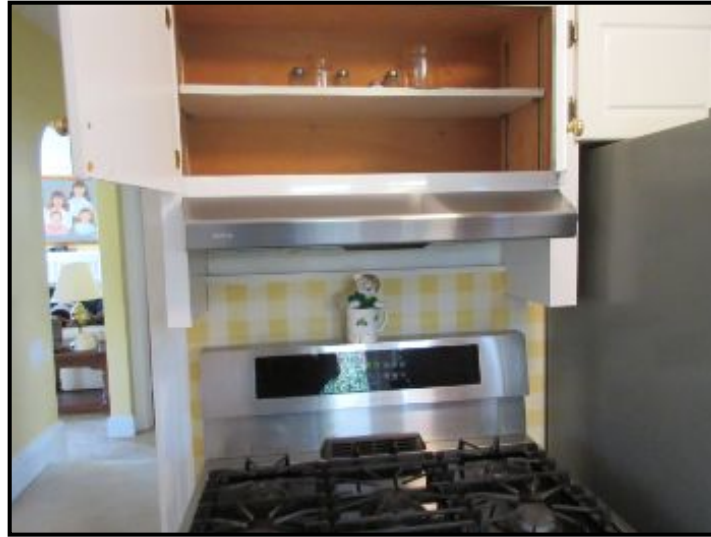
Exterior vented fan is recommended where gas appliances are in place.

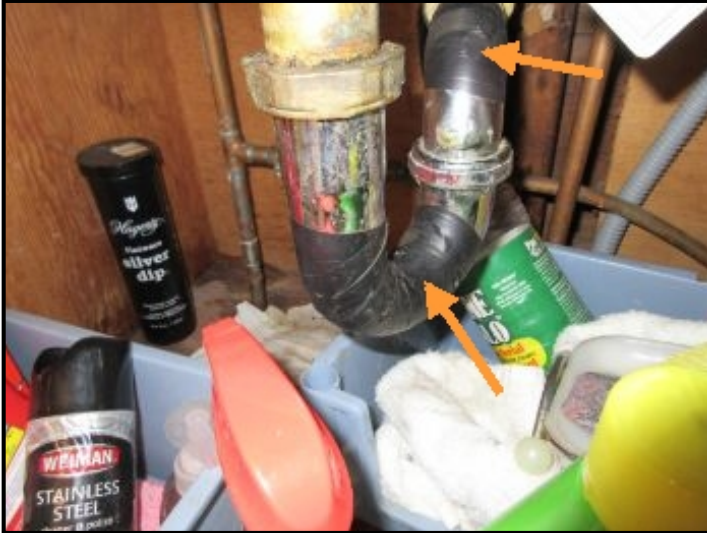
Electric tape used for plumbing repair.

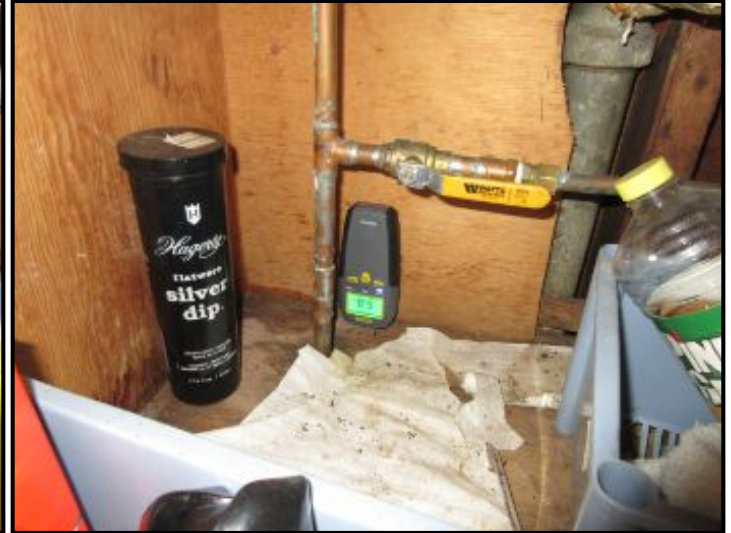
LEAK: Stains at sink cabinet floor, presumably from past leak(s) or spilled products.

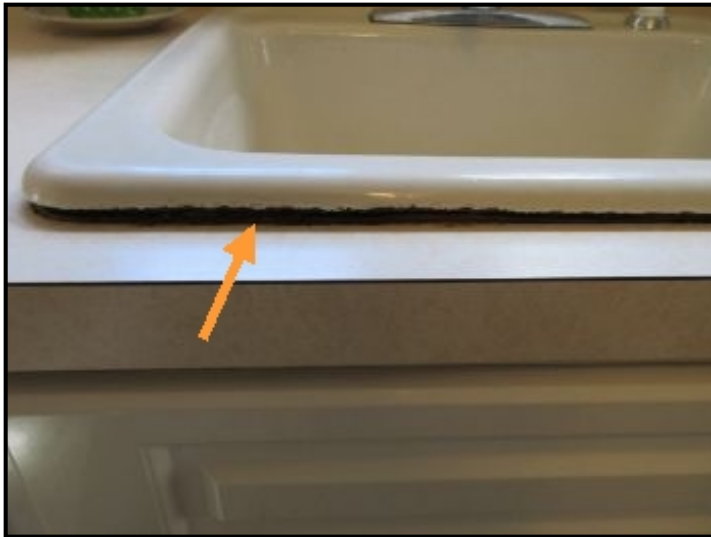
Rust noted at ceramic sink base.

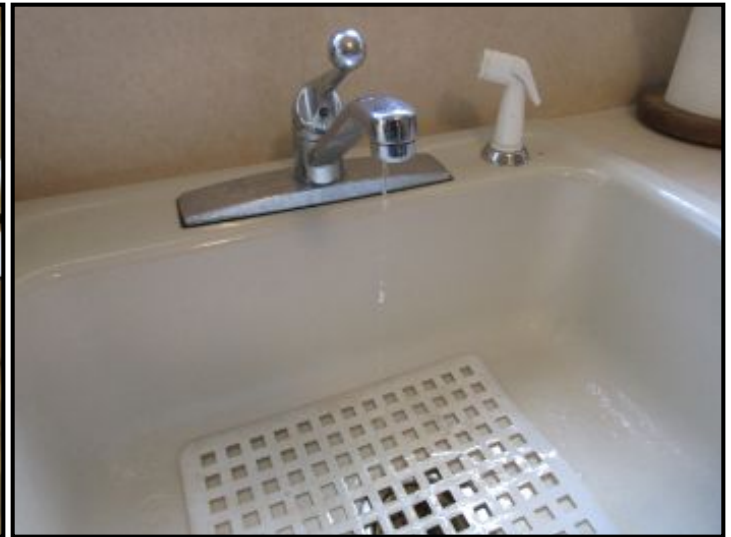
Kitchen faucet spout leaked. Recommend repair or replacement.

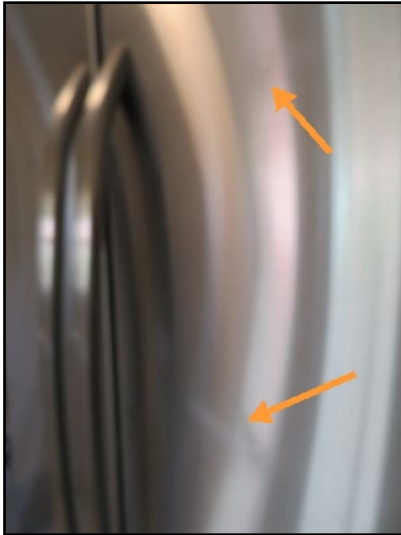
- Refrigerator/freezer operating and frost free.
- Refrigerator appears to be 5+ yrs old.
- Scratches noted.

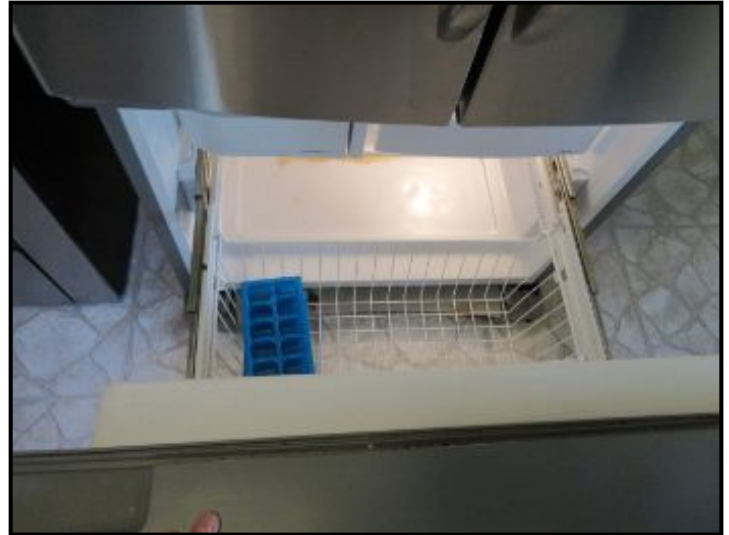
Refrigerator/freezer operating and frost free.

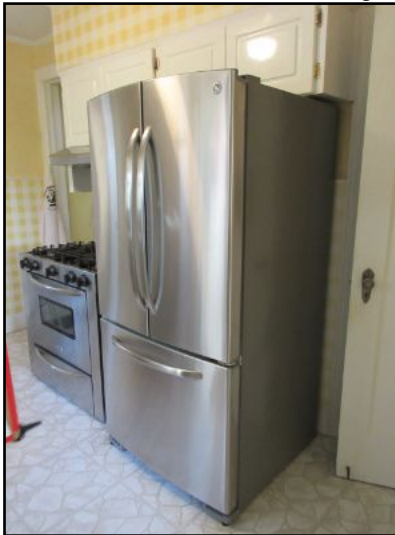
Refrigerator appears to be 5+ yrs old.

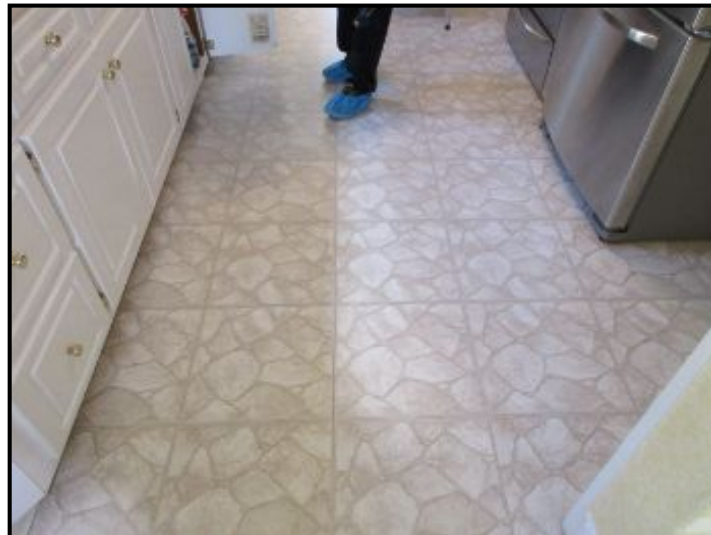
Vinyl squares (tiles) noted

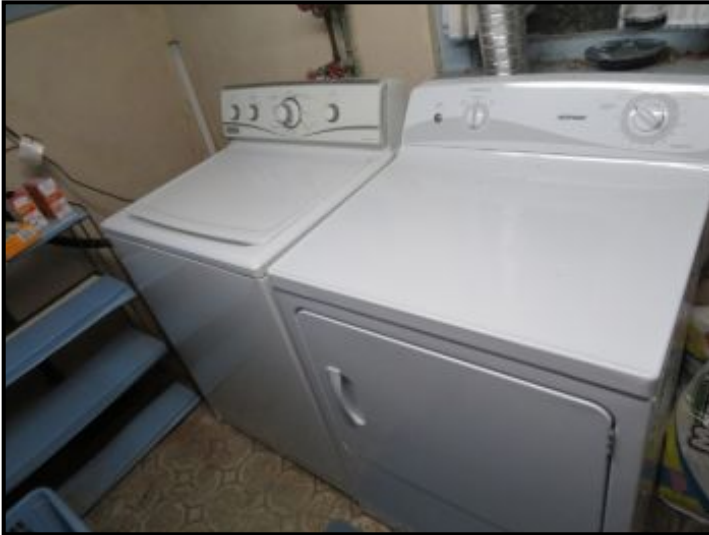
- Laundry in basement
- Leaks: None Observed
- Laundry receptacle is not GFCI protected. Refer to Electrical section.

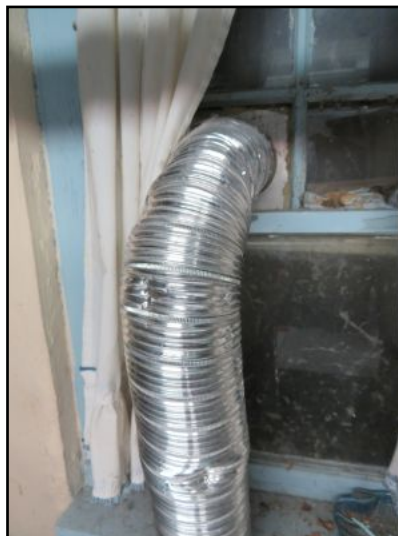
The dryer vent pipe is crushed in spots. This should be replaced due to the fact that lint can accumulate in the crushed areas and catch fire.

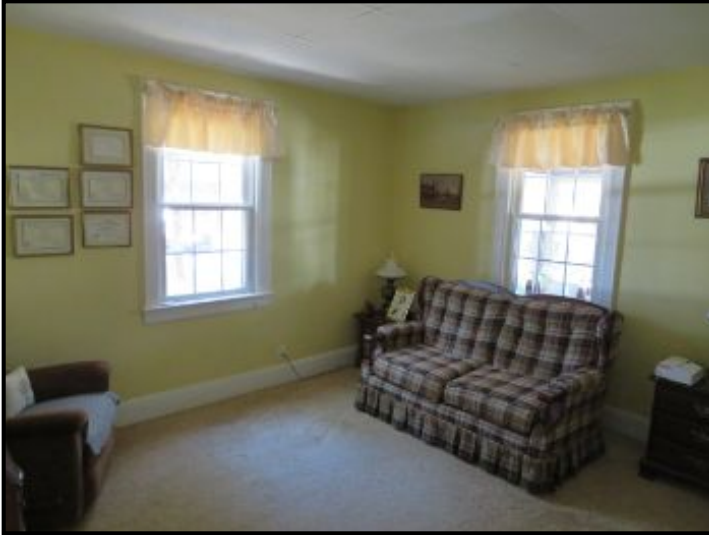
## 1. Interior General

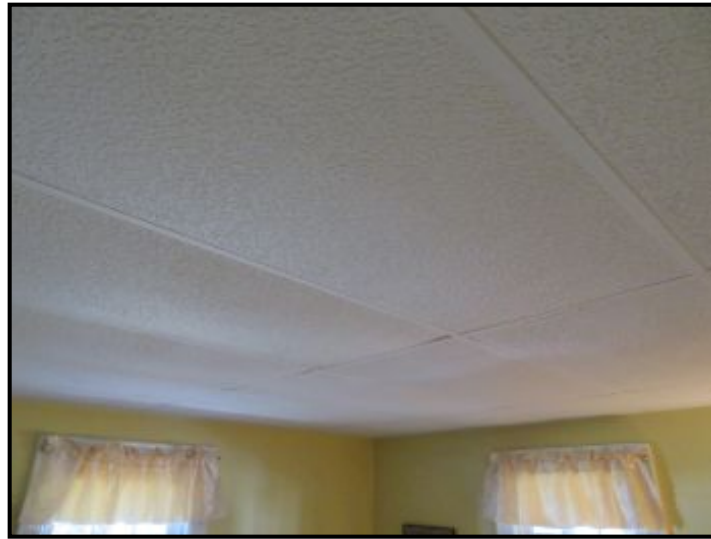
Hung ceiling noted in sitting room

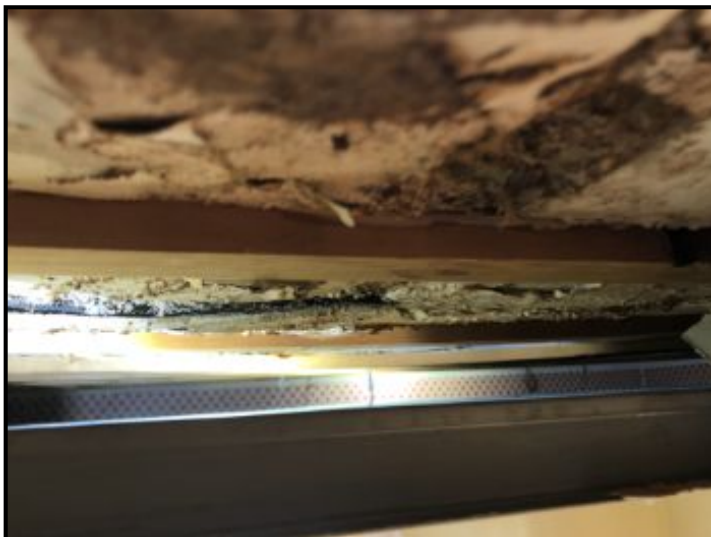
Conditions above hung ceiling in Sitting room show evidence of past plumbing leak. Mold-Like bio-growth observed. Recommend professional testing, evaluation and possible abatement of mold.

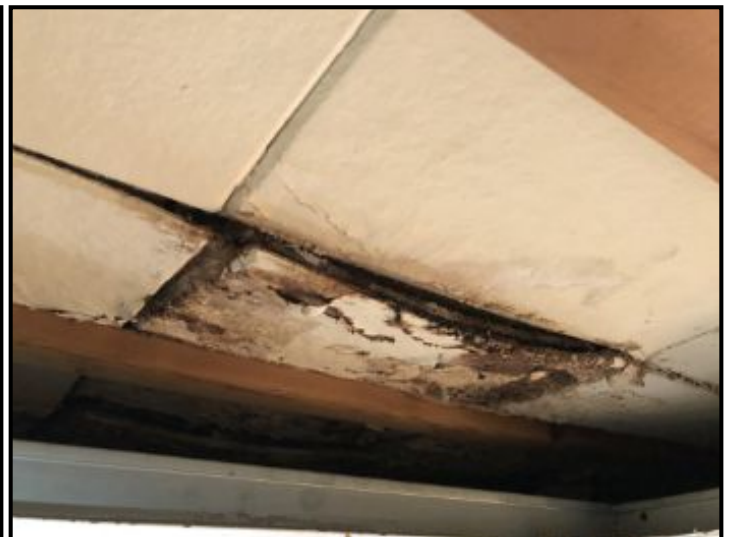
Conditions above hung ceiling in Sitting room show evidence of past plumbing leak. Mold-Like bio-growth observed. Recommend professional testing, evaluation and possible abatement of mold.

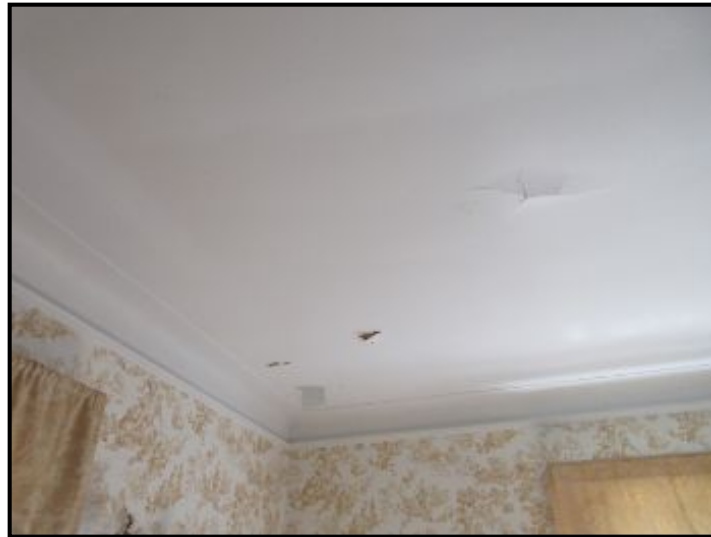
Signs of paint peeling and blistering on the dining room ceiling. The areas appeared dry at the time of the inspection, but should be monitored for further damage or possibly water intrusion.

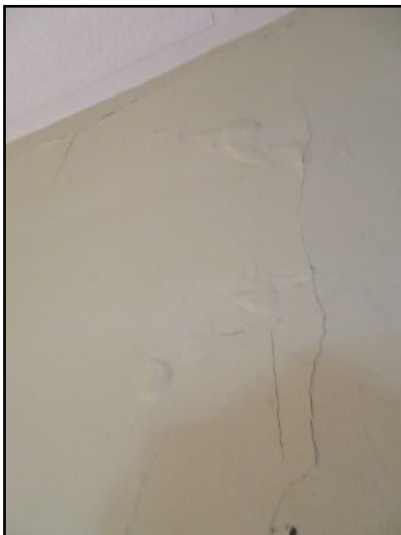
Sitting room wall damage believed to be from past water/plumbing leak.

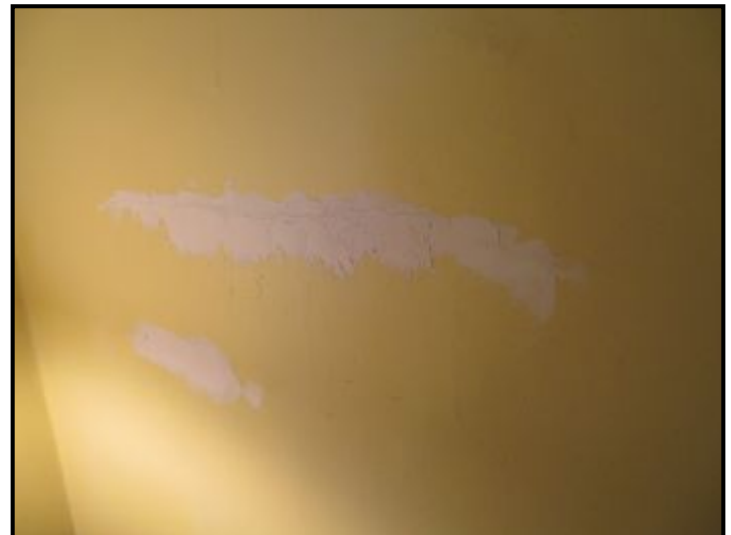
Unfinished wall repairs observed at stairway walls.

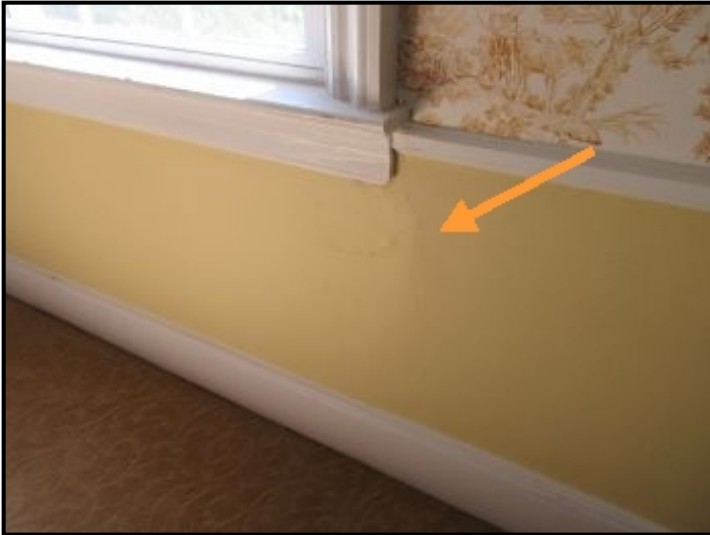
Signs of past water penetration/damage at dining room window below window.

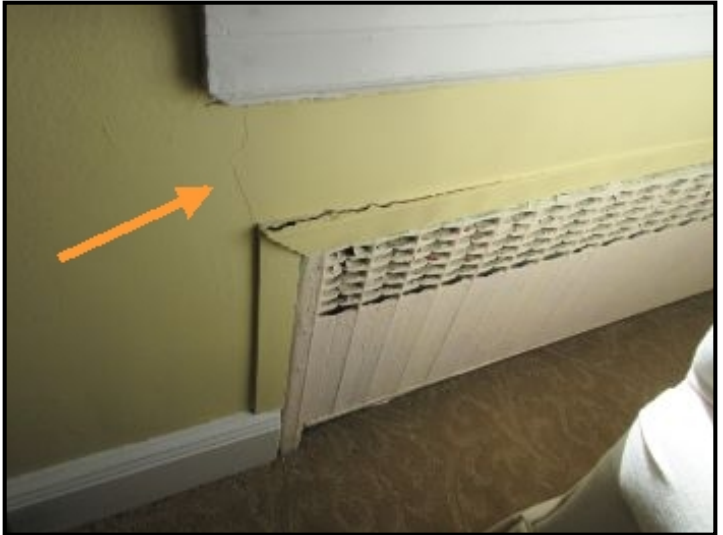
Signs of past water penetration/damage at living room window below window.

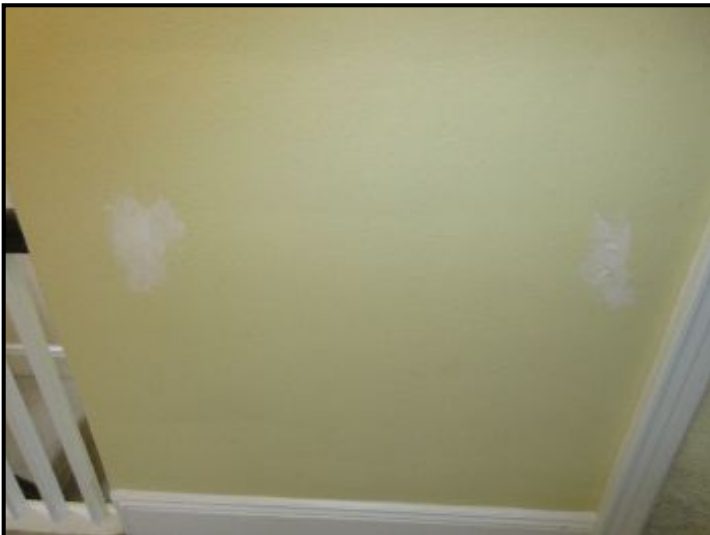
Unfinished wall repairs observed at stairway walls.

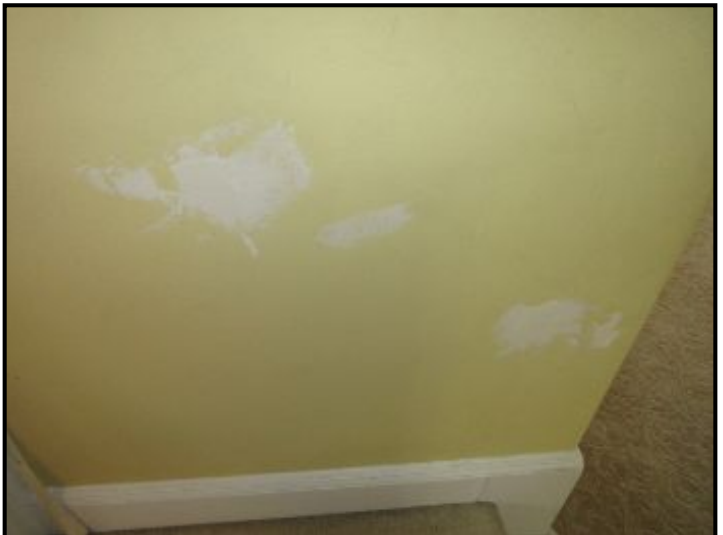
Unfinished wall repairs observed at stairway walls.

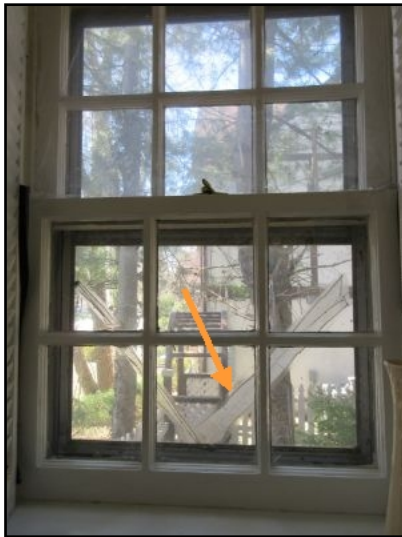
Cracked outer glass pane noted; tape repaired.  
Recommend proper repair.

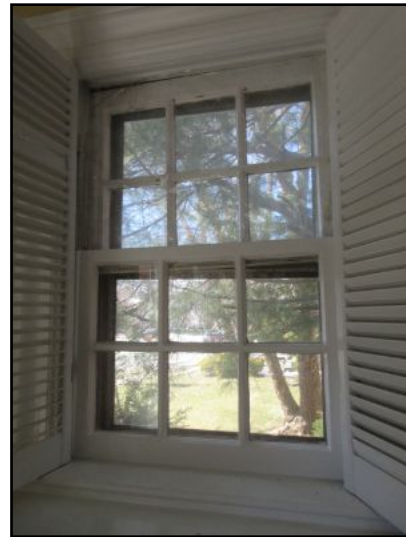
DEFERRED COST: Several windows are original, older wood type. Consider upgrading to thermally insulated windows.

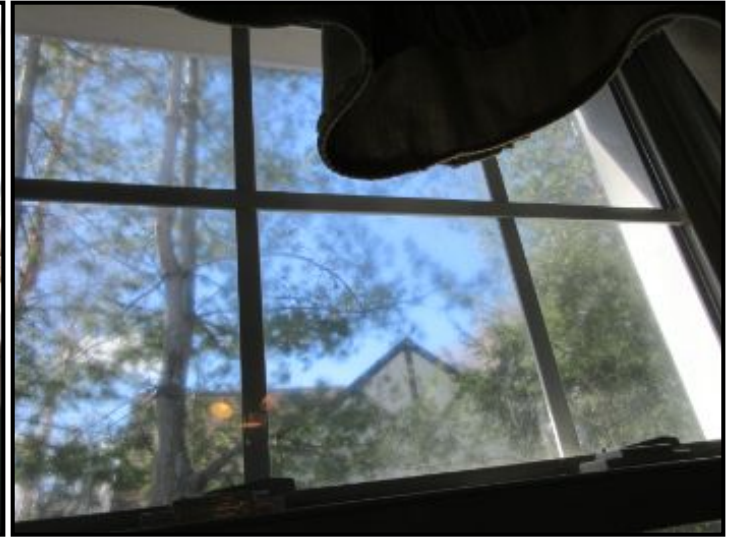
Fog/condensation observed in thermopane window at west bedroom. This is an indication of a failed seal. Recommend review for repair or replacement as necessary.

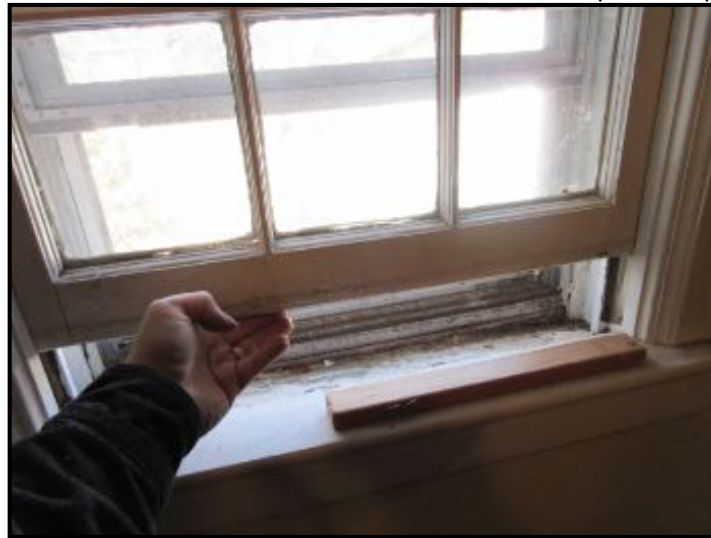
Broken sash wire/cord observed on window frame. This is a "Safety Concern". Sash wire/cord holds window in open position. Suggest repairs/replacement as needed to ensure safety.

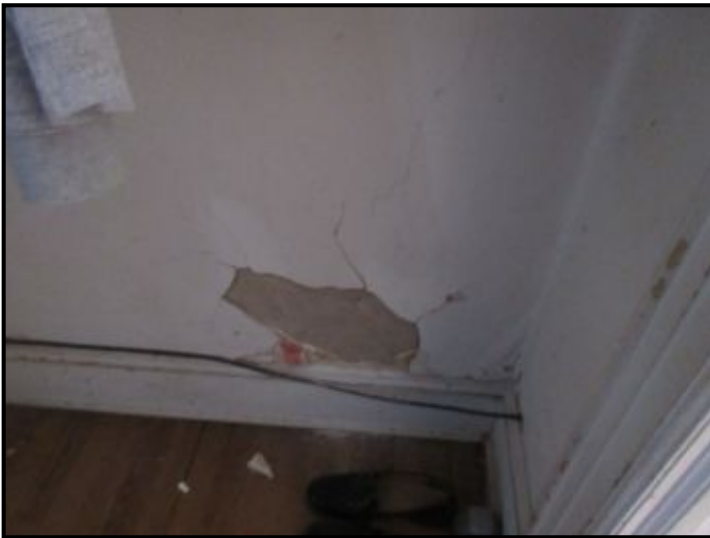
Cosmetic damage in west bedroom closet caused by structural settlement and subsequent neglect.

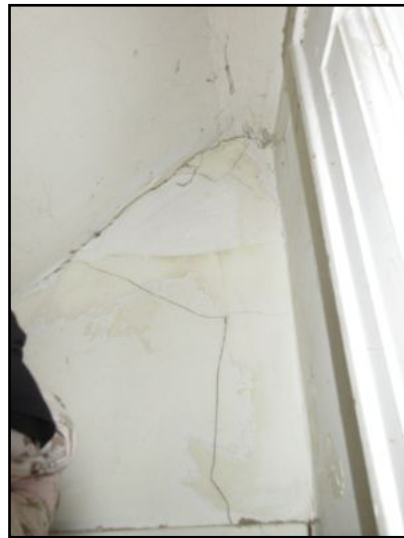
Cosmetic damage in west bedroom closet caused by structural settlement and subsequent neglect.

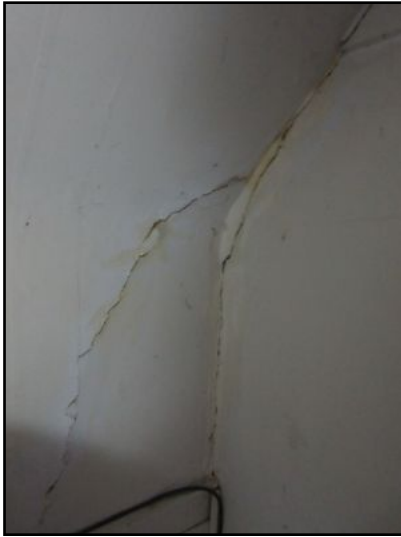
Cosmetic damage in west bedroom closet caused by structural settlement and subsequent neglect.

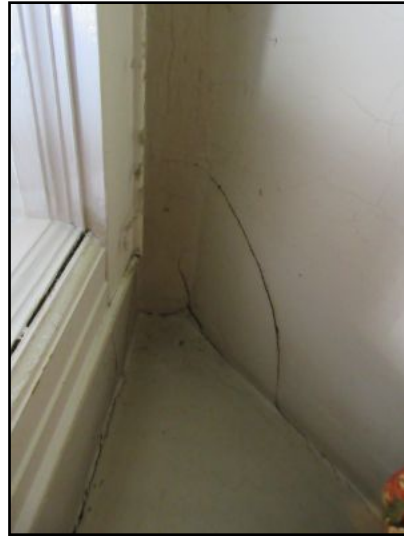
Cosmetic damage in west bedroom closet caused by structural settlement and subsequent neglect.

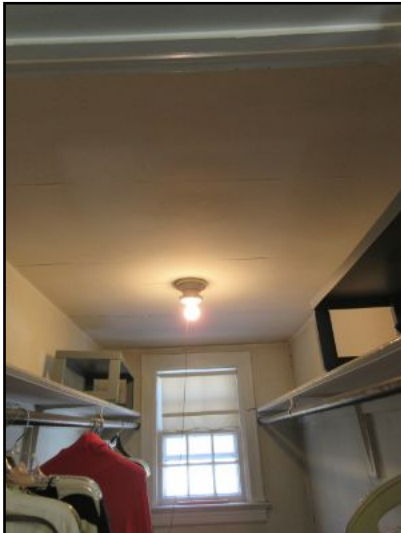
Wall paper painted over at walk-in closet.

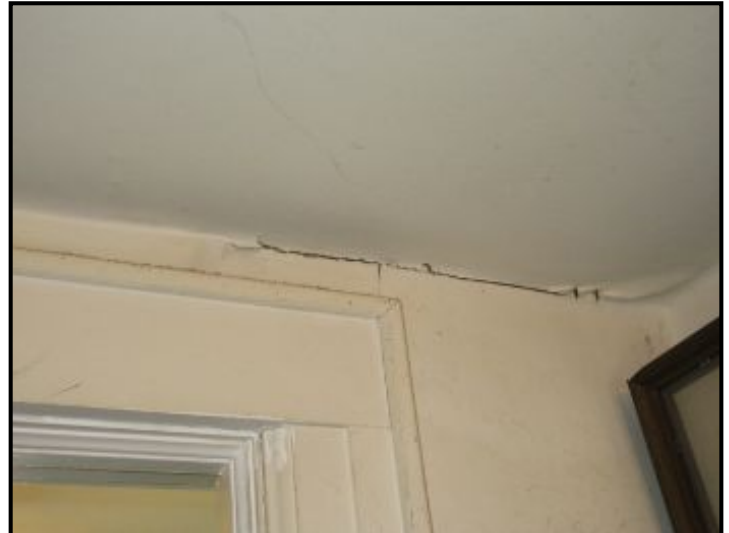
Cosmetic damage in master bedroom closet caused by structural settlement and subsequent neglect.

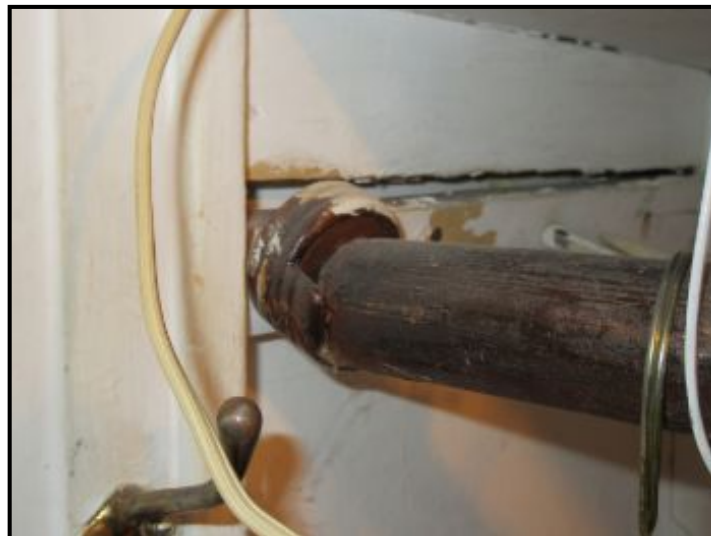
Older clothes hanger rod not long enough; possible wall movement had occurred from structural settlement.

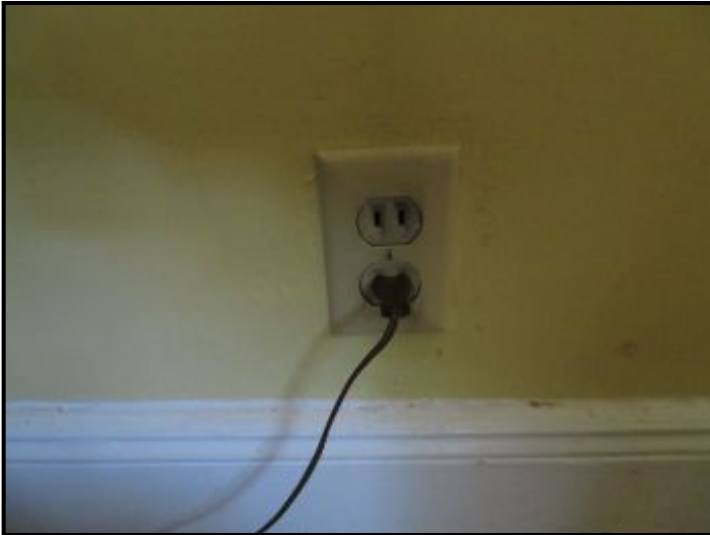
Existing electrical outlets are the older ungrounded 2-prong type. Suggest electrician install grounded 3-prong outlets.

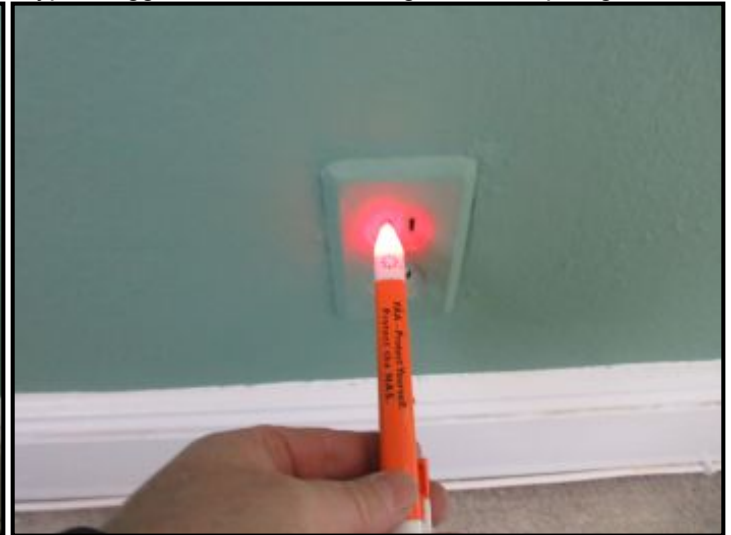
Power noted at 2 prong outlets.

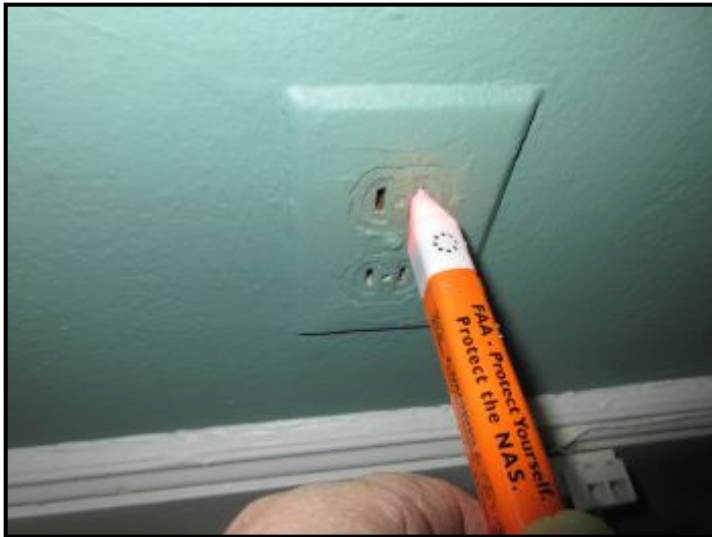
Power noted at 2 prong outlets.

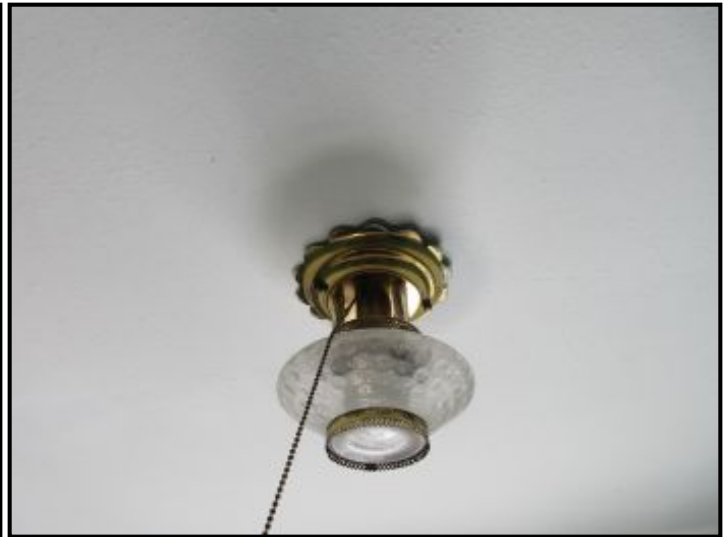
Bedroom light fixture not operable and not securely mounted. Suggest electrician evaluate and repair.

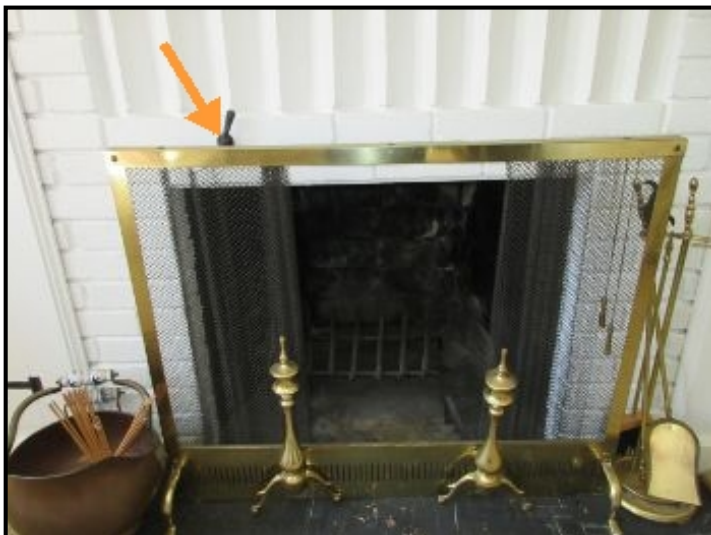
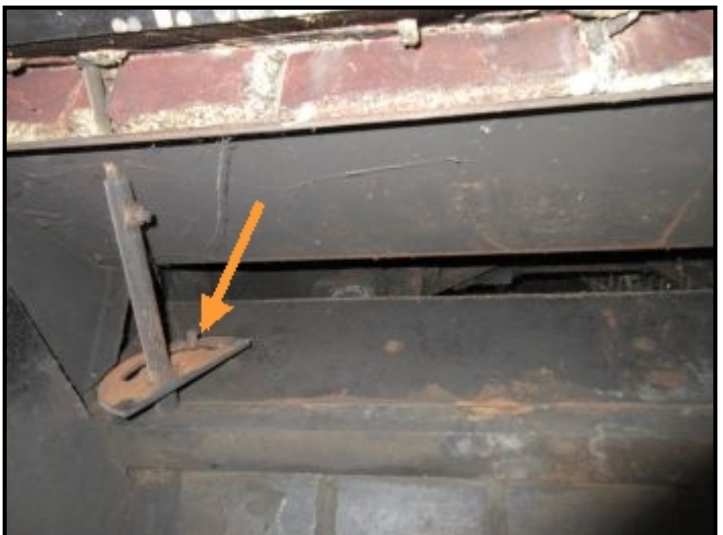
Fireplace enclosure in contact with damper lever, preventing proper operation of both the enclosure and damper.

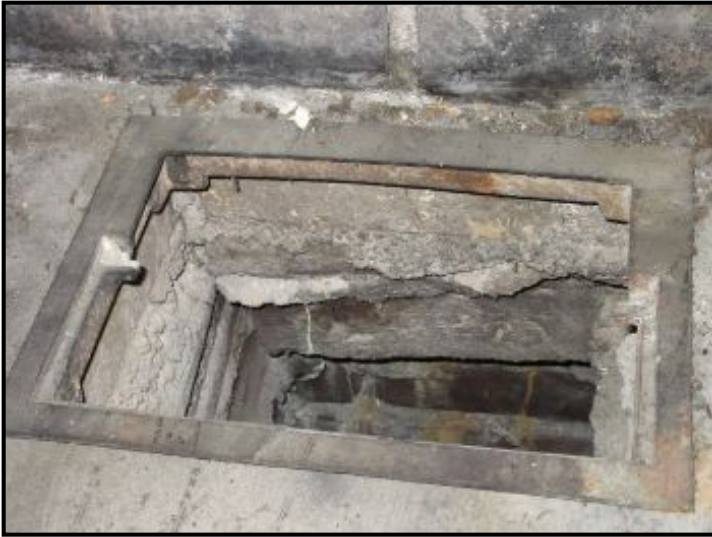
Proper ash dump door was missing. Suggest replacement.

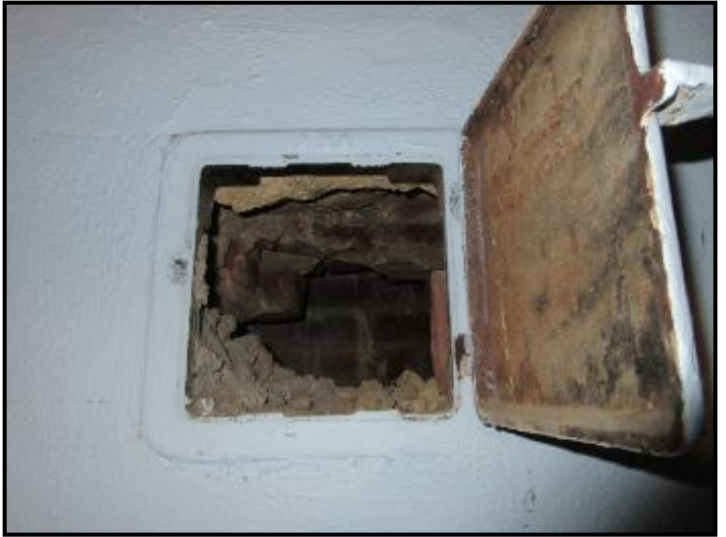
Fireplace clean-out door in boiler room.

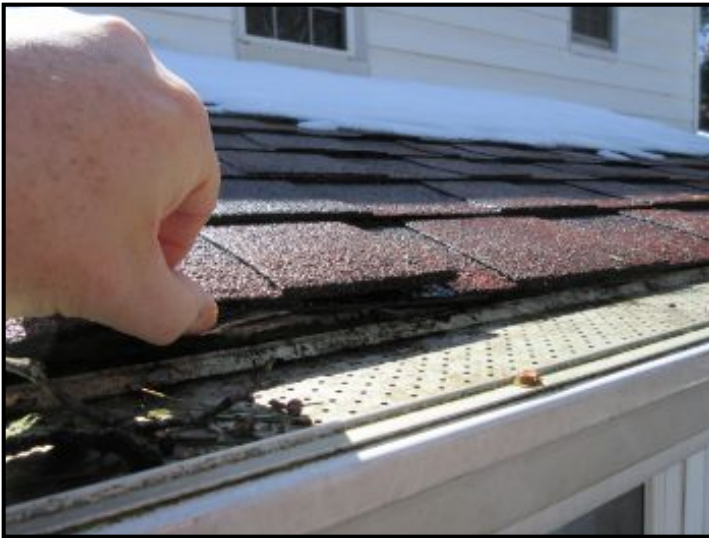
One layer of asphalt shingles noted.

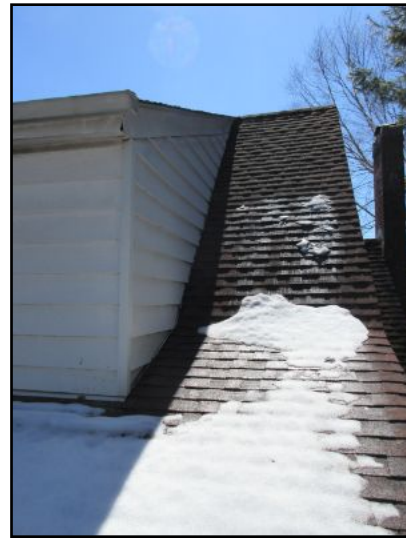
Partially snow covered, not fully inspected.

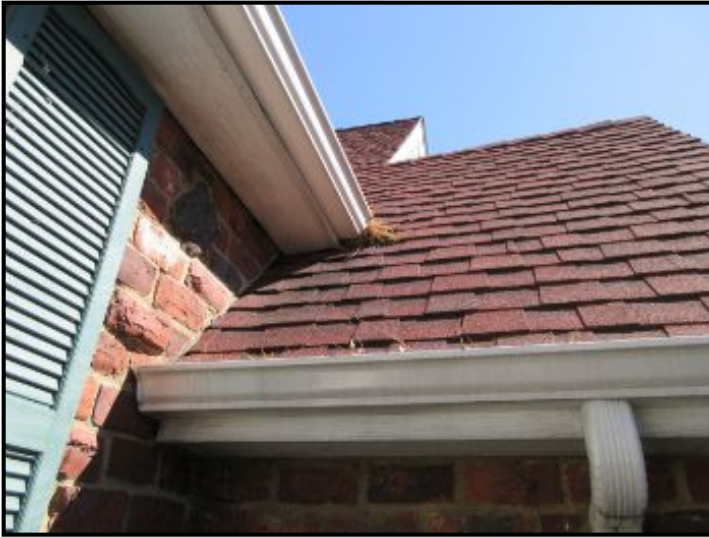
House top asphalt roof covering appeared to be approximately 8-10 yrs old.

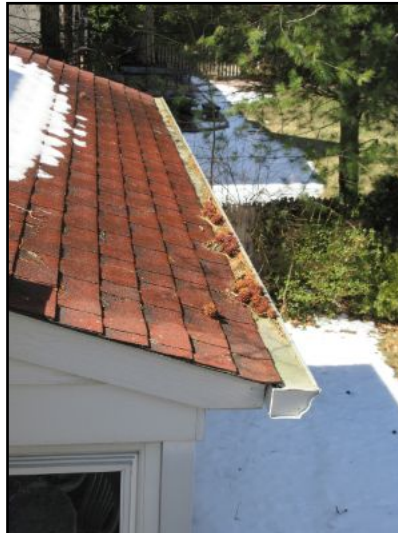
No major system safety or function concerns noted for the visible portions of the roof.
