# ProSpec Home Inspection of Long Island Property Inspection Report

213 Glenmore St, E. Williston NY, 11596  
Inspection prepared for: Name Deleted  
Date of Inspection: 3/24/2019 Time: 12:00 PM  
Age of Home: 88 yrs old  
Approx Year Built: 1930

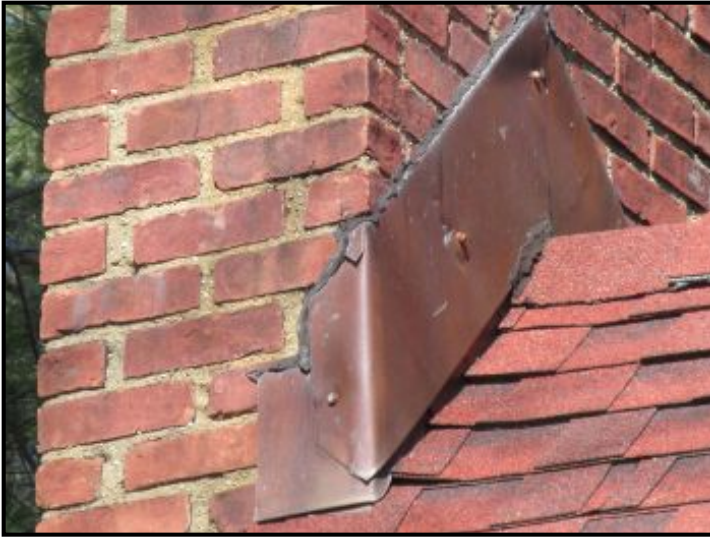
Copper flashing visible around chimney.

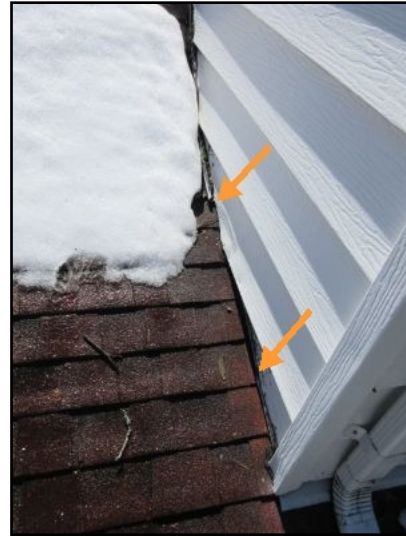
J-channel missing at east side of lower part of dormer.

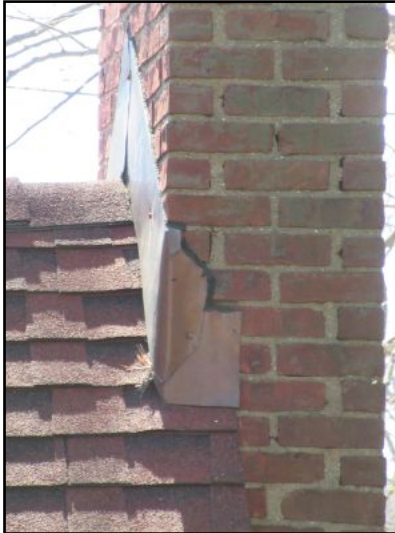
Chimney flashing appear intact and functional.

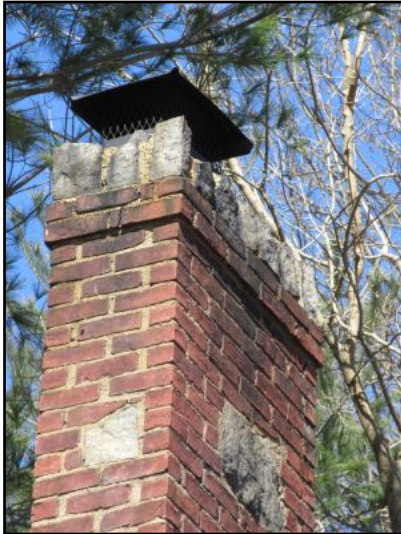
Combined fireplace and furnace chimney brick enclosure noted.

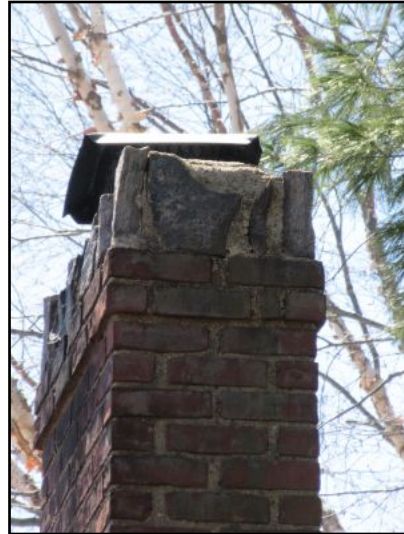
Boiler chimney flue liner was not visually accessible. Recommend chimney contractor check to see if a s.s. chimney liner was installed at time of the boiler update. Combined chimney requires a flue liner for boiler. Chimney crown cement not visible from ground. Suggest chimney contractor inspect further to ensure there's no water intrusion here.

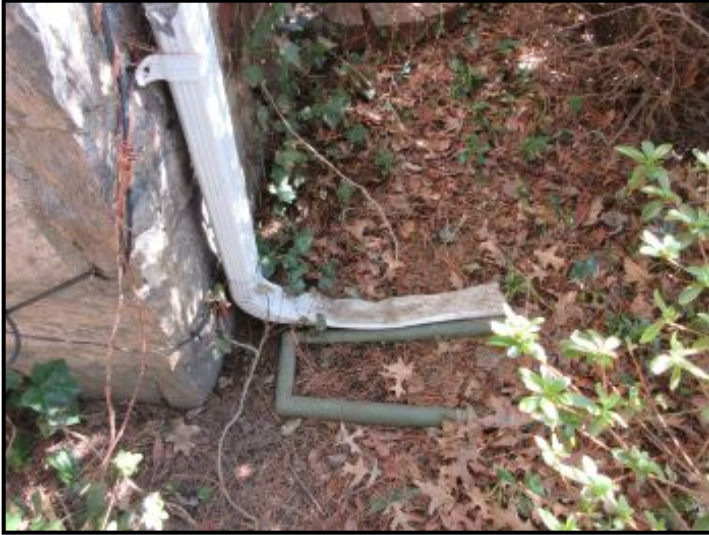
Crushed downspout extension noted.

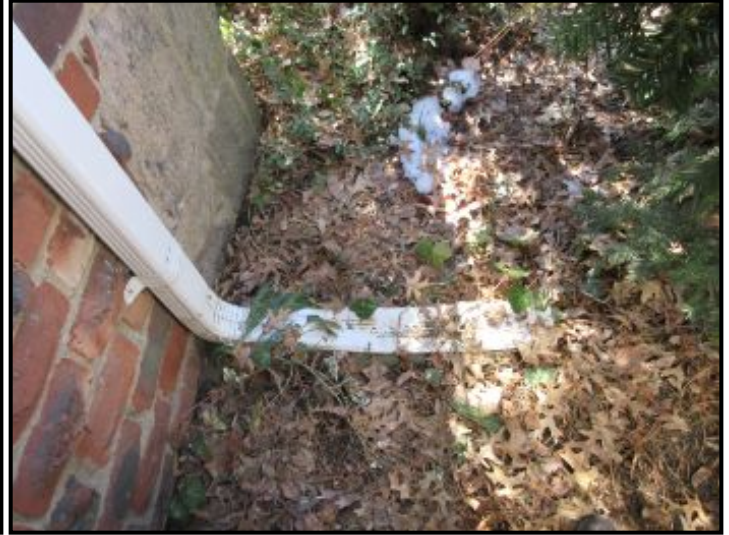
Crushed downspout extension noted.

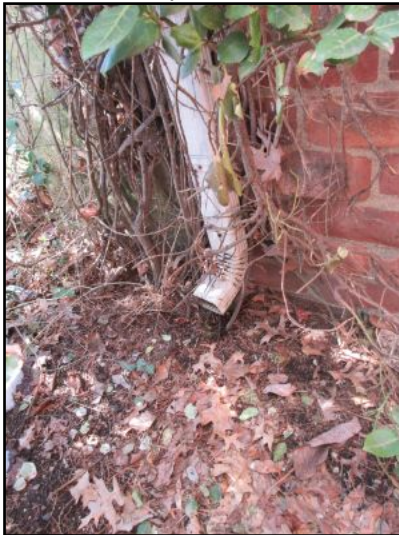
Downspout extension missing. Recommend extending downspouts 4 ft minimum where possible to direct run-off away from the foundation and prevent water seepage through foundation walls.

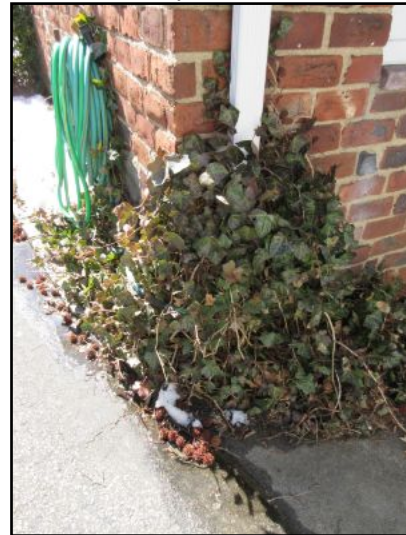
Downspout extension missing. Recommend extending downspouts 4 ft minimum where possible to direct run-off away from the foundation and prevent water seepage through foundation walls.

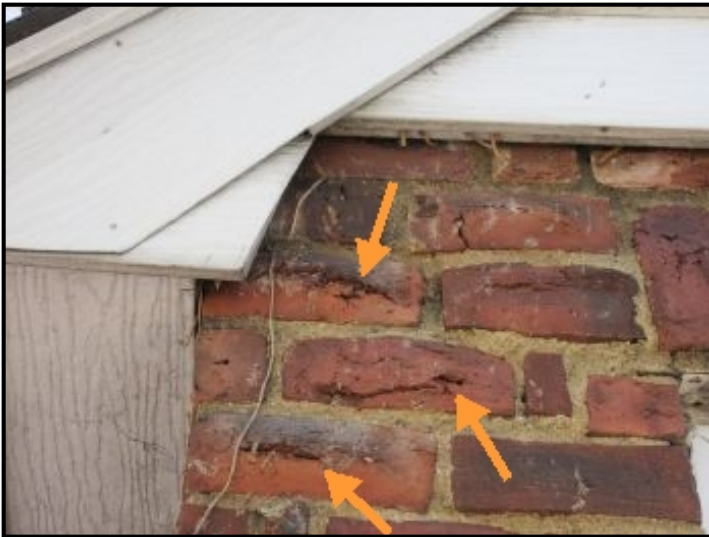
Distorted/bloated and cracked bricks noted at house and garage exteriors. This appears to be from a process defect, such as underburning of brick which results in a higher degree of water absorption and less compressive strength. Water absorption combined with frost weathering may have caused the excessive brick face cracks observed.

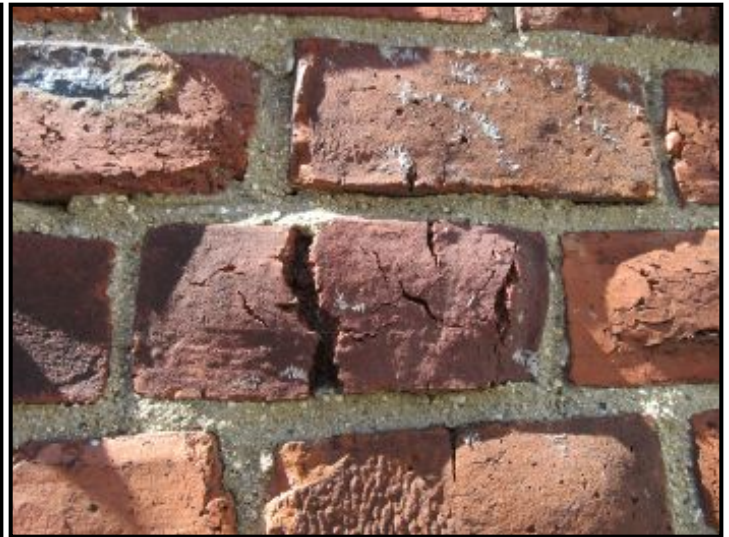
Distorted/bloated and cracked bricks noted at house and garage exteriors. This appears to be from a process defect, such as underburning of brick which results in a higher degree of water absorption and less compressive strength. Water absorption combined with frost weathering may have caused the excessive brick face cracks observed.

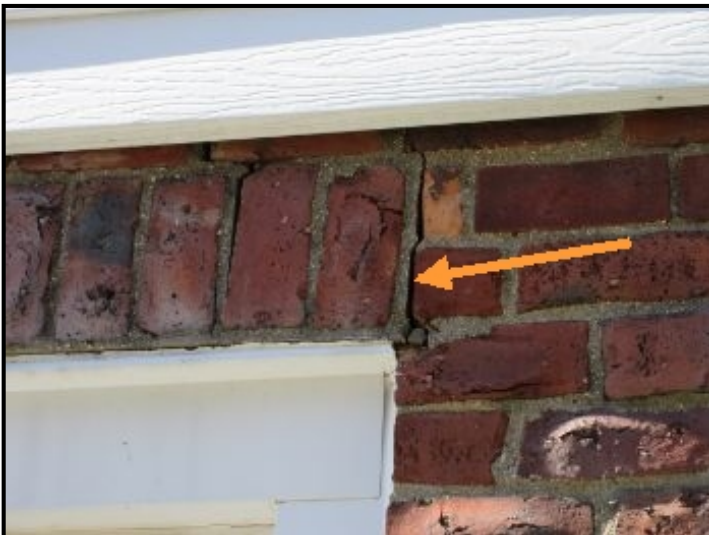
Settlement crack noted above window lintel. Suggest repair.

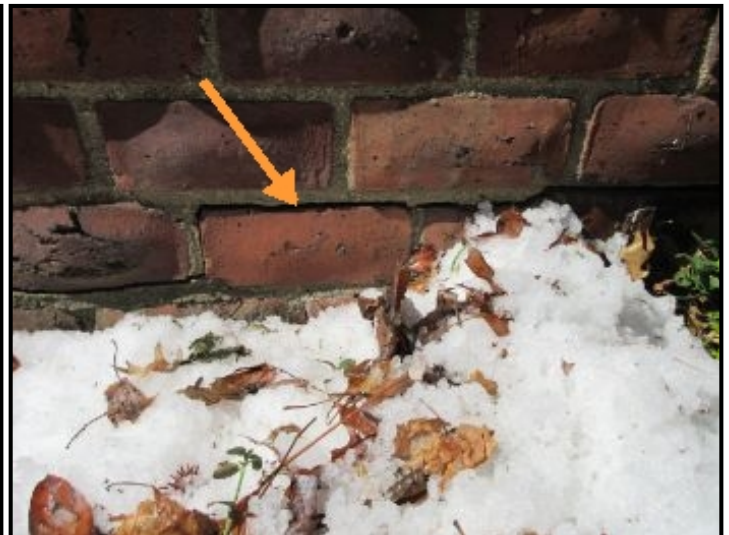
Settlement crack noted at lower wall by driveway. Suggest mortar repair.

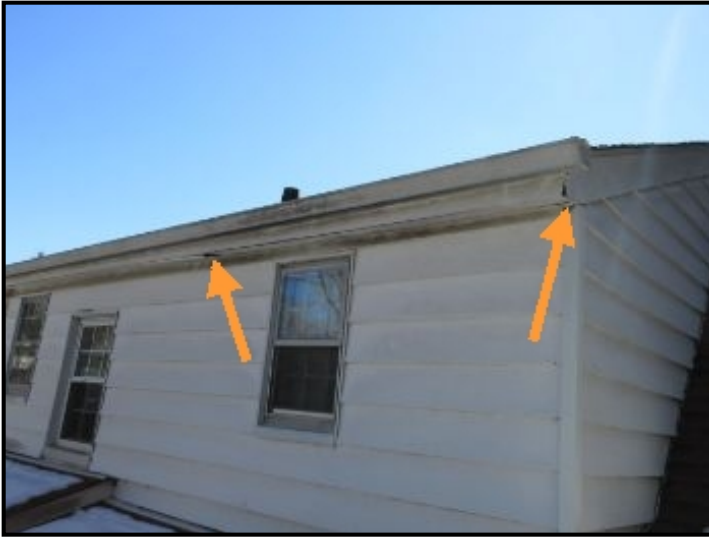
Some defects observed at fascia and soffit aluminum cladding. Suggest repairs to prevent water intrusion.

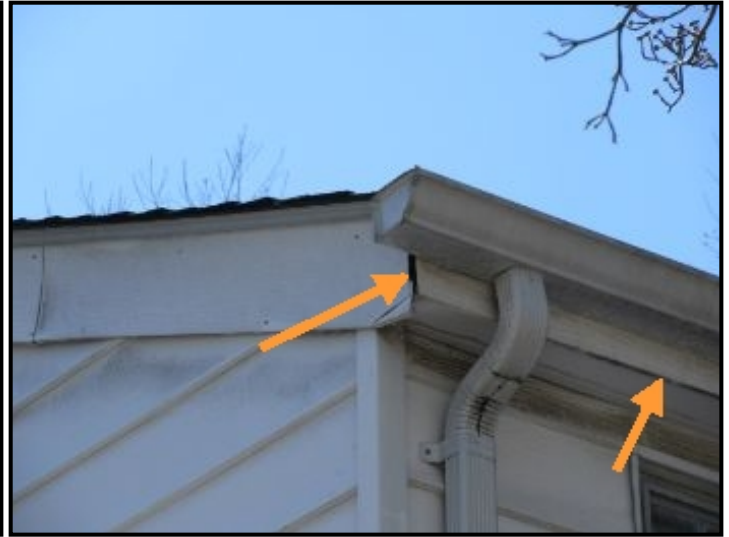
Some defects observed at fascia and soffit aluminum cladding. Suggest repairs to prevent water intrusion.

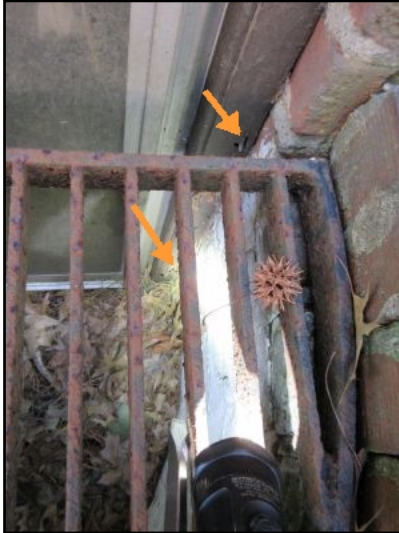
Deterioration of wooden frames noted. In the inspectors opinion the windows/frames are near the end of their useful life.

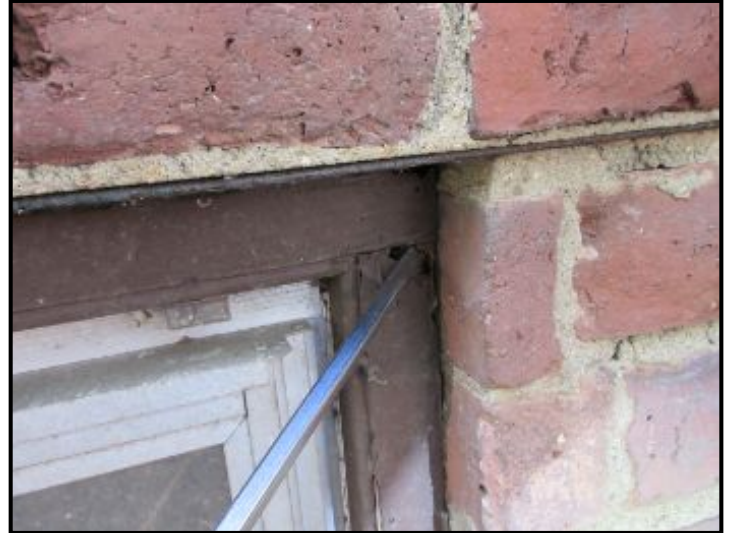
Deterioration of wooden frames noted.

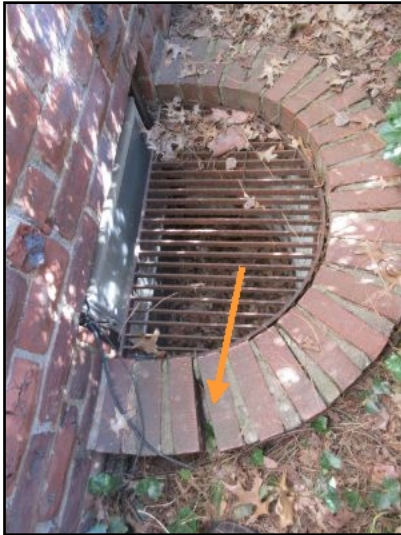
Mortar damage noted at window wells. Repair and ensure gratings are secure.

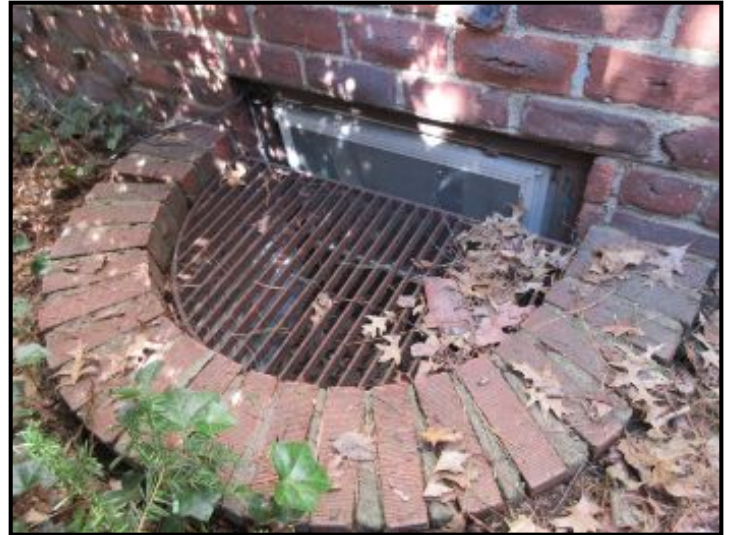
Masonry window wells with steel grating noted.

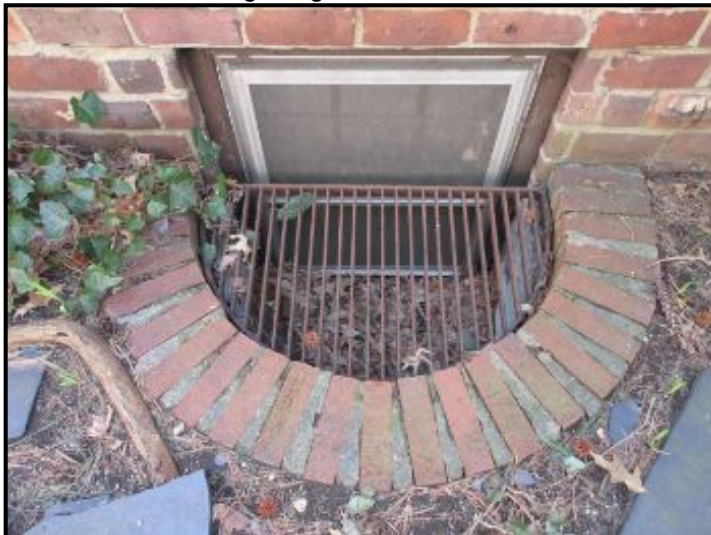
Masonry window wells with steel grating noted.

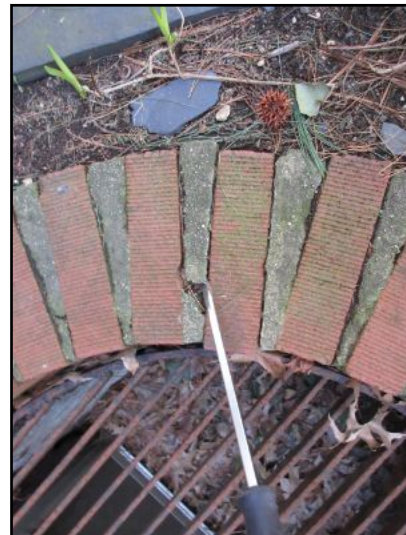
Mortar damage noted at window wells. Repair and ensure gratings are secure.

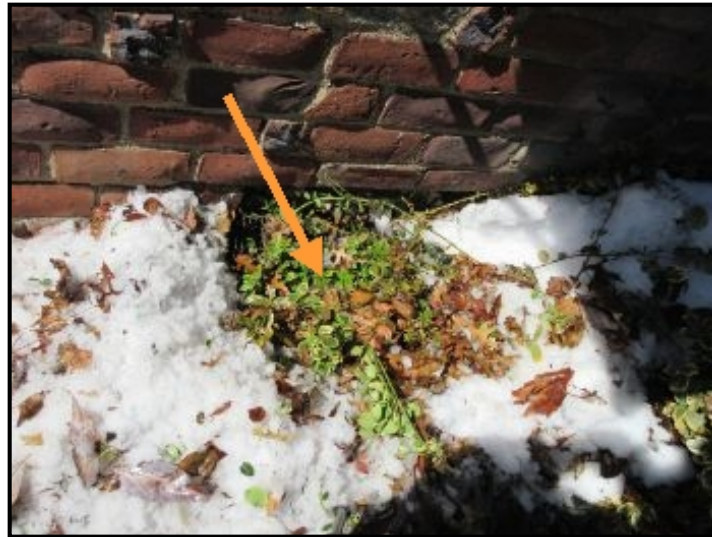
Basement window well grate covered by vegetation where dryer vent exhausts. This must be kept clean since the warm moisture provided excellent conditions for termites. Refer to noted termite activity in laundry room.

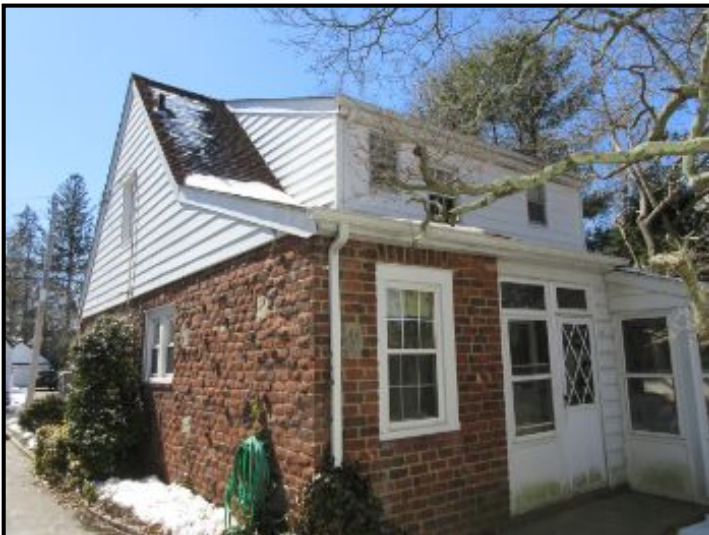
EXTERIOR North exterior

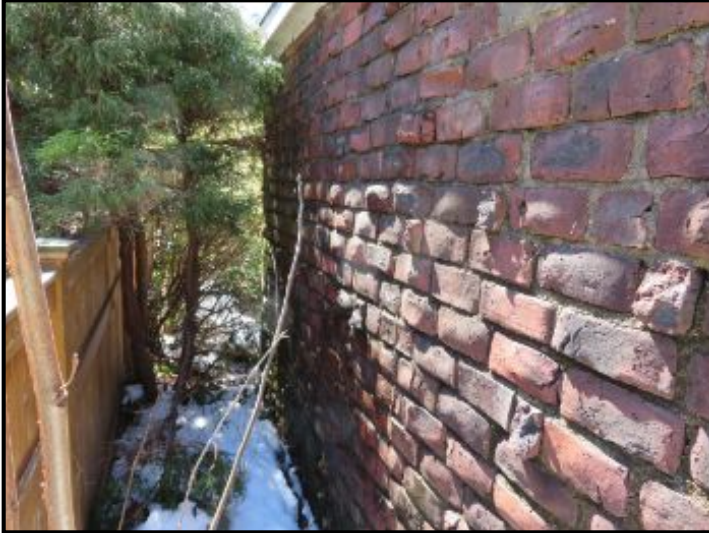
Distorted bricks observed at garage walls.

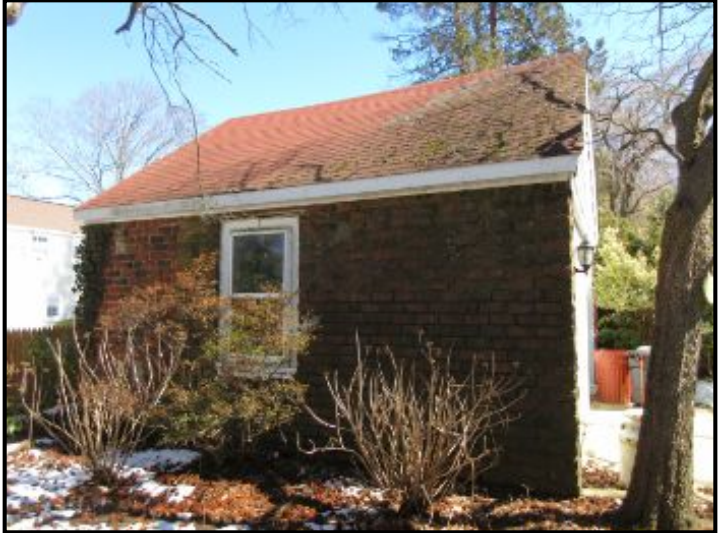
GARAGE Garage General

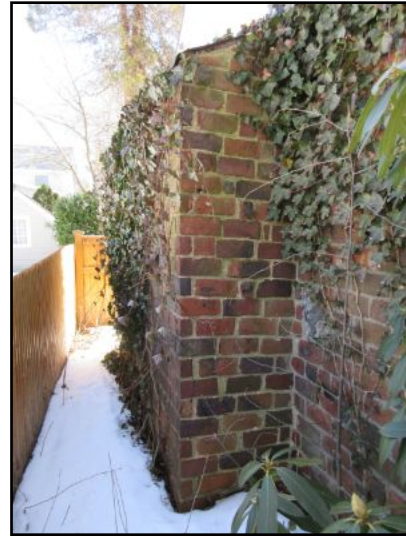
Vegetation (vines) growing up under roof covering can cause leaks. Recommend removing this vegetation.

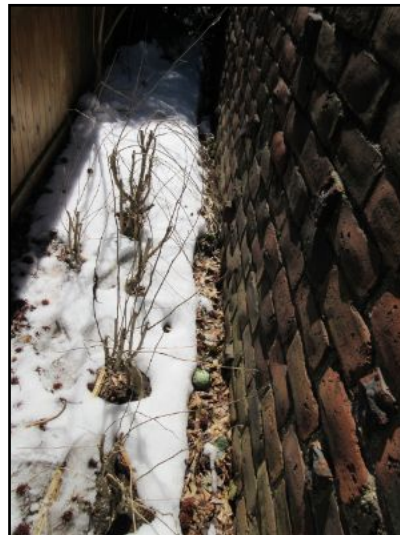
Standing water observed inside east wall from snow melting alongside of garage and lack of proper roof drainage system. Suggest improving drainage here and adding gutters w/downspouts to control runoff and prevent water intrusion.

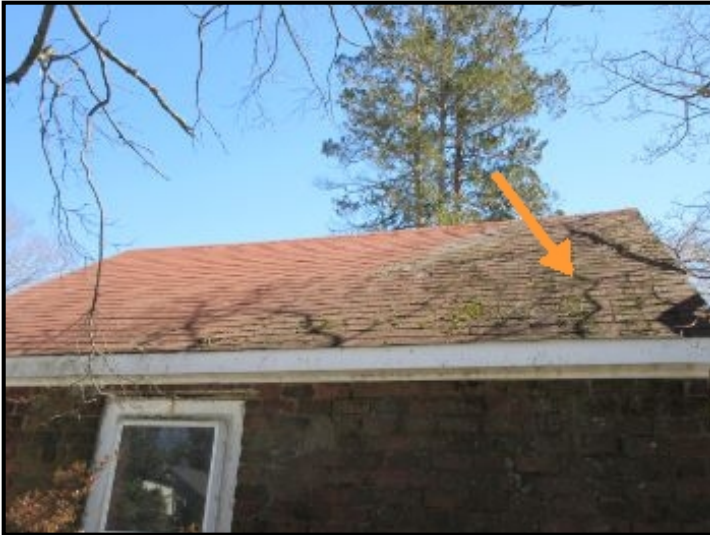
Moss on roof. This can lead to the premature failure of the roof and subsequent leaks. Recommend treating moss during its growing season (wet months) with a moss killer. For information on various moss treatment products and their pros and cons, visit <http://bryophytes.science.oregonstate.edu/page24.htm>

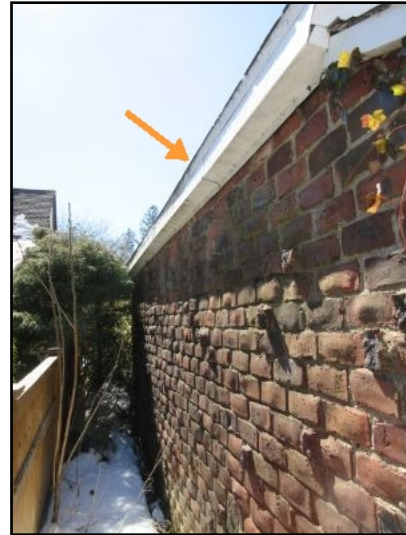
Garage roof gutters and downspouts missing. Recommend adding these to direct water away from the foundation and prevent water intrusion.

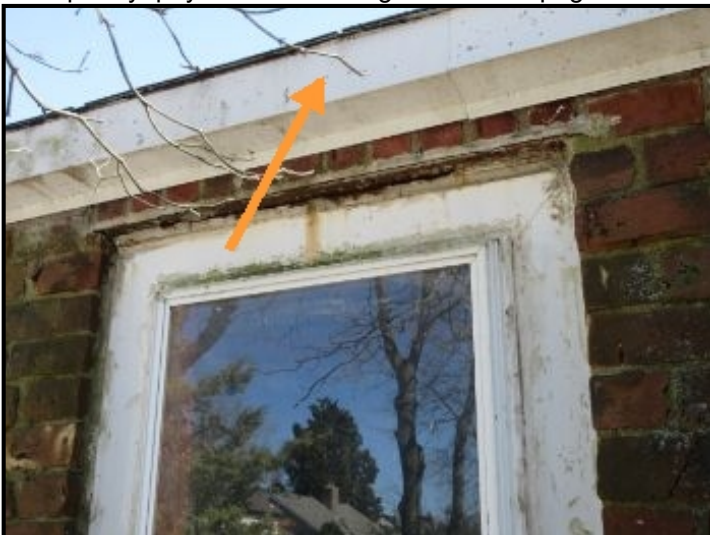
Garage roof gutters and downspouts missing. Recommend adding these to direct water away from the foundation and prevent water intrusion.

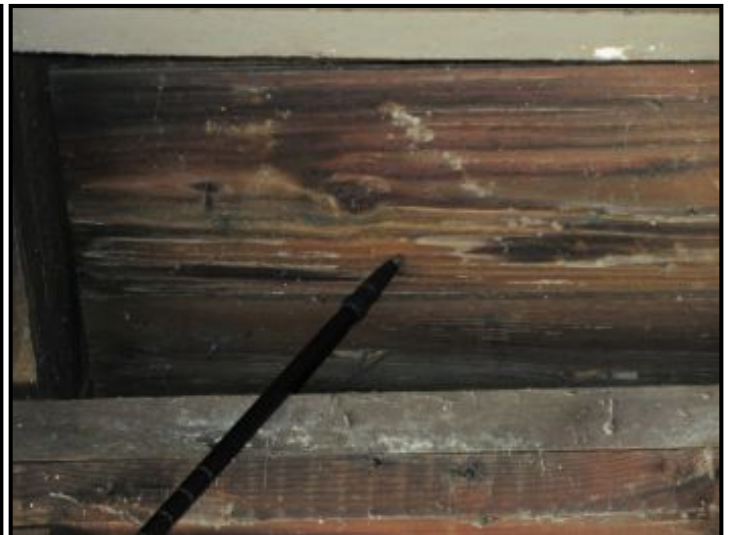
Decay noted at several roof board locations.

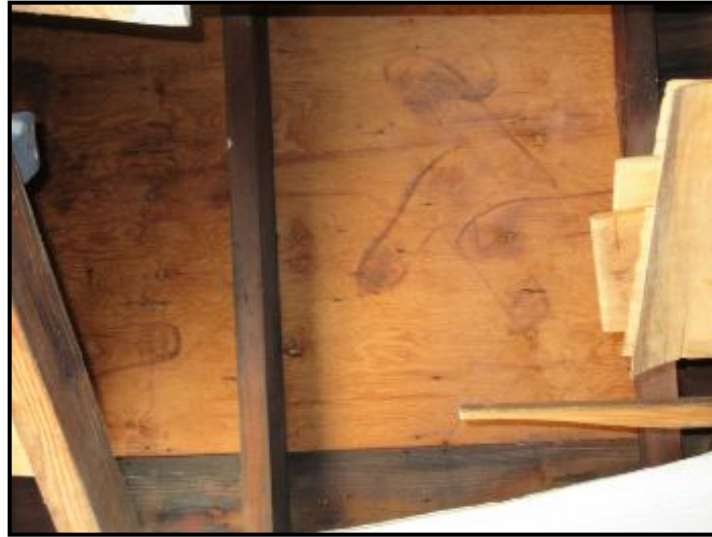
Roof board repairs noted.

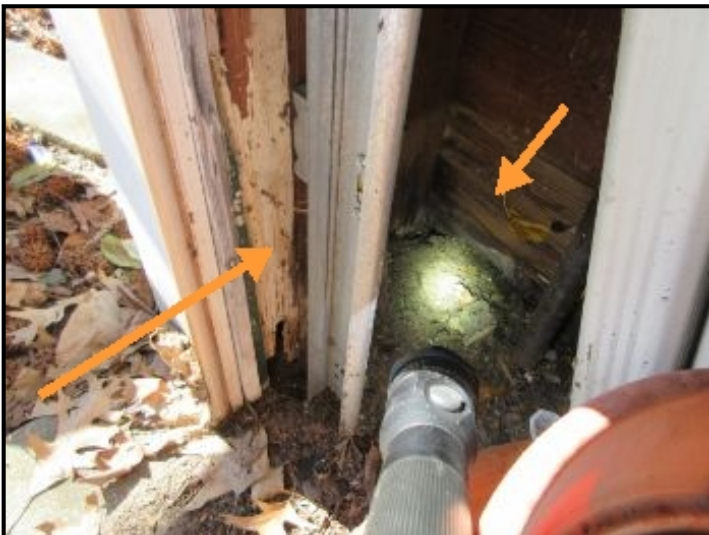
Termite damage noted at garage door jamb. Refer to NPMA-33 report form.

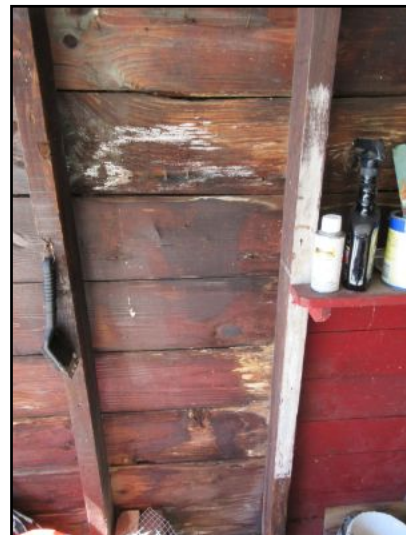
Extensive decay of wall boards noted.

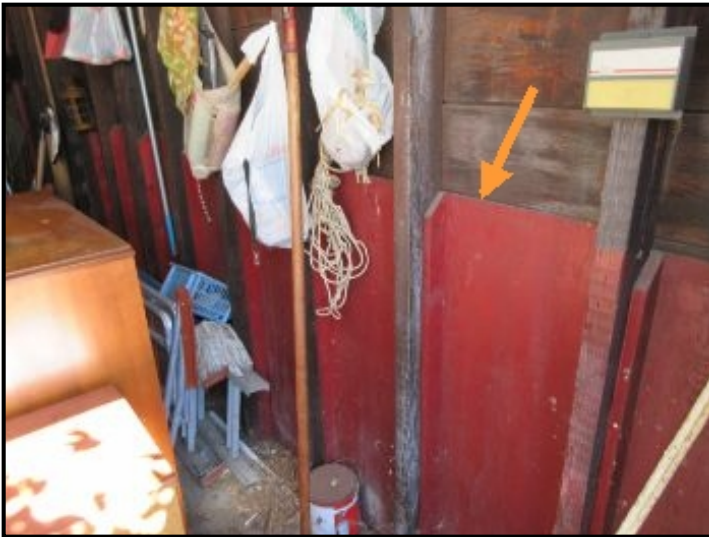
Sections of the wall boards covered over. Although termite activity was not observed here, wood to soil contact at east wall is an invitation to termites. Refer to NPMA-33 report form for treatment recommendation.

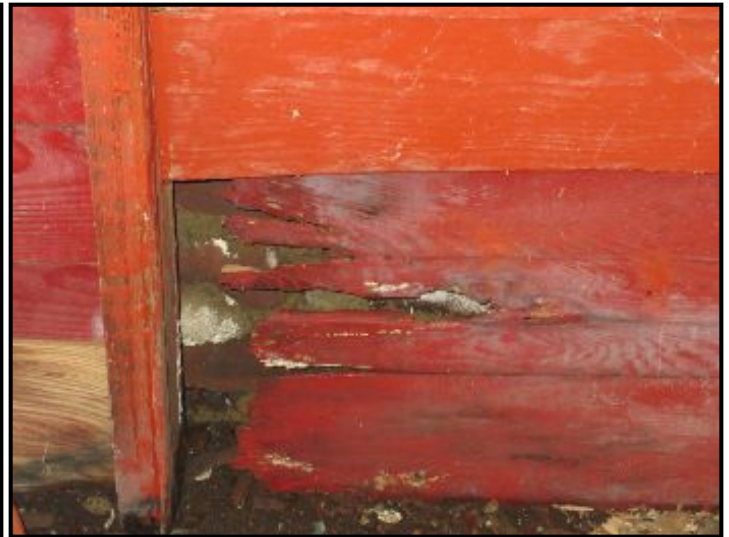
Extensive decay of wall boards and studs noted.

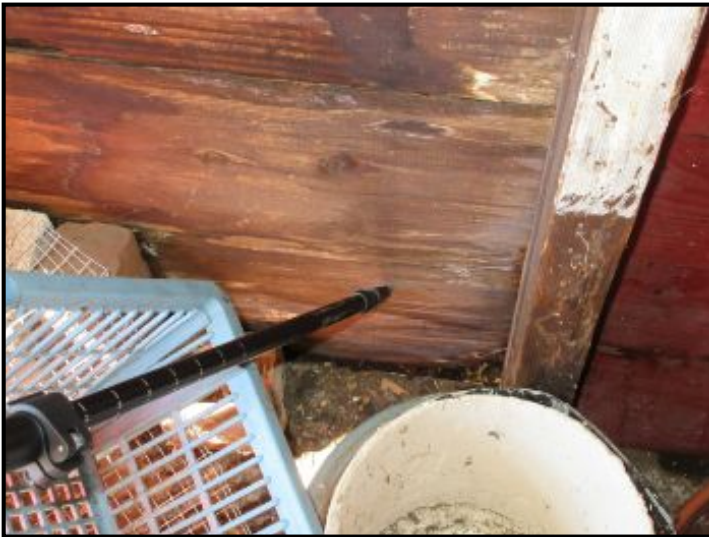
Decay of wall boards and studs noted.

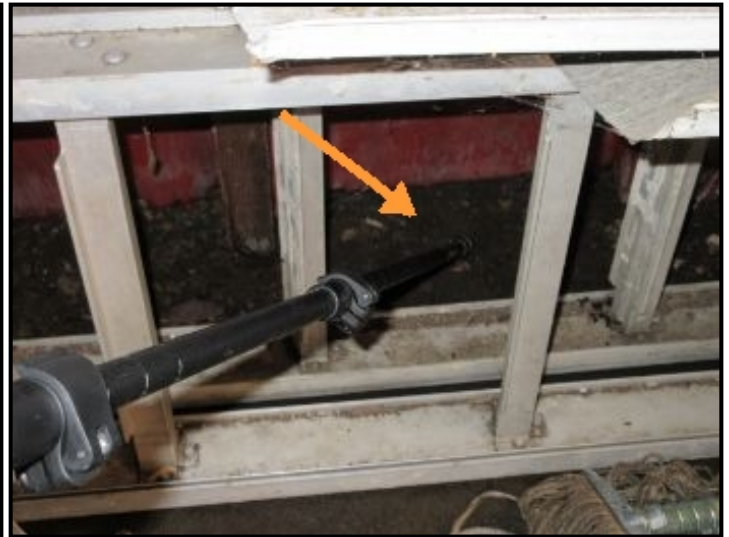
Wood to soil contact at east wall is an invitation to termites.

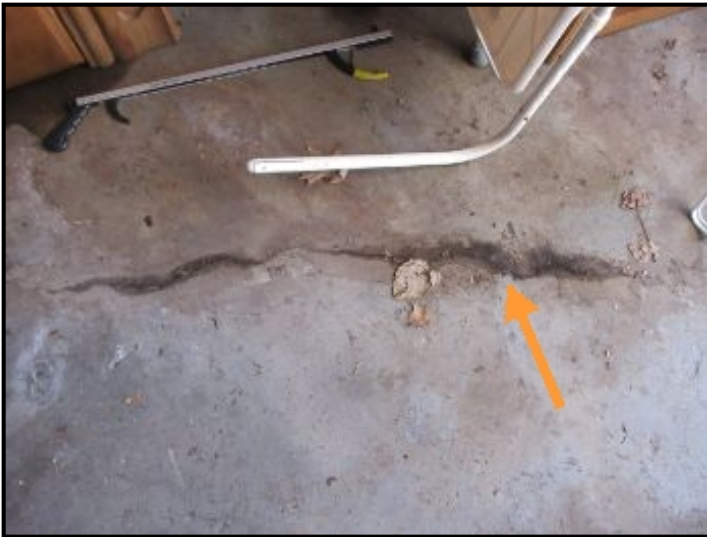
Water seepage up through floor crack noted.

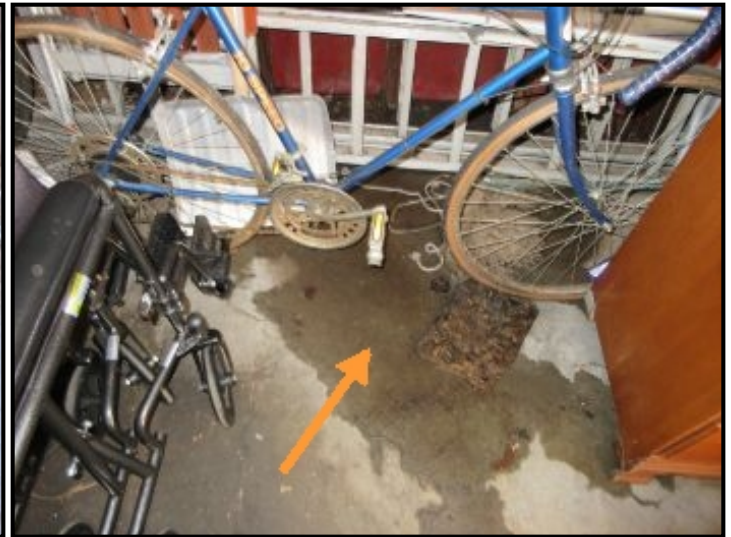
Standing water observed near east wall from snow melting alongside of garage.

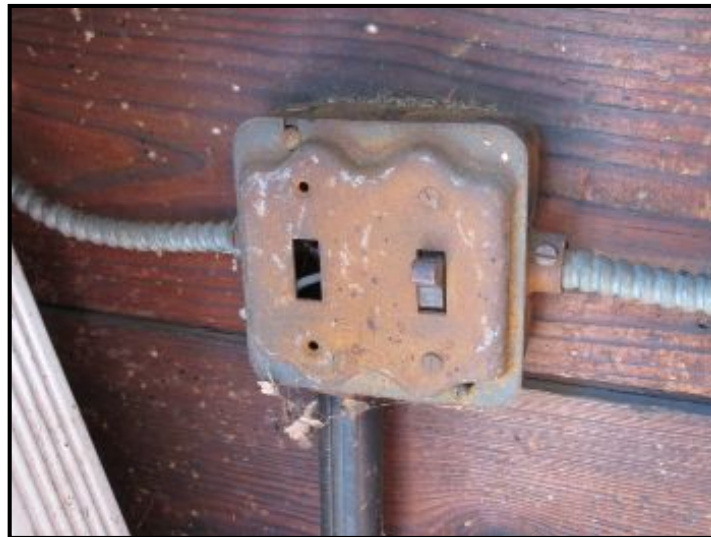
Light switch missing/inoperable.

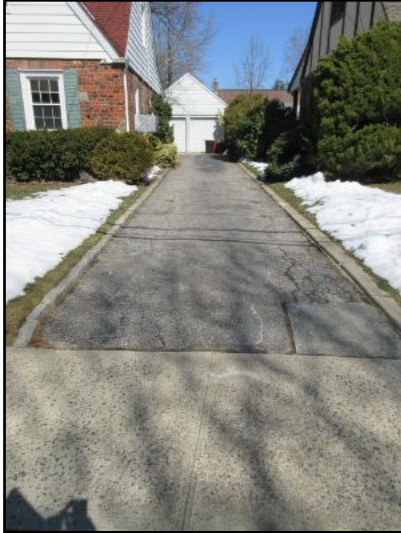
Asphalt driveways require sealing every 3-5 yrs to prevent freeze/thaw damage.

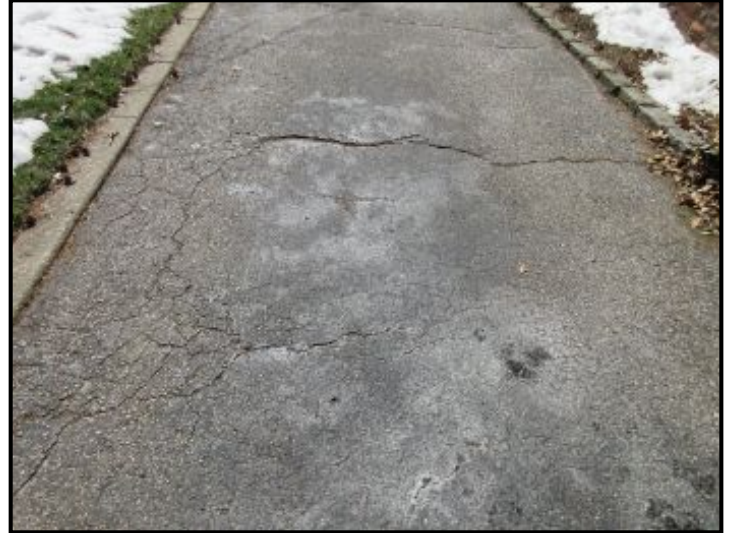
Moderate cracks in driveway. Repair and / or monitor for expansion and development of trip hazards.

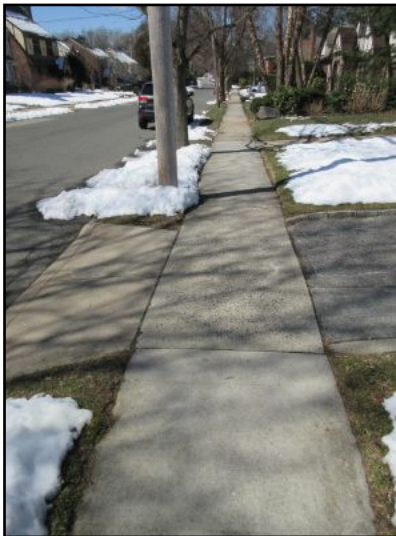
Sidewalks: No major system safety or function concerns noted at time of inspection.

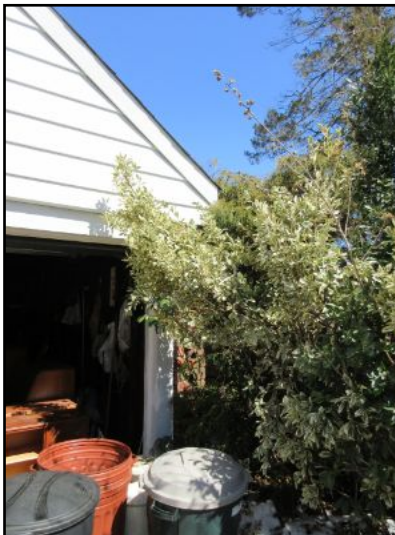
Trim trees/shrubs that are in contact or proximity to home, as branches can abrade siding and damage roofing.

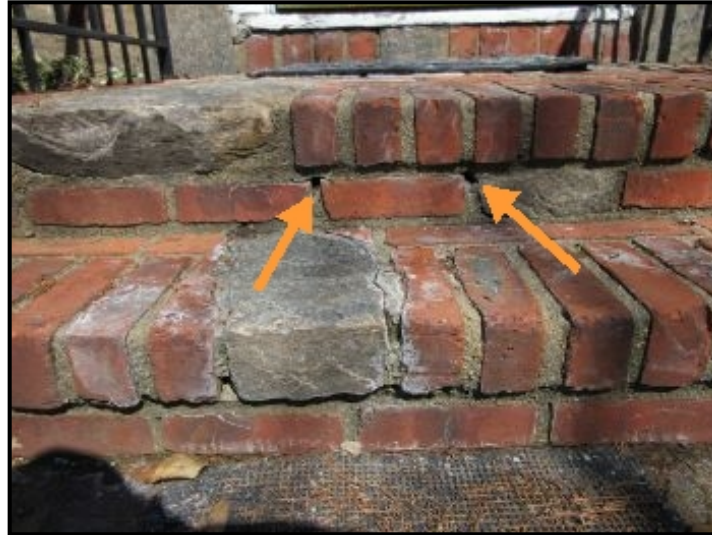
Some repointing needed.

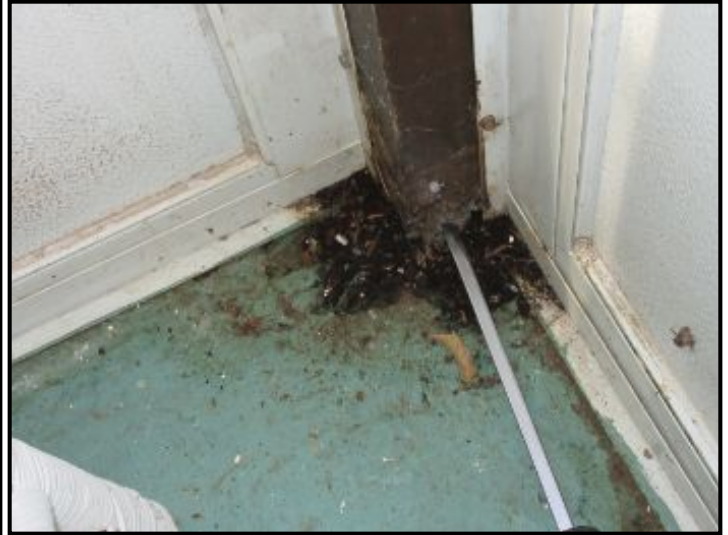
Water damage at base of porch roof posts (2 plcs). Recommend replacing decayed wood.

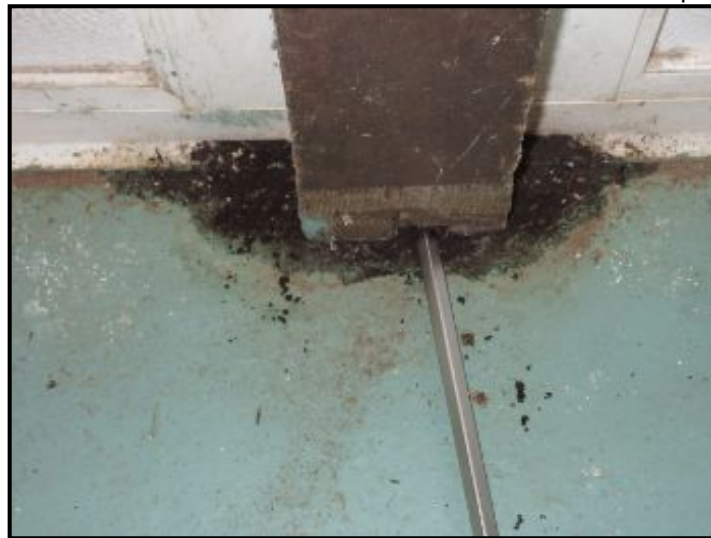
Water damage at base of porch roof posts (2 plcs). Recommend replacing decayed wood.

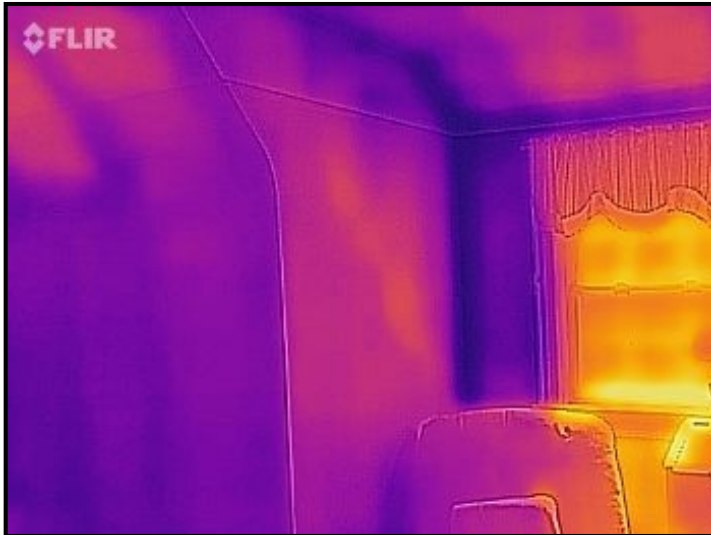
West bedroom southeast wall represents the average thermal condition for the home. Typical insulation here is 3 inches thick, estimated at R-9.5. This may be improved only slightly due to the limited wall cavity of 3.5".

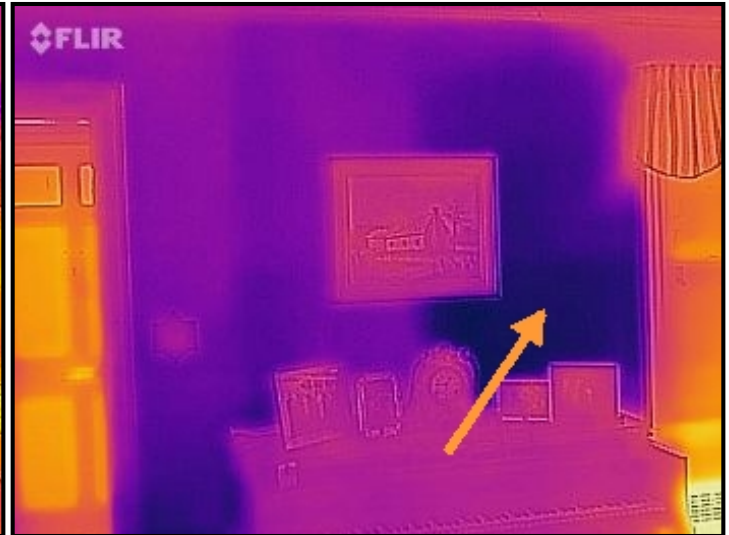
Darker (cooler) area at living room south wall indicates a lack of insulation. Suggest adding blown-in loose fill type insulation.

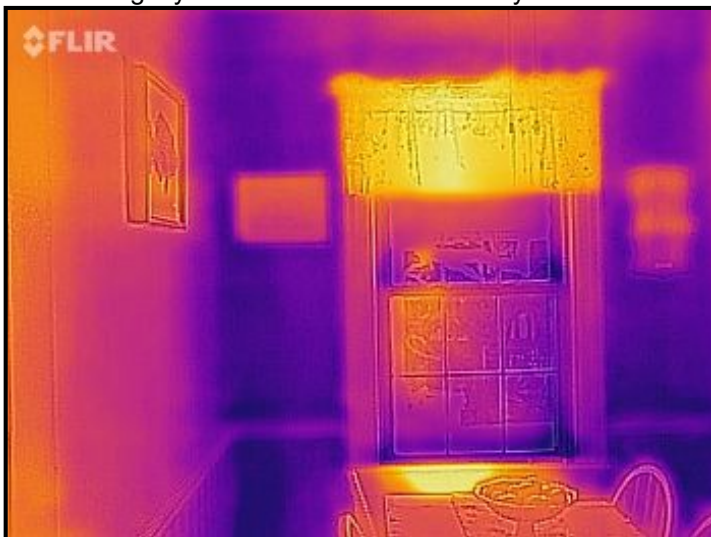
Dining room east wall is representative of the exterior wall insulation in the home. Typical insulation here is 3 inches thick, estimated at 9.5. This may be improved only slightly due to the limited wall cavity of 3.5". This may be improved only slightly due to the limited wall cavity of 3.5".

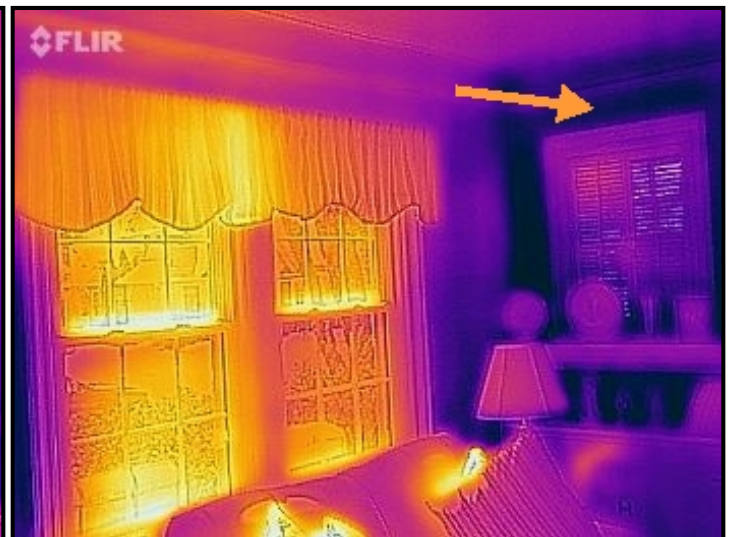
Darker (cooler) area at living room west wall around window indicates a lack of insulation and window infiltration. Suggest updating original windows, adding insulation to wall and window frame.

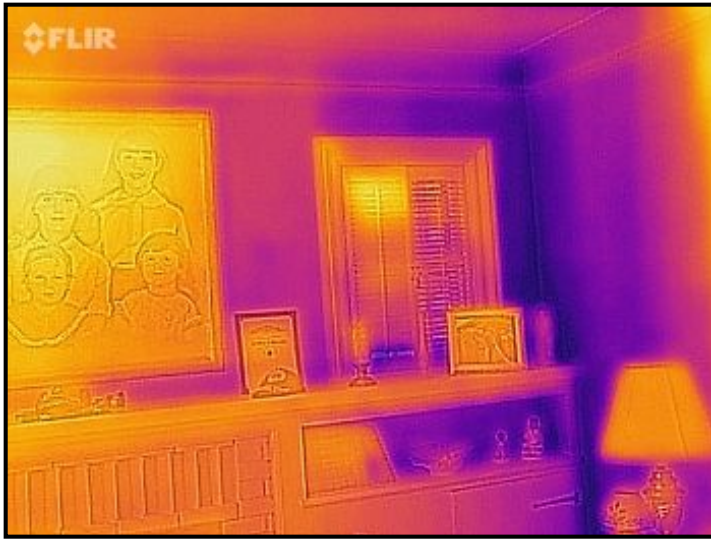
Living room northwest wall.

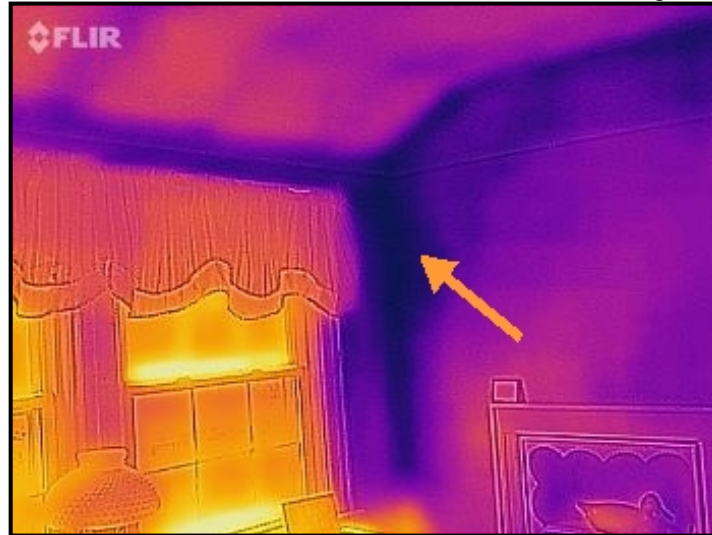
Deficient insulation noted at west bedroom corner wall.
