ProSpec Home Inspection of Long Island Property Inspection Report

9 Brookside Dr, Port Washington, NY 11050
Inspection prepared for: Name Deleted
Date of Inspection: 11/14/2020 Time: 10:00 AM
Age of Home: 1 yrs old Size: 5,200 sq.ft.
Approx. Year Built: 2020

Inspector: Russell J. Classi, P.E.
Phone: (516) 480-1848
Email: prospecfli@gmail.com
www.nassauprofessionalhomeinspector.com

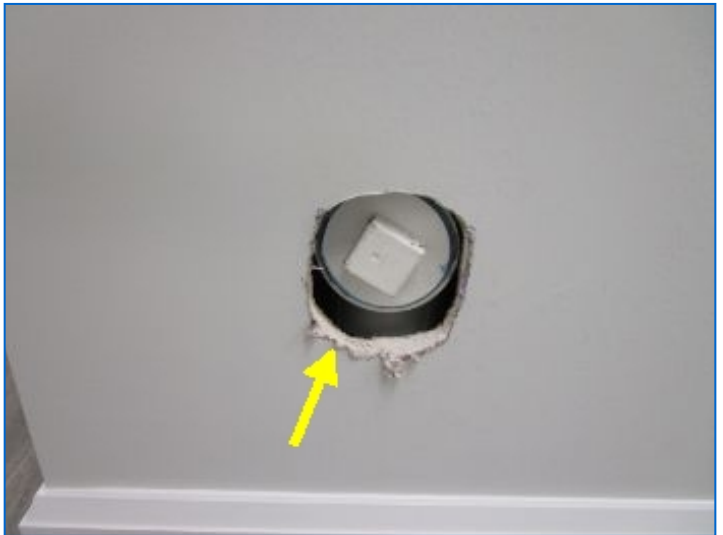
Storage Room: Access cover missing at plumbing clean-out plug.

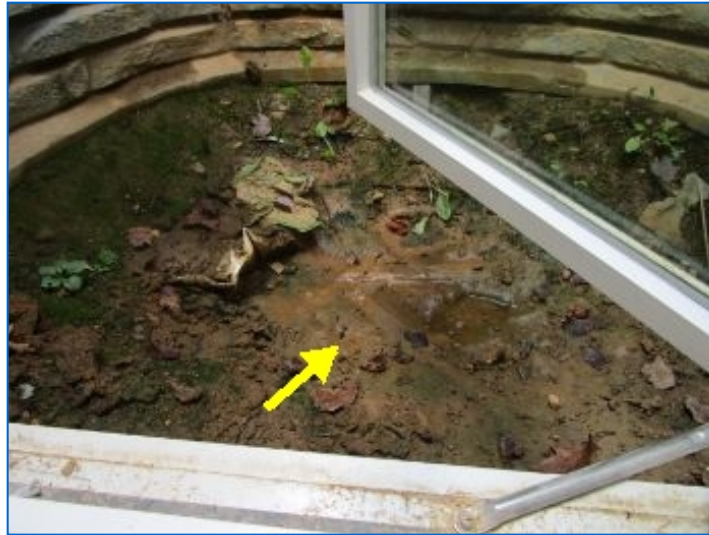
Suggest adding a layer of gravel to prevent muddy condition outside egress window.

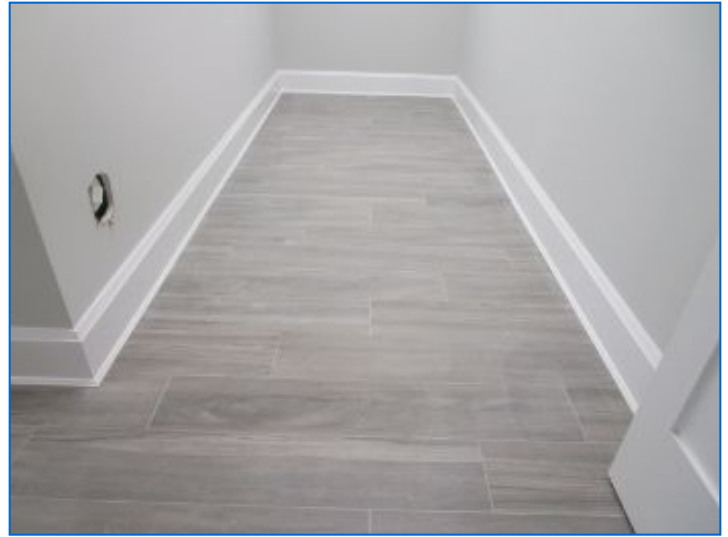
Incomplete data/telecom jack installation noted.
Recommend completion and/or finishes prior to close.

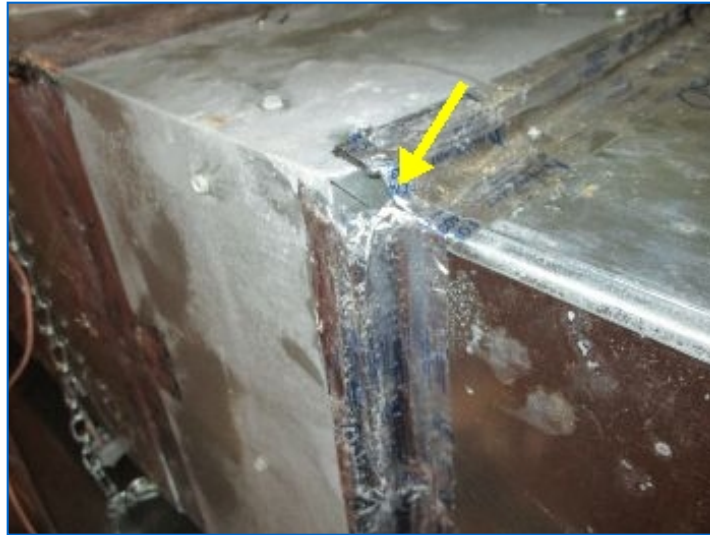
HVAC#3 duct supply air leakage provided, apparently for minimal air circulation inside attic space.

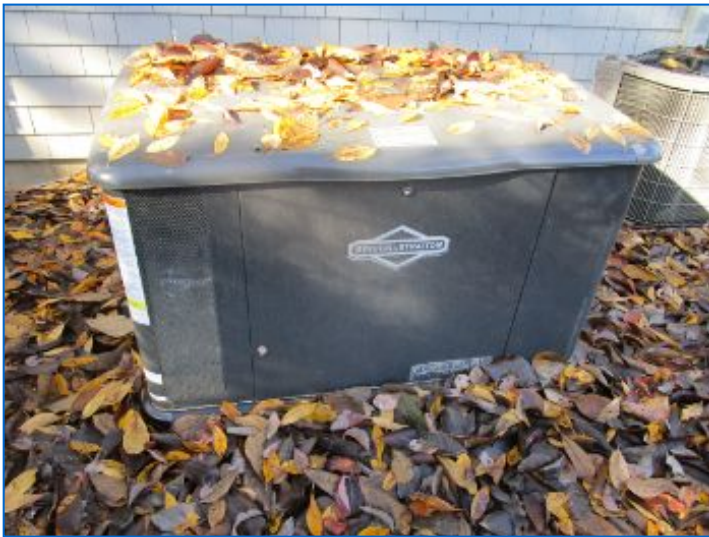
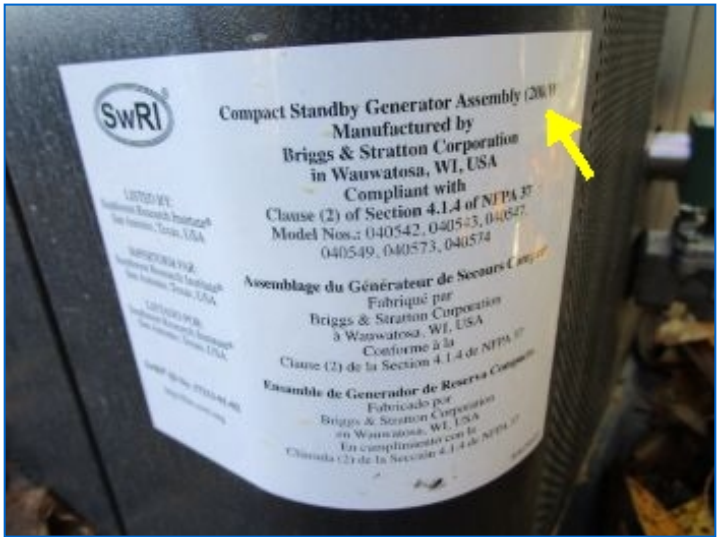
The home had a gas-powered backup generator installed to provide the home with electricity when power is not available from public utilities. Inspection of backup generators and their electrical components lies beyond the scope of the General Home Inspection. The Inspector recommends that before the expiration of your Inspection Objection Deadline you have this system tested by a licensed qualified electrical contractor.

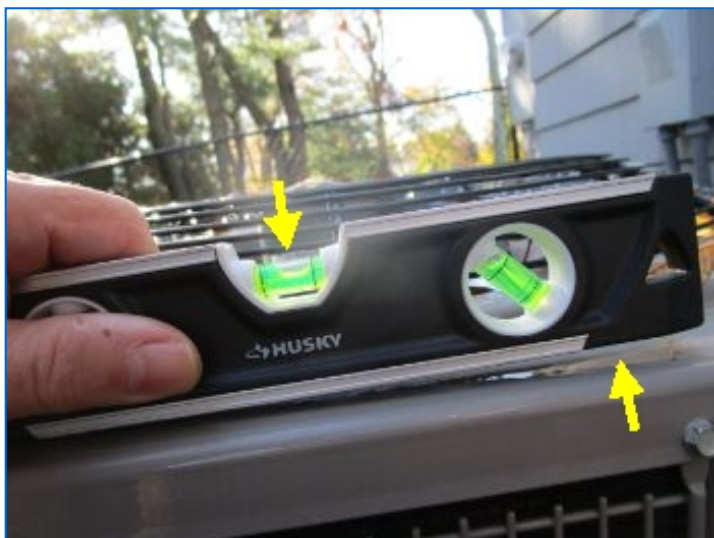
AC#2 Condenser was not level; this can shorten motor life. Suggest leveling mounting pad or the unit itself.

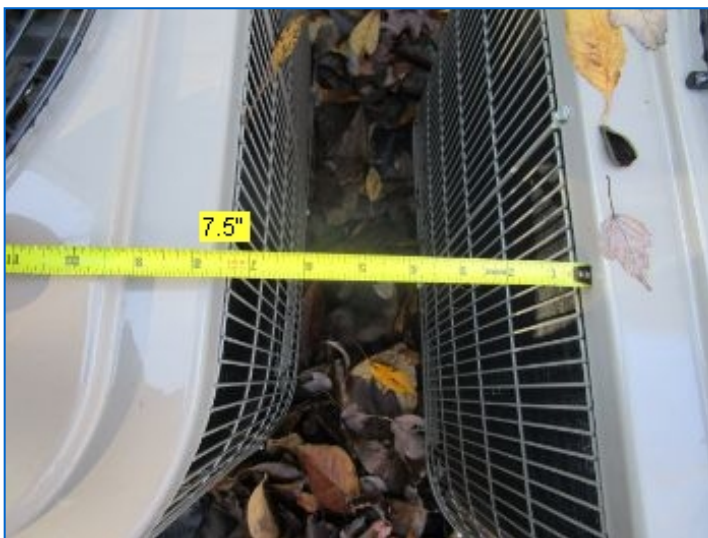
Outdoor condenser air flow appeared restrictive based on the distance between units. This conditions can negatively affect system performances by as much as 10% when both units are operating. Suggest checking manufacturer's clearance requirements.

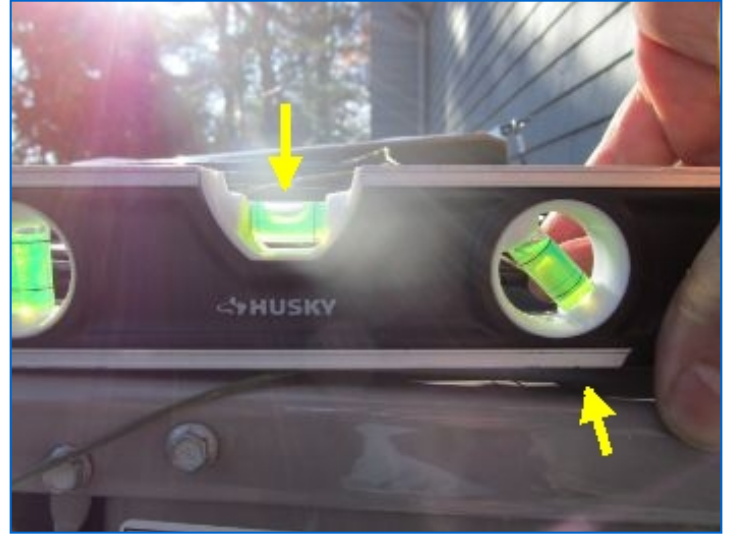
AC#5 Condenser was not level; this can shorten motor life. Suggest leveling mounting pad or the unit itself.

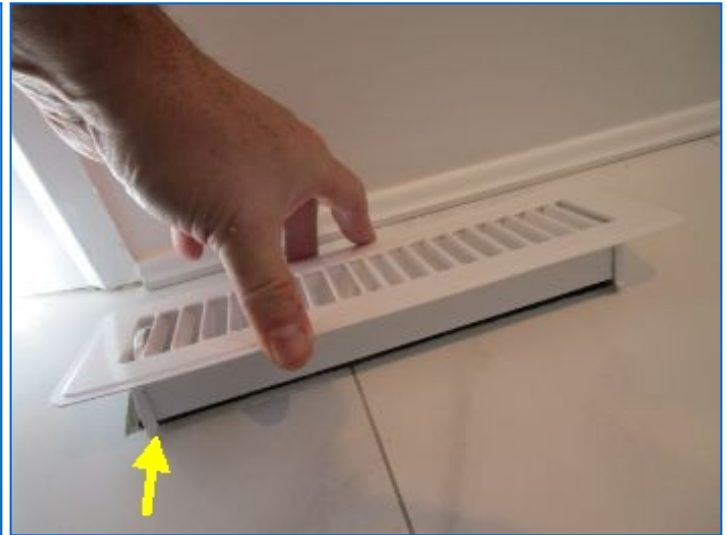
HVAC register not installed; didn't fit floor opening.
Recommend completion.

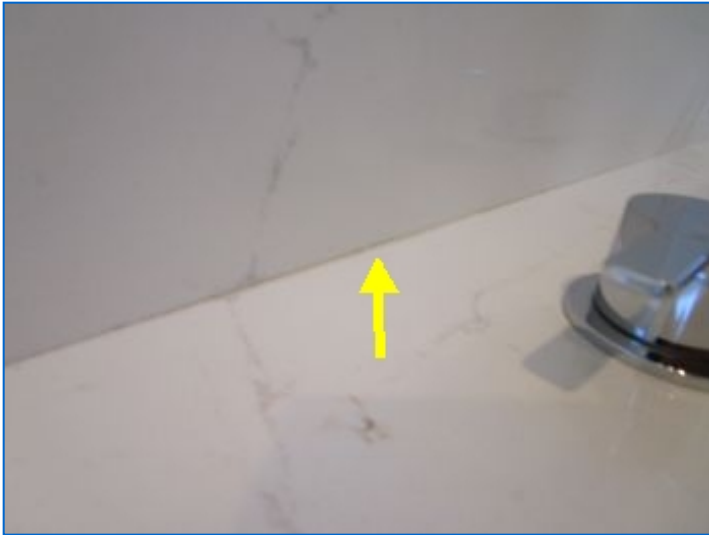
Vanity backsplash not adequately sealed.

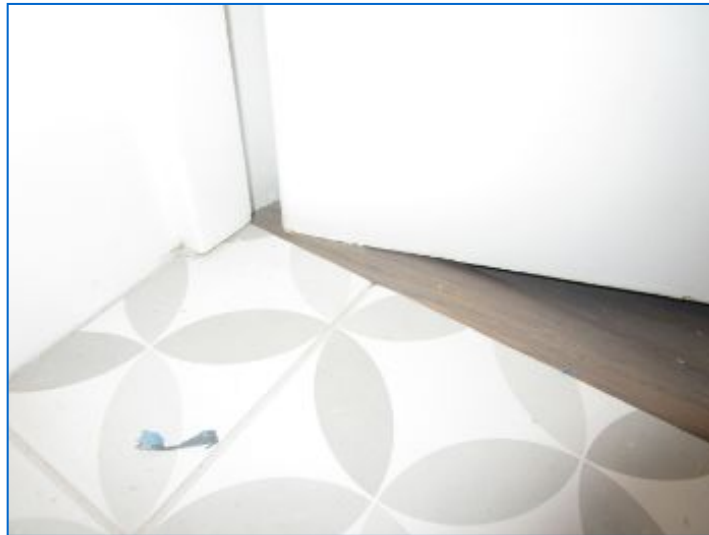
Bedroom #3 Door hit saddle and did not close. Recommend adjustments by a qualified contractor.

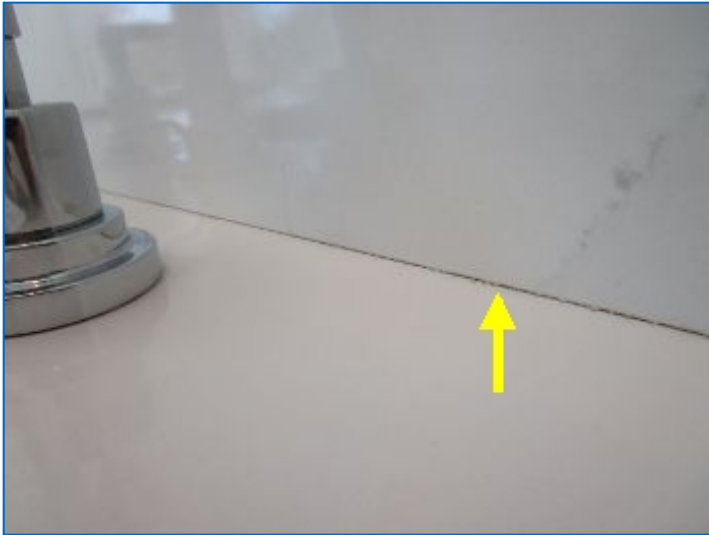
Vanity backsplash not adequately sealed.

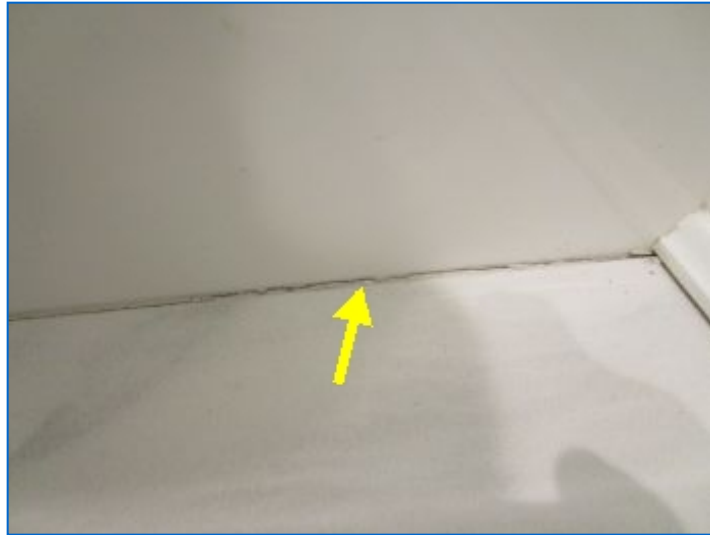
Exterior base grout was cracked/missing at Tub floor joint. Recommend grout repair to prevent water entry that may cause damage to floor boards/ceiling below.

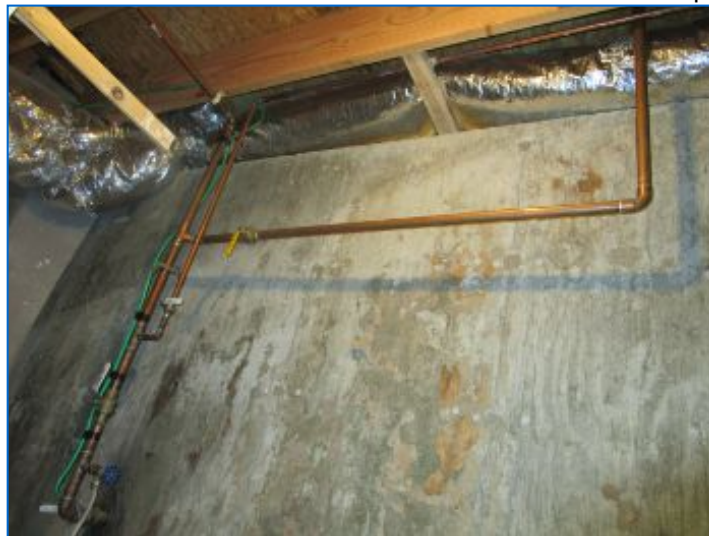
No visible backflow prevention device was observed at the water service entrance. See related comments.

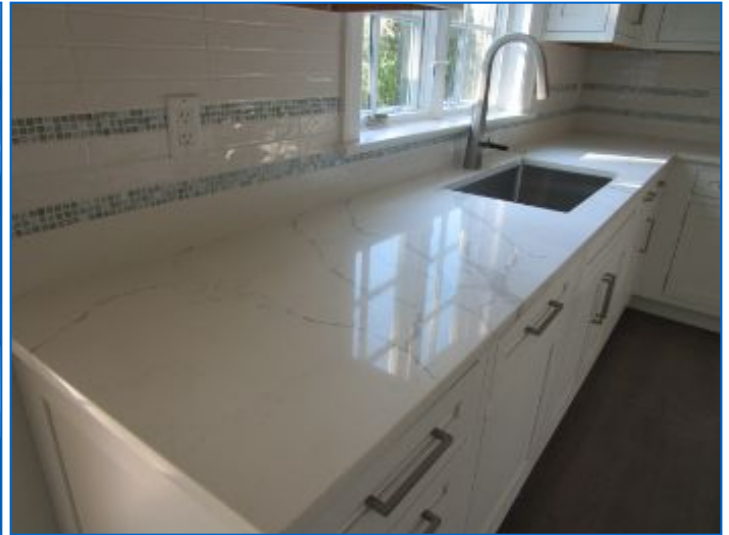
Grout/caulking at counter-top back splash (movement joint) was cracked. Suggest replacing defective grout/caulking with matching silicone based sealant along movement joint.

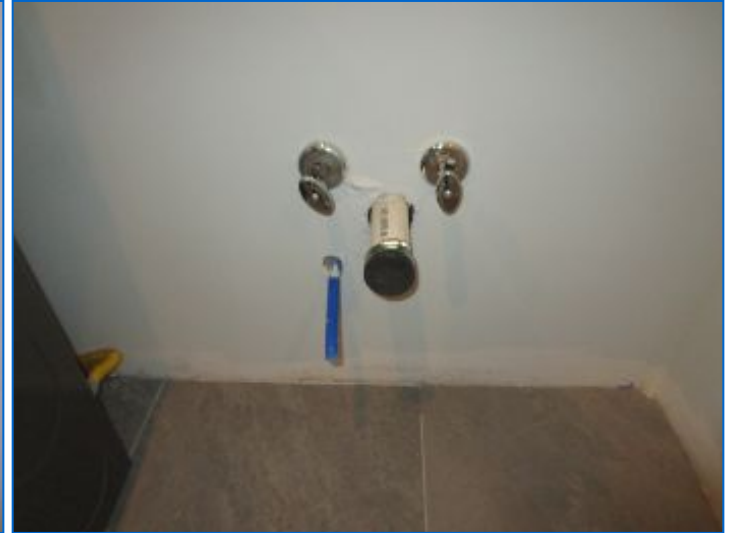
Plumbing supply and drain connections noted for future service sink. Water supply lines were charged. Blue PEX tubing was open-ended; unknown source. Recommend conferring with Seller on status of service sink provision/completion.

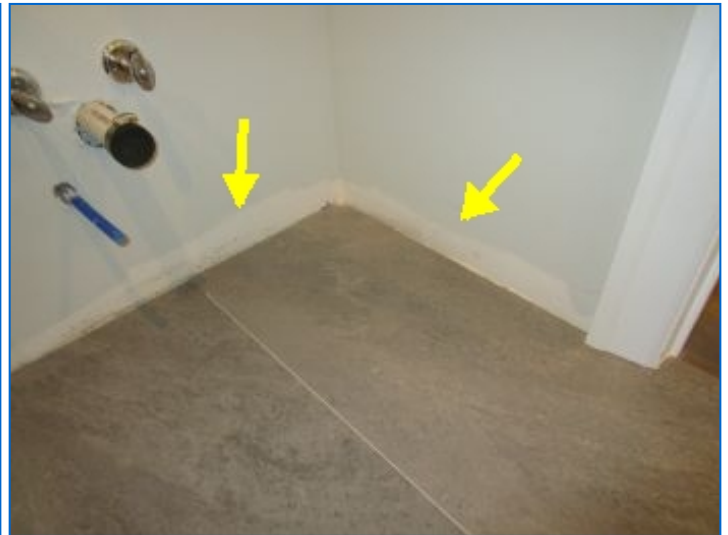
Some base molding was missing. Suggest completion.

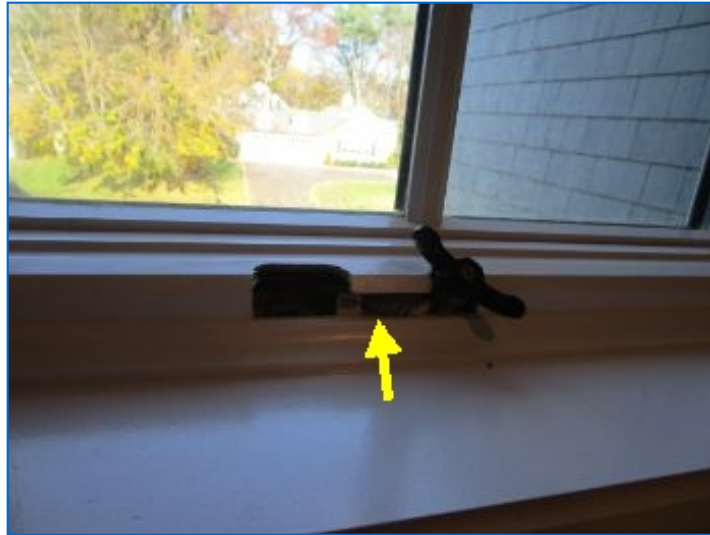
Casement window crank mechanism cover was missing. Recommend correction.

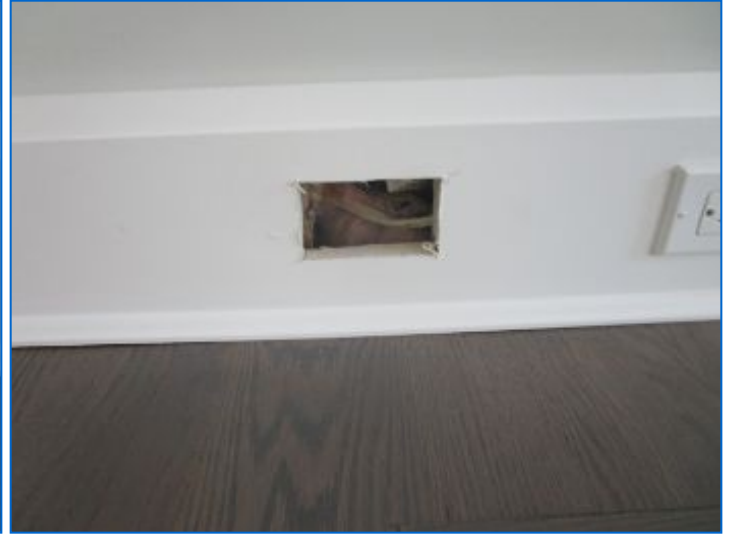
Incomplete data/telecom jack installation noted.
Recommend completion and/or finishes prior to close.

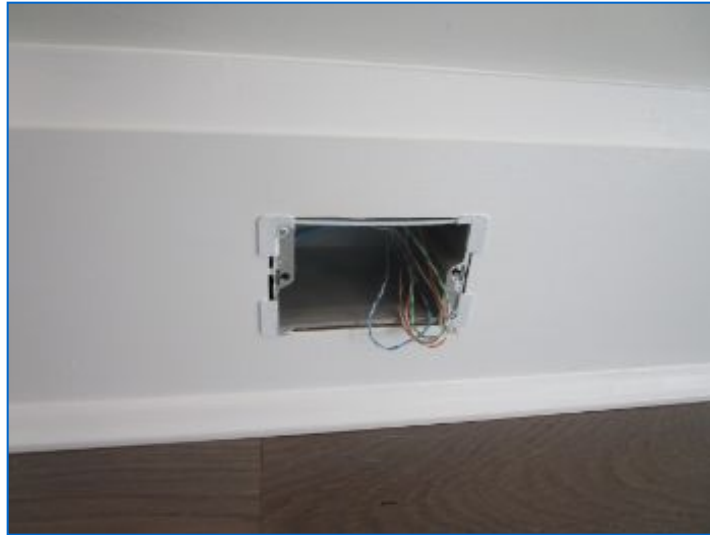
Incomplete data/telecom jack installation noted. Recommend completion and/or finishes prior to close.

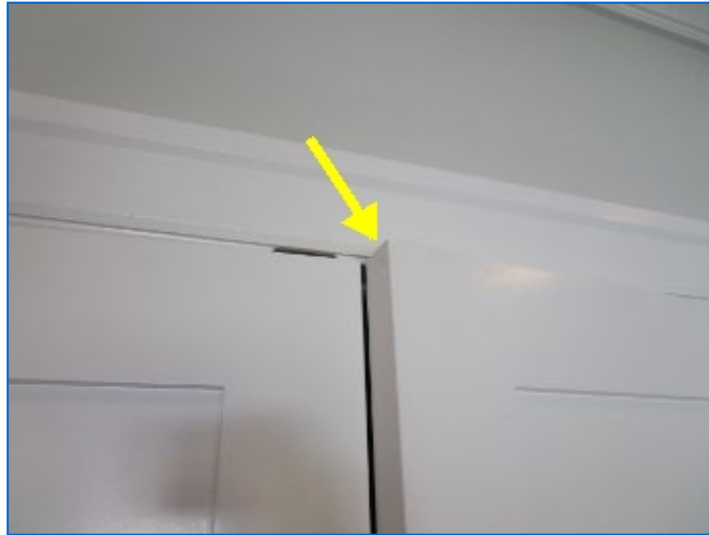
Door ball catch didn't latch properly . Recommend adjustments by a qualified contractor.

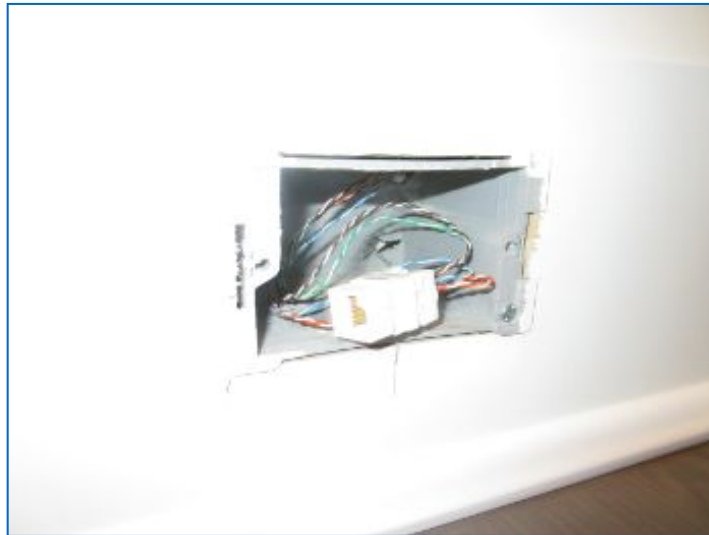
Incomplete data/telecom jack installation noted. Recommend completion and/or finishes prior to close.

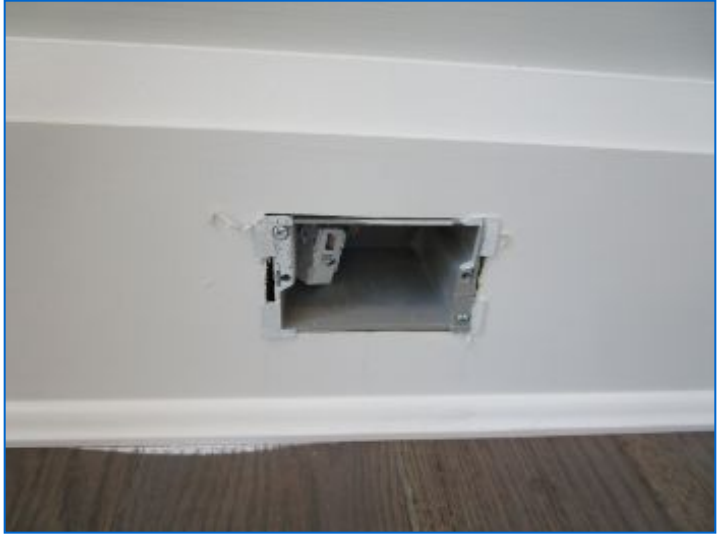
Incomplete data/telecom jack installation noted.
Recommend completion and/or finishes prior to close.

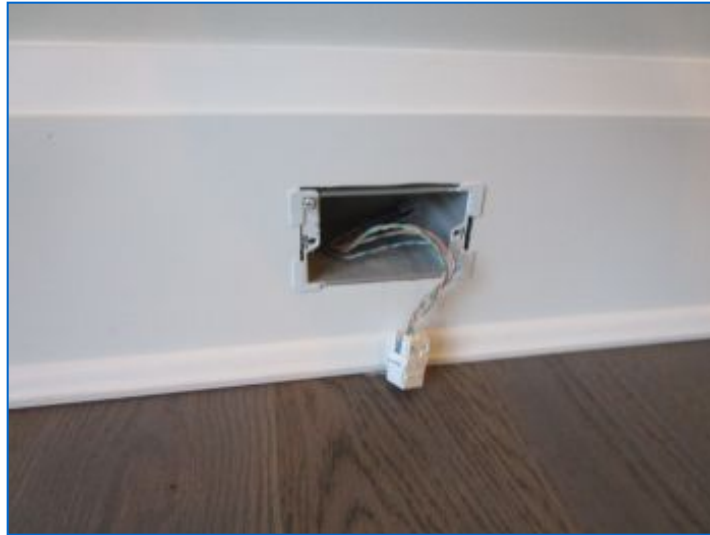
Incomplete data/telecom jack installation noted. Recommend completion and/or finishes prior to close.

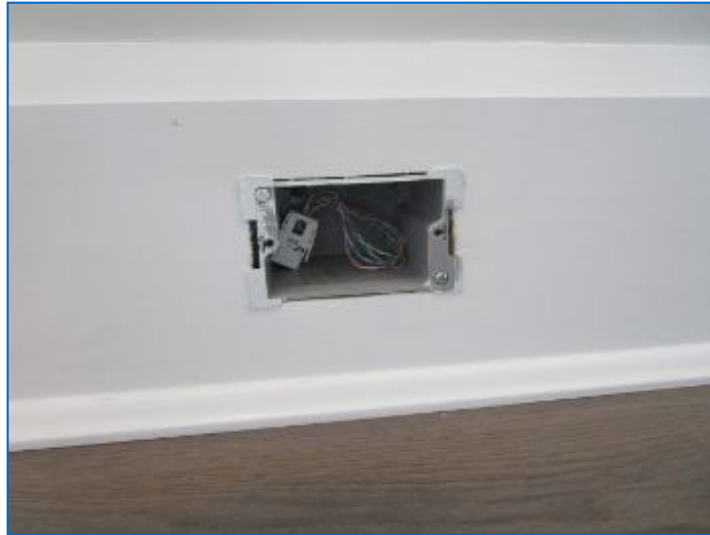
Incomplete data/telecom jack installation noted. Recommend completion and/or finishes prior to close.

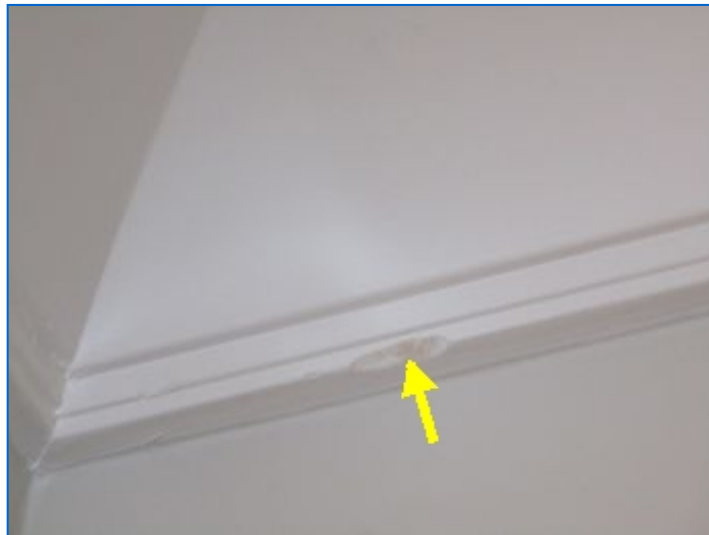
1st floor Hallway Storage Room: Nick noted in crown molding.

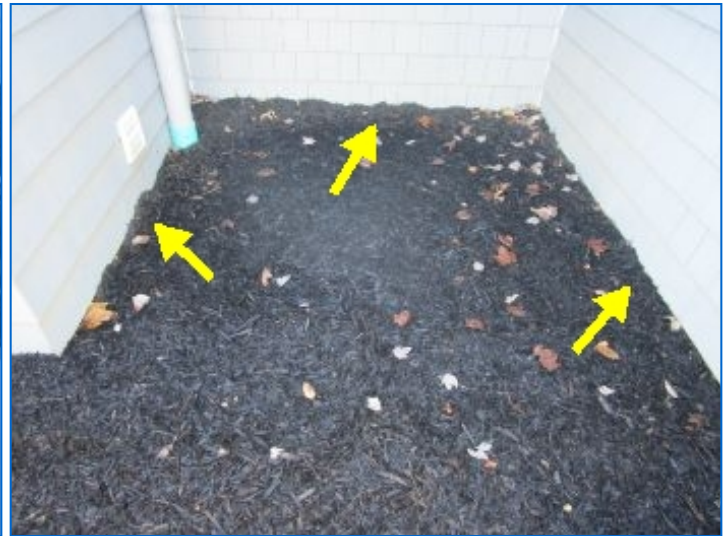
Soil in contact with, and/or in close proximity to siding. This can provide entrance of moisture or insects to siding. The Inspector recommends lowering soil level to 6" below siding.

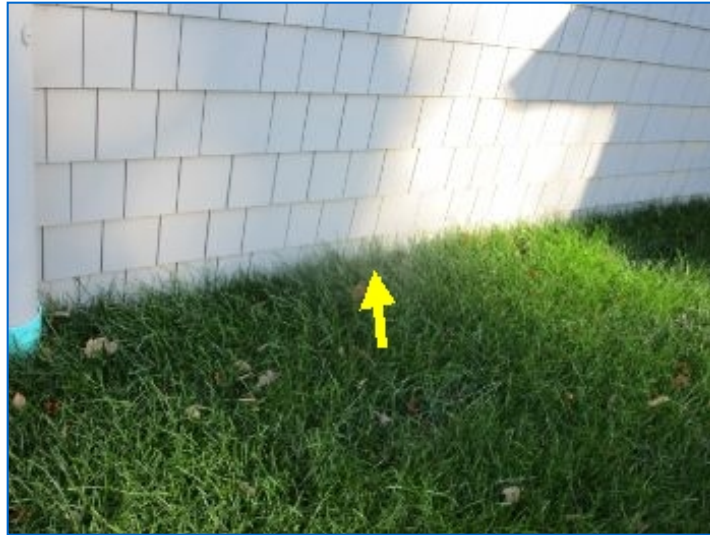
Soil in contact with, and/or in close proximity to siding. This can provide entrance of moisture or insects to siding. The Inspector recommends lowering soil level to 6" below siding. Also, this siding will be subjected to damage by lawn maintenance equipment. Recommend correcting this condition.

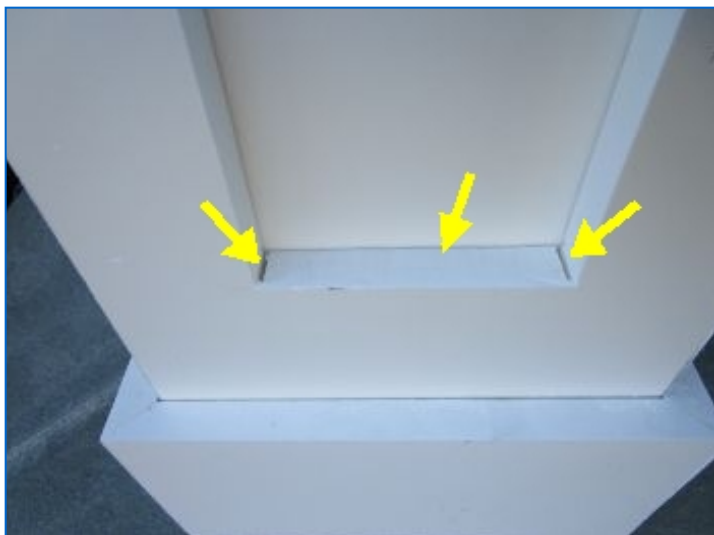
Portico Columns: Horizontal surfaces of trim where water does not readily drain from are subject to eventual moisture damage/decay. It is important to caulk all seams at these locations to prevent water penetration. Recommend caulking by a qualified contractor.

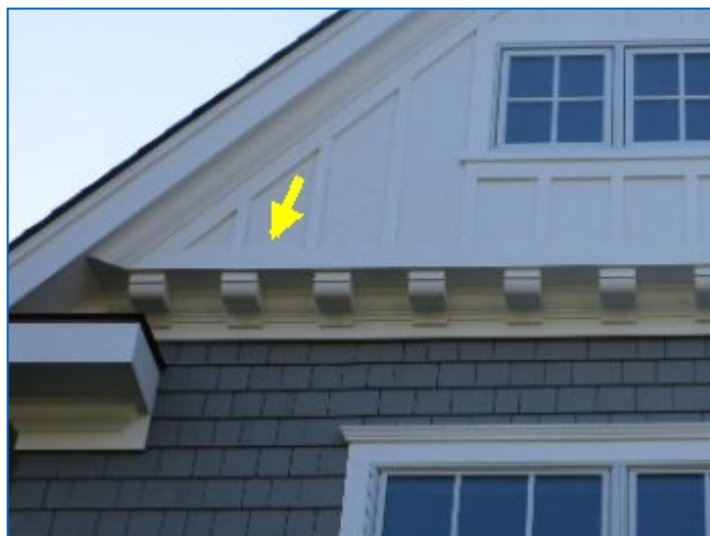
Gable Trim: Horizontal surfaces of trim where water does not readily drain from are subject to eventual moisture damage/decay. It is important to caulk all seams at these locations to prevent water penetration. Recommend caulking by a qualified contractor.

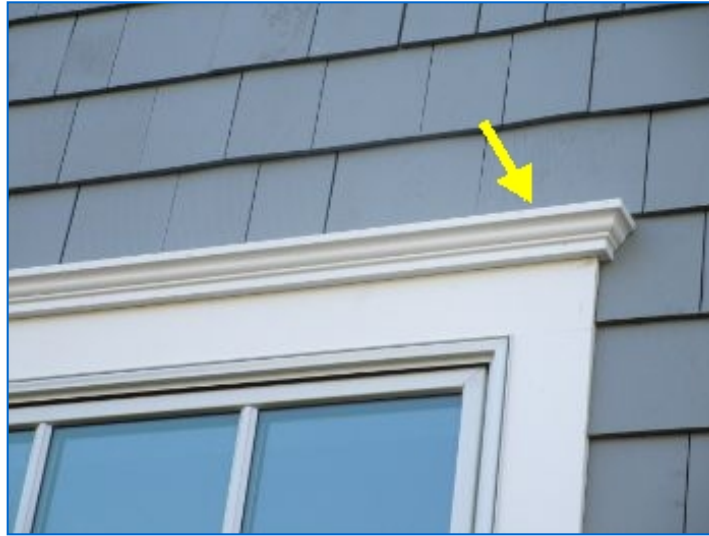
Window Crown Molding: Horizontal surfaces of trim where water does not readily drain from are subject to eventual moisture damage/decay. It is important to caulk all seams at these locations to prevent water penetration. Recommend caulking by a qualified contractor.

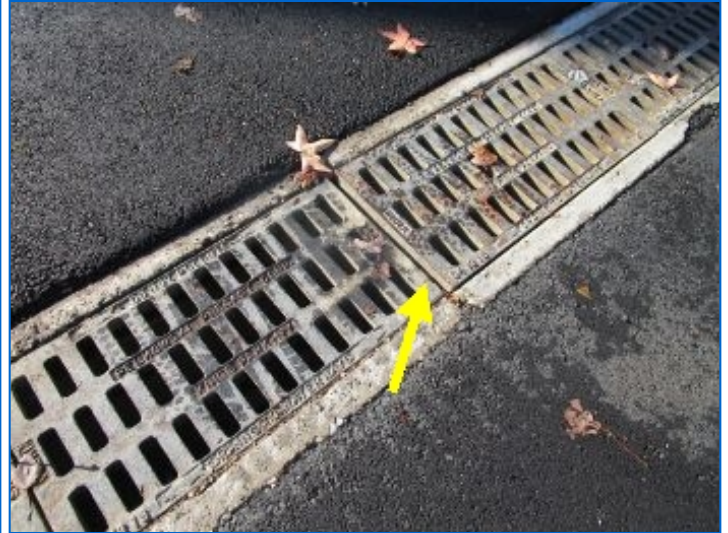
Uneven grate noted at trench drain.
