BUILDING ANALYSIS REPORT

Property Location: *55 Clinton Avenue, Unit 305*
Rockville Centre, NY 11570

Date of Inspection: *5/4/2017*

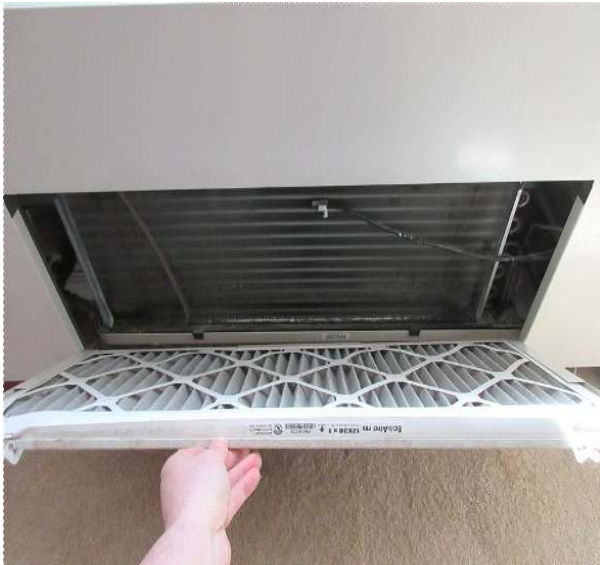
IMG_0270.JPG

Disposable filter slide behind the unit's face return grille. Cooling coils appear to be dirty. Suggest soft brush vacuum to clean coils.

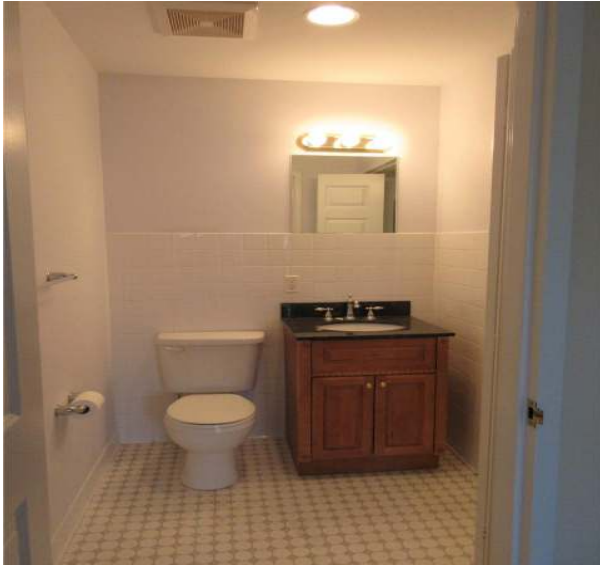
IMG_0279.JPG

Half Bathroom: Ceiling exhaust fan runs noisy!

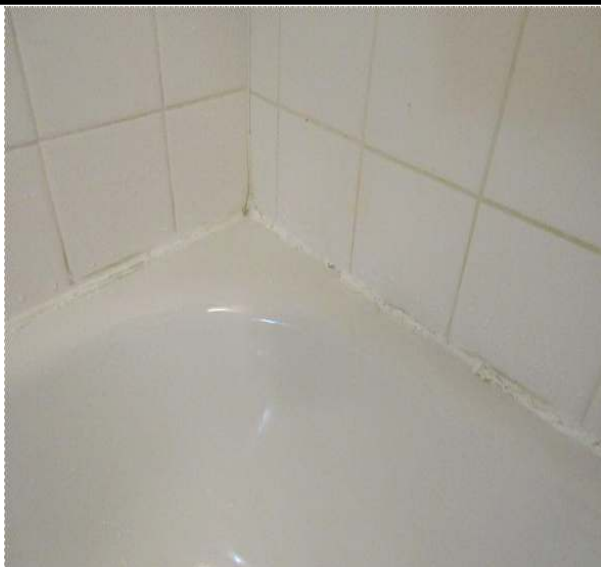
IMG_0282a.JPG
 Full Bathroom: Shoddy (but functional) silicone caulking job at tub perimeter.

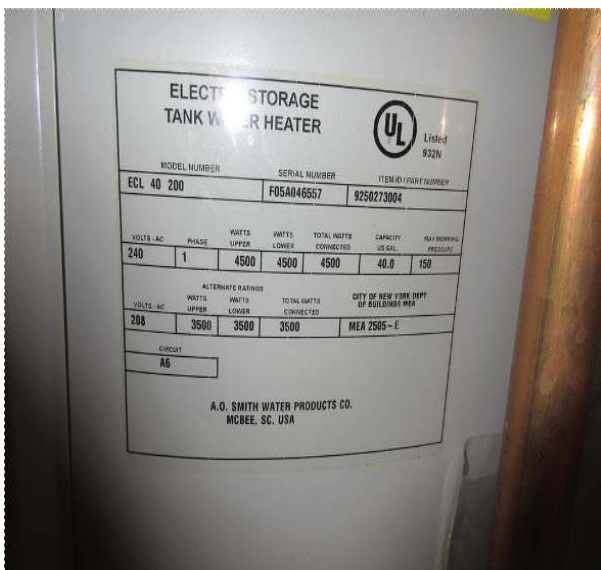
IMG_0290.JPG
 Water heater data tag indicates a 40 gal storage capacity. From the serial number the unit appears to be made in 2005 (11-12 yrs old).

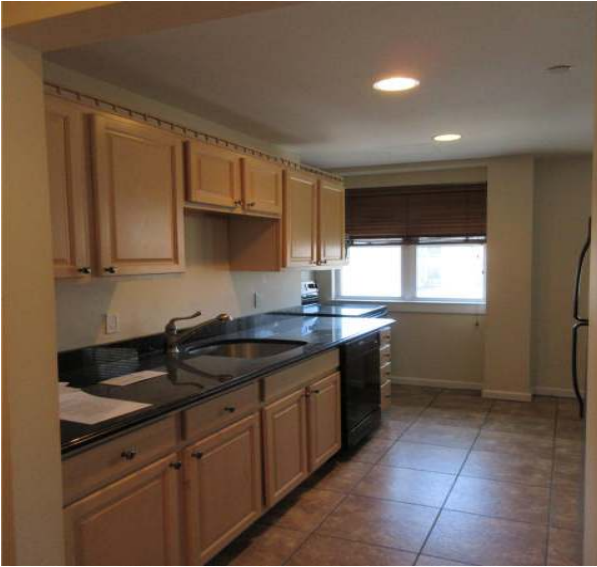
IMG_0258.JPG

Kitchen: A few cabinet door hinges are in need of adjustment.

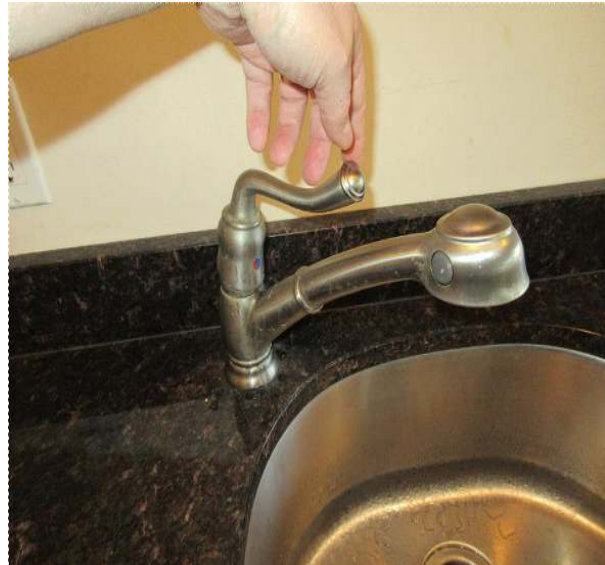
IMG_0261.JPG

Kitchen faucet appears worn; faucet handle is loose.

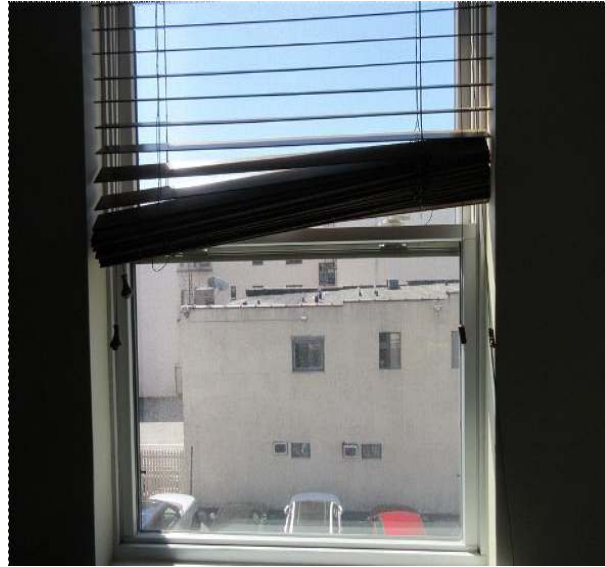
Living room window blinds appear defective.

IMG_0271a.JPG
Living room window blinds appear defective.

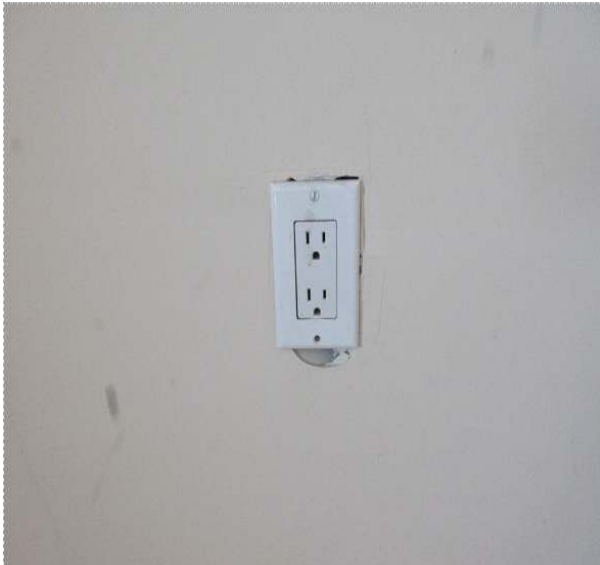
Cosmetic damage around wall outlet in living room.1

IMG_0301.JPG
Cosmetic damage around wall outlet in living room.l

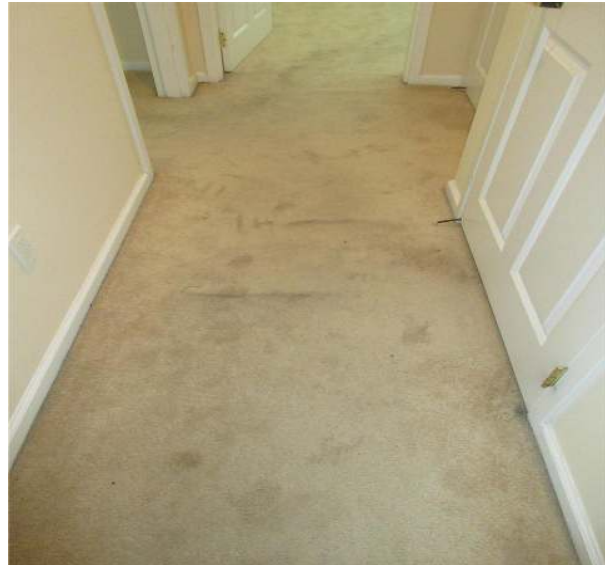
Hallway and master bedroom carpet is loose; trip hazard.

IMG_0302.JPG
Hallway carpet is loose; trip hazard.

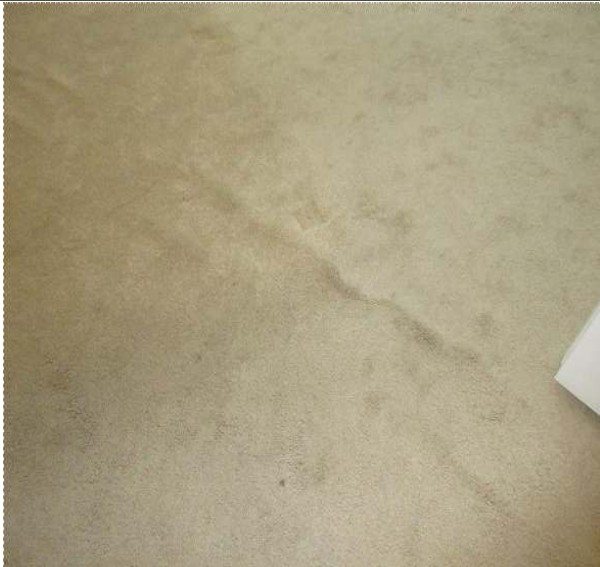
IMG_0303.JPG

Master bedroom carpet is loose; trip hazard.

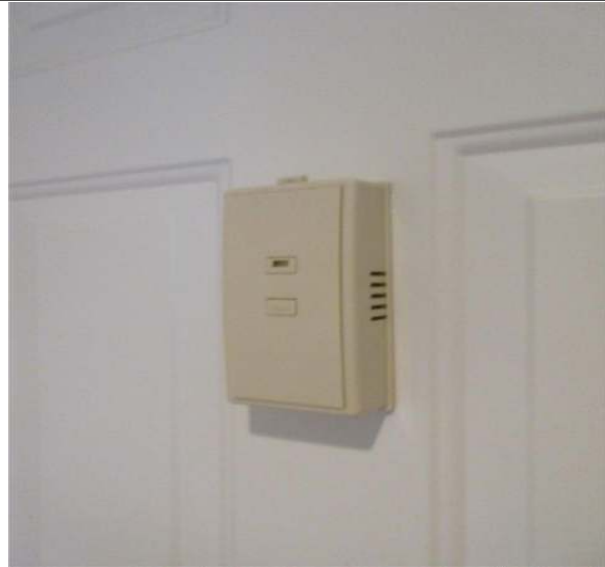
IMG_0262.JPG

Doorbell ringer doesn't work consistently; may be defective.
