# ProSpec Home Inspection of Long Island Property Inspection Report

154 Combs Ave, Woodmere, NY 11598  
Inspection prepared for: Name Deleted Date  
of Inspection: 5/21/2019 Time: 4:30 PM  
Age of Home: 73 yrs old Weather: Sunny,  
73degF Approx. Year Built: 1946

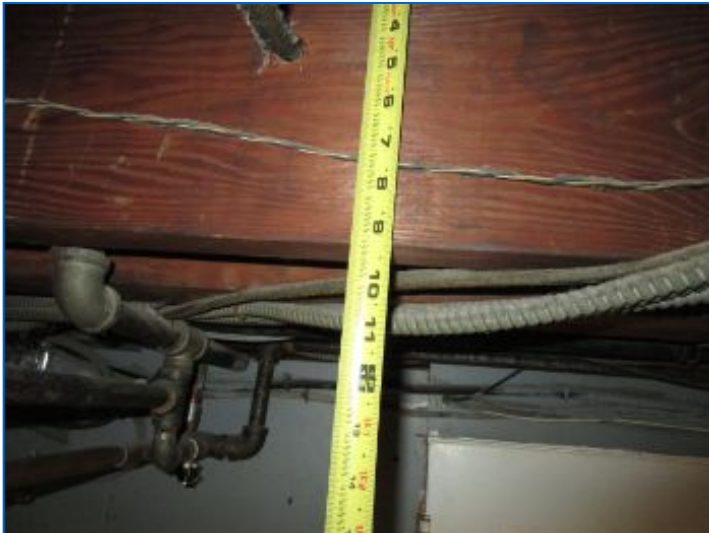
Main Floor Structure: Main beams supported by foundation walls, 2x10 Joists 16" O.C. (w/cross braces), T&G floor boards.

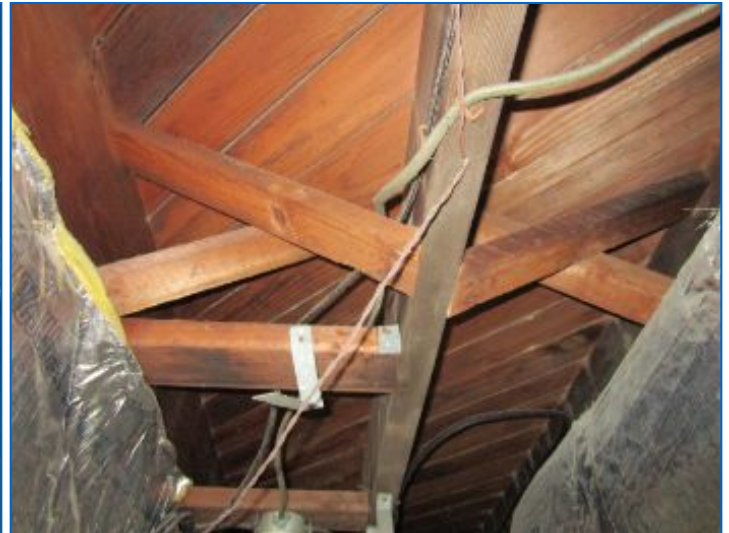
Main Floor Structure: Main beams supported by foundation walls, 2x10 Joists 16" O.C. (w/cross braces), T&G floor boards.

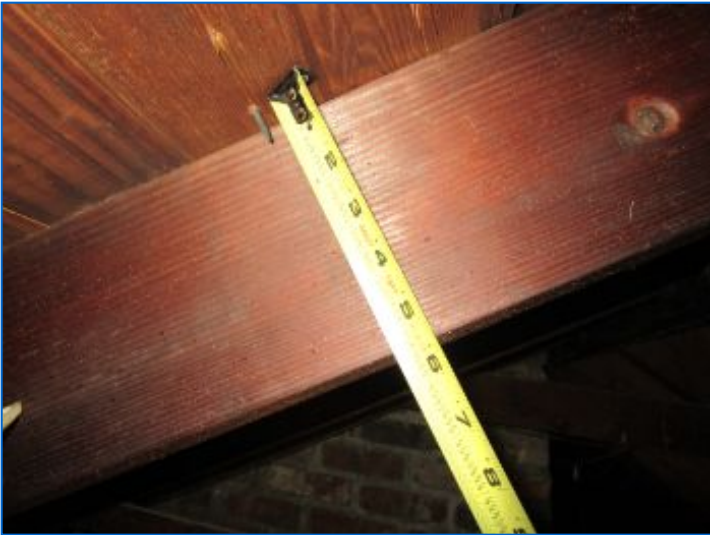
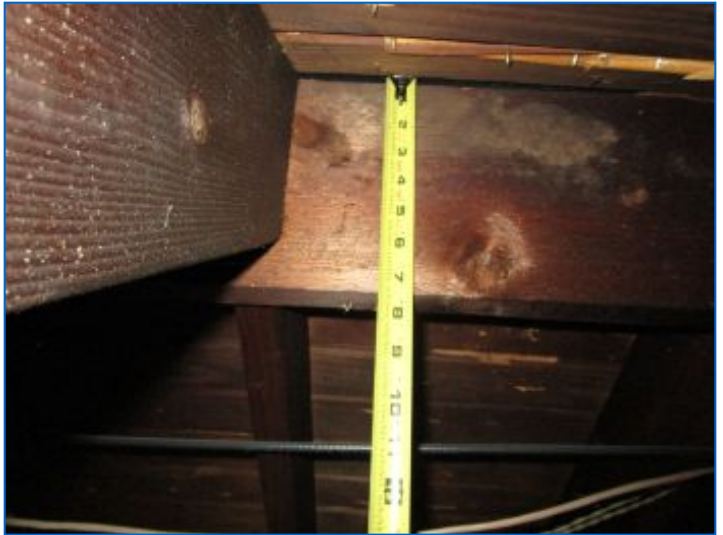
Main Roof Structure: 2x6 Rafters 16" O.C. w/collar-ties, 2x8 ridge beam, T&G roof boards.

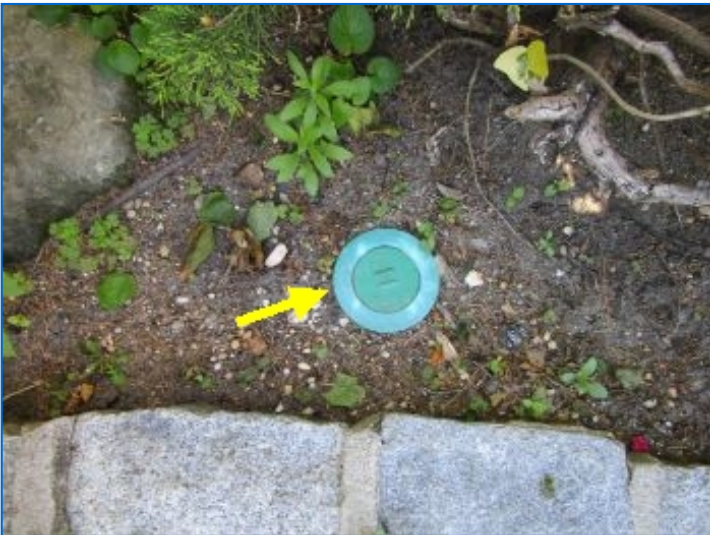
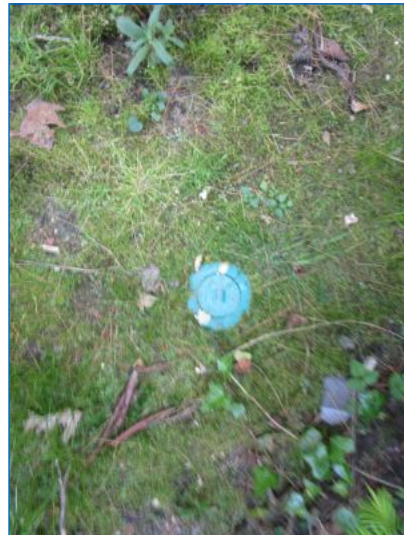
Previous Termite Treatment noted; Bait Stations observed at the perimeter of the structure. Refer to attached NPMA-33 report form.

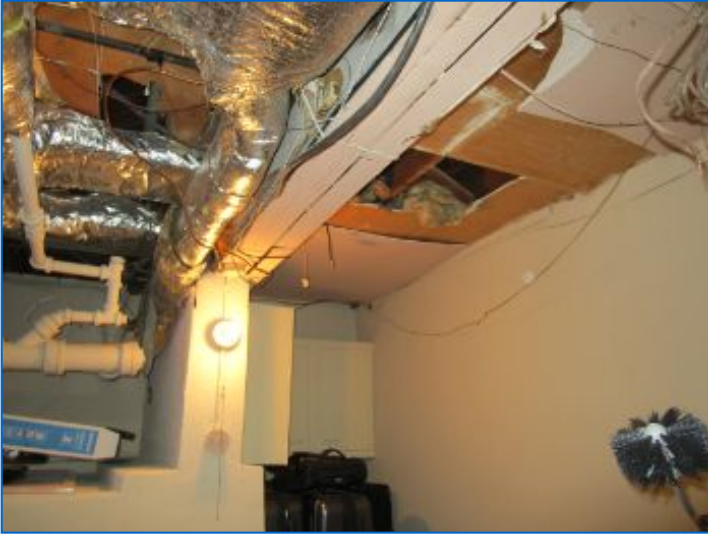
Ceiling conditions in southwest room in basement.

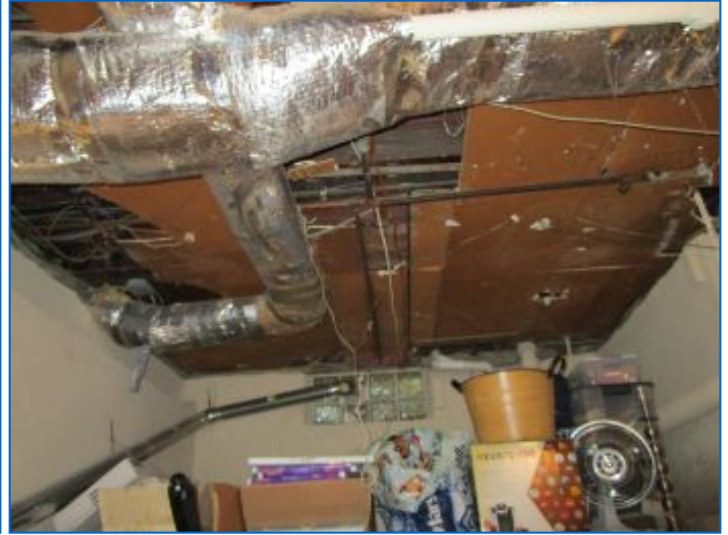
Ceiling conditions in southwest room in basement.

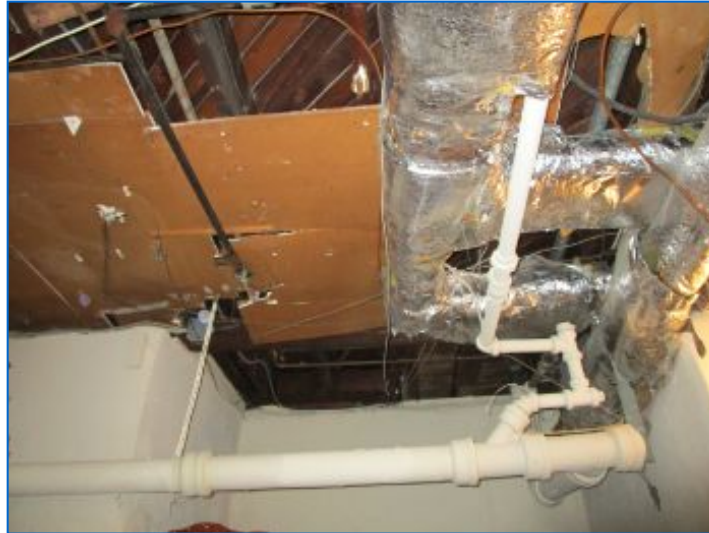
Ceiling conditions in southwest room in basement.

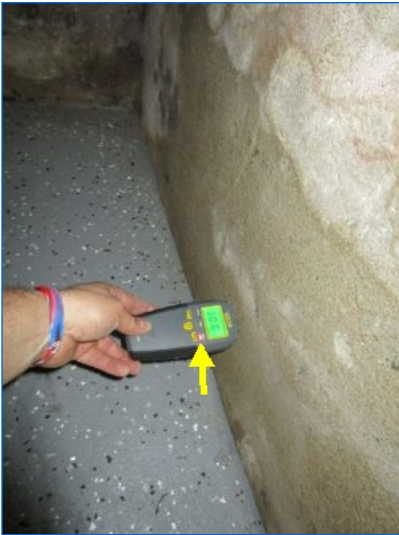
Moisture level tested high at lower part of foundation wall in basement extension under garage.

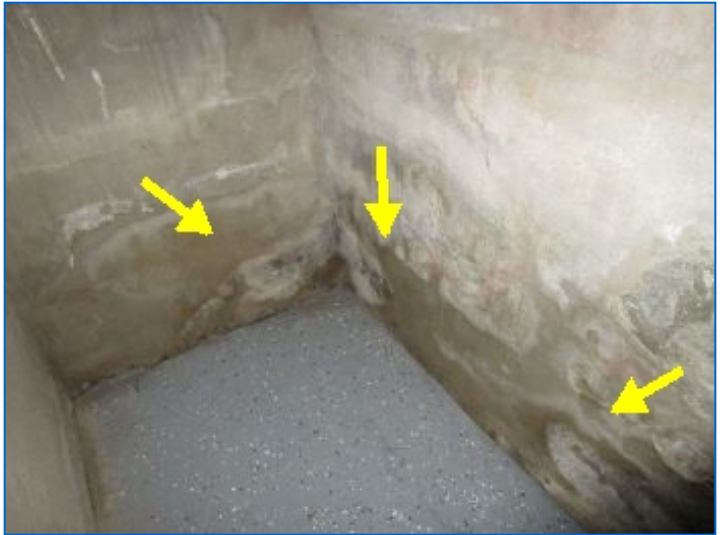
Area where moisture level tested high at lower part of foundation wall in basement extension under garage.

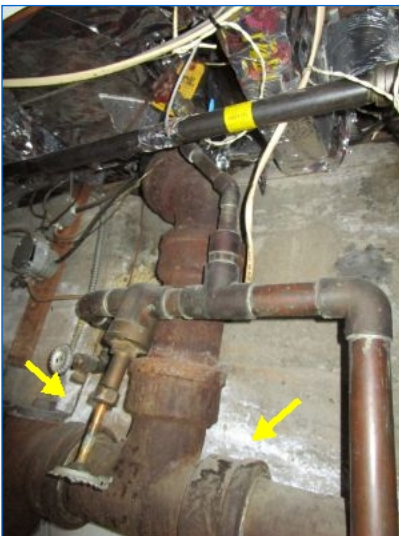
Moderate amounts of efflorescence was visible at Some of the interior surfaces of the foundation walls. Efflorescence is a white, powdery residue left by moisture seeping through the foundation wall and its presence indicates high moisture levels in soil near the foundation. Note: Excessively high moisture levels in soil supporting the foundation can cause various structural problems related to soil movement. The source of moisture should be identified and the condition corrected where possible.

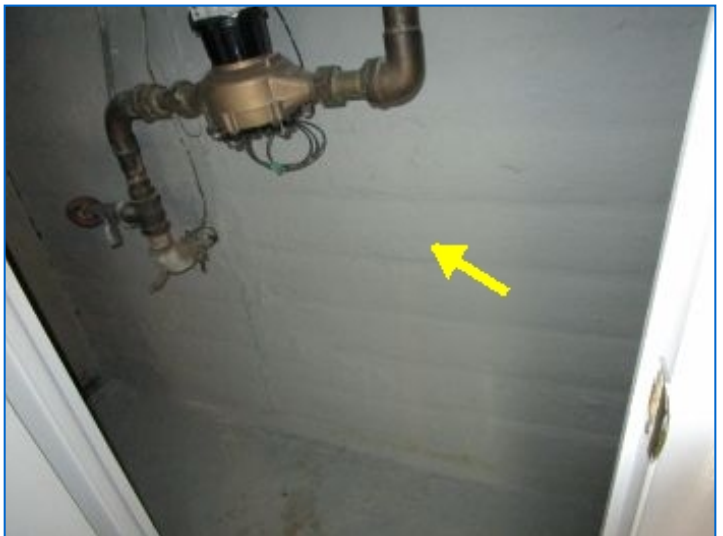
Limitation: Some interior foundation wall surfaces were painted with masonry waterproofing paint.

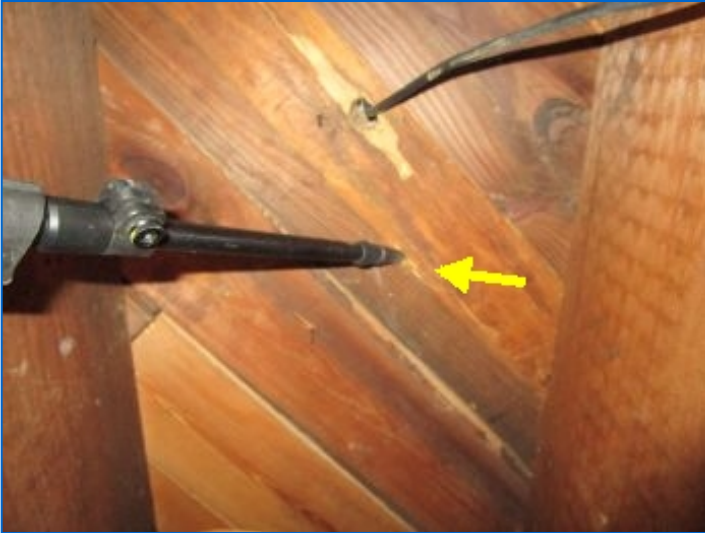
Damage noted from past termite activity at exposed floor boards above ceiling in southwest room of basement. Refer to NPMA-33 Report.

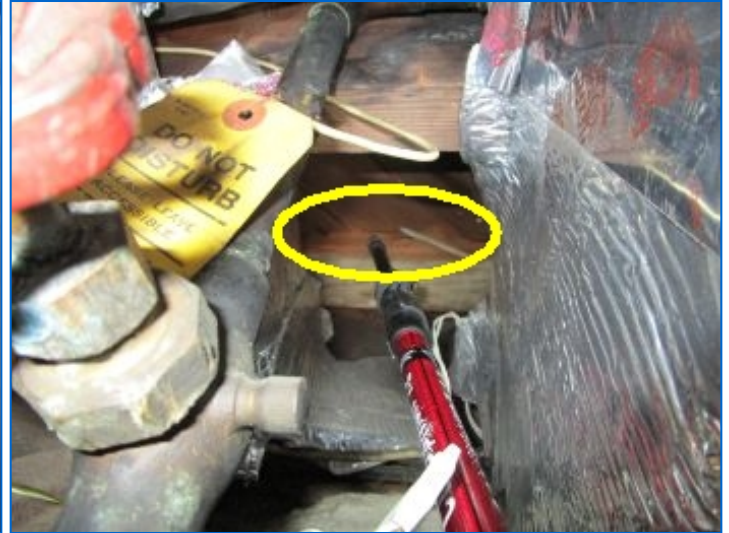
Damage noted from past termite activity at south sill plate in water meter closet. Refer to NPMA-33 Report.

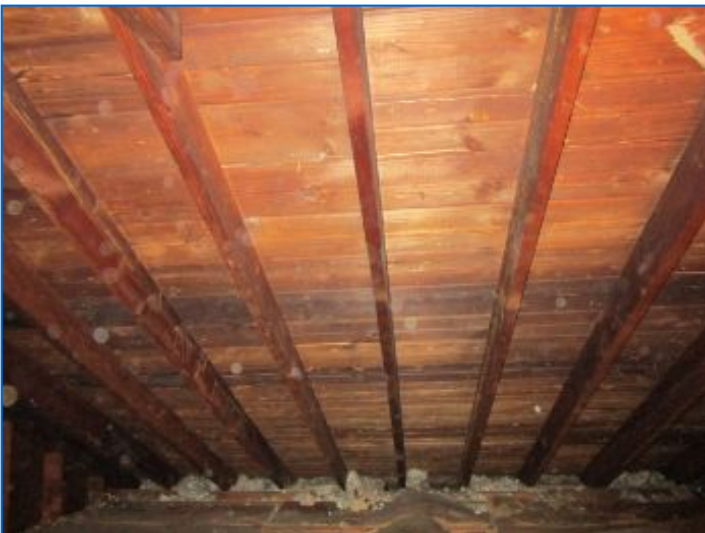
Visible areas of the roof structure appeared satisfactory.

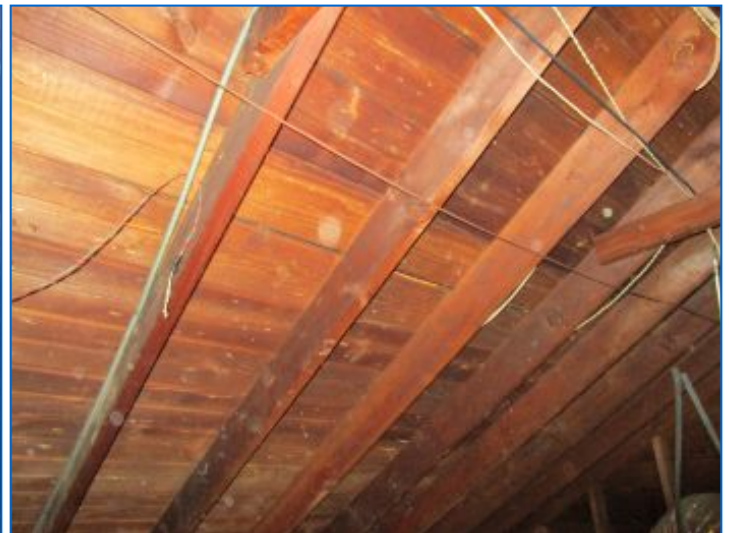
No Significant structural defects observed at the visible portions of the roof structure - In normal condition for its age.

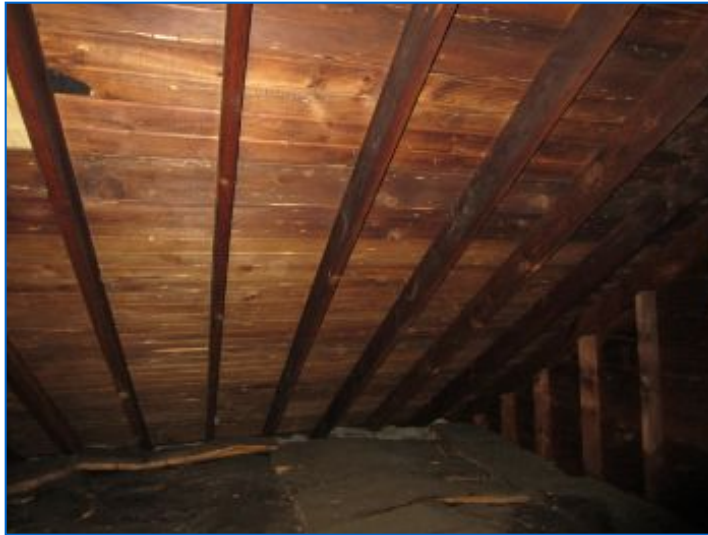
Visible areas of the roof structure appeared satisfactory.

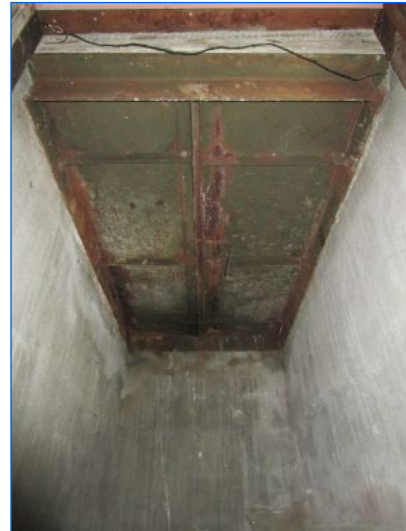
Basement extension under garage with steel access doors above. Doors showed signs of rust but appeared operable.

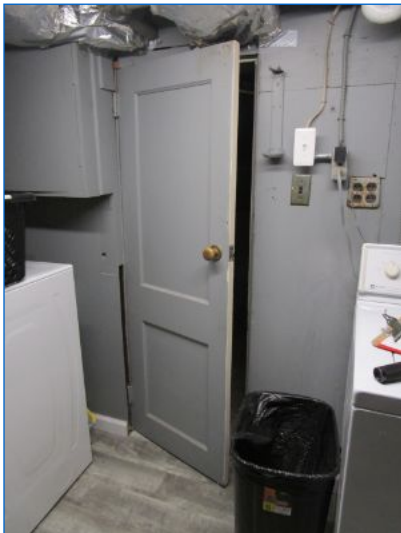
Door to southwest corner room.

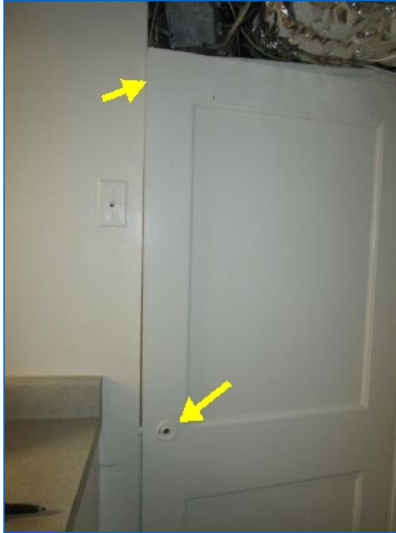
Northwest corner room door hit jamb and didn't close and knob/hardware was missing. Suggest adjustment and repair or replacement if necessary. Work should be performed by a qualified contractor.

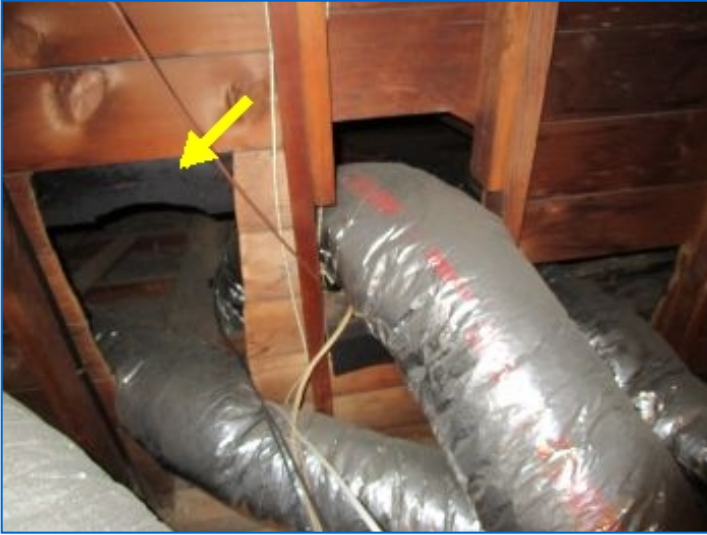
Not all areas of the attic were physically accessible at time of inspection.

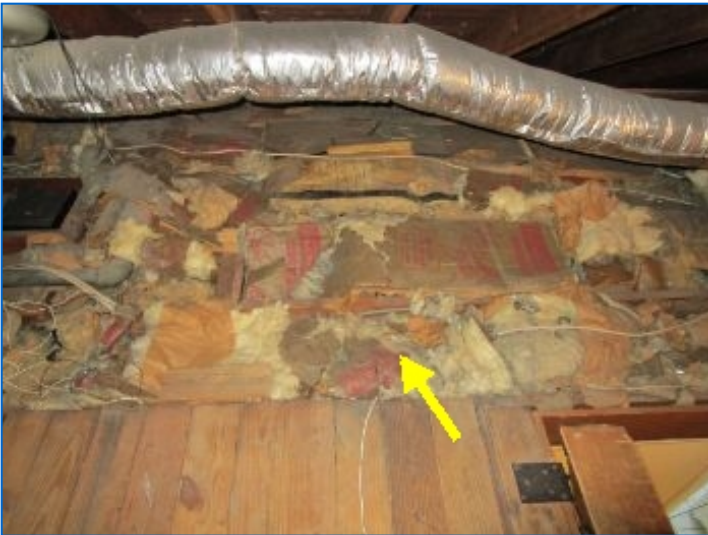
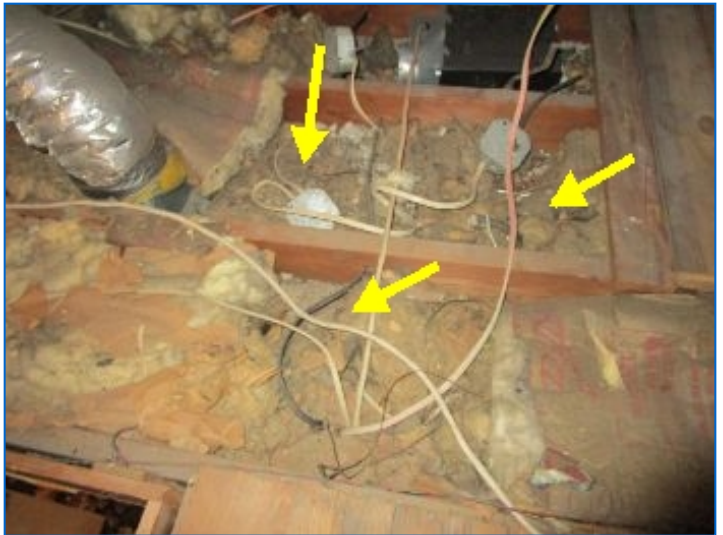
Insulation was sparse/damaged in some sections of the attic floor. Recommend installing new insulation with vapor barrier where needed.

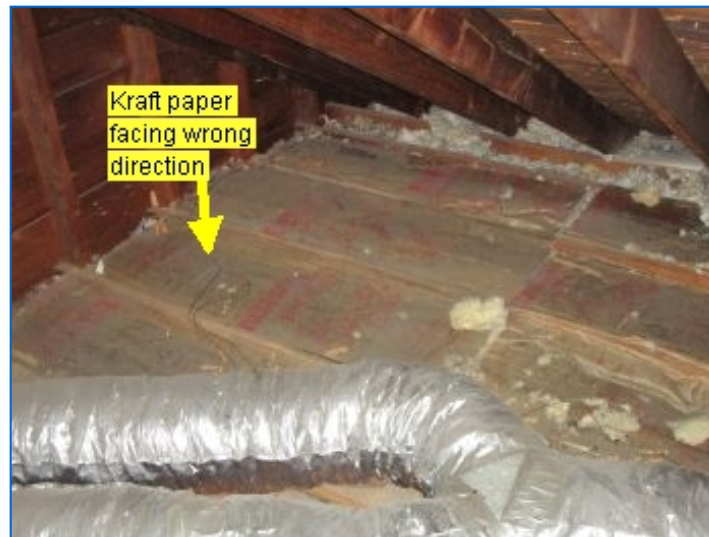
Insulation installed in the attic had paper or foil backing facing the wrong direction. Thermal insulation should always be installed with the paper or foil backing toward the source of heat. Reversal (backing on the cold side) may result in problems from the formation of excessive condensation. Excessive condensation may cause damage to home materials from decay or result in the development of microbial growth which can cause health problems, sometimes serious problems, in some people. At the time of the inspection, the Inspector did not observe any obvious problems which in the Inspector's experience could be directly related to this condition.

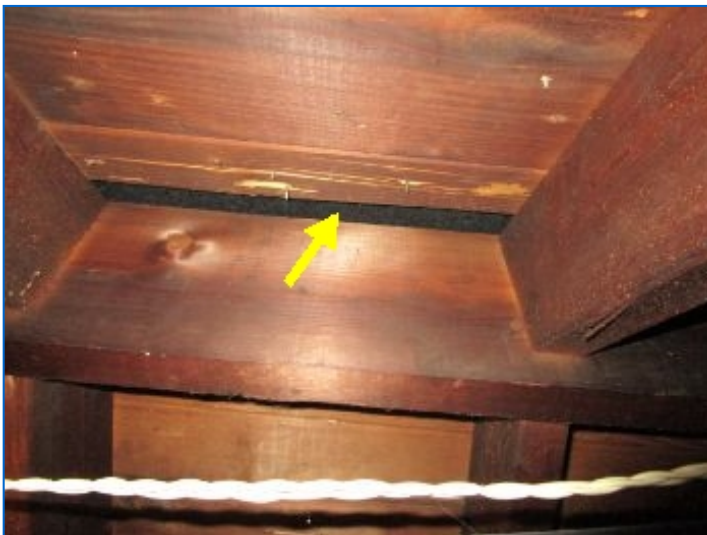
Ridge exhaust venting noted

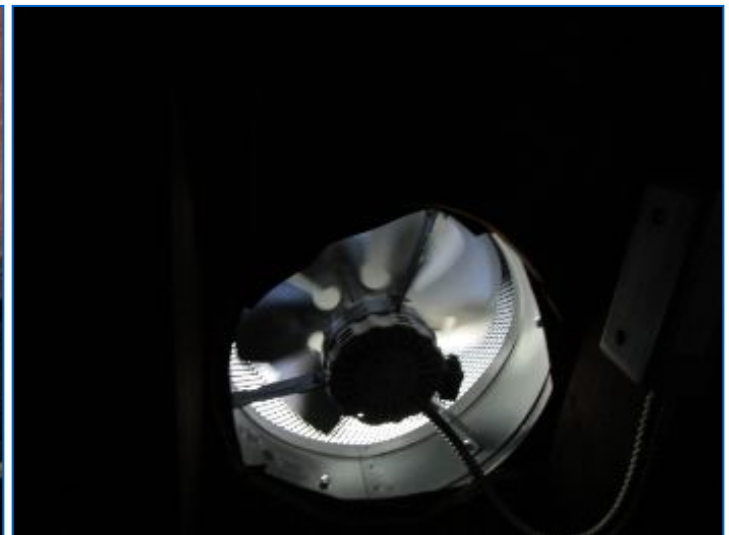
Thermostatically controlled Power Ventilator was operable.  
Recommended Temperature setting is 85 deg F.

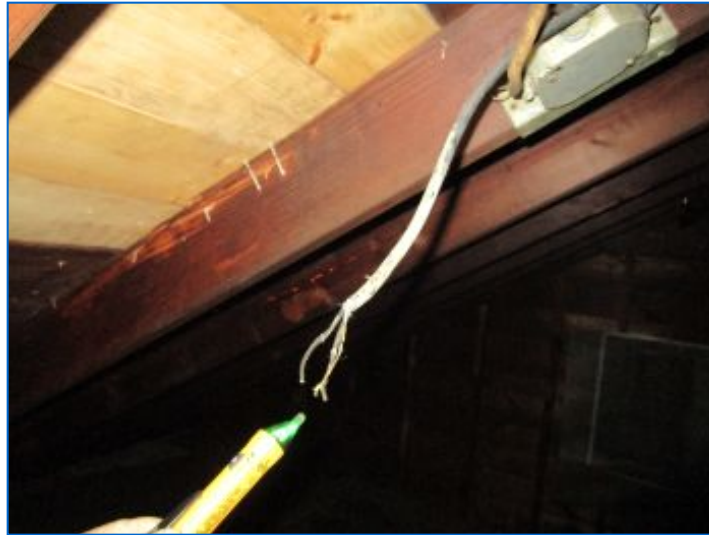
Abandoned electrical wiring noted. Suggest electrician remove any unused/abandoned electrical hardware and associated wiring.

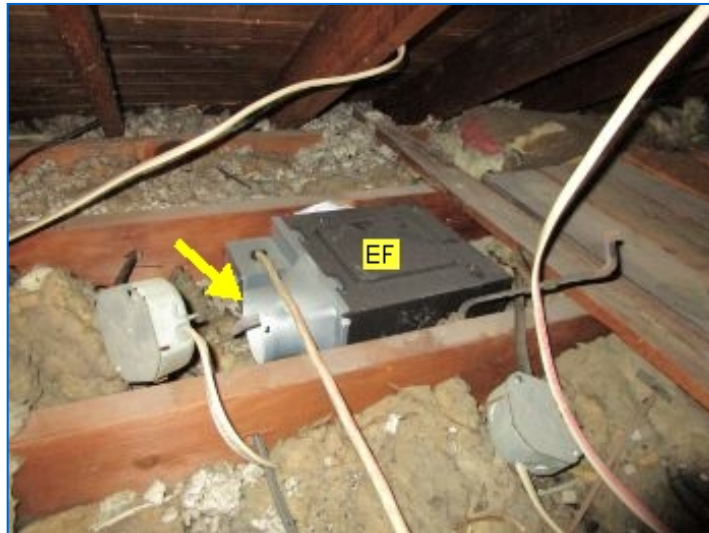
Bathroom exhaust fan duct or discharge terminated within the attic. Have duct routed to exterior to minimize moisture and possible development of mold.

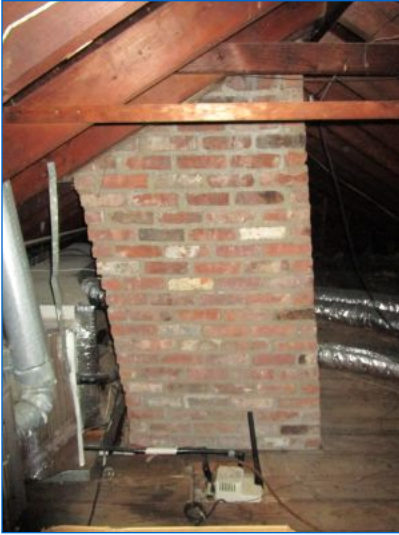
Chimney was built purposely in a non-vertical fashion and appears as if it is leaning within the attic space; did not show any deficiencies.

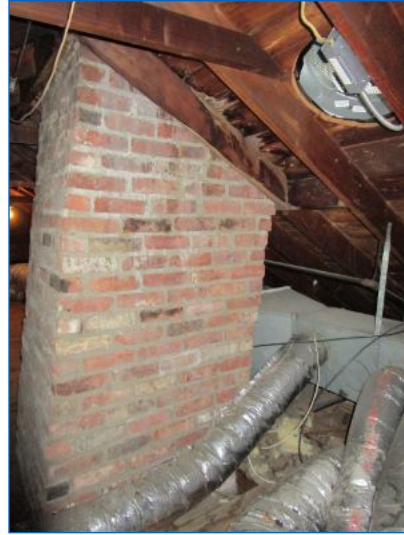
Chimney was built purposely in a non-vertical fashion and appears as if it is leaning within the attic space; did not show any deficiencies.

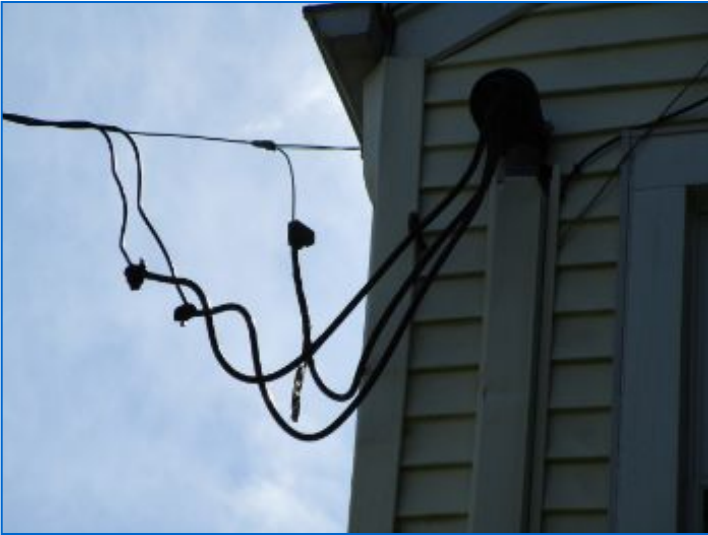
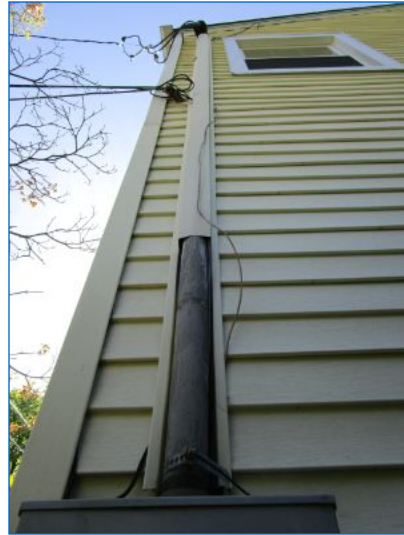
Overhead electrical service drop and riser showed no major system safety or function concerns at time of inspection.

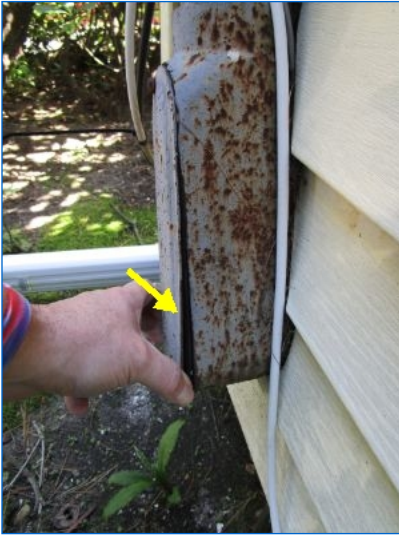
Cover at LB conduit body was note secured/sealed; recommend repair.

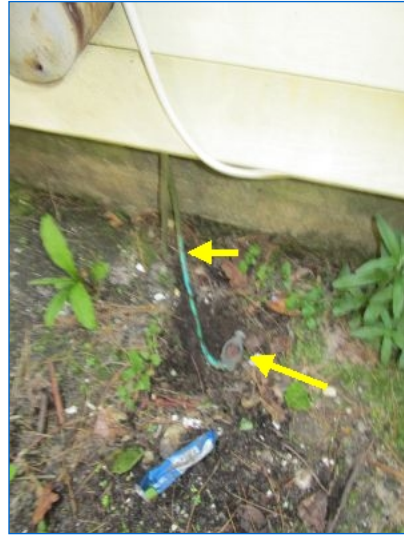
Grounding Rod and cable connection noted at service entrance.

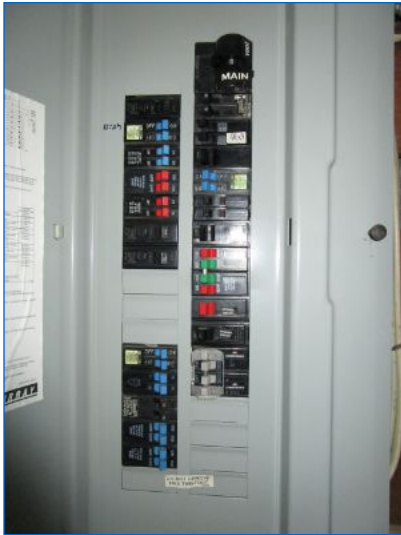
Main Panel Breakers: 32 circuit breaker spaces; 8 spare breaker space(s) noted.

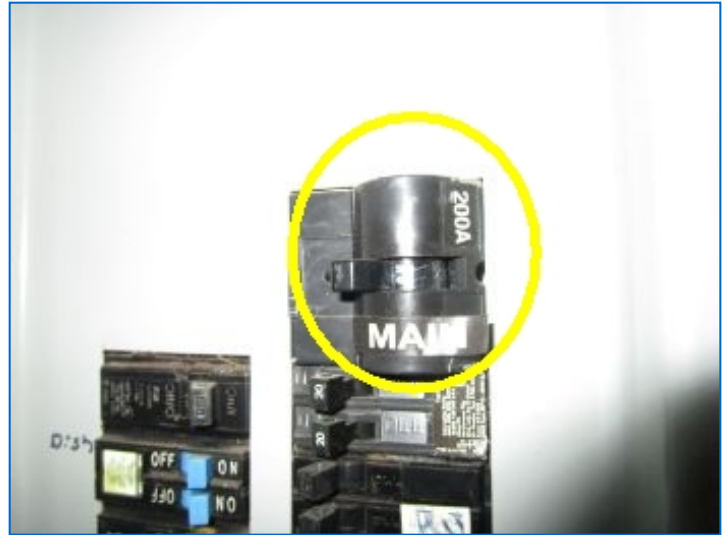
Main Disconnect: 200 amp main breaker serves the property.

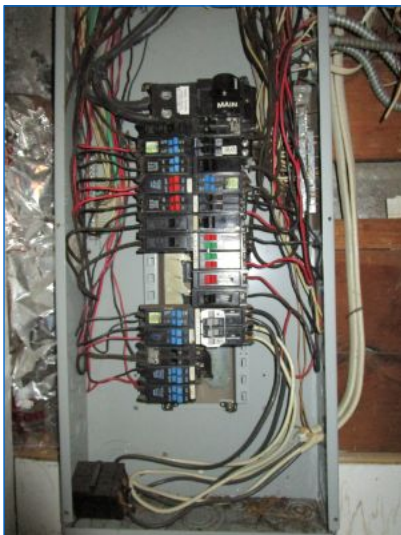
Main panel interior checked.

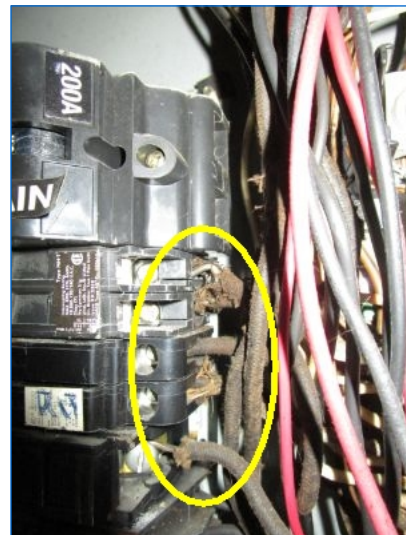
Some older cloth covered power cables are present in the home. Avoid damage to older cloth covered wiring; update when practicable. Suggest having a qualified electrician evaluate and apply corrective measures to avert hazard.

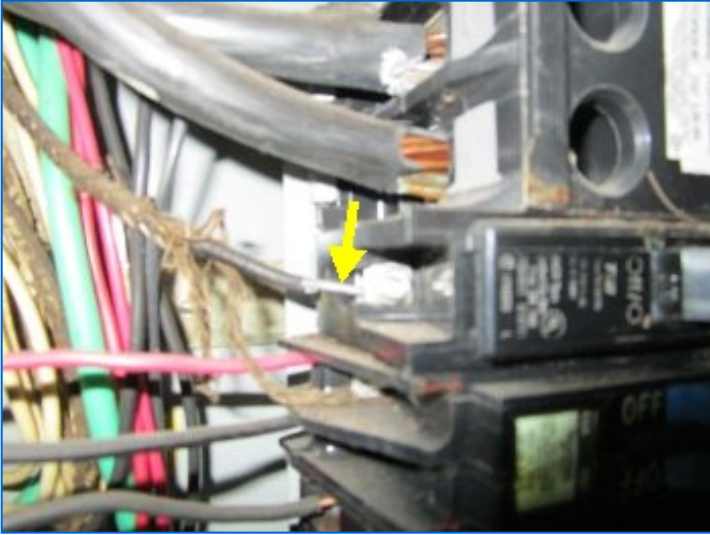
Aluminum wiring present — Recommend review and maintenance be performed by a licensed electrician prior to close.

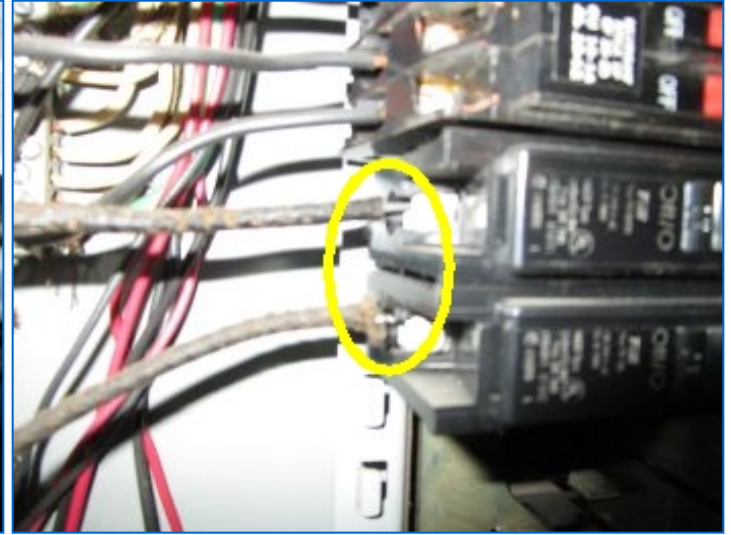
Aluminum wiring present — Recommend review and maintenance be performed by a licensed electrician prior to close.

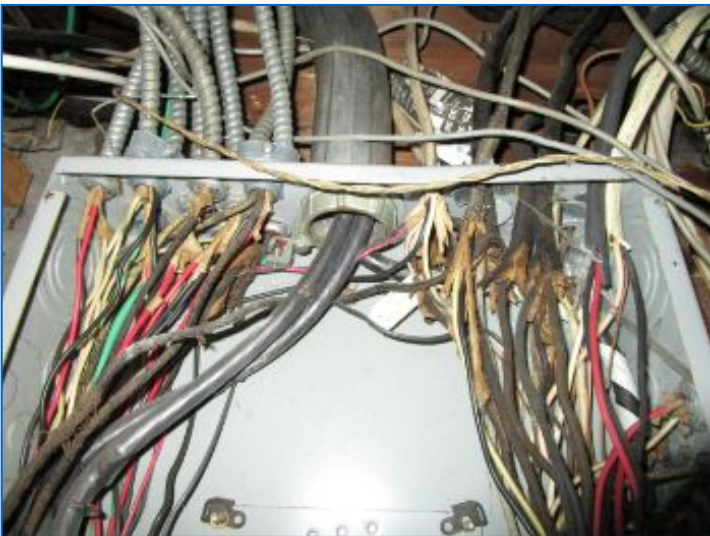
Distribution wiring observed consisted of copper and some aluminum, non-metallic and metallic armored cable.

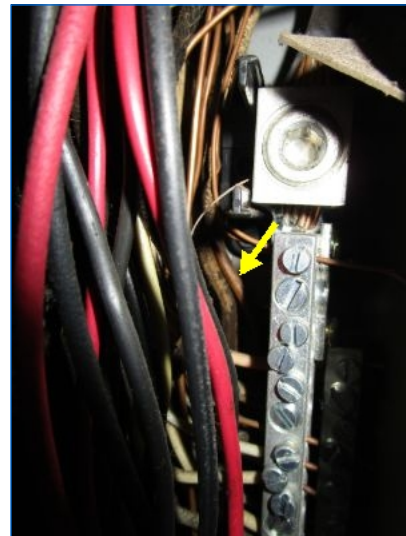
Neutral bus grounding observed. Suggest having electrician ensure that ground is continuous.

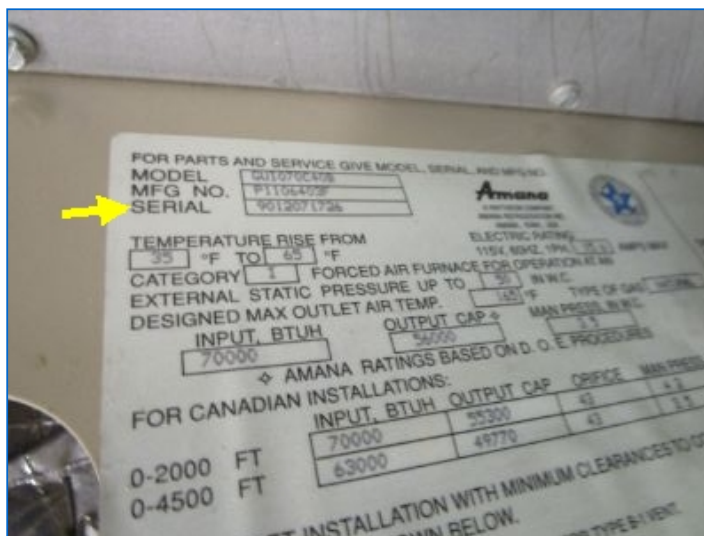
Amana Forced Air Furnace data plate/serial no. indicates a nominal heating capacity of 56,000 Btu/hr, and a manufacture date of 12/1990, (29 yrs old).

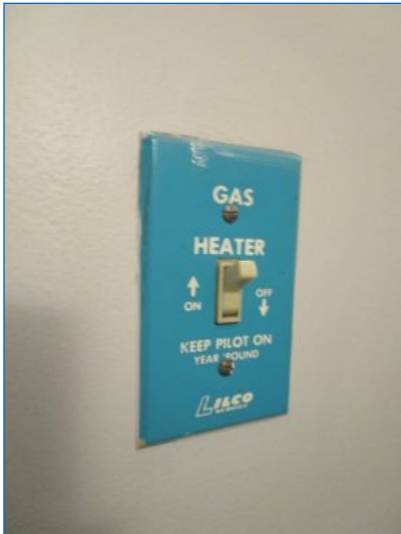
Remote Emergency Shut-off switch noted at basement stairs.

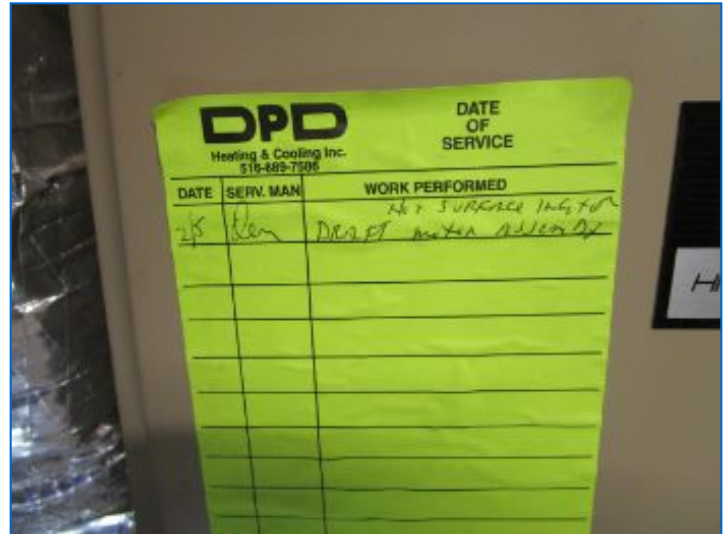
Service Tag indicates the boiler was last serviced on 2/2005. Recommend annual inspections/maintenance be performed by a licensed HVAC contractor to ensure safe and efficient operation.

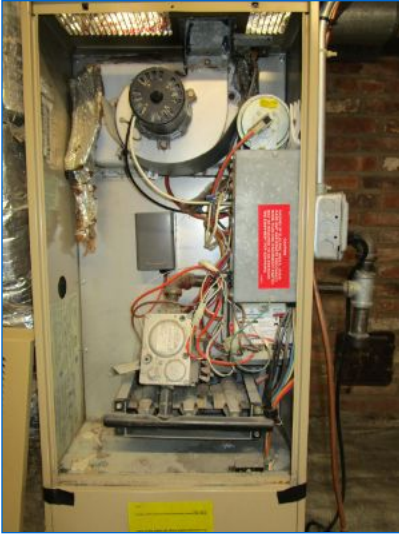
Forced Air Furnace: The heat exchanger in a Gas-fired furnace is mostly hidden from view; it cannot be fully examined and its condition determined without being disassembled. Since this is not possible during a visual inspection, it is recommended that an annual service contract be placed on the unit and a Service Call made prior to settlement to check the condition of the heat exchanger.

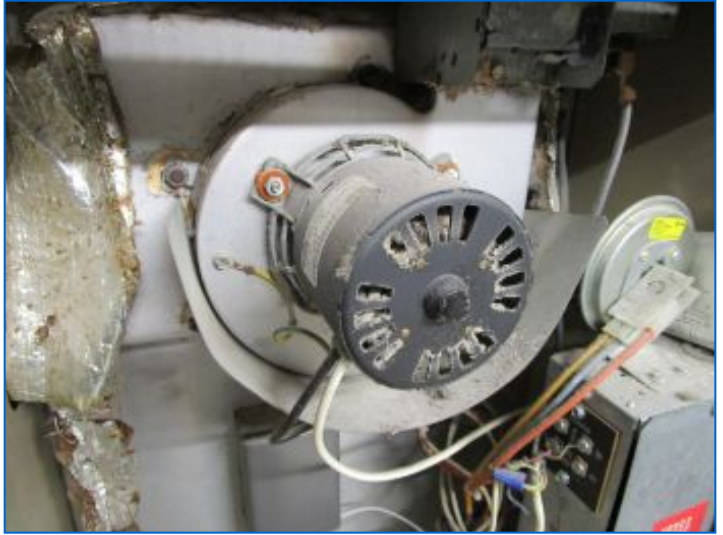
Furnace combustion fan made abnormal noise when the unit was started; refer to related notes.

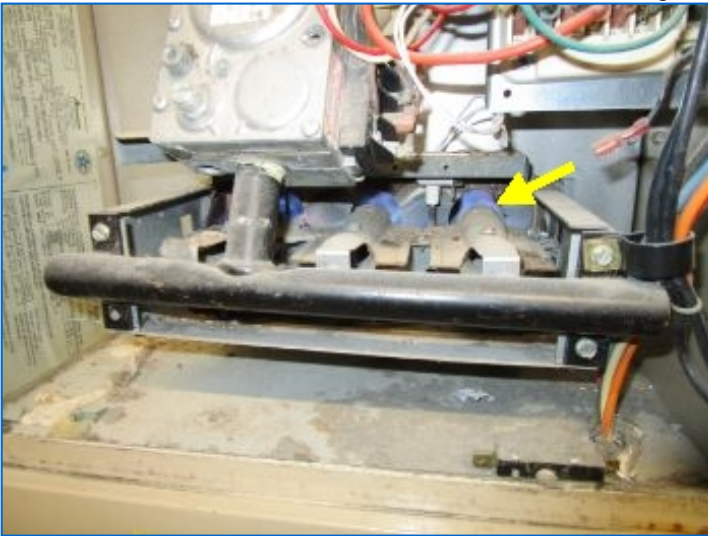
Burner fired by thermostat.

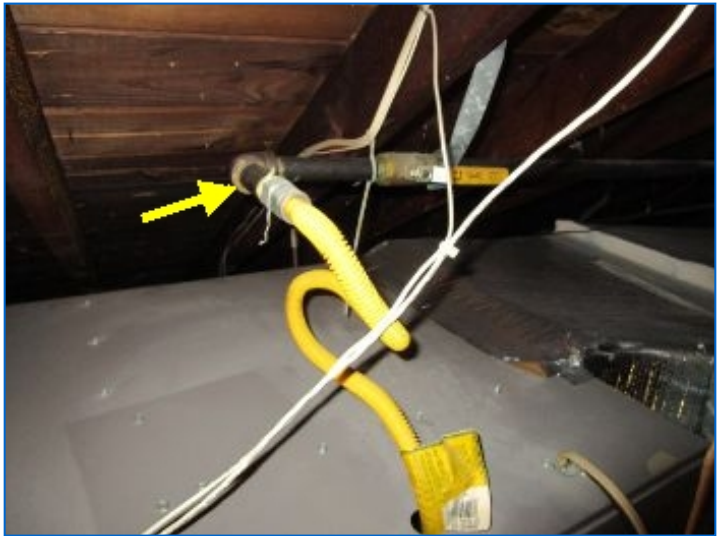
Gas pipe drip leg missing at furnace. This trap should be a tee fitting with a capped nipple having a minimum vertical length of 3 inches. This drip leg serves as a collection area for sediment to reduce the chance of clogging gas valves or burners.

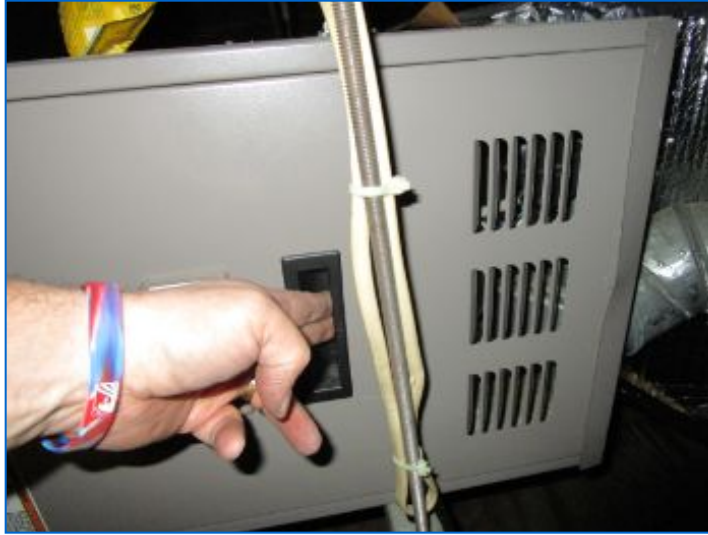
HVAC#2 Forced air furnace access panel was stuck closed; Inspector could not open without causing potential damage to the unit cabinet.

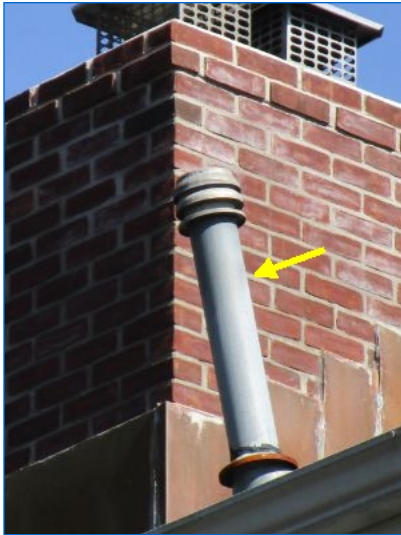
Metal flue pipe for HVAC#2 forced air furnace was not vertical/plumb. Refer to HVAC - Furnace Venting section for HVAC#2 comment.

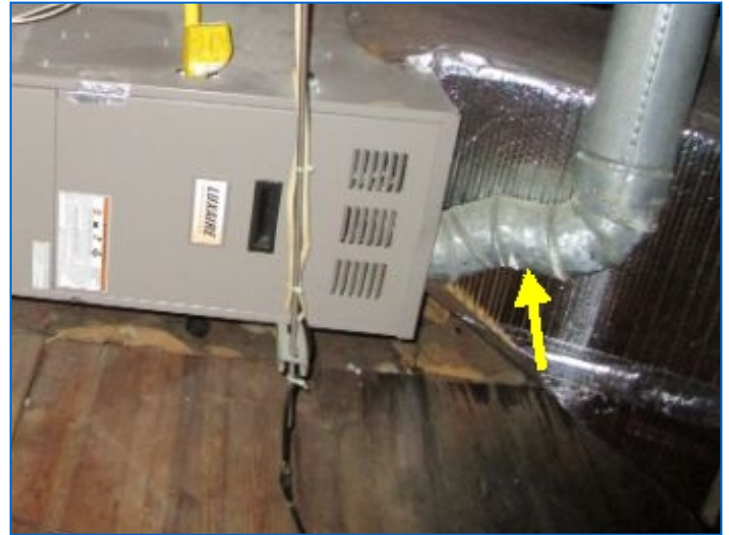
Single wall vent pipe from furnace cannot start in or pass through the attic area. Recommend replacing single wall pipe with double wall pipe in attic area.

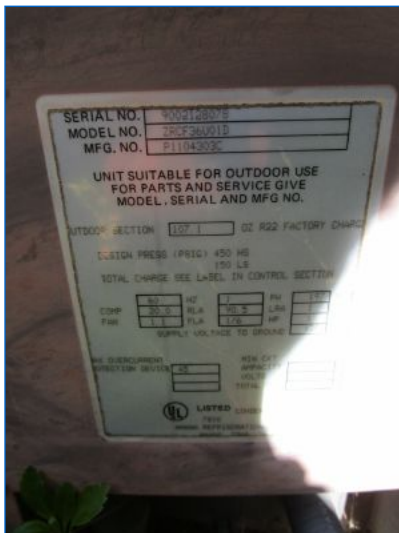
AC#1 Amana Condensing Unit data plate/serial no. indicates a cooling capacity of 3 tons, and a manufacture date of 2/1990, (29 yrs old).

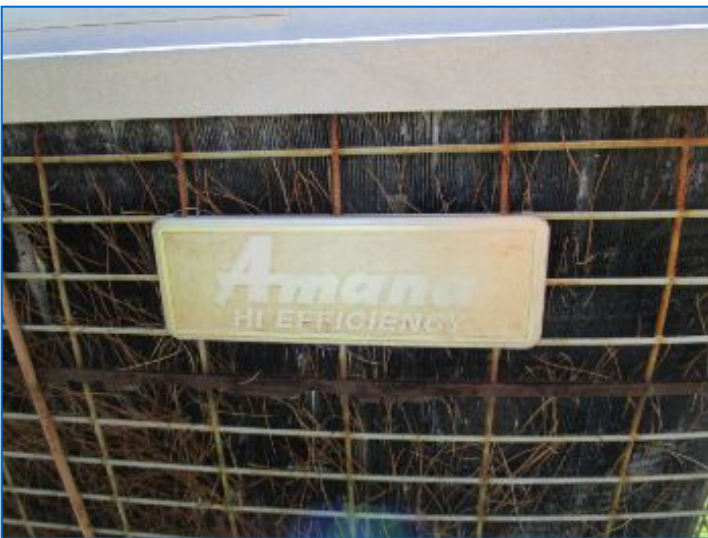
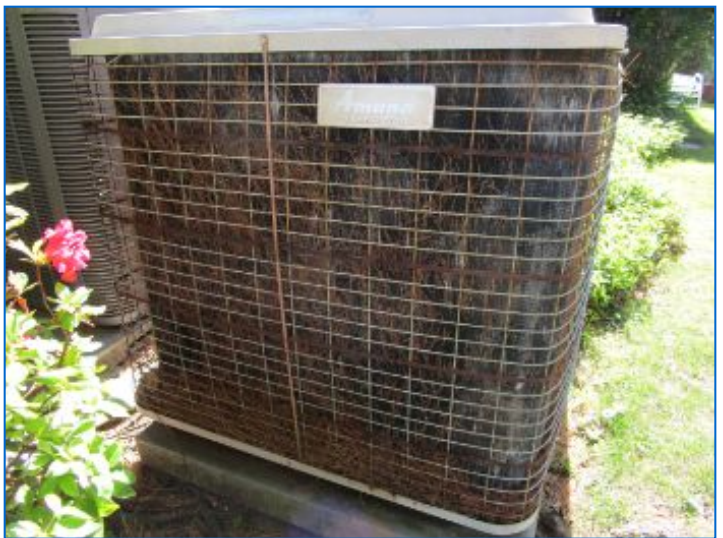
AC#1 condenser coil not properly maintained; aluminum fins degraded and clogged with pine needles. This has degraded the performance of this system.

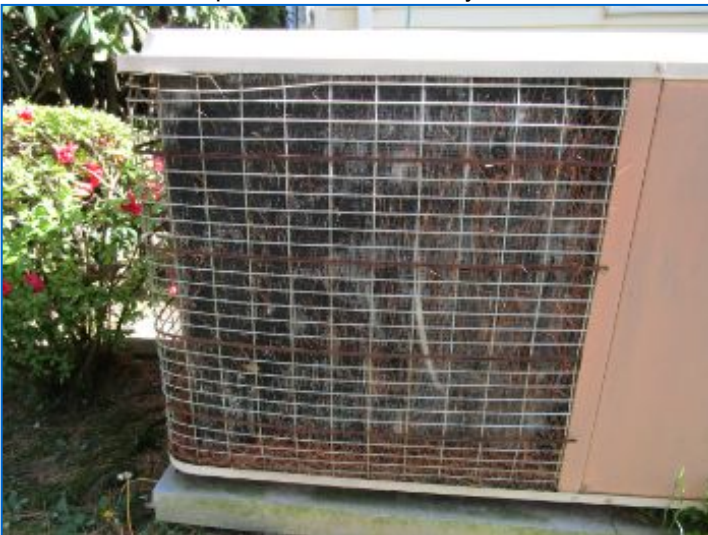
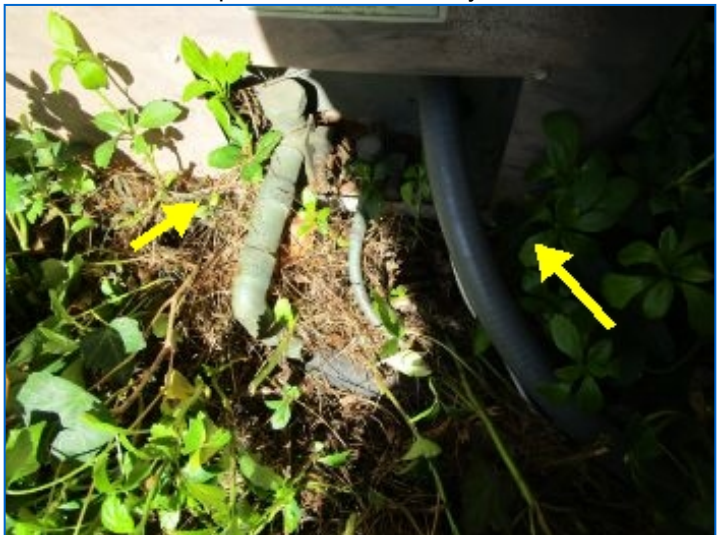
AC#1 condenser coil not properly maintained; aluminum fins degraded and clogged with pine needles. This has degraded the performance of this system.

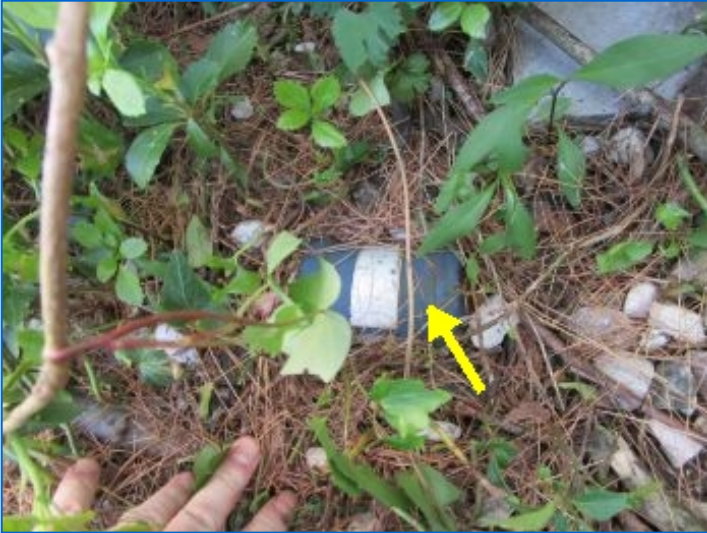
AC#1 refrigerant piping and filter/drier was buried by pine needles/soil. Recommend replacing and raising refrigerant pipe above ground to prevent corrosion that can lead to refrigerant leakage.

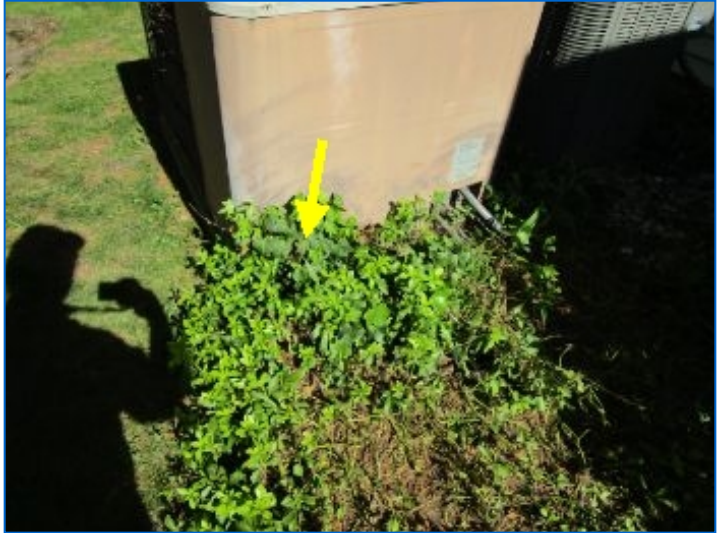
Ivy can grow aggressively; suggest removing ivy that is in close proximity to condensing units.

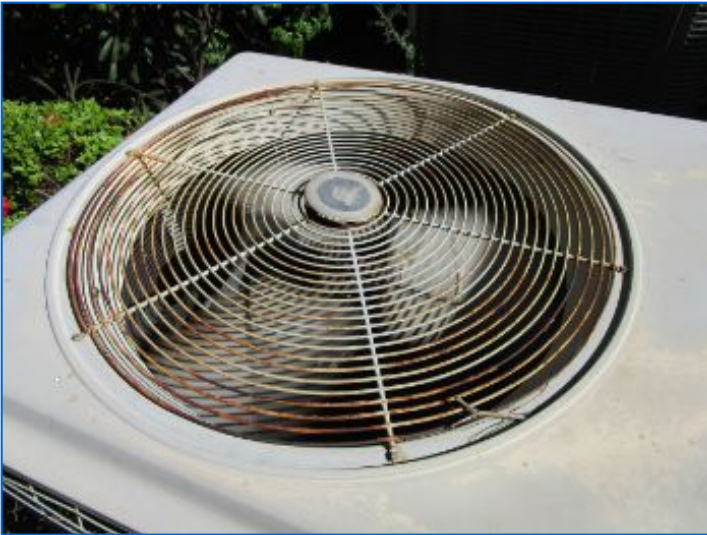
A/C systems 1 & 2 operated and appeared functional at the time of inspection, however the overall performance of the home air conditioning system may not be sufficient during warmer outdoor conditions due to the noted deficiencies.

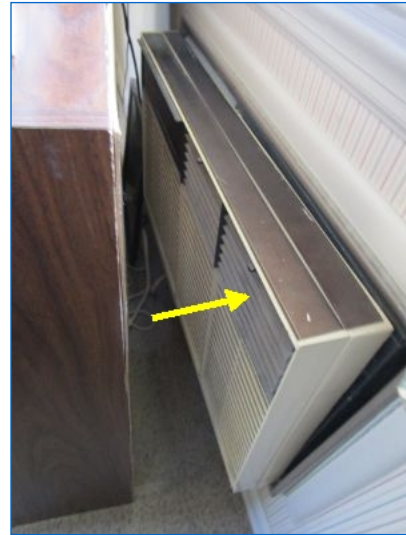
Older through-wall A/C unit (supplemental) in 2nd floor office was inoperable at time of inspection.

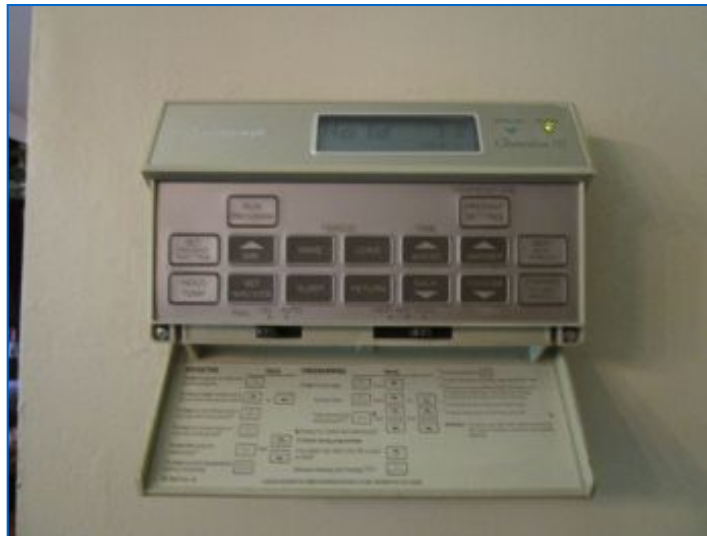
Digital Programmable type thermostat noted in Dining room for AC#1.
