# ProSpec Home Inspection of Long Island Property Inspection Report

154 Combs Ave, Woodmere, NY 11598  
Inspection prepared for: Name Deleted Date  
of Inspection: 5/21/2019 Time: 4:30 PM  
Age of Home: 73 yrs old Weather: Sunny,  
73degF Approx. Year Built: 1946

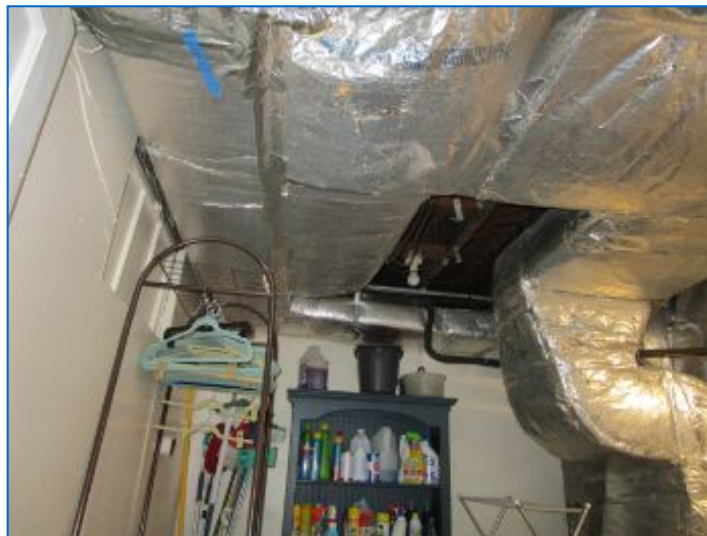
HVAC ductwork was well insulated.

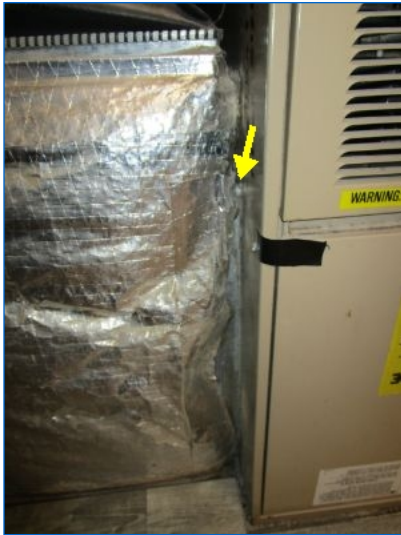
No filter located at HVAC#1 cabinet intake.

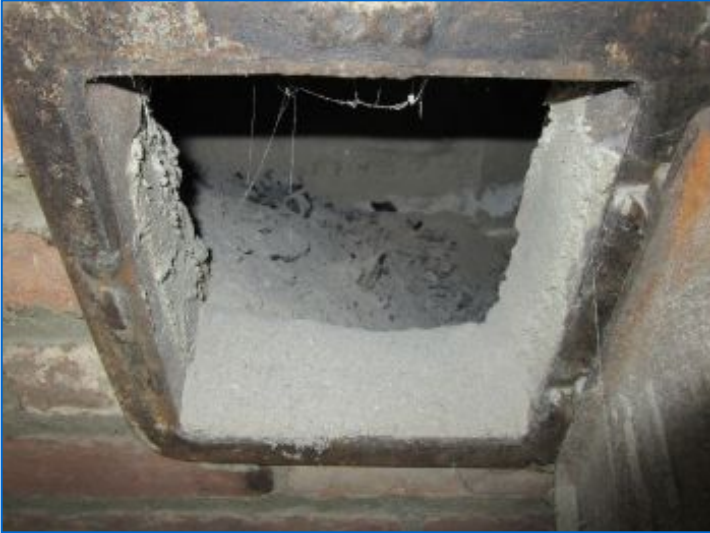
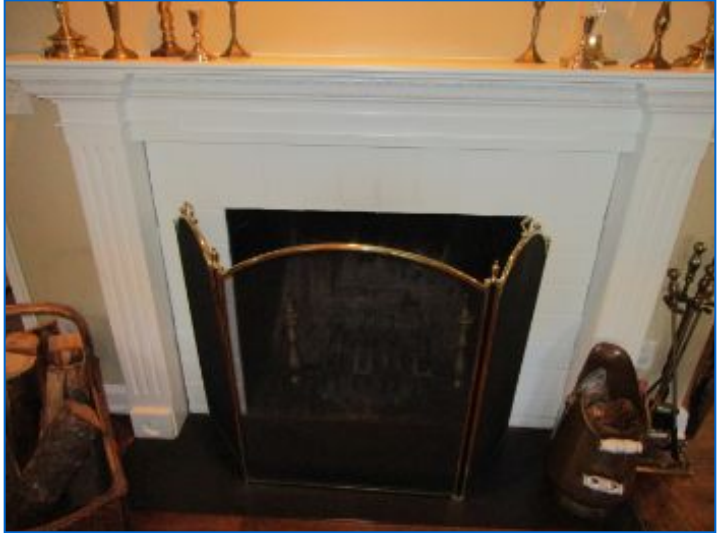
Signs of high usage noted based on the amount of ash. Recommend fireplace professional clean and further inspect the fireplace.

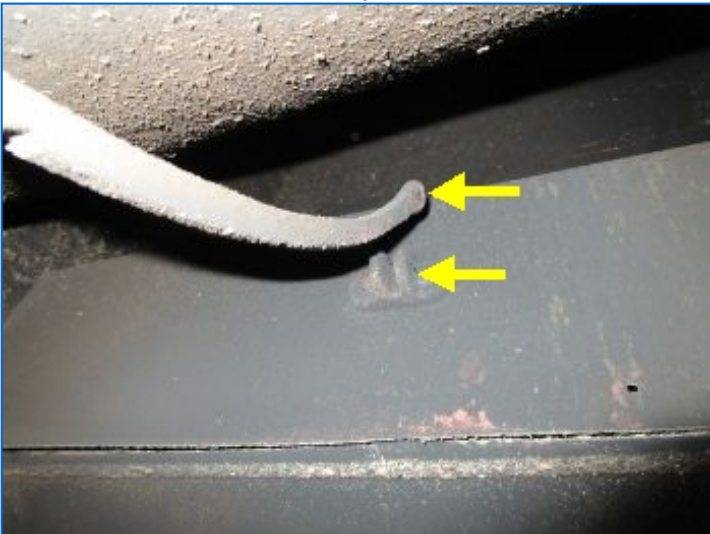
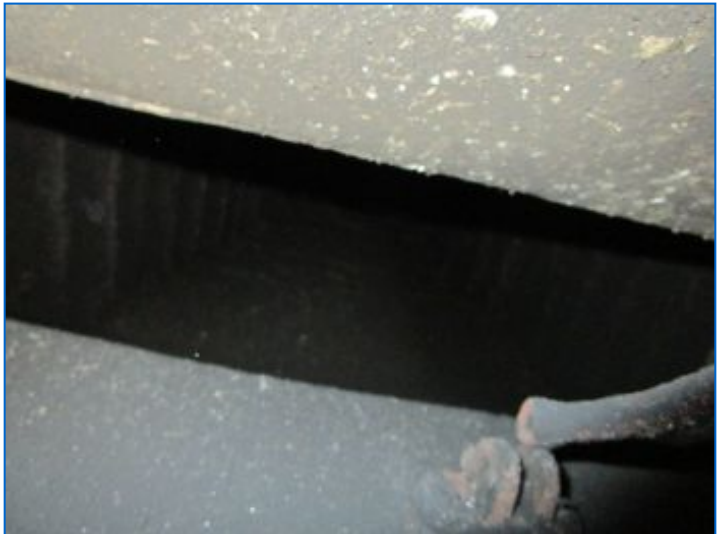
Damper was inoperable due to disconnected control arm, otherwise damper moved freely; repair linkage.

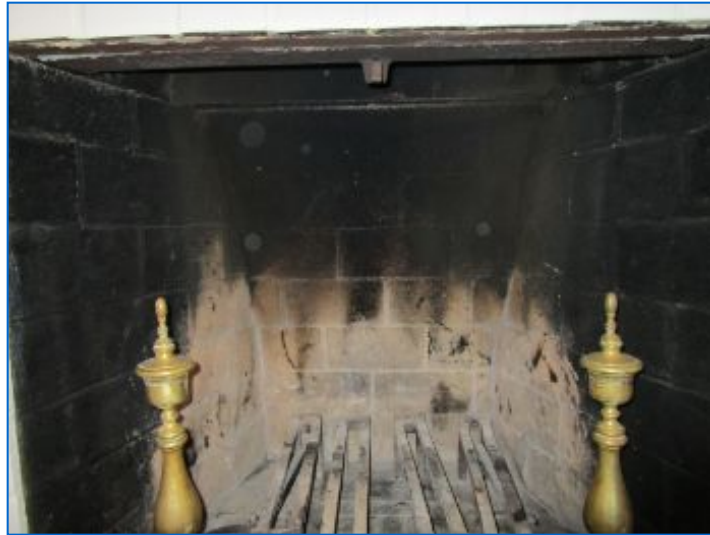
Signs of high usage noted based on the amount of ash and soot. Recommend fireplace professional clean and further inspect the fireplace.

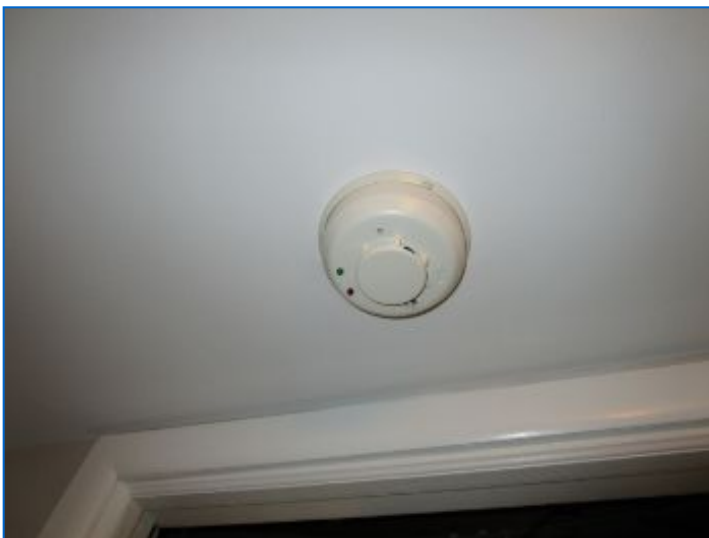
Smoke/Carbon Monoxide Detector noted in vicinity of furnace room. Maintain functioning Smoke/Carbon Monoxide detectors as recommended. Detectors are generally reliable for up to 5 yrs.

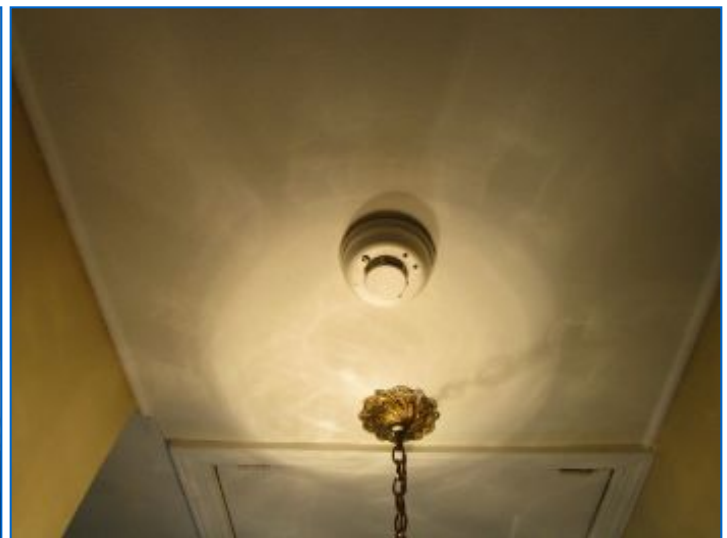
Smoke/Carbon Monoxide Detector noted in Hallway (2nd floor). Maintain functioning Smoke/Carbon Monoxide detectors as prescribed. Detectors are generally reliable for up to 5 yrs.

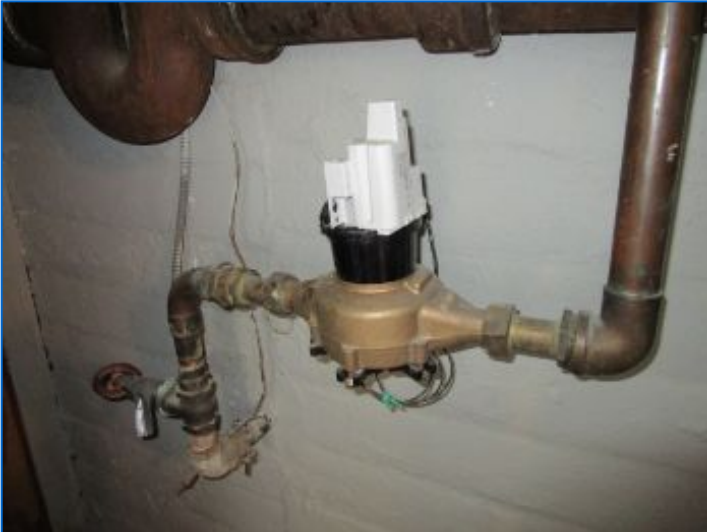
Water Service Entrance: 1" Galvanized line entering with meter and shutoff valve/s.

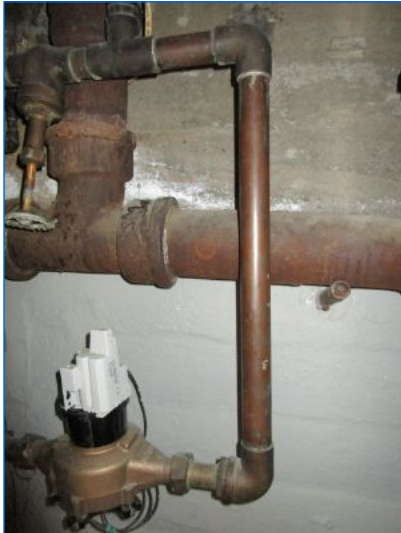
System Grounding: Ground wire connection noted at inlet-side of meter only; ground missing at outlet-side of meter. Suggest having licensed electrician ensure that plumbing system grounding is adequate.

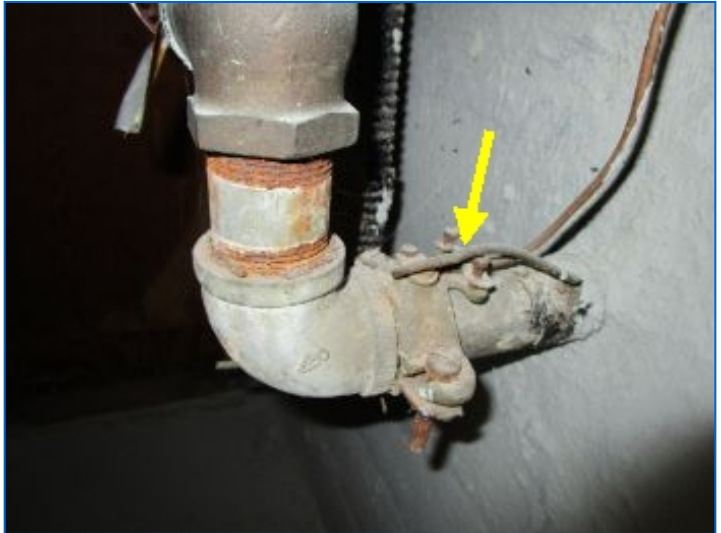
System Grounding: Ground wire connection noted at inlet-side of meter only; ground missing at outlet-side of meter. Suggest having licensed electrician ensure that plumbing system grounding is adequate.

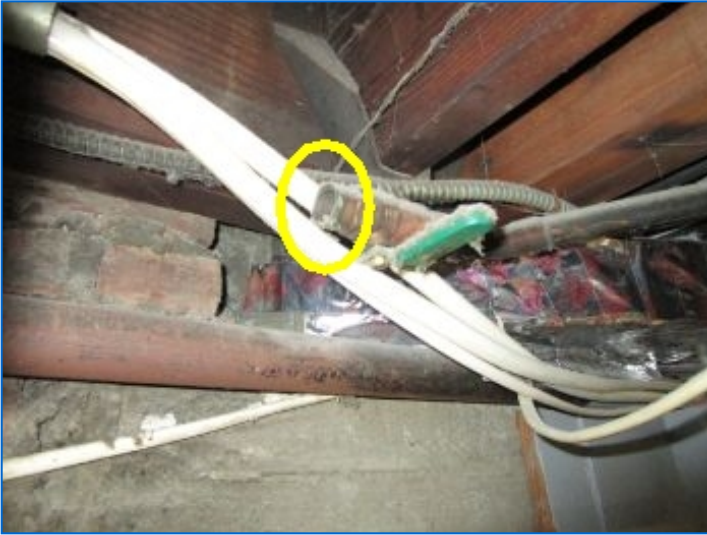
Uncapped supply valve noted in basement. All water pipes not supplying a fixture must be properly terminated/capped to prevent possible water damage and or personal injury from scald burns if valve is accidentally operated.

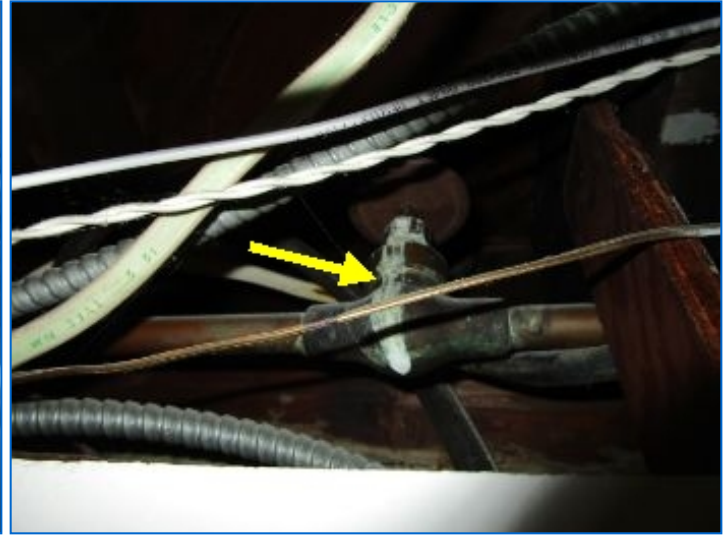
Deposits observed at water valve/s is a sign of past leakage and possible valve body corrosion. Suggest evaluation and repair by a qualified plumber.

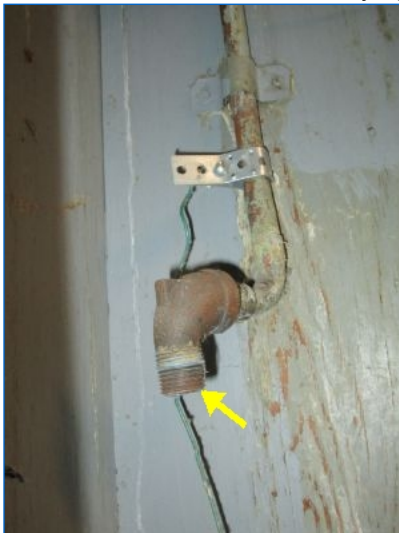
Uncapped supply line noted in basement. All water pipes not supplying a fixture must be properly terminated/capped to prevent possible water damage and or personal injury from scald burns if valve is accidentally operated.

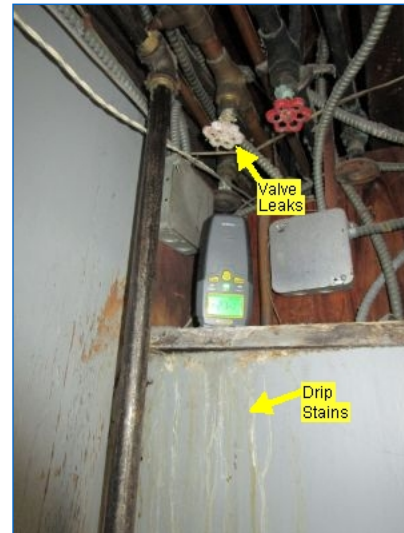
Deposits observed at water valve/s is a sign of leakage and possible valve body corrosion. Suggest evaluation and repair by a qualified plumber.

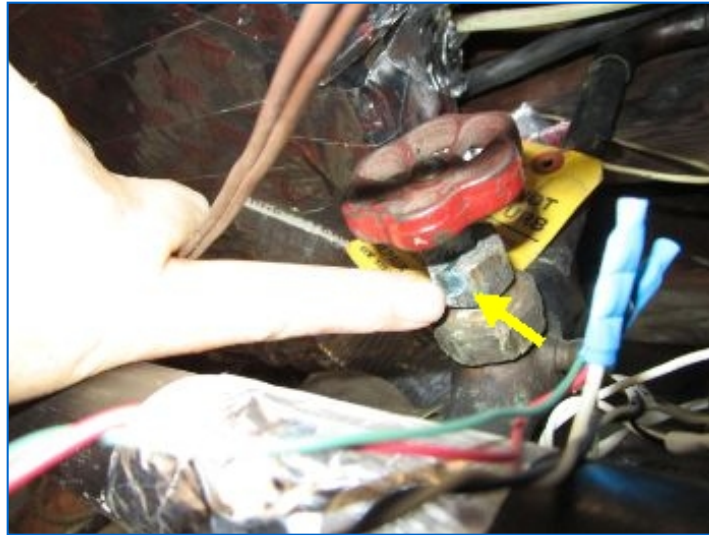
Valve leaking at packing nut in basement above water meter. Recommend repair.

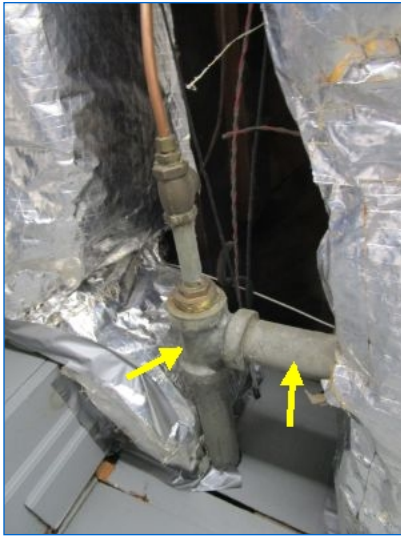
Galvanized DWV pipe noted.

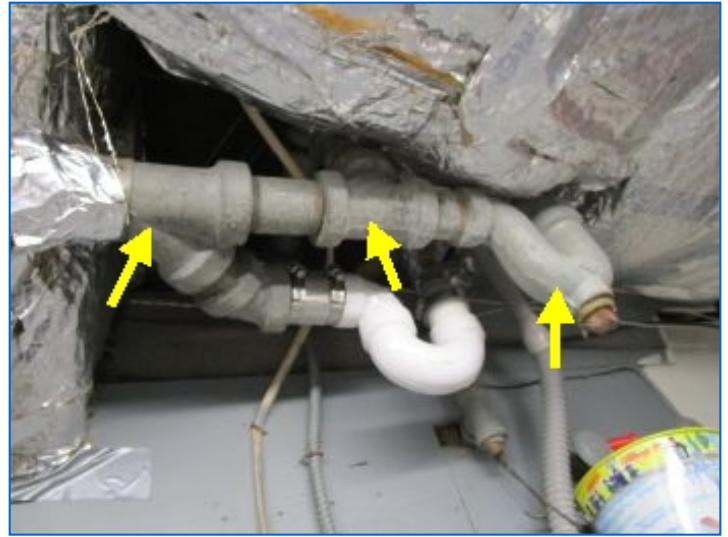
Galvanized DWV pipe noted.

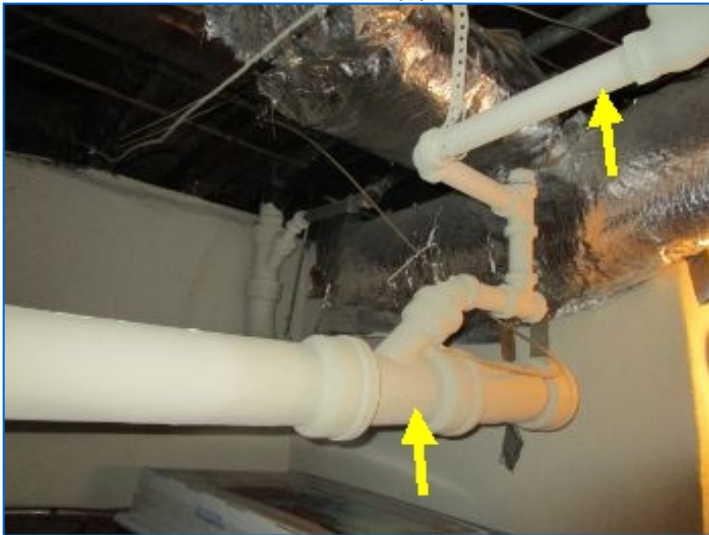
Some DWV pipes were recently painted.

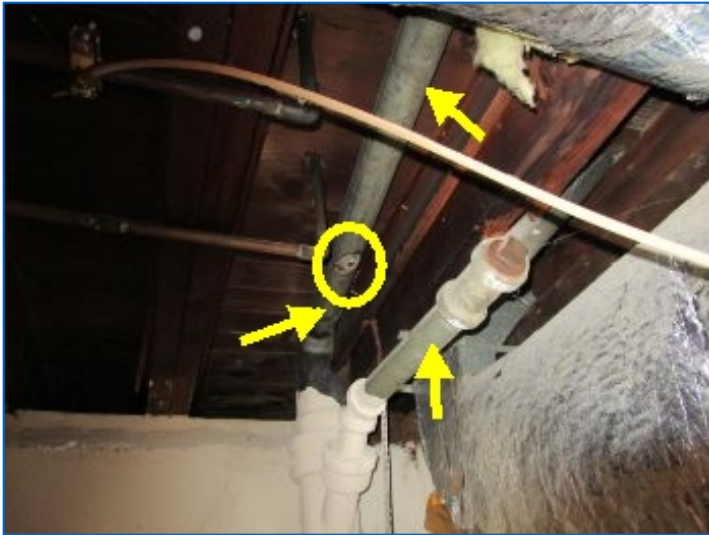
Galvanized DWV pipe noted.

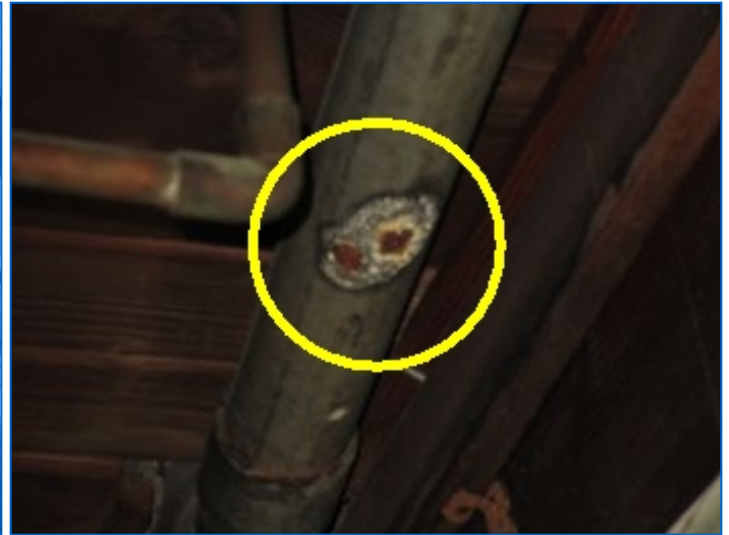
Galvanized DWV pipe corroded through. Recommend evaluation and repair of defective length/s of galvanized pipes by a licensed qualified plumber.

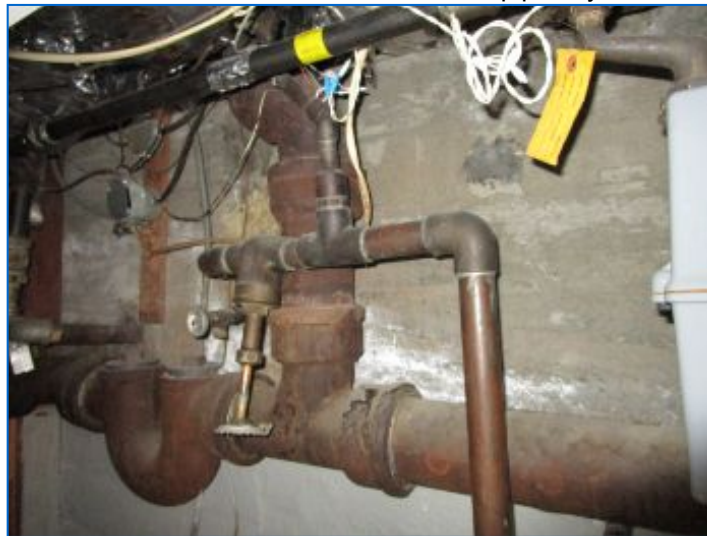
Waste Pipe Exit #2 located at the Southeast side of the house/basement includes whole-house trap w/vent and clean-out fitting..

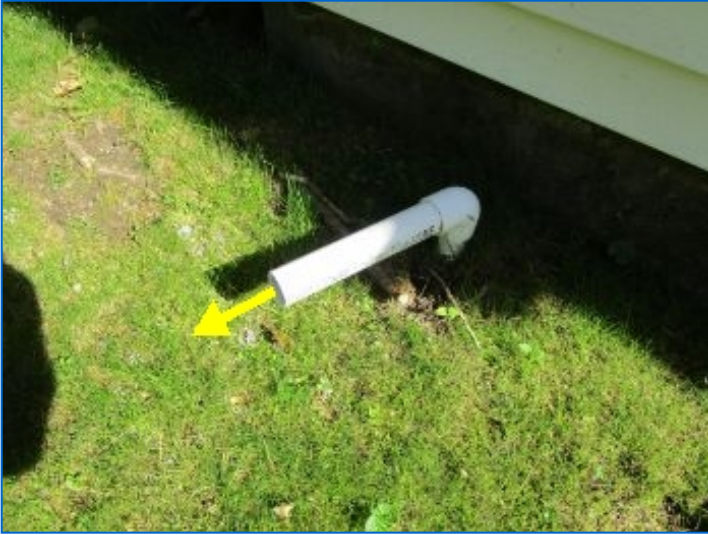
Basement sump pump discharge pipe noted at back yard.

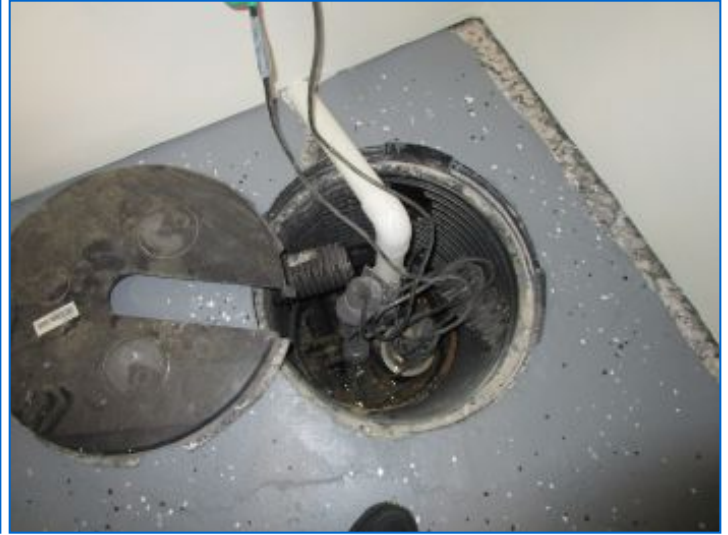
The basement contained a sump pump. A sump pump is a water pump installed in a pit in the lower level of the home. Sump pumps are installed to prevent rising groundwater from entering the home as well as protect the home from water intrusion by discharging rising groundwater or seepage from surface runoff to the exterior of the home or to a waste pipe or storm drain. Sump pumps should be tested on an annual basis to ensure that they are in working order. The pumps can be tested by lifting the float, but to avoid potential shock/electrocution hazard testing should be performed using a tool which will not conduct electricity. Pumps have an inlet screen that should be cleaned during routine maintenance.

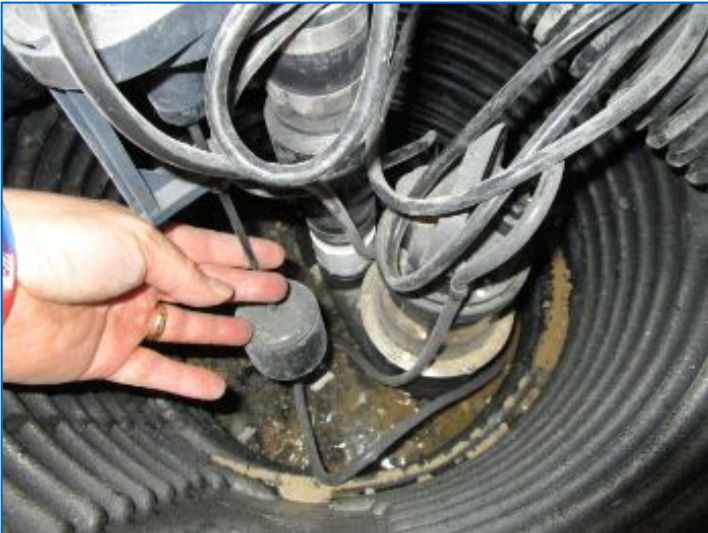
The sump pump responded to the controls at the time of the inspection.

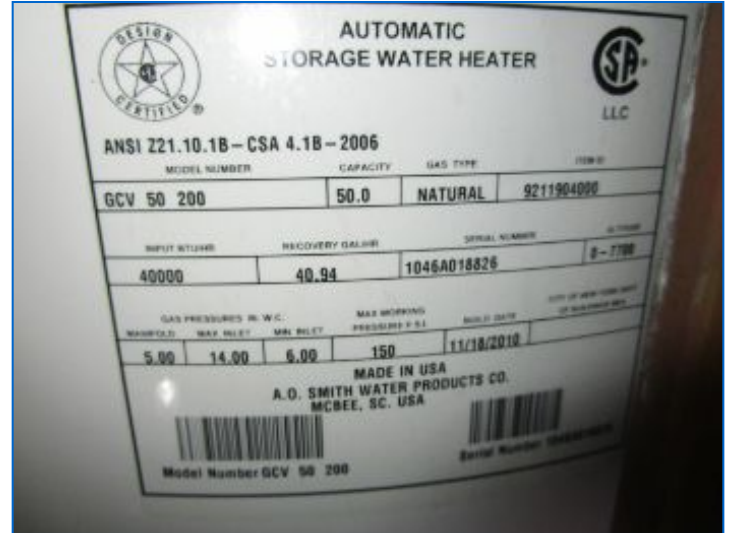
A.O. Smith 50 gallon capacity unit. Water Heater data plate/serial no. indicates a manufacture date of 11/2010 (8 yrs old).

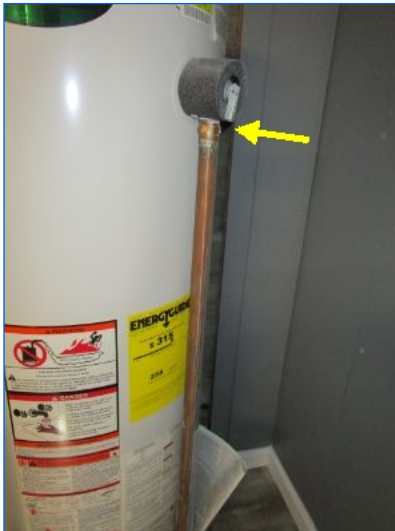
Temperature Pressure Relief (TPR) valve and discharge pipe showed no deficiencies.

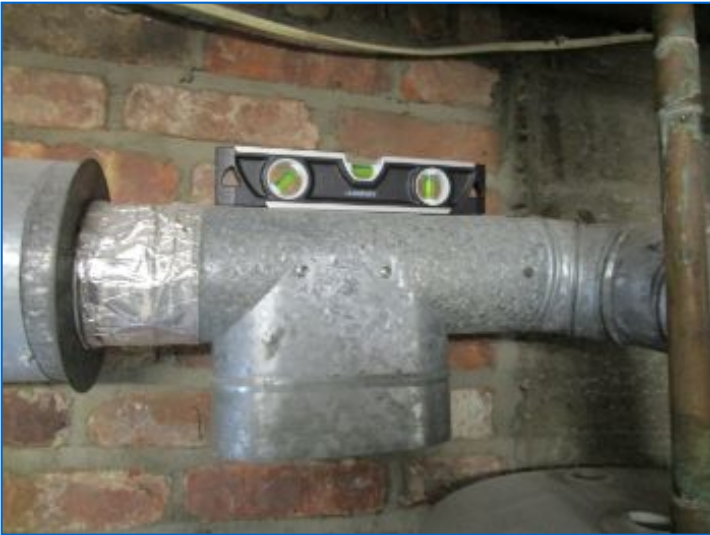
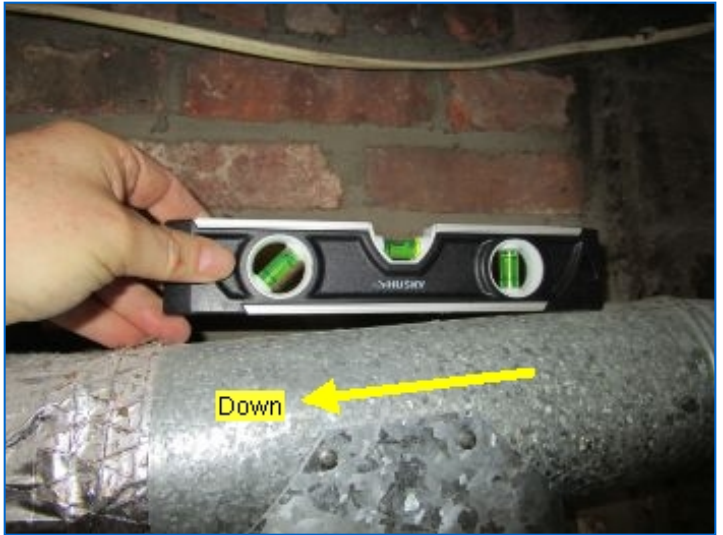
The vent pipe from the natural draft gas water heater fails to rise 1/4" per foot and may need re-locating or a power vent be installed. Recommend a licensed HVAC contractor inspect further and repair as needed.

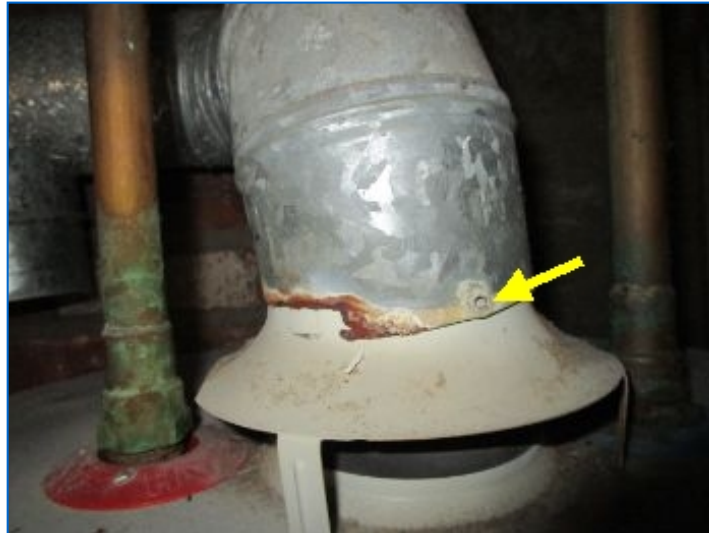
Vent pipe was not properly fastened to water heater vent hood; Recommend repair.

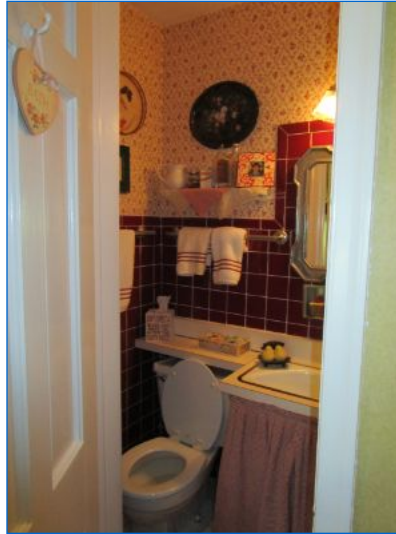
1st Floor 1/2 Bathroom

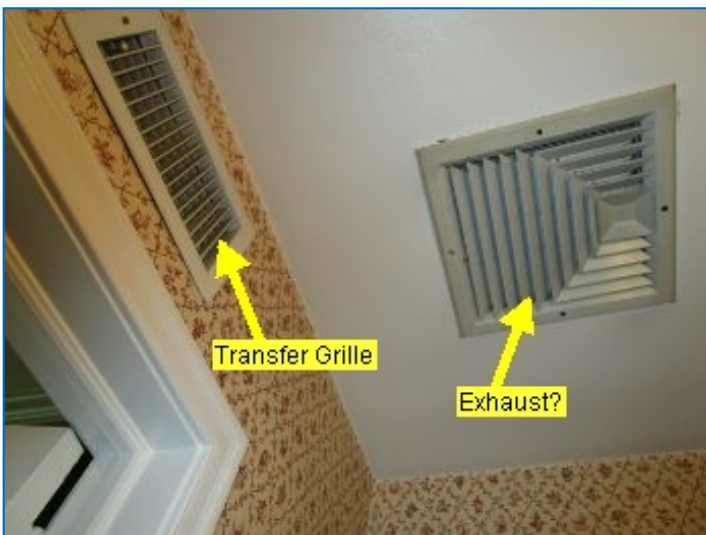
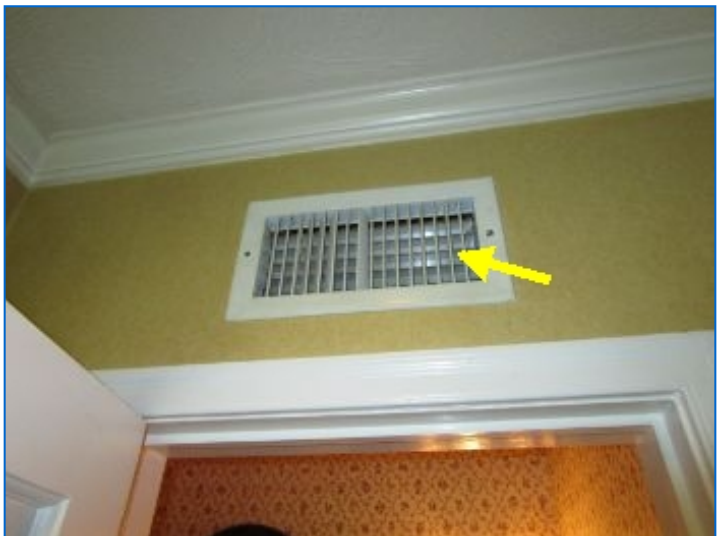
Transfer grille noted over bathroom door.

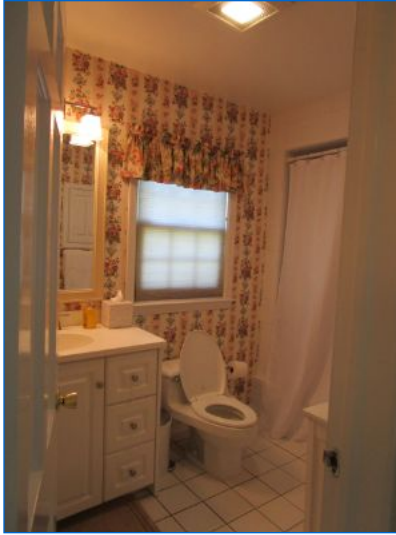
2nd Floor Hall Bathroom

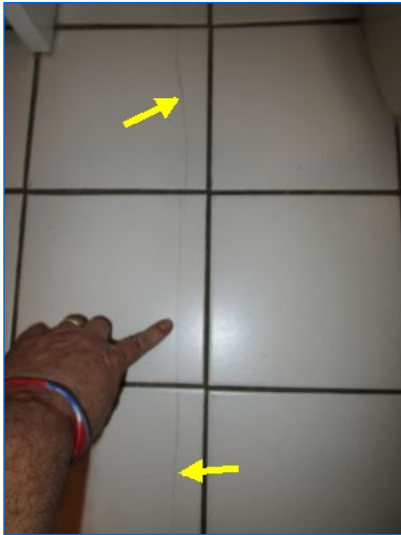
Floor tiles cracked from common structural settlement; suggest tile repair/s.

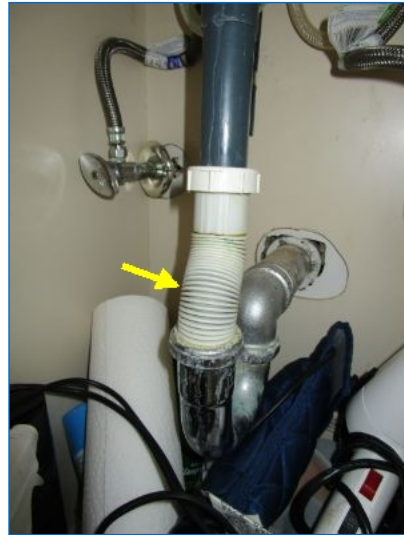
Flex drain connections are not compliant and are subject to frequent clogging. Recommend replacement with proper drain piping by a licensed plumber.

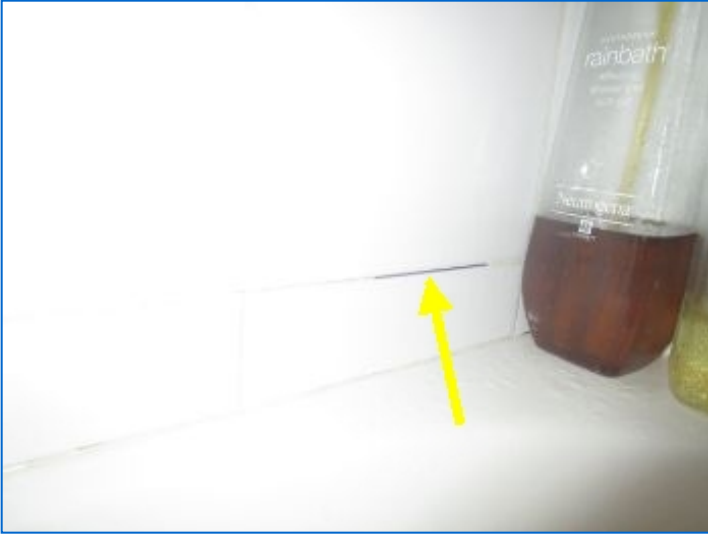
Wall tiles in tub area have damaged/missing grout; suggest re-grouting or adding grout where needed to prevent water damage.

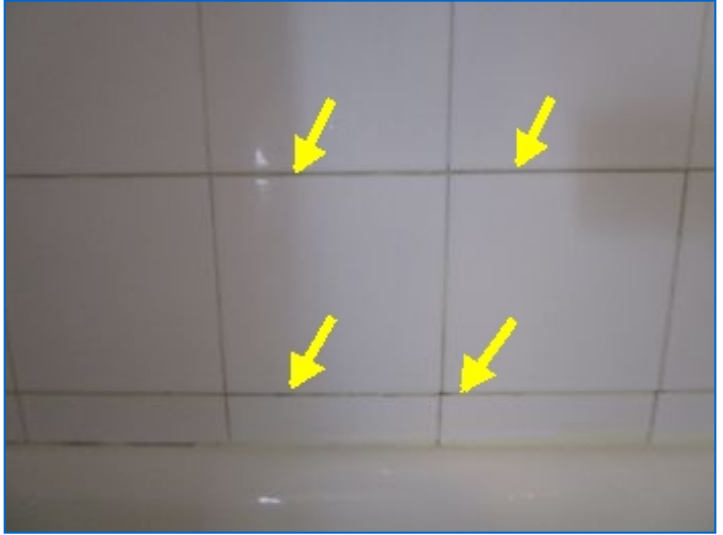
Wall tiles in tub area have damaged/missing grout; suggest re-grouting or adding grout where needed to prevent water damage.

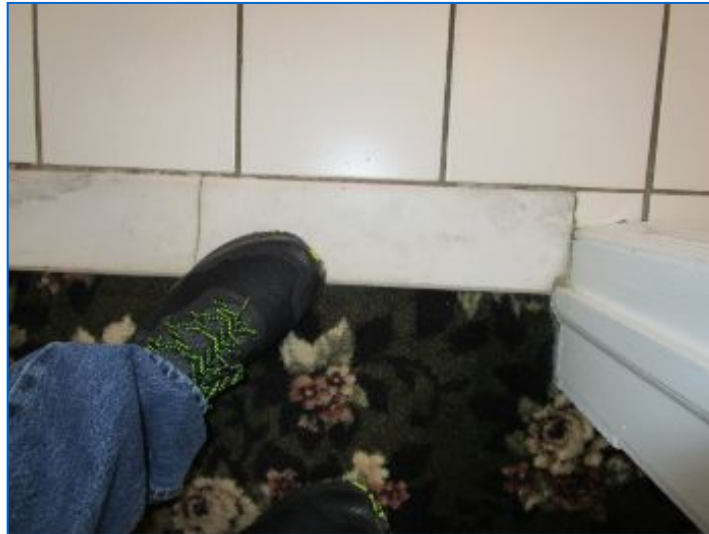
Marble door saddle was cracked and loose; recommend replacement.

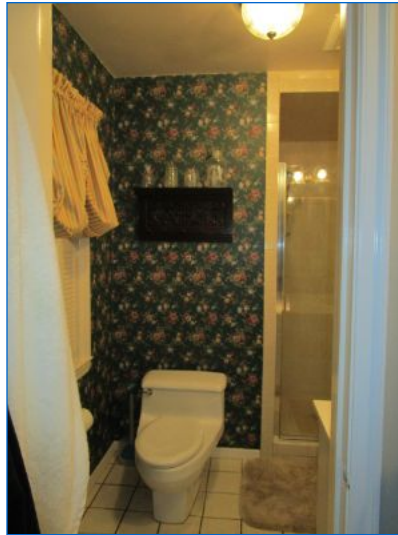
## BATHROOMS Continued

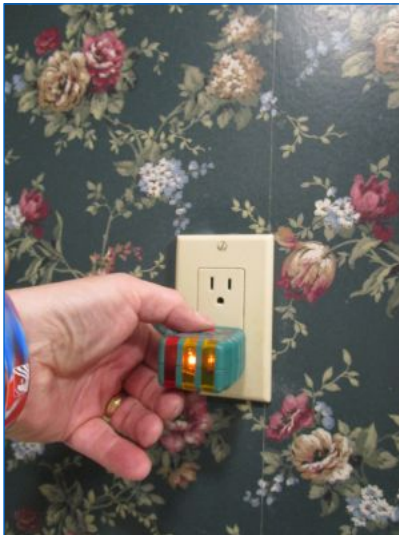
GFCI type receptacle did not trip when tested. Recommend rewiring/replacing GFCI receptacle.

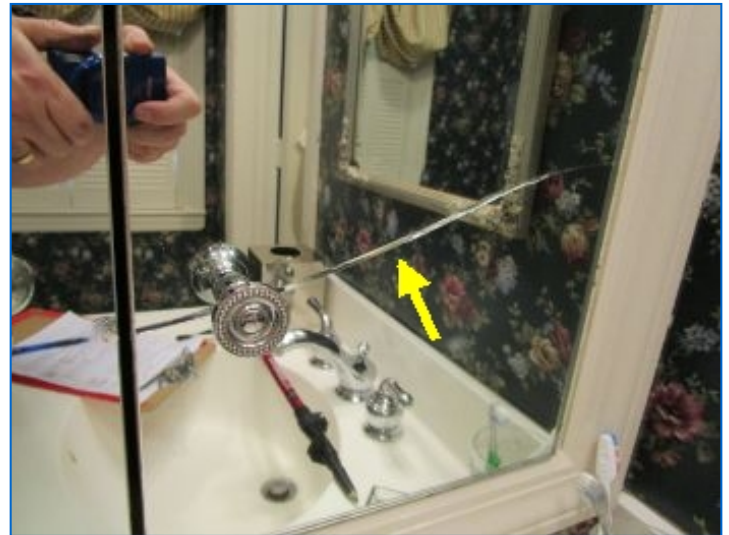
Cabinet mirror was cracked; recommend repair to prevent injury.

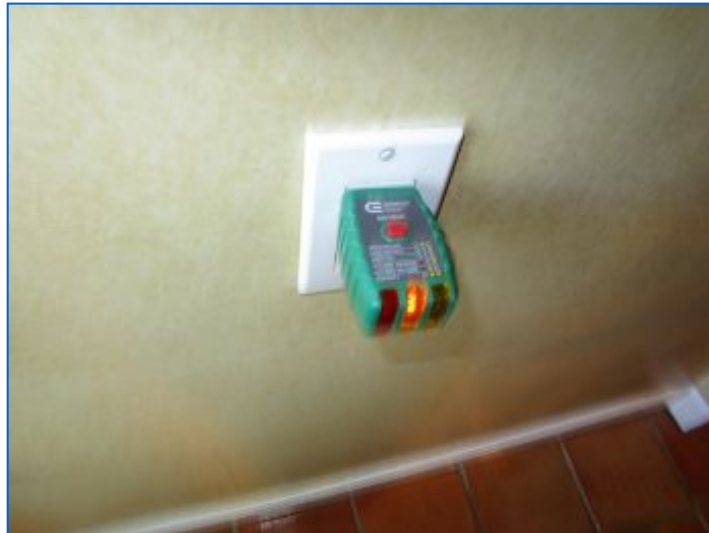
Random Outlet Test: Ungrounded receptacle noted.

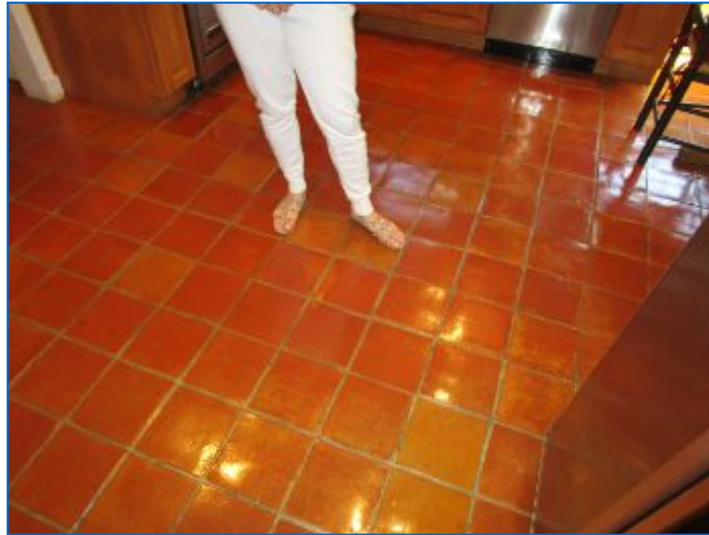
Ceramic/Porcelain tile flooring noted. No defects noted.

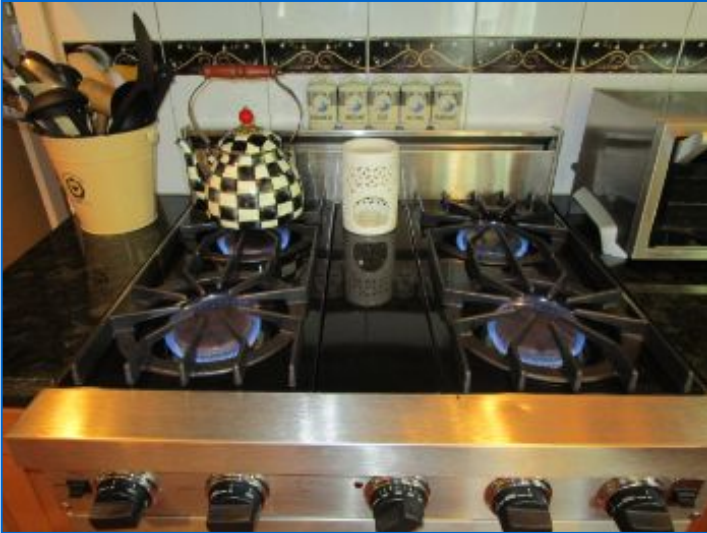
Gas-fired range; operable.

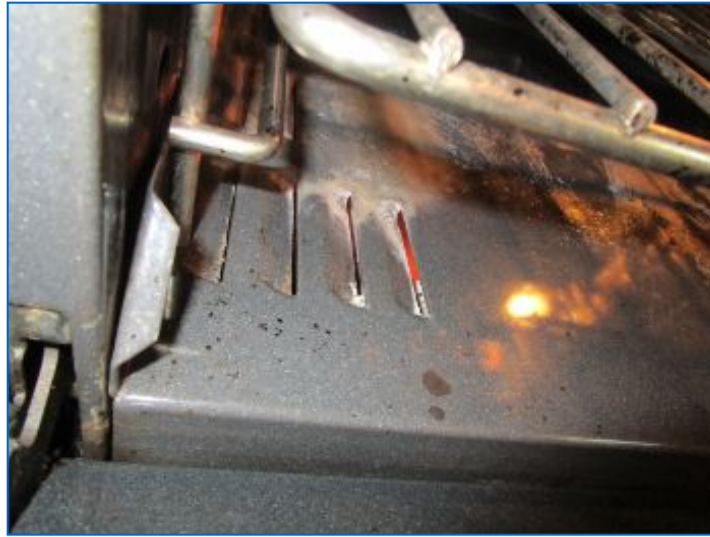
Inspection of ranges is limited to basic functions, such as testing of the range-top burners, and bake/broil features of the oven. The self-cleaning and convection features, as applicable, were not tested.

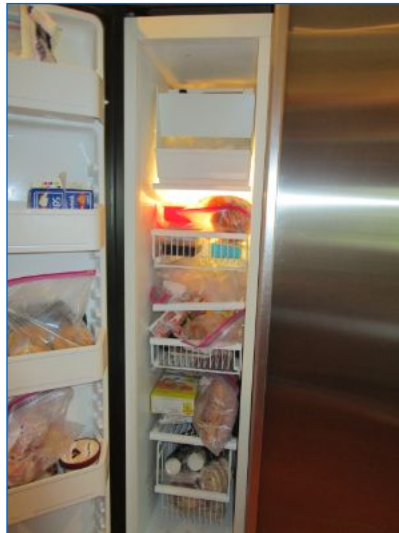
Refrigerator/freezer operating and frost free.

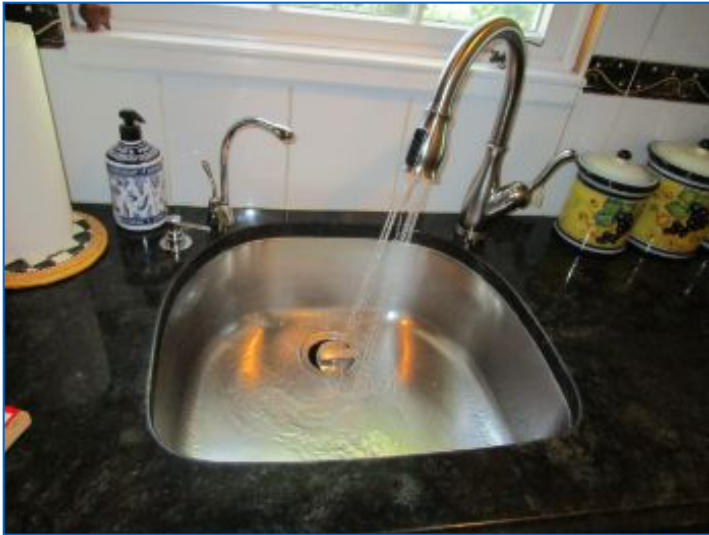
Main faucet operated normally at time of inspection.

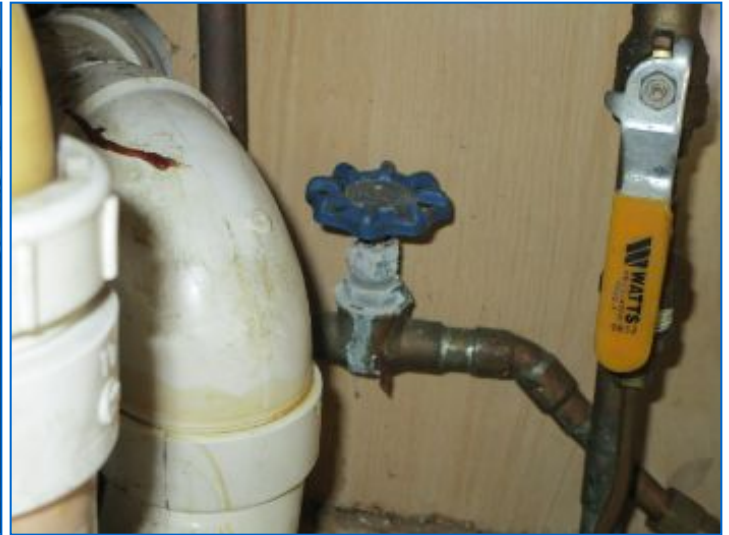
Deposits observed at water valve under sink is a sign of valve body corrosion and past leakage; recommend repair or replacement by a qualified plumber.

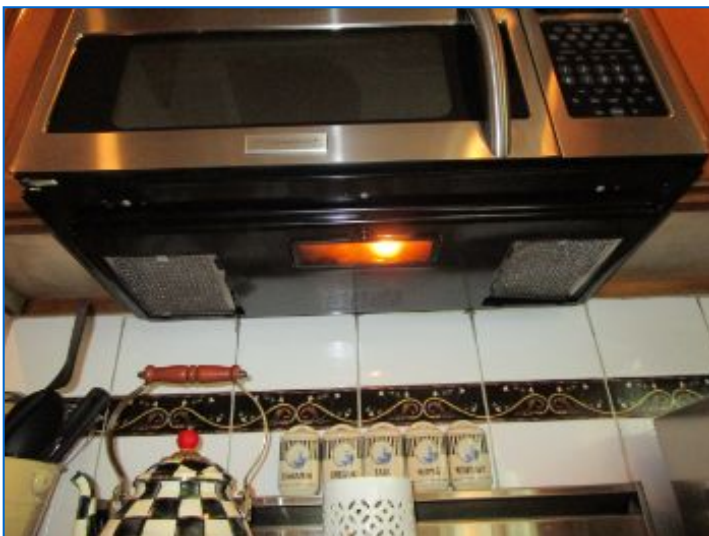
Microwave had an operable built-in Recirculating vent fan with grease filter and light.

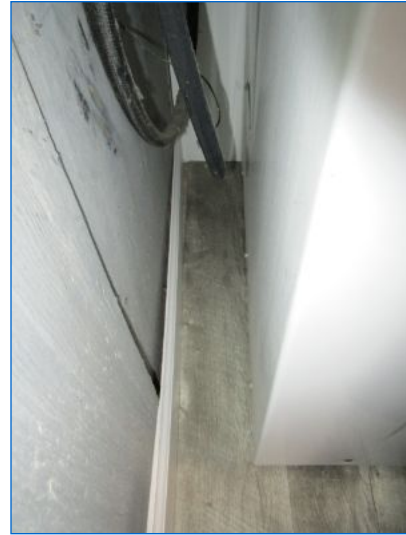
Leaks: No signs observed at time of inspection.

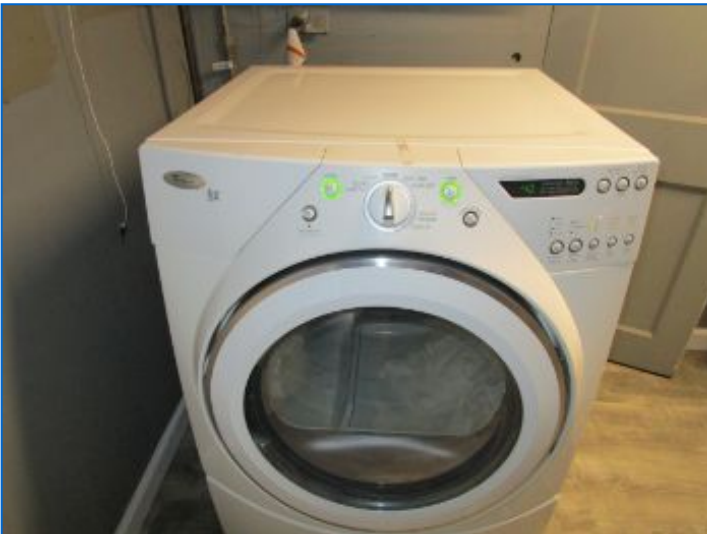
Gas dryer was operable. Estimated age of the dryer is 5+ yrs.

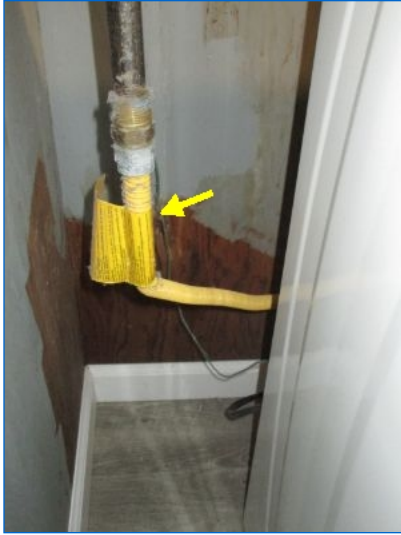
Gas pipe drip leg missing at dryer. This trap should be a tee fitting with a capped nipple having a minimum vertical length of 3 inches. This drip leg serves as a collection area for sediment to reduce the chance of clogging gas valves or burners.

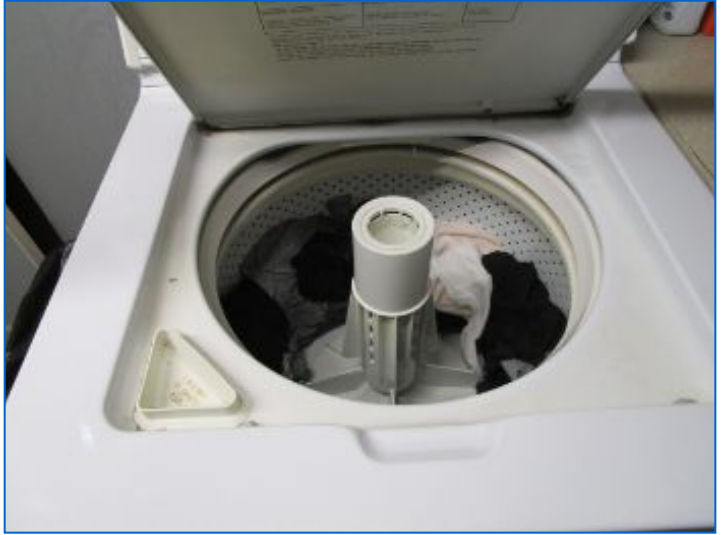
Washer was operable. Estimated age of the Washer is 5+ yrs.

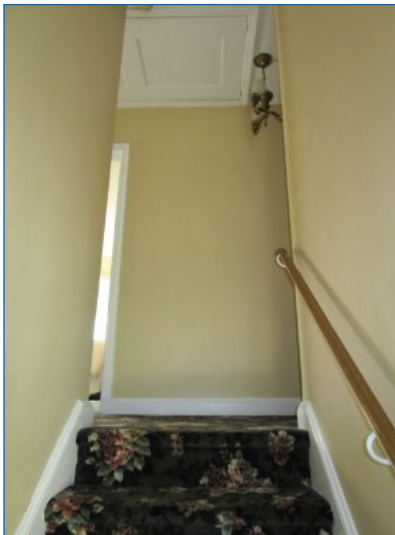
## 2. Stairs & Handrail

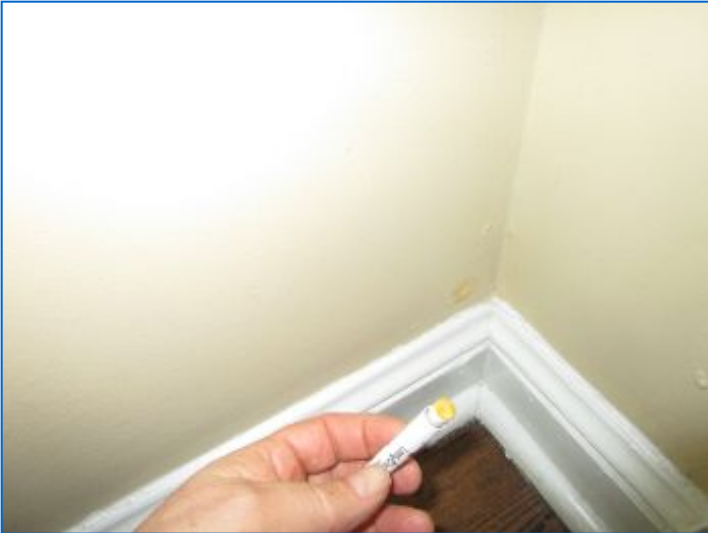
Testing for surface lead paint conducted in Dining room; test results were negative.

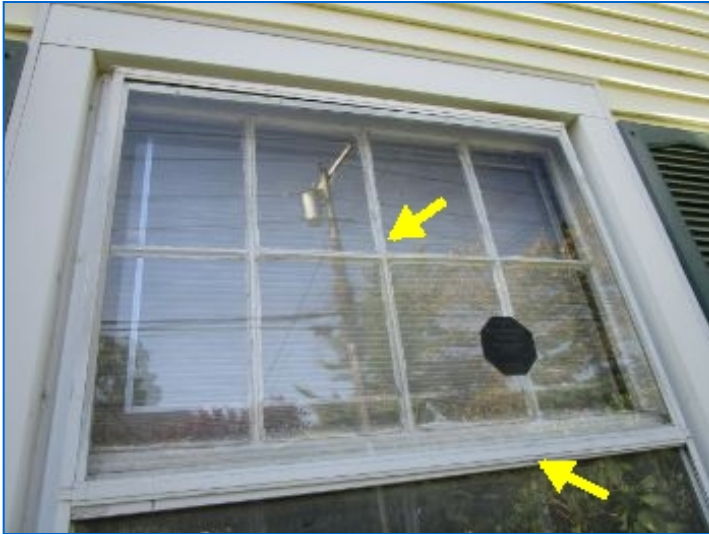
The home had the original Single pane Wood frame windows. Aluminum framed triple-track storm windows noted.

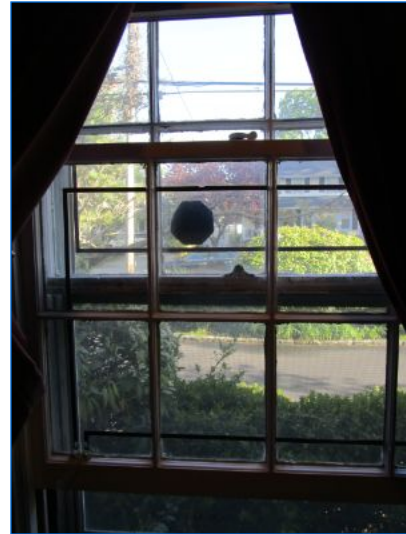
The home had the original Single pane Wood frame windows. Aluminum framed triple-track storm windows noted.

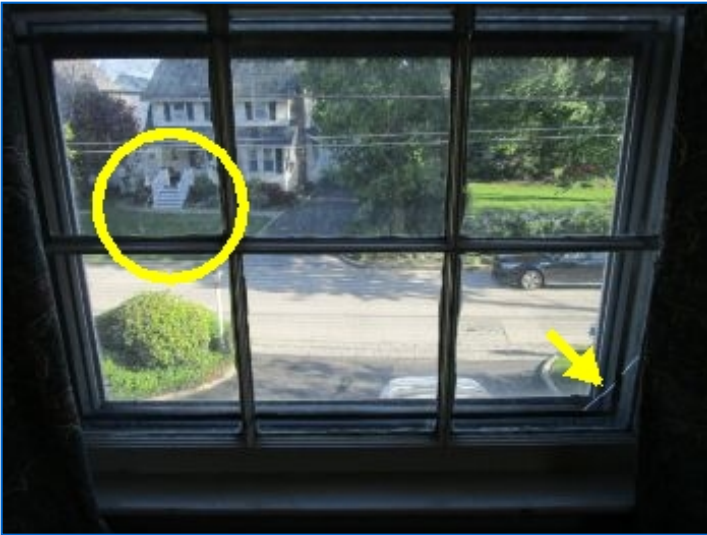
A window in the Office had cracked panes. Repair to prevent injury.

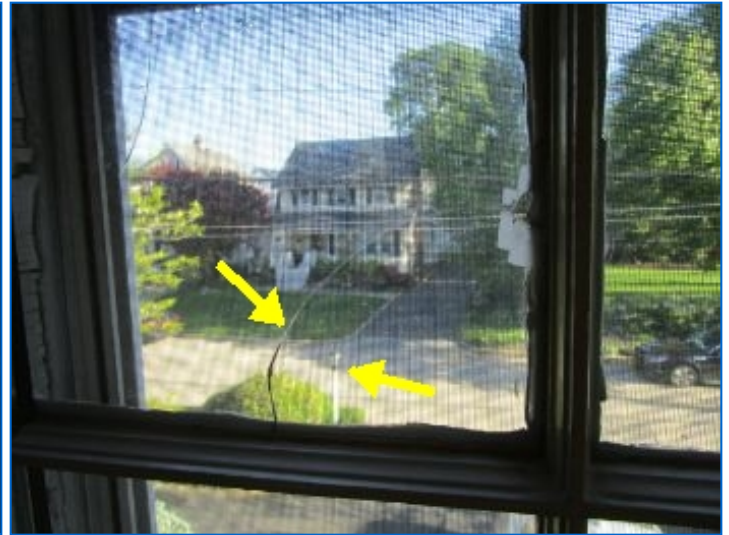
A window in the Office had cracked panes. Repair to prevent injury.

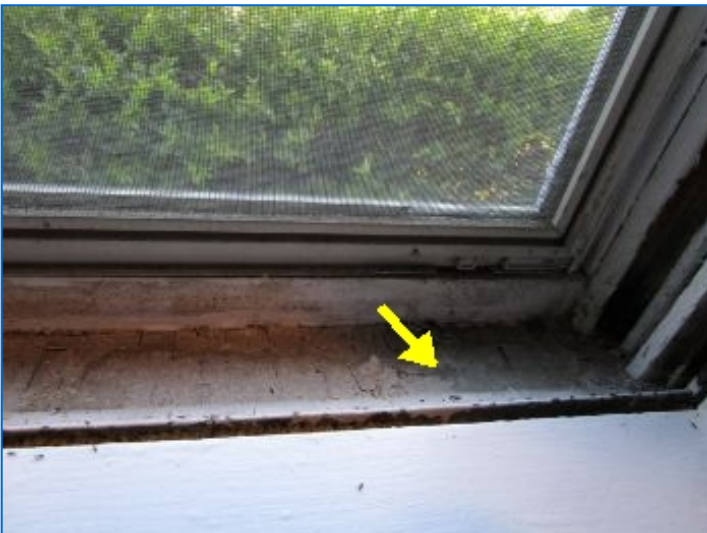
Window sills at original wood frame windows had peeling paint and are in need of maintenance. The Inspector recommends service by a qualified painting contractor.

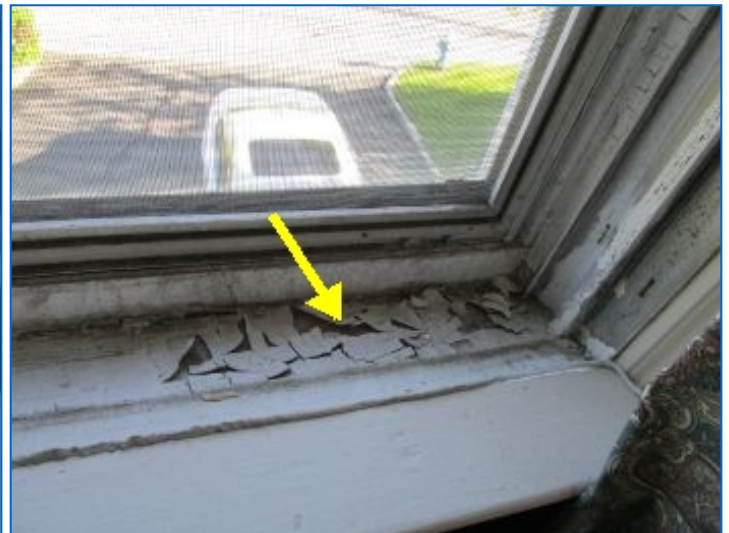
A window jamb in the Office had peeling paint and needed maintenance. The Inspector recommends service by a qualified painting contractor.
