# ProSpec Home Inspection of Long Island Property Inspection Report

154 Combs Ave, Woodmere, NY 11598  
Inspection prepared for: Name Deleted Date  
of Inspection: 5/21/2019 Time: 4:30 PM  
Age of Home: 73 yrs old Weather: Sunny,  
73degF Approx. Year Built: 1946

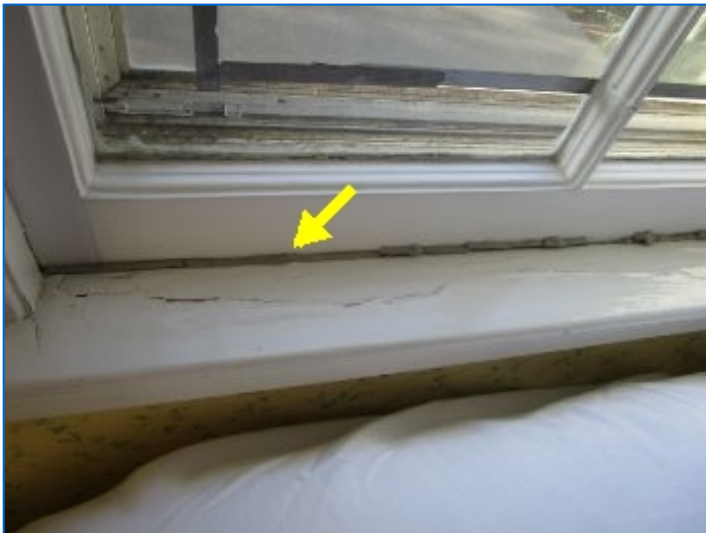
One window was caulked shut; inoperable; recommend bedroom window repair or replacement by a qualified contractor.

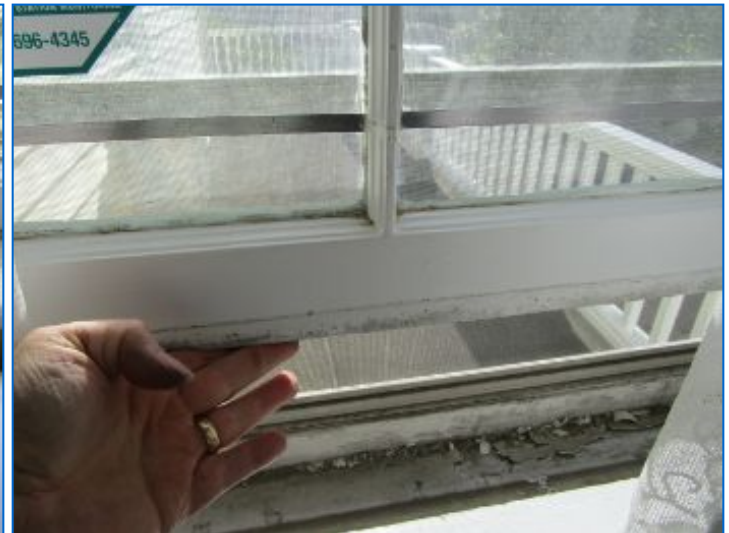
The lower sash of a double-hung window would not stay up when lifted and released; recommend bedroom window repair or replacement by a qualified contractor.

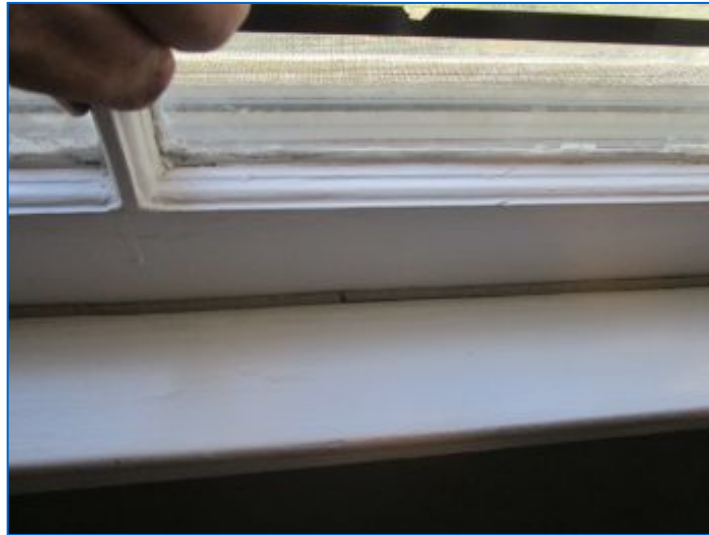
One window was caulked shut; inoperable; recommend bedroom window repair or replacement by a qualified contractor.

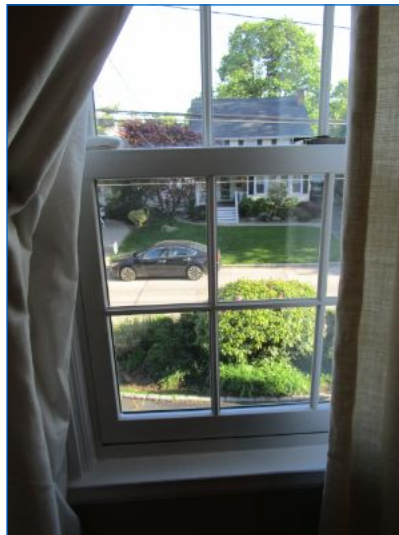
Newer insulated vinyl frame double-hung windows noted.

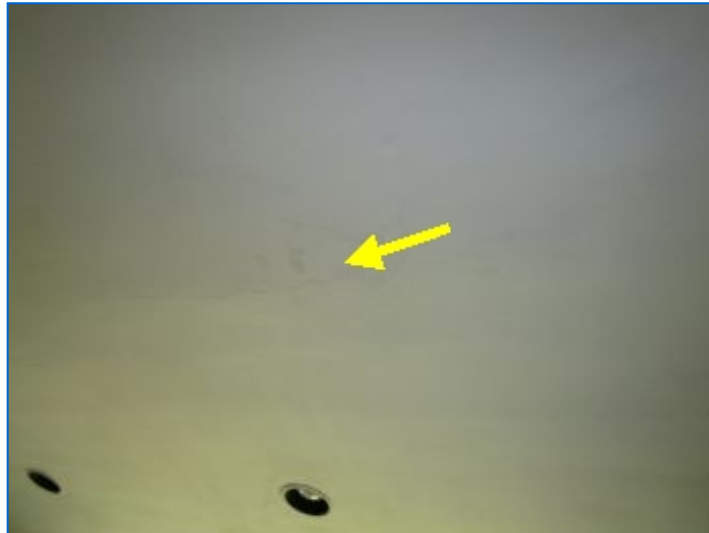
Den ceiling showed signs of a past roof leak. Recommend seller address possibility of water leakage at flat roof in this vicinity.

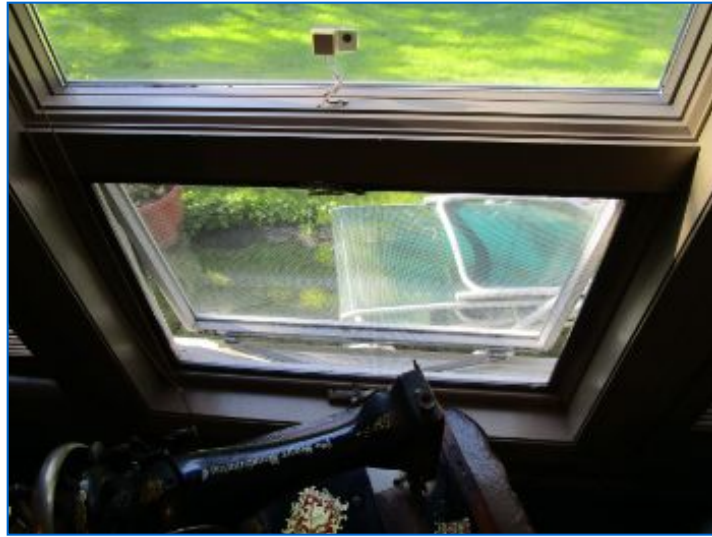
Wood framed awning windows noted in the Den.

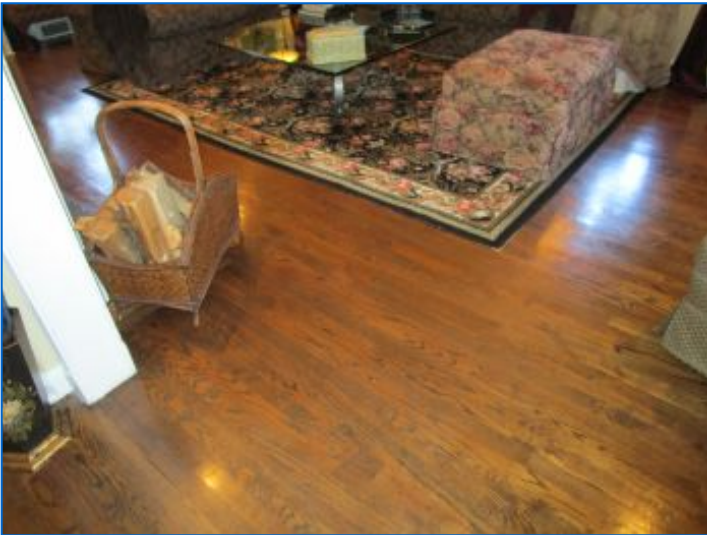
Moderate wear was noted.

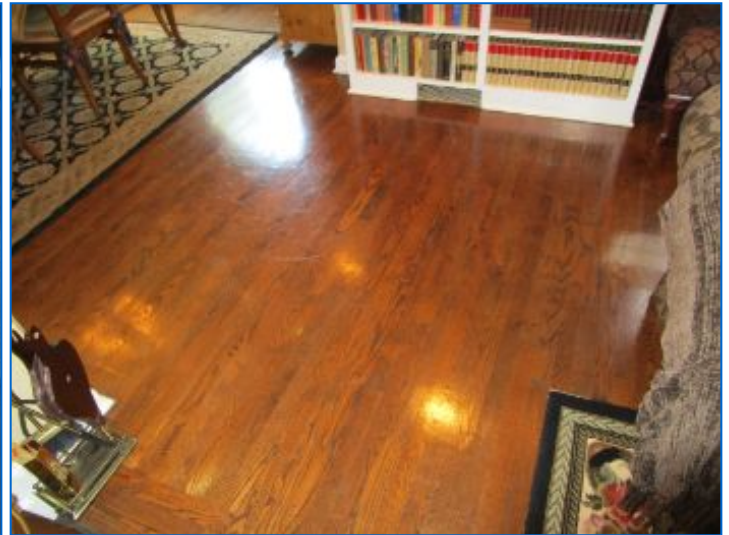
Solid hardwood floor noted.

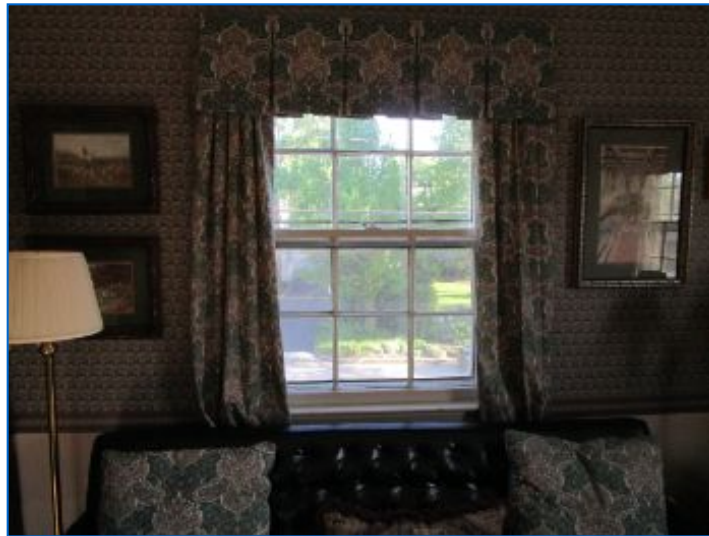
Refer to Window Glazing section.

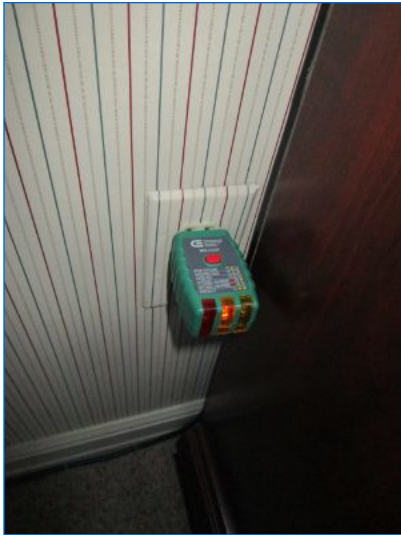
Open ground receptacle noted.

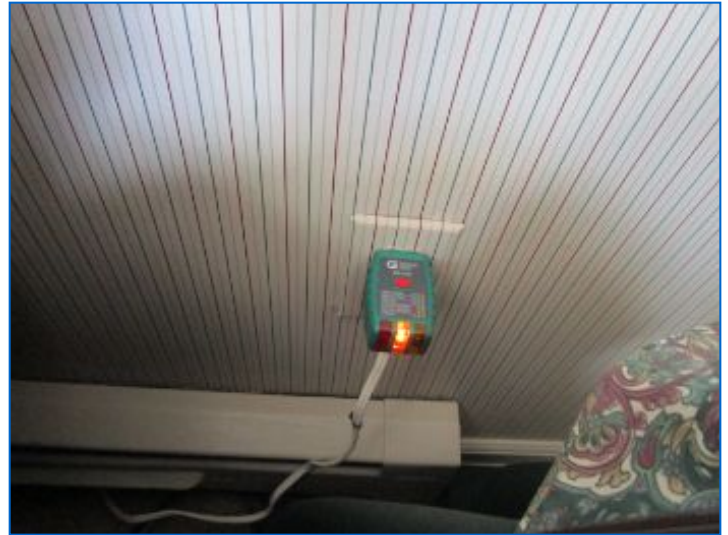
Open ground receptacle noted.

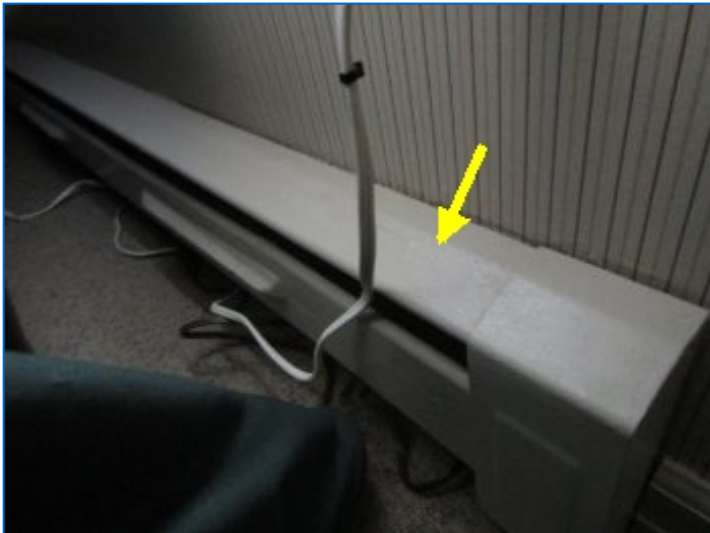
Defunct length of baseboard heating noted in office. Office heating is via ducted HVAC#2 system

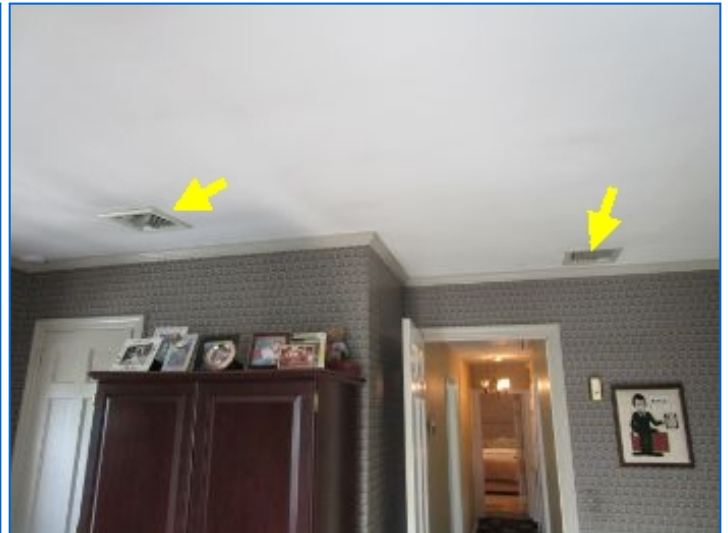
Office heating is via ducted HVAC#2 system

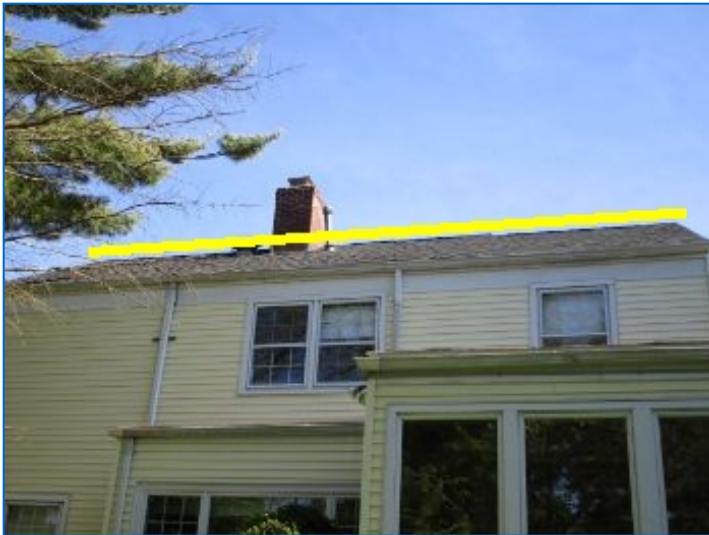
Roof ridge beam appeared straight and even overall.

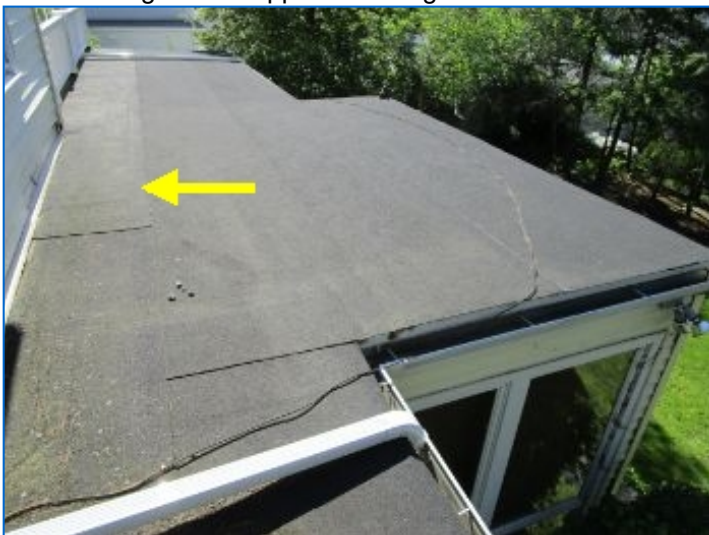
Flat roof, asphalt rolled roof noted (vicinity of Den). Additional layer and/or seam noted here. Refer to Den ceiling section.

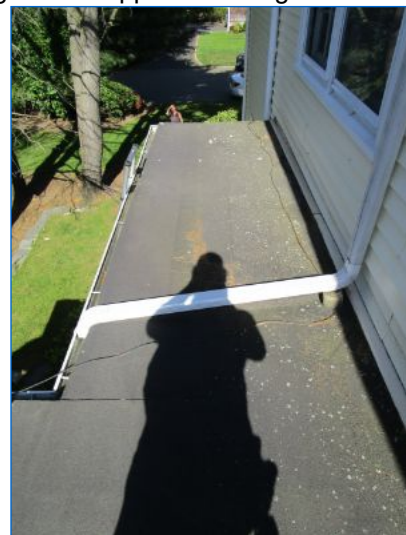
Flat roof, asphalt rolled roof noted.

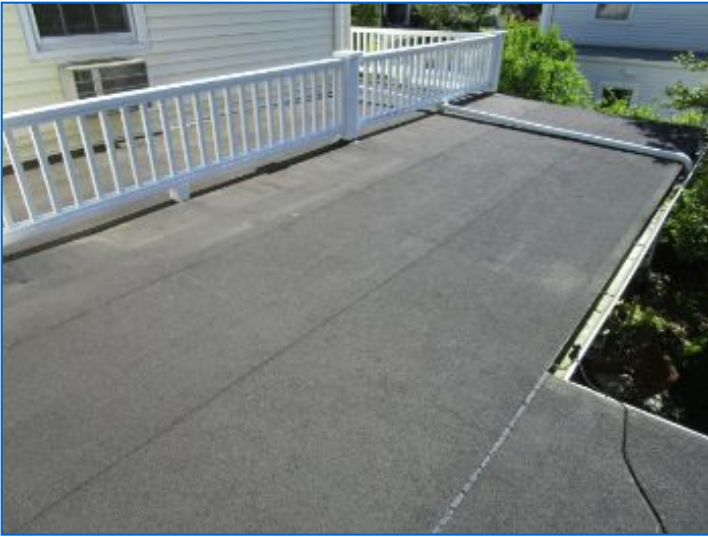
Flat asphalt roof covering showed conditions consistent with 10+ yr old roll roofing.

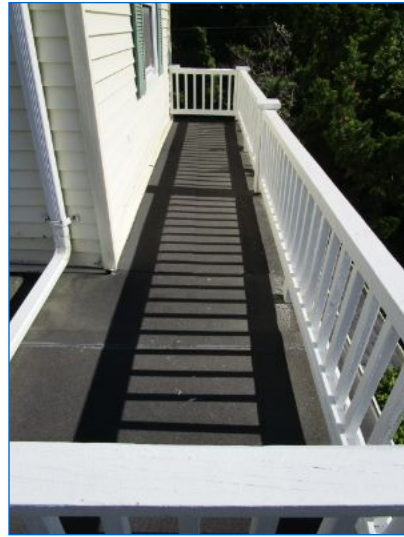
Flat roof, asphalt rolled roof noted.

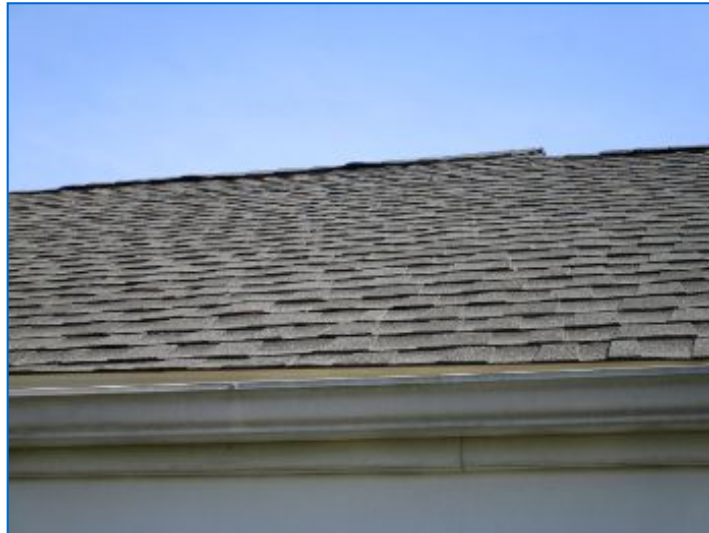
Top asphalt architectural shingle roof covering showed conditions consistent with < 1 yr old shingles. Confer with seller about transferring the installer and manufacturer warranties.

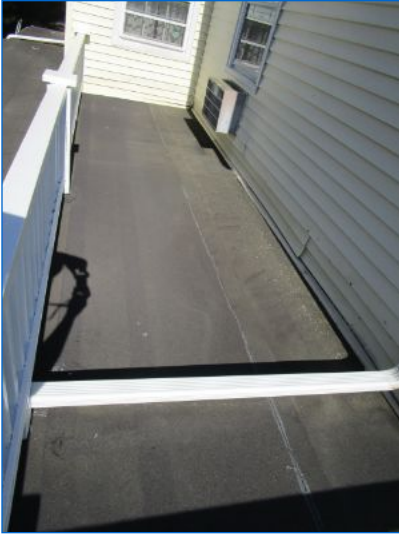
Flat asphalt roof covering showed conditions consistent with 10+ yr old roll roofing.

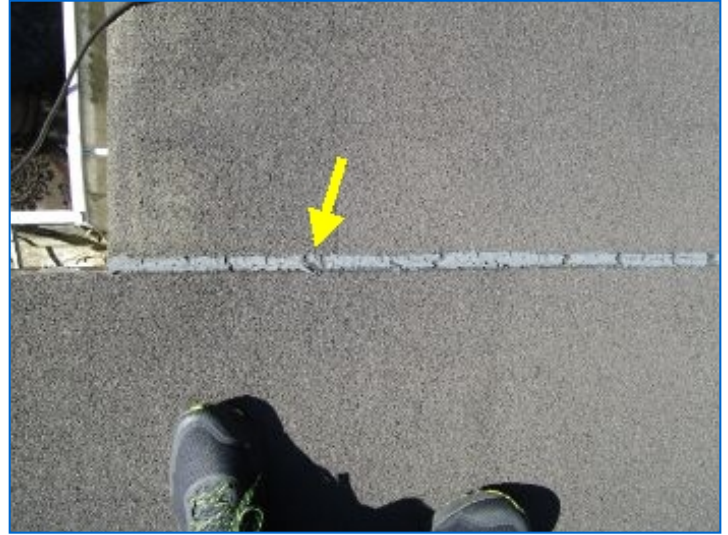
Mastic sealant along roof seam appeared to be in need of maintenance. Recommend hiring a qualified licensed roofing contractor to review and provide the necessary maintenance. Inspecting and re-sealing seams in roofing is a part of routine maintenance to prevent water entry.

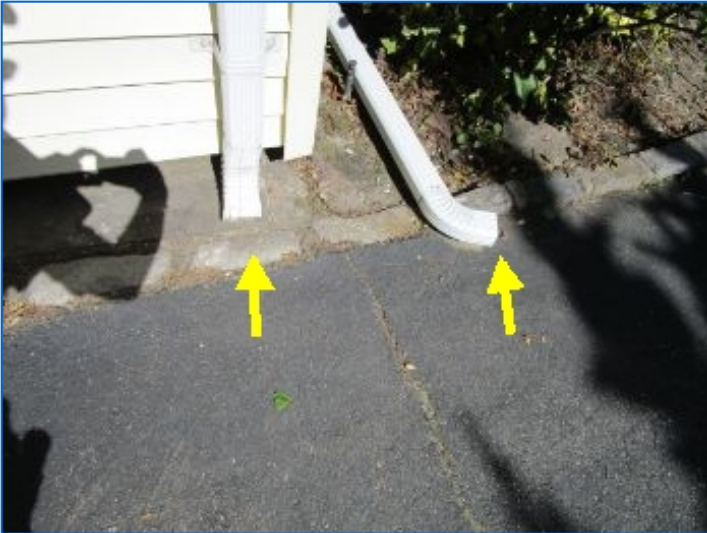
Downspout drains onto walkway/driveway. Recommend exploring ways to divert water away from this area, or at the very least, recognize this as a potential ice hazard; use ice melt products and exercise caution.

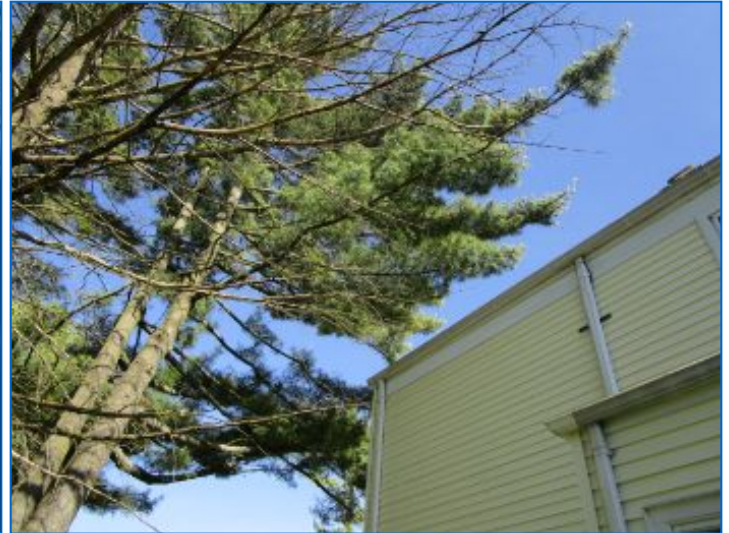
**MAINTENANCE:** Keep gutters cleared of organic debris to prevent downspouts from being clogged, causing overflow and ice damming at gutters; ensure that all downspouts have extensions to carry water away from the foundation.

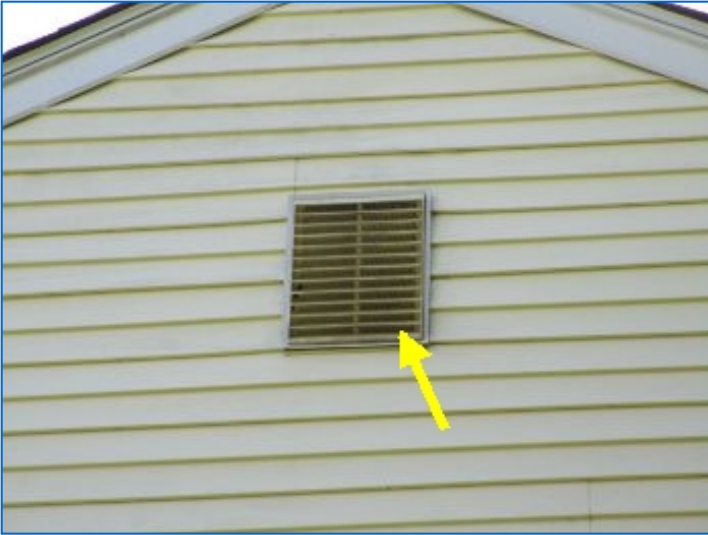
Gable-end louver vent(s) noted for attic ventilation.

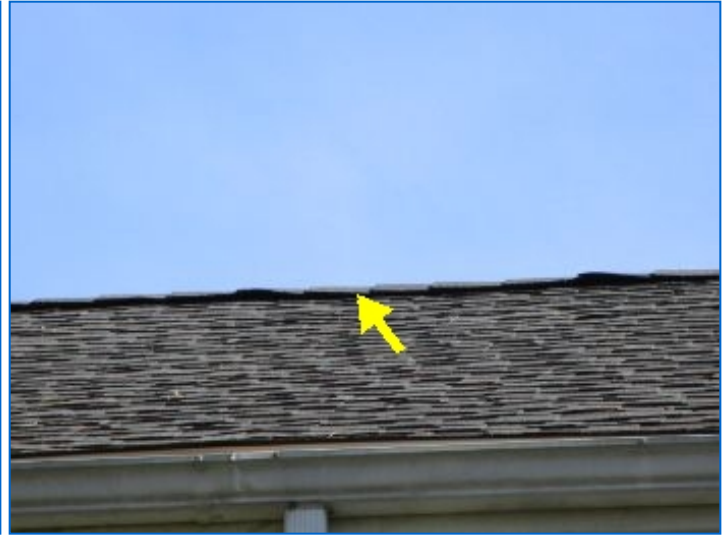
Upper roof ridge exhaust venting noted for attic ventilation.

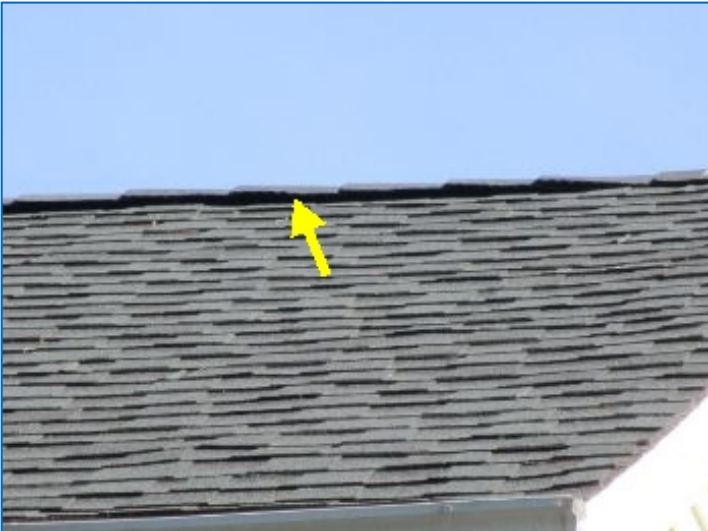
Lower roof ridge exhaust venting noted for attic ventilation.

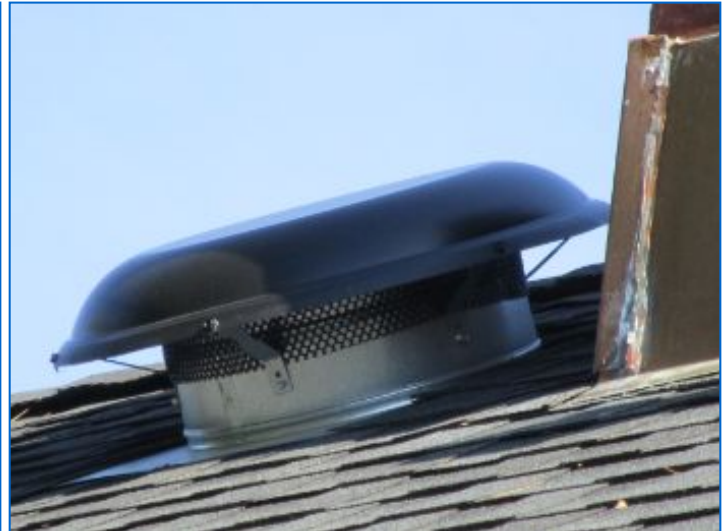
Power Ventilator noted for attic ventilation.

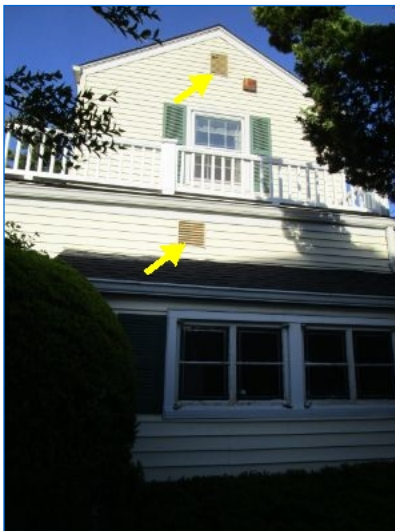
Gable-end louver vent(s) noted for attic ventilation at west exposure.

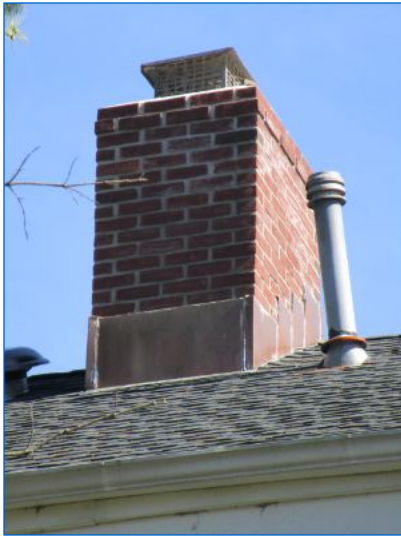
At the time of the inspection, the Inspector observed no deficiencies in the condition of the portions of the chimney visible from the ground.

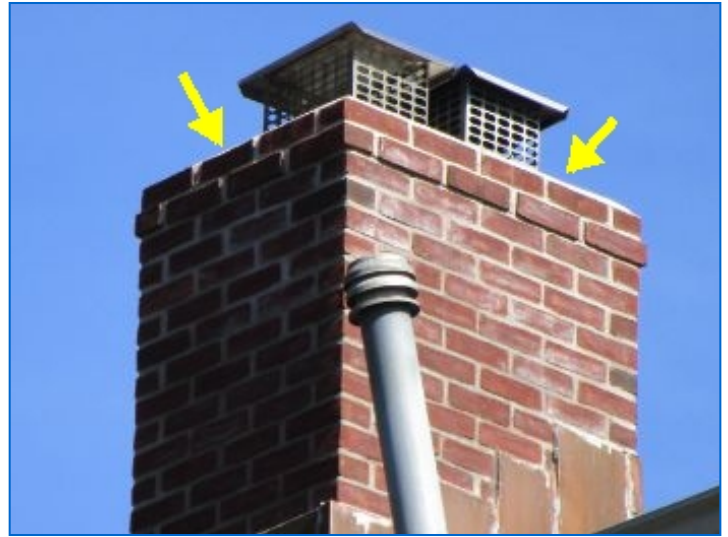
**LIMITATION:** Chimney crown cement not visible from inspection level. Suggest chimney contractor inspect further to ensure there's no water intrusion here.

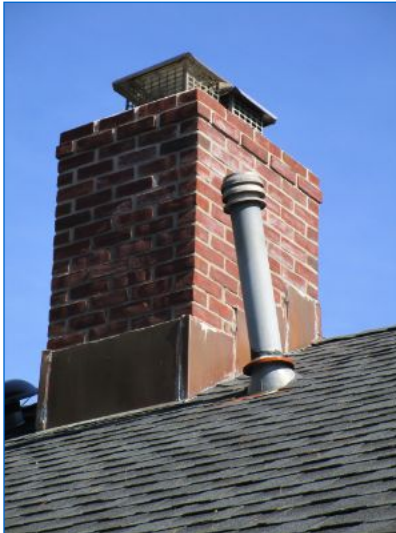
At the time of the inspection, the Inspector observed no deficiencies in the condition of the portions of the chimney visible from the ground.

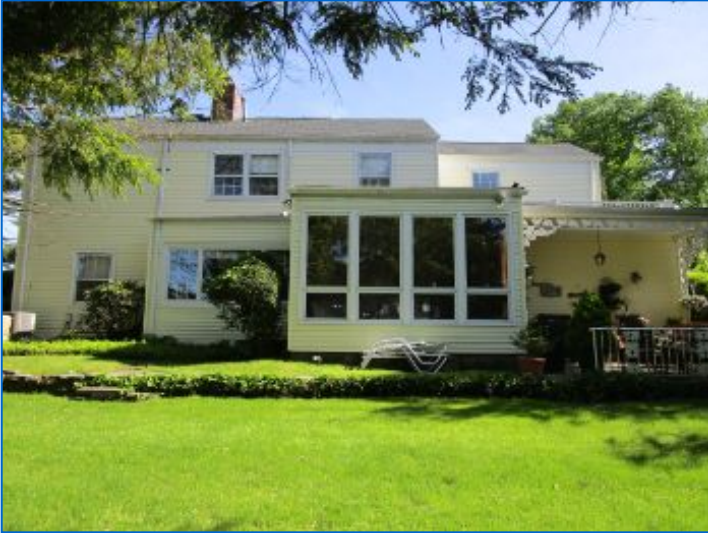
EXTERIOR North Exterior

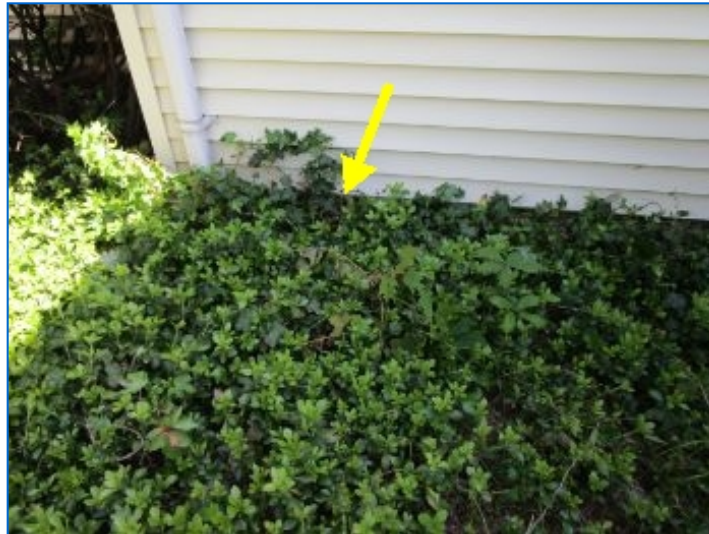
Some defects may be hidden behind dense foliage and cannot be included with this inspection.

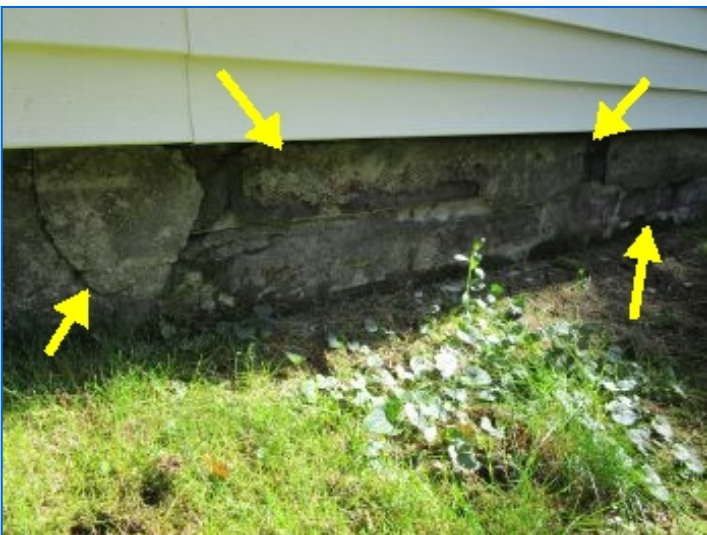
Parge Coat at foundation wall was cracked and flaking off at Rear exposure. Recommend hiring a qualified professional to repair/replace damaged parging to prevent further freeze/thaw damage.

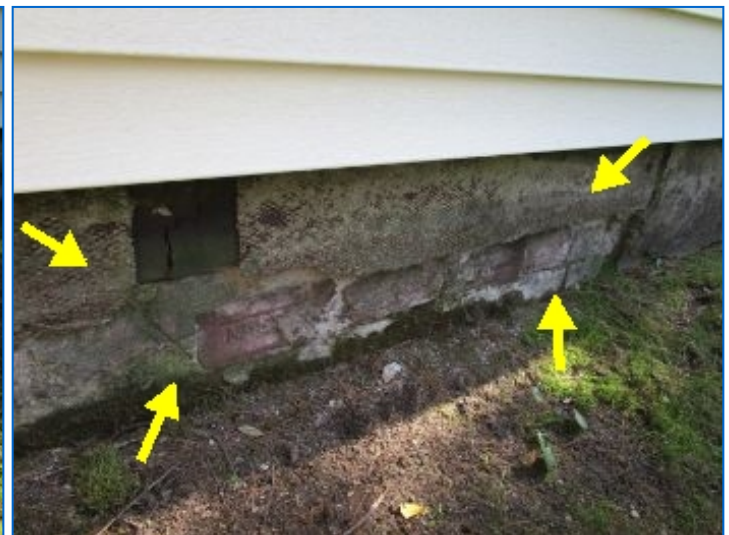
Parge Coat at foundation wall was cracked and flaking off at Rear exposure. Recommend hiring a qualified professional to repair/replace damaged parging to prevent further freeze/thaw damage.

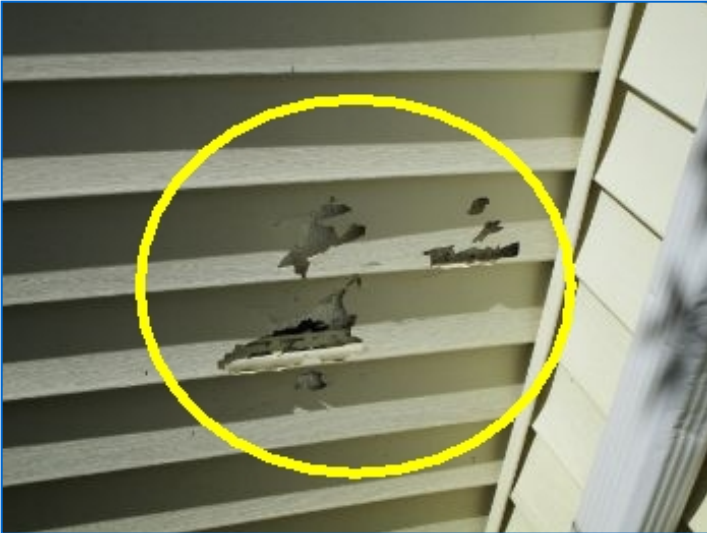
Cosmetic damage/s noted at Front siding by an unknown cause. Repair and seal all openings in siding to prevent water intrusion into the structure.

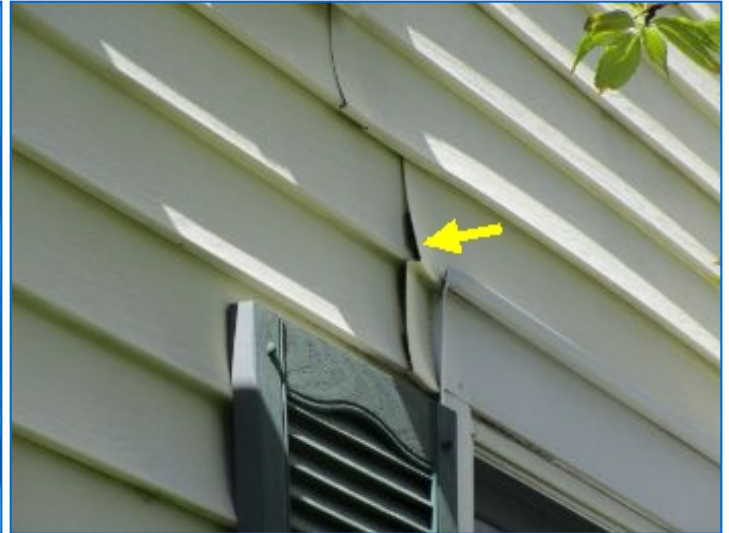
Irregular seam noted at front siding. Repair siding seam to prevent water intrusion into the structure.

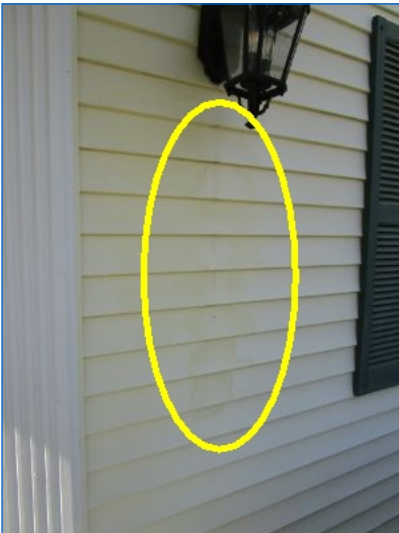
Cosmetic damage/discoloration noted at Front, perhaps caused by cleaning chemical.

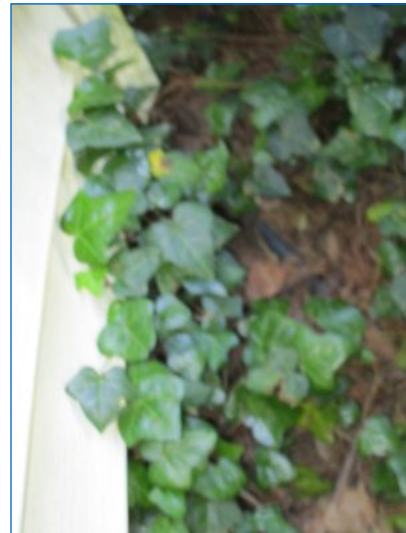
Ivy can grow aggressively; attracts insects and can damage siding and trim; suggest removing ivy that is in close proximity to the home.

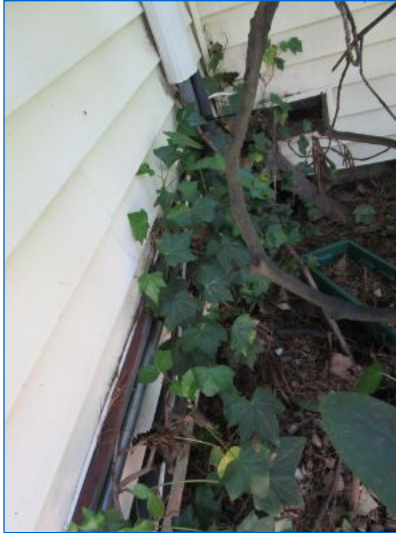
Ivy can grow aggressively; attracts insects and can damage siding and trim; suggest removing ivy that is in close proximity to the home.

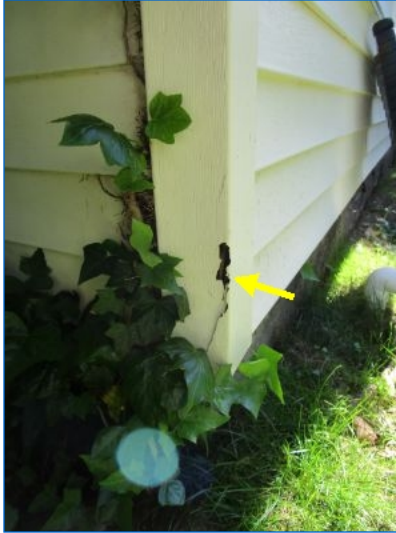
Corner trim at rear was damaged and needed repair at the time of the inspection. All work should be performed by a qualified contractor.

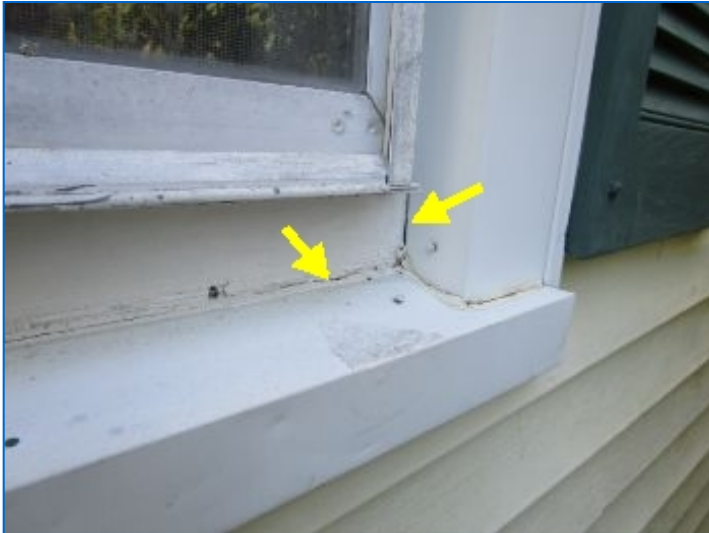
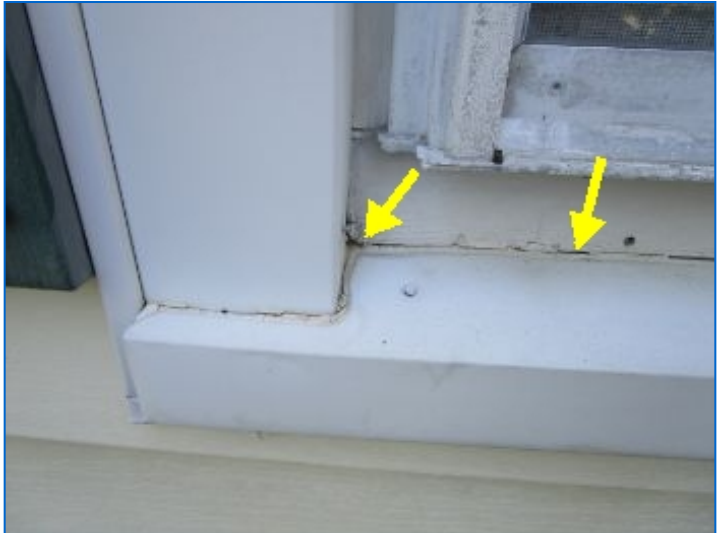
MAINTENANCE: Recommend updating caulking at windows and door frames as needed to prevent water intrusion.

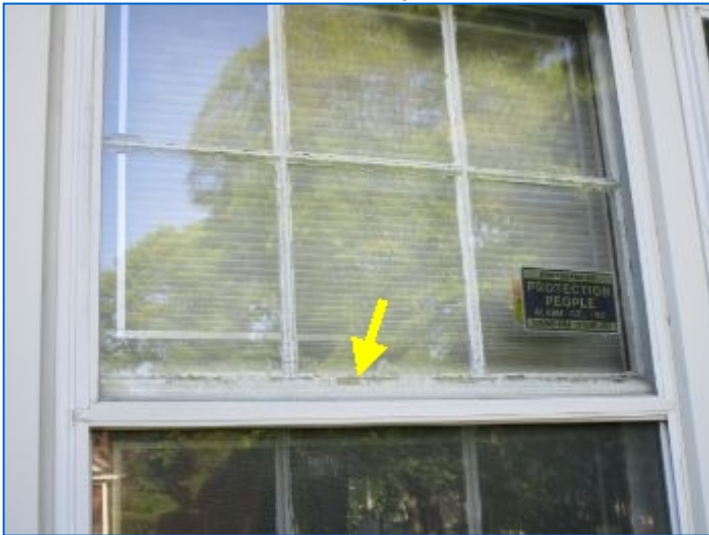
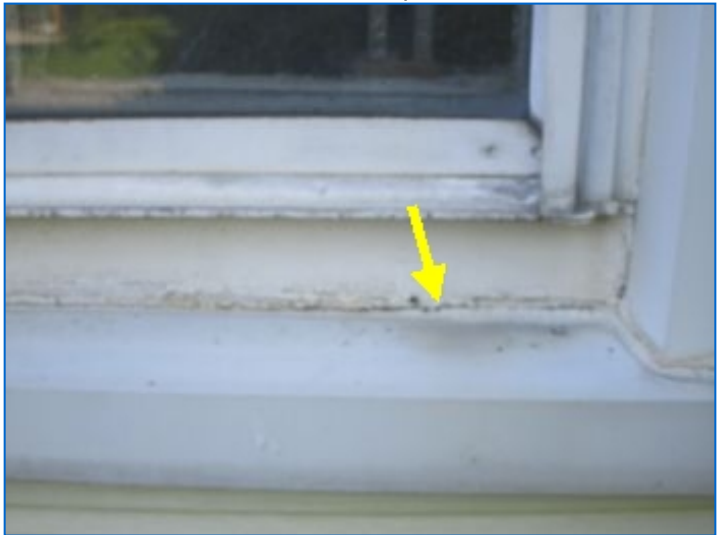
MAINTENANCE: Peeling paint observed, suggest scraping and painting as necessary.

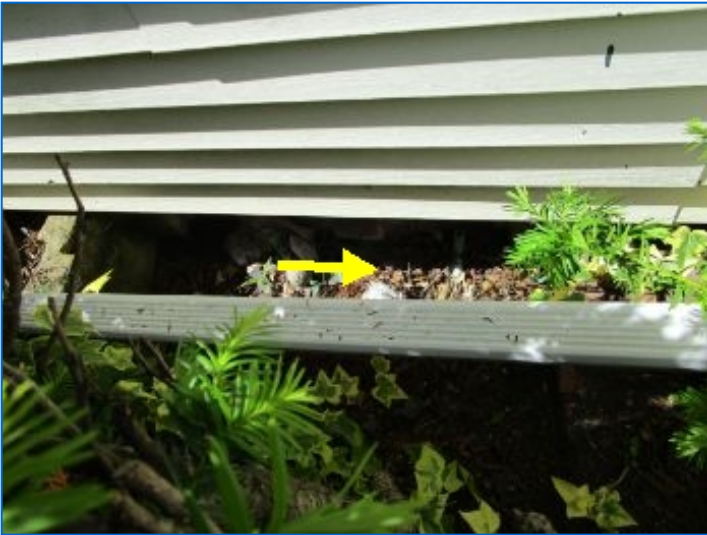
Basement window frames in contact with soil at Front exposure. Recommend regrading soil level to 6 inches below frame; repair and protect wood from further moisture damage.

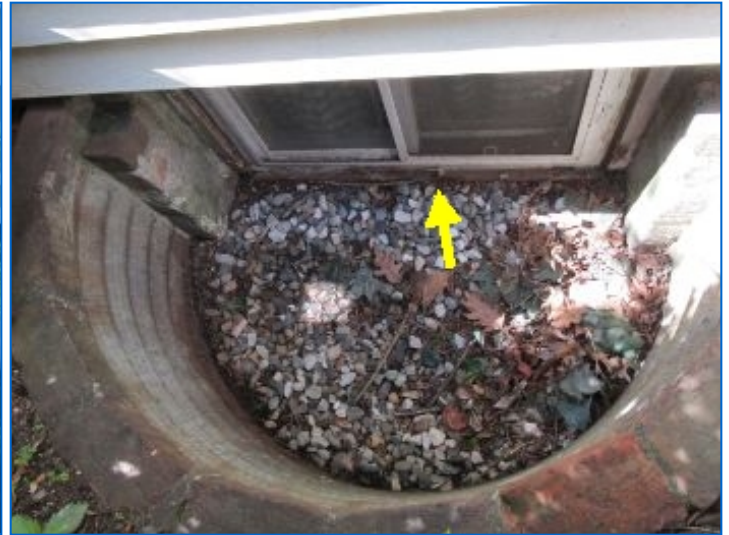
Basement window wood frames in contact with soil showed signs of moisture damage at Front exposure. Recommend regrading soil level to 6 inches below frame; repair and protect wood from further moisture damage.

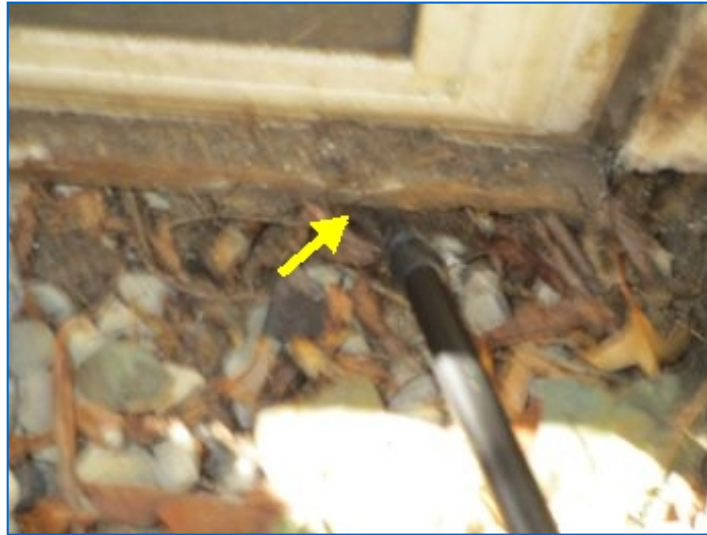
Basement window wood frames in contact with soil showed signs of moisture damage at Front exposure. Recommend regrading soil level to 6 inches below frame; repair and protect wood from further moisture damage.

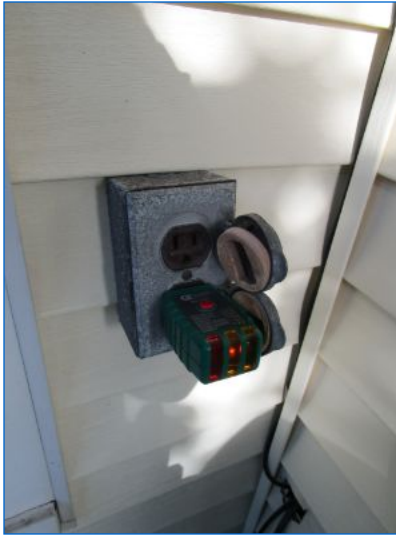
Receptacle not GFCI protected at Outdoor patio Area. Recommend updating to GFCI protected receptacle. Refer to Electrical section.

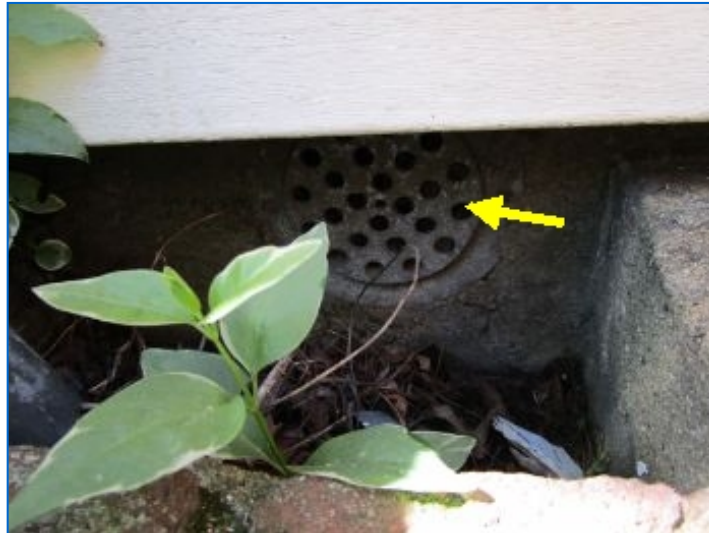
One of two plumbing vents for two waste line exits located at the front of the home.

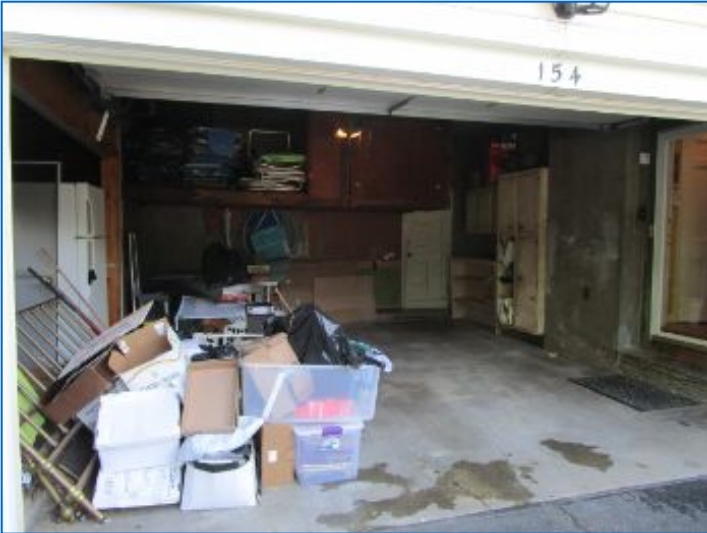
GARAGE General Conditions

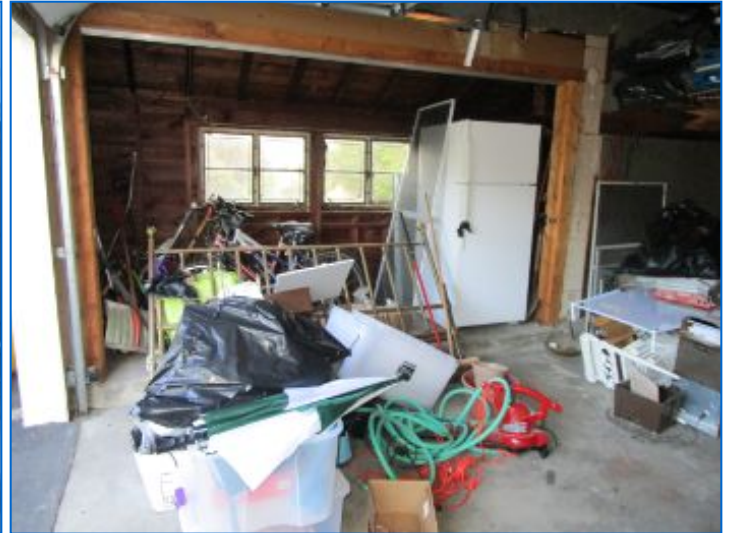
GARAGE General Conditions

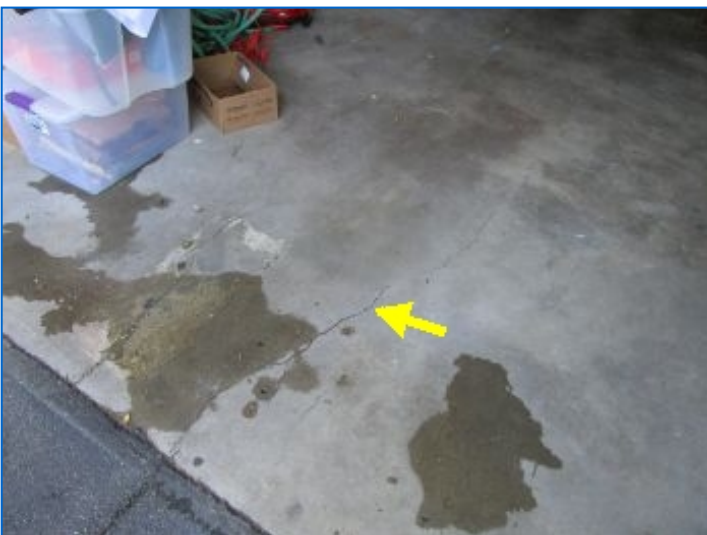
The garage floor had common settlement type cracks. These cracks are not a structural concern.

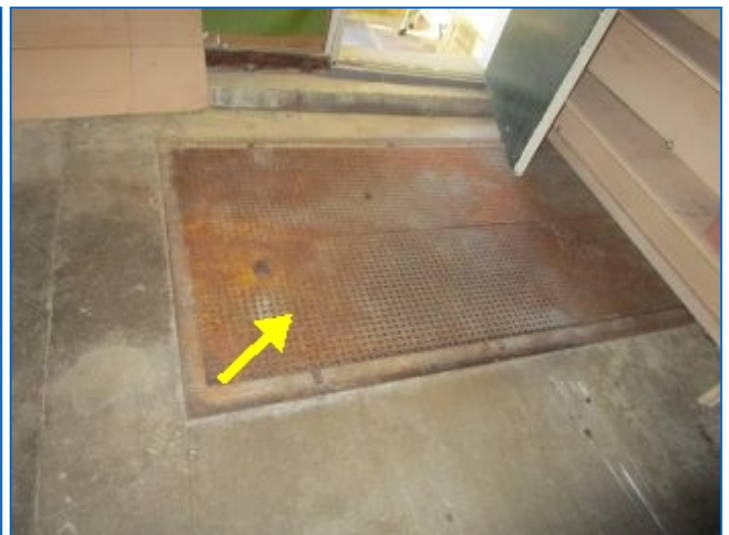
Steel plate floor hatch in garage to basement.

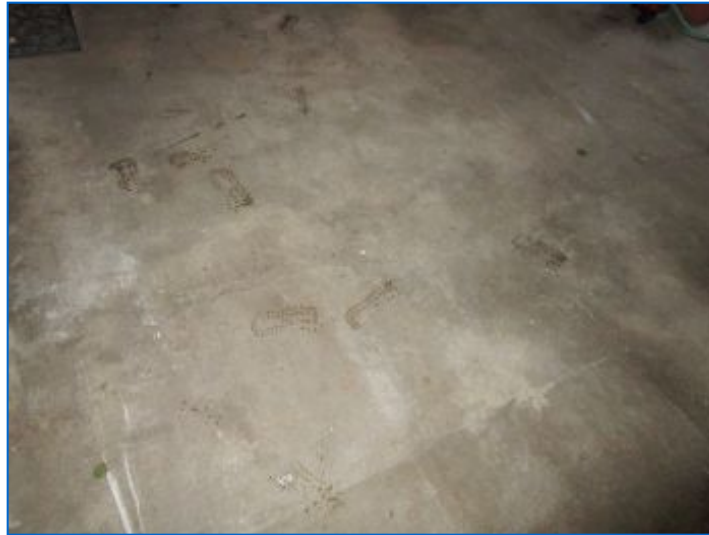
The garage floor had common settlement type cracks (thin line). These cracks are not a structural concern.

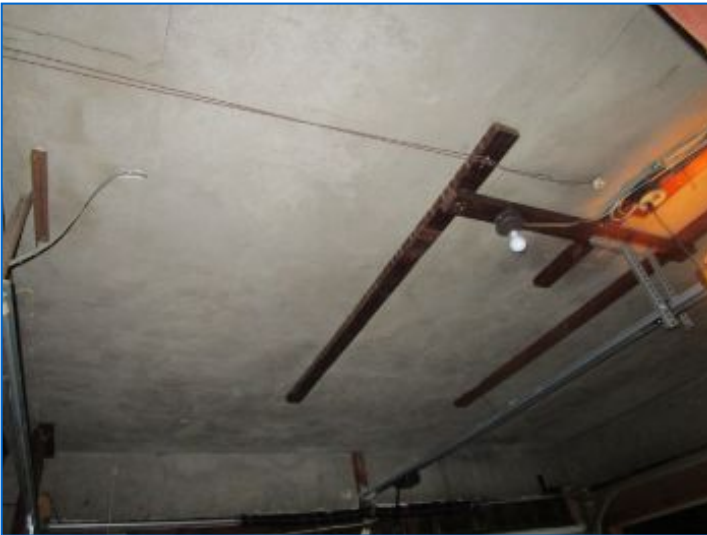
Lightweight concrete wall and ceiling finish noted.

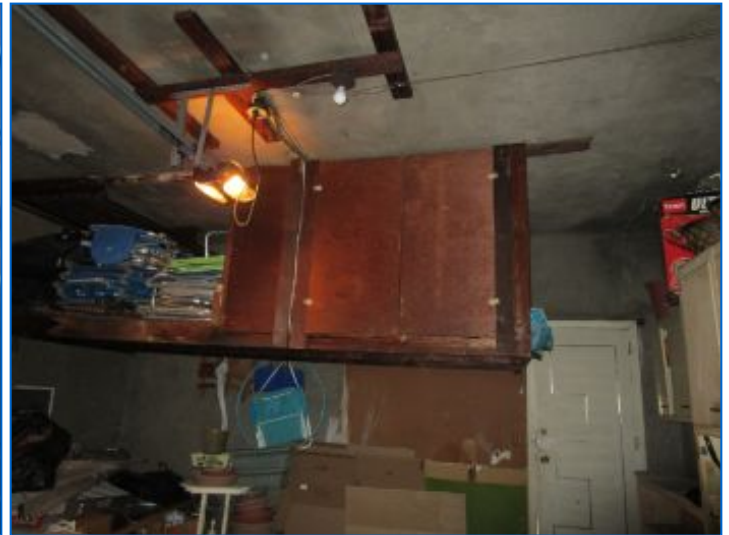
Limited review due to shelving/cabinets and stored items.

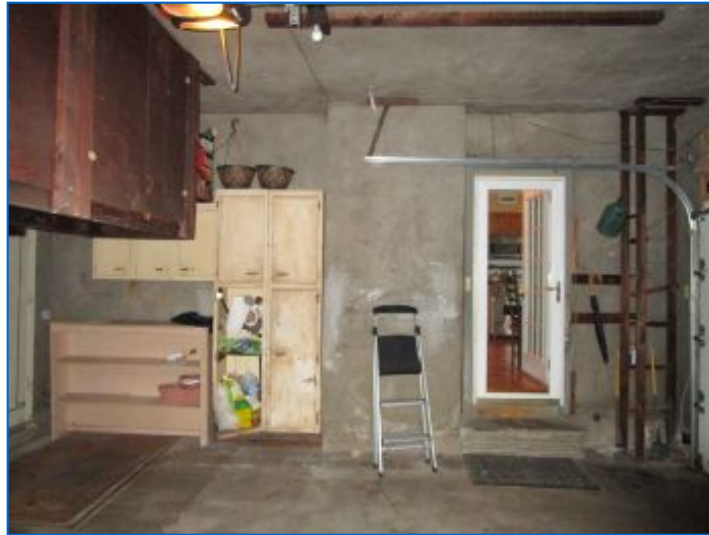
At the time of the inspection, the Inspector observed no major deficiencies in the condition of the visible garage walls and ceilings.

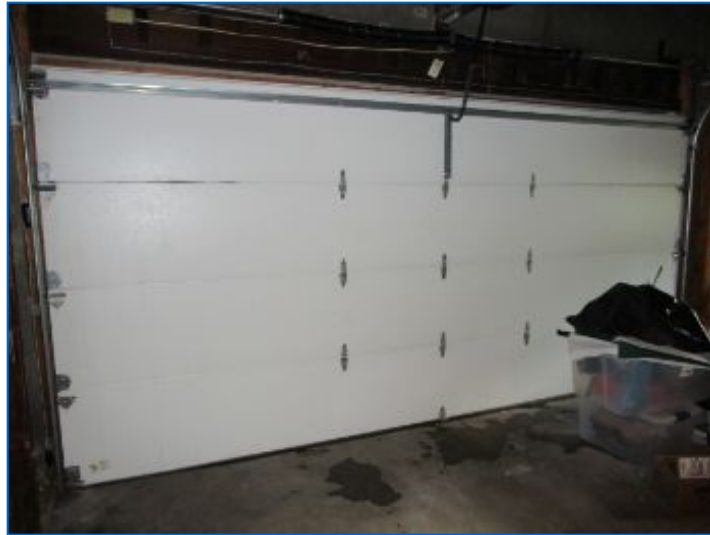
Fiberglass insulated sectional roll-up door noted. Vehicle door opener and safety reverse feature was operable.

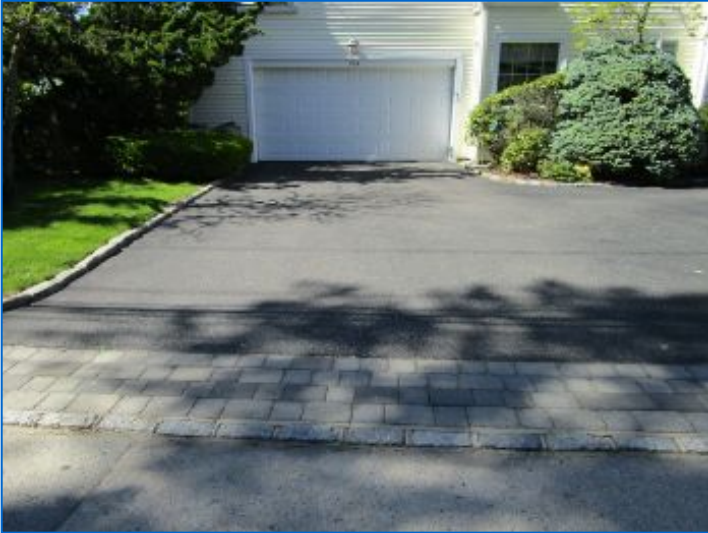
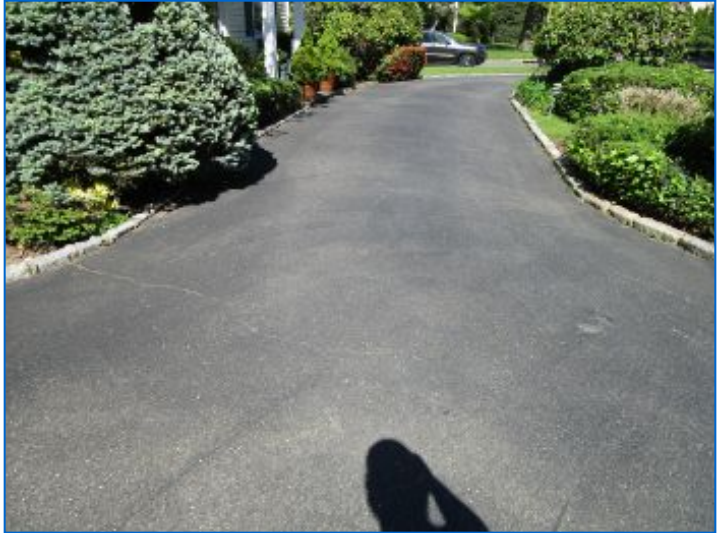
Driveway: Asphalt noted. Apron: Belgian Block noted. No major system safety or function concerns noted at time of inspection.

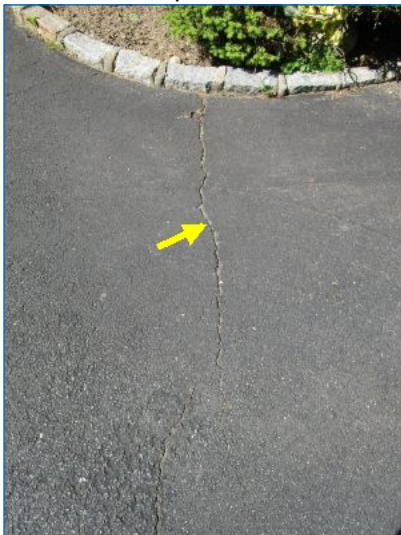
Normal cracks in asphalt driveway. Seal and/or repair cracks to prevent water entry leading to freeze-thaw damage. Monitor existing cracks for expansion.
