# ProSpec Home Inspection of Long Island Property Inspection Report

154 Combs Ave, Woodmere, NY 11598  
Inspection prepared for: Name Deleted Date  
of Inspection: 5/21/2019 Time: 4:30 PM  
Age of Home: 73 yrs old Weather: Sunny,  
73degF Approx. Year Built: 1946

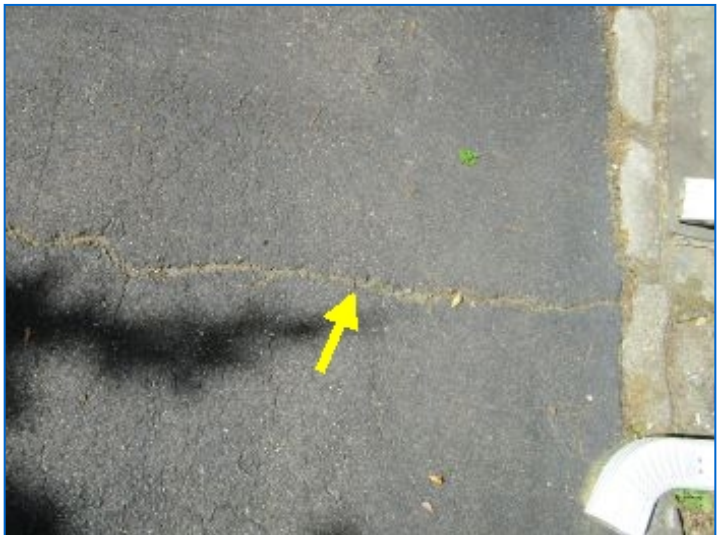
Normal cracks in asphalt driveway. Seal and/or repair cracks to prevent water entry leading to freeze-thaw damage. Monitor existing cracks for expansion.

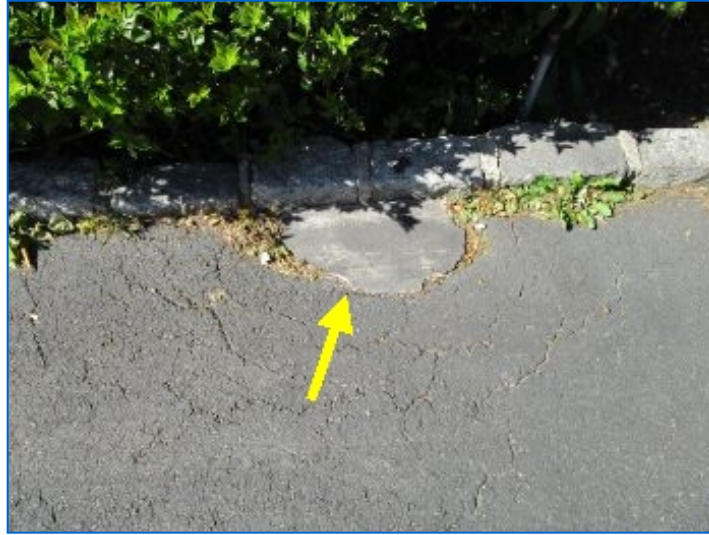
Patch repair noted in driveway.

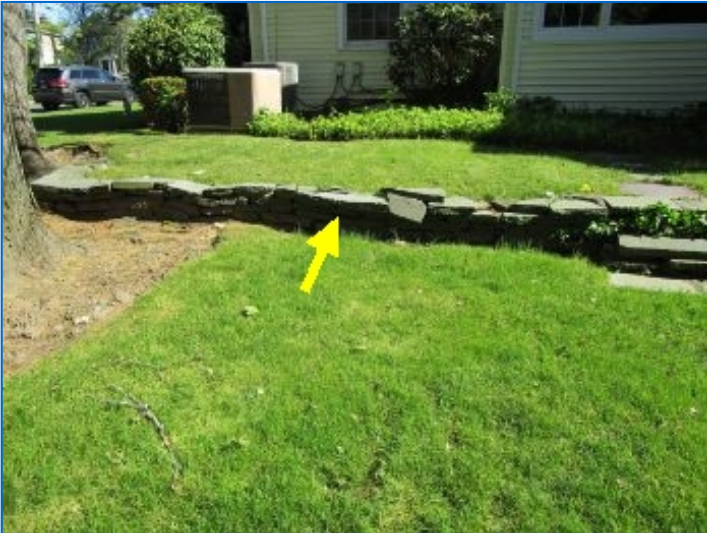
Stone retaining wall noted.

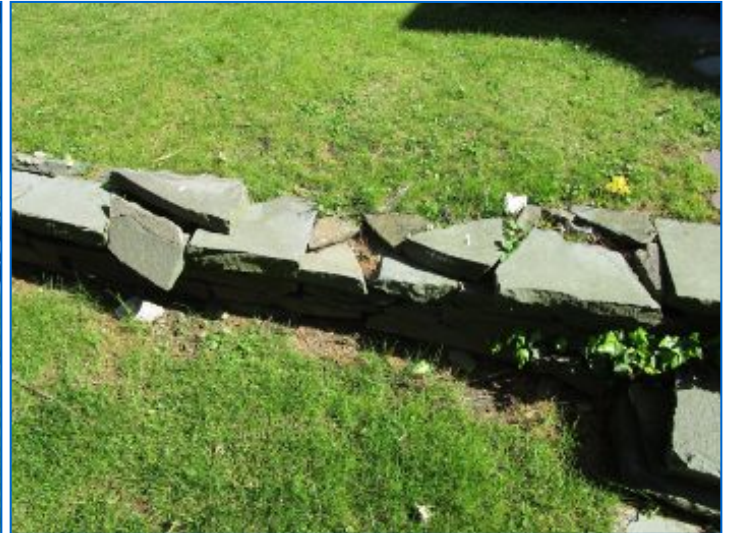
Loose stones creating trip hazards; Recommend review by a qualified professional for repair as necessary.

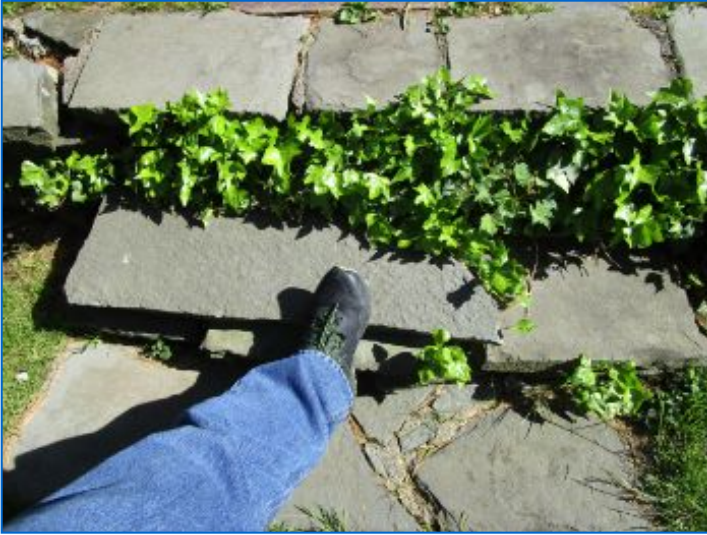
Loose stones creating trip hazards; Recommend review by a qualified professional for repair as necessary.

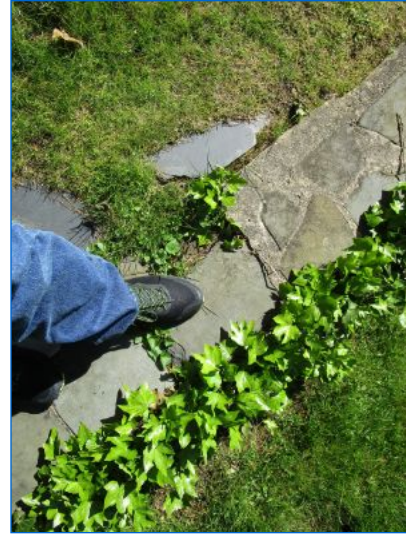
Damaged/ missing mortar observed, suggest repairs by a qualified professional.

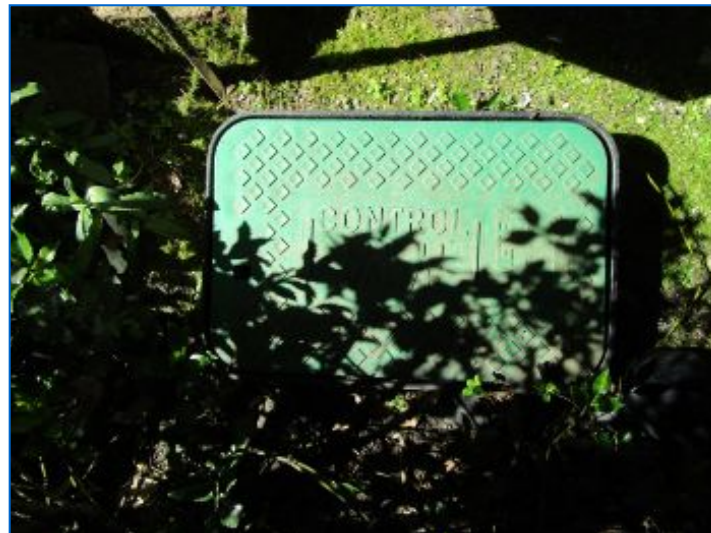
Sprinkler system noted; client is advised to seek advice of a specialist in evaluating this system before use.

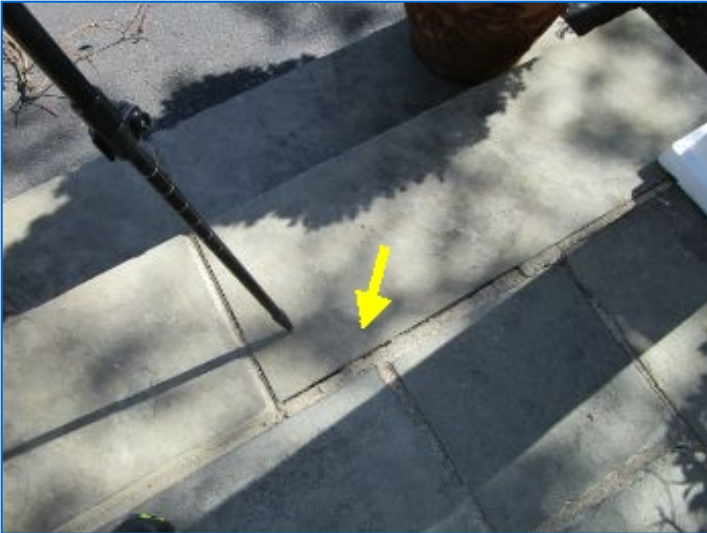
Deteriorated/cracked mortar at two Bluestone tiles at front steps; loosening tiles noted. Recommend repairs to eliminate potential trip/fall hazard.

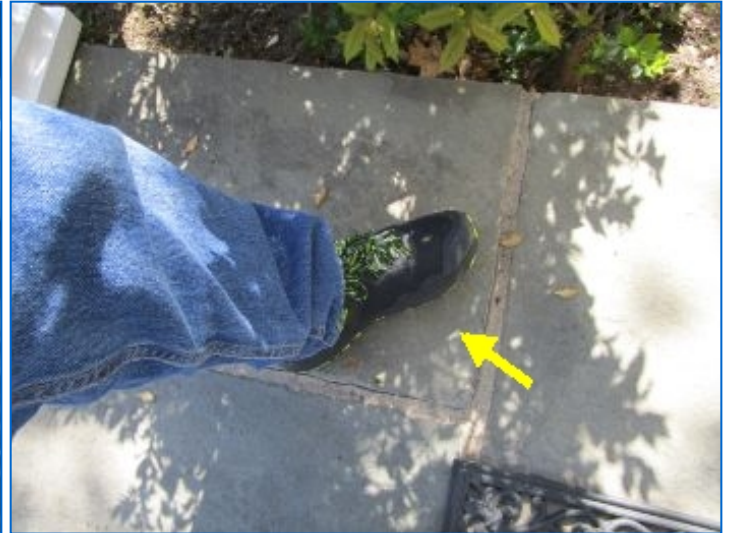
Deteriorated/cracked mortar at two Bluestone tiles at front steps/landing; loosening tiles noted. Recommend repairs to eliminate potential trip/fall hazard.

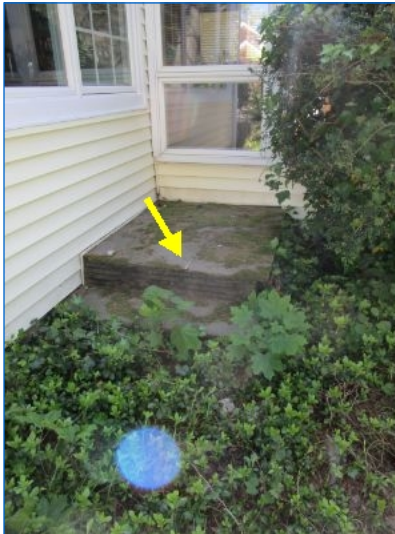
Abandoned steps noted at rear; confer with seller.

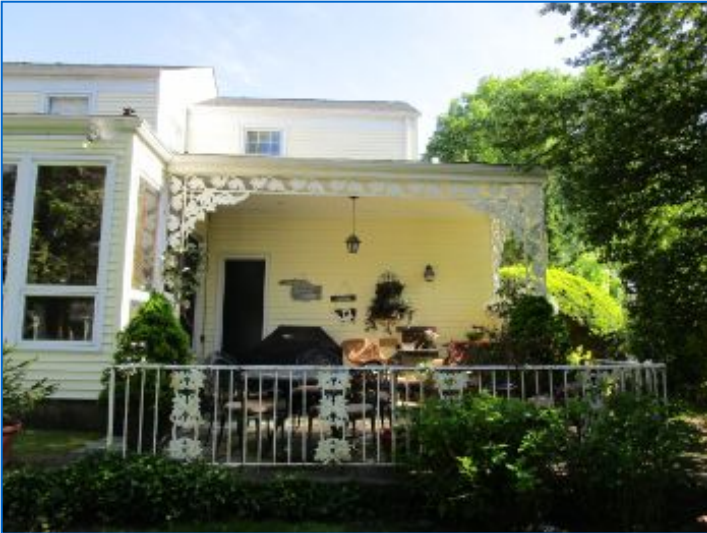
- Patio: Slate noted. • Wrought iron **handrail** was supportive, however showed signs of corrosion; Recommend stripping; apply a rust inhibitor type coating and repaint.
- Some cracking of mortar joints; some loosening of slates noted; Repair to avoid potential trip hazard.

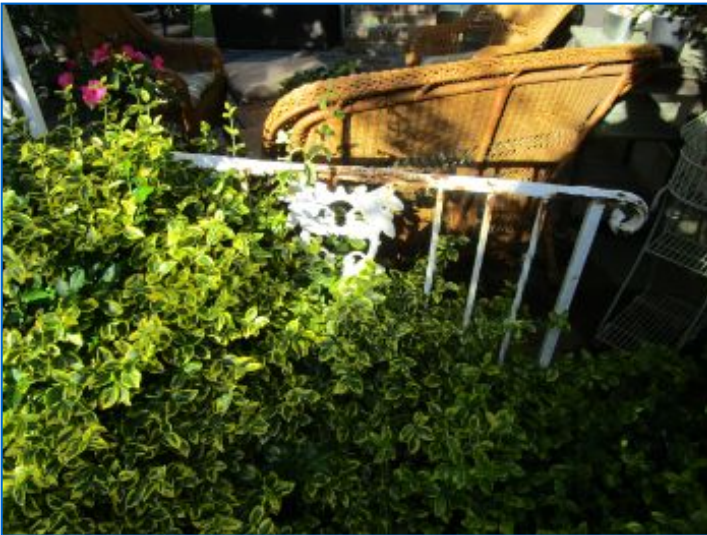
Wrought iron was supportive, however showed signs of corrosion; Recommend stripping; apply a rust inhibitor type coating and repaint.

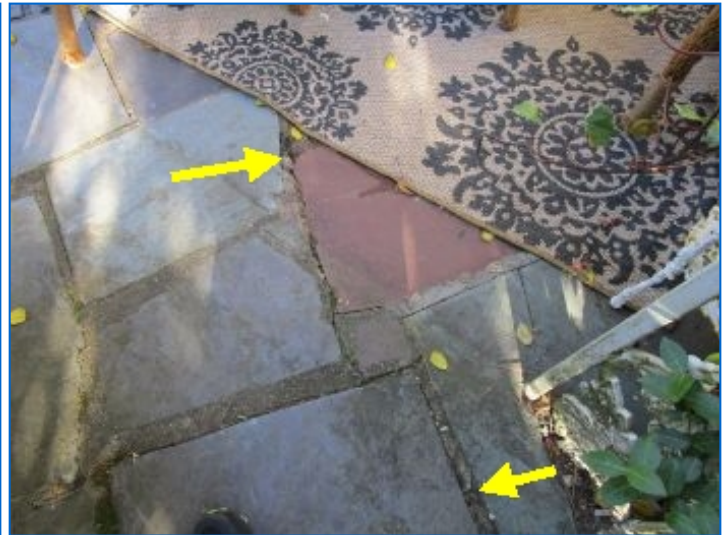
Some cracking of mortar joints; some loosening of slates noted; Repair to avoid potential trip hazard.

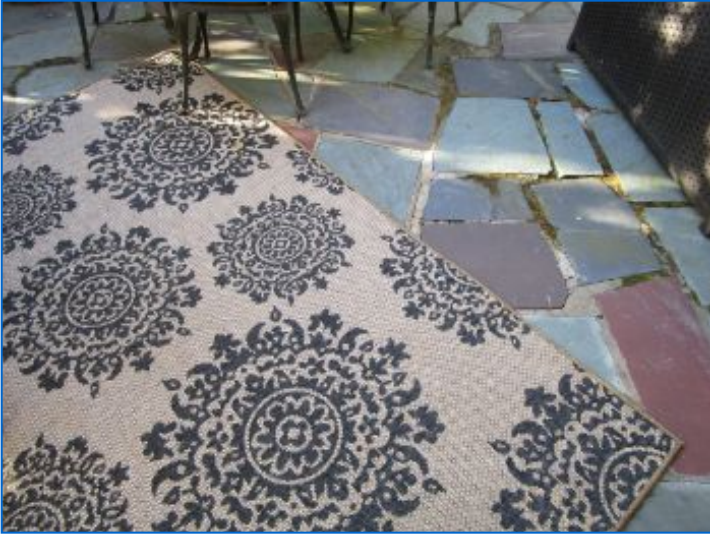
Some cracking of mortar joints; some loosening of slates under carpet noted; Repair to avoid potential trip hazard.

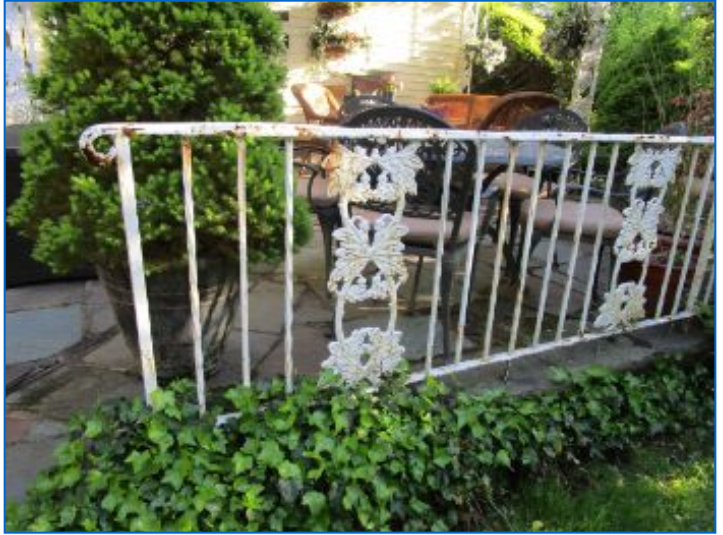
Wrought iron handrail was supportive, however showed signs of corrosion; Recommend stripping; apply a rust inhibitor type coating and repaint.

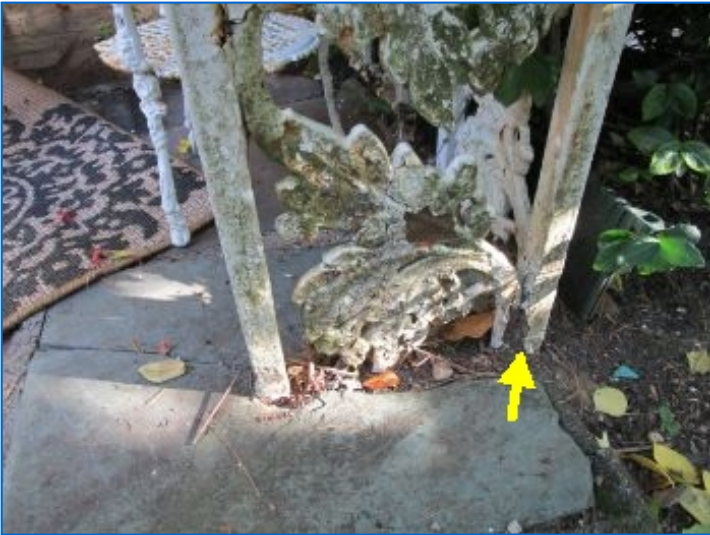
Wrought iron decorative type roof supports showed signs of corrosion where in contact with soil; Recommend removing soil from these areas around supports; repair where necessary; apply a rust inhibitor type coating and repaint.

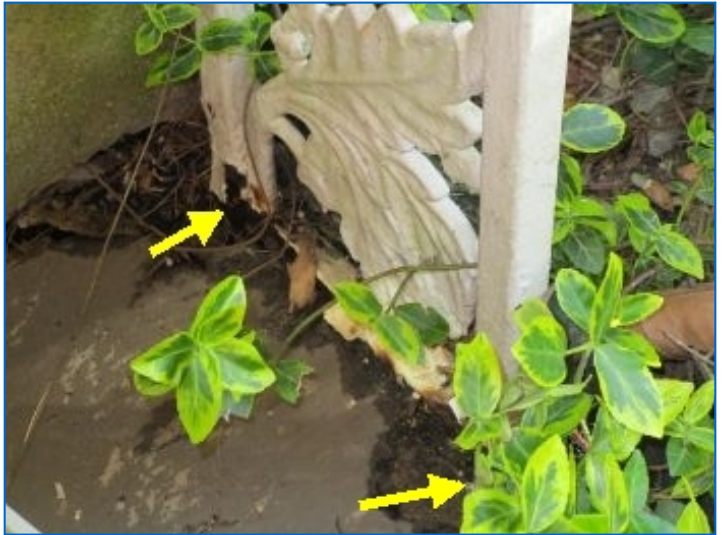
Wrought iron decorative type roof supports showed signs of corrosion where in contact with soil; Recommend removing soil from these areas around supports; repair where necessary; strip and apply a rust inhibitor type coating and repaint.

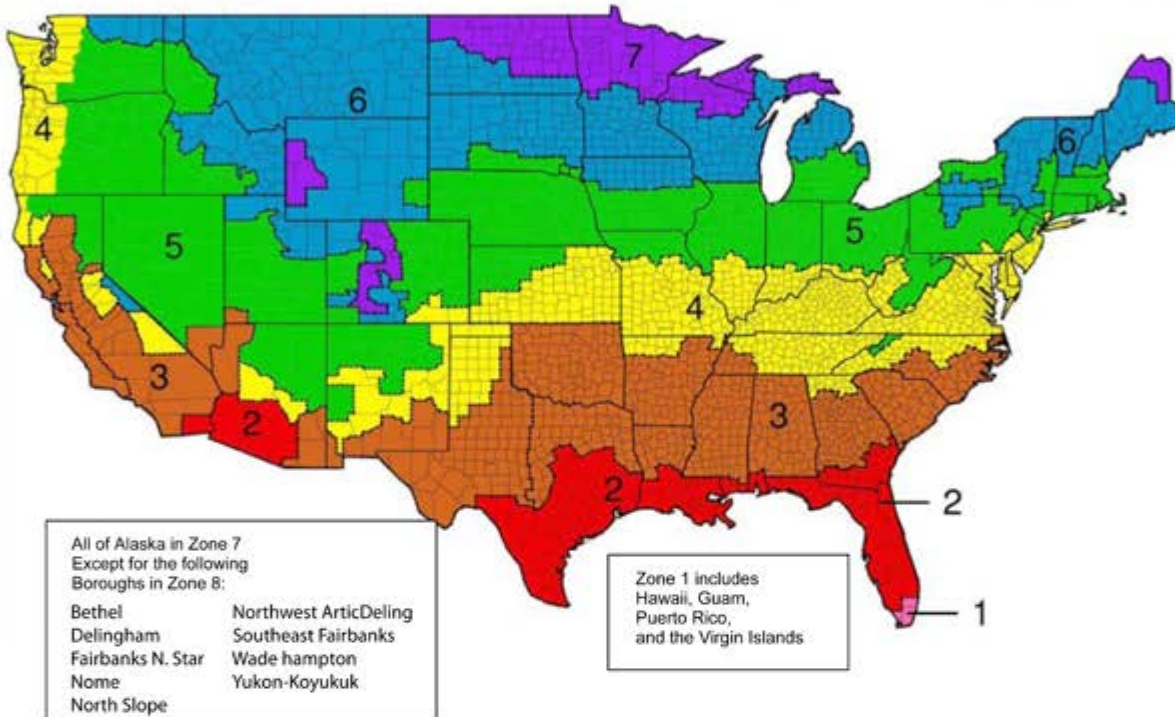
### Insulation Recommendations for New Wood-Framed Houses
