ProSpec Home Inspection of Long Island Property Inspection Report

2673 Walker St., Bellmore, NY 11710
Inspection prepared for: Name Deleted
Date of Inspection: 1/13/2018 Time: 10:00 AM
Age of Home: 60 yrs old Weather: Sunny, 40F
Approx Year Built: 1958

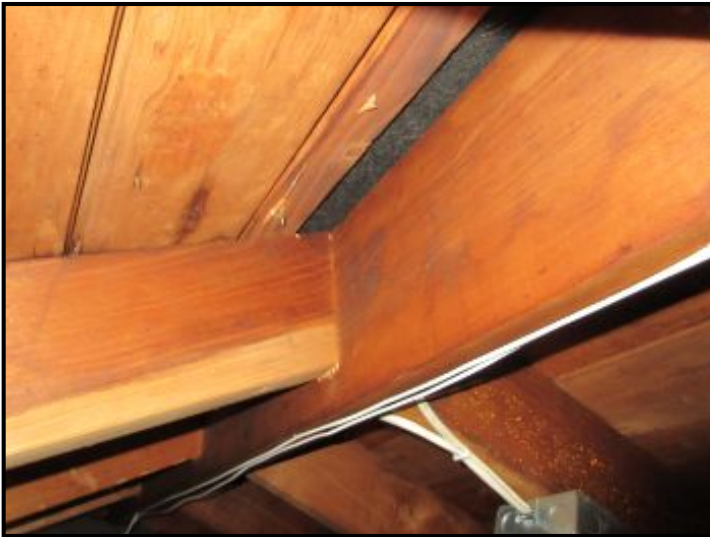
Roof Structure: 2x6 Rafters 16" O.C., 2x8 ridge beam, T&G roof boards.

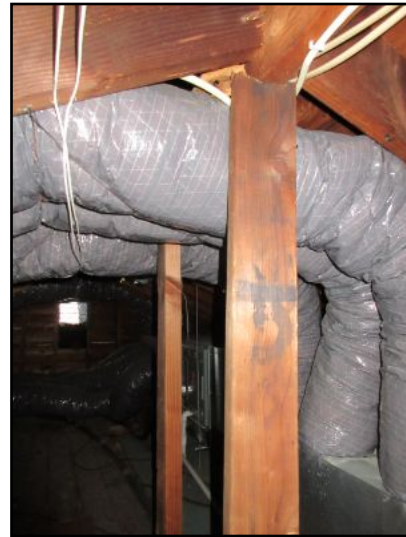
Vertical support of roof ridge beam noted.

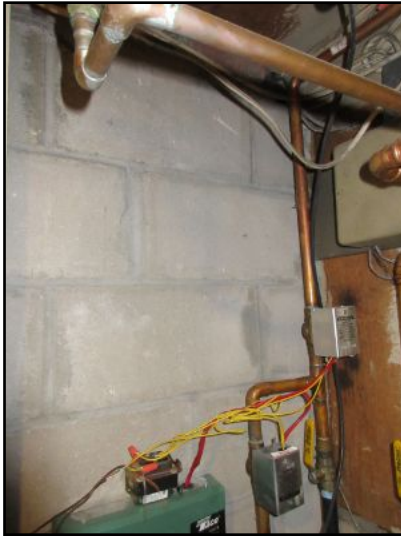
Foundation: Concrete Block also noted

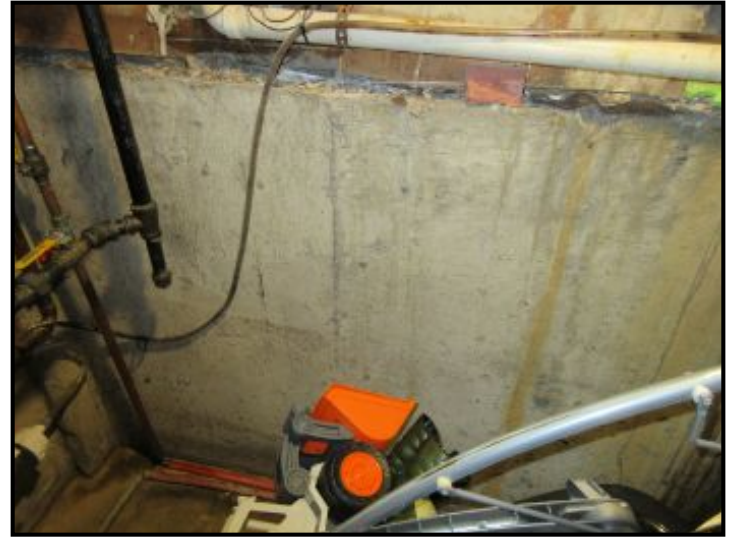
Foundation: Poured Concrete (w/stucco veneer).

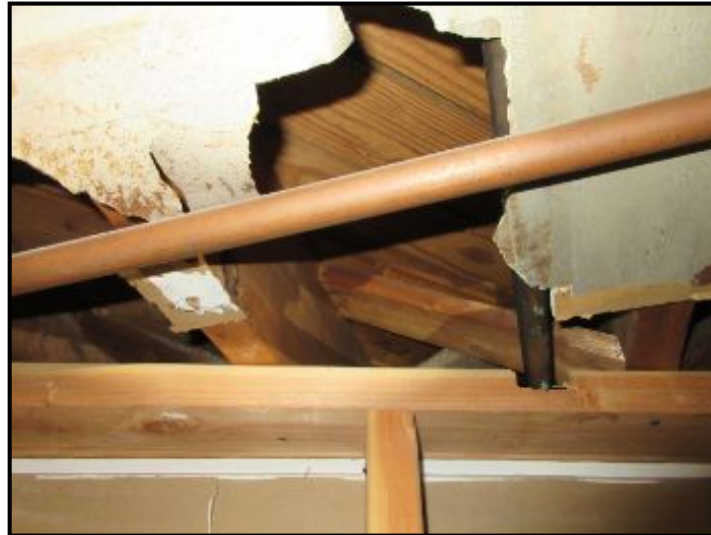
Floor Structure: 2x8 Joists 16" O.C. (w/cross braces), T&G floor boards.

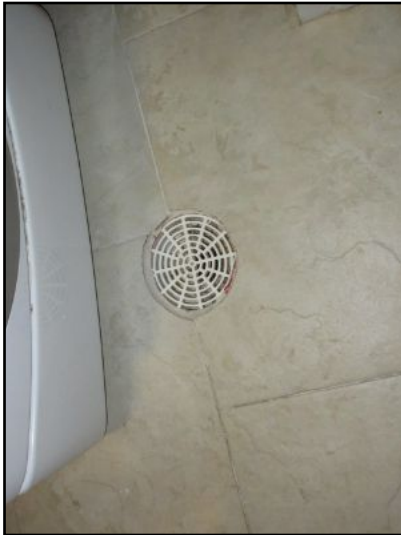
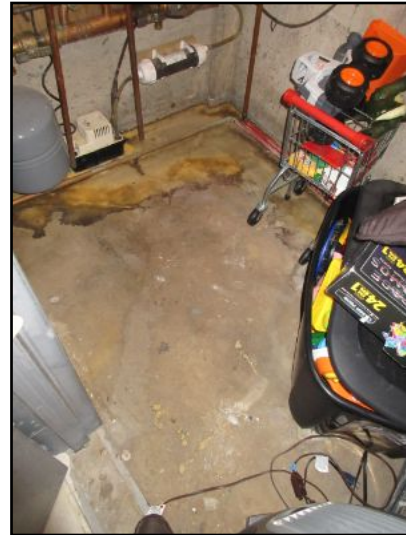
- Concrete slab only partially visible due to floor coverings.
- Floor Covering: All concrete floor slabs experience some degree of cracking due to shrinkage in the curing process. In most instances floor coverings prevent recognition of cracks or settlement in all but the most severe cases. Where carpeting and other floor coverings are installed, the materials and condition of the flooring underneath cannot be determined.
- No unusual cracks were observed at the visible portions of the slab foundations at the time of inspection.
- Visible portions of floor slab were dry at the time of the inspection.

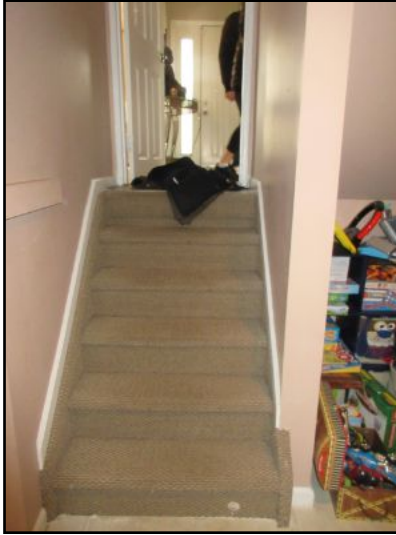
A handrail is missing.

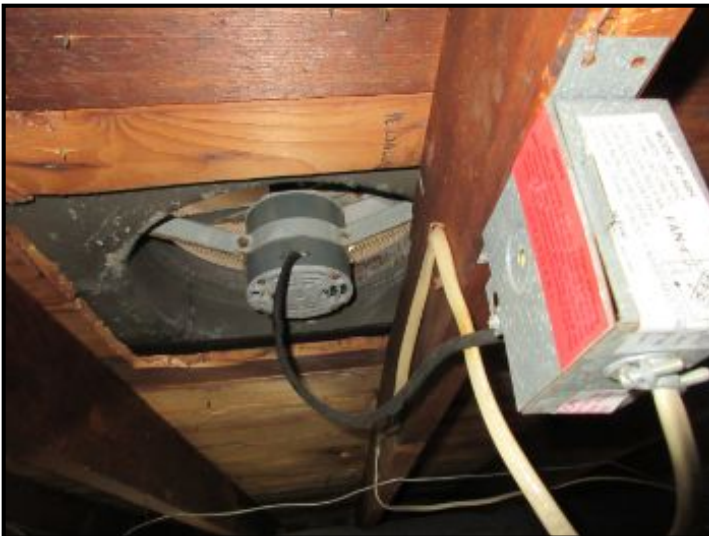
Thermostatically controlled Power Ventilator. Colder temperature prevented testing due to limit on thermostat. Suggest verification of performance. Recommended Temperature setting is 85 deg F.

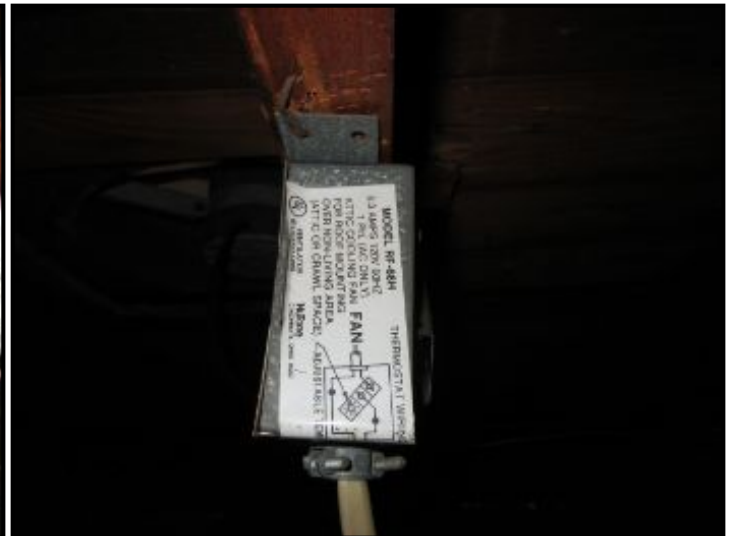
Thermostat functionality is questionable for Power Ventilator

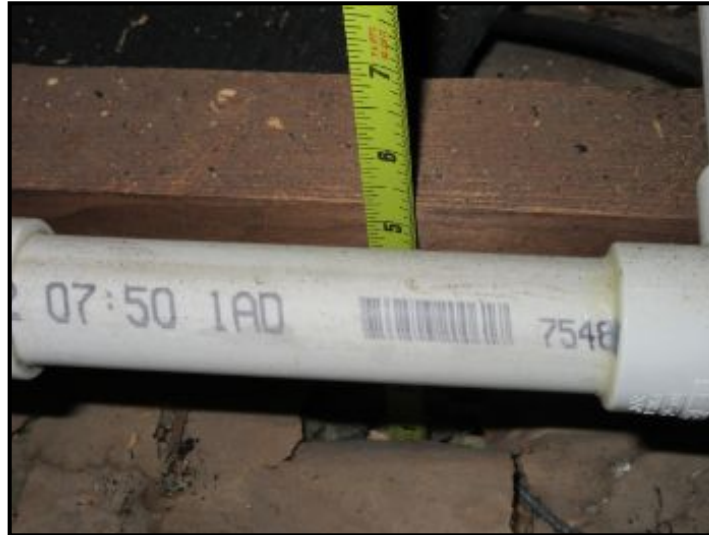
Insulation depth varies 1 - 2 inches (R-5); Poorly insulated; Recommend improvement.

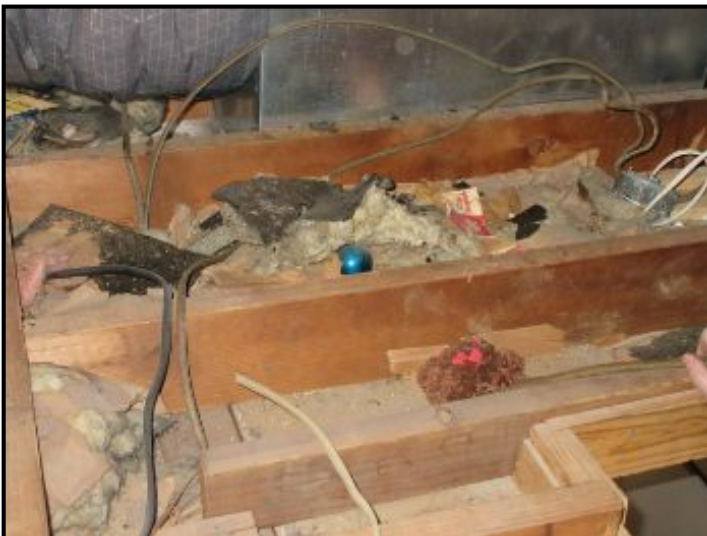
Insulation is missing and damaged in some sections of the attic floor.

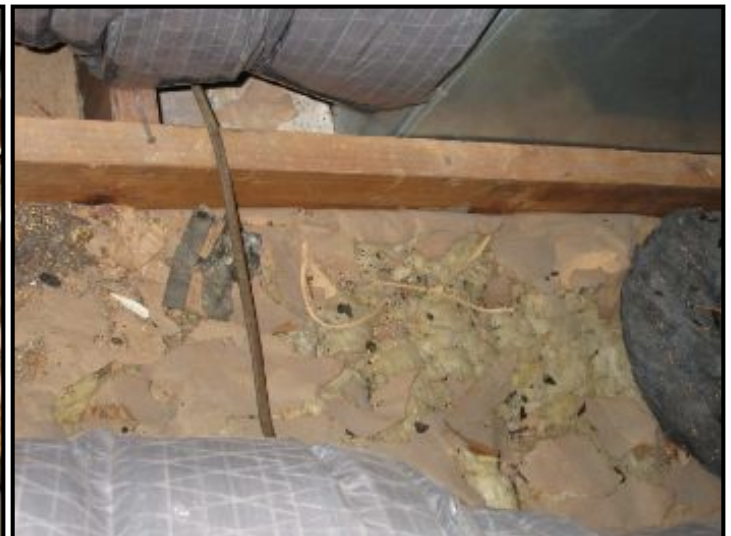
Insulation is missing and damaged in some sections of the attic floor.

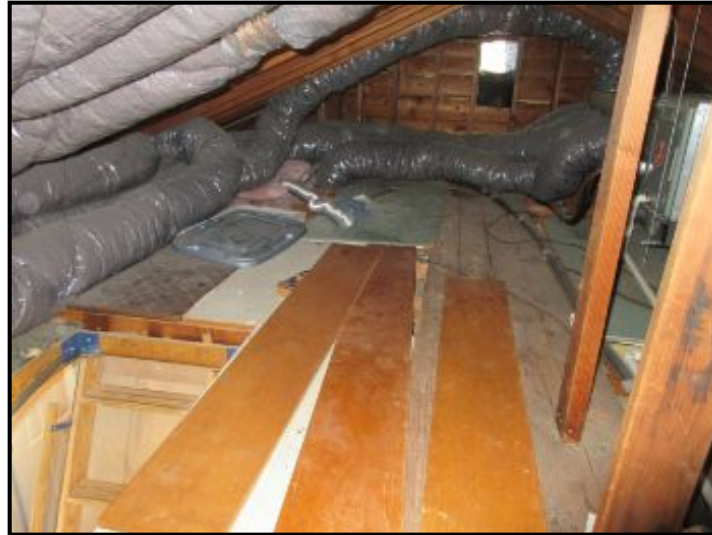
Attic space is partially floored, limiting the insulation between these floor joist cavities to 6.5".

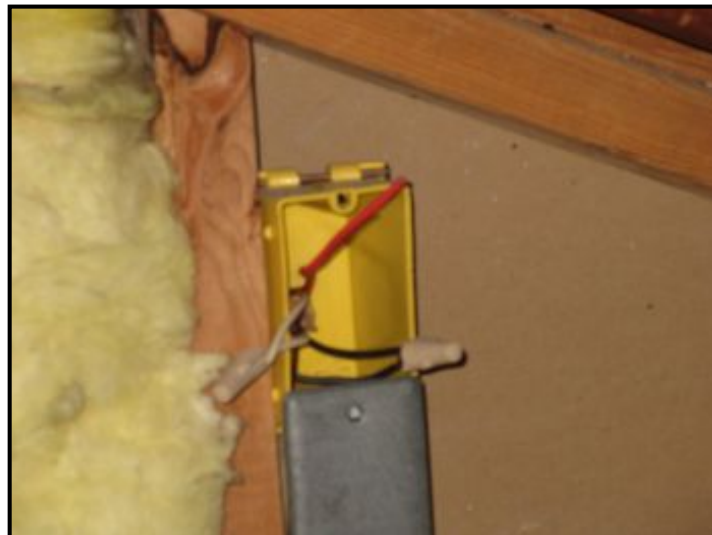
Electrical Box Covers missing. Wire ends are outside of a Junction Box, which is a potential shock or electrocution hazard.

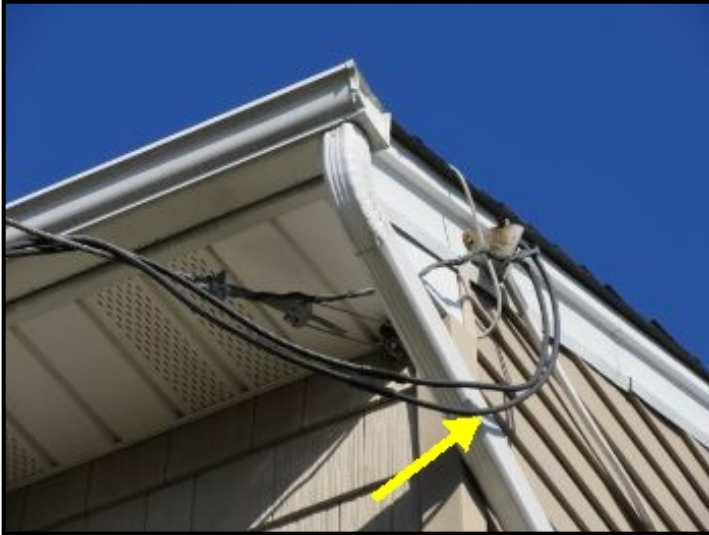
Overhead service drip loop should not be in contact with aluminum downspout. Recommend review by a licensed electrician for corrective repair.

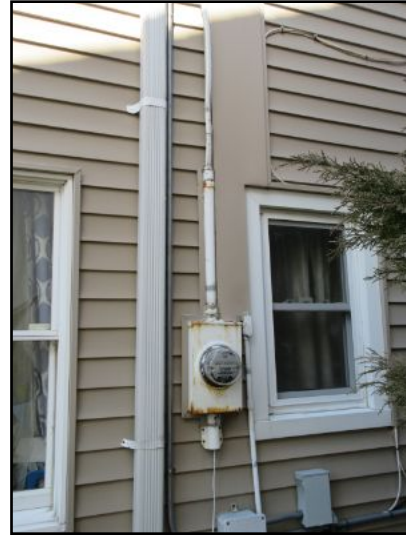
ELECTRICAL Electrical Service Entrance

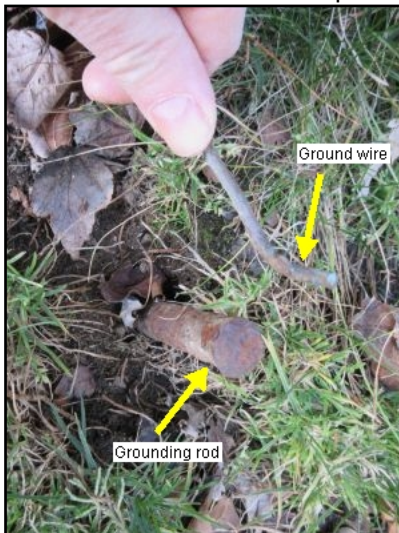
Electrical service ground wire was found disconnected from grounding rod. Recommend electrician to re-attach and check continuity.

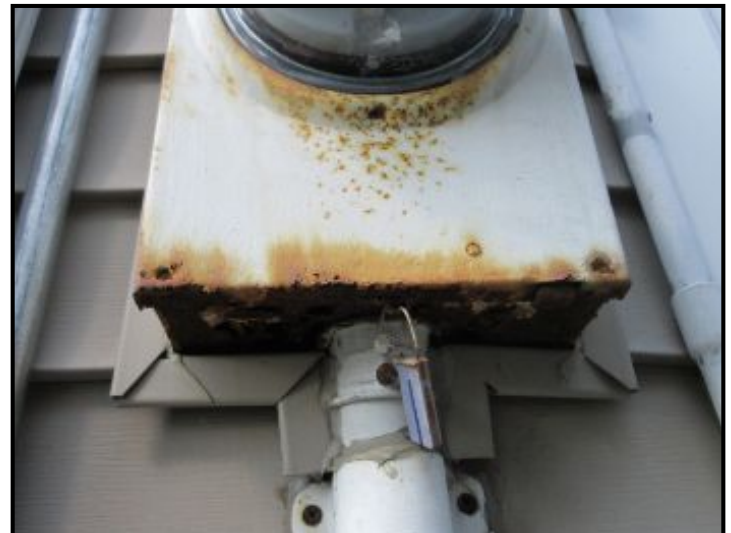
Older meter box badly rusted , caused by water entry. Recommend electrician to update.

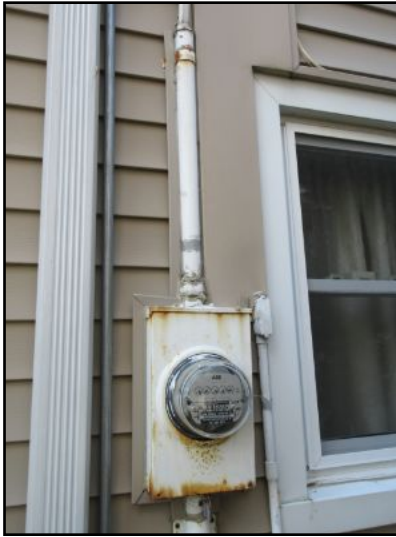
ELECTRICAL Electrical Service Entrance

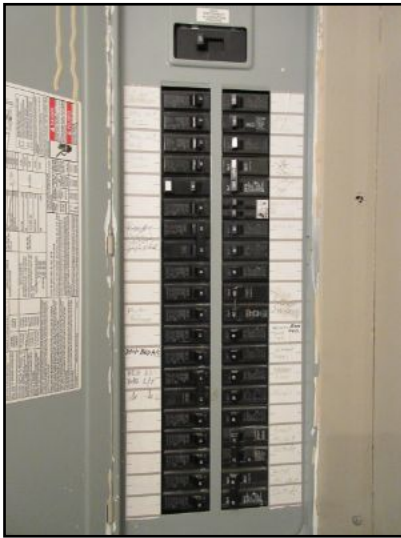
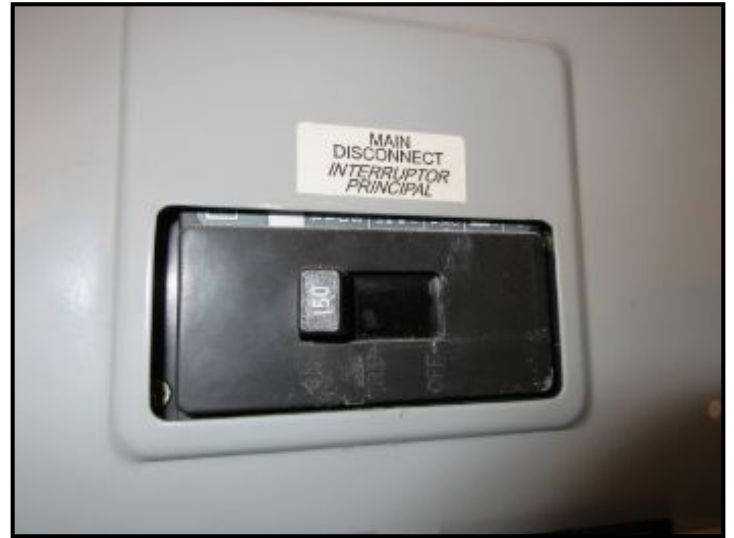
3. Main Panel Conditions

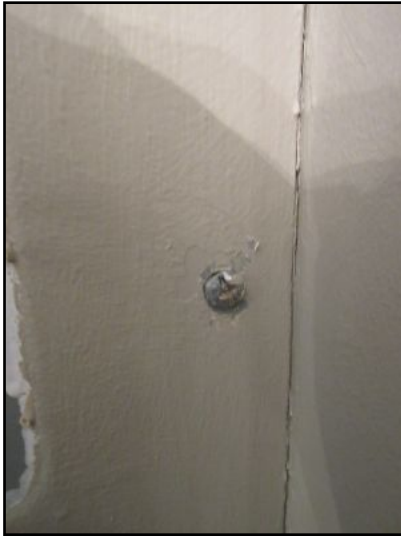
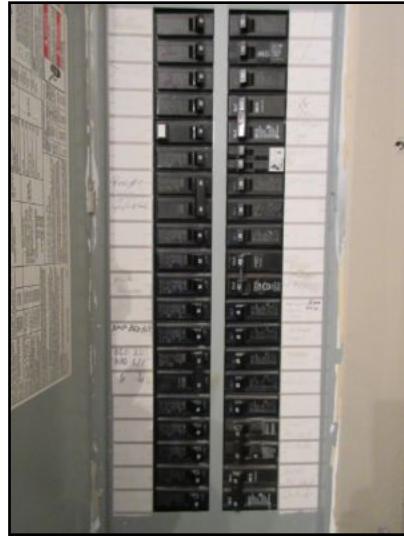
ELECTRICAL Continued

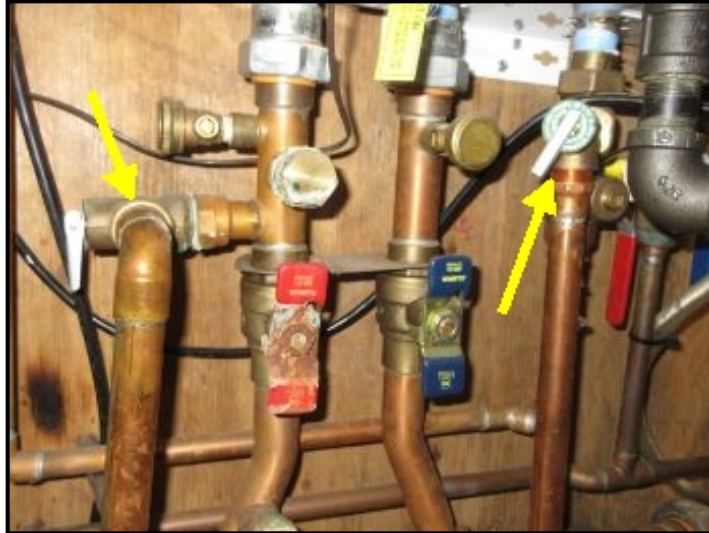
TPR (Temperature Pressure Relief) valves and discharge pipes show no deficiencies.

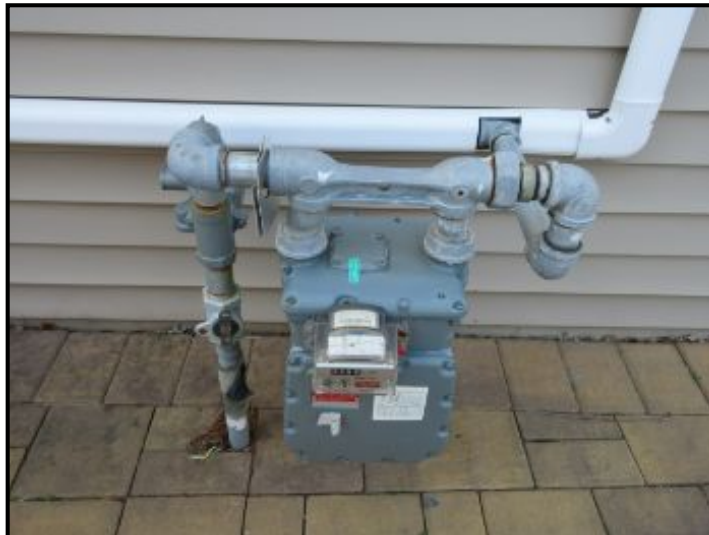
Public Gas Service: Meter, shutoff valve and vented regulator noted outside.

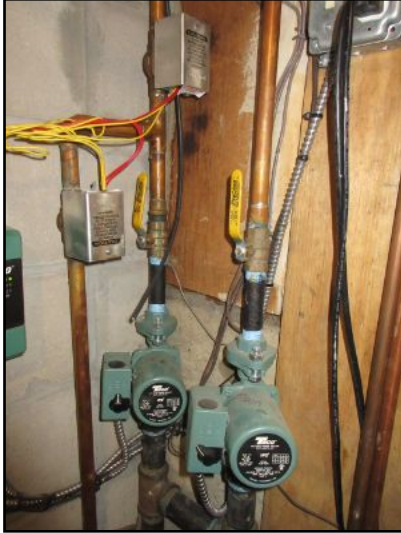
3-zone heating system noted.

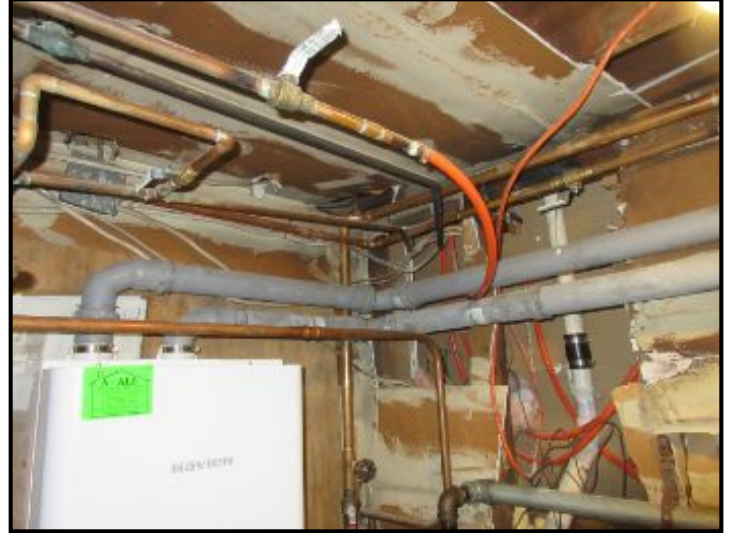
Copper, black iron pipe and PEX-AL-PEX tubing noted.

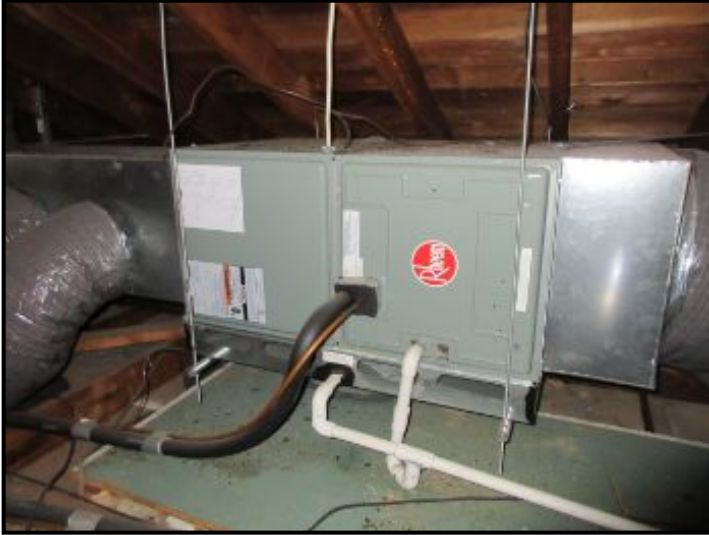
One of two Rheem central air handlers located in the attic. Only the units' fans were tested and found operable. See related A/C test limitation.

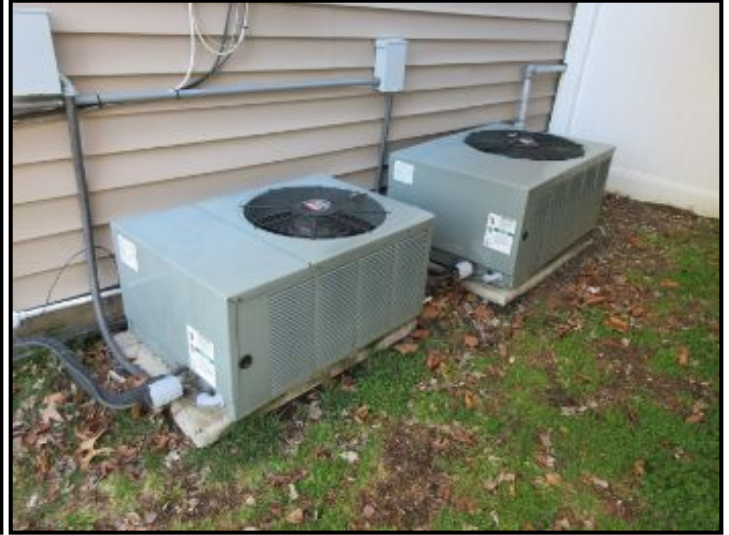
Two Central A/C split-systems, each with outdoor condenser and Ducted indoor air handler.

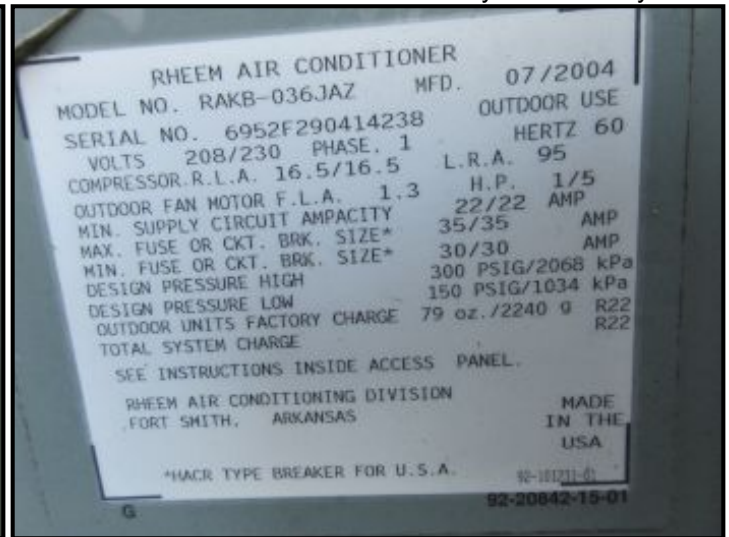
AC#2: Rheem A/C condensing unit data plate/serial no. indicates a cooling capacity of 3 tons, and a manufacture date of 7/2004, (14 yrs old).

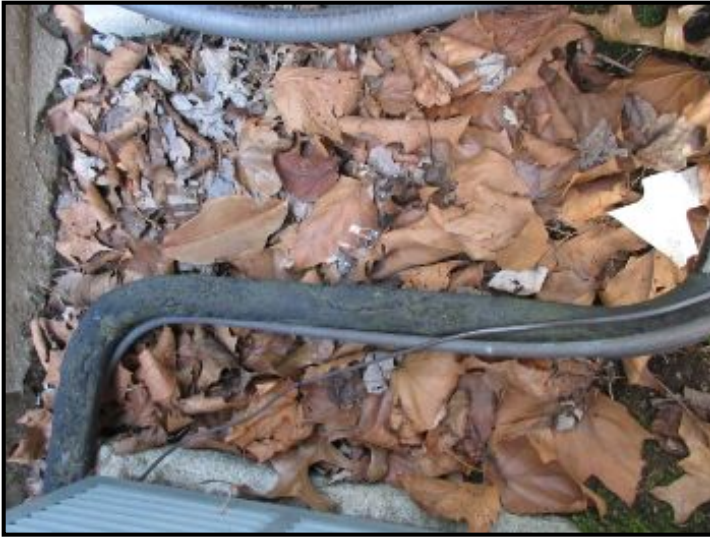
Outdoor refrigerant piping insulation is deteriorated. Recommend replacing outdoor deteriorated insulation.

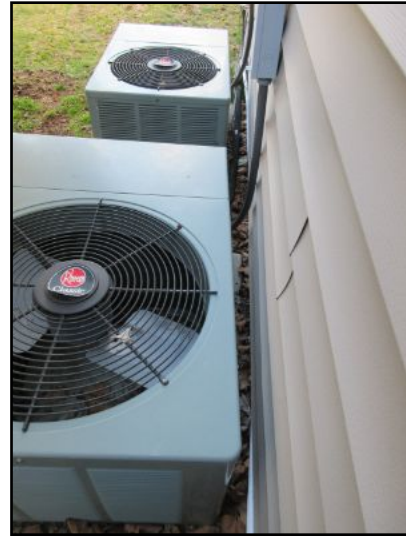
Outdoor condenser air flow appears restrictive based on its distance from the house. This can negatively affect system performance. Suggest checking manufacturer's clearance requirements.

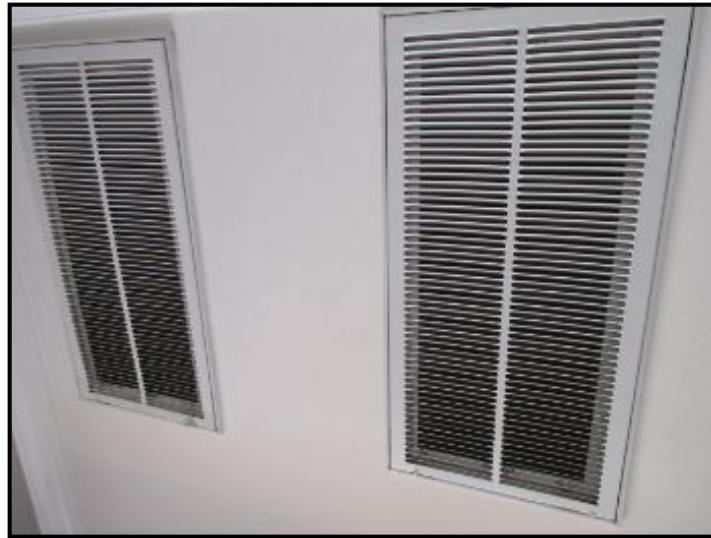
Disposable filters located inside two filter-grilles at 3rd floor hall ceiling. Air handler filters are dirty and need replacement. Filters help clean the house air, making the environment more pleasant. Filters also clean the air before it passes through the blower and heat exchanger. This helps to keep these furnace components working efficiently. It is recommended to change the filter and then regular inspection & maintenance is advised.

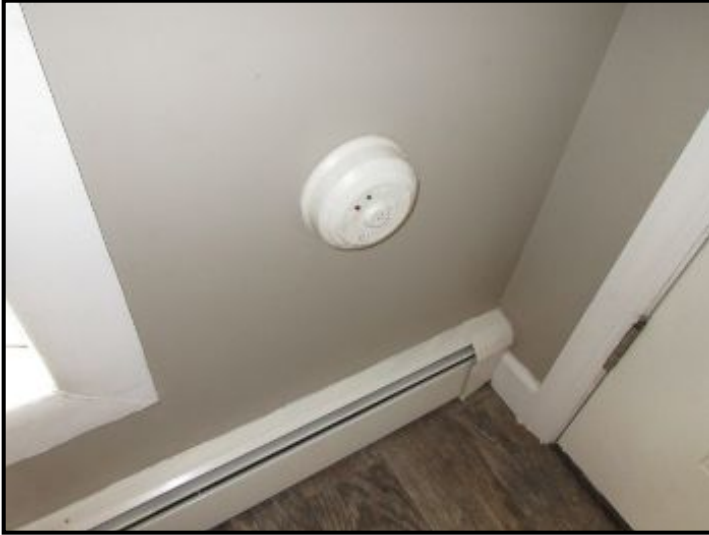
LIFE SAFETY: Maintain functioning Smoke and Carbon Monoxide detectors at each level of the home for Life Safety. Detectors are generally reliable for up to 5 yrs.

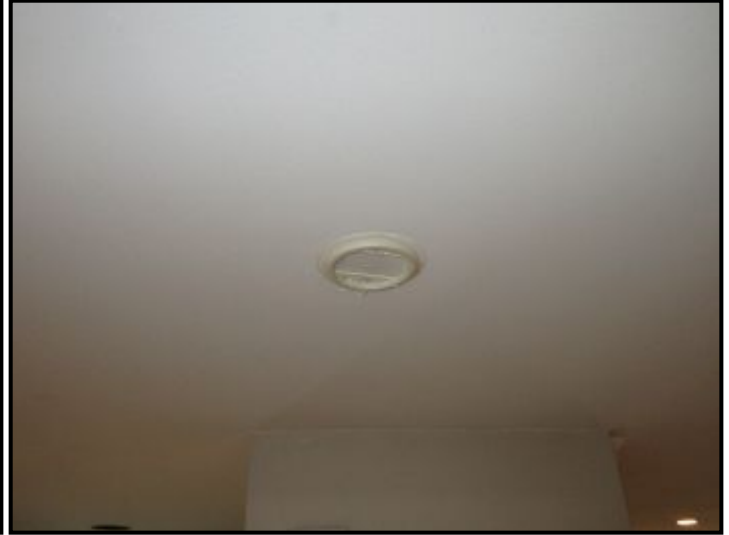
Smoke/Carbon Monoxide detector missing in main hall.

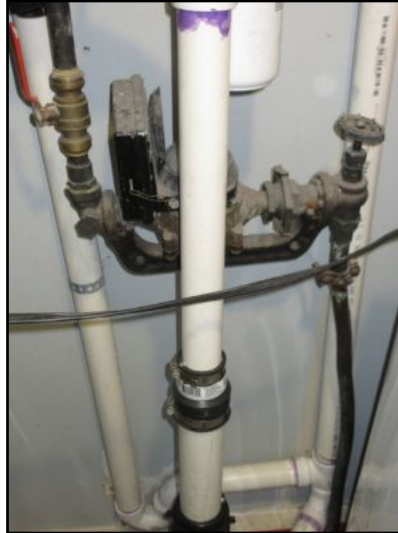
Water Service Entrance: 3/4" Copper, meter, shut-off valves and grounding observed.

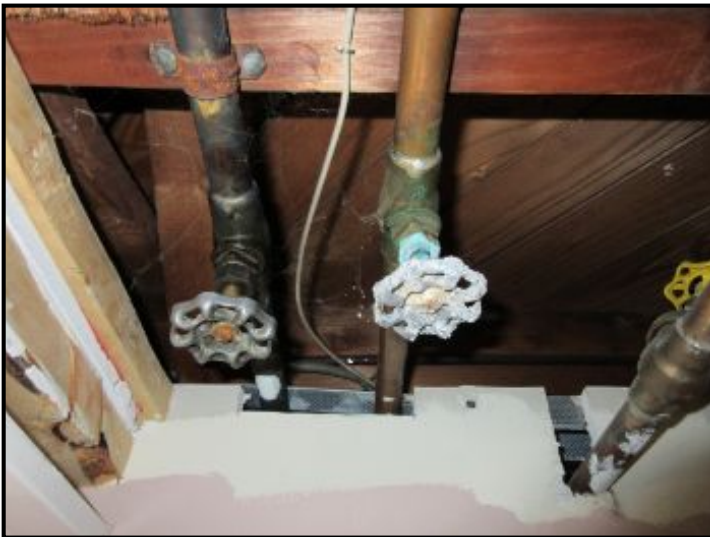
Leaky valve noted in basement. Deposits observed at water valves is a sign of valve body corrosion and past leakage.

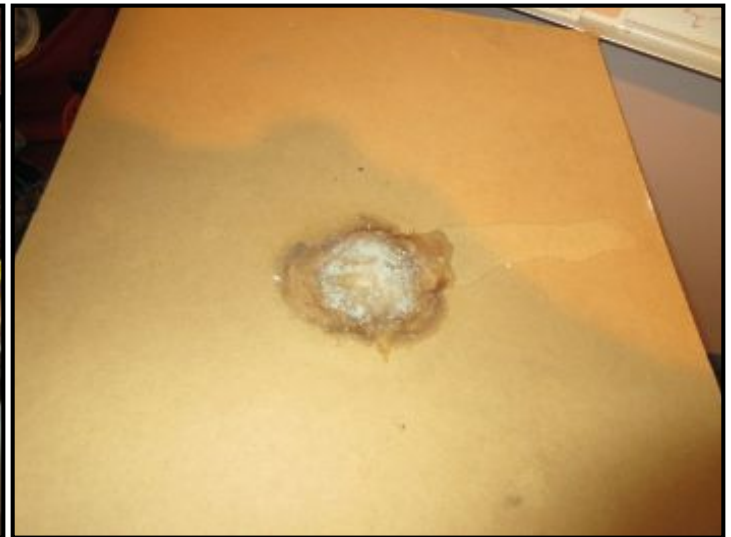
Leaky valve noted in basement.

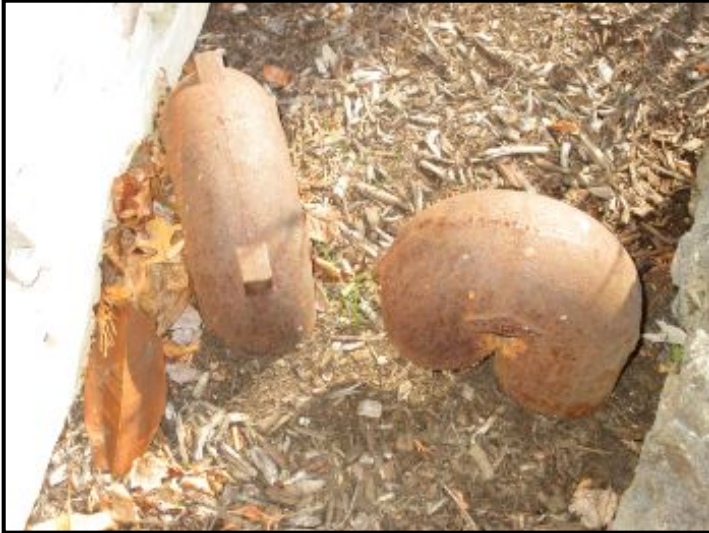
Waste Pipe Exit located at front of house with vent and whole-house trap.

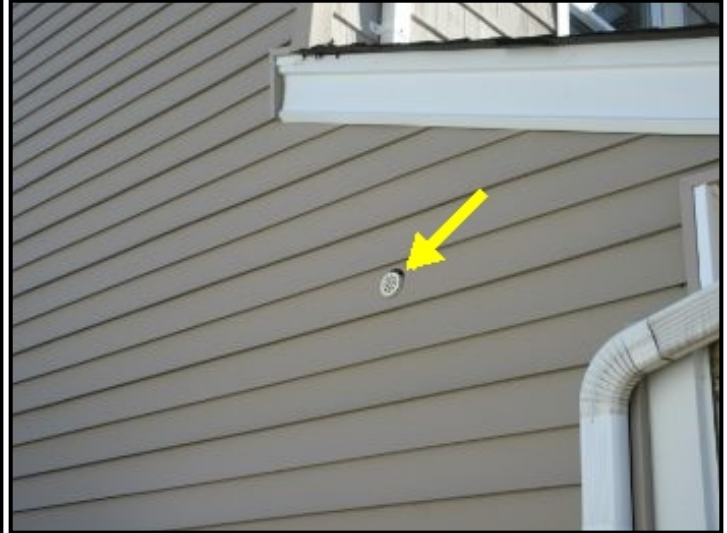
Vent pipe penetration at west exterior. Recommend caulk to seal around penetration to prevent moisture intrusion of the wall assembly.

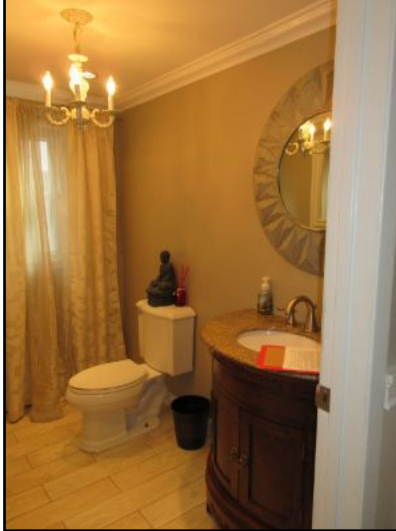
First Floor Hall, Toilet, Vanity, Window, Baseboard/convactor heat noted, Ceramic tile Floor

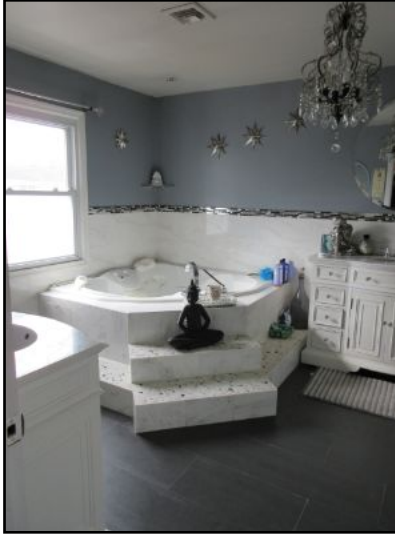
Master Bedroom, Toilet, Vanity, Stall Shower , Whirlpool, Exhaust Fan, Window, Baseboard/convector heat noted, Ceramic tile Floor, Ceramic tile Shower Wall

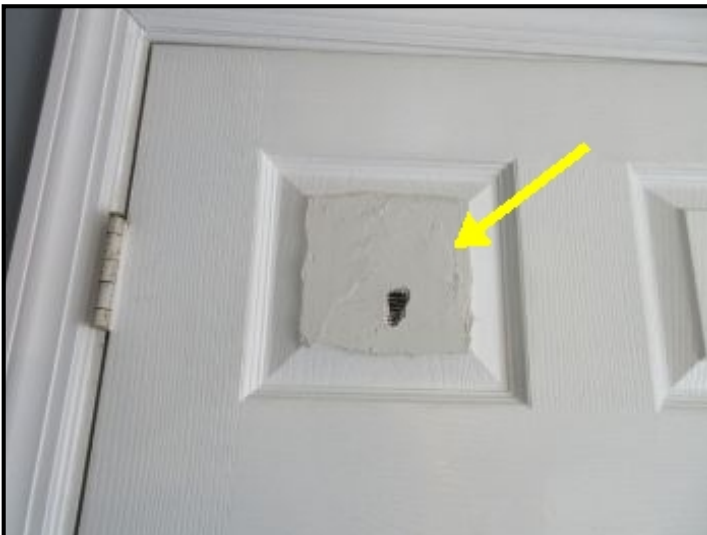
Damage and attempted repair of door.

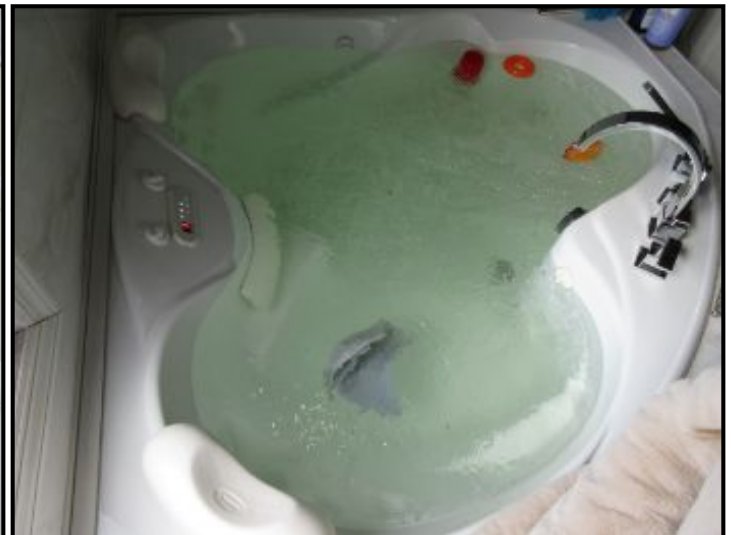
Whirlpool pump was operable.

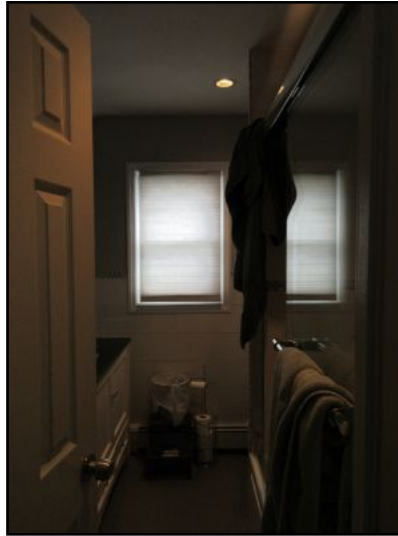
Second Floor Hall, Toilet, Vanity, Whirlpool, Exhaust Fan, Window, Baseboard/convactor heat noted, Ceramic tile Floor, Ceramic tile Shower Wall

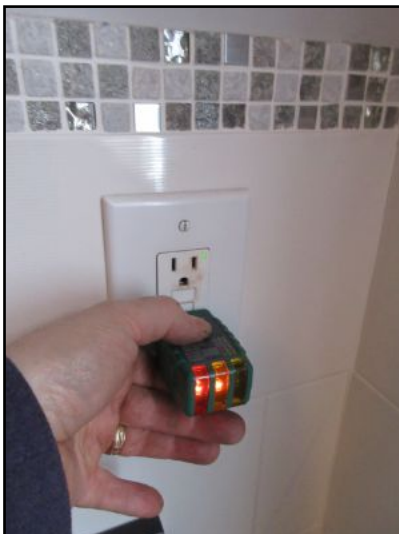
GFCI type receptacle did not trip when tested. Recommend replacing GFCI receptacle.

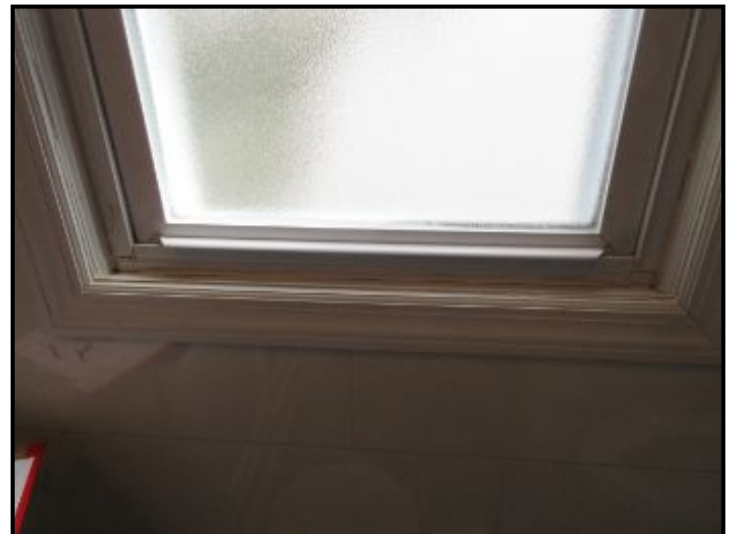
Window sill shows signs of moisture damage. Suggest repairing and refinishing affected wood.

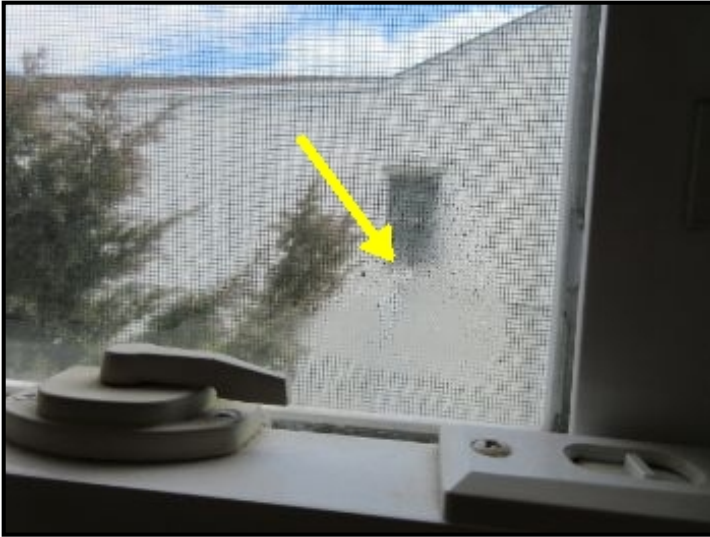
Insulated glass window gas seal may have broken; Repair insulated glass panel, or replace whole sash.

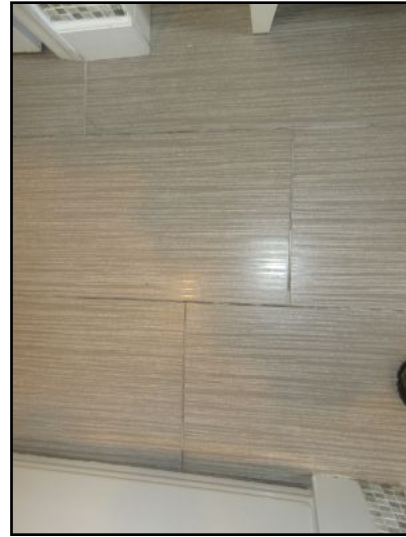
Floor tile grout cracked/missing; suggest grout repair(s).

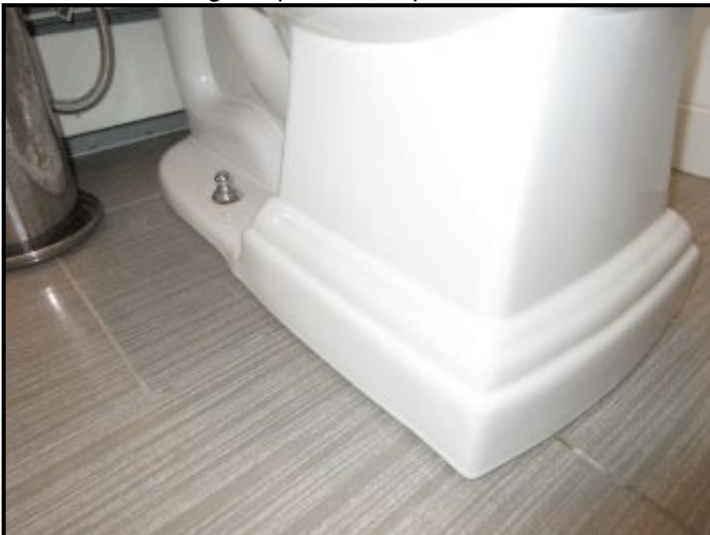
Toilet bowl is loose at floor anchor bolts. The wax ring inside the unit must have a snug, secure fit in order to keep from leaking. Properly resealing and re-securing this unit is suggested to prevent water leakage and damage to the sub-floor area. This type of damage is not always visible or accessible to the inspector at time of inspection.

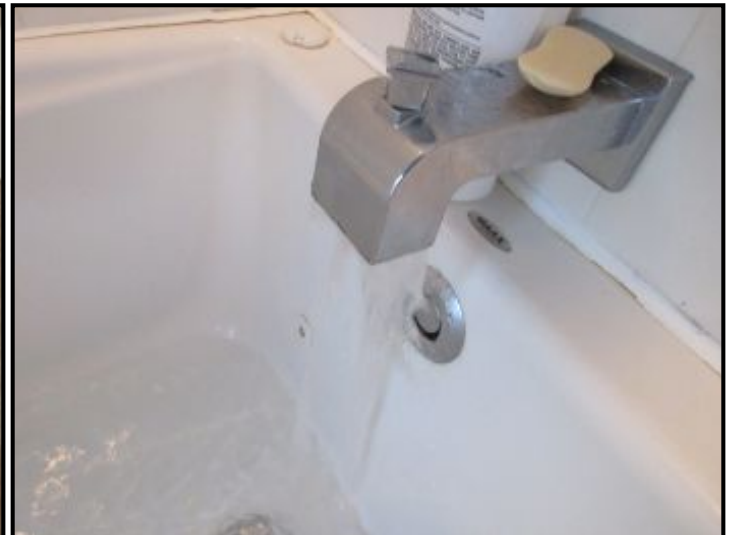
Whirlpool/tub faucet did not supply hot water. Recommend plumber to evaluate. Water pressure/flow is low when running other fixtures in one area.

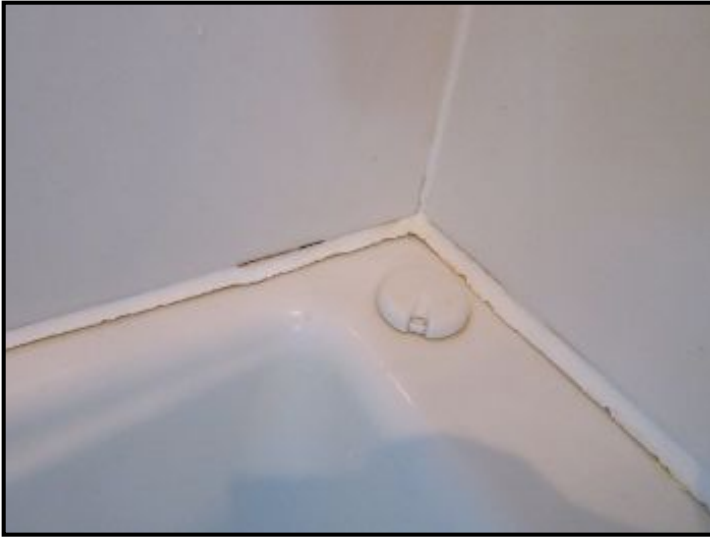
Suggest updating caulk at tub perimeter.

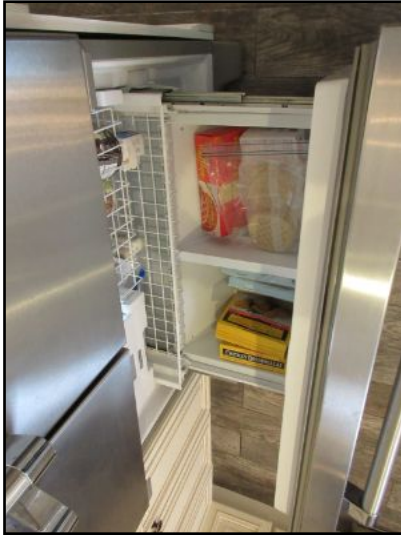
Refrigerator/freezer operating and frost free.

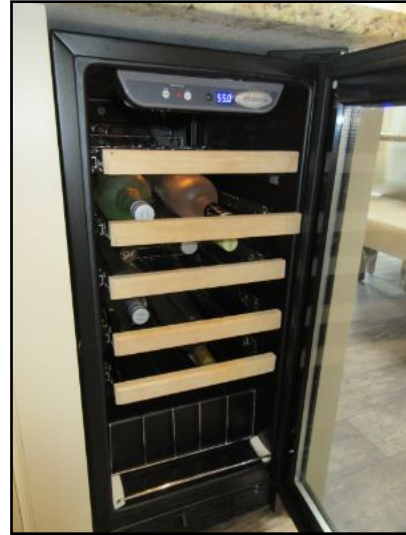
Wine refrigerator was operating.

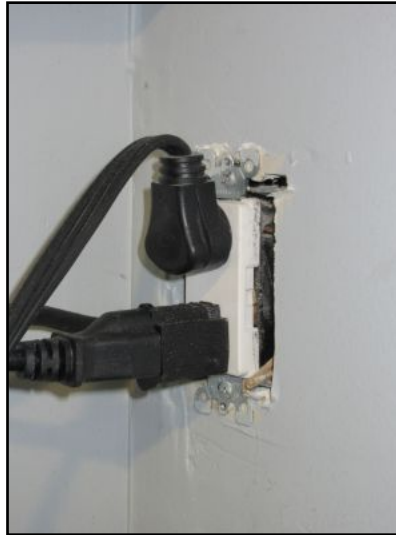
Laundry receptacle appear as non-GFCI protected. Refer to Electrical section. Cover plate missing. Provide missing receptacle and switch cover plates.

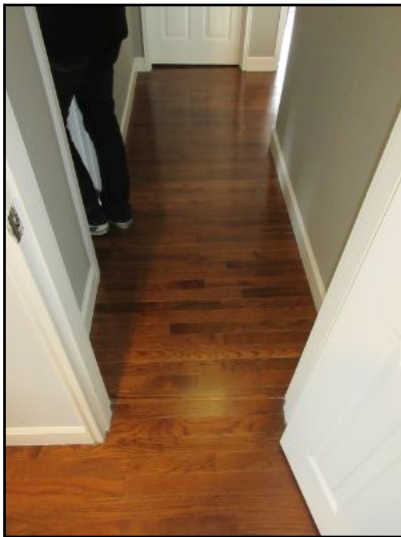
Hardwood floors noted at upper floor.

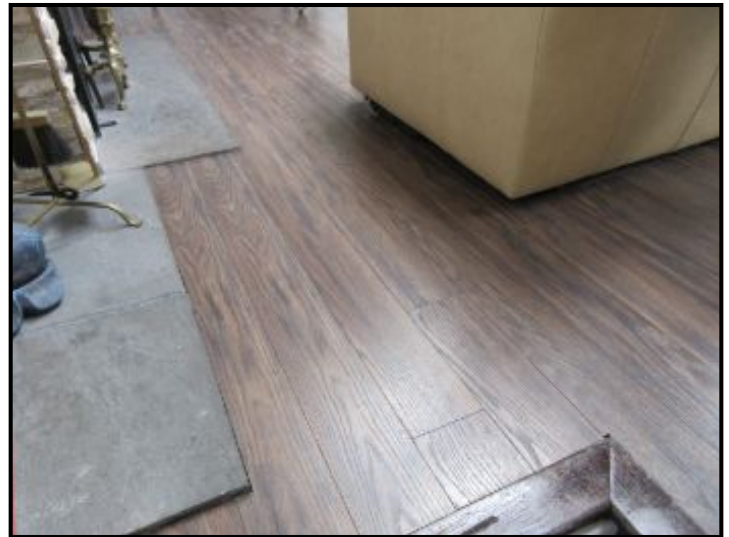
Living room floor is laminate.

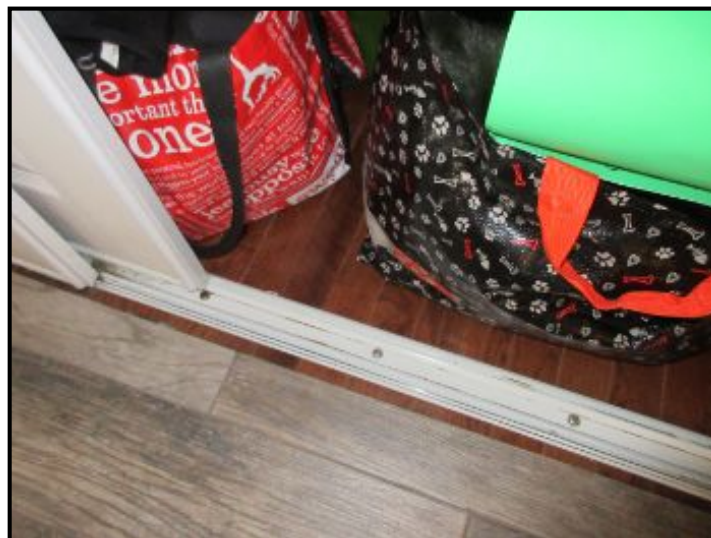
Original hardwood floors observed below.

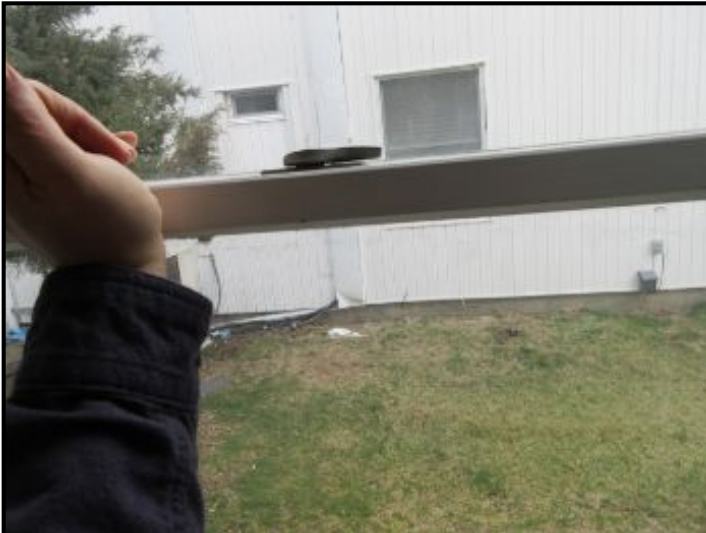
Dining room side window was stuck closed.

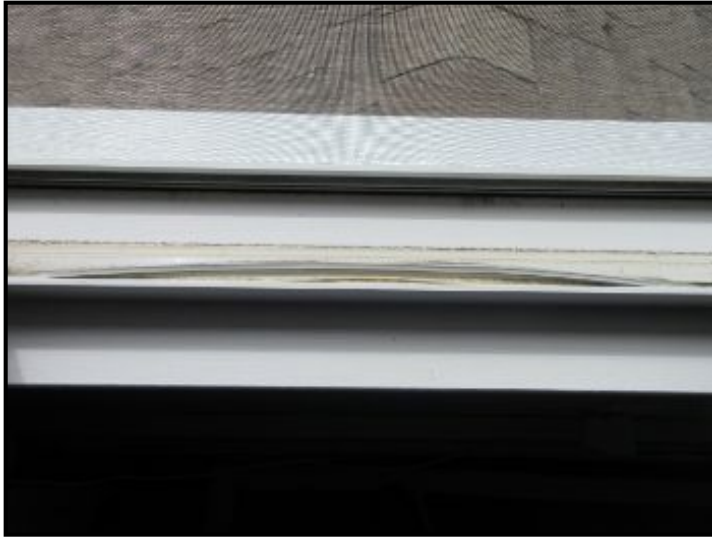
Front bedroom: Older (1991 manufactured) thermal windows - weatherstripping deteriorated.

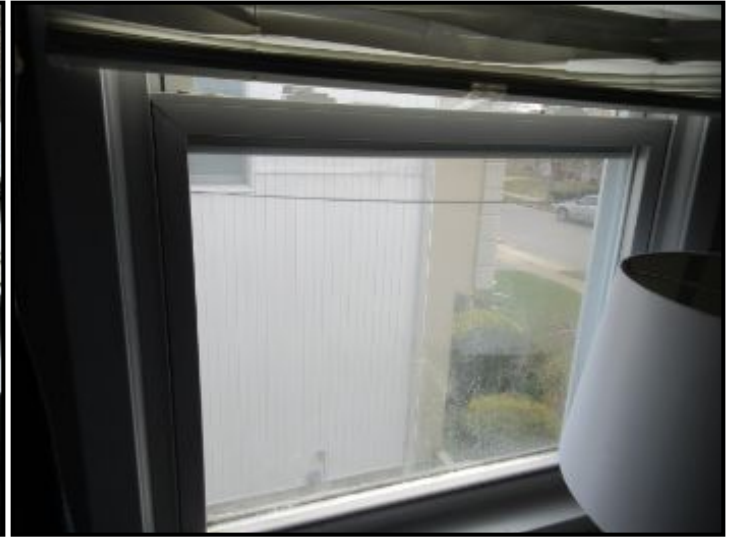
Cloudiness/condensation observed in a couple of thermopane double glazed windows in bedrooms. This is an indication of a failed seal. A qualified contractor should review for replacement as needed.

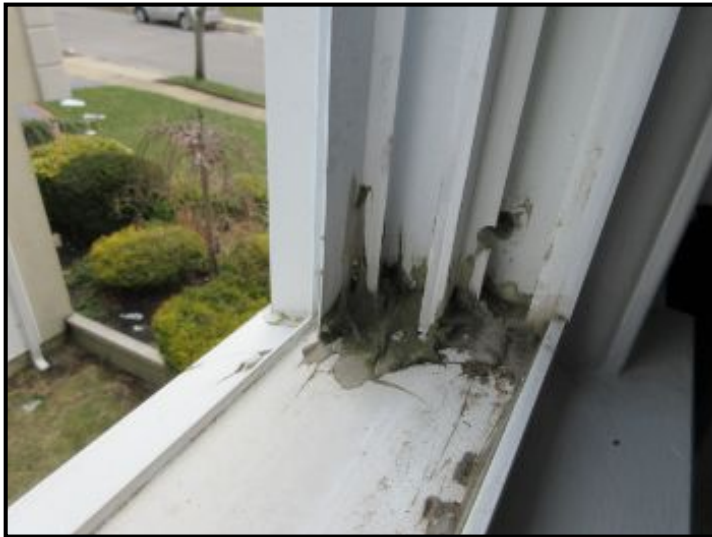
Sloppy caulking repair noted at front corner bedroom.

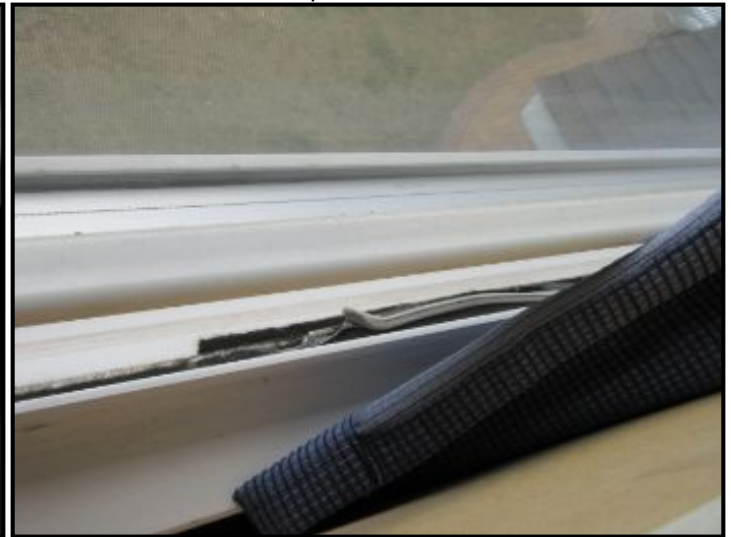
Older (1991 manufactured) thermal windows - weatherstripping deteriorated.

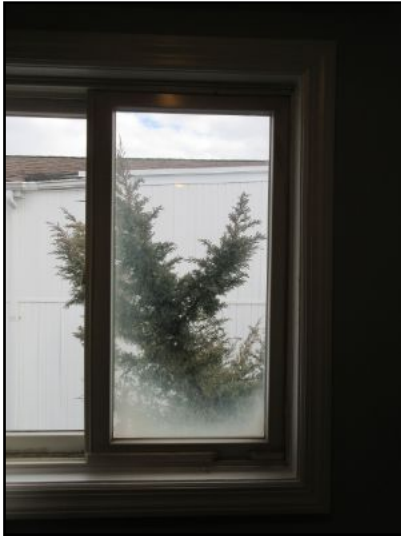
Rear bedroom: Cloudiness/condensation observed in a couple of thermopane double glazed windows in bedrooms. This is an indication of a failed seal. A qualified contractor should review for replacement as needed.

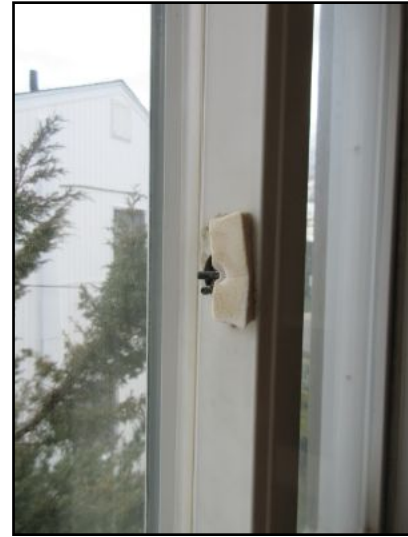
Damaged/missing hardware at Rear bedroom. Repair as needed.
