ProSpec Home Inspection of Long Island Property Inspection Report

2673 Walker St., Bellmore, NY 11710
Inspection prepared for: Name Deleted
Date of Inspection: 1/13/2018 Time: 10:00 AM
Age of Home: 60 yrs old Weather: Sunny, 40F
Approx Year Built: 1958

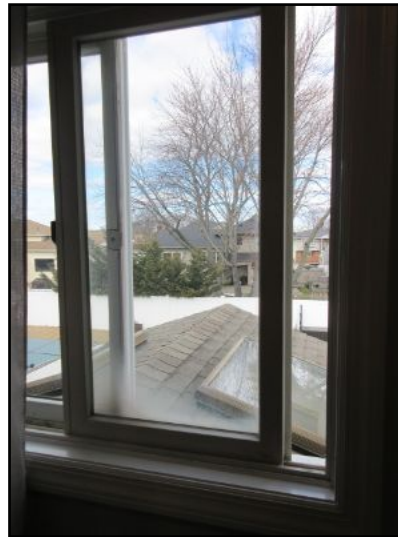
Rear bedroom: Cloudiness/condensation observed in a couple of thermopane double glazed windows in bedrooms. This is an indication of a failed seal. A qualified contractor should review for replacement as needed.

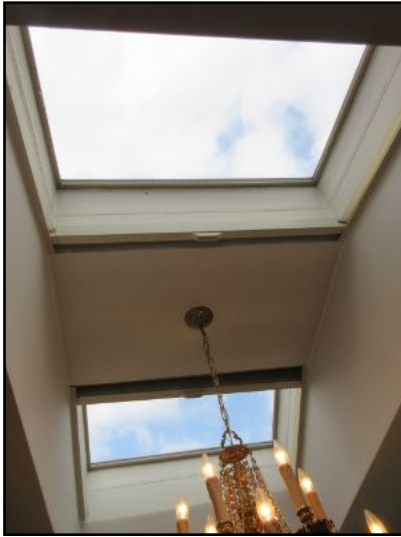
Kitchen skylights appeared serviceable with only minor cosmetic updates needed.

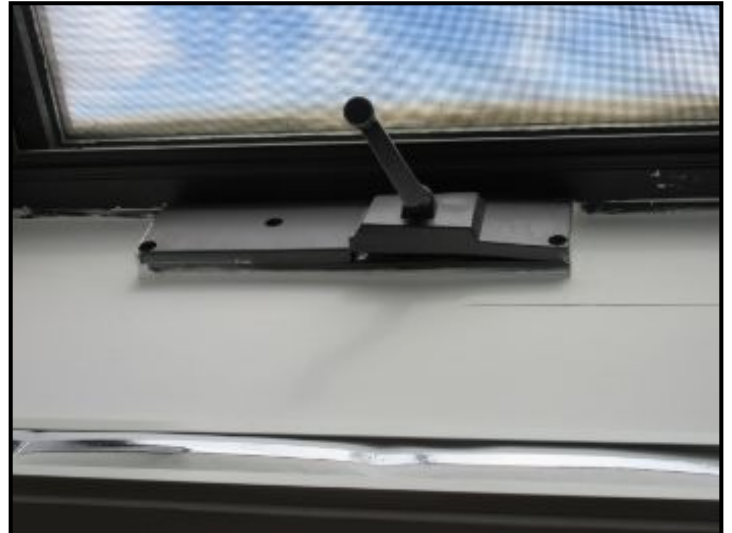
Rear bedroom: Skylight operator was broken and shouldn't be operated. Suggest repairing operator.

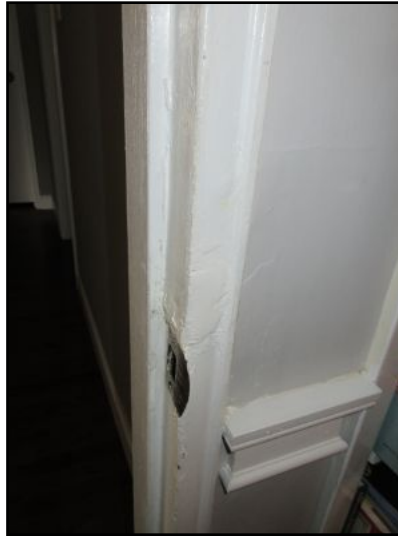
Cosmetic damage noted at front corner bedroom door frame..

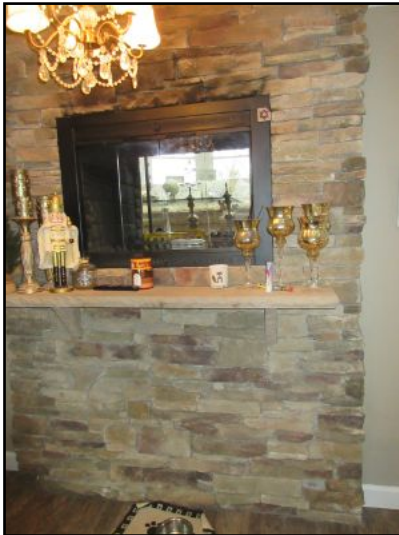
Living Room/Den fireplace noted.

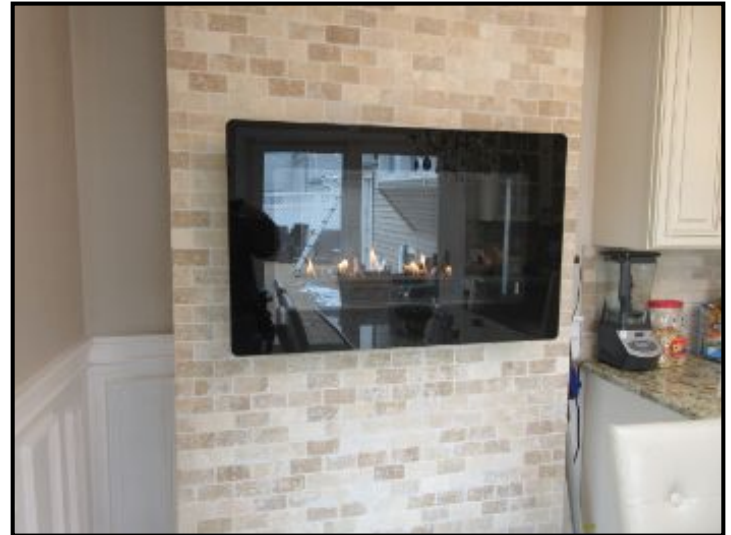
Kitchen nook fireplace noted. Gas fireplace operable.

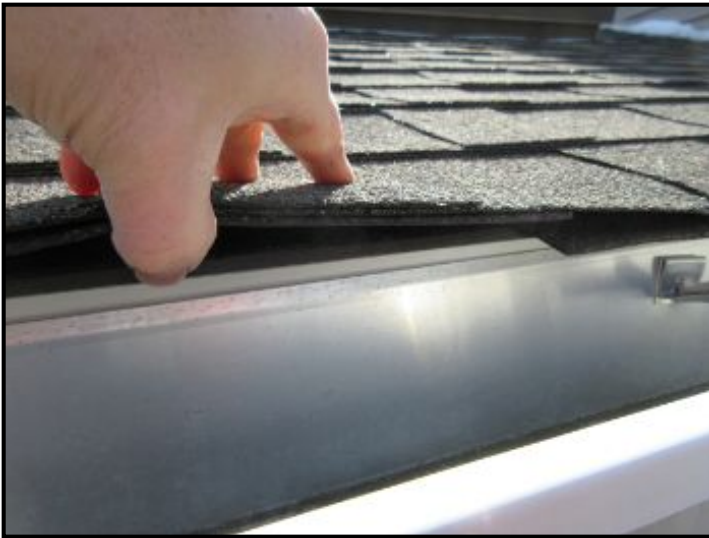
One layer of asphalt shingles noted at roof of kitchen addition.

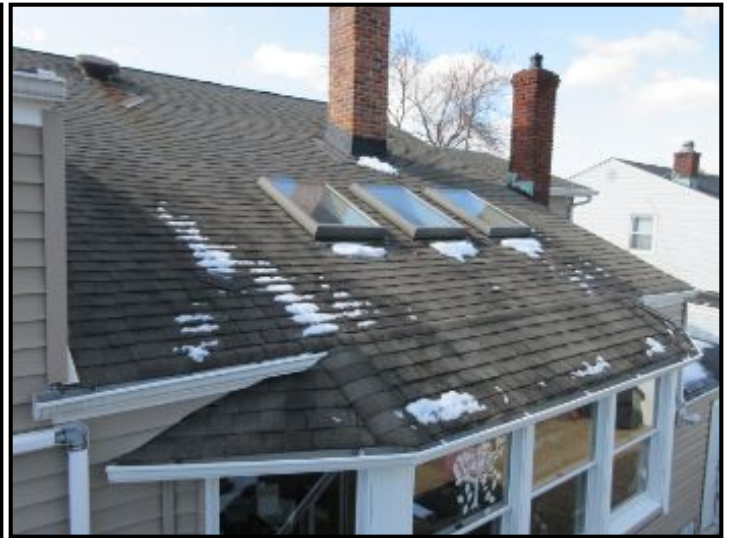
Asphalt shingles noted.

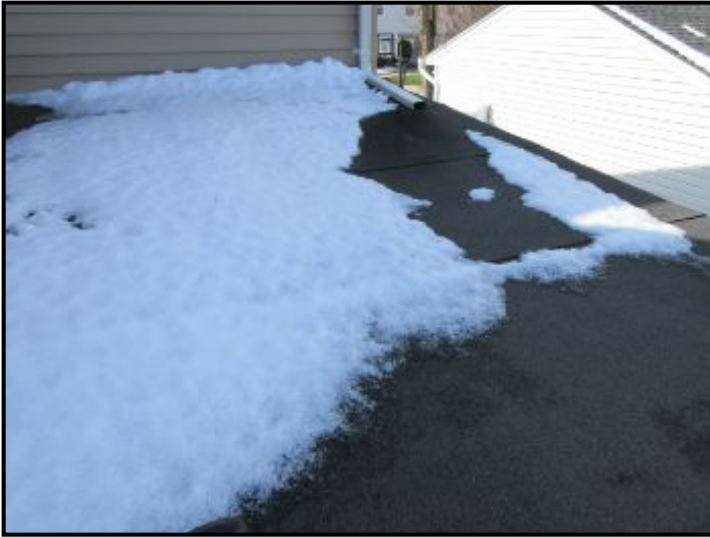
Asphalt rolled roofing noted.

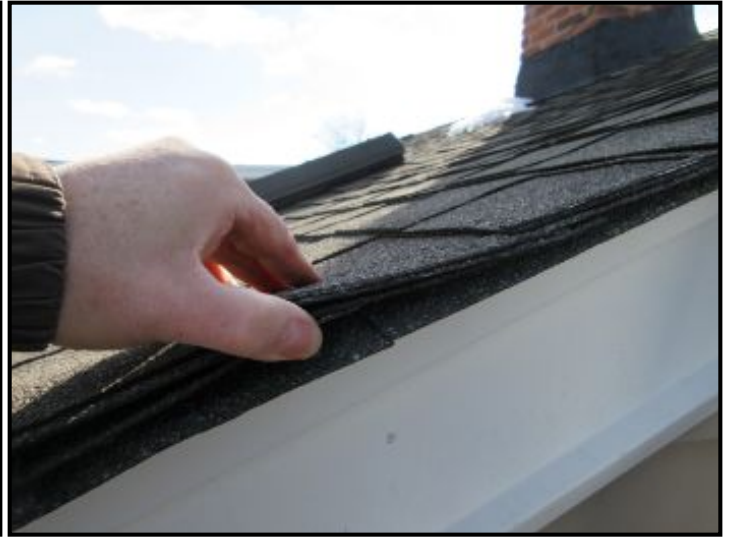
Two layers of asphalt shingles noted at upper roof.

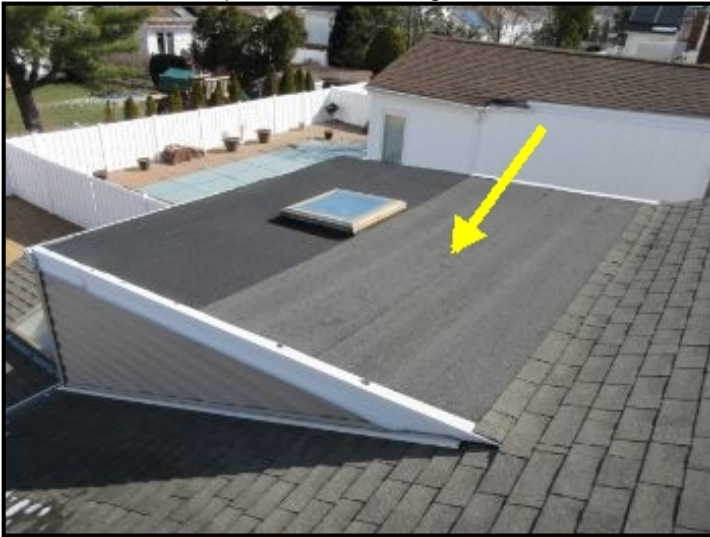
Asphalt rolled roofing noted.

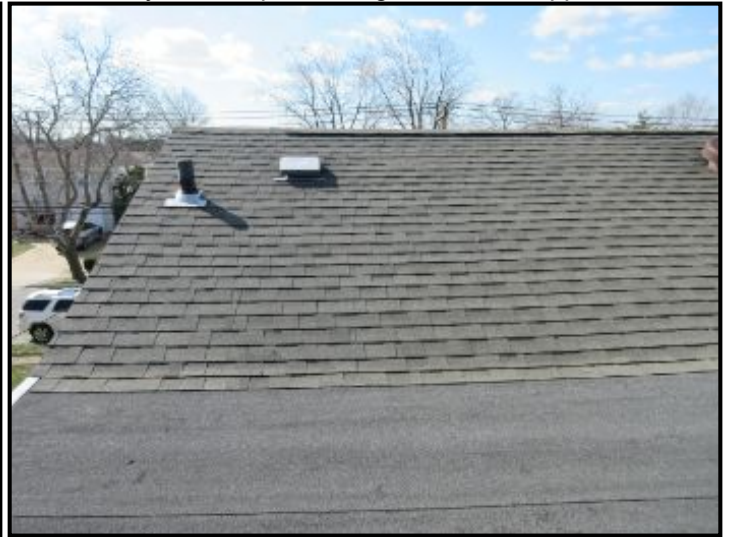
Rear roof looking south.

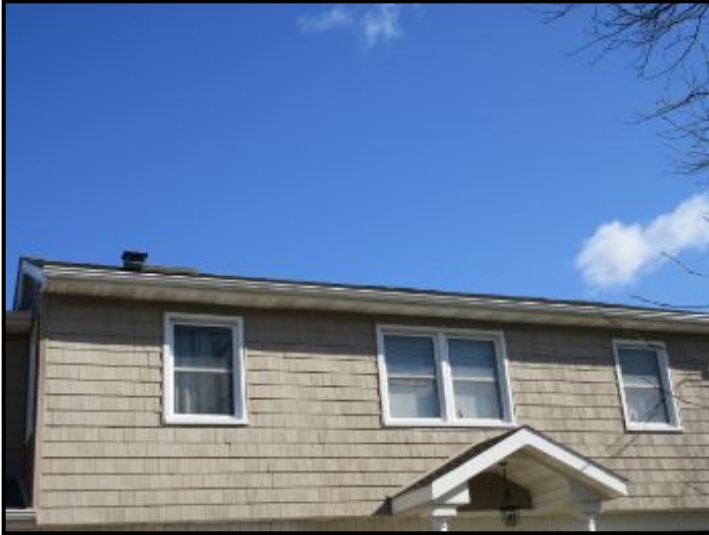
Roof ridge beam appeared straight and even.

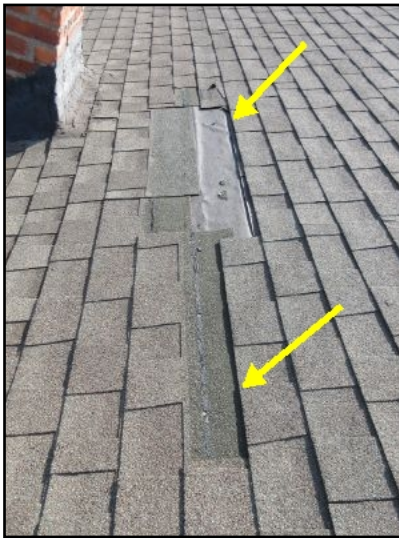
Section of shingles were apparently blow loose and are missing. Suggest priority repair.

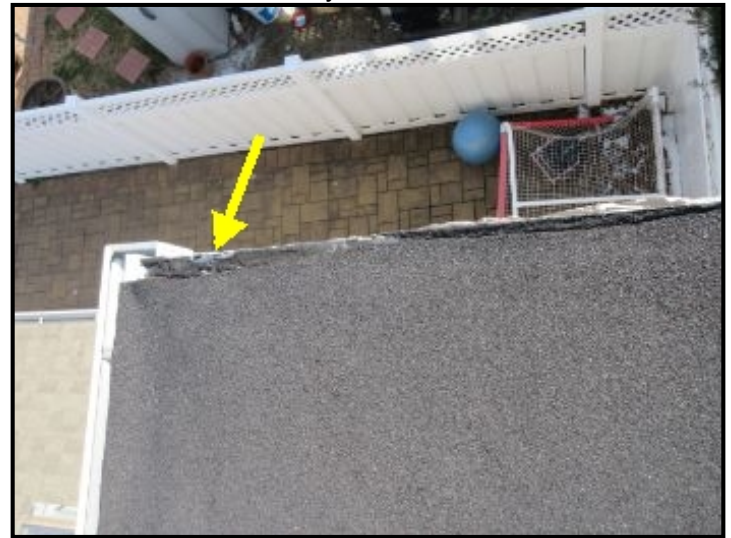
Condition along drip edge at rear bedroom addition roof should be sealed to prevent future water penetration.

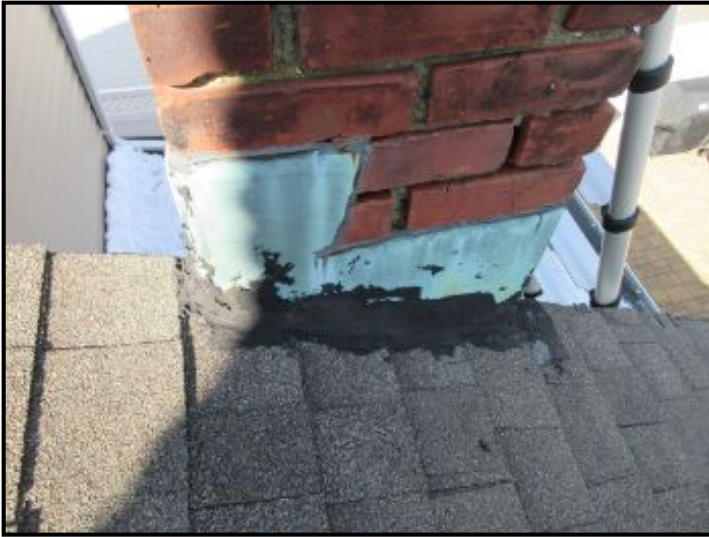
Copper flashing visible around chimney.

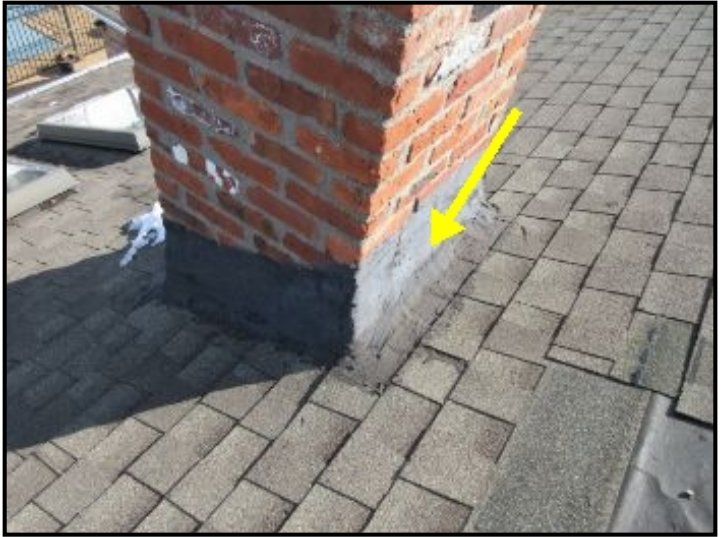
Flashings are mastic covered, recommend periodic re-sealing all through the roof vents and projections as a part of routine maintenance.

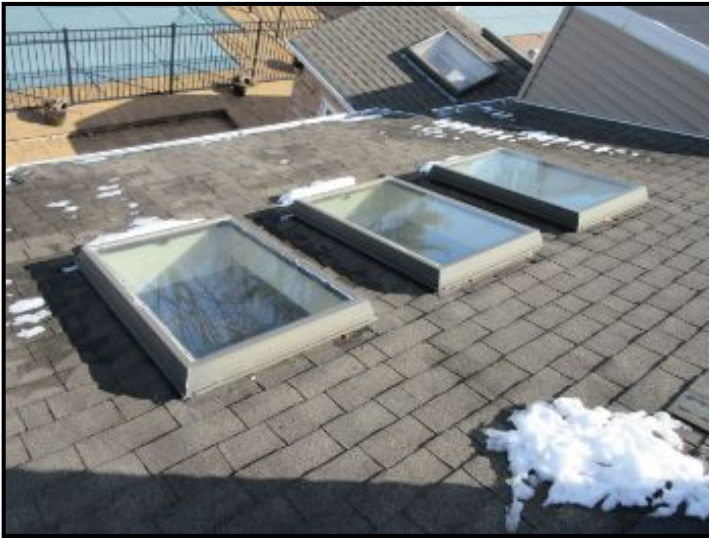
Skylights did not display any outward signs of active or past leaks at time of inspection.

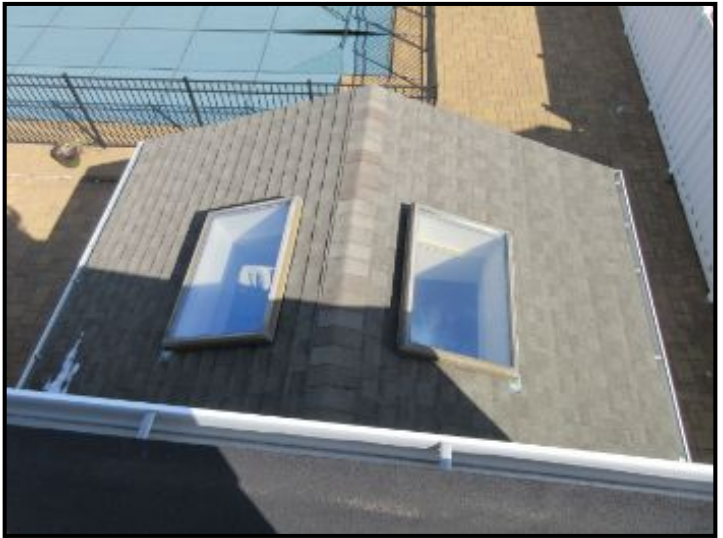
Roof over kitchen addition. Skylights did not display any outward signs of active or past leaks at time of inspection.

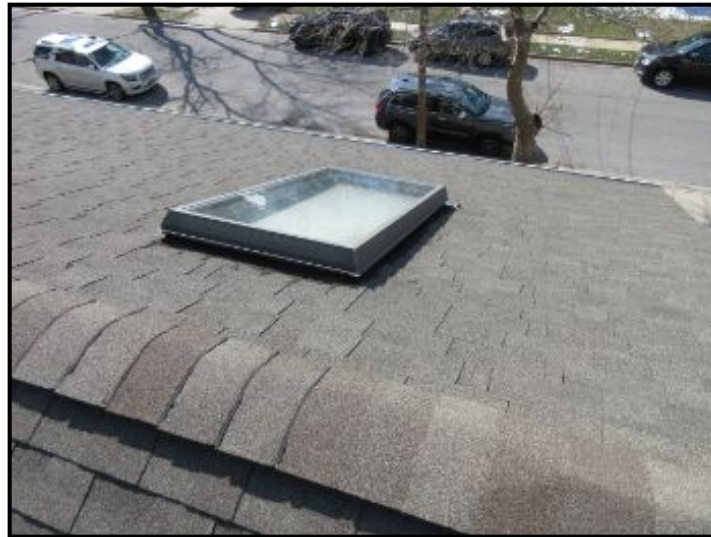
Master bedroom skylights did not display any outward signs of active or past leaks at time of inspection.

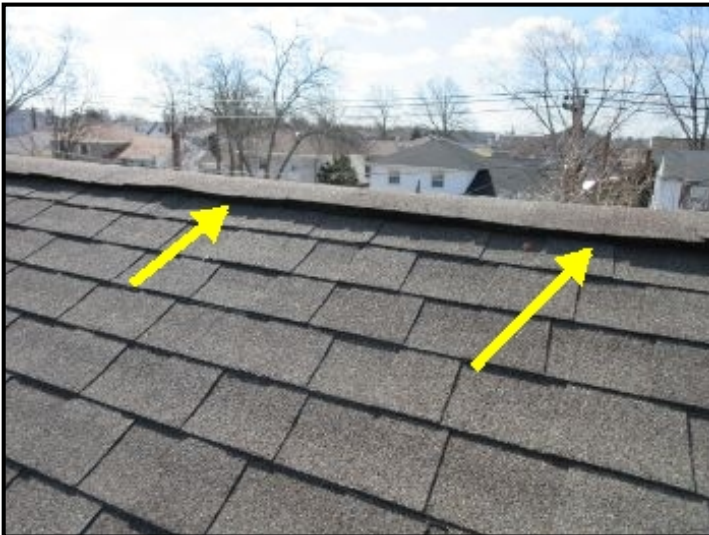
Ridge vent noted for attic ventilation.

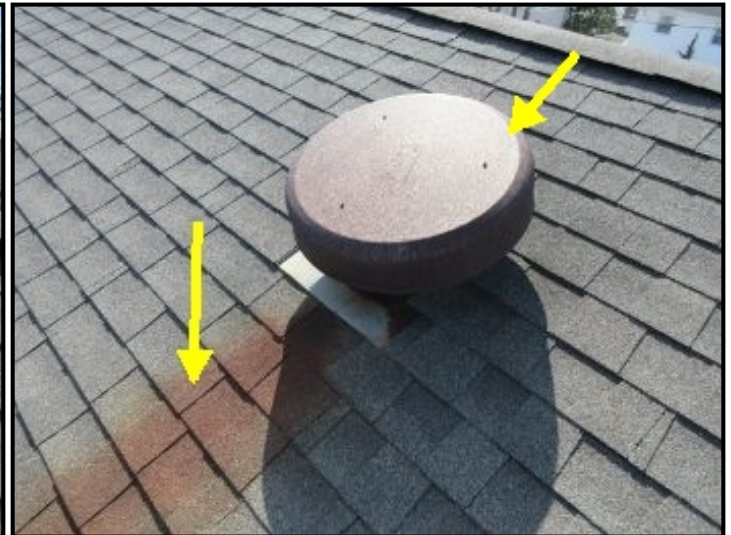
Power roof vent noted for attic ventilation. Rusty vent cover staining roof shingles.

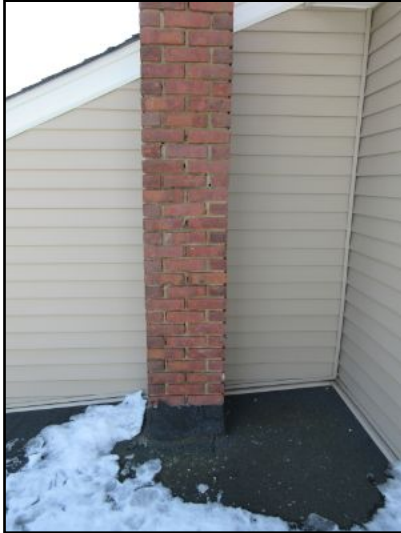
West chimney mortar shows sign of deterioration. Recommend repointing mortar joints where needed to prevent further degradation. The chimney is otherwise structurally sound.

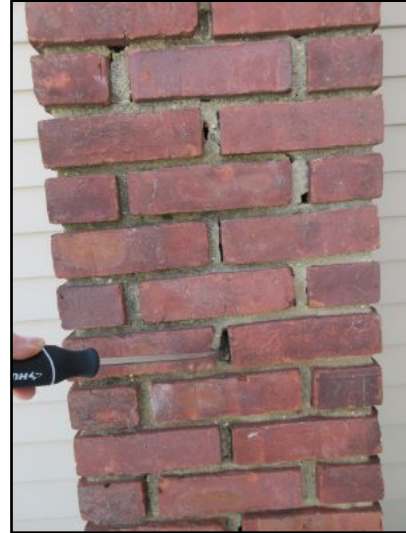
West chimney mortar shows sign of deterioration. Recommend repointing mortar joints where needed to prevent further degradation. The chimney is otherwise structurally sound.

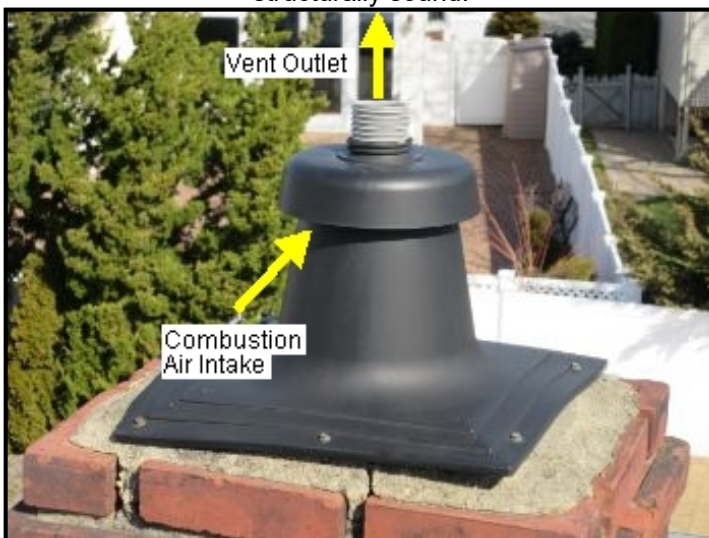
Combustion air intake/outlet (concentric vent termination) for tankless water heater located in basement.

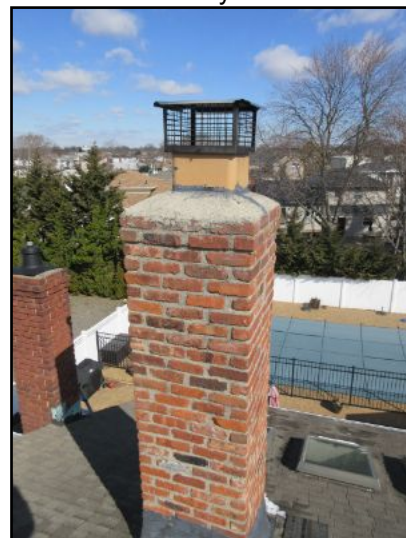
Fireplace chimney showed no major system safety or function concerns noted at time of inspection.

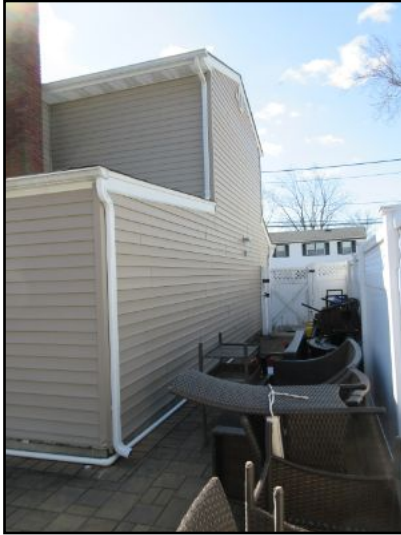
- Cosmetic finishes (gas pipe covering) with sections missing.

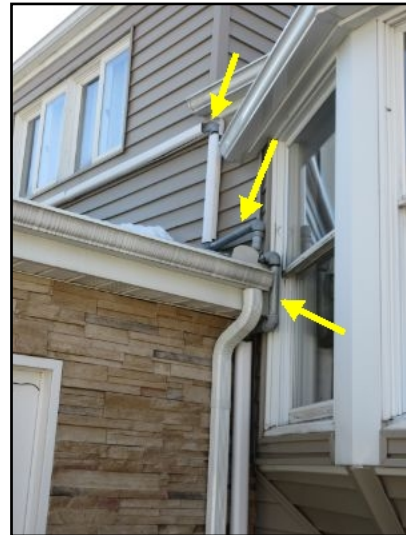
Cosmetic finishes (gas pipe covering) with sections missing.

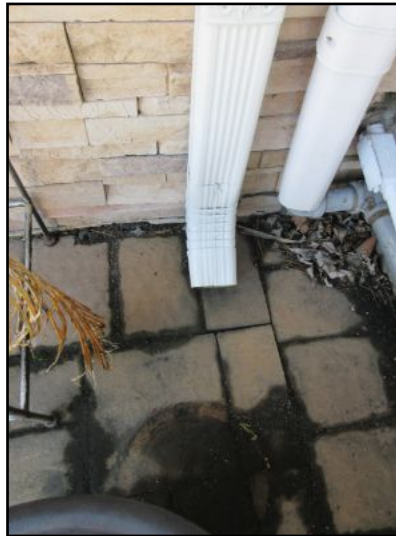
Downspout extensions missing. Recommend extending downspouts 4 ft minimum where possible to direct run-off away from structure and prevent water seepage through foundation walls. Adding dry well(s) may be considered as an option where necessary.

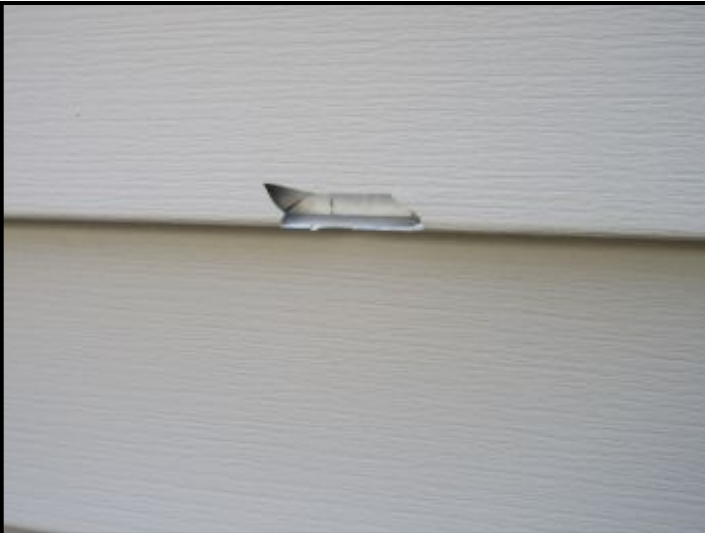
Vinyl siding damage noted at west exposure. Recommend repair or replacement of damaged section to prevent moisture intrusion of the wall assembly.

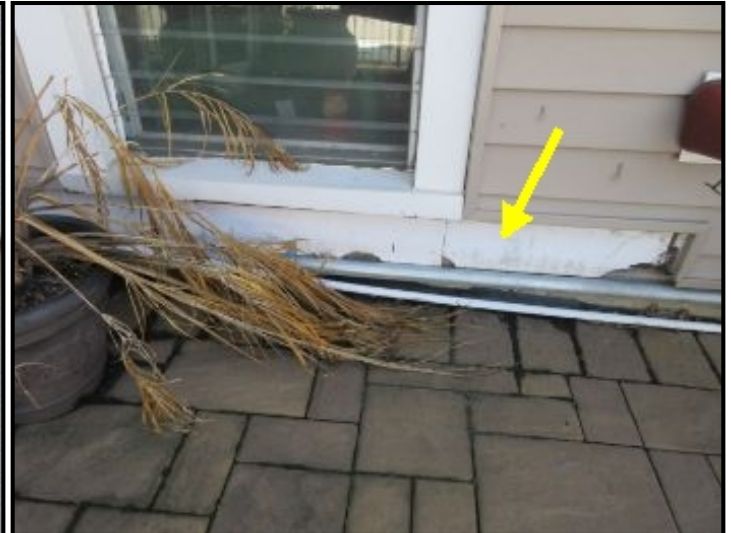
Asbestos cement siding noted beneath vinyl siding. Recommend covering with vinyl siding to prevent water penetrating the structure.

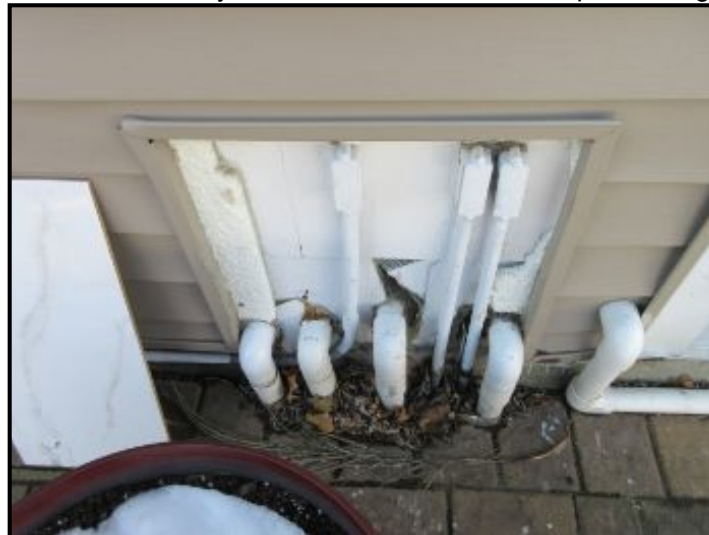
Pool filter pipe cover missing at garage rear exterior wall. Suggest fabricating a water resistance cover for cosmetic purposes.

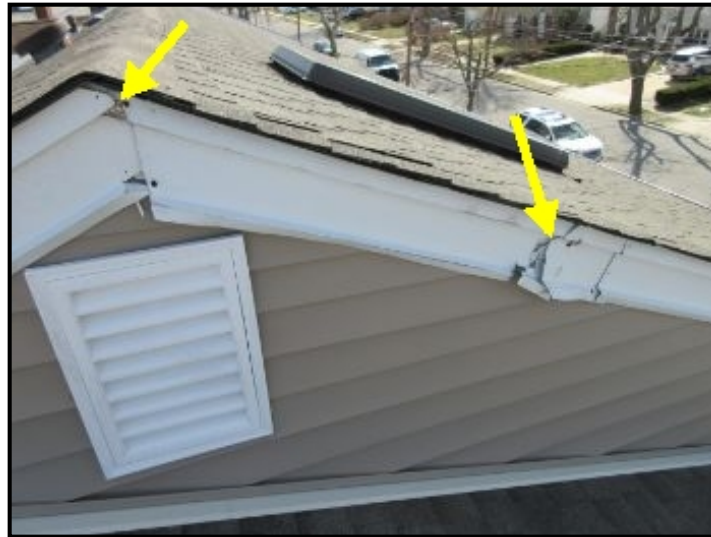
Cosmetic damage noted at aluminum cladding over barge board at west exterior. Suggest repair to prevent water penetration.

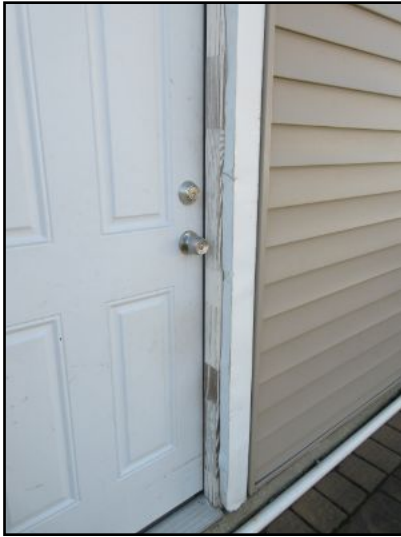
Paint on garage service door frame is beginning to get weathered.

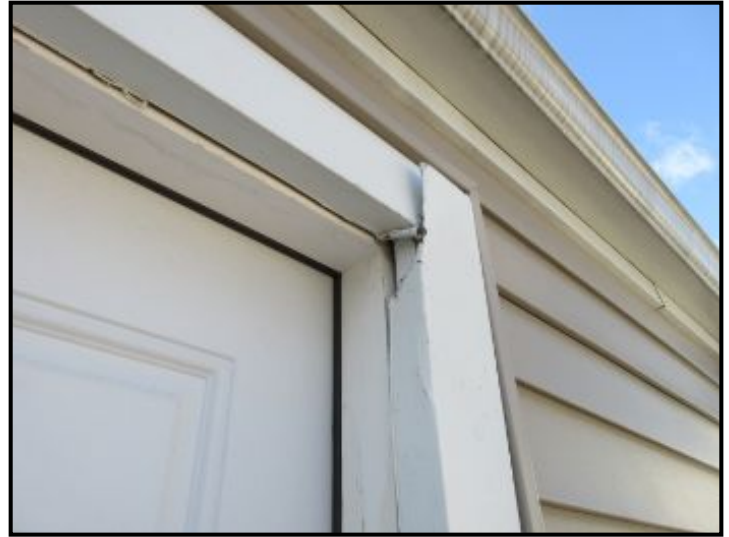
Cosmetic damage noted at garage service door frame trim.

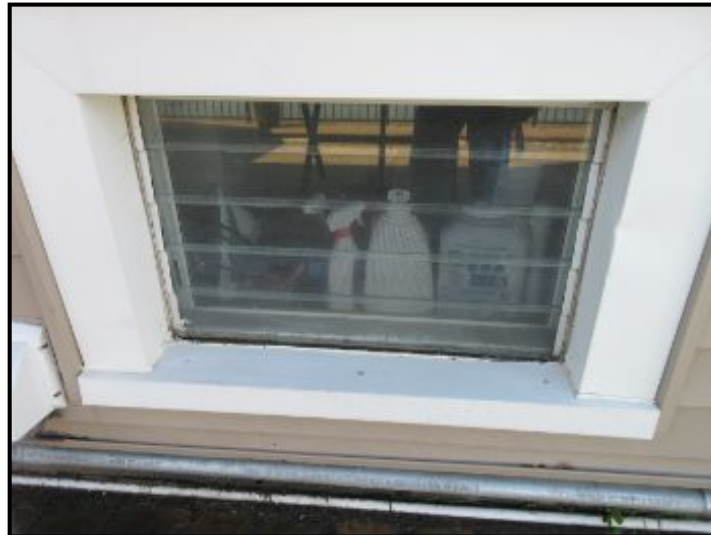
Aluminum framed Louvered windows noted. Recommend updating basement windows to insulated glass vinyl type windows for energy efficiency, maintenance and aesthetic reasons.

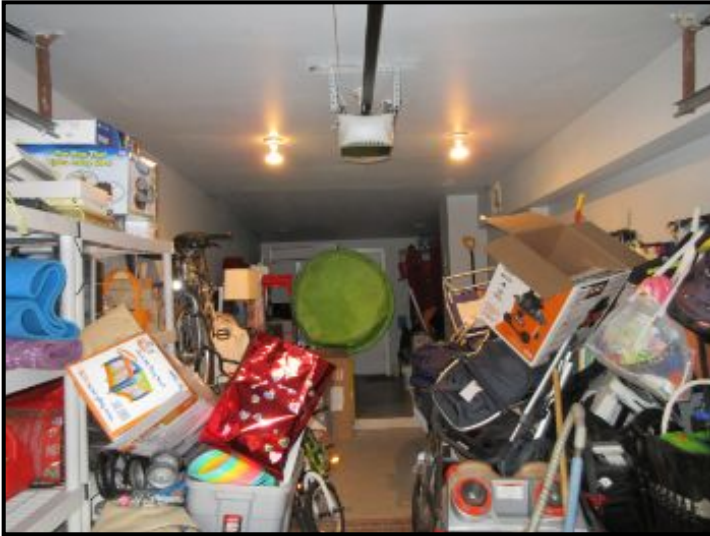
Garage walls and ceiling finished in drywall. Condition was filled with stored items.

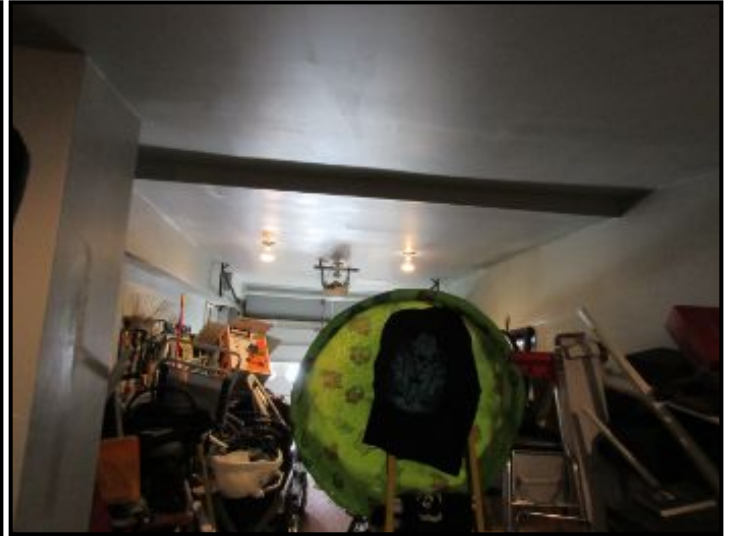
Garage walls and ceiling finished in drywall. Condition was filled with stored items.

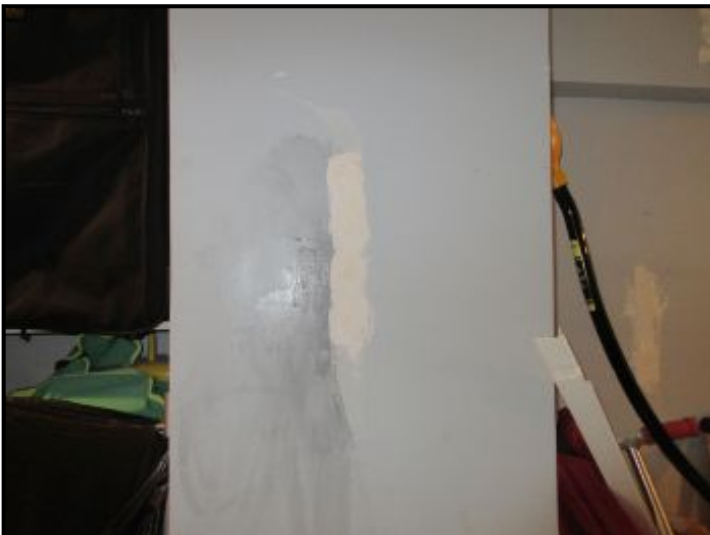
Garage drywall repairs unfinished.

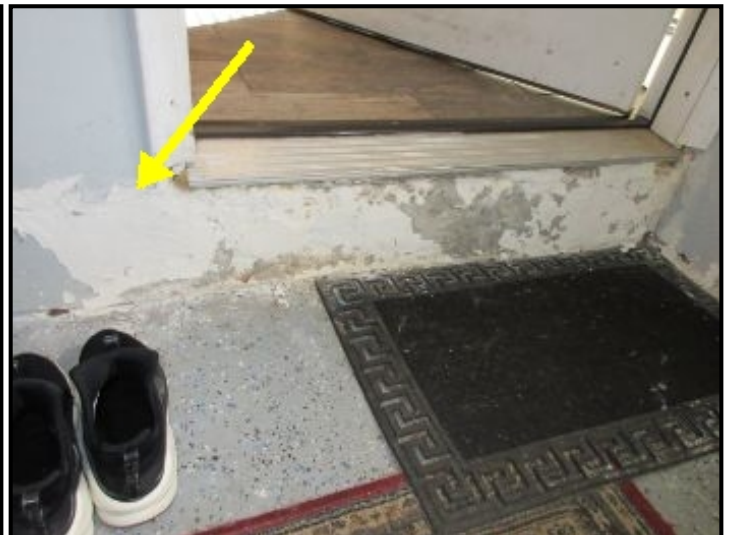
Drywall cover damaged at step riser.

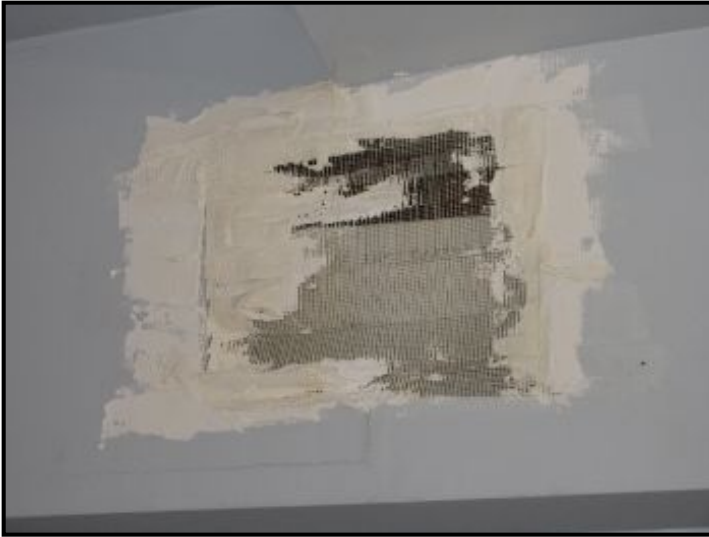
Attached garage interior wall penetration needs to be closed to prevent air communication to the home interior, and to provide the required fire rating per building standards.

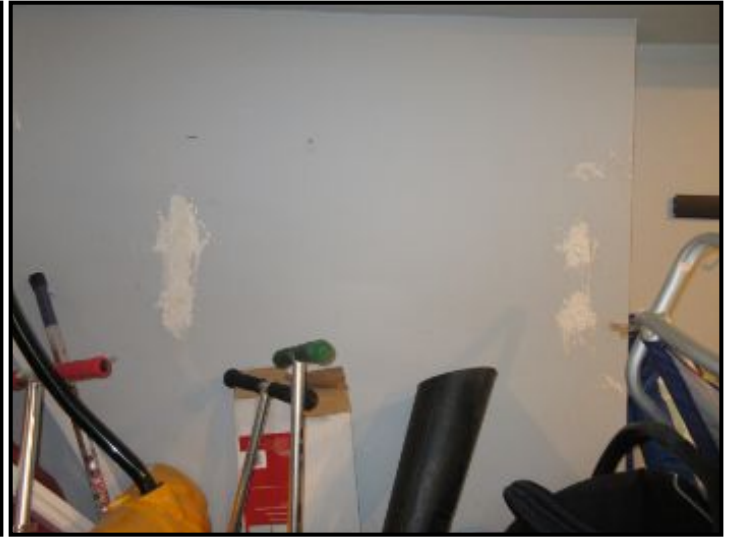
Garage drywall repairs unfinished.

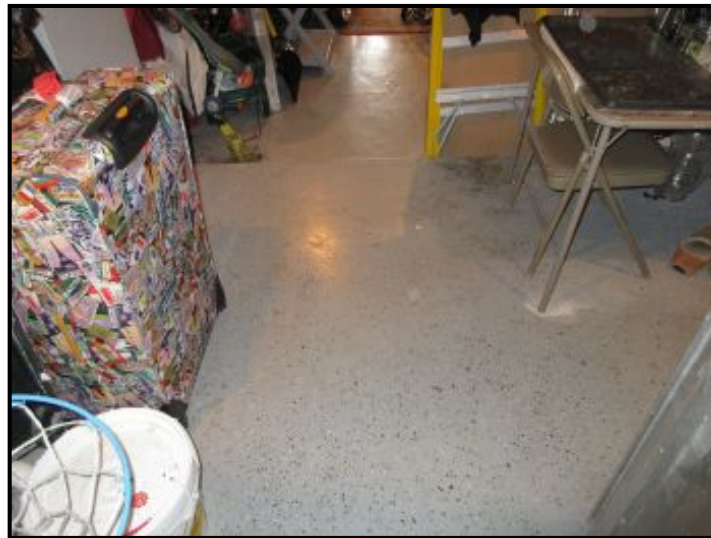
Epoxy coated floor in good conditions with minimal cracks.

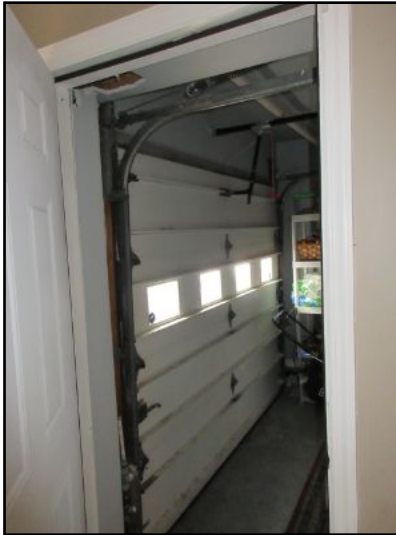
There is no self-closing device on the door from the house leading to the garage. It is strongly recommended that one be installed in order to protect the residence against garage originated fires.

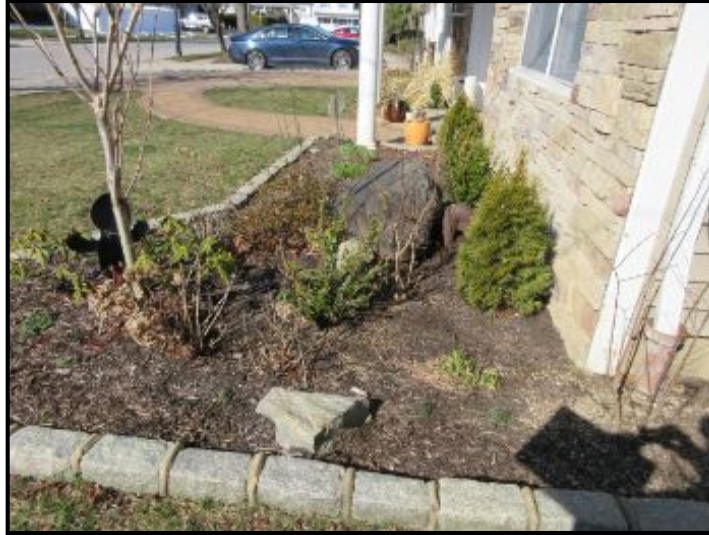
Perimeter Grading: Appears to slope towards building in areas. Recommend grading soil so it slopes down and away from the building to direct rainwater away.

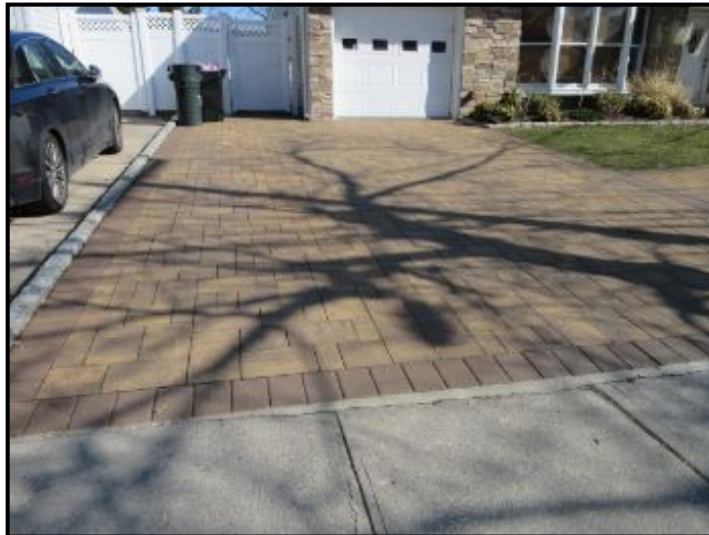
3. Sidewalk & Walkway

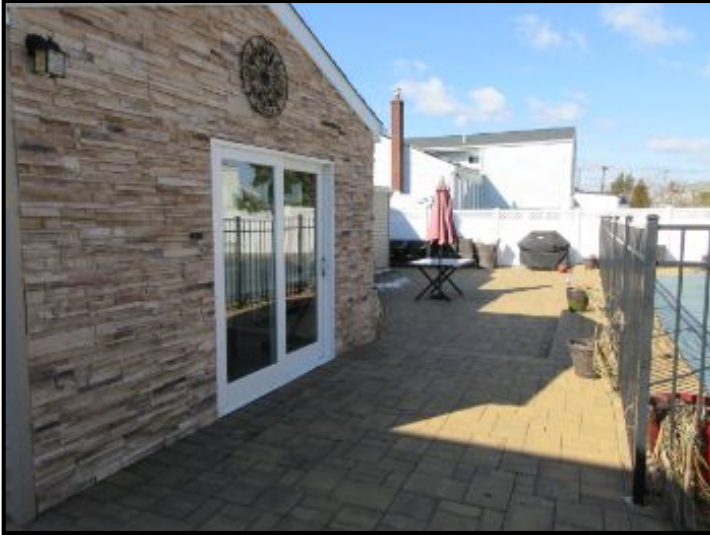
- Stone face missing at step riser.
- Floor mounted receptacle conduit broken; potential for water entry into conduit. Recommend priority repair.

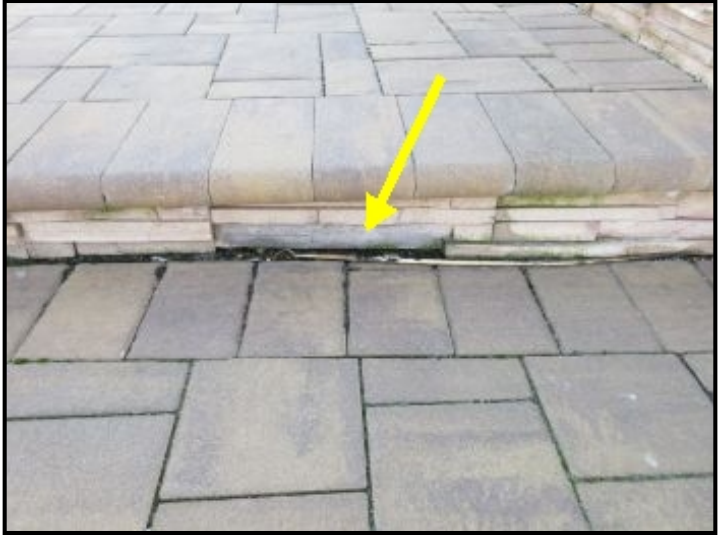
Stone face missing at step riser.

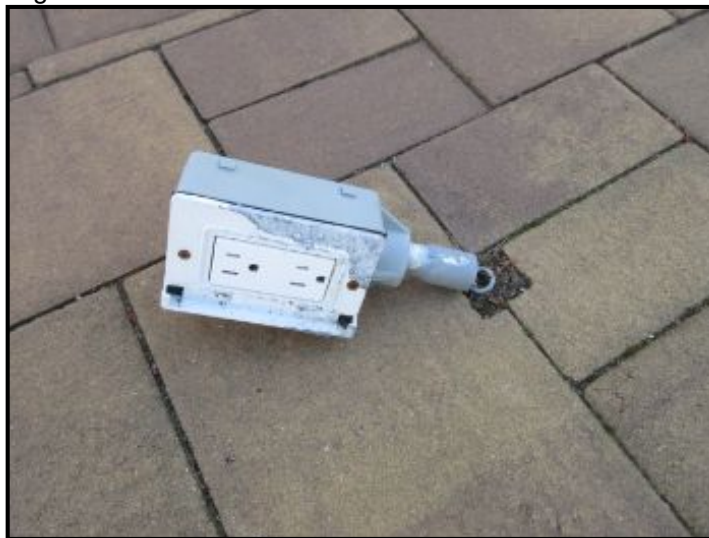
Floor mounted receptacle conduit broken; potential for water entry into conduit. Recommend priority repair.

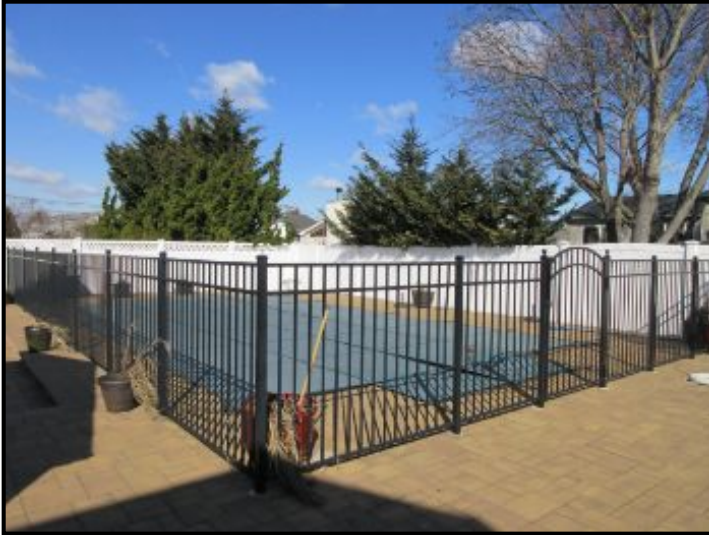
Pool area aluminum fencing in serviceable condition.

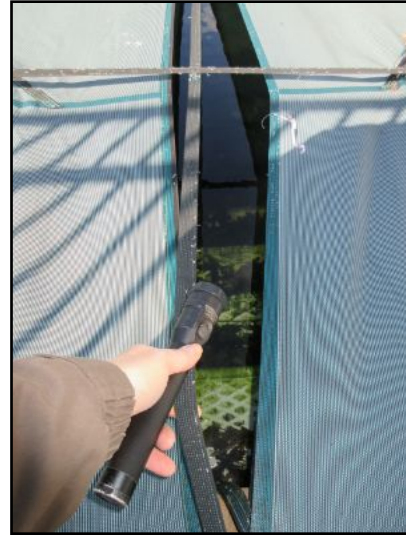
Pool not inspected. Recommend seller allowing for a qualified pool contractor inspect the pool liner for possible defects caused by ground settlement.
