# ProSpec Home Inspection of Long Island Property Inspection Report

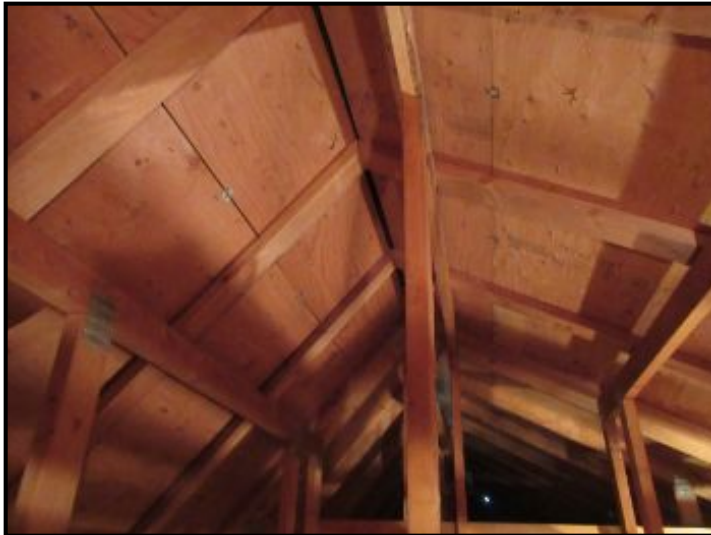
Roof boards appeared dry and unstained.

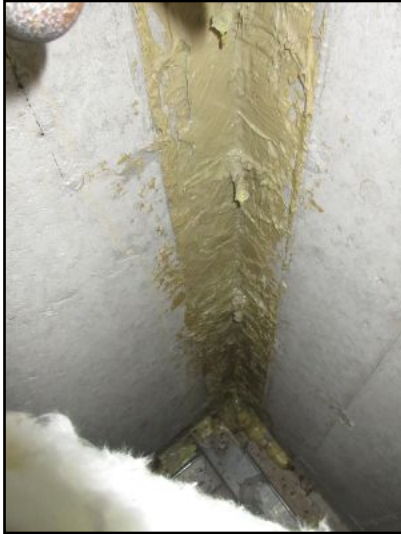
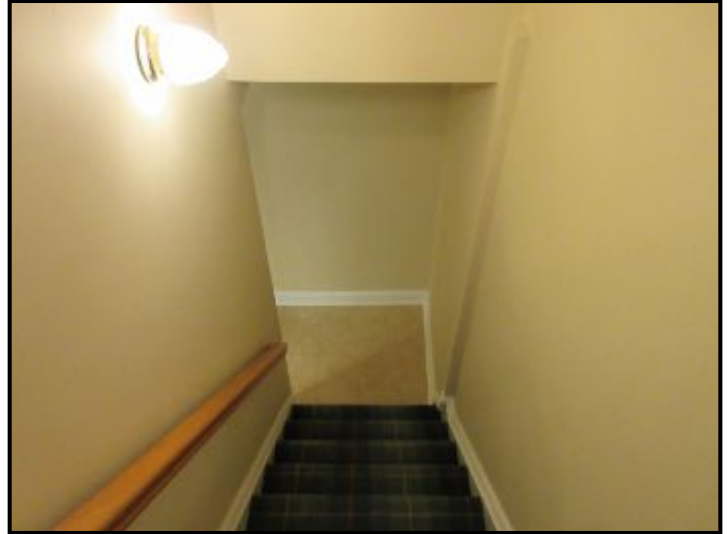
Basement stairs with handrail, lighted and in good condition.

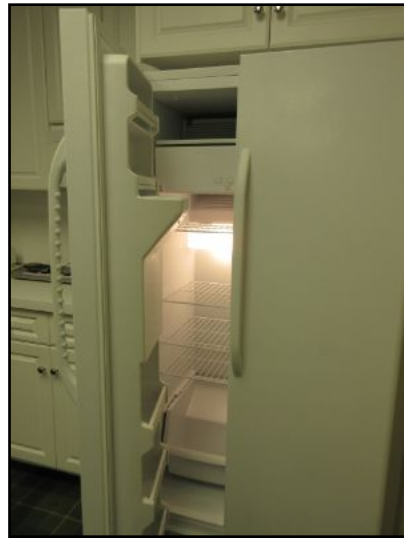
Basement refrigerator was operable and frost free.

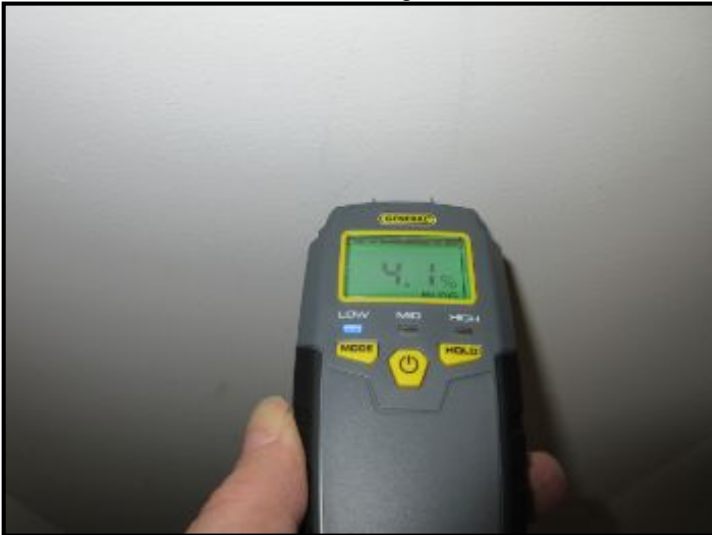
Moisture measurements taken at sample locations in the basement indicated "Low" moisture levels (left blue light on meter).

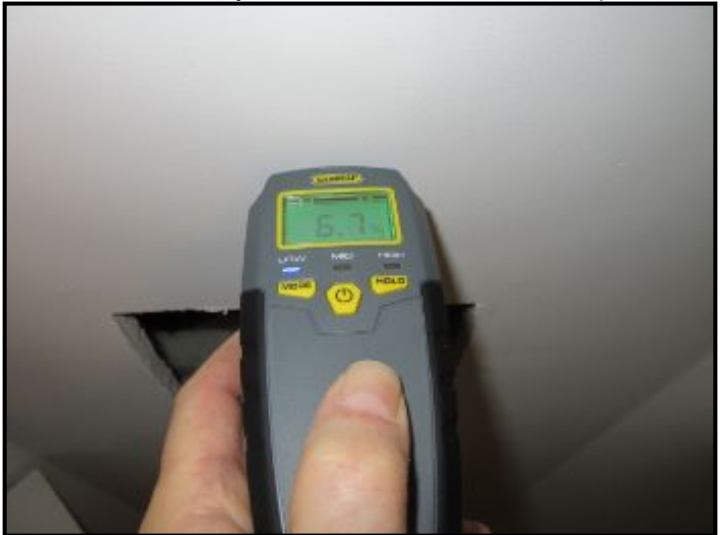
Moisture measurements taken at water service entrance in the basement indicated "Low" moisture levels (left blue light on meter).

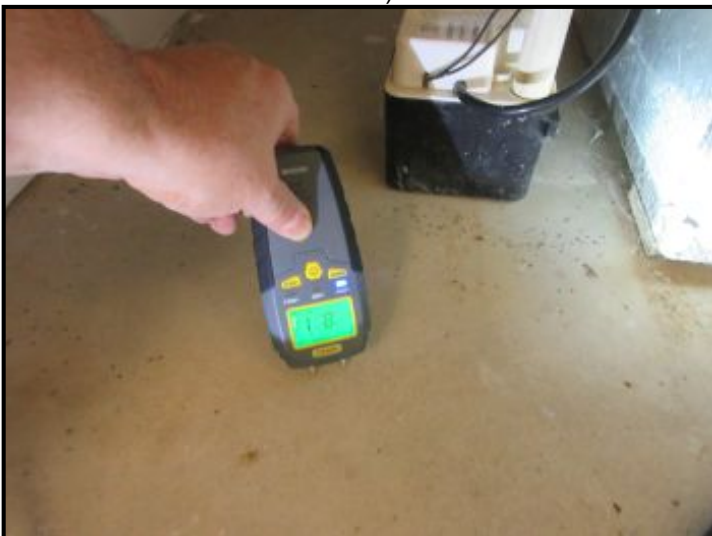
AC-3 air handler closet floor moisture reading was "Low".

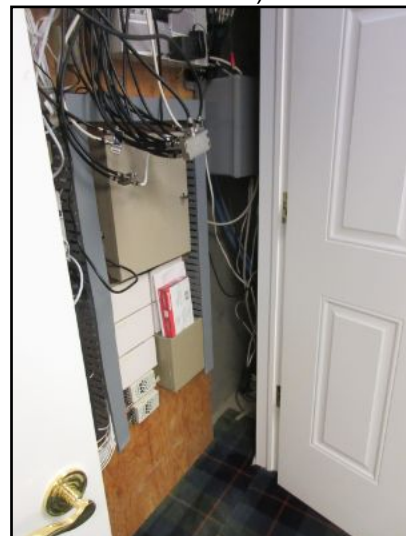
Checking south wall cavity conditions at electrical closet.

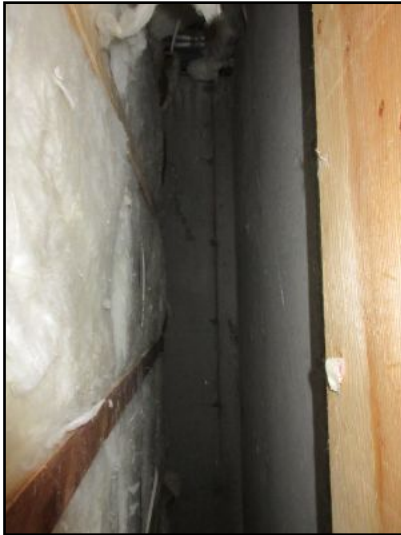
South wall cavity was dry; no musty odor.

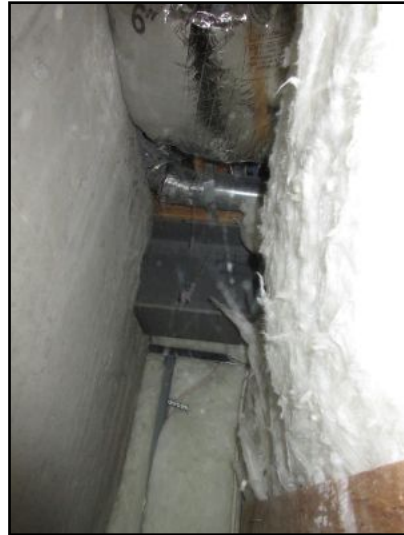
Steel beam noted above at south wall cavity; supports floor joist system.

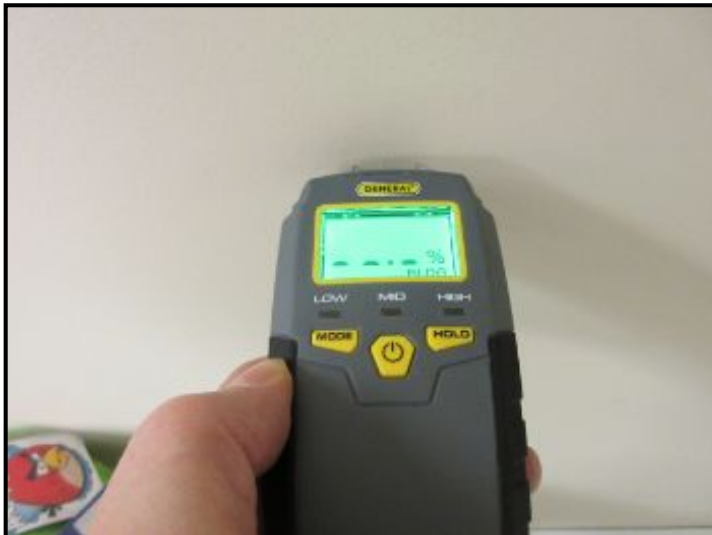
Moisture level at this location in was too low to register a reading.

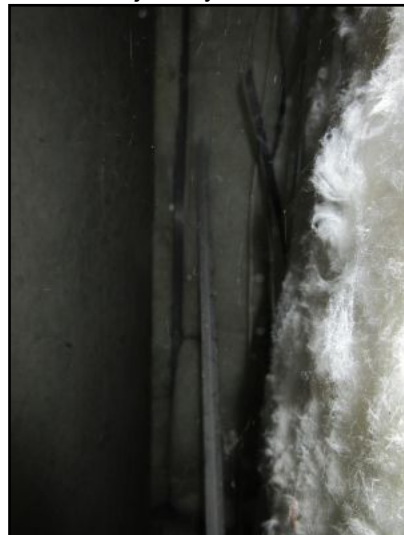
Accessible wall cavities were dry; no musty odor.

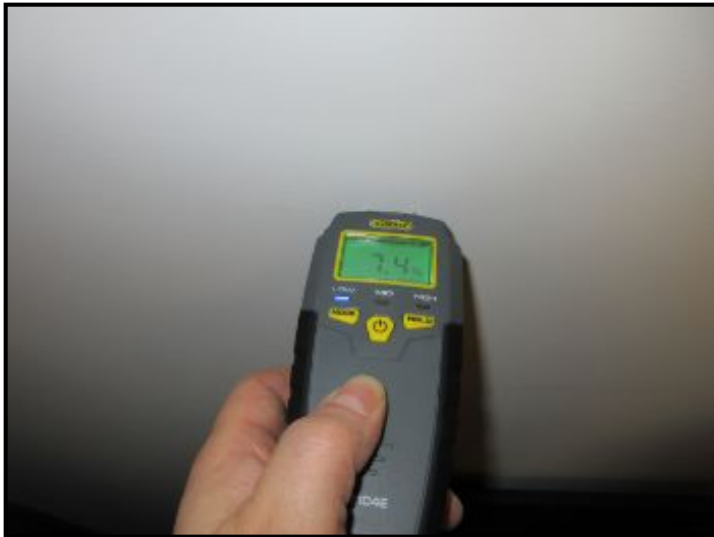
Moisture measurements taken at sample locations in the basement indicated "Low" moisture levels (left blue light on meter).

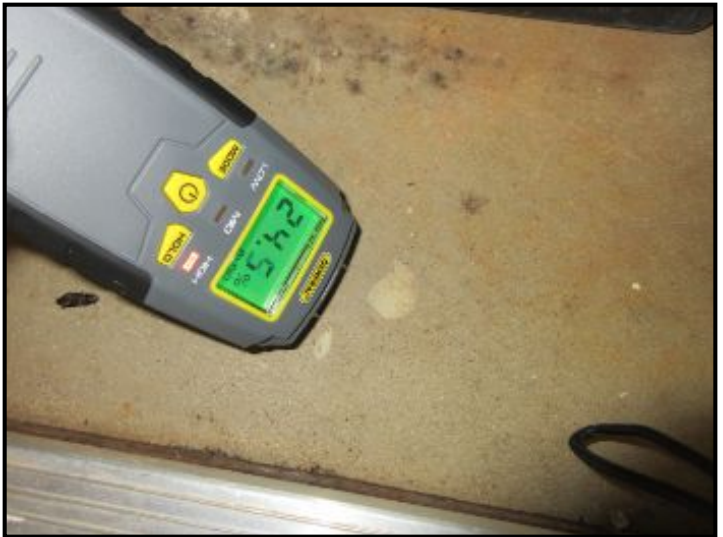
AC-4 Closet floor measured "high" moisture content due to condensate pump suspected to have been overflowing. See related notes. This was the only high moisture level reading taken.

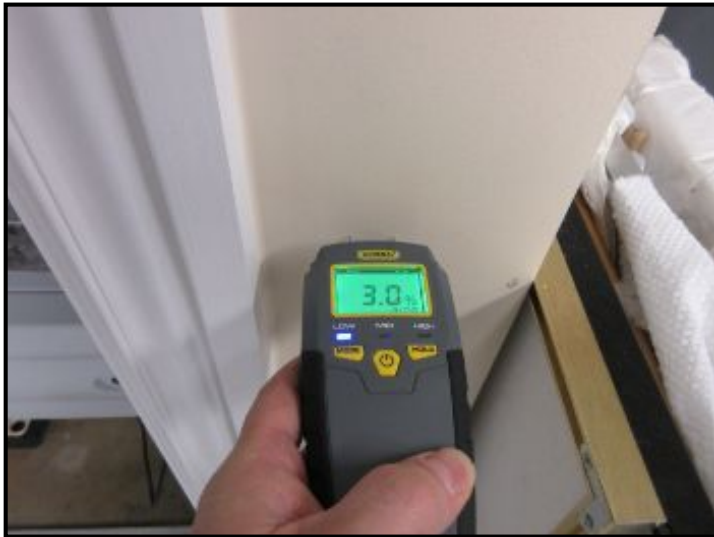
Wall outside AC-4 closet measured "Low" moisture content

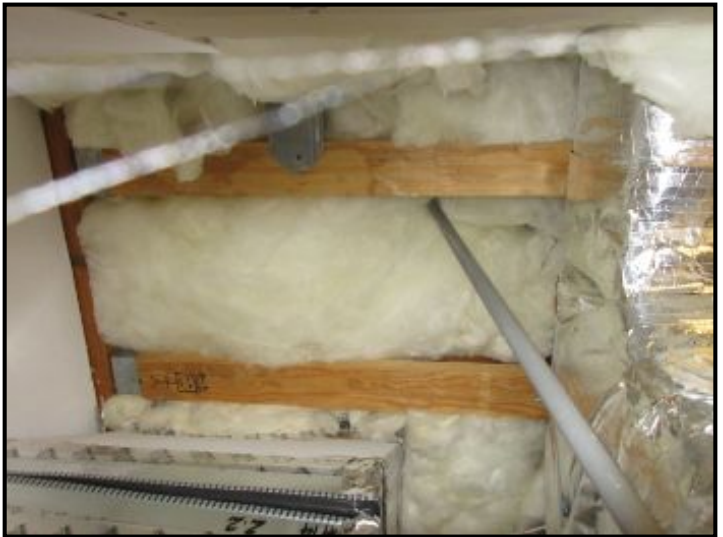
Floor Structure (above AC-4 closet): Engineered Joists - Laminated Veneer Lumber (LVL) or (Microllam) used. 16" O.C. Floor joist cavities are insulated.

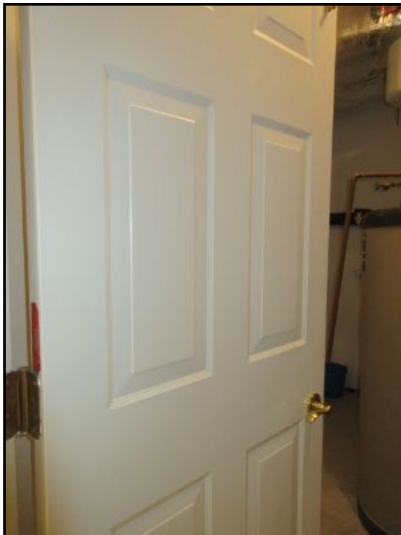
Fire resistant boiler room door in accordance with NFPA requirement.

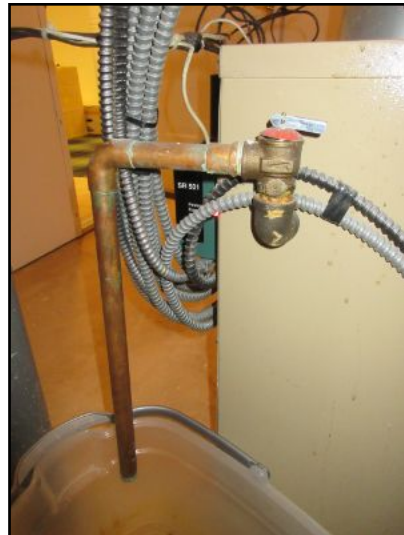
TPR valve leaks into a basin at the floor. This usually means that either the TPR valve, or the expansion tank is defective. Otherwise, the supply water regulator is either missing or it's not adequately reducing the supply water pressure to the boiler system. We recommend a licensed HVAC contractor review and repair as necessary to stop TPR valve leakage.

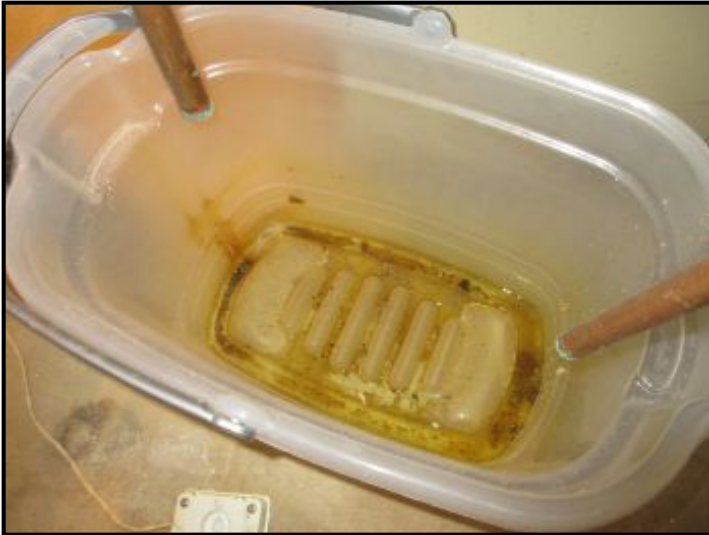
TPR valve (pipe on left) observed to leak into a basin at the floor.

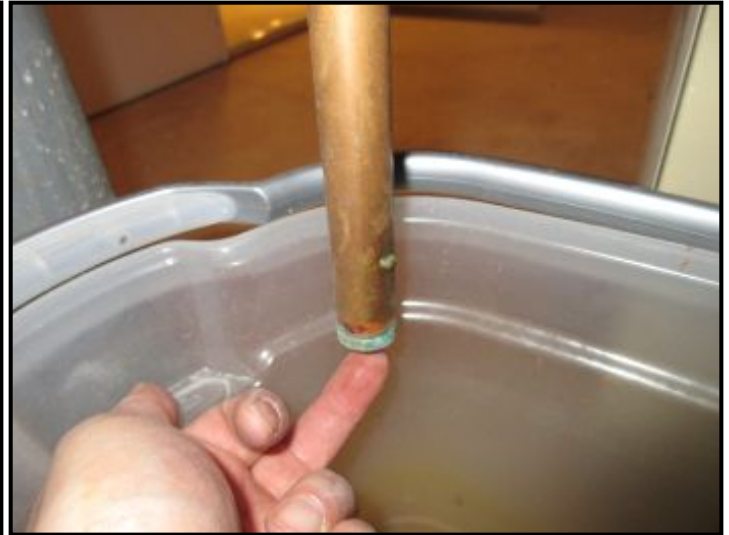
TPR valve (pipe on left) observed to leak into a basin at the floor.

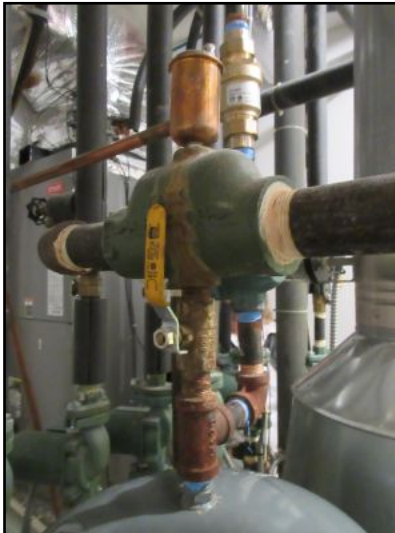
Automatic air vent atop air separator fitting shows signs of leakage, rusting steel pipe surfaces. This may also be caused by the same concerns relative to the TPR valve leak.

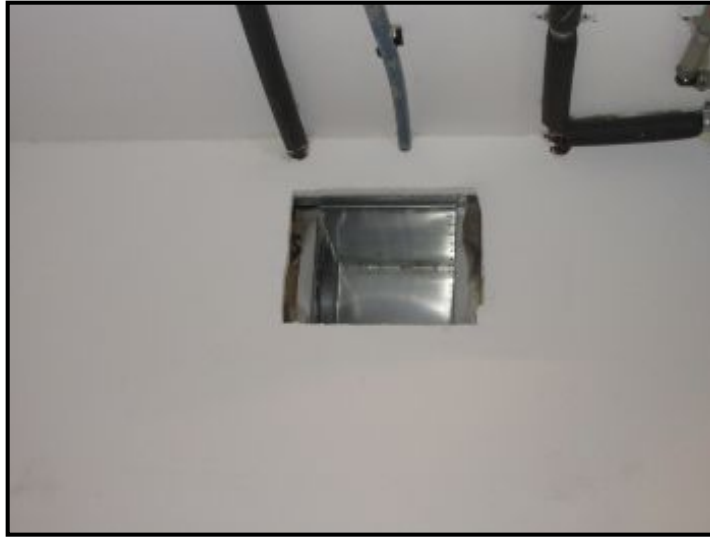
Combustion air is introduced/vented from an outside source. Maintain clearance of this vent at all times.

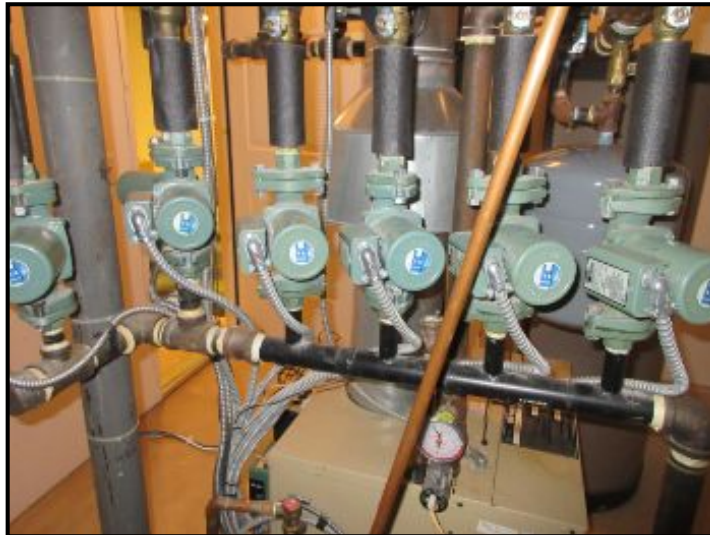
6-zone home heating with separate zone for integral domestic HW storage tank heating.

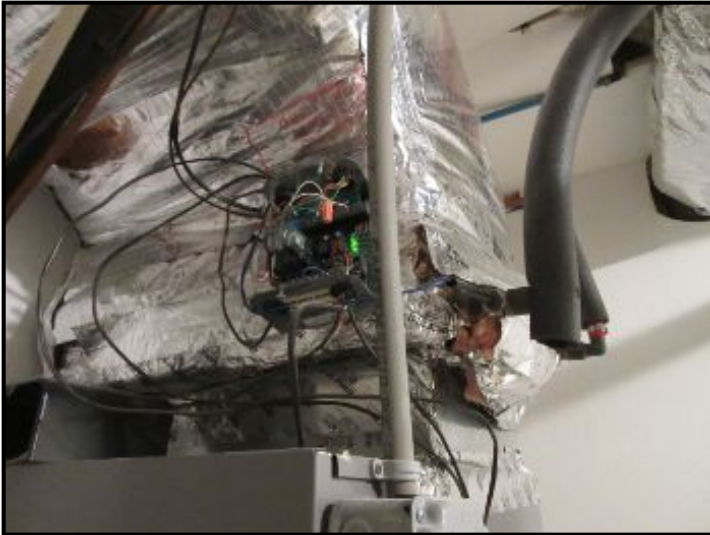
AC-1: Cover removed from HW heating coil controller and left on top of air handler. Suggest having HVAC technician check controller operation, repair as necessary and cover exposed wiring/components.

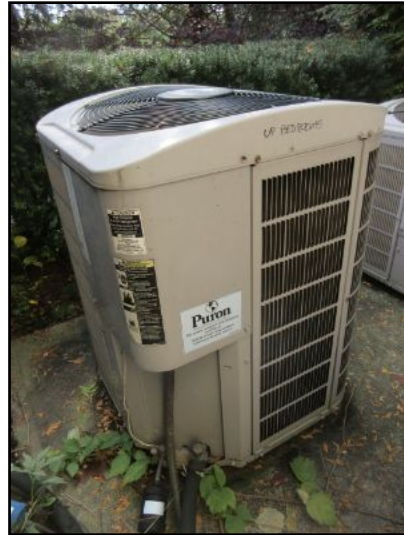
AC-2 condensing unit provides cooling; works in conjunction with the air handler located in the attic and serves the 2nd floor (south-side/bedrooms).

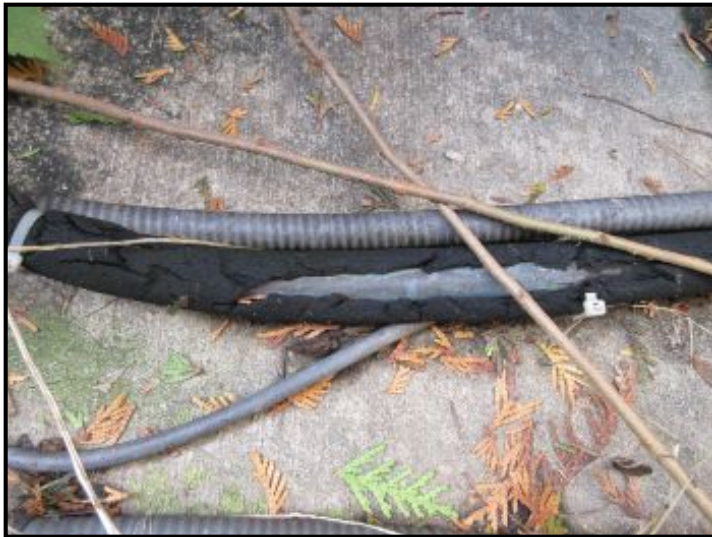
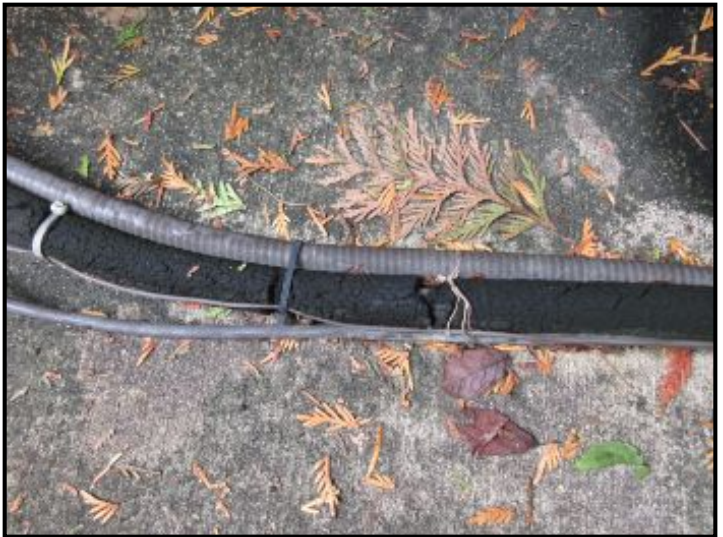
Refrigerant pipe insulation is deteriorated/missing at outdoor condensers. Recommend replacing outdoor deteriorated/missing insulation on the larger suction lines only.

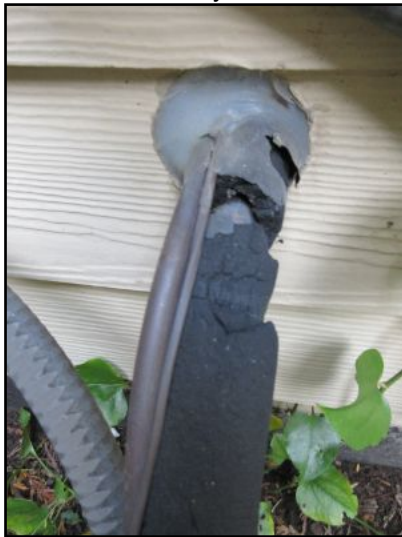
Refrigerant pipe insulation is deteriorated/missing at outdoor condensers. Recommend replacing outdoor deteriorated/missing insulation on the larger suction lines only.

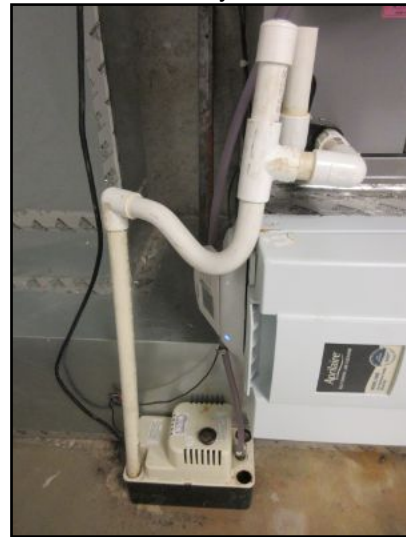
AC-4: condensate pump appeared to have been malfunctioning; pump basin has overflowed, evidenced by floor wetness here. Suggest HVAC technician evaluate and repair/replace the condensate pump.

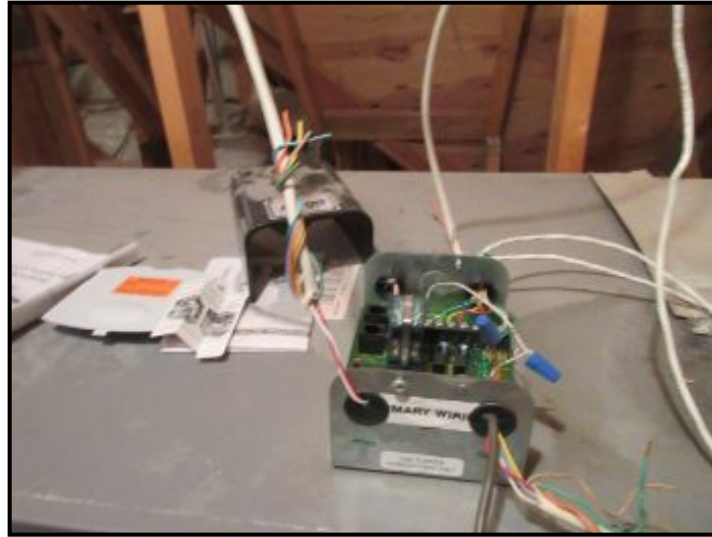
AC-5: Cover removed from HW heating coil controller and left on top of air handler. Suggest having HVAC technician check controller operation, repair as necessary and cover exposed wiring/components.

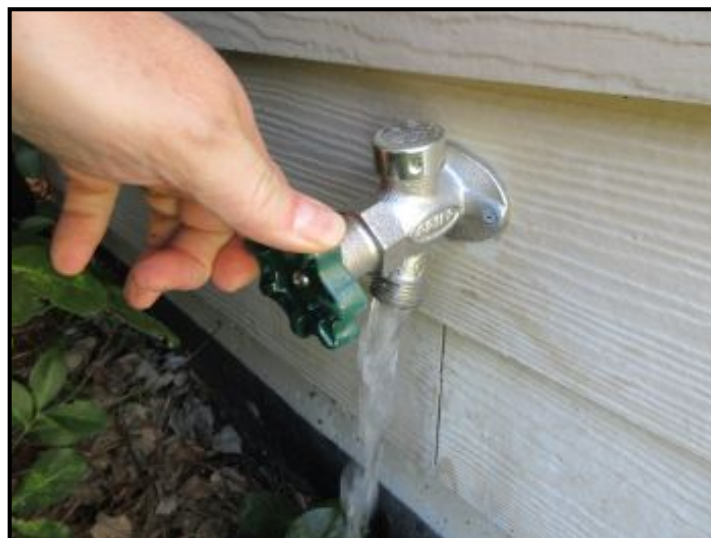
Outdoor hose bibb operable; frost free type.

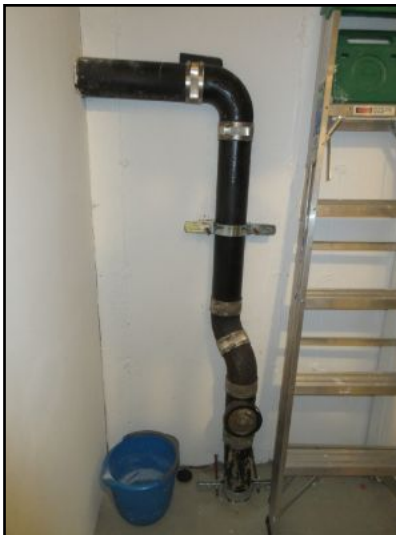
Sanitary waste pipe exit with clean-out located in boiler room.

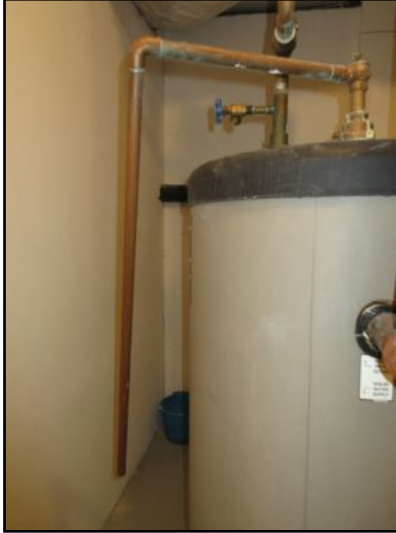
Temperature Pressure Relief (TPR) valve and discharge pipe show no deficiencies, except that it extends away from the tank, somewhat blocking access around heater.

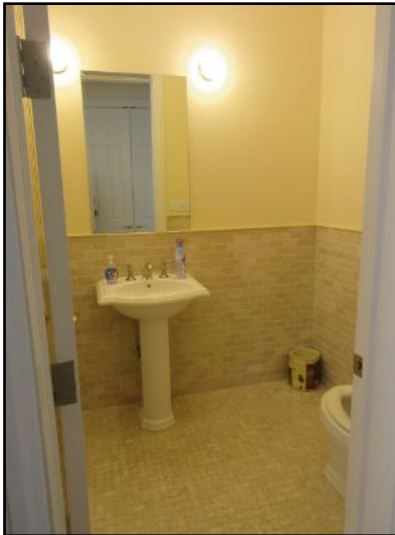
First floor hall 1/2 bath

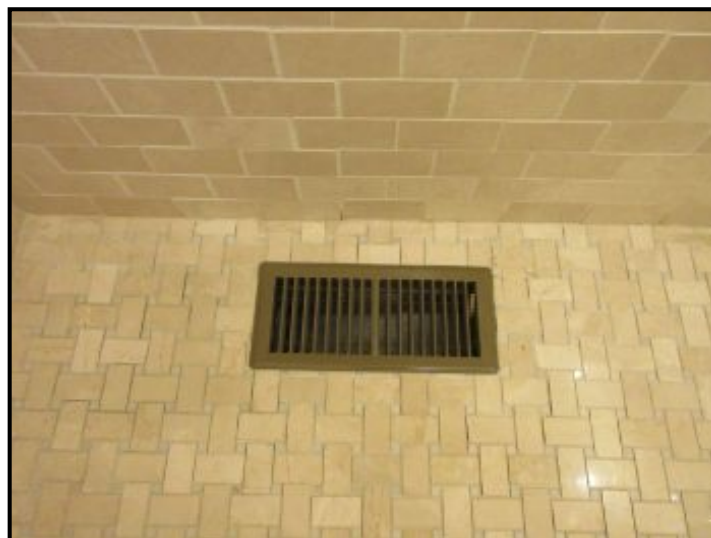
Floor supply grille may be subject to water entry.

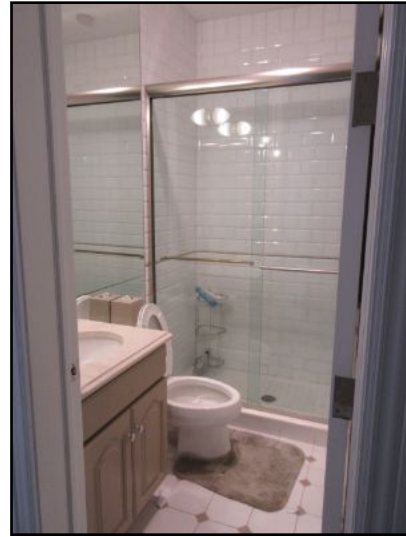
First floor bedroom bathroom

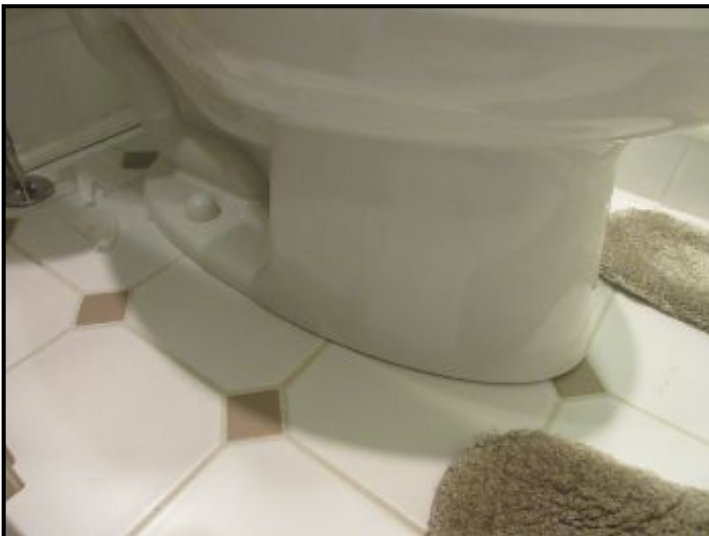
Toilet bowl is loose at floor anchor bolts. The wax ring inside the unit must have a snug, secure fit in order to keep from leaking. Properly resealing and re-securing this unit is suggested to prevent water leakage and damage to the sub-floor area. This type of damage is not always visible or accessible to the inspector at time of inspection.

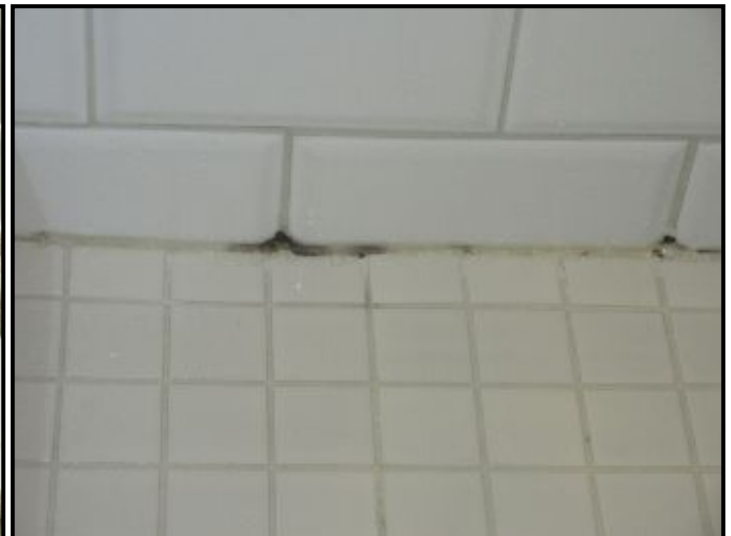
Mildew noted at shower pan perimeter.

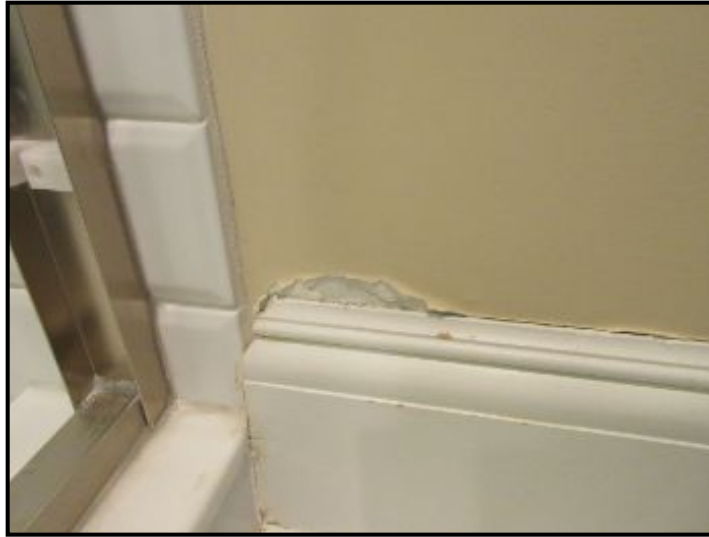
Cosmetic damage noted at wall above baseboard likely caused by shower water. Suggest wall repair and check shower door for proper seal during shower.

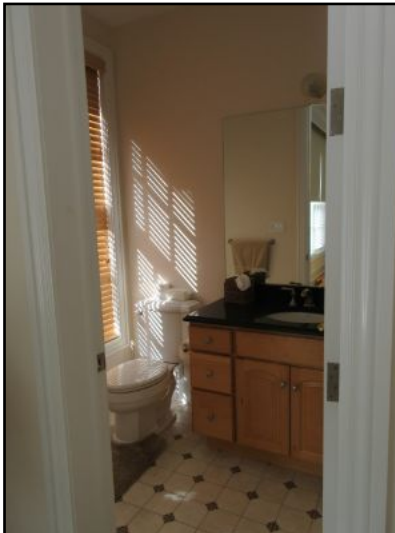
### 6. Bathroom#3 Condition

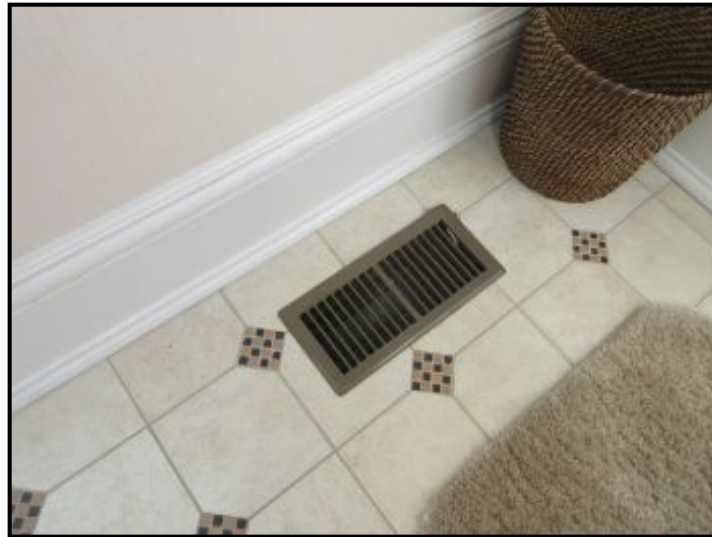
Floor supply grille may be subject to water entry.

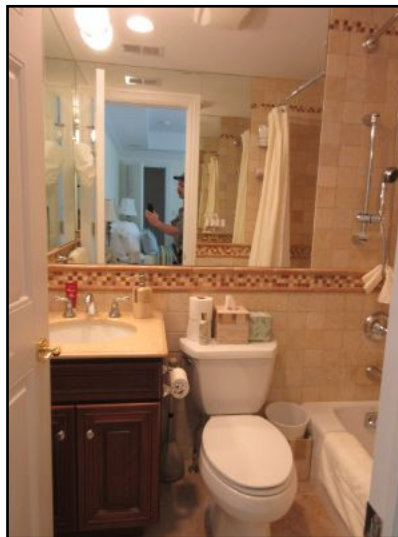
Second floor rear bedroom

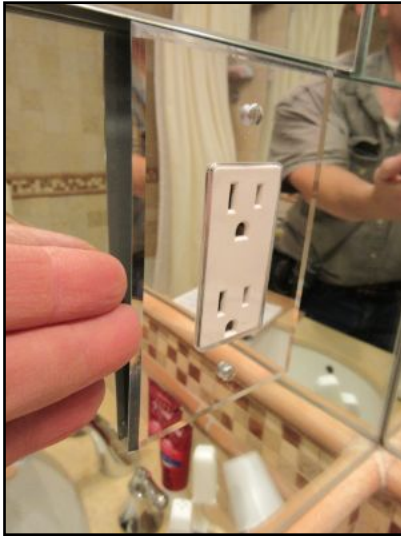
Wall receptacle not properly secured to the wall.  
Recommend repair.

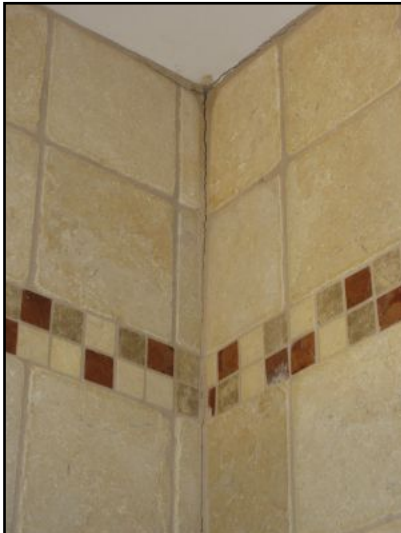
Grout cracked at tub left wall corner joint due to movement.  
This is common; suggest replacing grout with matching  
silicone based sealant at corner movement joints.

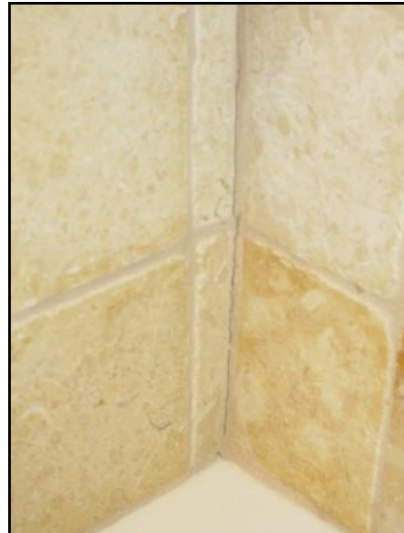
Grout cracked at tub left wall corner joint due to movement.  
This is common; suggest replacing grout with matching  
silicone based sealant at corner movement joints.

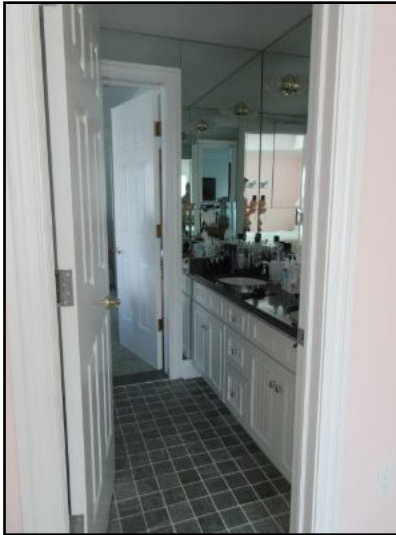
Second Floor double sink rear bathroom

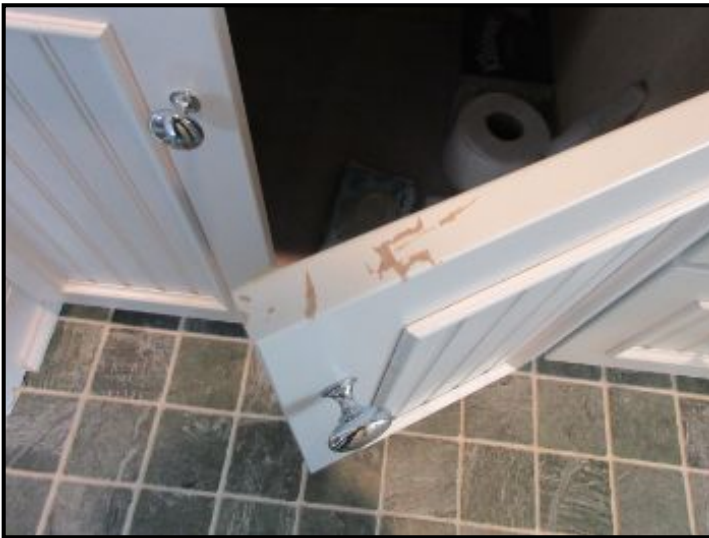
Vanity door finish shows signs of wear.

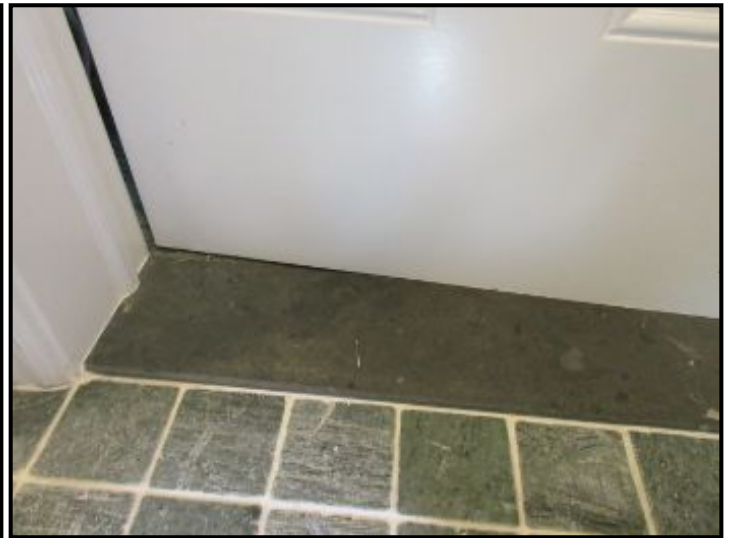
Door rubs against floor; suggest adjustment.

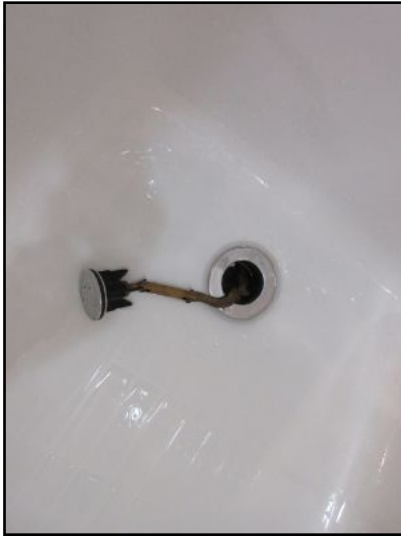
Tub stopper linkage was detached; suggest repair.

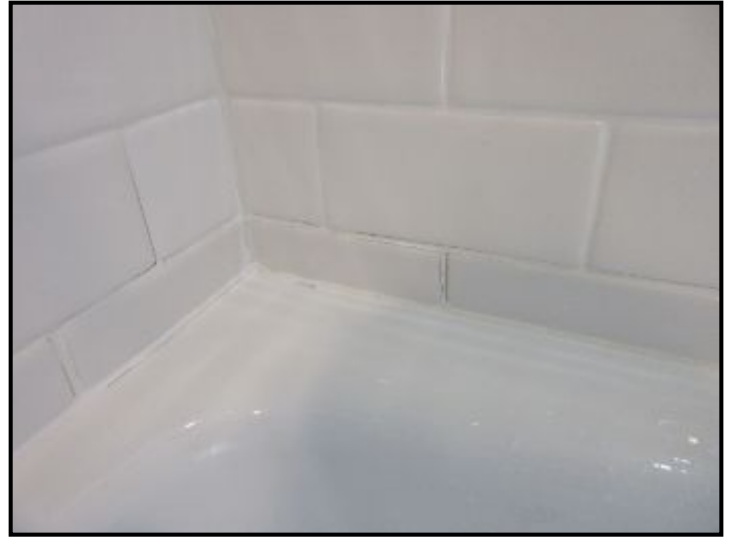
Grout slightly damaged/missing at wall tile at tub corner. Suggest grout repair to prevent water entry.

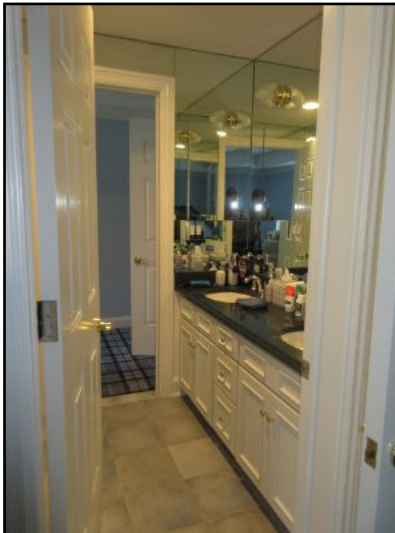
Second Floor double sink front bathroom

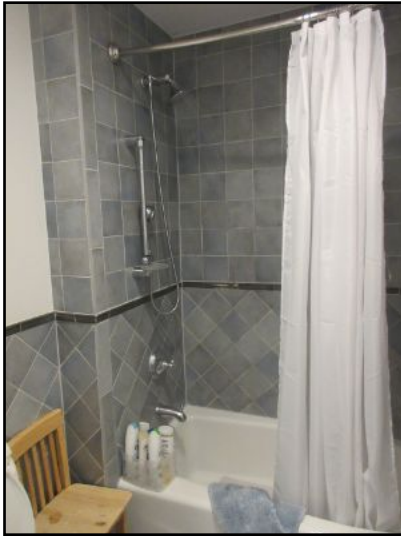
## Bathrooms Continued

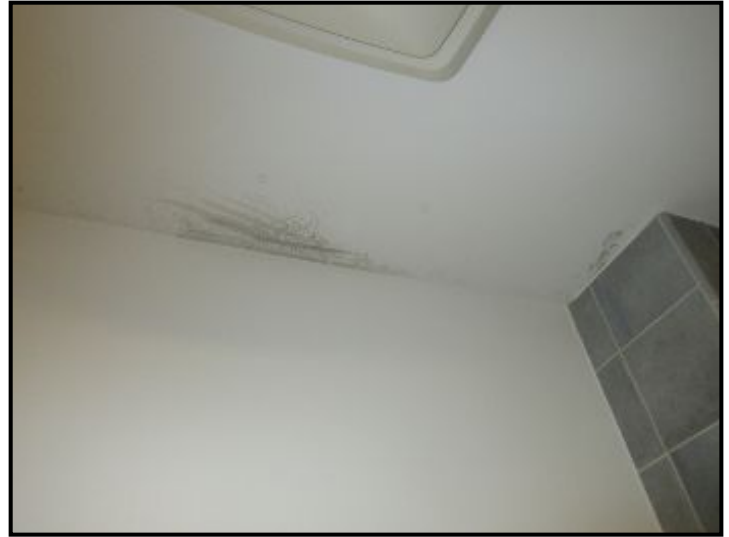
Signs of mildew noted at ceiling above tub.

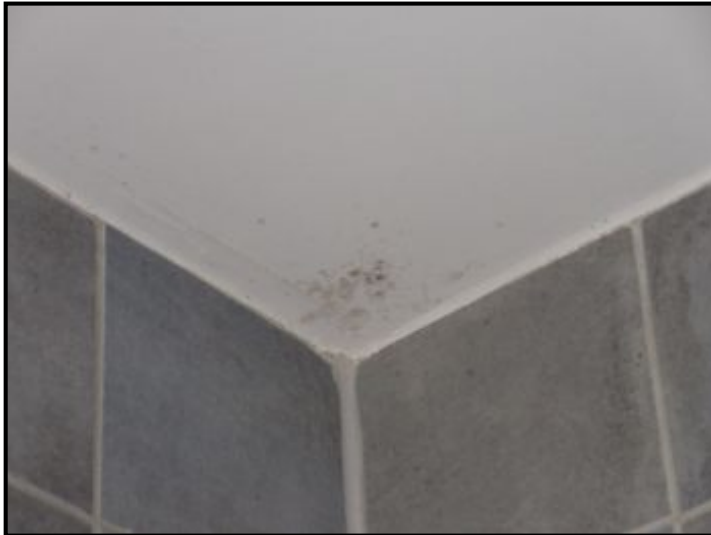
Signs of mildew noted at ceiling above tub.

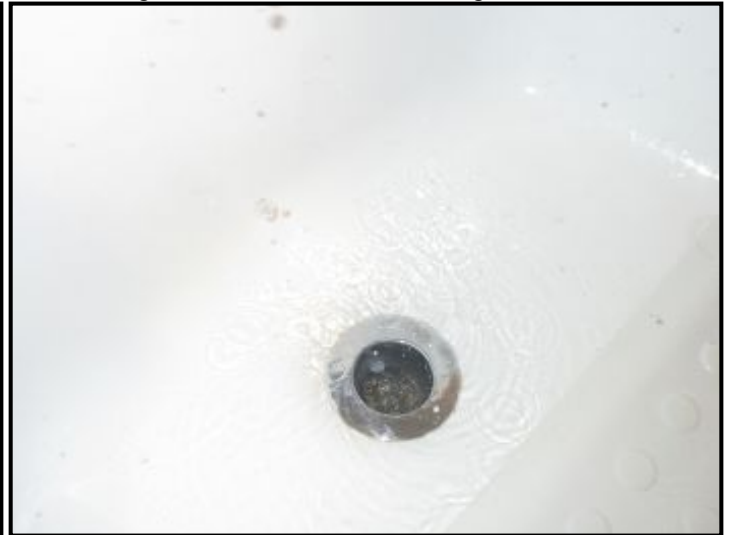
Tub stopper missing.

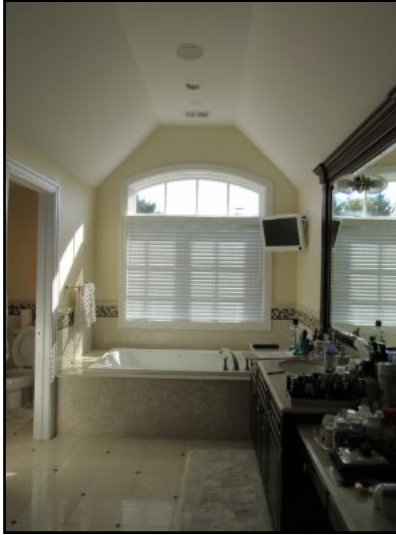
## Bathrooms Continued

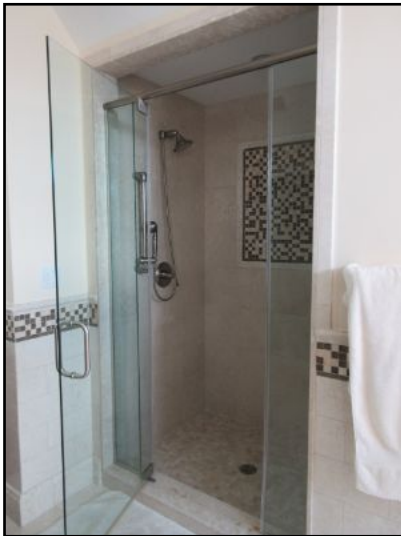
- Leaks: None Observed
- GFCI type outlet worked properly when tested.
- Signs of mildew noted at ceiling above shower.
- Condensation stains on supply register.

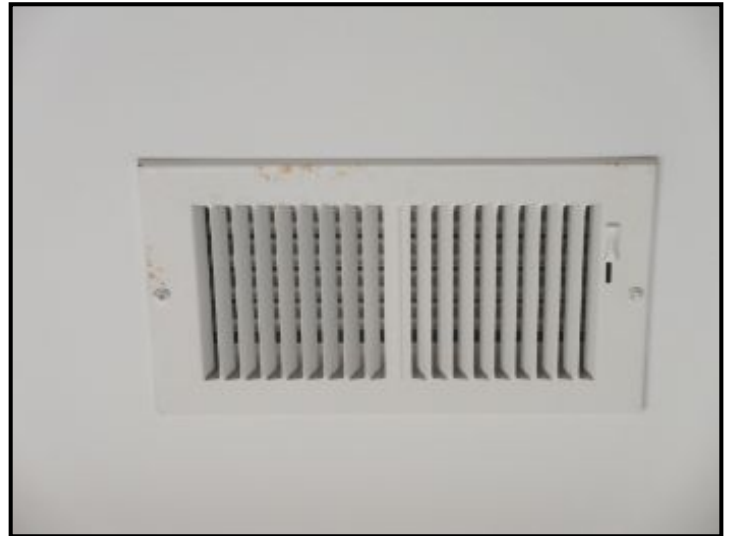
Condensation stains on supply register.

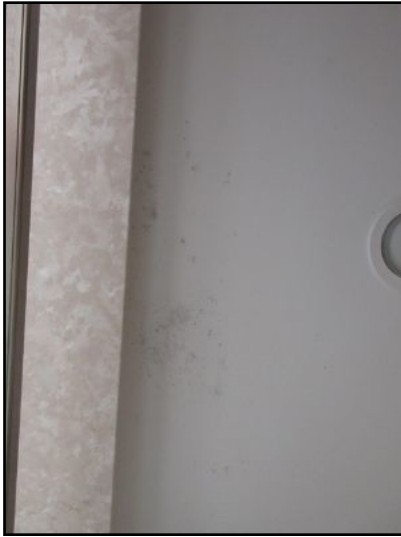
Signs of mildew noted at ceiling above shower.

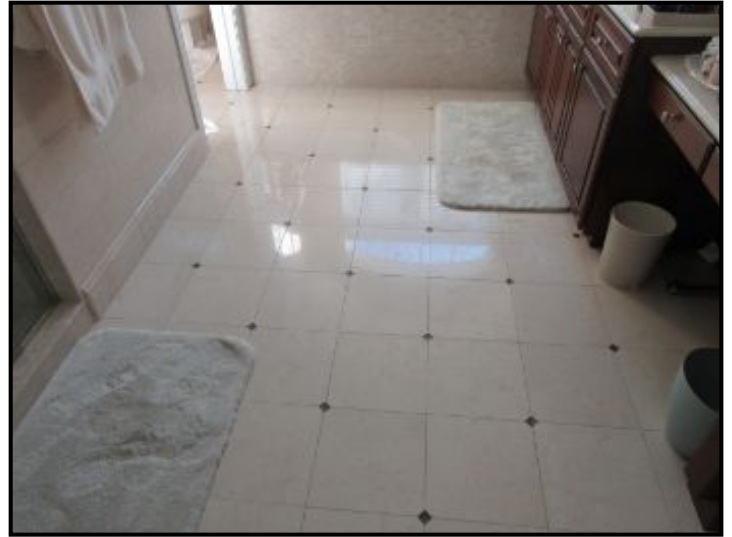
Marble tiled floor in good condition

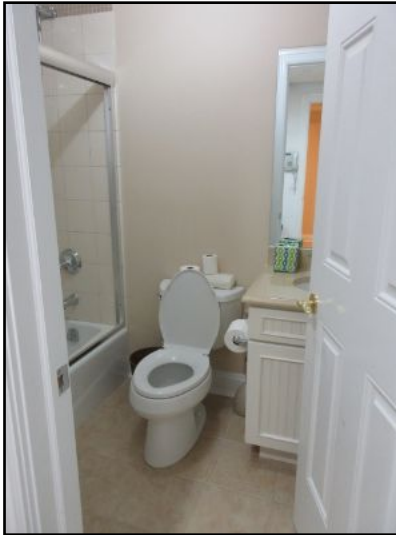
## Bathrooms Continued

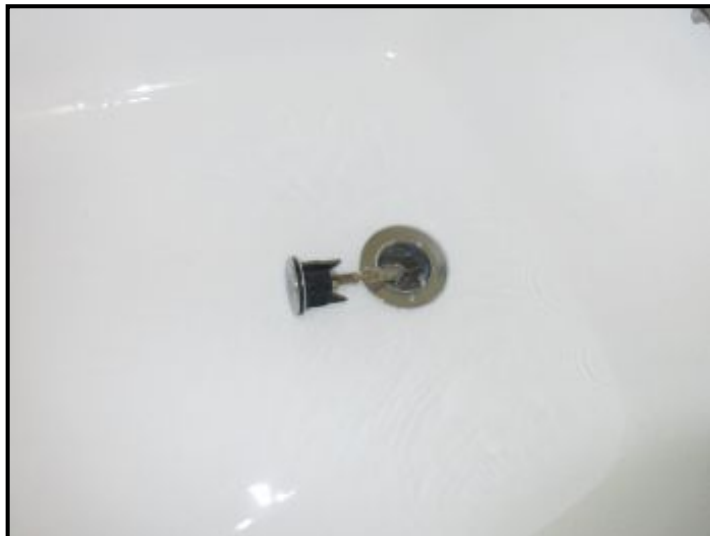
Tub stopper linkage was detached; suggest repair.

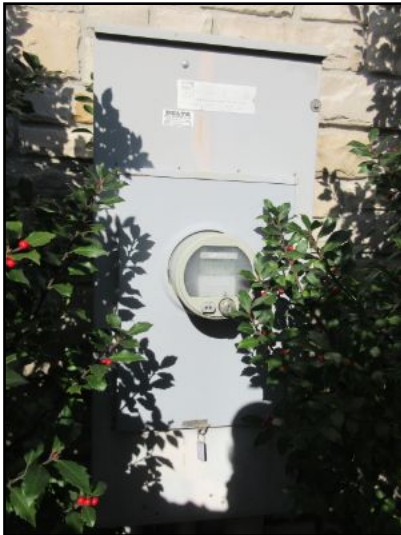
Electrical service meter.

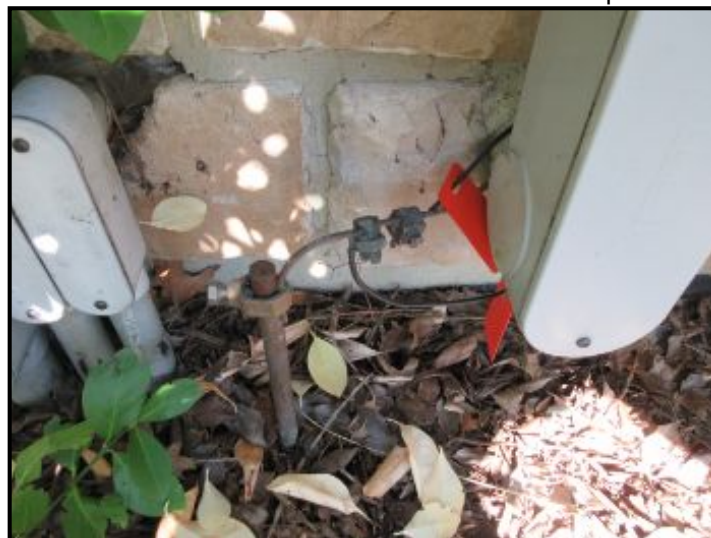
Grounding noted at service entrance.

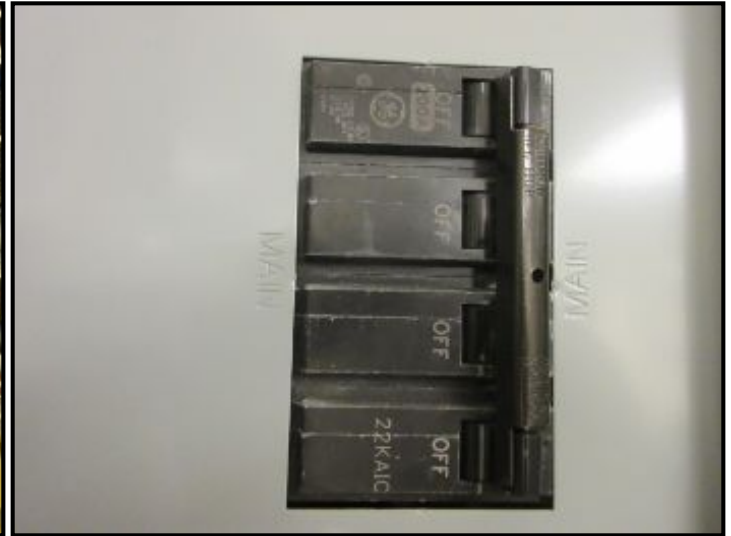
Each panel is fed through its 200 amp main breaker respectively.

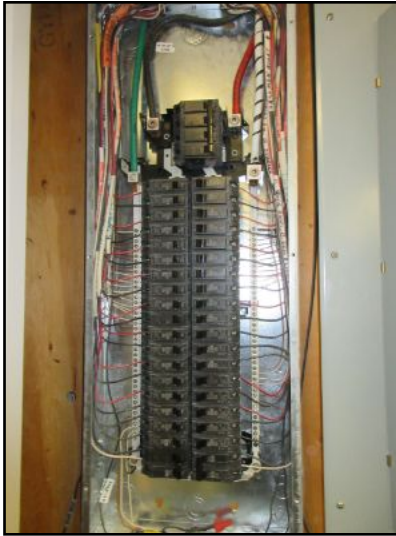
GFCI breaker noted. No major system safety or function concerns noted at time of inspection at distribution panel boxes.

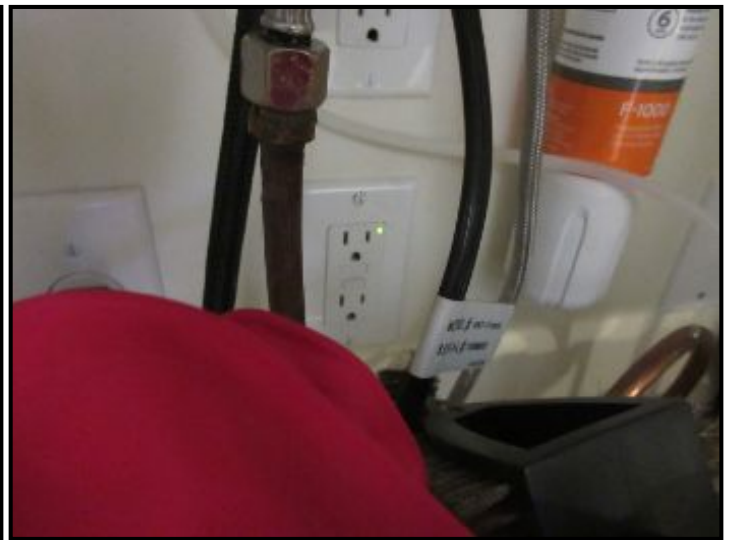
GFCI protected circuits noted.

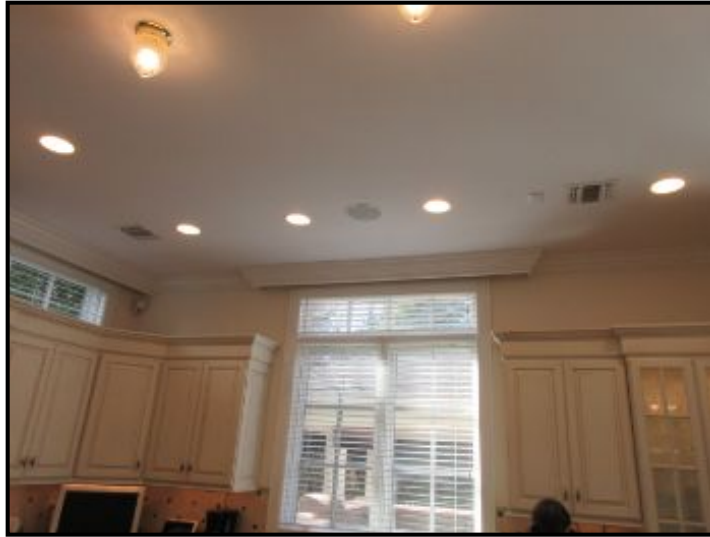
Kitchen lighting, shades, etc. are all controlled via whole house automation system. See related notes.

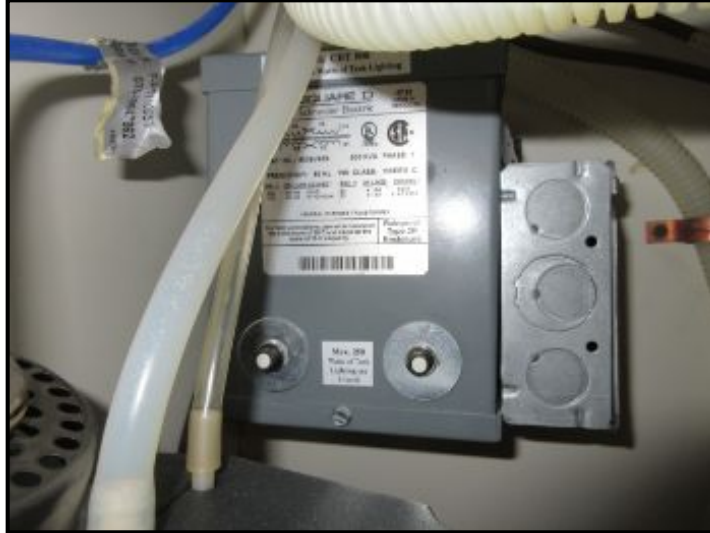
Step down transformer for counter top task lighting.

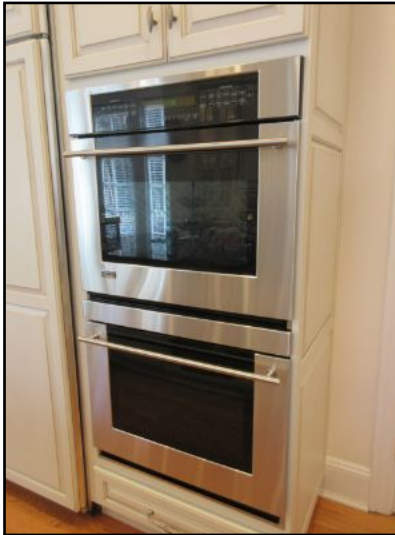
- Gas Oven
- Burners operated when tested.
