# ProSpec Home Inspection of Long Island Property Inspection Report

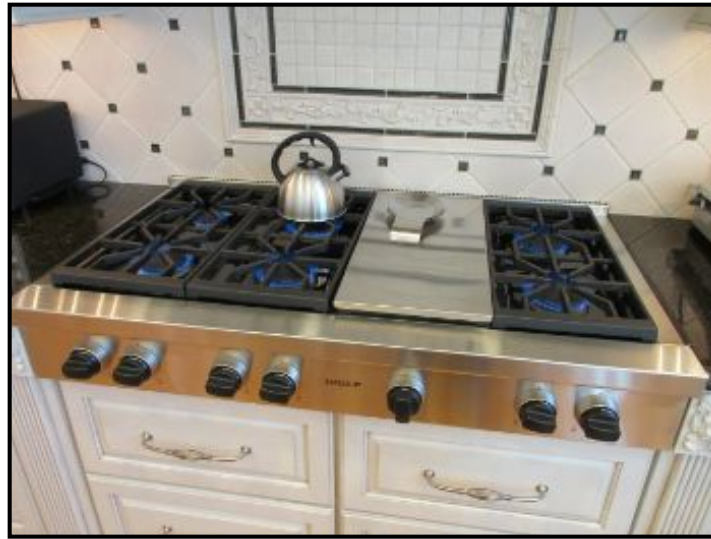
Gas Cooktop. All burners operated when tested.

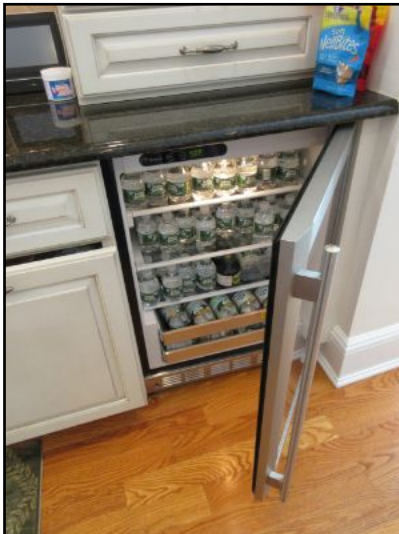
Refrigerator operable.

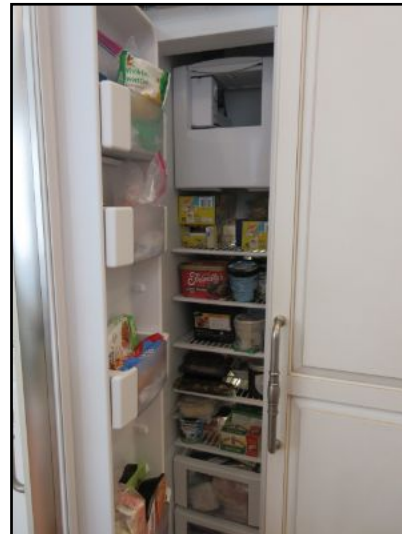
Refrigerator operable and frost free.

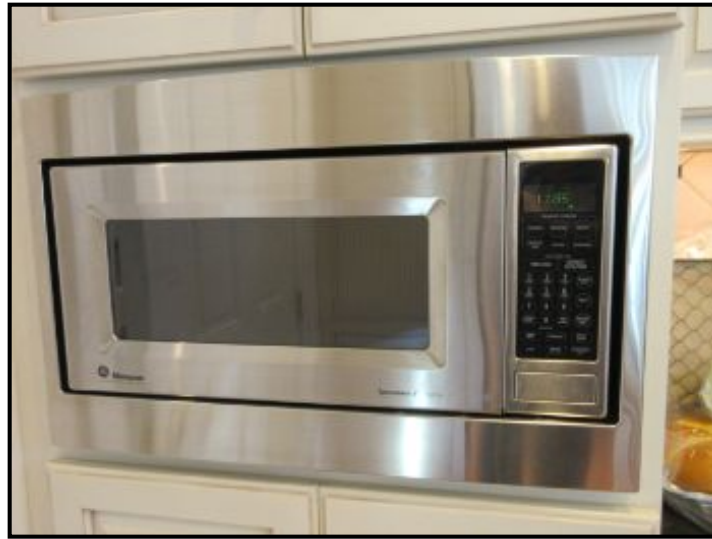
Built-in microwave oven operable.

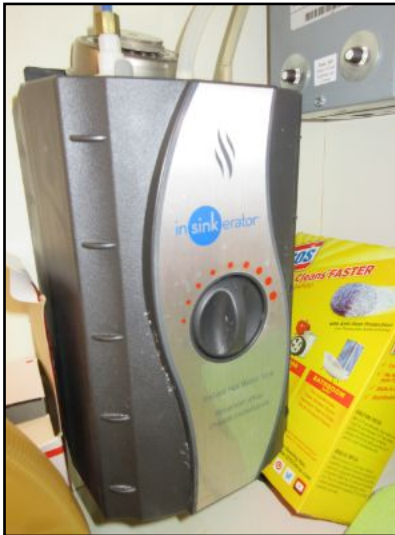
Hot water dispenser was inoperable.

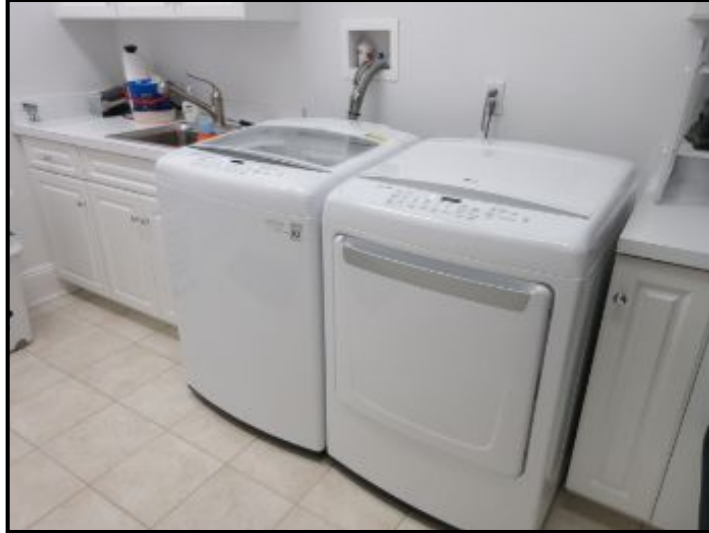
Laundry on 1st floor. No defects noted.

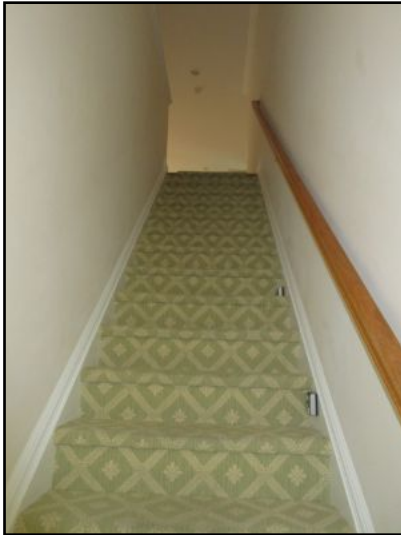
Service stairs and hand rail in good condition.

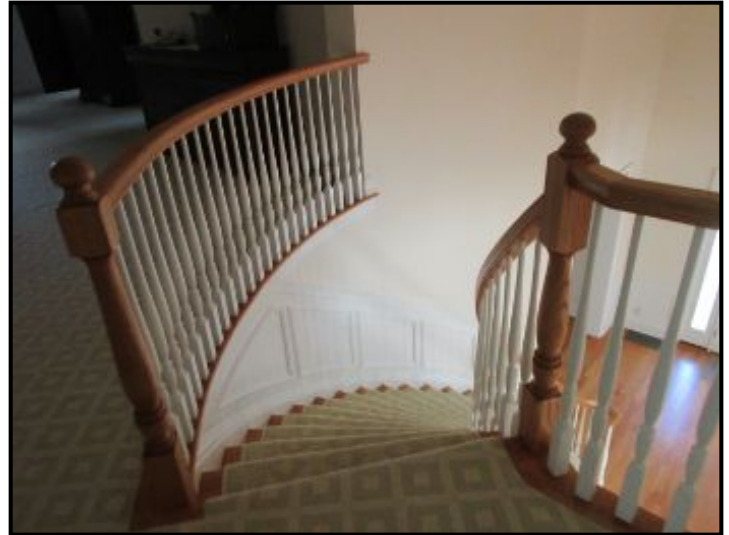
Main stairs and hand railing in good condition.

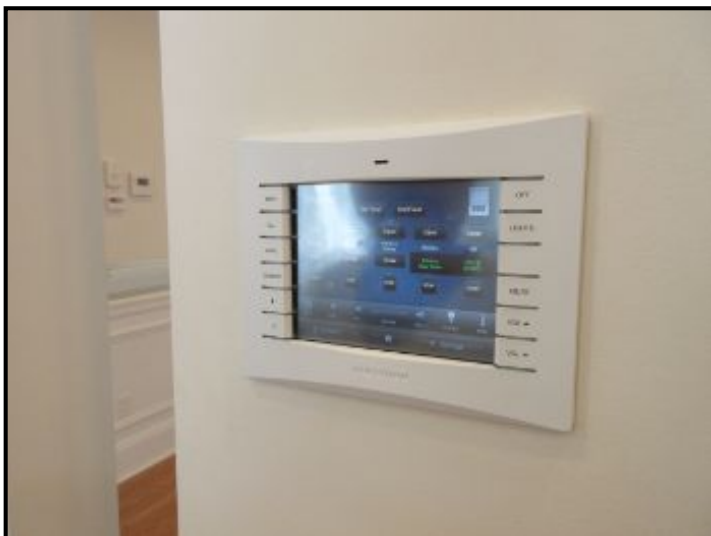
House lighting, HVAC, shades, audio, etc. are all controlled via whole house automation system. Suggest homeowner to provide full operating and maintenance instructions for this system, including peripheral devices such as motors, sensors and relays.

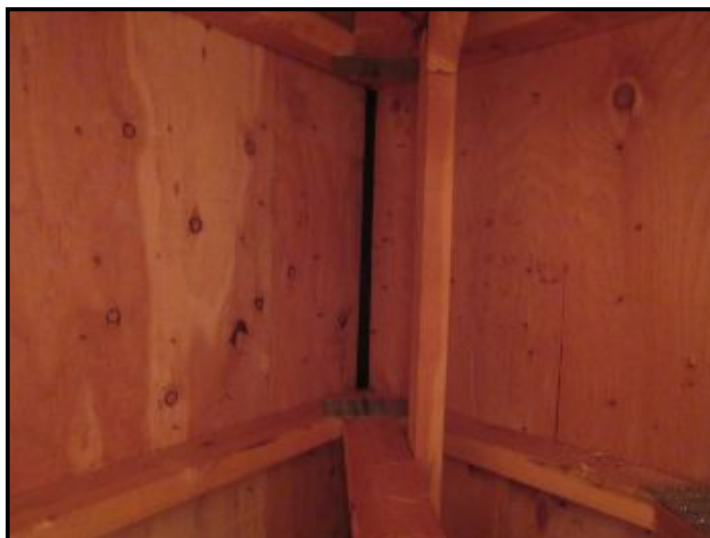
Attic roof ridge outlet vents observed. Under eave soffit inlet vents and fixed roof outlet vents also noted for attic ventilation.

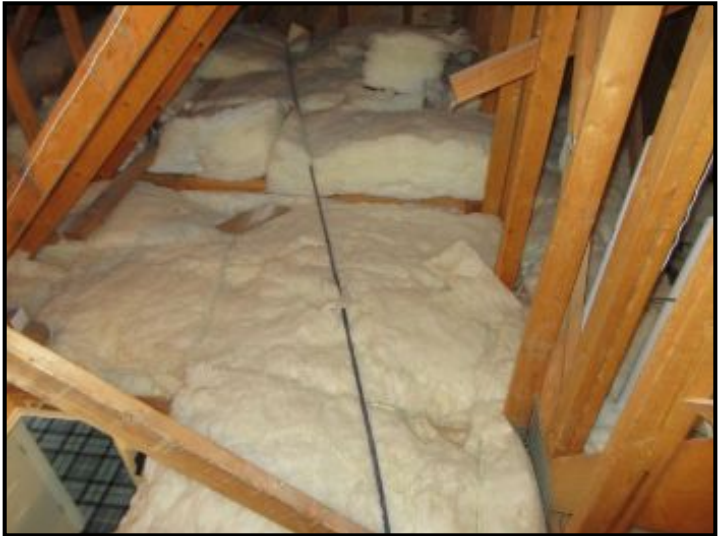
Fiberglass batts with kraft paper facing noted.

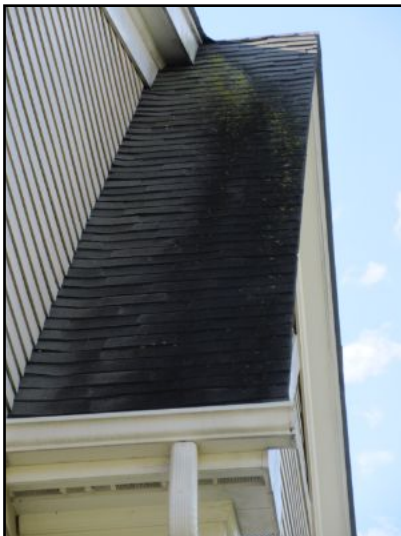
Original roof is just 10 yrs old but shows signs of weathering / wear and tear.

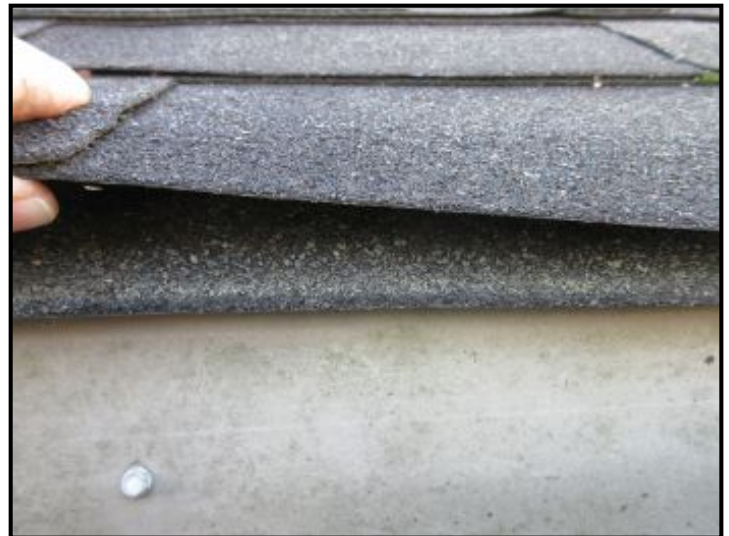
Ice shield observed beneath lower roof shingles.

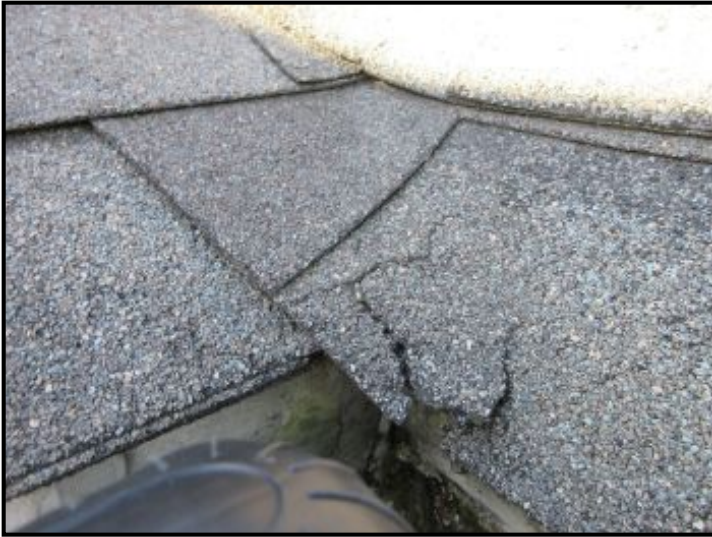
Some cracked shingles noted.

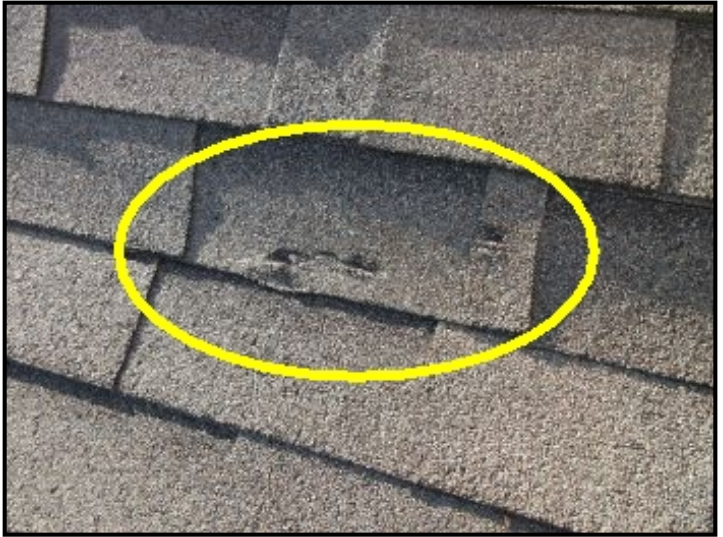
Surface damage noted at roof shingle.

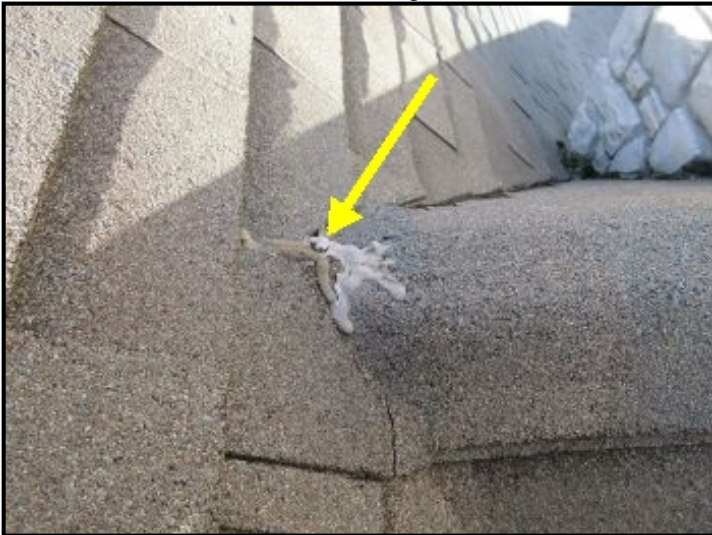
Exposed nails on roofing material. Maintain seal at all fastener heads.

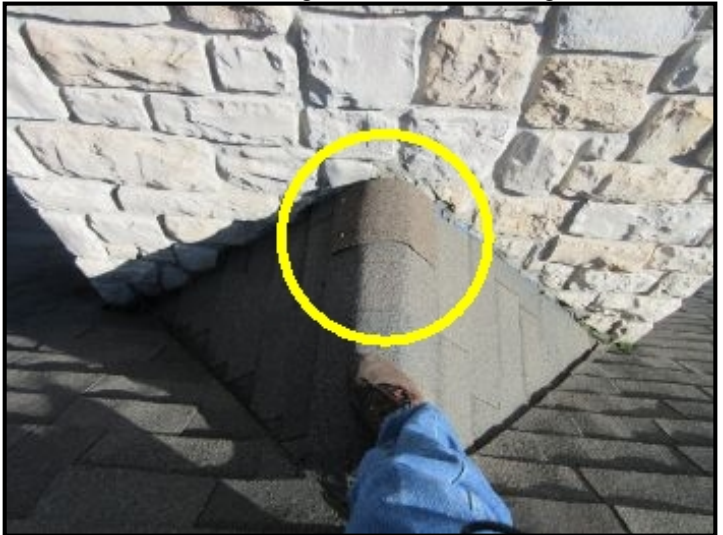
Shingle repair noted at chimney crickets.

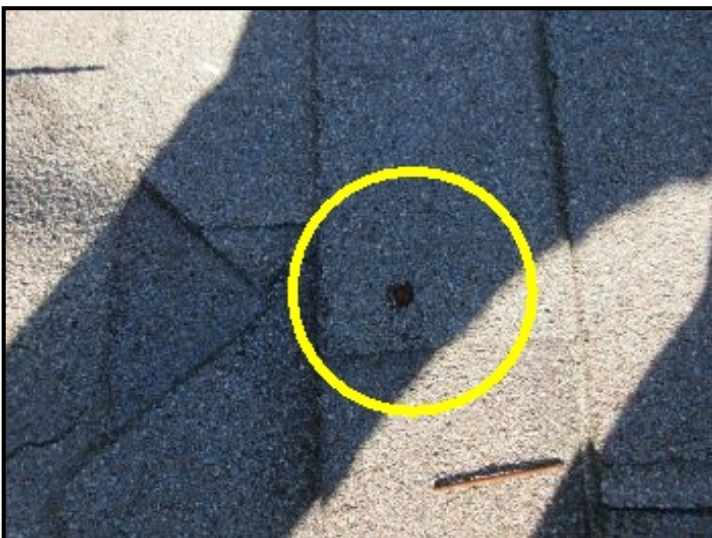
Exposed nails on roofing material. Recommend sealing all fastener heads.

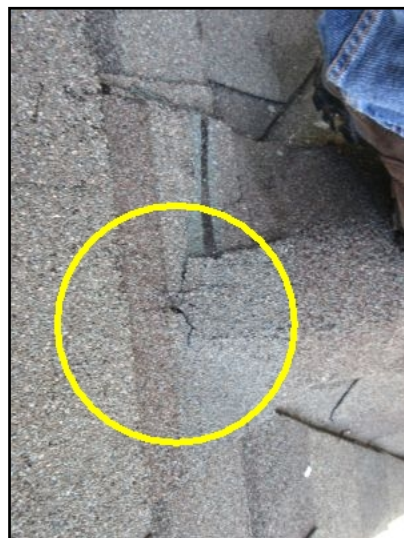
Some cracked shingles noted.

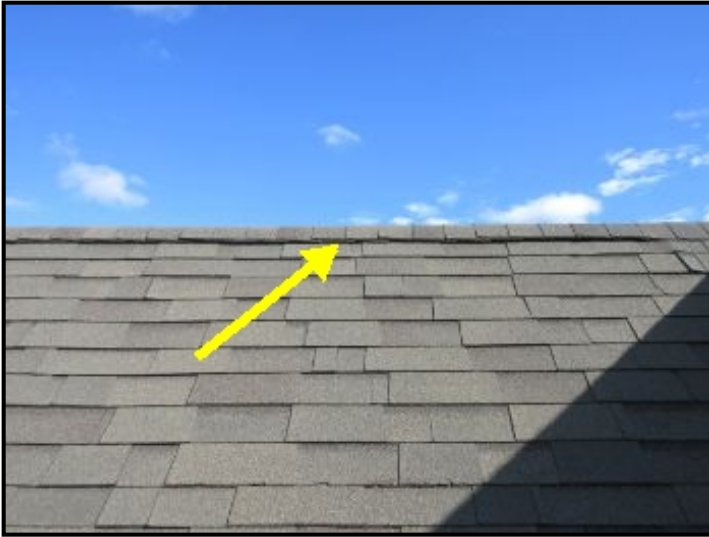
Ridge vent noted for attic ventilation.

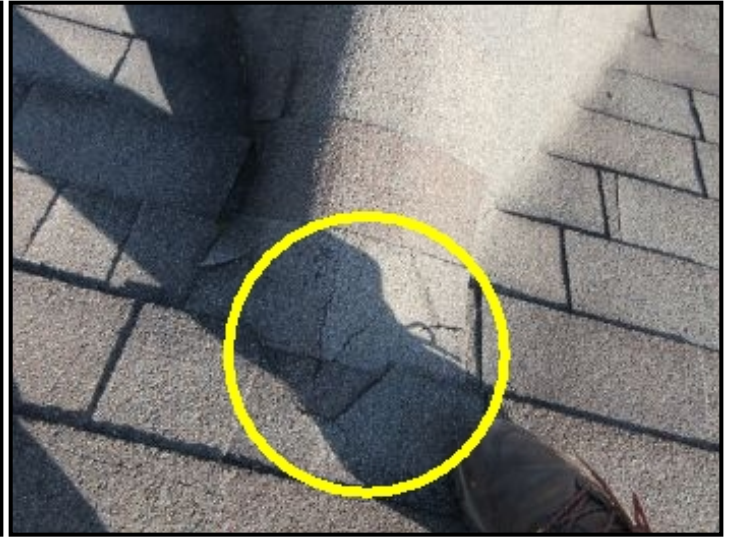
Some cracked shingles noted.

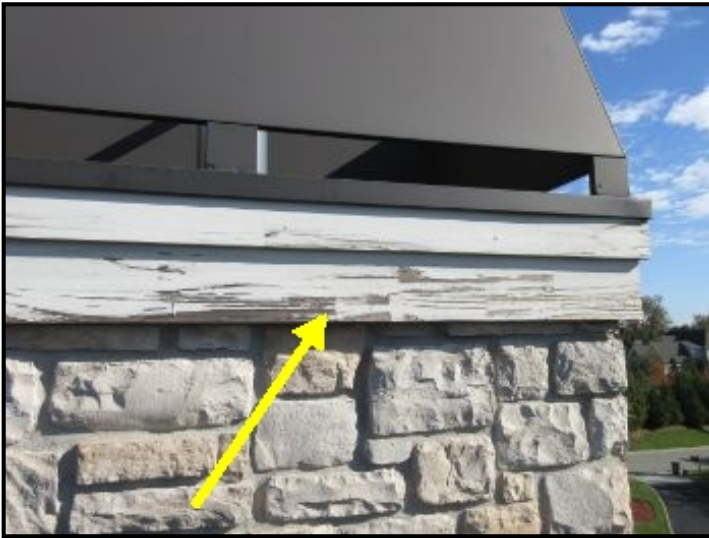
Chimney cap trim in need of paint update.

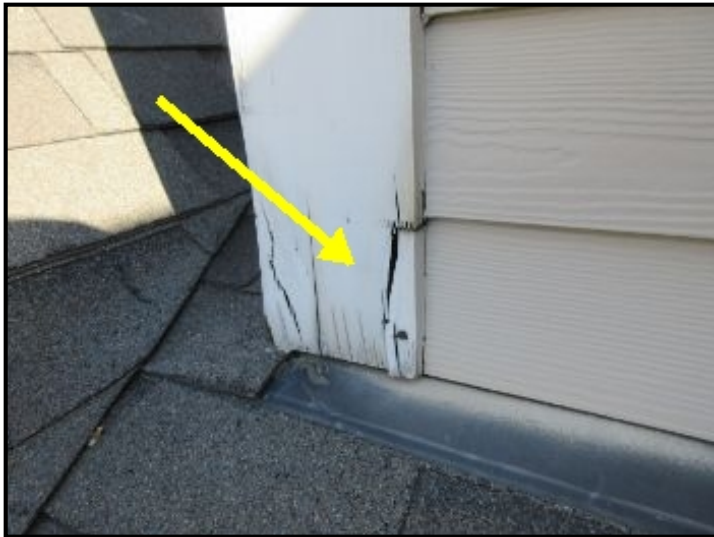
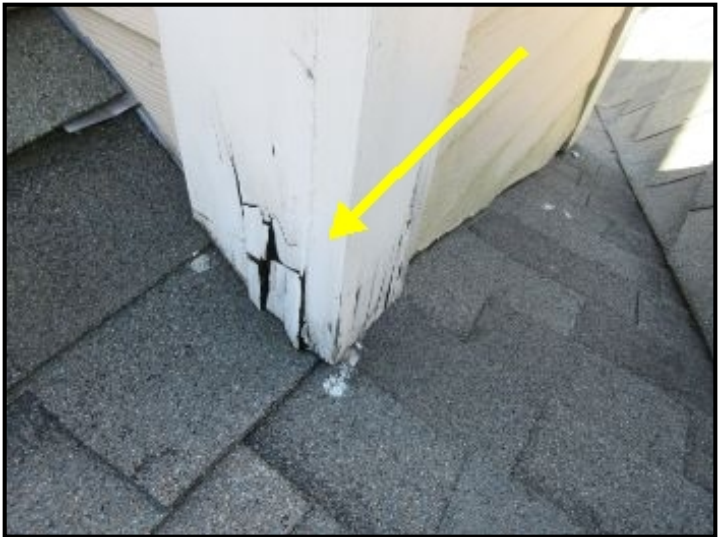
Chimney corner trim shows signs of water damage at base where in contact roofing. A 1" gap is recommended between roofing and wood trim to reduce water absorption and subsequent deterioration of the wood. Repairs and painting suggested.

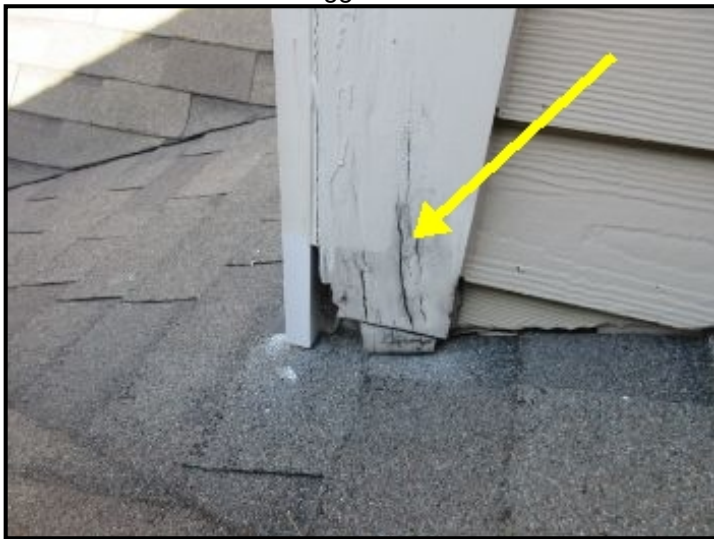
Chimney corner trim shows signs of water damage at base where in contact roofing. A 1" gap is recommended between roofing and wood trim to reduce water absorption and subsequent deterioration of the wood. Repairs and painting suggested.

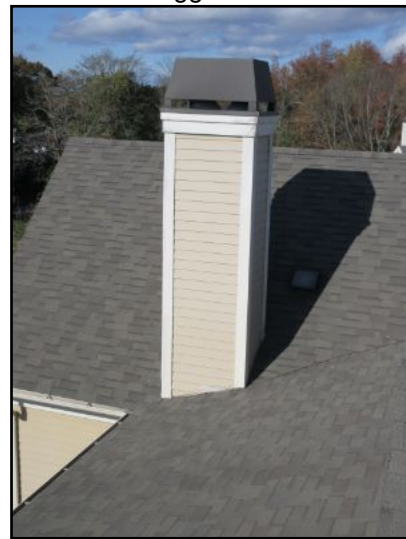
Two chimneys are metal flue pipe enclosed in an architectural chase.

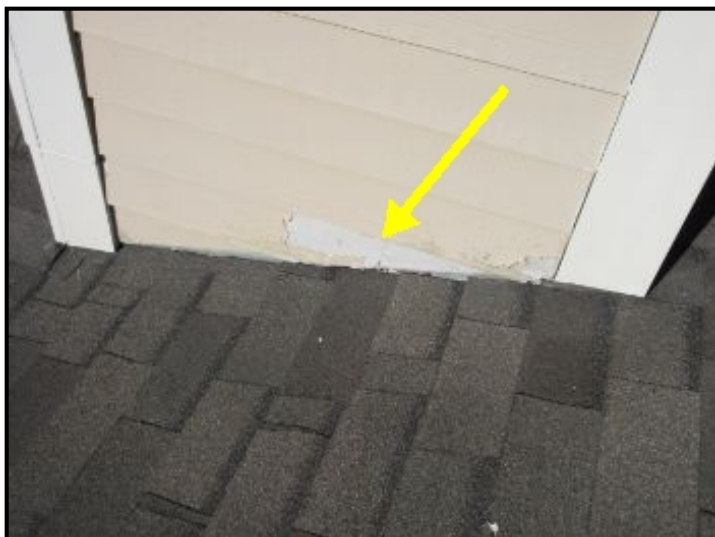
Fiber-cement siding has cosmetic damage at north chimney.

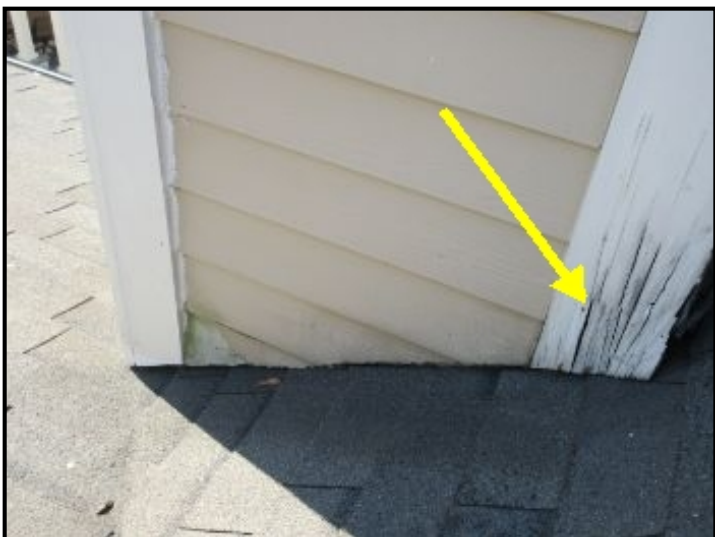
Chimney corner trim shows signs of water damage at base where in contact roofing. A 1" gap is recommended between roofing and wood trim to reduce water absorption and subsequent deterioration of the wood. Repairs and painting suggested.

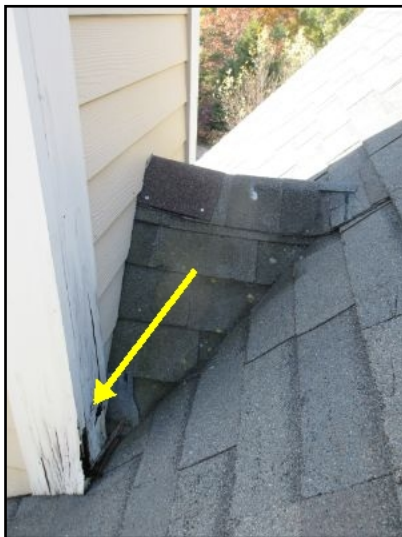
Chimney corner trim shows signs of water damage at base where in contact roofing. A 1" gap is recommended between roofing and wood trim to reduce water absorption and subsequent deterioration of the wood. Repairs and painting suggested.

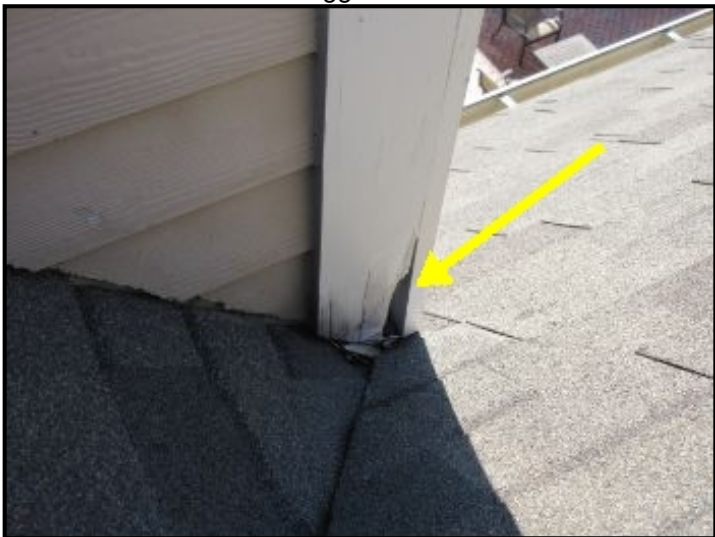
Chimney corner trim shows signs of water damage at base where in contact roofing. A 1" gap is recommended between roofing and wood trim to reduce water absorption and subsequent deterioration of the wood. Repairs and painting suggested.

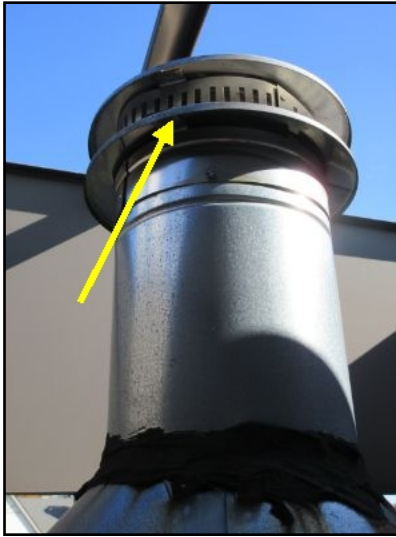
Chimney caps with spark arrestor noted.

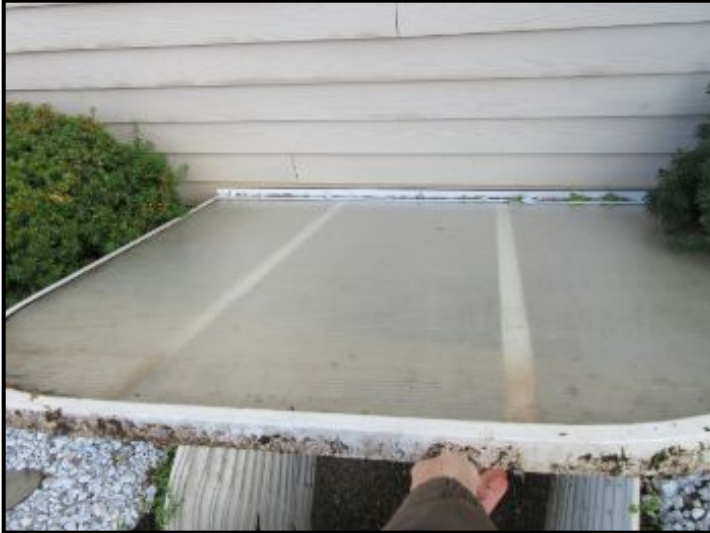
Basement emergency egress with ladder functional (with rain cap) noted at 2 places.

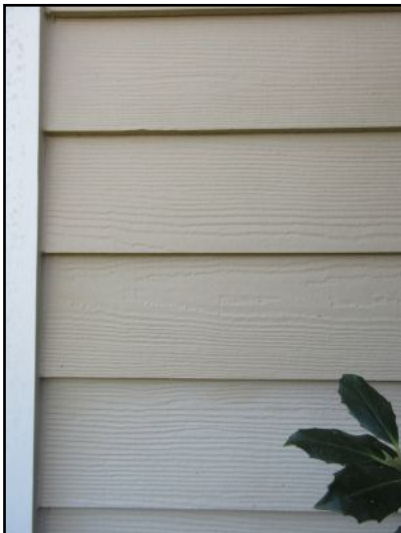
Fiber-cement siding noted.

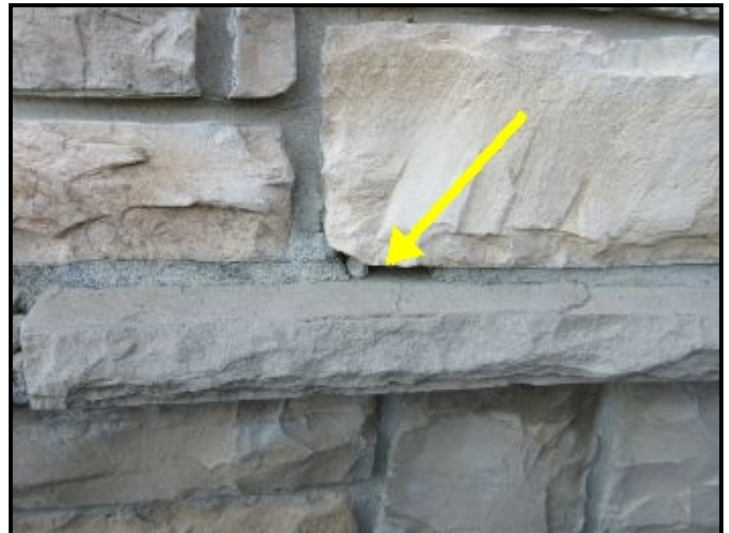
Stone veneer at front has a few gaps in the mortar joints. Suggest filling gaps with matching mortar to prevent water entry and freeze/thaw damage.

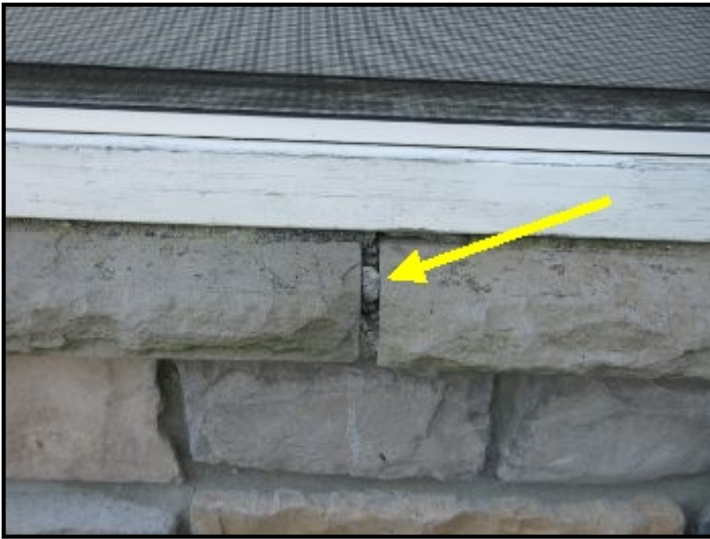
Stone veneer at front has a few gaps in the mortar joints. Suggest filling gaps with matching mortar to prevent water entry and freeze/thaw damage.

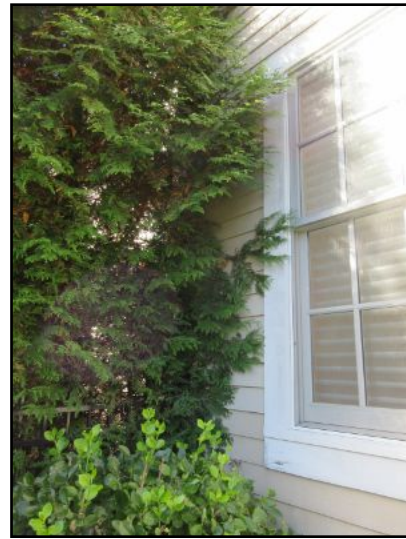
Recommend trimming back vegetation from contact with siding and gutters to prevent abrading/damage.

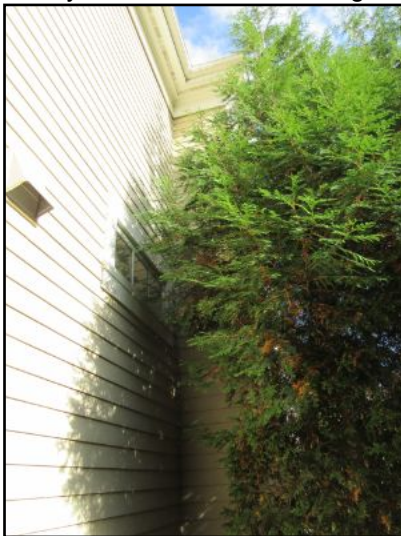
Recommend trimming back vegetation from contact with gutter and roof shingles to prevent damage to the house.

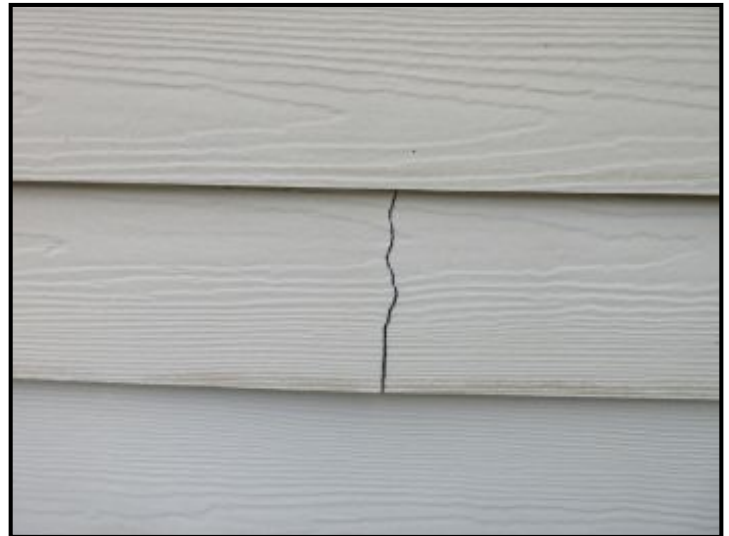
Cracked fiber-cement siding course at rear. Suggest repair.

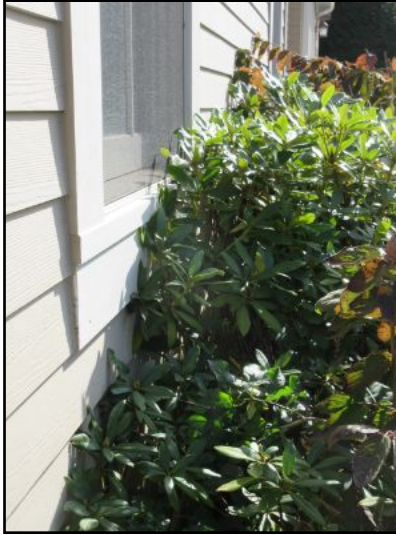
Recommend trimming back vegetation from contact with siding and gutters to prevent abrading/damage.

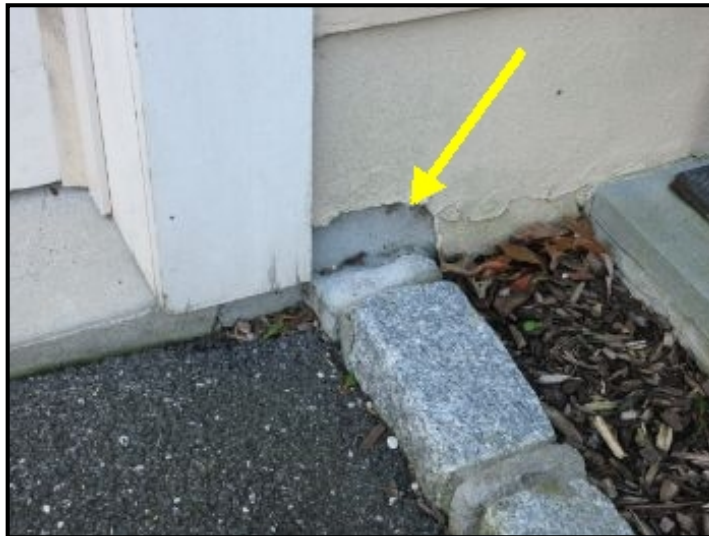
Cosmetic defect at synthetic stucco by garage door.

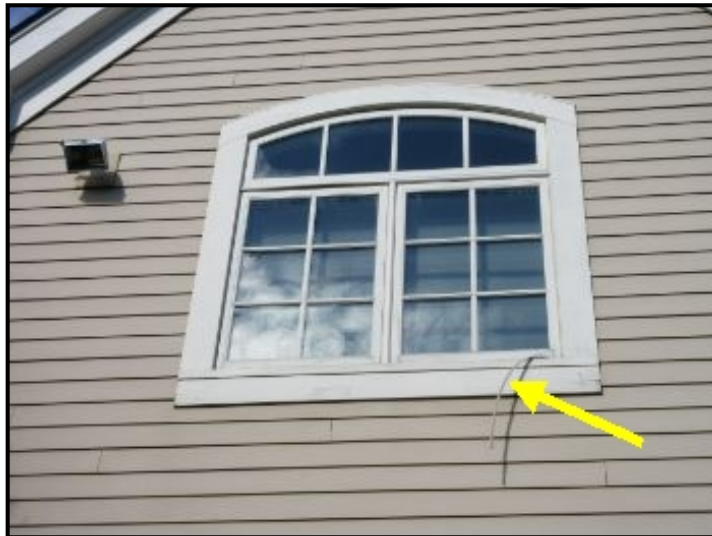
Window bottom weatherstripping had come loose and hanging.

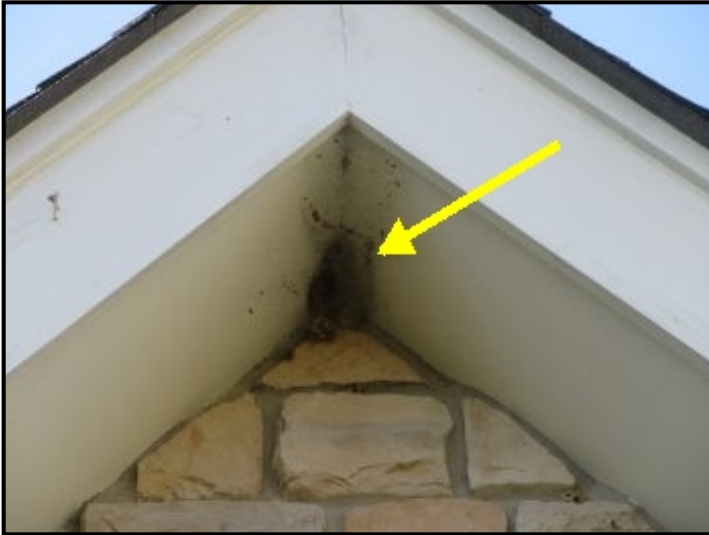
Bee's nest observed at underside of front lower peak.

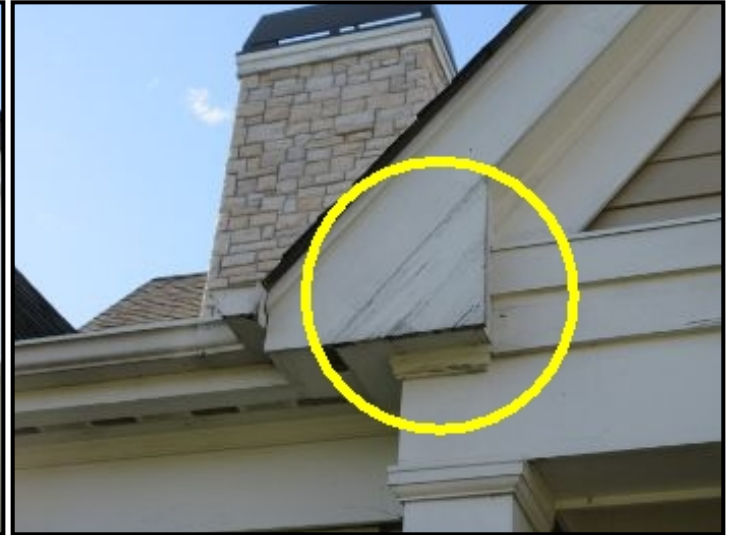
Bargeboards show signs of weathering.

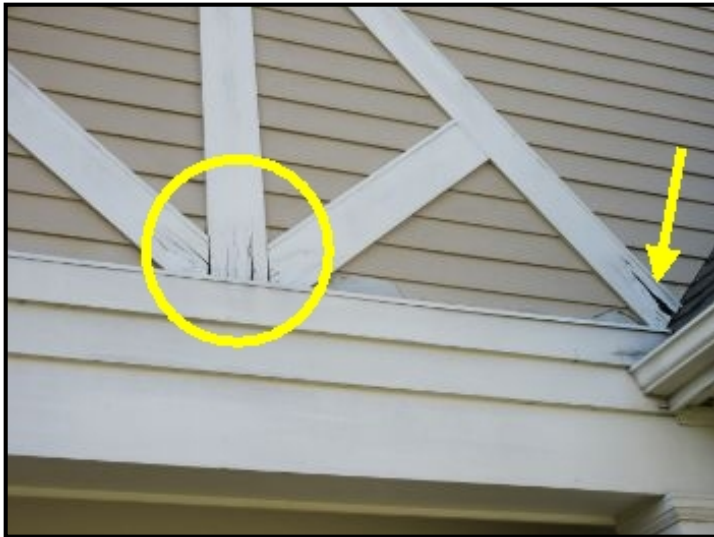
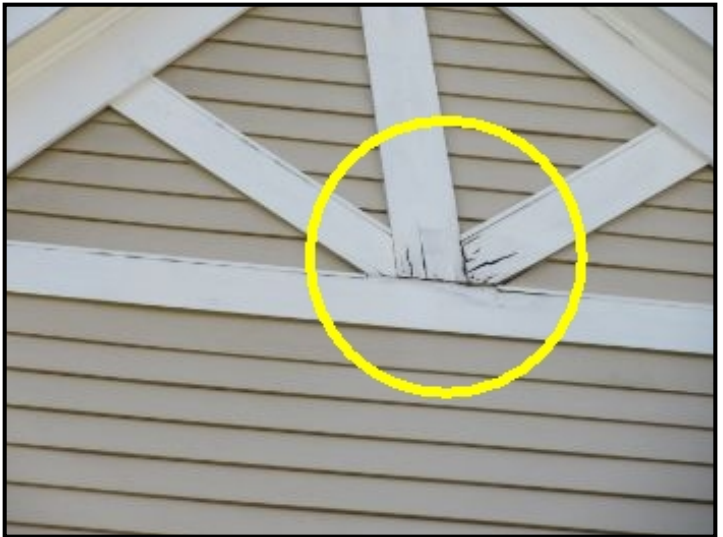
Wooden Gable Pediments show signs of water damage at front of house due to a lack of protection from the elements. Repairs and proper painting is recommended.

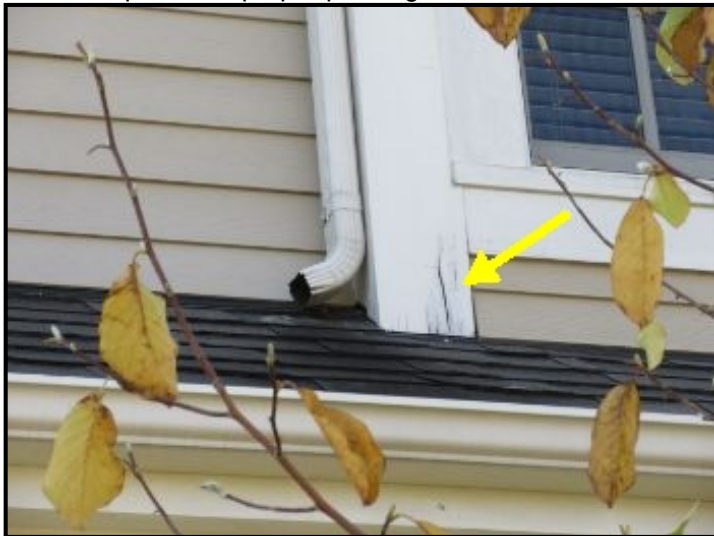
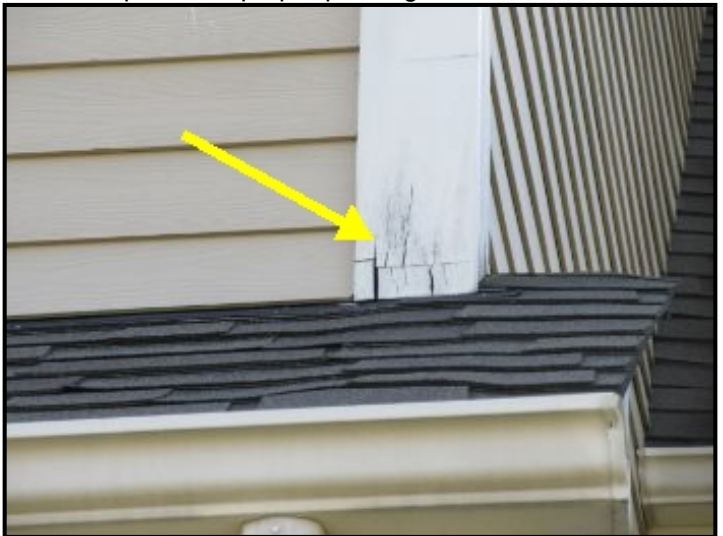
Window trim shows signs of weathering and possible water damage where in contact roof shingles. A 1" gap is recommended between roof shingles and wood trim to reduce water absorption and subsequent deterioration of the wood.

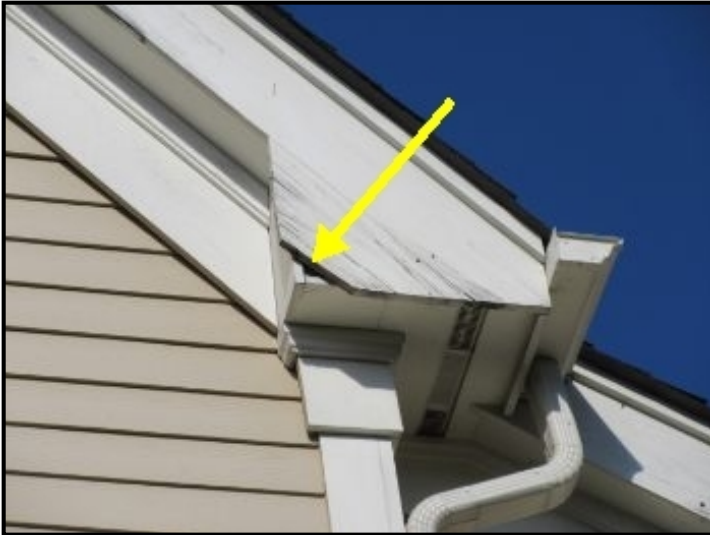
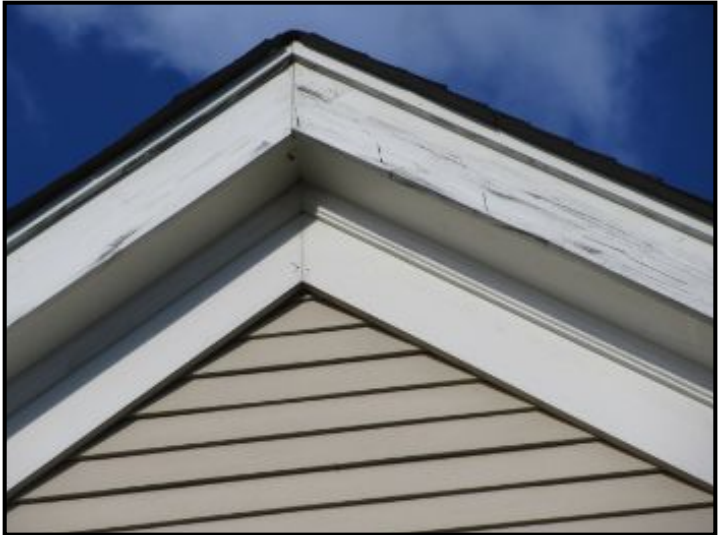
Bargeboard corner piece missing. Water can now enter here and cause damage to soffit and interior of trim work. Recommend repair to seal opening as a minimum.

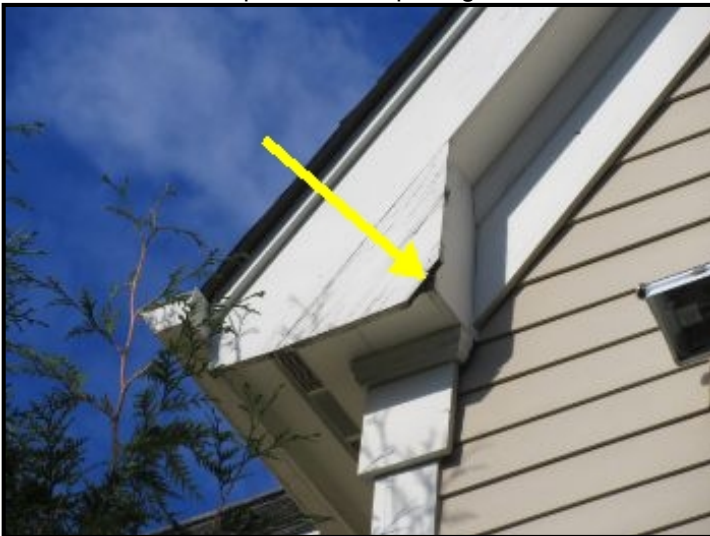
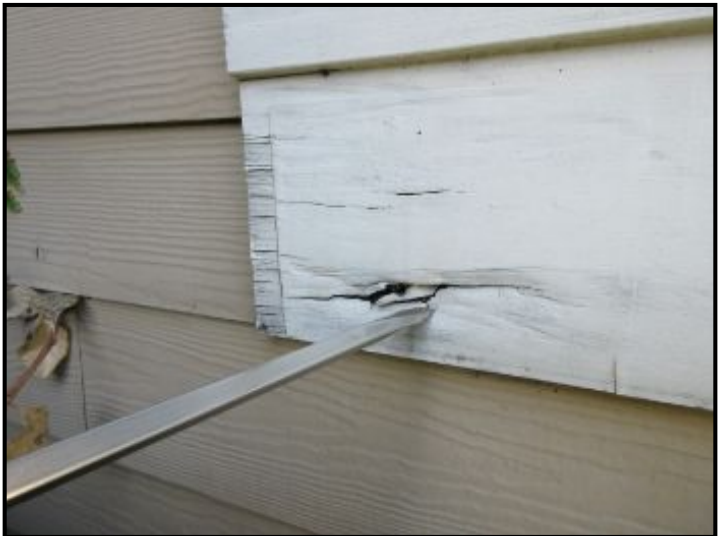
Bargeboard corner piece missing. Water can now enter here and cause damage to soffit and interior of trim work. Recommend repair to seal opening as a minimum.

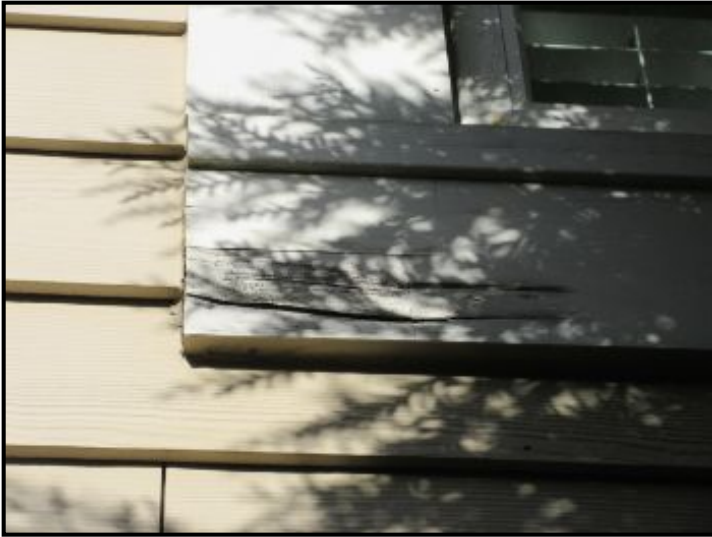
2nd floor window trim shows signs of water damage. Repairs and proper painting is recommended.

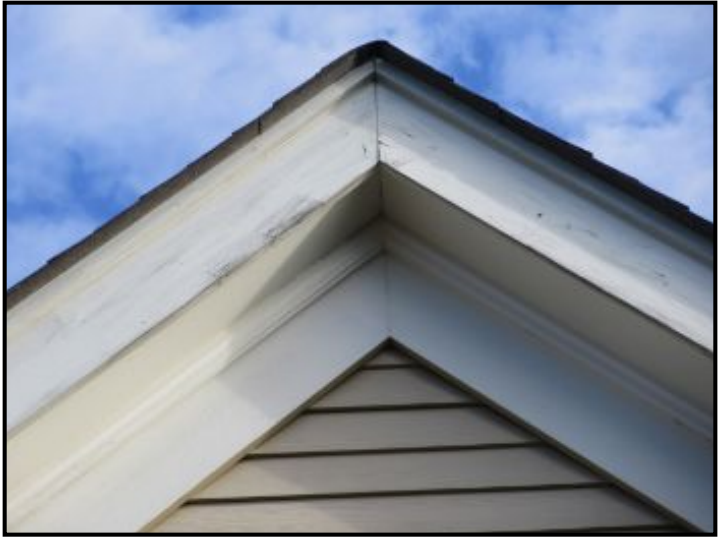
Peak bargeboards and trim in need of paint update.

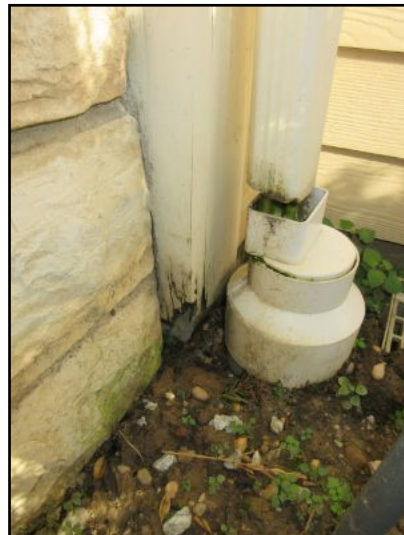
Downspout not connected to dry well inlet causing water damage to wood trim.

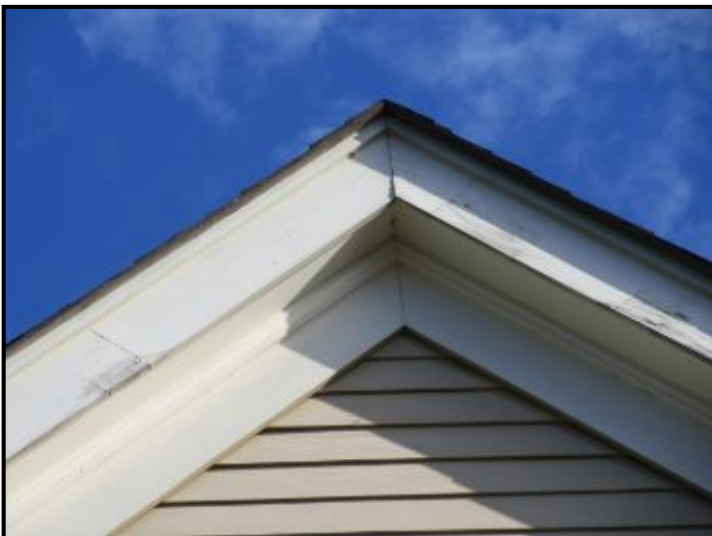
Peak bargeboards and trim in need of paint update.

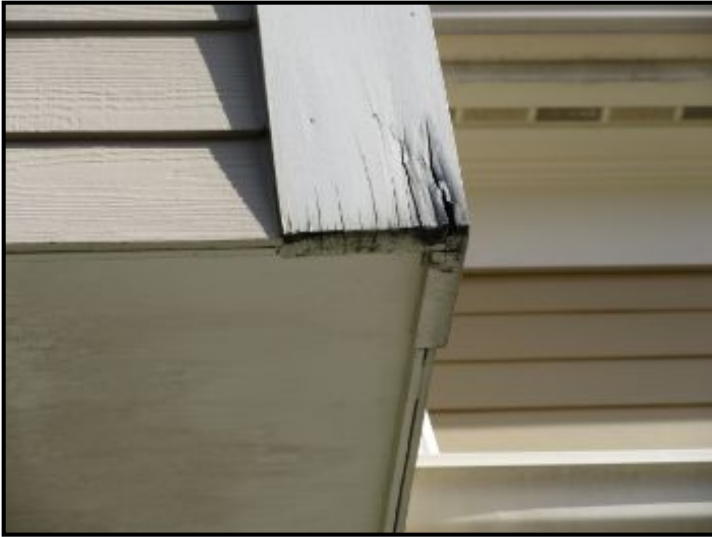
Wood trim show signs of water damage at rear of house due to a lack of protection from the elements. Repairs and proper painting is recommended.

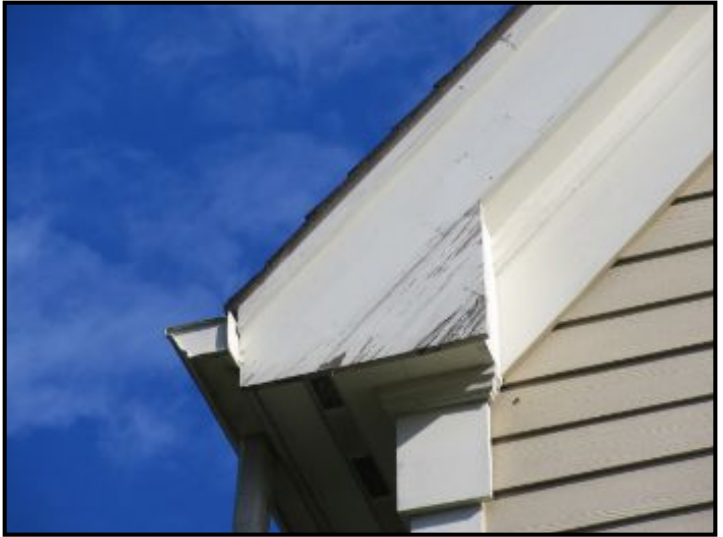
Bargeboards show signs of weathering.

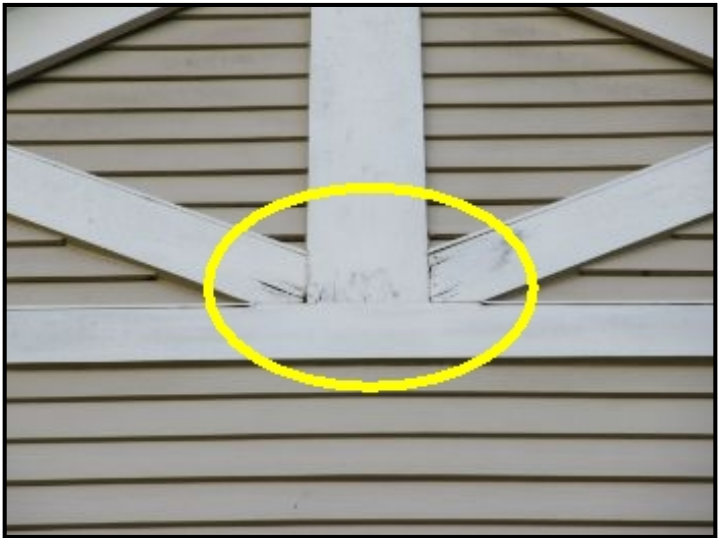
Wooden Gable Pediments show signs of water damage at front of house due to a lack of protection from the elements. Repairs and proper painting is recommended.

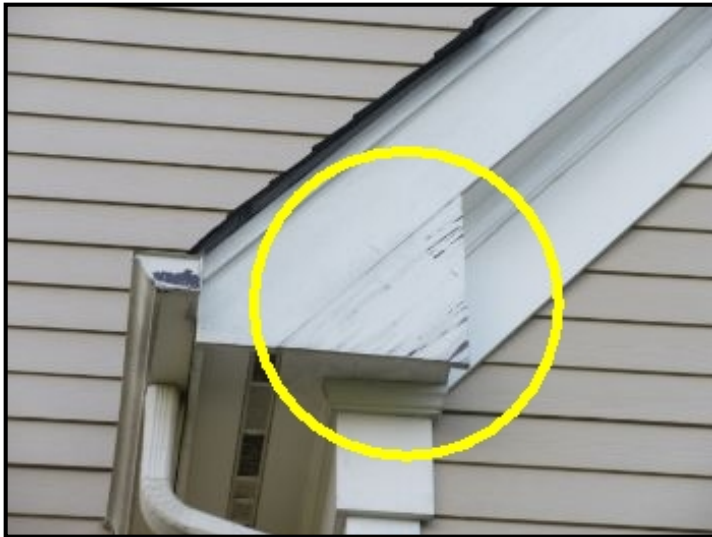
Bargeboards show signs of weathering.

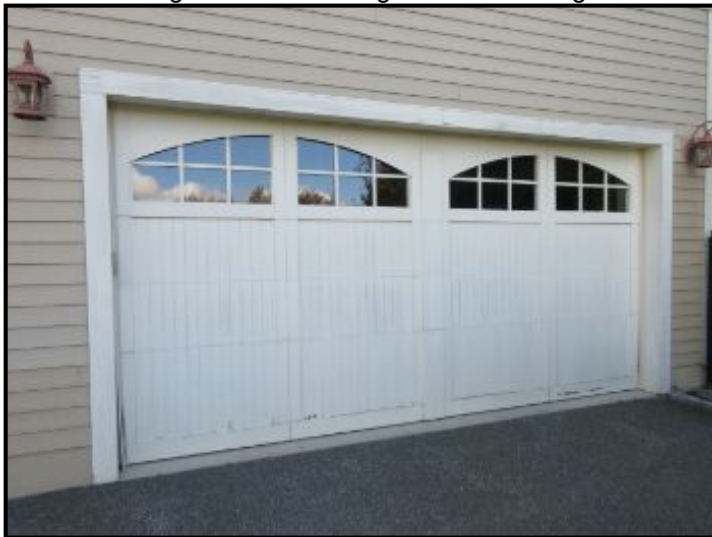
Garage wooden door shows signs of deterioration.

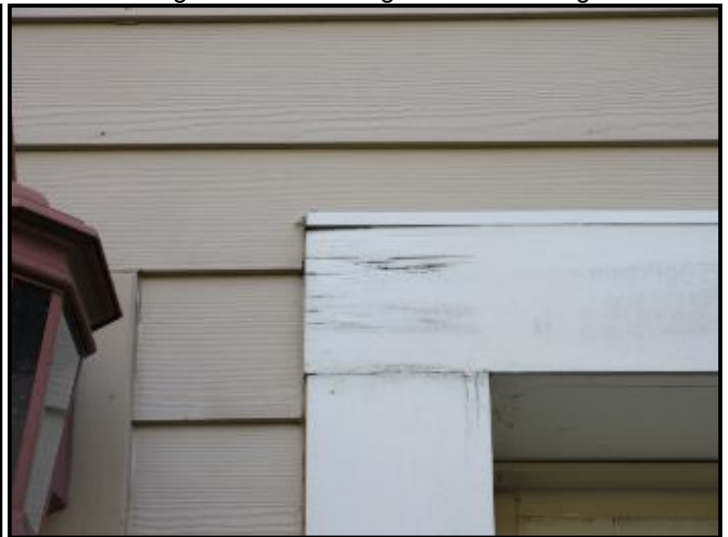
Wood trim at garage door show signs of water damage due to a lack of protection from the elements.

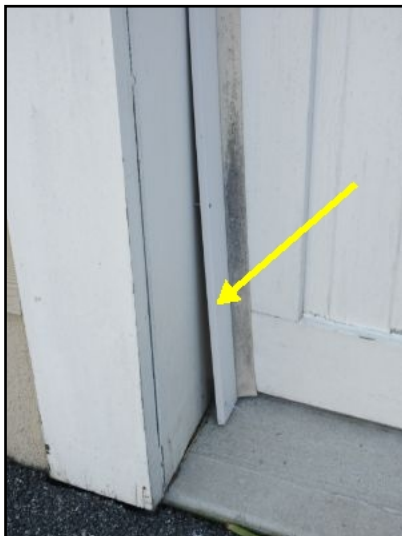
Garage door weather stripping coming loose at left side of larger door.

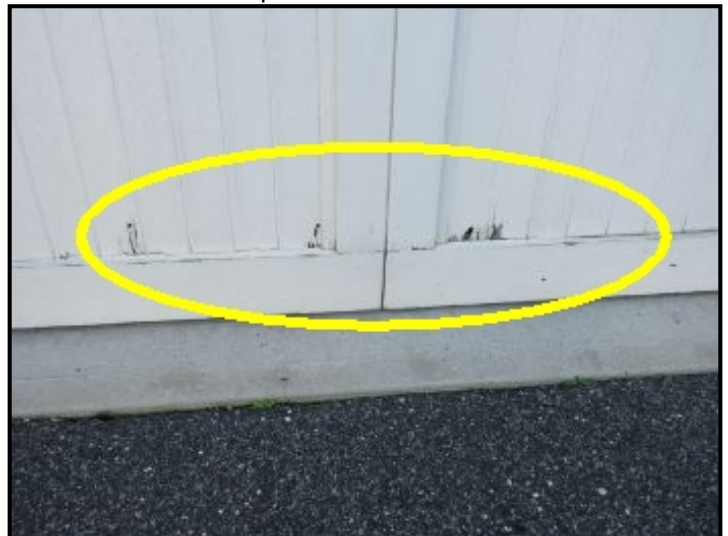
Garage wooden door shows signs of deterioration.
