# ProSpec Home Inspection of Long Island Property Inspection Report

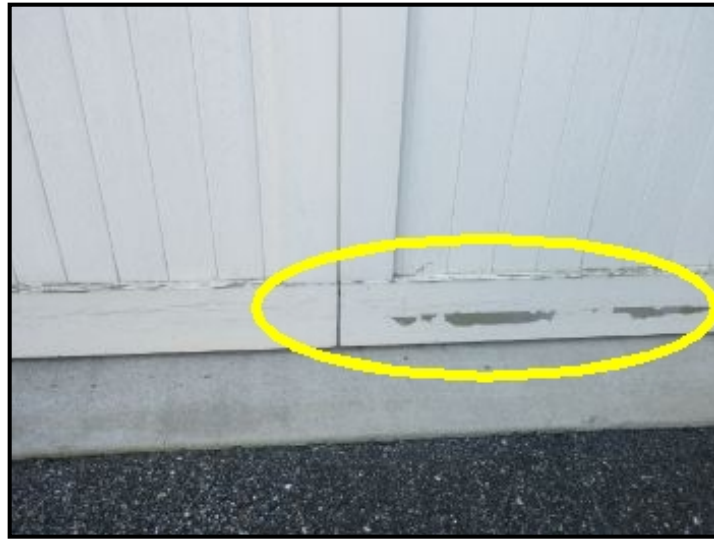
Garage wooden door shows signs of deterioration.

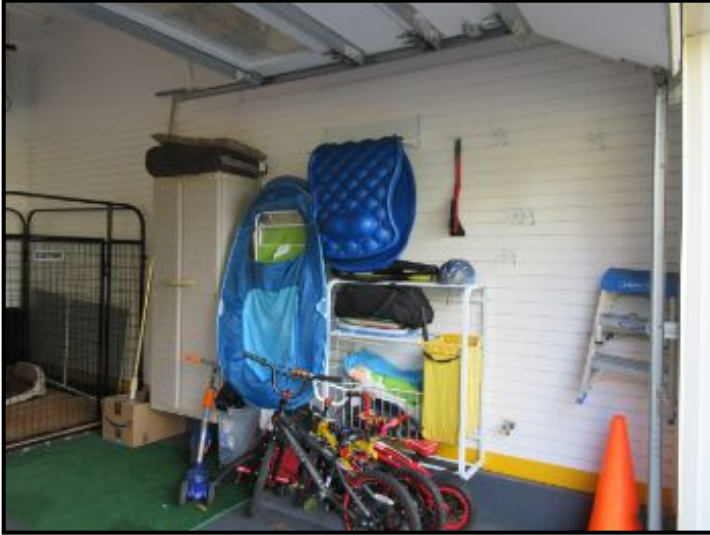
Garage wall hanging system noted.

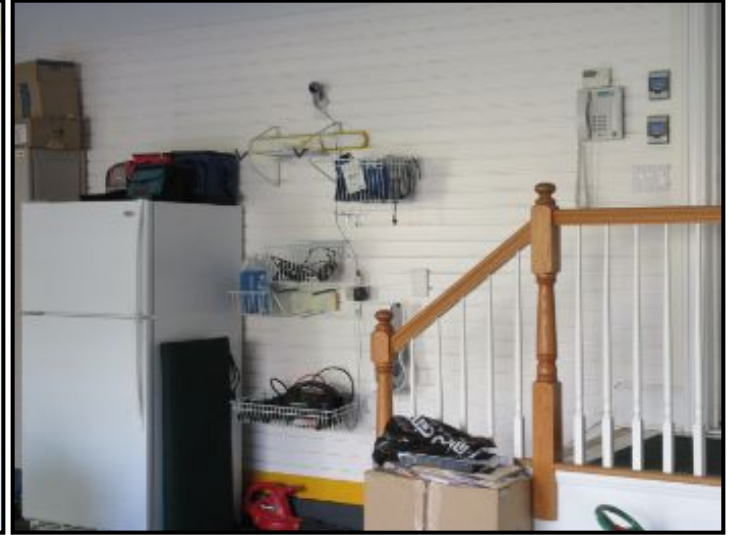
Garage wall hanging system noted.

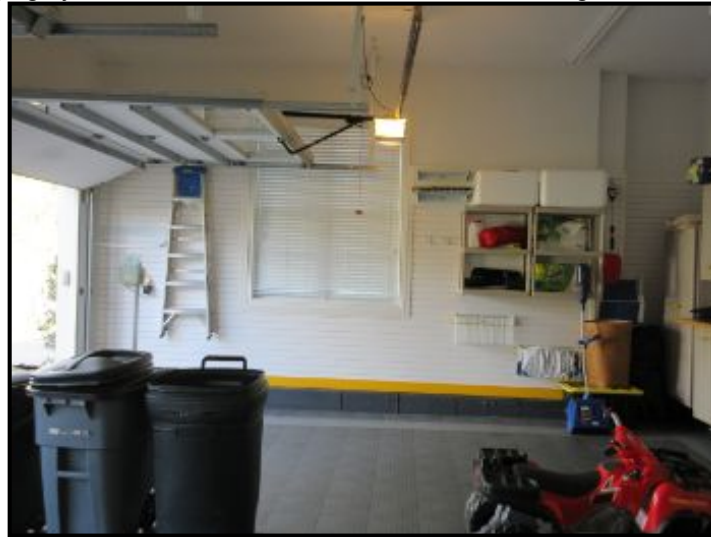
Garage walls, floor and ceiling are covered.

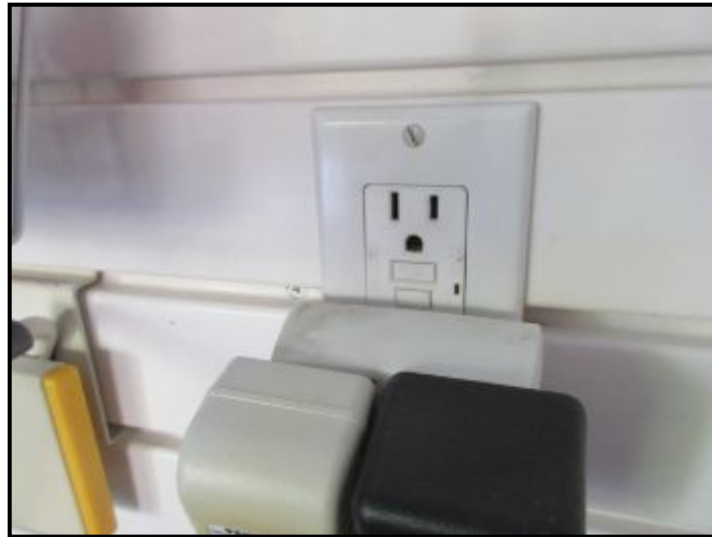
Garage GFCI protection noted.

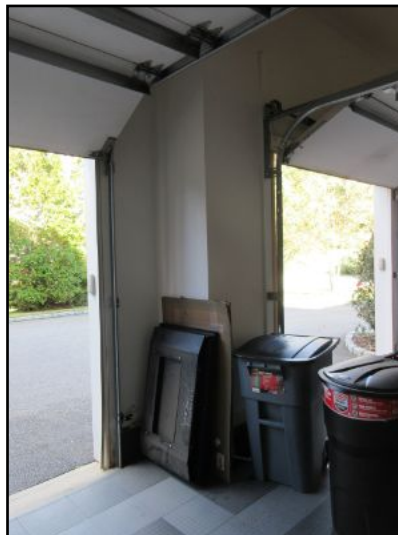
Garage vehicle door openers -- both operable.

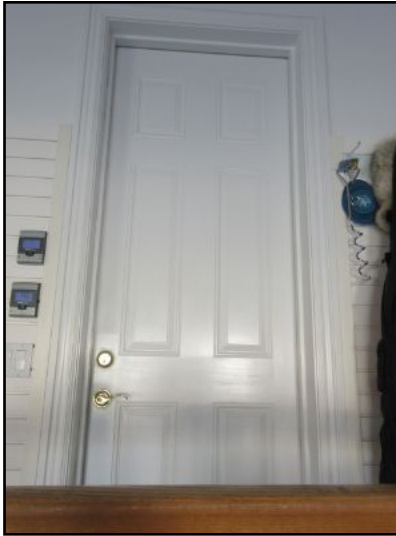
Garage metal fire resistant door noted.

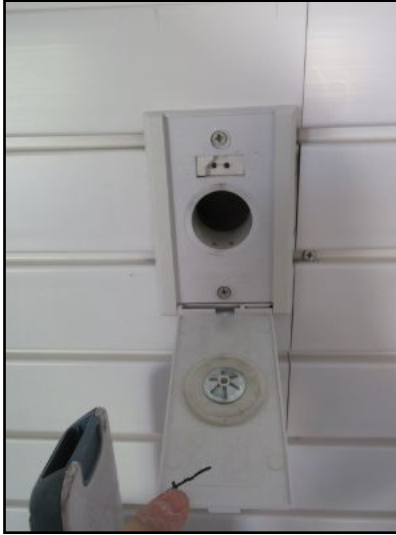
Garage central vacuum hose connection noted.

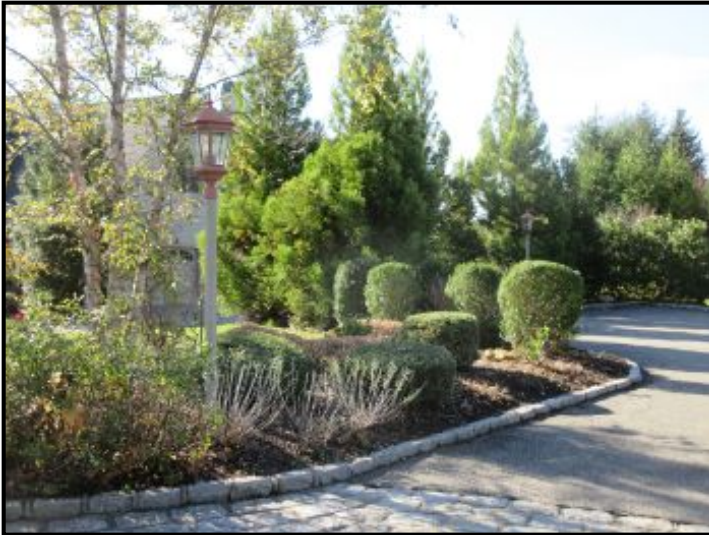
Belgium block curb borders.

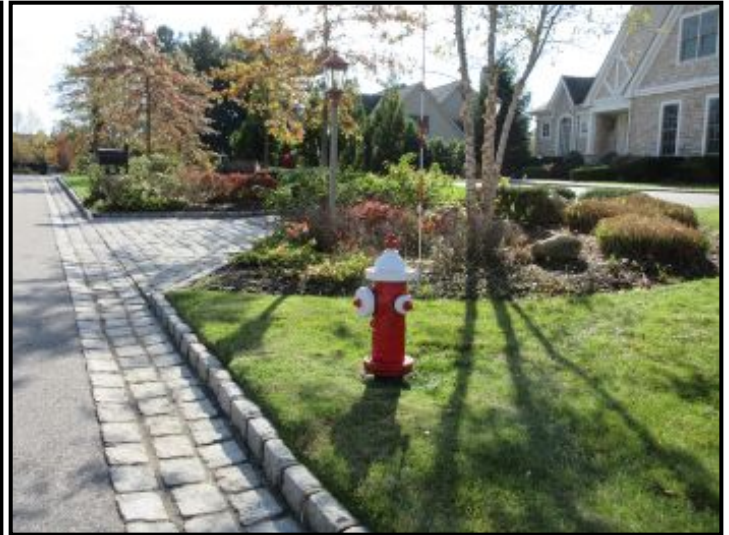
Belgium block curb and driveway aprons in good condition.

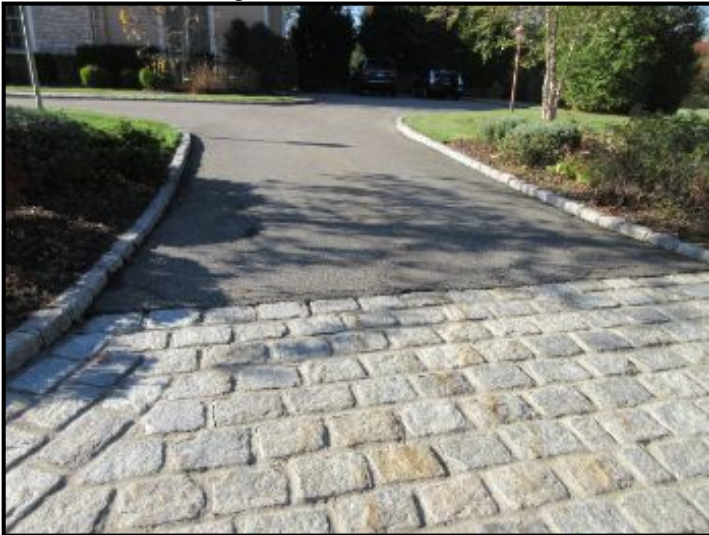
Belgium block driveway aprons in good condition.

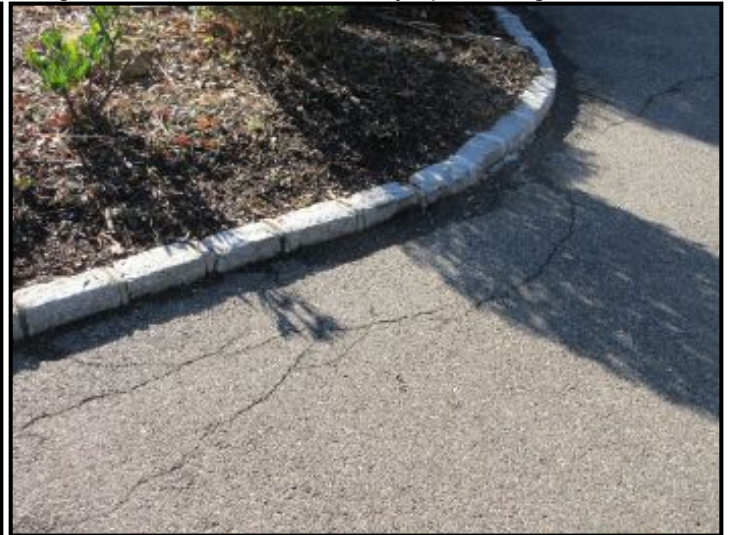
Asphalt driveways require sealing every 3-5 yrs to prevent freeze/thaw damage.

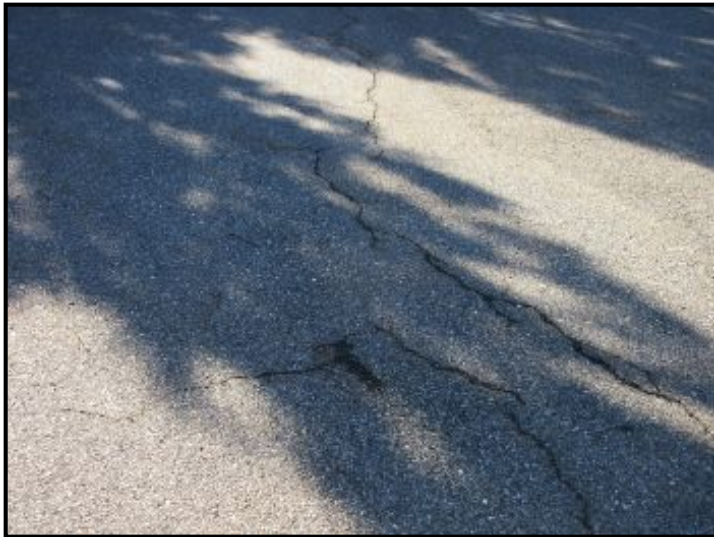
Moderate cracks in asphalt driveway. Suggest maintaining/sealing cracks to prevent wayer entry and freeze/thaw damage.

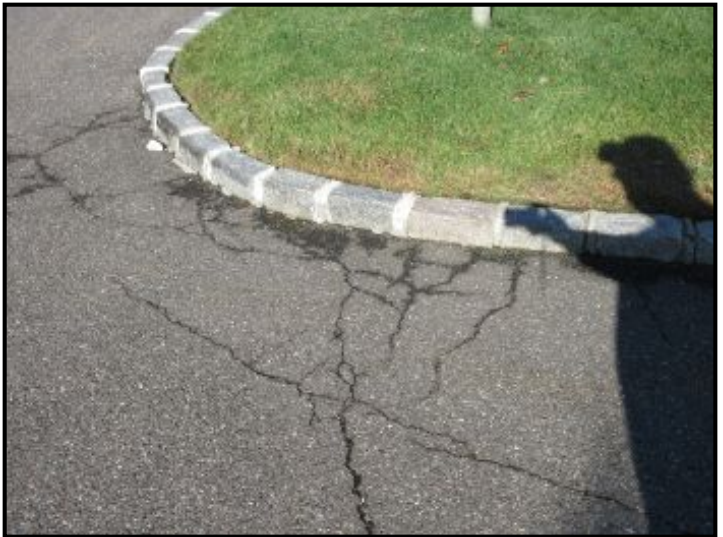
Moderate cracks in asphalt driveway. Suggest maintaining/sealing cracks to prevent wayer entry and freeze/thaw damage.

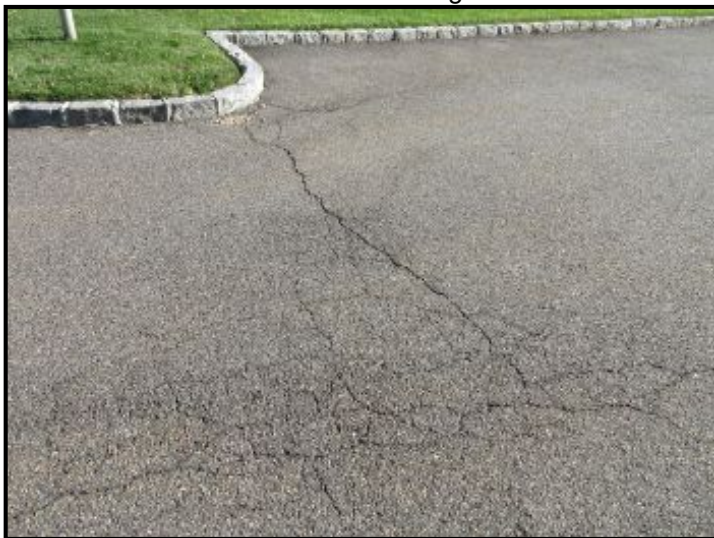
Moderate cracks in asphalt driveway. Suggest maintaining/sealing cracks to prevent wayer entry and freeze/thaw damage.

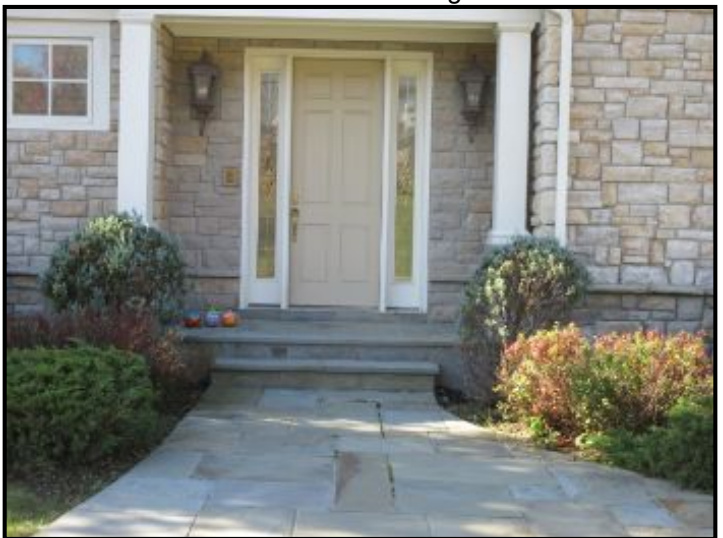
Bluestone (cleft cut) walkways.

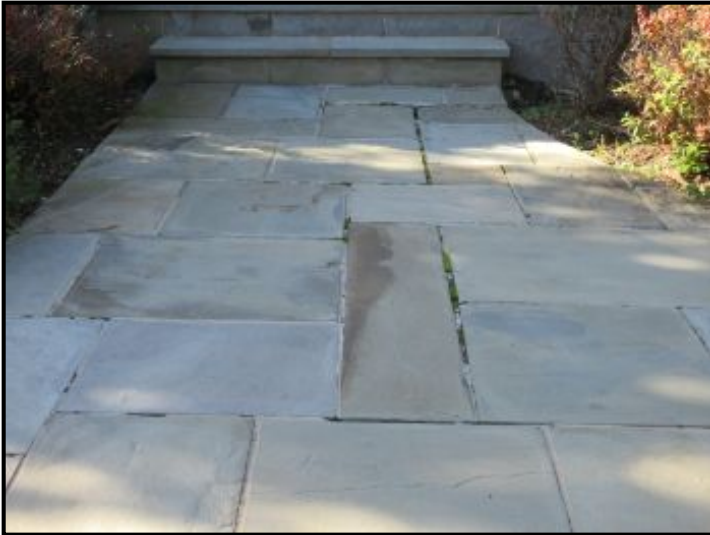
Bluestone walkways: Mortar cracked/missing observed. Suggest repair/replacement of defective mortar joints.

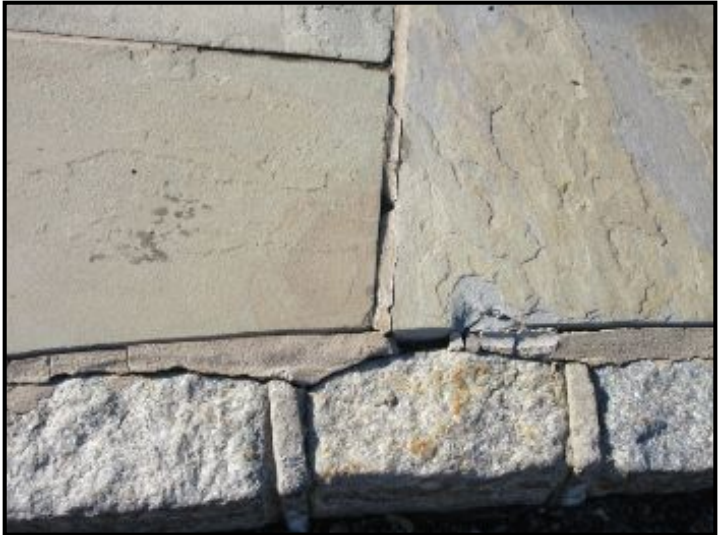
Bluestone walkways: Mortar cracked/missing observed. Suggest repair/replacement of defective mortar joints.

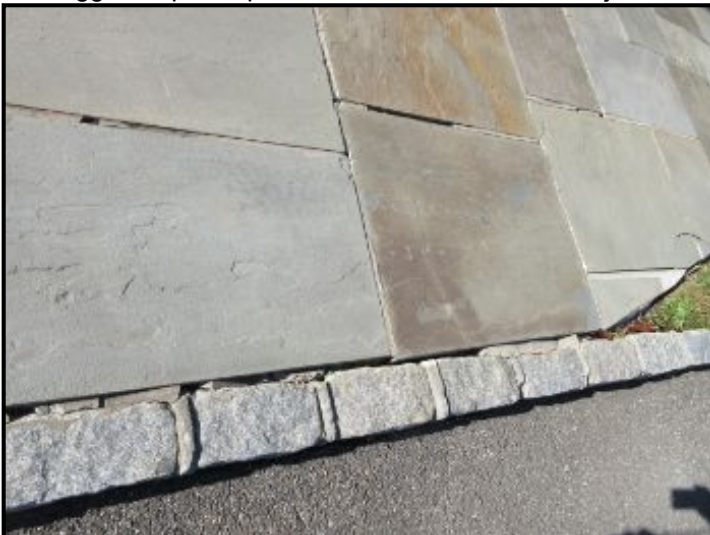
Bluestone walkways: Mortar cracked/missing observed. Suggest repair/replacement of defective mortar joints.

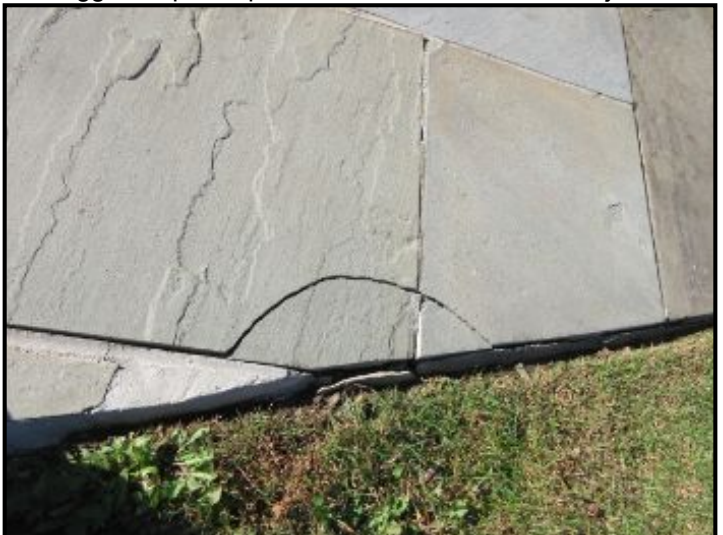
Bluestone walkways: Few cracked flags observed. Suggest replacing cracked flags.

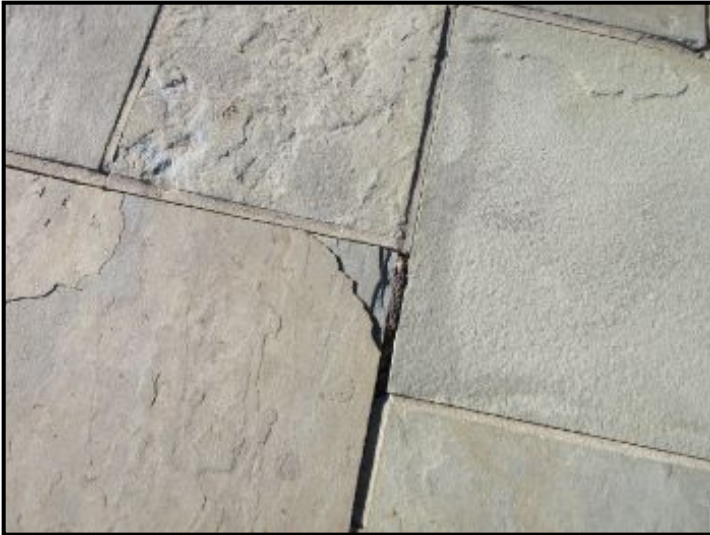
Bluestone walkways: Few cracked flags observed. Suggest repair/replacement of cracked flags.

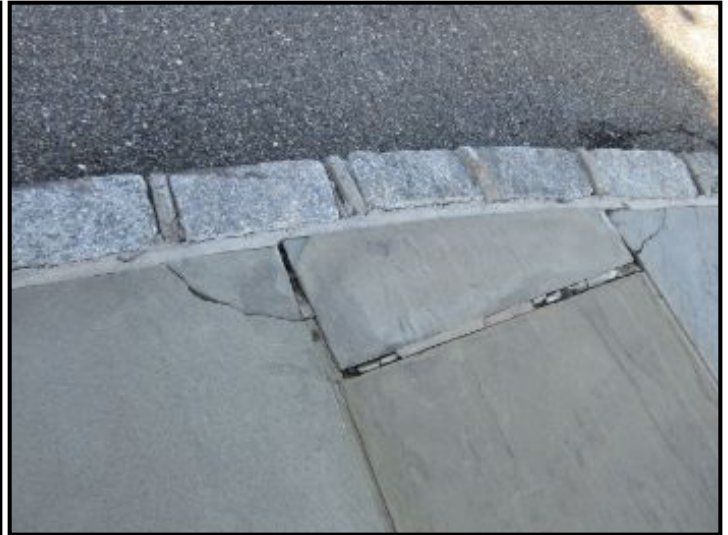
Cracked/missing mortar and cracked flags observed. Suggest mortar repairs and replacing cracked flags.

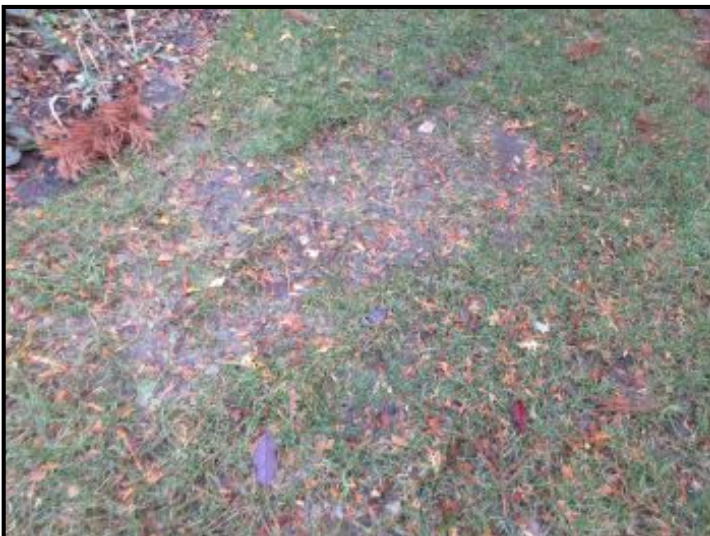
Lawn areas of the rear lot area were extremely soggy with some puddles noted. It is suggested that this is caused by over-watering. Soil drainage conditions are also a possible concern. Recommend reduce watering and monitor for normal drainage conditions.

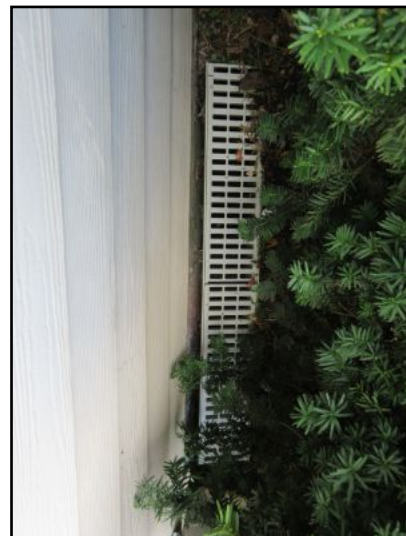
French drains observed in planting beds along the rear exterior wall.

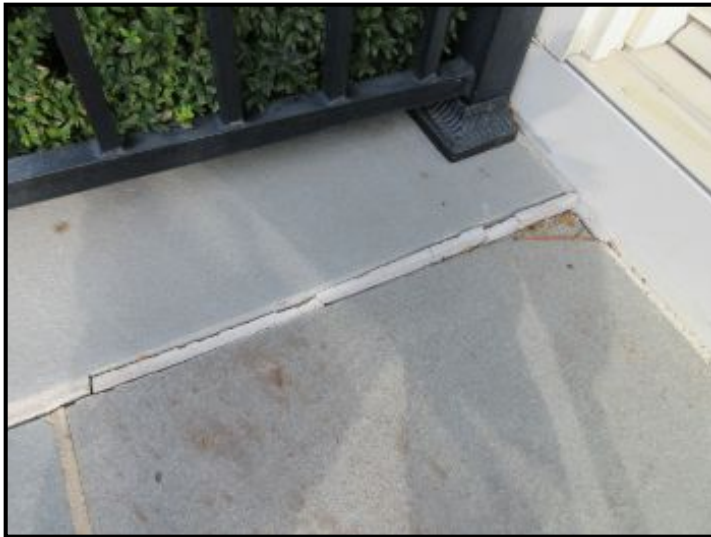
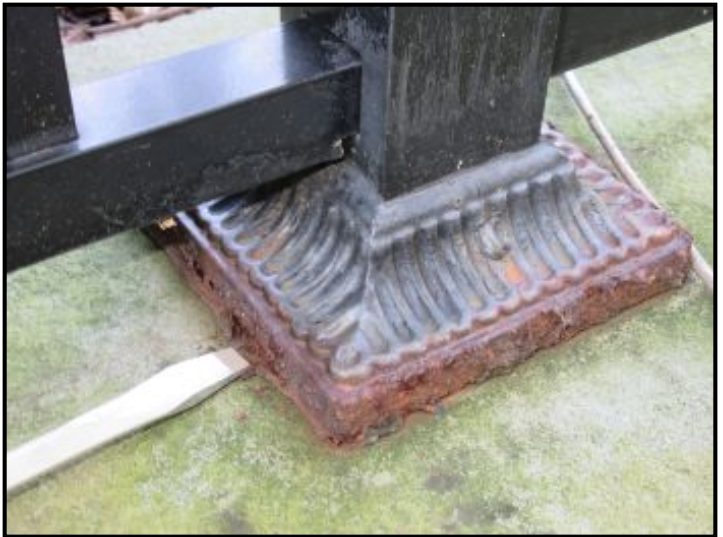
Steps at rear French door: Differential settlement at bluestone landing resulting in cracked perimeter mortar joint. Suggest repairing depressed flag(s) and mortar here.

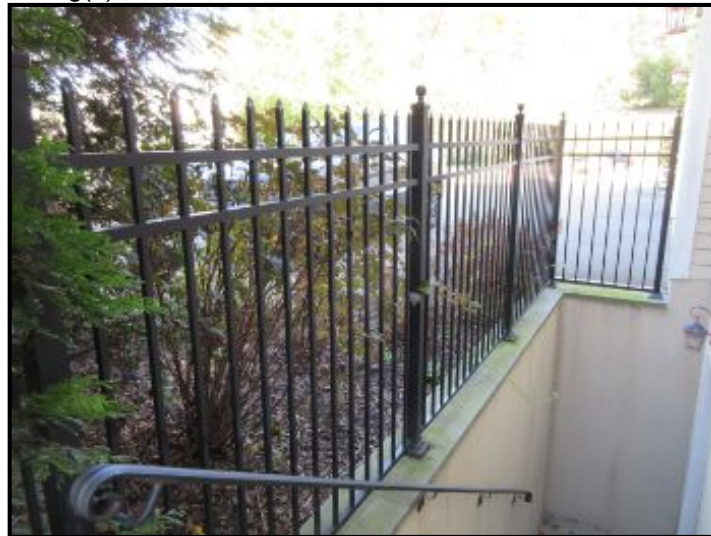
Guardrail at basement stairs.
