ProSpec Home Inspection of Long Island Property Inspection Report

623 Stewart Ave, Unit 121, Garden City, NY 11530
Inspection prepared for: Name Deleted
Date of Inspection: 12/27/2019 Time: 2:00 PM
Age of Home: 54 yrs old Size: 5,000 sq. ft.
Approx. Year Built: 1965

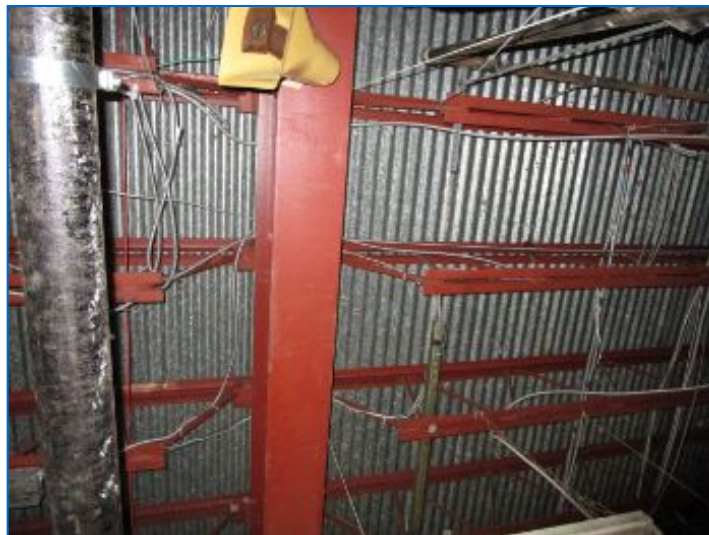
Steel columns, girders, bar joists supporting steel Q deck with poured concrete floor slab above i.e., 2nd floor above.

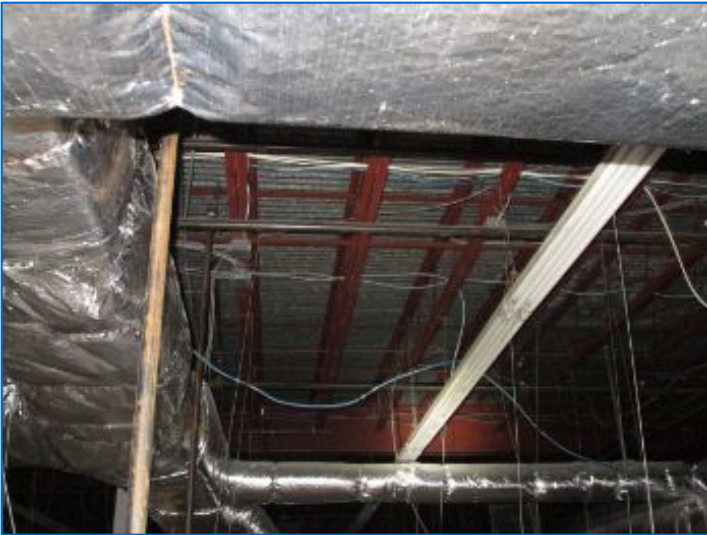
The Inspector observed no significant deficiencies in the condition of the structure above the suite at the time of the inspection - In normal condition for its age.

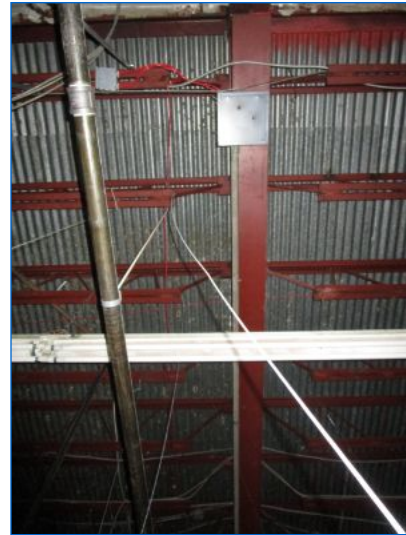
The Inspector observed no significant deficiencies in the condition of the structure above the suite at the time of the inspection - In normal condition for its age.

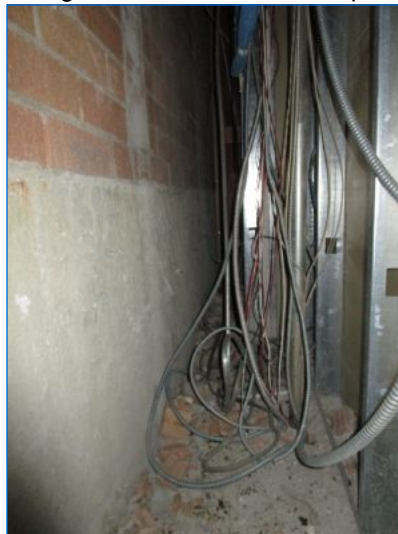
Wall cavity at northeast corner of the suite appeared dry at time of inspection.

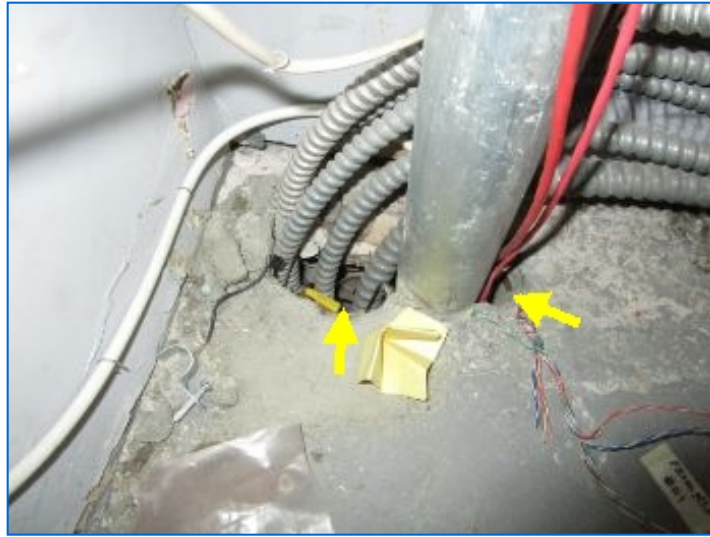
Fire-stopping was missing at floor penetration in electrical closet.

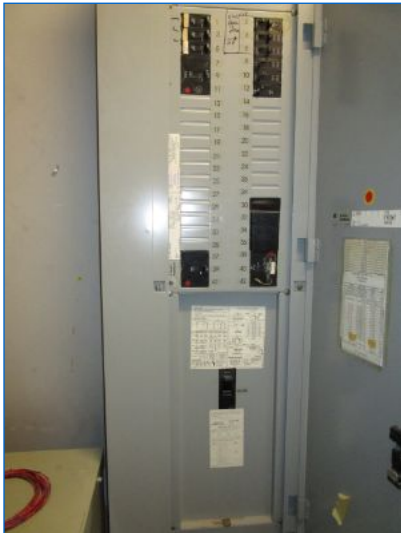
Main Panel# PP2: 42 circuit breaker spaces; 24 spare breaker spaces noted; 3 breakers were in the Off position.

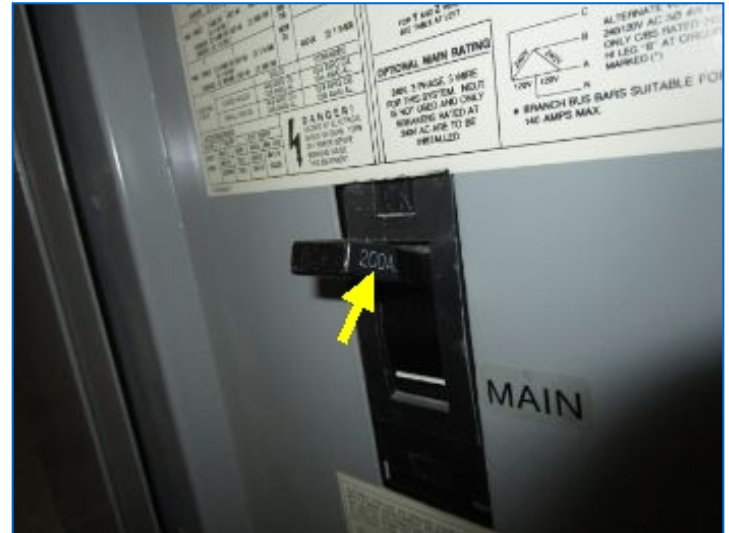
Main Panel# PP2 Disconnect: 200 amp main breaker serves the property.

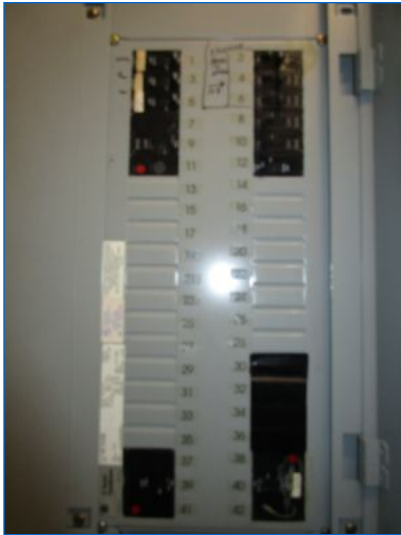
Main Panel# PP2: 42 circuit breaker spaces; 24 spare breaker spaces noted; 3 breakers were in the Off position.

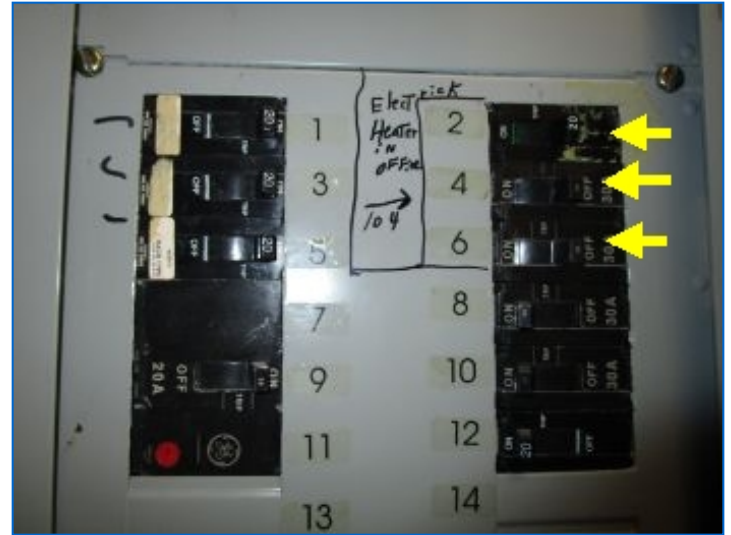
Main Panel# PP2 breakers labeled "Electric Heaters in Office (EBH-1 & EBH-2)" and "(WUH-1)" were in the Off position. These are believed to be the circuits for the electric baseboard heaters in the two front offices, and (WUH-1) is believed to be for the Unit Heater located at wall in entryway.

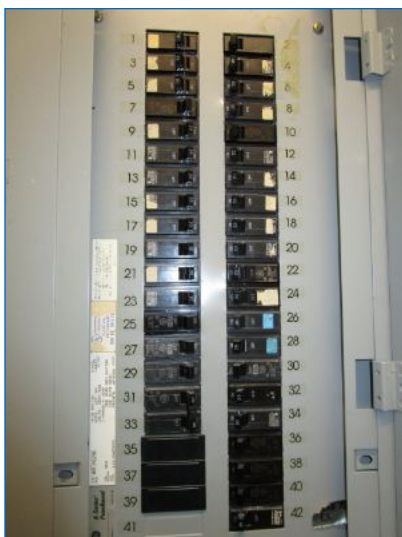
Main Panel# RP2: 42 circuit breaker spaces; 4 spare breaker spaces noted; 3 breakers were in the Off position.

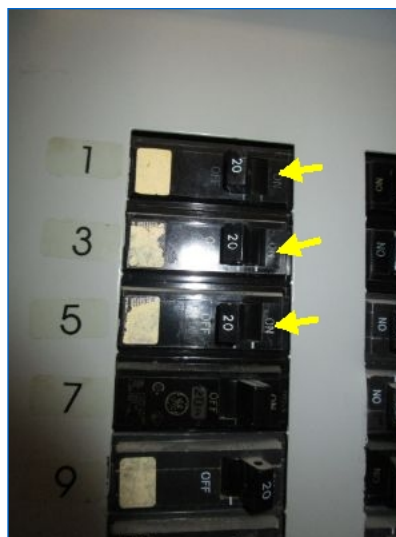
Main Panel# RP2 breakers labeled "#1 Conv. Rec", "#3 Microwave" and "#5 Microwave" were in the Off position. The Inspector was unable to detect the locations of these Off circuits within the rooms.

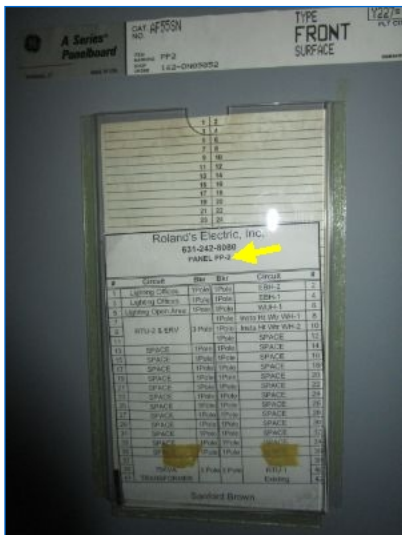
Main Panel# PP2 Circuit Index noted.

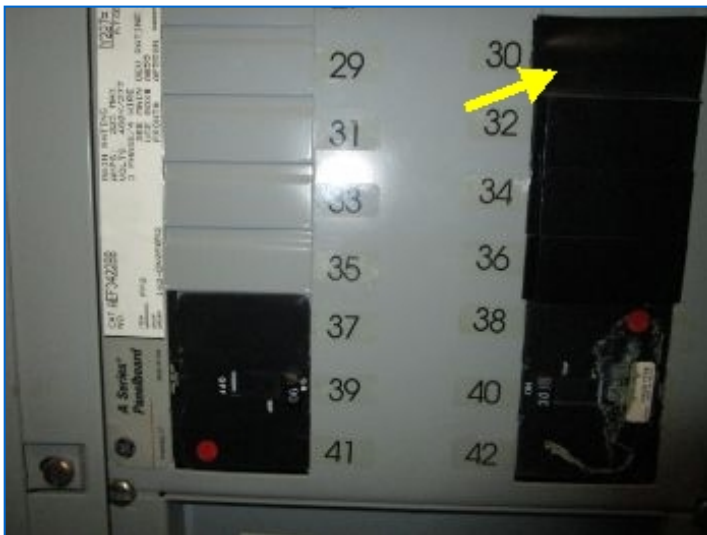
Main Panel# PP2: Tape over Unused Circuit Breaker Slots. Electrocutation hazard. Recommend electrician install snap-in knockout caps inside panel box. These are installed to avoid potential electrocutation hazard and to keep mice out of panel box.

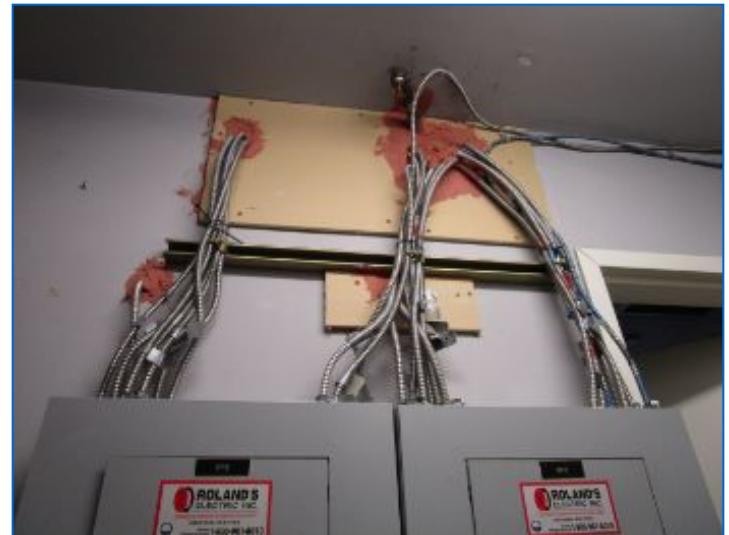
Distribution wiring observed consisted of copper, metallic armored cable.

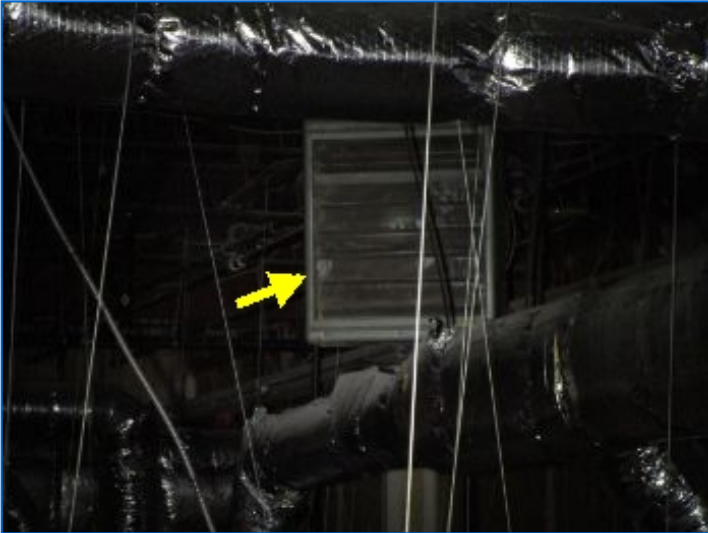
Unit heater suspended above hung ceiling near front of suite; status unknown -- appeared to be out of service based on current conditions. Suggest conferring with seller.

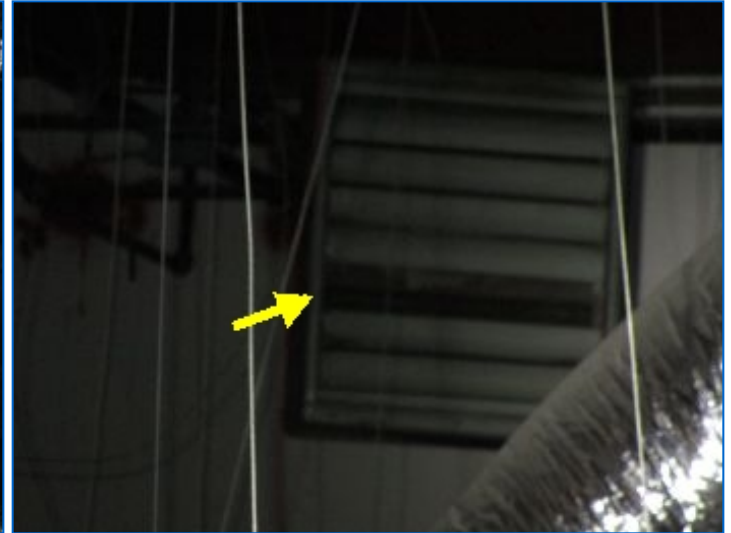
Unit heater suspended above hung ceiling near rear of suite; status unknown -- appeared to be out of service based on current conditions. Suggest conferring with seller.

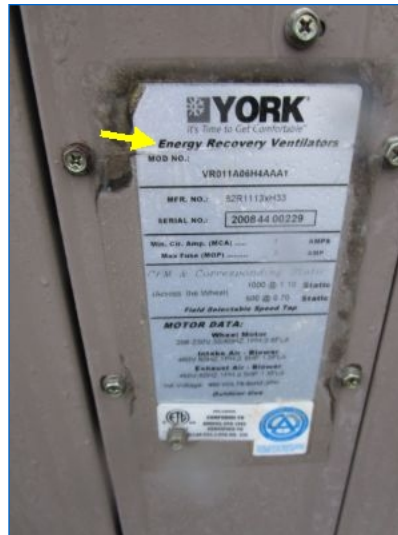
HVAC#1B was equipped with a York Energy Recovery Ventilator add-on for the purpose of recovering energy from the air that is exhausted from the building through this system. Manufactured in 2008, it is rated to handle up to 1000 CFM.

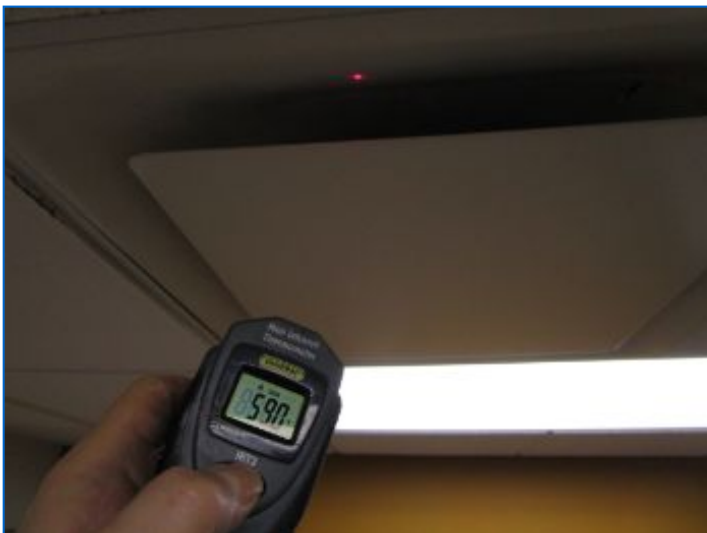
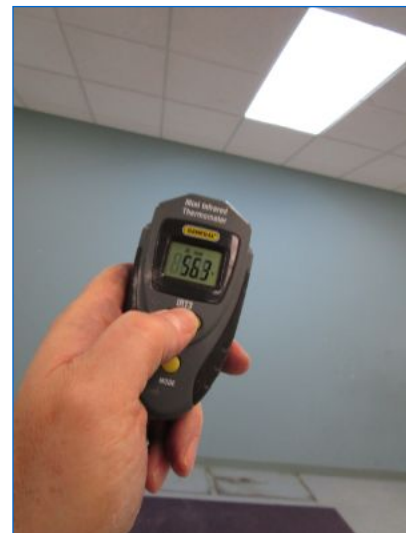
HVAC unit's fan ran but heating mode did not function due to gas being turned off.

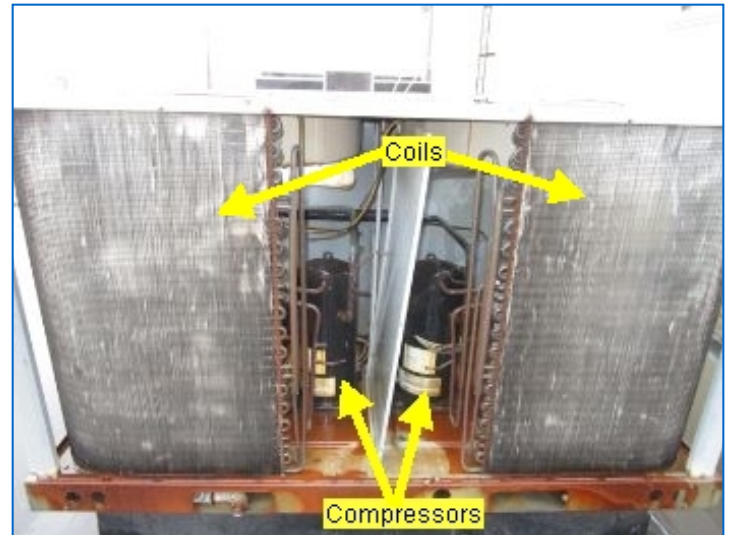
HVAC#1A: Access panel for compressor section was removed at time of inspection. Recommend inquiry as to what the status is of the cooling section of this unit; appears as if that ongoing access/service to the compressor section was needed. Condenser coil aluminum: some fins are bent and dirty; this will reduce performance and efficiency of the system. Recommend a qualified HVAC professional comb fins straight and clean coil to improve cooling system performance and efficiency. Refer to Service Recommendation heading.

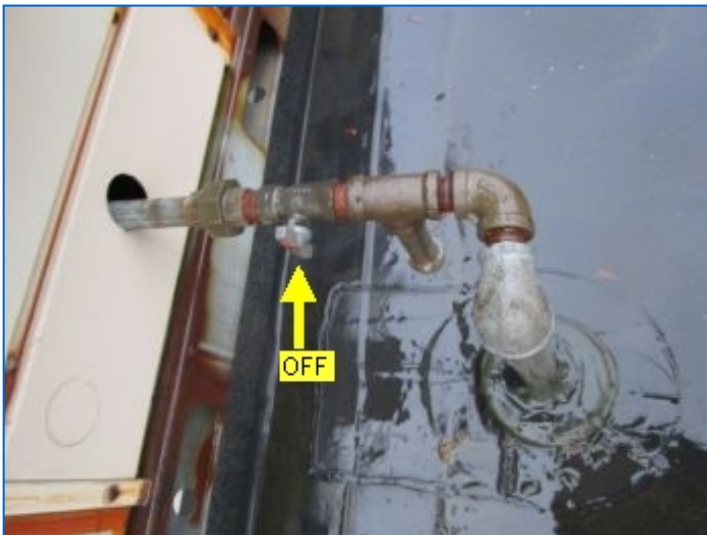
HVAC #1A: Gas to the heating section of the unit was turned off at time of inspection. Custodian was apparently not authorized to turn the gas on at the time of inspection. Recommend conferring with seller regarding start-up and testing of the heating section for this system.

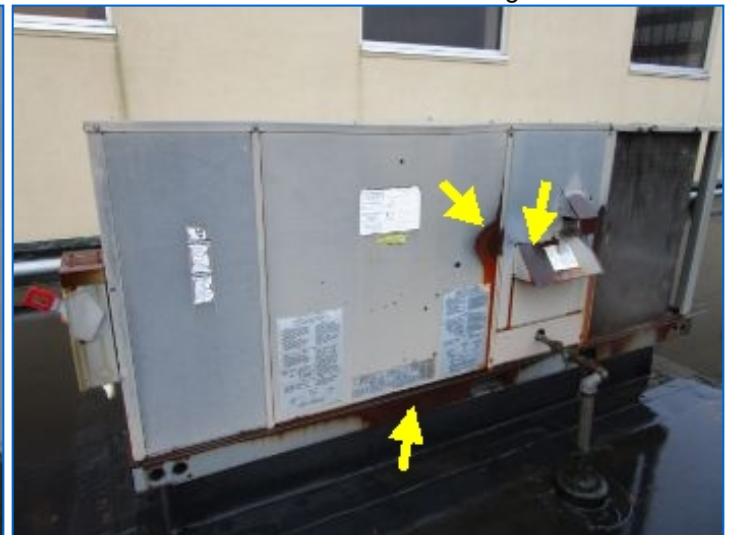
HVAC#1A is the older unit; showed signs of rust at cabinet and frame.

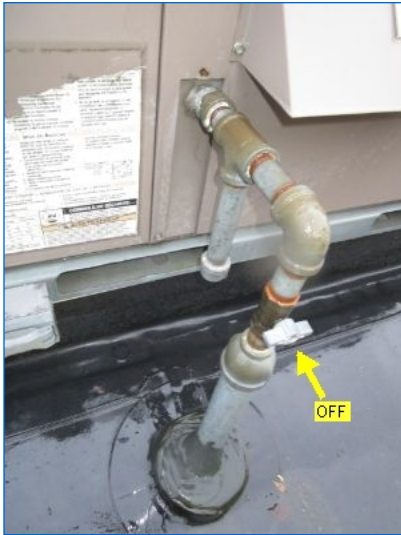
HVAC #1B: Gas to the heating section of the unit was turned off at time of inspection. Custodian was apparently not authorized to turn the gas on at the time of inspection. Recommend conferring with seller regarding start-up and testing of the heating section for this system.

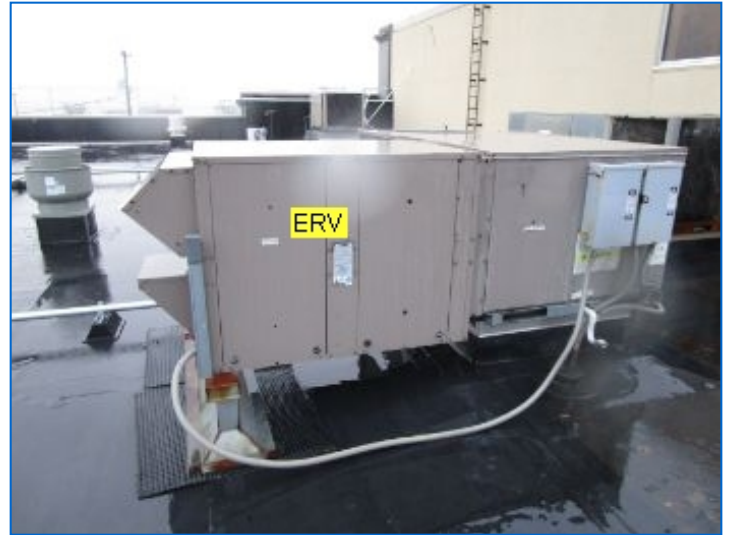
HVAC#1B Unit with Energy Recovery Ventilator (ERV) add-on.

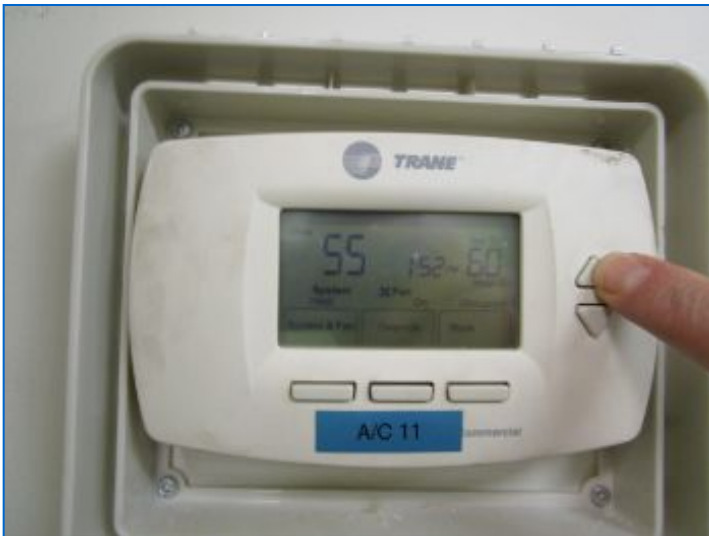
Digital Programmable type thermostat noted in Room #6; Heating & Cooling ; appeared functional. HVAC unit's fan ran but heating mode did not function due to gas being turned off.

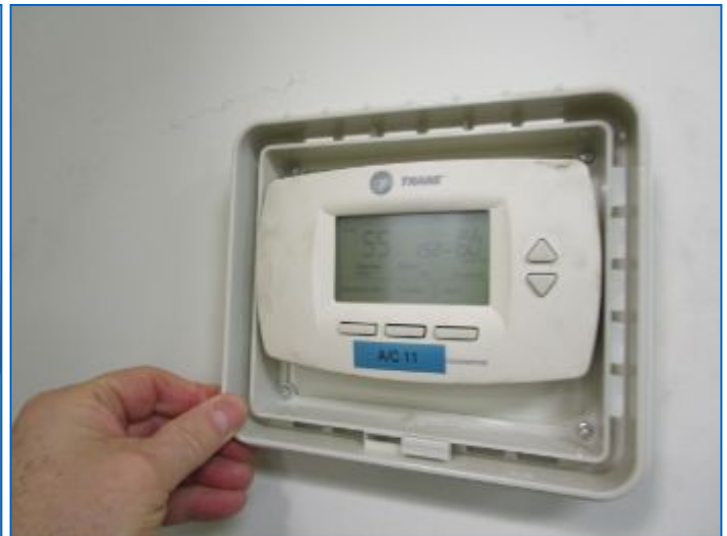
Security cover for Room #6 thermostat was missing.

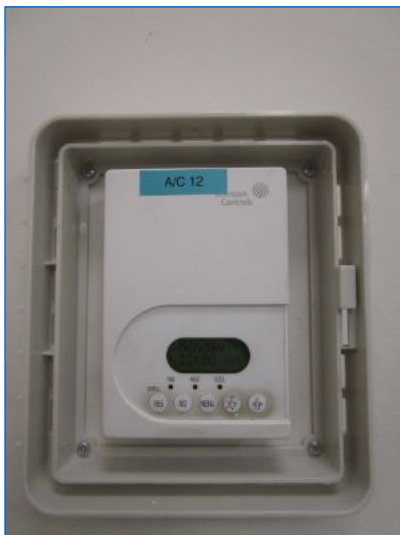
Digital Programmable type thermostat noted in Room #7; Heating & Cooling ; appeared functional. HVAC unit's fan ran but heating mode did not function due to gas being turned off.

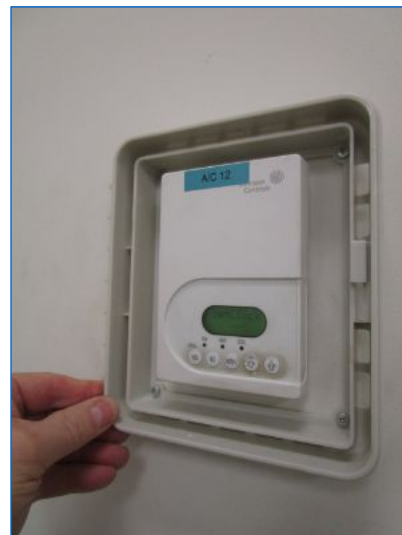
Security cover for Room #7 thermostat was missing.

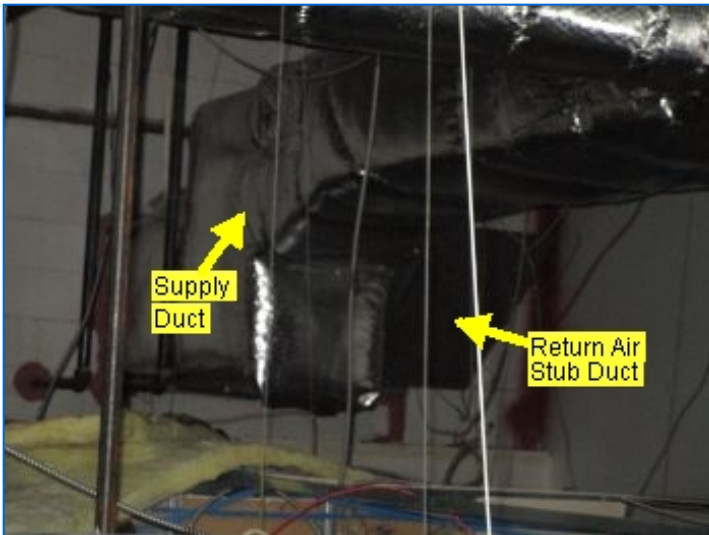
HVAC#1A: Supply ductwork and return stub duct (ceiling plenum return).

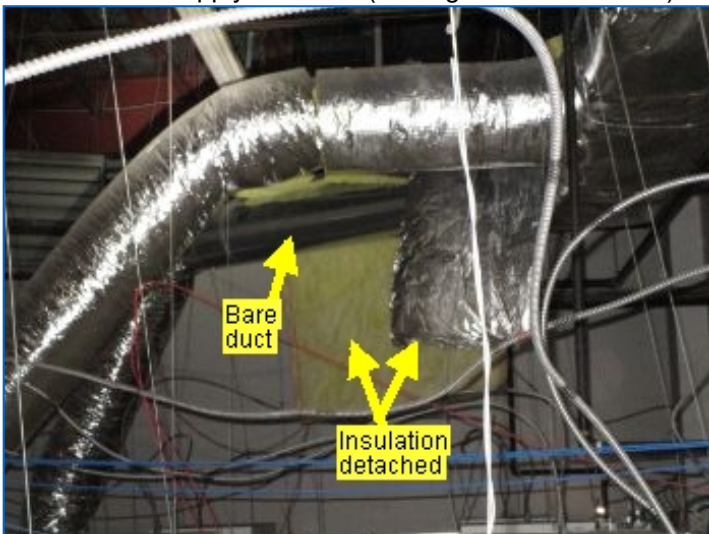
Insulation detached from HVAC#1A supply ductwork; recommend repairing insulation.

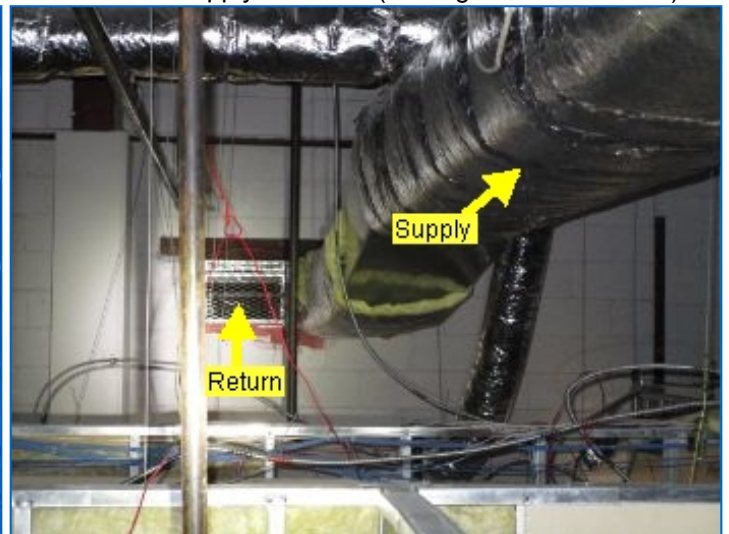
HVAC#1B: Supply ductwork and return stub duct (ceiling plenum return).

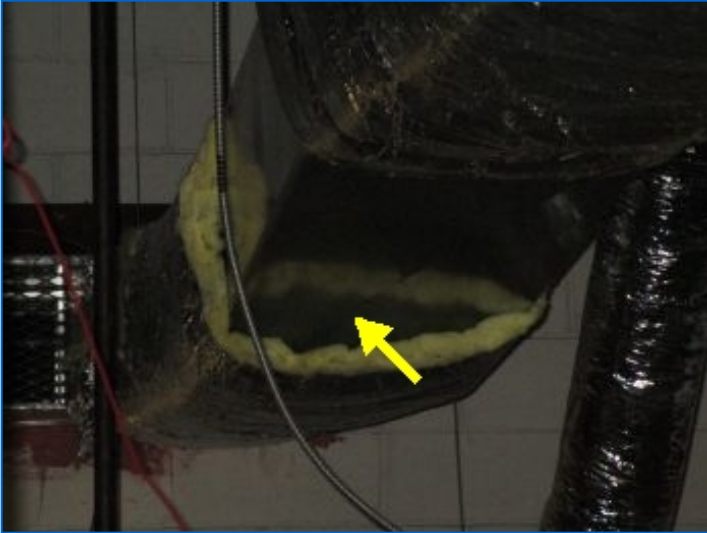
Insulation detached from HVAC#1B supply ductwork; recommend repairing insulation.

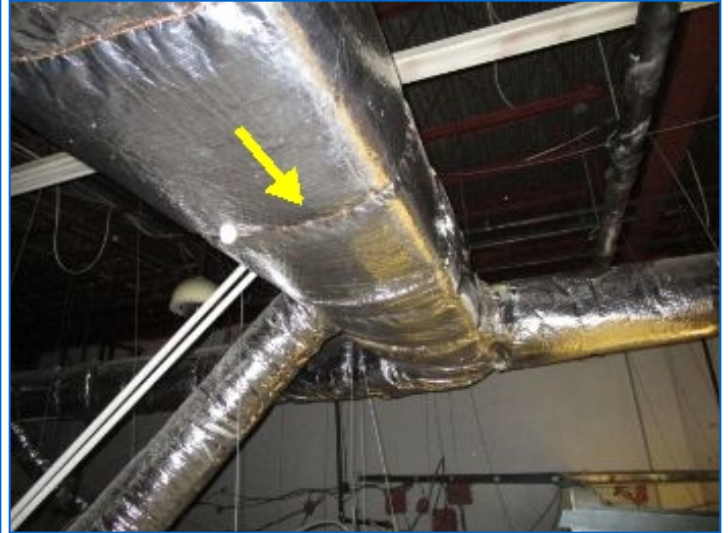
HVAC#1B Supply ductwork (looking south).

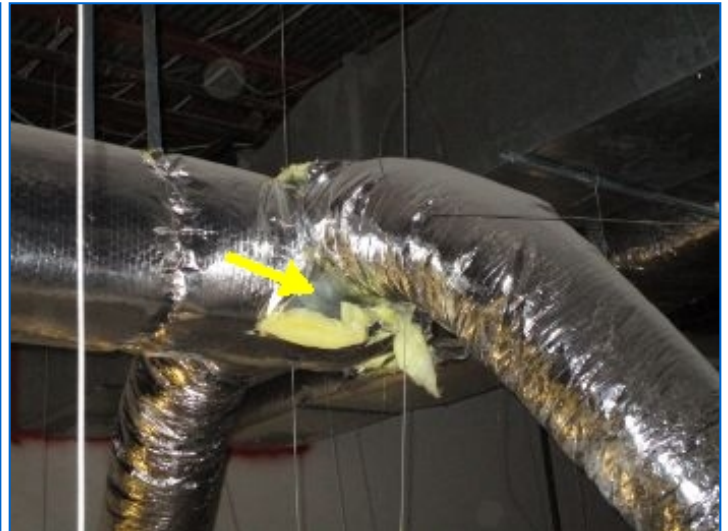
Insulation detached from HVAC#1B supply ductwork; recommend repairing insulation.

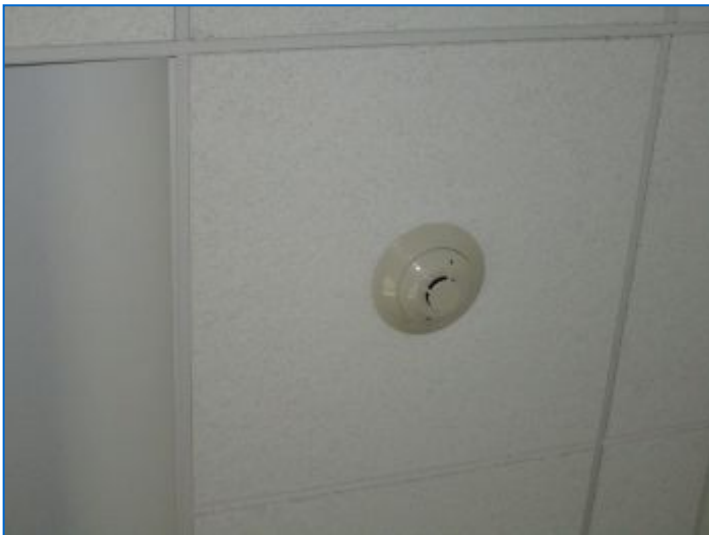
LIFE SAFETY: Maintain functioning Smoke and Carbon Monoxide detectors at the recommended locations.

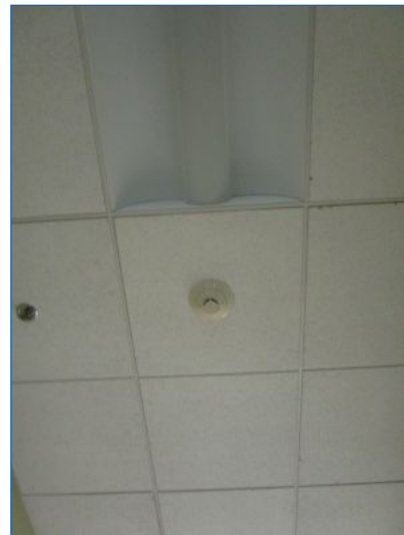
LIFE SAFETY: Maintain functioning Smoke and Carbon Monoxide detectors at the recommended locations.

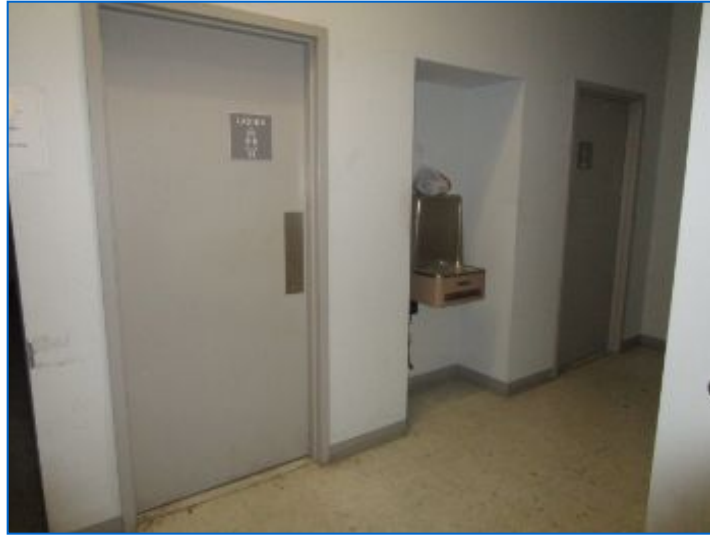
Bathrooms noted outside rear of suite.

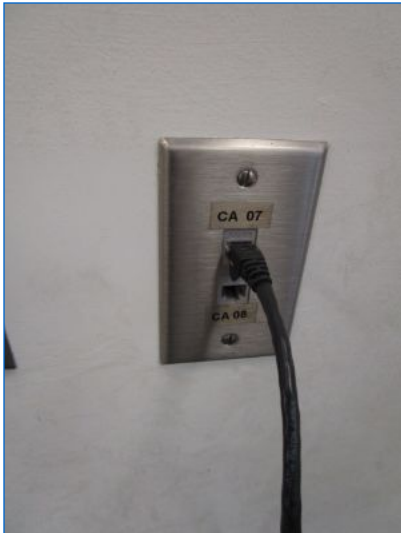
IT jacks noted in office spaces throughout.

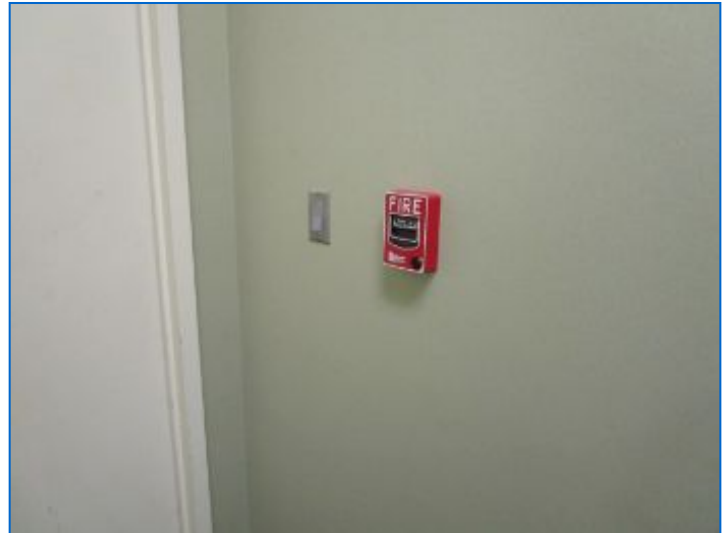
Fire alarm pull station noted.

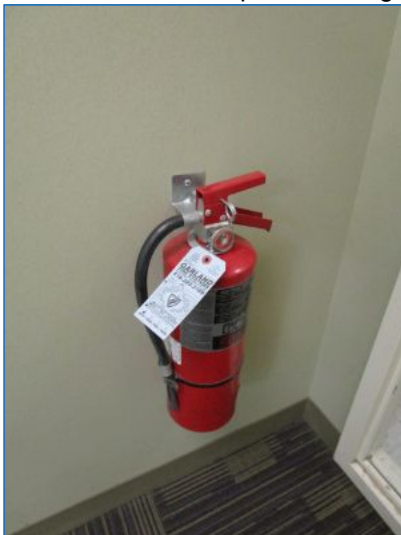
Maintain inspected/functioning fire extinguisher/s in accordance with the local Office of the Fire Marshall.

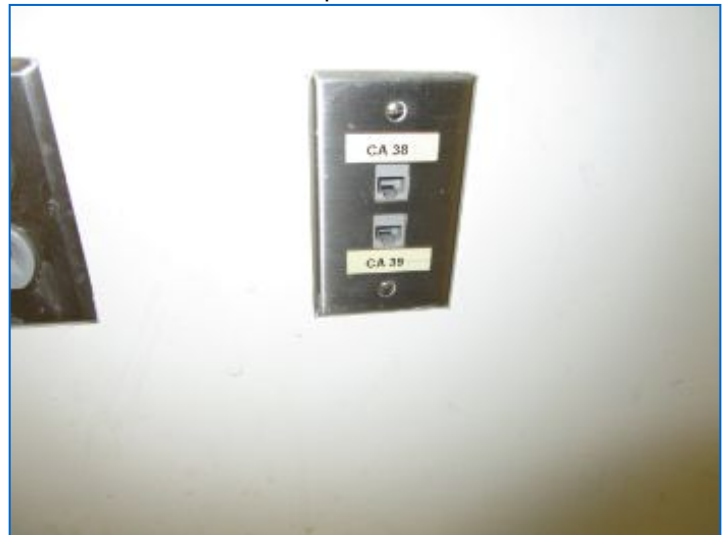
IT jacks noted in office spaces throughout.

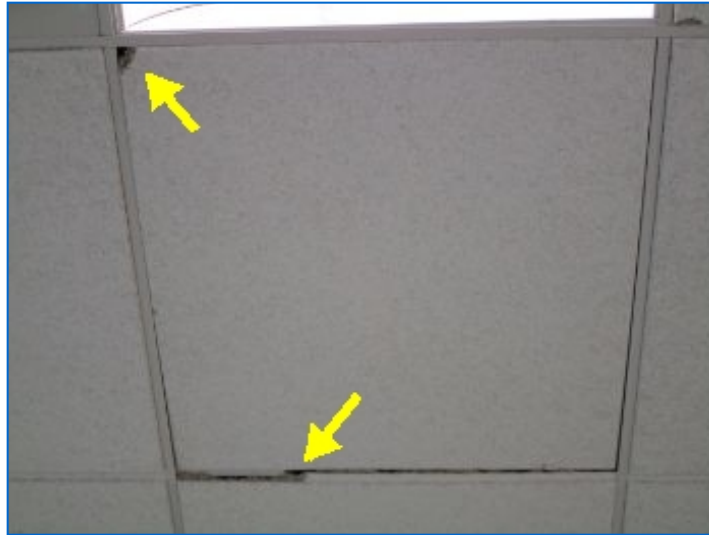
Some minor damages were observed at ceiling tiles in various places.

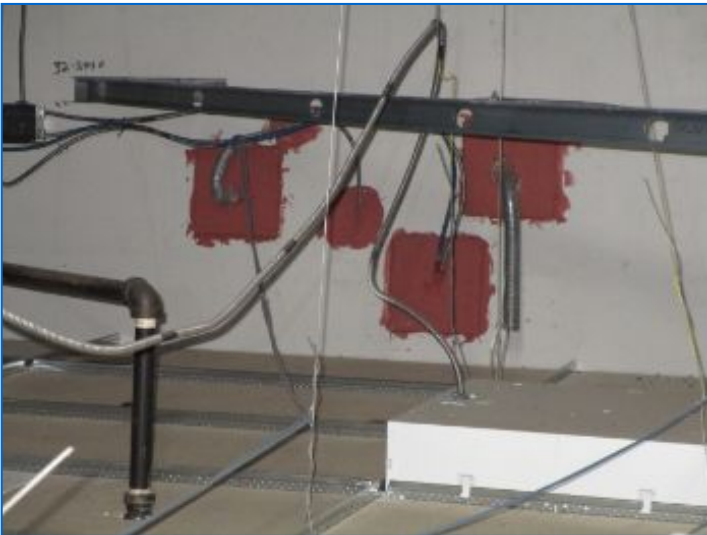
Repairs noted at fire barrier wall above hung ceiling separating the adjacent office suite.

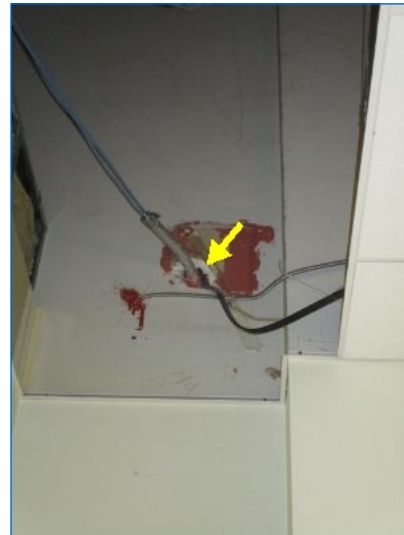
Inadequate fire-stopping noted at some penetrations through fire-rated barriers at suite border walls.

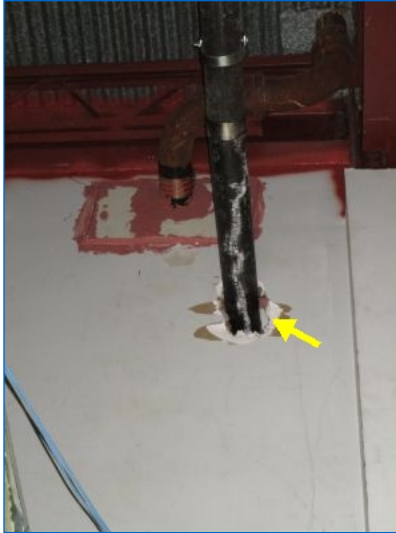
Inadequate fire-stopping noted at some penetrations through fire-rated barriers at suite border walls.

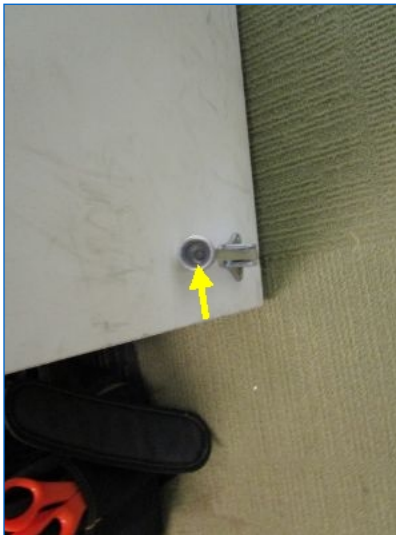
Few door stoppers were noted missing their rubber foot.

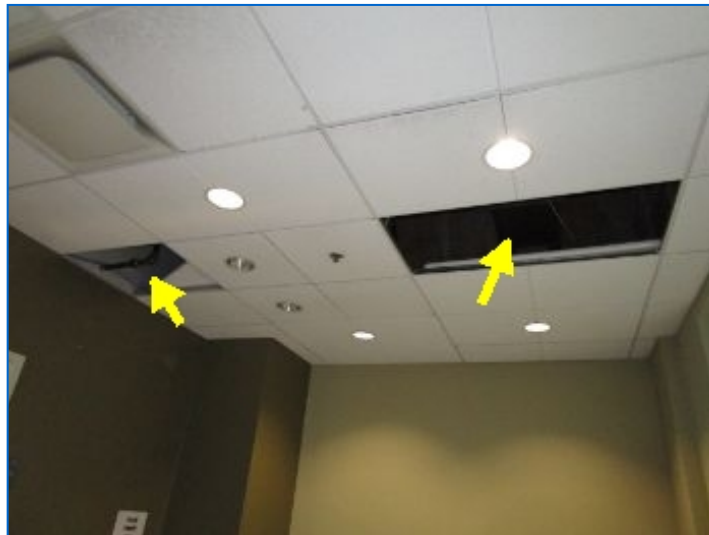
Ceiling tiles found removed.

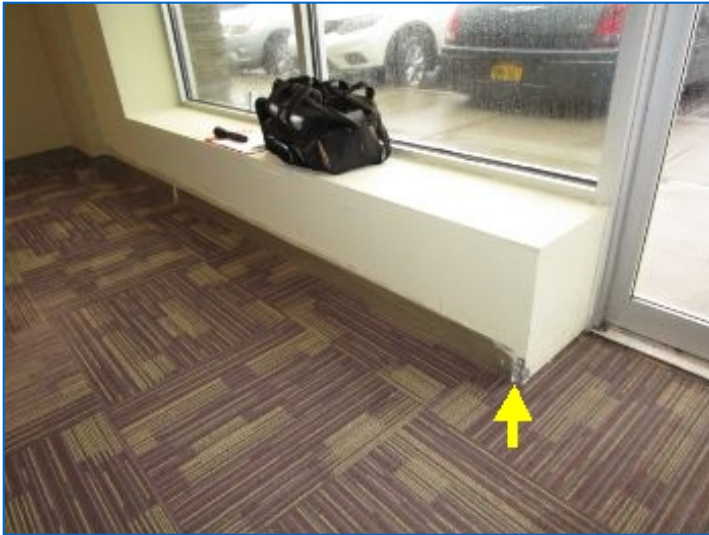
Cosmetic repair needed for cove base.

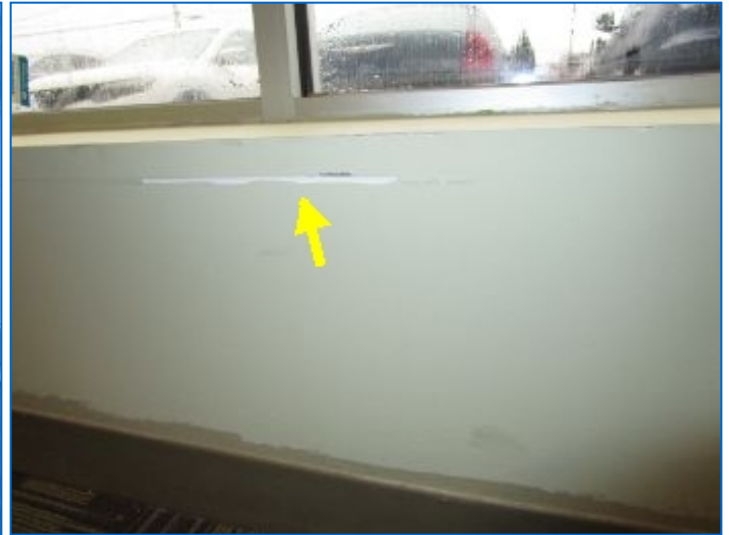
Cosmetic repair suggested for sill wall.

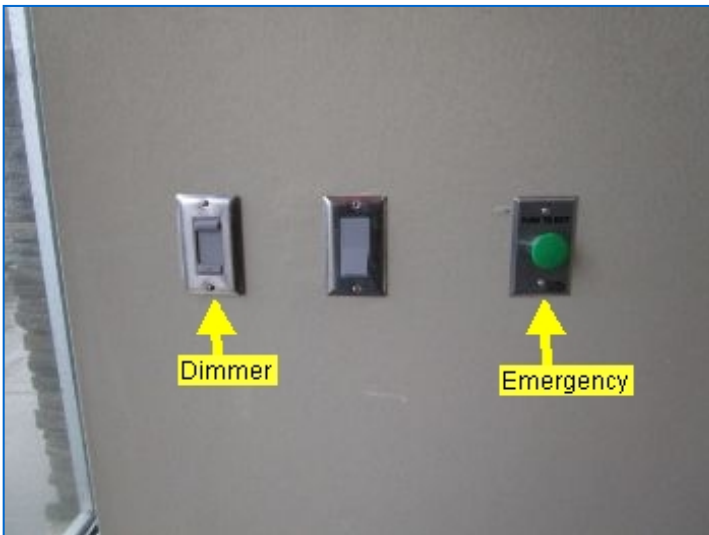
Dimmer switch and emergency door release button perhaps showed no apparent purpose at time of inspection. Confer with seller for functionality.

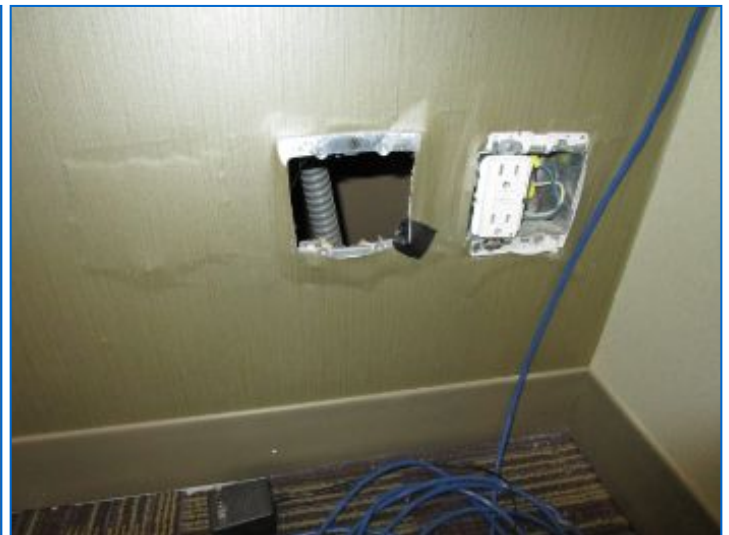
Entryway/Recep: Cosmetic damages at wall and electrical box cover missing. Repairs are recommended to eliminate shock/electrocution hazard.

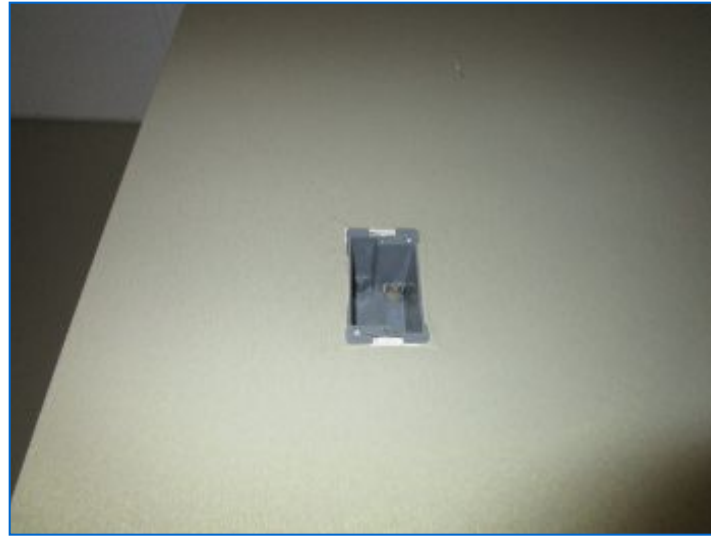
Unused electrical/cable box noted at wall in entryway.

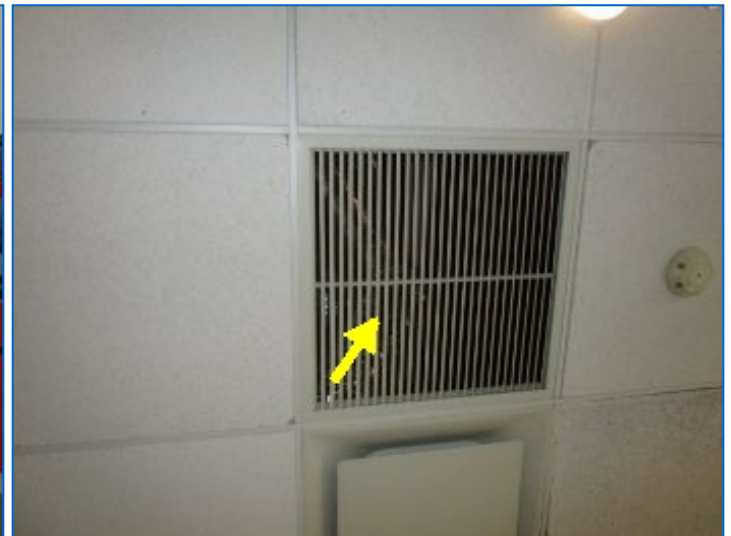
HVAC return grille to ceiling plenum noted.

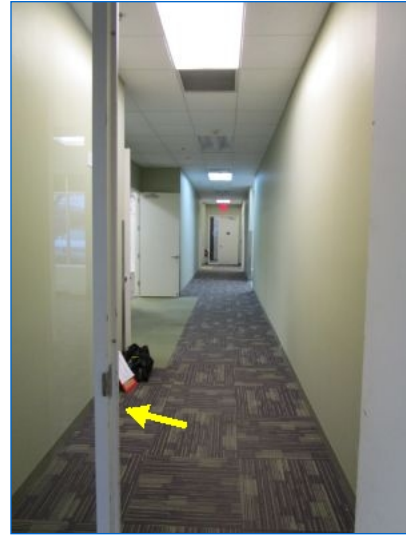
Hallway (rear portion); self-closing fire door/s noted.

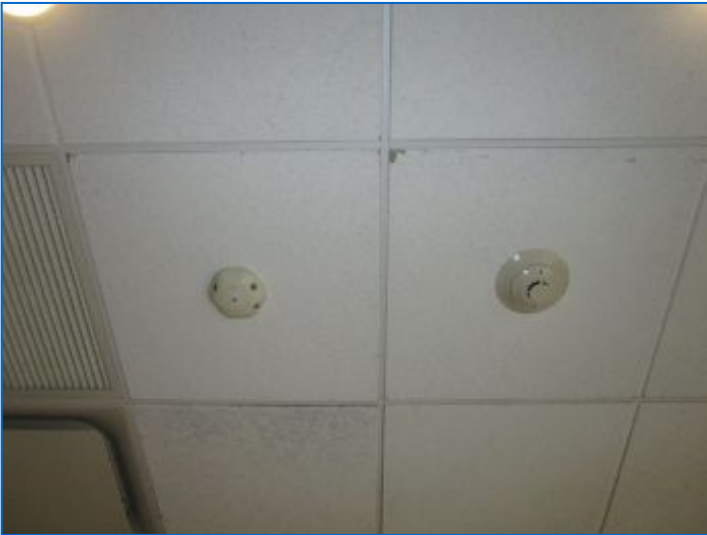
LIFE SAFETY: Maintain functioning Smoke and Carbon Monoxide detectors at required locations (Refer to Smoke/CO Detectors section).

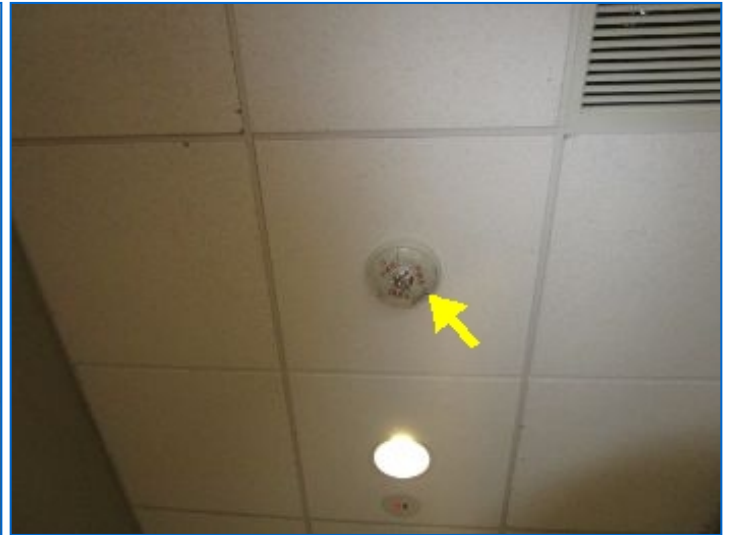
Fire strobe alarm noted.

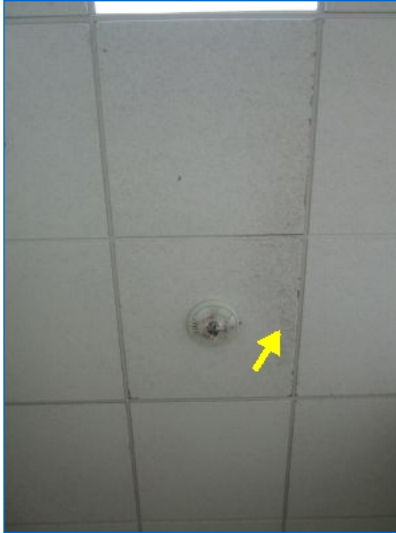
Some cosmetic stains and minor damages were observed at ceiling tiles in various places.

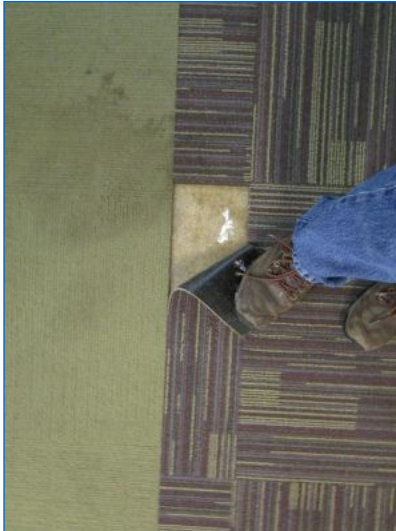
Carpet tile had lifted; potential trip hazard.

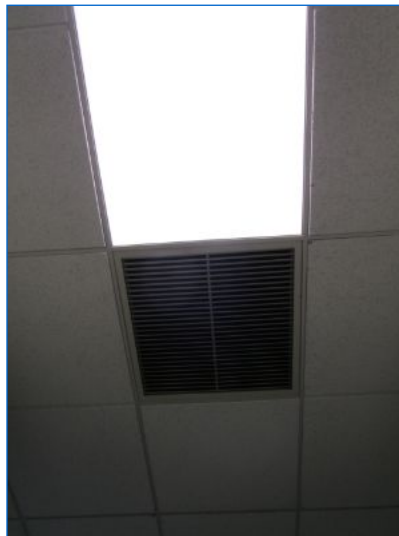
Hallway (rear portion); HVAC return grille to ceiling plenum noted.

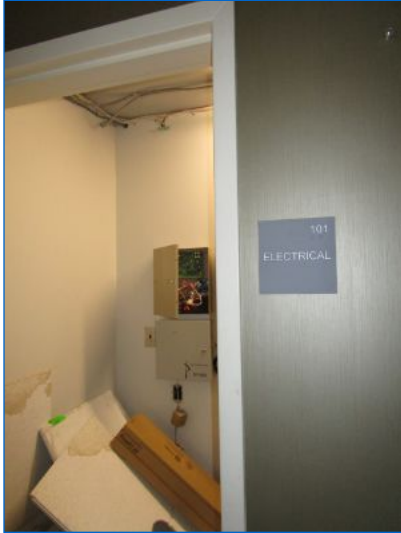
- Construction materials and debris noted in electrical closet.
- Smoke/Fire/Security panels noted in electrical closet. Confer with seller for installation/maintenance contractor information to ensure proper operation prior to close.

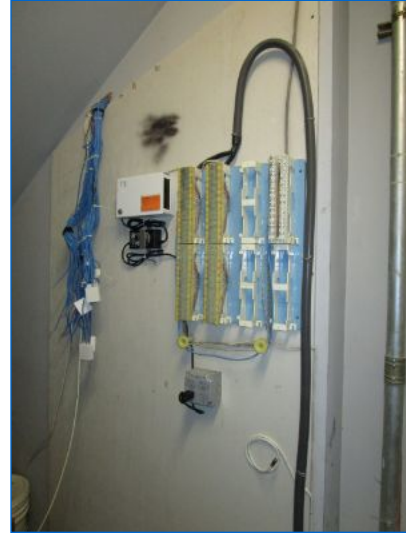
IT cables and telecom terminals noted in electrical closet.

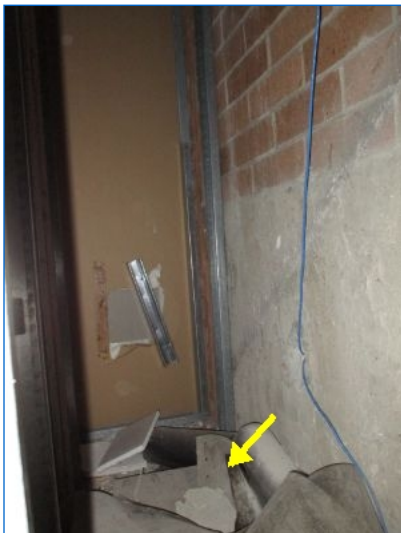
Construction debris noted inside wall cavity at northeast corner of the suite.

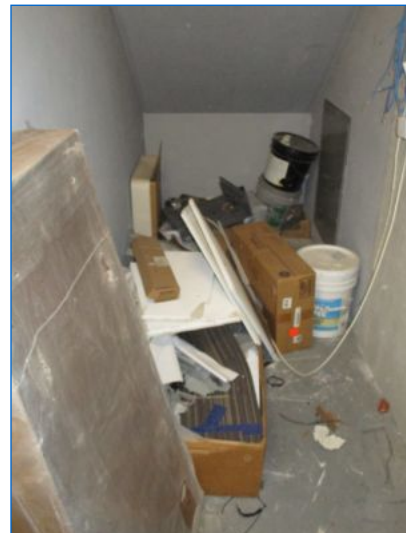
Construction materials and debris noted in electrical closet.

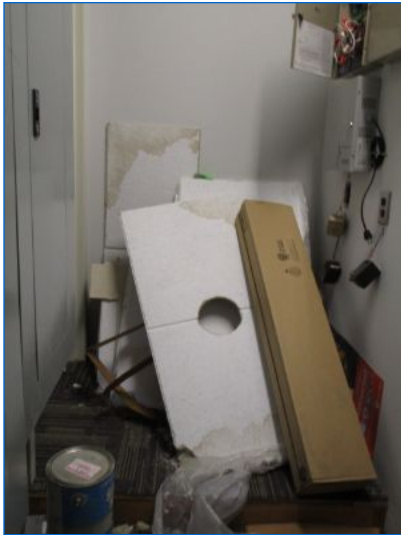
Construction debris noted in electrical closet.

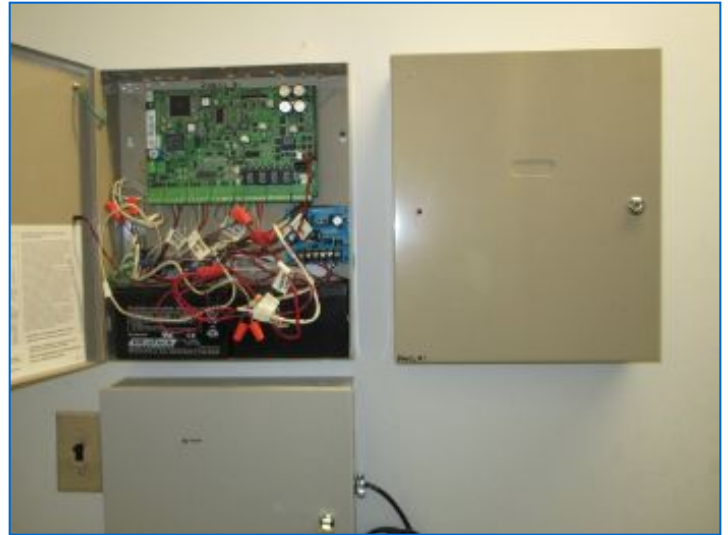
Smoke/Fire/Security panels noted in electrical closet. Confer with seller for installation/maintenance contractor information to ensure proper operation prior to close.

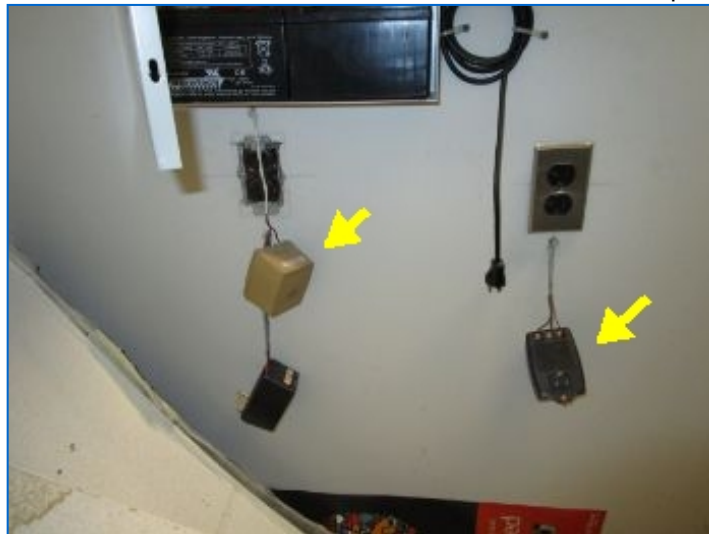
Smoke/Fire/Security panels deactivated in electrical closet. Confer with seller for installation/maintenance contractor information to ensure proper operation prior to close.
