ProSpec Home Inspection of Long Island Property Inspection Report

623 Stewart Ave, Unit 121, Garden City, NY 11530
Inspection prepared for: Name Deleted
Date of Inspection: 12/27/2019 Time: 2:00 PM
Age of Home: 54 yrs old Size: 5,000 sq. ft.
Approx. Year Built: 1965

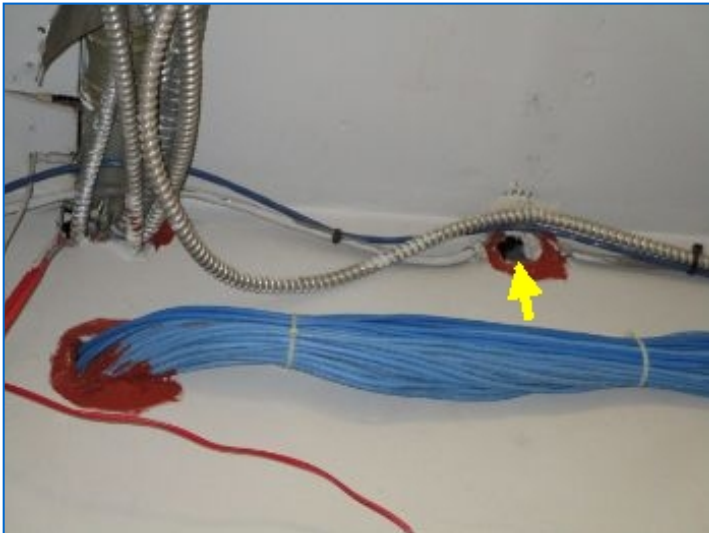
Inadequate fire-stopping noted at some penetrations through fire-rated barriers at suite border walls.

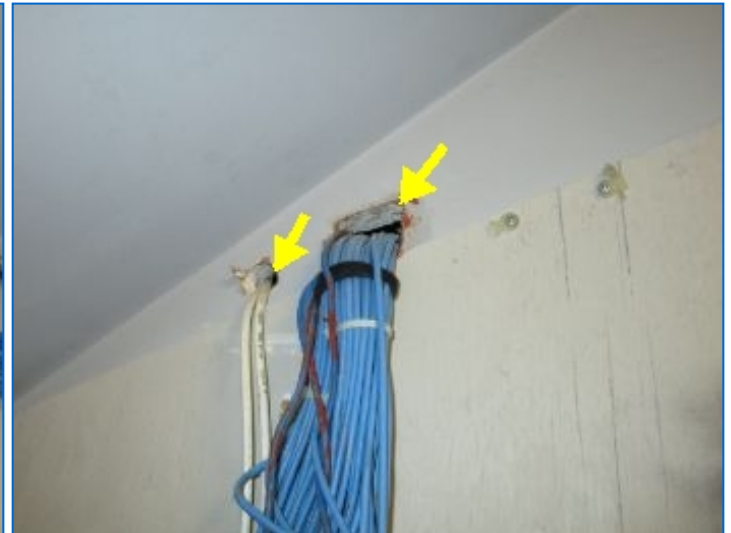
Inadequate fire-stopping noted at some penetrations through fire-rated barriers at suite border walls.

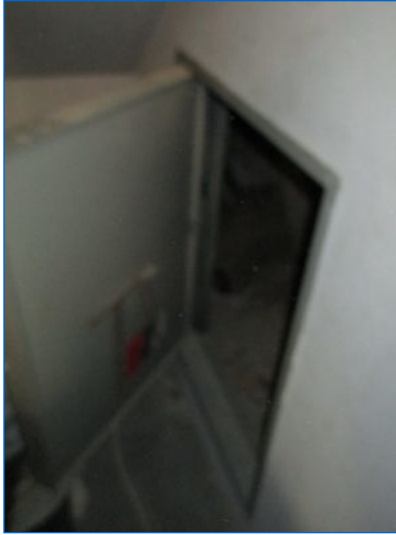
Access to northeast wall cavity.

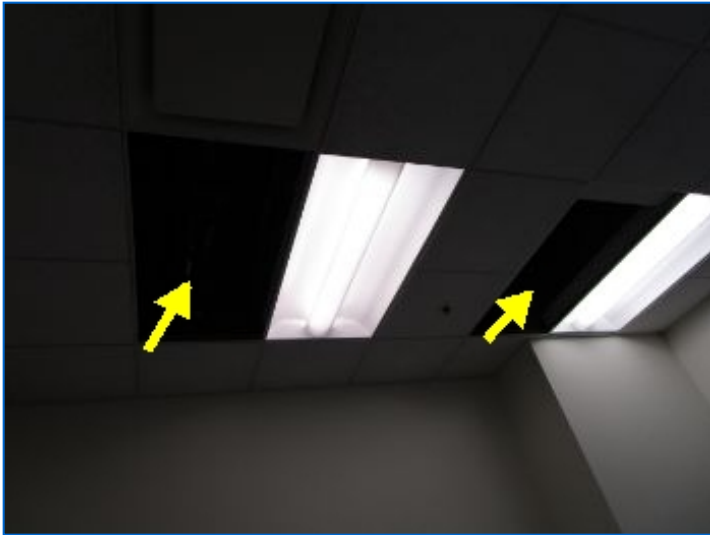
Ceiling tiles found removed.

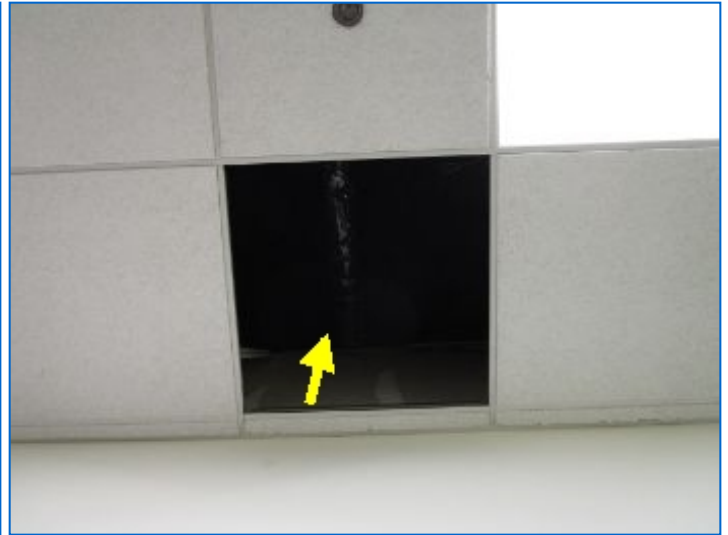
Ceiling tiles found removed.

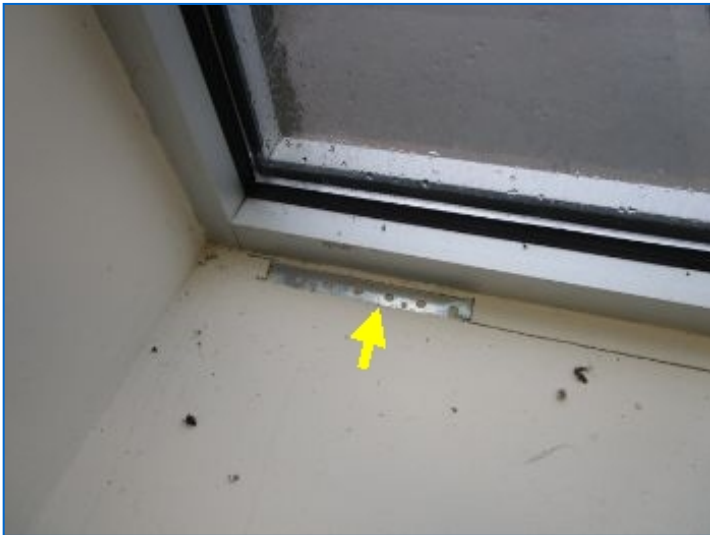
General cosmetic misc. repairs/finishes needed.

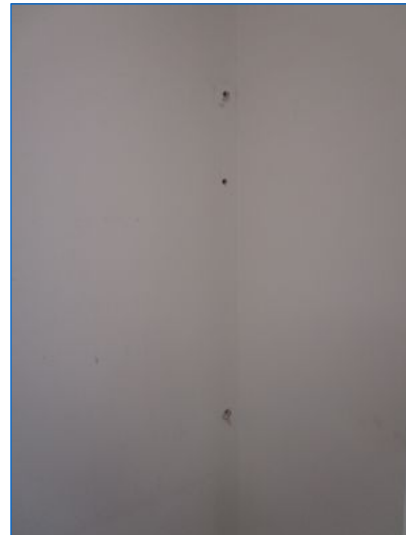
General cosmetic misc. repairs/finishes needed.

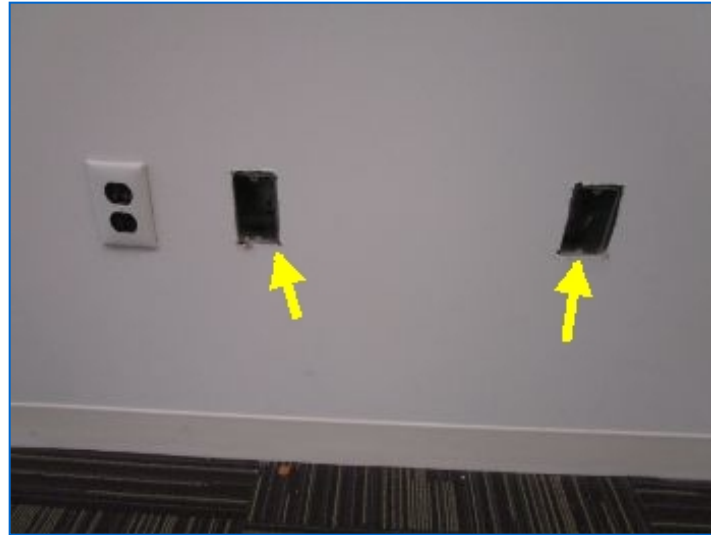
Unused electrical boxes noted at two places.

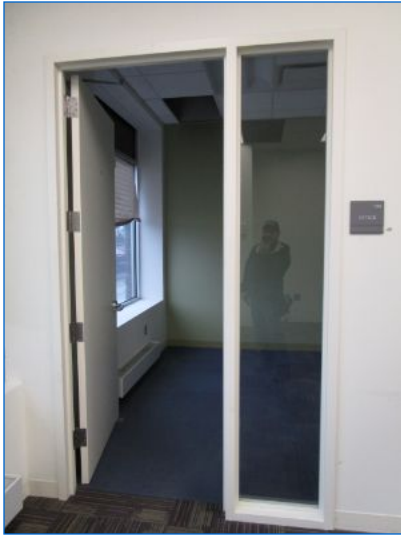
Office 104 accessed via Office 103 at front.

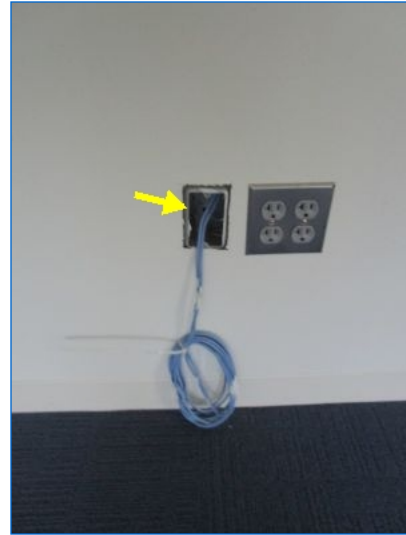
Uncovered IT cable box noted.

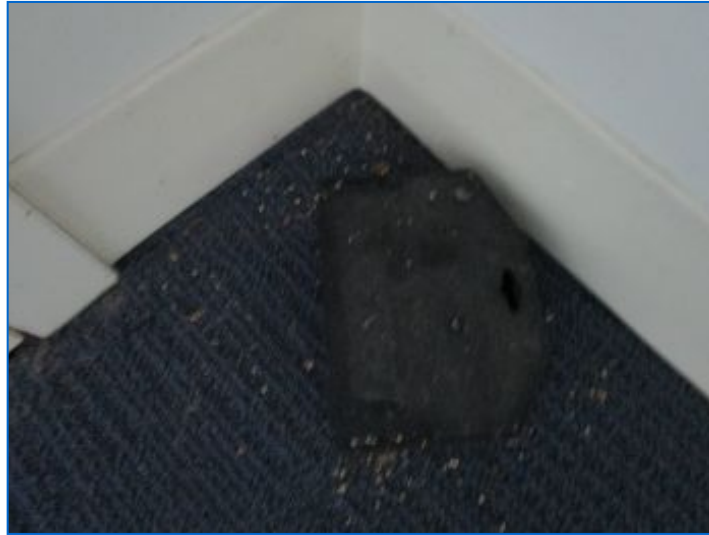
Mice bait station was observed.

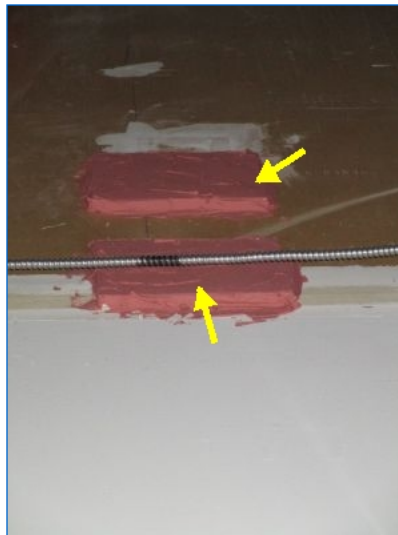
Repairs noted at fire barrier wall above hung ceiling separating the adjacent office suite.

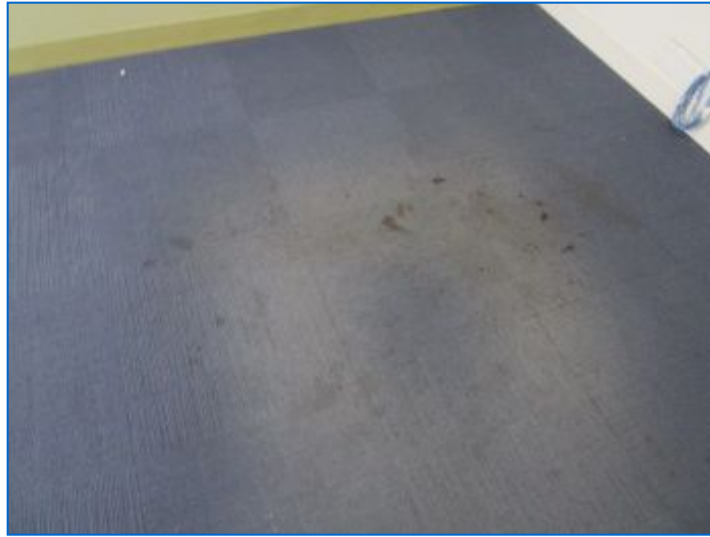
Cosmetic damage and wear at carpeted floor; typical throughout carpeted office areas.

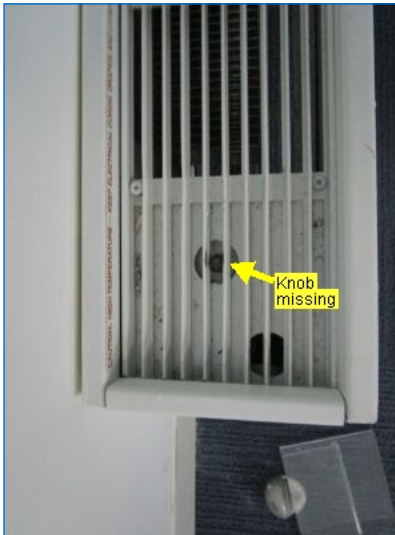
Electric Baseboard Heater located at front wall had no apparent on/off/temperature control switch and was apparently shut off at time of inspection. Refer to Electrical-Main Panel/s heading.

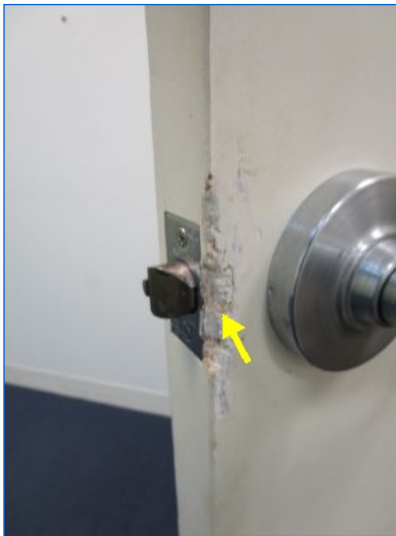
Cosmetic damage noted near door latch.

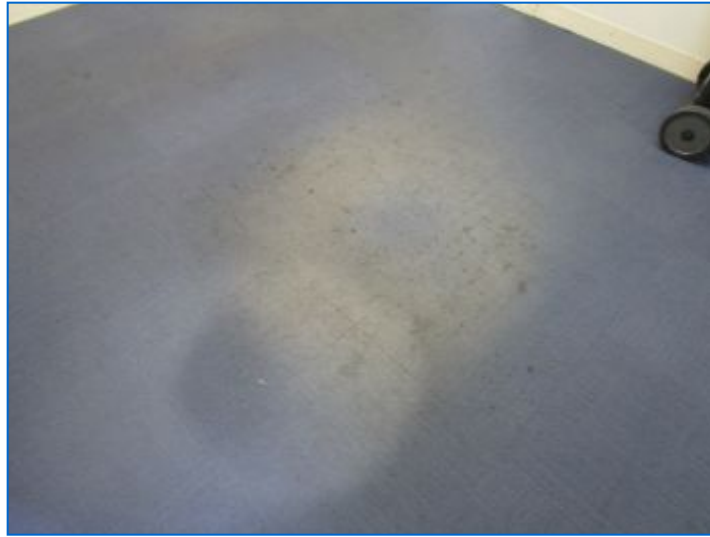
Cosmetic damage and wear at carpeted floor; typical throughout carpeted office areas.

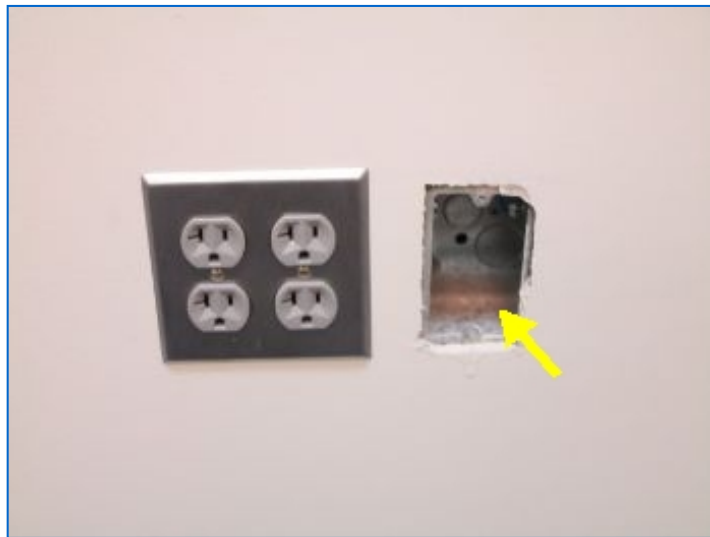
Unused electrical box noted.

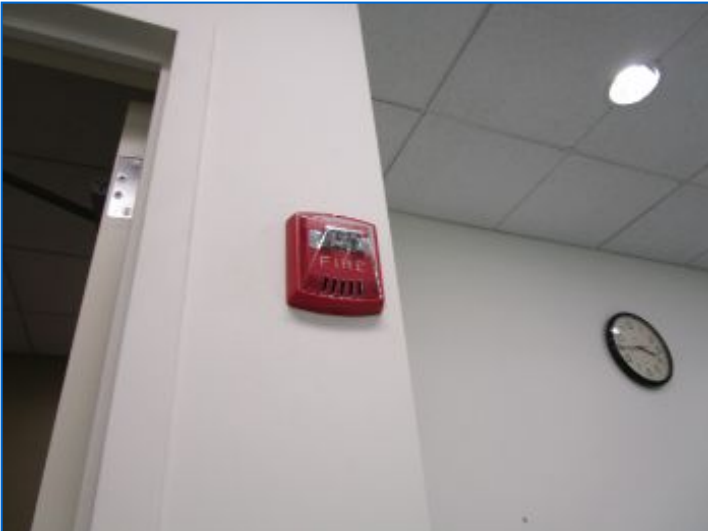
Fire alarm pull station noted.

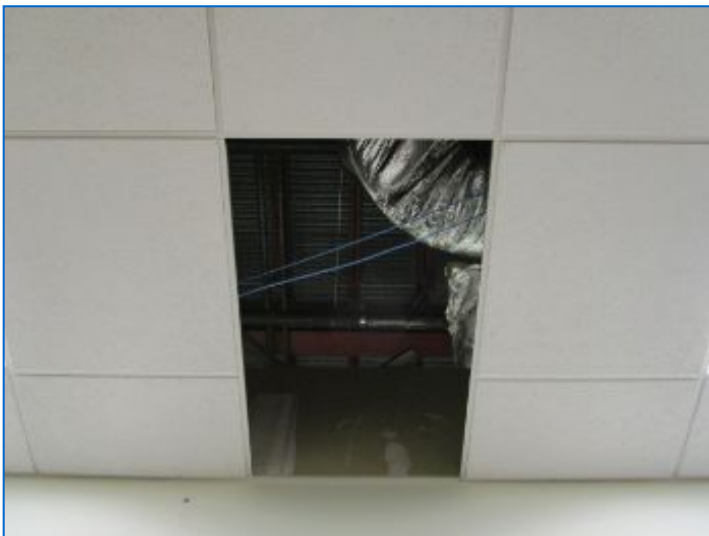
Ceiling tiles found removed.

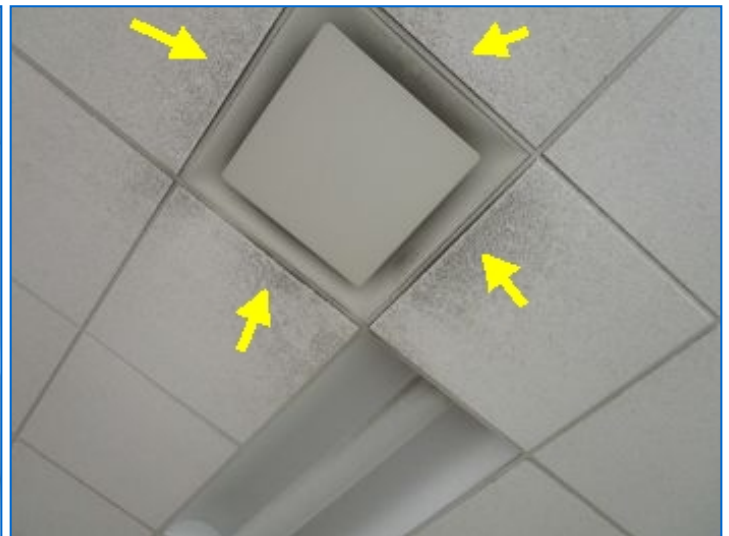
Cosmetic stains observed at ceiling tiles at HVAC outlet indicates a lack of HVAC unit maintenance.

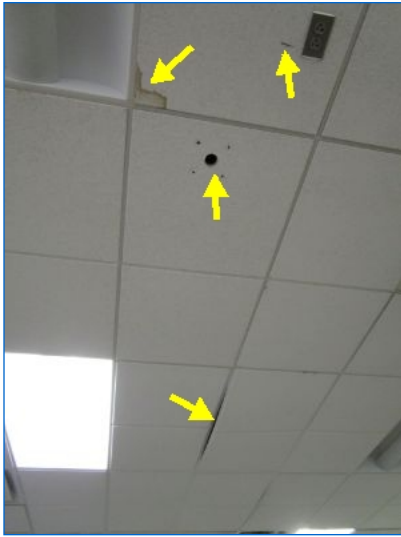
Some cosmetic stains and minor damages were observed at ceiling tiles in various places.

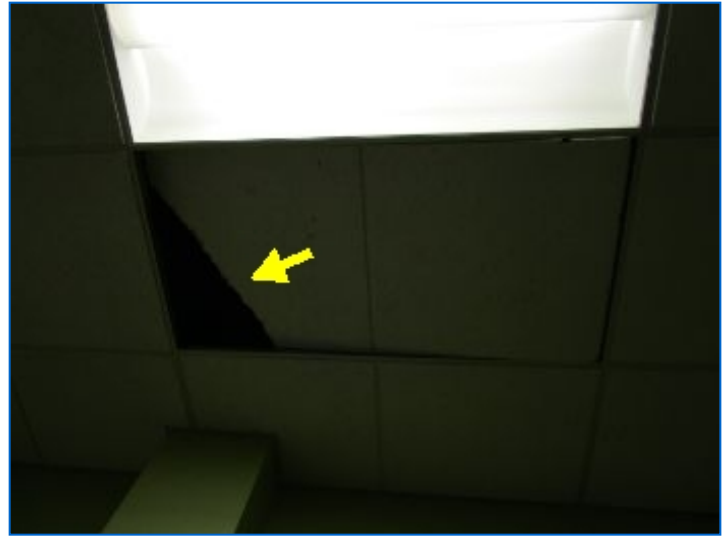
Some cosmetic damages were observed at ceiling tiles.

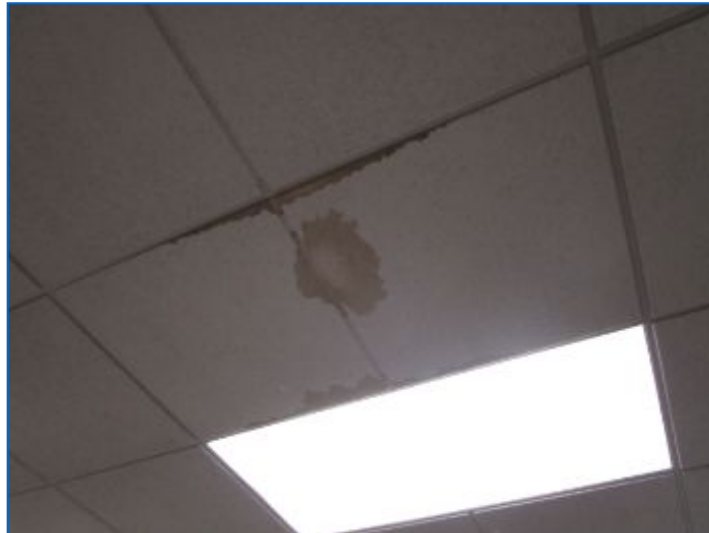
Moisture stains at ceiling tested dry at time of inspection; apparently from a past plumbing/sprinkler pipe leak that perhaps occurred during past construction activity. Replace damaged ceiling tiles and monitor.

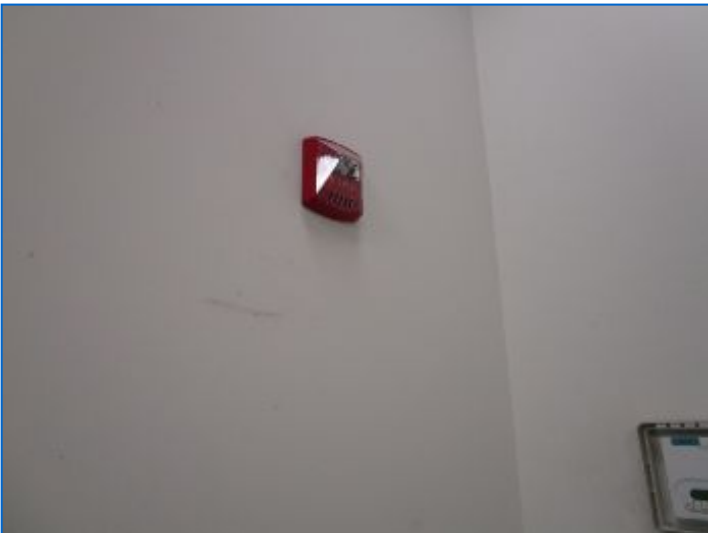
Fire alarm pull station noted.

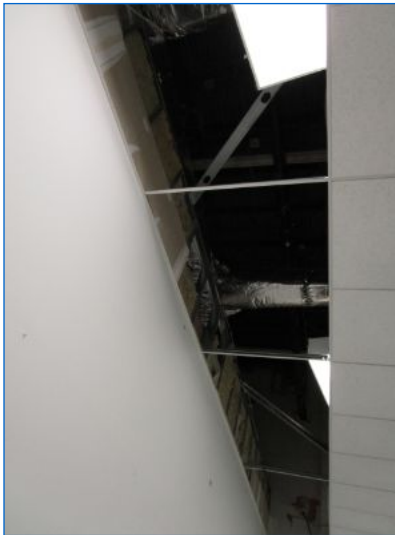
Ceiling tiles found removed apparently to perform work above the ceiling.

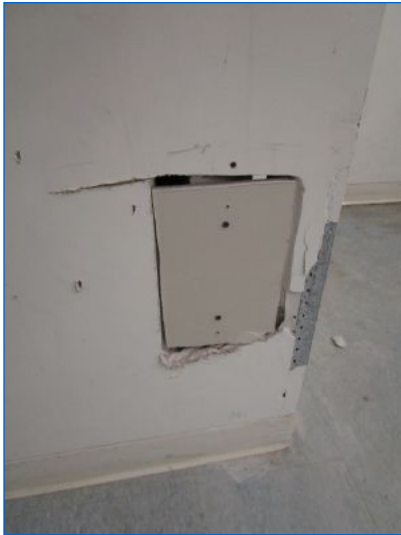
Shoddy and unfinished wall repair resulting from apparent installation of a roof drain riser pipe inside closet of the adjacent room.

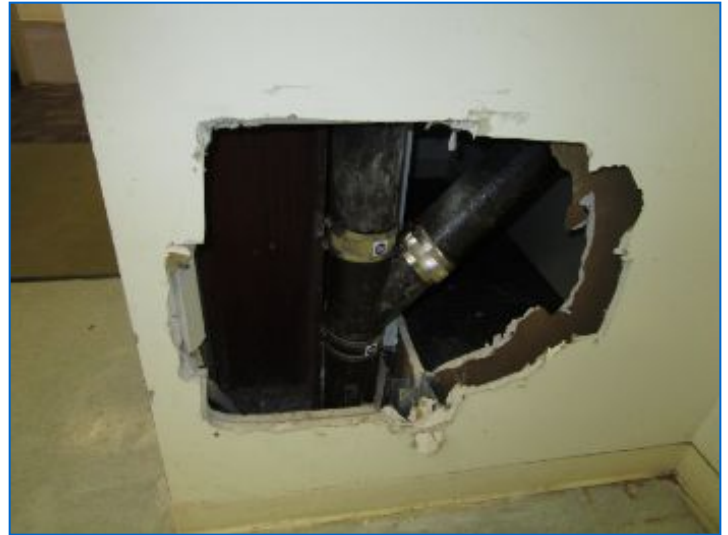
Wall repairs needed resulting from apparent installation of a roof drain riser pipe inside closet of the adjacent room.

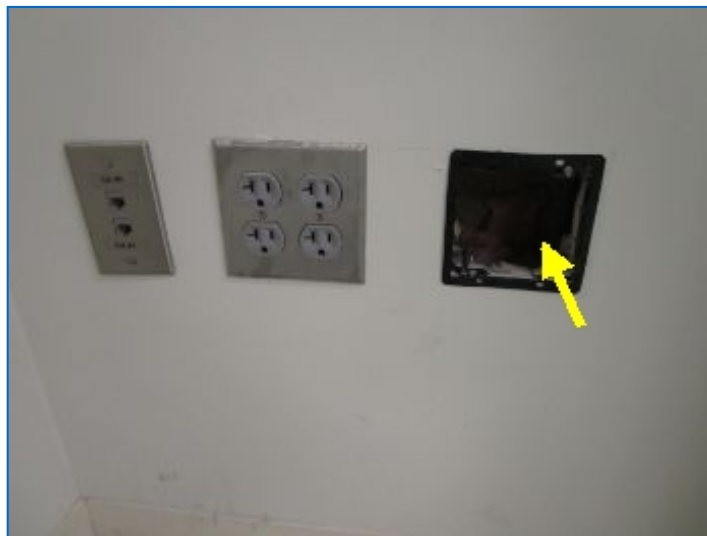
Opening in wall resulting from a damaged electrical box.

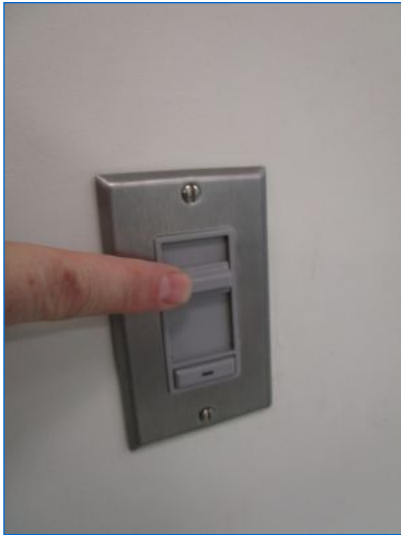
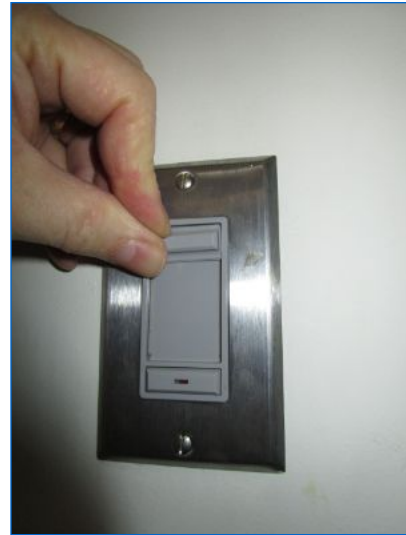
Several wall switches had unused/unknown purpose. Check with seller as needed.

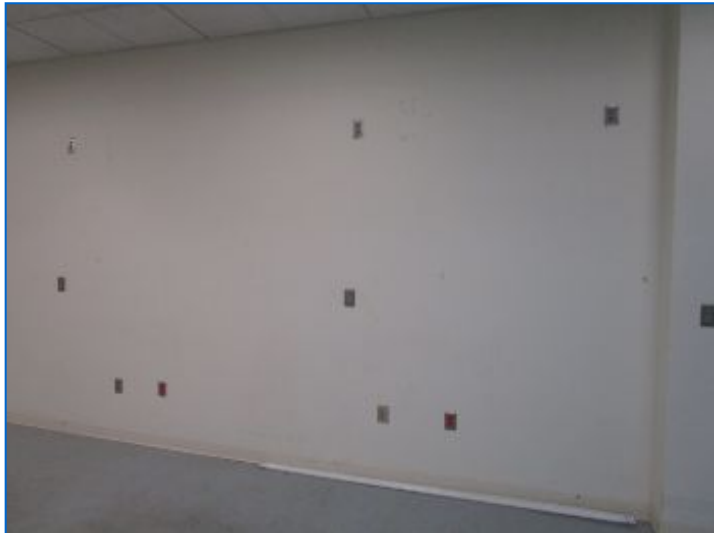
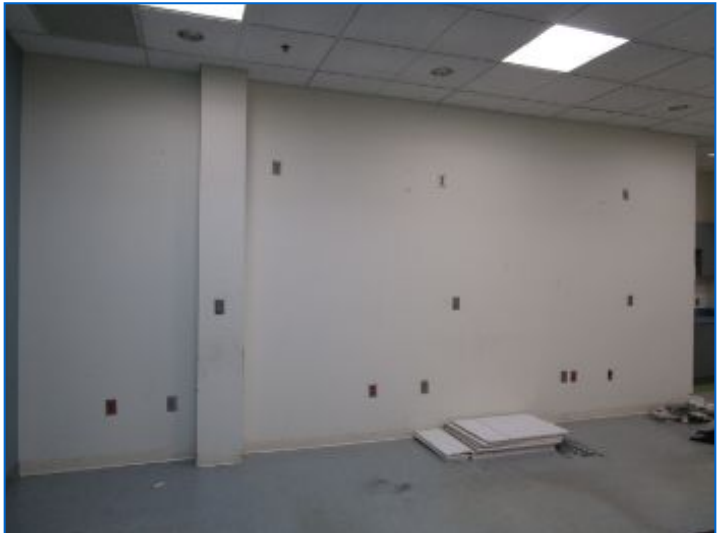
Numerous wall switches and receptacles noted in former Imaging Lab.

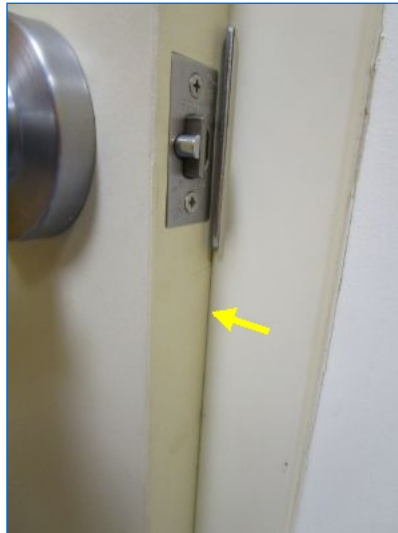
Door rubbed against jamb. Suggest adjustment, repair or replacement if necessary. Work should be performed by a qualified contractor.

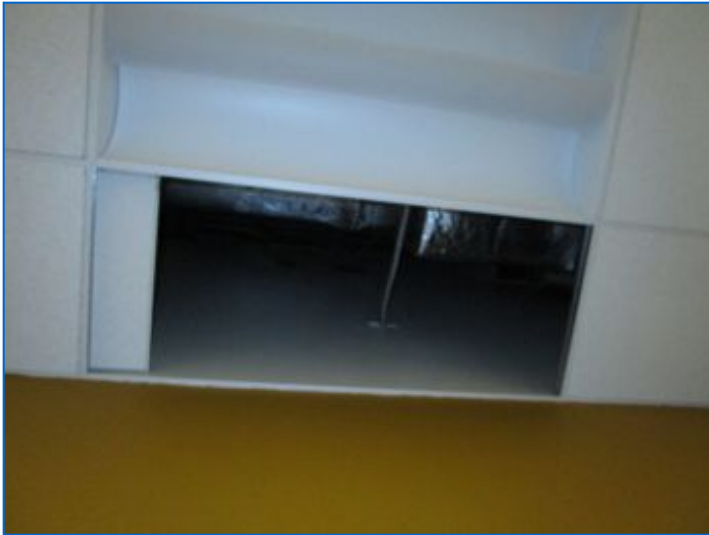
Ceiling tile found removed.

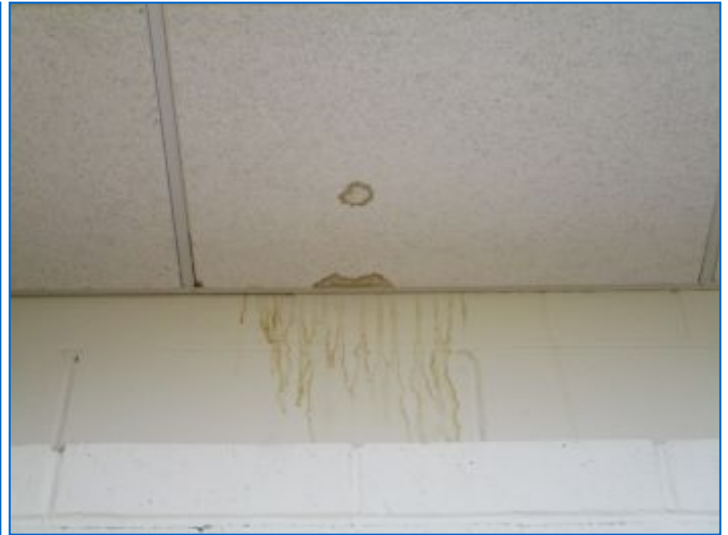
Water stains noted at ceiling tiles in Room #8; The areas were dry at the time of the inspection. Suggest cosmetic repairs and monitor for recurrence. Refer to Roof heading for related comment.

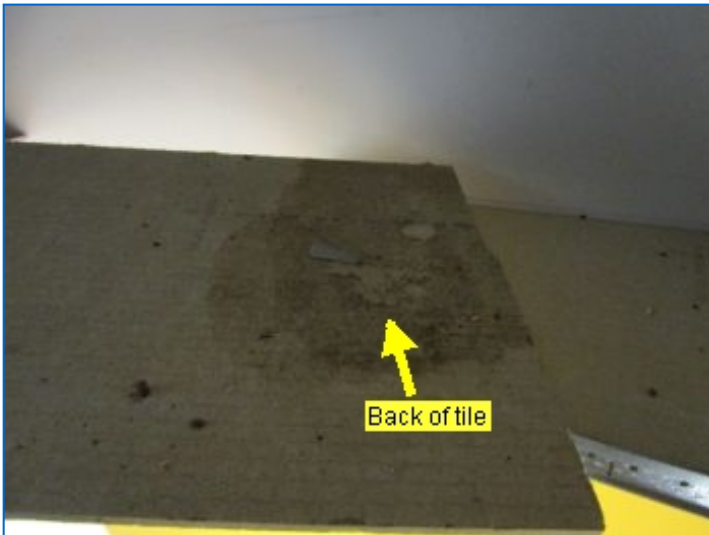
Water stains noted at ceiling tiles in Room #8; The areas were dry at the time of the inspection. Suggest cosmetic repairs and monitor for recurrence. Refer to Roof heading for related comment.

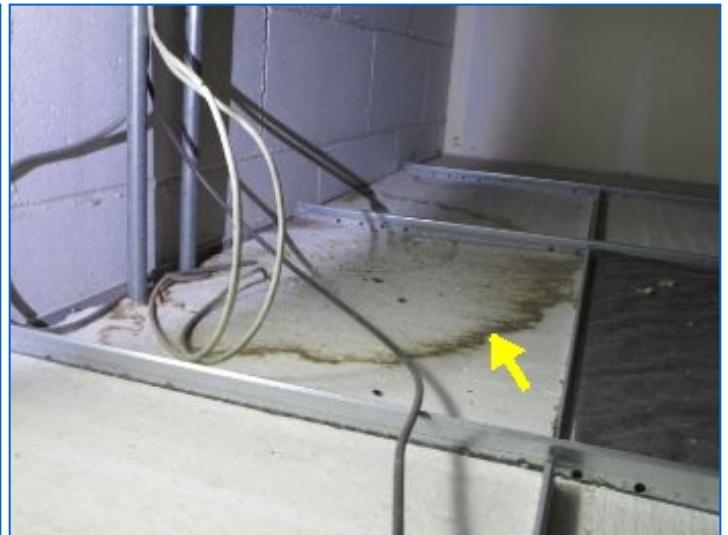
Water stains noted at ceiling tiles in Room #8; The areas were dry at the time of the inspection. Suggest cosmetic repairs and monitor for recurrence. Refer to Roof heading for related comment.

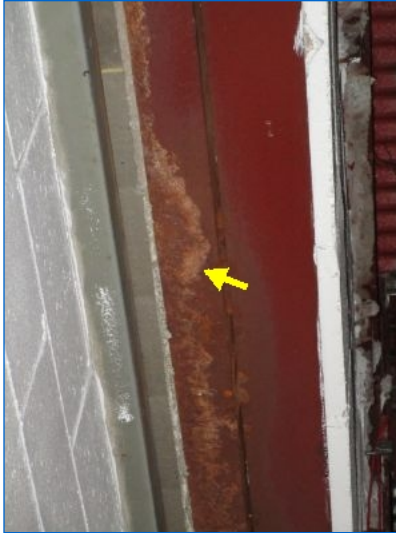
Rust stains noted at steel beam above ceiling tiles in Room #8; The areas appeared dry at the time of the inspection. Refer to Roof heading for related comment.

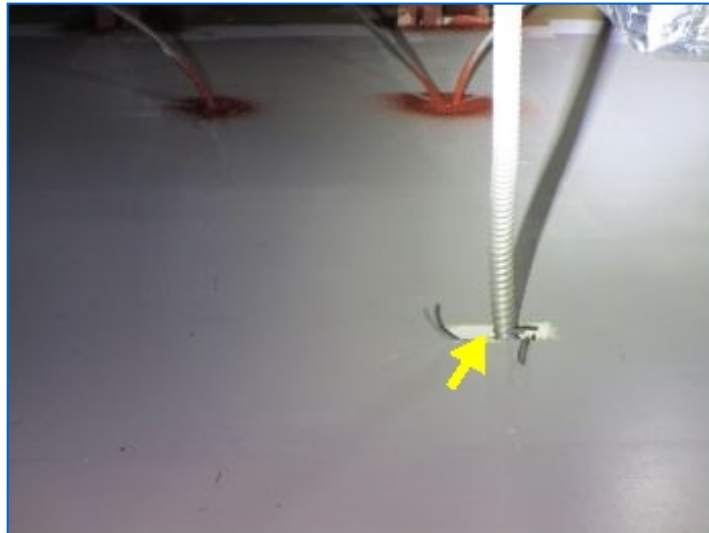
Missing fire-stopping noted at penetration through fire-rated barriers at suite border wall.

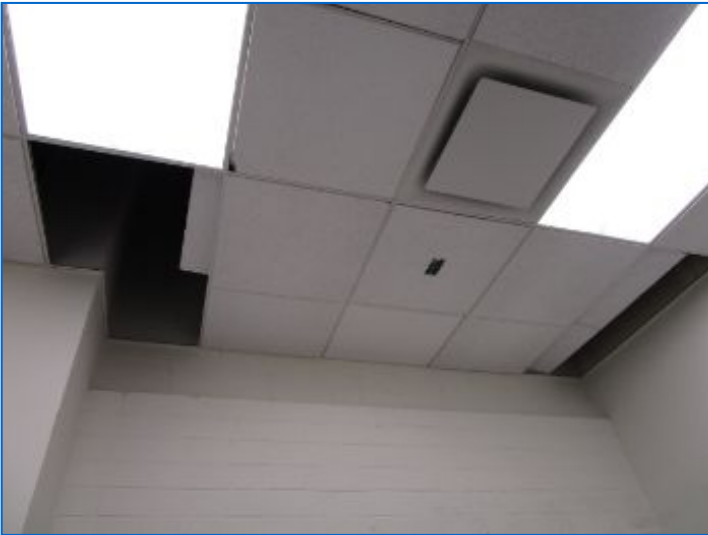
Ceiling tiles found removed.

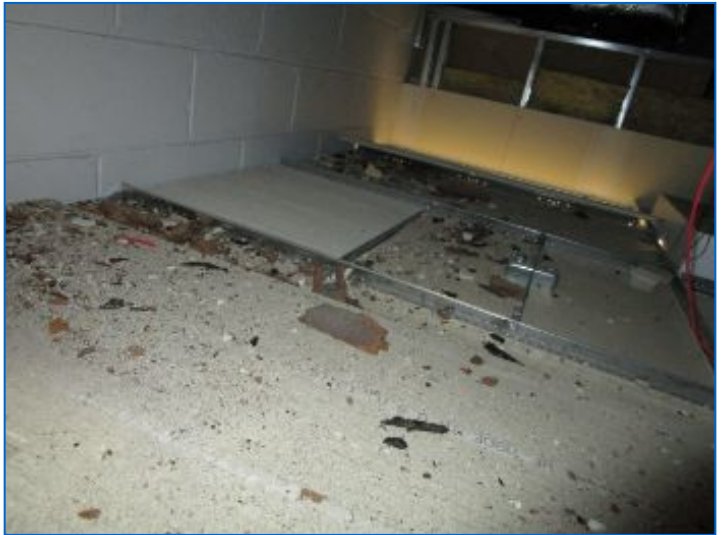
Some construction debris noted above ceiling tiles.

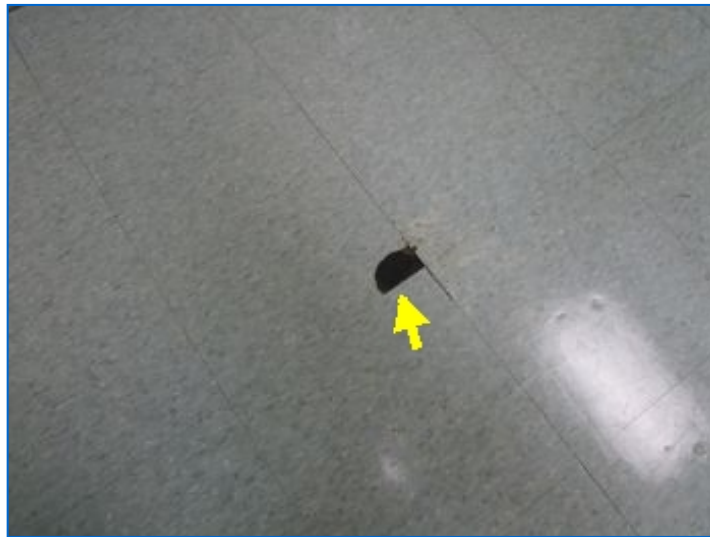
VCT flooring damage noted.

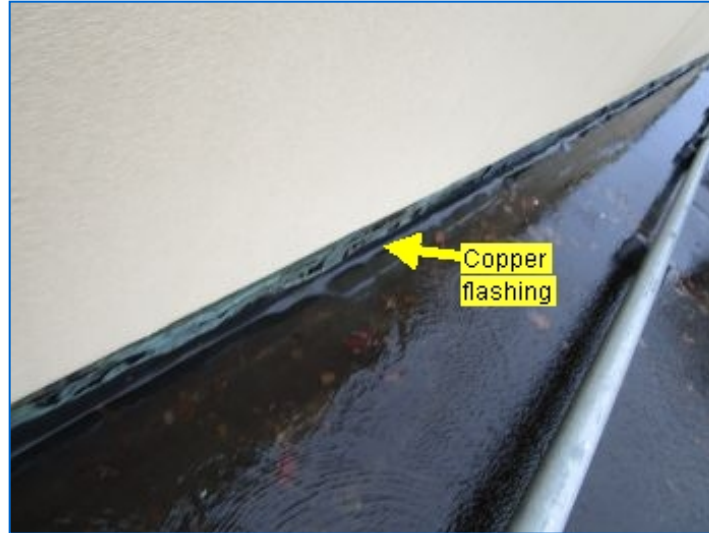
High amount of puddling observed on roof near location where signs of past leaks were observed above northwest room of suite (rust/moisture stains at structure and ceiling tiles).

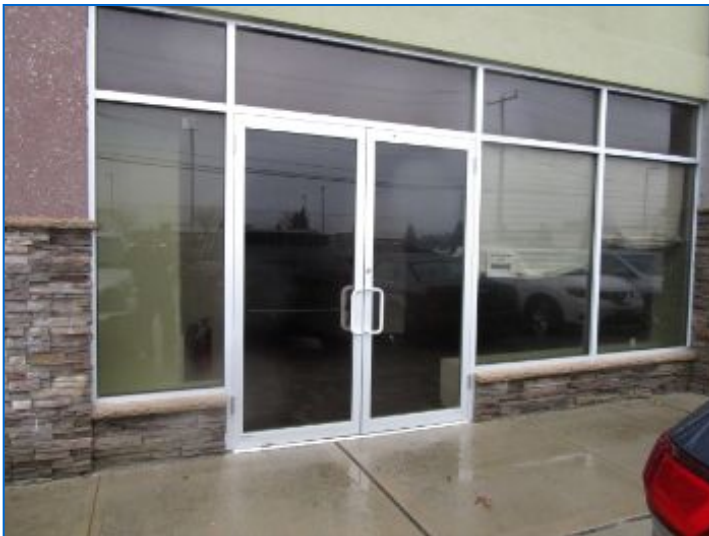
Aluminum storefront entrance was functional, with the exception of deteriorated weatherstripping observed along bottom of doors that allowed splashing raindrops to infiltrate beneath the doors. Replace deteriorated weatherstripping.

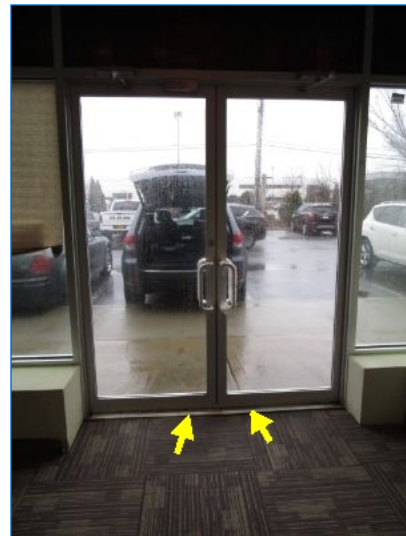
Aluminum storefront entrance was functional, with the exception of deteriorated weatherstripping observed along bottom of doors that allowed splashing raindrops to infiltrate beneath the doors. Replace deteriorated weatherstripping.

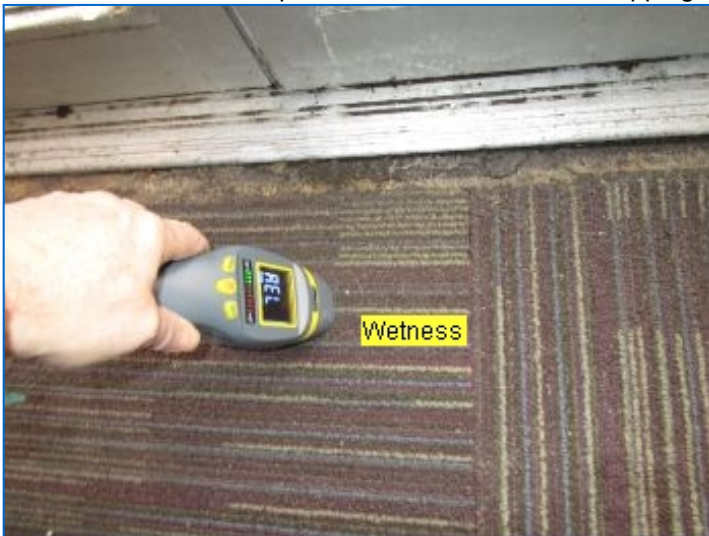
Aluminum storefront entrance was functional, with the exception of deteriorated weatherstripping observed along bottom of doors that allowed splashing raindrops to infiltrate beneath the doors. Replace deteriorated weatherstripping.

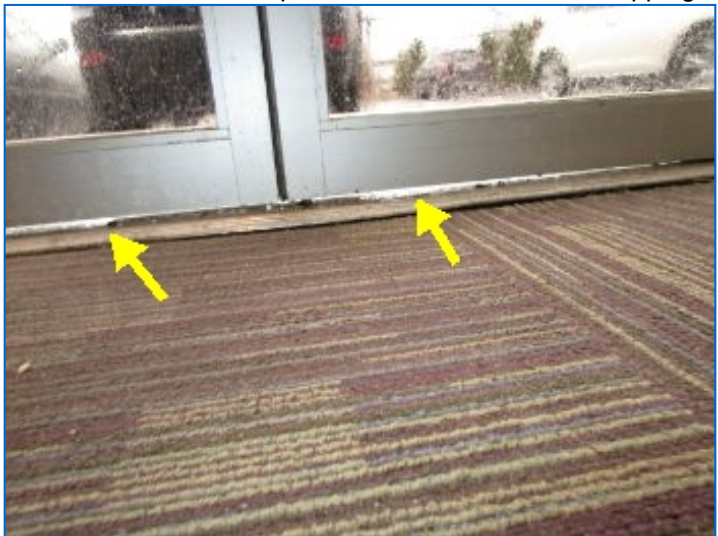
Aluminum storefront entrance was functional, with the exception of deteriorated weatherstripping observed along bottom of doors that allowed splashing raindrops to infiltrate beneath the doors. Replace deteriorated weatherstripping.

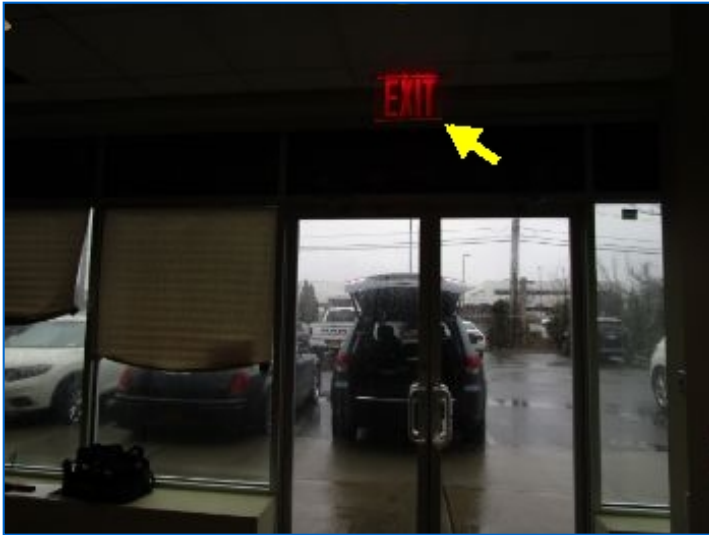
Exit signs noted for egress.

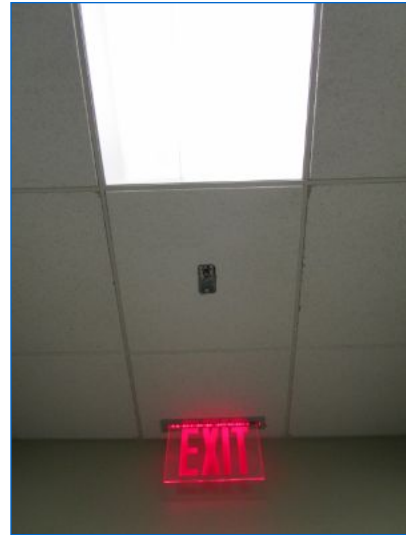
Exit signs noted for egress.

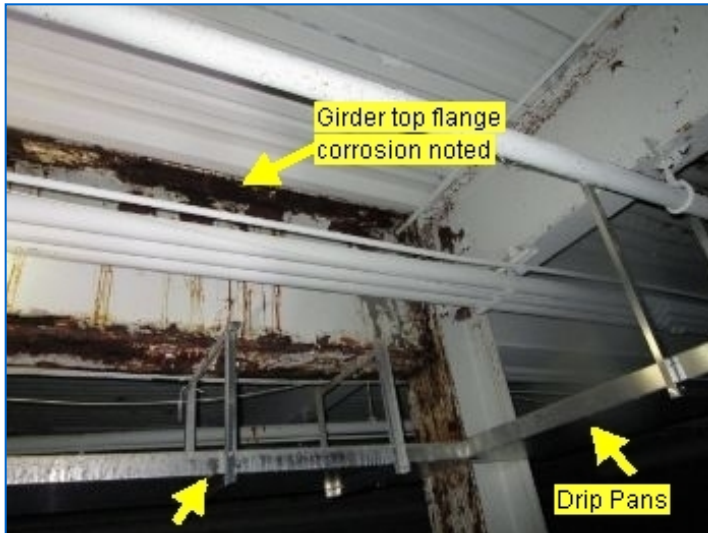
Steel girder corrosion at top flange noted. Drip pans used as a secondary band-aid repair.

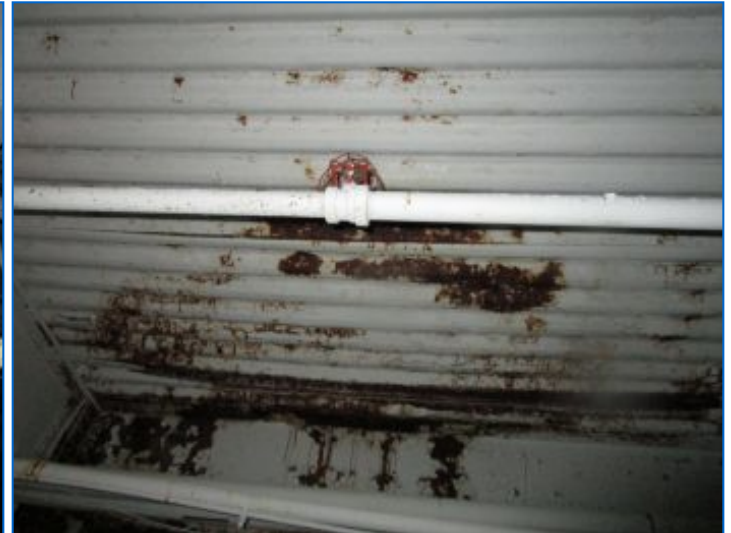
Water penetrating expansion joints in the concrete sidewalk and cracks in the asphalt parking area have penetrated the structural concrete base causing leaks and corrosion observed at few locations in the steel Q decking at the parking garage roof structure below the sidewalk/parking areas. This leaking and corrosion of the steel Q decking should be mitigated as soon as possible to prevent continued structural deterioration. Refer to related comments.

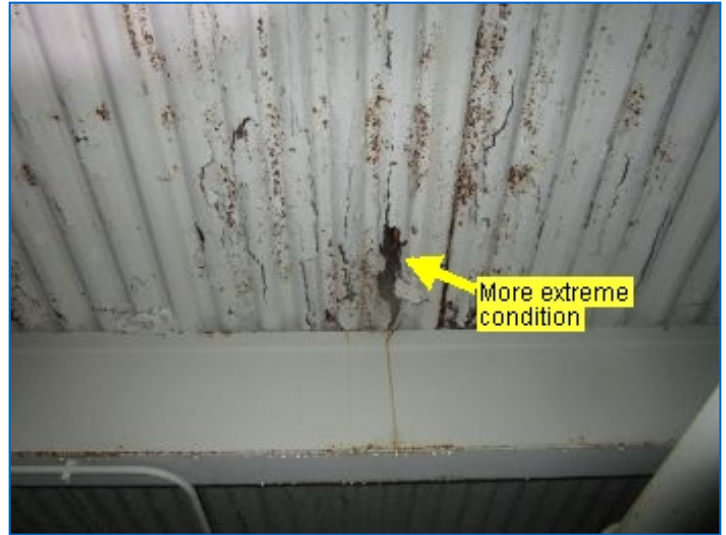
Water penetrating expansion joints in the concrete sidewalk and cracks in the asphalt parking area have penetrated the structural concrete base causing leaks and corrosion observed at few locations in the steel Q decking at the parking garage roof structure below the sidewalk/parking areas. This leaking and corrosion of the steel Q decking should be mitigated as soon as possible to prevent continued structural deterioration. Refer to related comments.

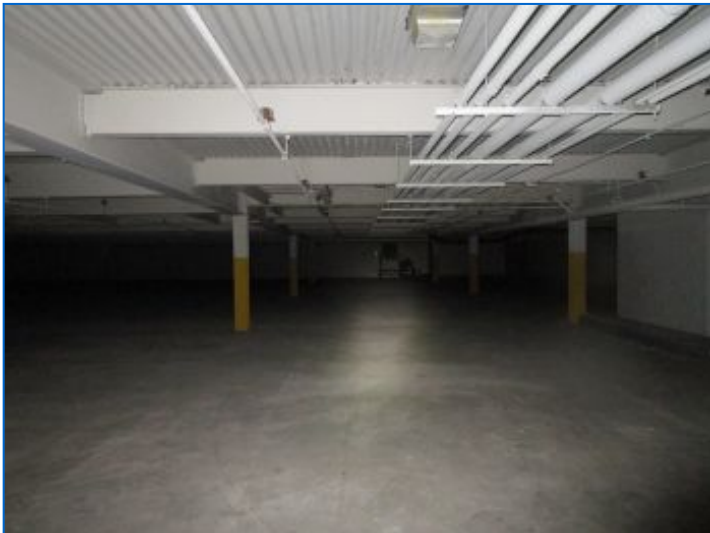
Structural conditions beneath the major portion of the office suite were satisfactory.

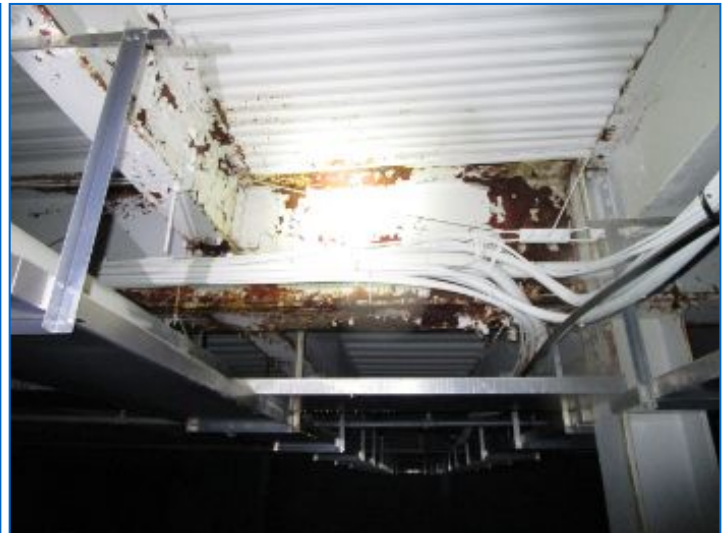
Steel girder corrosion at top flange noted. Drip pans used as a secondary band-aid repair.

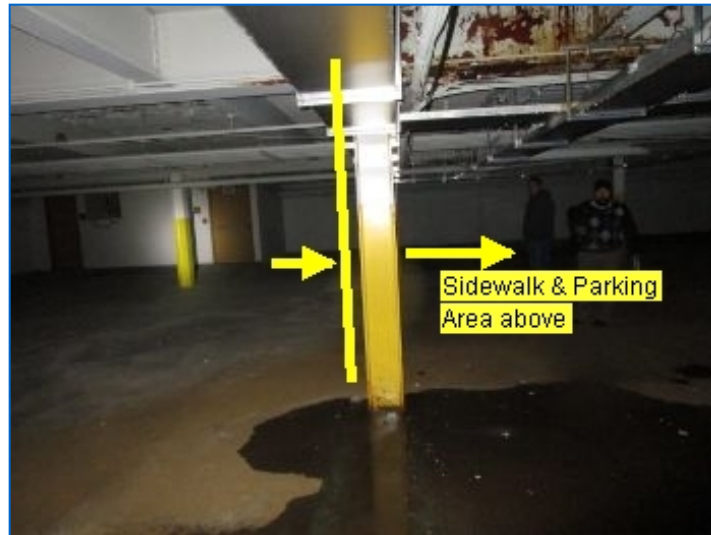
Approximate location of the suite's storefront.

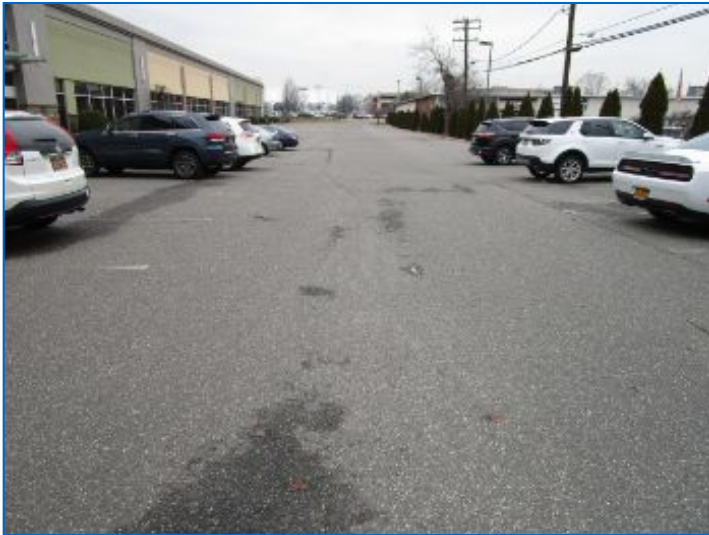
GROUNDS Parking Area

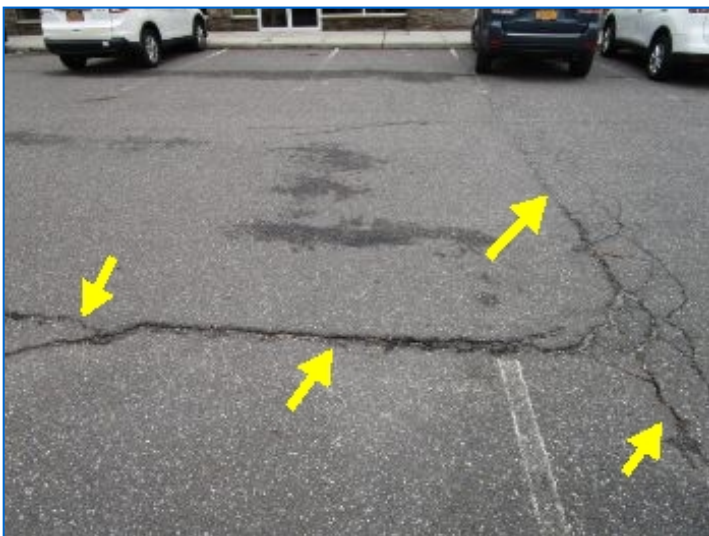
The asphalt parking area had moderate surface cracks. The Inspector recommends that before the expiration of your Inspection Objection Deadline you consult with a qualified contractor to discuss options and costs for repairing and sealing the asphalt pavement to enable water to drain away from this area toward the storm drain, particularly over the parking garage. Refer to related Garage-Structural heading.

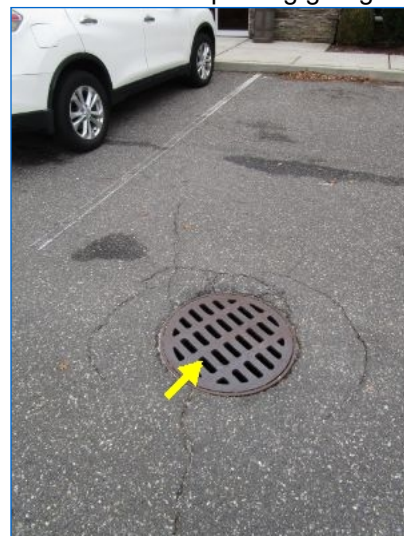
Storm drain located beyond the paved area above the parking garage.

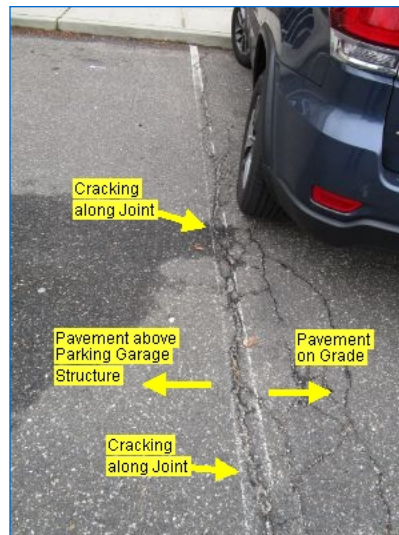
Water penetrating cracks in the asphalt parking lot will travel to expansion joints (or cracks) in the concrete sub layer causing the leaks and corrosion observed at the steel Q decking at the parking garage roof structure below the parking/sidewalk areas. It is critical to maintain sealed asphalt at the vicinity over the garage area to prevent continued water intrusion and subsequent corrosion of structural steel below.

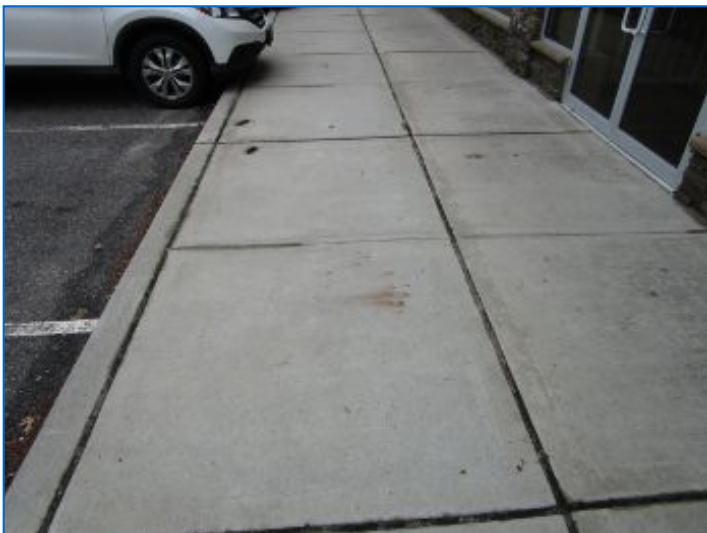
Sidewalk/s: Concrete noted.

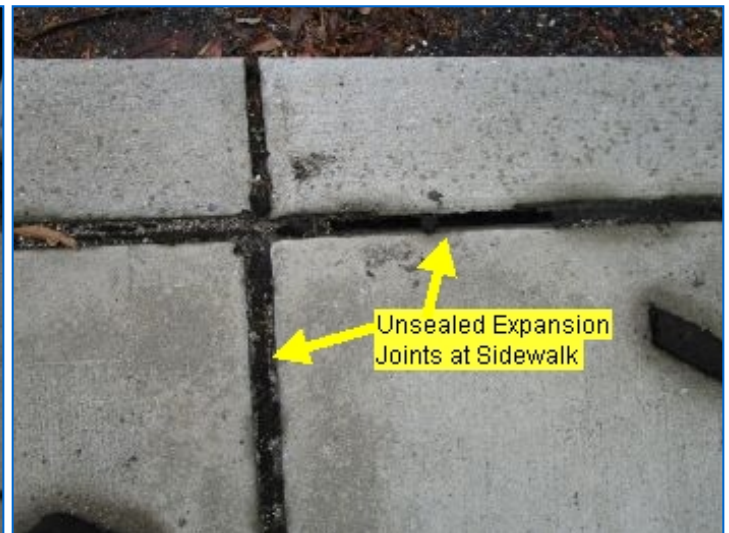
Water penetrating expansion joints in the concrete sidewalk will travel to where expansion joints (or cracks) in the concrete sub layer causing the leaks and corrosion observed at the steel Q decking at the parking garage roof structure below the sidewalk/parking areas. It is critical to maintain seals at sidewalk expansion joints to prevent continued water intrusion and subsequent corrosion of structural steel below.

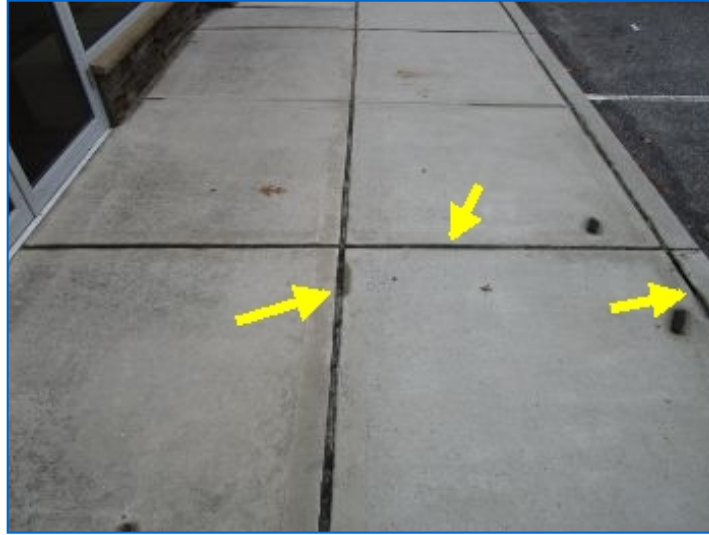
The sidewalk area had unsealed expansion joints. The Inspector recommends that before the expiration of your Inspection Objection Deadline you consult with a qualified contractor to discuss options and costs for sealing concrete paved area to enable water to drain away from this area toward the storm drain, particularly over the parking garage. Refer to related Garage-Structural heading.
