ProSpec Home Inspection of Long Island Property Inspection Report

Inspector: Russell J. Classi, P.E.
Phone: (516) 480-1848
Email: prospecofli@gmail.com
www.nassaprofessionalhomeinspector.com

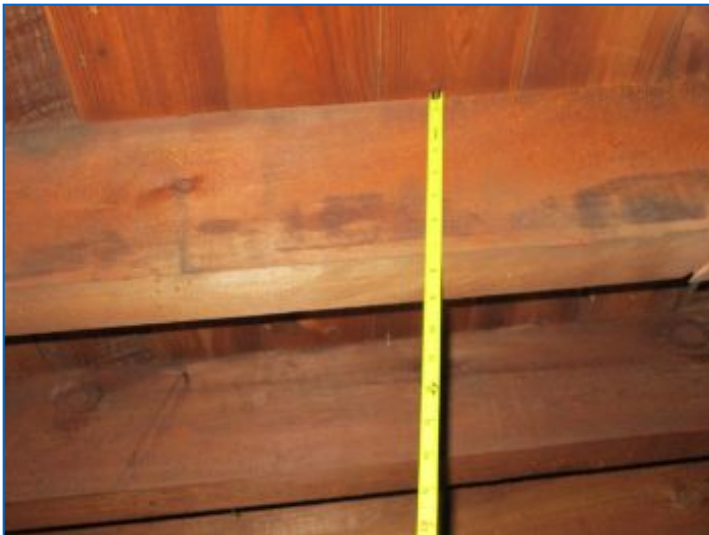
Main Roof Structure: 3x8 Rafters 16" O.C. w/collar-ties, 2x10 ridge beams, T&G roof boards.

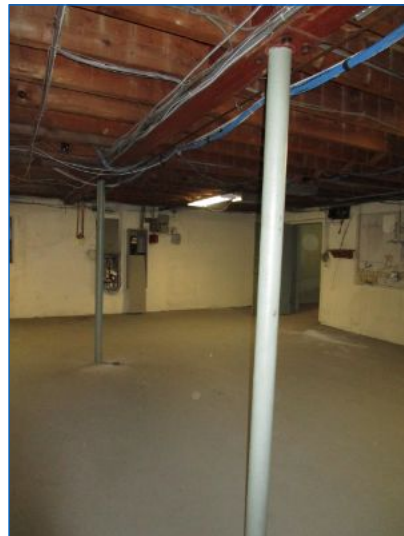
Main Floor Structure: Steel girder supported by steel lally columns and foundation walls, 2x10 Joists 16" O.C. (w/cross braces), T&G floor boards.

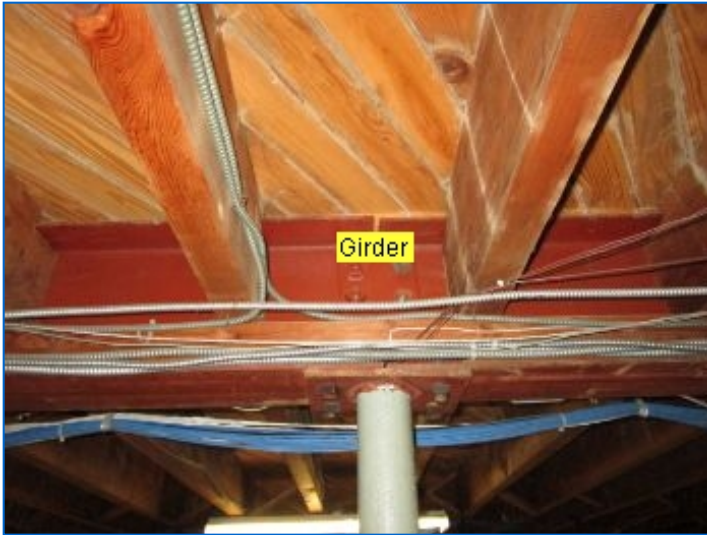
Main Floor Structure: Steel girder supported by steel lally columns and foundation walls, 2x10 Joists 16" O.C. (w/cross braces), T&G floor boards.

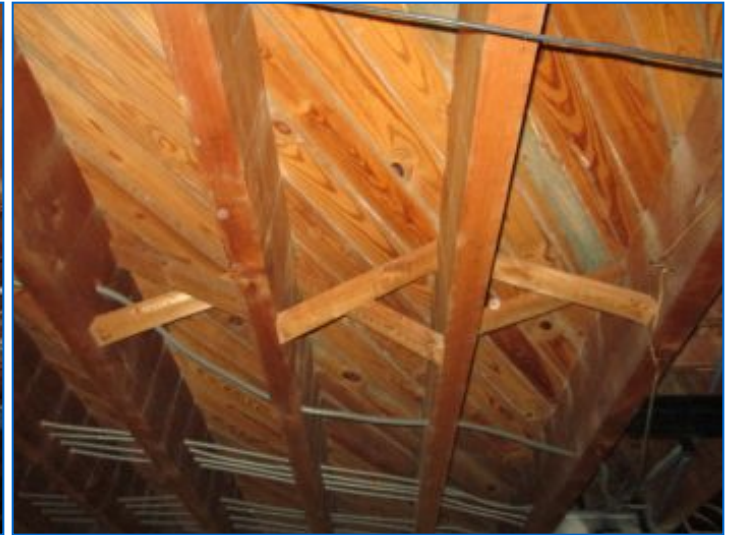
Main Floor Structure: Steel girder supported by steel lally columns and foundation walls, 2x10 Joists 16" O.C. (w/cross braces), T&G floor boards.

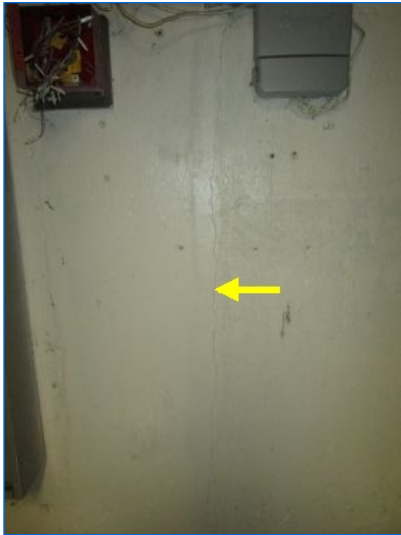
Cracks visible in the concrete foundation walls appeared to be typical shrinkage cracks that commonly develop as concrete cures. Shrinkage cracks are surface cracks and are not a structural concern.

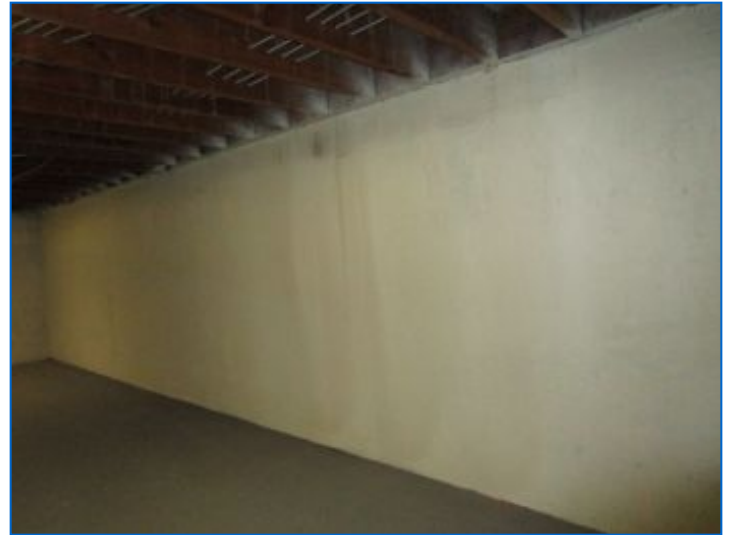
No evidence of current moisture intrusion was observed at the visible portions of the foundation walls at the time of inspection.

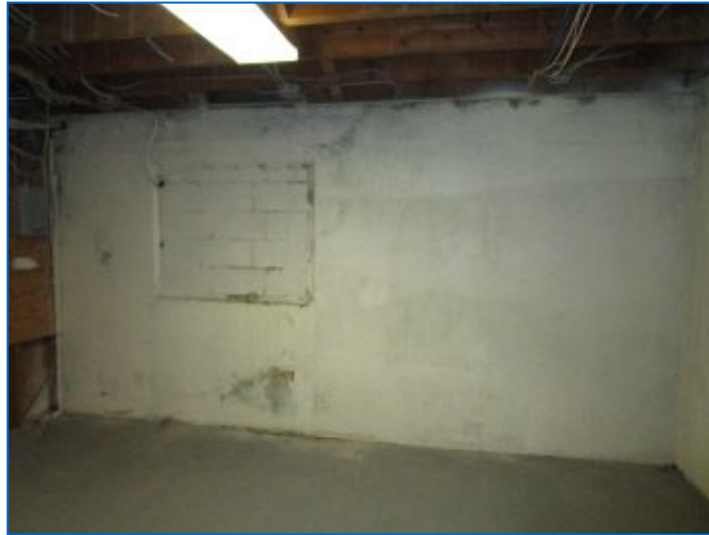
The Inspector observed no structural deficiencies at the visible portions of the foundation walls - In normal condition for age.

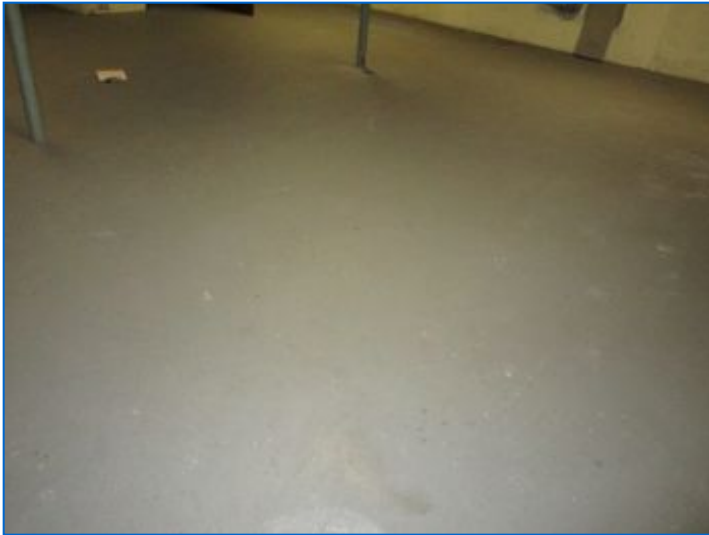
No significant deficiencies observed in the condition of the visible portions of the concrete floor slab at time of inspection - In normal condition for its age.

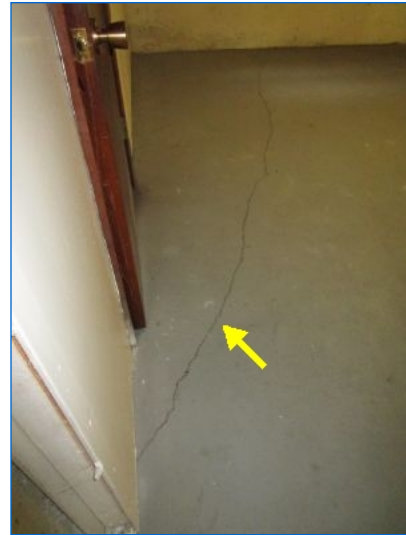
Common settlement crack observed. These can be a pathway for water entry. The Inspector suggests sealing cracks with epoxy filler if necessary to prevent water infiltration, and monitor for further movement.

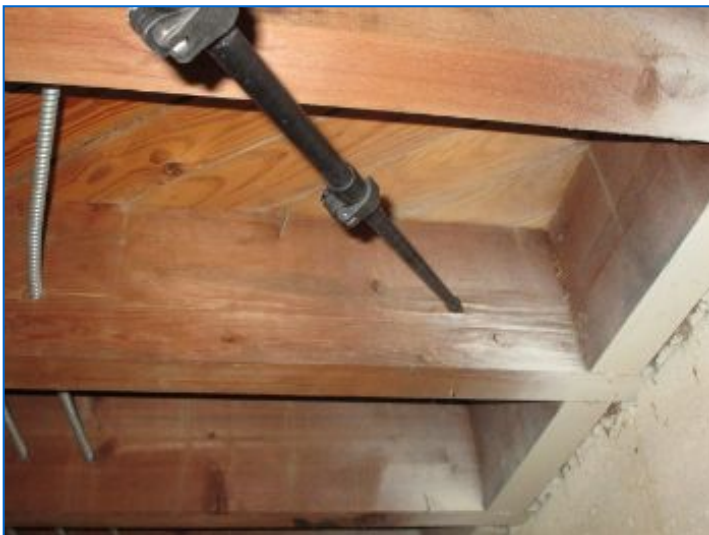
Signs of past Termite damage/activity at a floor joist at the North wall of the Basement. Refer to related Photos and NPMA-33 Report.

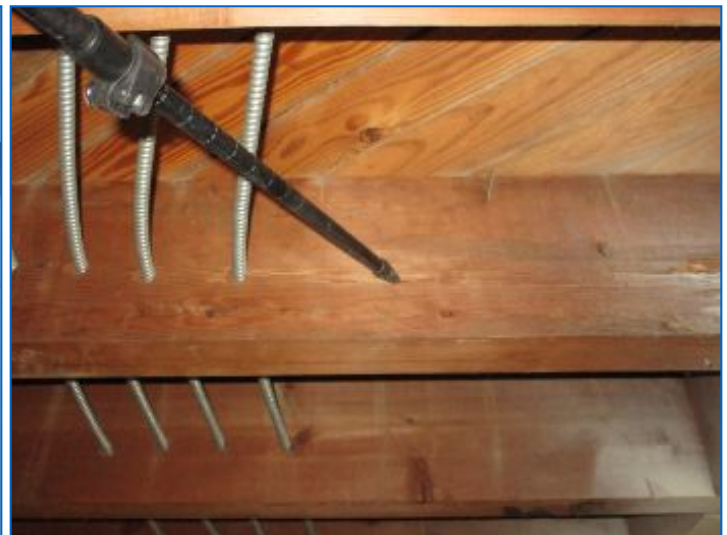
The floor joist strength was reduced by approximately 30%. The Inspector suggests corrective repair of damaged floor joist by a qualified contractor.

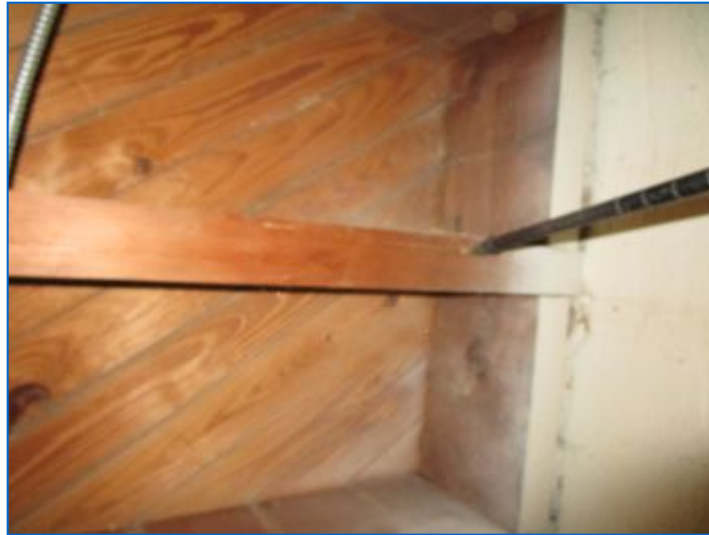
The floor joist strength was reduced by approximately 30%. The Inspector suggests corrective repair of damaged floor joist by a qualified contractor.

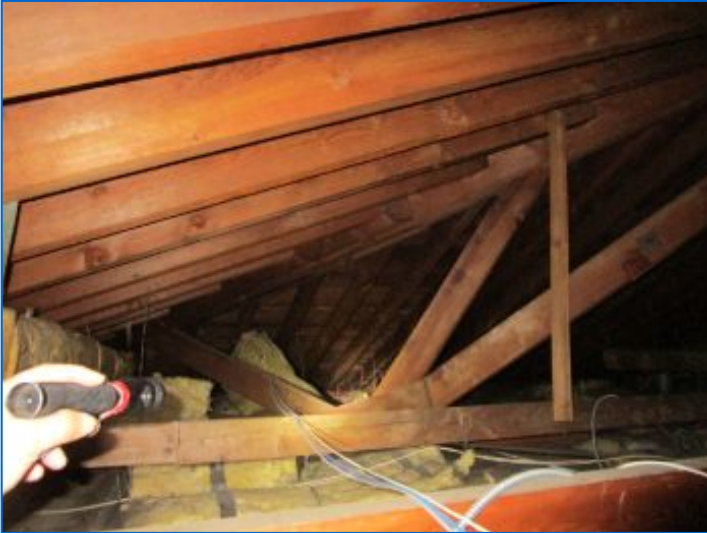
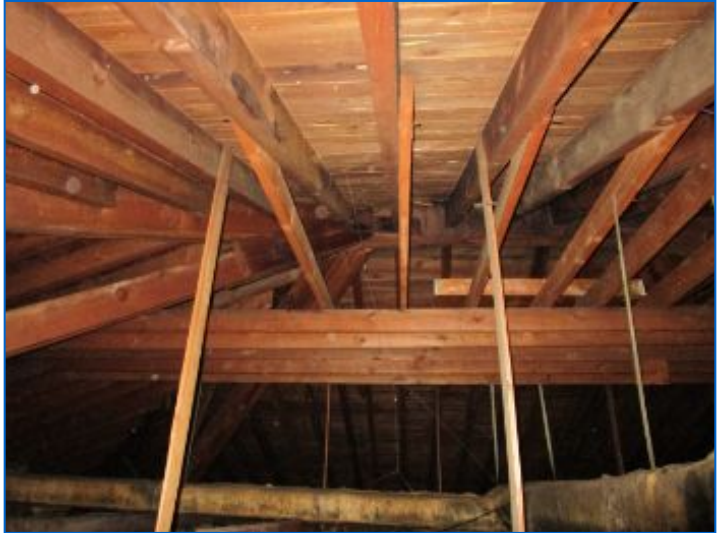
No Significant structural deficiencies observed at the visible portions of the roof structure - In normal condition for its age. No evidence of moisture penetration at the majority of visible portions of the roof structure were observed at time of inspection.

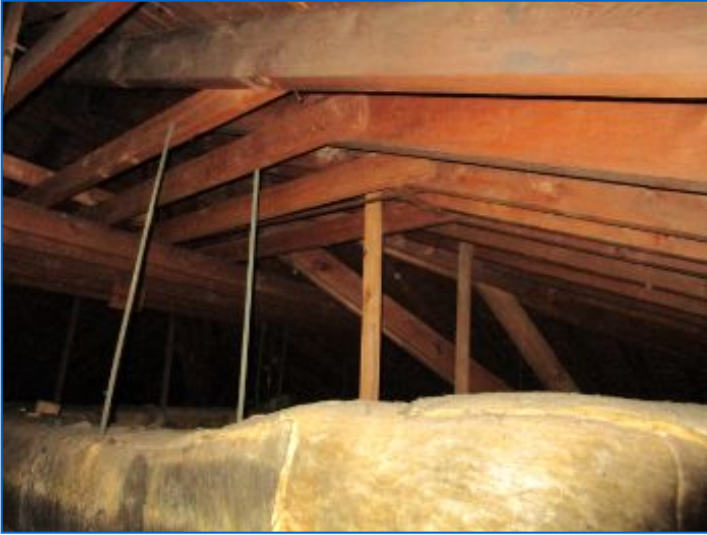
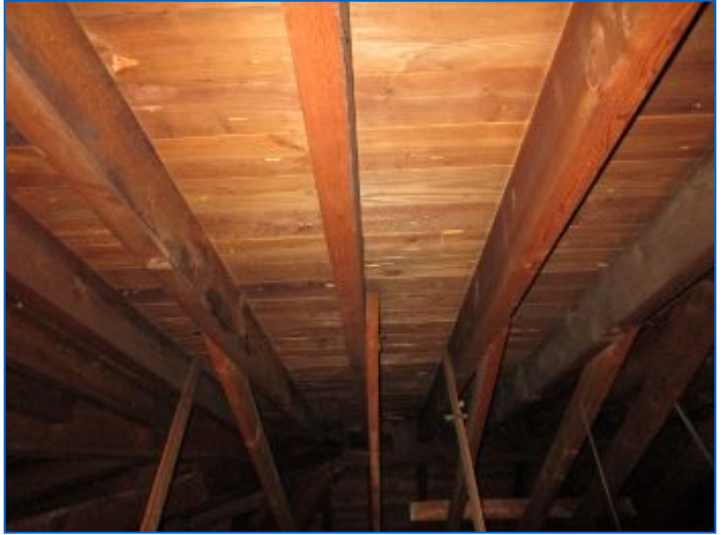
No evidence of moisture penetration at the majority of visible portions of the roof structure were observed at time of inspection.

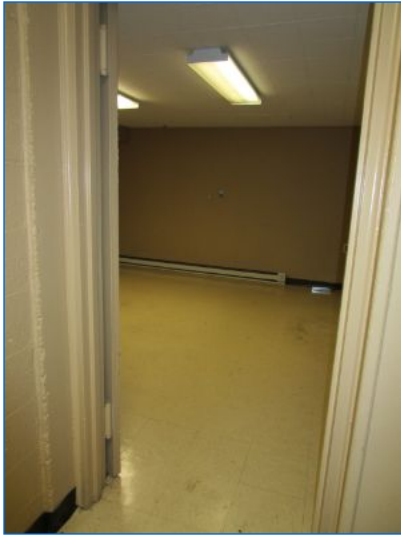
- Glue traps noted; mostly beetles and crickets.
- **Rodent bait stations observed.**

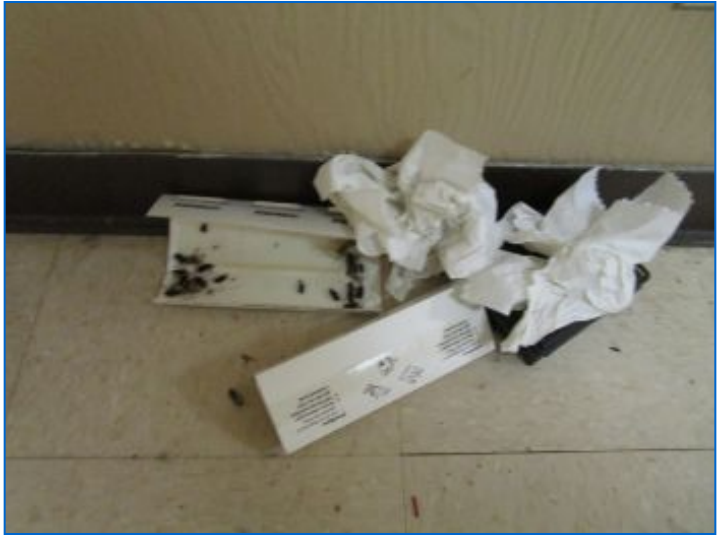
Glue traps noted; mostly beetles and crickets.

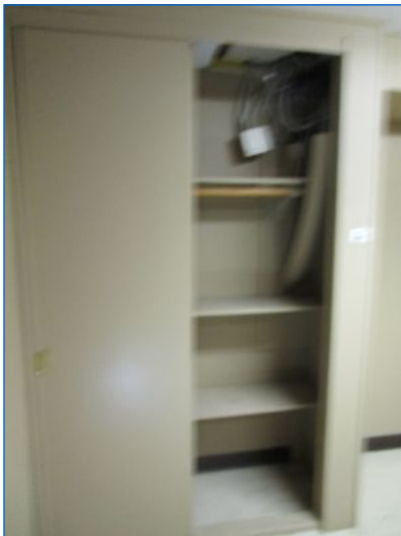
Cafeteria: Former telecom closet.

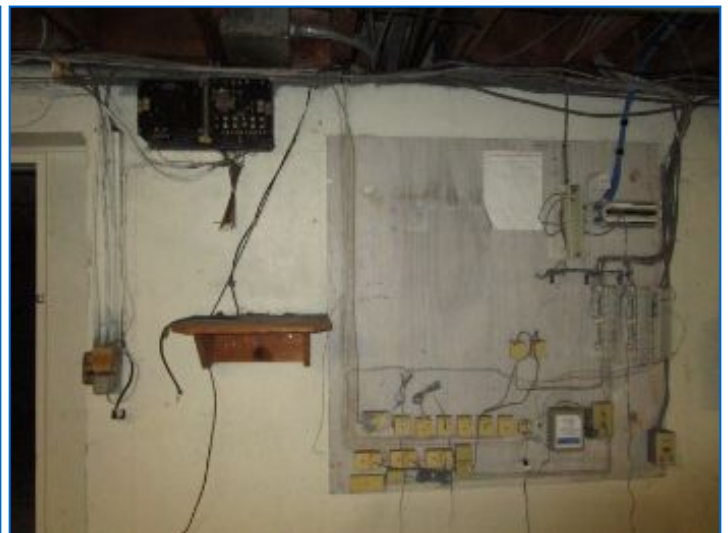
General Area: Old abandoned telecom equipment and circuits noted.

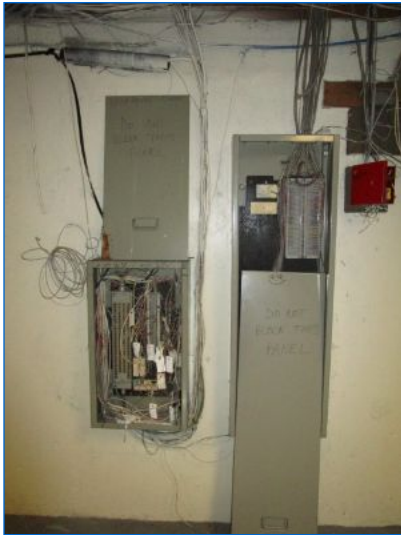
General Area: Old abandoned telecom equipment noted.

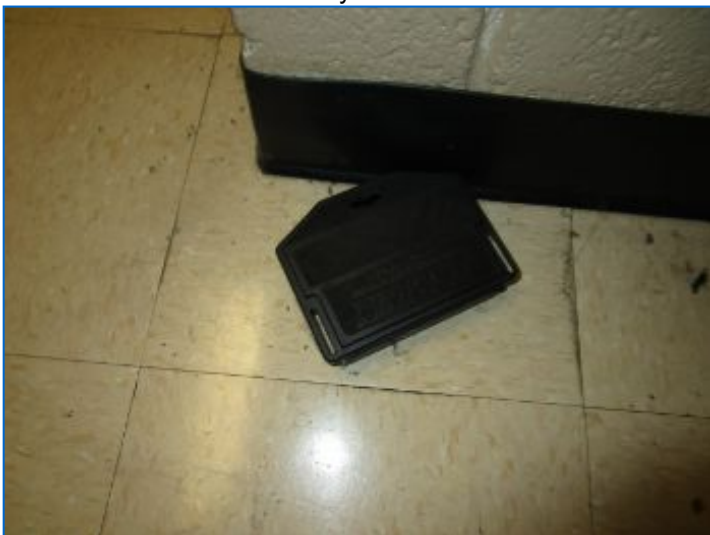
Rodent bait stations observed.

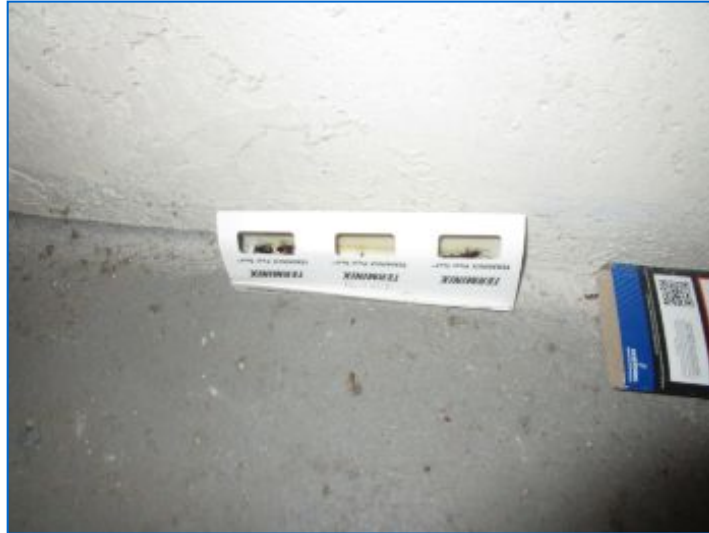
Glue traps noted; mostly beetles and crickets.

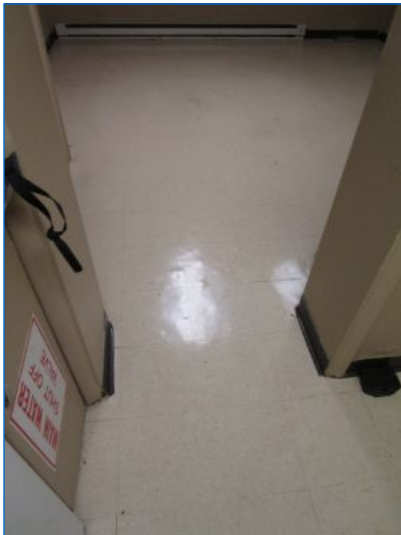
Cafeteria & Pantry: Floor covering was Vinyl Composition Tile (VCT)

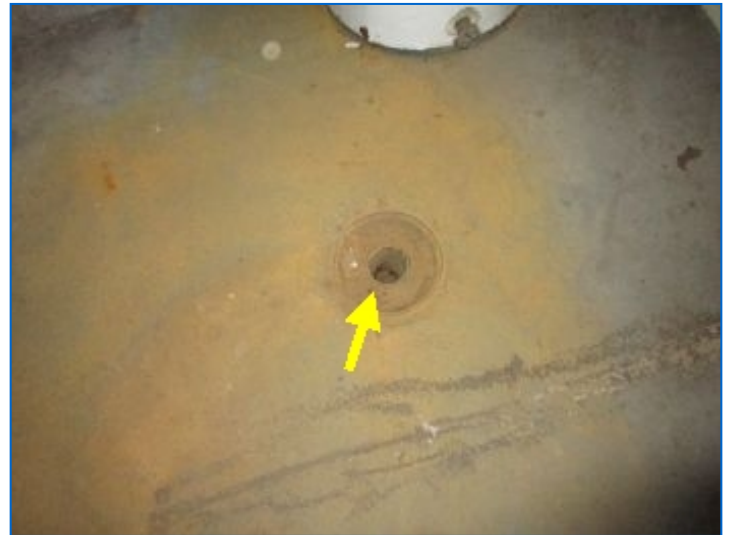
Open floor drain observed, suggest installing a grate or cover for safety. Floor drain observed but not tested. Suggest testing for proper operation.

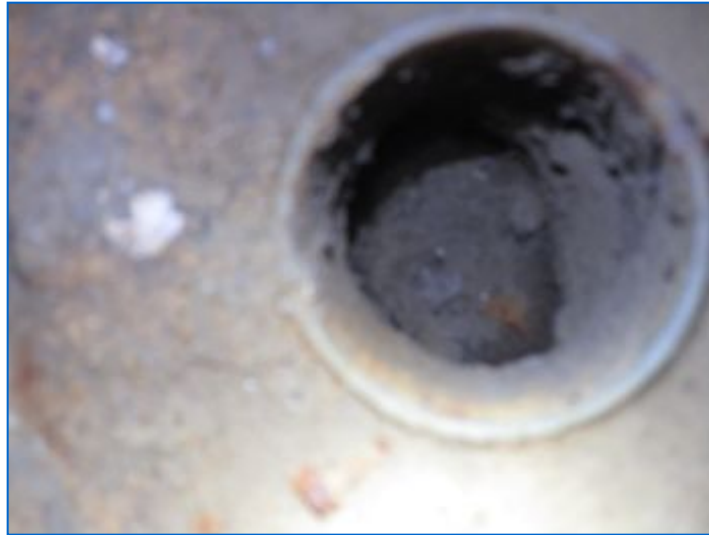
Open floor drain observed, suggest installing a grate or cover for safety. Floor drain observed but not tested. Suggest testing for proper operation.

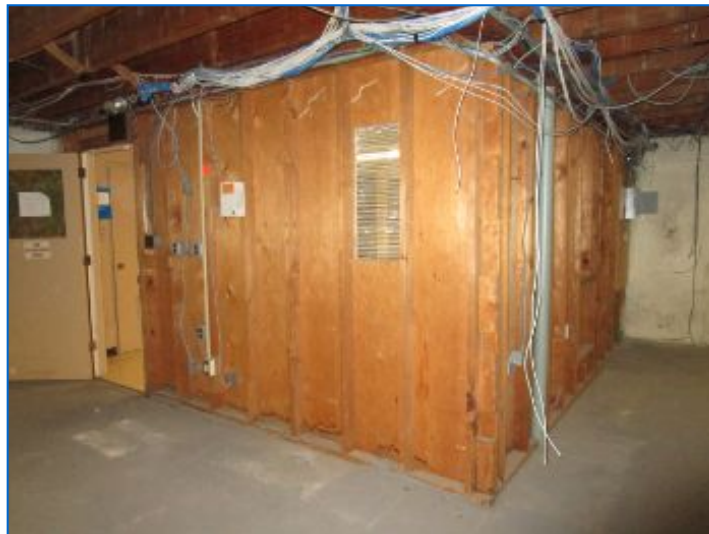
Cafeteria: Plywood walls noted.

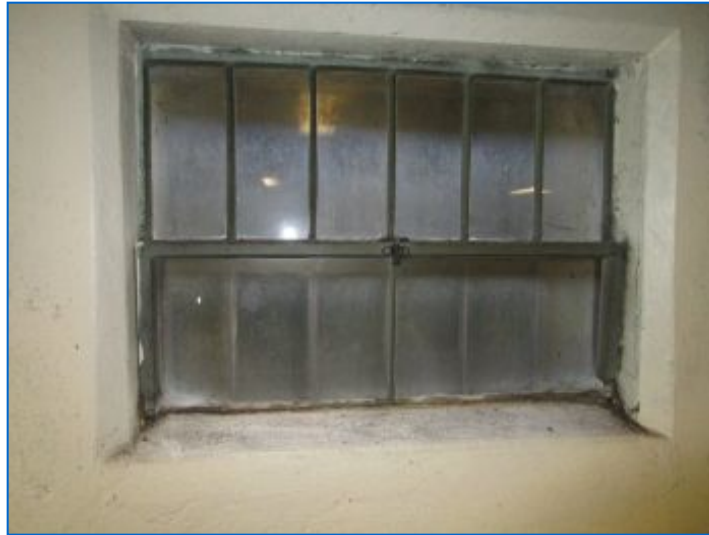
Basement windows were Steel frame, hopper style, Single-pane (non-insulated) windows.

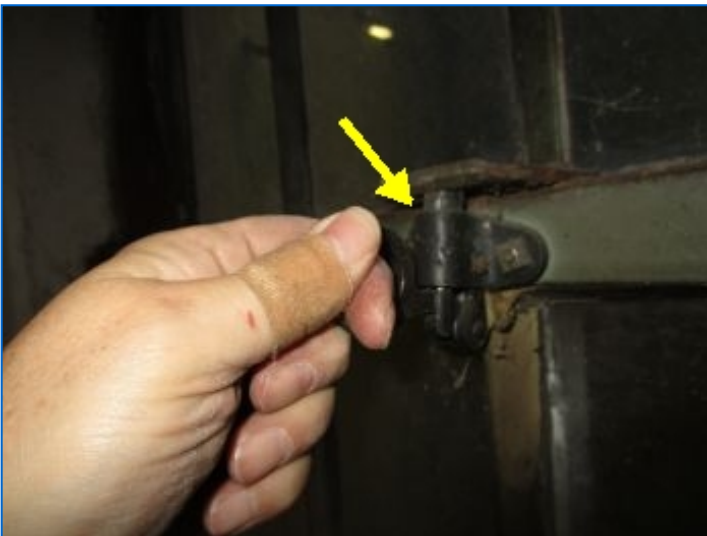
No basement windows opened when tested due to frozen latches from lack of use and/or paint layers. Recommend windows be serviced for proper operation prior to close.

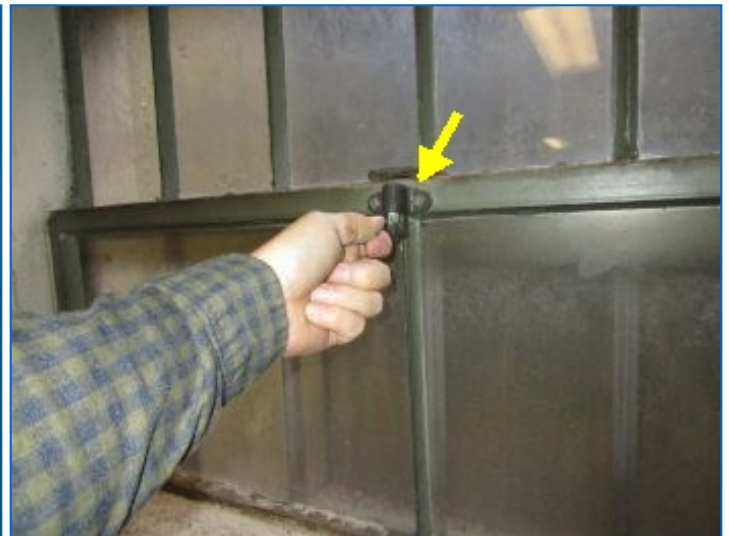
No basement windows opened when tested due to frozen latches from lack of use and/or paint layers. Recommend windows be serviced for proper operation prior to close.

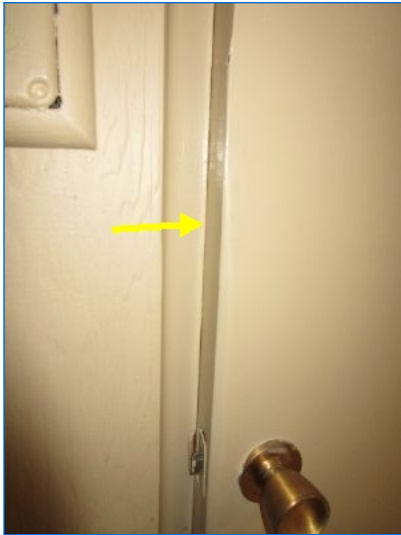
Cafeteria: Doors hit frame; didn't close properly. Suggest adjustment, repair or replacement if necessary.

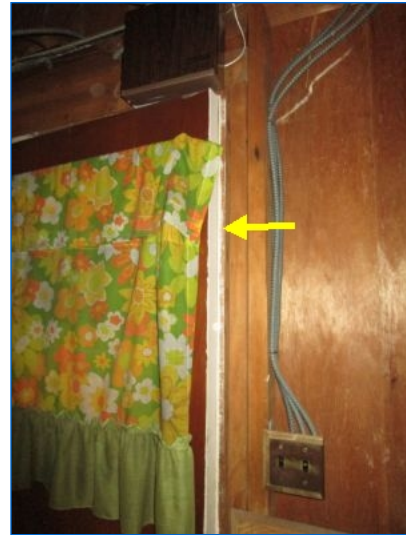
Cafeteria: Doors hit frame; didn't close properly. Suggest adjustment, repair or replacement if necessary.

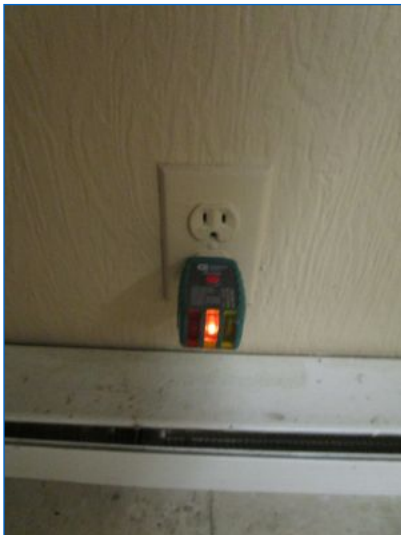
Cafeteria: Random Outlet Test - Ungrounded receptacle noted.

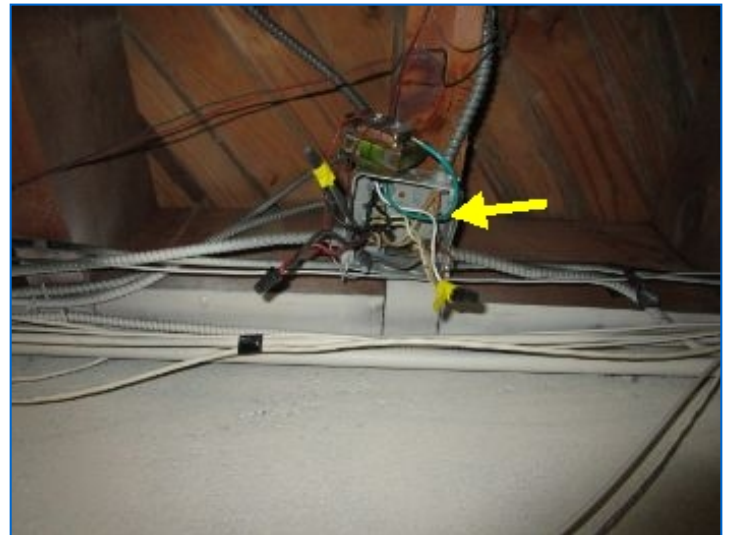
Open junction box observed. This condition is a shock/electrocution hazard. Approved cover plates should be installed by a qualified electrical contractor to prevent direct contact with energized electrical components.

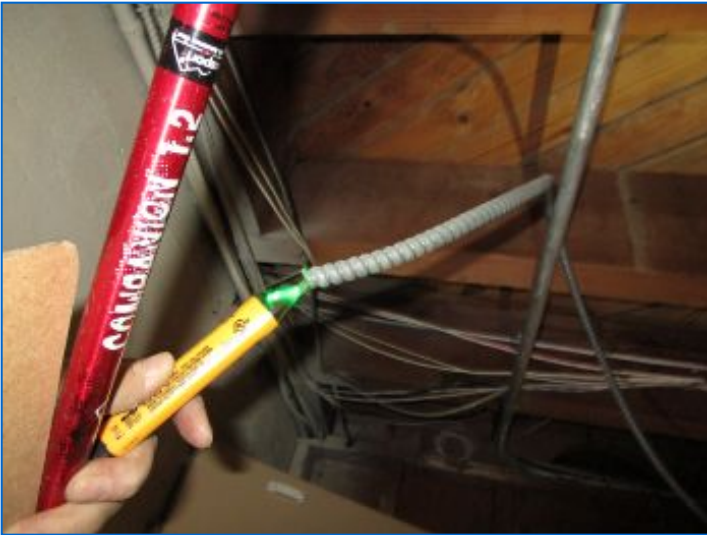
Electrical wires exposed to touch in the basement. This is an electric shock hazard should the wires become energized. Wire splices should be contained within an electric box with a listed cover installed.

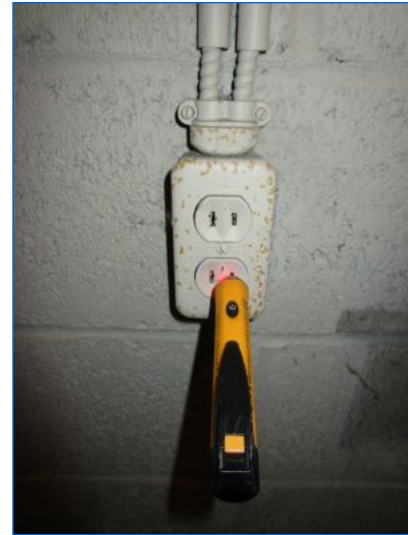
Equipment Room: Some outdated, ungrounded 2-prong receptacles noted in unfinished basement area. Recommend having a licensed electrician update these to GFCI protected receptacles for occupant safety.

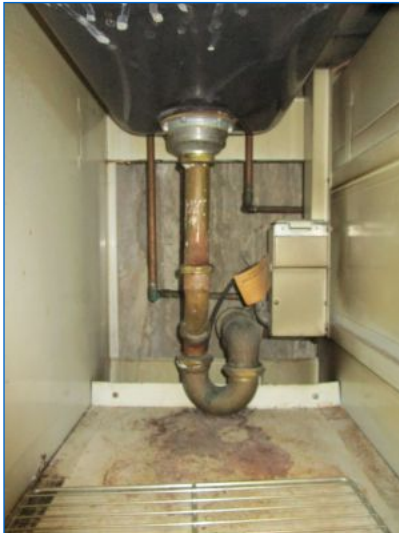
Cafeteria Pantry: Kitchenette sink was plumbed in.

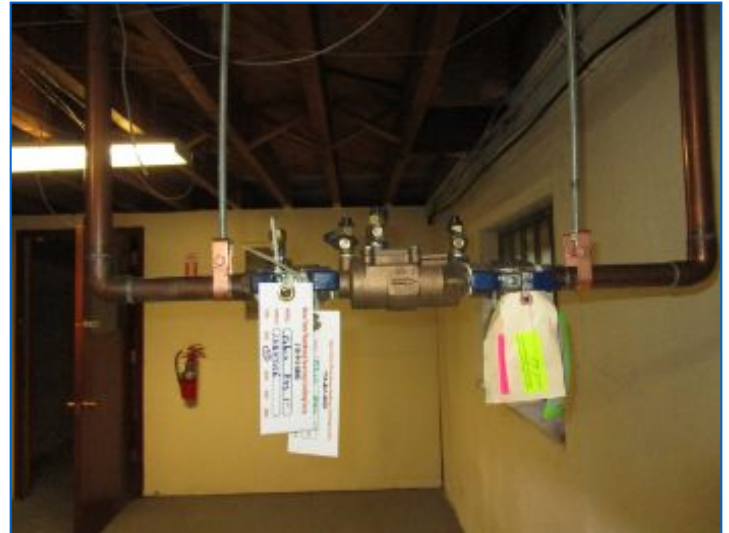
General Area: Backflow preventer noted for sprinkler system/garden hose.

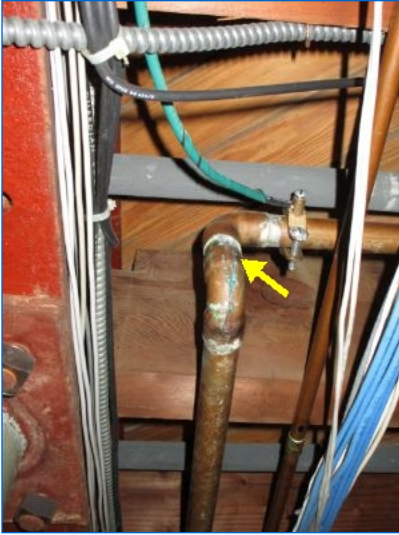
General Area (East-side): Active leaks observed at water supply pipe at time of inspection. Recommend repair by a Qualified Plumber.

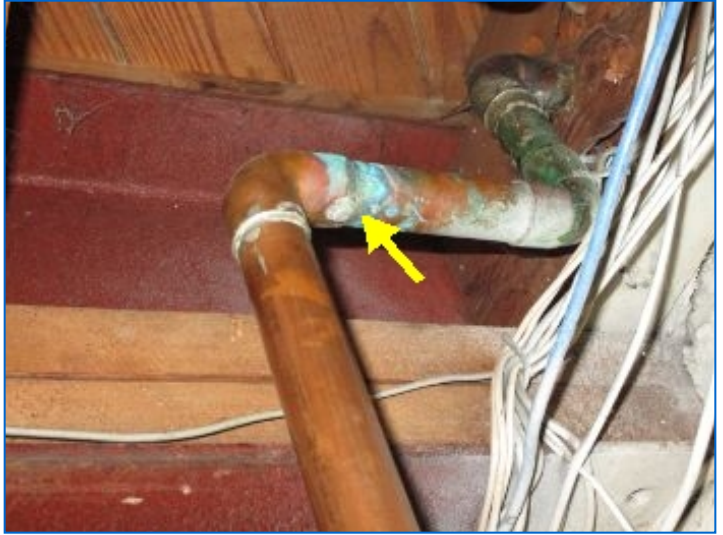
General Area (East-side): Active leaks observed at water supply pipe at time of inspection. Recommend repair by a Qualified Plumber.

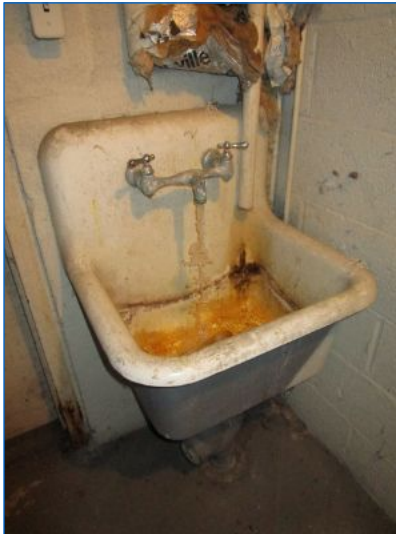
Equipment Room: Old service sink had functional flow and drainage.

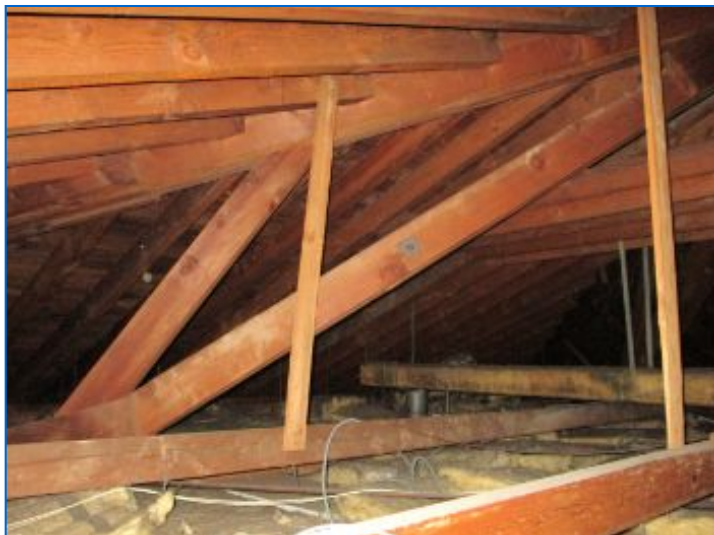
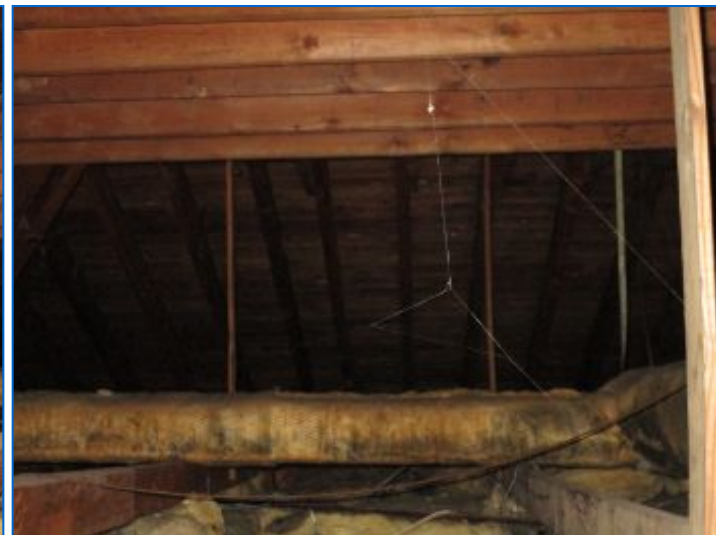
For this purpose, Attic is defined as the space above the hung ceiling.

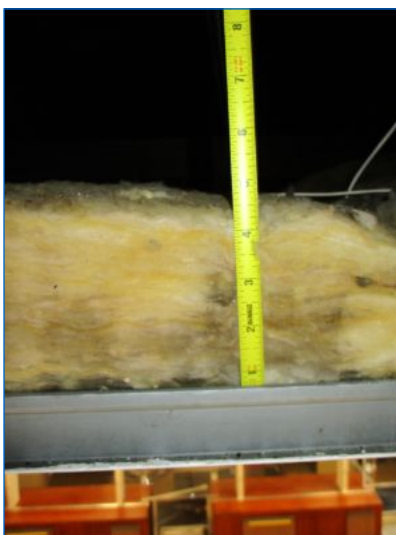
Insulation depth varied 4 - 5 inches (R-15.5 overall). Latest energy conservation standards call for 8-9 inches (R-30). Additional insulation should be installed where possible for enhanced energy efficiency of the home. Refer to attached US Department of Energy R-Value Recommendations.

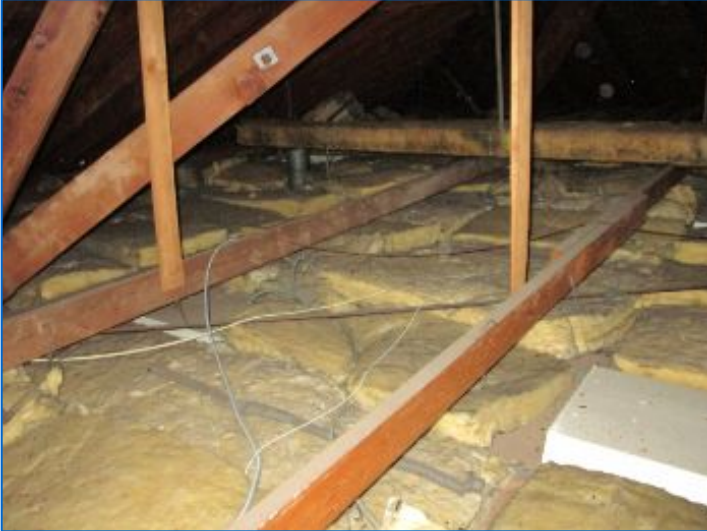
The inspector observed no significant deficiencies in the condition of the thermal insulation at the time of the inspection.

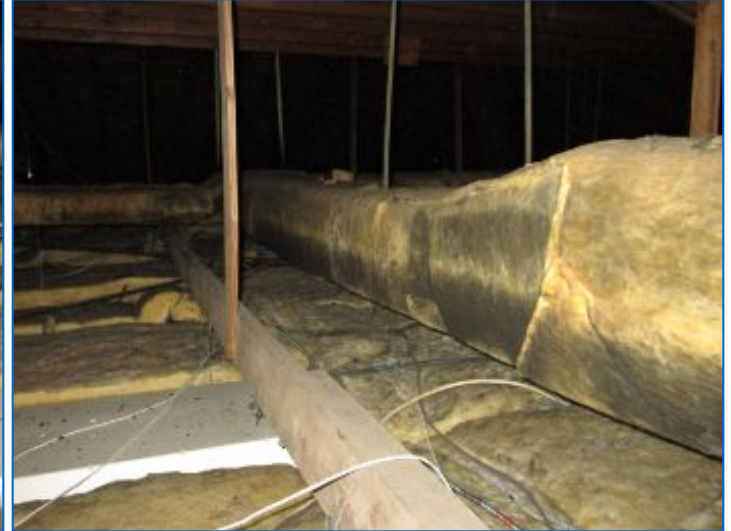
The inspector observed no significant deficiencies in the condition of the thermal insulation at the time of the inspection.

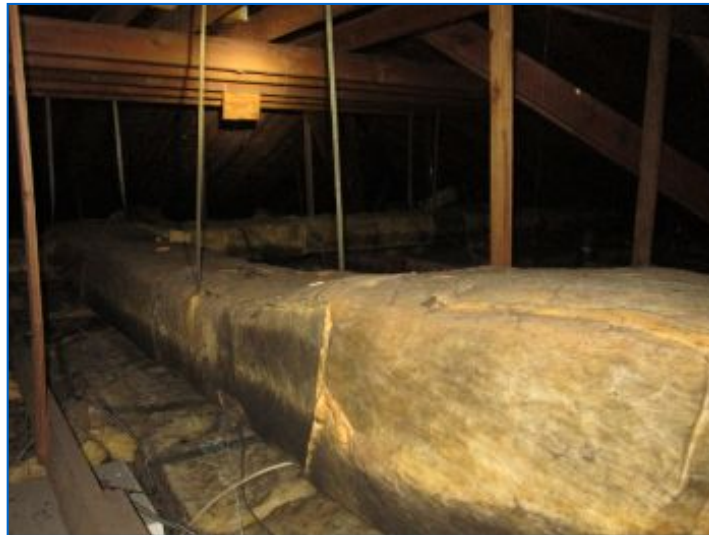
Insulated ductwork noted above hung ceiling.

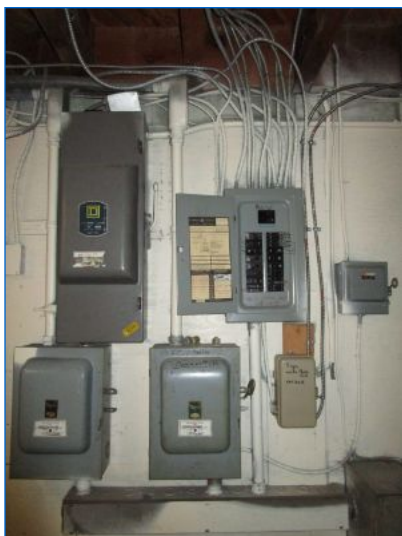
Older switch gear in Utility Room appeared serviceable at time of inspection.

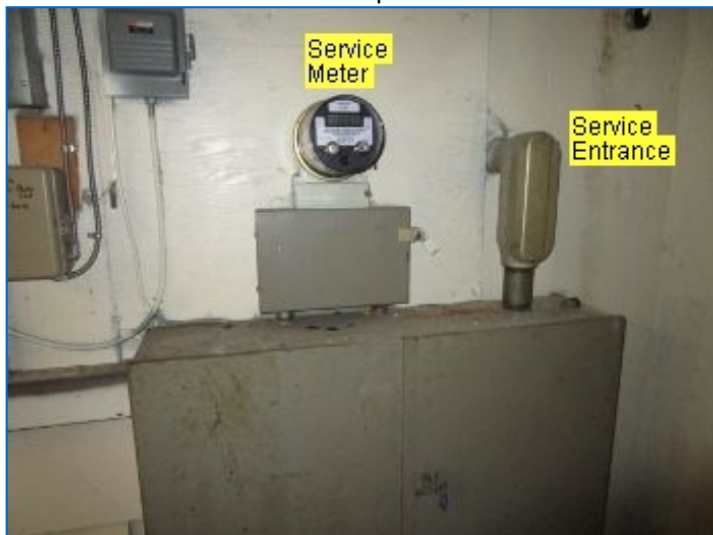
Capacity rating for overall electric service was not available at time of inspection; main disconnect cabinet was locked by utility company. Recommend consulting with PSEGLI for service capacity information as needed.

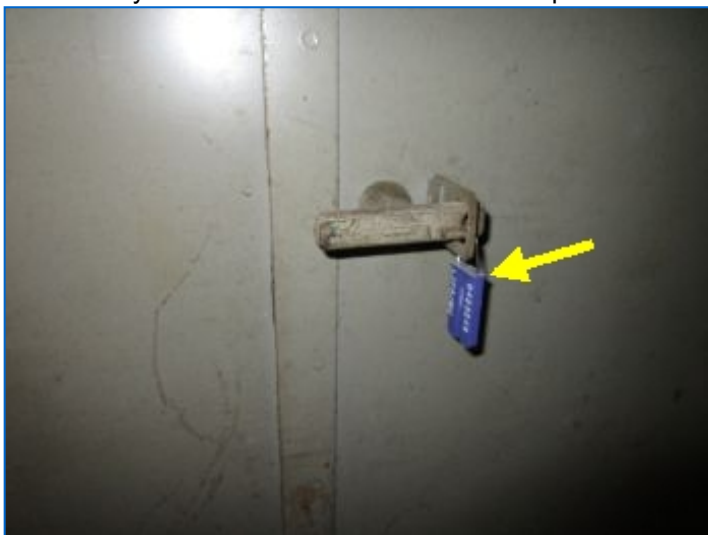
Capacity rating for overall electric service was not available at time of inspection; main disconnect cabinet was locked by utility company. Recommend consulting with PSEGLI for service capacity information as needed.

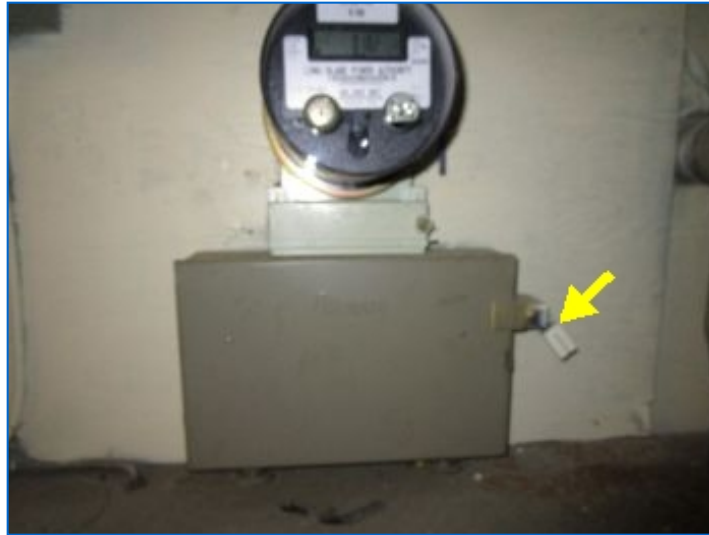
Capacity rating for overall electric service was not available at time of inspection; main disconnect cabinet was locked by utility company. Recommend consulting with PSEGLI for service capacity information as needed.

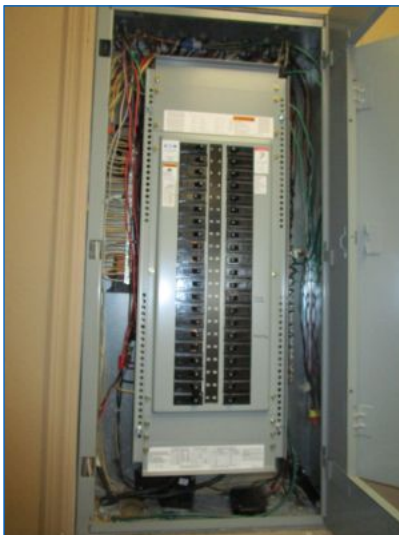
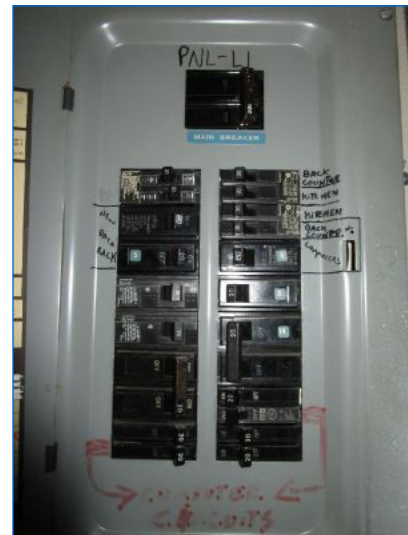
Main Panel #1 located in Interior Area-3 Stair/Hallway. Main Panel Breakers: 42 full-size circuit breaker spaces; 0 spare breaker space/s noted; 0 breaker/s in the Off/Tripped position. Main Disconnect located in Basement at Service Entrance.

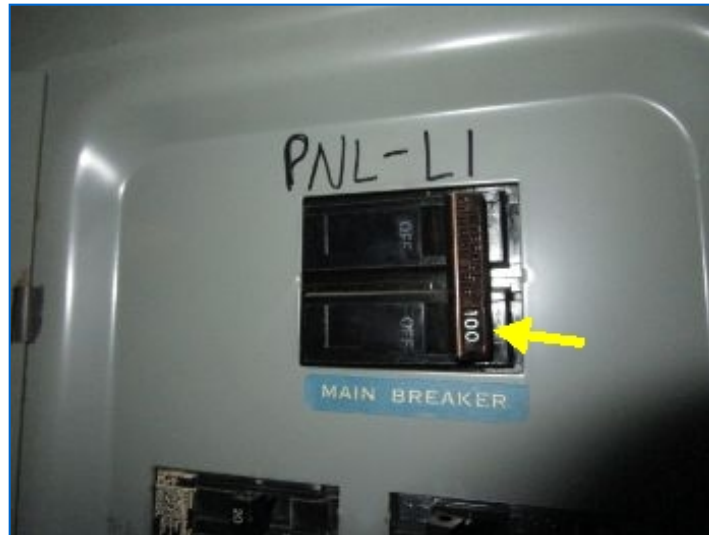
Main Panel #2 Disconnect: 100 amp main breaker serves Part of the property.

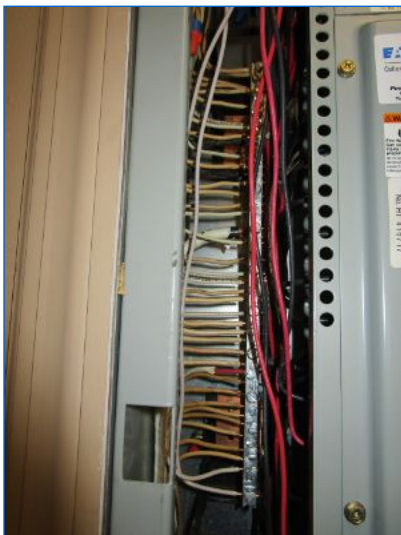
Main Panel #1: Neutral bus grounding could not be confirmed at time of inspection. Recommend having a licensed electrician evaluate to ensure there's proper system grounding per current standard.

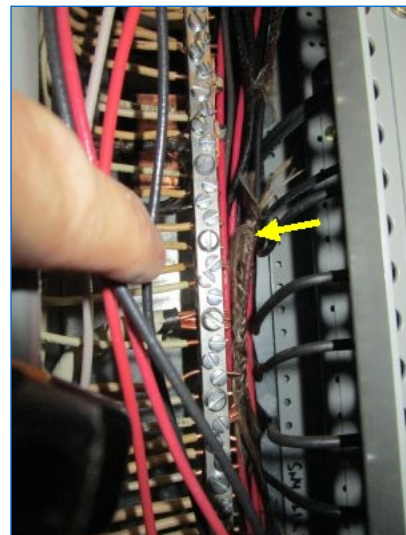
Main Panel #1: Some older fabric covered electrical wires still exist in the home. Recommend having a licensed electrician evaluate and apply corrective measures to avert hazard.

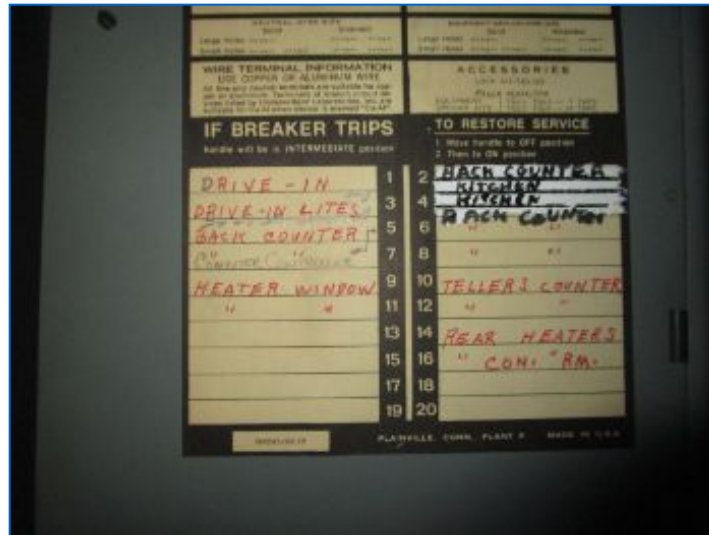
Main Panel #2 Circuit Index noted.

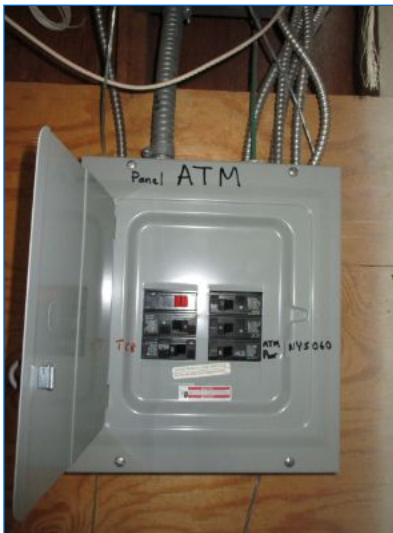
Sub Panel "ATM" located in Basement General Area. Sub Panel Breakers: 8 full-size circuit breaker spaces; 2 spare breaker space/s noted; 1 breaker/s in the Off/Tripped position. Sub Panel 20 amp breaker labeled "TCR" was in the Off/Tripped position.

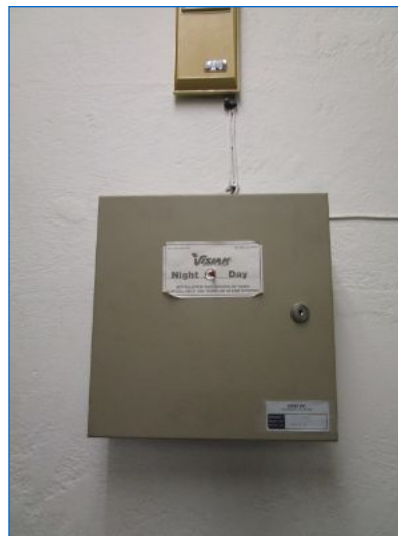
Apparently defunct security system panel noted in Bank Vault.

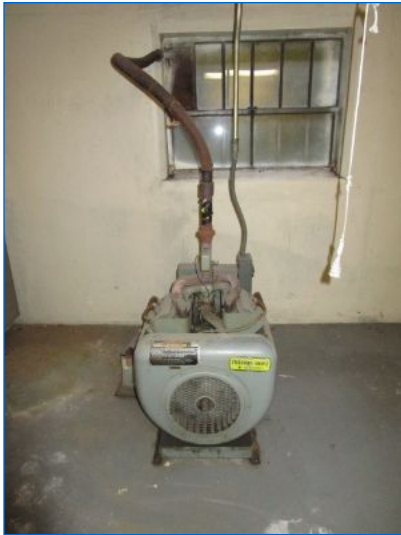
Old defunct engine generator with 30 amp disconnect; no fuel source observed. Recommend removal.

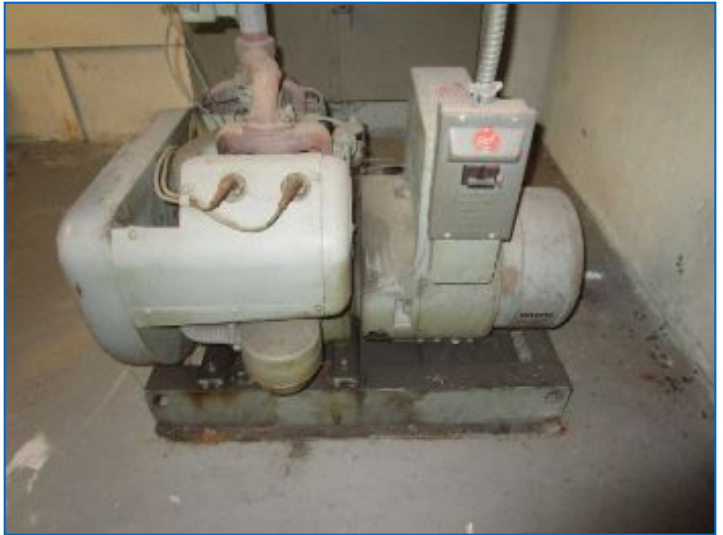
Old defunct engine generator with 30 amp disconnect; no fuel source observed. Recommend removal.

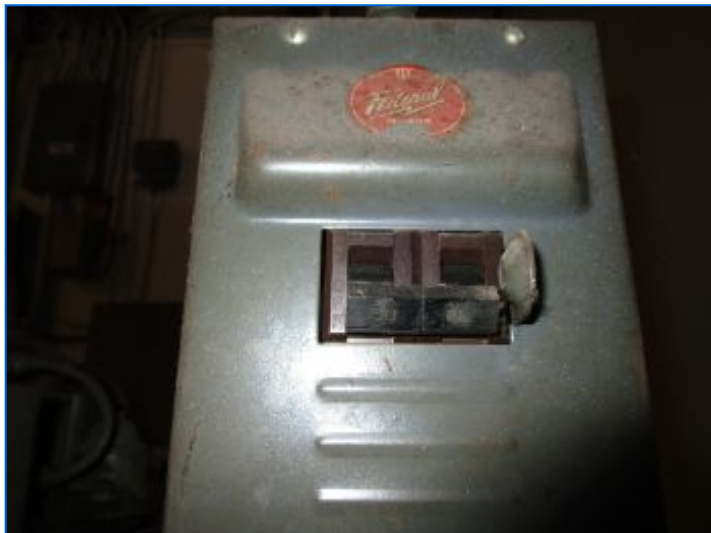
Old defunct engine generator with 30 amp disconnect; no fuel source observed. Recommend removal.

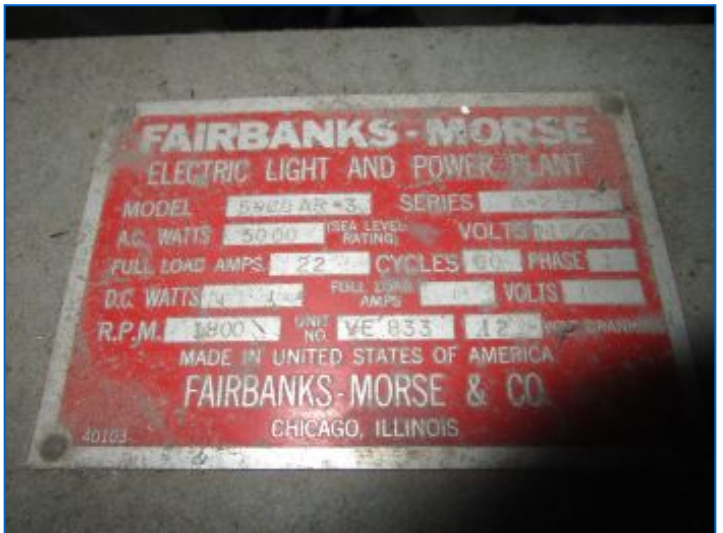
Old defunct engine generator with 30 amp disconnect; no fuel source observed. Recommend removal.

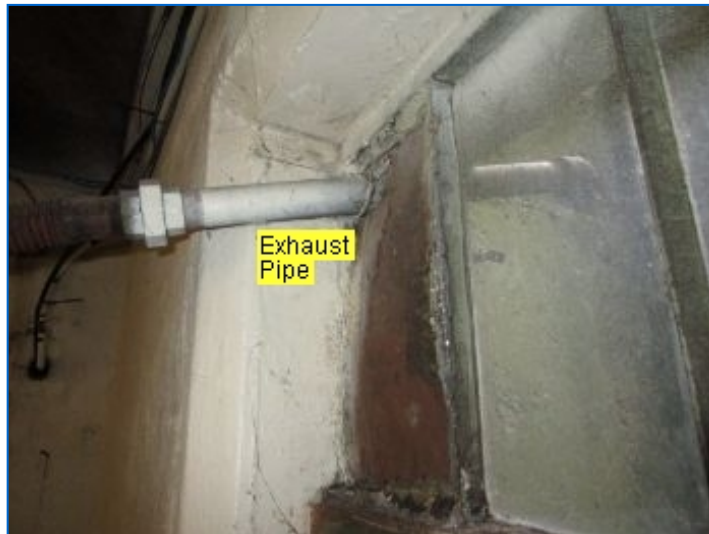
Old defunct engine generator with 30 amp disconnect; no fuel source observed. Recommend removal.
