ProSpec Home Inspection of Long Island Property Inspection Report

Inspector: Russell J. Classi, P.E.
Phone: (516) 480-1848
Email: prospecofli@gmail.com
www.nassaprofessionalhomeinspector.com

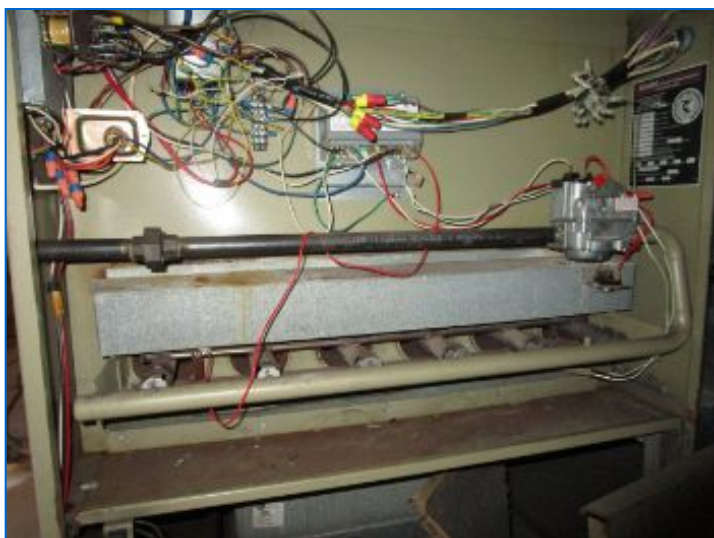
Forced Air Furnace: The heat exchanger in a Gas-fired furnace is mostly hidden from view; it cannot be fully examined and its condition determined without being disassembled. Since this is not possible during a visual inspection, it is recommended that an annual service contract be placed on the unit and a Service Call made prior to settlement to check the condition of the heat exchanger.

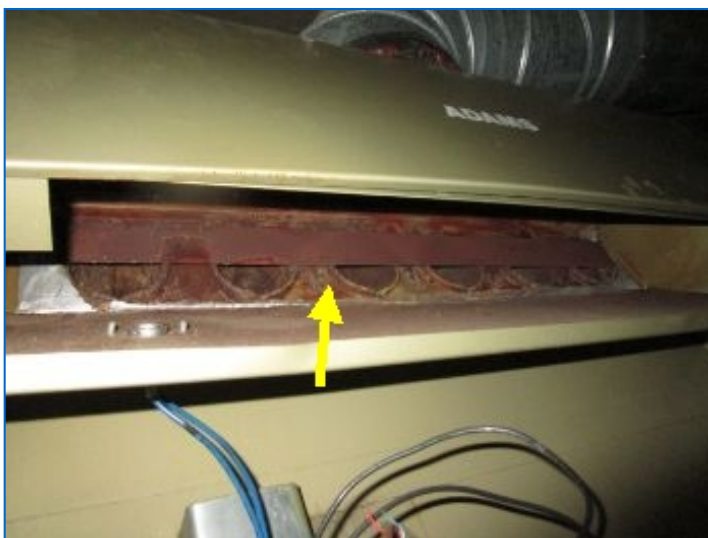
Rust/corrosion in burner chamber; this unit appears to be at the end of its useful life. A service review is urged immediately for the safety of occupants. This unit will likely be red tagged at time of service.

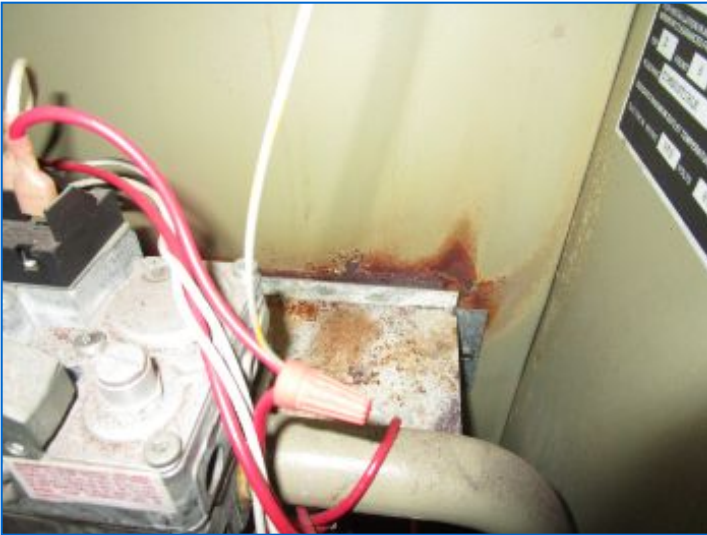
Forced Air Furnace: The heat exchanger in a Gas-fired furnace is mostly hidden from view; it cannot be fully examined and its condition determined without being disassembled. Since this is not possible during a visual inspection, it is recommended that an annual service contract be placed on the unit and a Service Call made prior to settlement to check the condition of the heat exchanger.

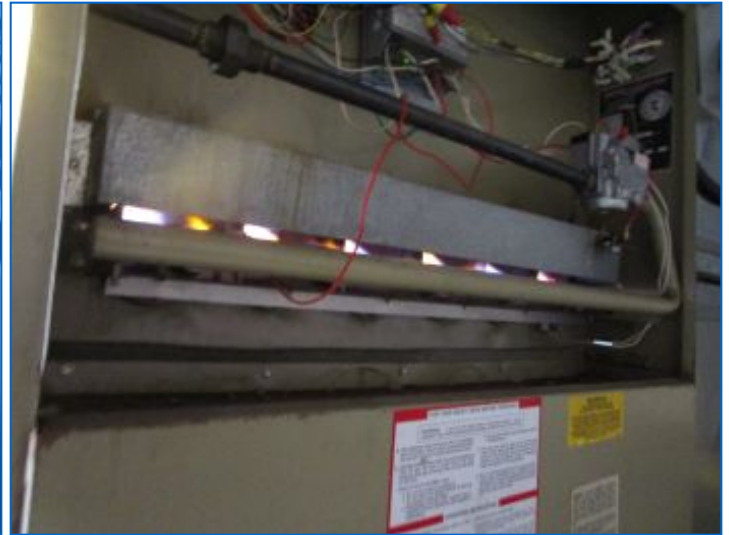
Burner was fired via thermostat.

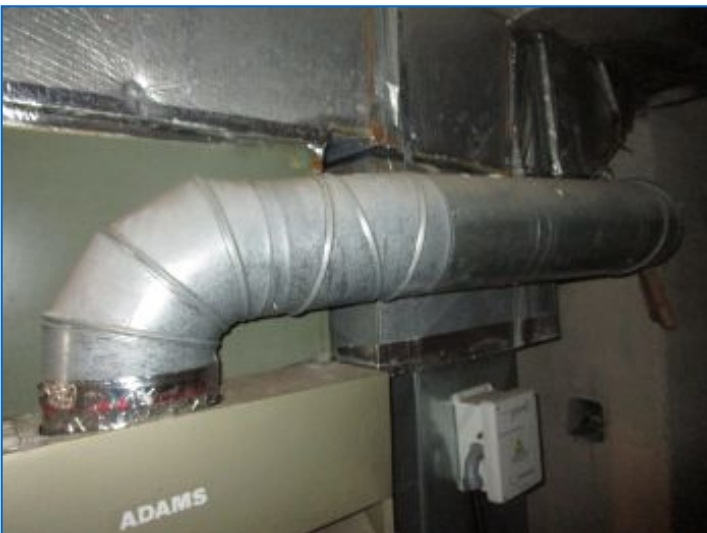
Visible portions of the vent pipes appeared functional.

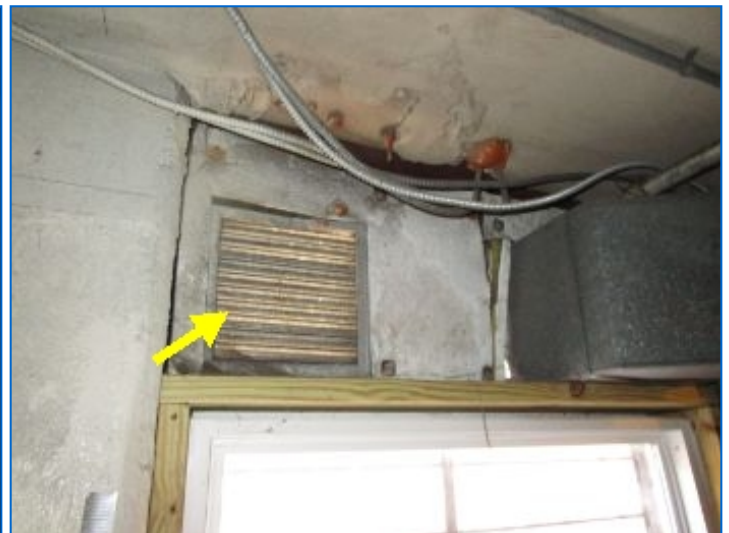
Furnace minimal exterior venting noted.

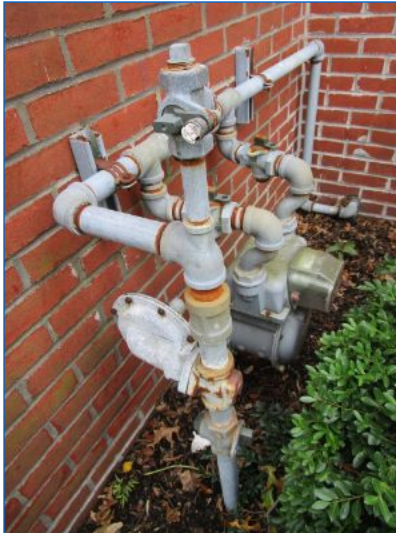
Public Gas Service: Outside meter w/shutoff valve and vented regulator noted at east side (set back from driveway).

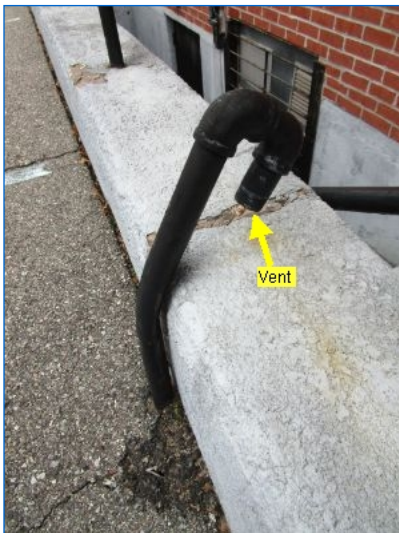
Vent pipe emerging from the ground at the South side of the property. This appeared to be from an abandoned underground oil tank. See related comments.

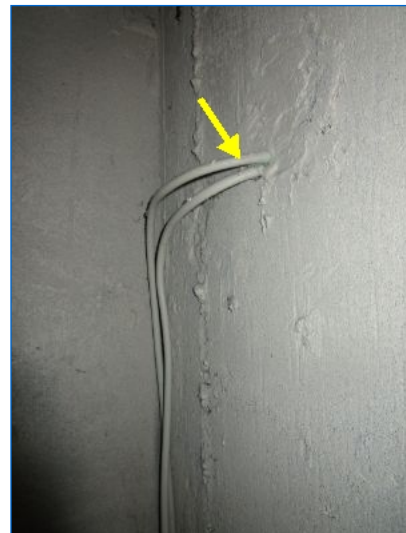
Oil supply lines through foundation wall in equipment room; apparent abandoned (or abated) underground oil tank (See related comments).

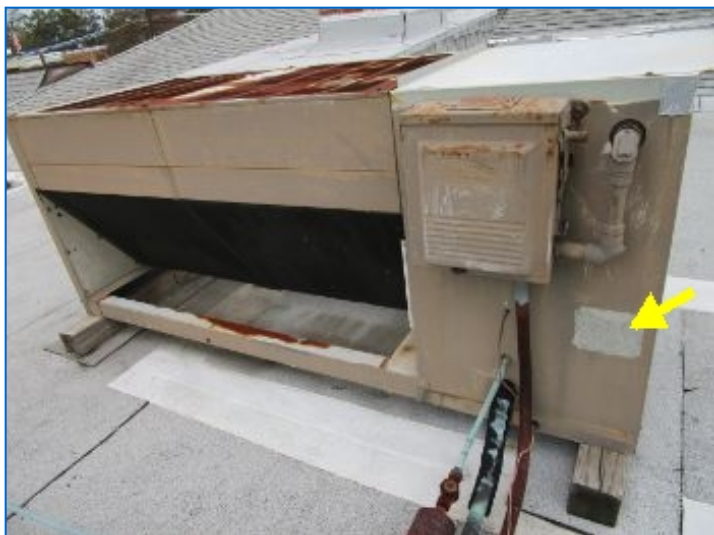
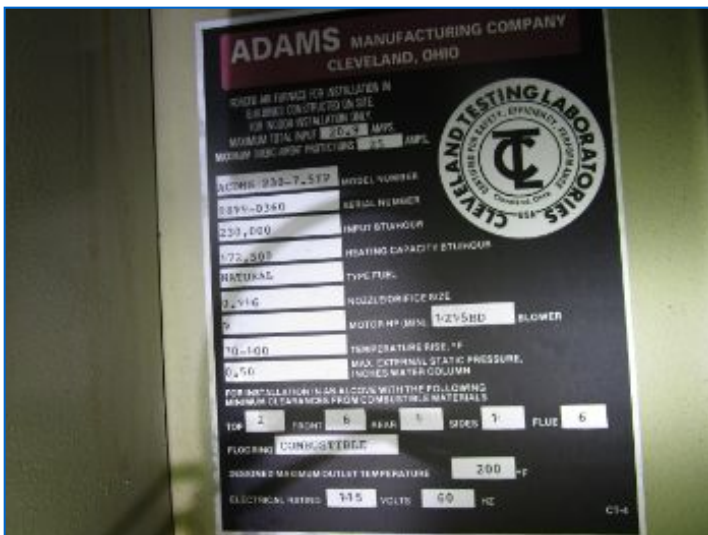
Outdoor Condenser data-plate/serial no. was not legible, however based on the available information and general condition, this equipment is estimated to be 22+ yrs old, similar to the indoor forced air unit. Condensing Unit normal design service life expectancy is 20-25 yrs with some maintenance. It is the Inspector's opinion that the A/C Condensing Unit has Exceeded its designed life expectancy. Recommend replacement.

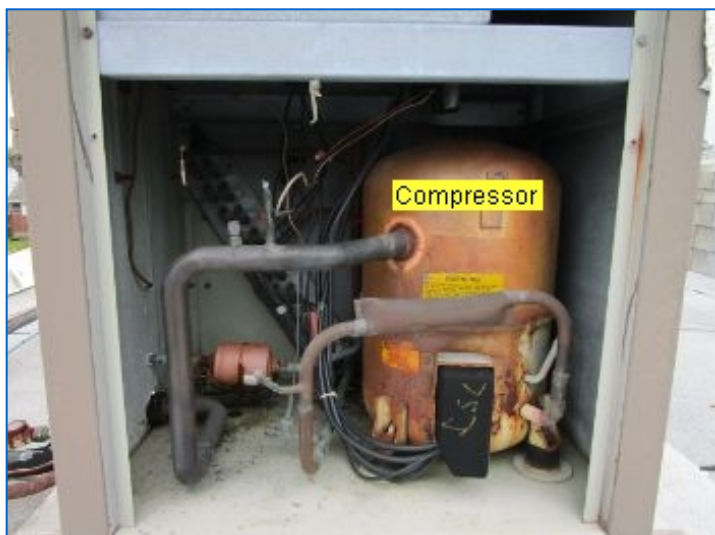
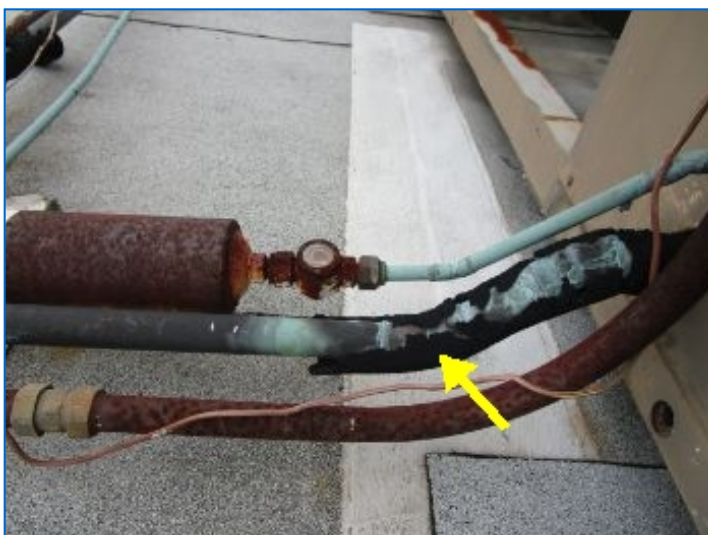
Equipment access panel was missing/not installed at time of inspection. Testing of Air Conditioning Cooling Modes: If the outside temperature has not been at least 60 degrees F. for the past 24 hours, an air conditioning cooling system cannot be checked without possibly damaging the compressor. In this situation, it is suggested that the present owner of the property warrant the operational status of the unit on an one-time start-up and cool-down basis when warmer weather allows.

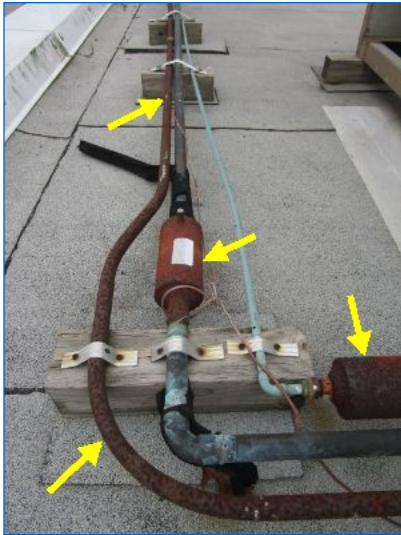
Exterior refrigerant pipe/appurtenances and conduit was corroded and has reached its service life expectancy. Recommend replacement to ensure safe and reliable service.

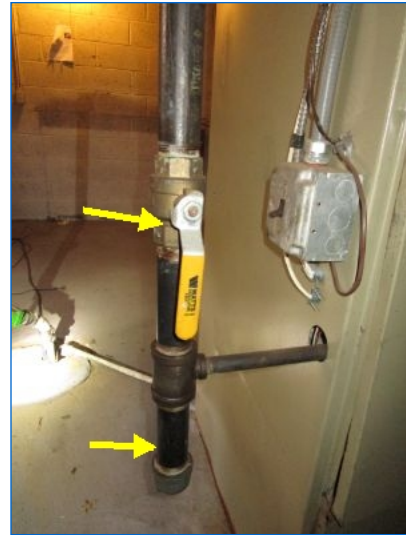
Gas shut-off valve and proper drip leg noted at burner.

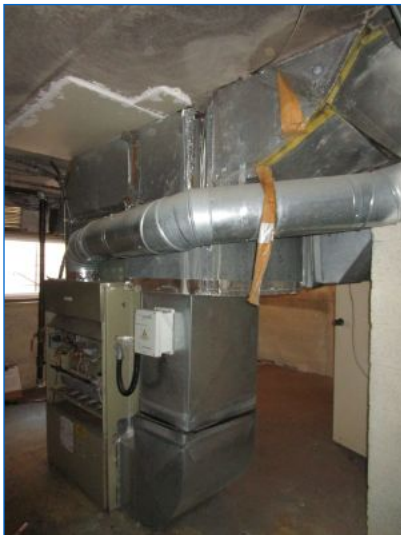
Heating system was originally found in the OFF position at the thermostat. The Inspector returned the thermostat to the original OFF position. This lack of heat could jeopardize plumbing systems in the building during winter.

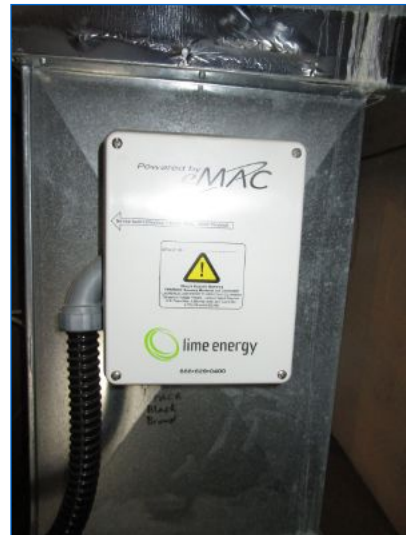
Unidentified and questionable component mounted to HVAC system return duct.

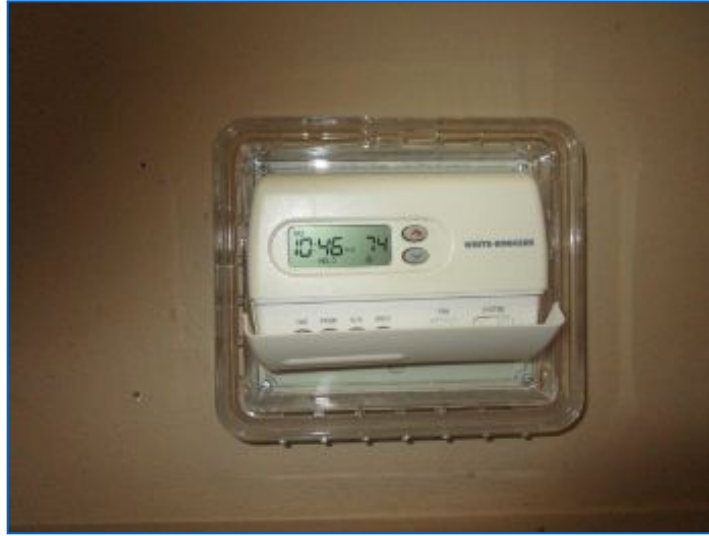
Digital Programmable type thermostat noted in Interior Area 1; for Heating & Cooling.

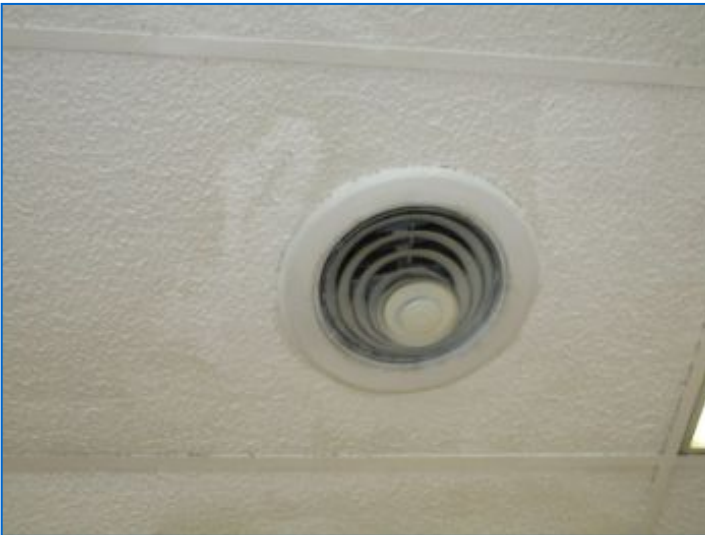
Ductwork with supply & return air registers for distribution of Heating & Cooling noted at main level.

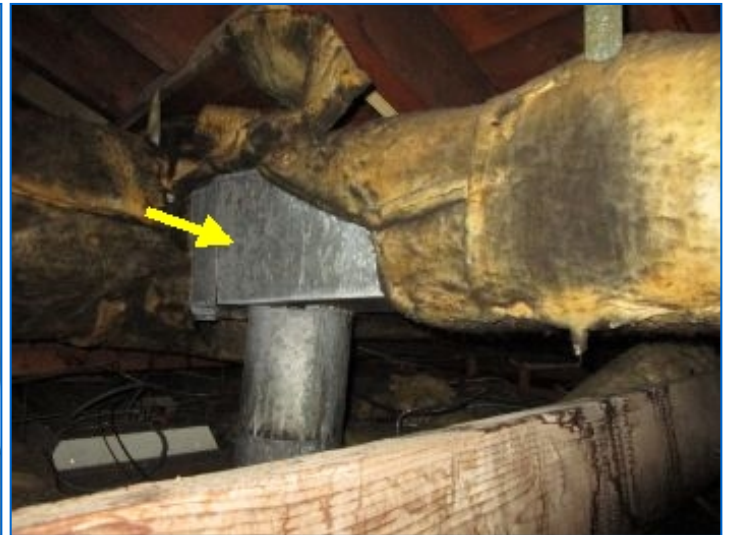
Section of ductwork was missing insulation. Suggest repair to prevent condensate drips.

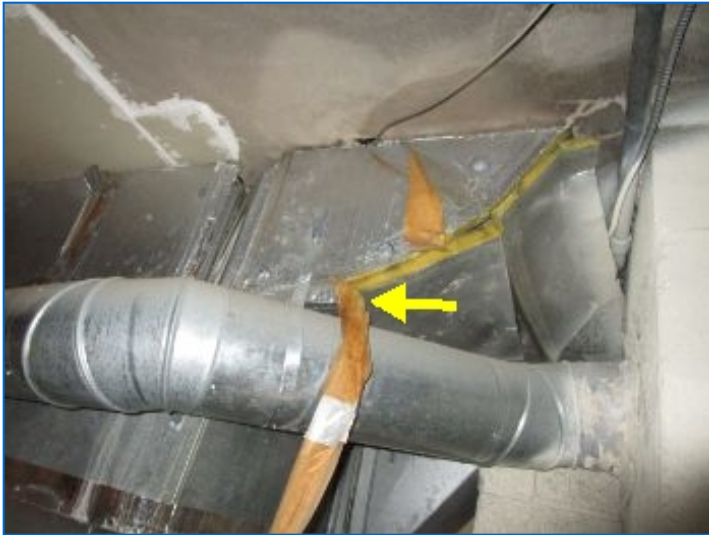
Some insulation tape had detached the duct insulation. Recommend corrective repairs by a qualified contractor.

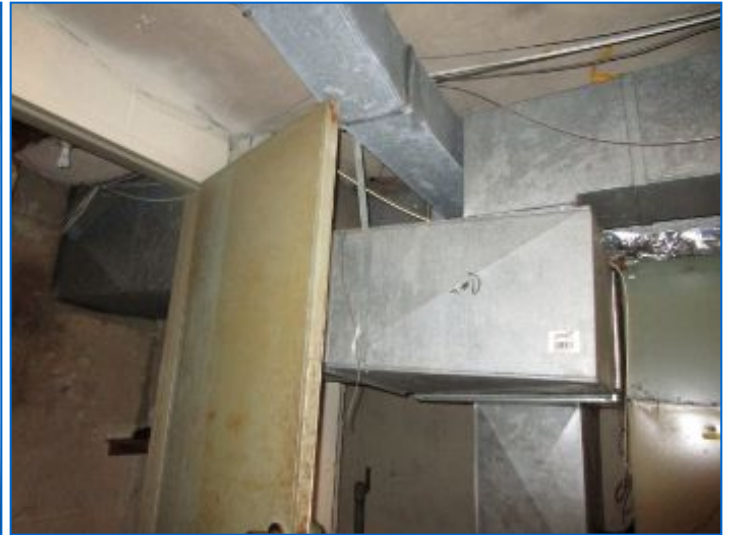
Ductwork appeared in serviceable condition. Recommend replacing supply and return registers/grilles as standard for cosmetic purposes.

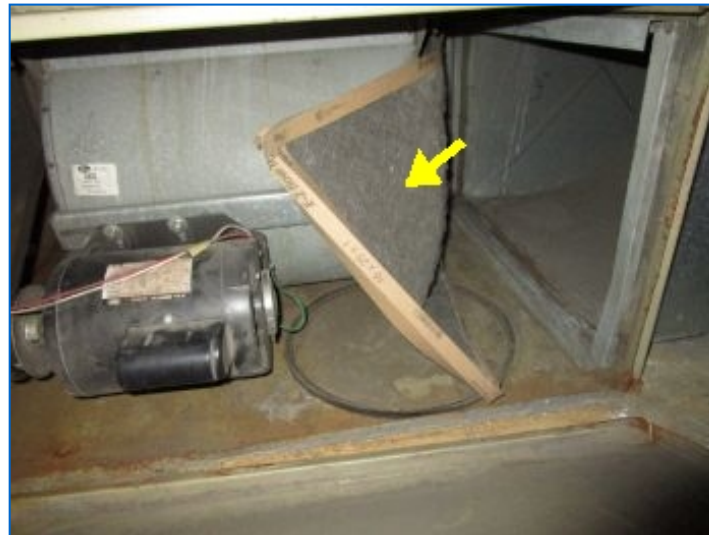
Disposable filter located inside return duct at air handler intake. Air filter was very dirty/clogged and collapsed. Replace with new fiberglass disposable filter; sign of poor maintenance.

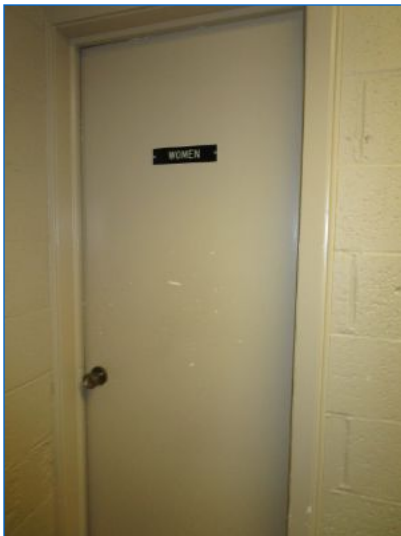
Womens Bathroom, (2) Toilets, Lavatory, Window, Bathroom Floor: Floor: Ceramic tile, Ceiling register appeared as a supply outlet. No exhaust grille noted; window for ventilation.

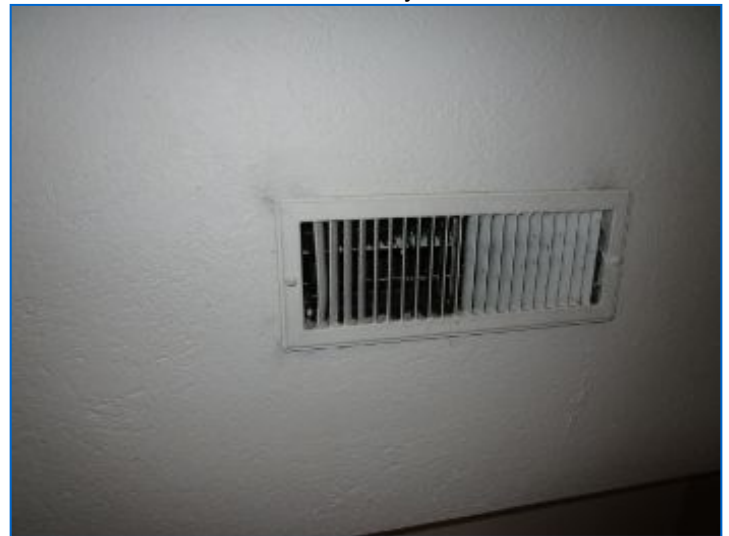
Ceiling register appeared as a supply outlet. No exhaust grille noted; window for ventilation.

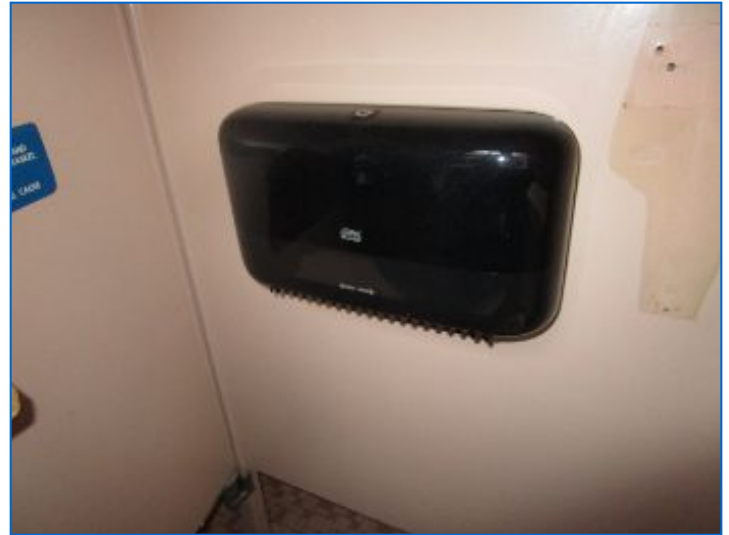
Bathroom accessories noted.

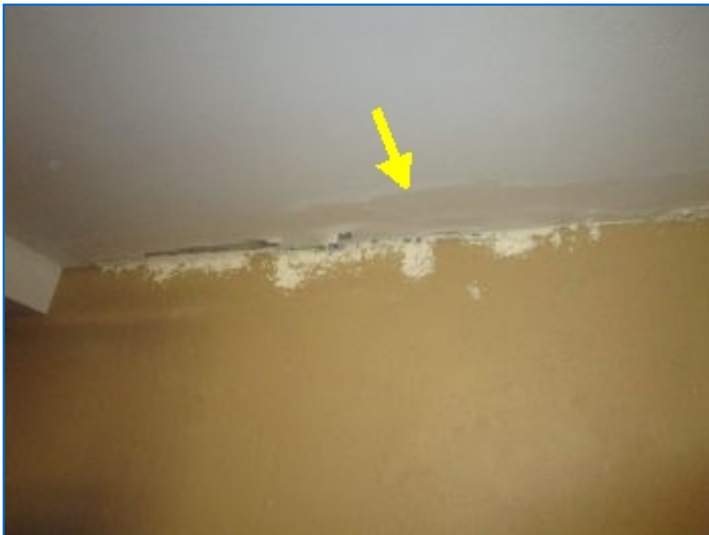
Moisture damage noted at ceiling along west wall; active moisture intrusion - wet condition noted. Refer to related comments in Grounds- Grading section. Recommend corrective repair by a licensed qualified contractor.

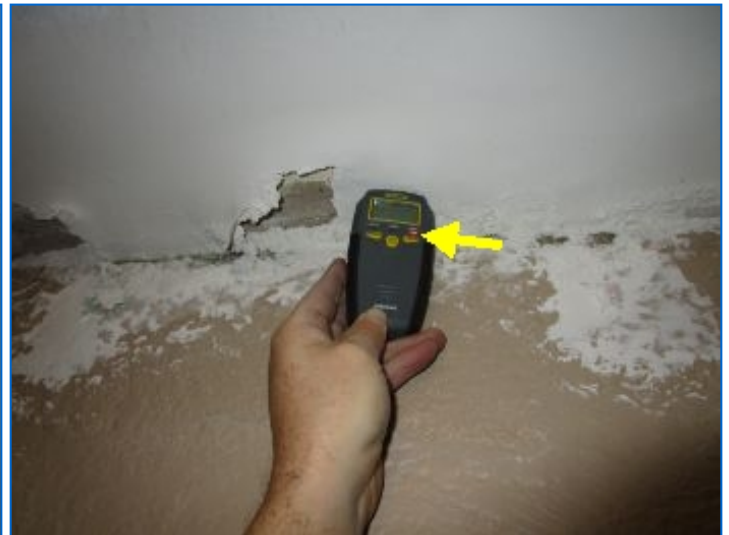
Moisture damage noted at ceiling along west wall; active moisture intrusion - wet condition noted. Refer to related comments in Grounds- Grading section. Recommend corrective repair by a licensed qualified contractor.

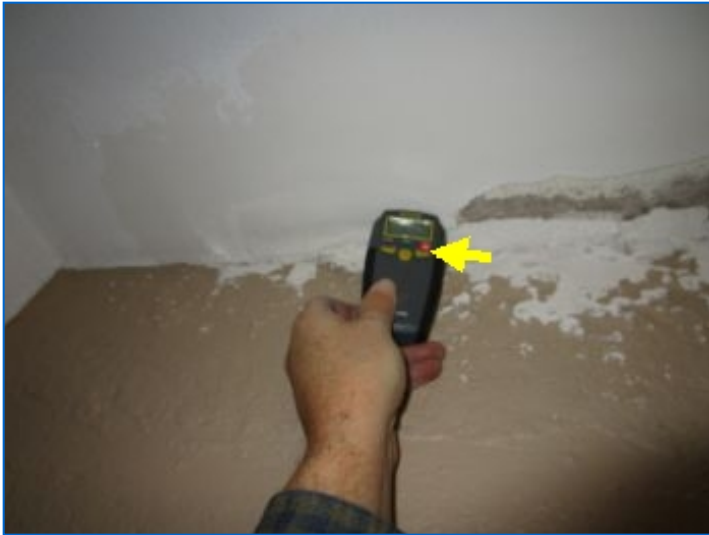
Moisture damage noted at ceiling along west wall; active moisture intrusion - wet condition noted. Refer to related comments in Grounds- Grading section. Recommend corrective repair by a licensed qualified contractor.

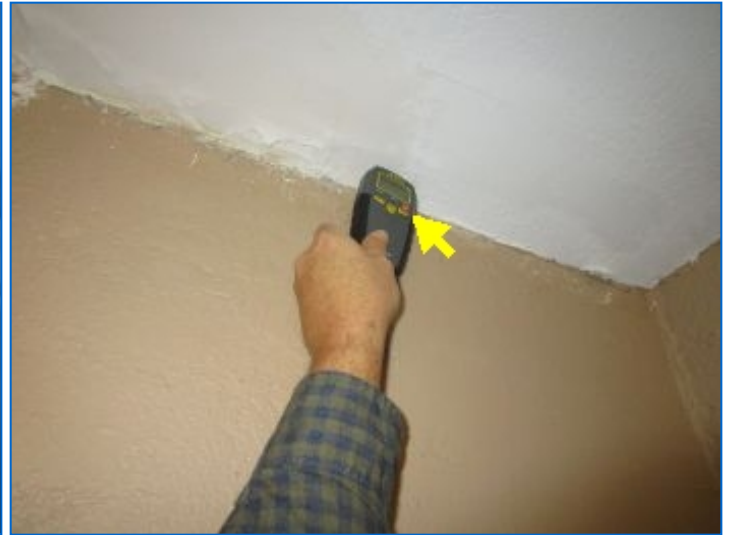
Moisture damage noted at ceiling along west wall; active moisture intrusion - wet condition noted. Refer to related comments in Grounds- Grading section. Recommend corrective repair by a licensed qualified contractor.

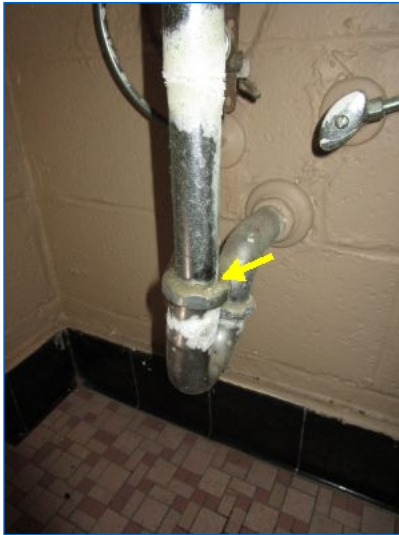
Lavatory drain connection leaked. Recommend repair by a qualified contractor.

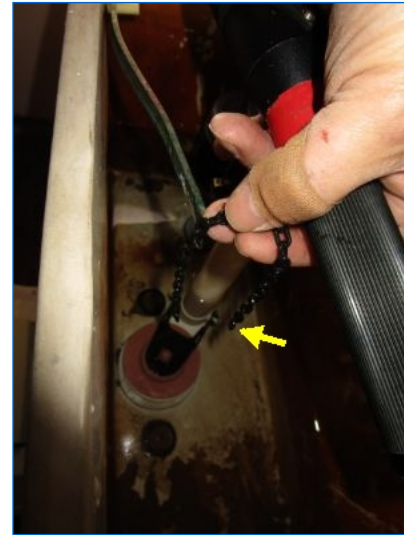
A toilet flapper chain was broken/disconnected; pulled chain to flush. Recommend repair.

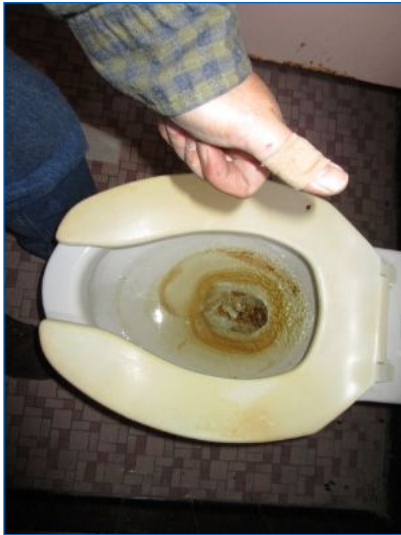
A toilet flush assembly chain was broken/disconnected; pulled chain to flush. Recommend repair.

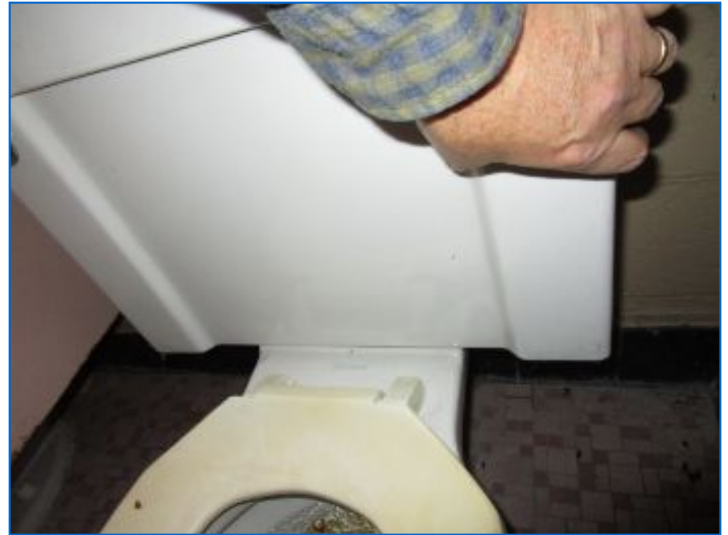
A toilet had a loose tank mount. Recommend repair by a qualified contractor.

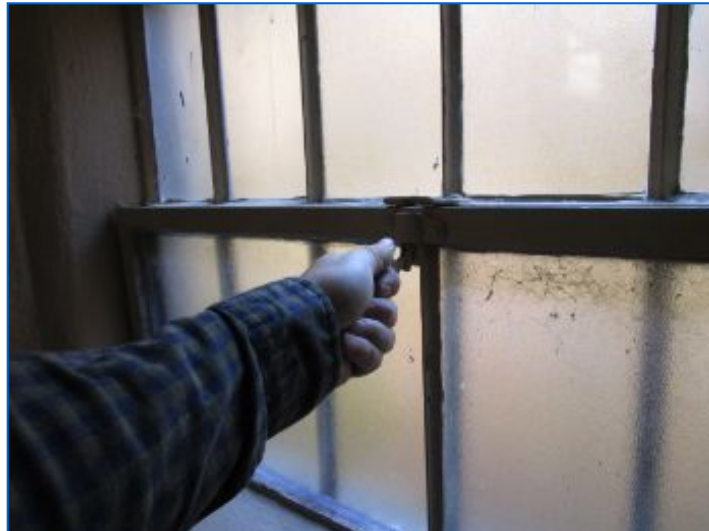
Bathroom window did not open when tested due to frozen latches from lack of use and/or paint layers. Recommend windows be serviced for proper operation prior to close.

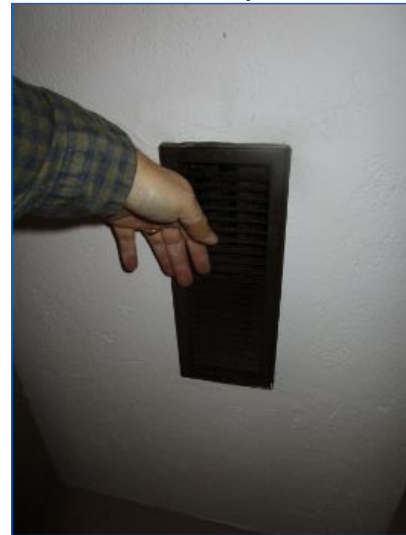
Ceiling register appeared as a supply outlet. No exhaust grille noted.

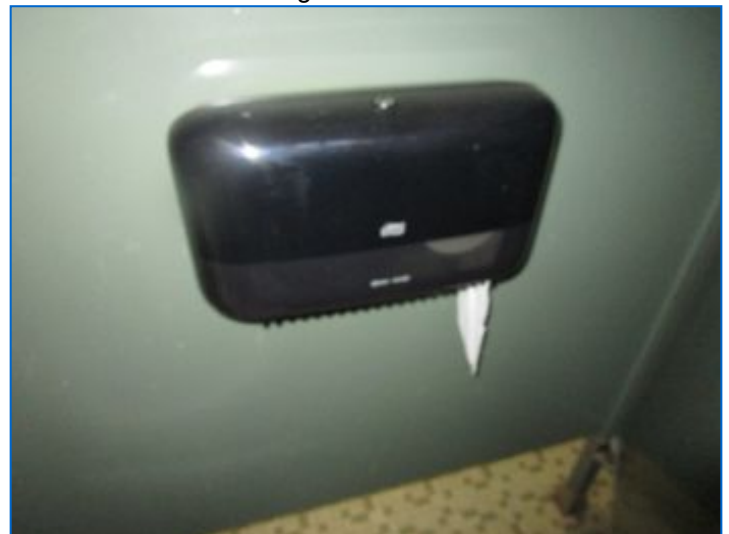
Bathroom accessories noted.

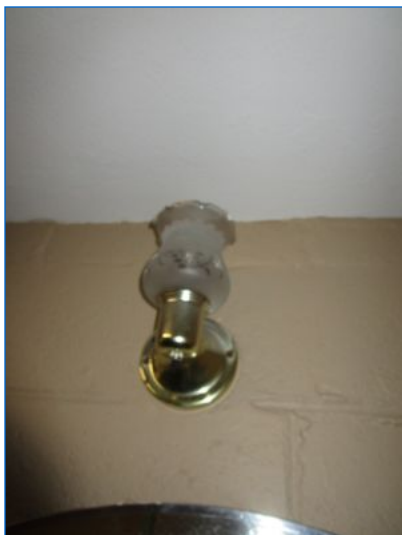
Light fixture or bulb apparently inoperable. Change bulb and check.

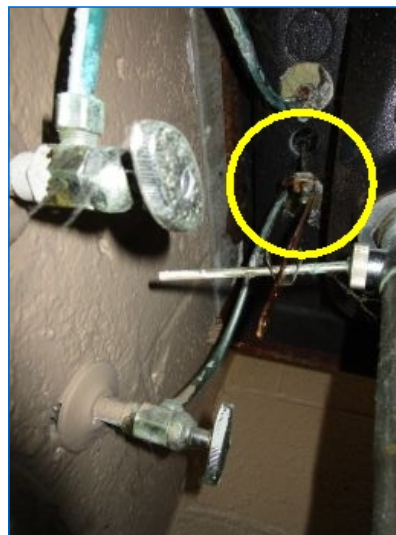
Visible leaking under the sink. Source of existing leak could not be determined; Recommend qualified plumber evaluate and repair.

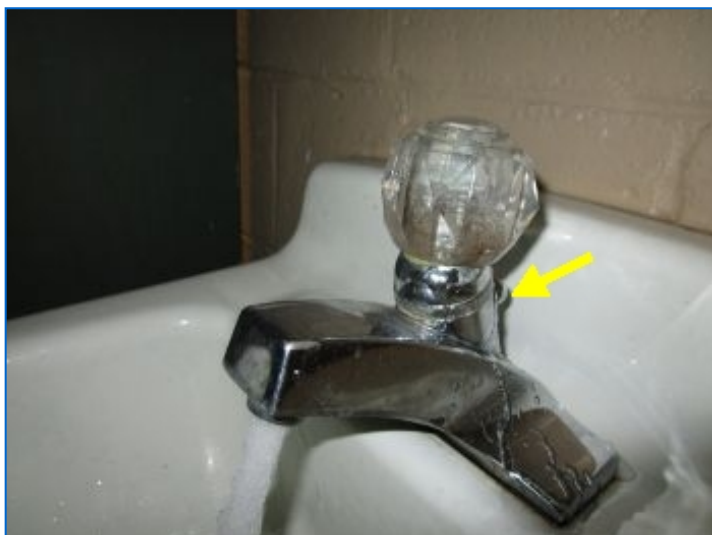
Lavatory faucet leaks from handle; Recommend faucet repair or replacement.

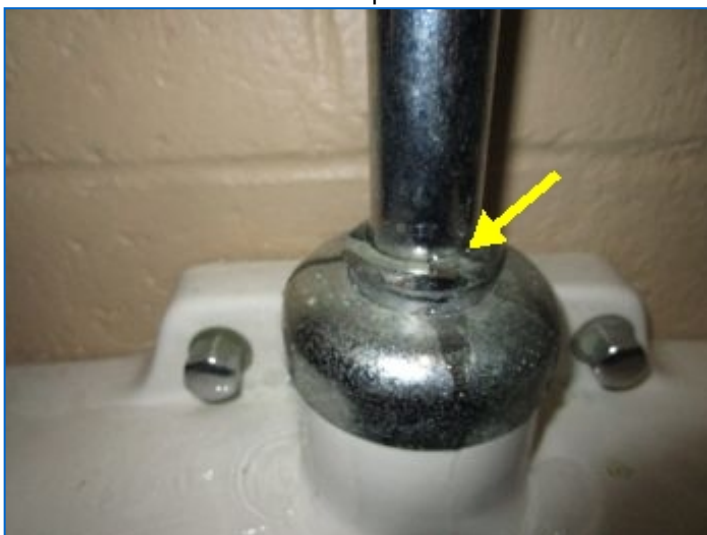
Leak noted at urinal flushometer pipe connection. Recommend repair by a licensed qualified plumber.

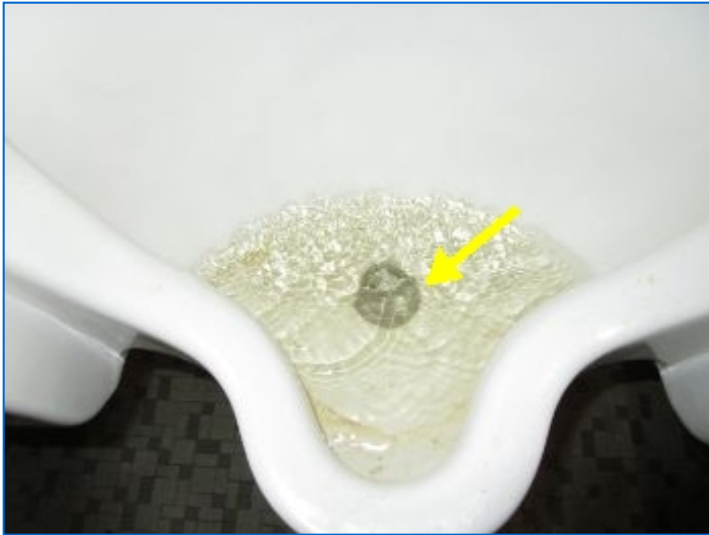
Urinal drain strainer was missing.

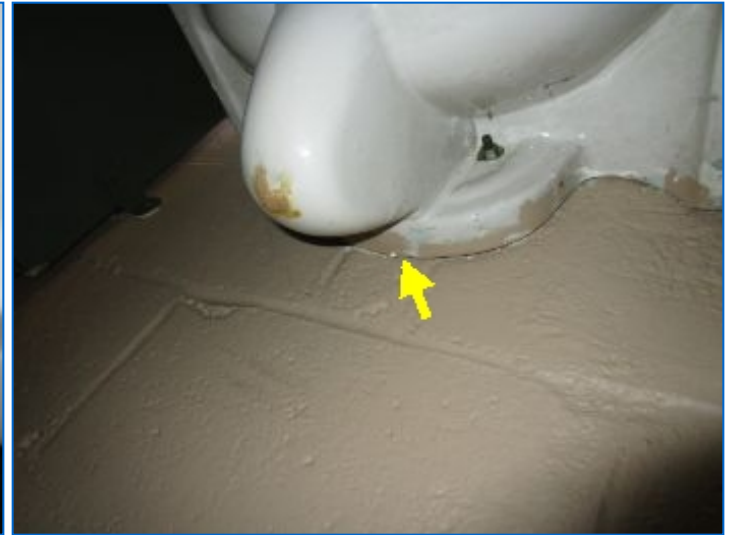
Visible drip leak under the urinal. Source of existing leak could not be determined; Recommend qualified plumber evaluate and repair.

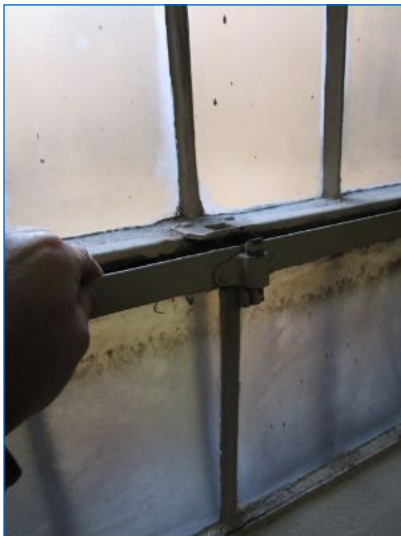
Bathroom window did not open when tested due to frozen latches from lack of use and/or paint layers. Recommend windows be serviced for proper operation prior to close.

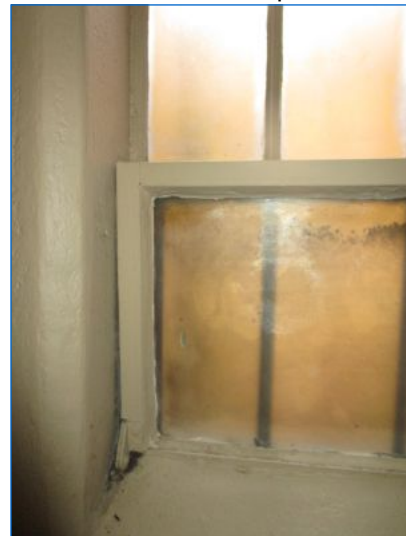
Bathroom window did not open when tested due to frozen latches from lack of use and/or paint layers. Recommend windows be serviced for proper operation prior to close.

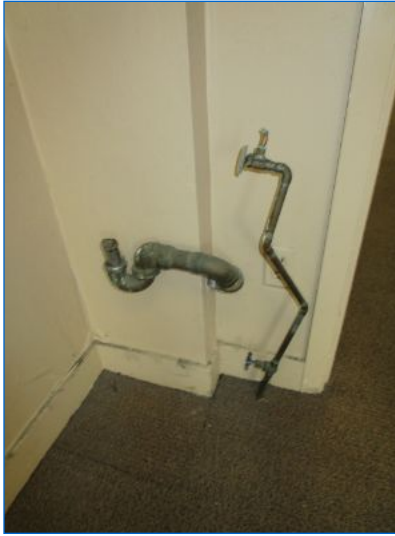
Interior Area-3, Teller Admin: CW supply and drain for water fountain noted at west side.

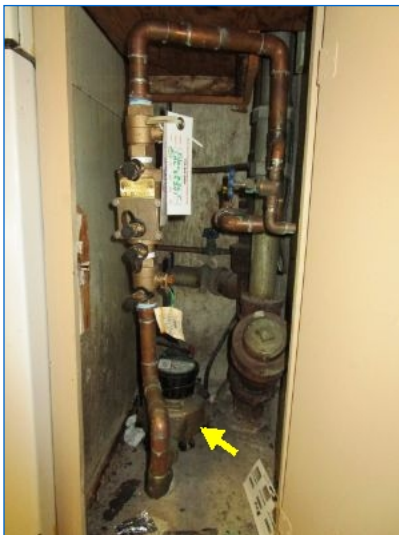
Public water service entrance located in Basement Cafeteria Pantry. Water Service Entrance: 3/4" Copper line with Meter and shutoff valve/s.

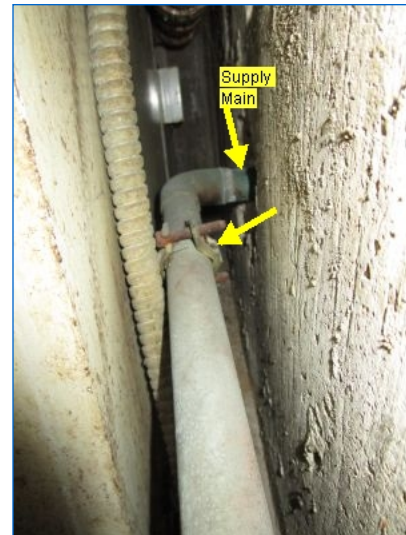
Although the water supply pipe appeared to be included as part of the bonding system, no jumper was installed across the water meter. The meter may interrupt the electrical continuity of the pipes. The Inspector recommends a jumper be installed and verification of a continuous ground by a qualified electrical contractor.

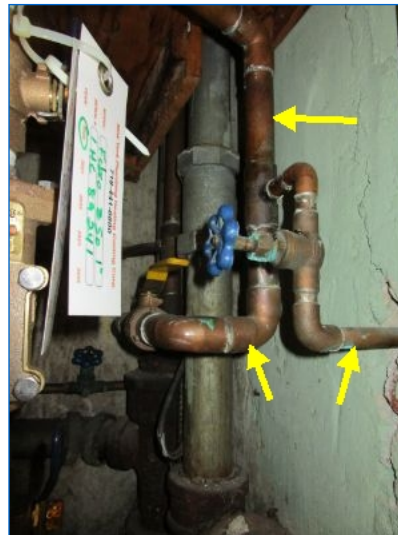
Water supply pipe observed included: Copper.

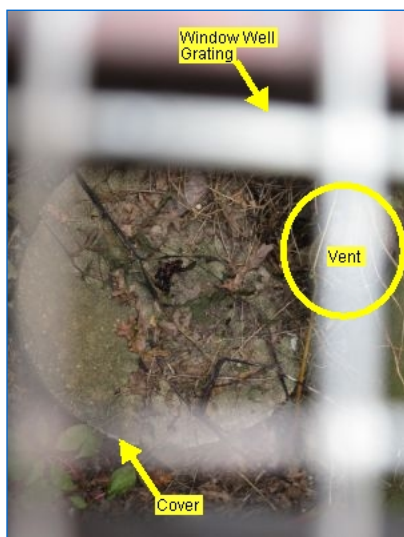
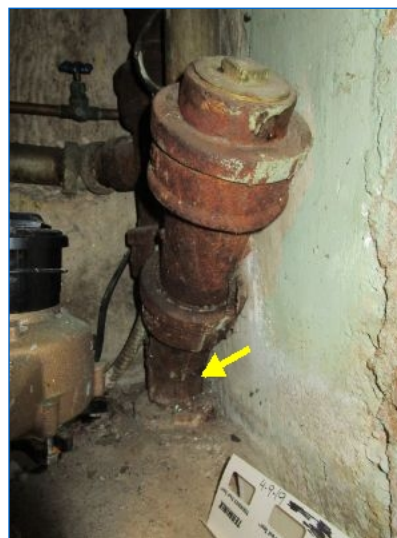
Waste Pipe Exit located in the window well at the Southwest corner of the building typically includes whole-house trap w/vent and clean-out fitting. Whole-house trap and clean-out located below floor of window well and covered.

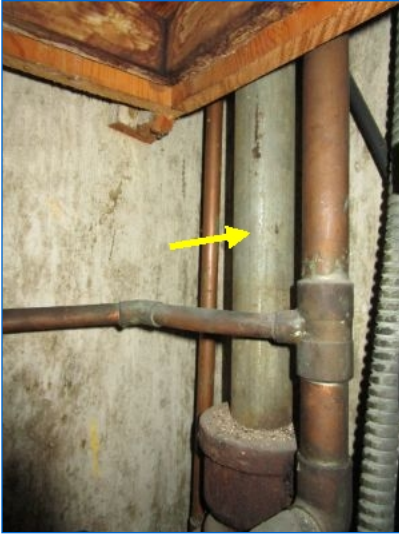
Waste pipe materials observed included some original galvanized pipes. The extent of the galvanized waste pipes in the home is unknown due to concealment by finishing systems. See related comments.

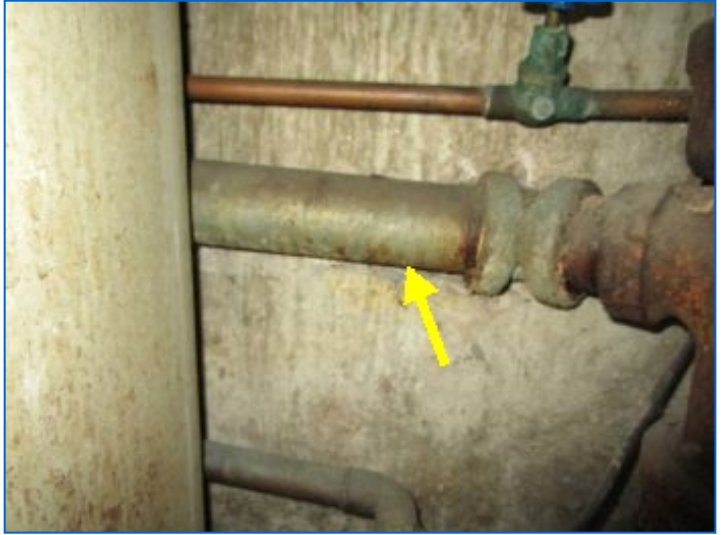
Waste pipe materials observed included some original galvanized pipes. The extent of the galvanized waste pipes in the home is unknown due to concealment by finishing systems. See related comments.

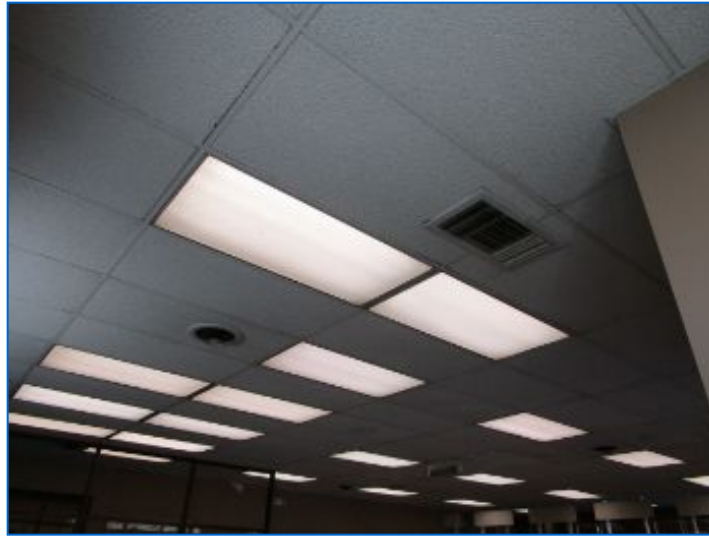
Acoustical tile w/grid ceilings noted.

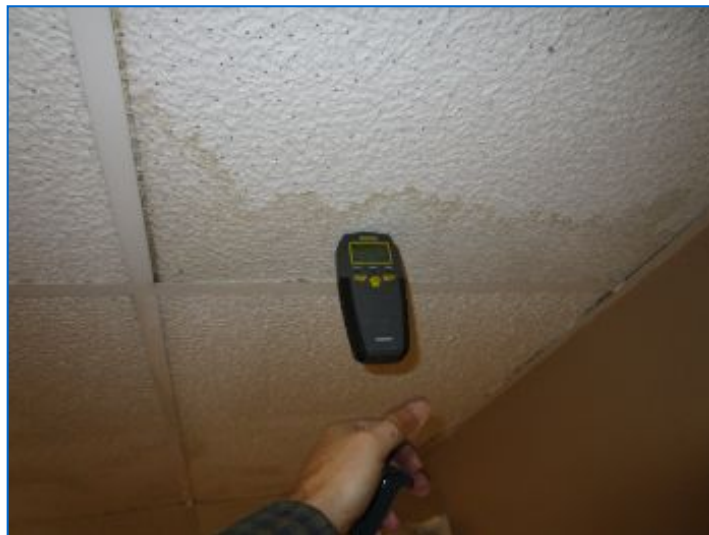
Moisture stains noted from roof leak and past condensation. General stains tested dry at the time of the inspection. Suggest refreshing or updating the hung ceiling.

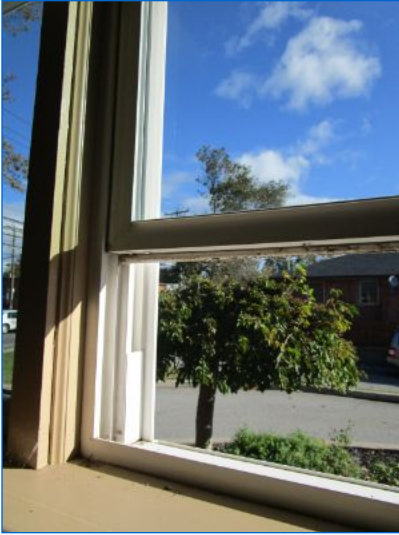
All screens were missing or not installed at the time of inspection. Confer with Seller.

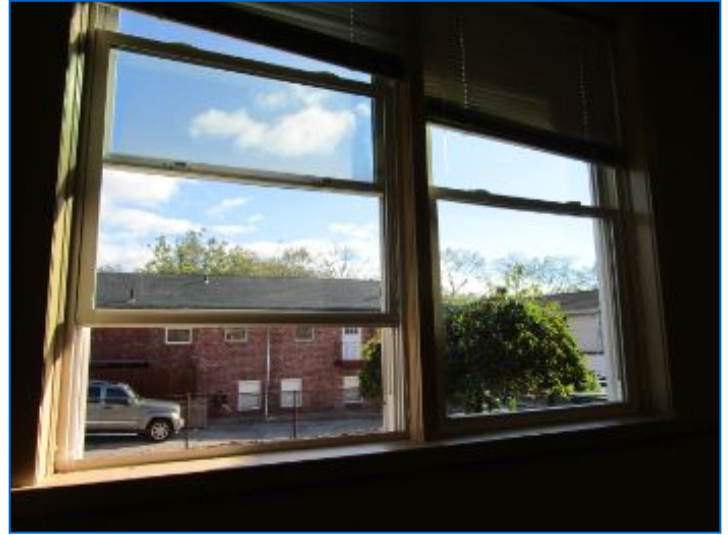
All screens were missing or not installed at the time of inspection. Confer with Seller.

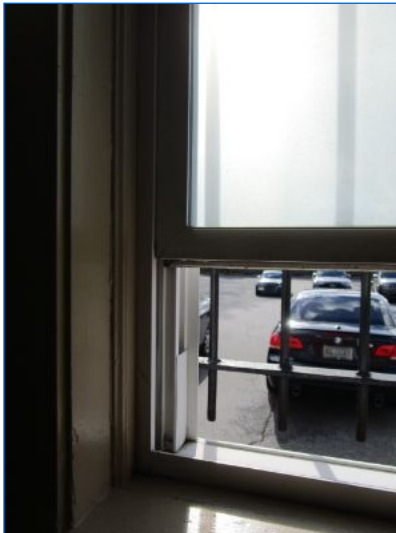
All screens were missing or not installed at the time of inspection. Confer with Seller.

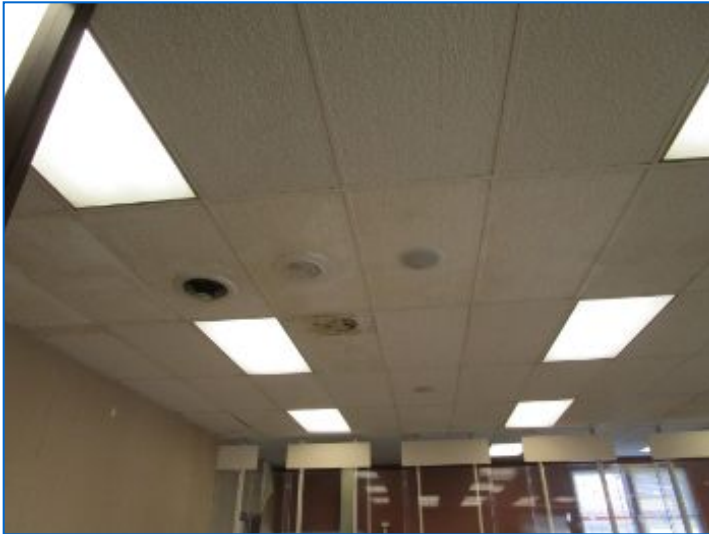
Ceiling: 2'x4' Acoustical tile w/grid and recessed light fixtures noted.

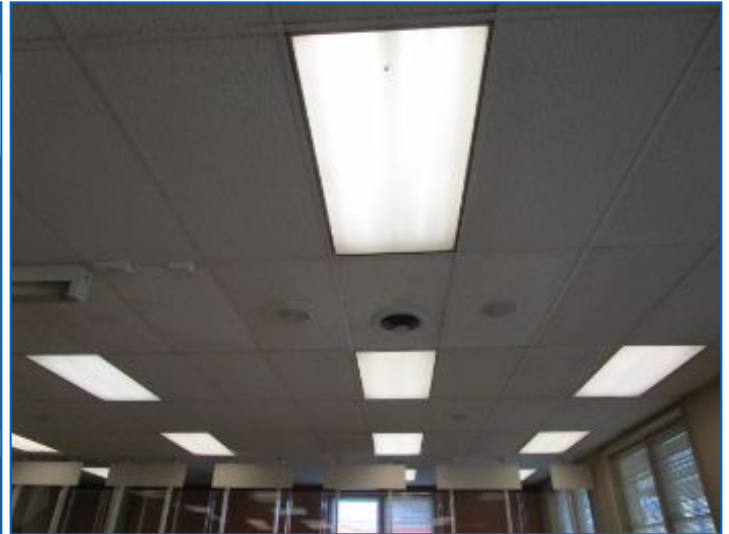
Ceiling: 2'x4' Acoustical tile w/grid and recessed light fixtures noted.

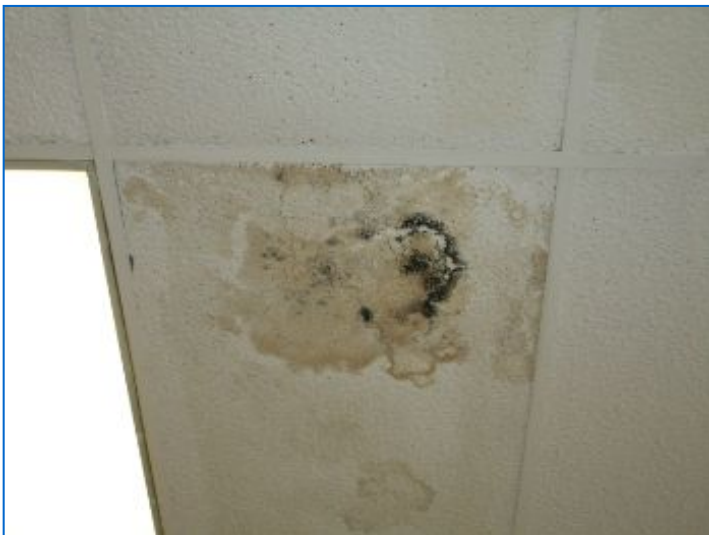
Signs of a roof leak.

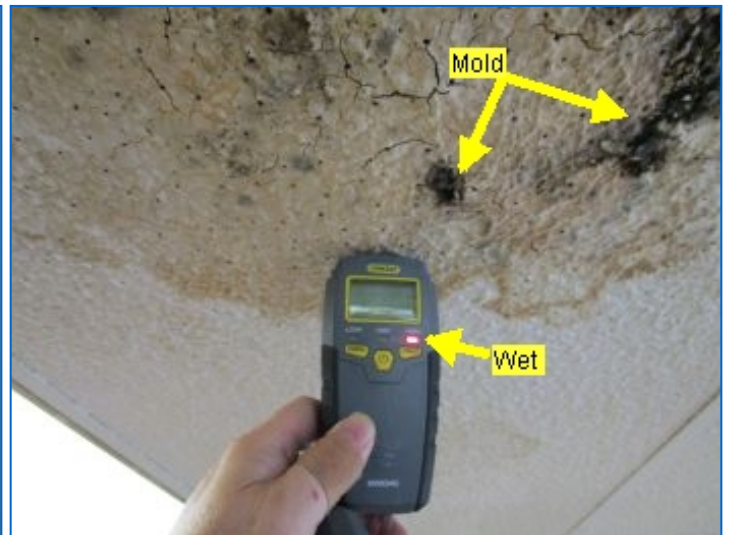
Signs of a roof leak. Moisture detected with signs of mold observed at two ceiling tiles at noted roof leak.

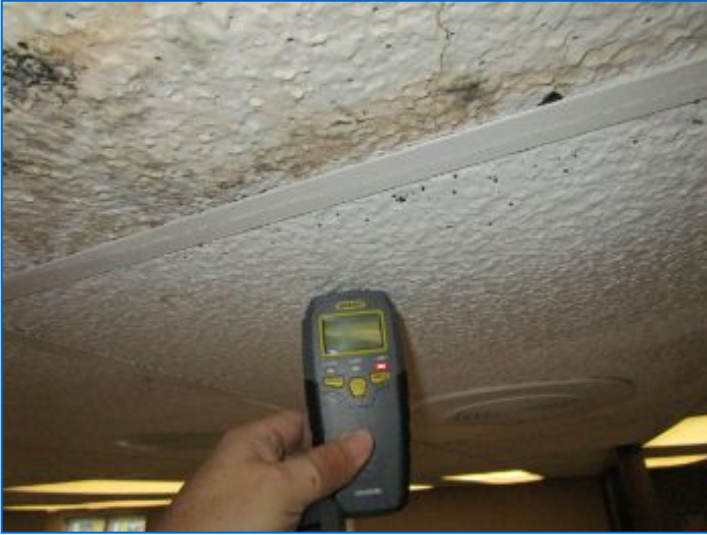
Signs of a roof leak. Moisture detected with signs of mold observed at two ceiling tiles at noted roof leak.

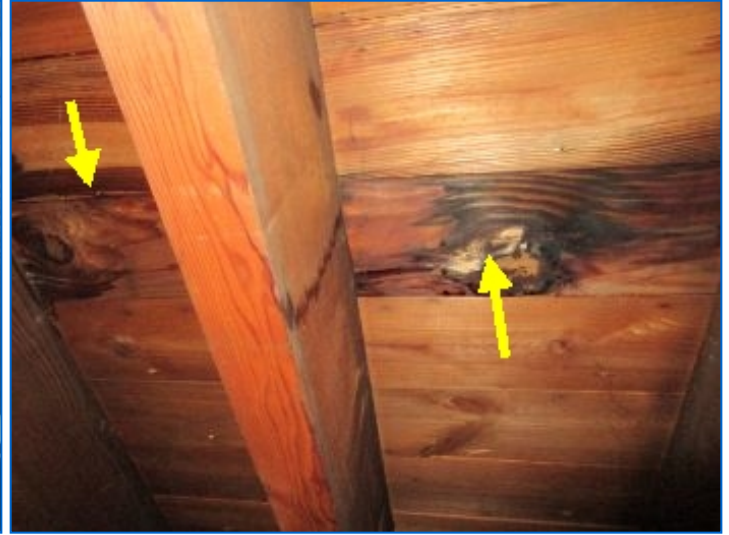
Signs of a roof leak noted above area of wet ceiling tile.

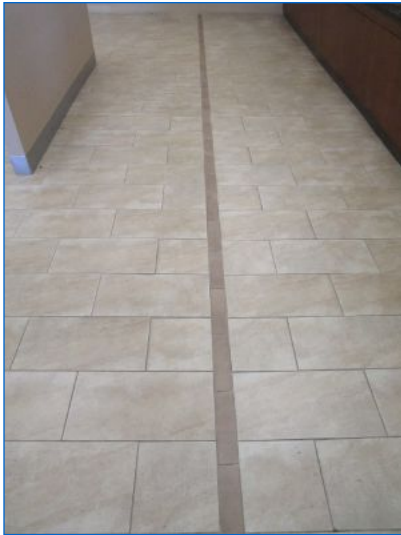
Porcelain tile floor noted.
