ProSpec Home Inspection of Long Island Property Inspection Report

Inspector: Russell J. Classi, P.E.
Phone: (516) 480-1848
Email: prospecofli@gmail.com
www.nassaprofessionalhomeinspector.com

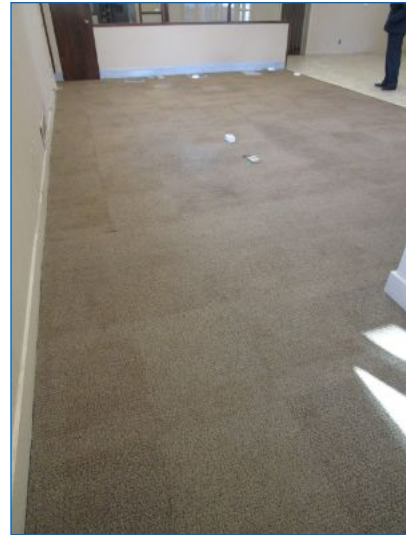
Carpeted floor noted. Floor area had a framed/raised floor system with floor recessed and surface mounted electrical/telecom receptacles installed.

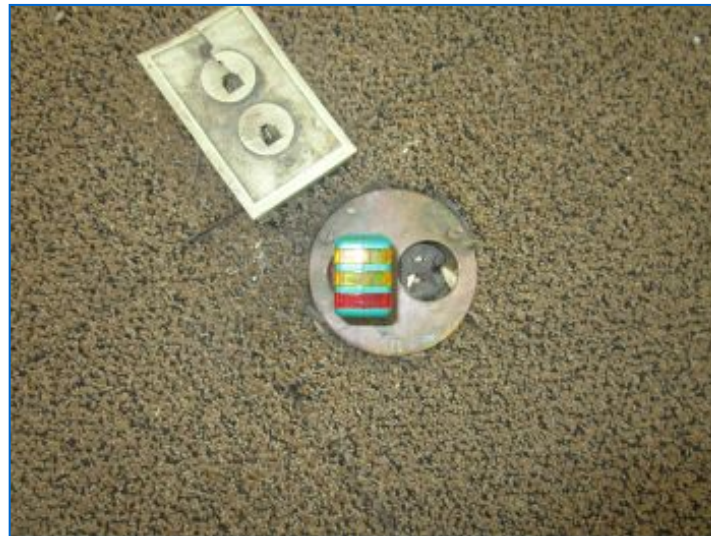
Floor area had a framed/raised floor system with floor recessed and surface mounted electrical/telecom receptacles installed.

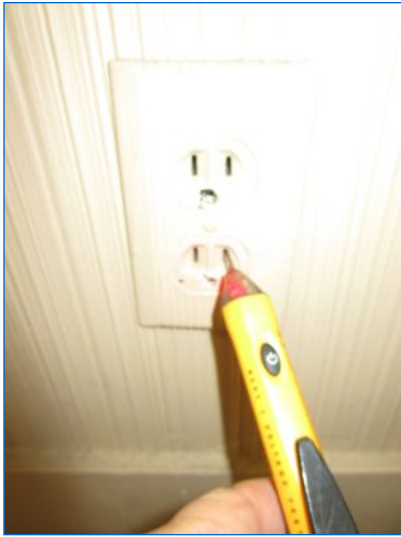
Receptacles were painted over; Active. Recommend replacements by a licensed electrician.

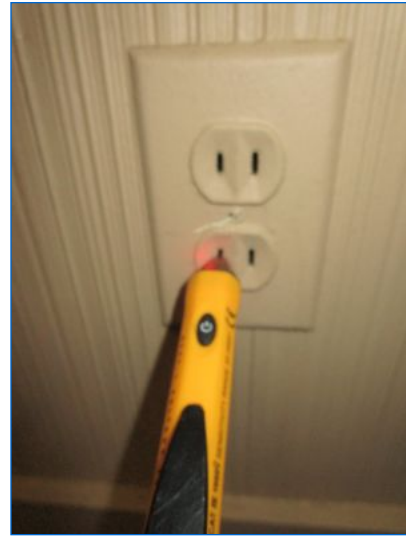
Several receptacles are the outdated, ungrounded 2-prong electrical outlets. Recommend having an electrician update these to meet generally-accepted current standards (grounded 3-prong outlets).

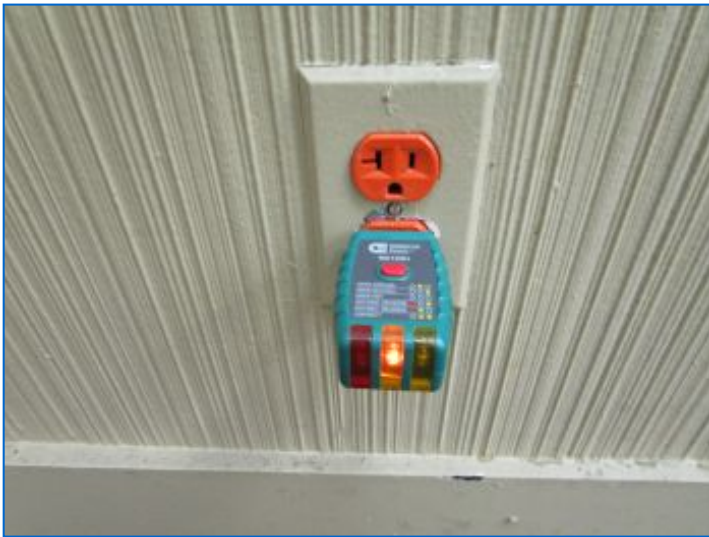
Orange receptacles generally indicate the circuit is backed up by emergency power. Open Ground receptacle noted.

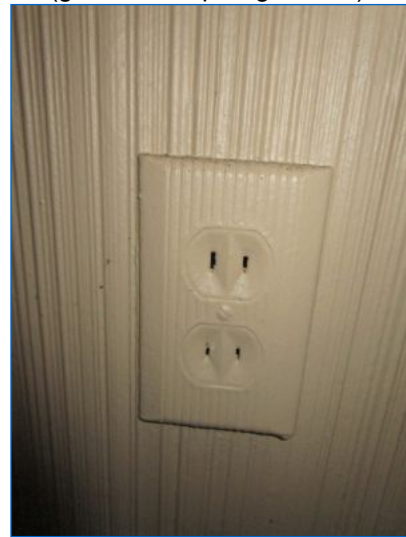
ATM room: Receptacle outdated, ungrounded 2-prong electrical outlets. Recommend having an electrician update these to meet generally-accepted current standards (grounded 3-prong outlets).

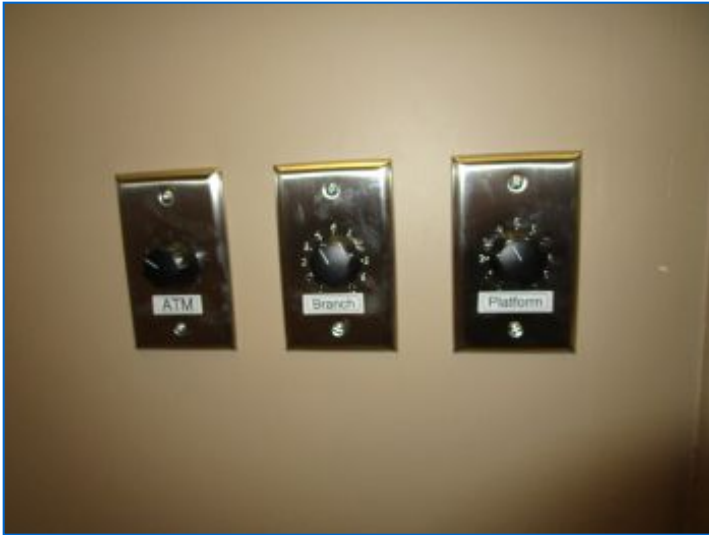
ATM room: Unknown switches noted.

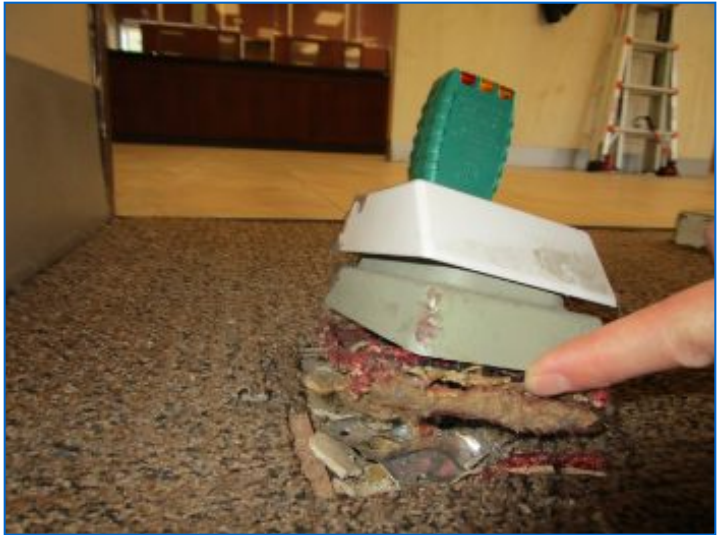
Loosely installed active receptacle noted at floor.
Recommend repair by a licensed qualified electrician.

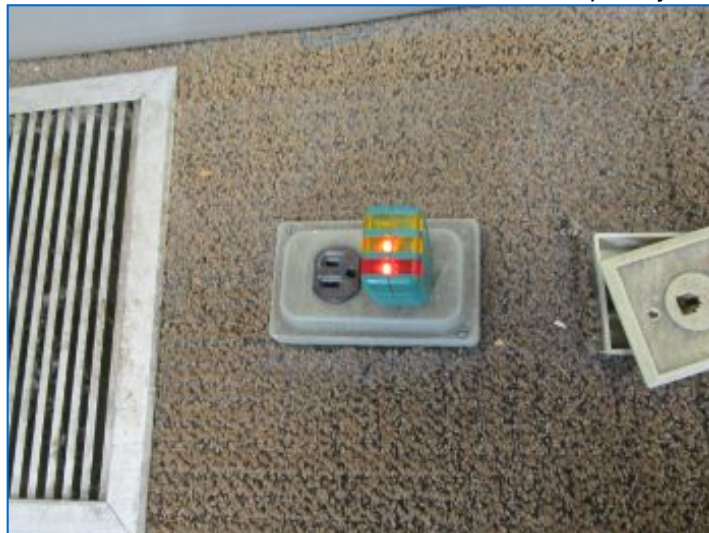
Reverse Polarity receptacle noted.

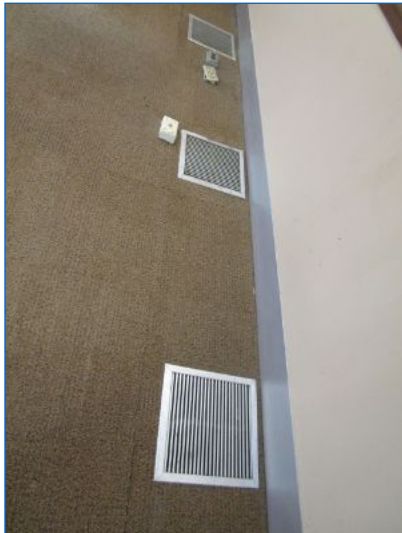
Floor return grilles noted.

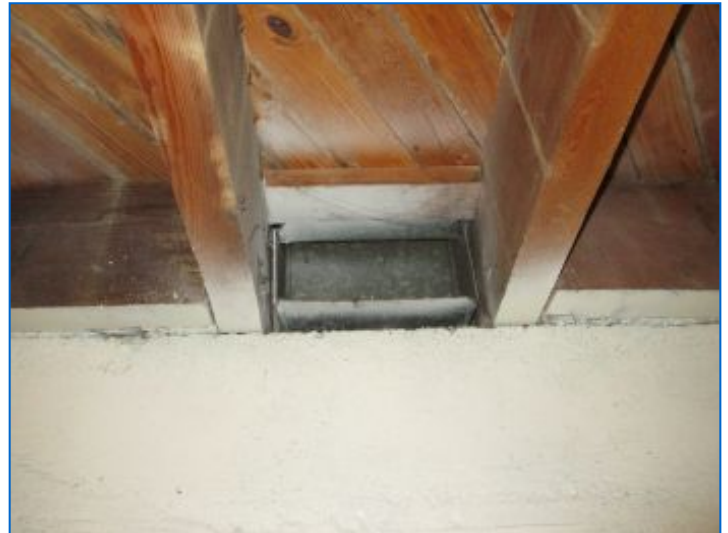
HVAC supply registers at east exterior wall not connected to an HVAC system; open-ended at basement ceiling (typical of 4).

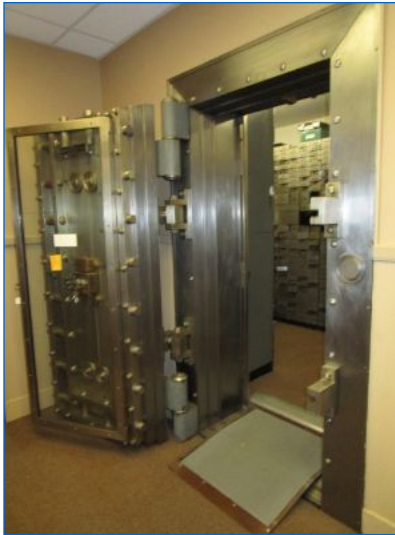
Bank Vault Door: Depending on the grade a vault door can weigh several thousand pounds and can be very difficult to remove. Recommend consulting with a specialist prior to planning for removal.

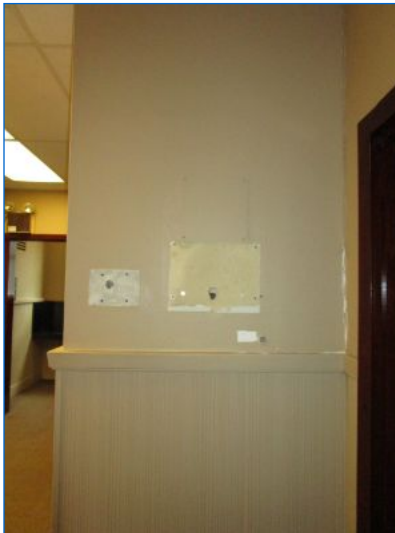
Hallway area: Cosmetic updates and repairs needed throughout.

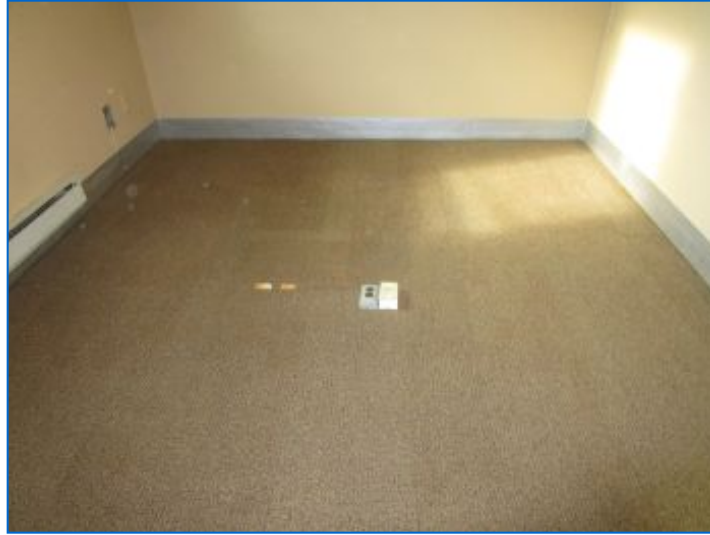
Bank Admin: Carpeted floor noted.

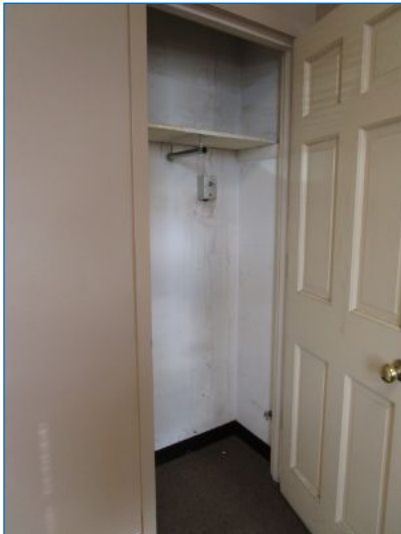
- Bank Admin: Stains were present on the closet walls likely from past condensation. Although they tested dry at time of inspection, they should be noted.

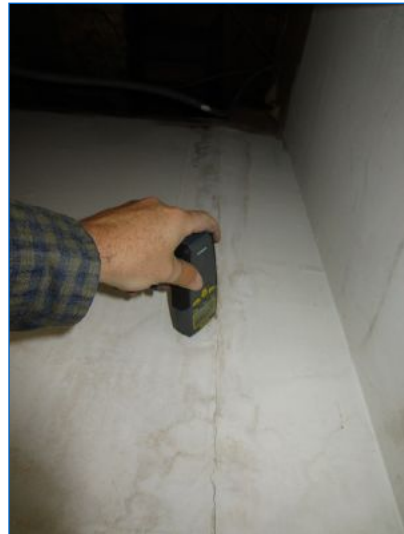
Bank Admin: Stains were present on the closet walls likely from past condensation. Although they tested dry at time of inspection, they should be noted.

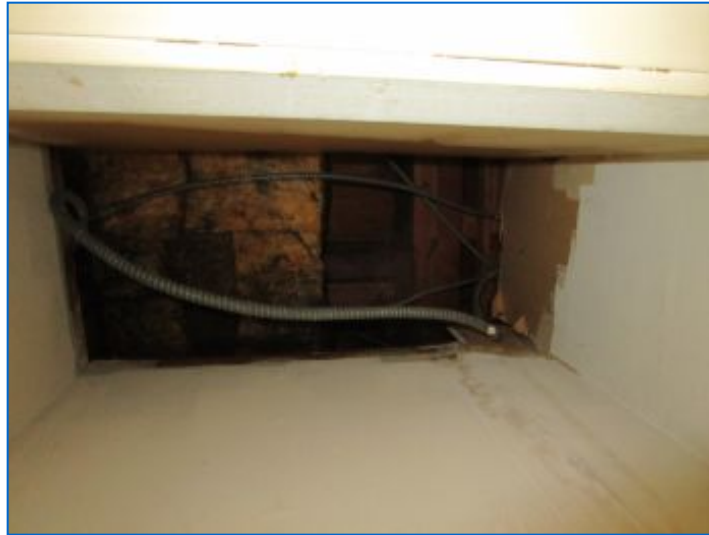
Bank Admin: Closet ceiling was open to attic.

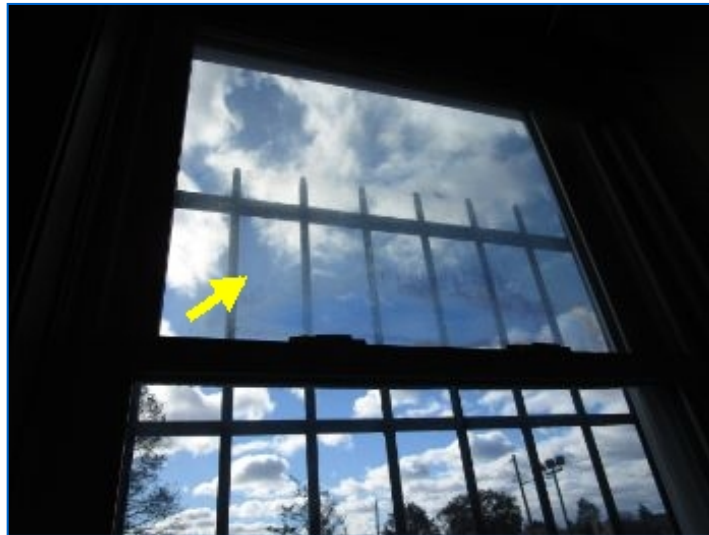
South Viewing Room: Although no condensation was visible at the time of the inspection, staining of the glass at a window indicated a loss of thermal integrity. In some situations repair is possible, but if irreparable damage has occurred, the window sash will need to be replaced.

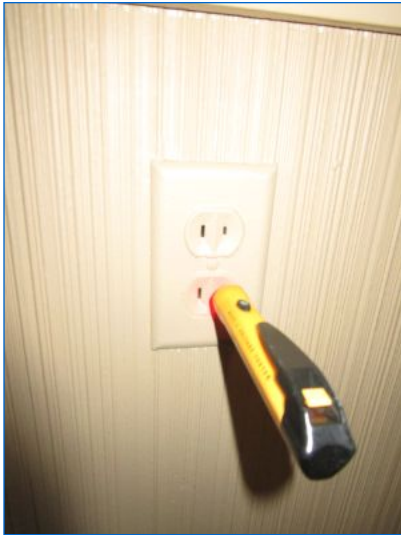
East Viewing Room: Receptacle was an outdated, ungrounded 2-prong electrical outlet. Consider having an electrician update these to meet generally-accepted current standards (grounded 3-prong outlets).

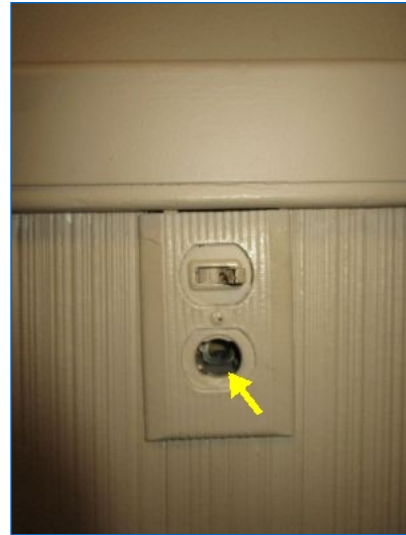
Defective switch plate; electric shock hazard. Recommend correction by a qualified electrician.

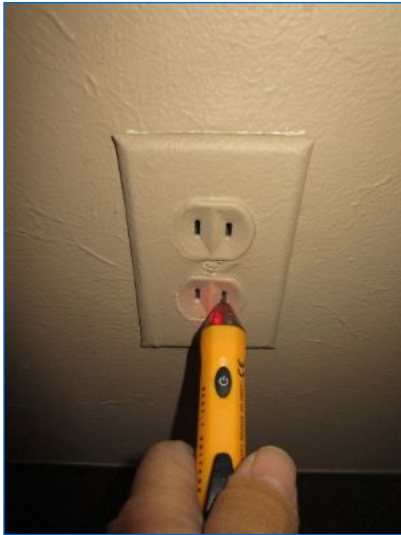
Bank Admin: (1) receptacle was the outdated, ungrounded 2-prong electrical type. Recommend having an electrician update these to meet generally-accepted current standards (grounded 3-prong outlets).

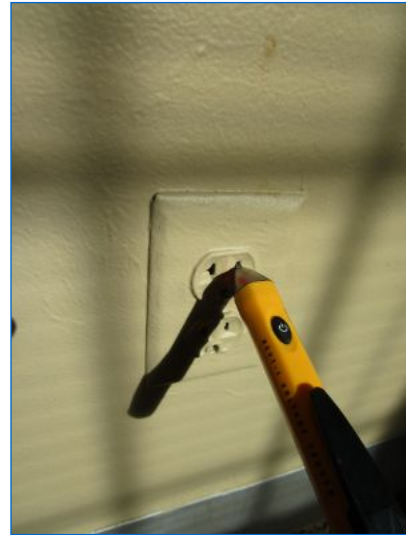
Bank Admin: Random Outlet Test - No Power at a receptacle at time of inspection. Suggest seller locate or restore source of power prior to close.

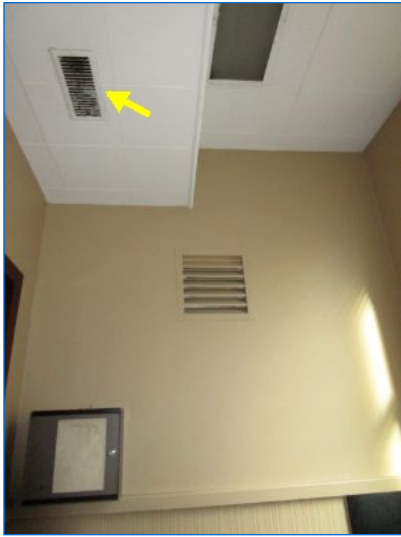
East Viewing Room HVAC supply noted.

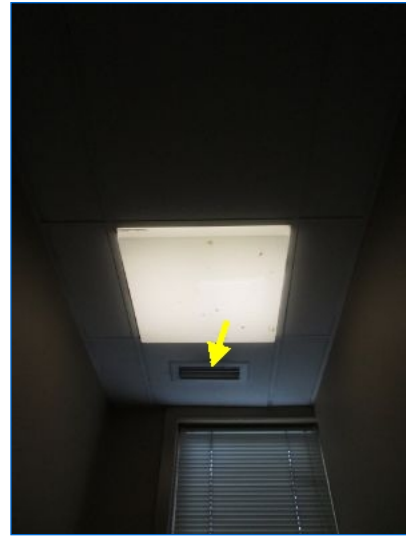
South Viewing Room: HVAC supply noted.

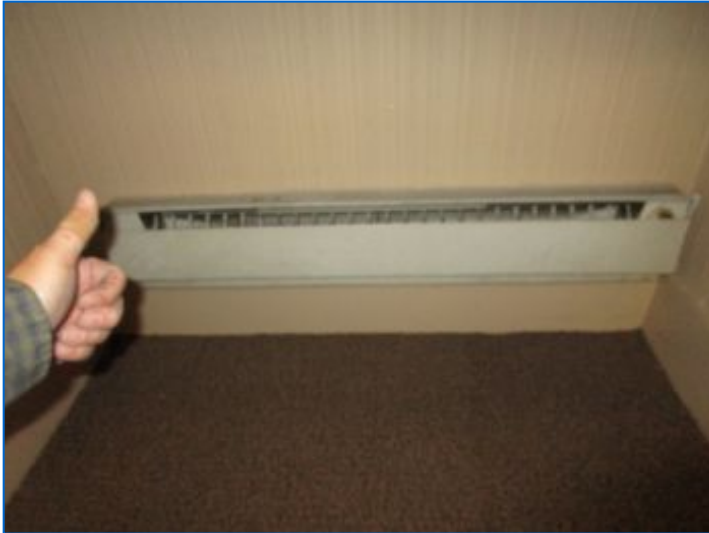
South Viewing Room: Heat distribution types included Electric Baseboard (operable).

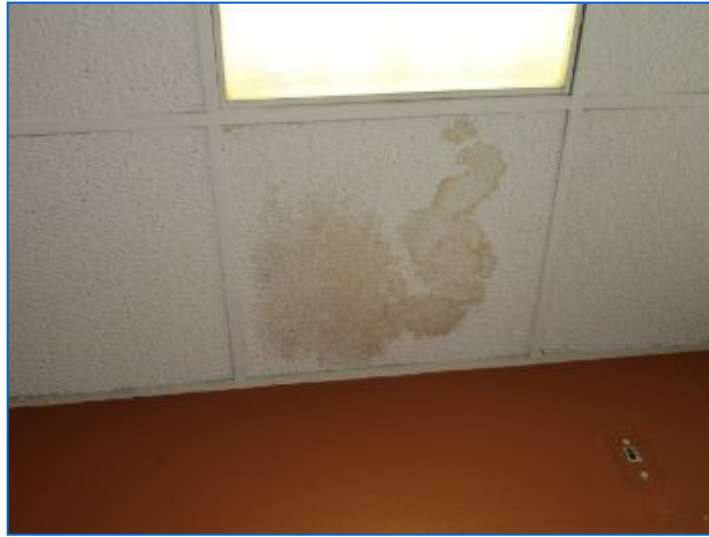
Tellers: Moisture stain noted at ceiling likely caused by a past roof leak. This area appeared dry at the time of the inspection. Suggest monitoring.

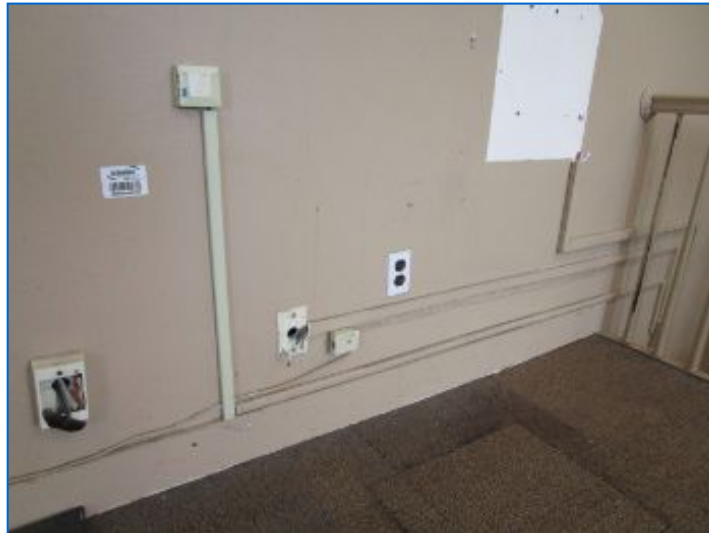
Teller Admin: Surface mounted telecom wires and jacks noted.

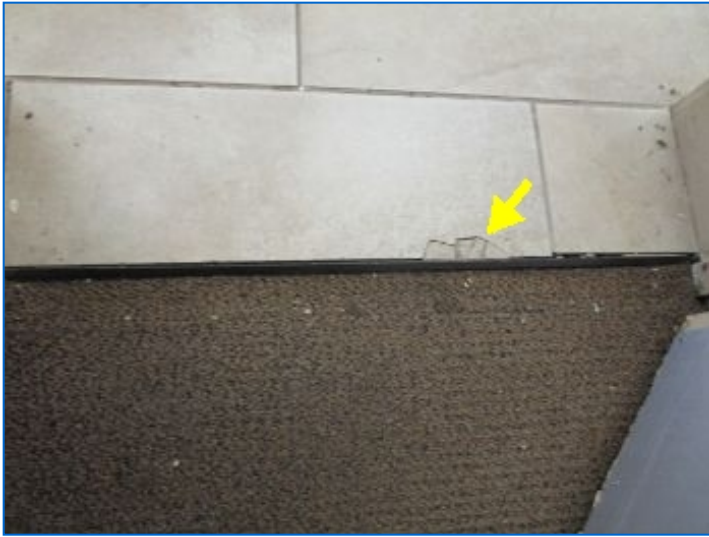
Hall/Stairway Area: Cracked tile noted at threshold.

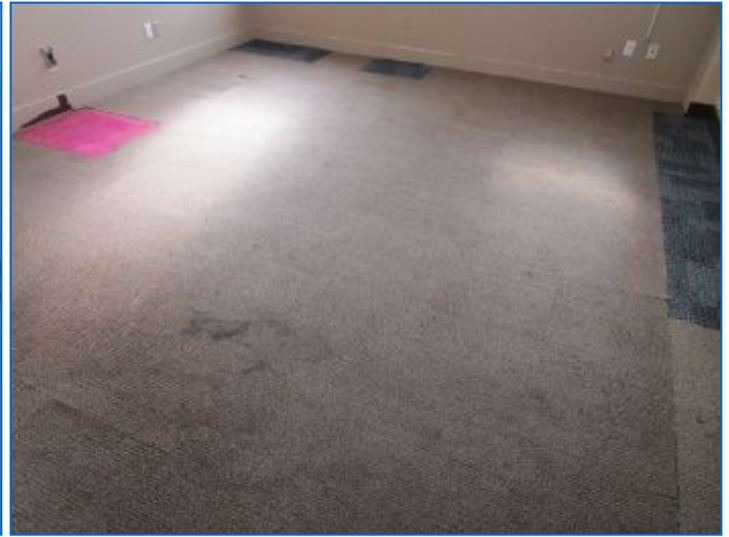
Carpeted floor noted.

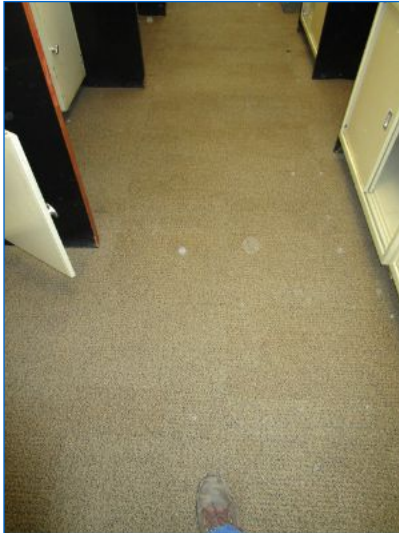
Tellers: Carpeted floor noted.

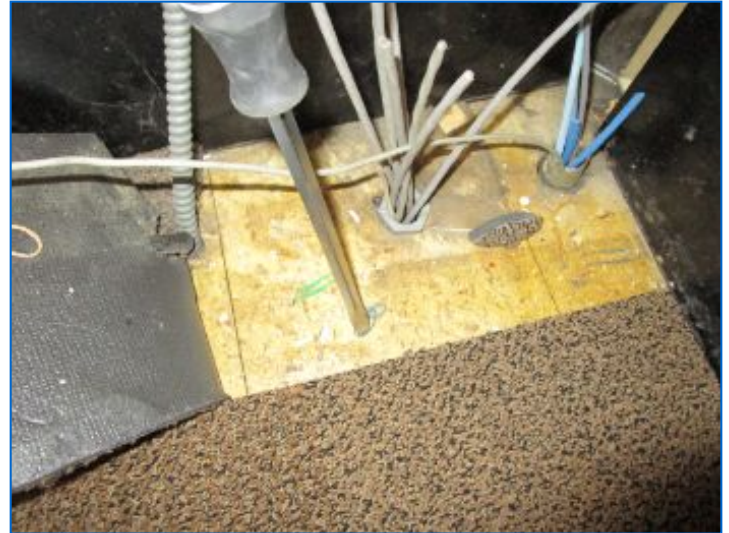
Tellers: Floor area had a framed/raised floor system with floor recessed and surface mounted electrical/telecom receptacles installed.

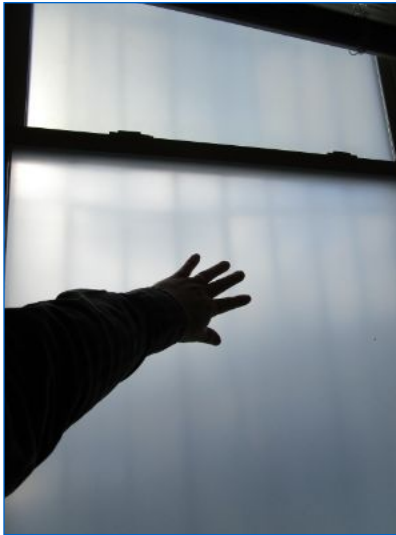
Teller Admin: Frosted windows with burglar bars noted.

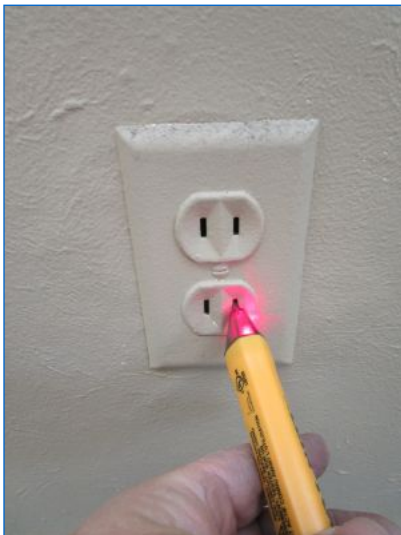
Teller Admin: (2) receptacles were the outdated, ungrounded 2-prong electrical type. Recommend having an electrician update these to meet generally-accepted current standards (grounded 3-prong outlets).

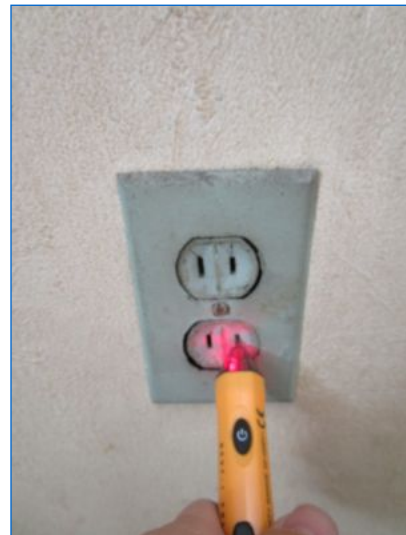
Teller Admin: (2) receptacles were the outdated, ungrounded 2-prong electrical type. Recommend having an electrician update these to meet generally-accepted current standards (grounded 3-prong outlets).

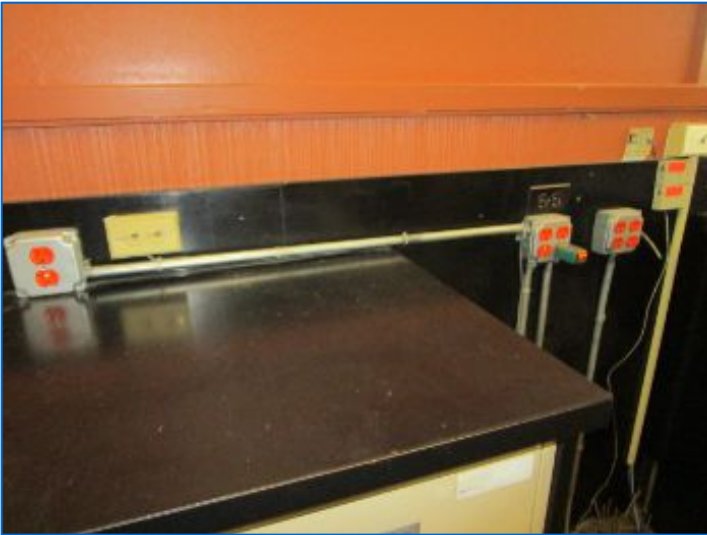
Tellers: Orange receptacles generally indicate the circuit is backed up by emergency power.

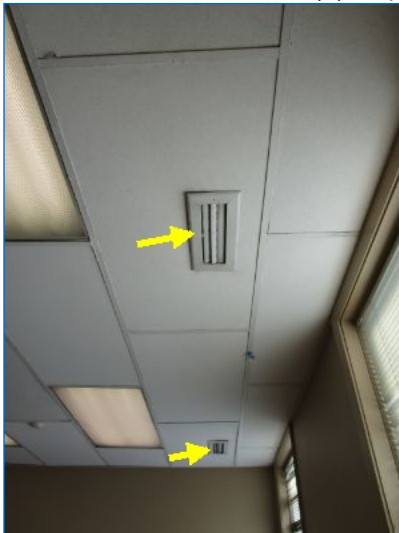
Teller Admin: HVAC supply registers noted.

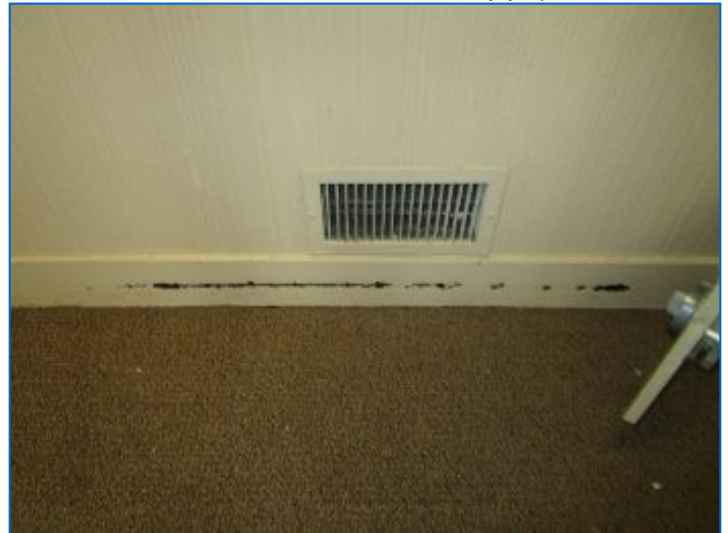
Tellers: HVAC supply registers at east exterior wall not connected to an HVAC system; open-ended at basement ceiling.

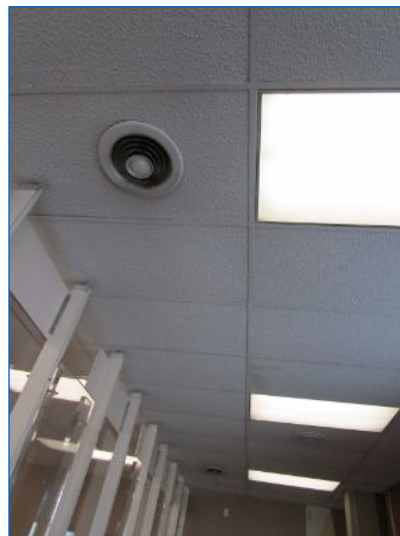
Tellers: HVAC supply registers noted.

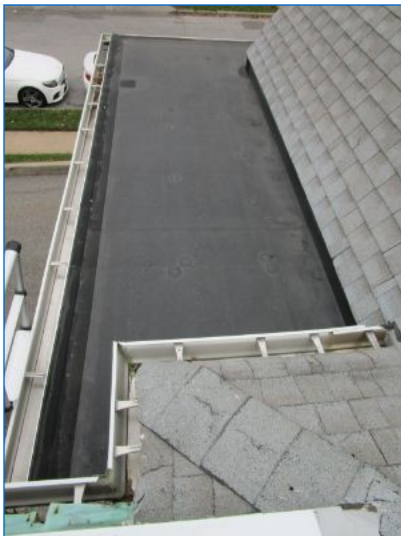
Roof covering consisted of a combination of Architectural asphalt shingles and Rubber membrane (flat roof).

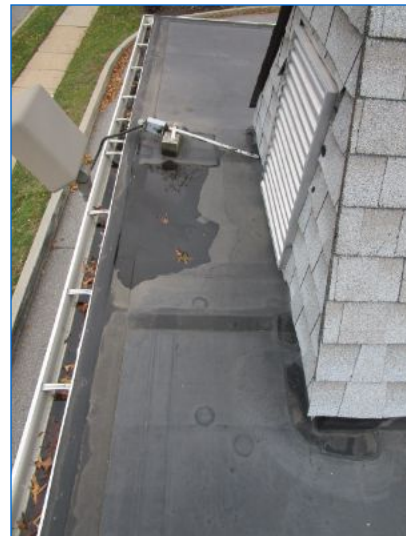
Canopy rubber membrane roof covering showed conditions consistent with 1 - 2 yr old materials.

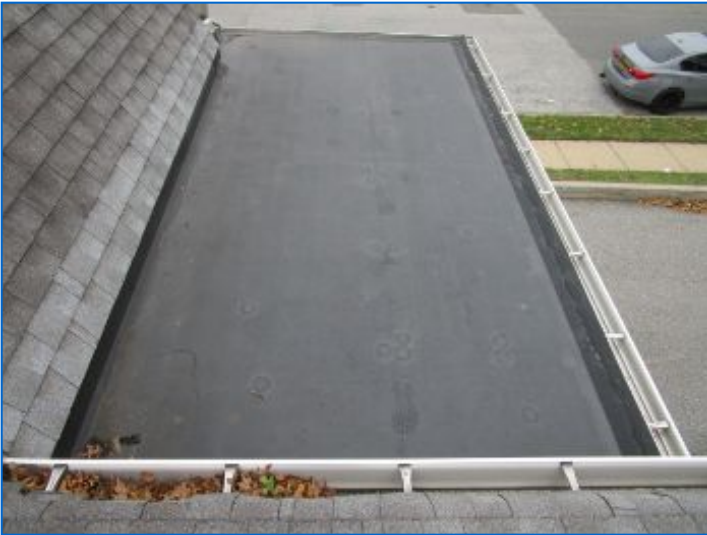
Canopy rubber membrane roof covering showed conditions consistent with 1 - 2 yr old materials.

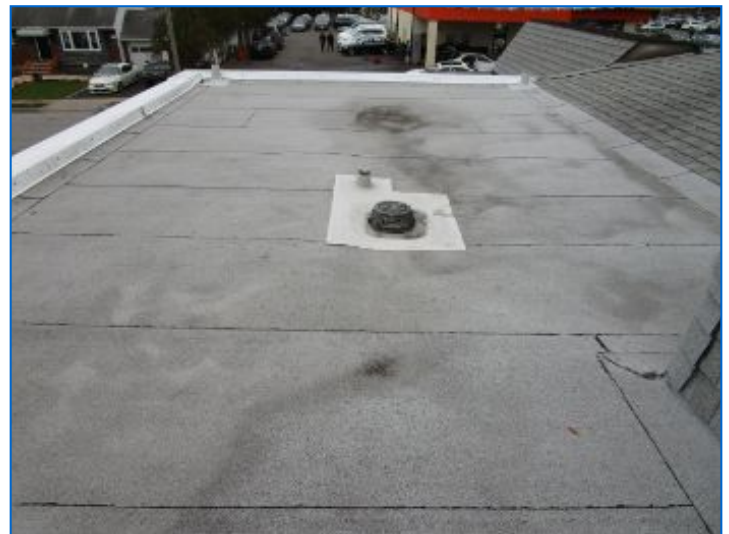
Asphalt roll roof covering showed conditions consistent with 15 yr old material.

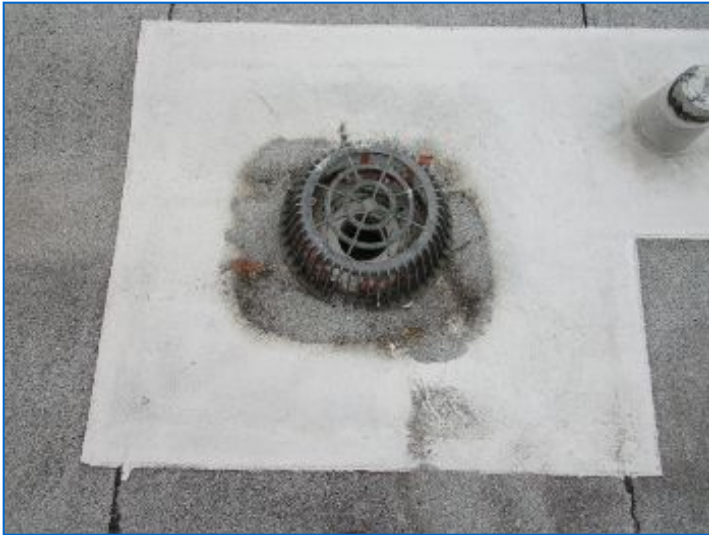
Roof drain appeared clear at flat roof.

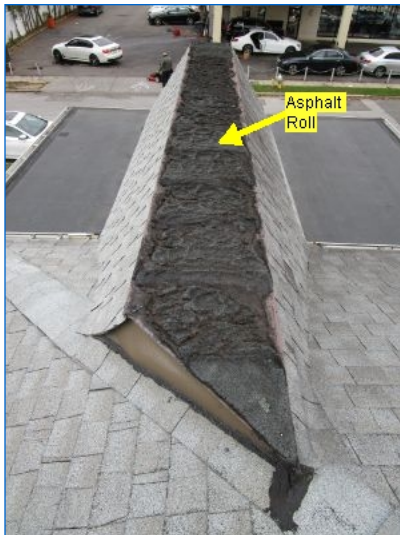
Roof over bank pneumatic tube conveyor consisted of architectural shingles, metal cap flashing and asphalt roll roofing. Asphalt roll roofing was deteriorated exposing the underlying cap flashing; conditions that potentially leak noted here.

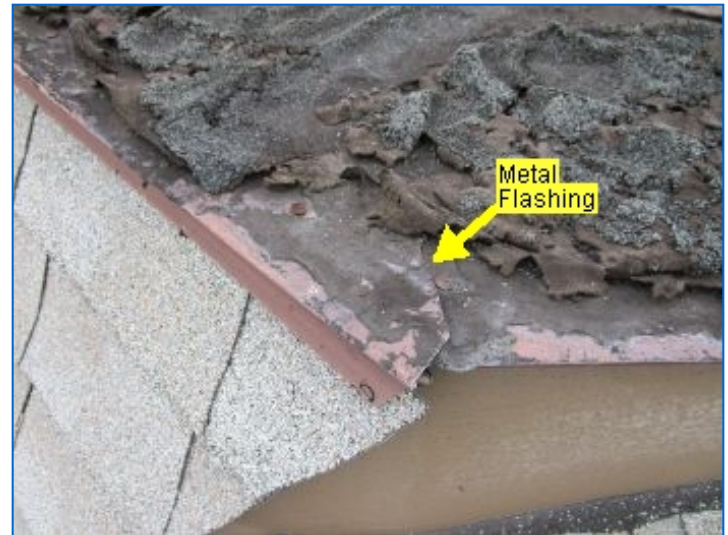
Roof over bank pneumatic tube conveyor consisted of architectural shingles, metal cap flashing and asphalt roll roofing. Asphalt roll roofing was deteriorated exposing the underlying cap flashing; conditions that potentially leak noted here.

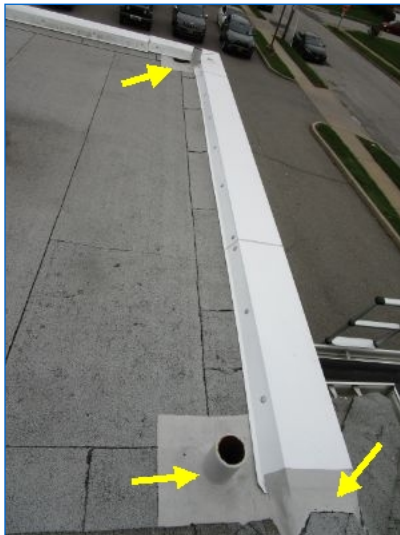
Recent roof repairs noted around roof penetration/flashings.

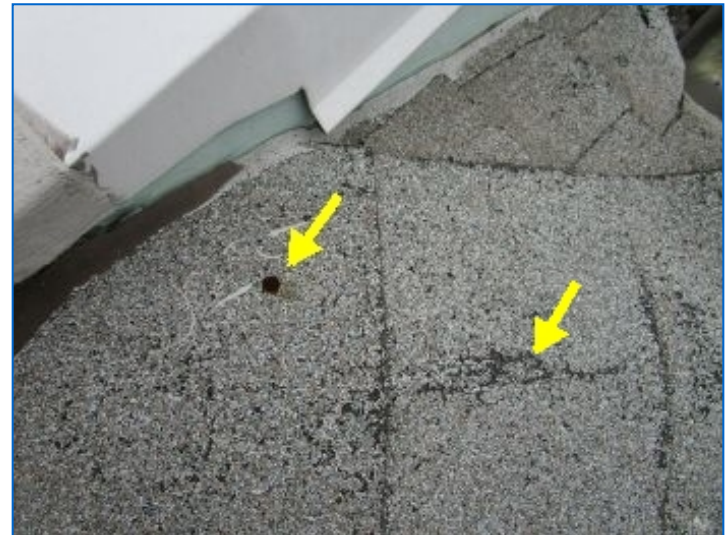
Some exposed nail heads noted on roofing material. Recommend sealing all fastener heads. Miscellaneous minor damage and cracked shingles noted. Suggest review and repairs by a qualified contractor.

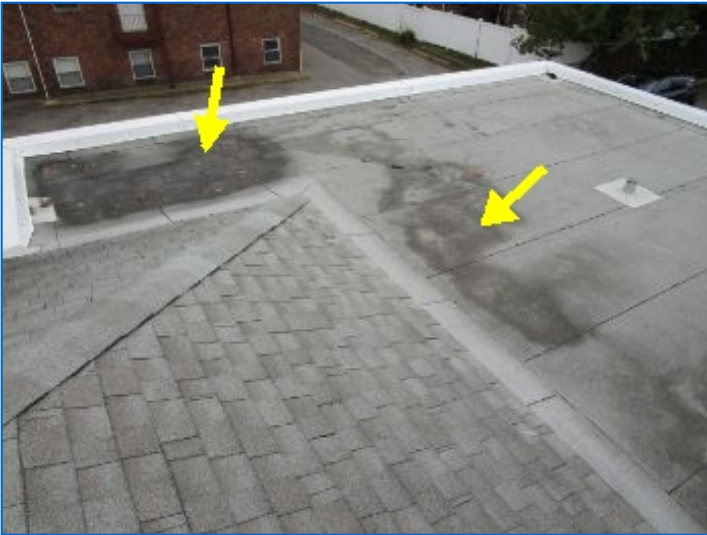
Signs of past ponding at front flat roof area. Maintain seal at seams to prevent roof leaks.

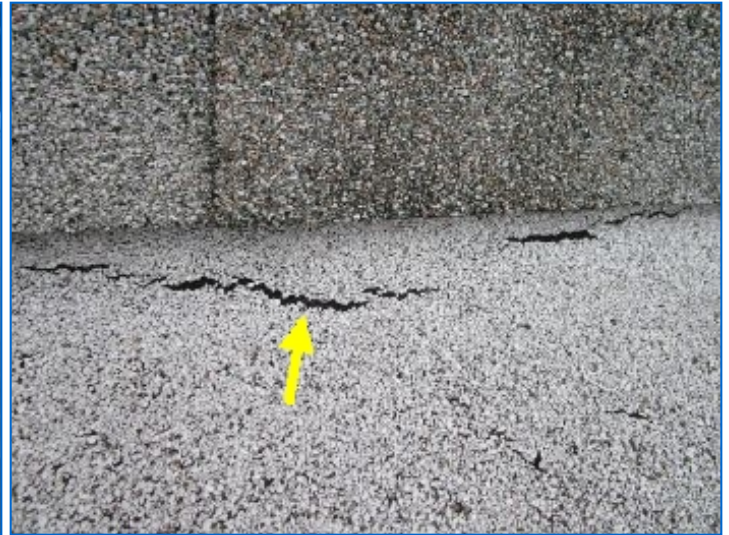
Conditions that can result in roof leaks noted.

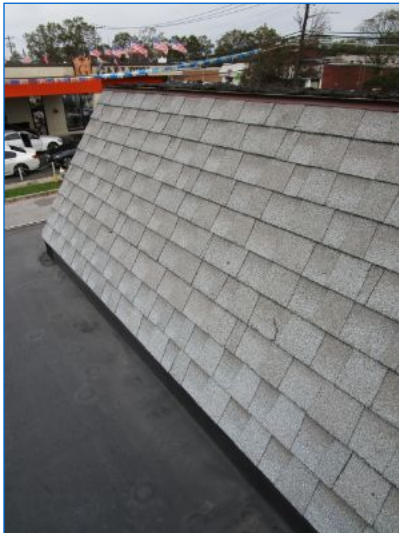
Roof over bank pneumatic tube conveyor consisted of architectural shingles, metal cap flashing and asphalt roll roofing.

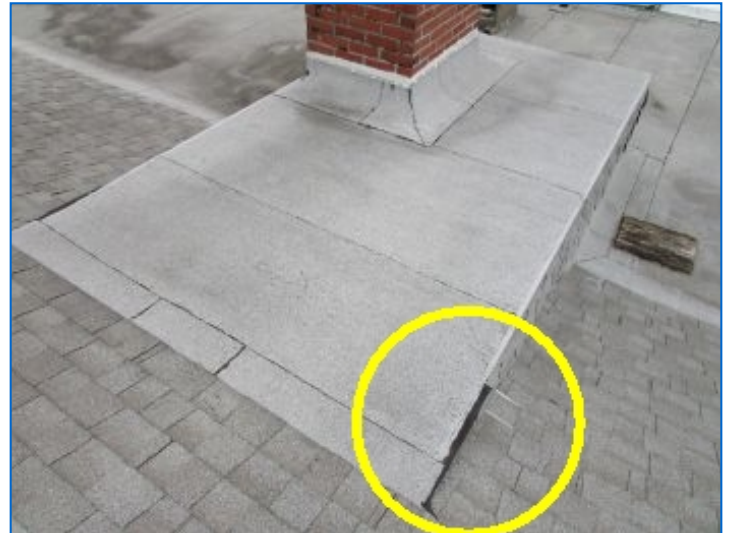
Vicinity of roof leak noted where moisture was observed inside building. Refer to related comments. Recommend evaluation and corrective repair by a qualified roofing contractor.

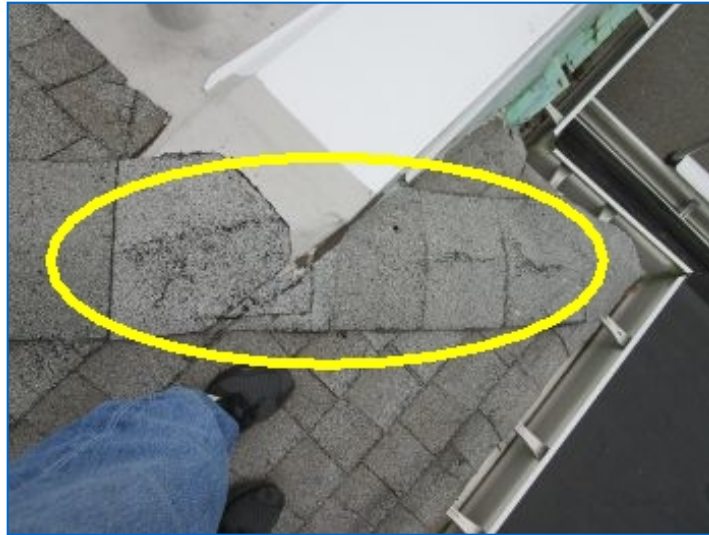
The asphalt composition cap shingles had moderate visible wear/damage which appeared to be made by workmen access/activity.

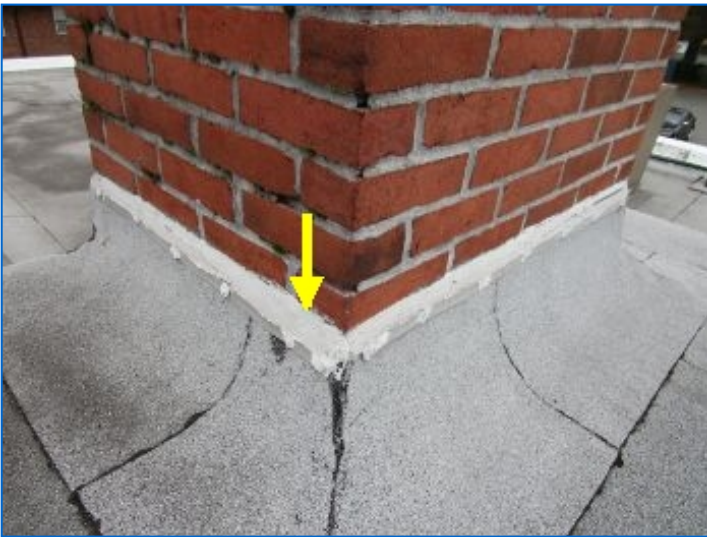
Flashing at base of chimney was mastic sealed/covered; Recommend periodic inspection and re-sealing this flashing as part of routine maintenance to ensure a continued waterproof seal.

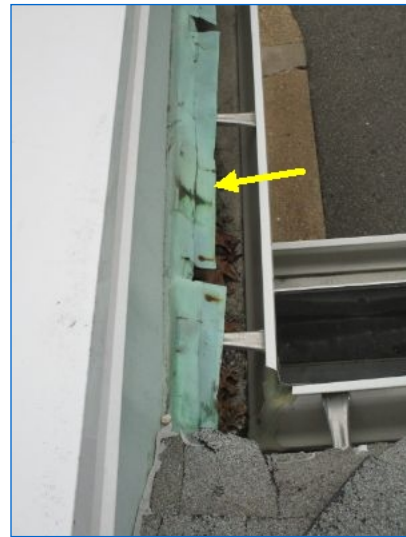
Original copper flashing noted at rear flat roof.

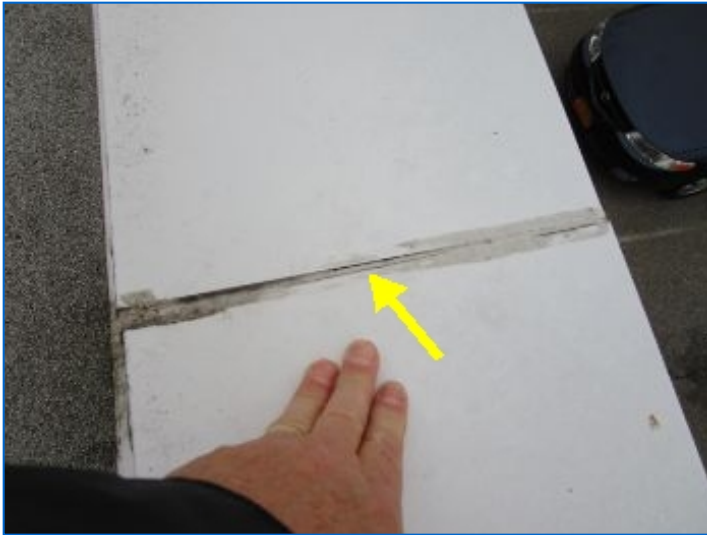
Typical maintenance necessary, now and on an annual or semi-annual basis. This generally consists of resealing gaps at through-the-roof projections and at the parapet wall coping as necessary.

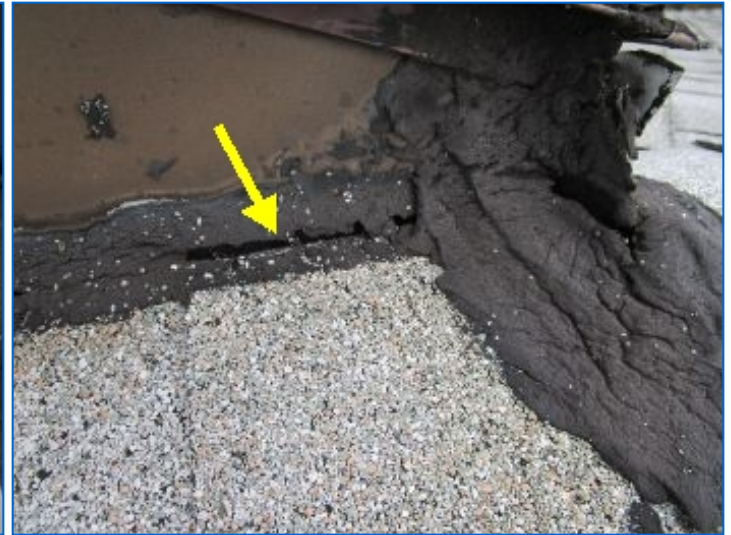
Conditions that can result in roof leaks noted. Flashing mastic maintenance recommended, now and on an annual or semi-annual basis. This generally consists of resealing gaps at through-the-roof projections as necessary.

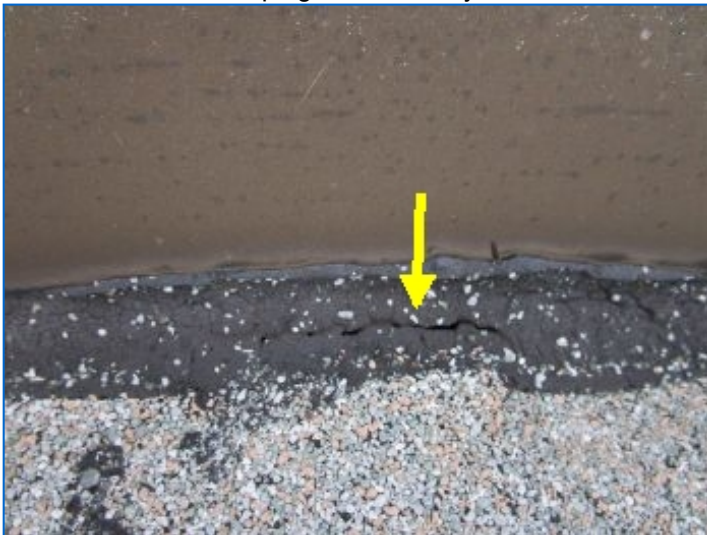
Conditions that can result in roof leaks noted. Flashing mastic maintenance recommended, now and on an annual or semi-annual basis. This generally consists of resealing gaps at through-the-roof projections as necessary.

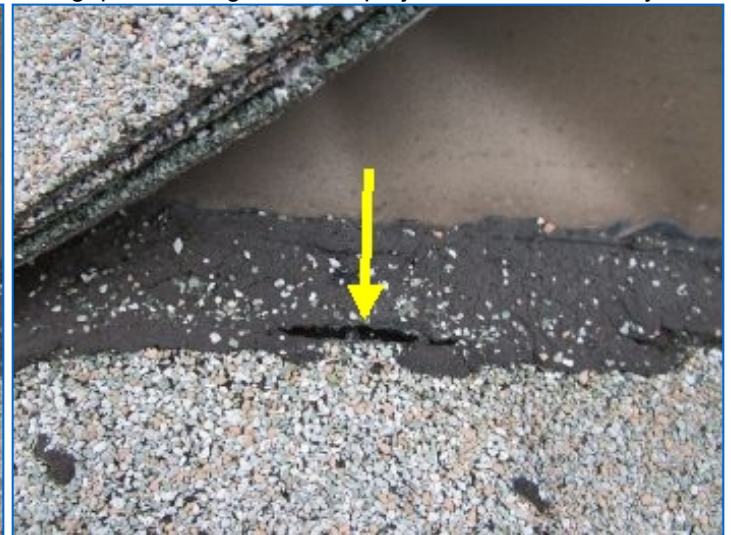
Conditions that can result in roof leaks noted. Flashing mastic maintenance recommended, now and on an annual or semi-annual basis. This generally consists of resealing gaps at through-the-roof projections as necessary.

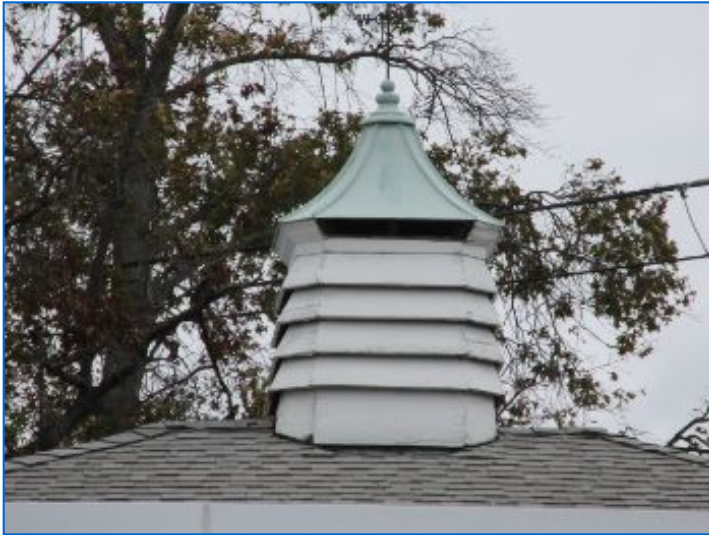
Cupola with copper cap noted; fixed roof exhaust vent for roof system ventilation.

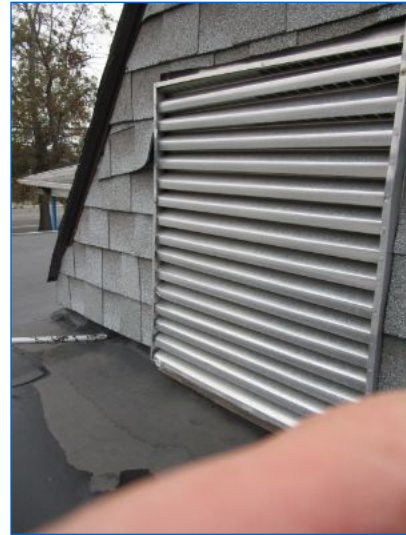
Gable-end louver vents noted for roof system ventilation.

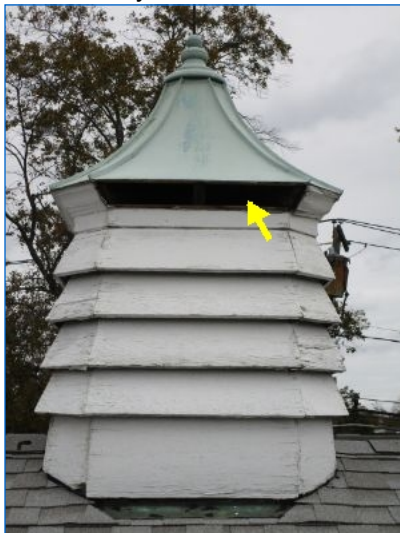
Cupola upper trim piece was missing; potential for wildlife nesting (none noted at time of inspection). Wood softening noted at some louvers of cupola; early signs of deterioration.

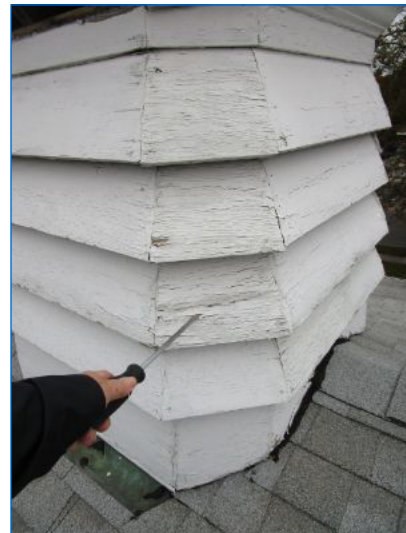
Cupola upper trim piece was missing; potential for wildlife nesting (none noted at time of inspection). Wood softening noted at some louvers of cupola; early signs of deterioration.

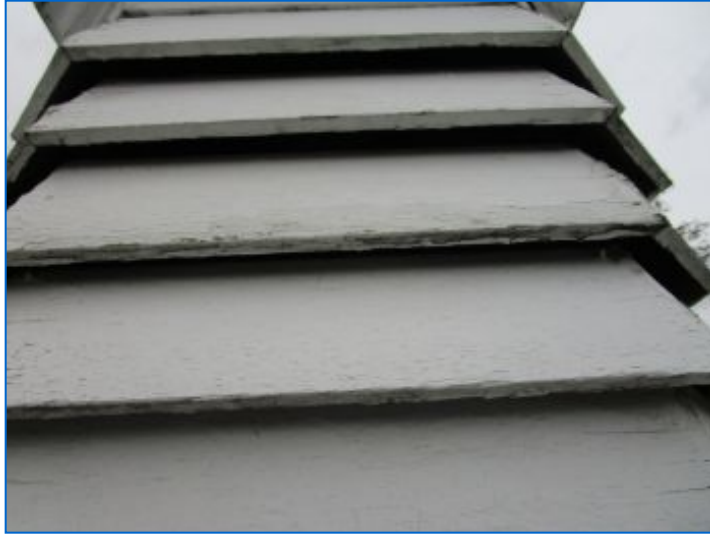
Apparent screen behind louvers.

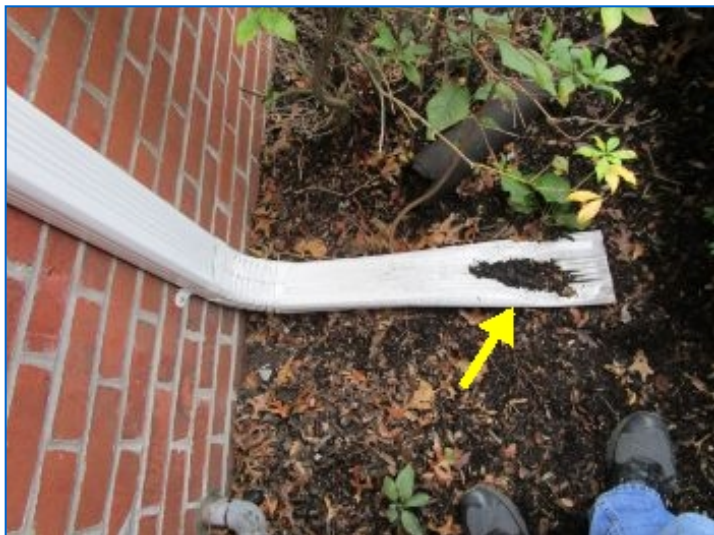
Crushed downspout extension noted at east side. Recommend extending downspouts 4 ft minimum where possible to divert run-off away from the structure to prevent water seepage through the foundation.

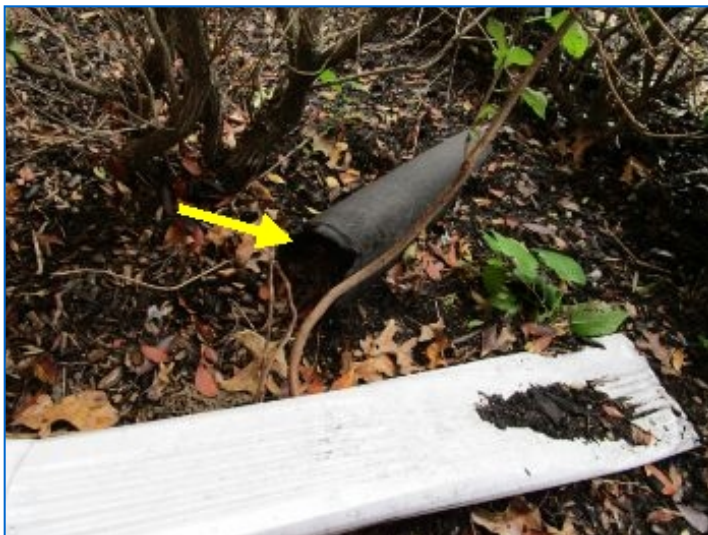
Former downspout connection apparently to underground drywall was not in use; perhaps clogged.

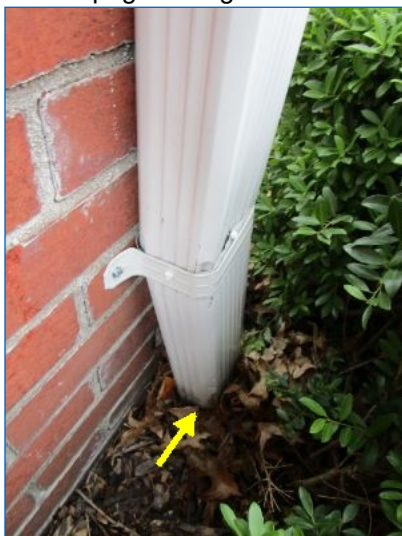
Downspout at East side drains to underground drainage system/drywell; Recommend lowering soil level to prevent dirt/debris from entering and clogging drainage system.

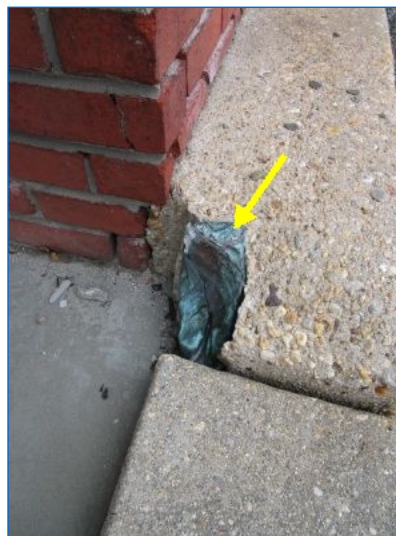
Original copper downspout connection to drywell at NW corner was terminated.

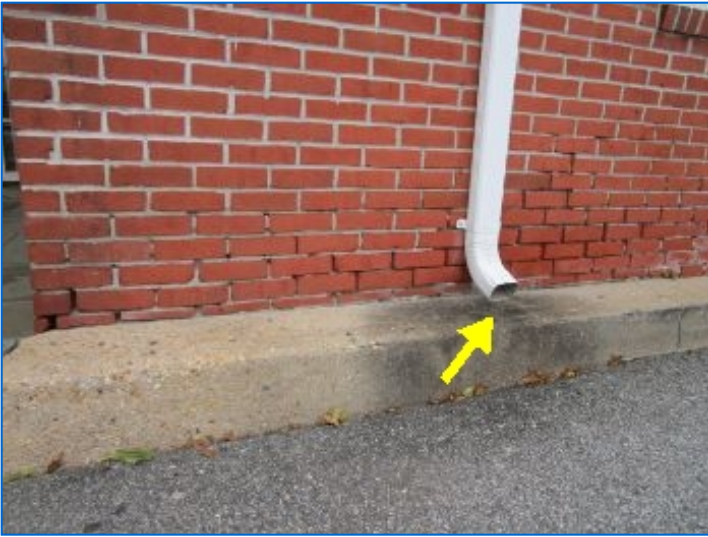
Downspouts at west side drain onto walkway/driveway. Recommend exploring ways to divert water away from this area, or at the very least, recognize this as a potential ice hazard; use ice melt products and exercise caution.
