ProSpec Home Inspection of Long Island Property Inspection Report

Inspector: Russell J. Classi, P.E.
Phone: (516) 480-1848
Email: prospecofli@gmail.com
www.nassaprofessionalhomeinspector.com

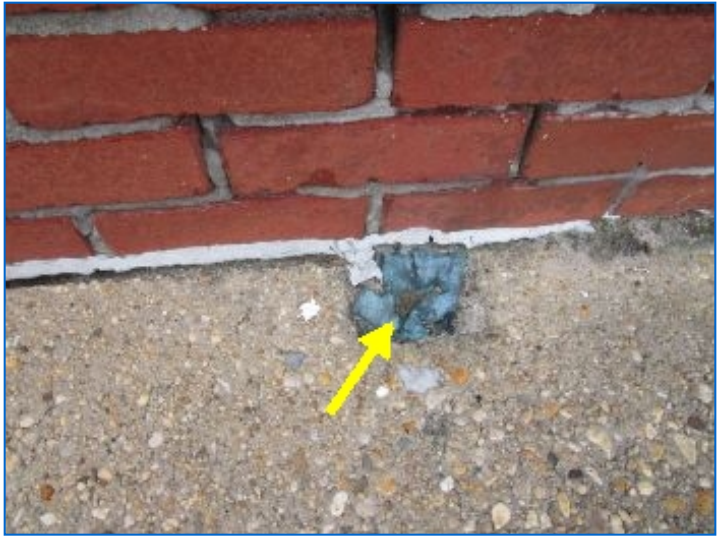
Original copper downspout connection to drywell at SW corner was terminated.

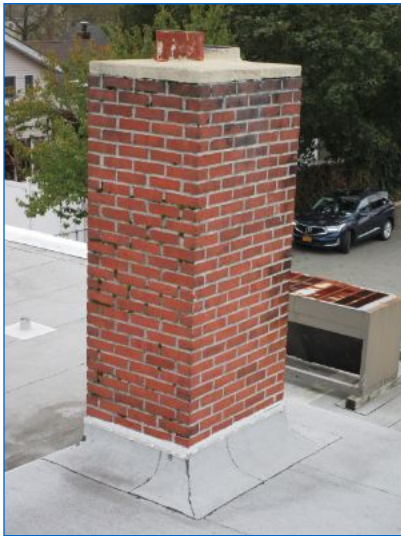
Double stack chimney noted.

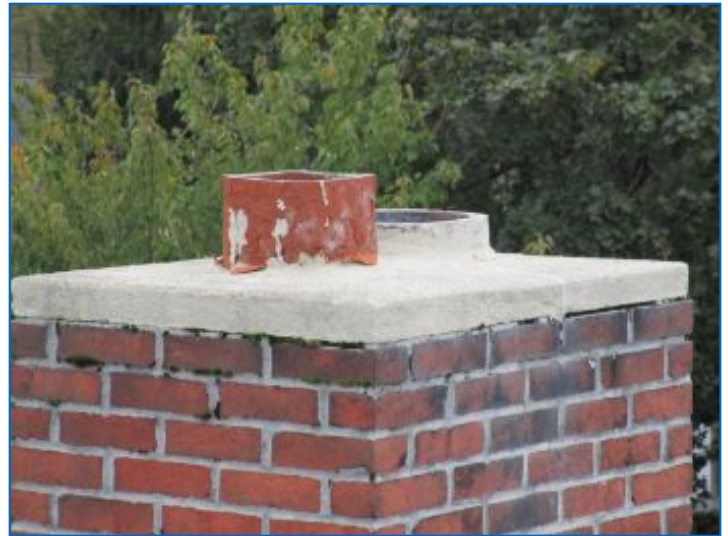
The chimney stacks appeared to have Unlined Flues. While this may have been acceptable at the time of construction, flue liners are a fire safety feature. The Inspector generally recommends installing chimney liner for active chimney flue. Refer to Chimney Liner in Glossary.

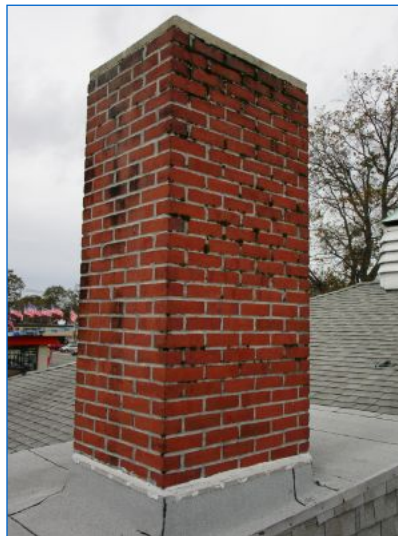
The Inspector observed no deficiencies in the condition of the visible portions of the chimney structure.

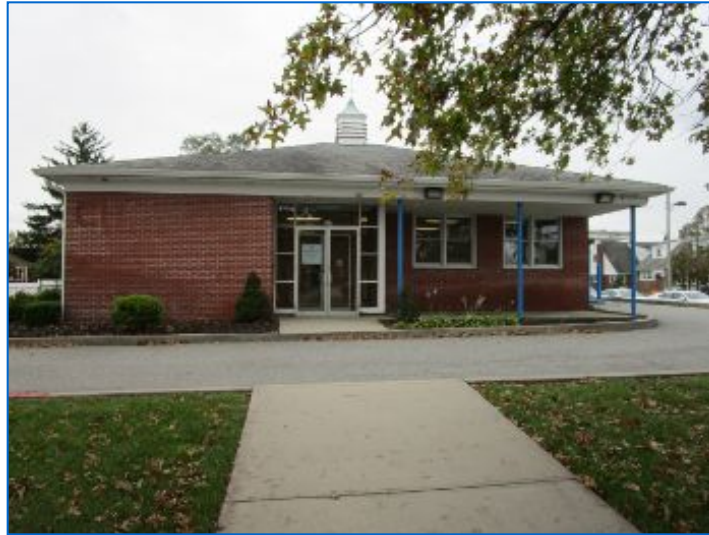
Front-North Exterior.

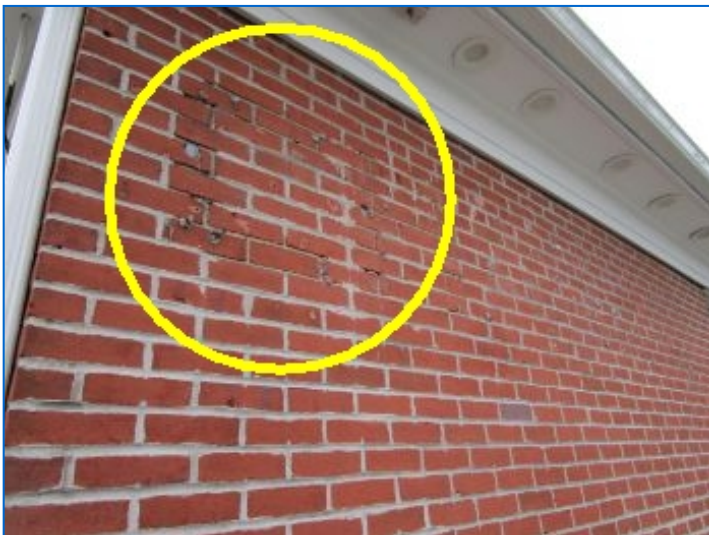
Cosmetic damage noted at front from past signage mounting.

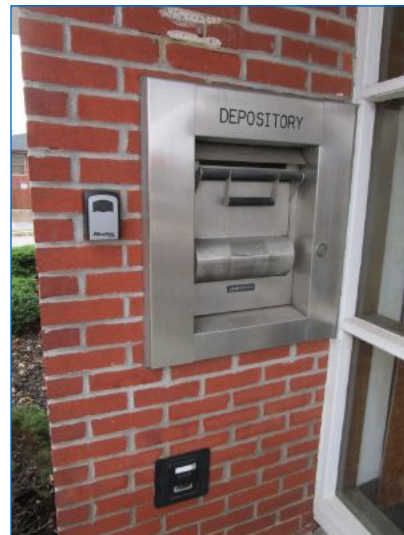
Exterior bank related equipment and components noted at front.

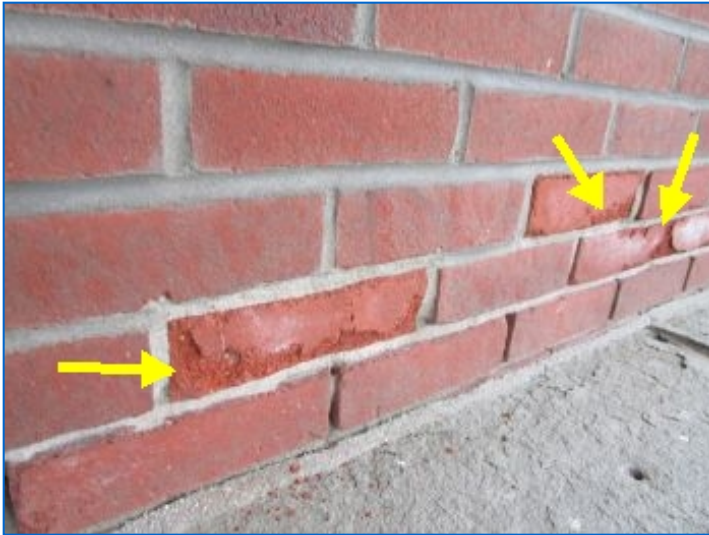
Some brick face damage from frost weathering was noted at lower north facing wall; cosmetic damage.

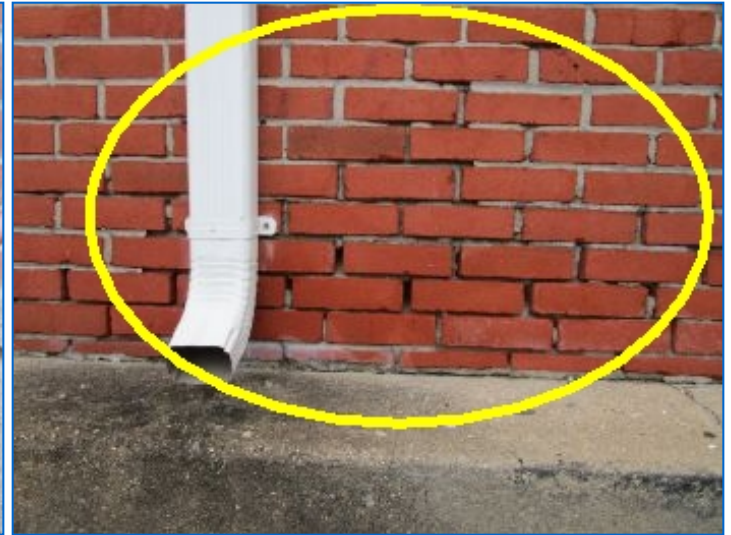
Maintenance: Mortar joint deterioration noted at west side. Repointing of deteriorated mortar is recommended to prevent further deterioration from frost weathering.

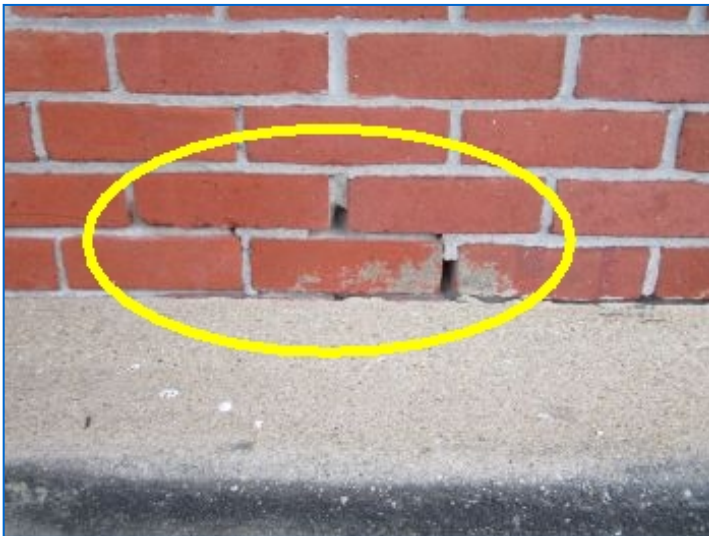
Maintenance: Mortar joint deterioration noted at west side. Repointing of deteriorated mortar is recommended to prevent further deterioration from frost weathering.

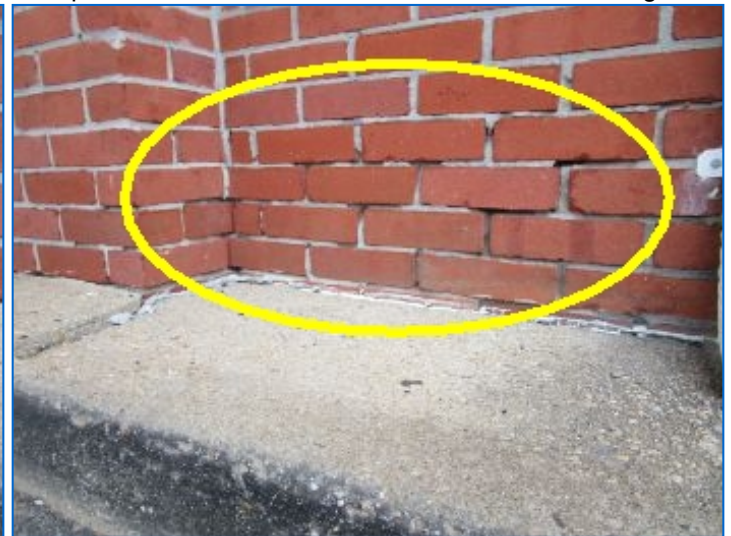
Maintenance: Mortar joint deterioration noted at west side. Repointing of deteriorated mortar is recommended to prevent further deterioration from frost weathering.

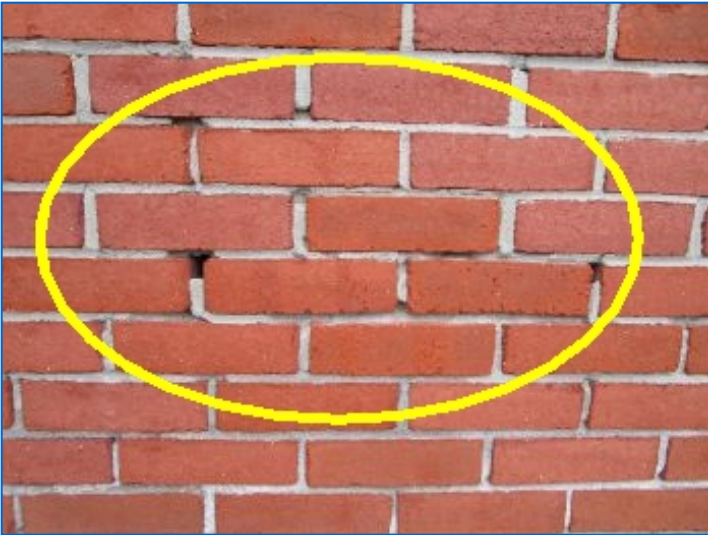
Maintenance: Mortar joint deterioration noted at west side. Repointing of deteriorated mortar is recommended to prevent further deterioration from frost weathering.

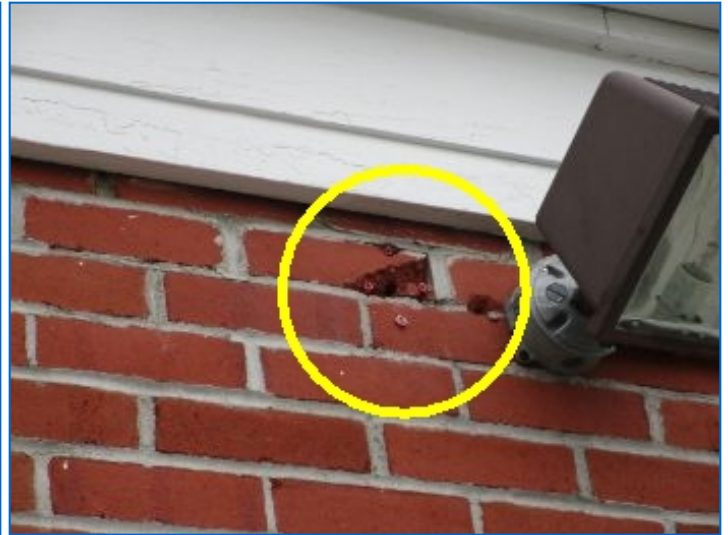
Cosmetic damage noted at west side from past light fixture mounting.

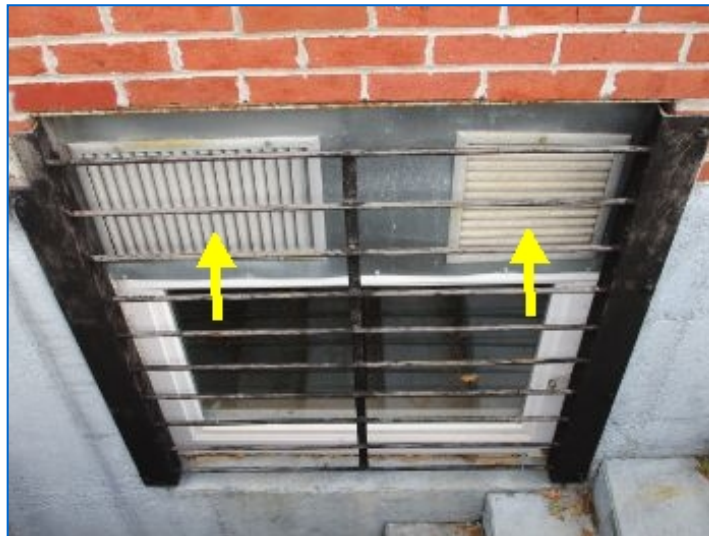
HVAC System ventilation intake and furnace combustion air intake louvers.

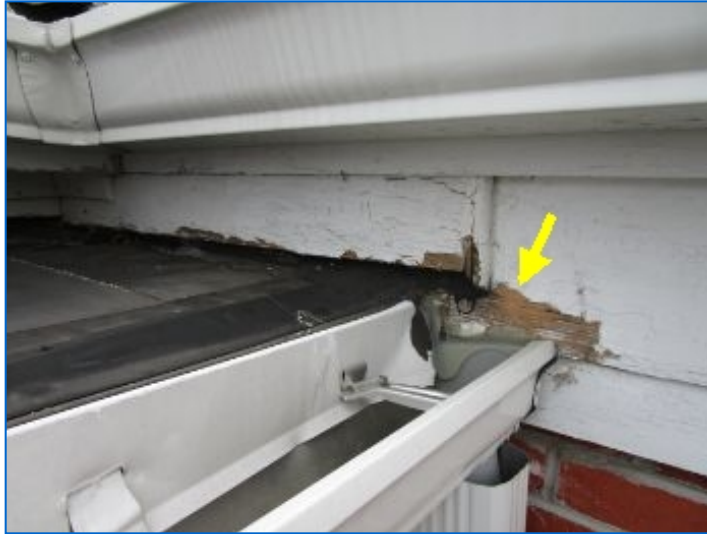
Peeling paint observed, suggest scraping and painting as necessary.

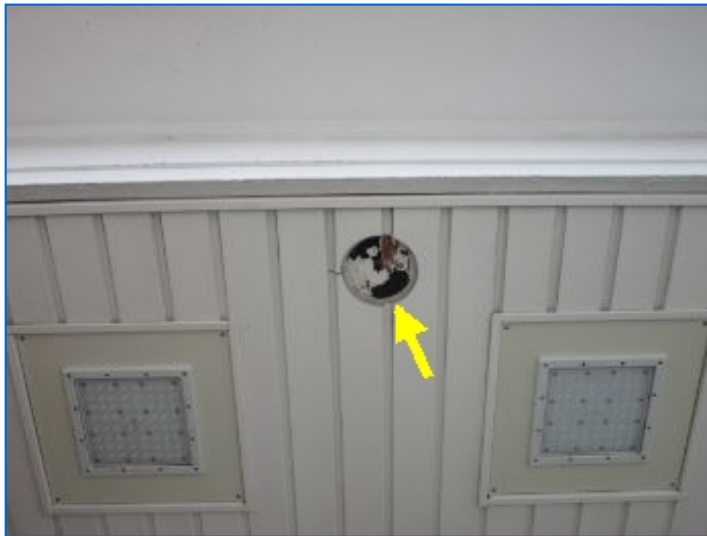
Soffit mounted component removed at front.

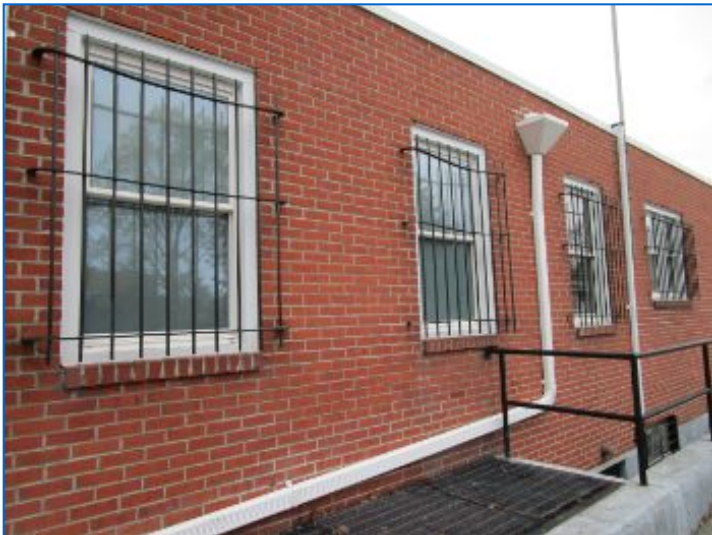
Steel burglar bars mounted to brick wall at 4 rear windows.

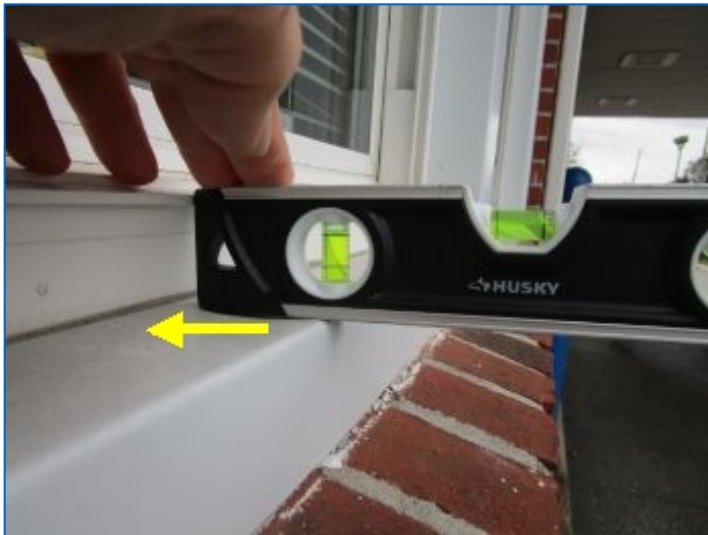
Few aluminum cladded window sills were improperly sloped toward caulked joint where water intrusion can occur, making it critical that caulking is maintained here. Maintenance: Recommend periodic inspection to update caulking around windows to prevent water entry.

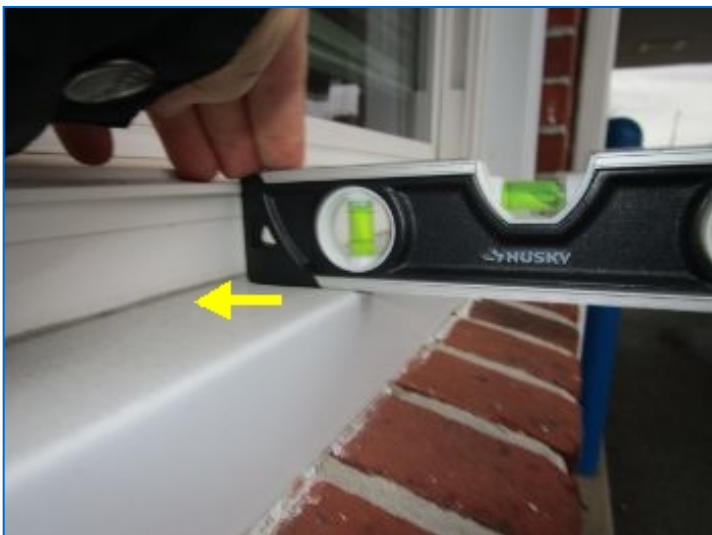
Few aluminum cladded window sills were improperly sloped toward caulked joint where water intrusion can occur, making it critical that caulking is maintained here. Maintenance: Recommend periodic inspection to update caulking around windows to prevent water entry.

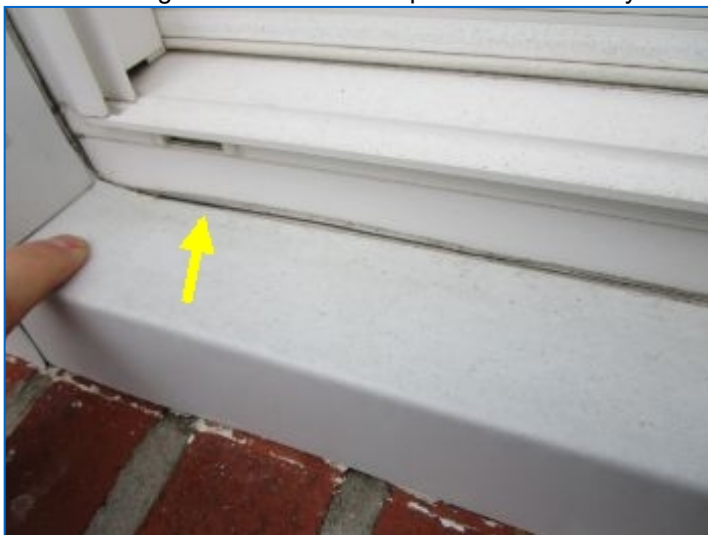
MAINTENANCE: Recommend updating caulking at window frames as needed to prevent water intrusion.

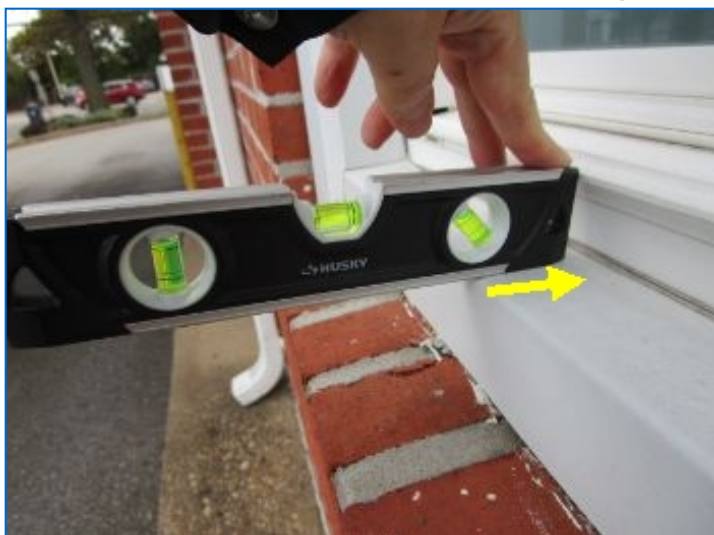
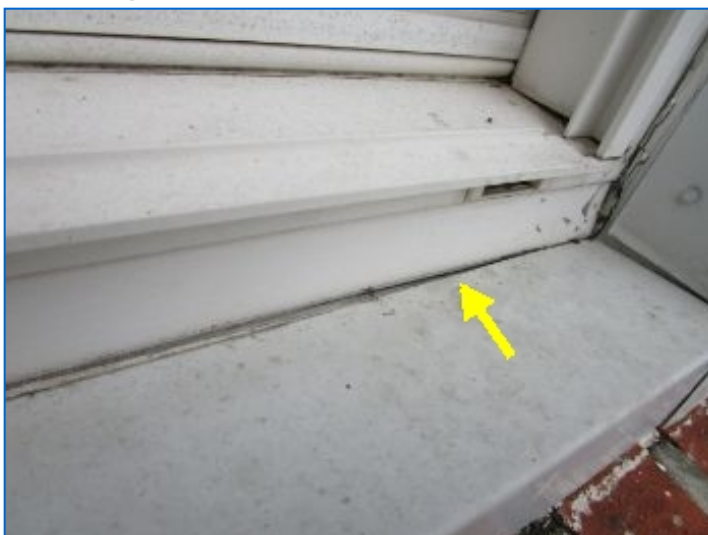
Few aluminum clad window sills were improperly sloped toward caulked joint where water intrusion can occur, making it critical that caulking is maintained here. Maintenance: Recommend periodic inspection to update caulking around windows to prevent water entry.

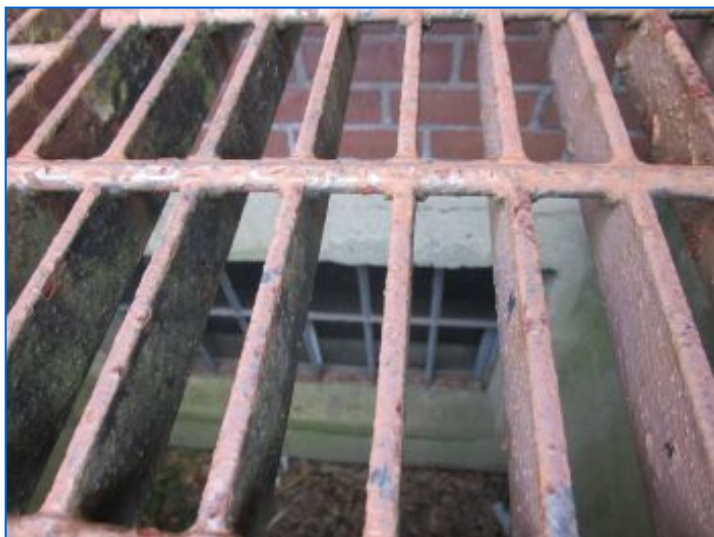
WINDOWS (Exterior) Basement Windows (Exterior)

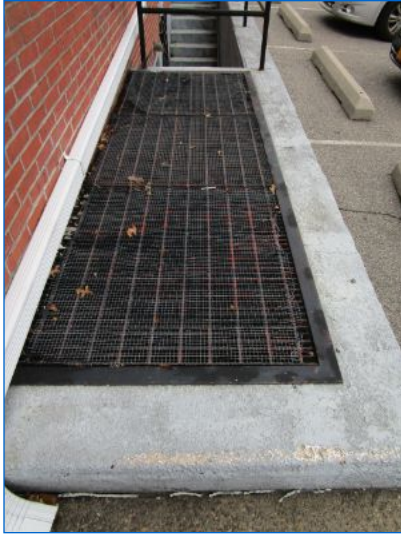
Concrete window wells with steel grating noted at east and south sides. No system safety or function concerns noted at time of inspection.

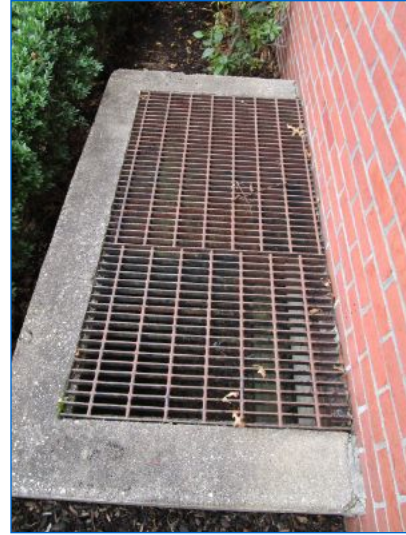
Concrete window wells with steel grating noted at east and south sides. No system safety or function concerns noted at time of inspection.

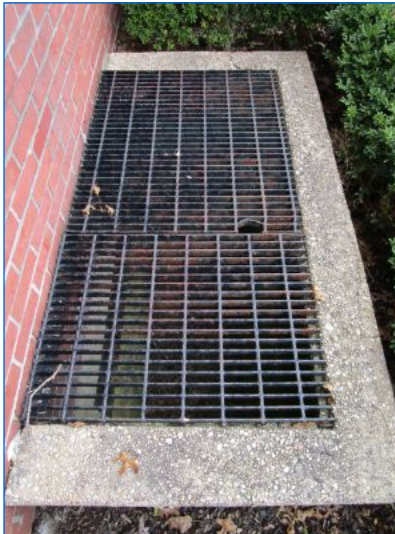
Concrete window wells with steel grating noted at east and south sides. No system safety or function concerns noted at time of inspection.

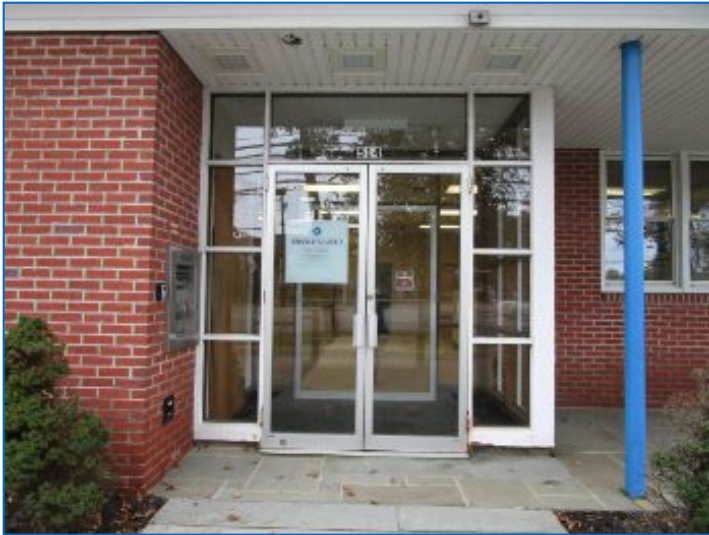
Front doors and vestibule included aluminum frame doors and wood constructed vestibule enclosure.

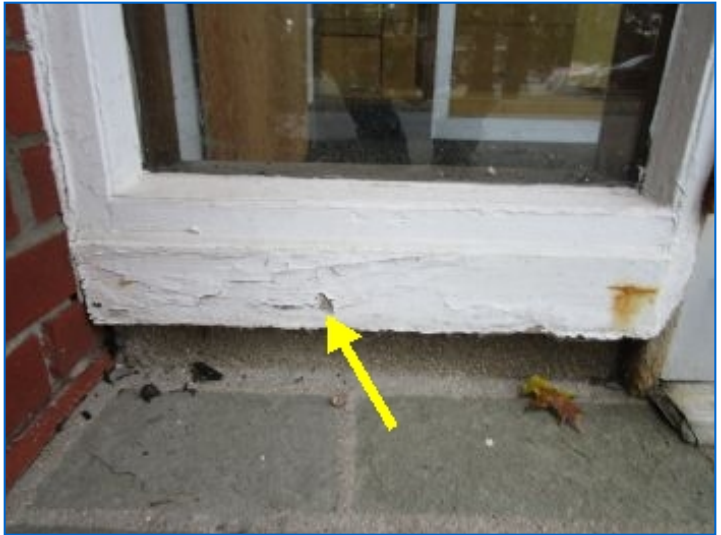
Front vestibule frame/trim had peeling paint; signs of wood deterioration noted. Suggest scrape or strip and repaint to prolong life.

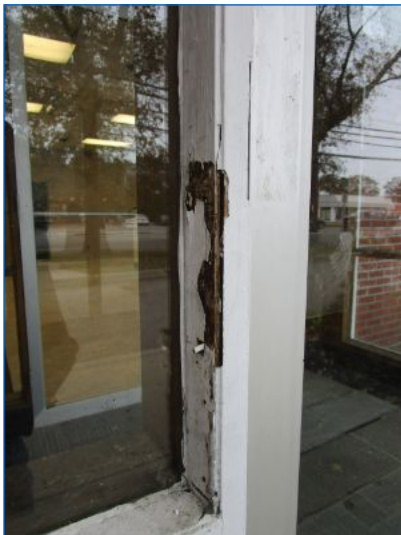
Front vestibule frame/trim had peeling paint; signs of wood deterioration noted. Suggest scrape or strip and repaint to prolong life.

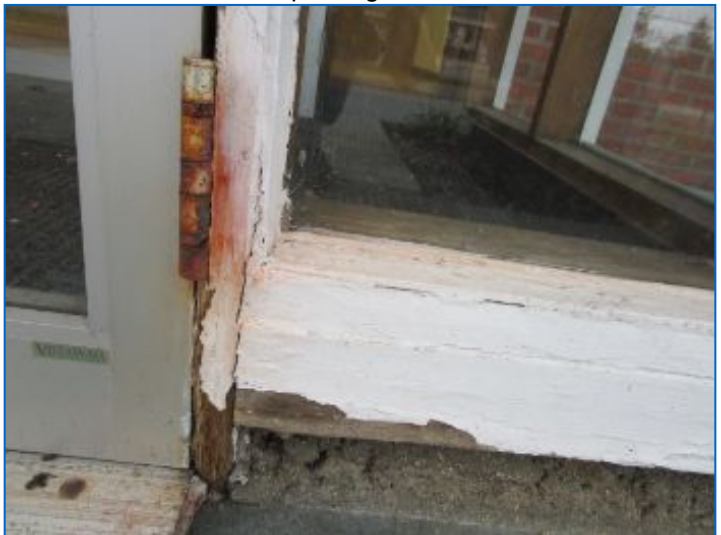
Front vestibule frame/trim had peeling paint; signs of wood deterioration noted. Suggest scrape or strip and repaint to prolong life.

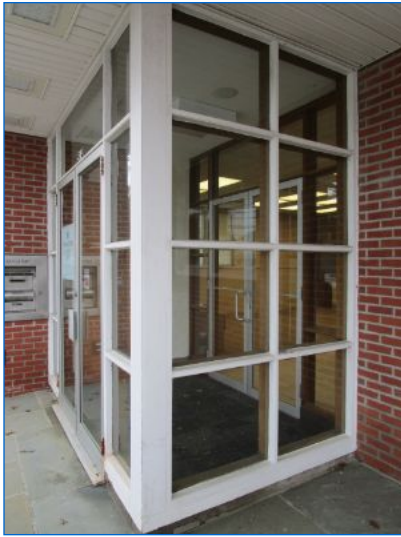
Front doors and vestibule included aluminum frame doors and wood constructed vestibule enclosure.

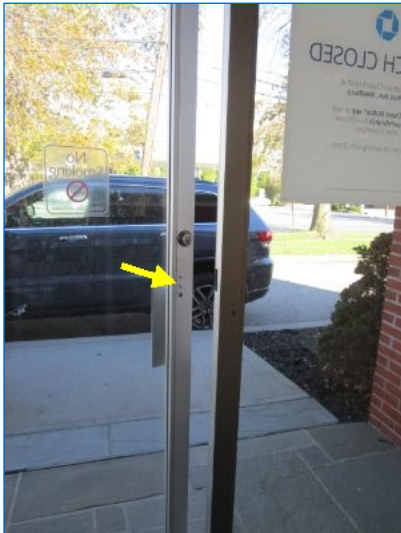
Front door push bar missing. Door did not close completely. Recommend corrective repairs by a qualified contractor.

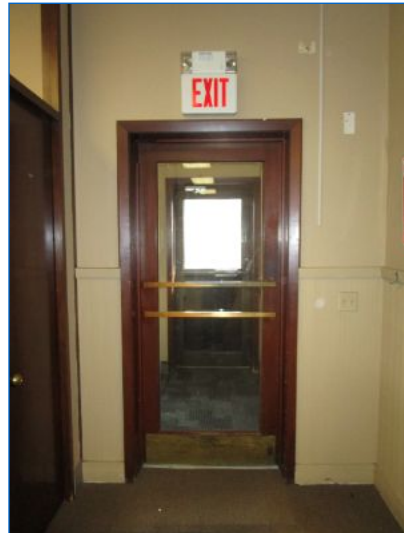
East vestibule; to handicap ramp.

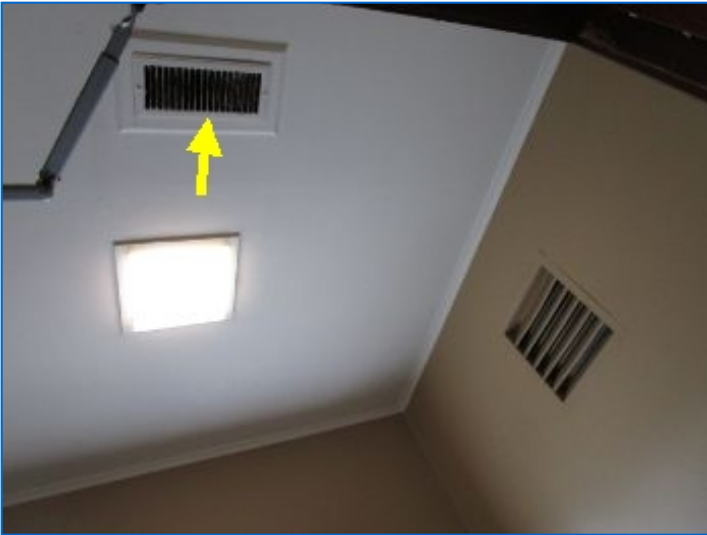
East vestibule HVAC distribution noted.

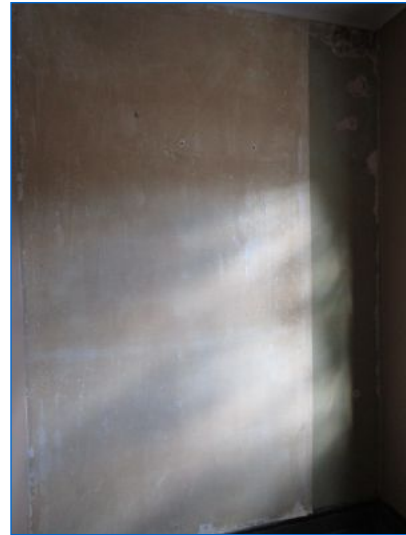
East vestibule walls. Cosmetic updates and repairs needed throughout.

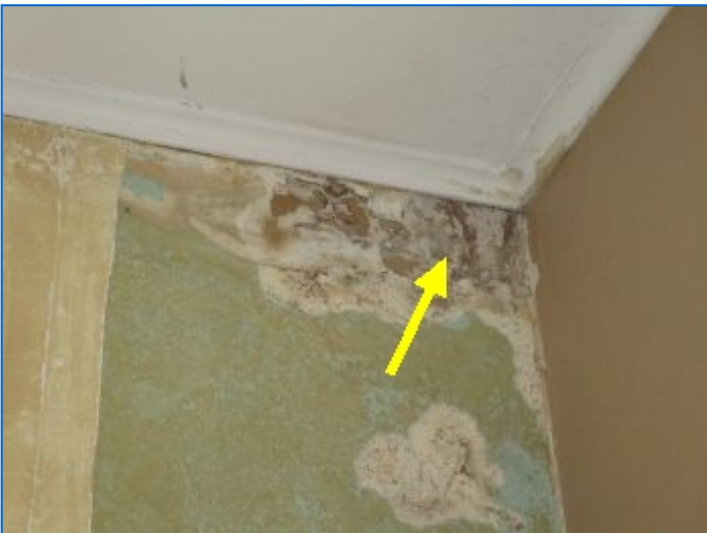
East vestibule; Signs of a past roof leak noted at exterior wall tested dry at time of inspection.

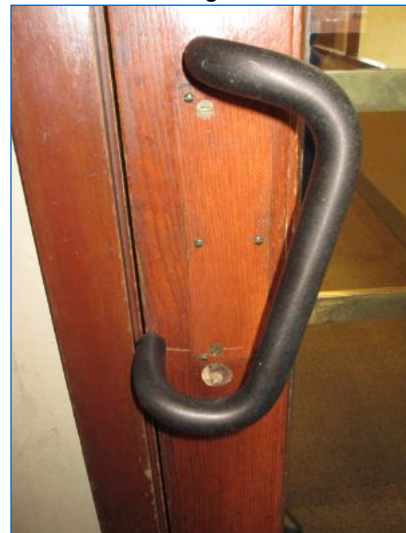
East vestibule; inside door handle was loose. Suggest repair.

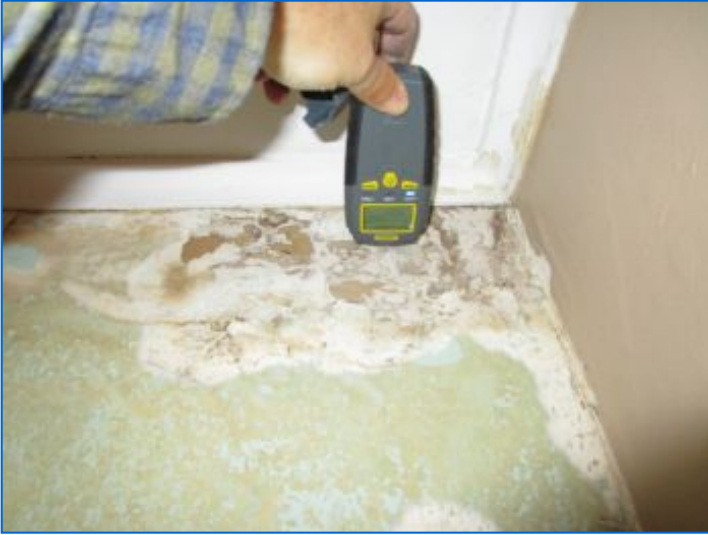
East vestibule; Signs of a past roof leak noted at exterior wall tested dry at time of inspection.

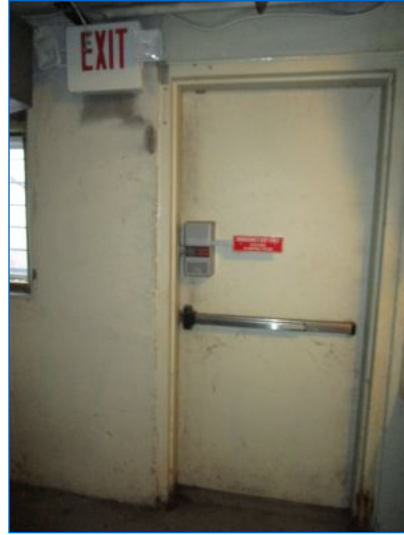
Egress door in basement was locked at time of inspection.

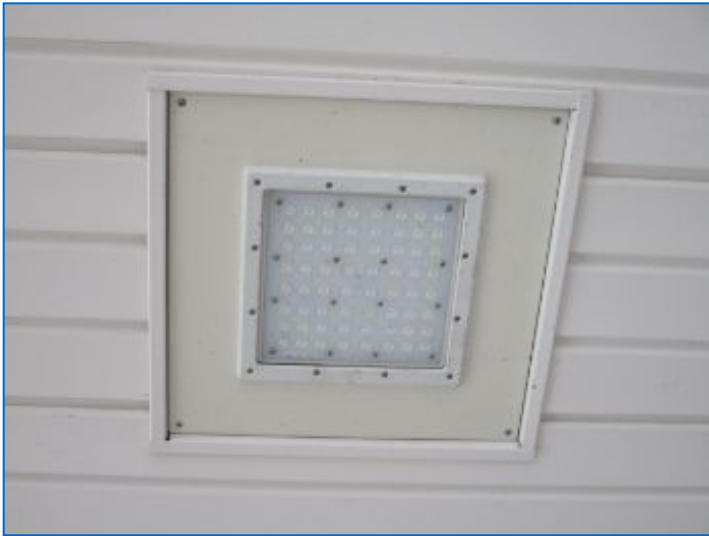
LED lighting noted at front and west soffits; exterior lighting controlled by remote timer schedule.

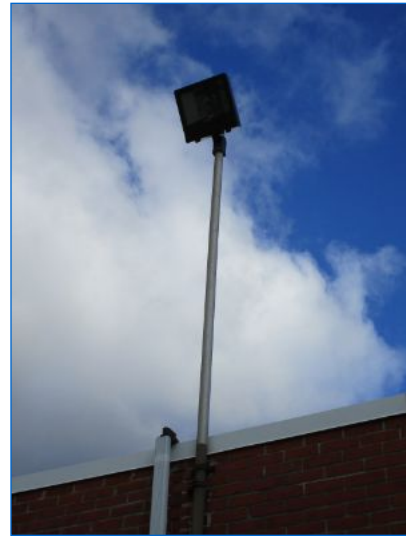
Exterior lighting controlled by remote timer schedule; not tested. Recommend testing prior to close.

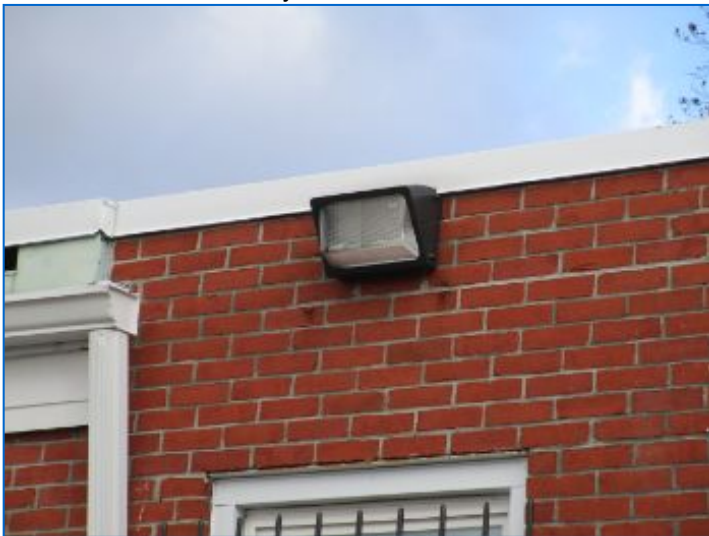
Exterior lighting controlled by remote timer schedule; not tested. Recommend testing prior to close.

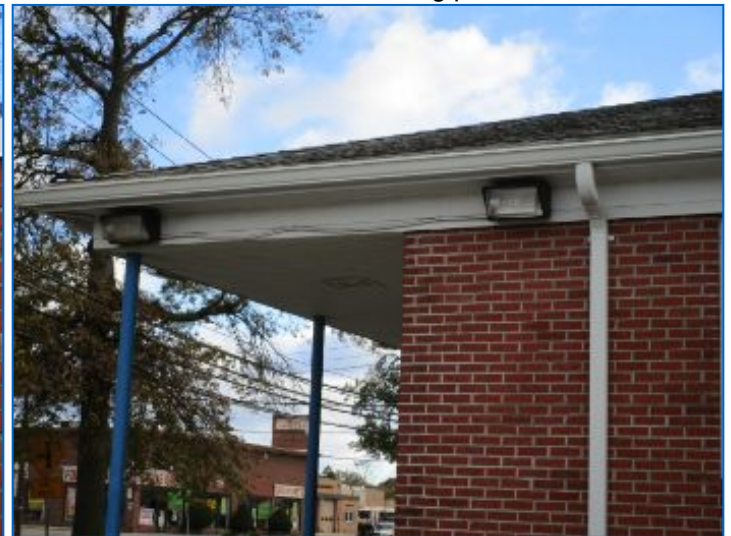
Exterior lighting controlled by remote timer schedule; not tested. Recommend testing prior to close.

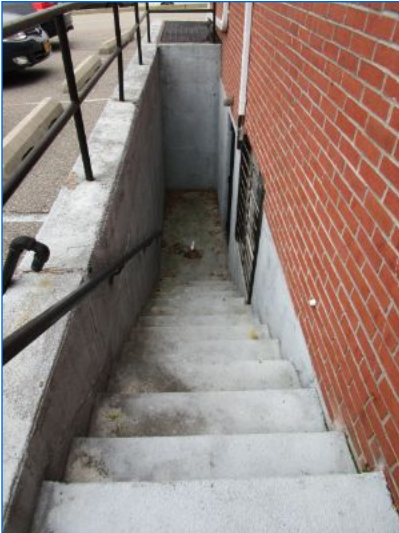
Exterior steps to basement. No system safety or function concerns noted at time of inspection.

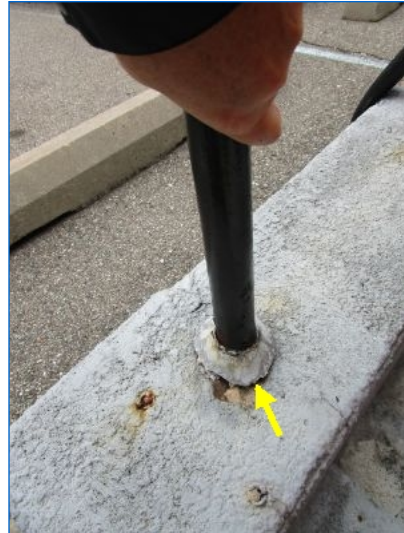
First post for guardrail at basement steps showed signs of loosening.

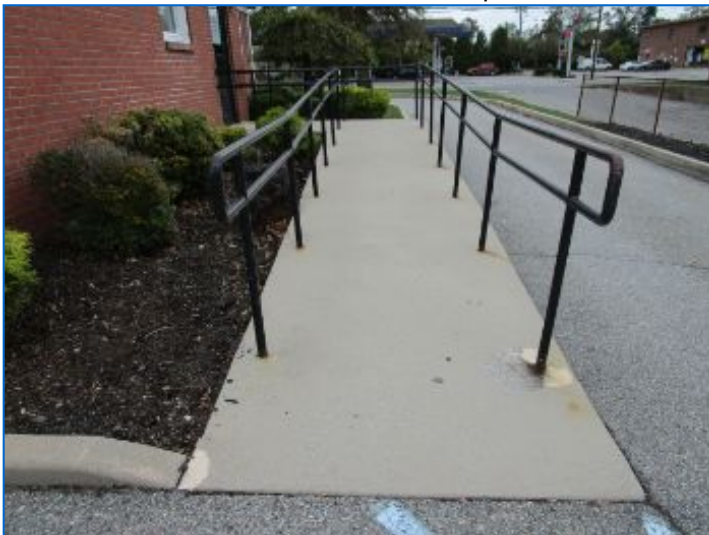
Concrete handicap ramp at east side entrance.

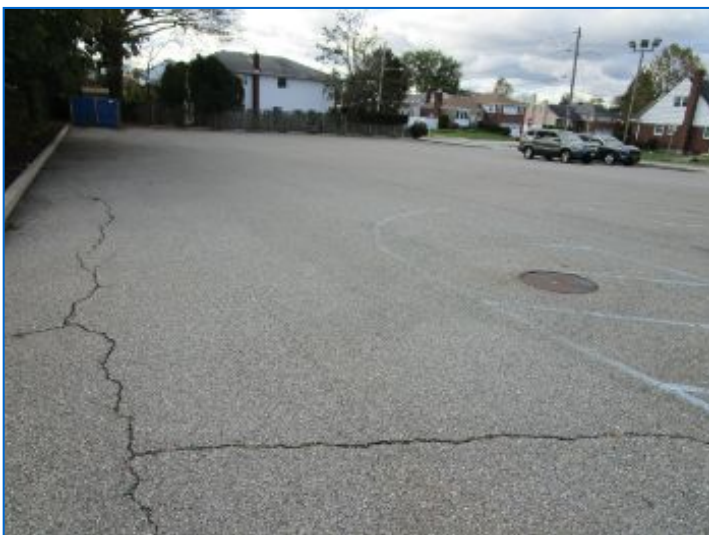
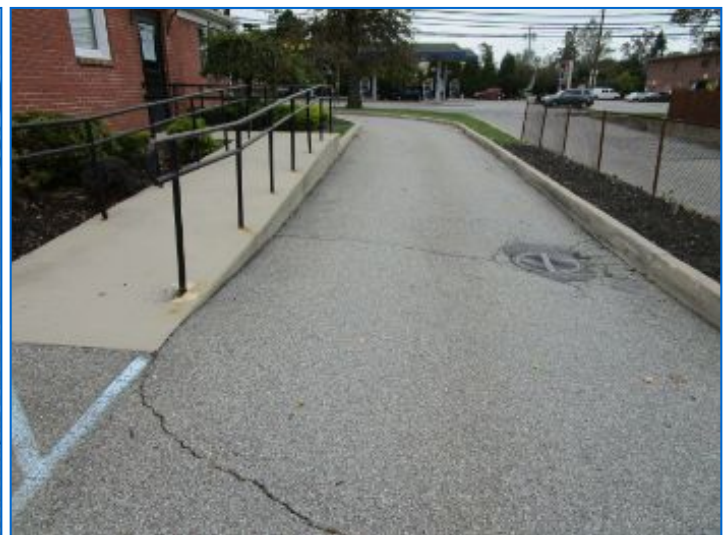
- **Moderate cracks in parking area and driveway. Monitor cracks for the development of trip hazards and have cracks repaired by a qualified contractor.**

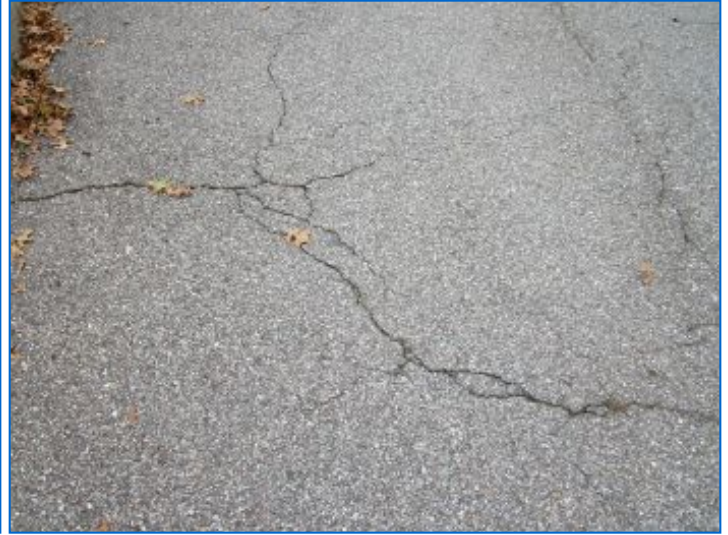
Moderate cracks in driveway. Monitor cracks for the development of trip hazards and have cracks repaired by a qualified contractor.

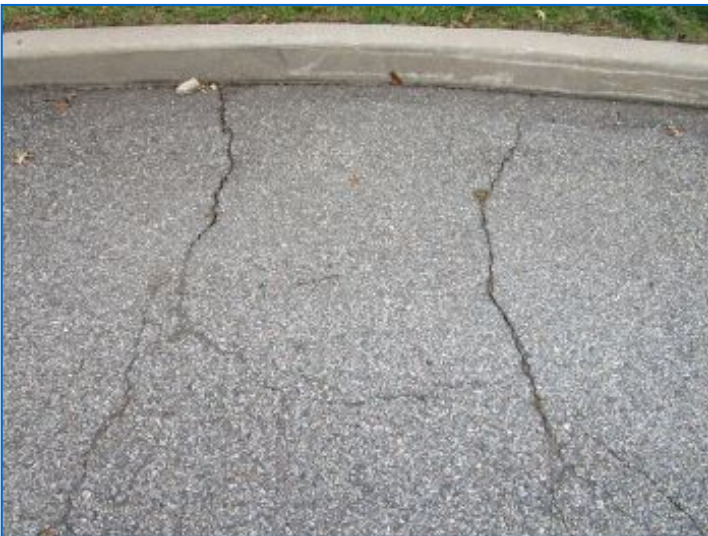
Moderate cracks in driveway. Seal and/or repair cracks to prevent water entry leading to freeze-thaw damage.

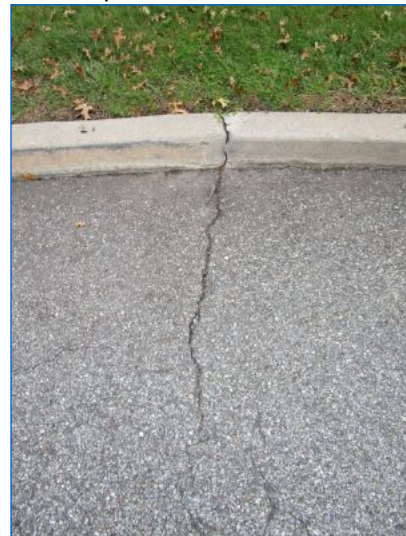
Moderate cracks in driveway. Monitor cracks for the development of trip hazards and have cracks repaired by a qualified contractor.

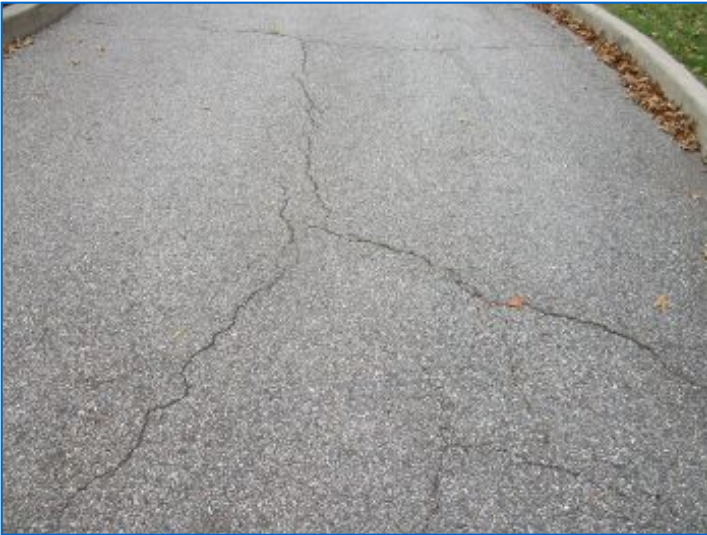
Moderate cracks in parking area and driveway. Seal and/or repair cracks to prevent water entry leading to freeze-thaw damage.

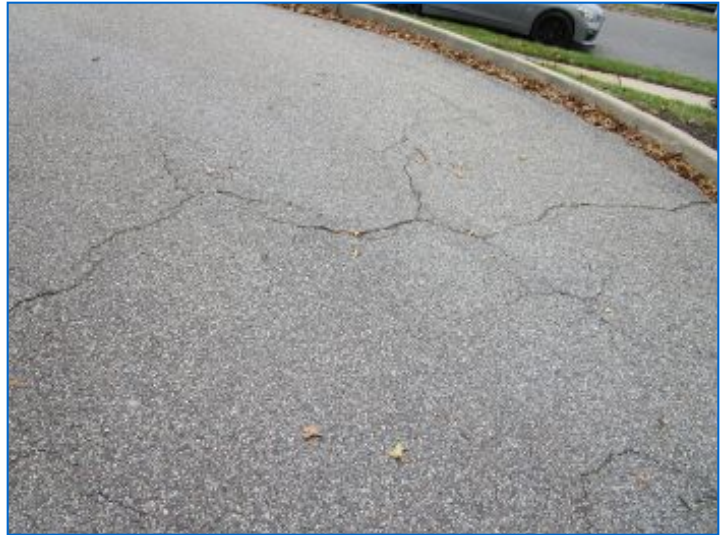
Moderate cracks in driveway. Seal and/or repair cracks to prevent water entry leading to freeze-thaw damage.

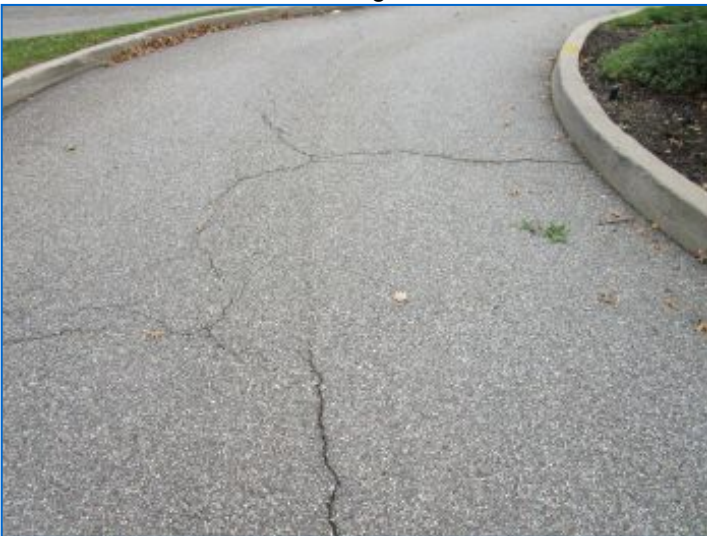
Moderate cracks in parking area and driveway. Seal and/or repair cracks to prevent water entry leading to freeze-thaw damage.

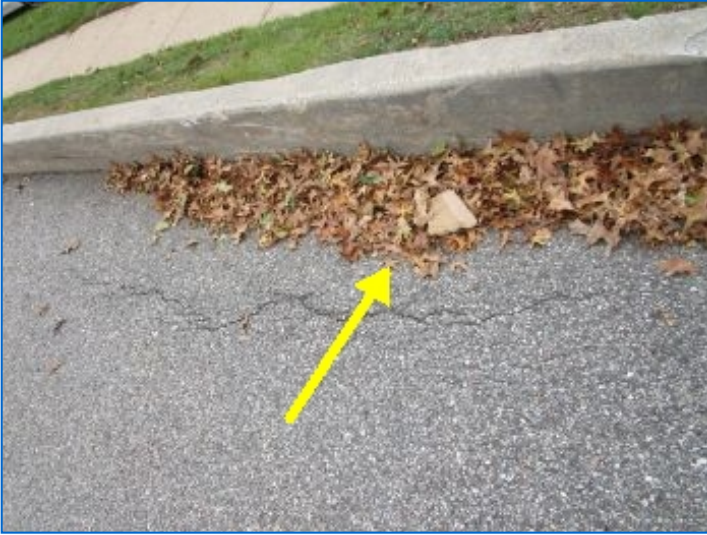
Small area of settlement of soil beneath the driveway at west side appeared to be due to inadequate compaction at the time of original construction. Most settling takes place in the first few years after original construction, after which settling stops and soil in the affected area becomes stable.

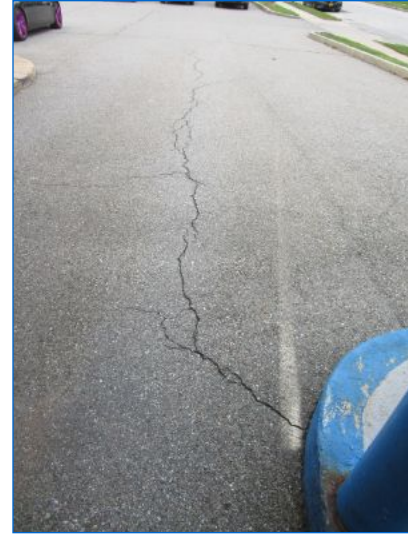
Moderate cracks in driveway. Seal and/or repair cracks to prevent water entry leading to freeze-thaw damage.

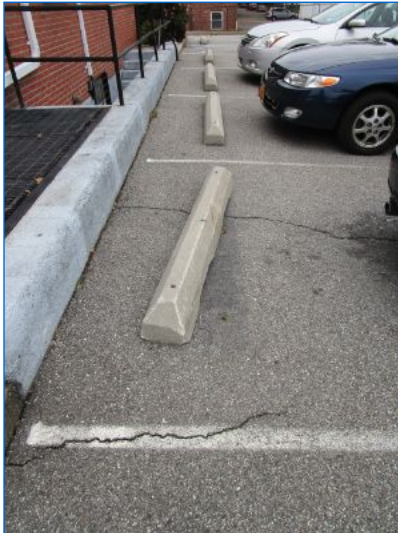
Moderate cracks in parking area. Monitor cracks for the development of trip hazards and have cracks repaired by a qualified contractor.

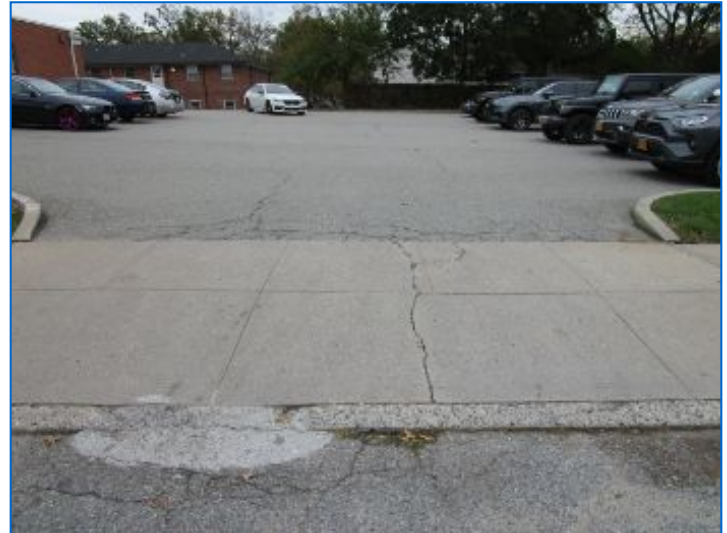
Driveway/Parking: Asphalt noted; Concrete aprons noted.

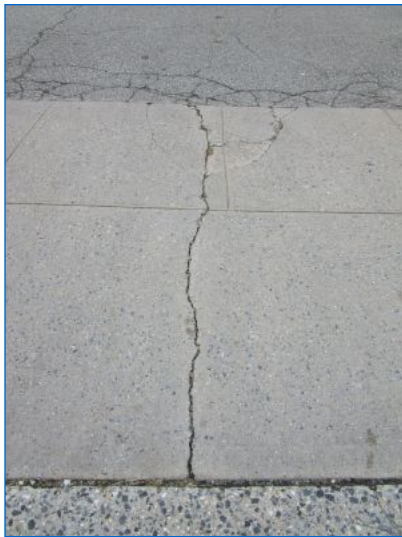
Moderate crack in concrete driveway. Repair or replace damaged areas as necessary to prevent trip hazards. Seal or repair cracks to prevent water entry that will cause further freeze-thaw damage.

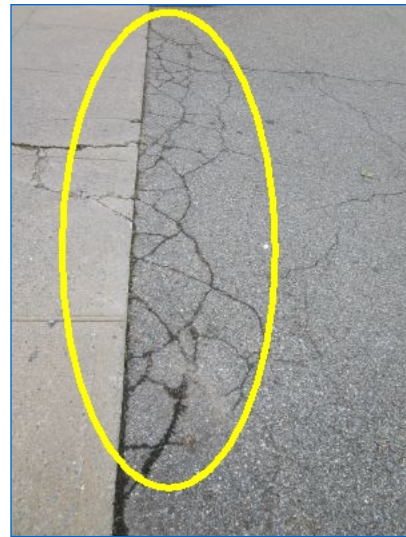
Moderate alligator cracking noted which is a load associated structural failure. The failure can be due to weakness in the surface, base or sub grade; a surface or base that is too thin; poor drainage or the combination of all three. It often starts in the wheel path as longitudinal cracking and ends up as alligator cracking after severe distress. The Fix: Because a structural failure is taking place the only possible solution to alligating is to perform a full-depth patch.

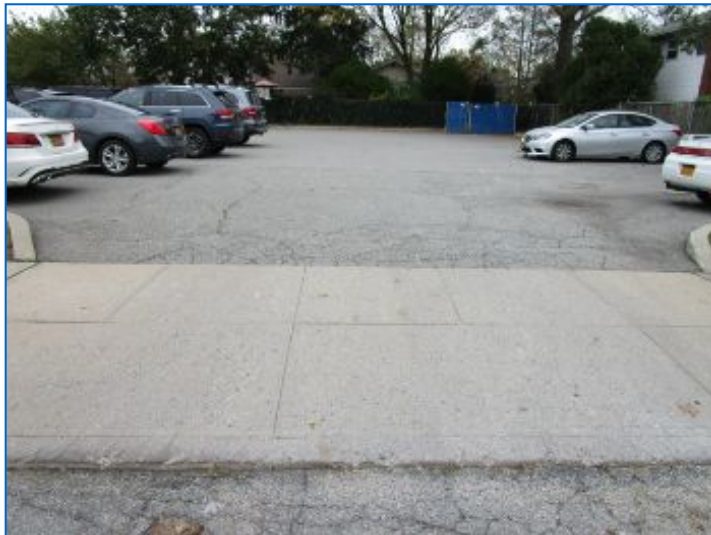
Driveway/Parking: Asphalt noted; Concrete aprons noted.

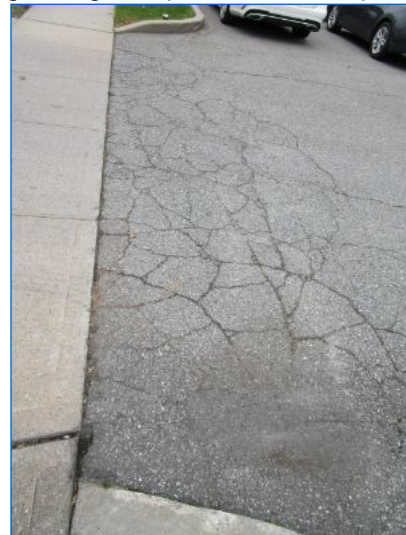
Moderate alligator cracking noted which is a load associated structural failure. The failure can be due to weakness in the surface, base or sub grade; a surface or base that is too thin; poor drainage or the combination of all three. It often starts in the wheel path as longitudinal cracking and ends up as alligator cracking after severe distress. The Fix: Because a structural failure is taking place the only possible solution to alligating is to perform a full-depth patch.

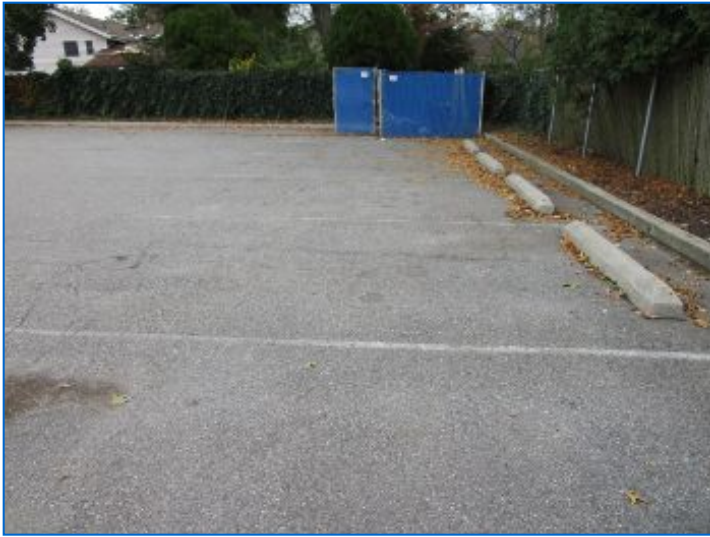
GROUNDS Driveway/Parking

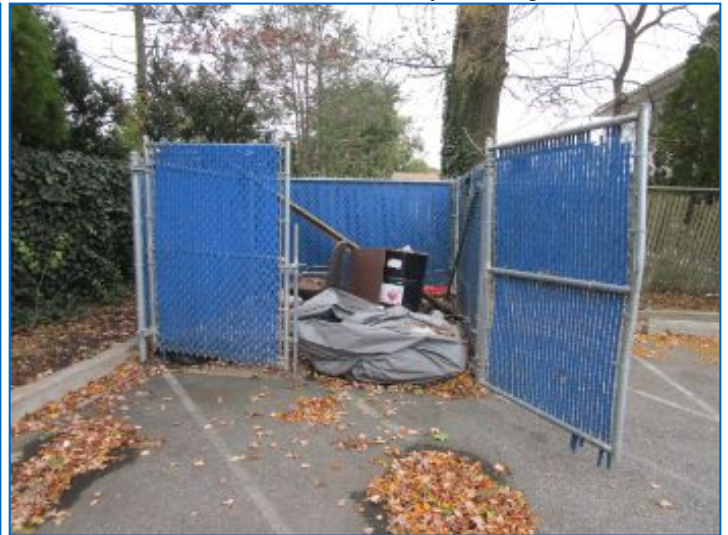
Parking lot storage area noted.
