ProSpec Home Inspection of Long Island Property Inspection Report

Inspector: Russell J. Classi, P.E.
Phone: (516) 480-1848
Email: prospecofli@gmail.com
www.nassaprofessionalhomeinspector.com

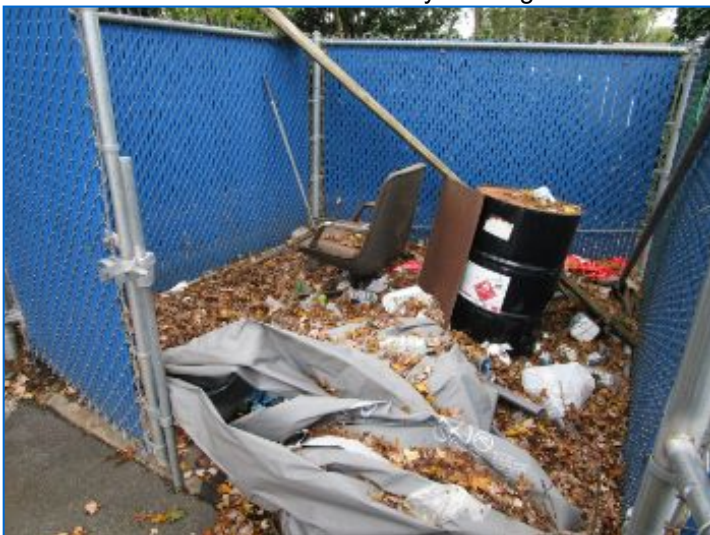
Parking lot storage area noted.

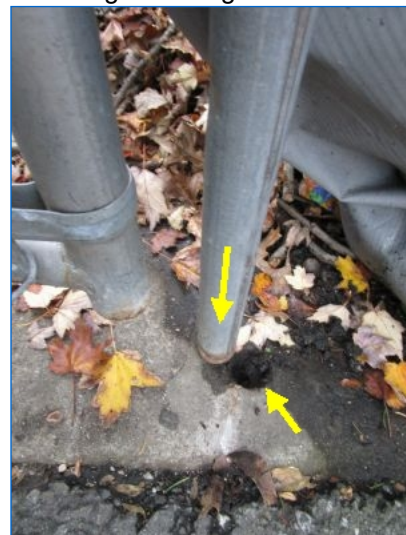
Parking lot storage area: Gate drop tube latch was not aligned with hole.

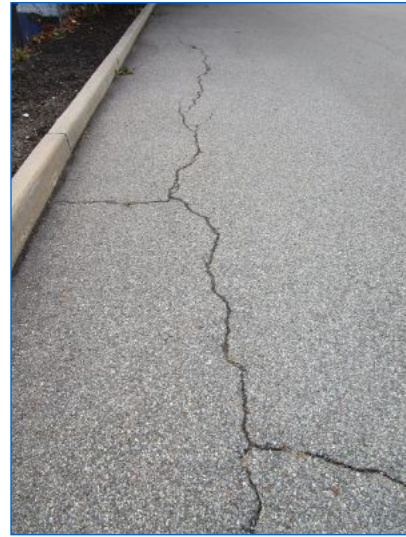
Moderate cracks in driveway. Seal and/or repair cracks to prevent water entry leading to freeze-thaw damage.

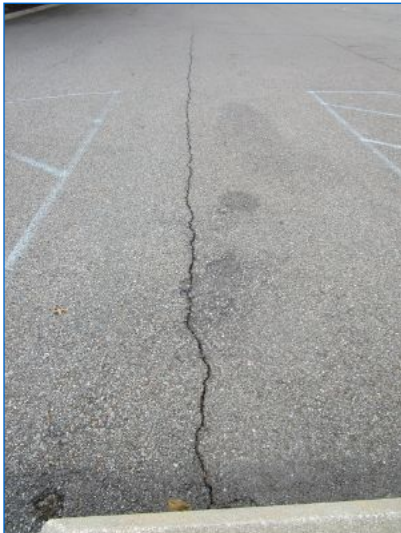
Moderate cracks in parking area. Seal and/or repair cracks to prevent water entry leading to freeze-thaw damage.

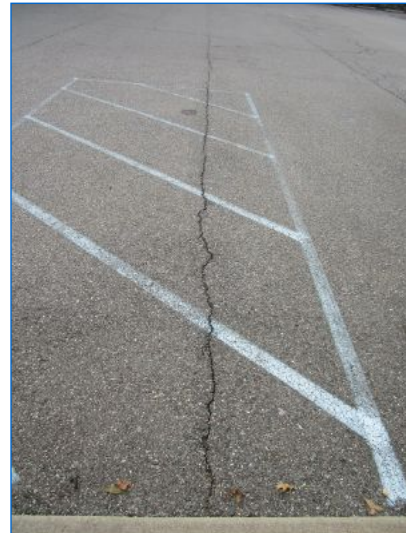
Moderate cracks in parking area. Seal and/or repair cracks to prevent water entry leading to freeze-thaw damage.

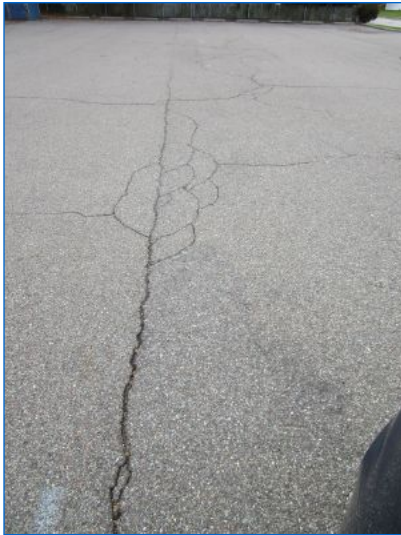
Moderate cracks in parking area. Seal and/or repair cracks to prevent water entry leading to freeze-thaw damage.

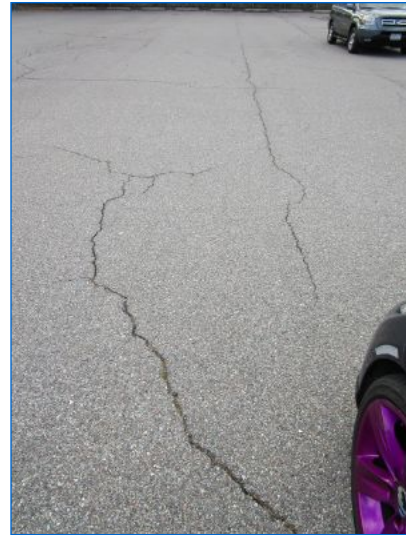
Moderate cracks in parking area. Seal and/or repair cracks to prevent water entry leading to freeze-thaw damage.

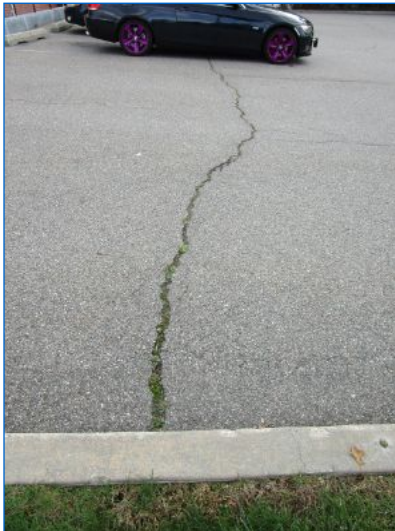
Moderate cracks in parking area and driveway. Monitor cracks for the development of trip hazards and have cracks repaired by a qualified contractor.

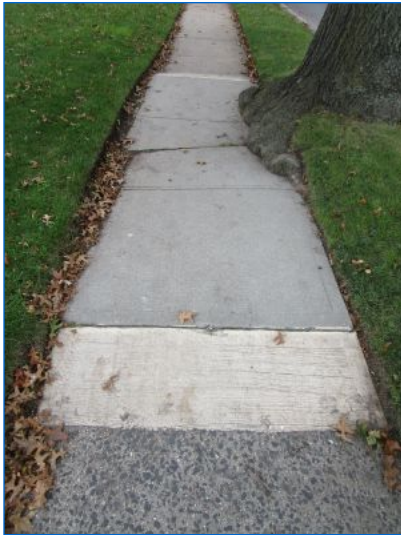
Sidewalk flag/s heaved/cracked by tree roots; monitor for trip hazards. Repair as necessary.

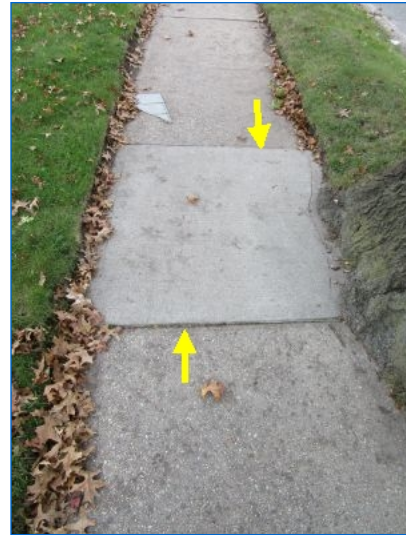
Sidewalk flag/s heaved by tree roots; trip hazards noted. Repair as necessary.

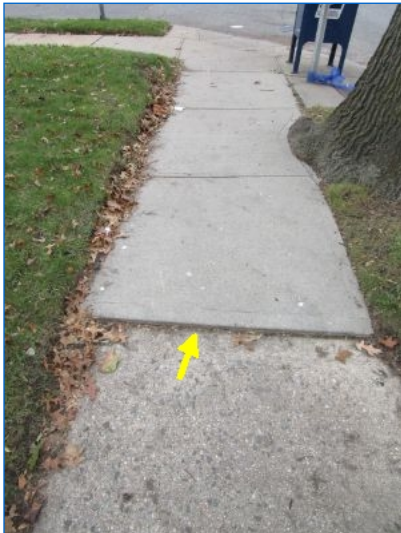
Sidewalk flag/s heaved by tree roots; trip hazards noted. Repair as necessary.

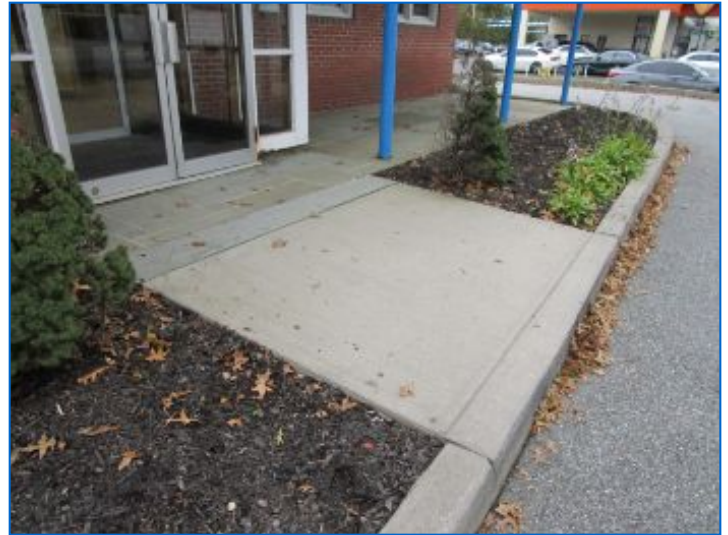
Walkway/s: Concrete and Bluestone was noted. Walkways: No major system safety or function concerns noted at time of inspection.

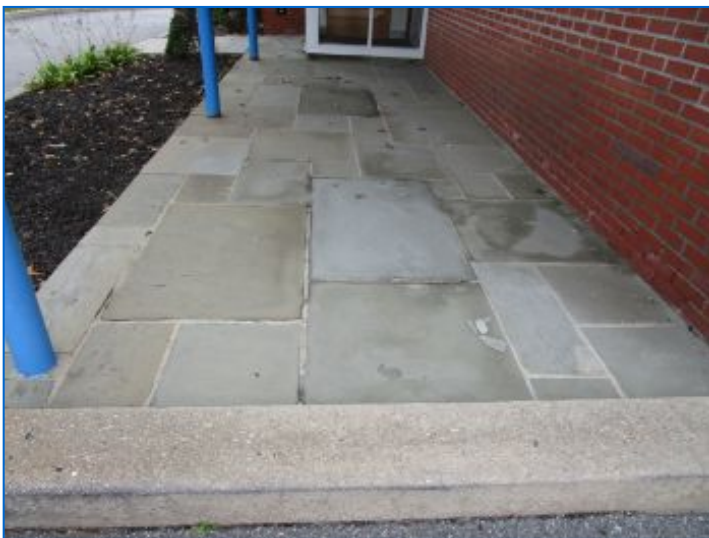
Walkway/s: Concrete and Bluestone was noted.

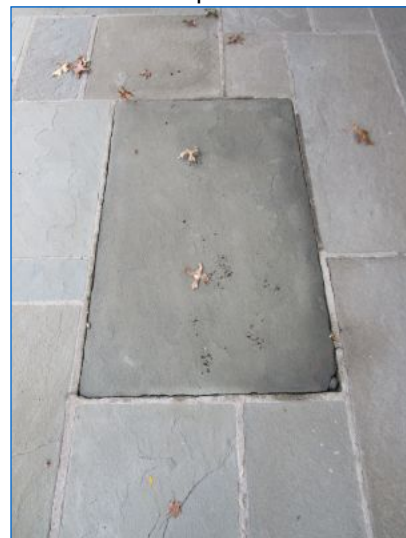
Cracked mortar noted around a bluestone flag.

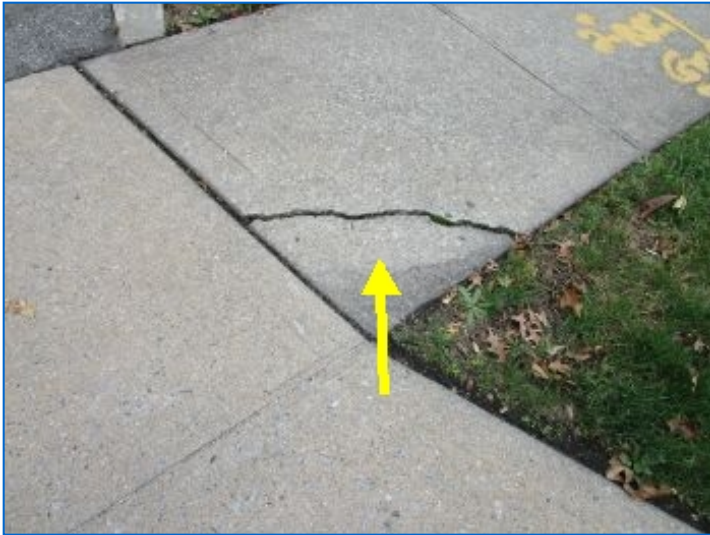
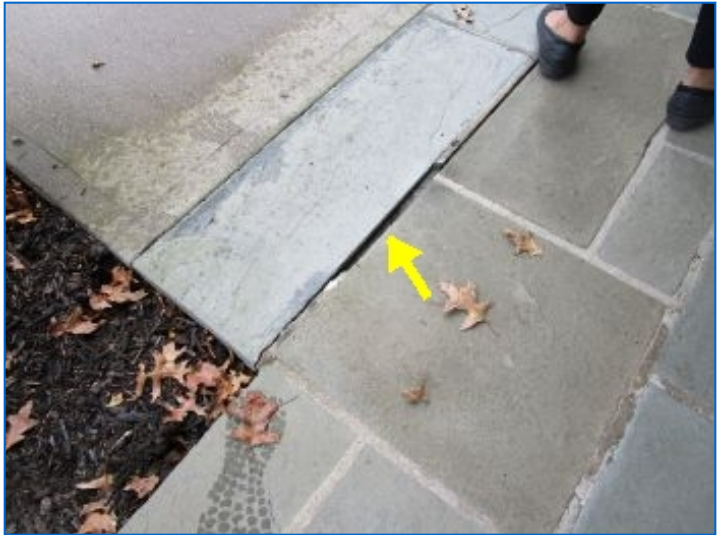
Potential Trip Hazard/s developing at sidewalk; monitor and repair as necessary.

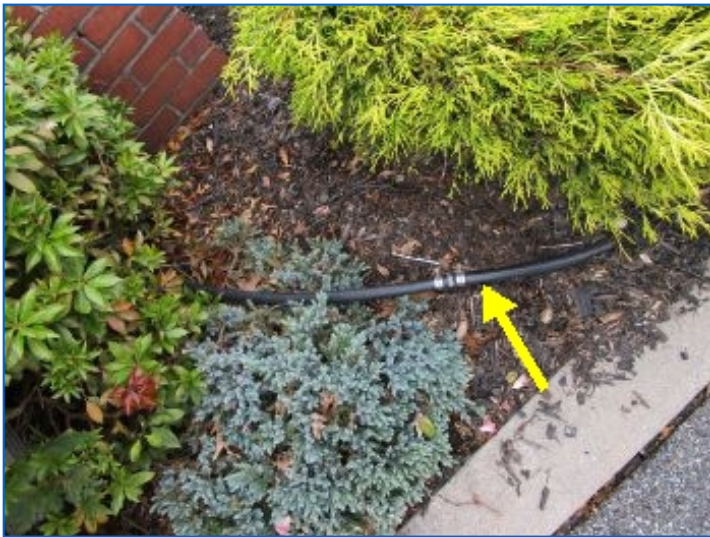
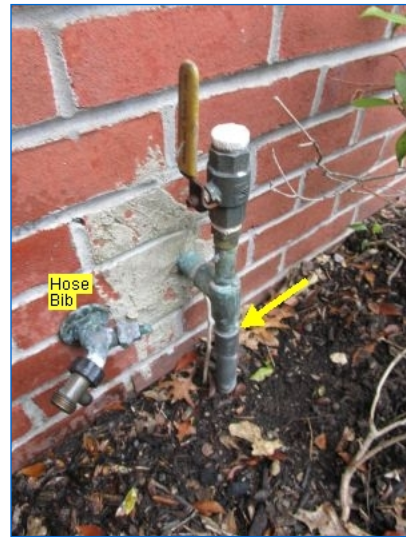
Sprinkler underground pipe at Southeast corner was pushed above ground and is subject to damage.

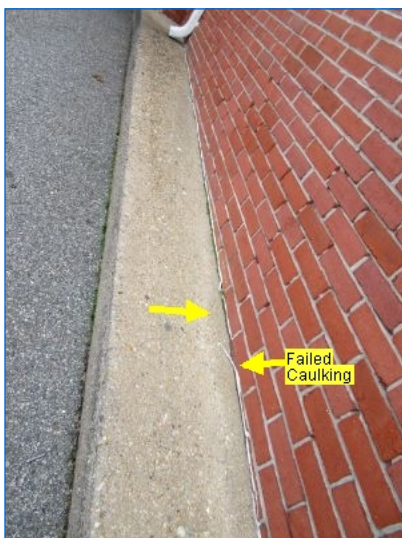
Downspouts draining onto paved areas (west/SW wall) having negative slope prevents runoff from draining away from the structure that eventually penetrates the foundation wall. Recommend regrading pavement and/or extending downspouts to divert runoff away from these areas. See related comment for Women's Bathroom.

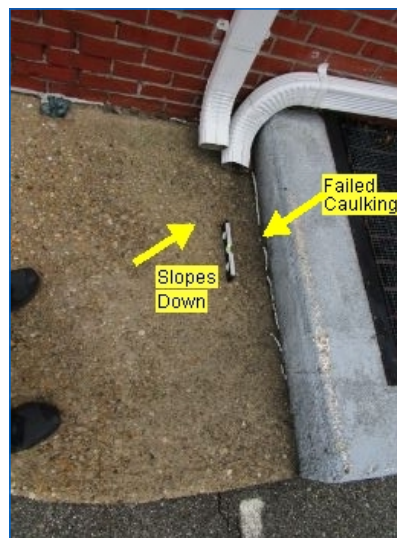
Downspouts draining onto paved areas (west/SW wall) having negative slope prevents runoff from draining away from the structure that eventually penetrates the foundation wall. Recommend regrading pavement and/or extending downspouts to divert runoff away from these areas. See related comment for Women's Bathroom.

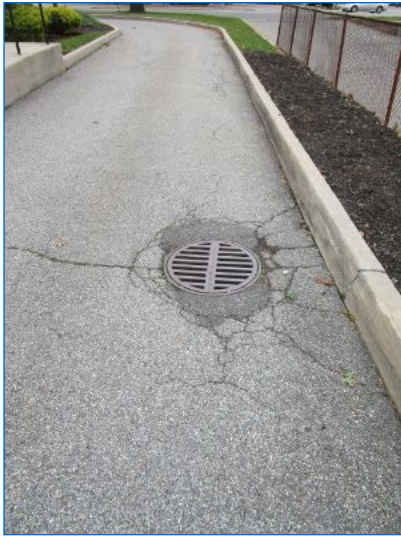
Driveway/parking lot was equipped with two visible drainage wells; east side drainage well.

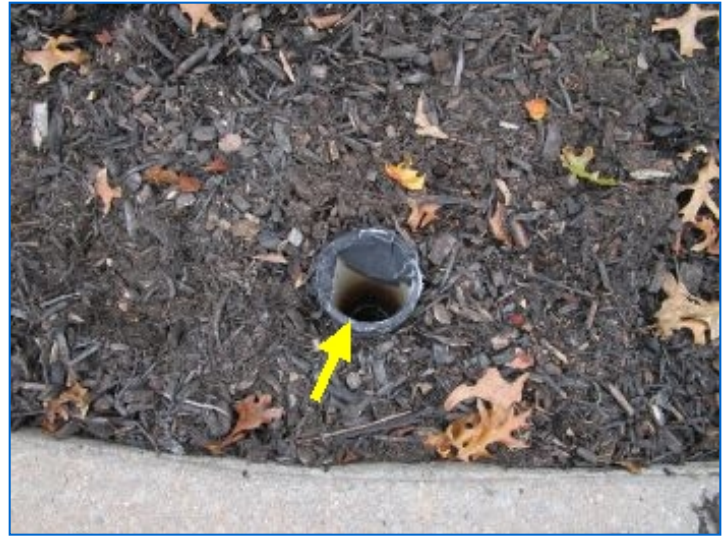
Apparent drain connection to underground drywell at NE planting bed was left unprotected from organic debris entering and causing clogging. Recommend adding screen or cap to protect.

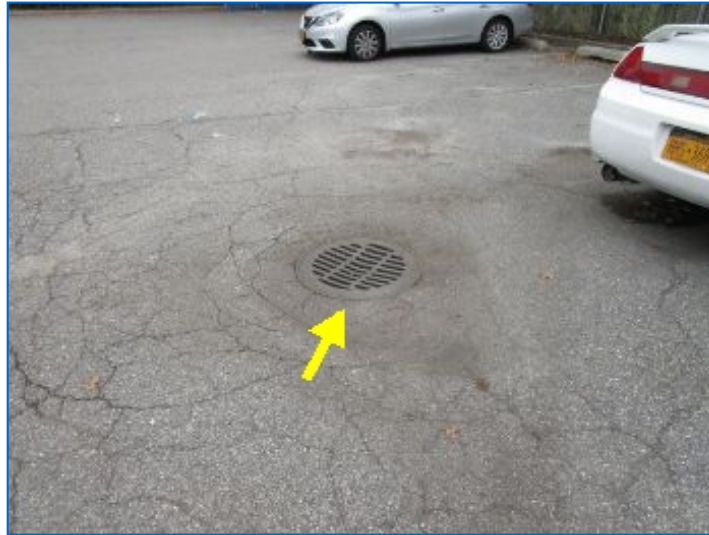
Driveway/parking lot was equipped with two visible drainage wells; SW drainage well.
