# ProSpec Home Inspection of Long Island Property Inspection Report

143 Island Parkway W, Island Park, NY 11558  
Inspection prepared for: Name Deleted  
Date of Inspection: 6/16/2020 Time: 5:00 PM  
Age of Home: 44 yrs old  
Approx. Year Built: 1976

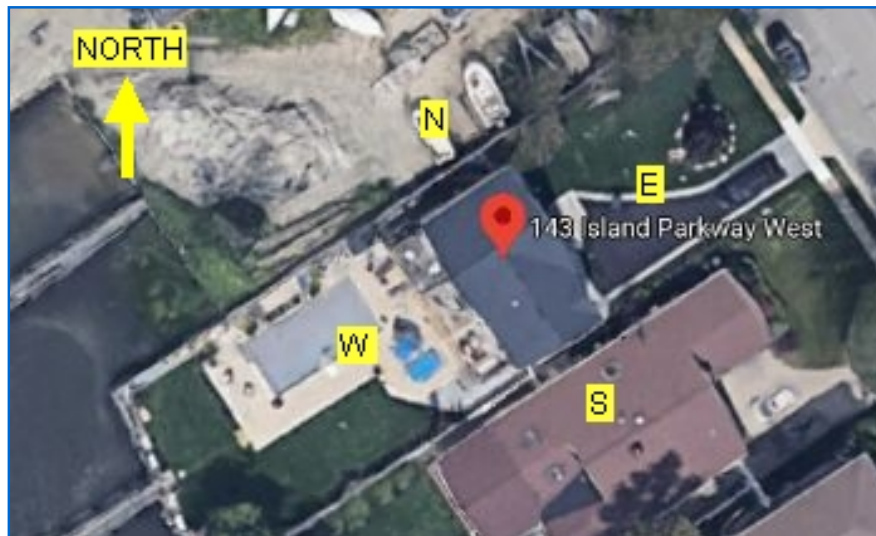
INSPECTION DETAILS Satellite Map

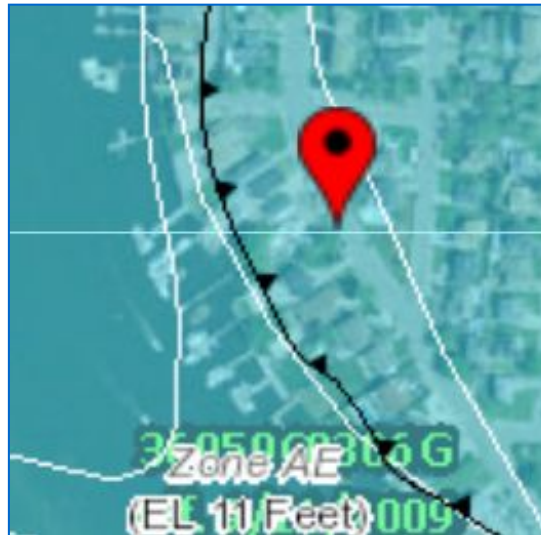
FEMA High-risk flood Zone AE: The home was located in an area designated by the Federal Emergency Management Agency (FEMA) as an AE Zone, which is a high flood risk area lying within a 100-year flood zone and described by FEMA as having a 26% chance of flooding over the life of a 30-year mortgage.

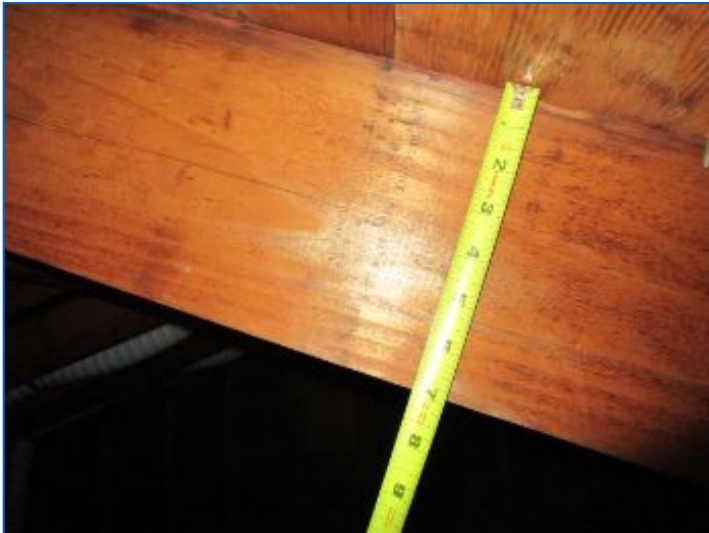
Main Roof Structure: 2x8 Rafters 16" O.C., 2x10 ridge beam, Plywood roof boards.

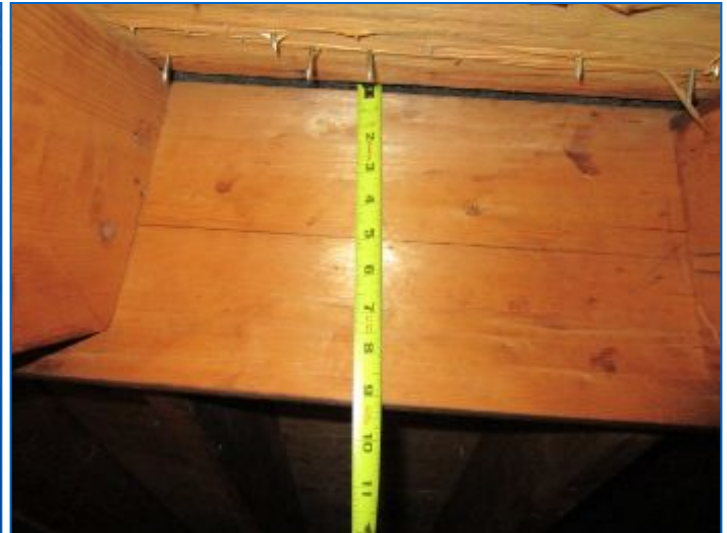
Main Roof Structure: 2x8 Rafters 16" O.C., 2x10 ridge beam, Plywood roof boards.

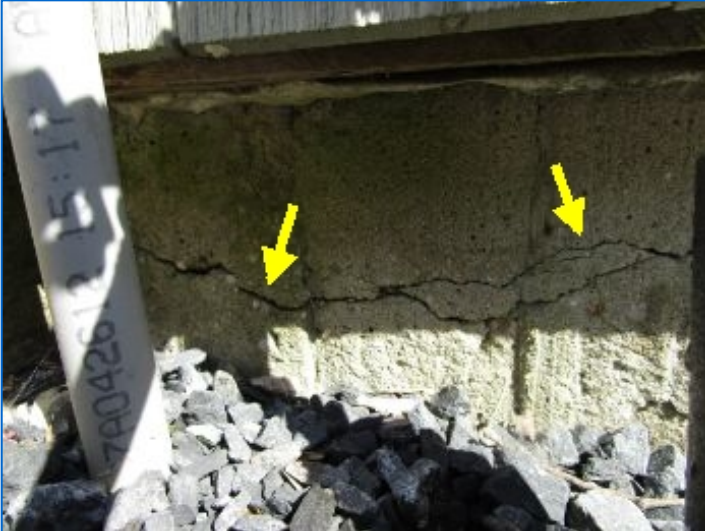
Horizontal cracks observed at north side of slab on grade foundation. It is the Inspector's opinion that these cracks were caused by hydrostatic pressure imposed on the slab foundation from past flooding; hydrostatic pressure pushing up the slab in a dome shape.

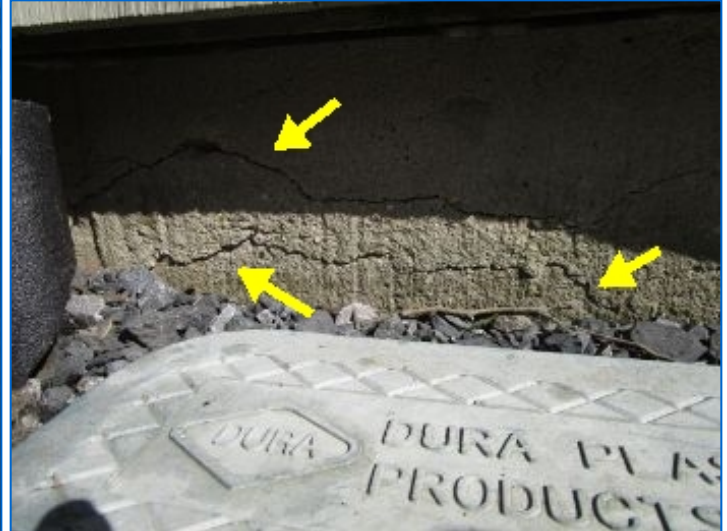
**RECOMMENDATION:** Hire a qualified foundation specialist to further evaluate, repair and seal cracks with epoxy filler to prevent water intrusion, and monitor for further movement.

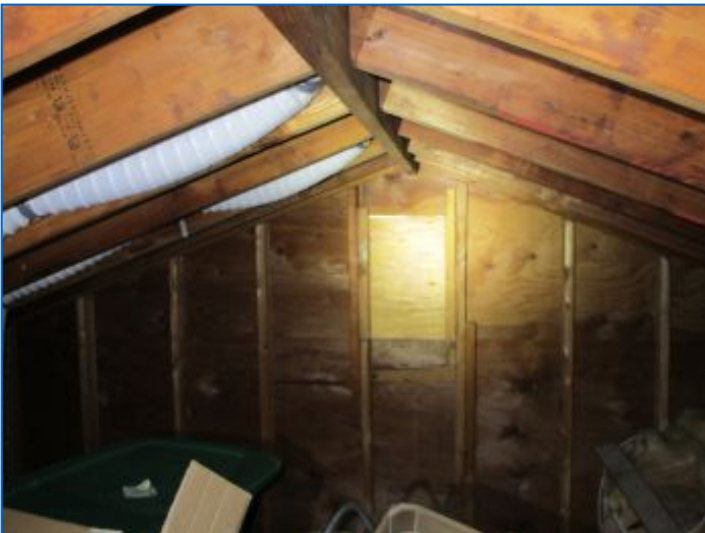
No significant structural deficiencies observed at the visible portions of the roof structure - In normal condition for its age.

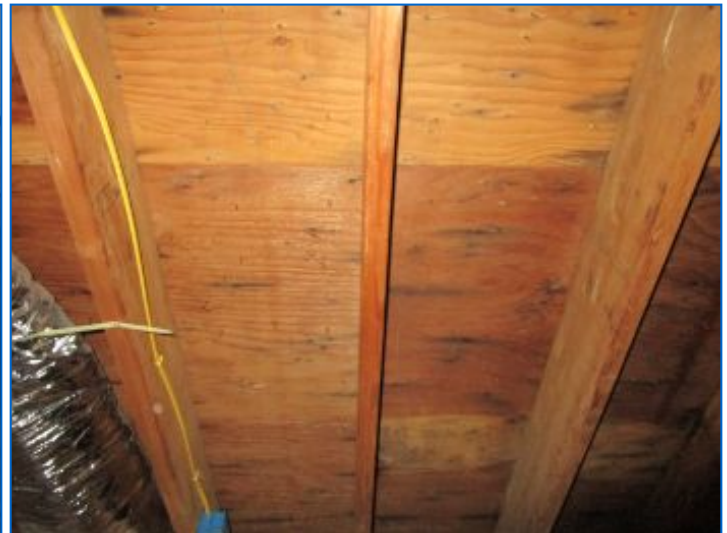
No evidence of moisture penetration at visible portions of the roof structure were observed at time of inspection.

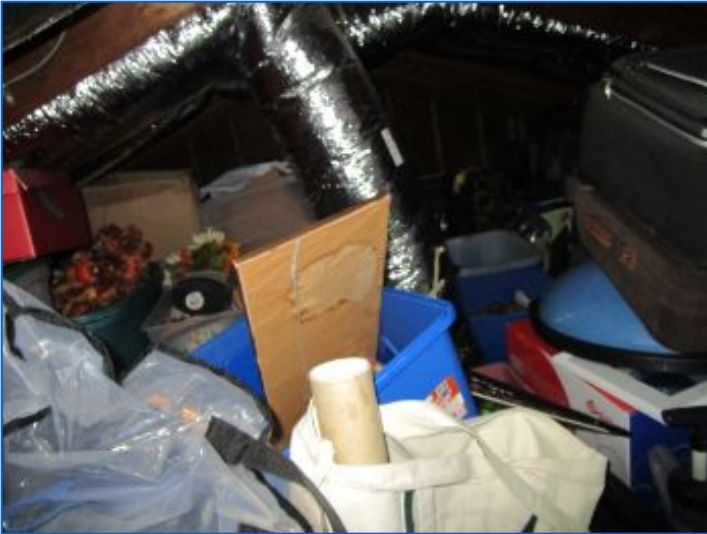
Not all areas of the attic were accessible due to heavy storage of personal items.

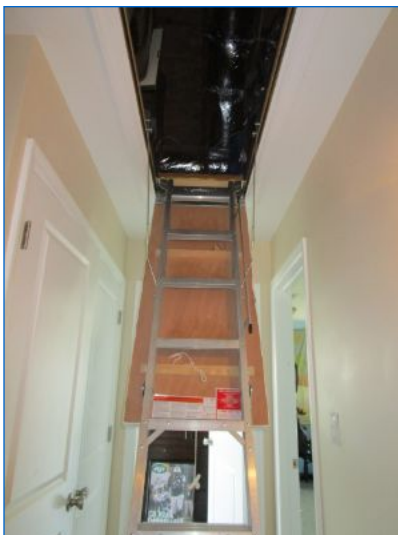
Pull-down ladder located in Hallway (2nd floor).

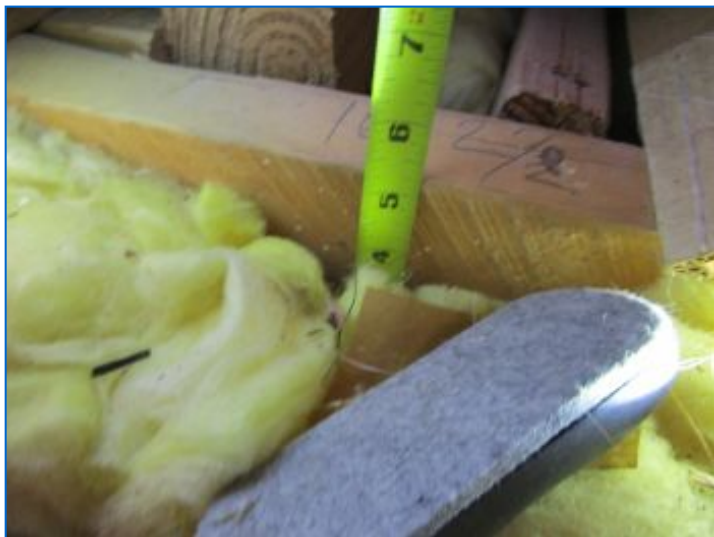
Insulation depth varied 4 - 5 inches (R-15.5 overall). Latest energy conservation standards call for 8-9 inches (R-30). Additional insulation should be installed where possible for enhanced energy efficiency of the home. Refer to attached US Department of Energy R-Value Recommendations.

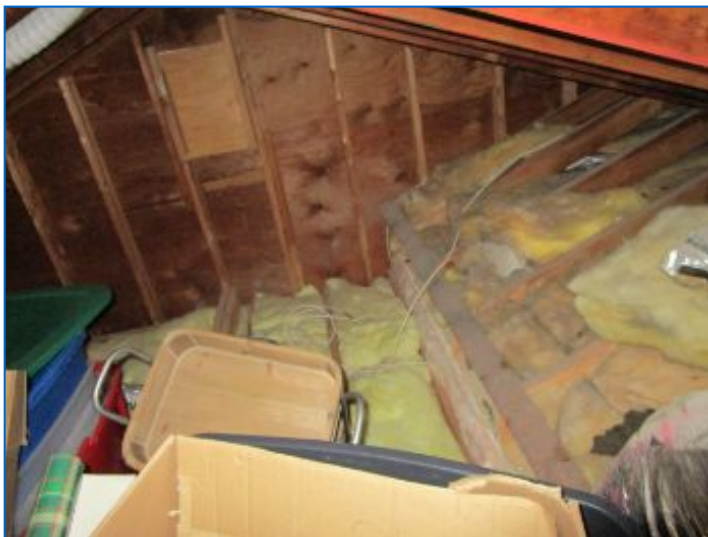
Insulation installed in floor joist cavities / vaulted area wall cavities.

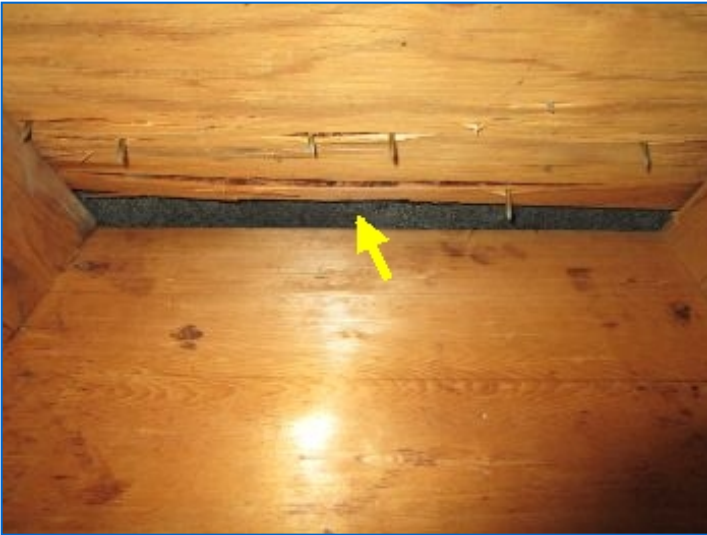
Ridge exhaust venting noted

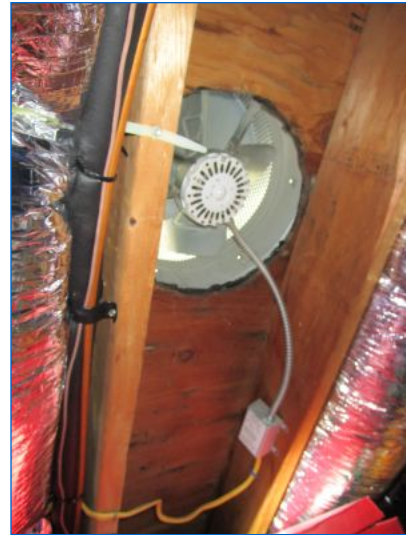
Thermostatically controlled Power Ventilator was operable.  
Recommended Temperature setting is 85 deg F.

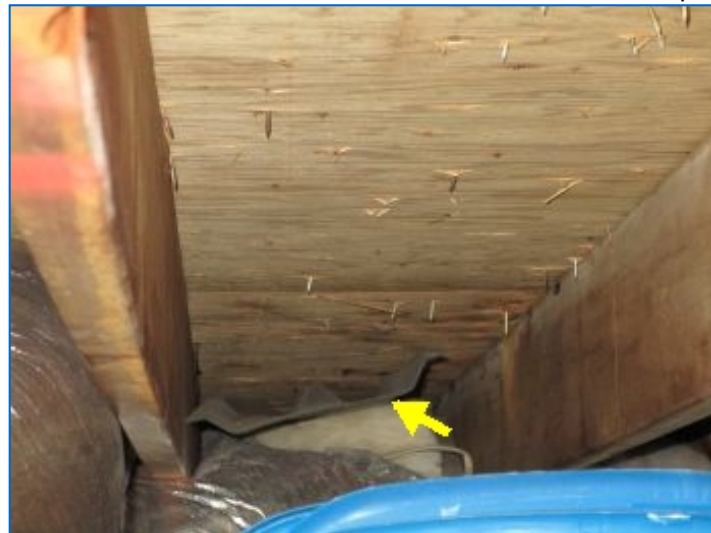
Some insulation baffles noted to facilitate under eave soffit venting.

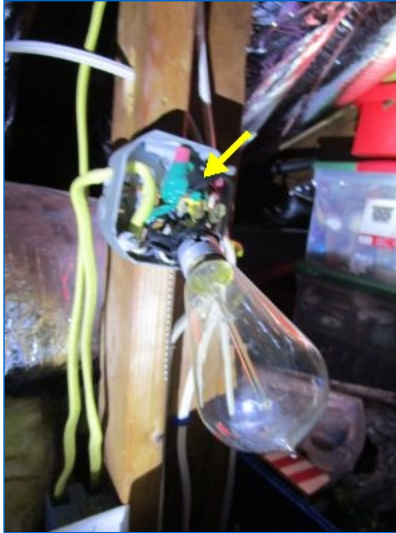
Exposed electrical wiring observed at open Junction Box; potential shock or electrocution hazard. Recommend electrician perform corrective repair to ensure safety; install proper cover to enclose exposed wires.

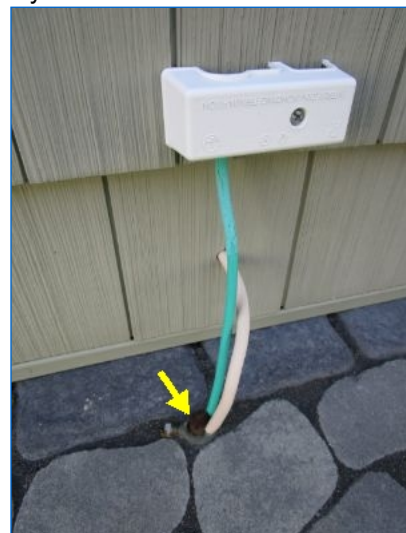
Ground conductor to ground rod noted at service entrance per current standard.

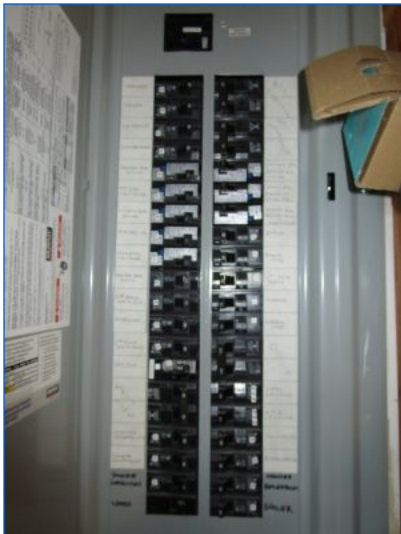
Main Panel Breakers: 40 full-size circuit breaker spaces; 0 spare breaker space/s noted; 1 breaker/s in the Off/Tripped position.

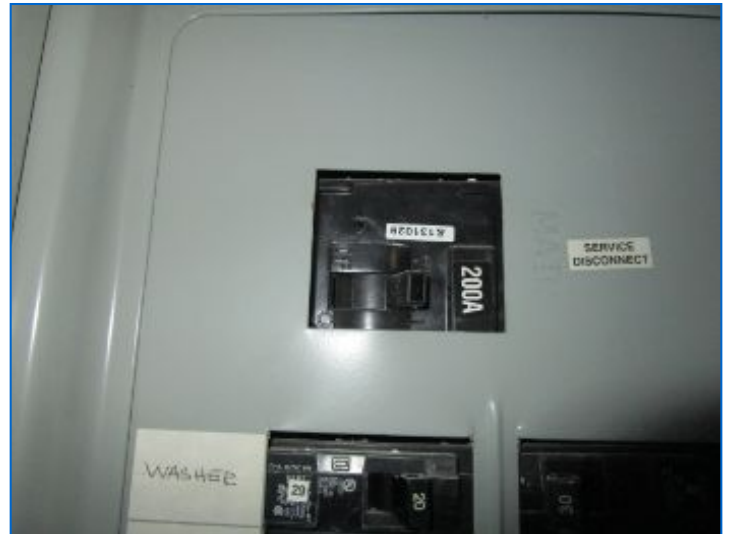
Main Disconnect: 200 amp main breaker serves the property.

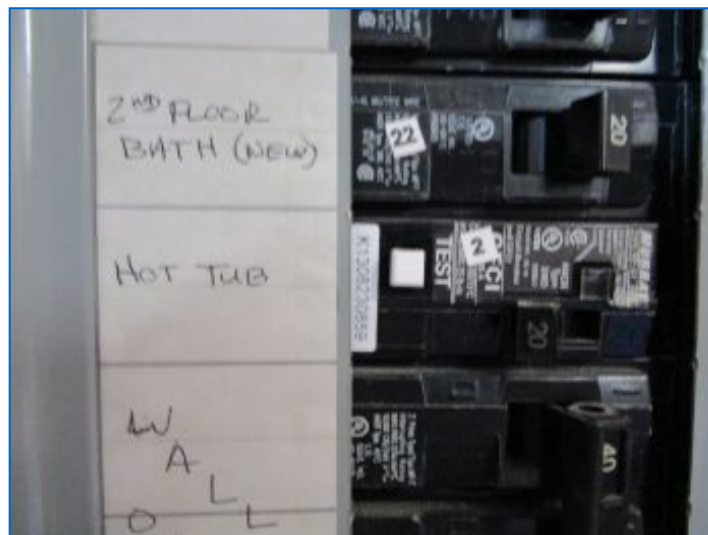
Main Panel 20 amp breaker labeled "Hot Tub" was in the Off/Tripped position.

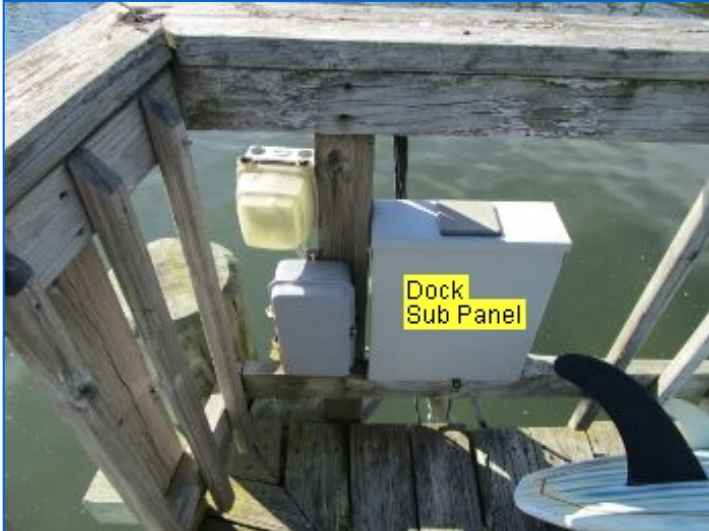
Dock sub panel and lighting timer/switches noted at NW corner of bulkhead.

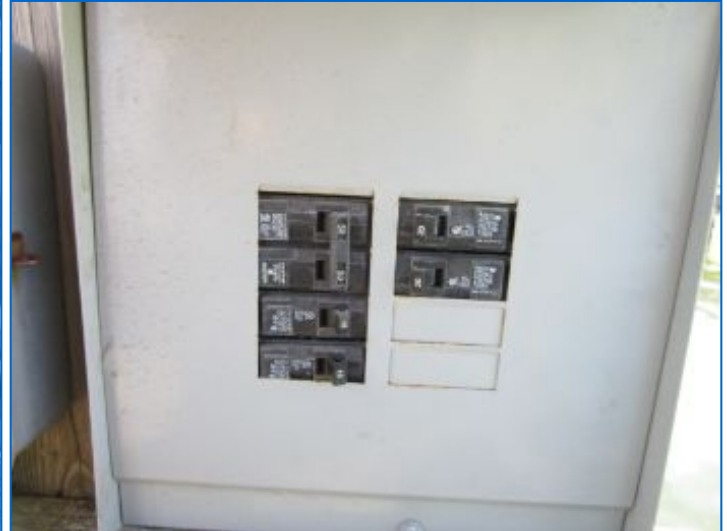
Dock Sub Panel located at NW corner of bulkhead. Sub Panel Disconnect: 100 amp main breaker located in the Main Panel. Sub Panel Breakers: 8 full-size circuit breaker spaces; 2 spare breaker space/s noted; 0 breaker/s in the Off/Tripped position.

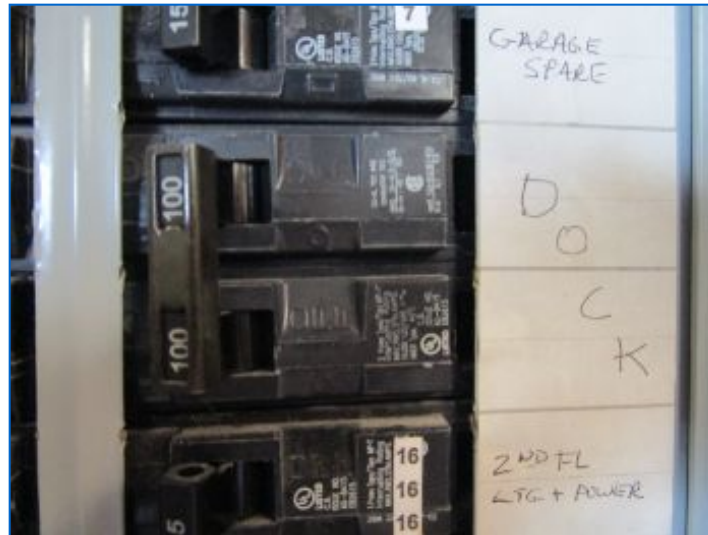
Sub Panel Disconnect: 100 amp main breaker located in the Main Panel.

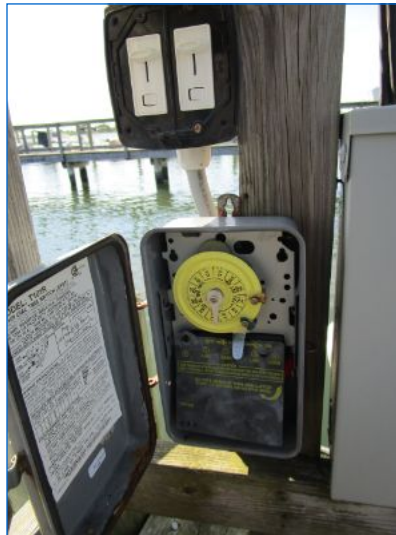
Dock lighting timer/switches at NW corner of bulkhead

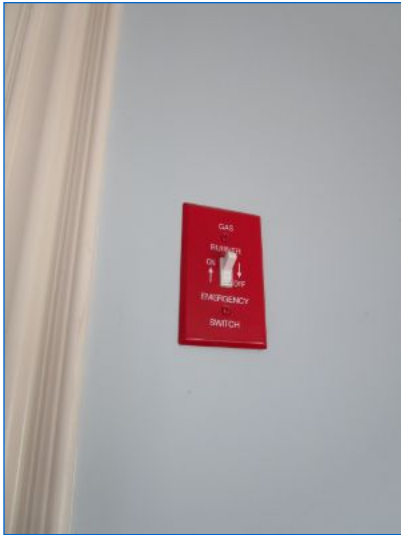
Gas Burner: Remote Emergency Shut-off switch noted.

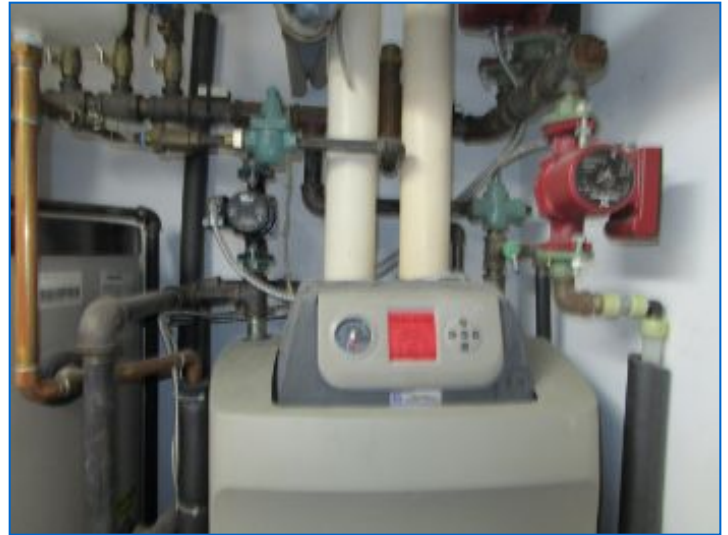
Forced hot water heating was disabled by the unit's controller "WARM WEATHER SHUTDOWN"; unable to test comfort heat distribution system at time of inspection. Recommend having seller demonstrate proper operation of this mode using the zone thermostats prior to close. System's integral Domestic HW Heating mode was functional at time of inspection.

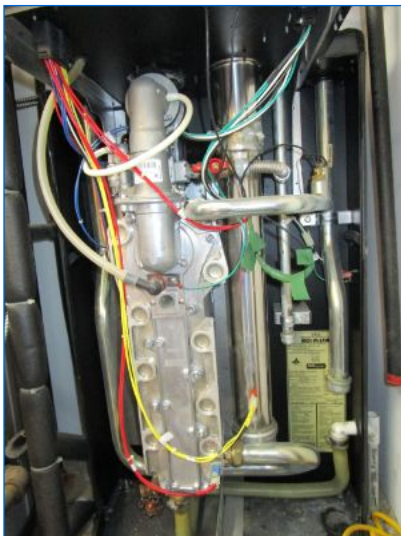
Due to the higher efficiency of this unit, this review is limited. Most areas are sealed and inaccessible. We suggest review by a licensed heating contractor if a more detailed review is desired.

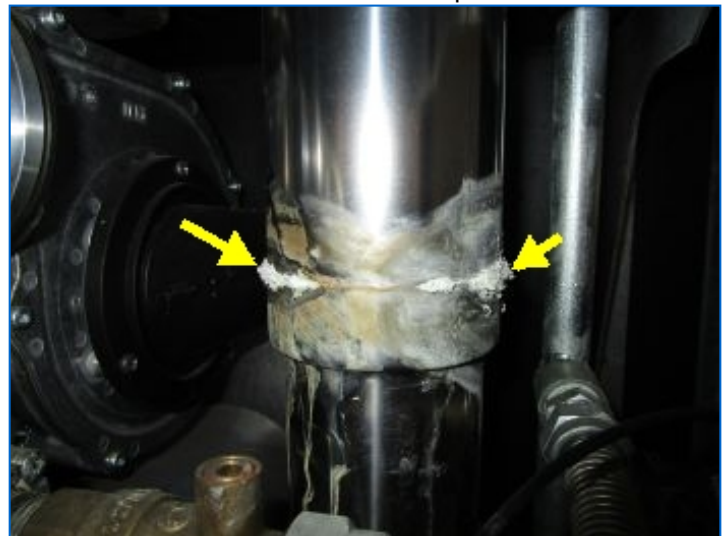
Deposits observed at boiler's flue pipe connection inside the unit. Recommend review by a licensed heating contractor.

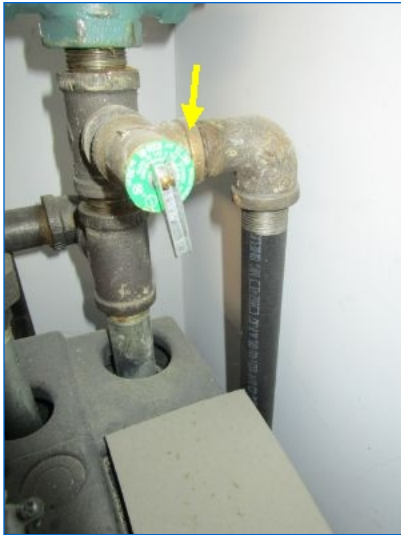
TPR (Temperature Pressure Relief) valve and discharge pipe installation showed no deficiencies.

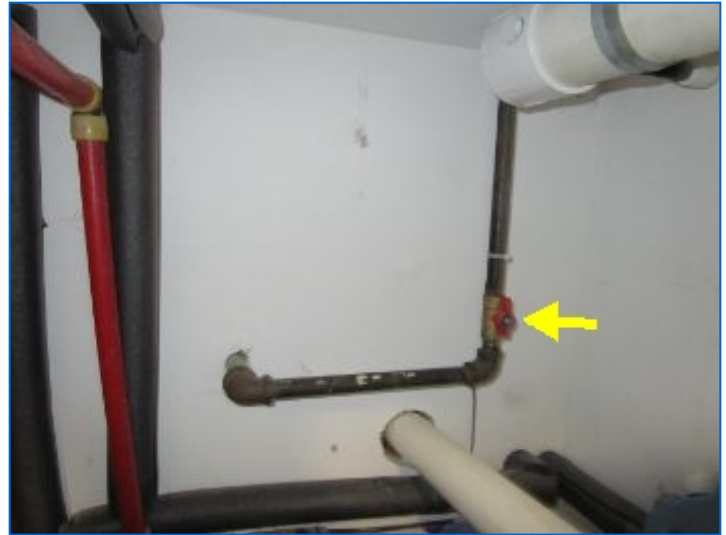
Gas shut-off valve noted at burner.

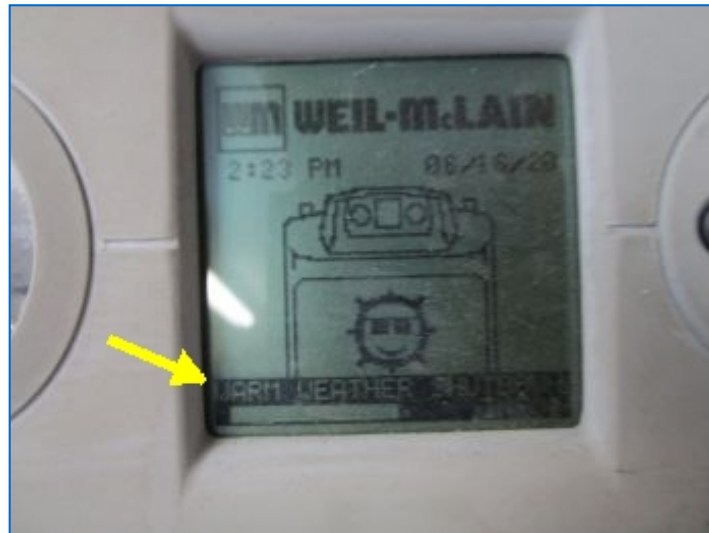
Forced hot water heating was disabled by the unit's controller "WARM WEATHER SHUTDOWN"; unable to test comfort heat distribution system at time of inspection. Recommend having seller demonstrate proper operation of this mode using the zone thermostats prior to close. System's integral Domestic HW Heating mode was functional at time of inspection.

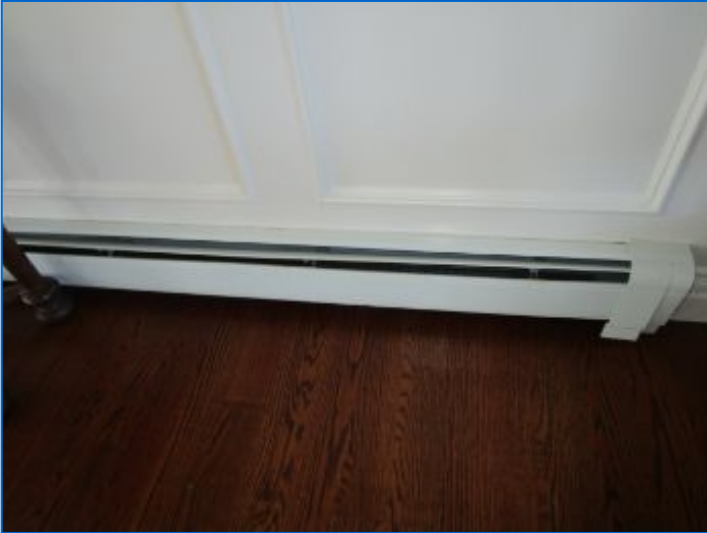
Heat distribution type/s included Baseboard.

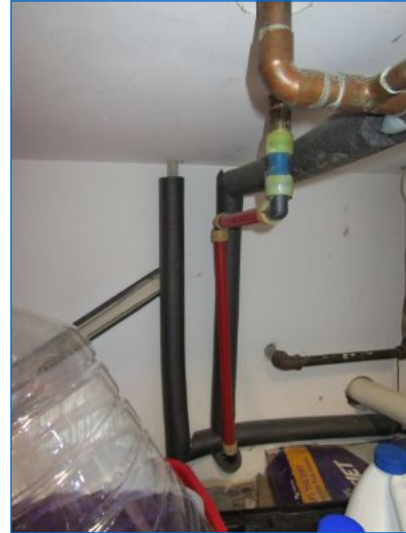
Heat Distribution Piping observed included: Black steel, copper and PEX.

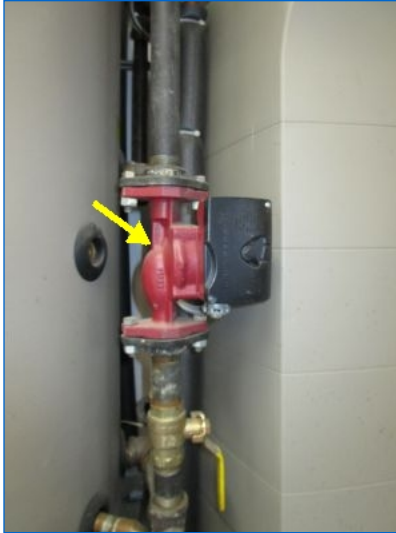
One pump is dedicated to water heater storage tank.

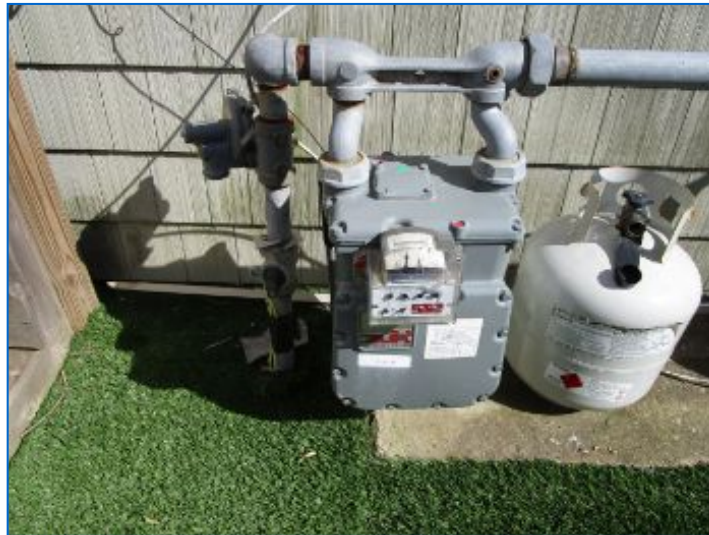
Public Gas Service: Outside meter w/shutoff valve and vented regulator noted.

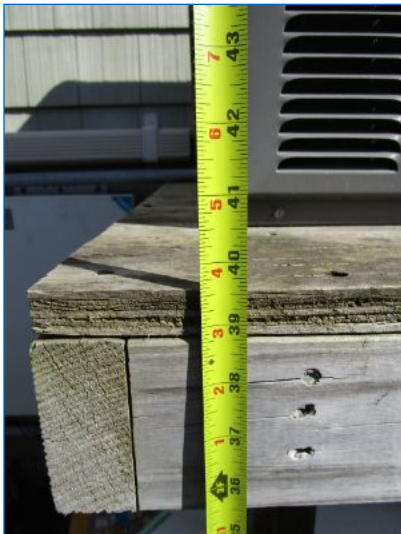
Coastal Areas: The most effective flood-resistant design for outdoor HVAC equipment is to strap or bolt the equipment onto a platform above the Design Flood Elevation (DFE).

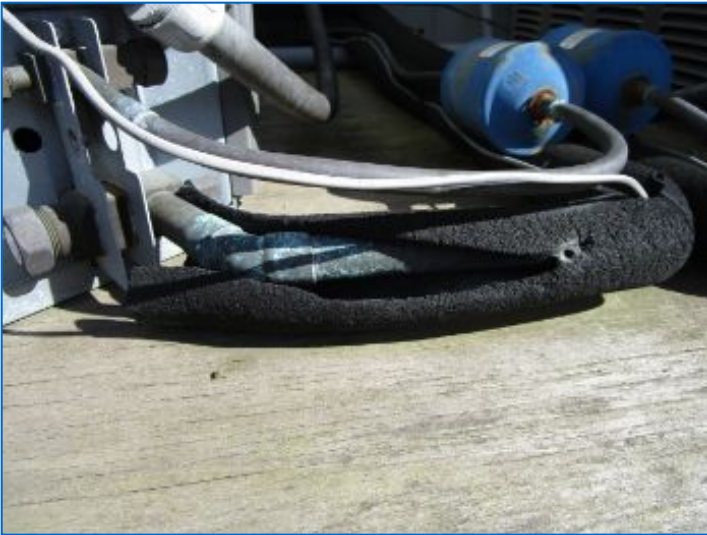
AC#2 section of outdoor refrigerant pipe insulation to outdoor condenser was Deteriorated/Missing. Recommend repairing defective insulation for the larger suction line.

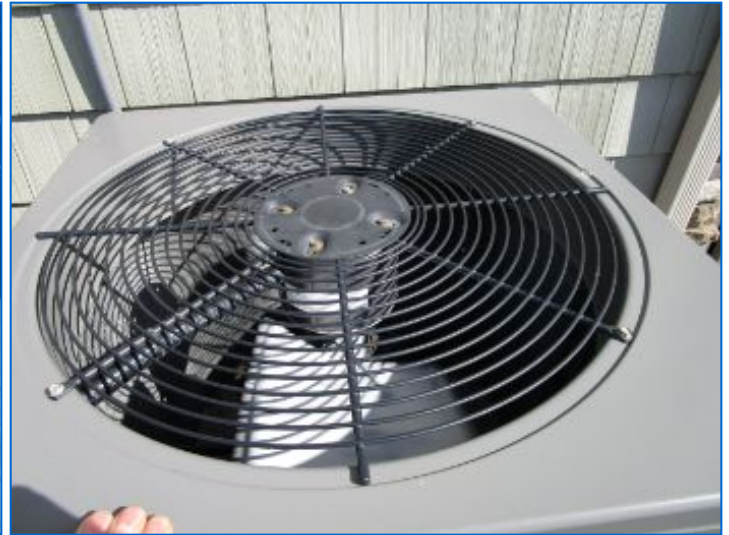
A/C systems operated by means of their thermostat.

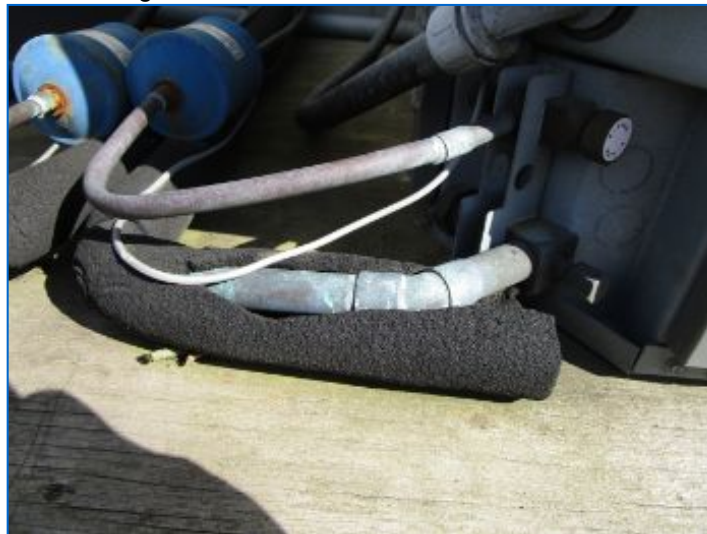
AC#1 section of outdoor refrigerant pipe insulation to outdoor condenser was Deteriorated/Missing. Recommend repairing defective insulation for the larger suction line.

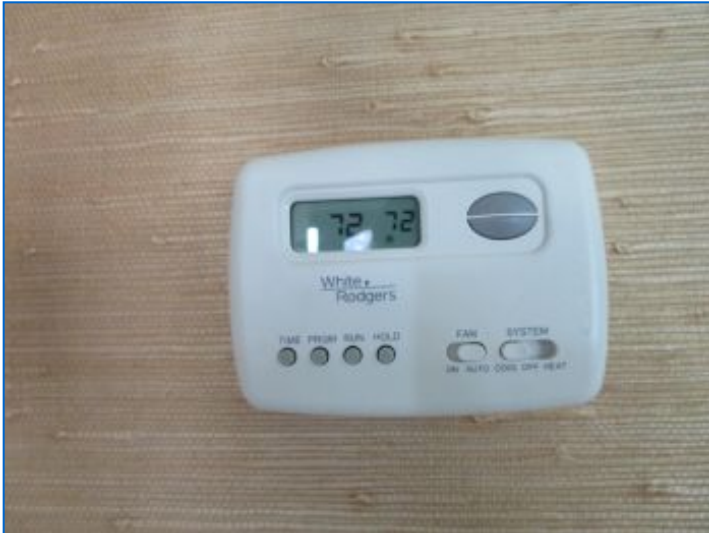
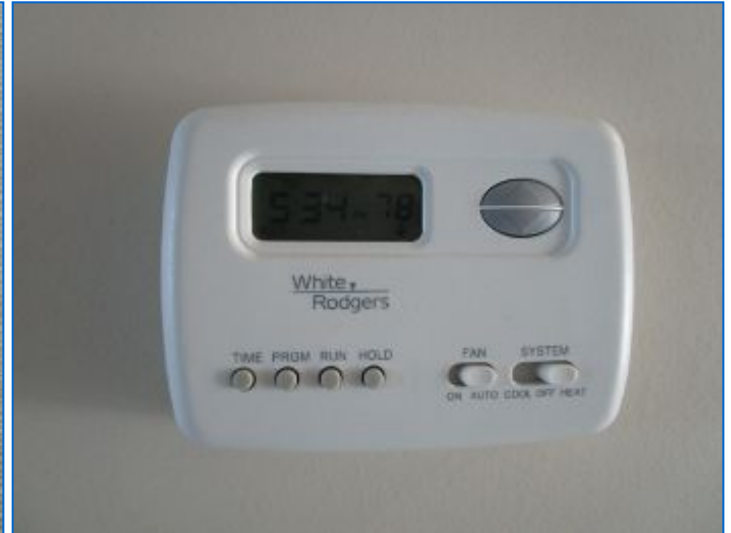
Digital Programmable type thermostat noted in Living room; for Heating & Cooling. Digital Programmable type thermostat noted in Hallway (2nd floor); for Heating & Cooling.

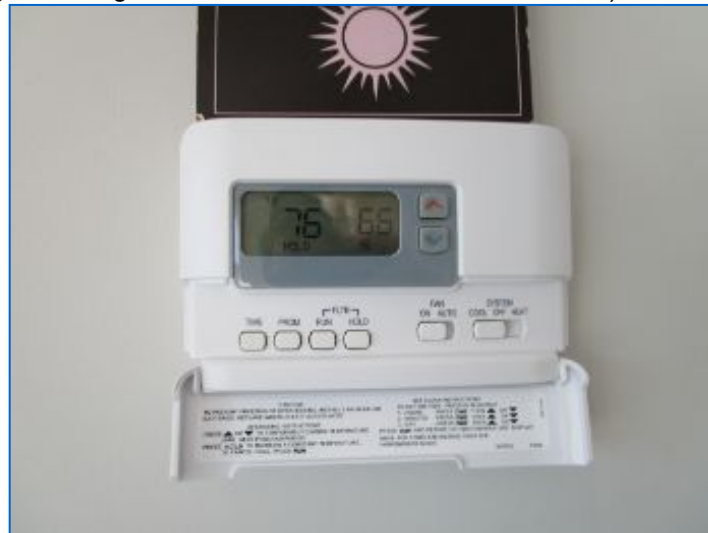
Digital Programmable type thermostat noted in Master bedroom; for Heating only.

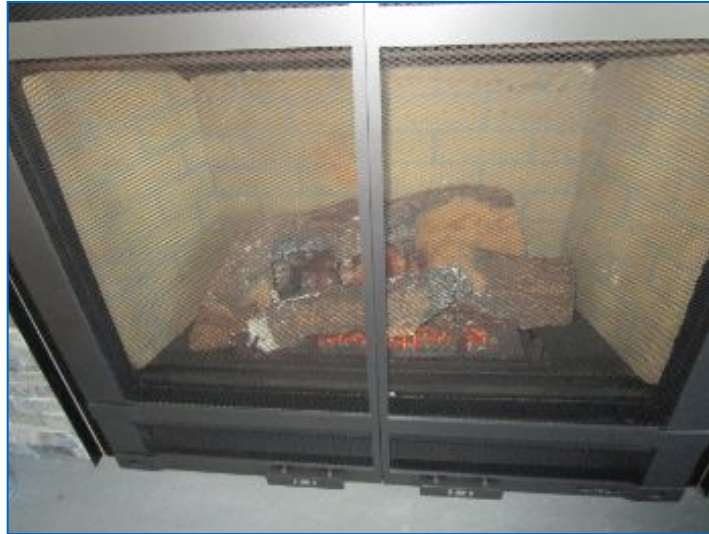
Gas-burning fireplace in the Living room was operable.

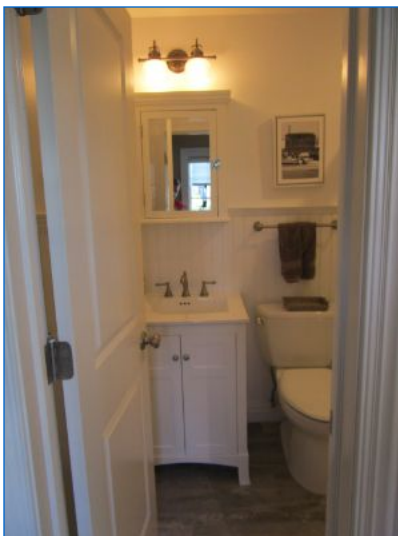
1st Floor Bathroom, Stall Shower, Toilet, Lavatory, Exhaust Fan (operable), Shower/Tub Walls: Ceramic tile, Floor: Porcelain/Ceramic tile, HVAC (Baseboard), HVAC (A/C Register)

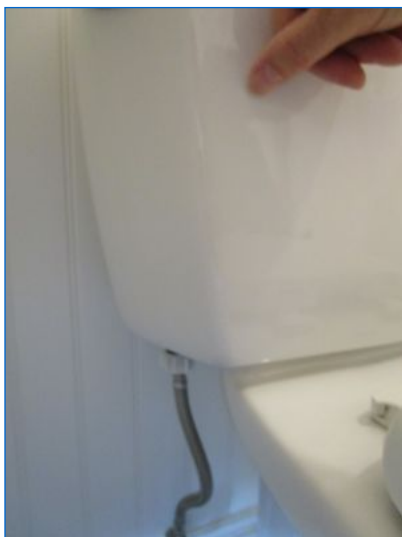
Toilet tank did not appear securely mounted to the bowl. Suggest corrective repair to ensure adequate seal at bolt connections.

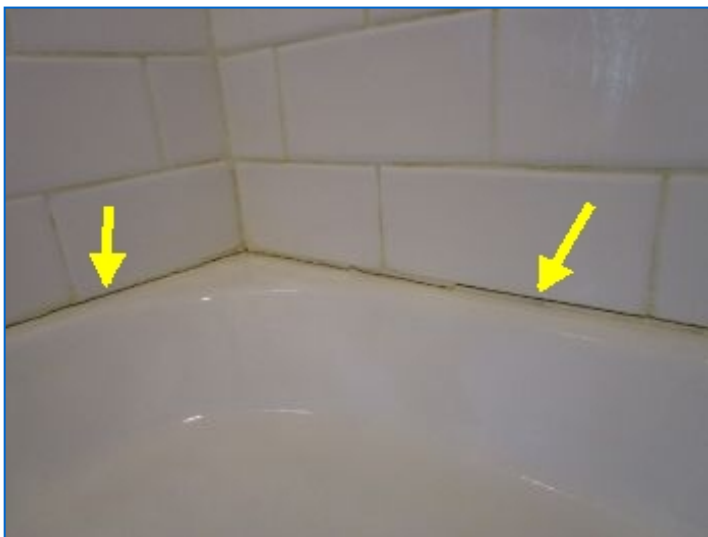
Shower pan perimeter grout (movement joint) is cracked/missing. Recommend replacing grout with matching silicone based sealant at movement joints to prevent further water penetration.

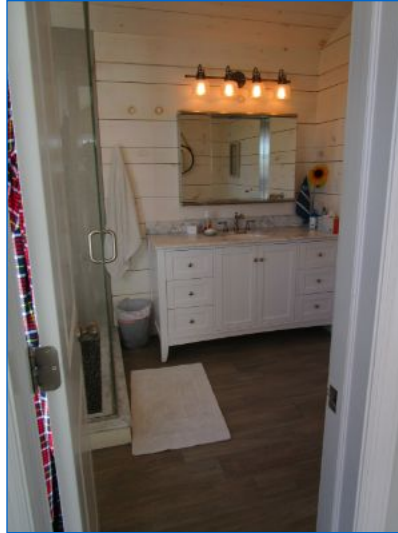
## BATHROOMS Continued

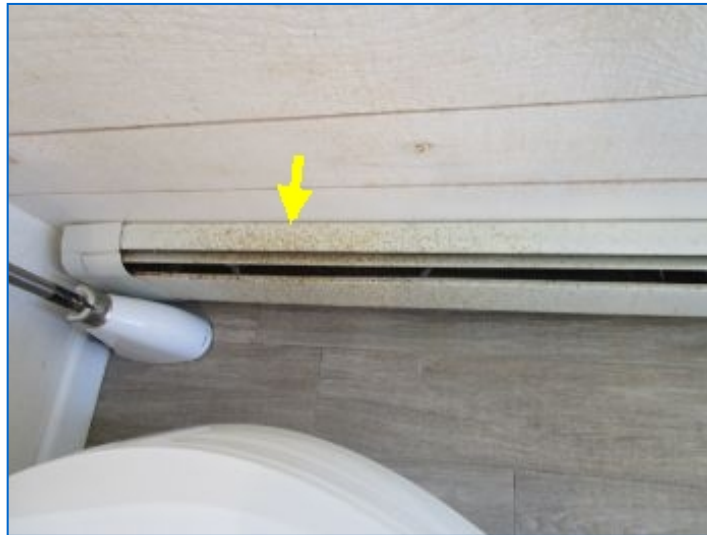
Baseboard enclosure had rusted finish.

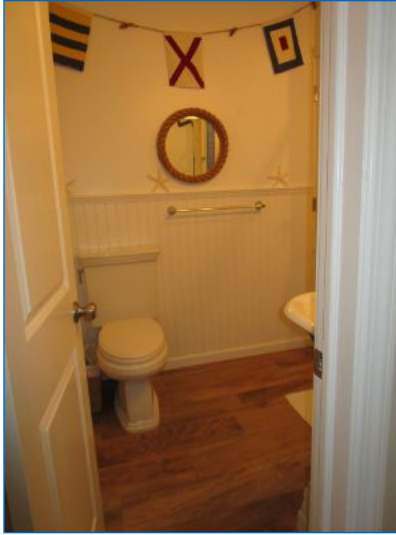
2nd Floor Hall Bathroom

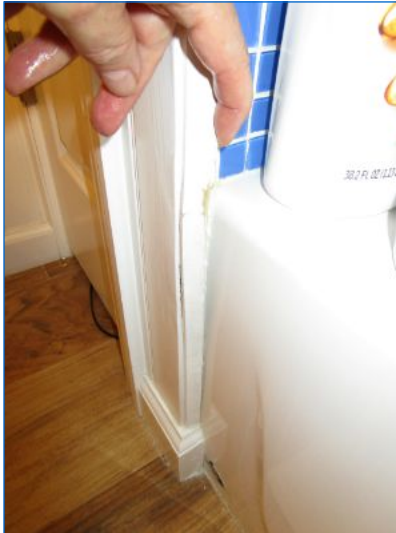
Wood at tub molding was moisture damaged; recommend repair.

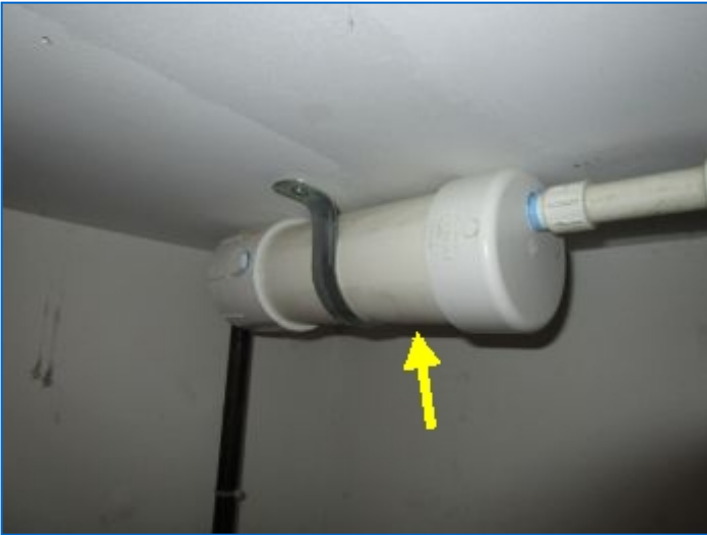
Condensate neutralizer noted. This vessel is installed in the condensate drain from a condensing boiler, water heater or furnace (before it enters the sewer). It's filled with media which raises the pH level of the condensate, making it safe to discharge into the sewage or septic system.

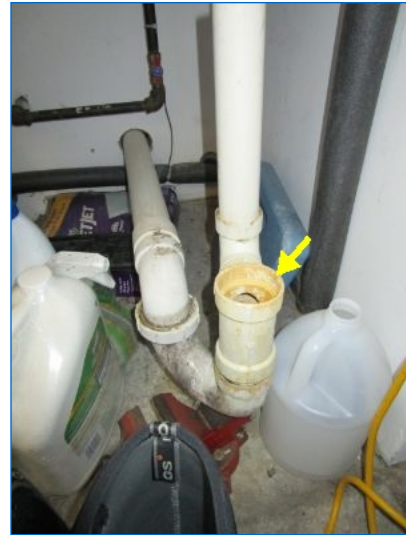
Open DWV pipe noted. Recommend review and correction by a licensed plumbing/heating contractor to ensure that sewer gases don't enter the home.

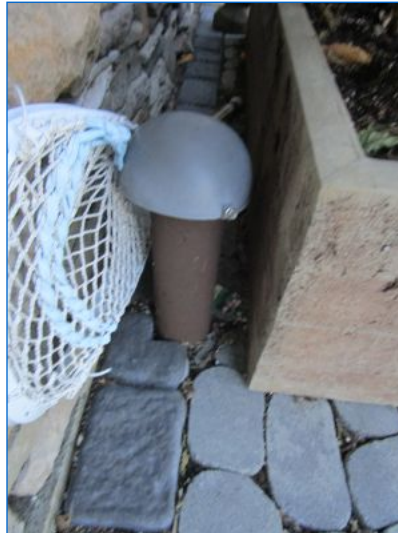
Plumbing Vent for waste line exit located at Front exterior. Whole-house trap is at this location, covered by soil and non-mortared pavingstones.

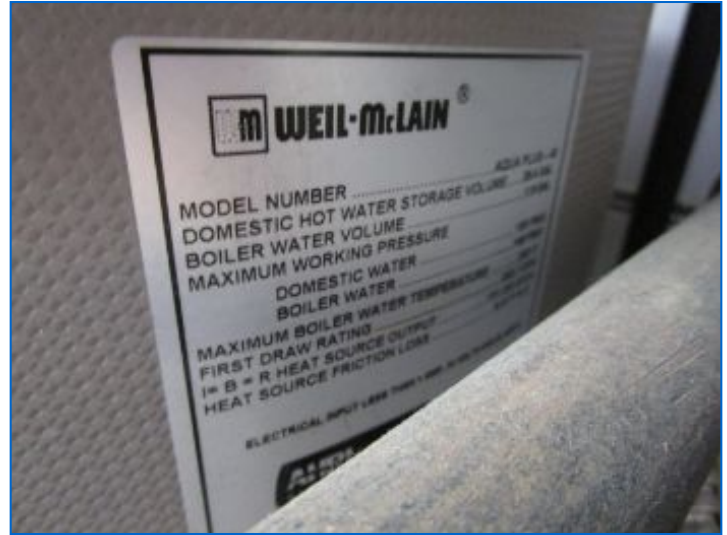
Weil McLain 39 gallon capacity unit. Water Heater Storage Tank data plate/serial no. indicates a manufacture date of 4/2014, (6 yrs old).

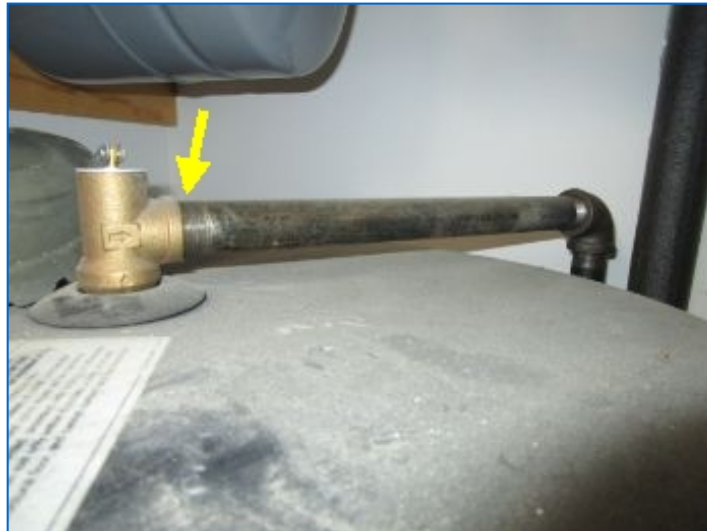
Temperature Pressure Relief (TPR) valve and discharge pipe showed no deficiencies.

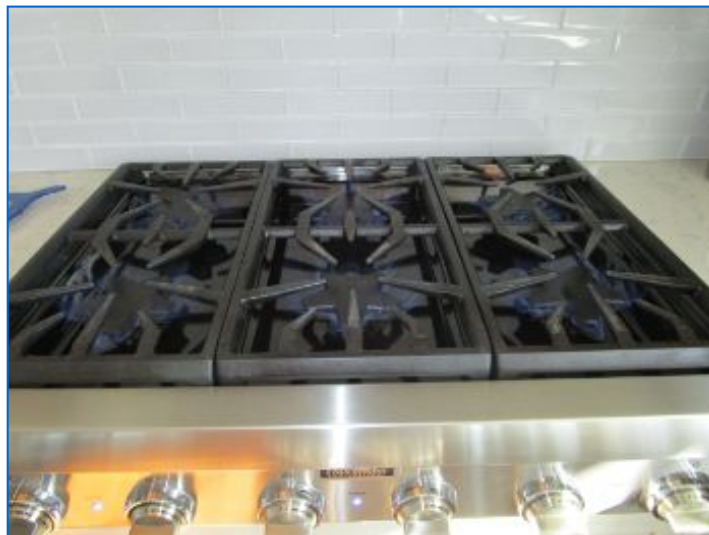
Gas-fired cooktop was operable at time of inspection.

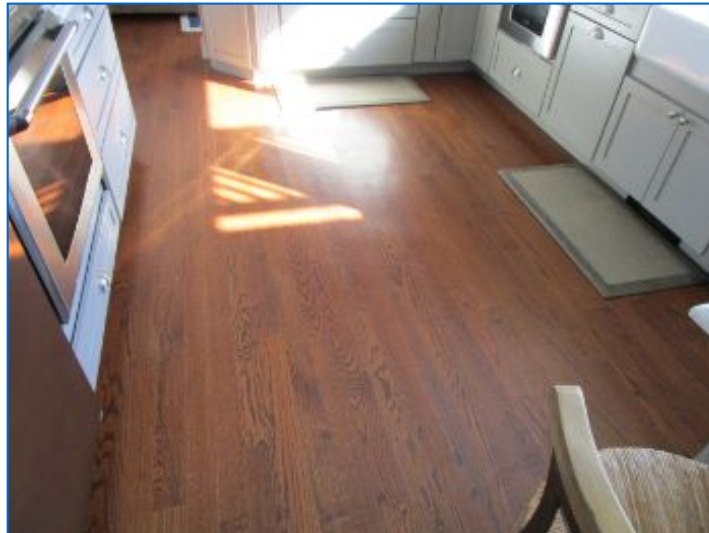
Solid Hardwood flooring noted.

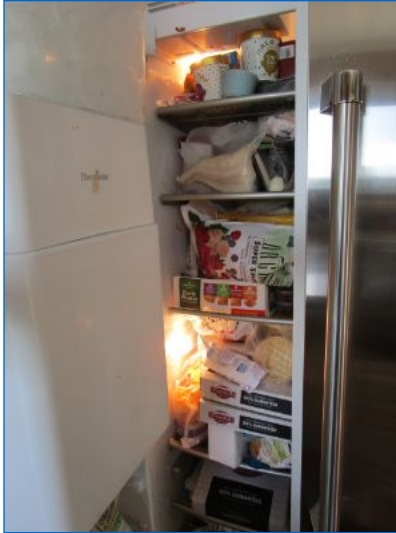
Refrigerator/freezer operating and frost free at time of inspection.

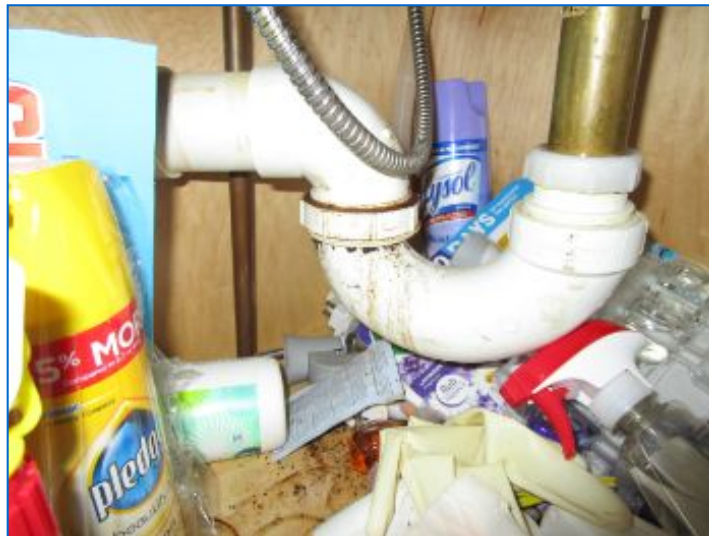
Signs of past drain pipe leaks at coupling; suggest checking for tightness and monitor. Stains/cosmetic damage noted at sink cabinet floor; signs of past leaks or spilled products.

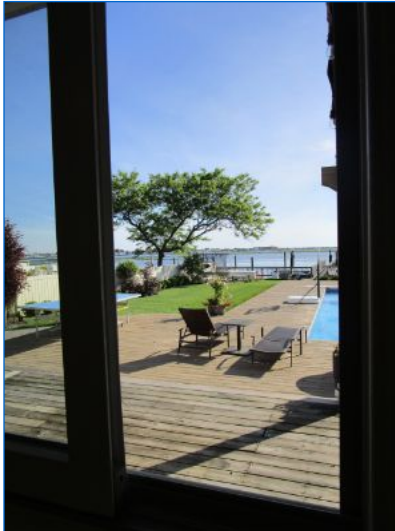
Screens missing or not installed at the time of inspection (check attic).

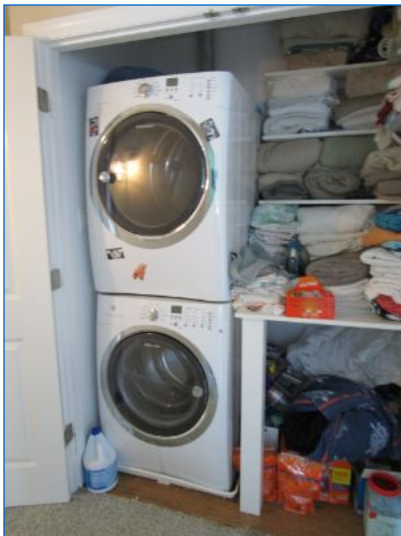
LAUNDRY - Upper Level Laundry - Upper Level

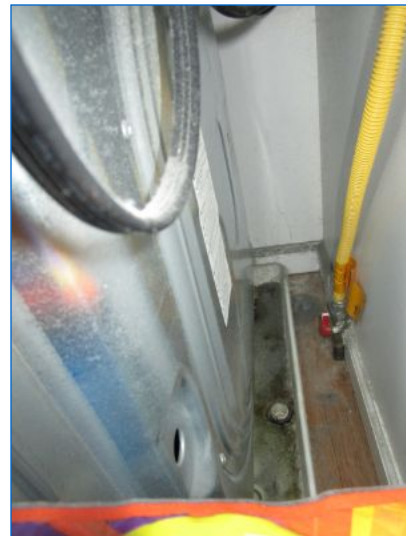
Leaks: No signs observed at time of inspection.

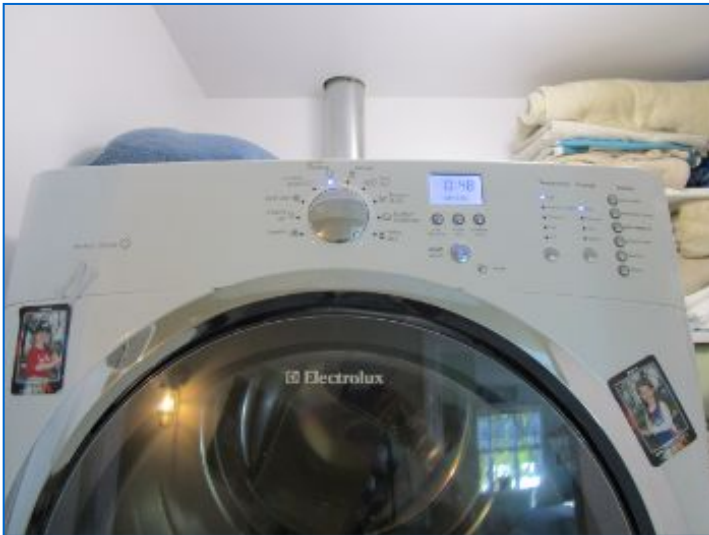
Gas Dryer was operable at time of inspection.

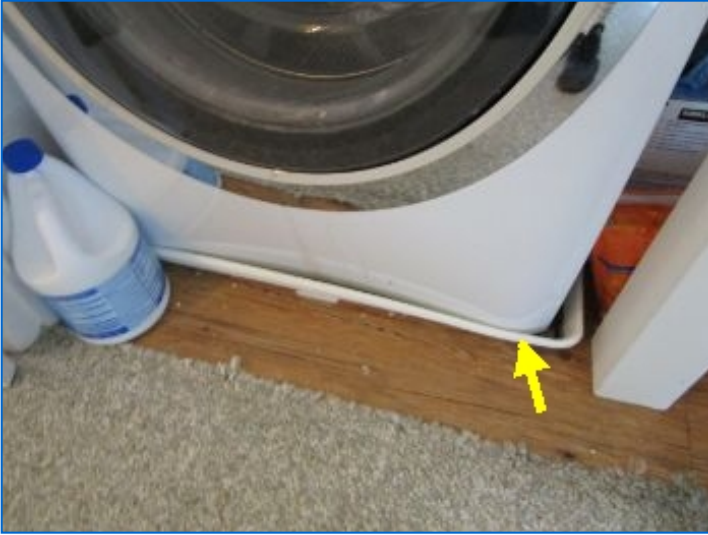
Washer area appeared contained, however a floor drain was not observable at time of inspection; no water leak catch pan noted under the clothes washer appliance. Where a washer is installed in a location where a major water leak from the washer appliance could cause damage, a floor drain or water leak catch pan should be installed under the washer. Confer with Seller as to the existence of a floor drain hidden from view under the appliance.

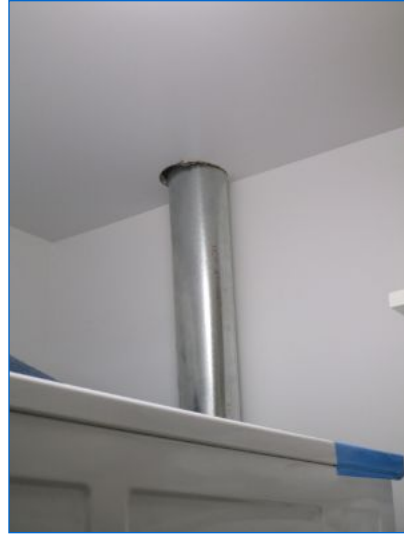
Dryer appeared to be vented to the exterior.

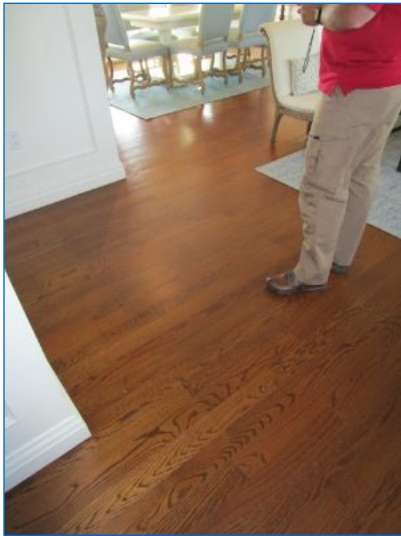
Main Level flooring included Solid Hardwood throughout.
