# ProSpec Home Inspection of Long Island Property Inspection Report

143 Island Parkway W, Island Park, NY 11558  
Inspection prepared for: Name Deleted  
Date of Inspection: 6/16/2020 Time: 5:00 PM  
Age of Home: 44 yrs old  
Approx. Year Built: 1976

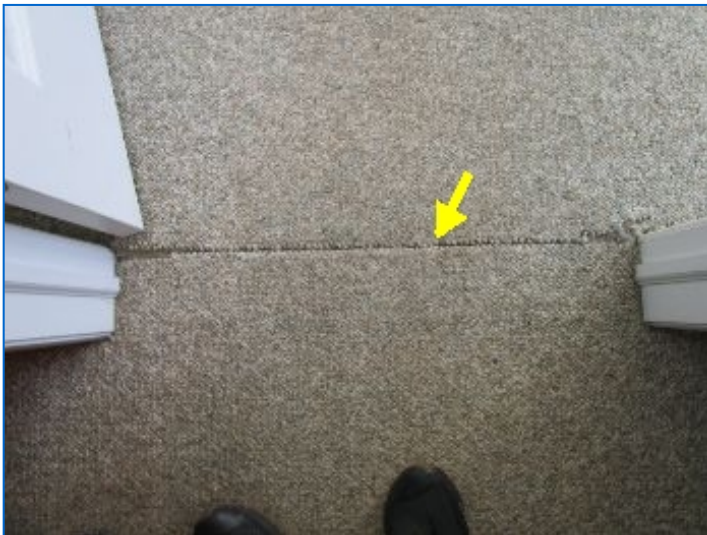
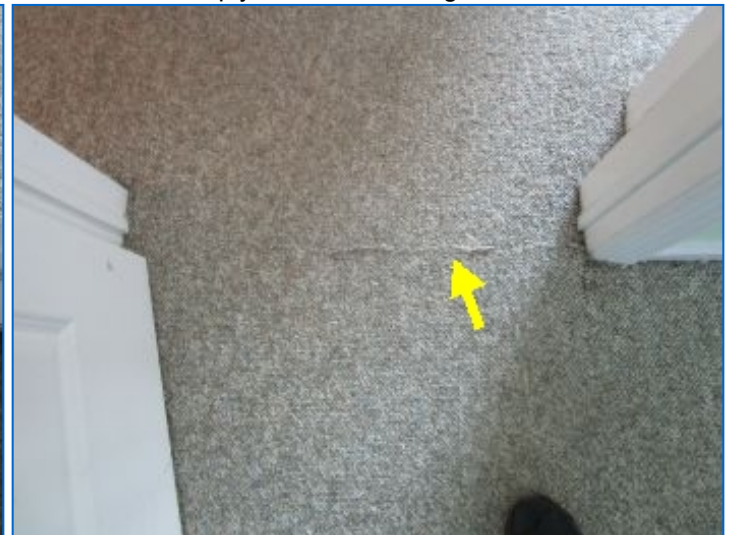
Transition strips missing at upstairs bedroom carpet seams. Transition strips missing at upstairs bedroom carpet seams.

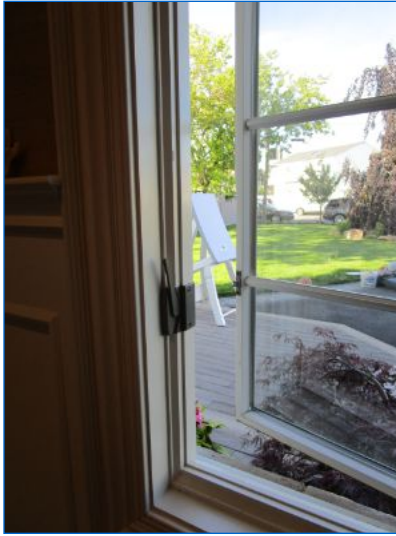
Screens missing or not installed at the time of inspection (check attic).

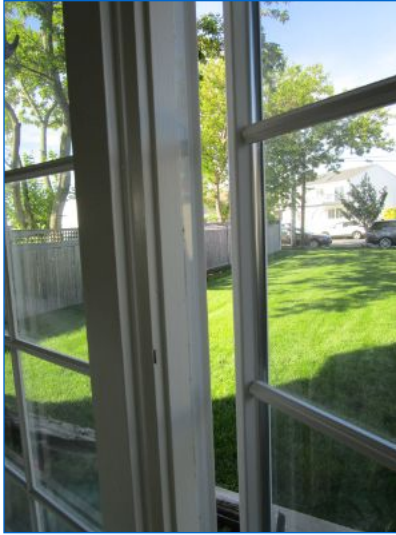
Screens missing or not installed at the time of inspection (check attic).

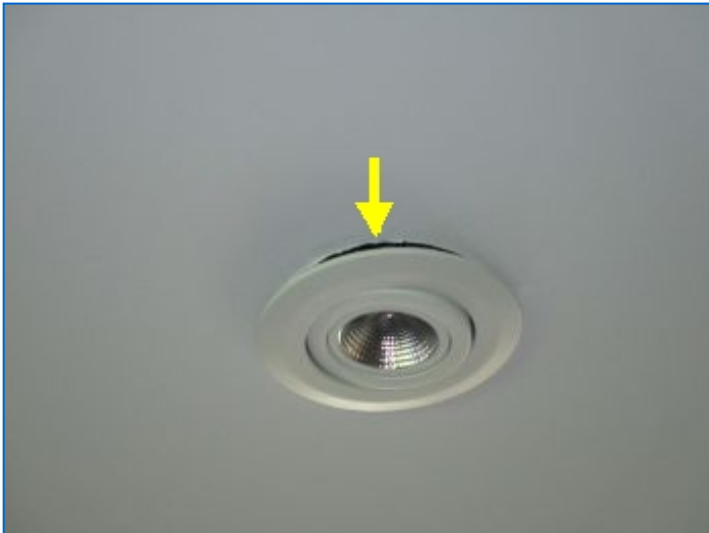
Some cosmetic deficiencies noted at a few recessed light fixtures.

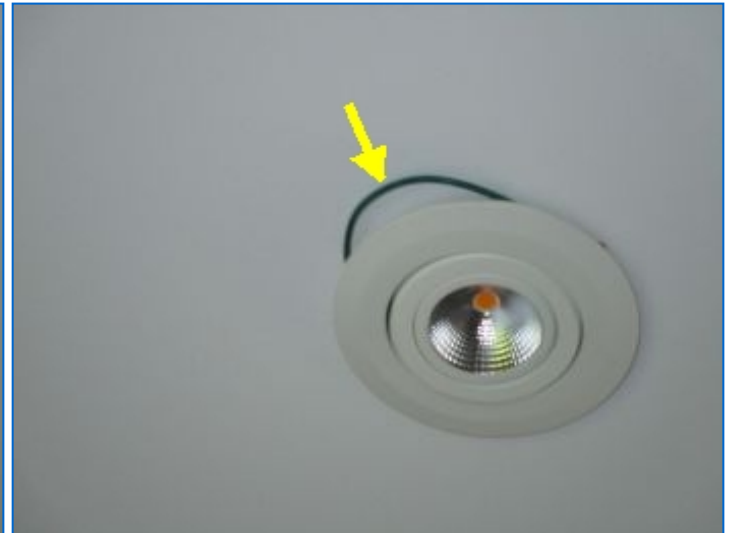
Some cosmetic deficiencies noted at a few recessed light fixtures.

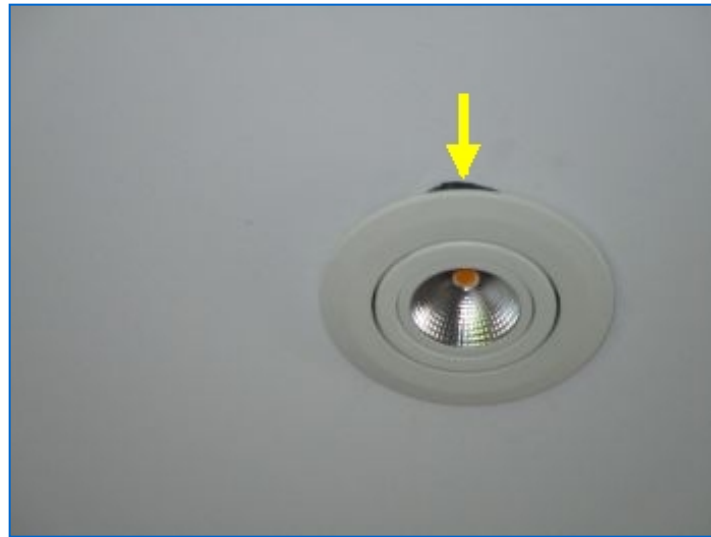
Some cosmetic deficiencies noted at a few recessed light fixtures.

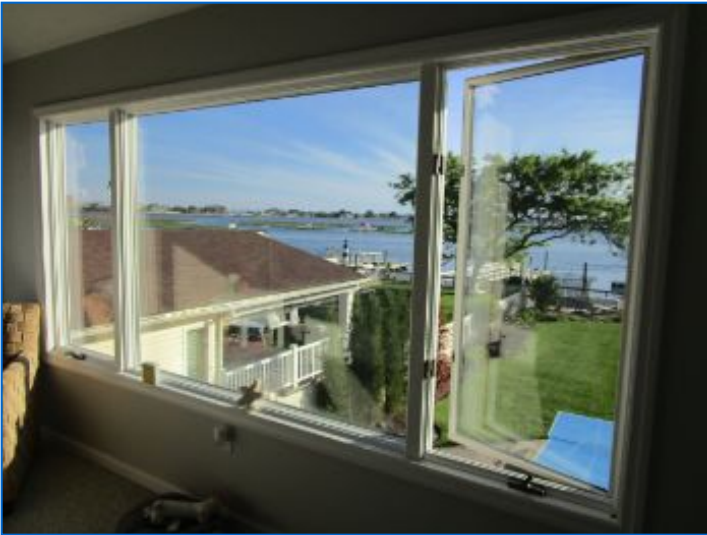
Screens missing or not installed at the time of inspection.

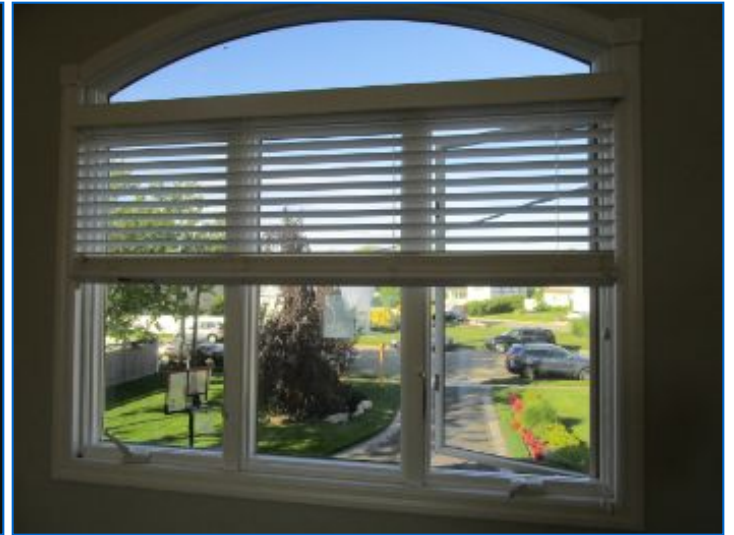
Screens missing or not installed at the time of inspection.

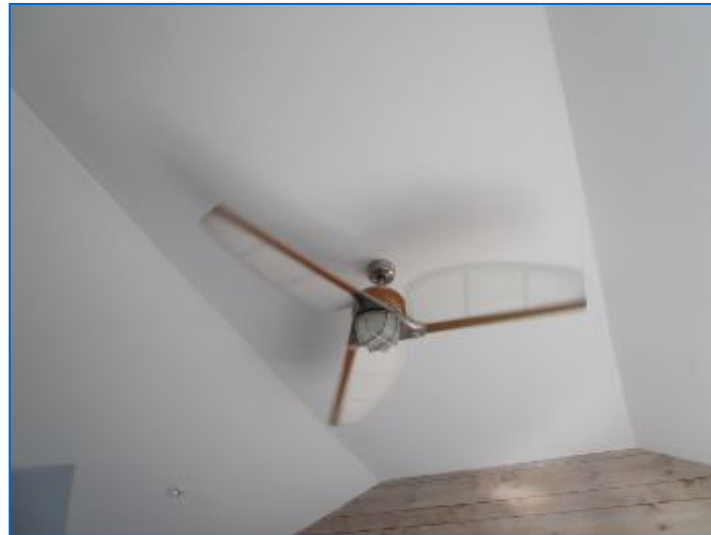
Ceiling fan operated normally when tested at time of inspection.

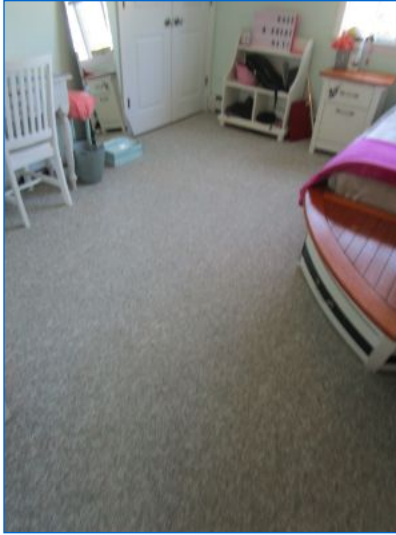
Carpeted floor noted.

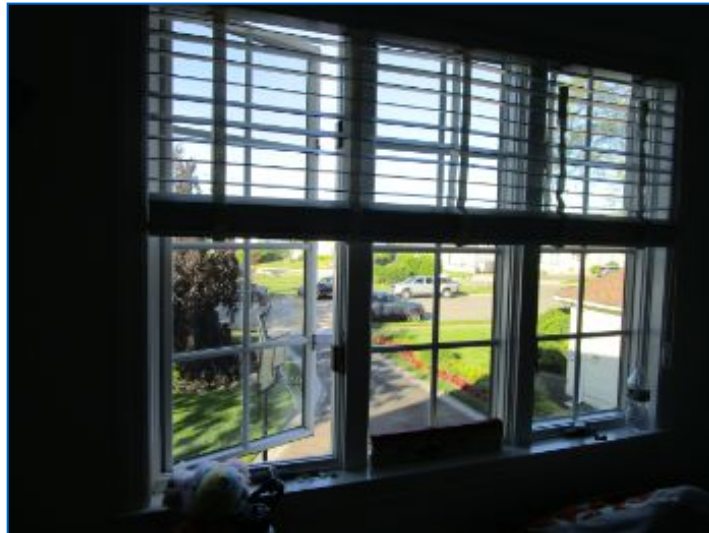
Screen missing or not installed at the time of inspection.

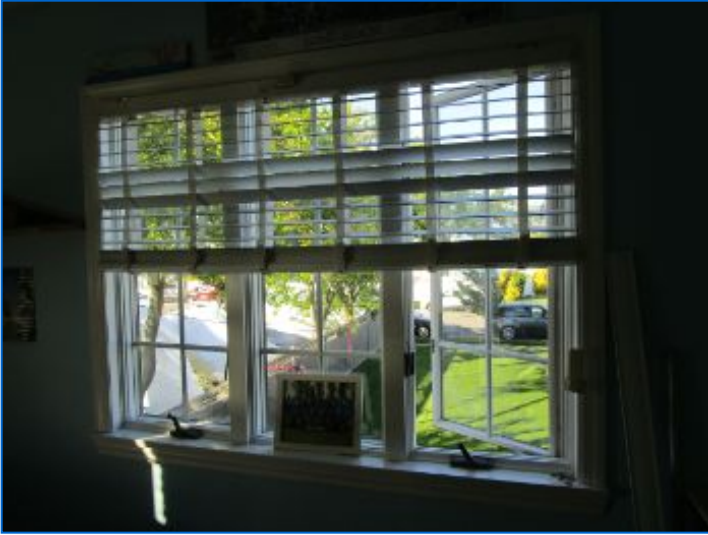
Screens missing or not installed at the time of inspection.

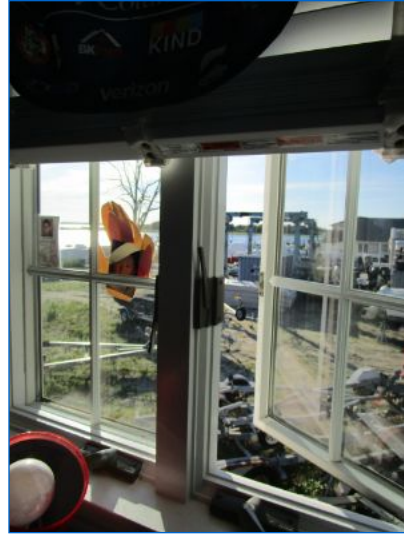
Screens missing or not installed at the time of inspection.

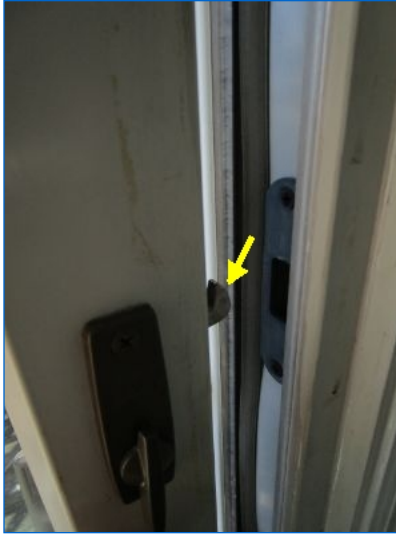
Exterior sliding door did not close or latch properly. Recommend evaluation and repair or replacement by a qualified contractor.

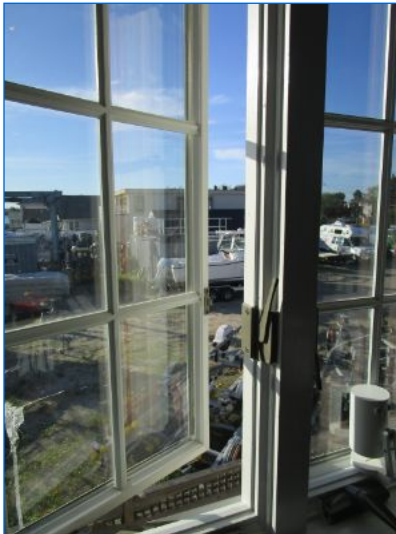
Screen missing or not installed at the time of inspection.

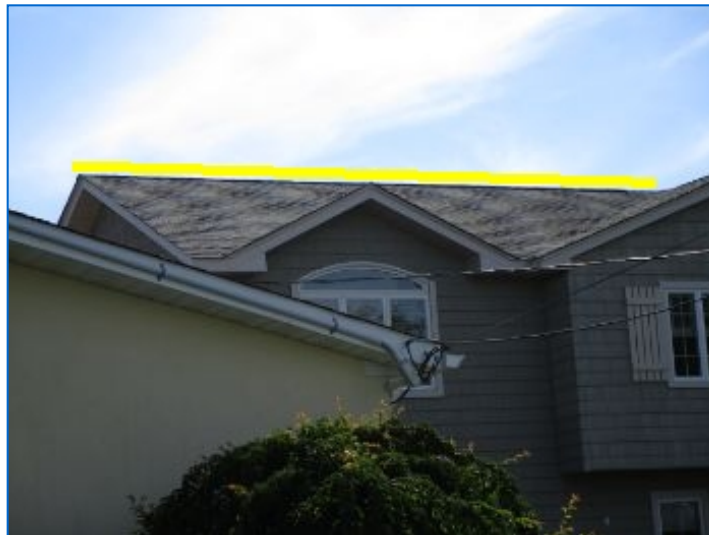
Roof ridge beam appeared straight and even overall based on the age of the structure.

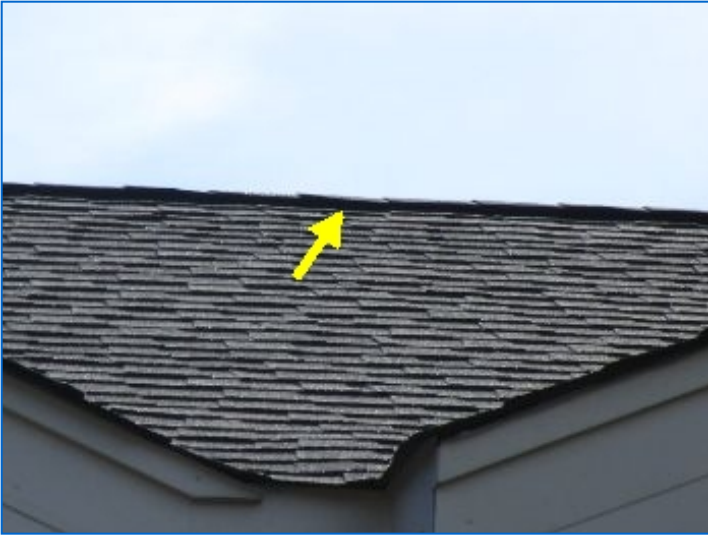
Ridge exhaust venting noted for attic ventilation.

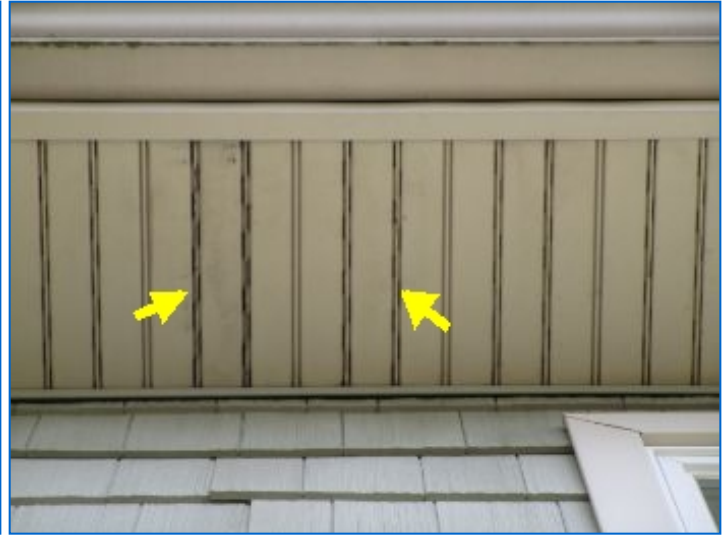
Under eave soffit inlet vents noted for attic ventilation.

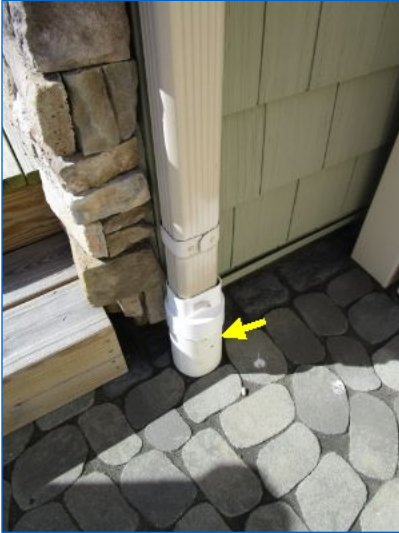
Downspouts connect to underground drainage system/s;  
drywell/s.

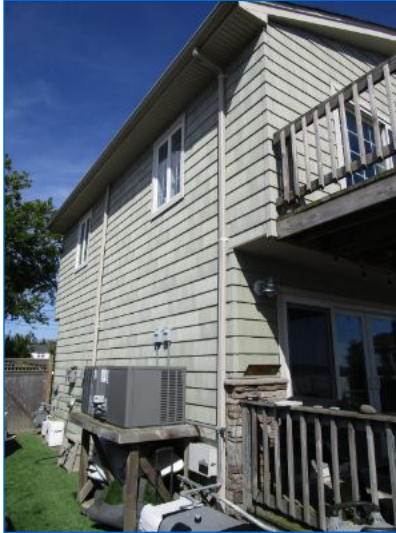
EXTERIOR North Exterior

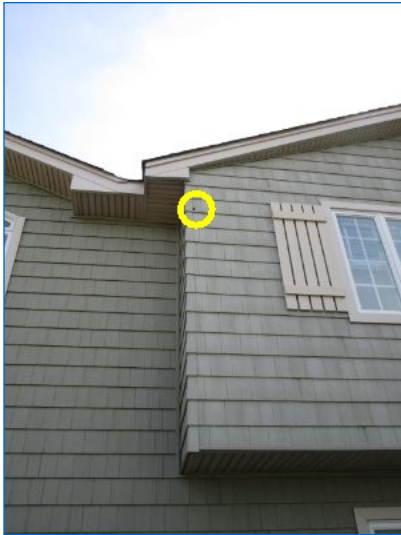
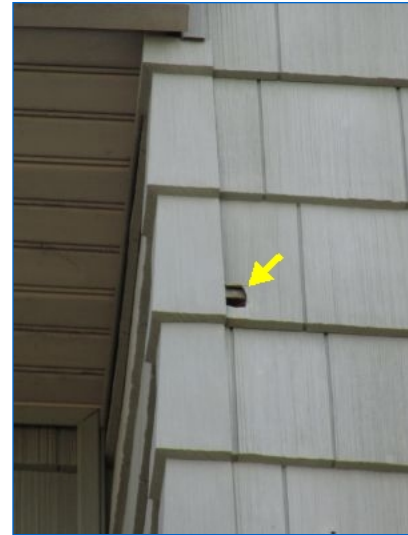
Vinyl siding noted. Normal design service life expectancy for vinyl siding is 30-50 yrs.

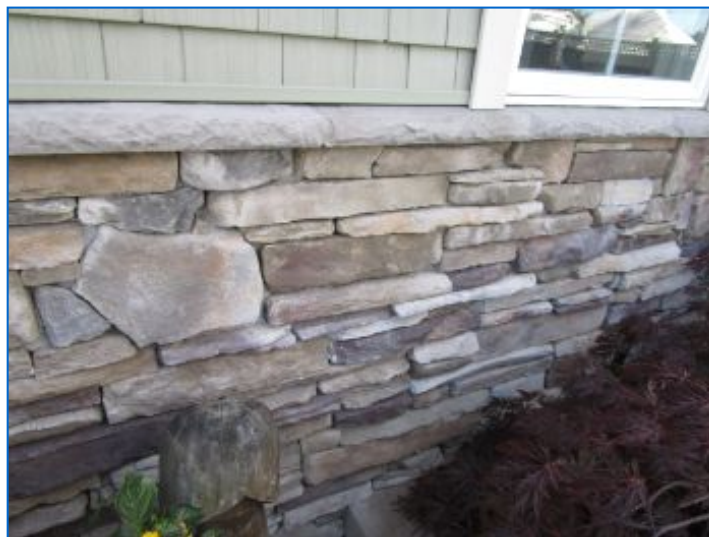
Stone veneer appeared to be in satisfactory condition - In normal condition for its age.

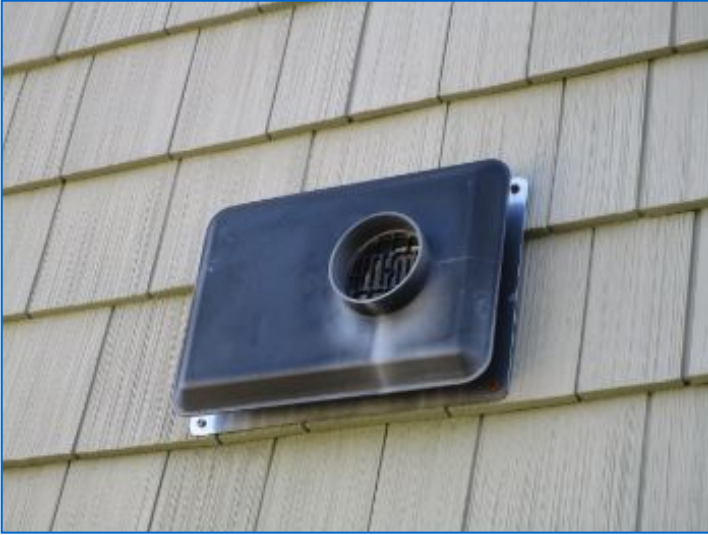
Combination inlet and exhaust boiler vent noted at South wall.

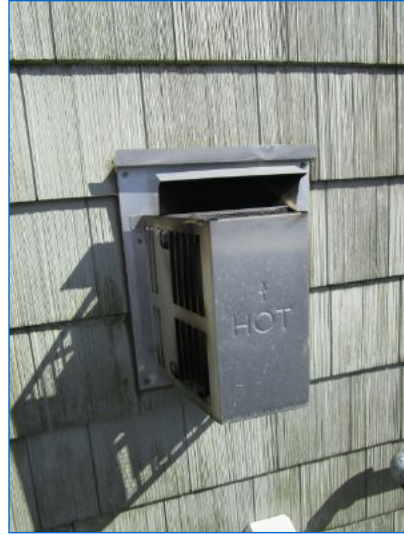
Gas fireplace direct vent noted at North exterior wall.

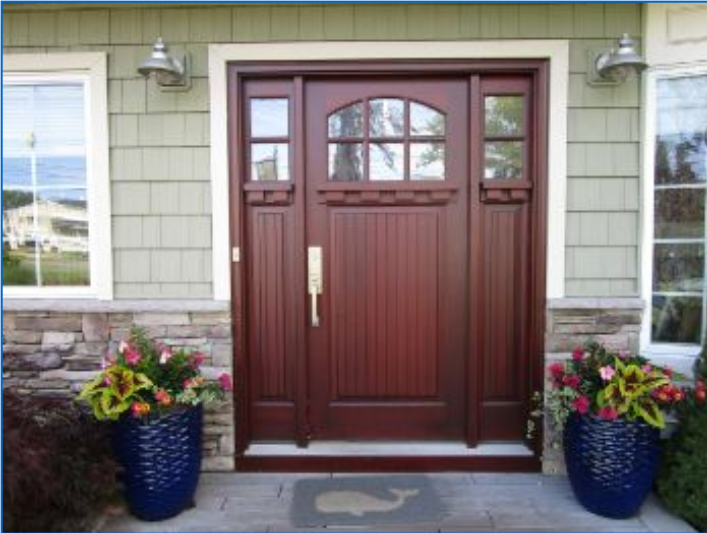
Front doorbell operated normally when tested.

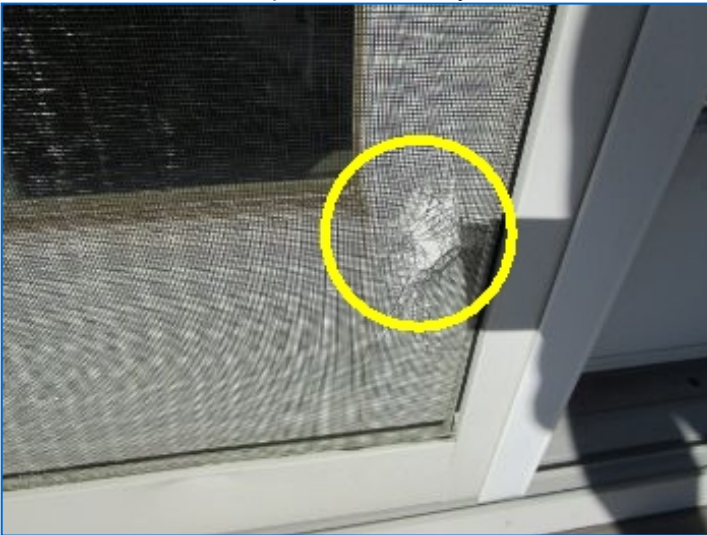
Sliding door screen was damaged at rear sliding door to den. Suggest repair.

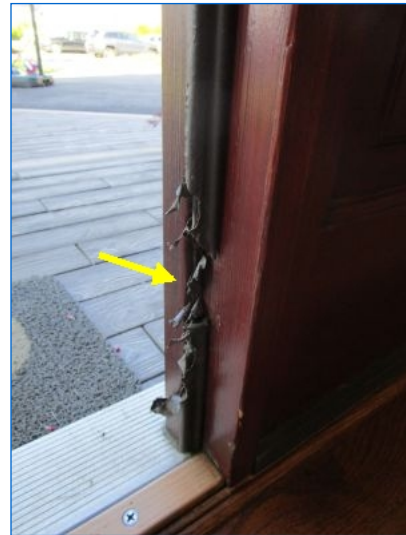
Weatherstripping damaged at front door. Suggest repair.

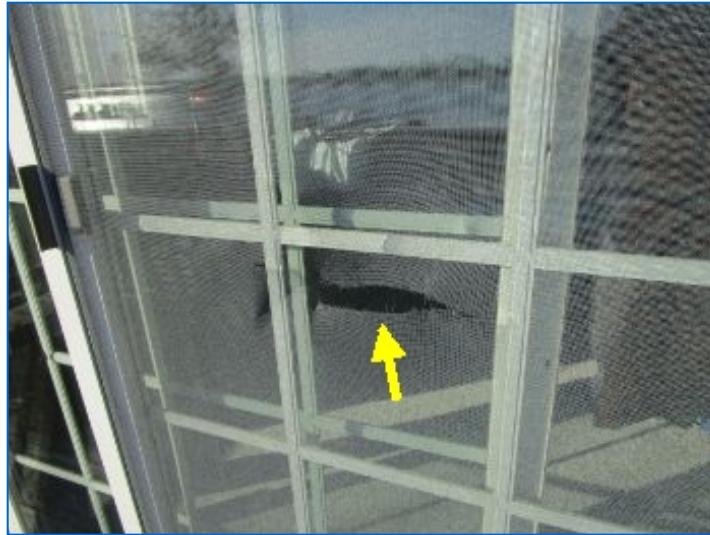
Sliding door screen was damaged at exterior sliding door. Suggest repair.

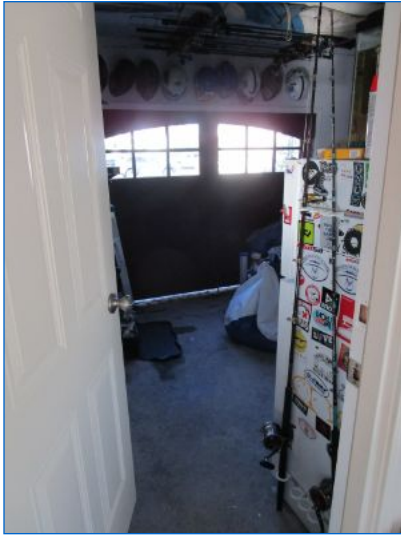
GARAGE General Conditions

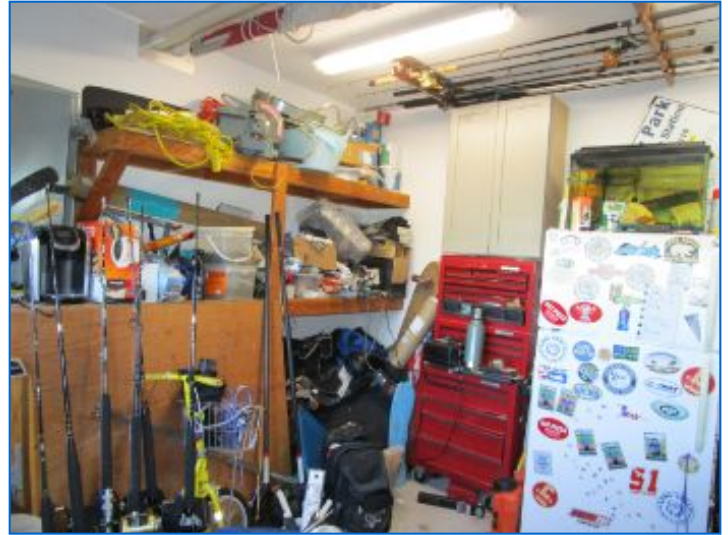
GARAGE General Conditions

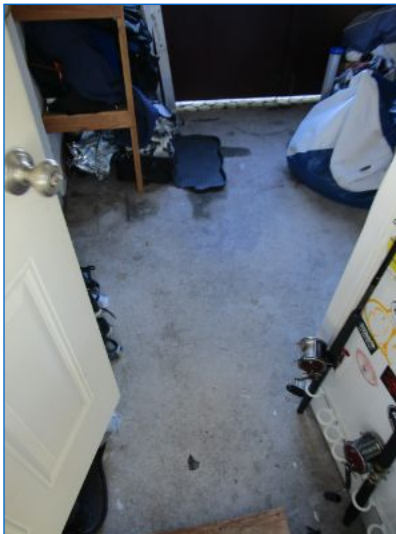
At the time of the inspection, the Inspector observed no significant deficiencies at the visible portions of the garage floor.

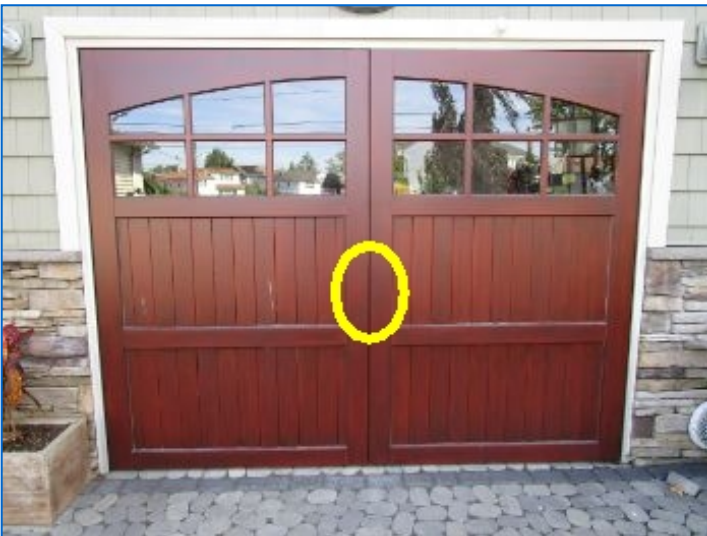
Wooden barn style doors noted. Suggest adding door handles.

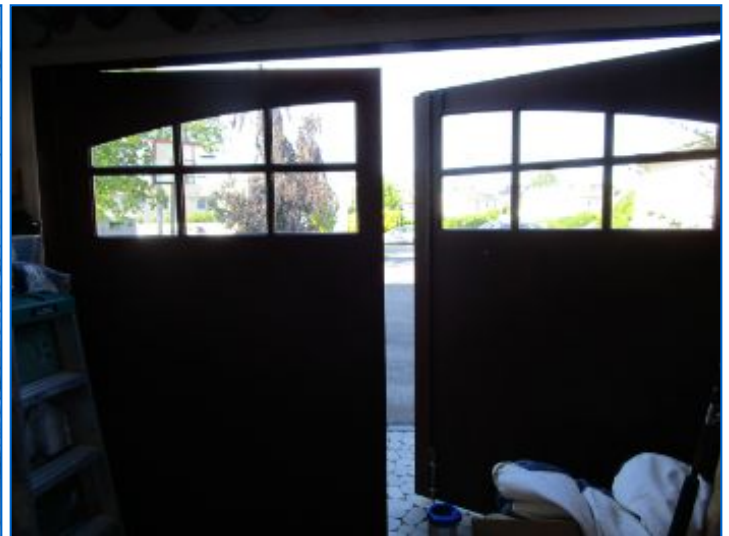
Wooden barn style doors were operable. Suggest adding door handles.

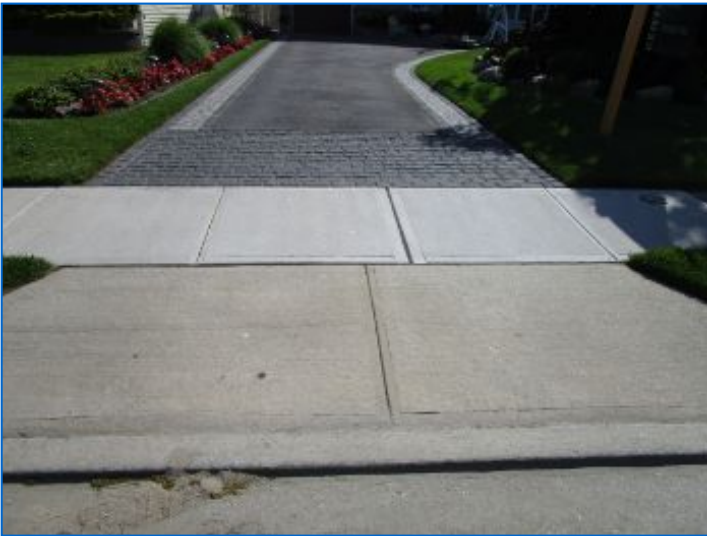
Driveway: Asphalt and Pavingstone noted; Concrete apron noted.

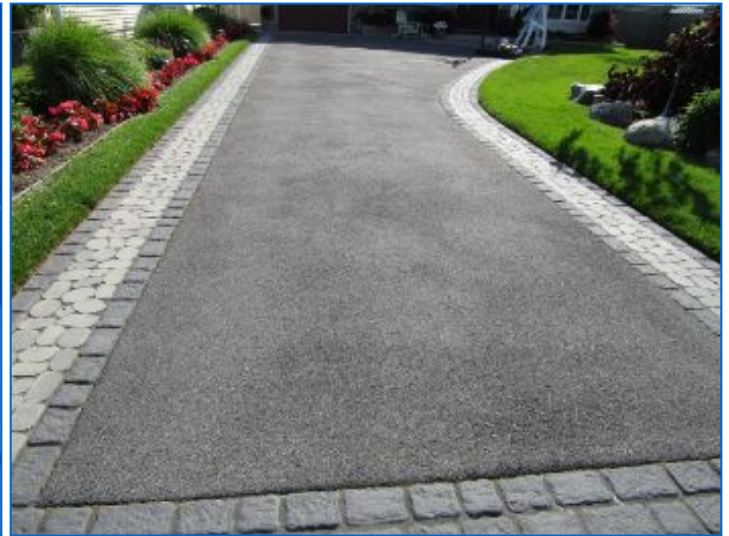
Maintenance: Asphalt driveways require sealing every 3-5 yrs to prevent water penetration and freeze-thaw damage.

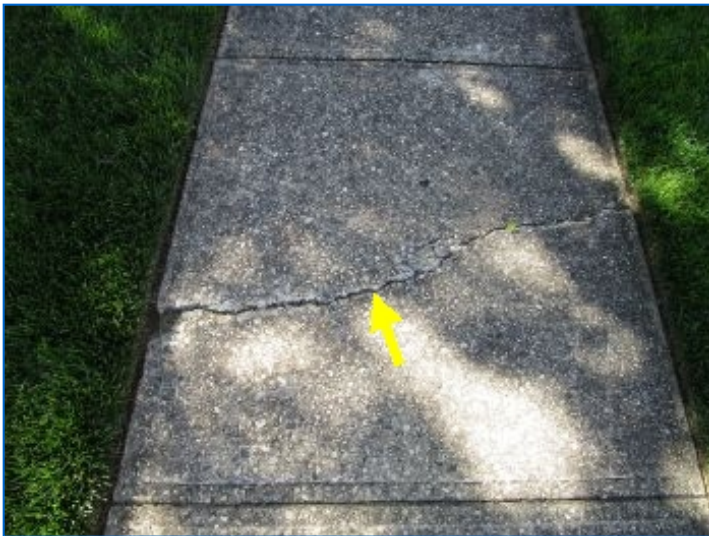
Moderate settlement cracking observed at up to 2 concrete flags at sidewalk. Further deterioration can occur from frost weathering. Recommend sealing the cracks to prolong the life of the concrete and/or replace damaged flags as needed.

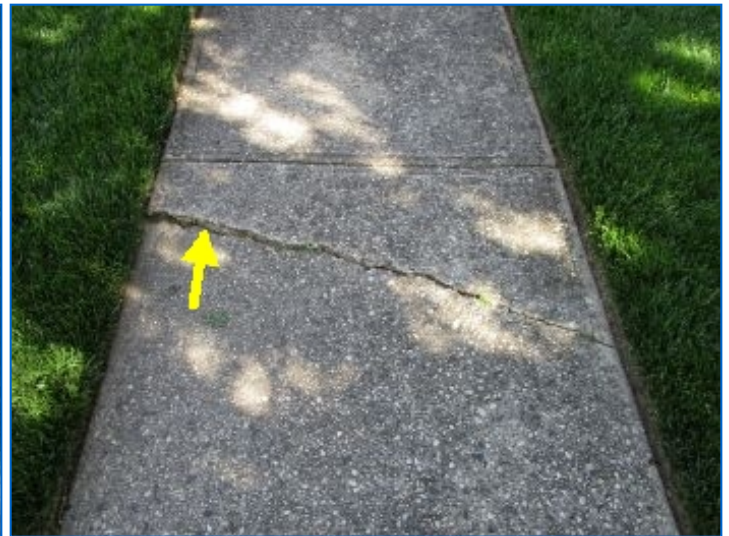
Potential Trip Hazards noted at sidewalk; repair as necessary.

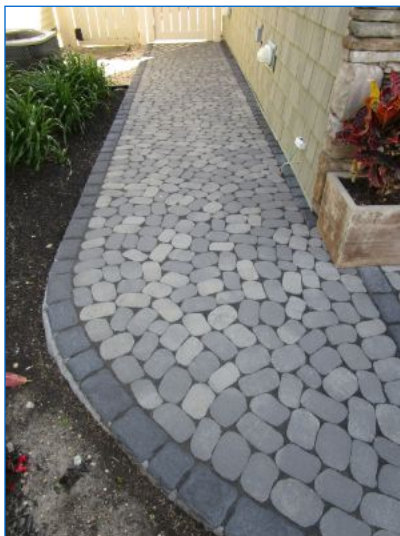
Walkway/s: Pavingstone was noted.

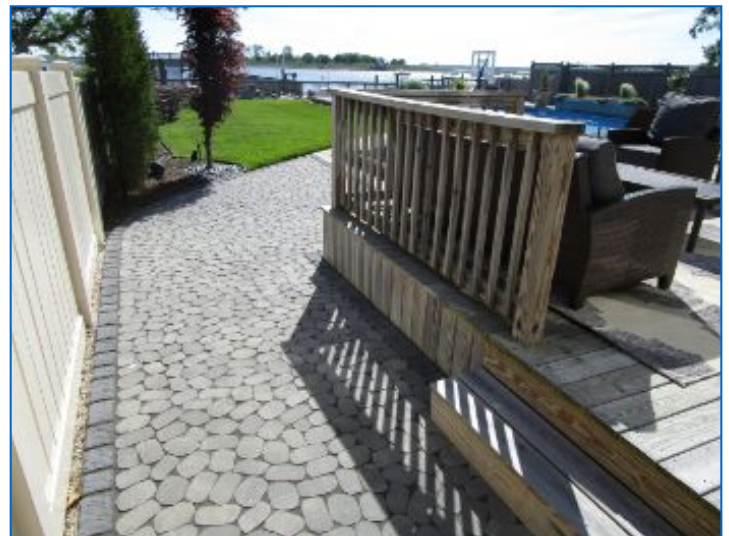
GROUNDS Sidewalk & Walkway

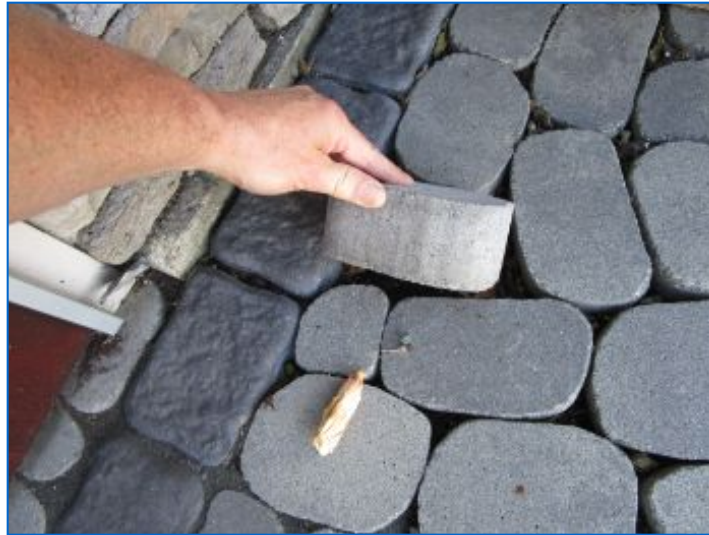
Loose unfitted pavingstone noted at front in non-mortared area where the house trap was buried.

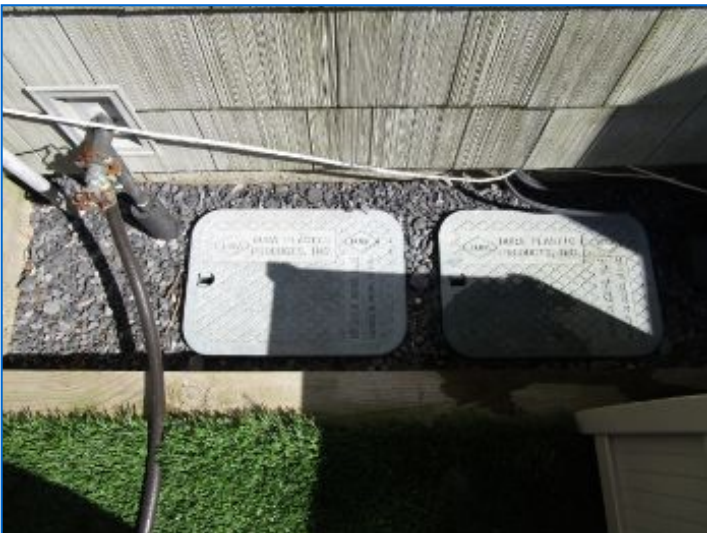
Property is equipped with an underground sprinkler system.

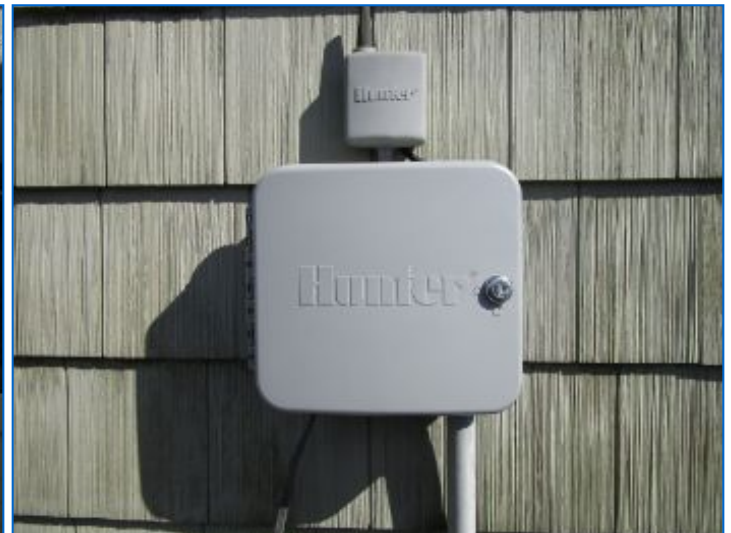
Control panel for sprinkler system located at the north exterior.

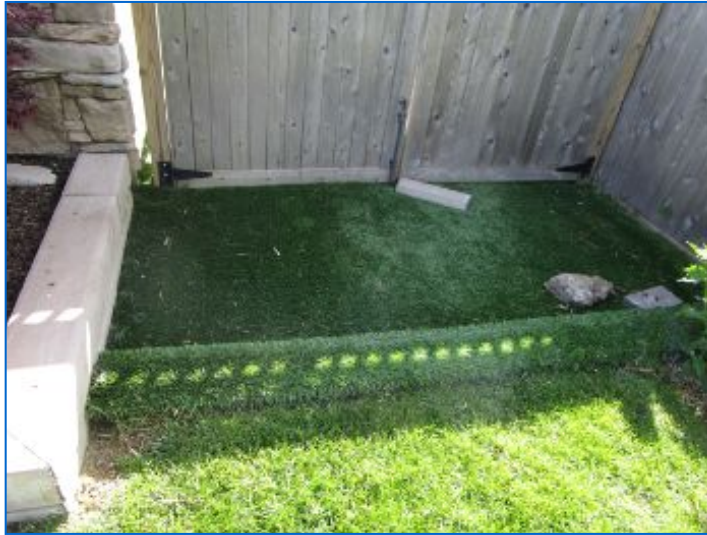
Artificial grass noted at north side.

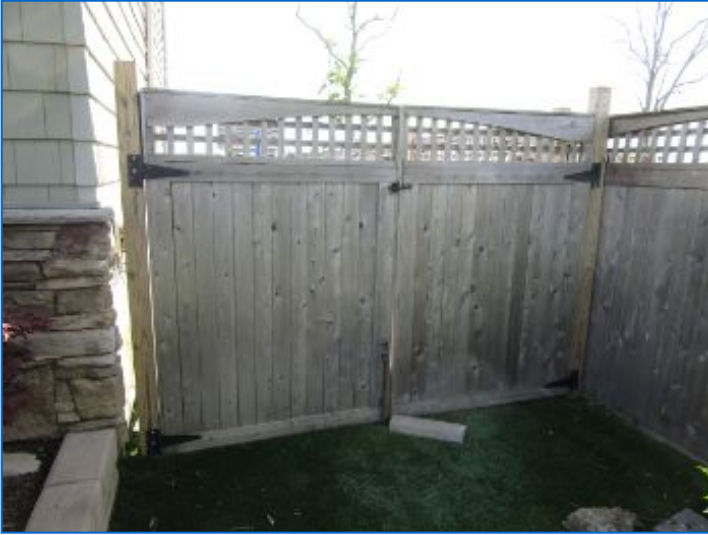
Wood fencing and gates noted.

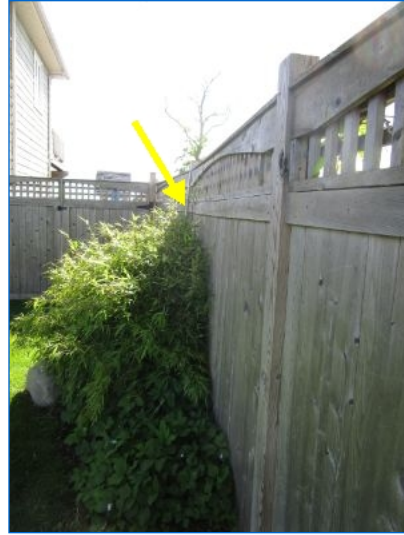
Fence was leaning in one post area.

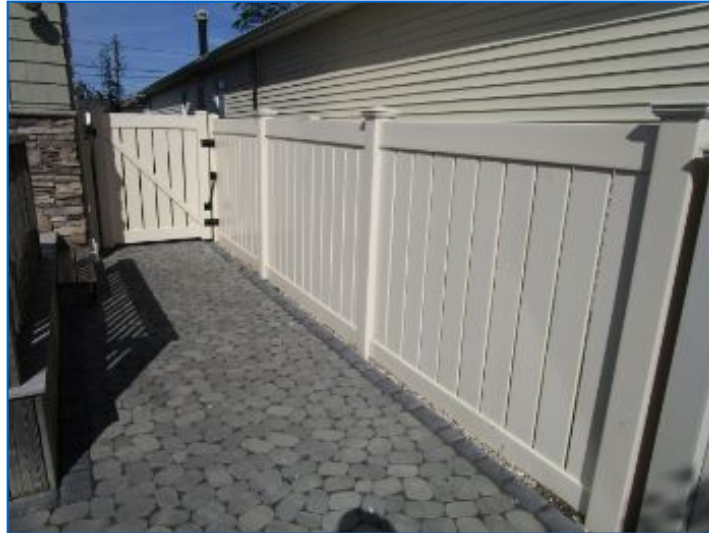
PVC fencing and gates noted.

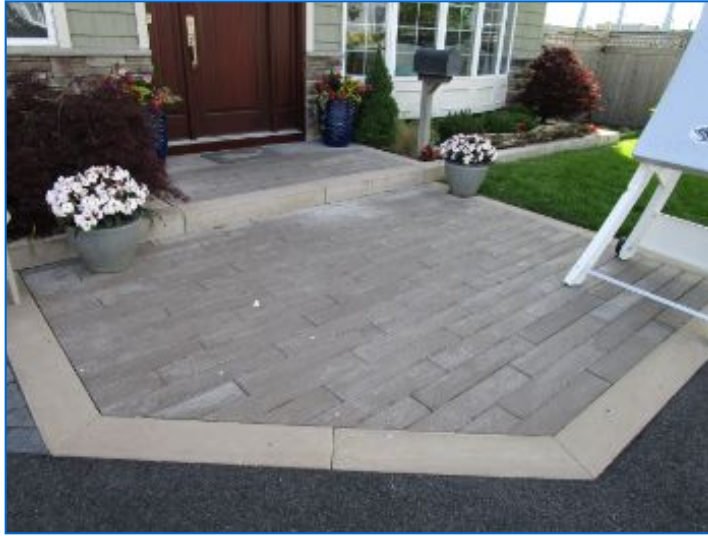
Concrete barnwood plank paver Steps and Landing noted at Front entrance.

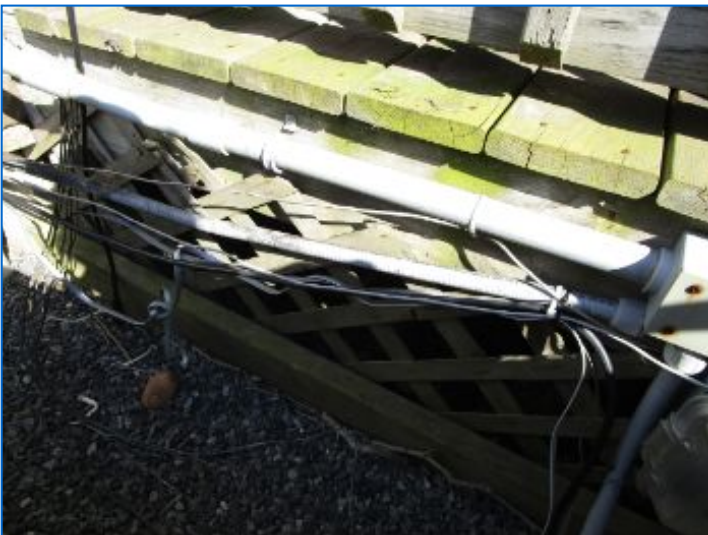
Limited review of deck foundation due to limited or no access below.

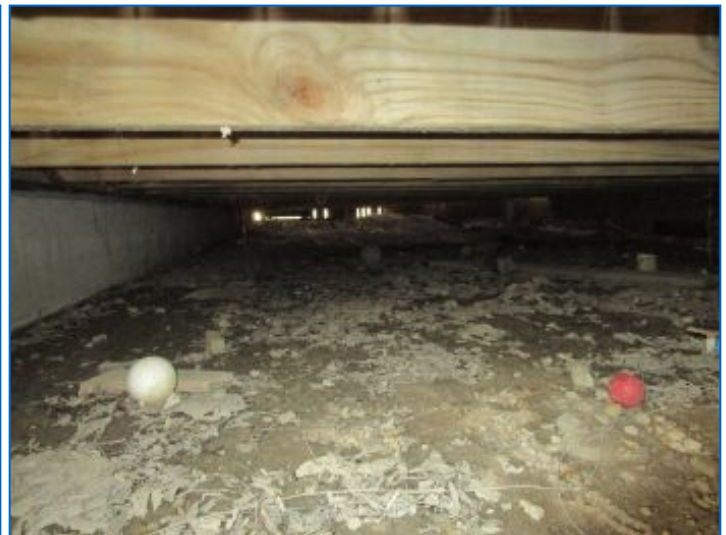
The basic deck structure was built of wood.

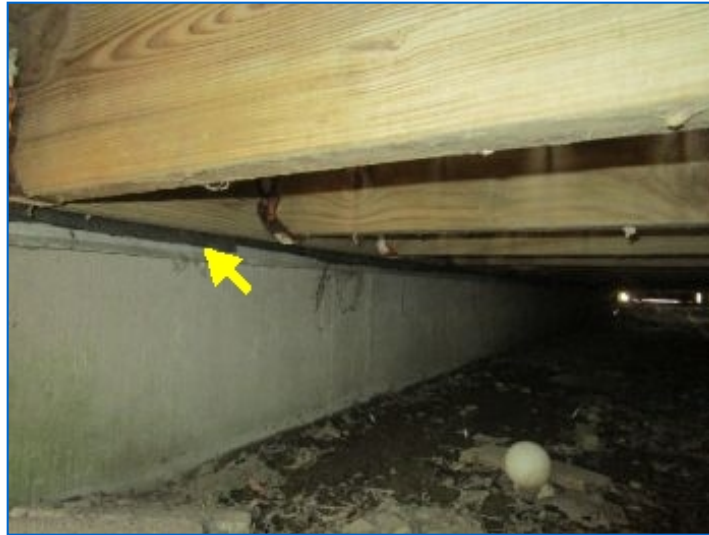
The ledger attaching the deck structure was flashed. Flashing is designed to protect the wall assembly from moisture intrusion where the deck attaches to the home.

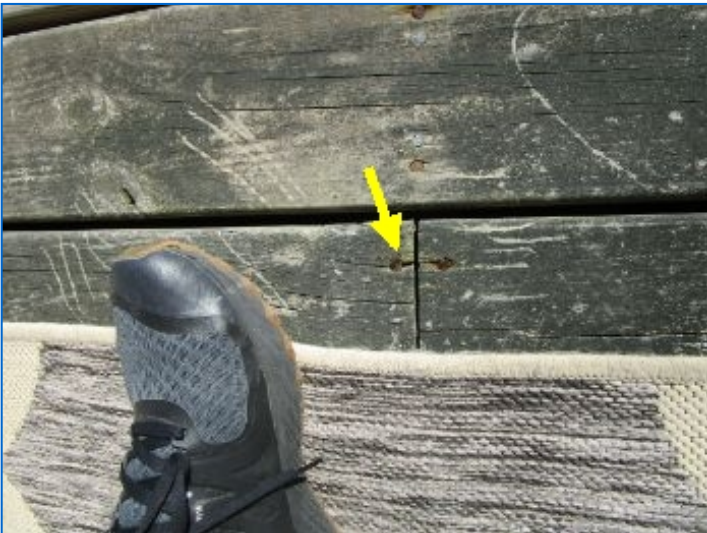
Several plank fasteners had failed, resulting in loose and raised plank ends; trip hazard concern. Recommend corrective repairs.

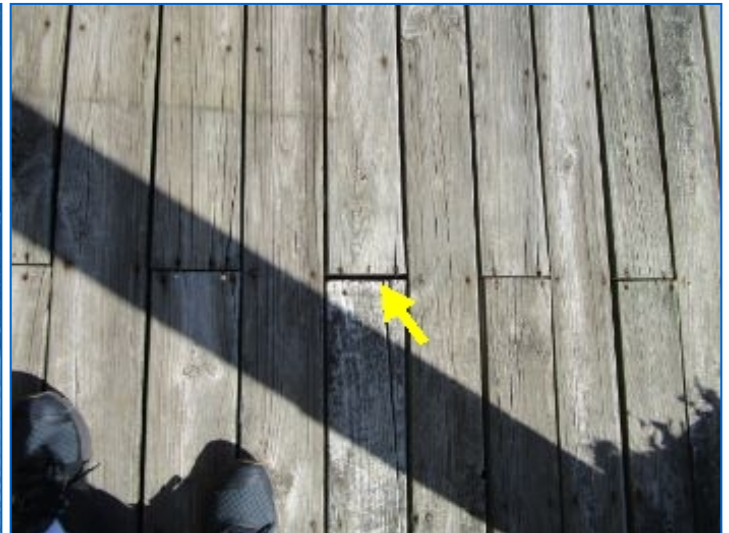
Several plank fasteners had failed, resulting in loose and raised plank ends; trip hazard concern. Recommend corrective repairs.

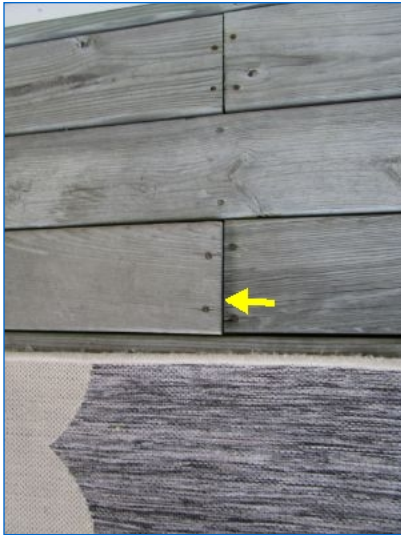
Several plank fasteners had failed, resulting in loose and raised plank ends; trip hazard concern. Recommend corrective repairs.

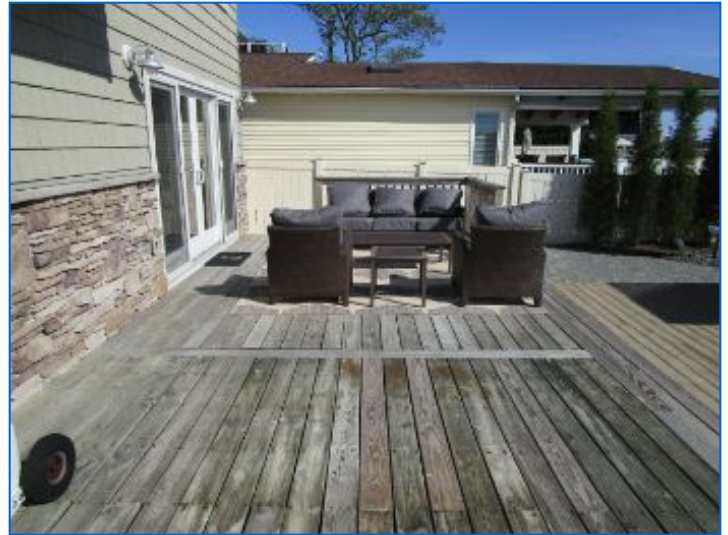
Deck planking (the walking surface) had moderate deterioration visible at the time of the inspection. Routine maintenance will improve its lifespan.

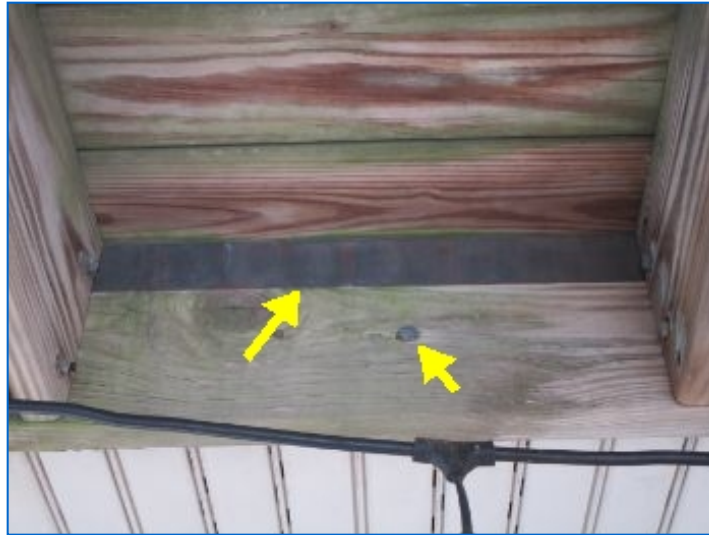
The balcony deck was attached to the home with a ledger bolted to the exterior of the structure. The ledger attaching the deck structure was flashed. Flashing is designed to protect the wall assembly from moisture intrusion where the deck attaches to the home.

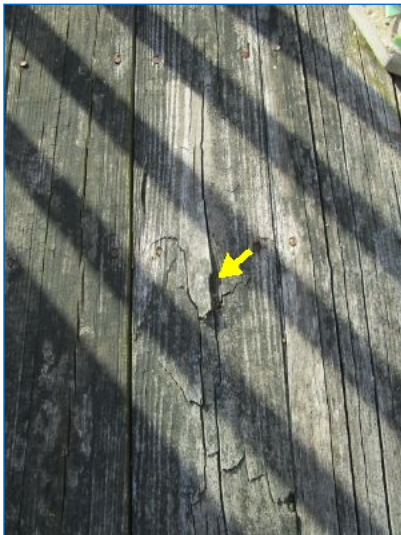
Some deck planking (the walking surface) had areas of localized decay visible at the time of the inspection.

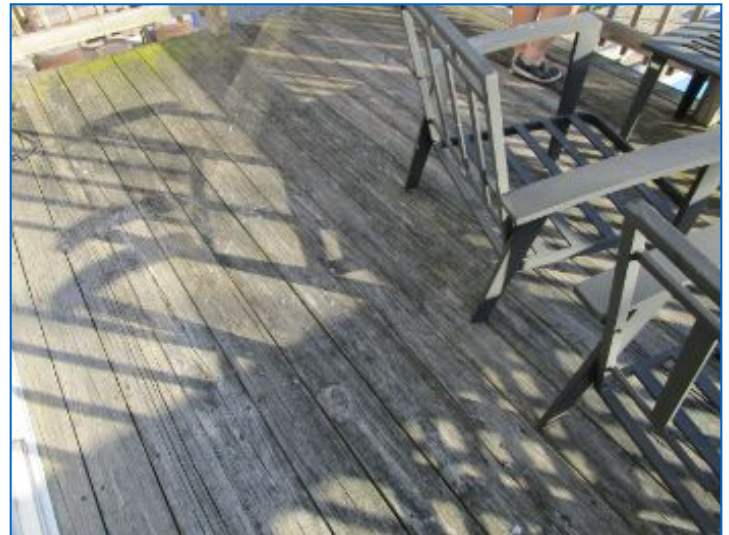
Deck planking (the walking surface) had areas of severe wear or deterioration which may require some maintenance, repair or replacement. The Inspector recommends that before the expiration of your Inspection Objection Deadline you consult with a qualified contractor to discuss options and costs.

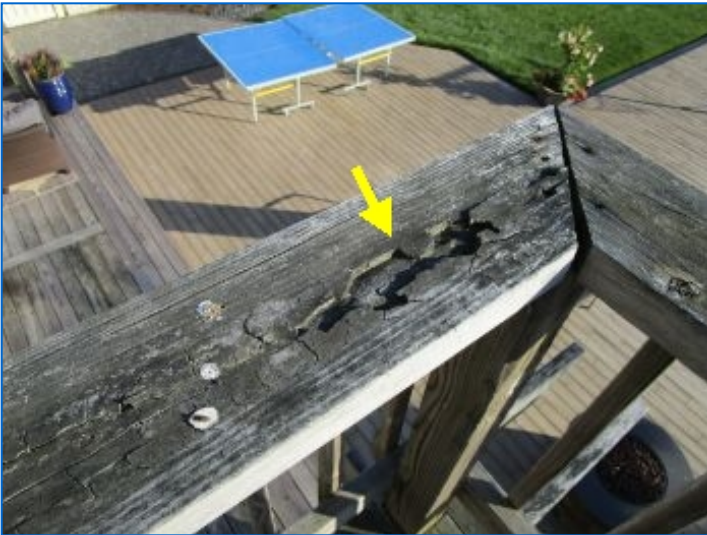
The top rail of the guardrail exhibited moderate deterioration and localized decay. Suggest replacing damaged wood.

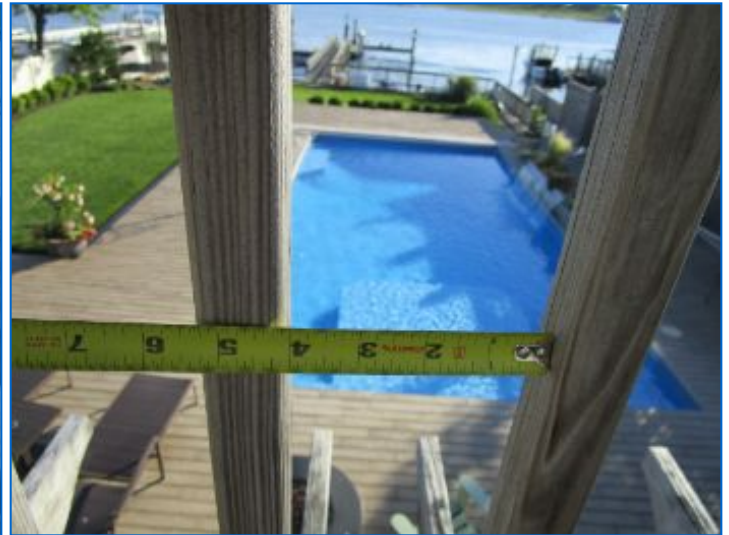
Spaces between deck guardrail balusters were too wide. Safe building practices dictate that a 4 inch sphere may not pass through the handrail at any point. This condition is hazardous to small children. Recommend that this condition be updated to meet generally-accepted modern safety standards by a qualified contractor.

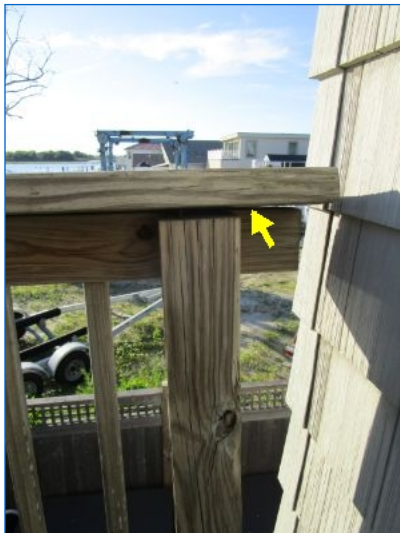
Top rail of guardrail had separated from the post.

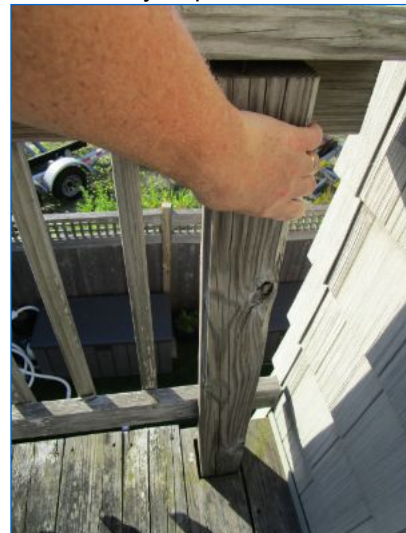
A post supporting the deck guardrail assembly was loose and should be secured by a qualified contractor.

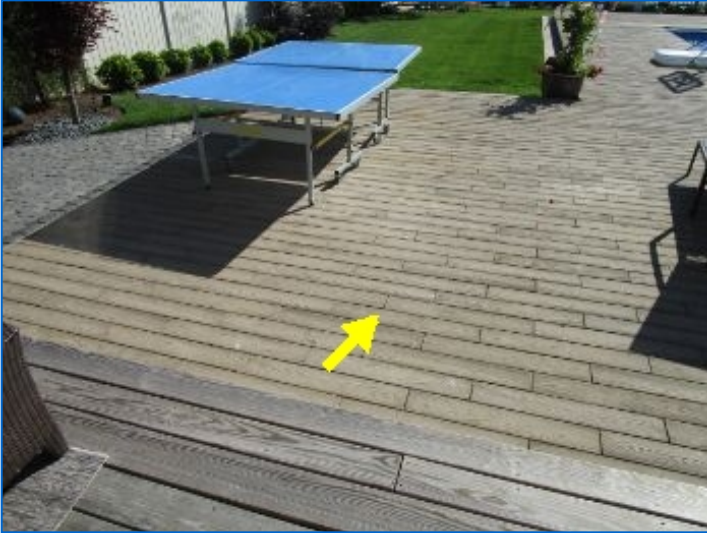
Concrete barnwood plank pavers noted at patio.

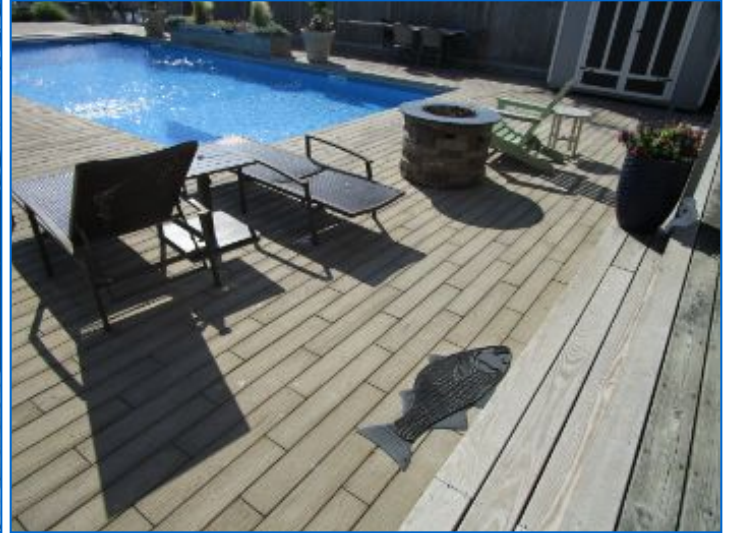
Concrete barnwood plank pavers noted at patio.
