# ProSpec Home Inspection of Long Island Property Inspection Report

143 Island Parkway W, Island Park, NY 11558  
Inspection prepared for: Name Deleted  
Date of Inspection: 6/16/2020 Time: 5:00 PM  
Age of Home: 44 yrs old  
Approx. Year Built: 1976

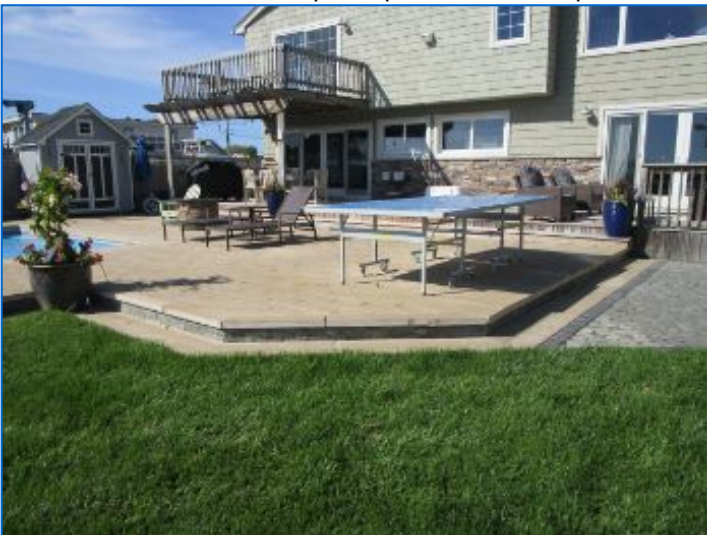
Patio appeared in satisfactory and functional condition.

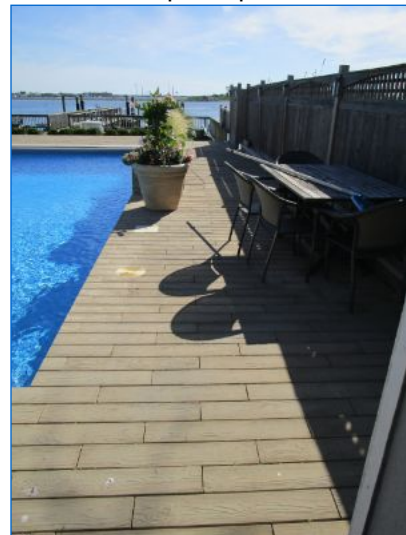
Concrete barnwood plank pavers noted at patio.

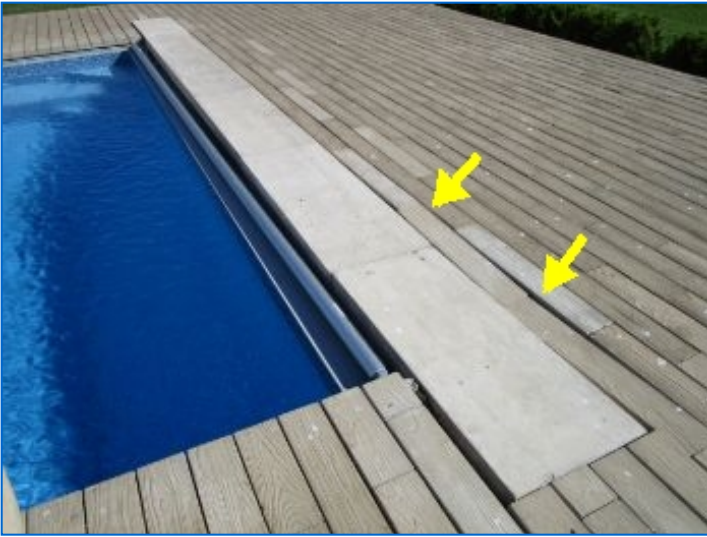
Some uneven settlement of patio pavingstones noted around the area where the automatic pool cover is housed. Recommend corrective repairs to even pavingstone here.

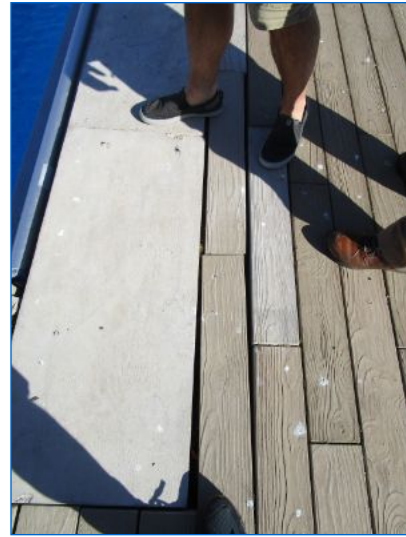
Some uneven settlement of patio pavingstones noted around the area where the automatic pool cover is housed. Recommend corrective repairs to even pavingstone here.

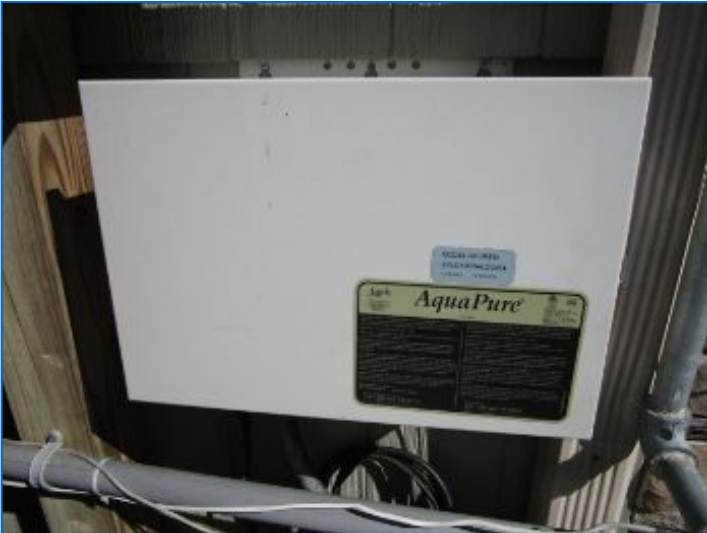
AquaPure Salt Chlorine Generator noted.

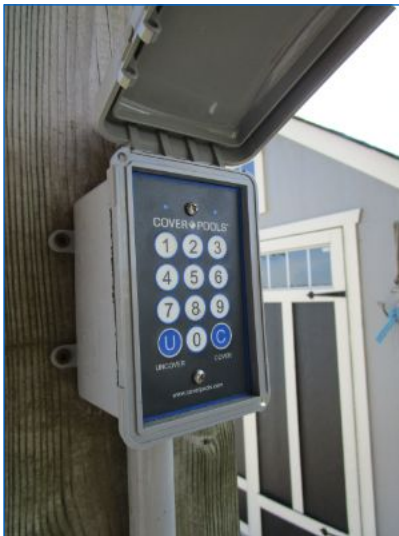
Automatic pool cover control pad noted.

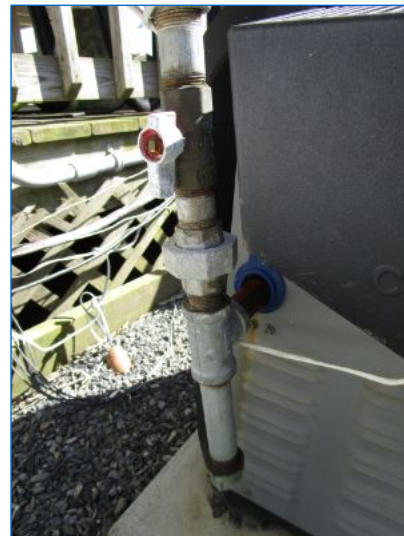
Gas shut-off valve and proper drip leg noted at burner.

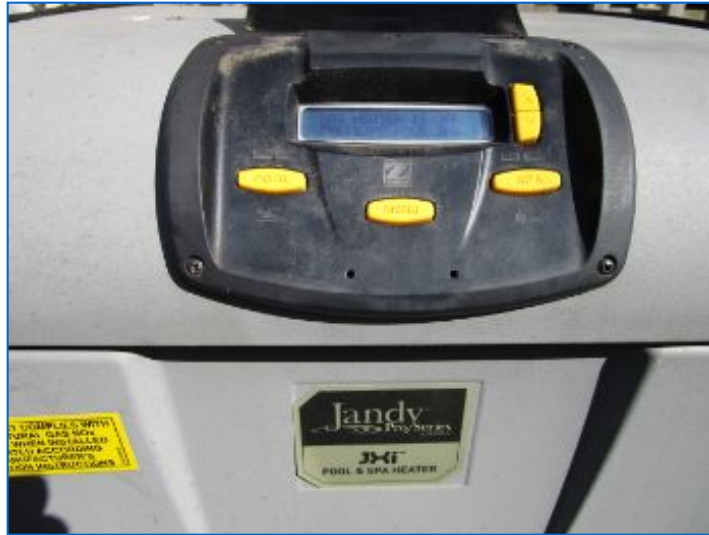
Jandy Pool Heater (gas-fired) was off at time of inspection. Suggest seller demonstrate operation at final inspection.

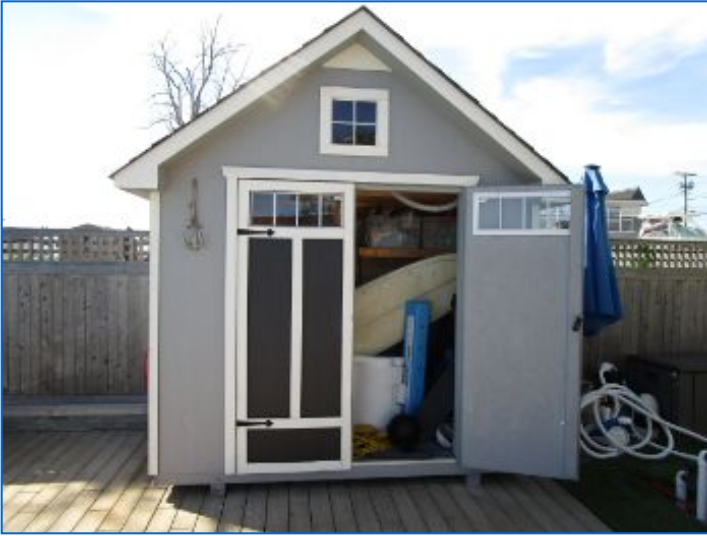
No major defects noted for visible structure of the shed - in normal condition for its age.

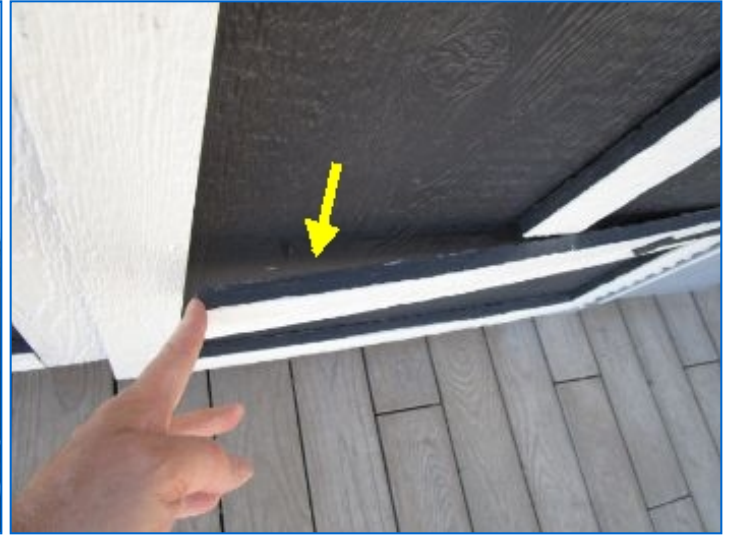
Loose/detached plank noted at shed door.

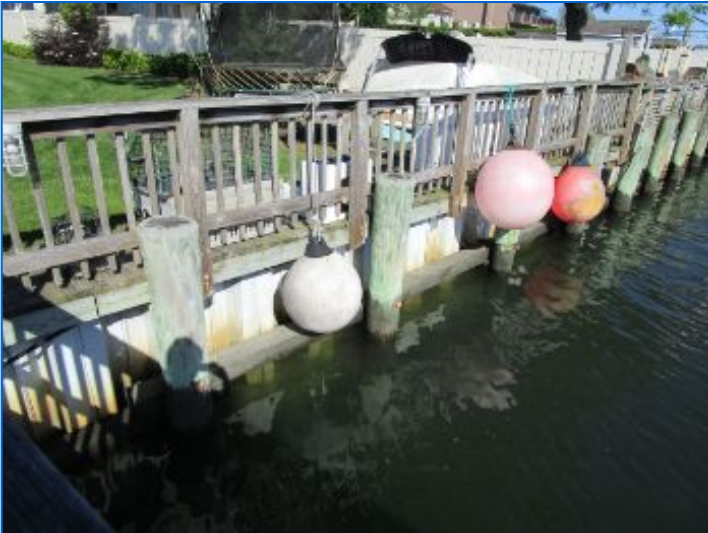
Vinyl sheet and wood pile bulkhead noted.

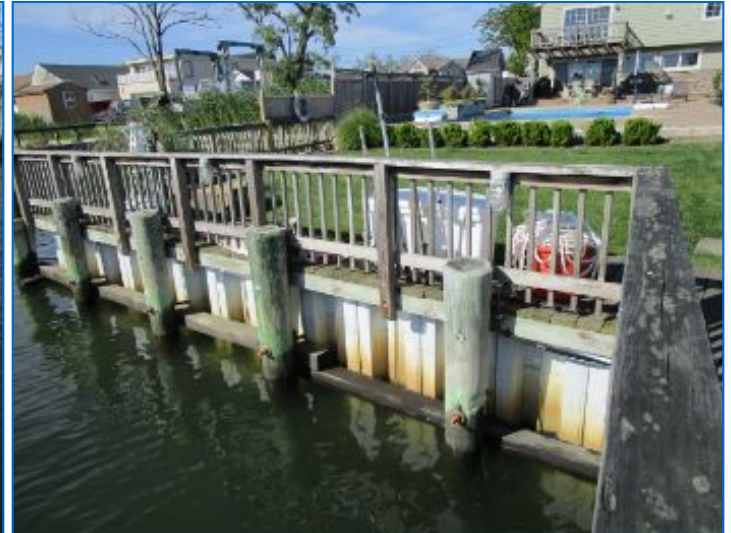
Bulkhead appeared to be well constructed, however not all structural components of the bulkhead system are visible. Suggest acquiring drawings and specs as available for further review by a bulkhead specialist.

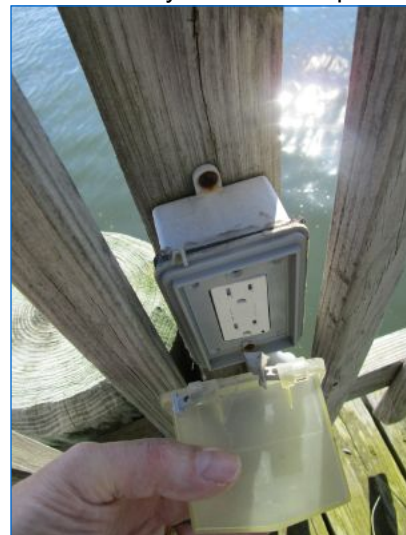
Exterior receptacle weatherproof cover was defective at non-WR GFCI receptacle.

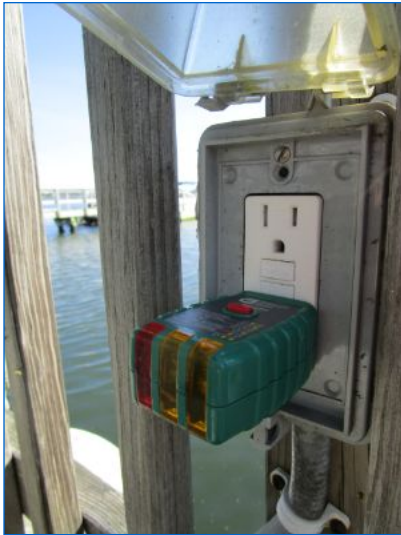
No power at GFCI type receptacle located at the NW corner of bulkhead at time of inspection. Recommend having seller identify or restore power source prior to close.

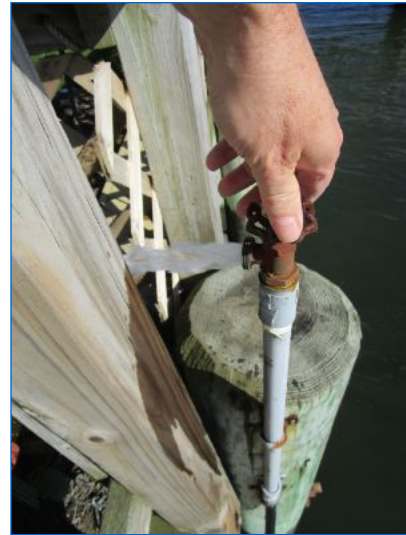
Hose bibs were operable at time of inspection.

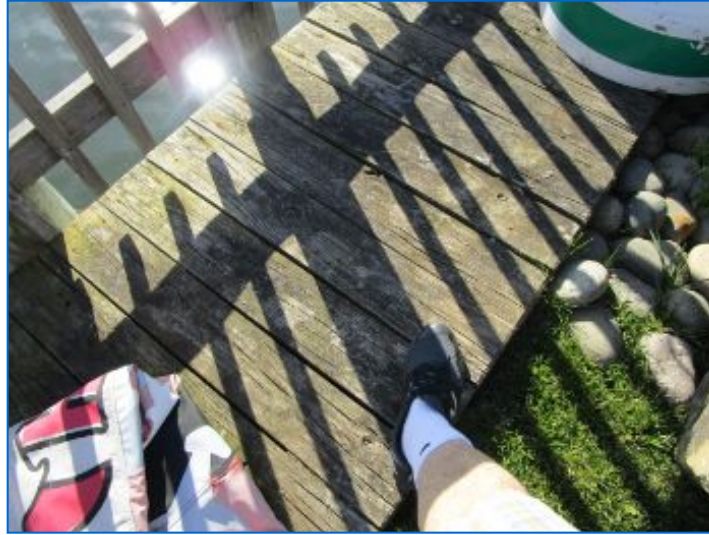
Several plank fasteners had failed at bulkhead walkway, resulting in loose planks. Recommend corrective repairs.

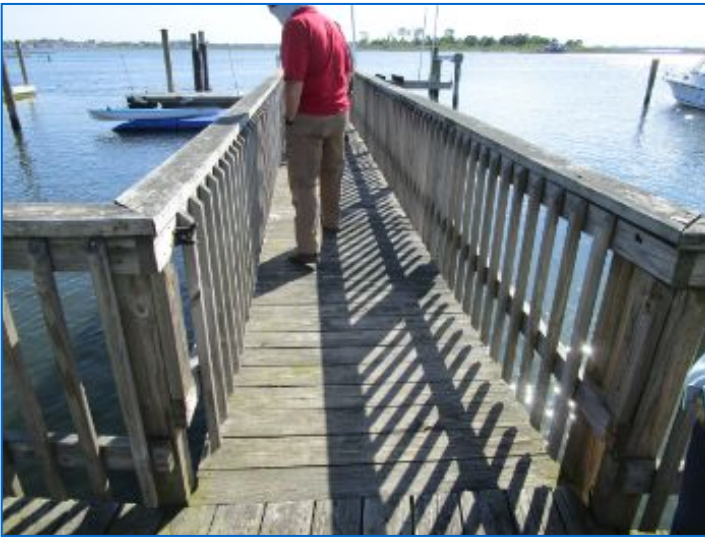
- Several plank fasteners had failed at dock gangway, resulting in loose planks. Recommend corrective repairs.
- Boat lift control panel was not adequately mounted to the dock guardrail.
- Surface mounted light fixture had a broken mount.

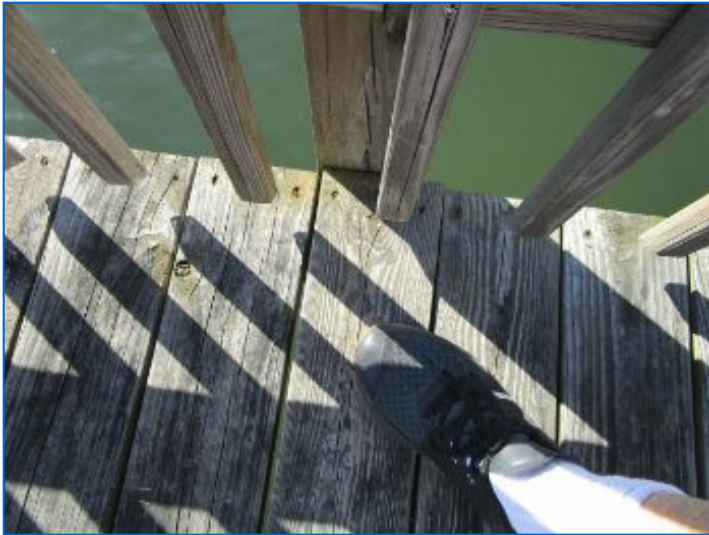
Several plank fasteners had failed at dock gangway, resulting in loose planks. Recommend corrective repairs.

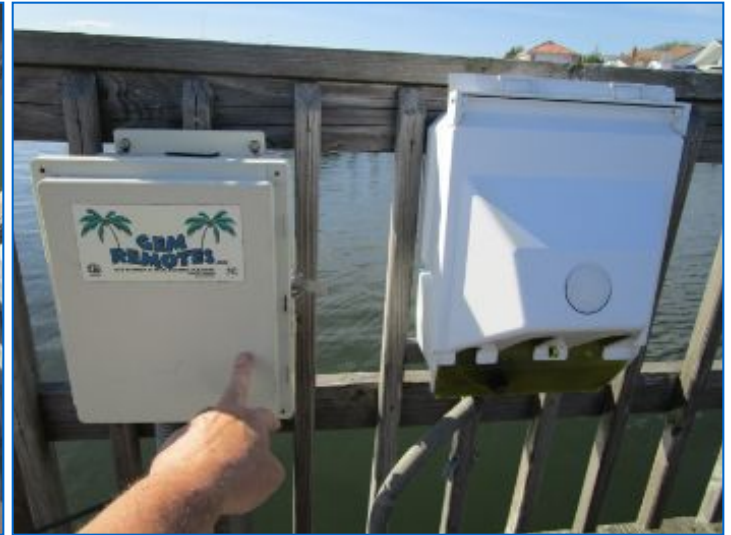
Boat lift control panel and marine sub panel at dock gangway.

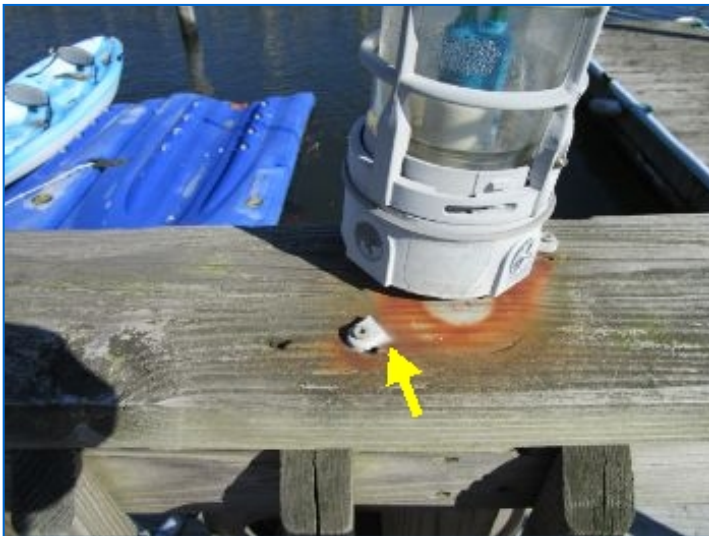
Surface mounted light fixture had a broken mount.

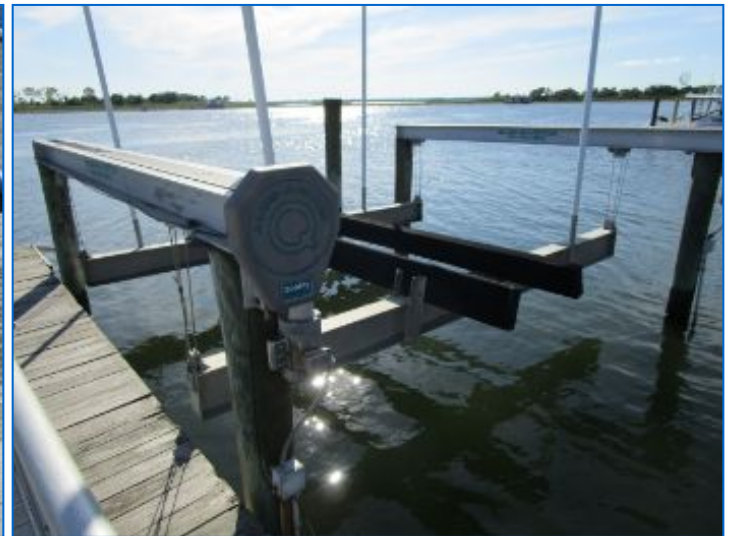
Boat lift was operable at time of inspection.

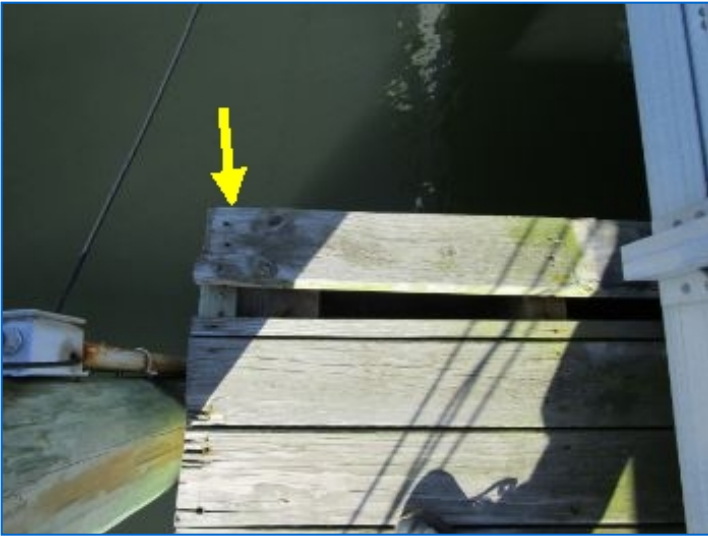
Several plank fasteners had failed at dock gangway, resulting in loose planks. Recommend corrective repairs.

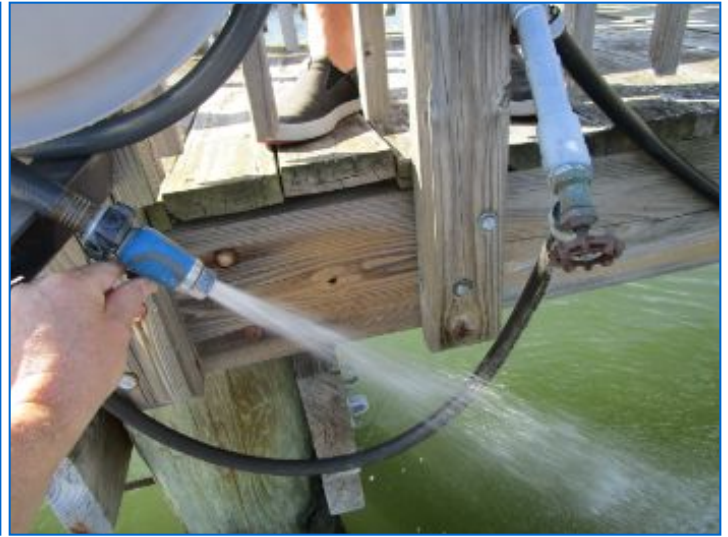
Hose bibs were operable at time of inspection.
