# ProSpec Home Inspection of Long Island Property Inspection Report

Massapequa, NY 11758

Inspection prepared for: Name Deleted  
Date of Inspection: 1/25/2019 Time: 10:00 AM  
Age of Home: 68 yrs old Size: 2,006 sq. ft.  
Approx. Year Built: 1950

Inspector: Russell Classi, P.E.  
License #16000077480  
Phone: (516) 580-1848  
Email: ProSpecofLI@gmail.com  
[www.NassauProfessionalHomeInspector.com](http://www.NassauProfessionalHomeInspector.com)

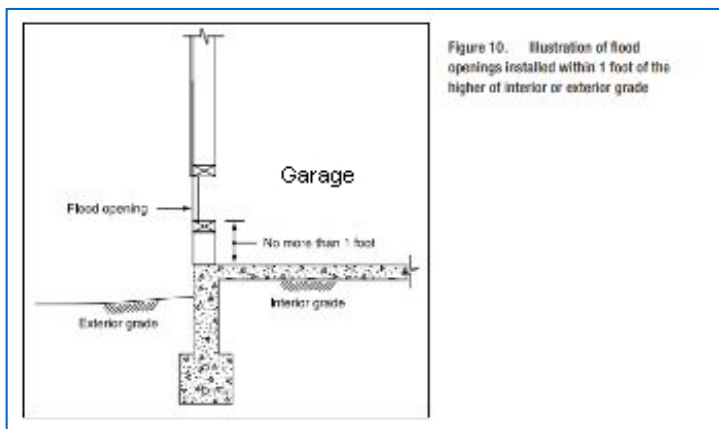
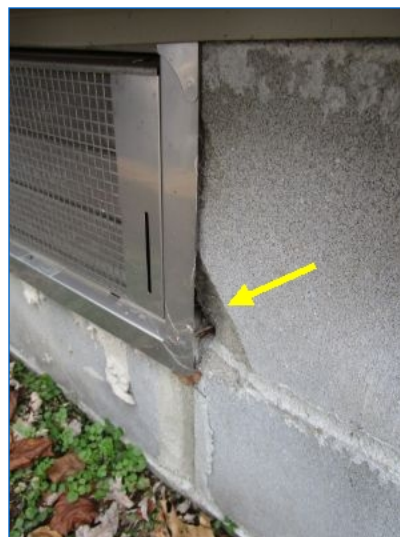
Damaged concrete block at flood opening at rear of garage. Suggest concrete repair.

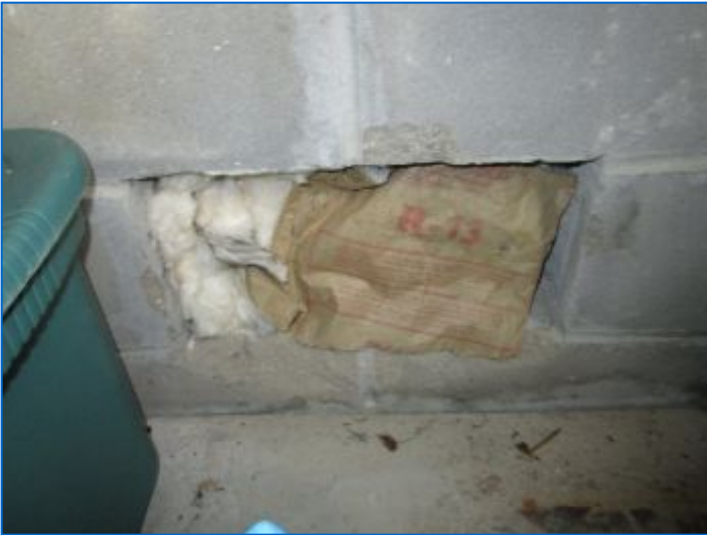
All flood opening vents must be FEMA compliant. Recommend unblocking flood vents upon completion of work.

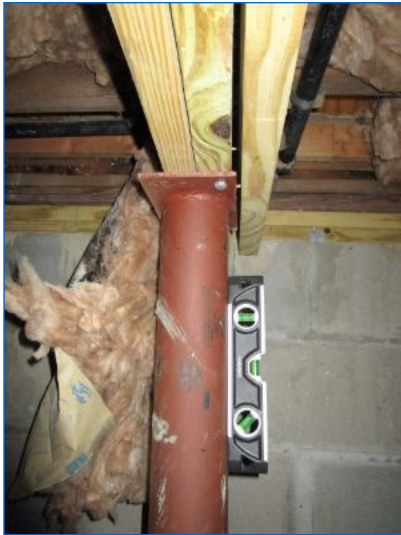
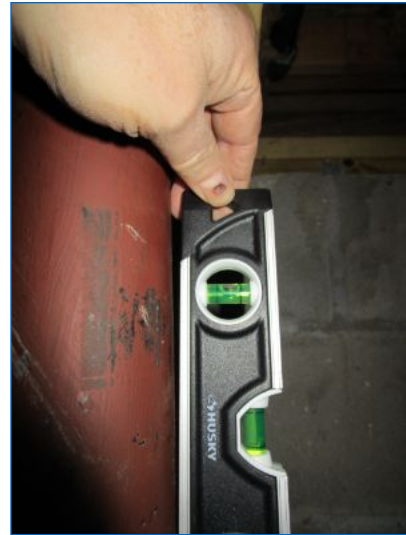
South most column was not centered under the main beam leaving it partially unsupported (note: main beam not supported by foundation wall). This column was not installed vertically, resulting in triple beam separation. Recommend structural repair by a licensed qualified contractor to provide proper support of the main beam.

South most column was not centered under the main beam leaving it partially unsupported. This column was not installed vertically.

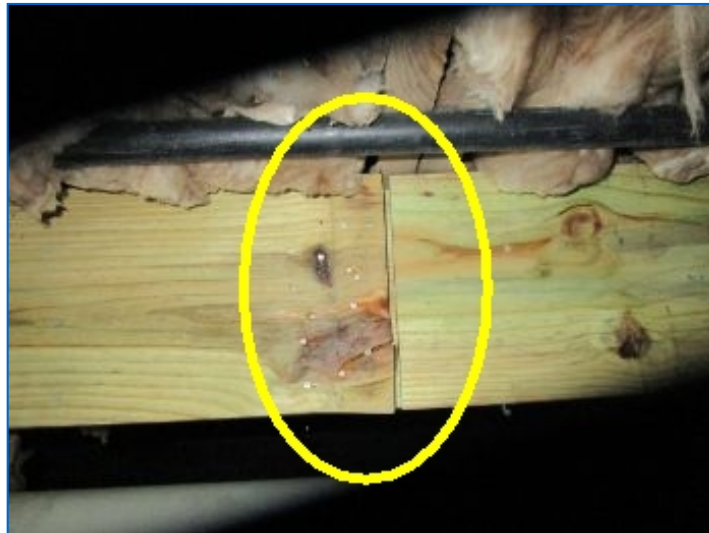
Nailed splices of main beam components noted at unsupported locations (no column) along beam spans. The Inspector recommends providing a properly arranged through-bolt pattern at each of these locations by a licensed qualified contractor.

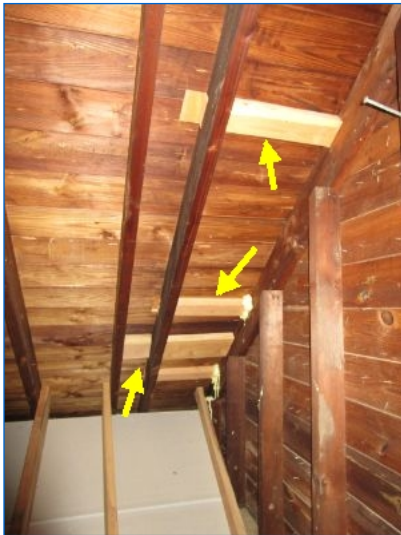
Roof board repairs noted, due to damage incurred during roof cover replacement.

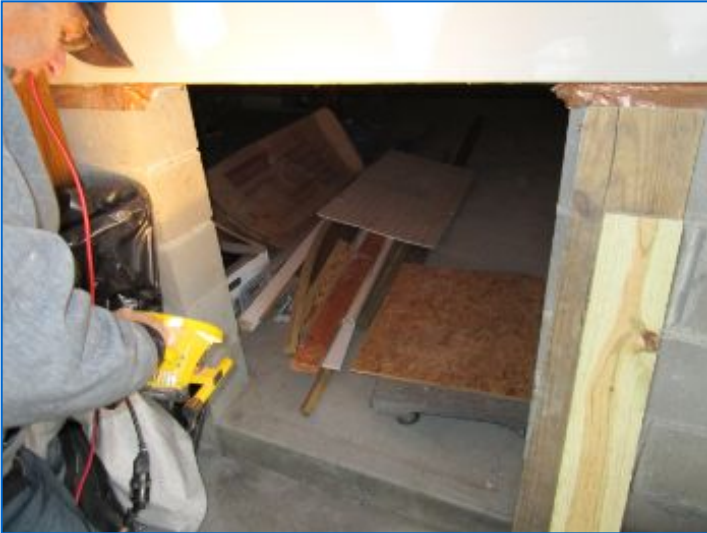
Crawlspace access door was missing. Recommend a proper door be installed.

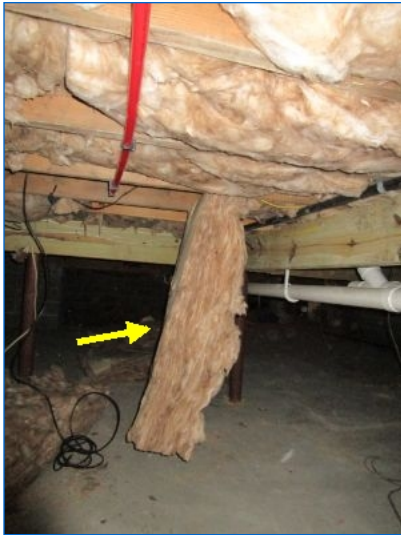
Batt insulation was observed to be hanging/missing at a few joist cavity locations. Recommend restoring missing/hanging insulation and securing in place using insulation support wires.

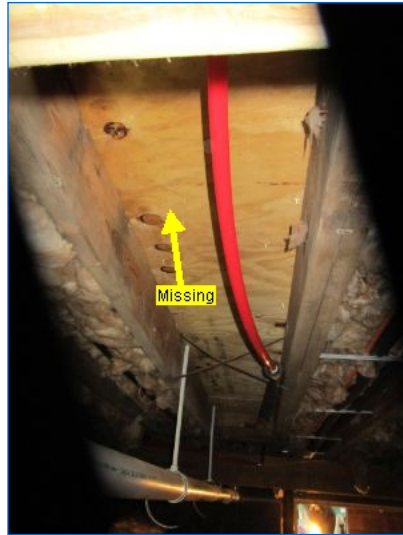
Batt insulation was observed to be hanging/missing at a few joist cavity locations. Recommend restoring missing/hanging insulation and securing in place using insulation support wires.

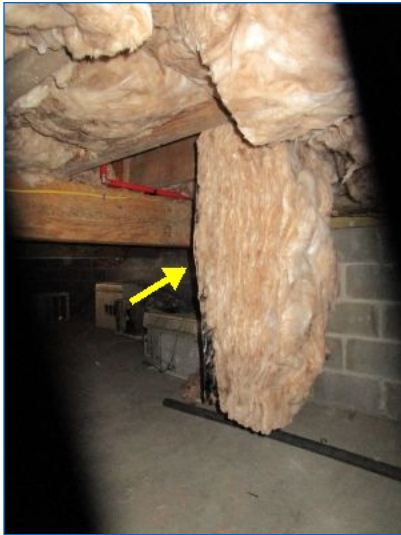
Batt insulation was observed to be hanging/missing at a few joist cavity locations. Recommend restoring missing/hanging insulation and securing in place using insulation support wires.

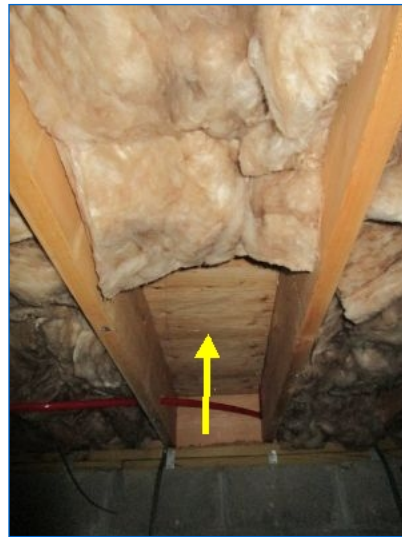
Batt insulation was observed to be hanging/missing at a few joist cavity locations. Recommend restoring missing/hanging insulation and securing in place using insulation support wires.

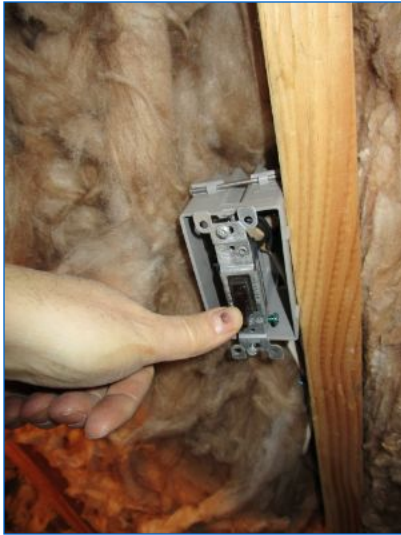
Proper lighting and GFCI type receptacles were not installed in the crawlspace. Recommend licensed electrician provide lighting and GFCI receptacle provisions.

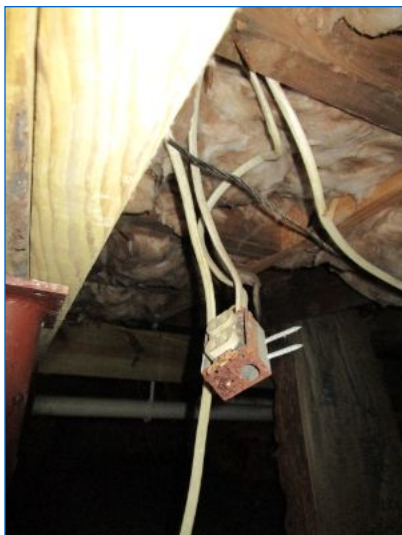
Hanging, uncovered receptacle box should be mounted to the structure and covered using a listed cover.

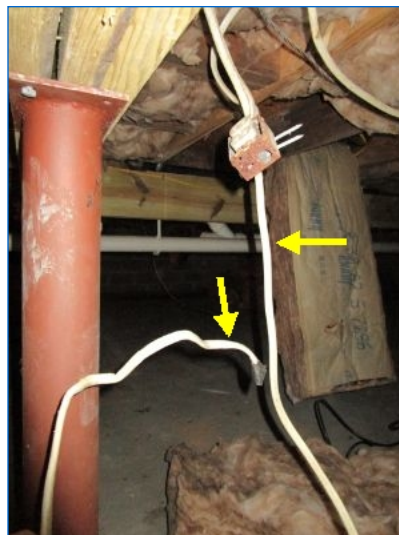
Potentially abandoned wiring visible in the crawlspace should be evaluated by a qualified electrical contractor to determine whether any wiring is still energized. Improperly terminated, energized wiring is a shock/electrocution hazard.

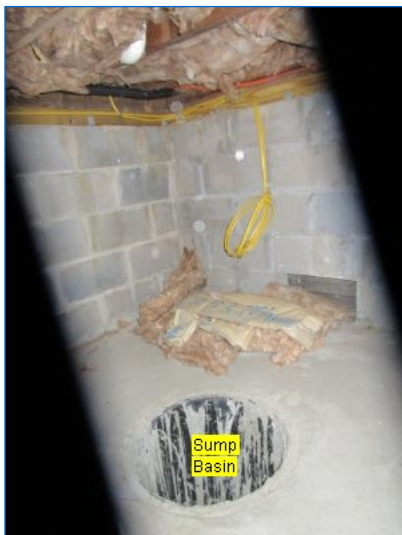
Main Crawlspace: Sump pump installation was incomplete (pump/cover missing, electric, drain and vent piping missing).

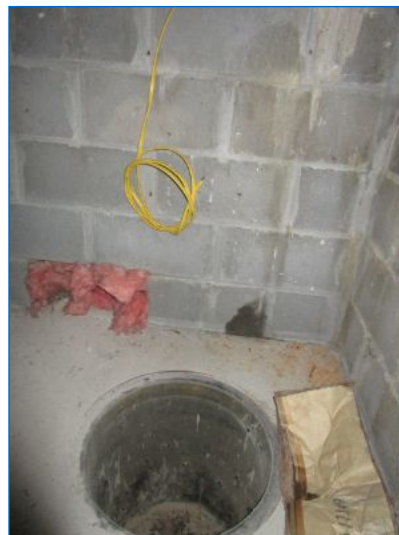
East Crawlspace: Sump pump installation was incomplete (pump/cover missing, electric, drain and vent piping missing).

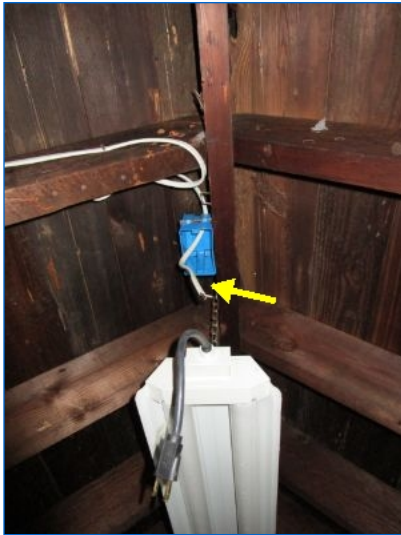
Incomplete electrical for attic lighting noted.

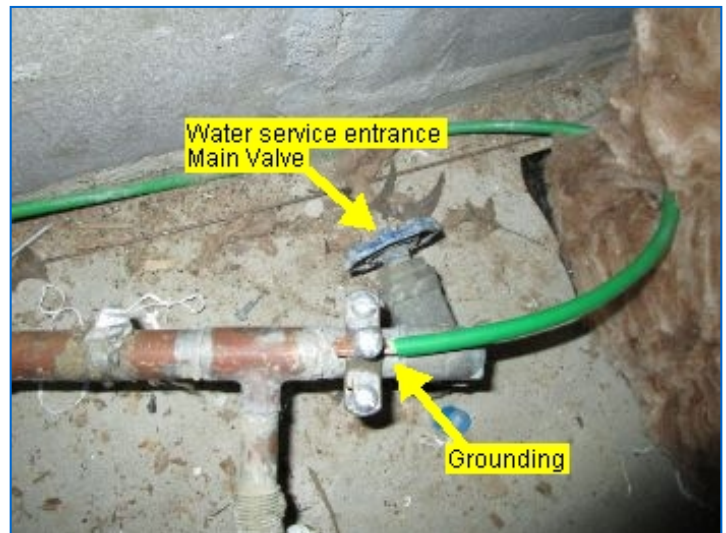
System Grounding: Ground wire connection noted at water main. Suggest having electrician ensure that ground is continuous.

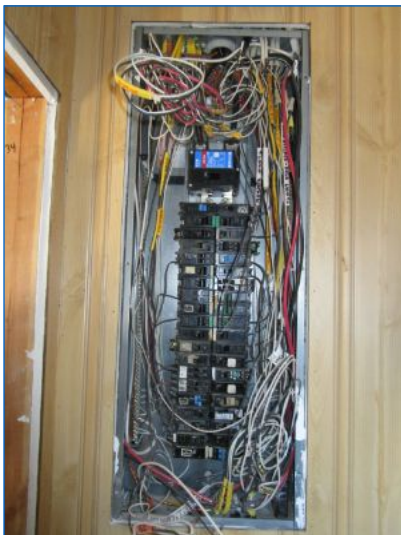
Panel cover was found removed at time of inspection. Exposing live electrical wires is an electrocution hazard. Recommend immediate reinstallation of panel box cover; ongoing construction. Upon completion of construction the Inspector recommends having a licensed qualified Electrician provide final inspection of the electrical system and issue an Underwriter's Certificate.

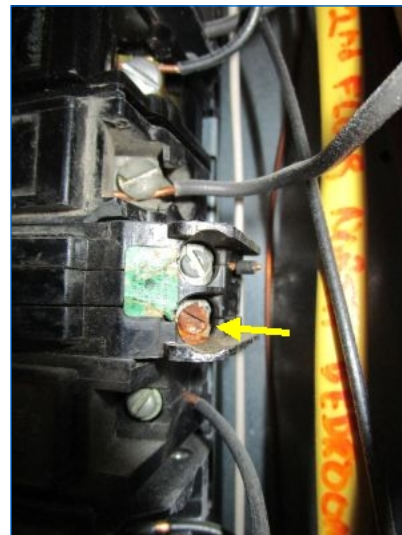
Rust stain at breaker/s; signs of corrosion at breaker terminal may cause overheating. Recommend having breaker connections evaluated by a licensed electrician.

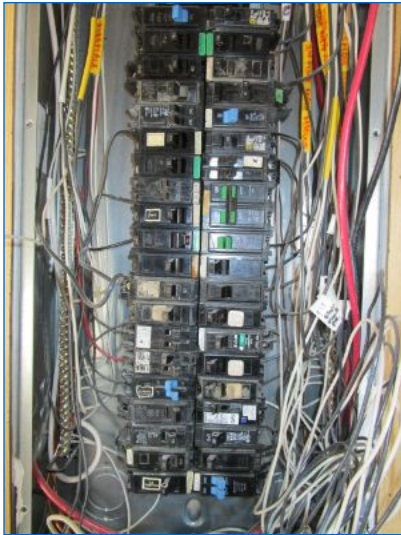
Excessive wire lengths in panel box; overcrowded condition. Recommend qualified electrician reduce crowding by shorten wire lengths. Provide proper circuit breaker index.

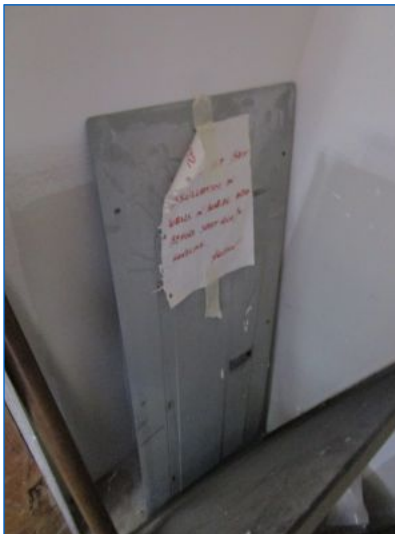
Panel cover was found removed at time of inspection. Exposing live electrical wires is an electrocution hazard. Recommend immediate reinstallation of panel box cover.

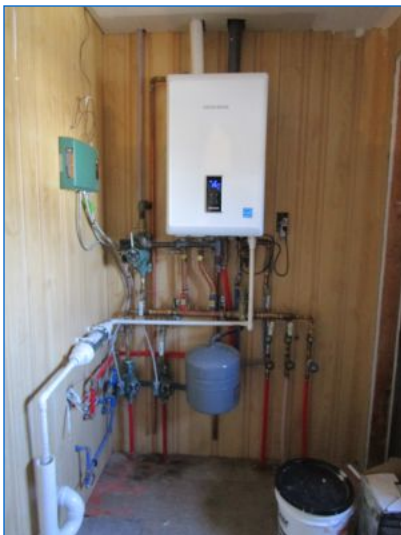
Heater Type: Gas-fired, Combination Tankless Boiler & Water Heater (CBWH); Manufactured by Navien.

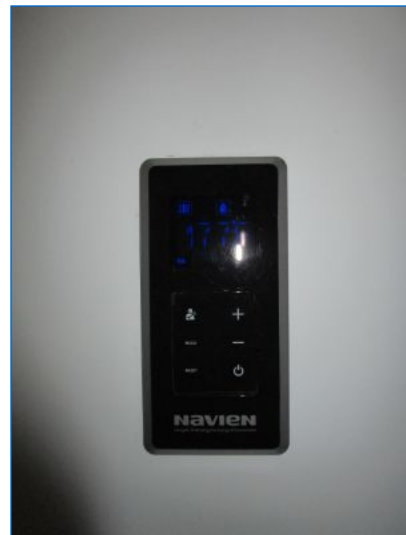
Heating Equipment located in Garage area was operable; delivering 177F supply water temperature.

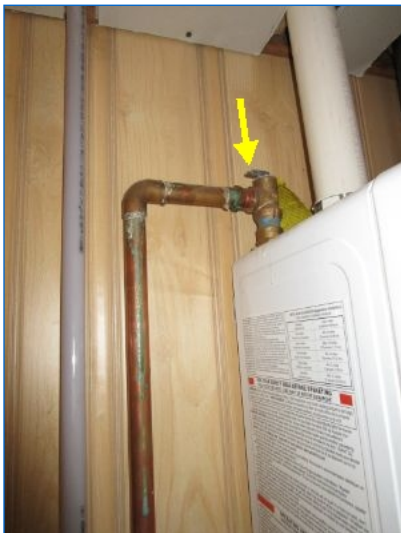
TPR (Temperature Pressure Relief) valve and discharge pipe show no deficiencies.

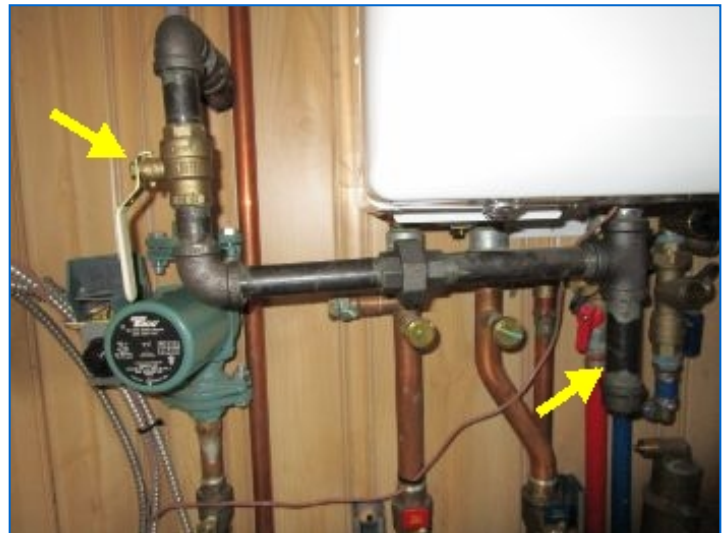
Gas shut-off valve and drip leg located at boiler.

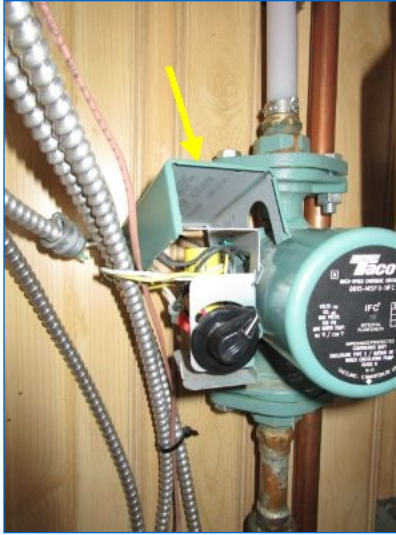
Circulator terminal box cover was open; exposed wires, contractor to close box.

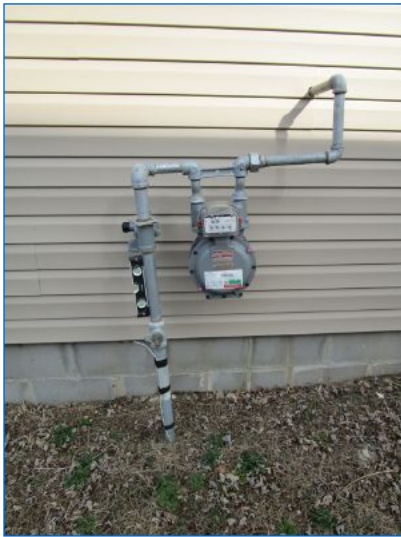
Gas service elevated pressure pipe was not vertical; possibly stressing the pipe. This is not typical of gas company installations. Recommend asking National grid to review installation and coordinate corrective action with contractor.

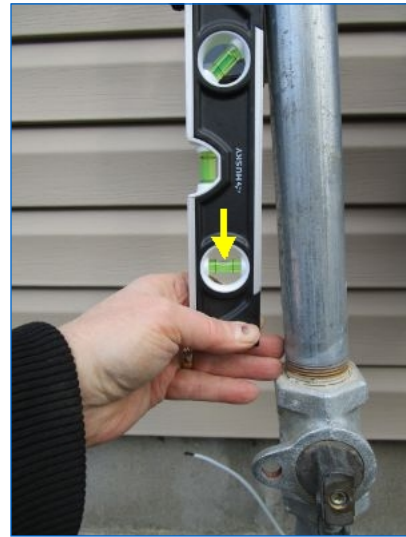
Gas service elevated pressure pipe was not vertical; possibly stressing the pipe. This is not typical of gas company installations. Recommend asking National grid to review installation and coordinate corrective action with contractor.

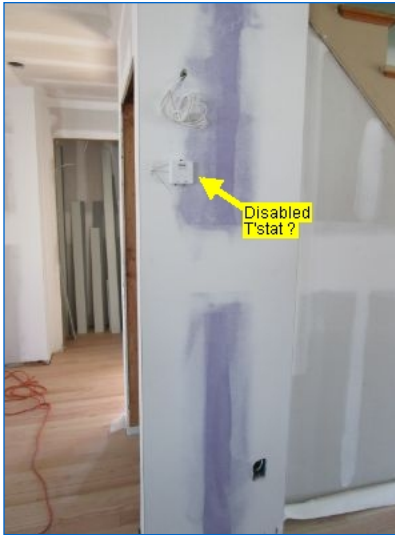
Distribution pump/piping installed indicates a 3 zone system, however only 2 thermostats were made active. All pumps had operated at time of inspection. It appeared that the 1st floor west-side t'stat was disabled.

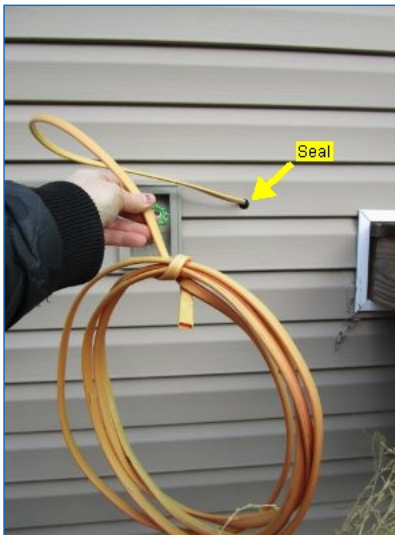
Unused cable for future A/C condenser at south side. Seal all openings in siding to prevent water intrusion into the structure.

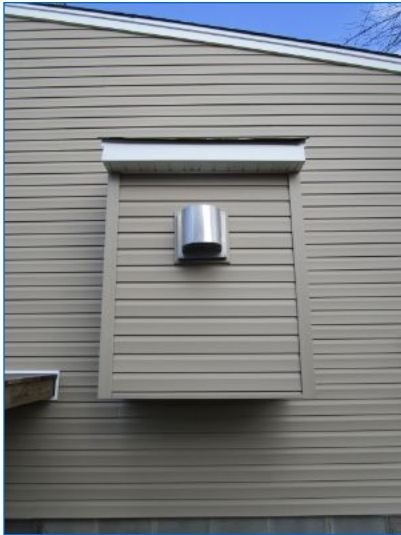
Gas fireplace surround/mantle, stone hearth and manufacturer approved startup of fireplace was yet to be completed.

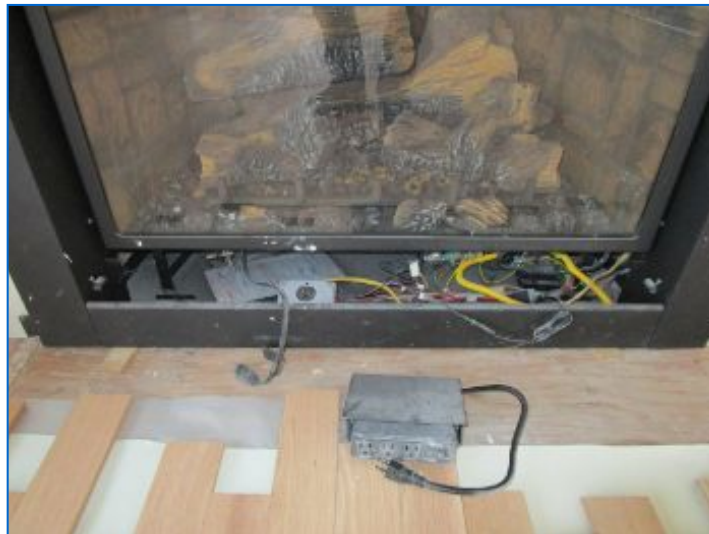
Gas fireplace surround/mantle, stone hearth and manufacturer approved startup of fireplace was yet to be completed.

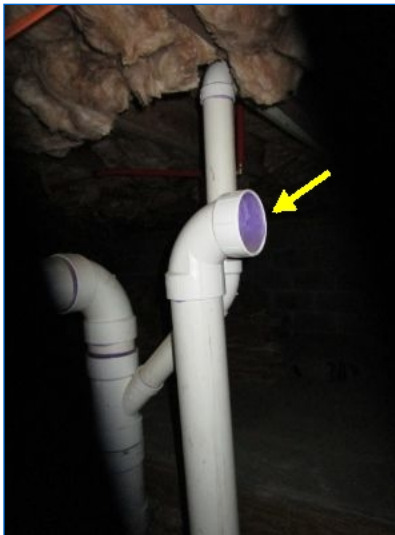
DWV pipe for proposed bathroom; unfinished plumbing work noted for the 1st floor (kitchen and bathroom).

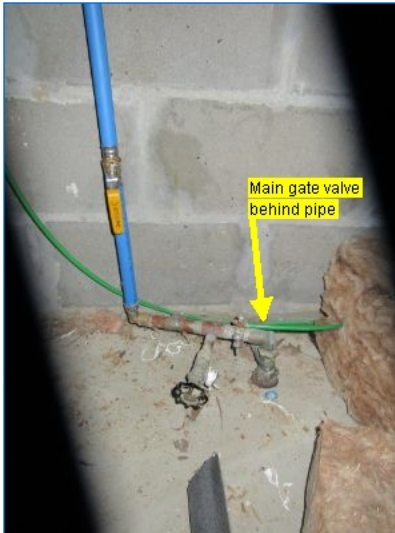
Water Service Entrance: 3/4" Copper line with shutoff valve/s. Meter external to the structure. The main water supply valve to the home was only slightly open at the time of inspection. This resulted in poor water flow rate at the 2nd floor bathroom. The Inspector was instructed to leave it in the opened position which improved the flow rate.

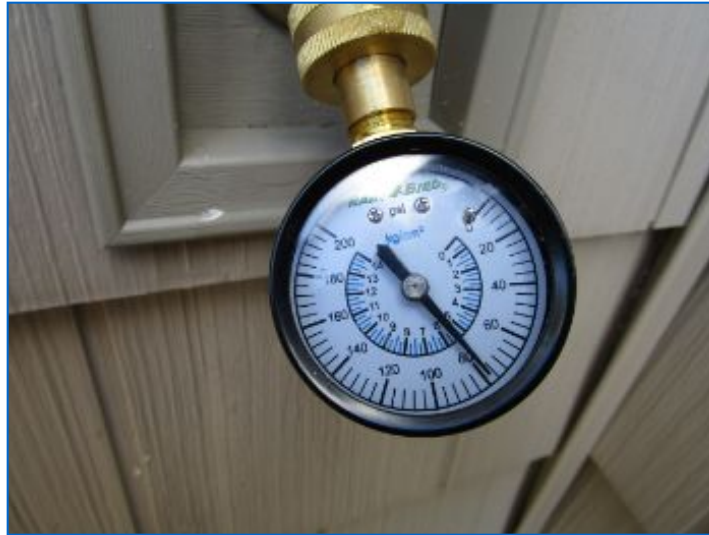
Water pressure measured 80 pounds per square inch (psi) at the time of the inspection. Acceptable water pressure is between 40 and 90 psi.

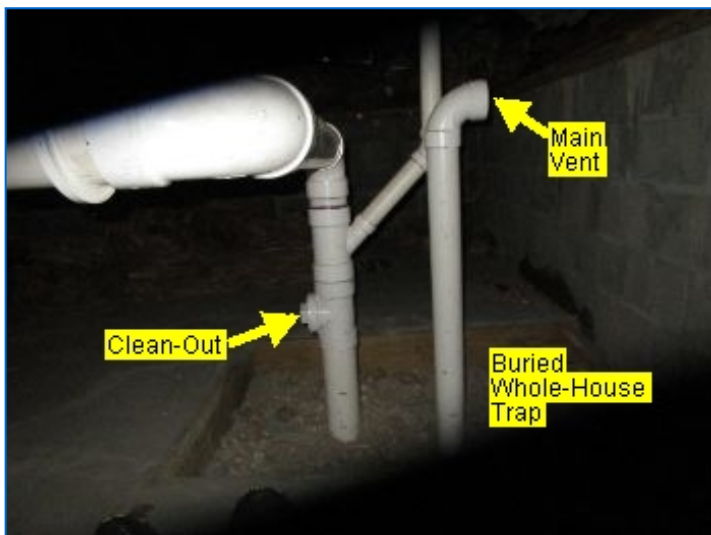
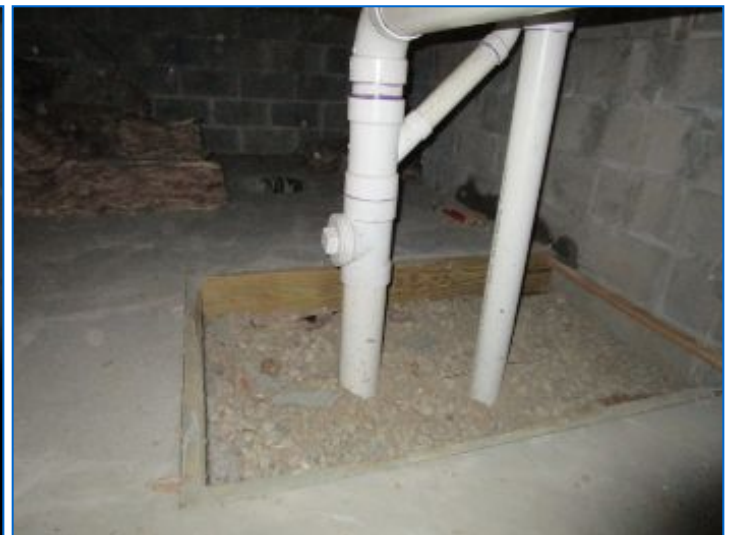
Waste Pipe Exit located at the south side of the house/crawlspace. Point of main waste pipe exit was buried below grade; not visible. Normally the whole-house trap and vent pipe are visually accessible here. Whole-house is likely buried and the main vent was incomplete. Final inspection for local code compliance by the town.

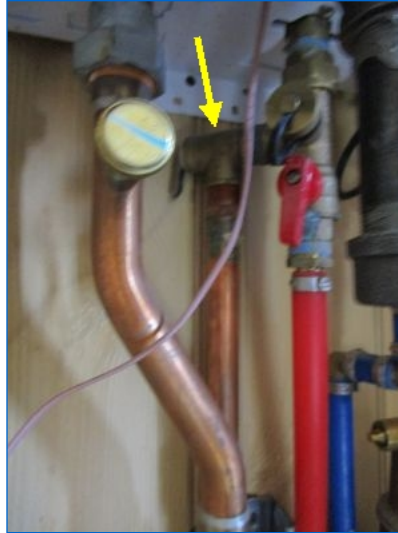
Temperature Pressure Relief (TPR) valve and discharge pipe showed no deficiencies.

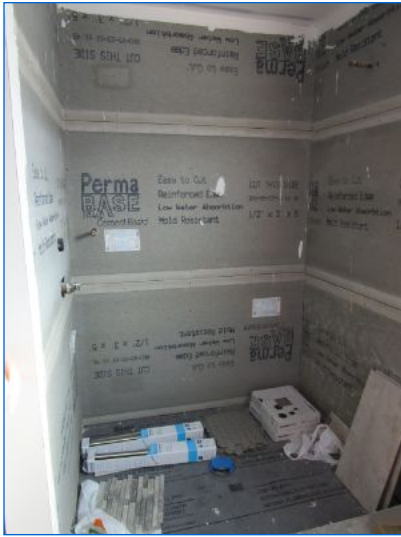
Shower tile work, plumbing/fixtures, wall accessories, grab bar, enclosure, lighting, finishes, etc. were not installed.

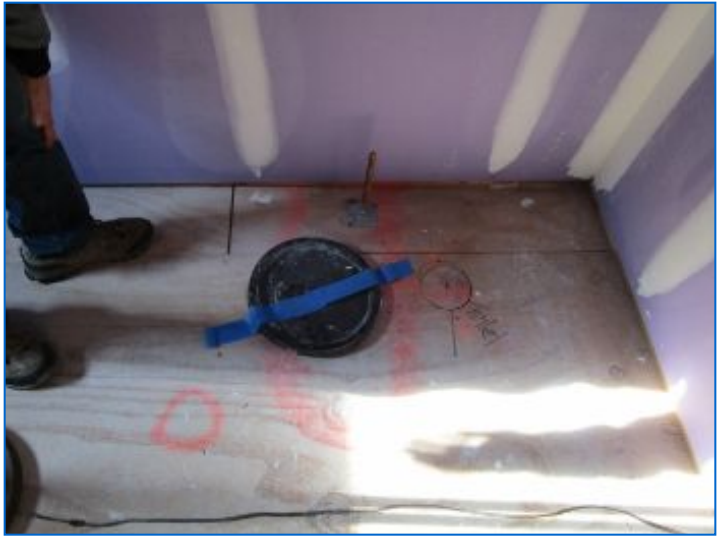
Floor tile, baseboard heat, door/window hardware, casings, sills, baseboard, moldings/trim, transitions, GFCI/receptacles, switches, lighting, exhaust fan, cabinets/counters, plumbing fixtures, accessories, grab bars, finishes, etc. were not installed.

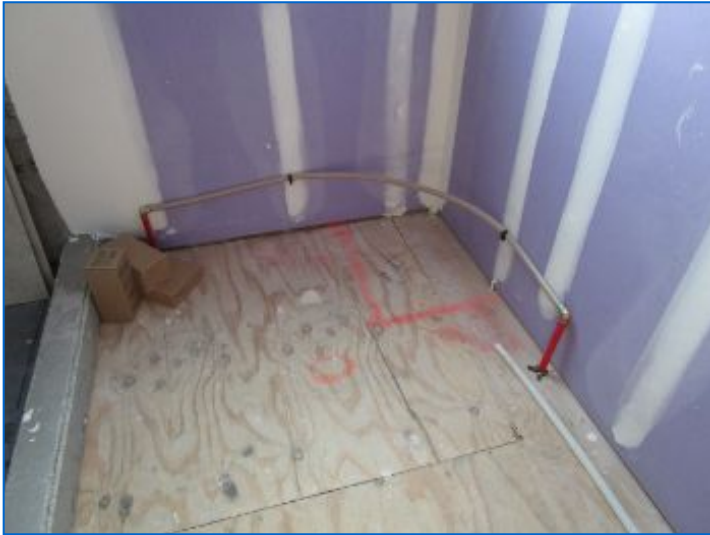
Floor tile, baseboard heat, door/window hardware, casings, sills, baseboard, moldings/trim, transitions, GFCI/receptacles, switches, lighting, exhaust fan, cabinets/counters, plumbing fixtures, accessories, grab bars, finishes, etc. were not installed.

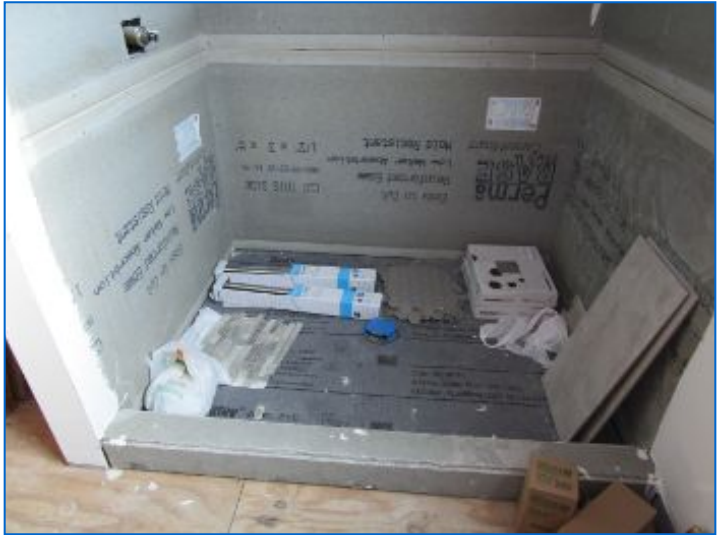
Shower tile work, plumbing/fixtures, wall accessories, grab bar, enclosure, lighting, finishes, etc. were not installed.

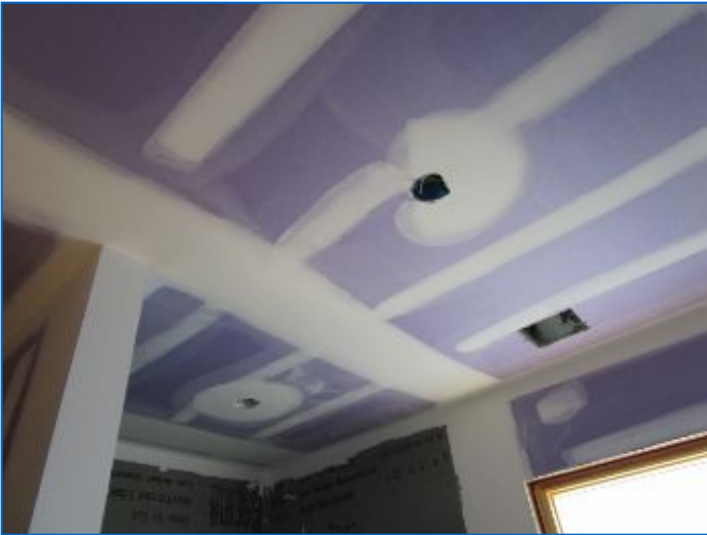
Floor tile, baseboard heat, door/window hardware, casings, sills, baseboard, moldings/trim, transitions, GFCI/receptacles, switches, lighting, exhaust fan, cabinets/counters, plumbing fixtures, accessories, grab bars, finishes, etc. were not installed.

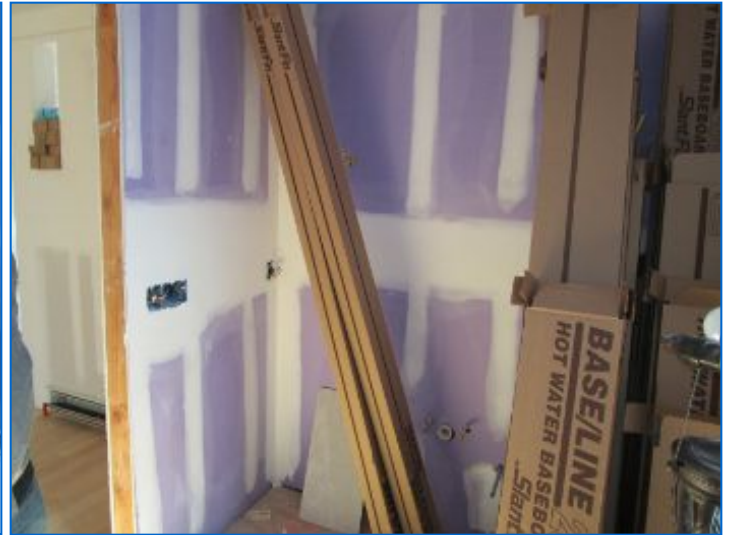
Floor tile, baseboard heat, door/window hardware, casings, sills, baseboard, moldings/trim, transitions, GFCI/receptacles, switches, lighting, exhaust fan, cabinets/counters, plumbing fixtures, accessories, grab bars, finishes, etc. were not installed.

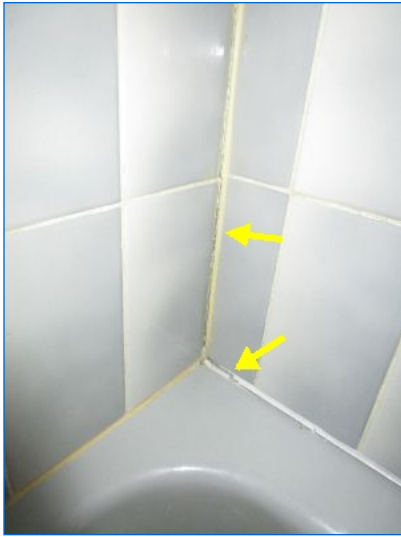
Cracked grout at corner joints noted to have been caused by the structure elevation. Grout repairs recommended to prevent water entry.

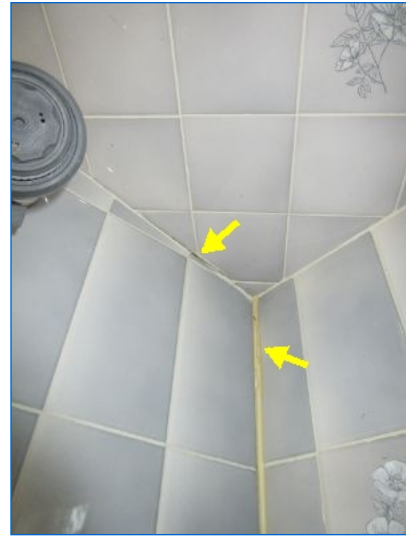
Cracked grout at corner joints noted to have been caused by the structure elevation. Grout repairs recommended to prevent water entry.

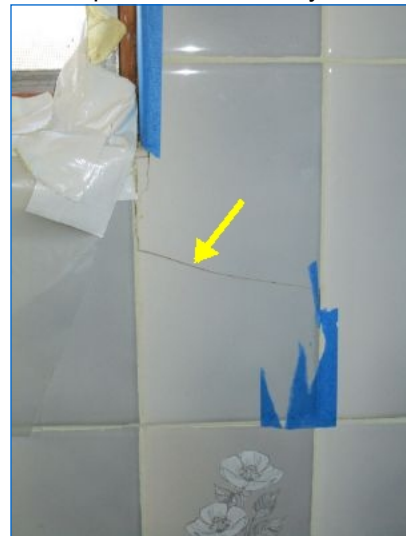
Cracked tile at outer wall noted to have been caused by the structure elevation. Tile and grout repairs recommended around window to prevent water entry.

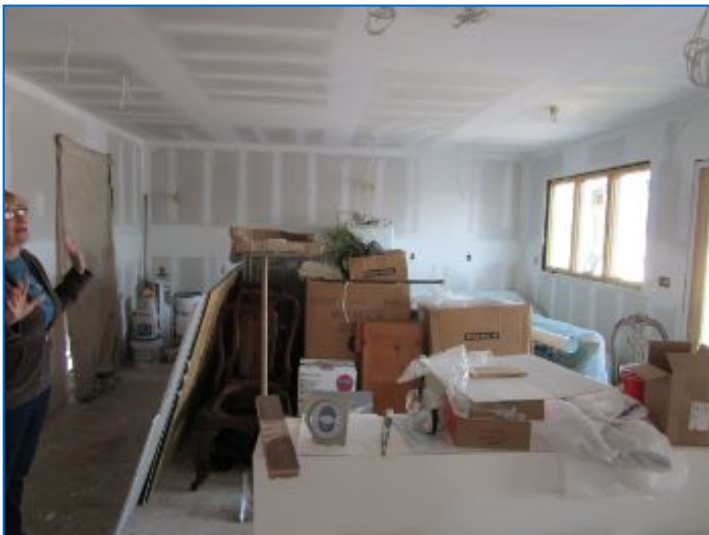
Kitchen porcelain tile flooring, door/window hardware, baseboard, casings, sills, moldings/trim, transitions, kickspace heater, GFCI/receptacles, switches, lighting, cabinets/counters, finishes, appliances, etc. were not yet installed.

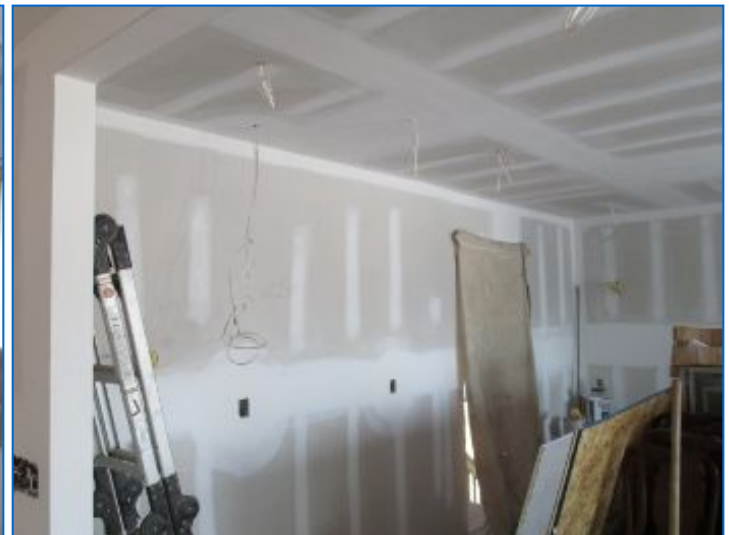
Kitchen porcelain tile flooring, door/window hardware, baseboard, casings, sills, moldings/trim, transitions, kickspace heater, GFCI/receptacles, switches, lighting, cabinets/counters, finishes, appliances, etc. were not yet installed.

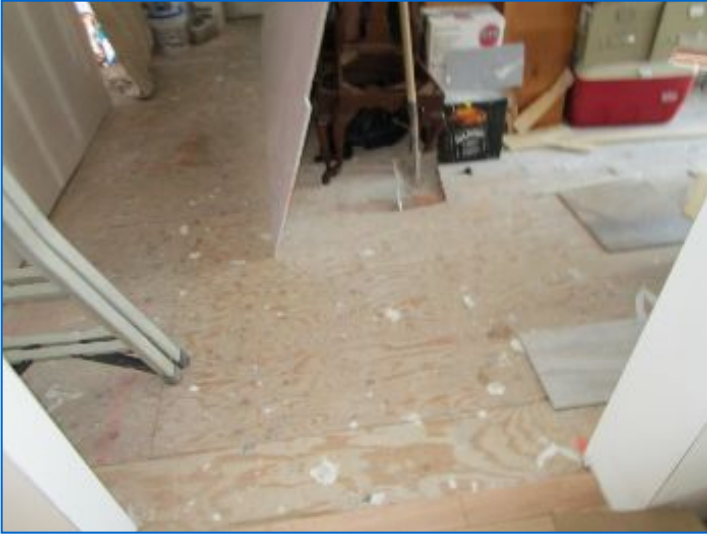
Kitchen porcelain tile flooring, door/window hardware, baseboard, casings, sills, moldings/trim, transitions, kickspace heater, GFCI/receptacles, switches, lighting, cabinets/counters, finishes, appliances, etc. were not yet installed.

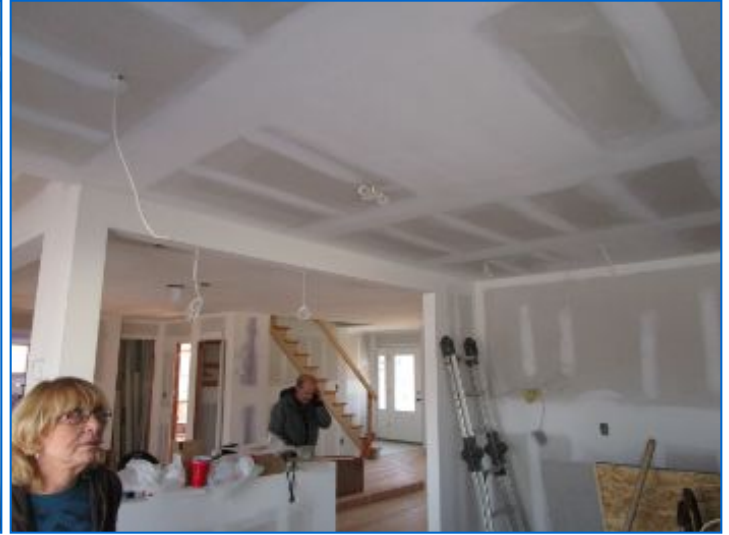
Kitchen porcelain tile flooring, door/window hardware, baseboard, casings, sills, moldings/trim, transitions, kickspace heater, GFCI/receptacles, switches, lighting, cabinets/counters, finishes, appliances, etc. were not yet installed.

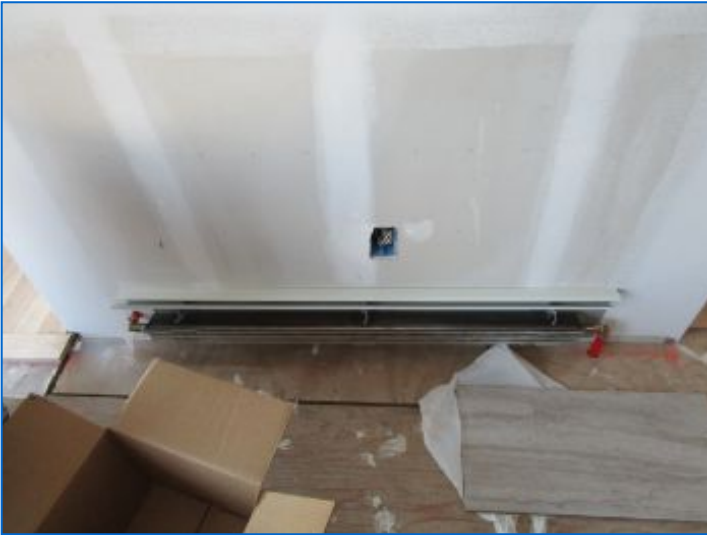
Baseboard enclosure parts missing.

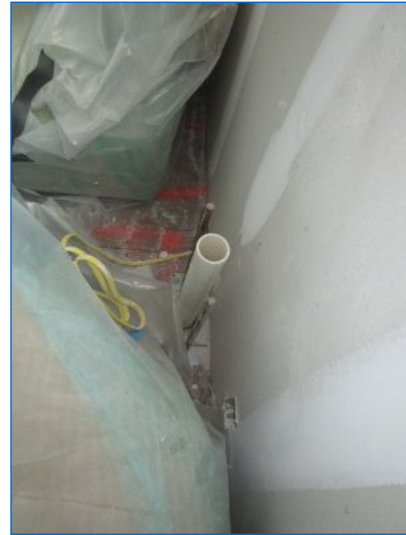
Some plumbing stub-ups noted.

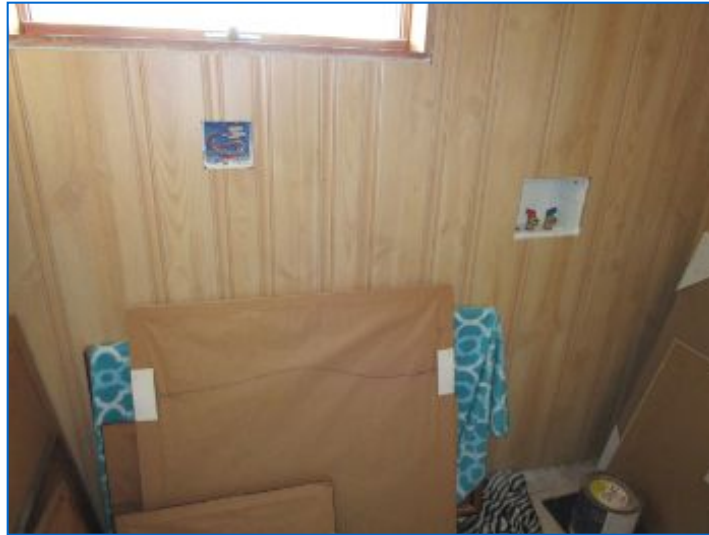
LIMITATION: Unable to test functionality of utilities serving appliances due to the lack of completion of the laundry installation at the time of inspection.

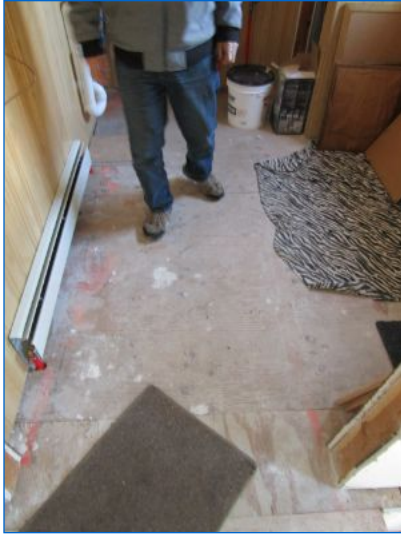
Utility Room: flooring, doors, baseboard, casings, moldings/trim, transitions, baseboard end-caps, receptacles, switches, lighting, finishes, etc. were not yet installed.

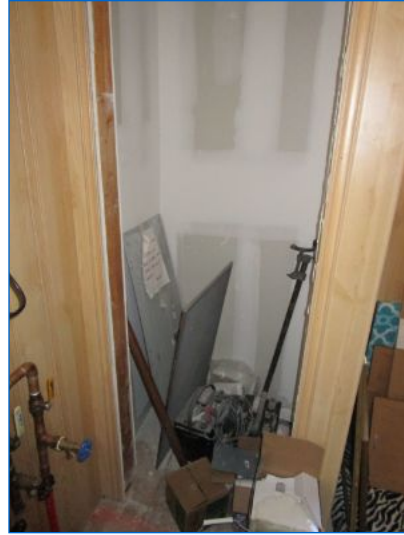
Utility Room: flooring, doors, baseboard, casings, moldings/trim, transitions, baseboard end-caps, receptacles, switches, lighting, finishes, etc. were not yet installed.

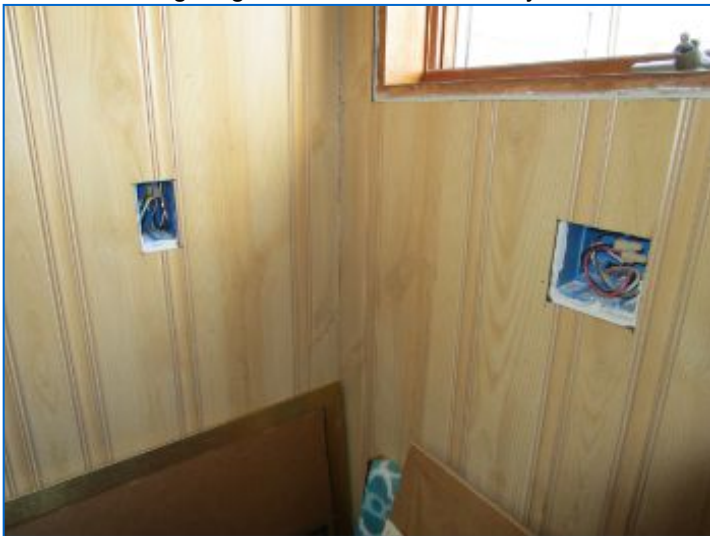
Utility Room: flooring, doors, baseboard, casings, moldings/trim, transitions, baseboard end-caps, receptacles, switches, lighting, finishes, etc. were not yet installed.

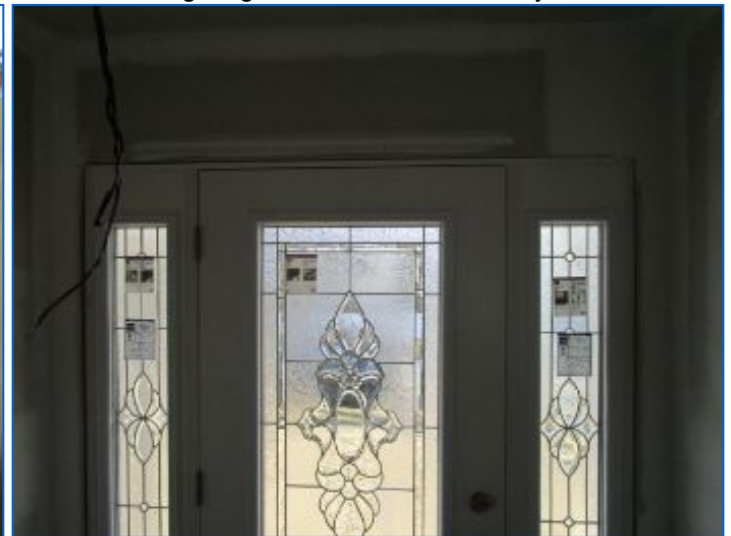
Entryway door hardware, casing, baseboard enclosure, transitions, receptacles/switches, lighting, baseboard, molding, finishes, etc. were not yet installed.

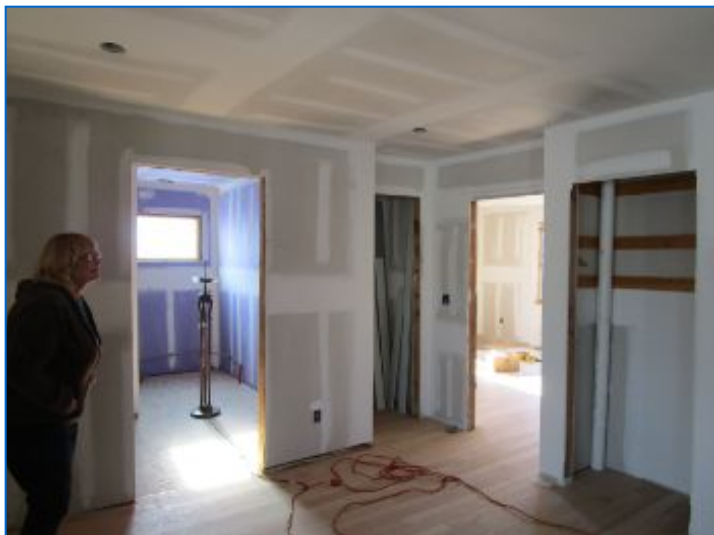
Interior doors, hardware, casing, baseboard, transitions, receptacles/switches, lighting, finishes, etc. were not yet installed.

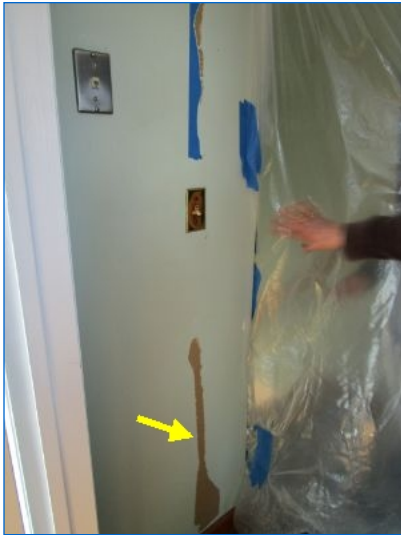
Drywall surface damage caused by masking tape.  
Recommend wall repairs.

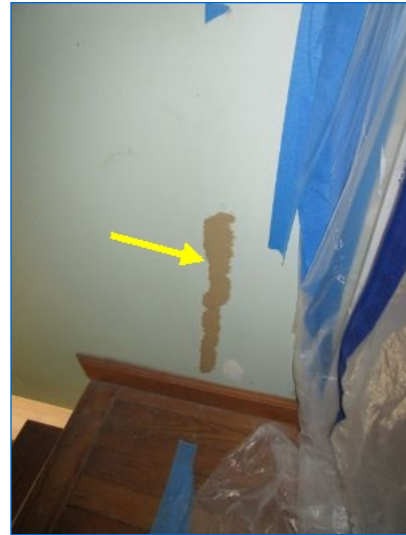
Drywall surface damage caused by masking tape.  
Recommend wall repairs.

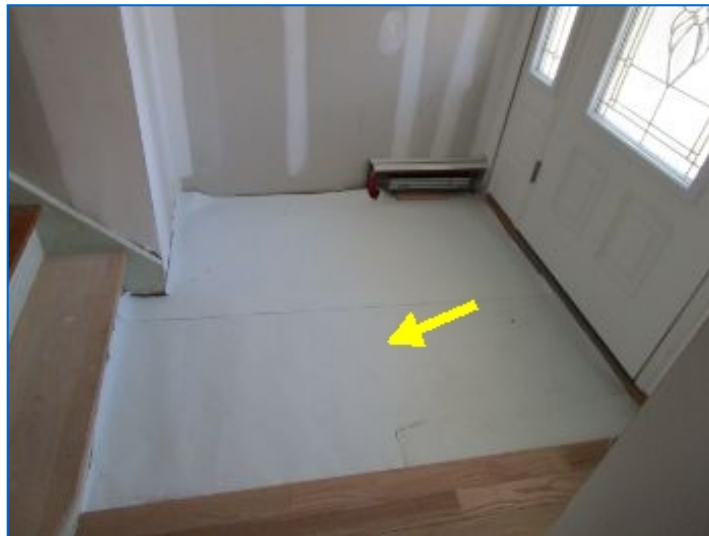
Entryway flooring was not installed.

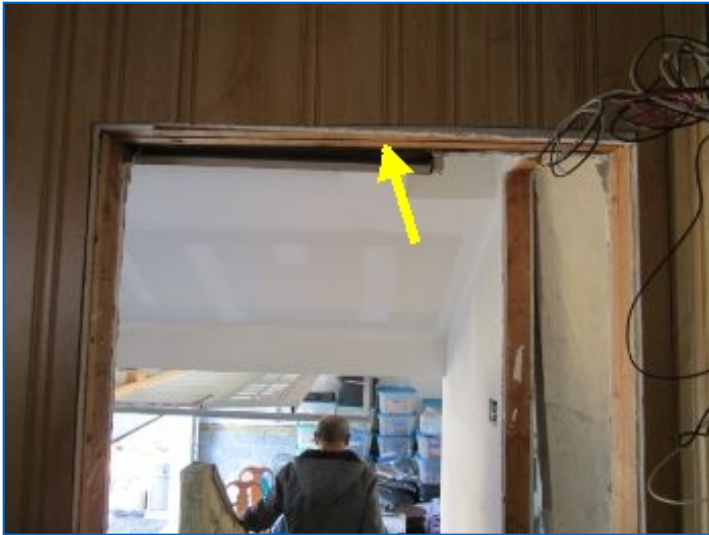
Utility Room: The height of a standard doors is 6 feet 8 inches. The height of the rough opening for a door is the door height plus 2-5/8 inches, therefore 82-5/8 inches. The height of the existing rough opening for the utility room door is only 74 inches which is 8-5/8 inches too short. Non-standard interior doorway dimensions noted. Interior passage doorways are commonly 6'-8" high and 30" to 32" wide.

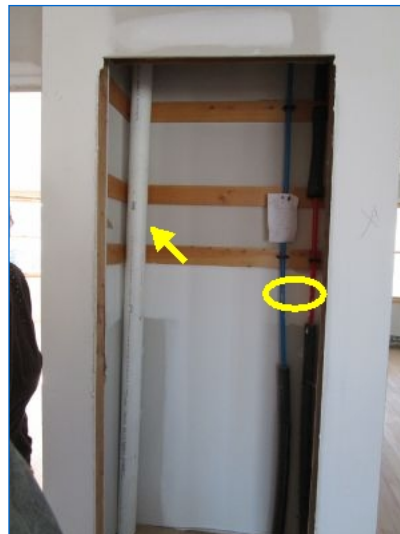
1st floor closet configuration included plumbing risers which was not conducive to the clients needs. Contractor was to reroute risers as requested.

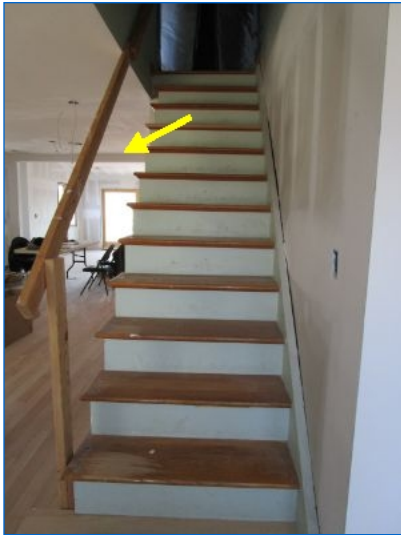
A compliant handrail was not installed.

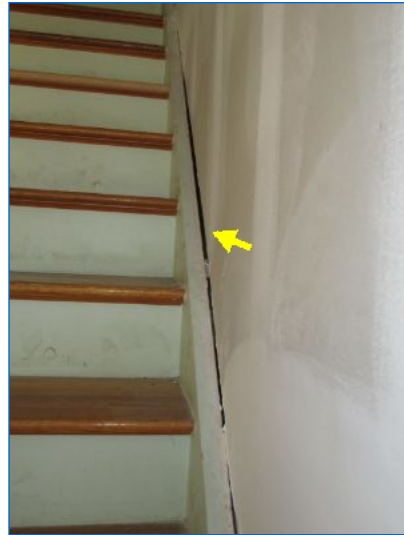
Molding and finishes not yet completed.

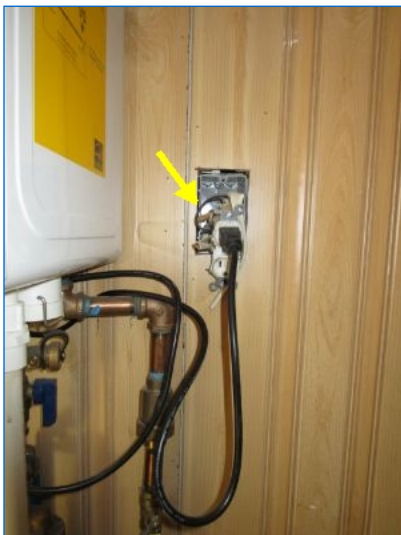
One or more electrical receptacles in the utility room was missing a cover plate at the time of the inspection. This condition is a shock/electrocution. Approved cover plates should be installed by a qualified electrical contractor to prevent direct contact with energized electrical components.

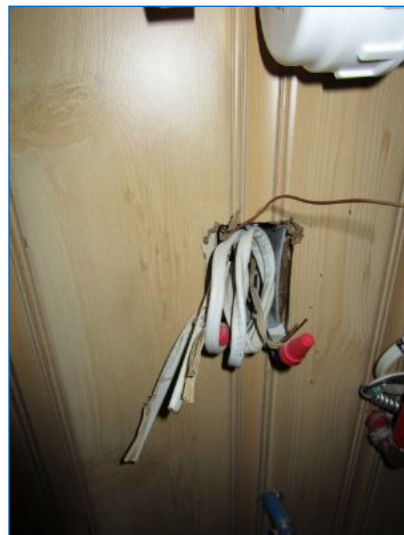
Open electrical junction box in Boiler room missing cover plate at the time of the inspection. This condition is a shock/electrocution hazard. Approved cover plates should be installed by a qualified electrical contractor to prevent direct contact with energized electrical components.

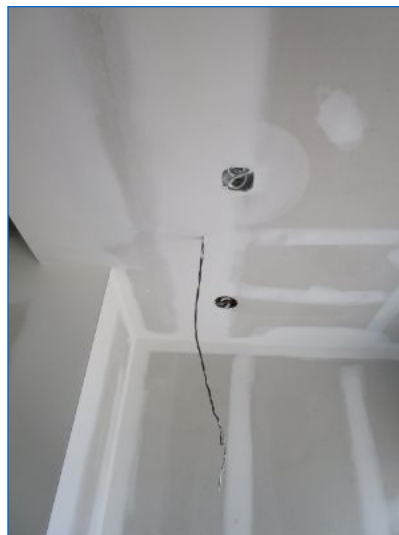
Entryway electrical and lighting incomplete.

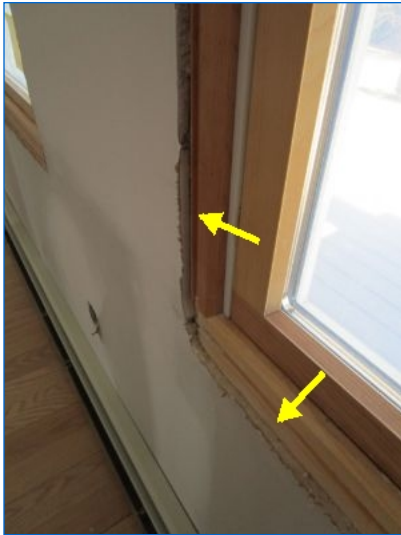
Several windows were observed to have inadequate jamb extension and were not flush with the wall. The Inspector recommends that the Contractor provide the manufacturer recommended jamb extensions for proper casing finishes.
