# ProSpec Home Inspection of Long Island Property Inspection Report

Massapequa, NY 11758

Inspection prepared for: Name Deleted  
Date of Inspection: 1/25/2019 Time: 10:00 AM  
Age of Home: 68 yrs old Size: 2,006 sq. ft.  
Approx. Year Built: 1950

Inspector: Russell Classi, P.E.  
License #16000077480  
Phone: (516) 580-1848  
Email: ProSpecofLI@gmail.com  
[www.NassauProfessionalHomeInspector.com](http://www.NassauProfessionalHomeInspector.com)

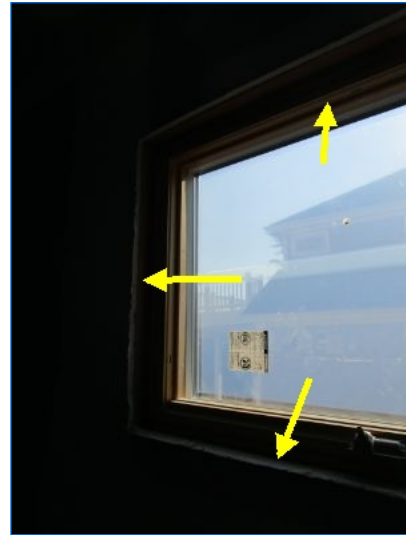
Several windows were observed to have inadequate jamb extension and were not flush with the wall. The Inspector recommends that the Contractor provide the manufacturer recommended jamb extensions for proper casing finishes.

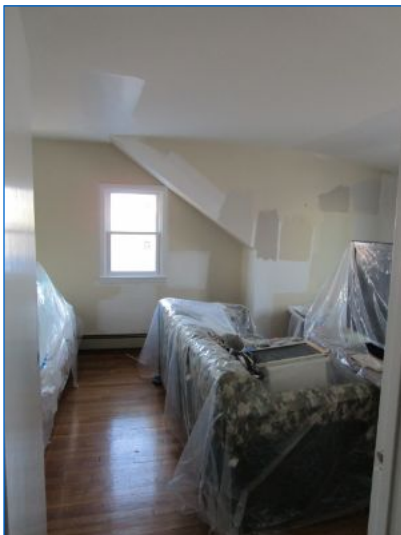
Bedroom (2nd floor): Needs to be repainted.

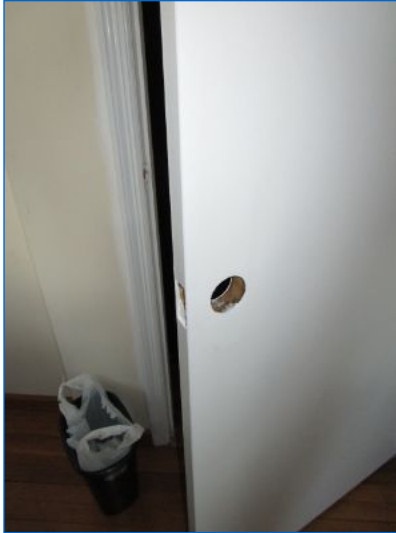
Door hardware noted as missing.

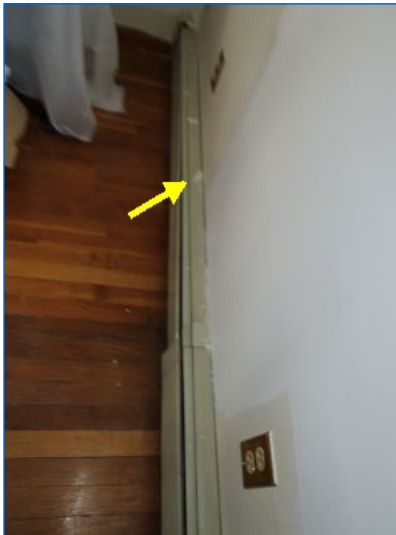
Contractor is responsible to clean up all spackle/paint drippings.

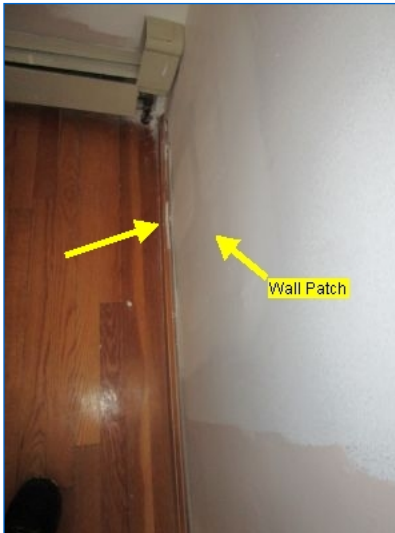
Contractor is responsible to clean up all spackle/paint drippings.

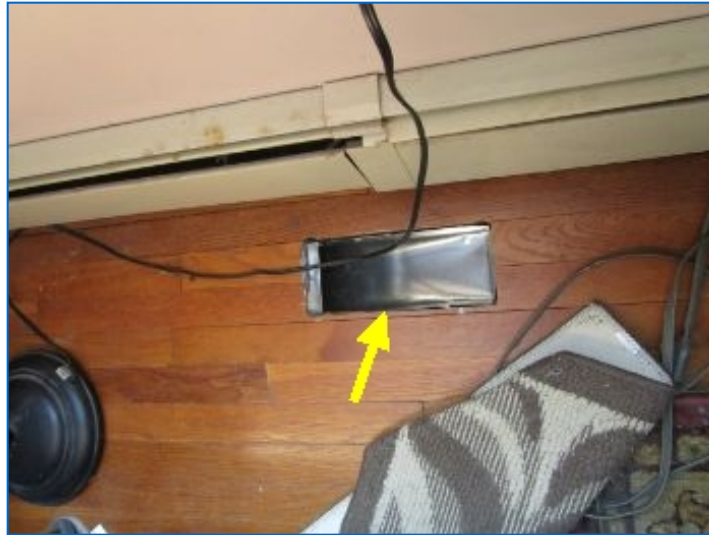
Duct penetration through floor that's not to be used; suggest proper closure of floor opening.

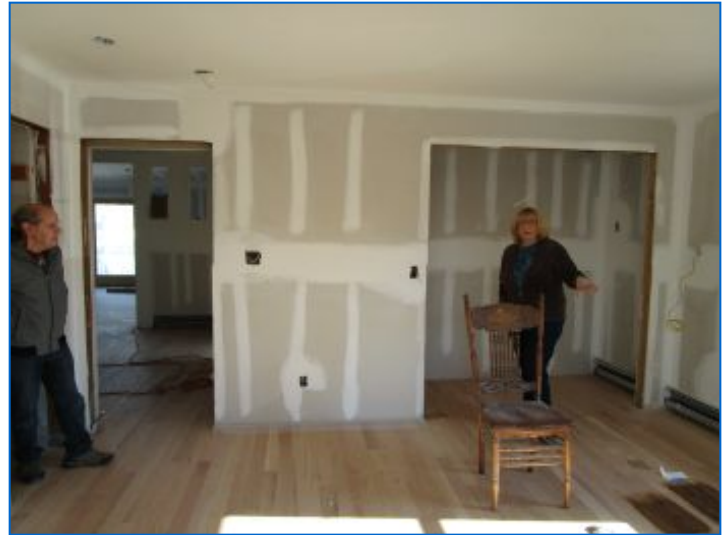
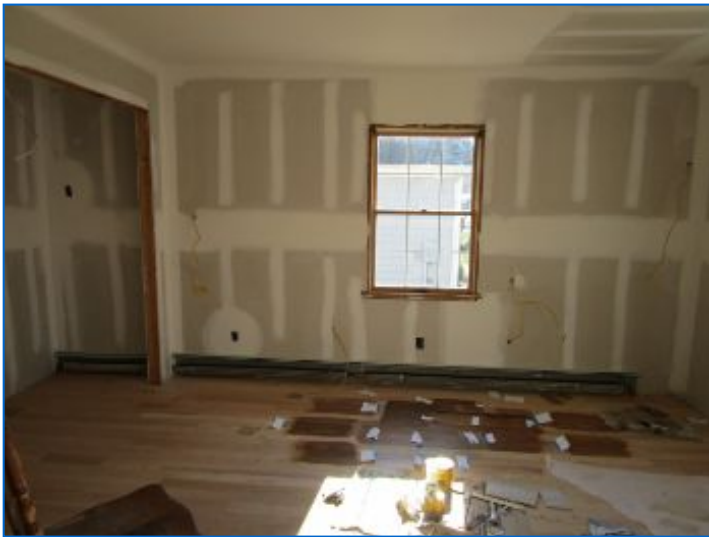
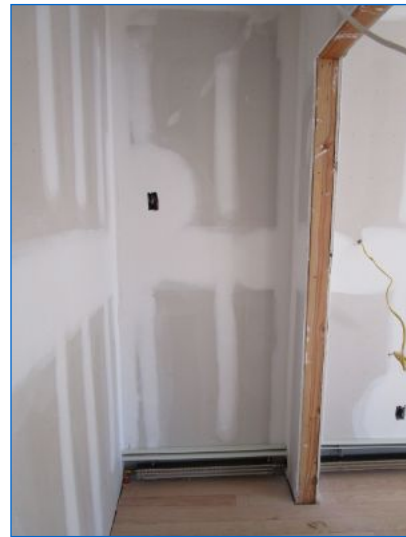
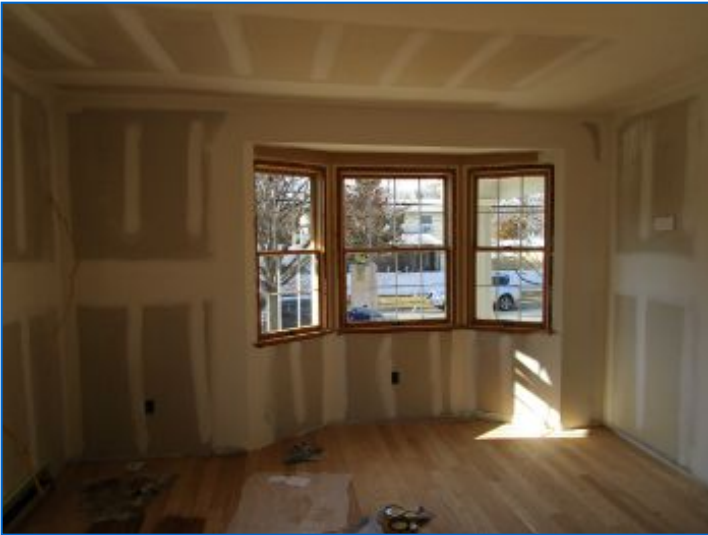
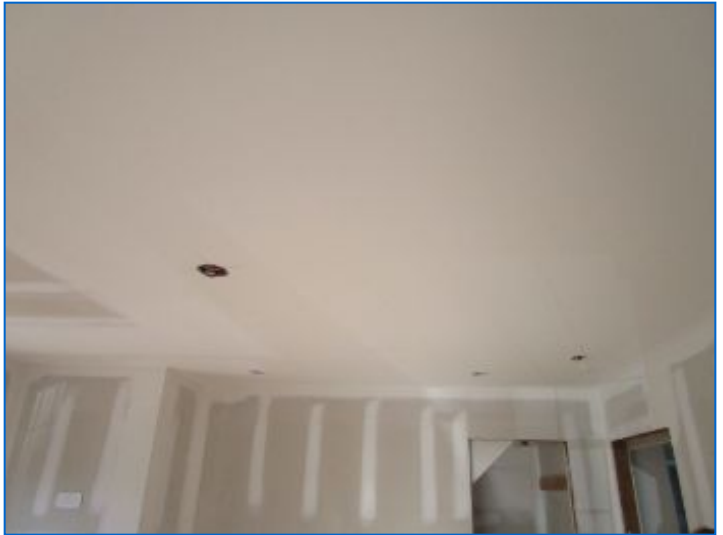
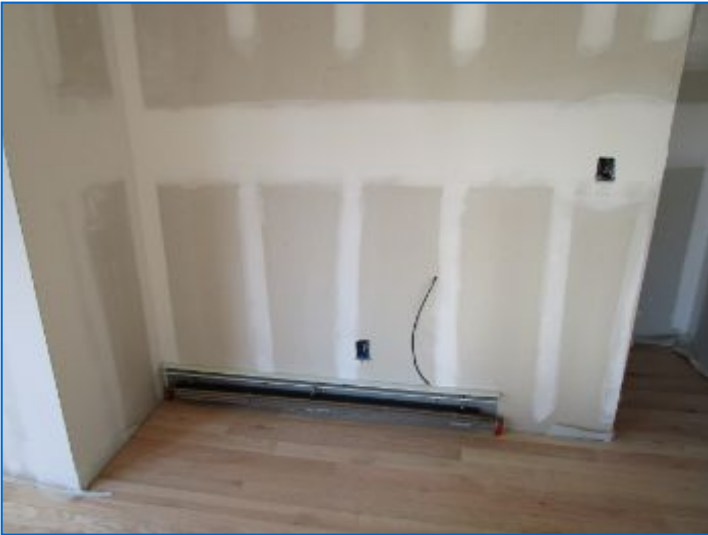
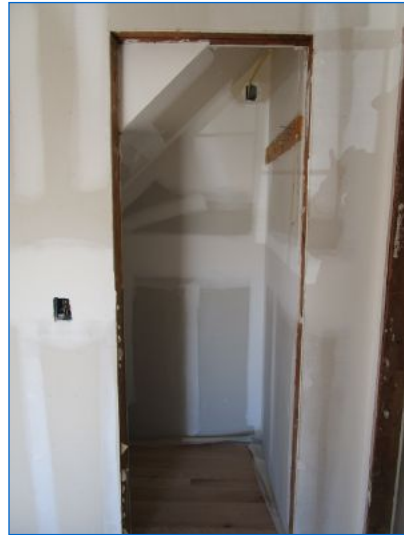
Doors, door/window hardware, baseboard, casings, sills, moldings/trim, transitions, receptacles, switches, lighting, baseboard enclosure parts, finishes, etc. were not yet installed.

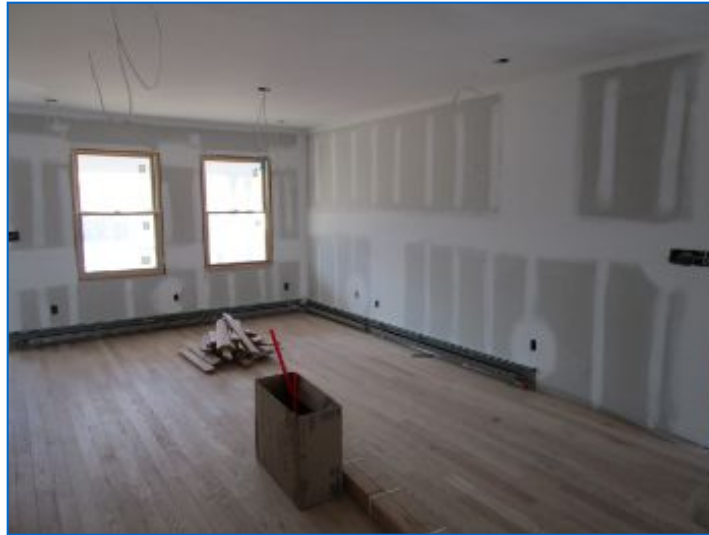
Window hardware, baseboard, casings, sills, moldings/trim, transitions, receptacles, switches, lighting, baseboard enclosure parts, finishes, etc. were not yet installed.

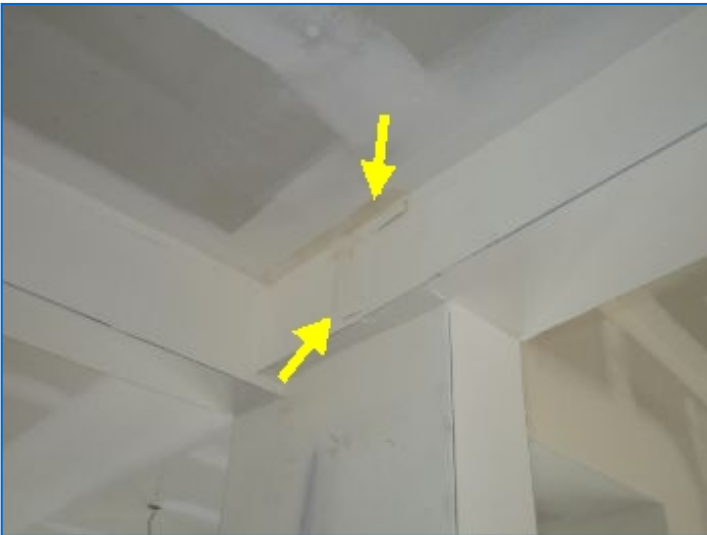
Inferior wall tape and joint work; rework suggested here.

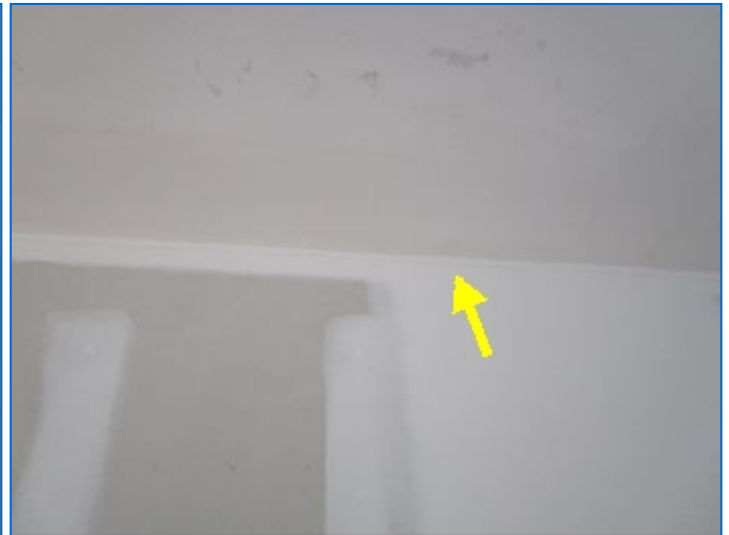
Uneven corner joint work; rework/add'l sanding suggested here.

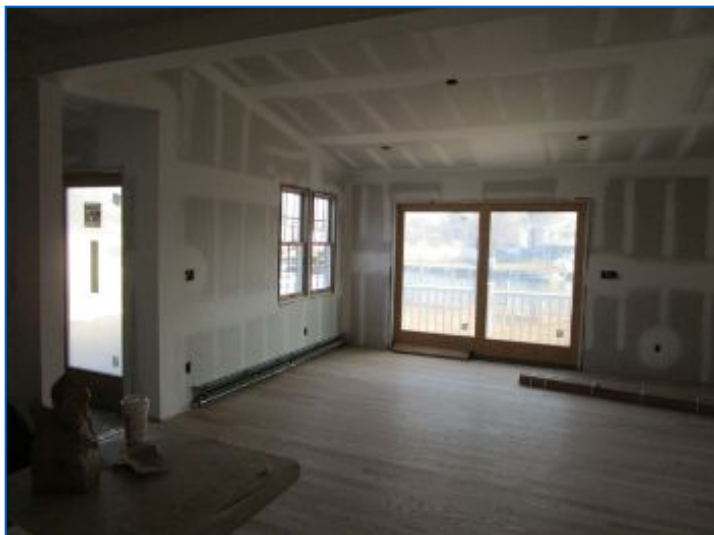
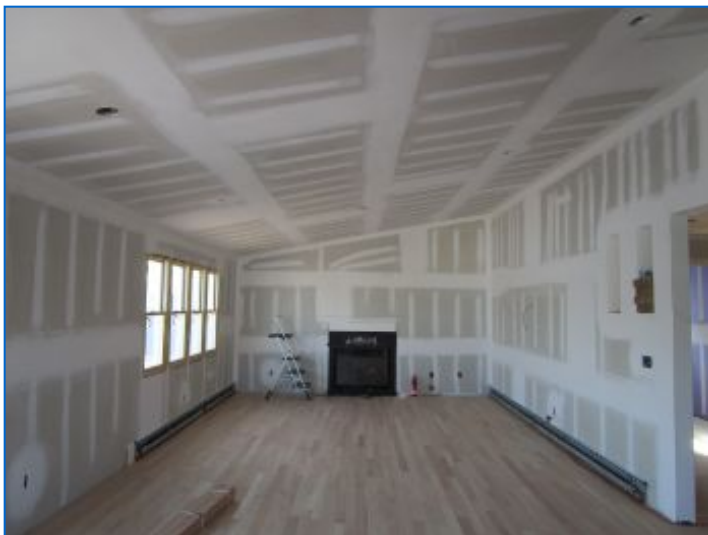
Door/window hardware, baseboard, casings, sills, moldings/trim, transitions, receptacles, switches, lighting, baseboard enclosure parts, finishes, etc. were not yet installed.

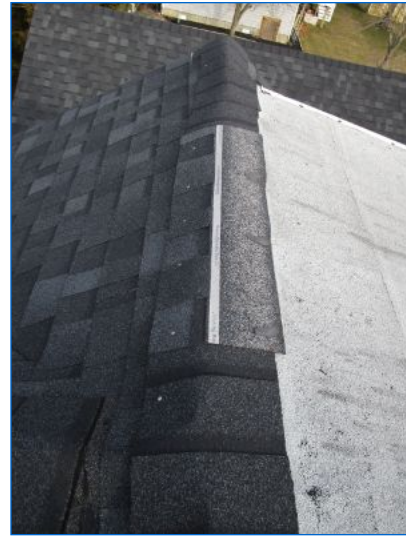
Signs of inferior workmanship by roofers. Conditions that can lead to water intrusion noted. The Inspector recommends review by a qualified roofing contractor to provide remedial improvements and warranty workmanship for the roof.

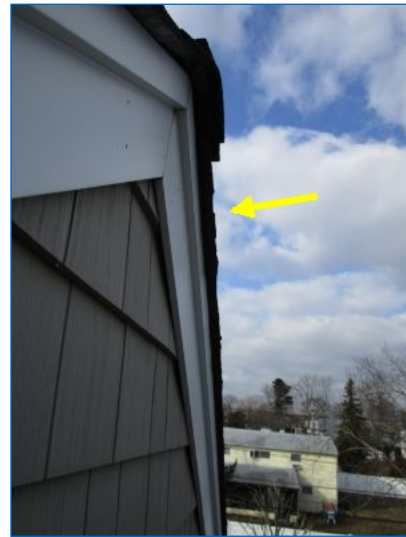
Signs of inferior workmanship by roofers. Conditions that can lead to water intrusion noted. The Inspector recommends review by a qualified roofing contractor to provide remedial improvements and warranty workmanship for the roof. Exposed and countersunk nail heads at roofing material. Recommend sealing all fastener heads.

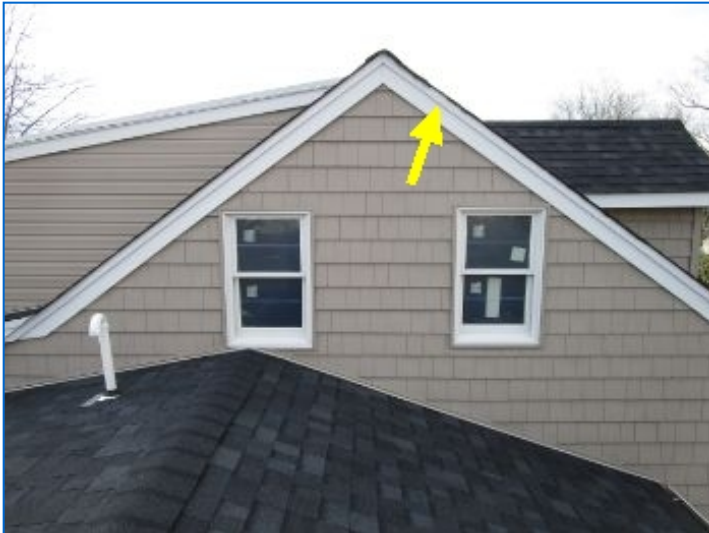
Signs of inferior workmanship by roofers. Jagged shingle cut/damaged edges.

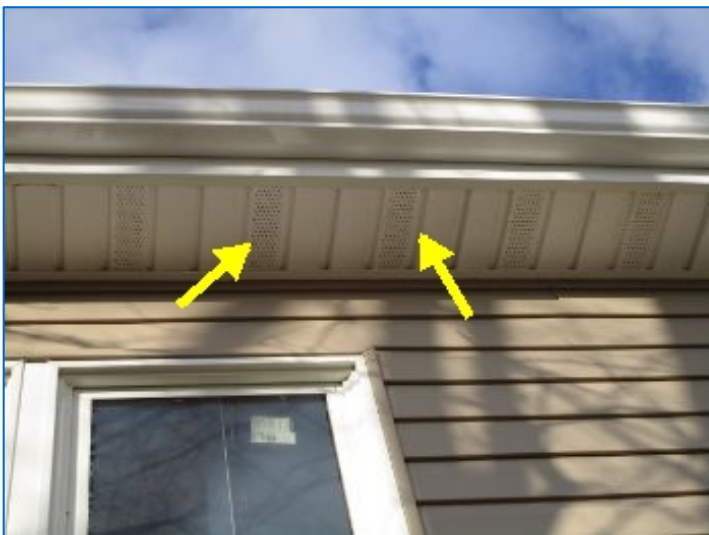
Under eave soffit inlet vents noted for attic ventilation.

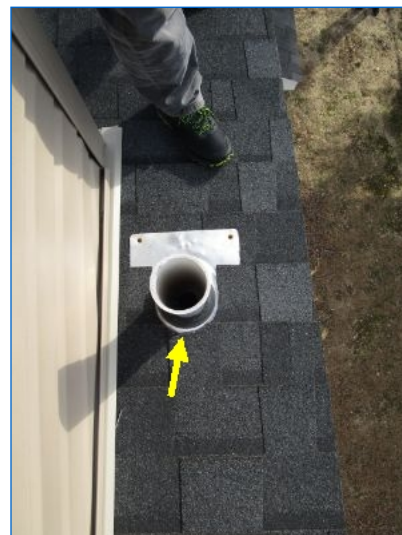
Due to the low-slope roof where plumbing vent penetrates roof the Inspector recommends sealing around shingle cut to ensure that no snow/ice/water intrusion occurs at this south side location.

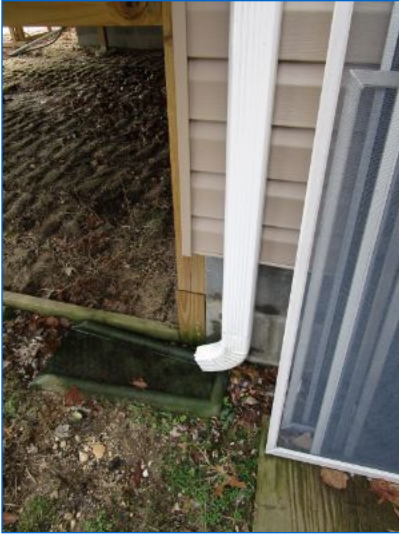
Downspout extensions missing: splash blocks insufficient. Recommend extending downspouts 4 ft minimum where possible to divert run-off away from the structure to prevent soil erosion at the slab foundation perimeter and to prevent water seepage through foundation walls.

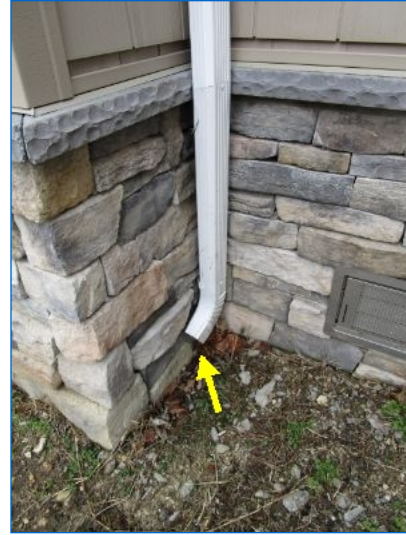
Downspout extensions missing: splash blocks insufficient. Recommend extending downspouts 4 ft minimum where possible to divert run-off away from the structure to prevent soil erosion at the slab foundation perimeter and to prevent water seepage through foundation walls.

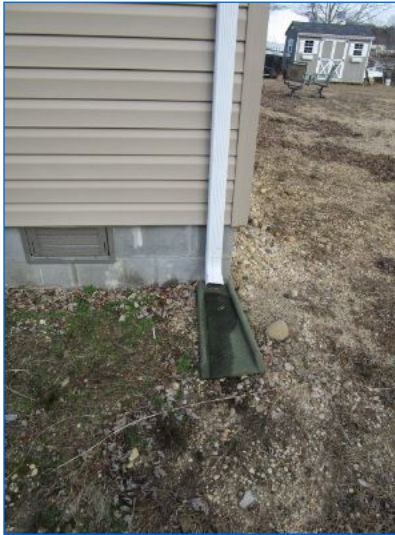
Downspout extensions missing: splash blocks insufficient. Recommend extending downspouts 4 ft minimum where possible to divert run-off away from the structure to prevent soil erosion at the slab foundation perimeter and to prevent water seepage through foundation walls.

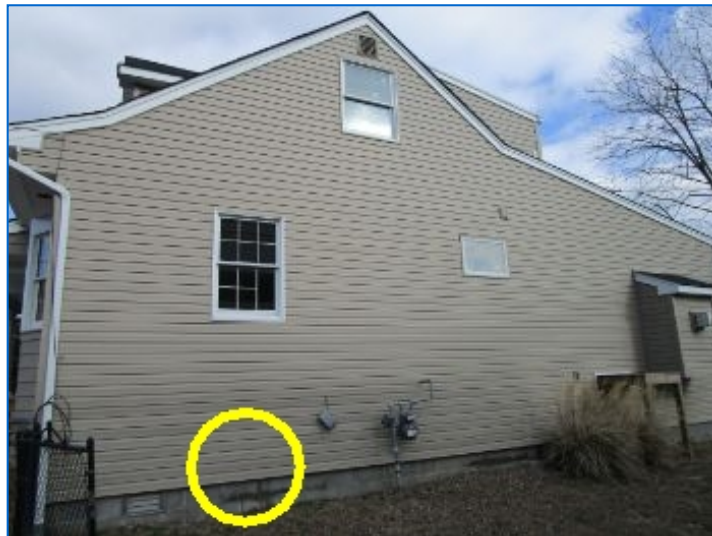
EXTERIOR South Exterior

- Per the Foundation Plan a crawlspace access door is required at the south exterior wall.

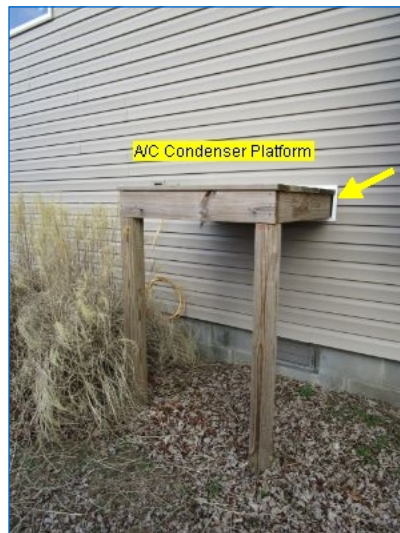
Seal all openings in siding penetrations to prevent water intrusion into the structure.

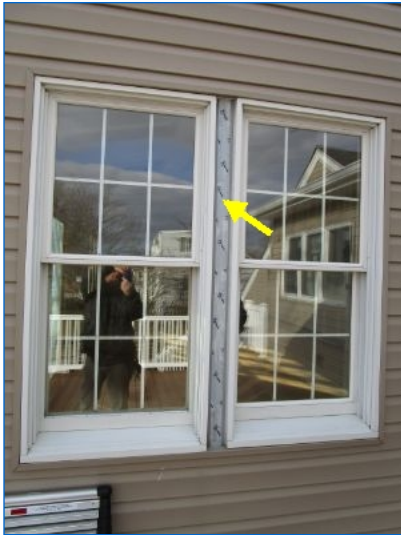
Missing trim noted at mullion.

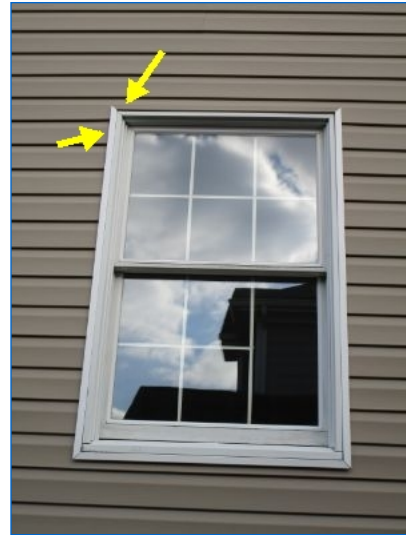
Color mismatched at south facing window trim. Other window trim is tan.

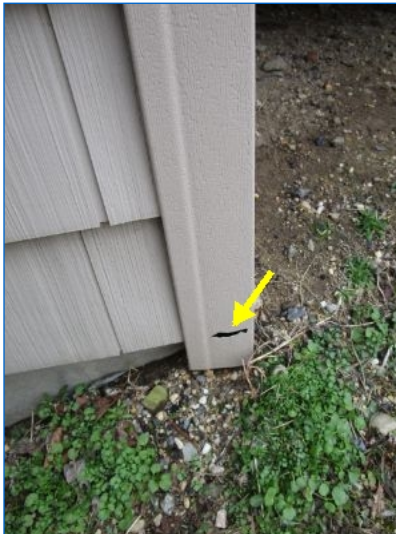
Cracked/damaged vinyl corner trim noted.

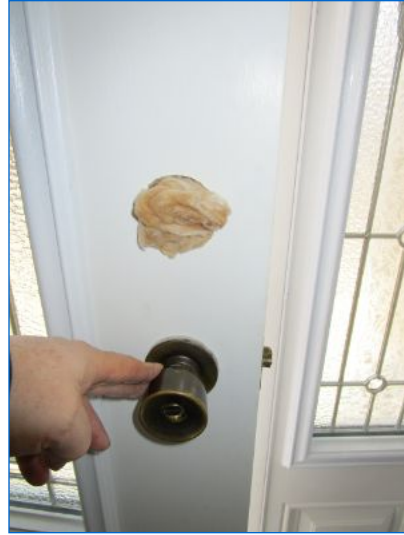
Front door hardware was missing.

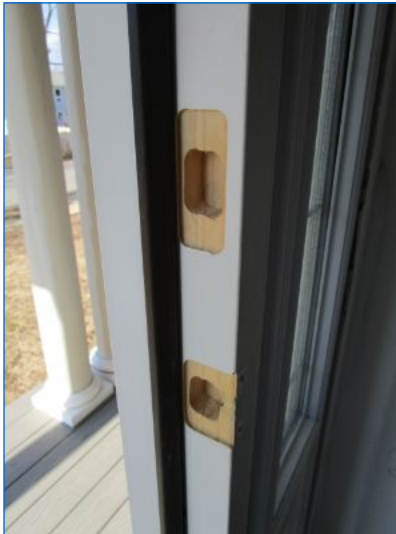
Front door hardware was missing.

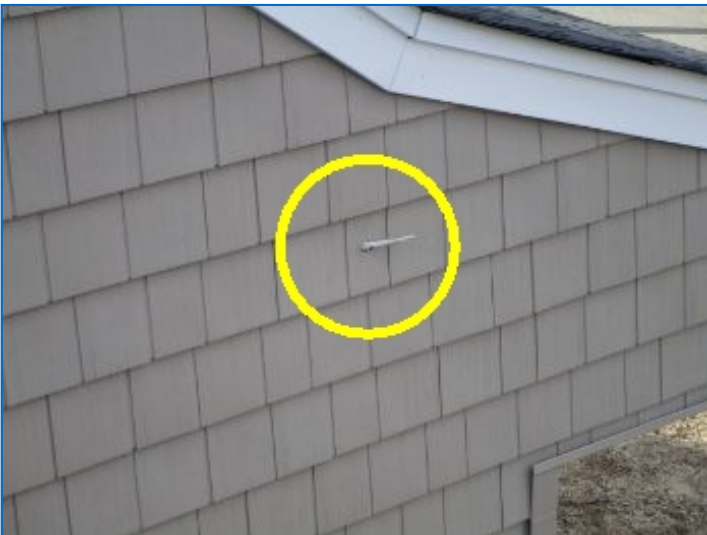
Exterior fixture/device not installed at north-facing wall leaving exposed wires.

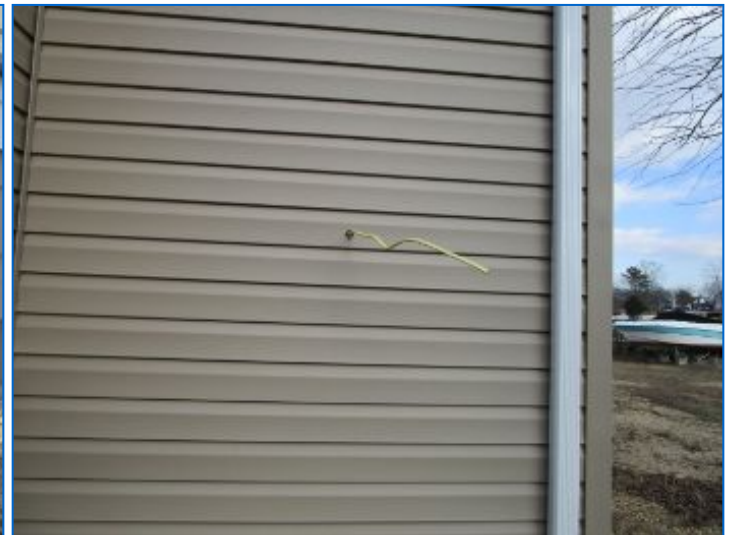
Exterior fixture/device not installed at south-facing wall leaving exposed wires.

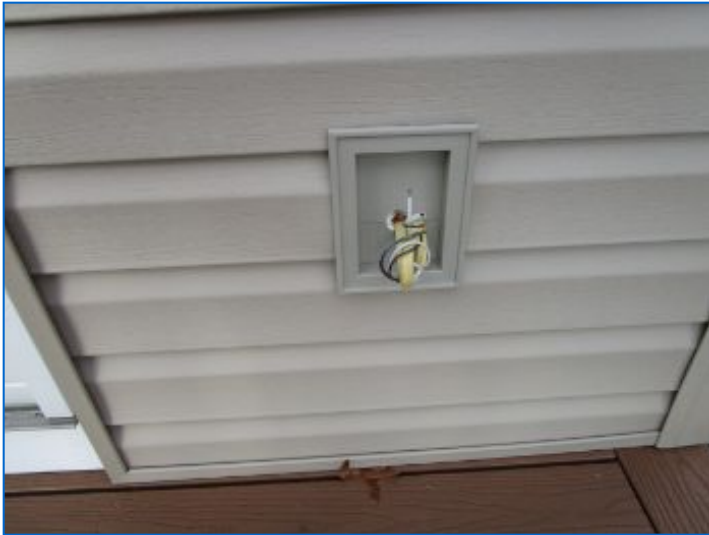
Exterior GFCI type receptacles were not installed at east side (2 places) leaving exposed wires that can potentially become energized.

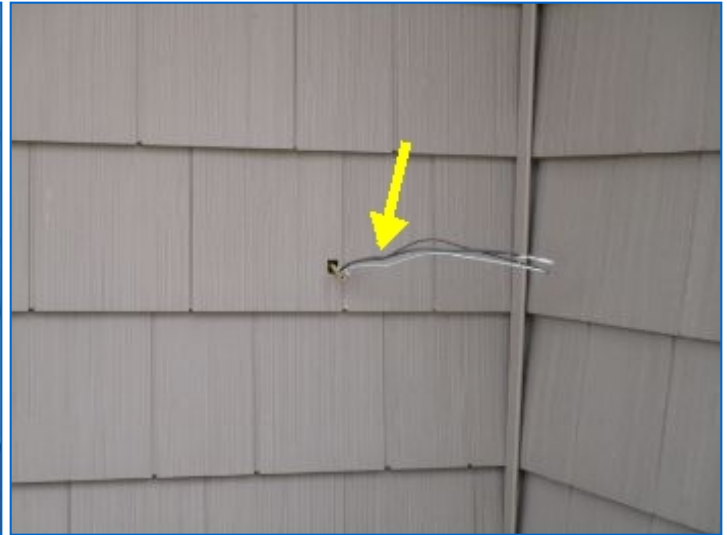
Exterior GFCI type receptacles were not installed at front leaving exposed wires that can potentially become energized.

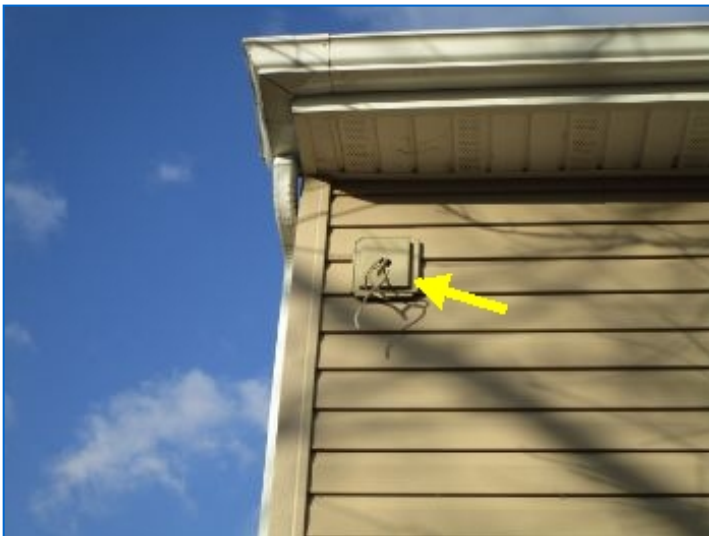
Exterior light fixture not installed at SE corner leaving exposed wires that can potentially become energized.

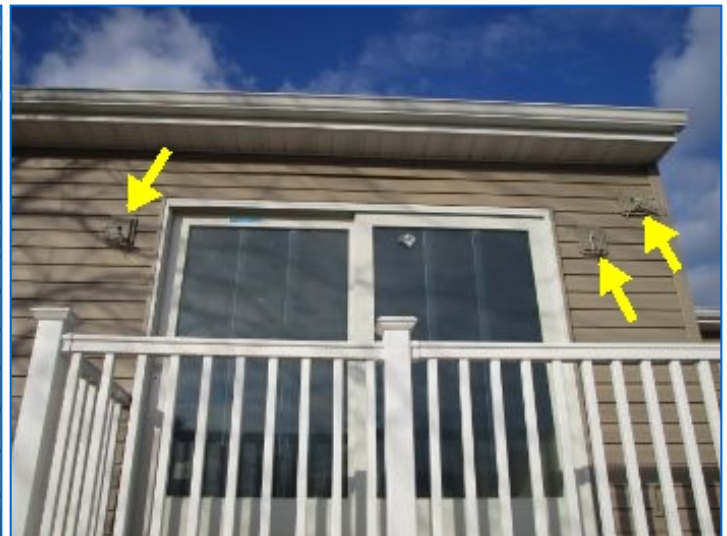
Exterior light fixtures not installed at three mounting bases at the east wall, leaving exposed wires that can potentially become energized.

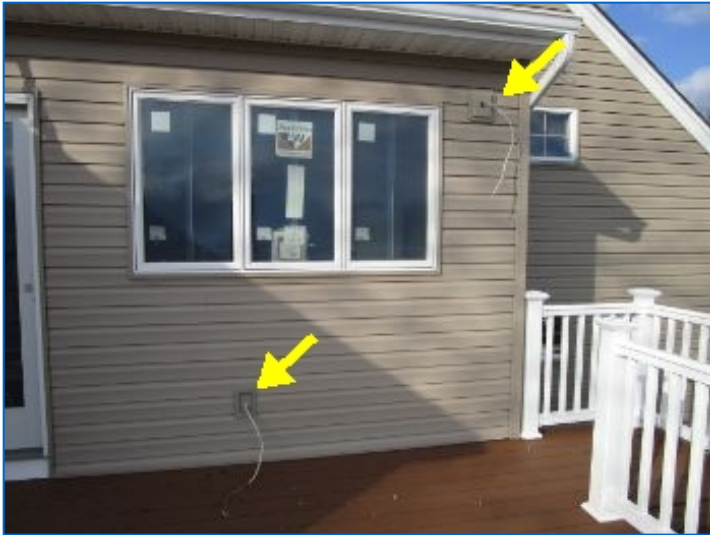
Exterior two light fixtures not installed at east facing wall leaving exposed wires that can potentially become energized.

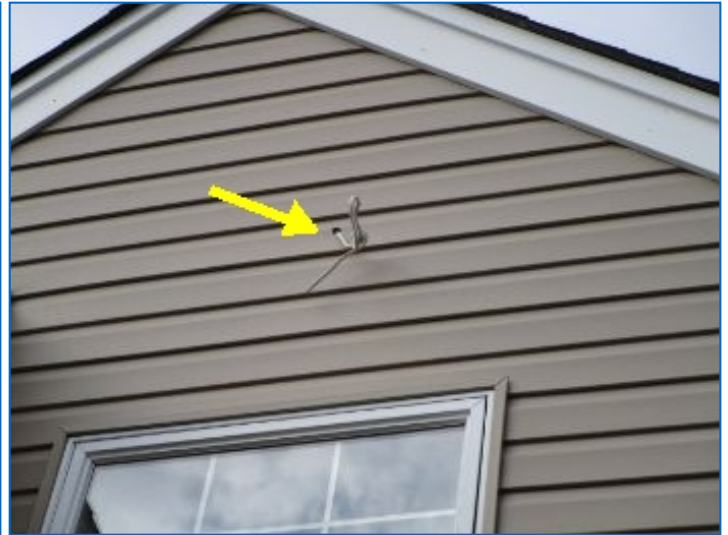
Exterior light fixture not installed at east facing wall leaving exposed wires that can potentially become energized.

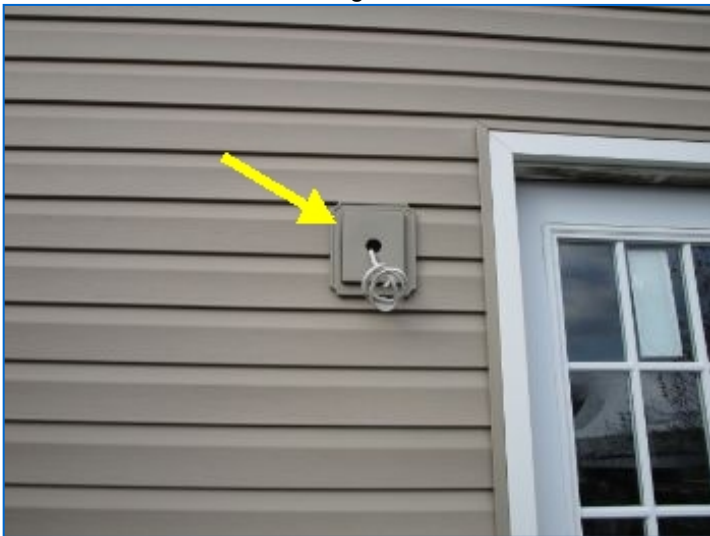
Exterior light fixture not installed at east facing wall leaving exposed wires that can potentially become energized.

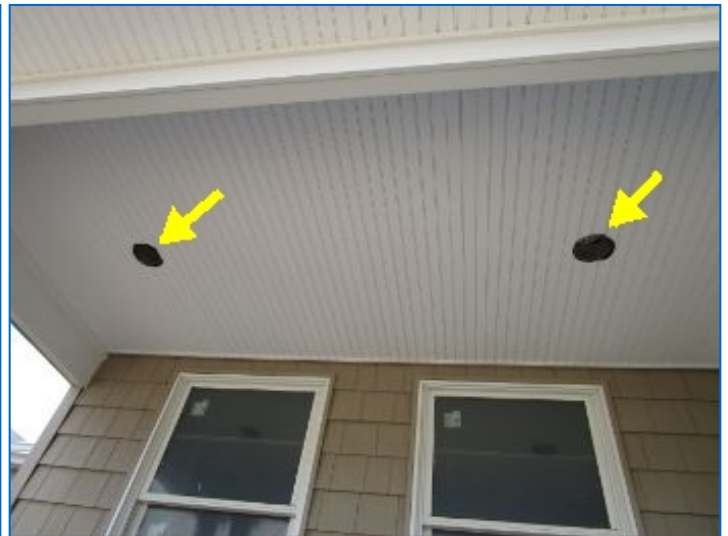
Exterior recessed can trim rings and bulbs not installed at front porch.

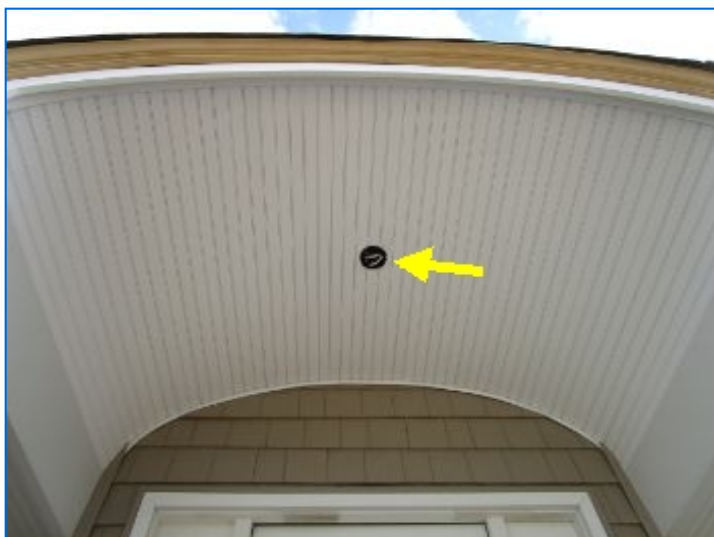
Exterior light fixture not installed at front porch.

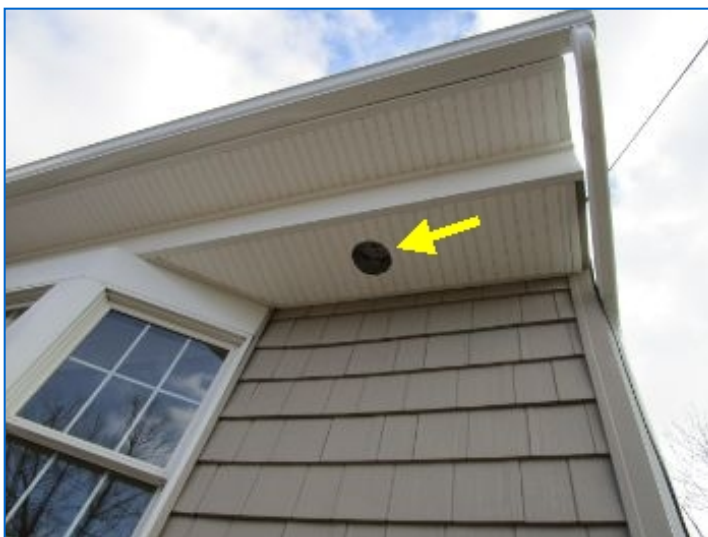
Exterior recessed can trim rings and bulbs not installed at front porch.

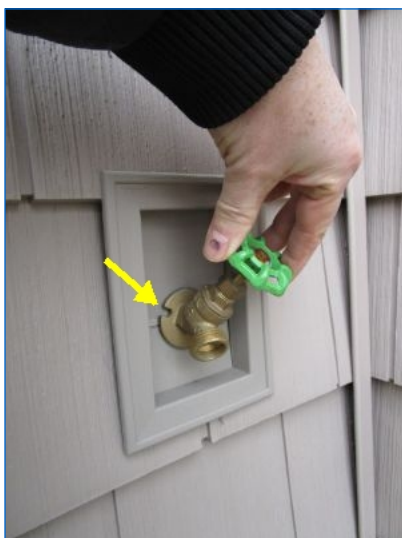
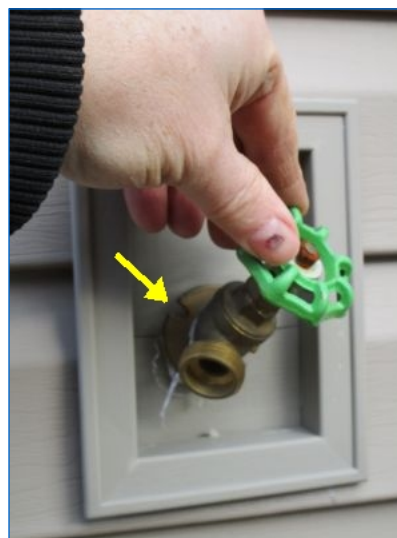
Hose bibs were not properly mounted; twisted occurs at PEX tube connection when used causing potential for leak inside the wall. Recommend completing installation of hose bibs asap to prevent the twisting.

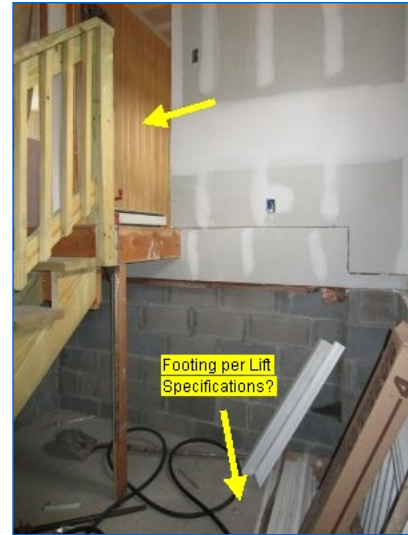
Drawings call for a "Footing for lift as per manufacturer specifications" adjacent to the stairs. Did the contractor request the lift manufacturer specifications in order to size the footing and coordinate the dimensions of the stairs, etc. in order to allow clearance for the lift? Guardrail (temporary) for fall protection was missing at time of inspection.

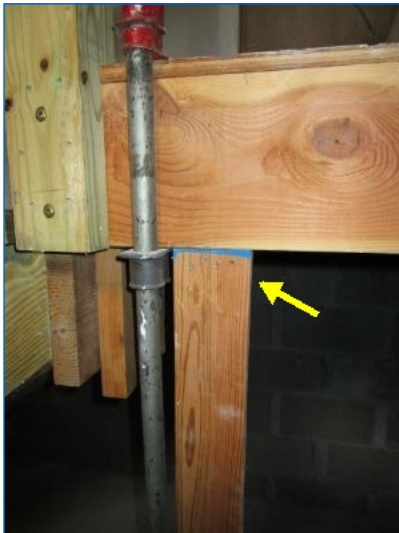
2x4 post supporting the stair landing appears temporary and is insufficient. Drawings call for a 4x4 post anchored to slab.

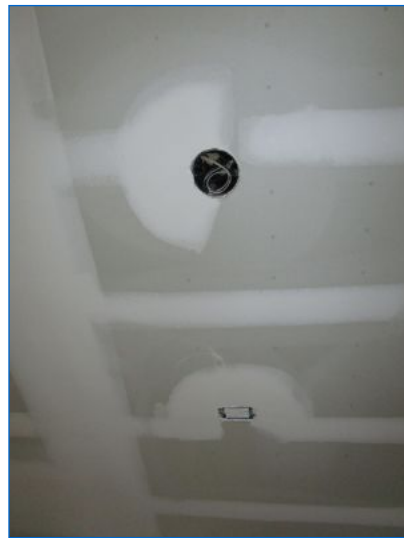
Exposed electrical wires at garage ceiling for missing garaged door opener and light fixture.

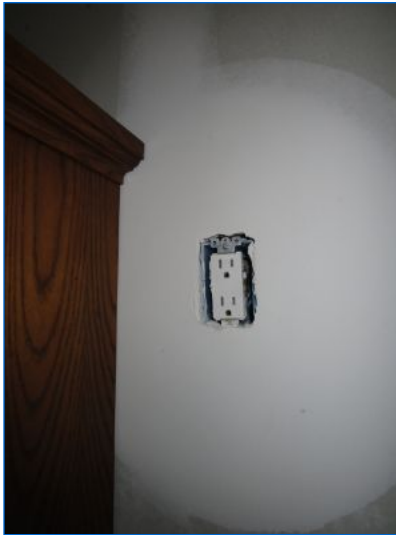
Cover plates missing. Provide missing receptacle and switch cover plates.

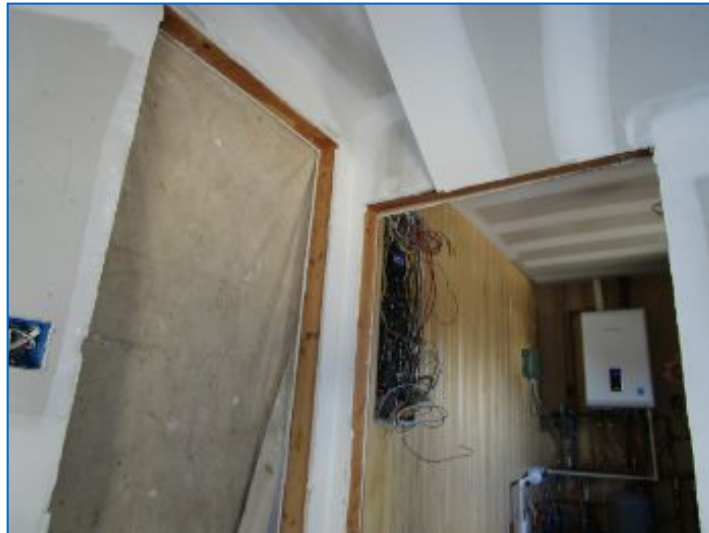
Fire rated doors to living spaces with self-closing hardware were not installed.

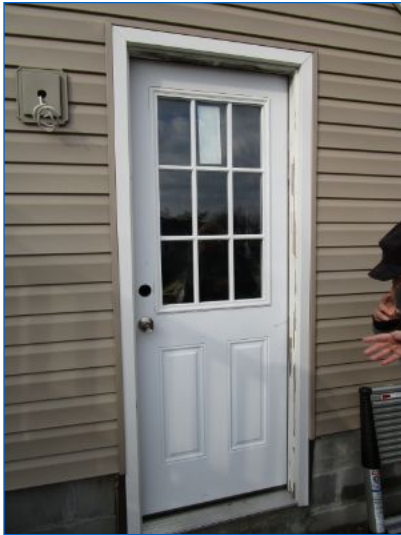
Rear garage door appeared weathered with signs of peeled paint and mildew at painted frame. Signs of water intrusion due to a lack of weather proofing. Recommend repainting and caulking all gaps where water can enter the garage.

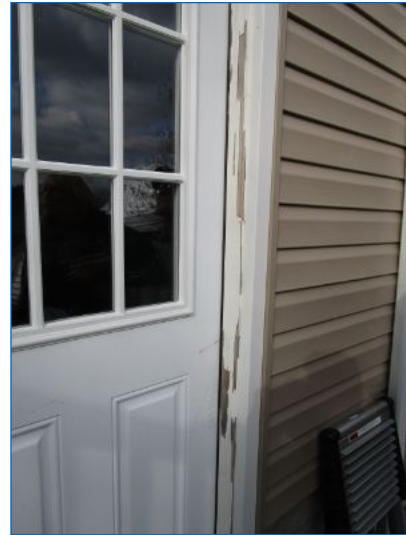
Rear garage door appeared weathered with signs of peeled paint and mildew at painted frame. Signs of water intrusion due to a lack of weather proofing. Recommend repainting and caulking all gaps where water can enter the garage.

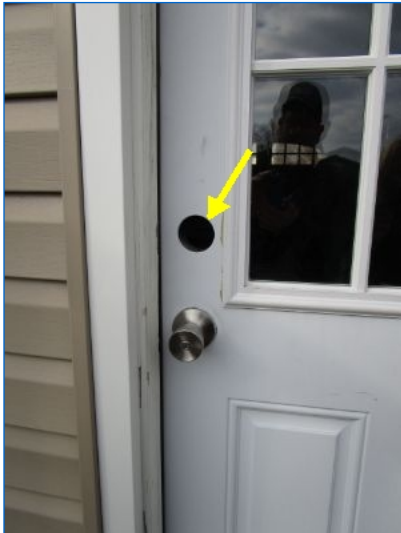
Rear door dead bolt hardware missing.

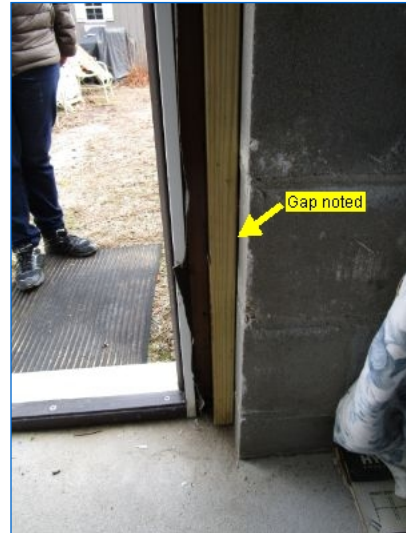
Rear garage door: Signs of water intrusion due to a lack of weather proofing. Recommend caulking all gaps where water can enter the garage.

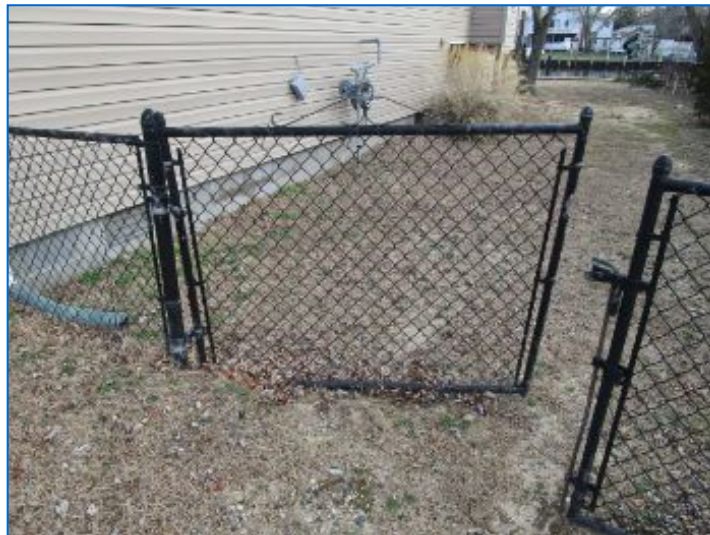
- Gate rendered inoperable due to grading issue.

Gate rendered inoperable due to grading issue.

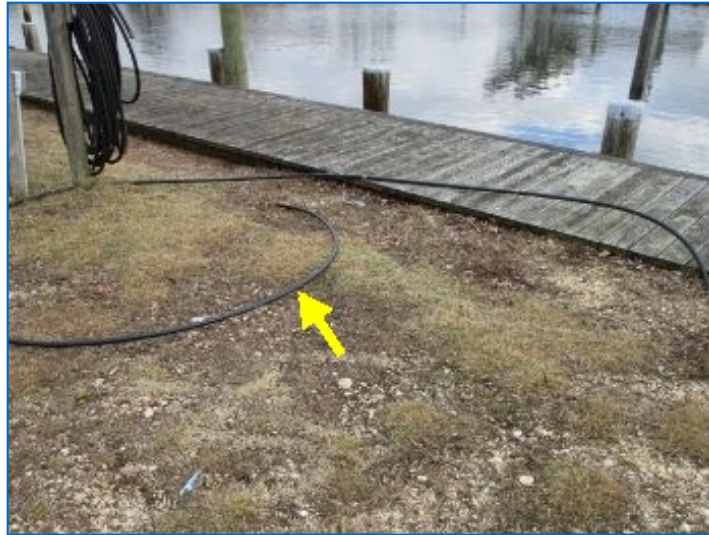
Underground water supply work was incomplete at east side/dock area.

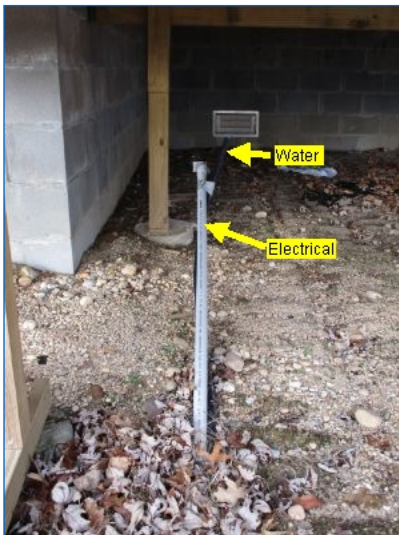
Underground electrical work was incomplete at east side and dock area.

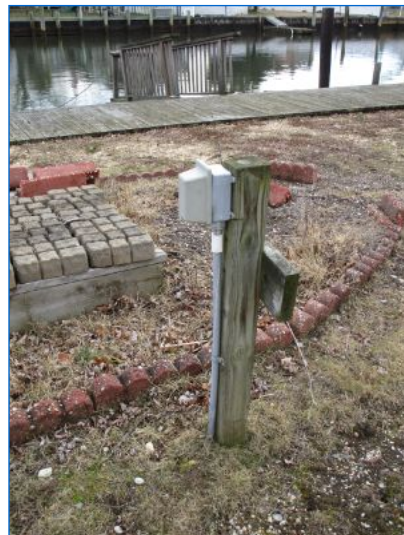
Underground electrical work was incomplete at east side and dock area.

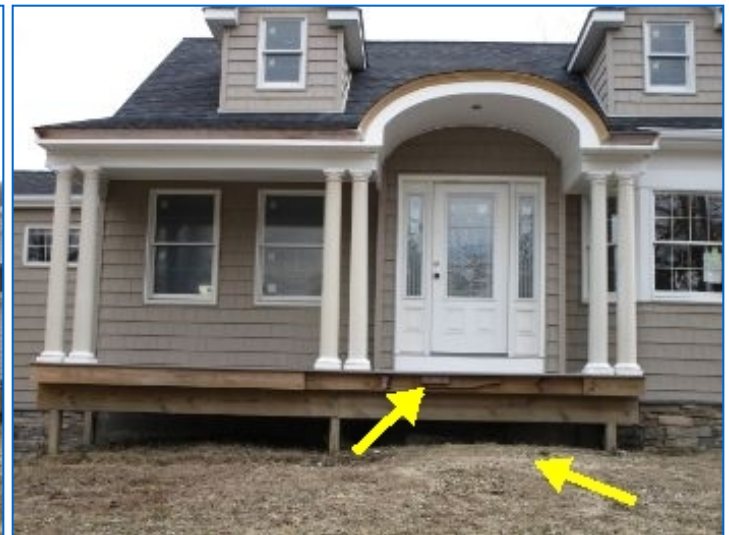
Porch steps and concrete walkway was not installed.

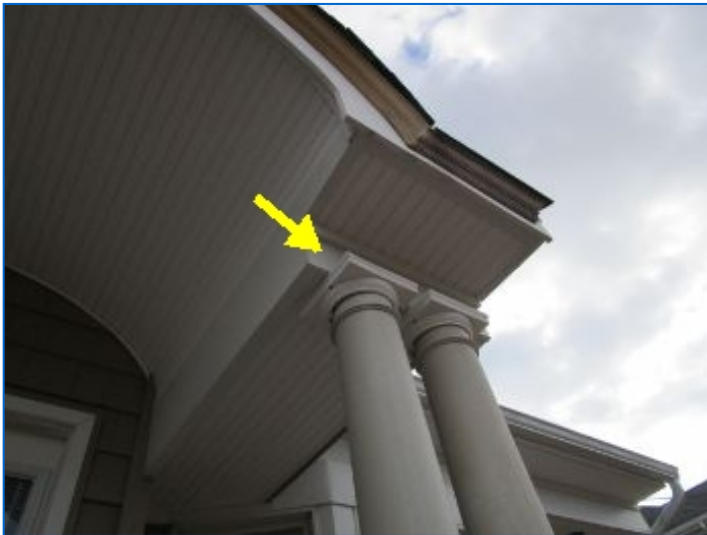
Columns/Crowns not properly fitted to portico. This appears to be a cosmetic concern. Suggest corrective action.

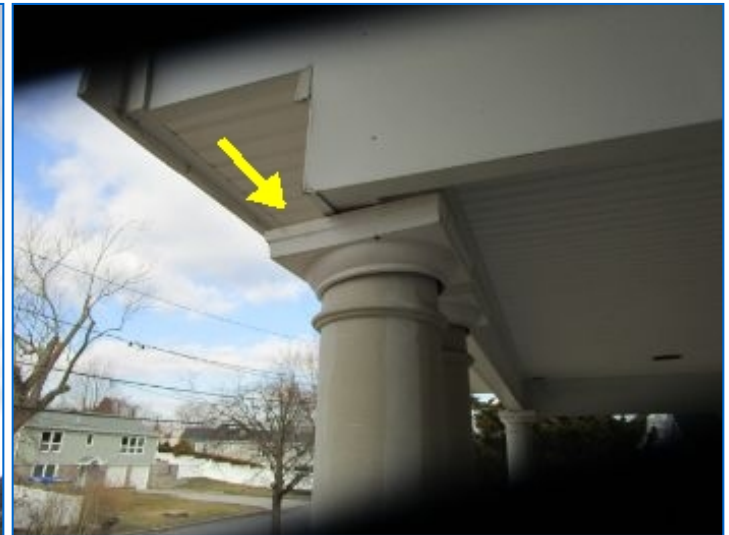
Columns/Crowns not properly fitted to portico. This appears to be a cosmetic concern. Suggest corrective action.

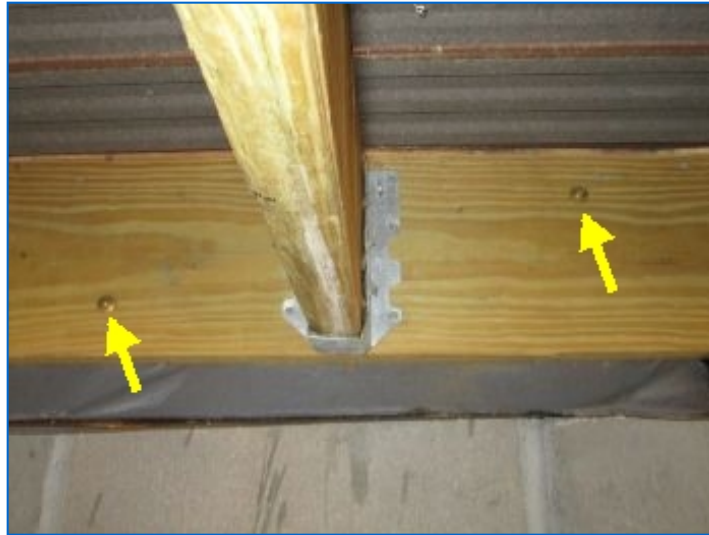
The deck was attached to the home with a ledger lag-bolted to the exterior of the foundation walls.

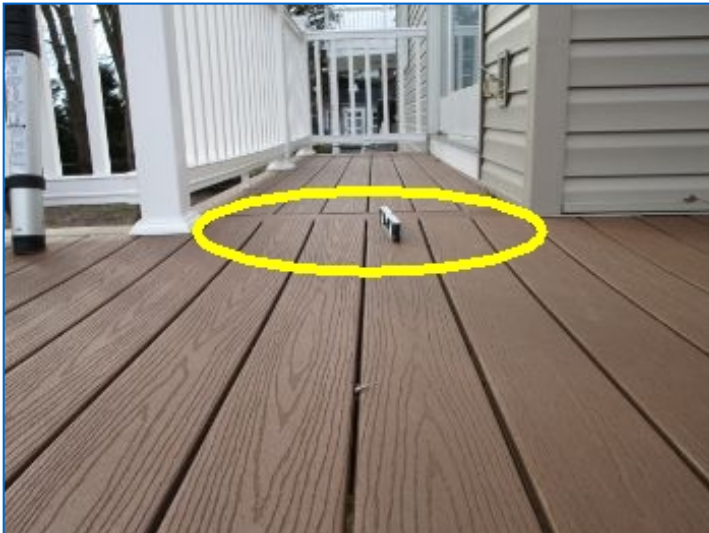
The planking was uneven where connected to adjoining deck area. Potential trip hazard. Suggest shimming planks to reduce severity.

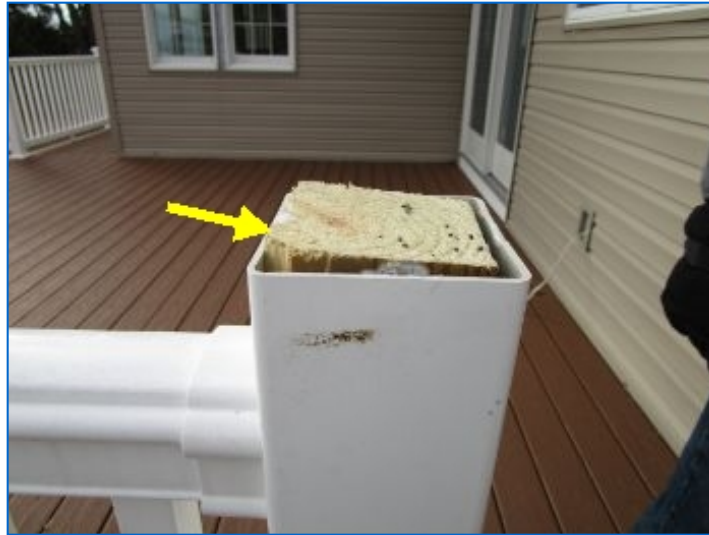
Post cap did not fit properly due to over extended wood post.

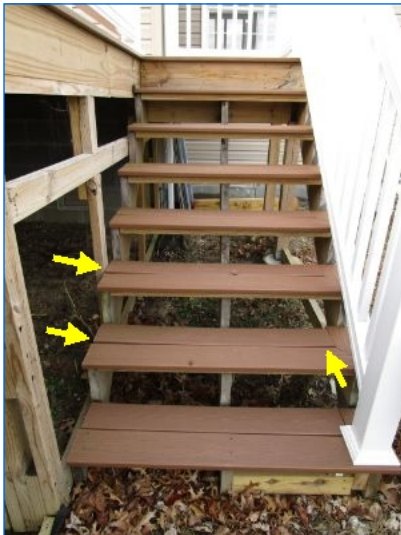
Composite planks at steps were not adequately fastened and were lifting at stringers. These planks were not fastened using the manufacturer clips. Recommend securing all plank ends to stringers. Recommend providing a masonry foundation at the base of the deck stairs such as a poured concrete landing.
