ProSpec Home Inspection of Long Island Property Inspection Report

9 Brookside Dr, Port Washington, NY 11050
Inspection prepared for: Name Deleted
Date of Inspection: 11/14/2020 Time: 10:00 AM
Age of Home: 1 yrs old Size: 5,200 sq.ft.
Approx. Year Built: 2020

Inspector: Russell J. Classi, P.E.
Phone: (516) 480-1848
Email: prospecfli@gmail.com
www.nassauprofessionalhomeinspector.com

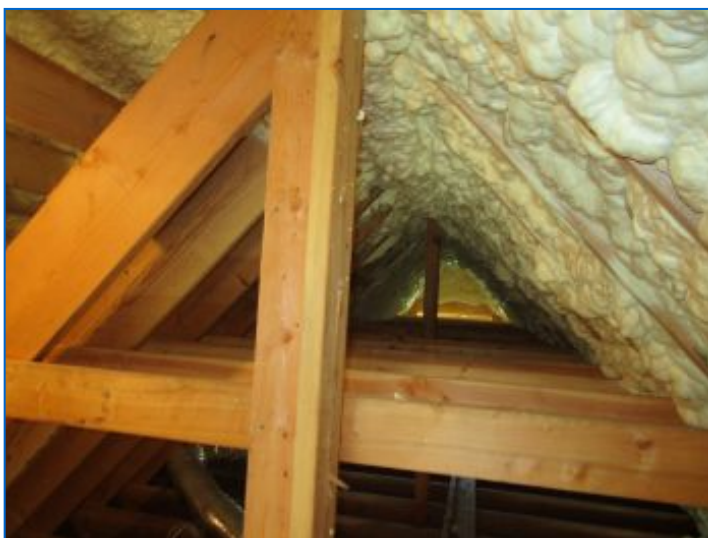
Vertical support of the roof ridge beam was noted.

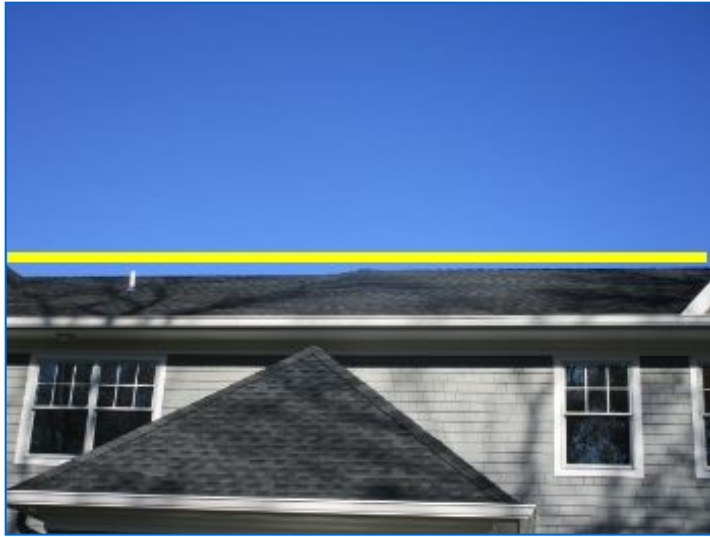
Roof ridge beam appeared straight and even overall.

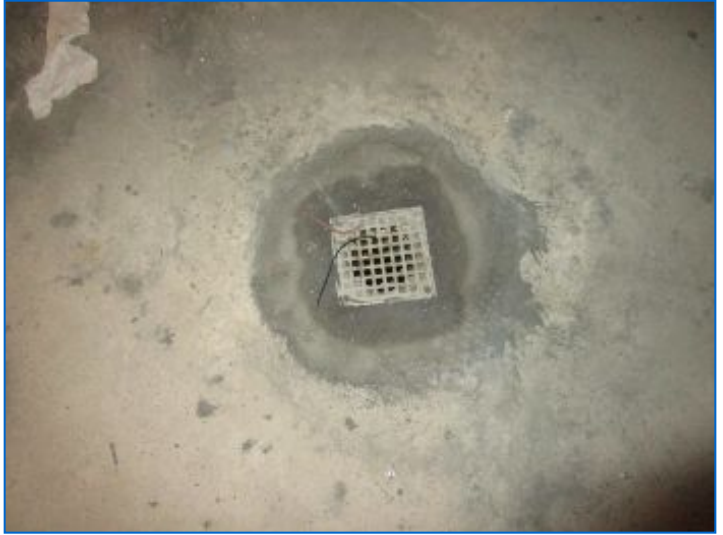
Floor drain observed in boiler room but not tested. Suggest testing for proper operation.

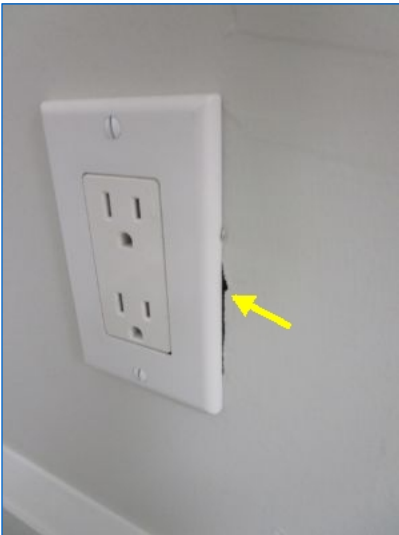
NE corner room: Cosmetic defect noted at outlet.

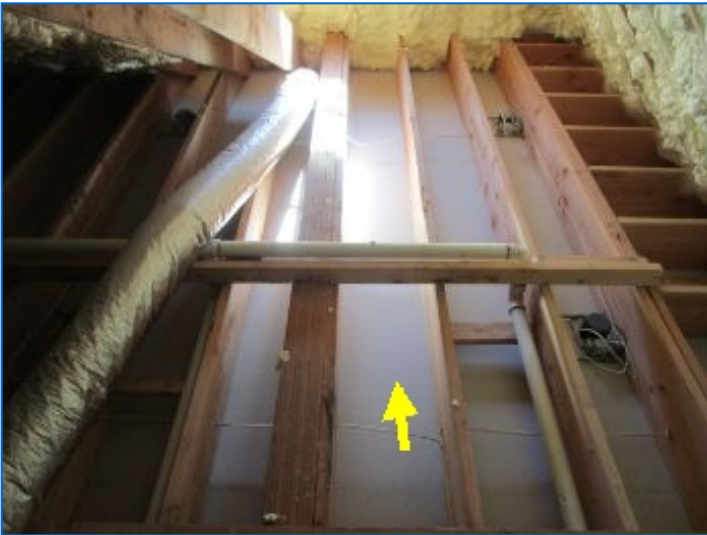
Some floor areas had no floor boards. Suggest adding floor boards for safe access to these areas.

- Pull-down ladder located in Hallway (2nd floor).
- Attic floor Partially covered with loose planks or boards.
- Limited floor boards/planks in attic space at floor joist cavities. Inspector could not safely access all areas of the attic without risking damage to drywall ceilings below and ductwork. This limited accessibility into attic to conduct a more thorough inspection of the attic and roof structure. Suggest providing additional floor boards/planks for improving access.

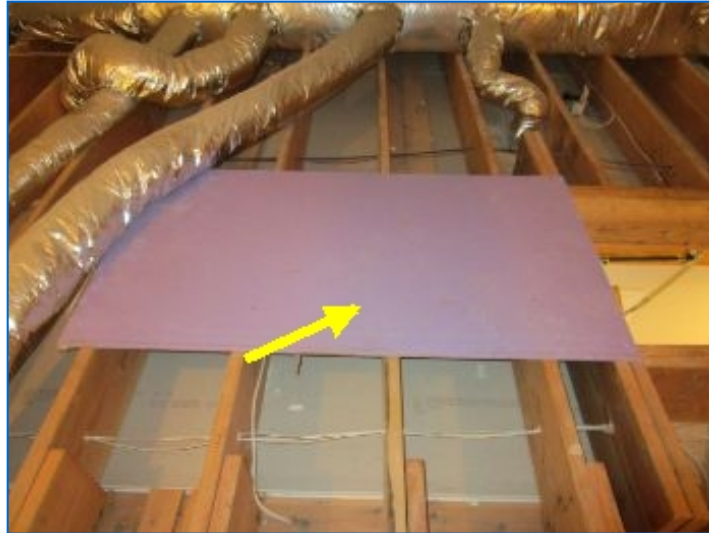
Drywall cover meant for pull-down ladder opening only.

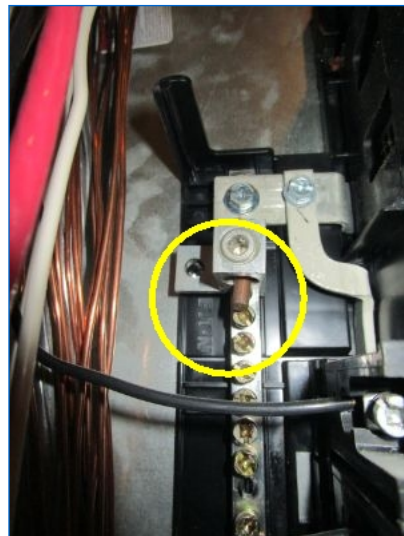
Main Panel #2: Proper Neutral Bus Grounding was not observed. Recommend licensed electrician to ensure proper system grounding per current standard.

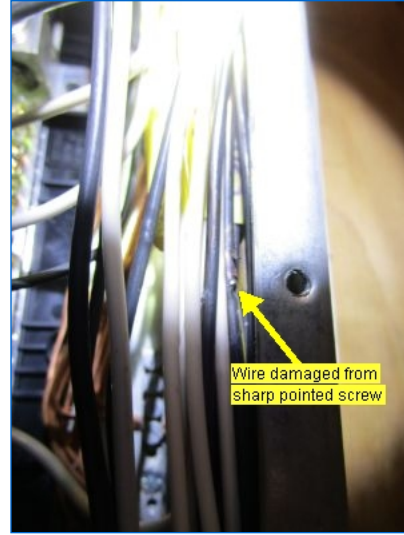
Sharp-pointed metal screws hold panel cover in place. These are a potential hazard as they can puncture wire insulation and electrify panel box, becoming a shock or electrocution hazard. These screws should be replaced with approved, flat-tipped screws. Repair existing damaged wire insulation!

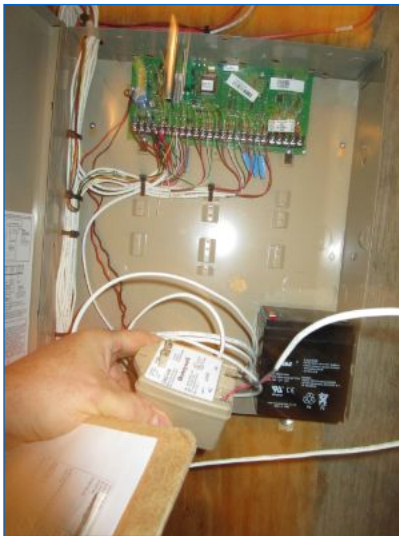
Control panel for the integrated control located in Basement. No available outlet near panel.

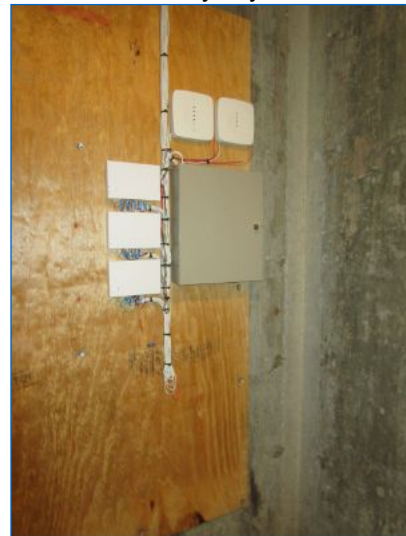
Control panel for the integrated control located in Basement. The Inspector recommends conferring with the seller for system and service contact information for customization and completion of installation.

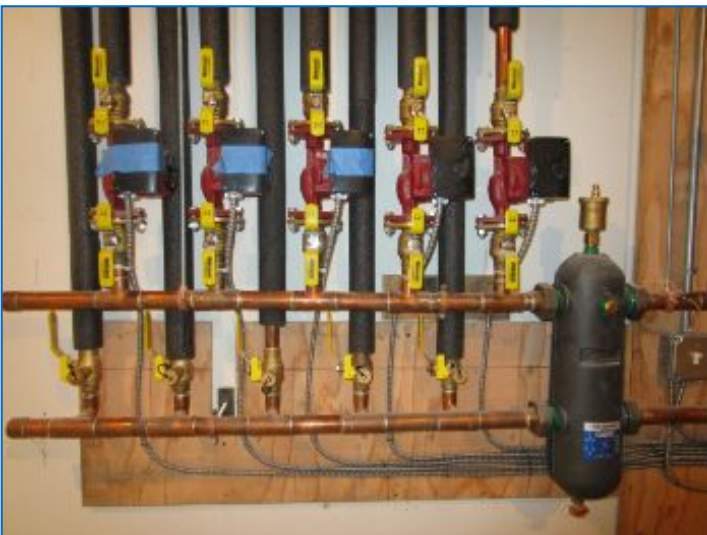
Distribution Piping: 5-zone heating system noted.

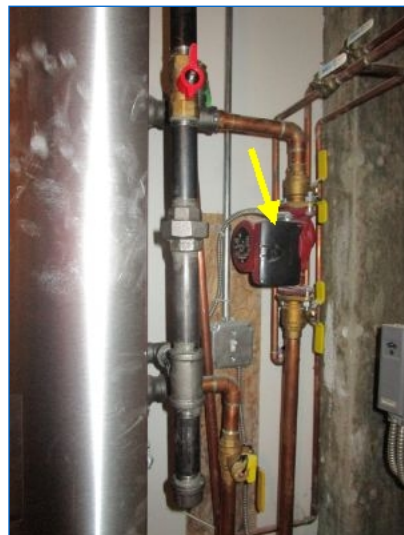
One pump dedicated to water heater storage tank.

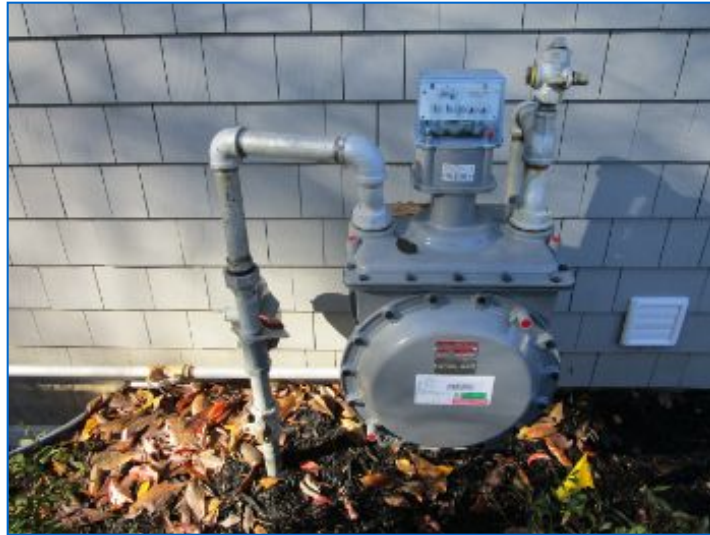
Public Gas Service: Meter w/shutoff valve and vented regulator Outside.

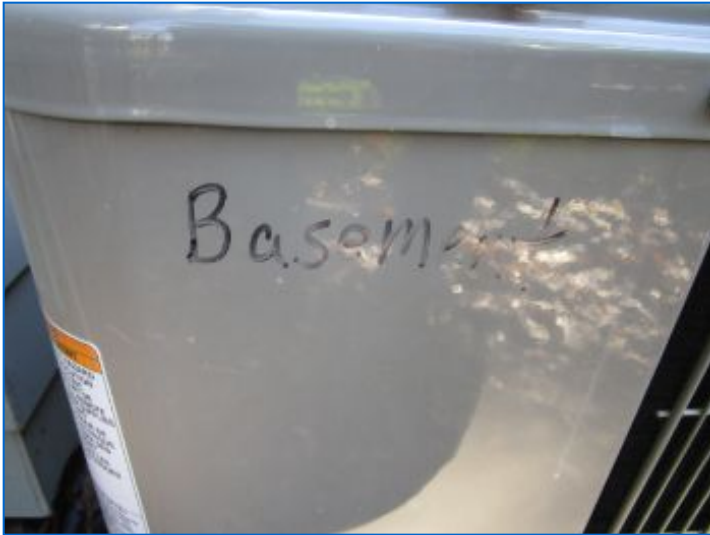
AC#1 Condenser; corresponding ducted air handler located in the Basement.

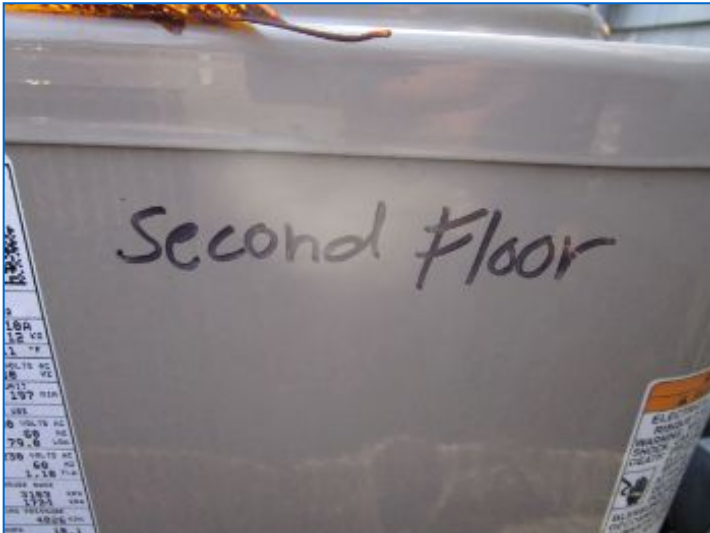
AC#2 Condenser; corresponding ducted air handler located in the Attic.

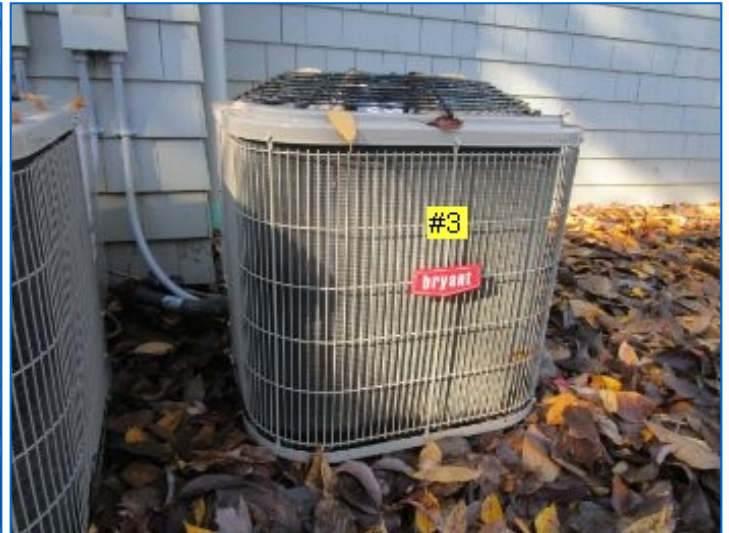
AC#3 Condenser; corresponding ducted air handler located in the Attic.

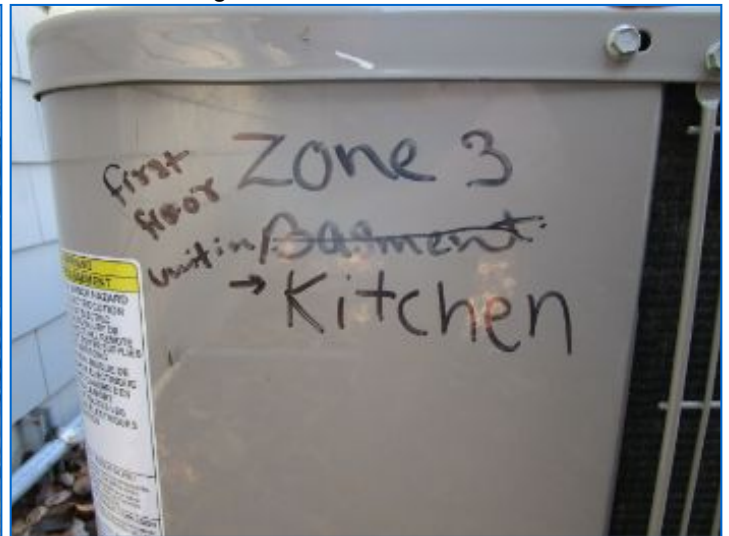
AC#4 Condenser; corresponding ducted air handler located in the Basement.

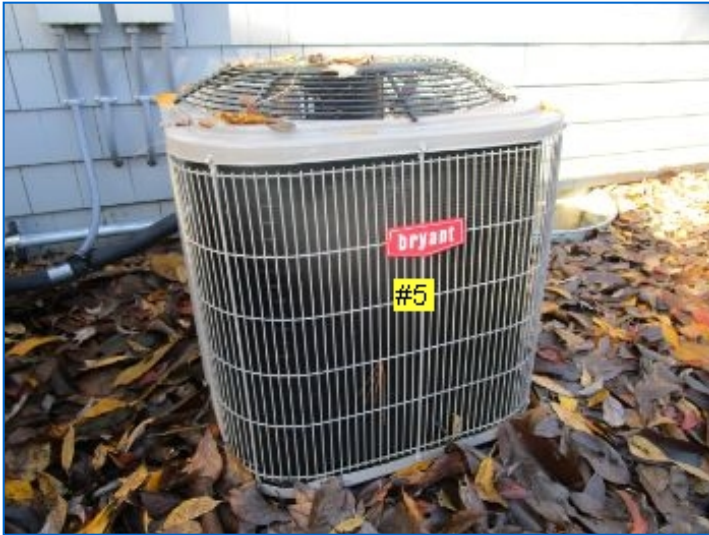
AC#5 Condenser; corresponding ducted air handler located in the Basement.

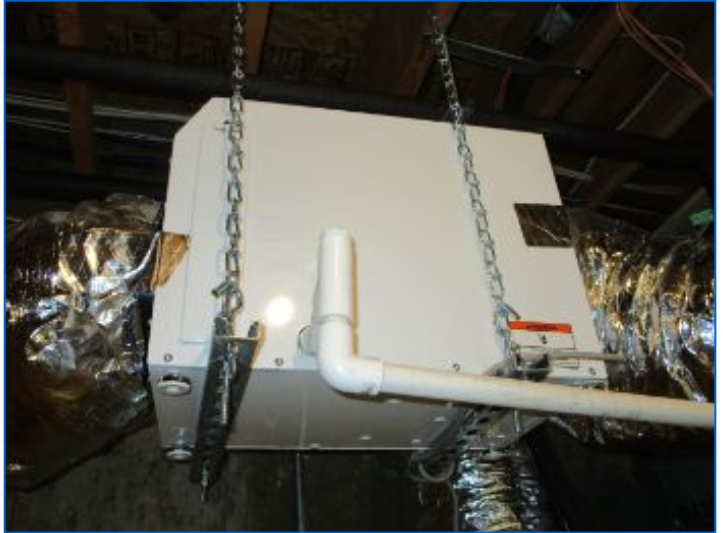
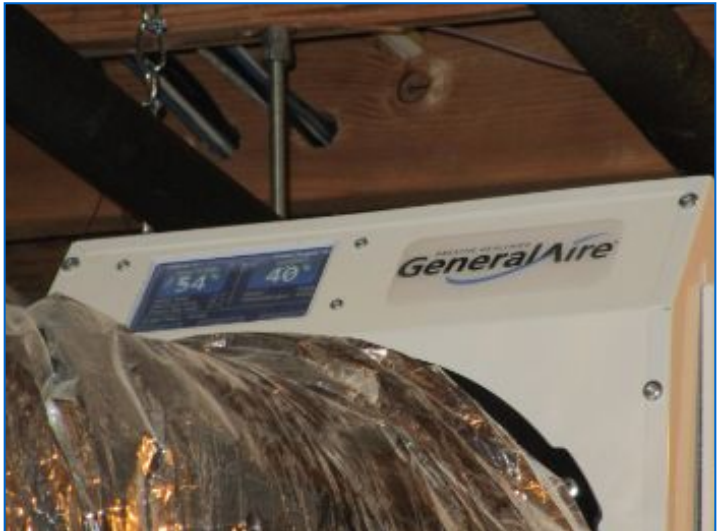
The basement HVAC#1 system was equipped with an operable ducted dehumidifier. Refer to related comment.

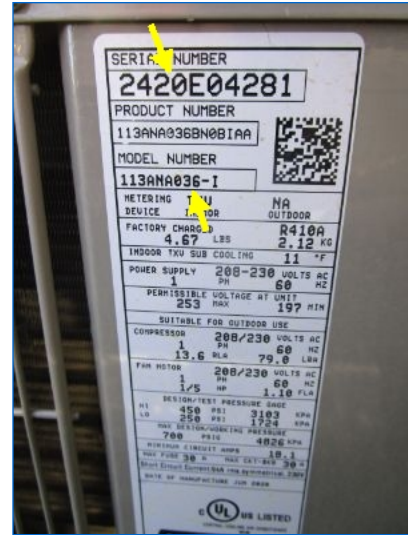
AC#2 Bryant Condenser data-plate/serial no. indicated a cooling capacity of 3 tons, and a manufacture date of 6/2020, (0.5 yr old).

- AC#2 Condenser was not level; this can shorten motor life. Suggest leveling mounting pad or the unit itself.
- LIMITATION: Testing of Air Conditioning Systems: If the outside temperature has not been at least 60 degrees F. for the past 24 hours, an air conditioning system cannot be checked without possibly damaging the compressor. In this situation, it is suggested that the present owner of the property warrant the operational status of the unit on a one-time start-up and cool-down basis when warmer weather allows.

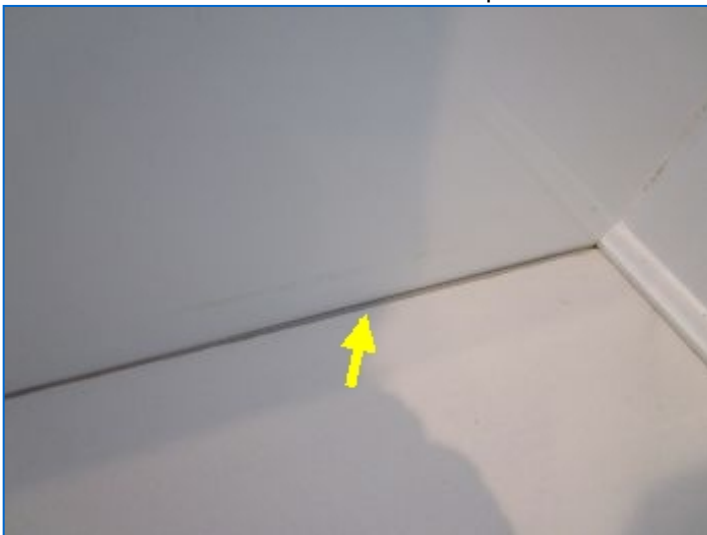
Exterior base grout was cracked/gapped at Tub floor joint.
Recommend grout repair to prevent water entry that can cause damage to floor boards/ceiling below.

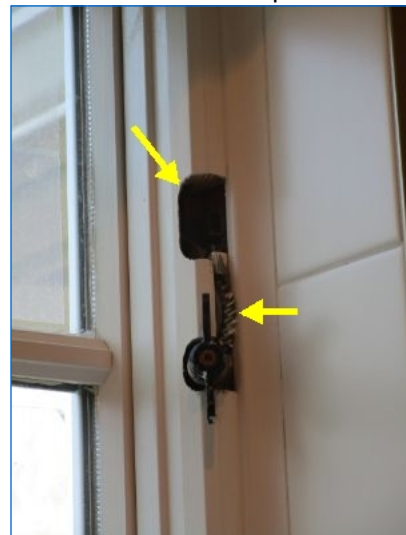
Casement window crank mechanism cover was missing.
Recommend correction.

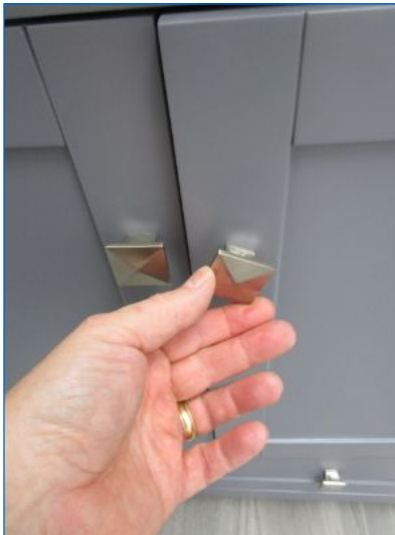
- Leaks: None observed at time of inspection.
- GFCI protected receptacle in place and operational.
- Vanity door knob was loose.

Vanity door knob was loose.

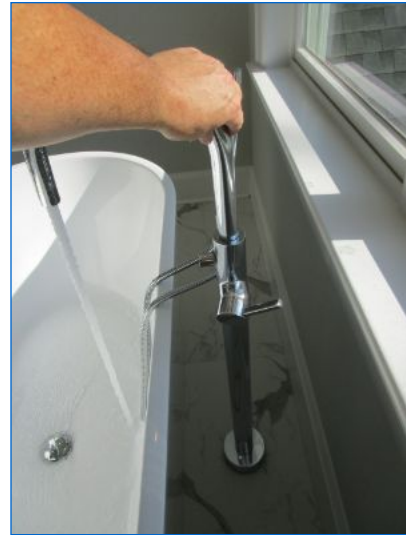
- Leaks: None observed at time of inspection.
- GFCI protected receptacle in place and operational.
- **Vanity backsplash not adequately sealed.**
- **Free-standing floor mounted tub filler was not securely installed at the floor mount. Recommend evaluation and correction by a qualified contractor.**

Free-standing floor mounted tub filler was not securely installed at the floor mount. Recommend evaluation and correction by a qualified contractor.

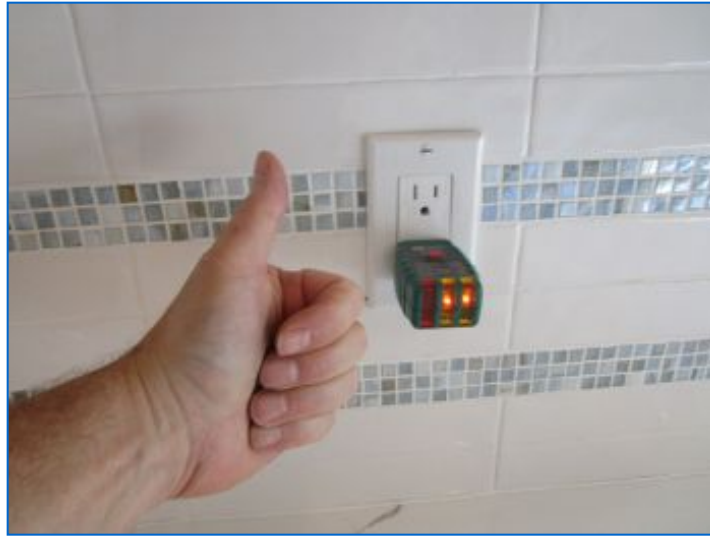
GFCI protected receptacles in place and operational.

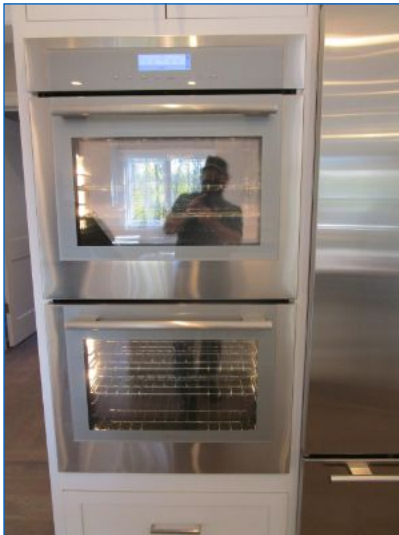
Electric powered built-in double oven; operable. New built-in oven may require initial setup prior to operating elements. Suggest having Seller demonstrate bake/broil modes prior to close.

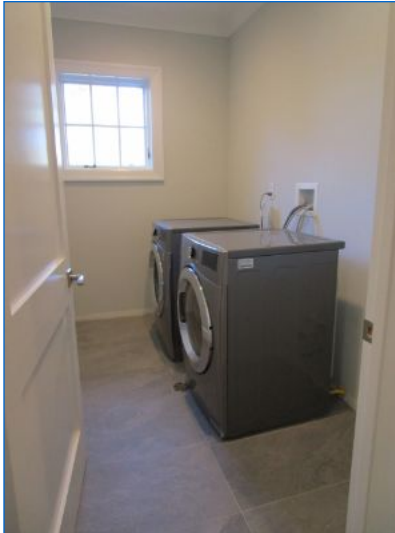
Laundry-1 Location: 2nd floor.

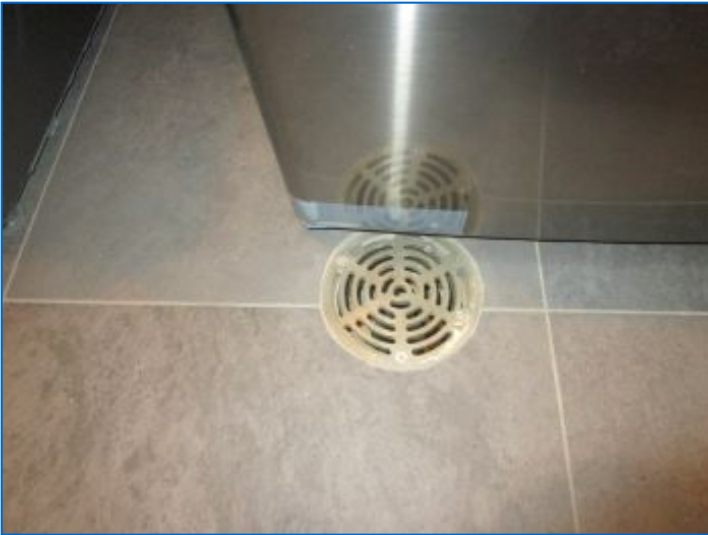
Floor drain noted; not tested. Suggest testing for proper operation.

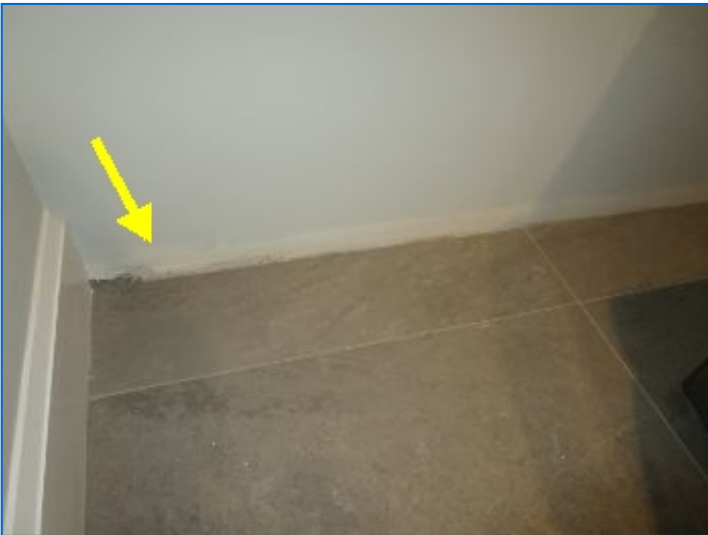
Some base molding was missing. Suggest completion.

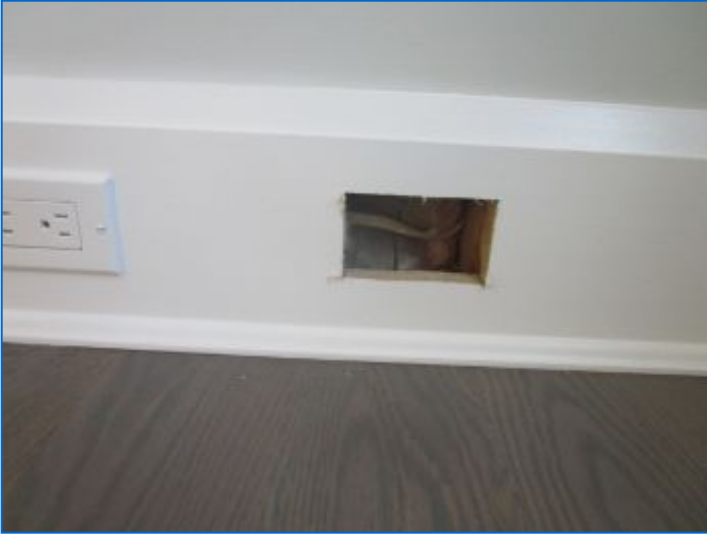
Incomplete data/telecom jack installation noted.
Recommend completion and/or finishes prior to close.

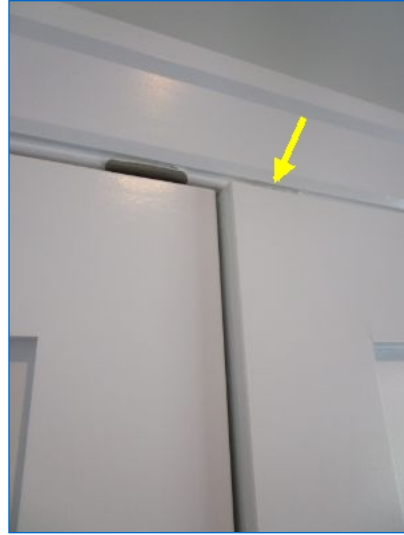
Bedroom- 2 Closets

Door ball catch didn't latch properly . Recommend by a qualified contractor.

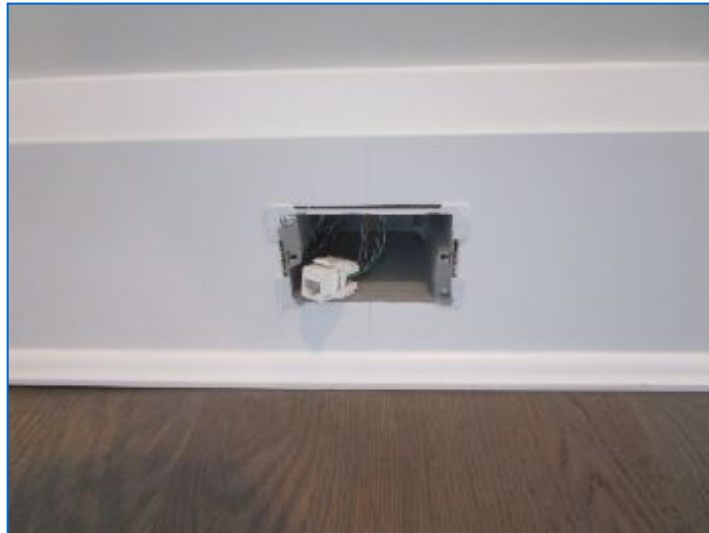
Incomplete data/telecom jack installation noted. Recommend completion and/or finishes prior to close.

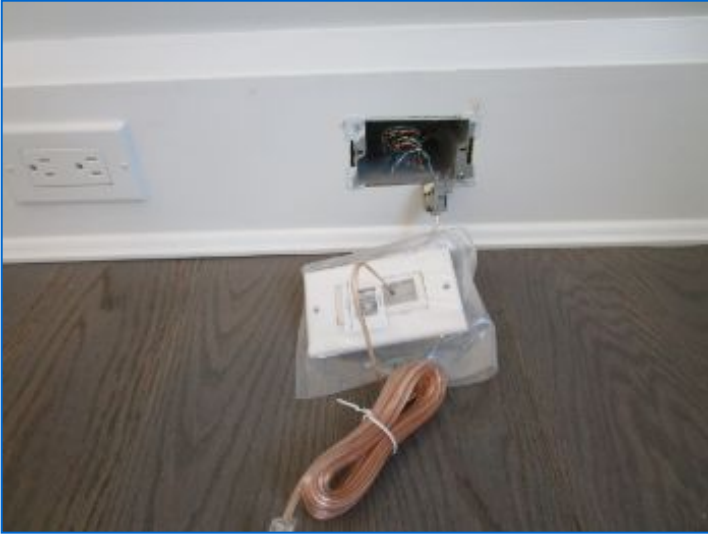
Incomplete data/telecom jack installation noted.
Recommend completion and/or finishes prior to close.

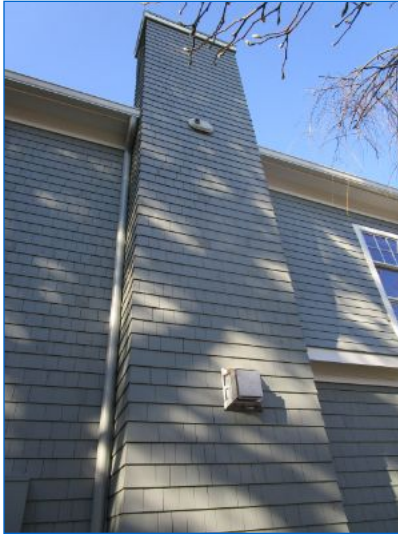
Chimney: Framed, covered with siding; apparent mock chimney.

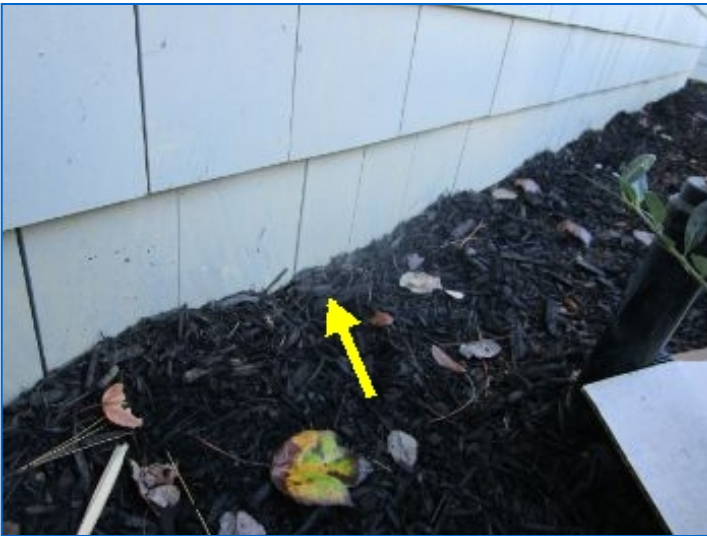
Soil in contact with, and/or in close proximity to siding. This can provide entrance of moisture or insects to siding. The Inspector recommends lowering soil level to 6" below siding.

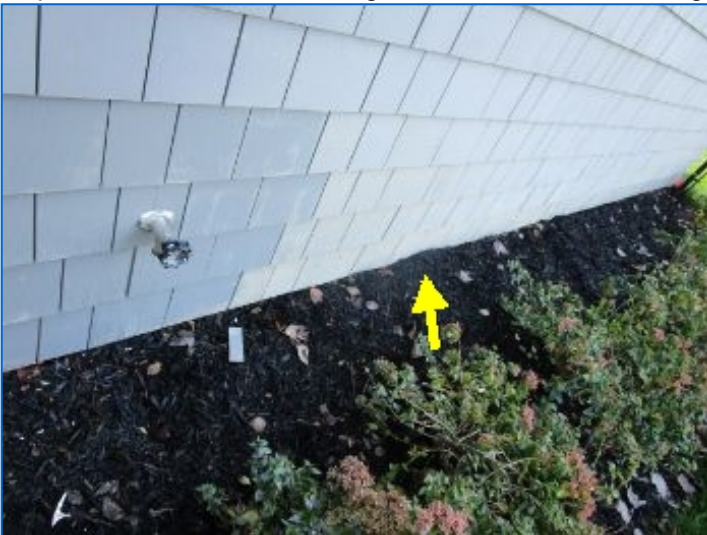
Soil in contact with, and/or in close proximity to siding. This can provide entrance of moisture or insects to siding. The Inspector recommends lowering soil level to 6" below siding.

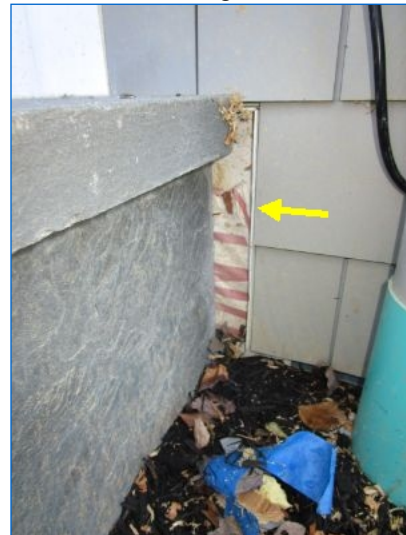
Cedar siding fell short of the steps at the side entrance. Recommend correction by contractor.

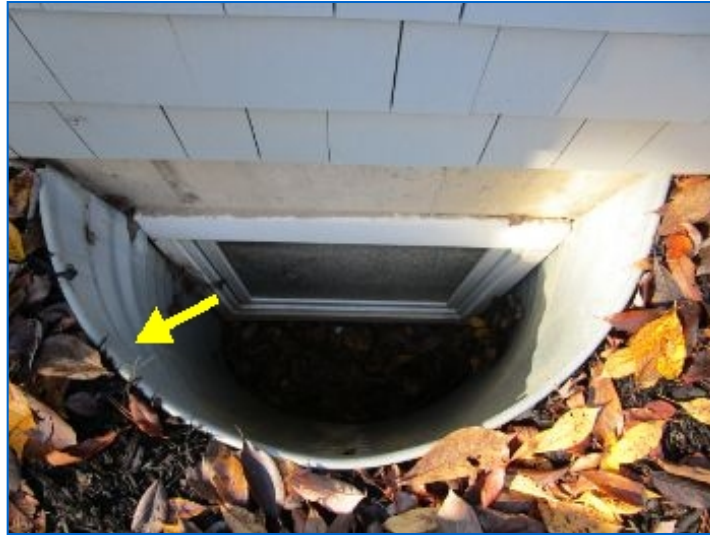
Steel window wells noted.

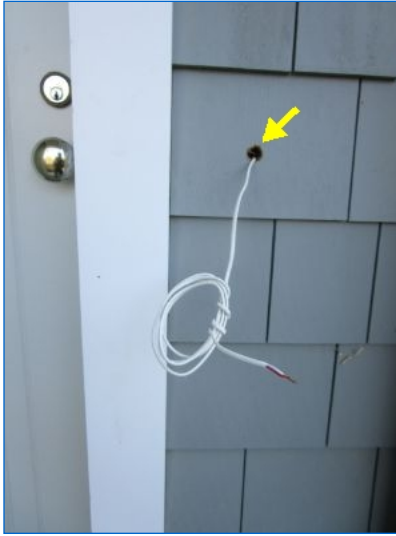
Side doorbell was not installed at time of inspection.

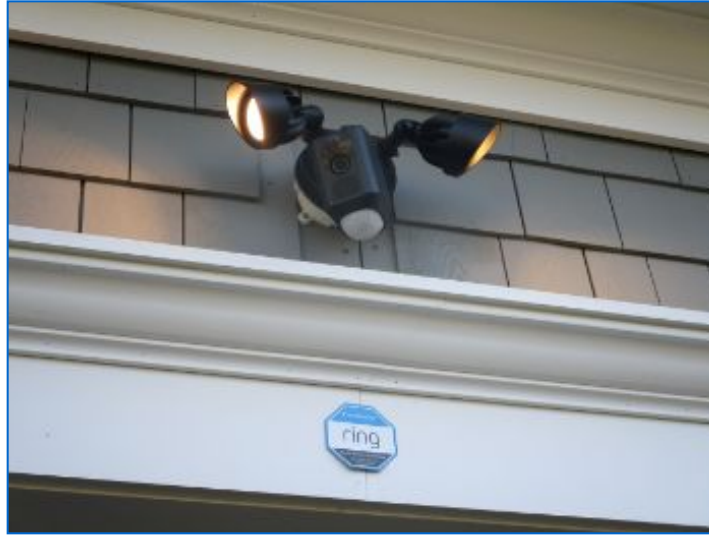
Adjust exterior lighting for dawn-to-dusk operation.

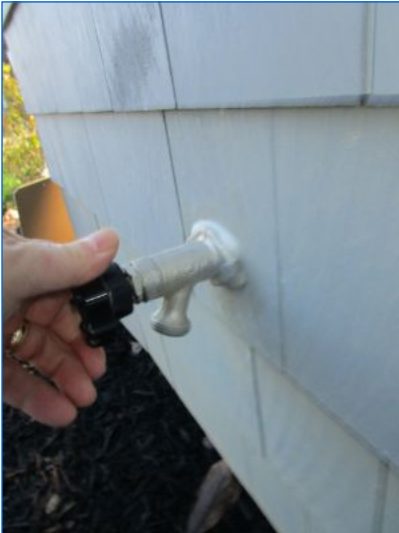
Hose bib at Front was Not active at time of inspection; possibly turned off from inside (winterized) or possible repair needed. Suggest having seller activate and test prior to close.

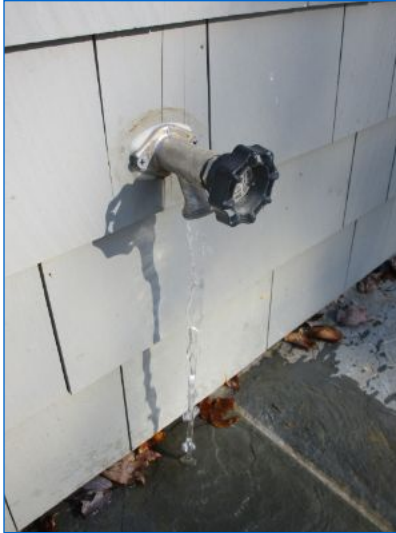
Hose bib at Rear was active at time of inspection.

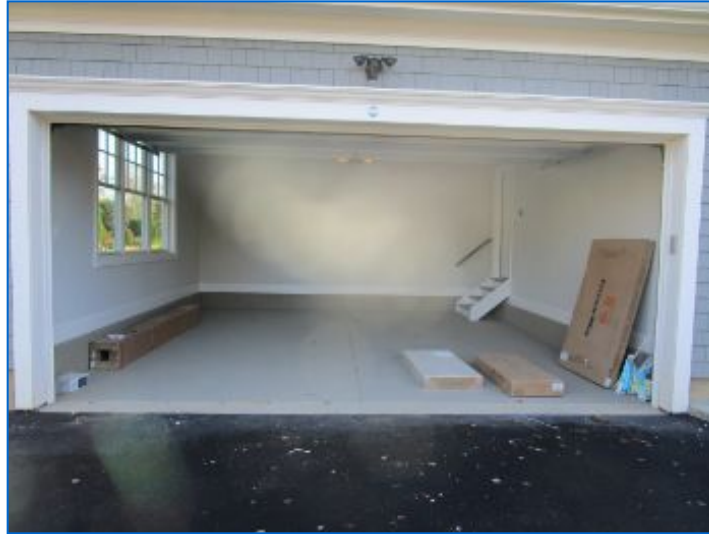
Garage structure is Integral to the house structure.

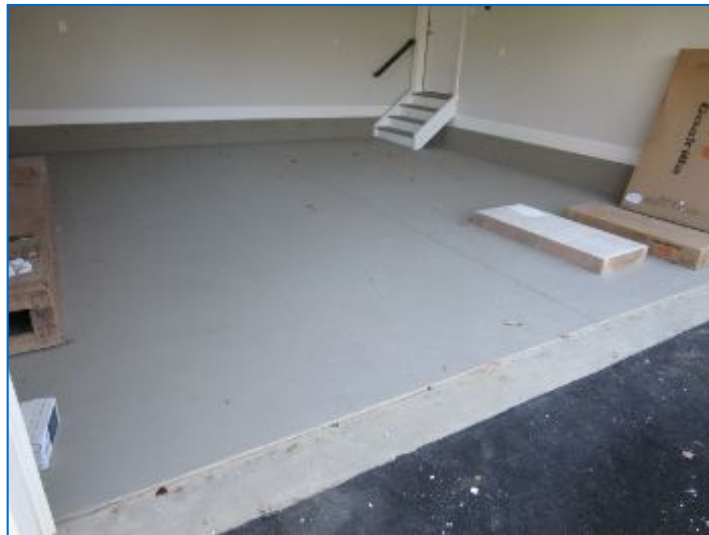
Painted concrete floor noted. The Inspector observed no deficiencies in the condition of the garage floor.

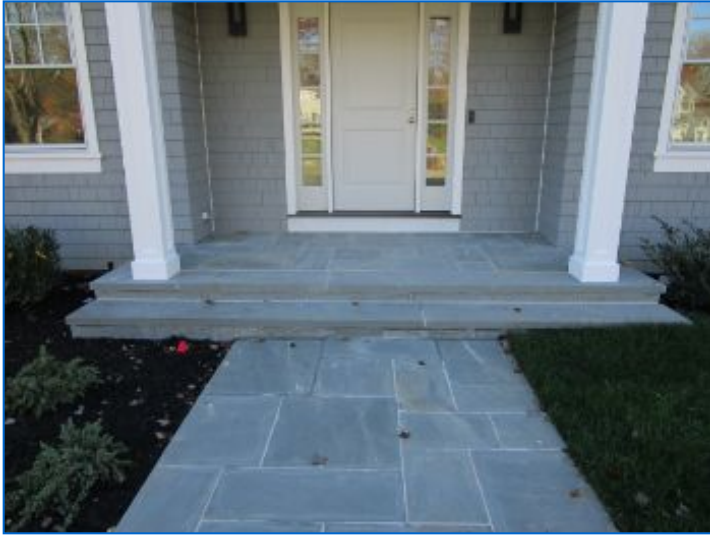
Masonry Steps and Landings noted at Front and side entrances. No system safety or function concerns noted at time of inspection.

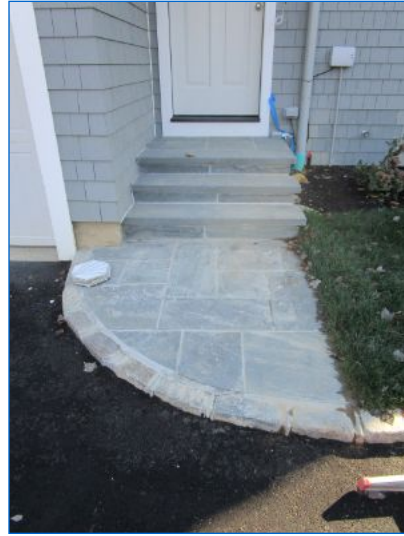
Masonry Steps and Landings noted at Front and side entrances. No system safety or function concerns noted at time of inspection.

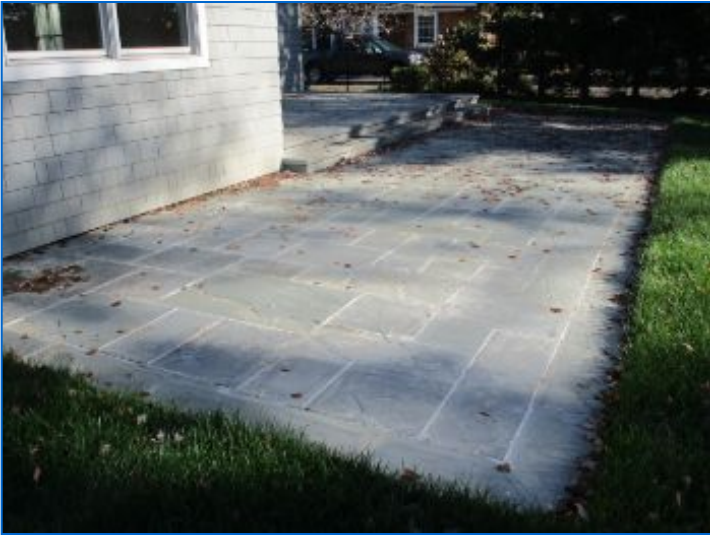
Patio: Bluestone in mortar noted.

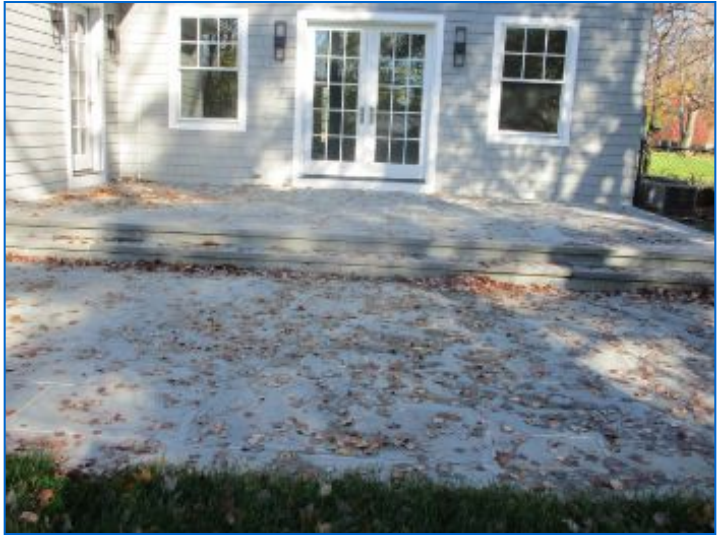
No system safety or function concerns at the visible portions of the patio at time of inspection.

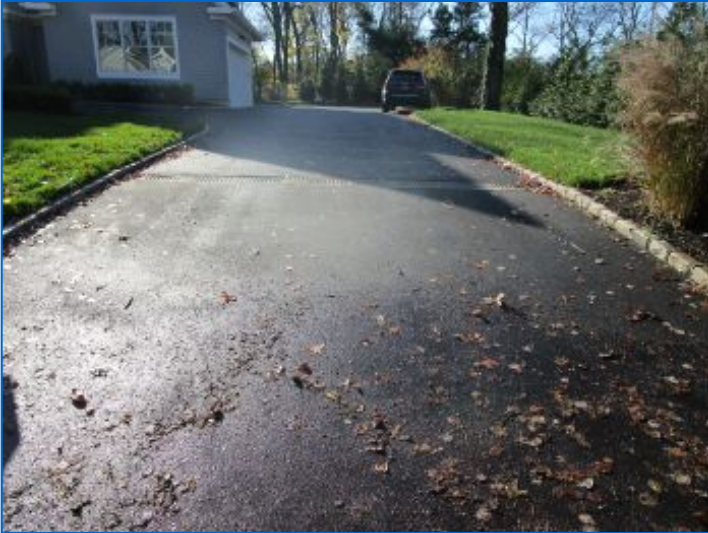
Asphalt driveway appeared new. We recommend sealing within one year to extend life and maintain appearance.
