BUILDING ANALYSIS REPORT

Property Location: *118 Lott Street*
Brooklyn, NY 11226

Date of Inspection: *1/3/2016*

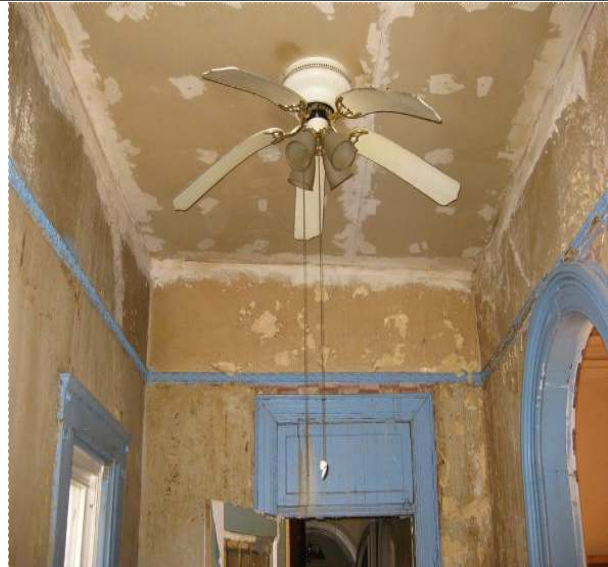
IMG_2540.JPG

Other plaster surfaces may be restored or reused once the home is dried out by either resurfacing or applying 1/4" sheetrock overlay.

Replace approximately 70% of the plaster ceilings and approximately 30% of the plaster walls 1/2" with sheetrock; Provide 3'5" min thick batt insulation in walls (and ceilings for sound proofing); Restore other plaster and painted wood surfaces by resurfacing/refinishing or applying 1/4" sheetrock overlay and finishing as applicable. Repair damaged structural studs and floor boards; Replace approximately 65% of the hardwood flooring; Resurface and refinish salvageable hardwood flooring. Rooms with extensive damage particularly on the first/second floors will require complete gut renovation. Est'd Cost: \$220,000

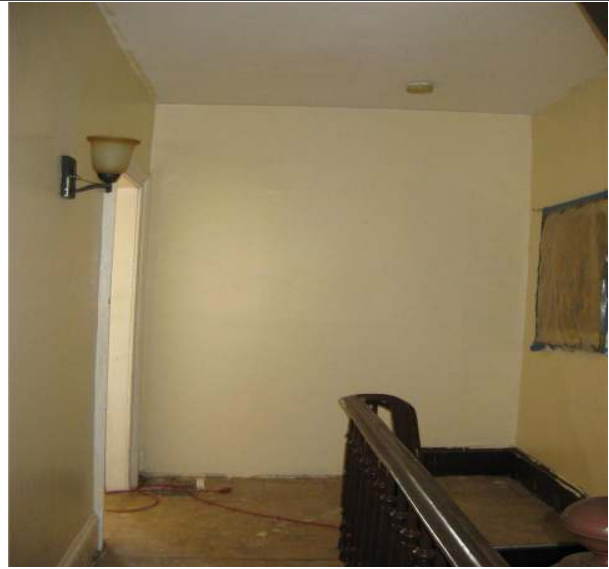
IMG_2553.JPG

3rd floor landing at top of staircase feels very unlevel. Window blanked off.

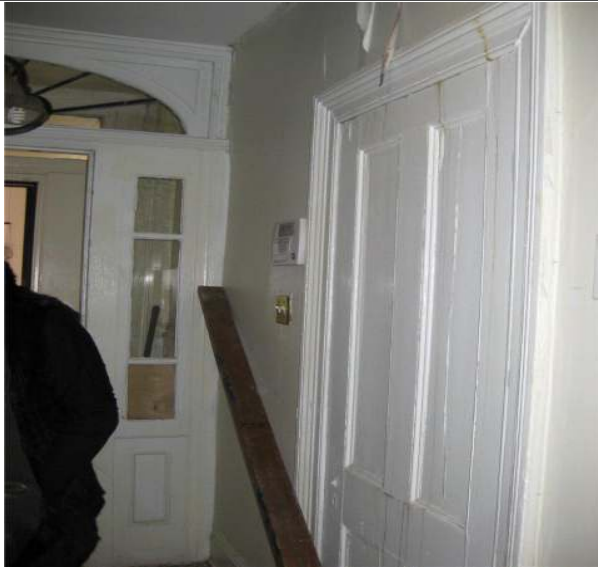
IMG_2529.JPG

3rd floor double door made unuseable by living room mirror installation.

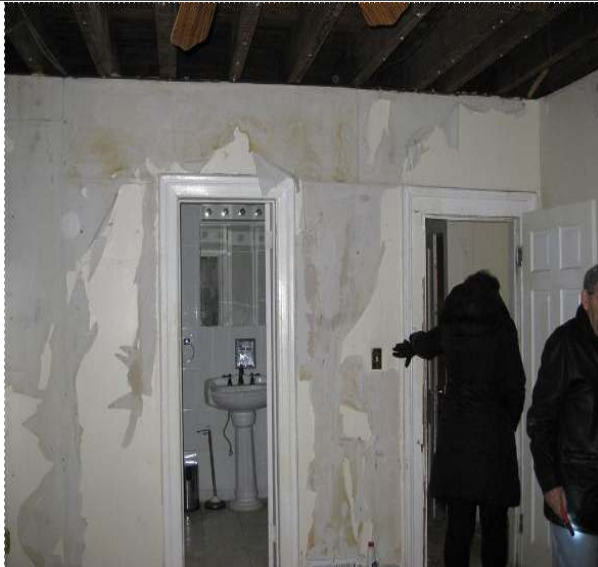
IMG_2512.JPG

Photo shows the degree and path taken by water passing through the structure.
