ProSpec Home Inspection of Long Island Property Inspection Report

9 Brookside Dr, Port Washington, NY 11050
Inspection prepared for: Name Deleted
Date of Inspection: 11/14/2020 Time: 10:00 AM
Age of Home: 1 yrs old Size: 5,200 sq.ft.
Approx. Year Built: 2020

Inspector: Russell J. Classi, P.E.
Phone: (516) 480-1848
Email: prospecfli@gmail.com
www.nassauprofessionalhomeinspector.com

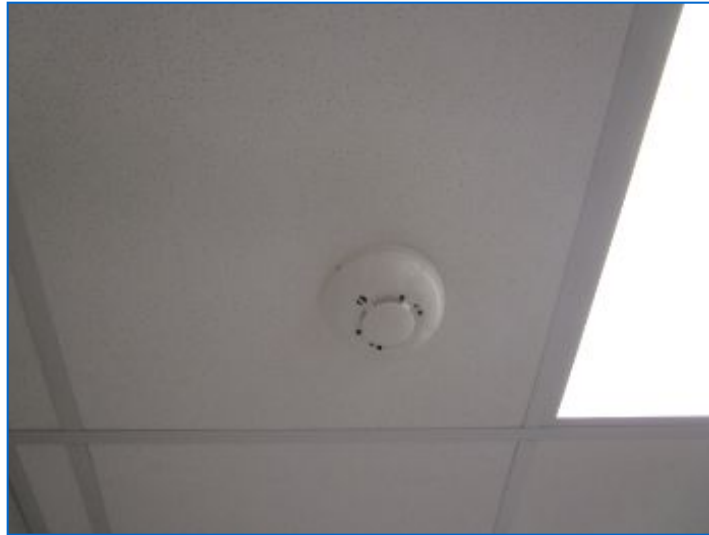
LIFE SAFETY: Maintain functioning Smoke and Carbon Monoxide detectors at required locations (Refer to Smoke/CO Detectors section).

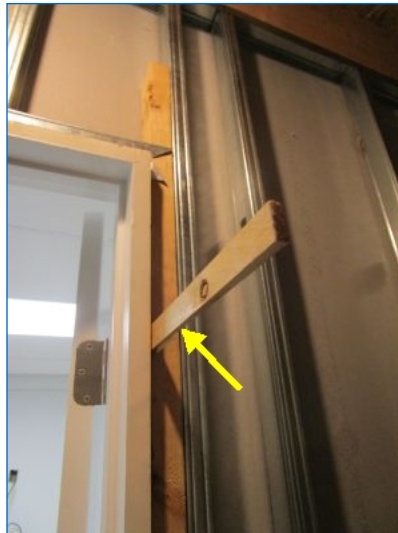
- NE corner room: Shims incomplete at door to utility closet. Recommend completion of all unfinished work.

NE corner room: Shims incomplete at door to utility closet. Recommend completion of all unfinished work.

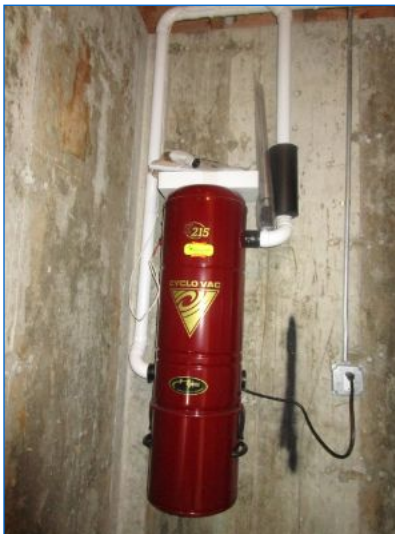
Home was equipped with a central vacuum system. Vacuum systems are beyond the scope of a Home Inspection. The inspector recommends client confer with homeowner for operation/maintenance instructions.

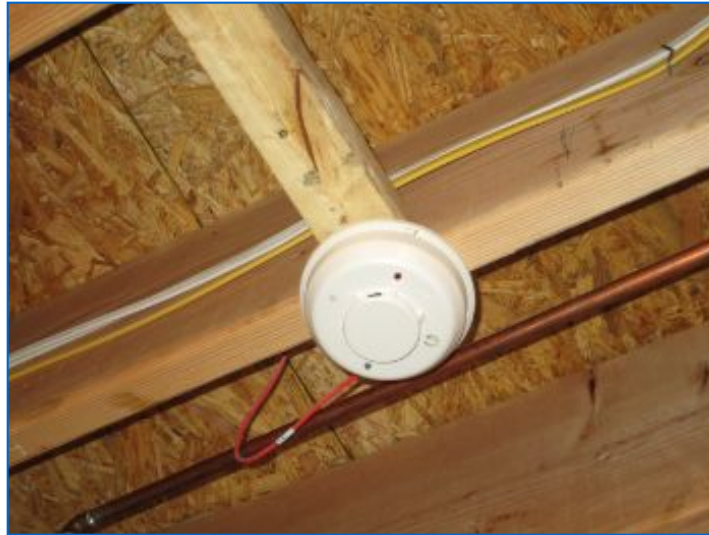
LIFE SAFETY: Maintain functioning Carbon Monoxide Detector near, but not directly above, combustion appliances such as furnaces (Refer to Smoke/CO Detectors section).

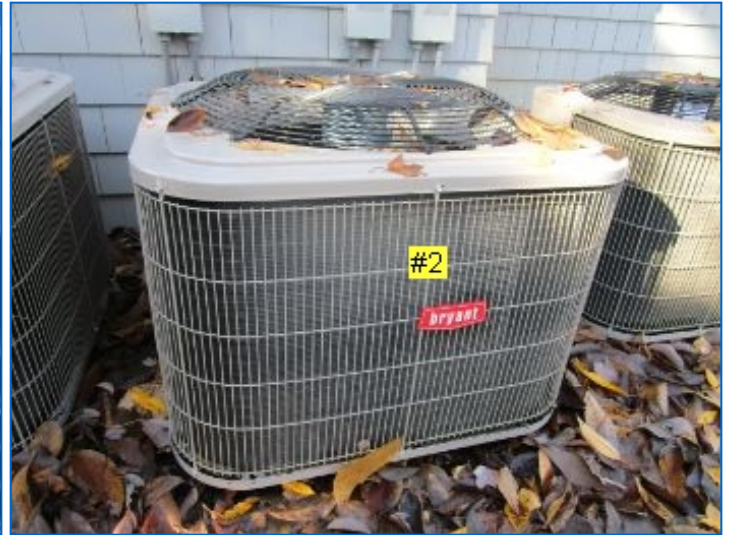
AC#2 Condenser; corresponding ducted air handler located in the Attic.

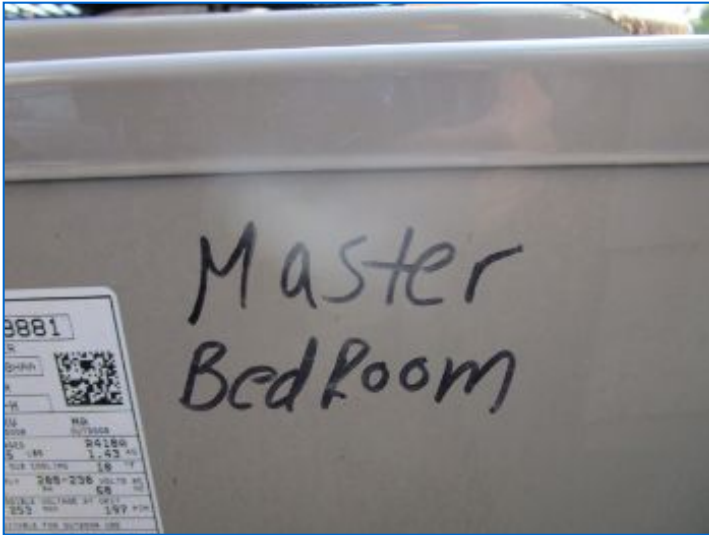
AC#3 Condenser; corresponding ducted air handler located in the Attic.

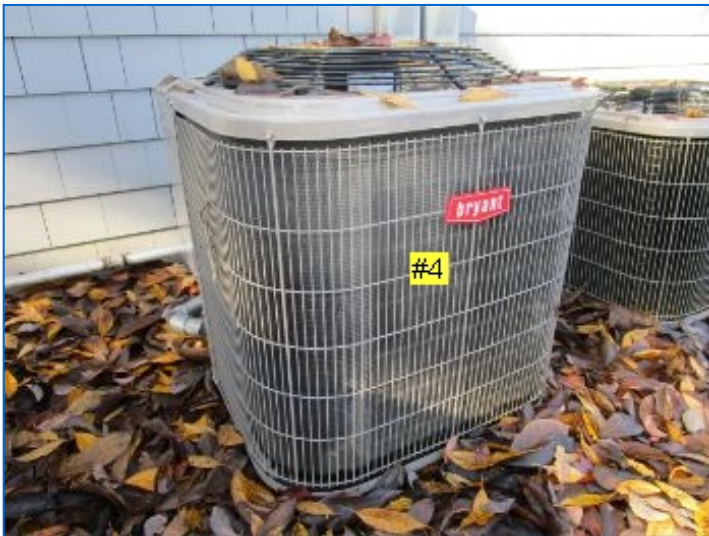
AC#4 Condenser; corresponding ducted air handler located in the Basement.

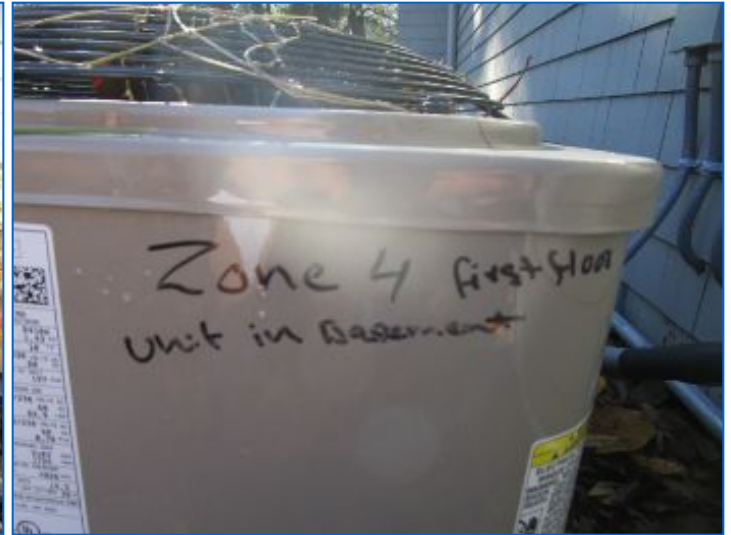
AC#5 Condenser; corresponding ducted air handler located in the Basement.

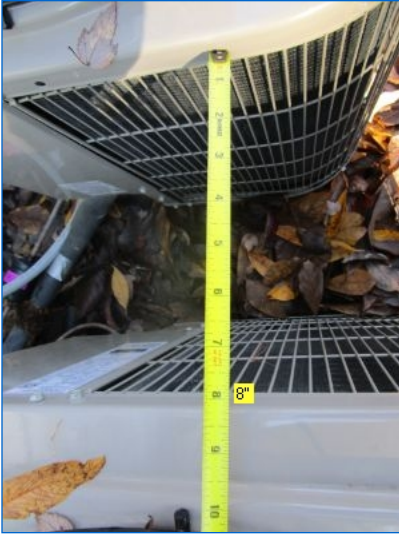
- Outdoor condenser air flow appeared restrictive based on the distance between units. This conditions can negatively affect system performances by as much as 10% when both units are operating. Suggest checking manufacturer's clearance requirements.

Outdoor condenser air flow appeared restrictive based on the distance between units. This conditions can negatively affect system performances by as much as 10% when both units are operating. Suggest checking manufacturer's clearance requirements.

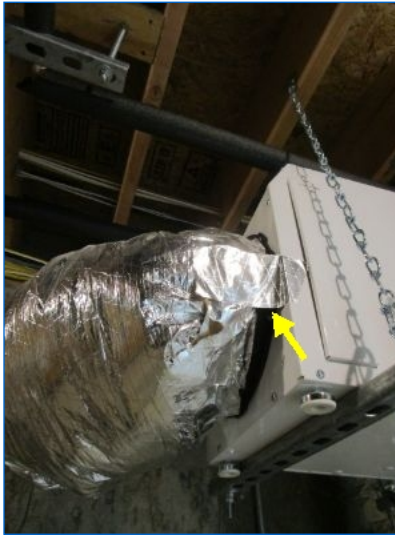
Suggest correcting foil duct tape at unit connection.

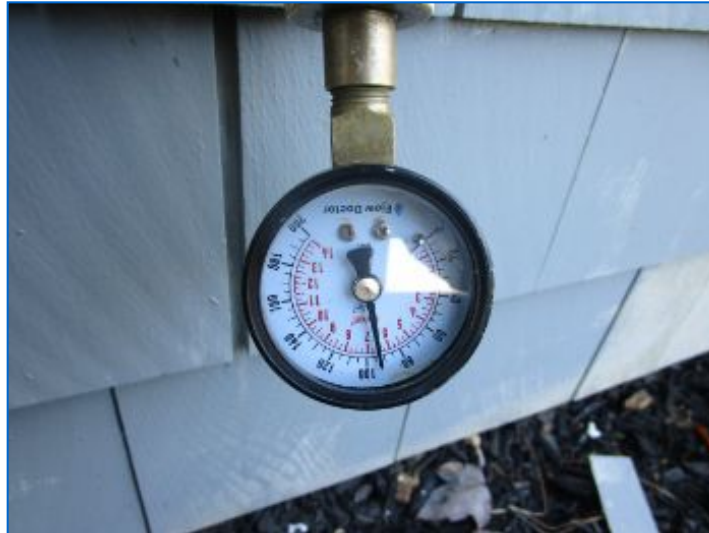
- Water pressure measured 92 pounds per square inch (psi) at the time of the inspection. Acceptable water pressure is between 40 and 90 psi.
- Water pressure exceeded 90 pounds per square inch (psi) at the time of the inspection. This is considered excessively high. Acceptable water pressure is between 40 and 90 psi. Excessively high water pressure can cause leaks and pipe damage. The Inspector suggests installation of a pressure regulator by a qualified plumbing contractor.

Water pressure measured 92 pounds per square inch (psi) at the time of the inspection. Acceptable water pressure is between 40 and 90 psi.

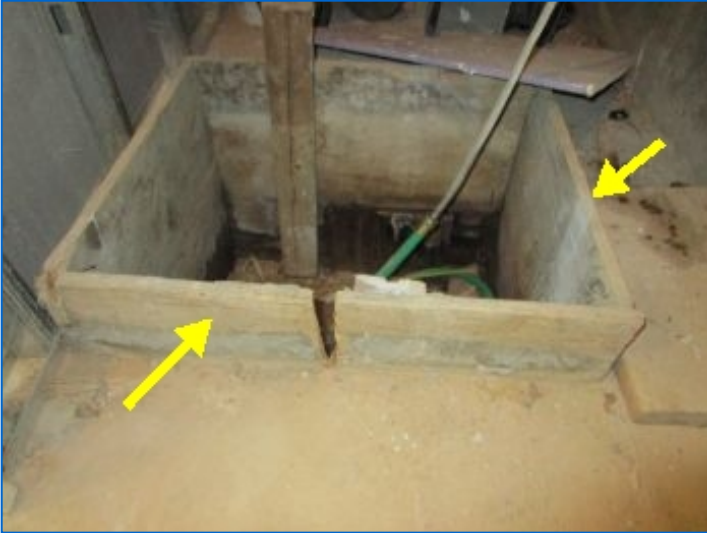
Remove wood forms around waste main pit to avoid attracting termites. Install steel plate cover over pit.

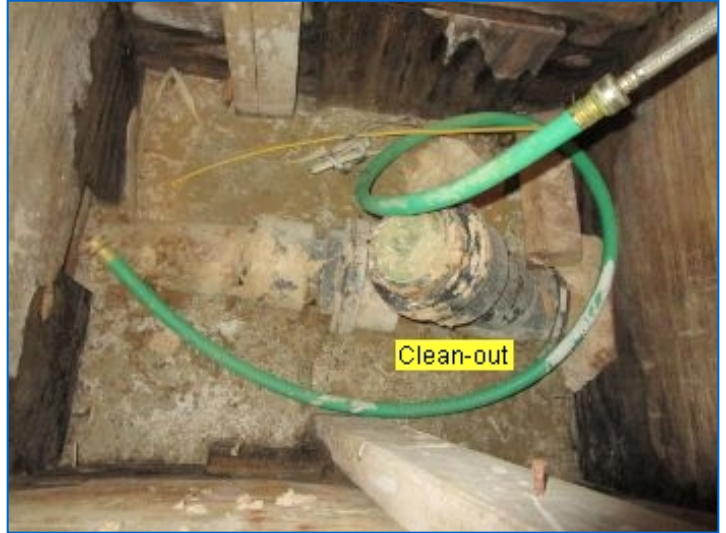
Whole house trap w/vent pipe was not visible at time of inspection, only the waste pipe exit with clean-out was visible at time of inspection. Request seller to identify location. Exterior plumbing vent for the waste line exit was not visible at the front exterior at time of inspection; This vent be at another location or perhaps blocked by cedar siding. Confer with Seller for this required plumbing vent provision.

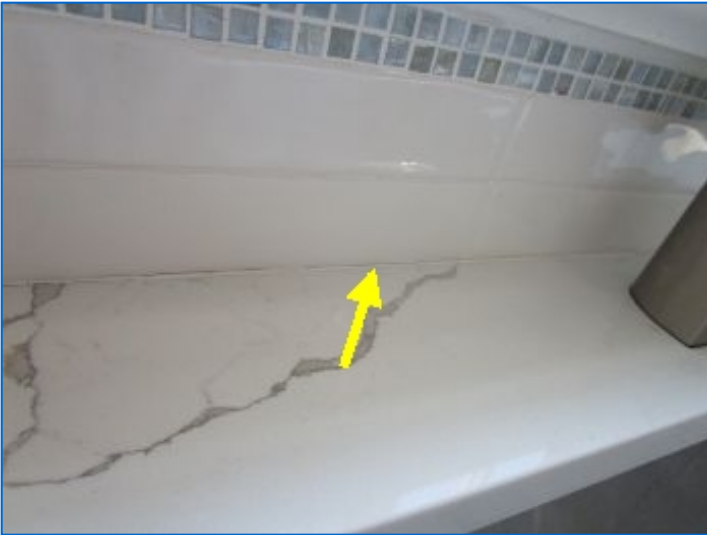
Grout/caulking at counter-top back splash (movement joint) was cracked. Suggest replacing defective grout/caulking with matching silicone based sealant along movement joint.

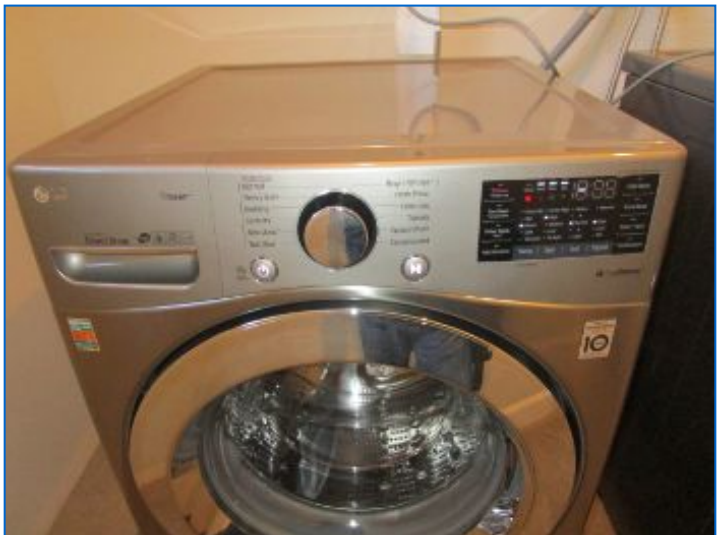
Washer was operable at time of inspection. New appliances should be cycled through all their respective functions in order to ensure they perform their full operational sequences.

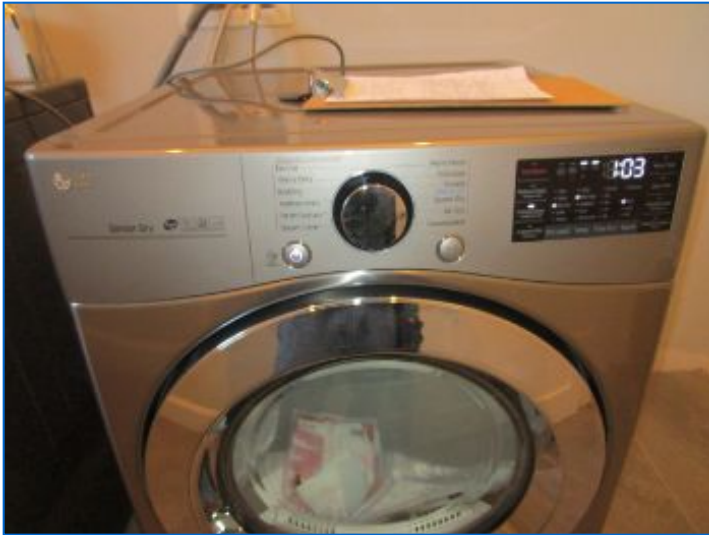
Gas Dryer was operable at time of inspection. New appliances should be cycled through all their respective functions in order to ensure they perform their full operational sequences.

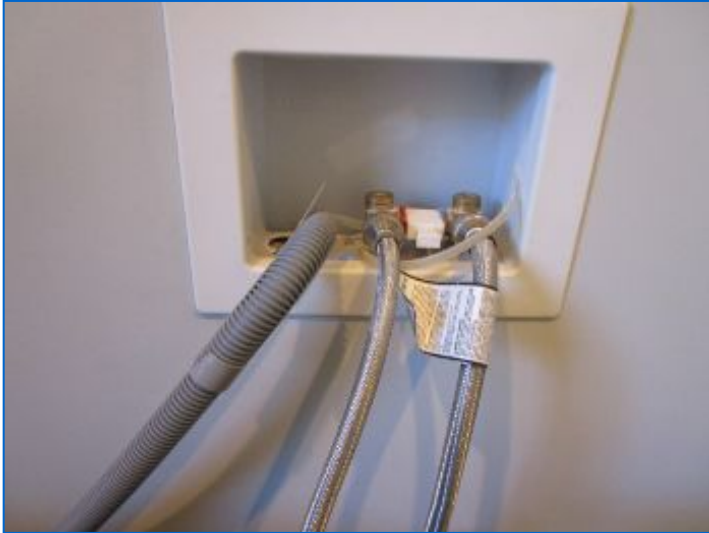
Washer supply and drain hook-up noted.

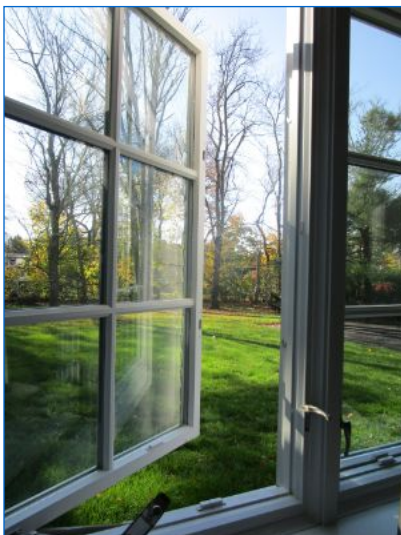
All screens were not installed or missing at the time of inspection. Confer with seller for screen provisions.

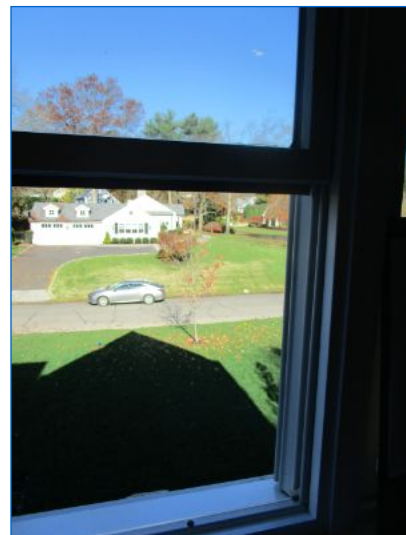
All screens were not installed or missing at the time of inspection. Confer with seller for screen provisions.

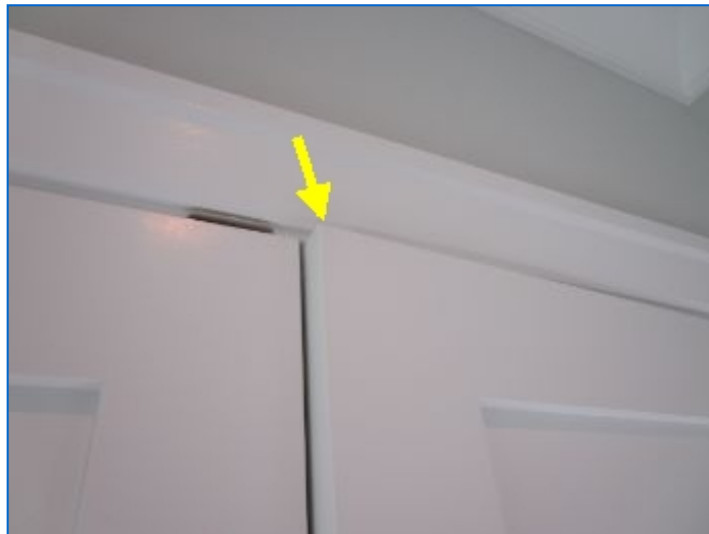
Door ball catch didn't latch properly . Recommend adjustments by a qualified contractor.

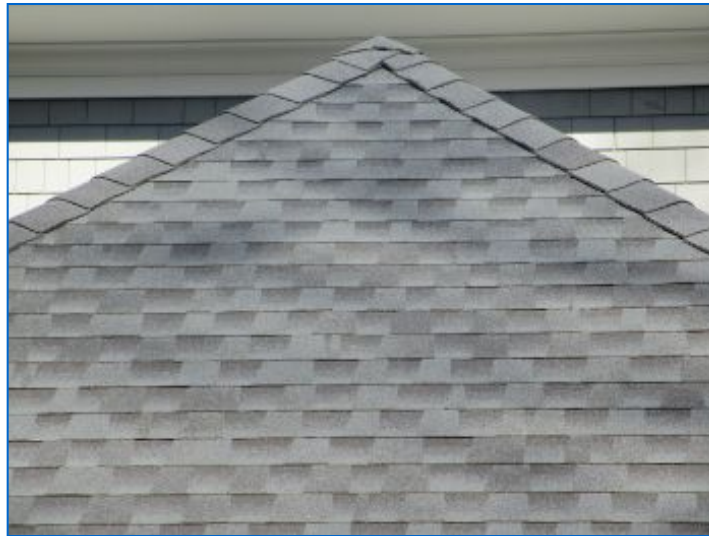
The roof had One layer of asphalt shingles installed at the time of the inspection. Normal design service life expectancy for Architectural asphalt shingles is 25 yrs. depending on local conditions.

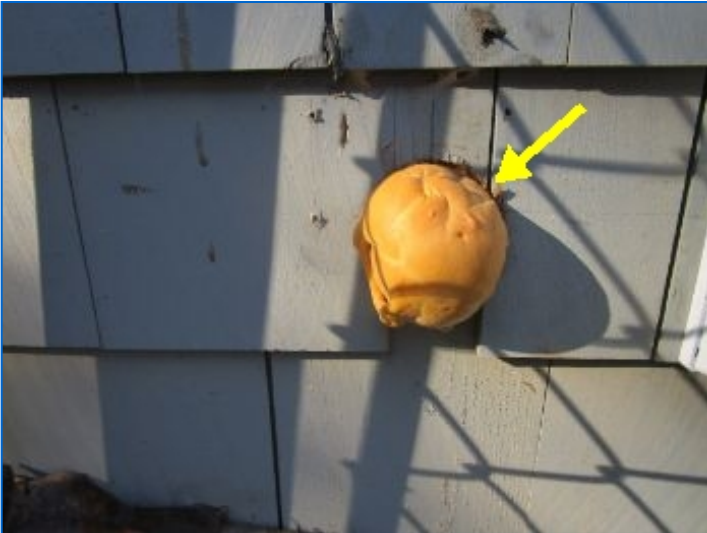
Expandable foam insulation was used to plug an unused hole in the exterior wall at the electrical service entrance location. Recommend proper infill and repair of the cedar siding.

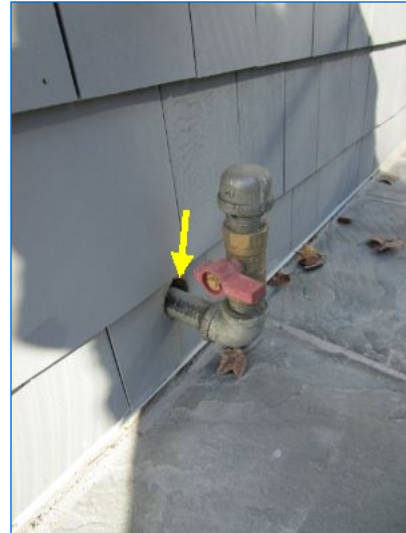
Ensure that all penetrations through exterior walls are adequately sealed to prevent moisture and pests from entering the structure.

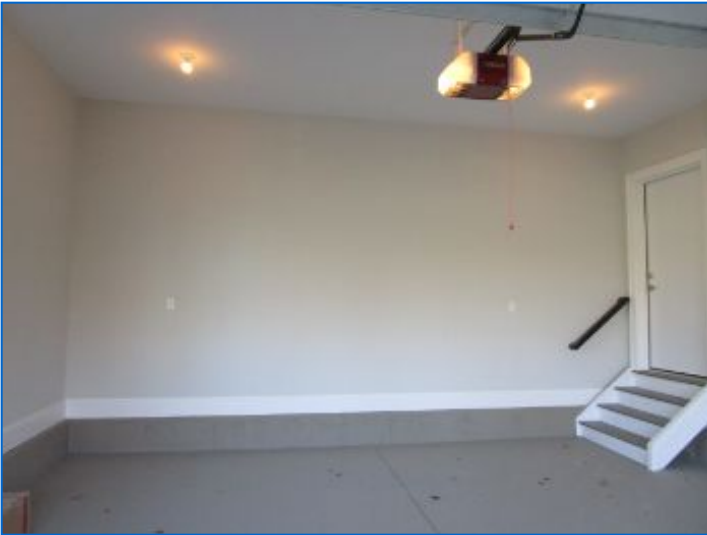
The walls and ceiling separating the garage from the home living space appeared to meet generally-accepted current standards for fire barriers.

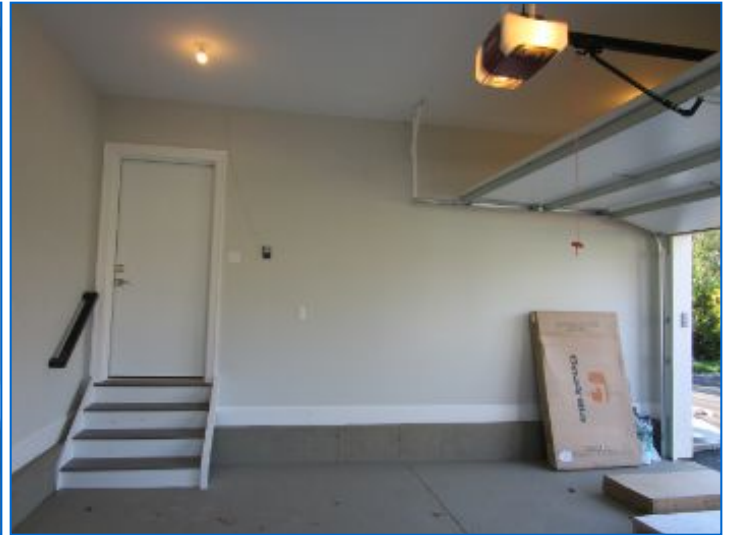
The walls and ceiling separating the garage from the home living space appeared to meet generally-accepted current standards for fire barriers.

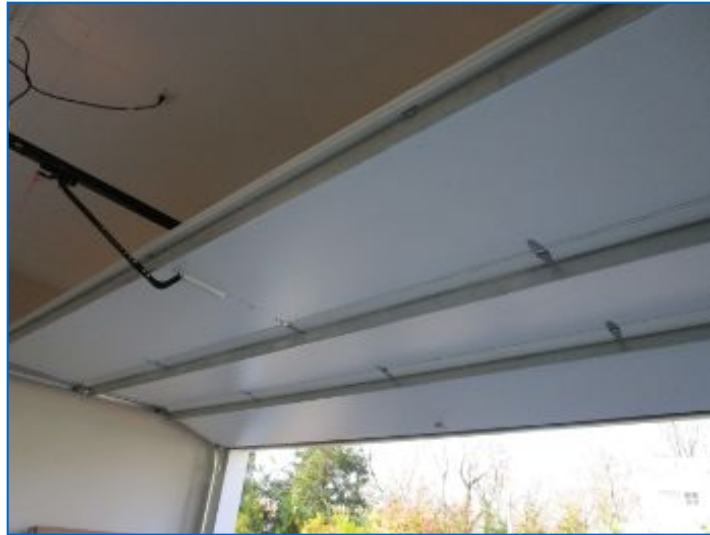
Aluminum sectional roll-up door noted. Vehicle door was operable and in good condition.

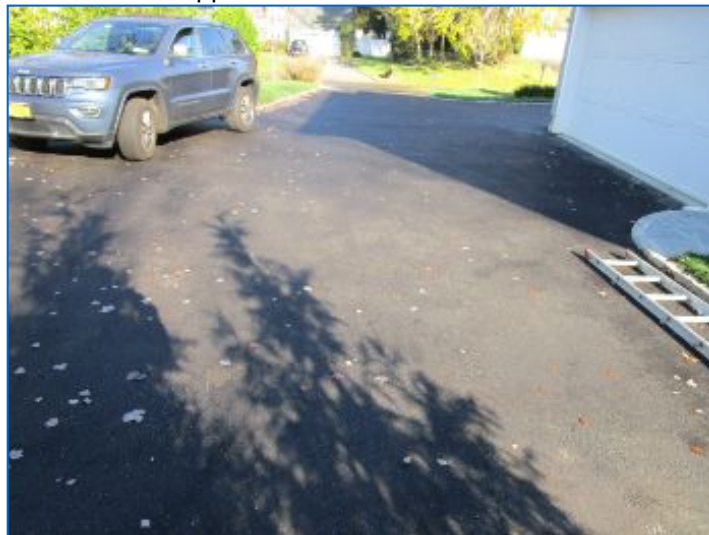
Maintenance: Asphalt driveways require sealing every 3-5 yrs to prevent water penetration and freeze-thaw damage.

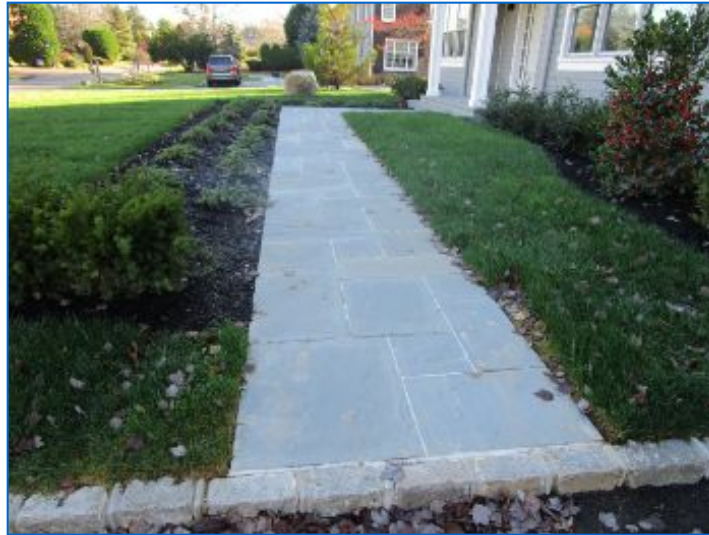
Walkway/s: Bluestone in mortar noted. No system safety or function concerns noted at time of inspection.
